**A Historic Building Photographic  
Survey of a barn and sheds and an  
Archaeological Trial Trench  
Evaluation at  
Ashby House Farm,  
Church Lane,  
Hungarton,  
Leicestershire**

**NGR: SK 69130 07245**

**ULAS Report Number 2017-014**  
**©2017**  
**Accession Number X.A136.2016**

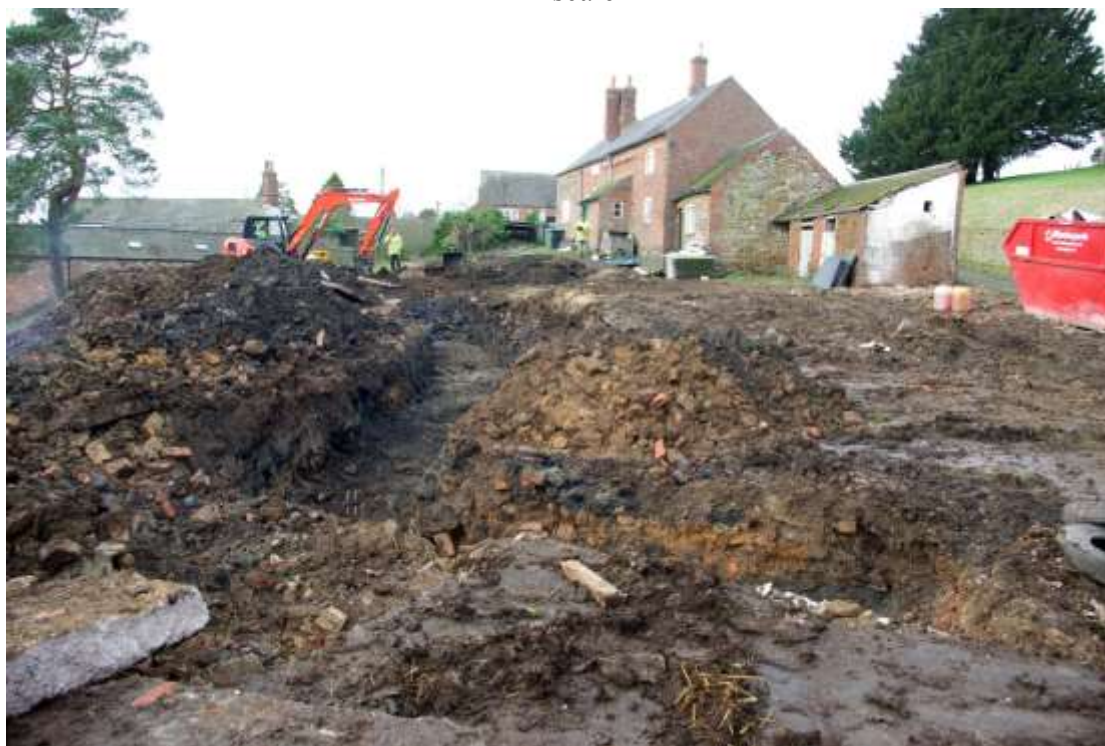
Trench 2 was placed on a south-east to north-west alignment through the centre of the development area and joined the southern end of Trench 1 (Fig. 34). As with Trench 1 the overburden consisted of modern building rubble beneath a surface of concrete. Removal of the overburden at the western half of the trench exposed an undisturbed natural substratum of sandy clay, dark greyish brown in appearance with inclusions of small rounded stones and gravel. The natural still appeared to be stained and contaminated in this trench. The south eastern half of the trench exposed the same thick layer of made ground as seen in Trench 1 (Fig. 36). At this point and beyond, the natural substratum was inaccessible due to the steep drop of the natural ground profile. This made ground consisted of modern bricks, rubble, tarmac, concrete and pieces of corrugated asbestos roofing material.

Figure 38: Trench 2 looking west  
Trench 1 in the foreground.
