**A Level 2 Historic Building Recording  
and watching brief at Tansor Lodge  
Farm, Oundle Road,  
Elmington, Oundle,  
Northamptonshire.**

**NGR: TL 05541 89885**

ULAS Report No. 2017-013

**For: Mintridge Consulting Ltd.**

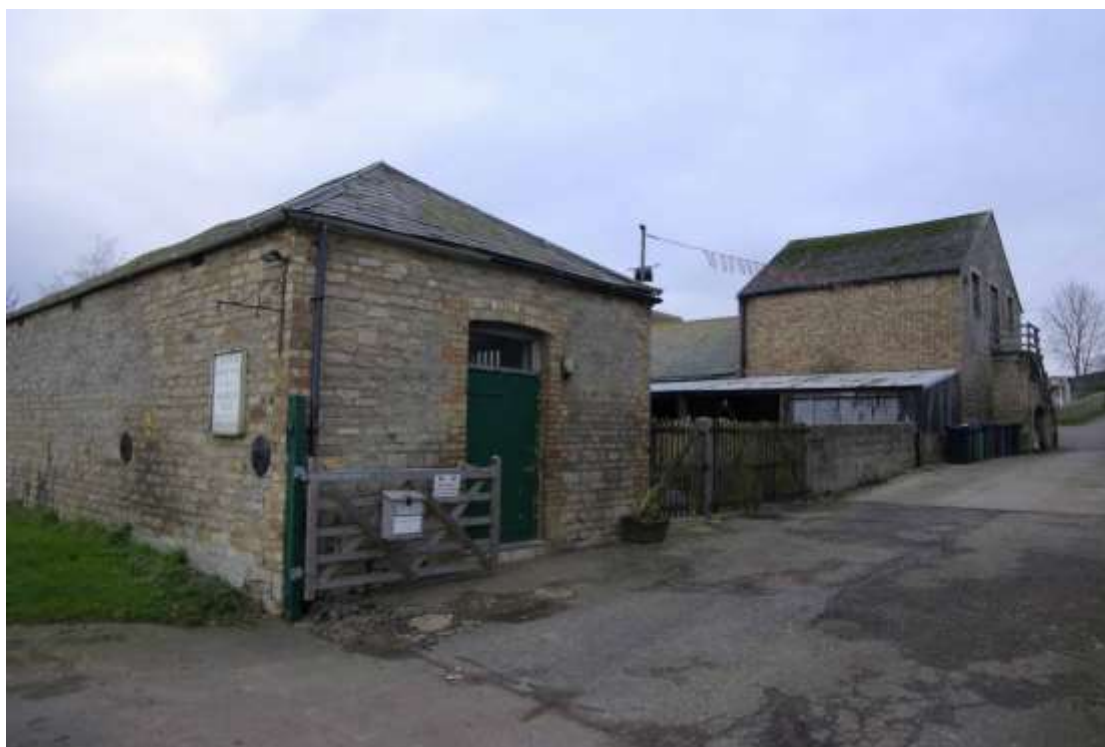
The courtyard buildings are built from coursed rubble limestone with slate roofs (Figs 8 - 9). The roof slate appears to be Welsh slate rather than locally sourced material as seen on the earlier buildings. The two-story component of the buildings is roofed using corrugated sheet metal which is clearly a later replacement. The use of pale red and yellow coloured bricks is in evidence throughout the courtyard buildings. Most of the brickwork is seen around window and door openings but is also used as quoins at the corner of each elevation. Tansor Lodge Farmhouse uses faced ashlar limestone and Collyweston slates which perhaps indicates that more money was expended on this building and may also suggest that, when this was built, local transport was such that Collyweston slates were easier to obtain than Welsh slate. The other listed buildings have an assortment of modern roof coverings which may have replaced Collyweston slates (Fig. 10).

Figure 8 Courtyard buildings seen from entrance  
Looking north east

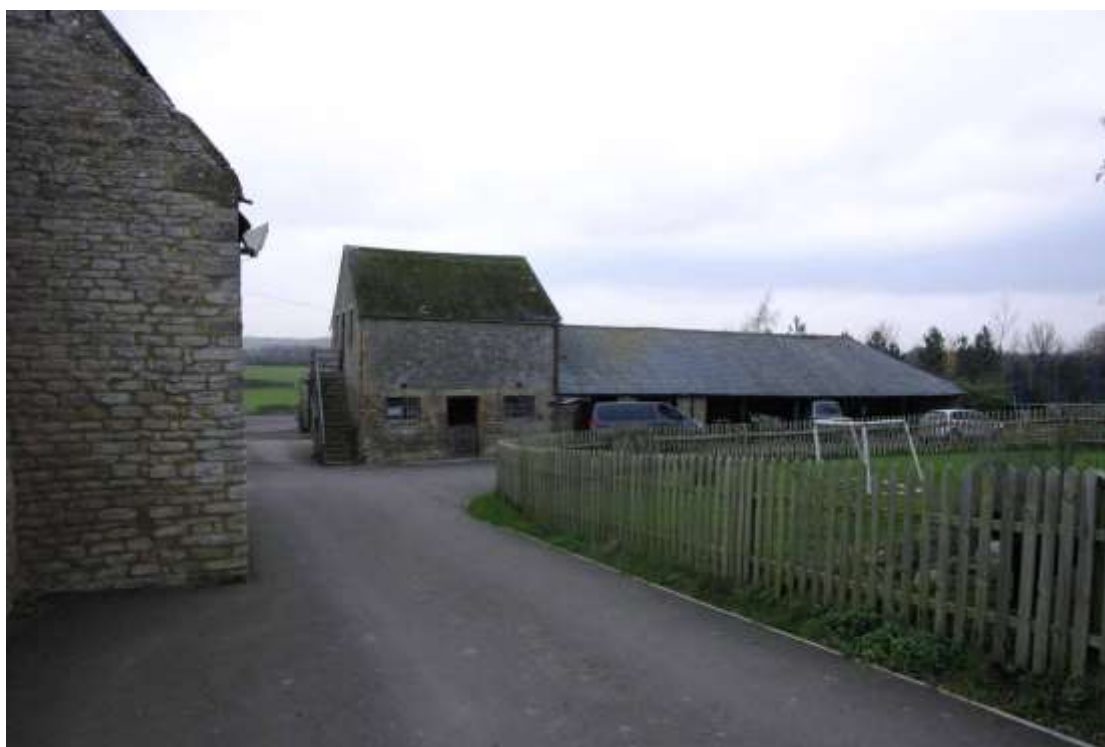
Figure 9 Courtyard buildings  
Listed agricultural buildings on left of picture. Looking north west

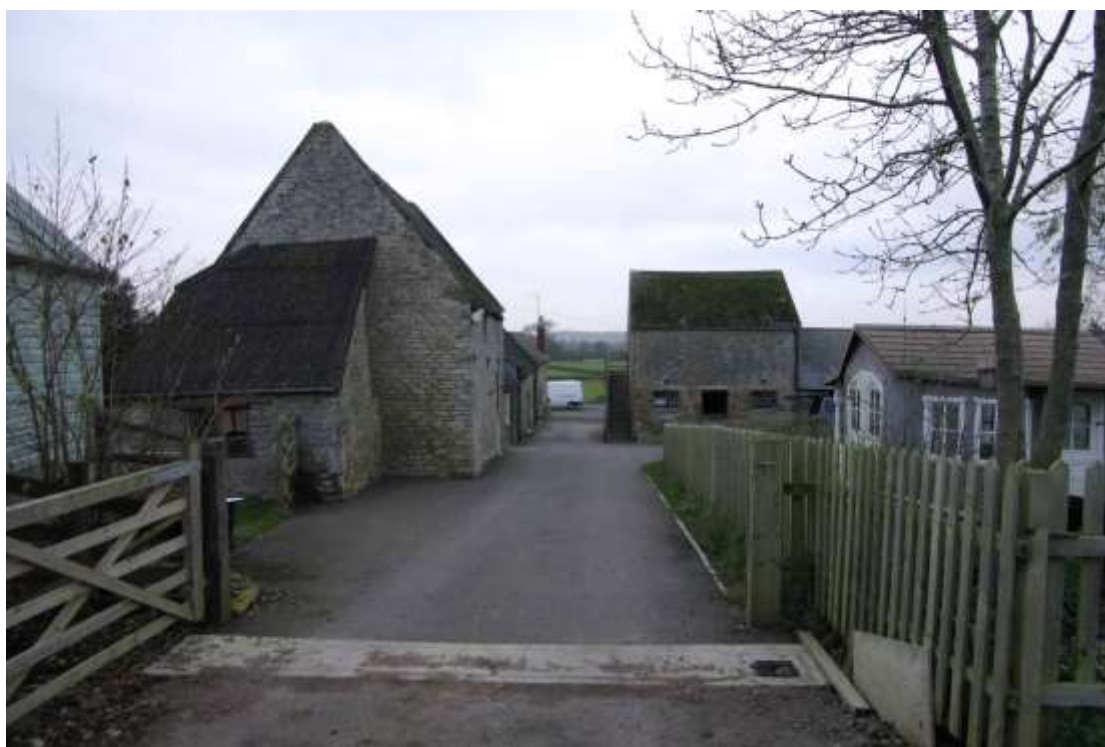
Figure 10 Courtyard and listed buildings  
Looking west

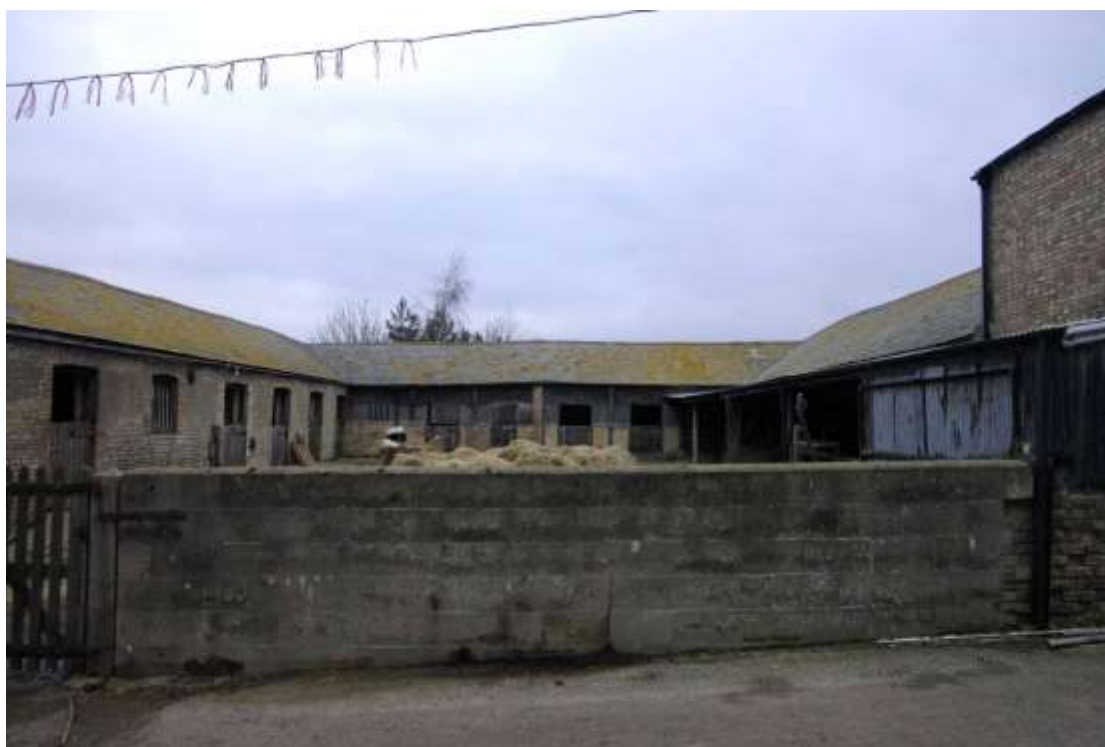
The south-west facing courtyard has a concrete surface with a number of sloping levels to aid drainage (Fig. 11). A modern concrete wall partially blocks the courtyard entrance which has a wooden gateway. With the exception of the cart shed on the eastern side, all of the surrounding buildings face into the courtyard. They all have the same limestone with brick detail walls with decorative rounded boards over the doors of the north and east ranges. The two storey hayloft building has brick faced walls which are discussed below. The earlier Ordnance Survey maps indicate that the yard was originally divided into two but only a gate post on the western side and a line of bricks at floor level under the lean-to remain of this division. The bricks do however suggest that the division was a reasonably substantial and permanent feature. Although most of the buildings surrounding the courtyard will not be affected by the proposed work, because they were designed and built as a whole, it is useful to give a brief description.

Figure 11 Main courtyard  
Looking north east

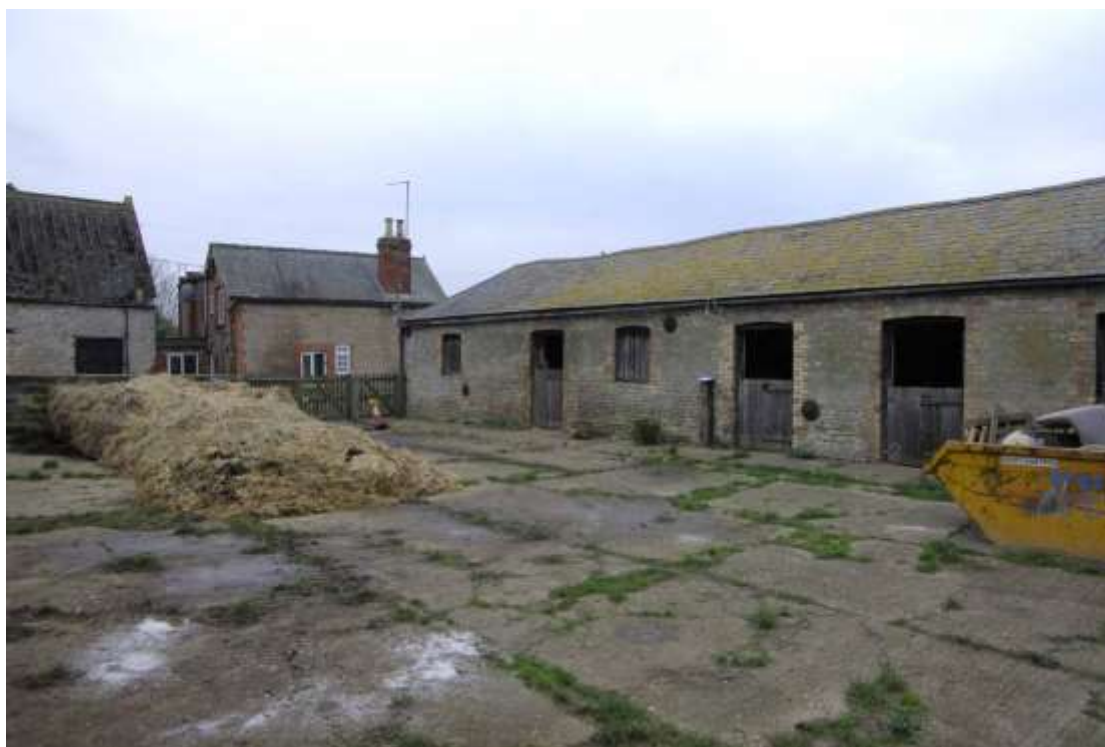
Figure 12 Main courtyard and west range  
Gatepost to left of centre doorway indicates location of original dividing wall. Looking south west

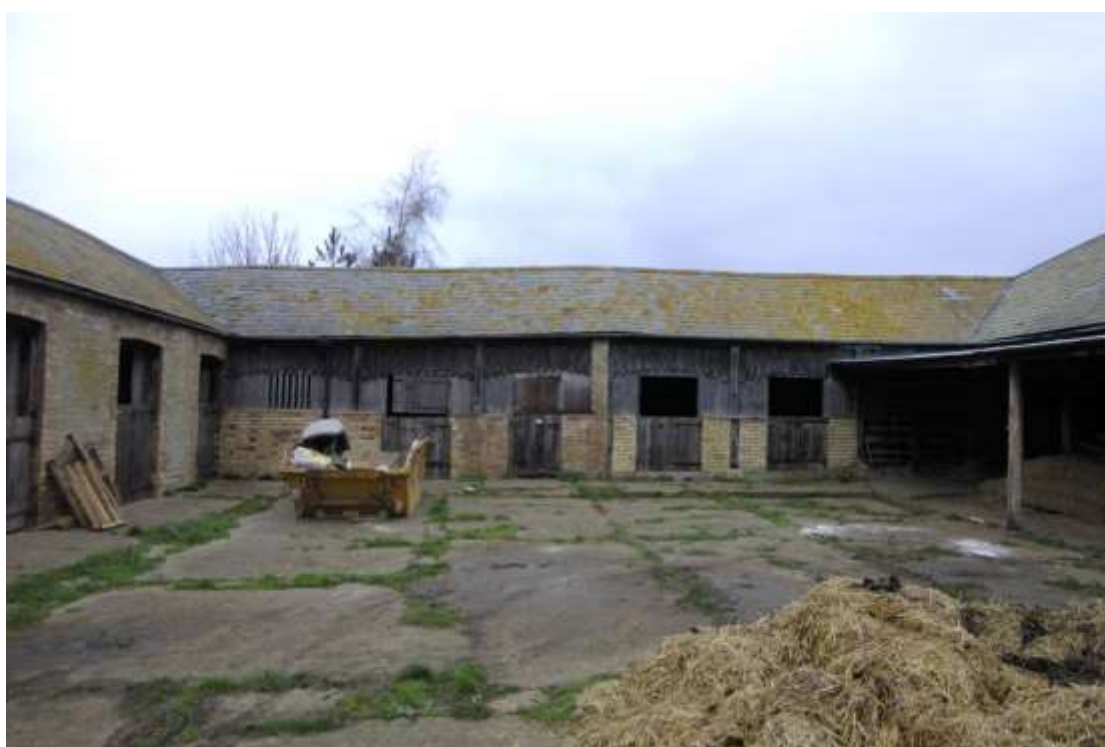
The northern range is also in use as stabling and has a blank unbroken north facing elevation of coursed limestone rubble. The south facing elevation is relatively narrow and is only supported by brick panels rather than brick and stone. The upper parts of the brick walls are made using timber planks with decorative boards hanging down from the eaves (Fig. 13). The roof is supported by a central brick pillar with flanking timber posts.

Figure 13 Main courtyard, north range  
Looking north east

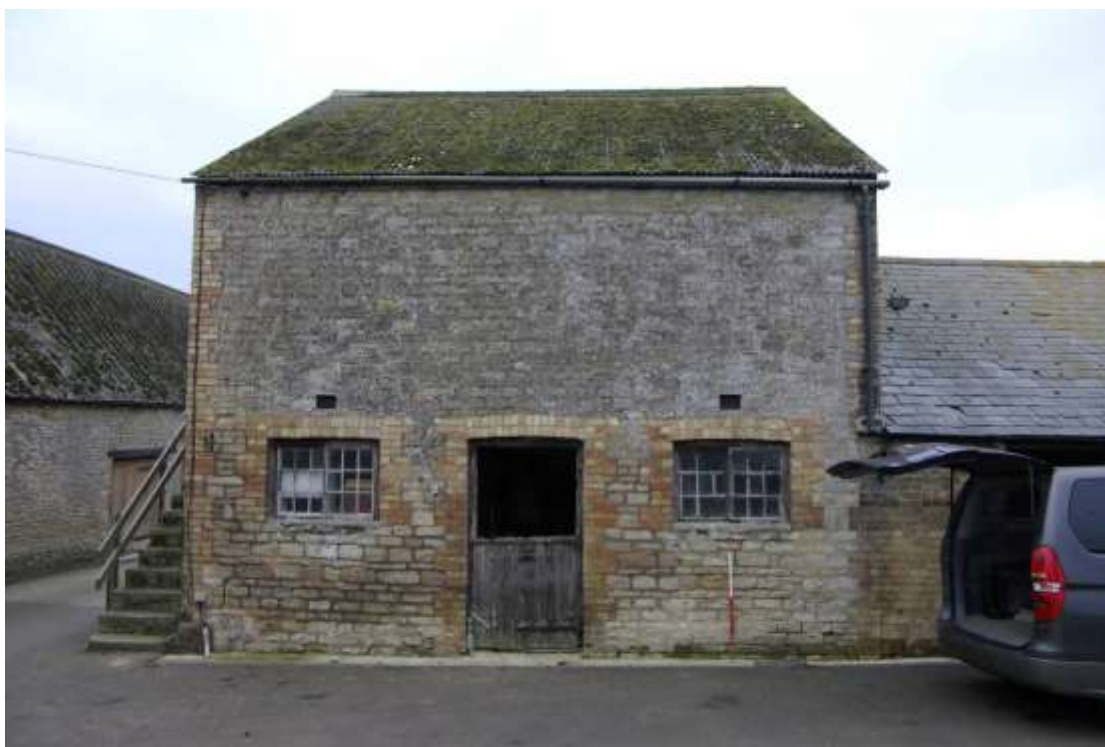
Figure 16 East facing elevation of hayloft building  
Looking north west. 1m scale

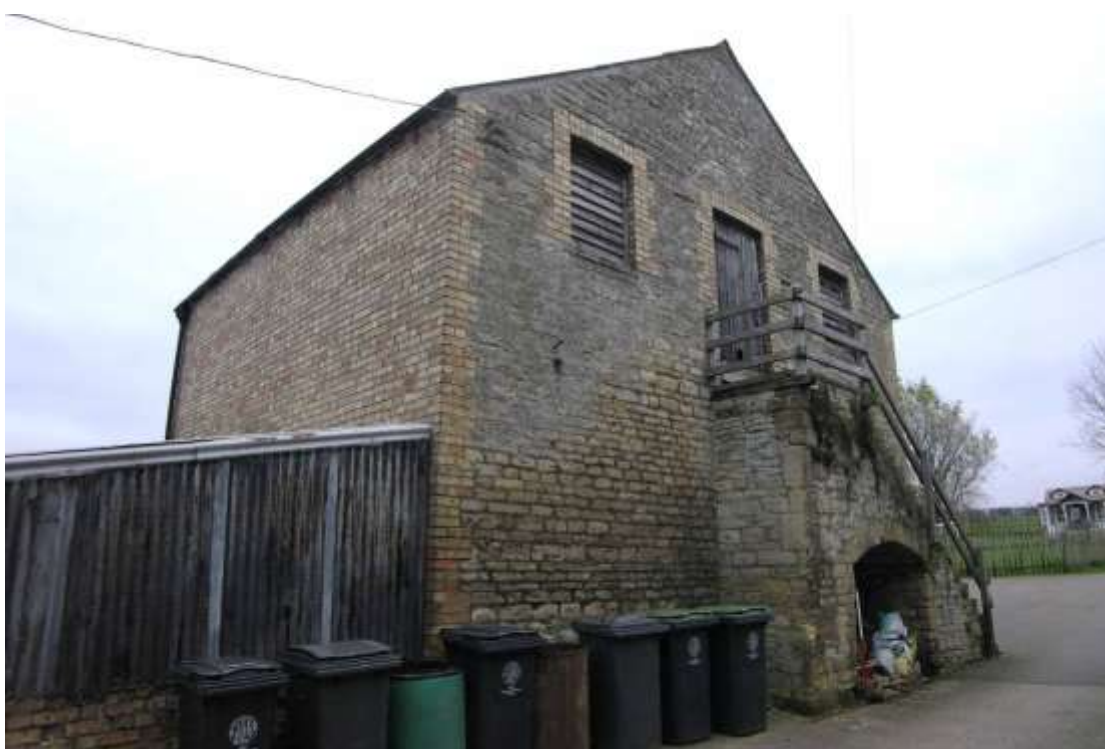
Figure 17 South facing elevation  
Looking north east. Corrugated lean-to on left. 1m scale

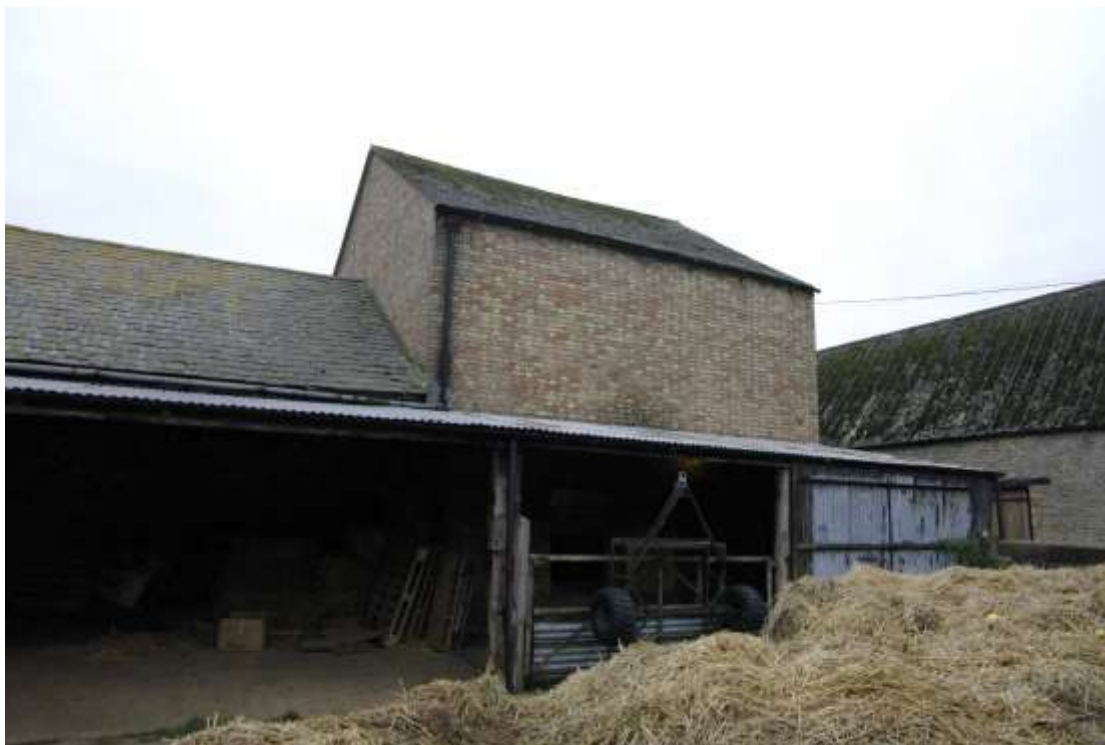
Figure 18 West facing elevation of hayloft  
Looking south east

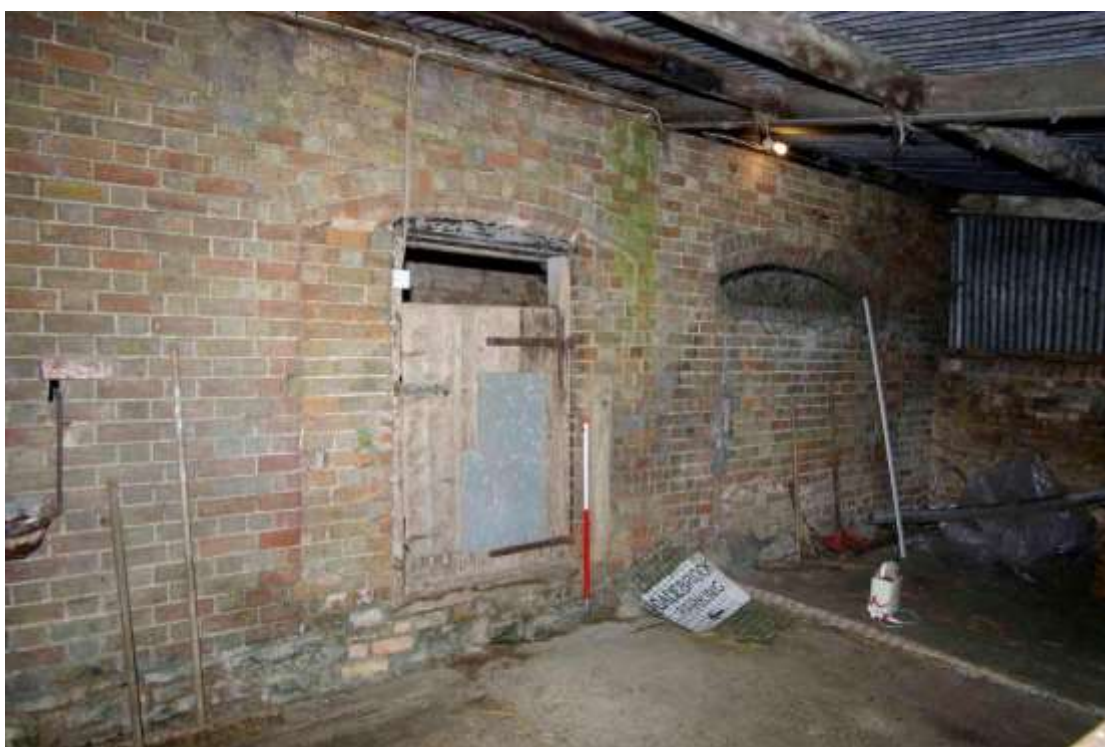
Figure 19 Ground floor of west facing elevation of hayloft  
Looking south east. 1m scale

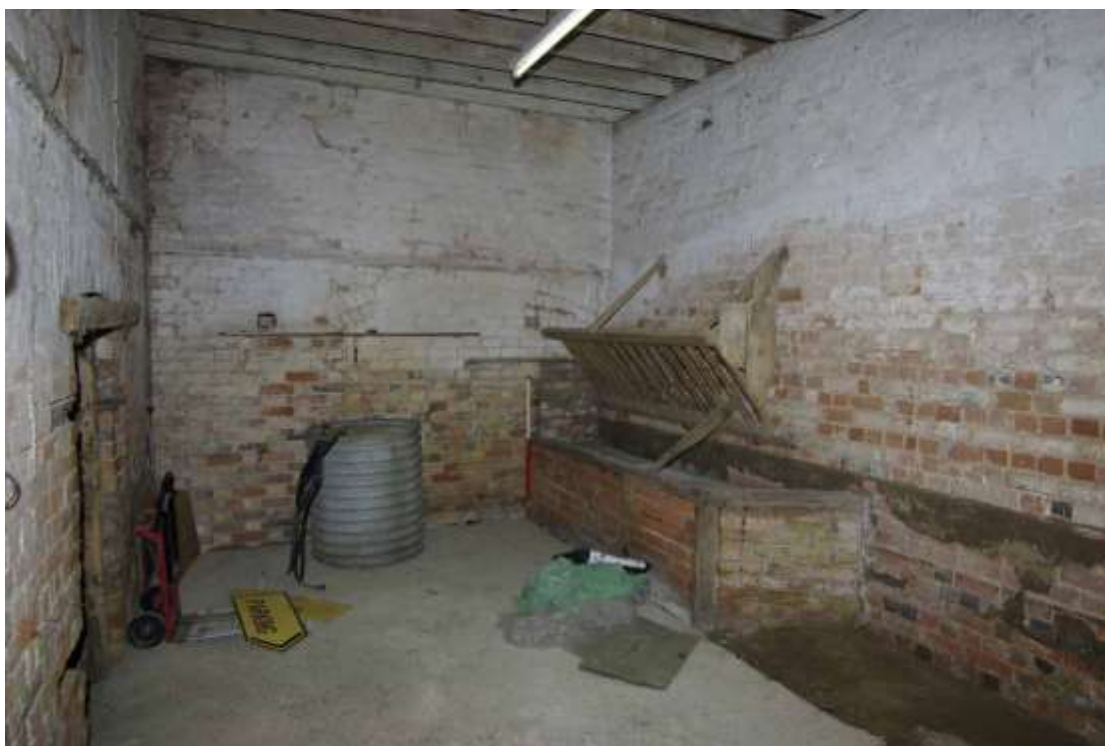
Figure 21 Hayloft building, ground floor western room (tack room)  
Looking north east. 1m scale

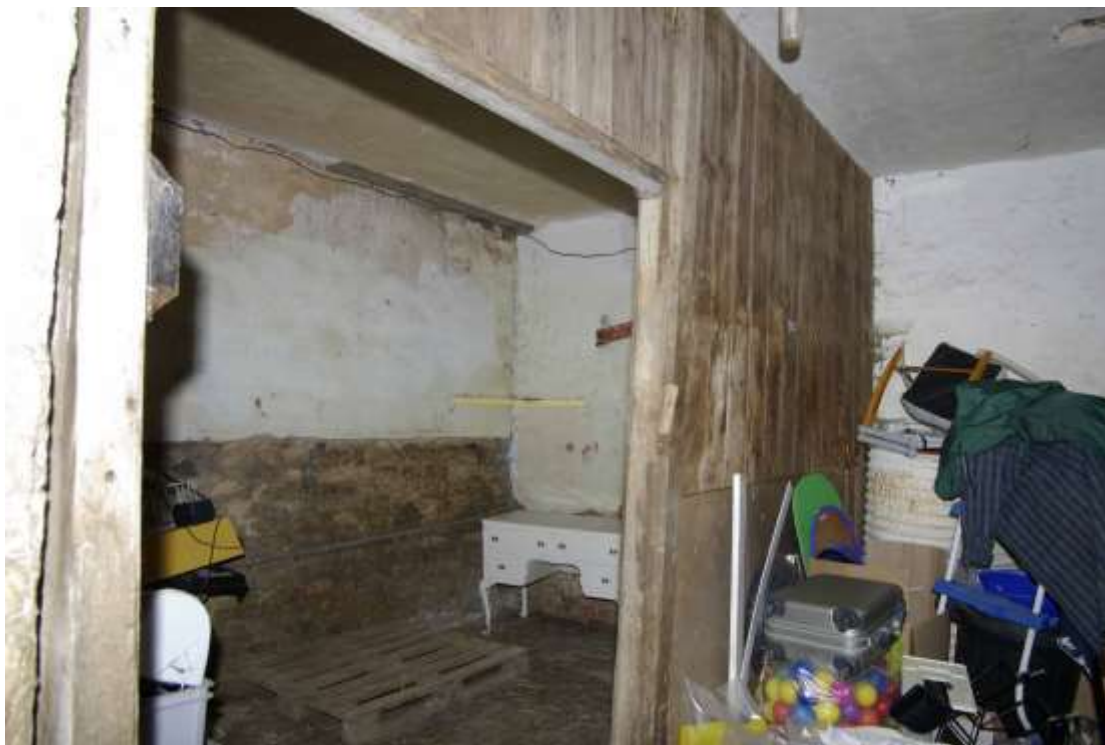
Figure 22 Hayloft building, ground floor, eastern room  
Looking south west

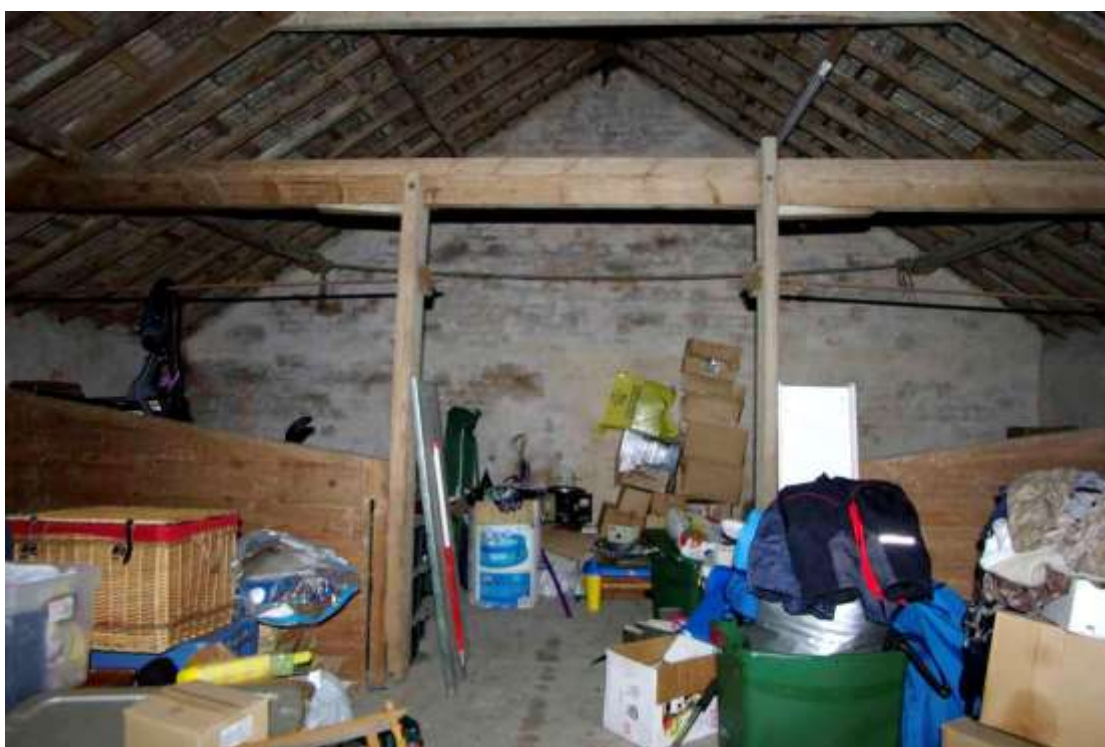
The first floor of the hayloft is an open room with low wooden dividers running across the room (Fig. 23). The plaster floor appears to be original and the roof is supported by the brick built gable end walls and a tie-beam in the middle of the room above the wooden dividers. Next to the door is a small amount of graffiti which may be some sort of tally of bales being delivered (Fig. 24).

Figure 23 Hayloft building, first floor  
Looking north. 1m scale

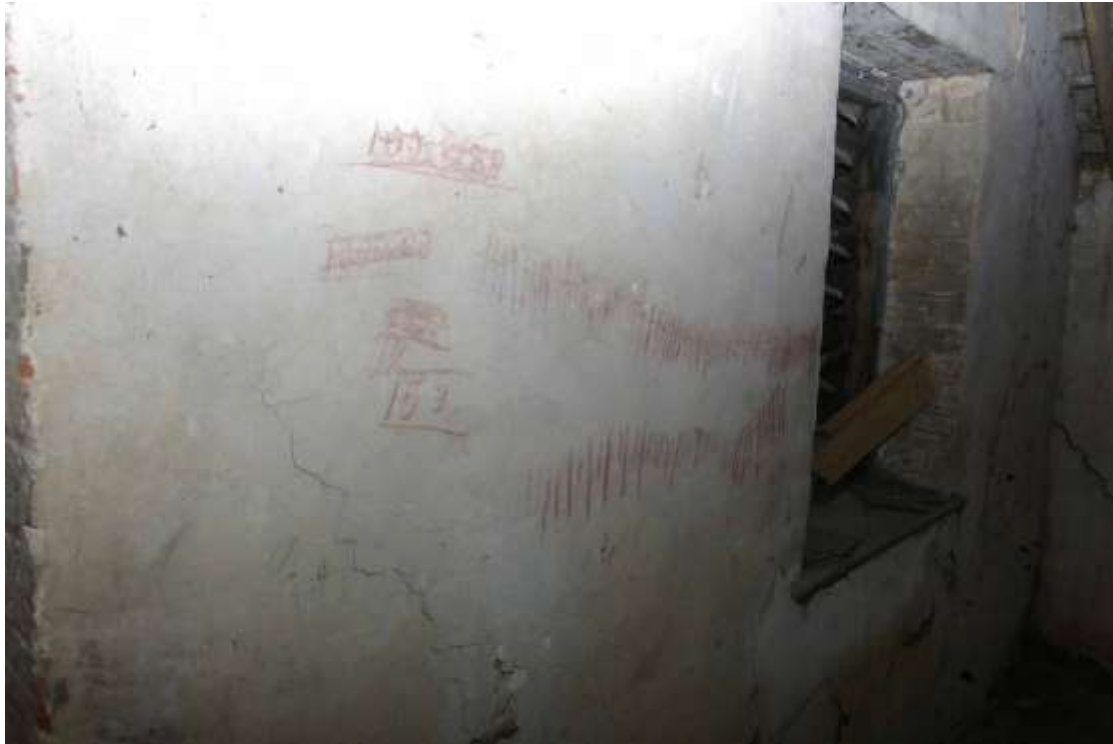
Figure 24 Graffiti on first floor hayloft building

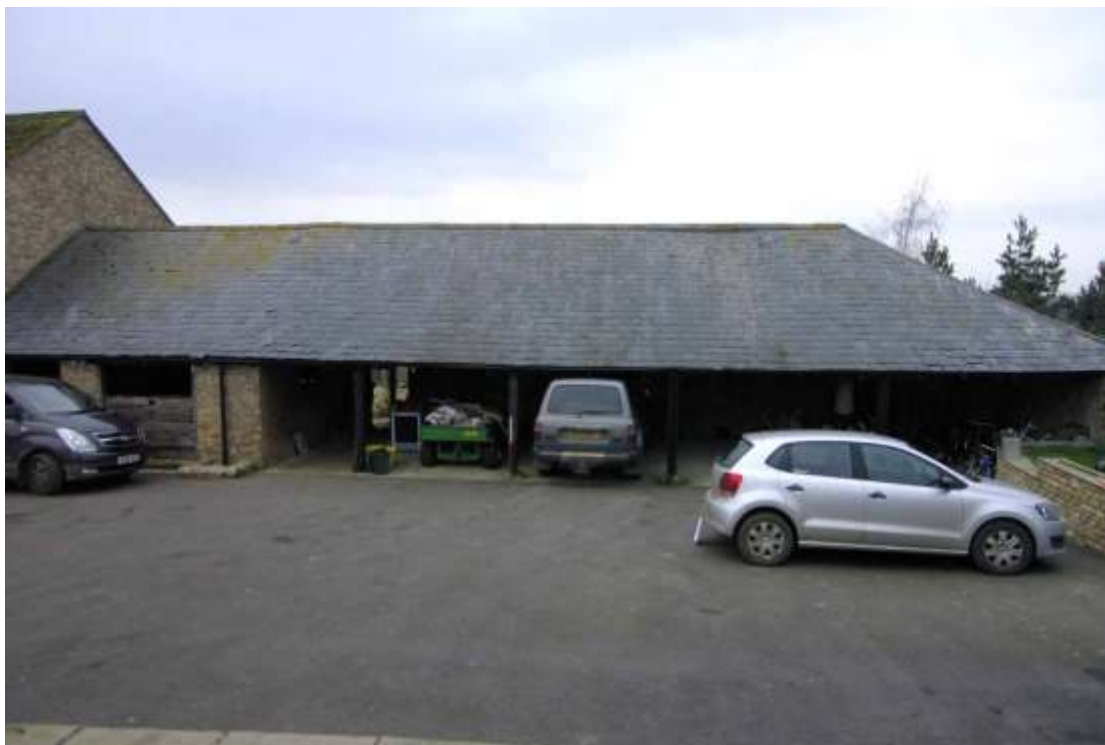
The east facing cart shed, to the north of the hayloft building, was first built as a completely open-fronted structure supported by square section timbers standing on low stone plinths (Fig. 25). The south end of the cart shed has been modified by adding a brick-built single storey stable which butts against the ground floor of the hayloft. This room has a brick floor and a low wooden room divider (Figs 26 - 27).

Figure 25 East facing elevation. Cart shed  
Looking north west. 1m scale

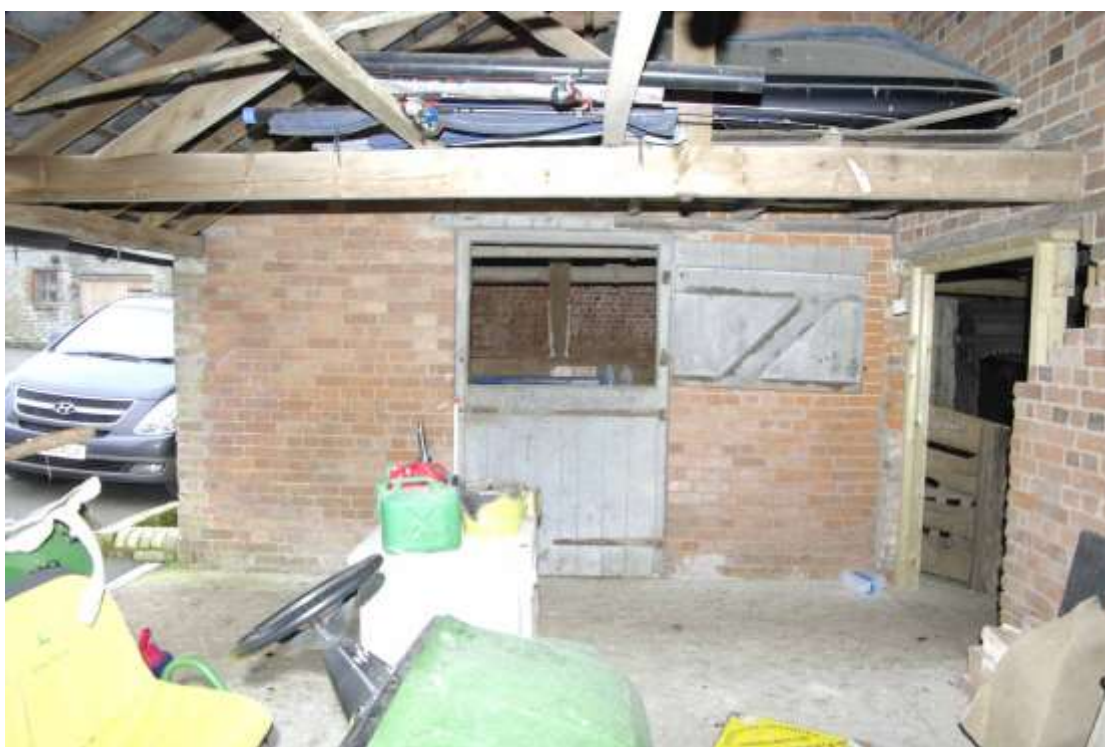
Figure 26 Later building in cart shed  
Looking south west

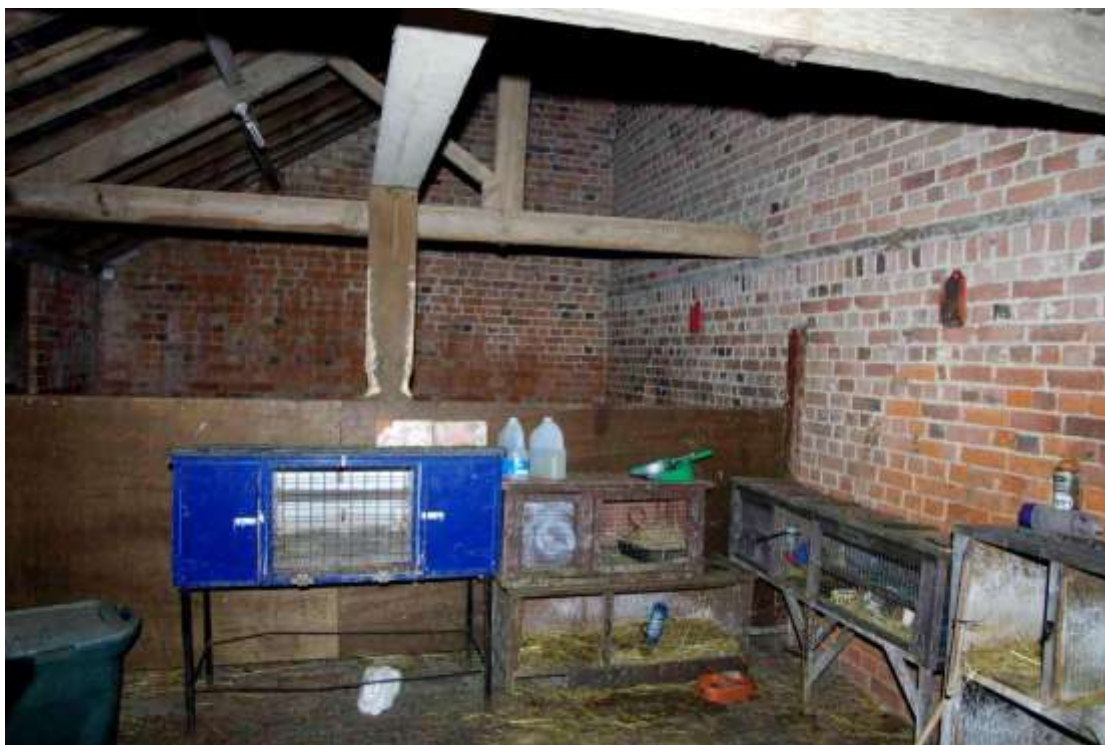
Figure 27 Internal view of added building under cart shed  
Looking south west

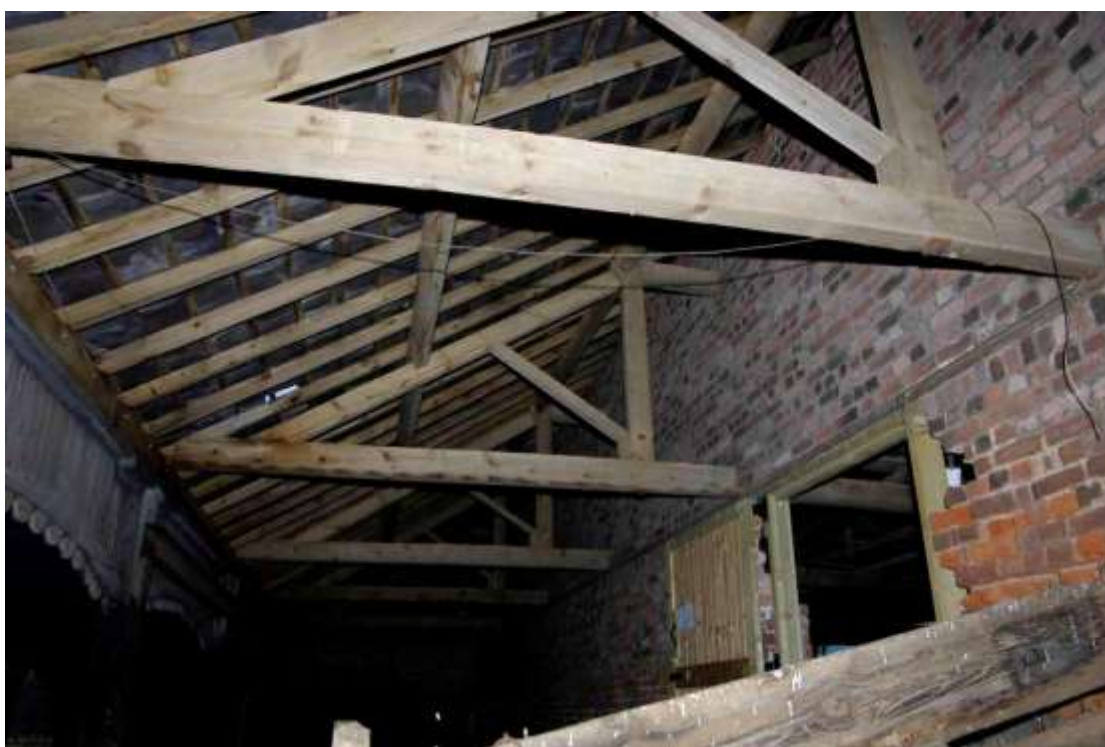
Running down the length of the cart shed range is a brick-built wall laid in an English bond. The wall is slightly off-centre to make the cart-shed slightly wider than the open shed which faces into the courtyard (see Figs 14 - 15). A single doorway passes through the dividing wall and leads from the back of the cart shed into the open shed and the courtyard. The roof structure of this range consists of queen posts with raking struts supporting the principal rafters. The clasped purlins sit on the backs of the principals (Fig. 28). The main trusses sit on a continuous wooden wall plate built into the brick dividing wall.

Figure 28 East range roof structure  
Looking north east

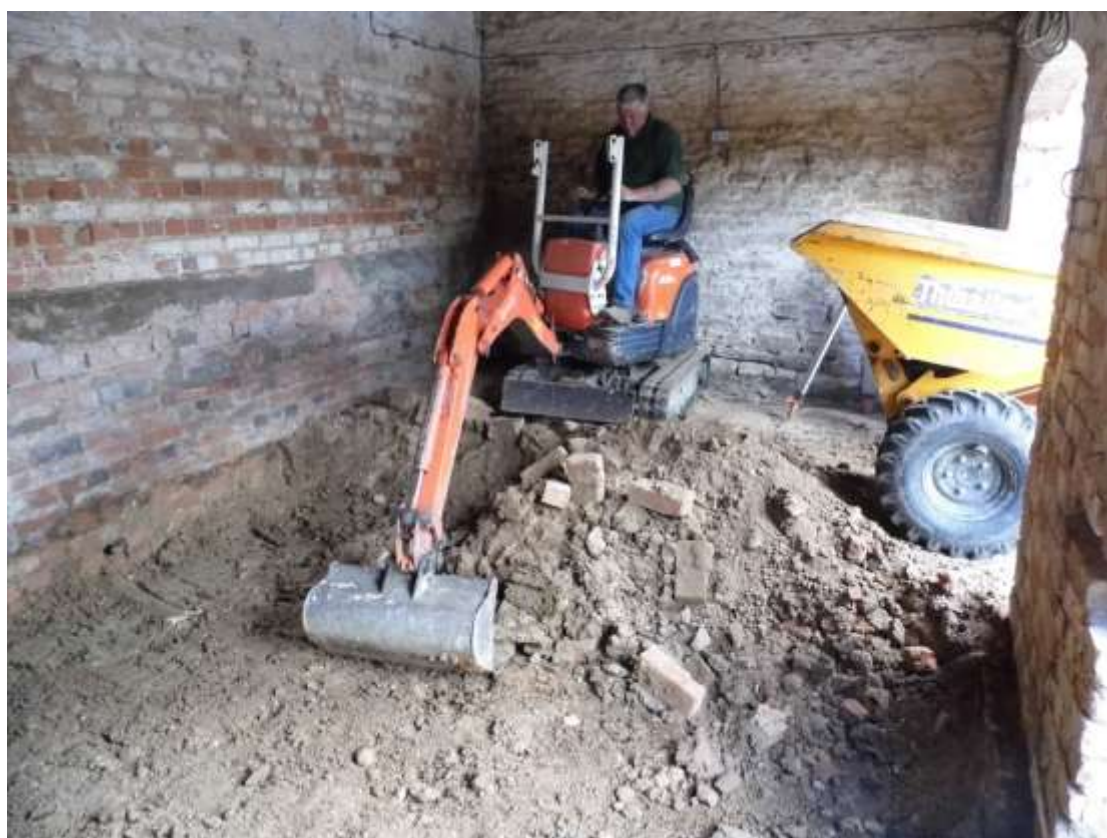
Figure 30: Work in progress inside former tack room, looking south

The reduction of ground levels was undertaken within the tack room of the building on 8th June 2015. Around 0.35m of soil, bricks and made-up ground was removed. No archaeological features were observed (Figure 30).

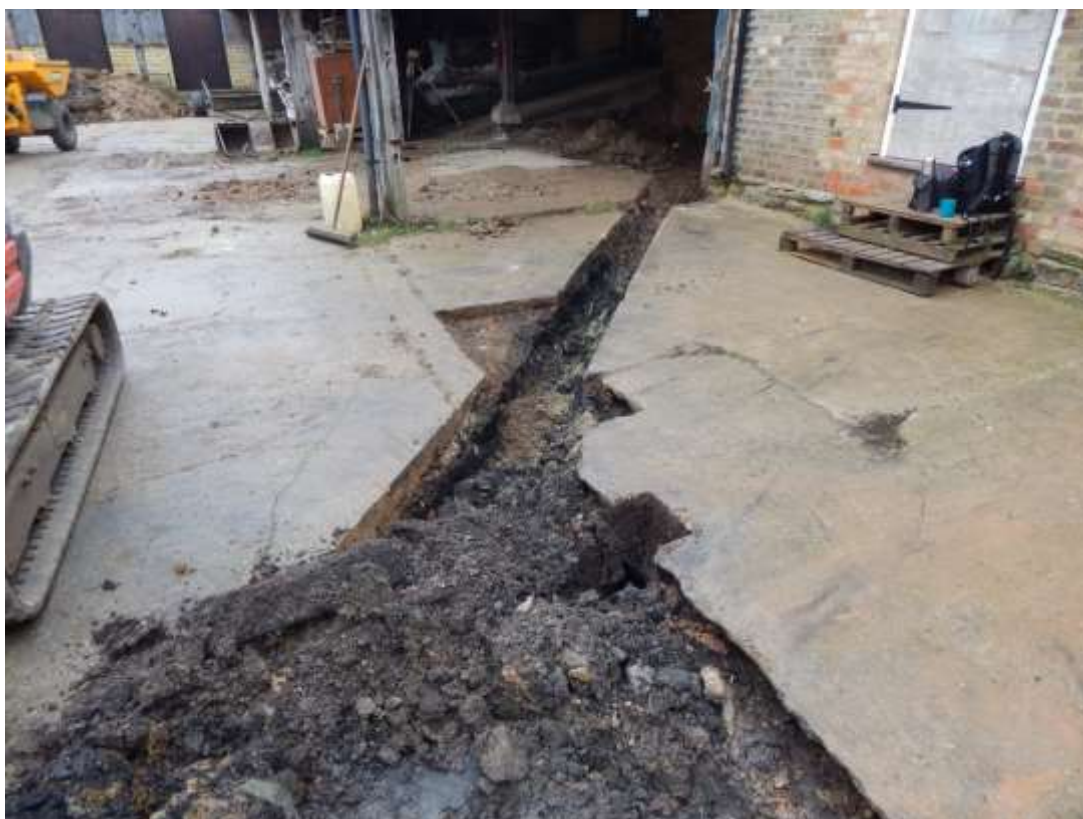
Figure 31: The drain leading from the former cart shed, looking east

The drain from the former cart shed was also 0.3m wide and 0.4m deep and showed 100mm concrete over disturbed degraded asphalt over yellow and grey clay.

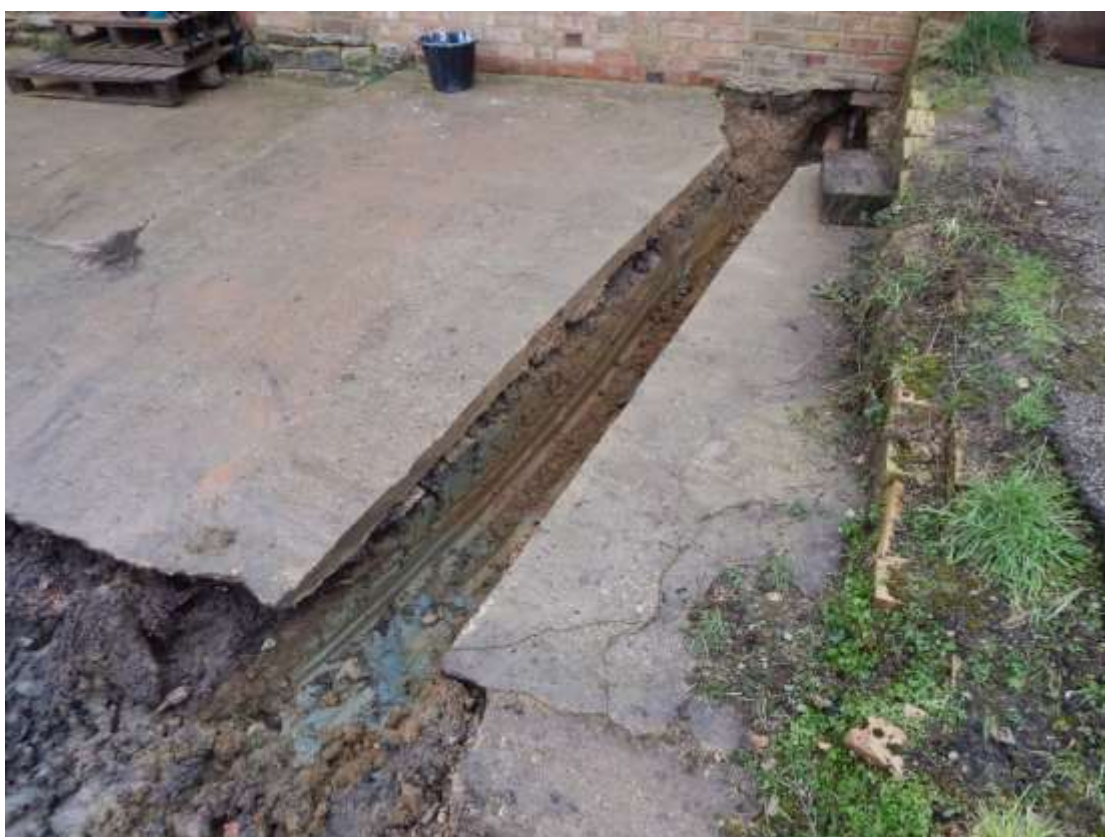
Figure 32: The drain leading from the tack room, looking east

The concrete in the area had been removed prior to the arrival of the archaeologist. The drain from the tack room was 0.3m wide and 0.5m deep and showed a sequence of 100mm of concrete onto yellow grey clay (Figure 31).

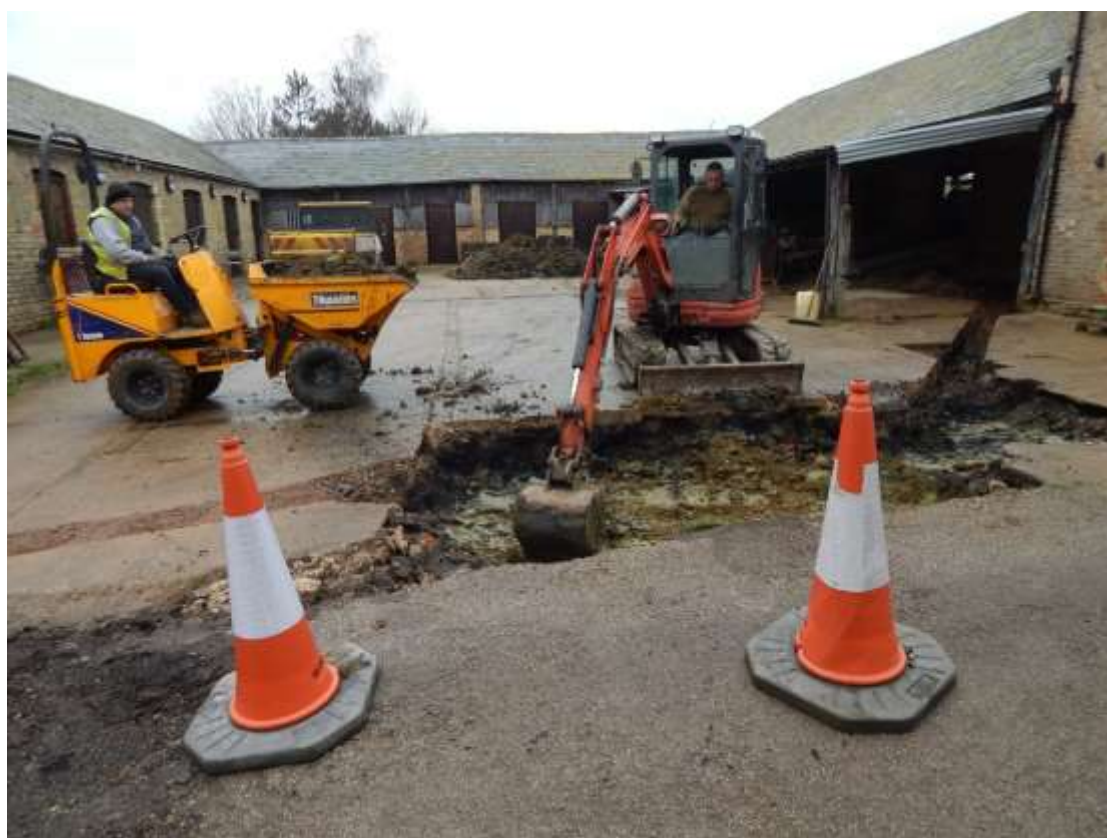
The trench for the new septic tank was 3.6m by 2.4m, oriented north-west to south-east. The upper soil levels were stripped using a flat bladed bucket onto the natural clay (Figures 33-34); then a toothed bucket was used to excavate down through the clay and limestone brash to the base of the trench (Figure 35). The sequence showed 100m concrete over 0.35m of degraded asphalt over 1m yellow or grey clay, which lay over a mixture of limestone brash and yellow clay to the base at 2.1m. Due to the difference in ground level the north facing section of the trench consisted of 100mm more recent asphalt, over 0.35m of made-up ground over around 1.3m of clay over the brash and clay mixture.

Figure 33: Work in progress on septic tank trench

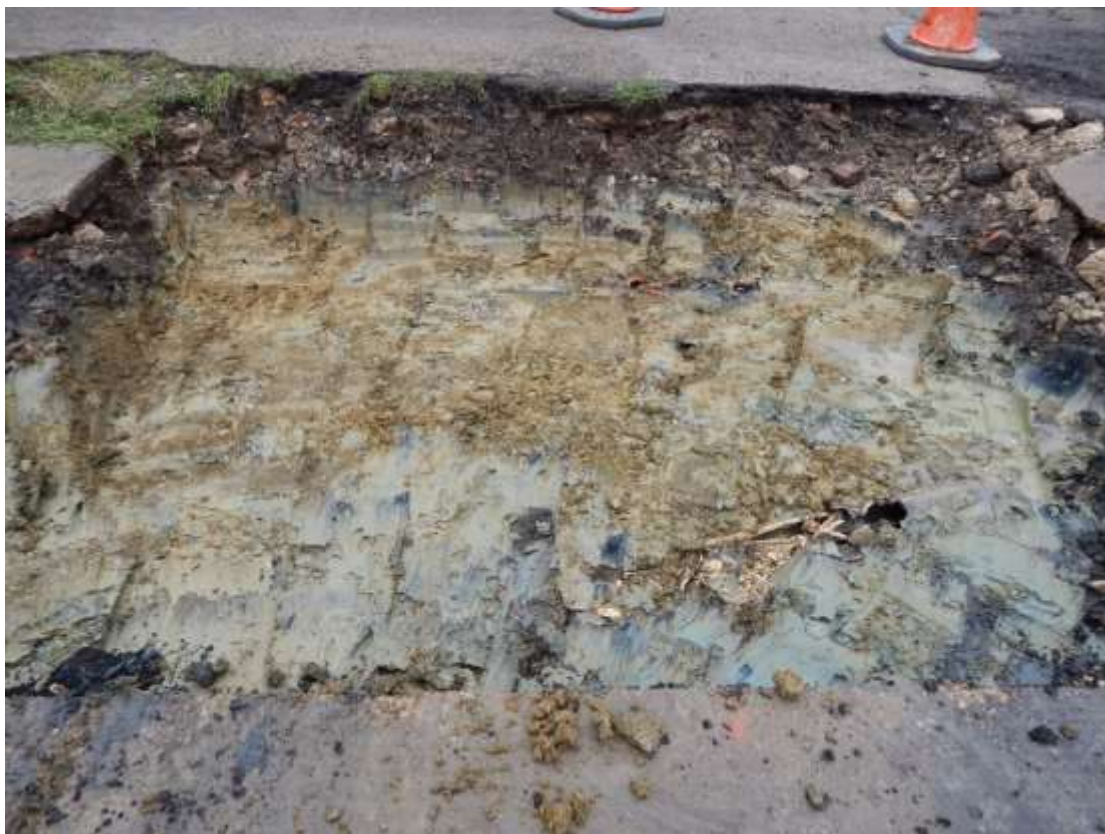
A field drain was exposed running north-west to south-east through the area on the southern side of the trench and a disused sewer pipe was revealed running east to west on the northern side of the trench.

Figure 34: The trench excavated to the top of the clay, looking south-east

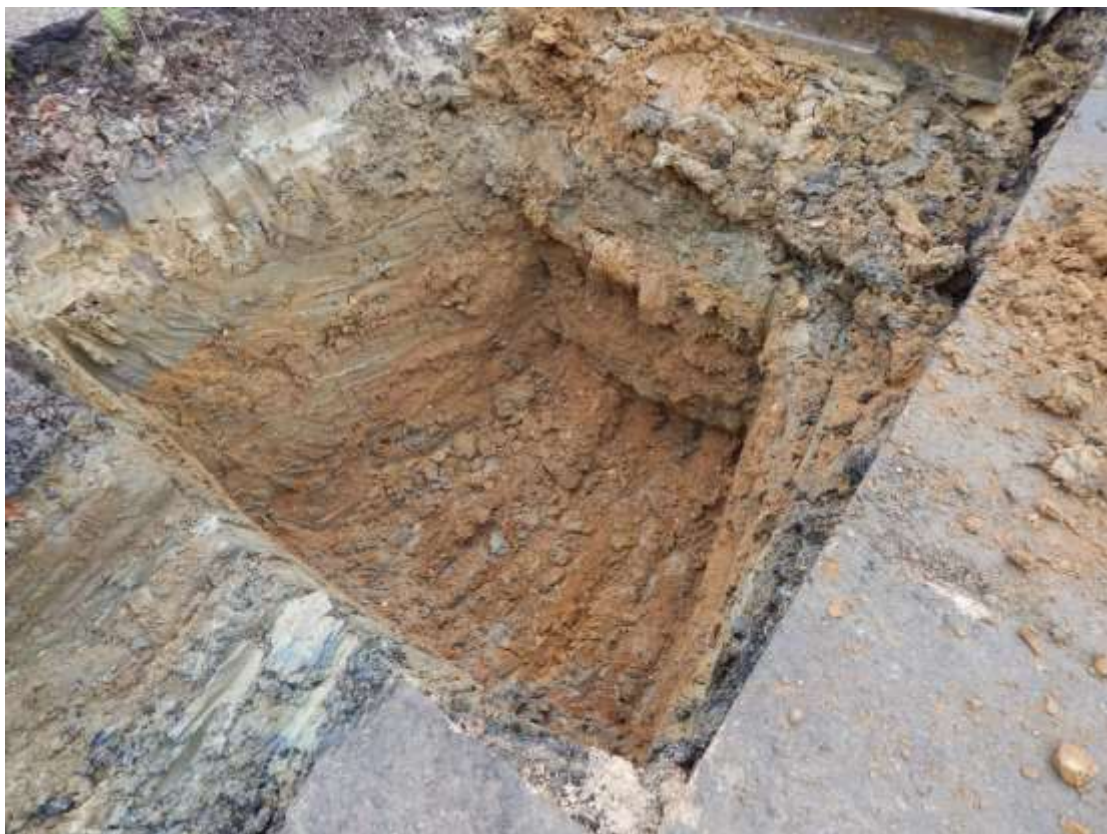
Figure 35: The trench excavated to full depth, looking south-west
