**A Level 3 Historic Building Survey at  
Home Farm,  
Markfield Road,  
Groby,  
Leicestershire**

**NGR: SK 51099 08227**

ULAS Report No. 2018-014  
©2018

**For: Cawrey Limited**

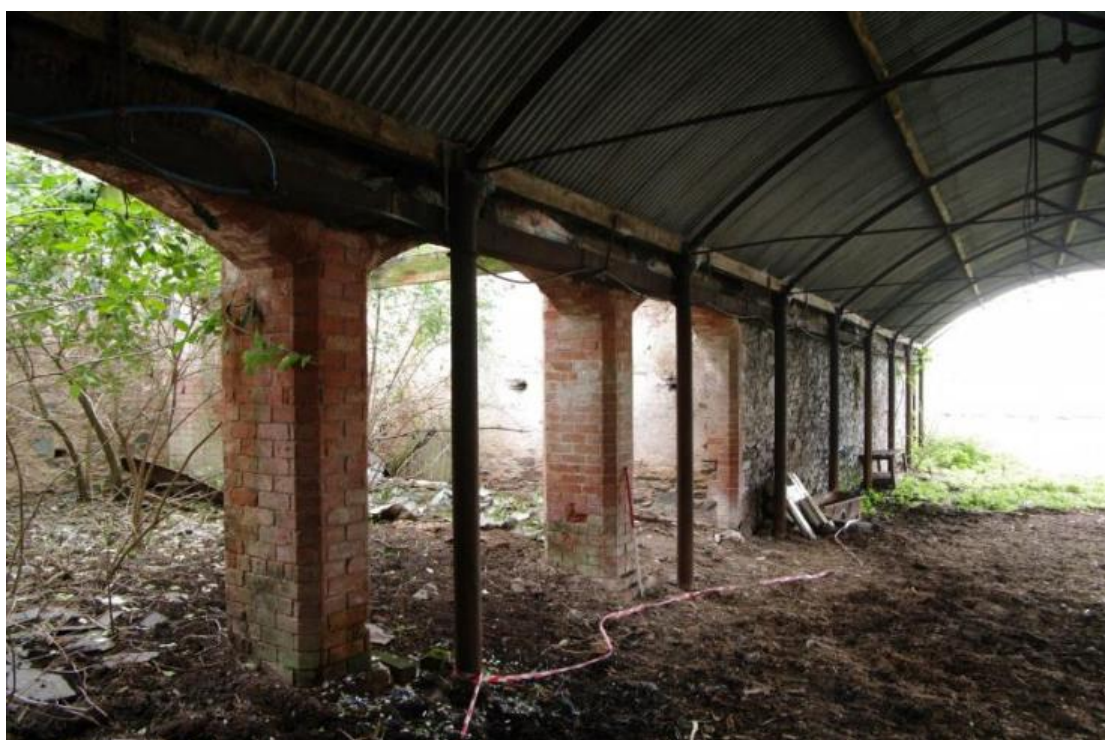
Figure 16 Building A south-facing elevation  
Looking north-east. 1m scale. Building A has no roof at this point hence the trees  
growing inside. Photo taken from inside the open barn filling the yard space

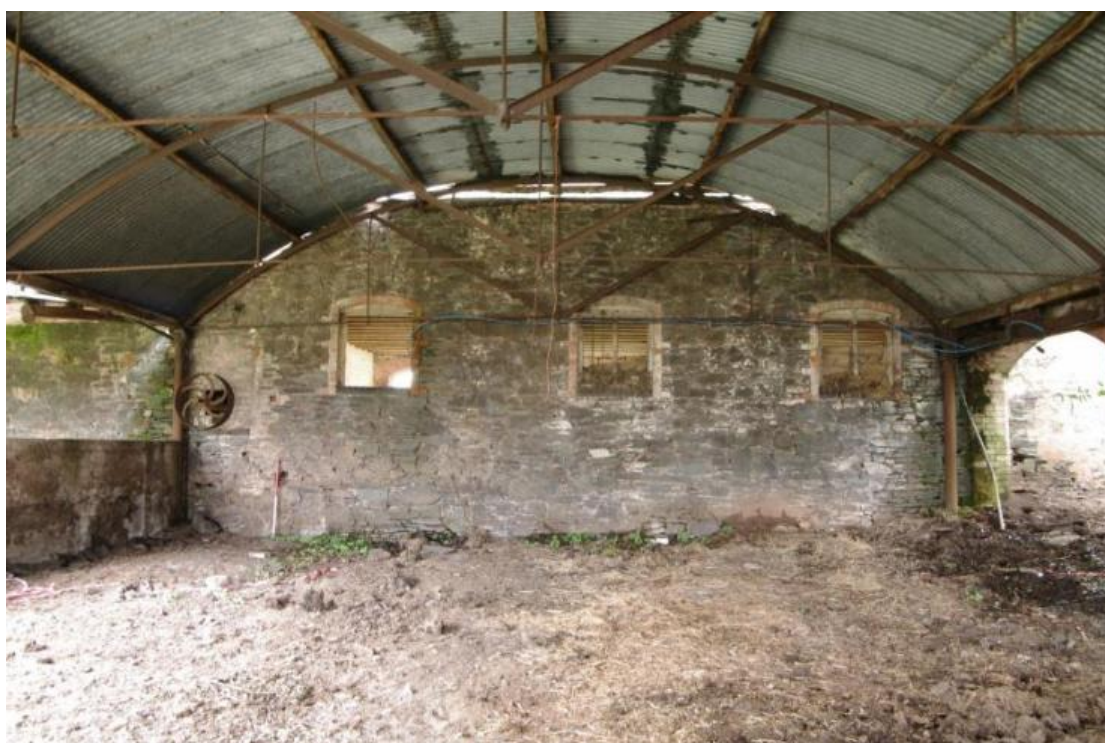
Figure 26 Building B north end of east-facing elevation  
Looking west. 1m scale. Building A on right. Note drive wheel extending out from a  
blocked window

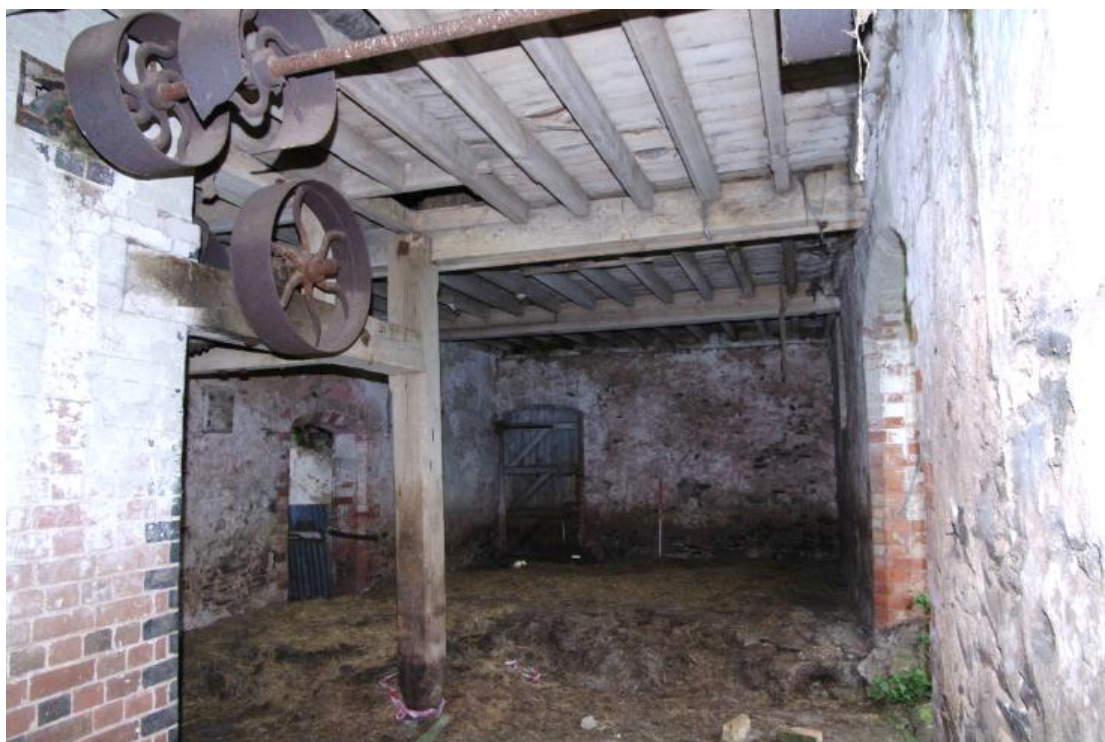
Due to the heavy weight of the millstones the floor timbers are substantial and are supported by a centrally placed wooden post (see figure 27). This has two distinct burn or scorch marks made by a candle or other flame. There is no evidence of any attachment for a holder below the marks which are deep and clearly made (Fig. 32). Also, they are too low to usefully hold a light. It is possible therefore that they may be apotropaic marks such as those often seen on roof timbers and are made to ward off malign spirits.

Figure 27 Building B ground floor south room  
Looking south. 1m scale. Door on left leads in Building C, far door leads outside to south-facing elevation. Door on right leads to west-facing elevation

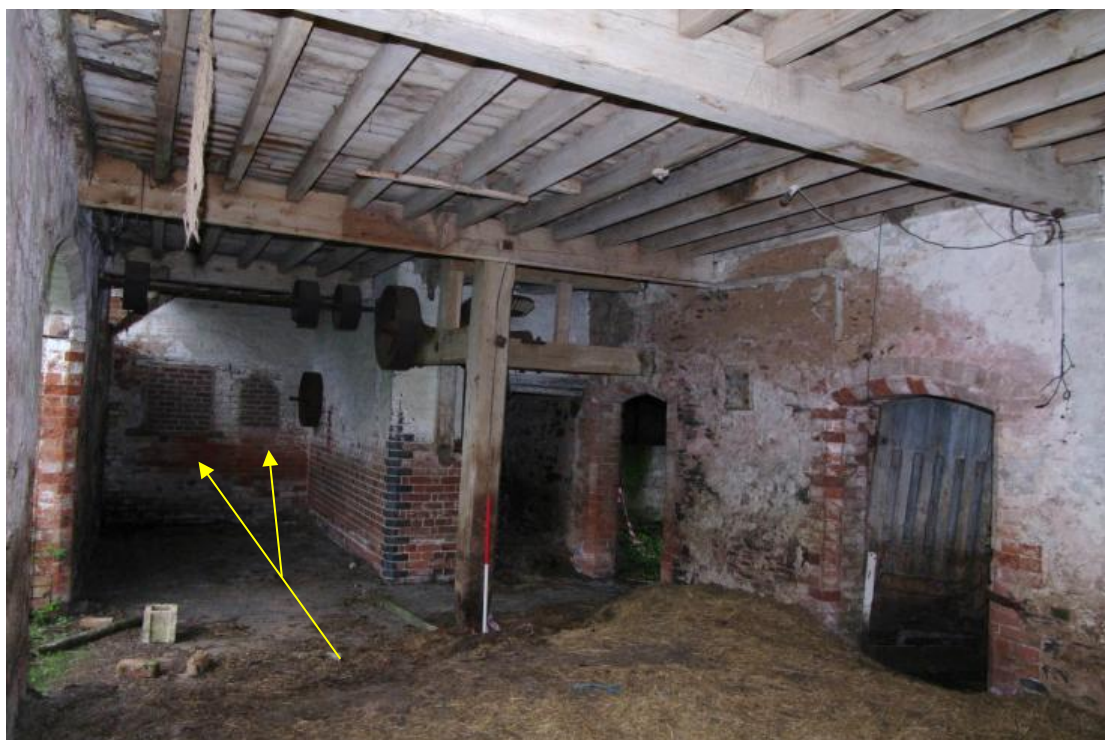
Figure 31 Building B ground floor south room  
Looking north-east. 1m scale. Blocked windows on north wall shown with arrows

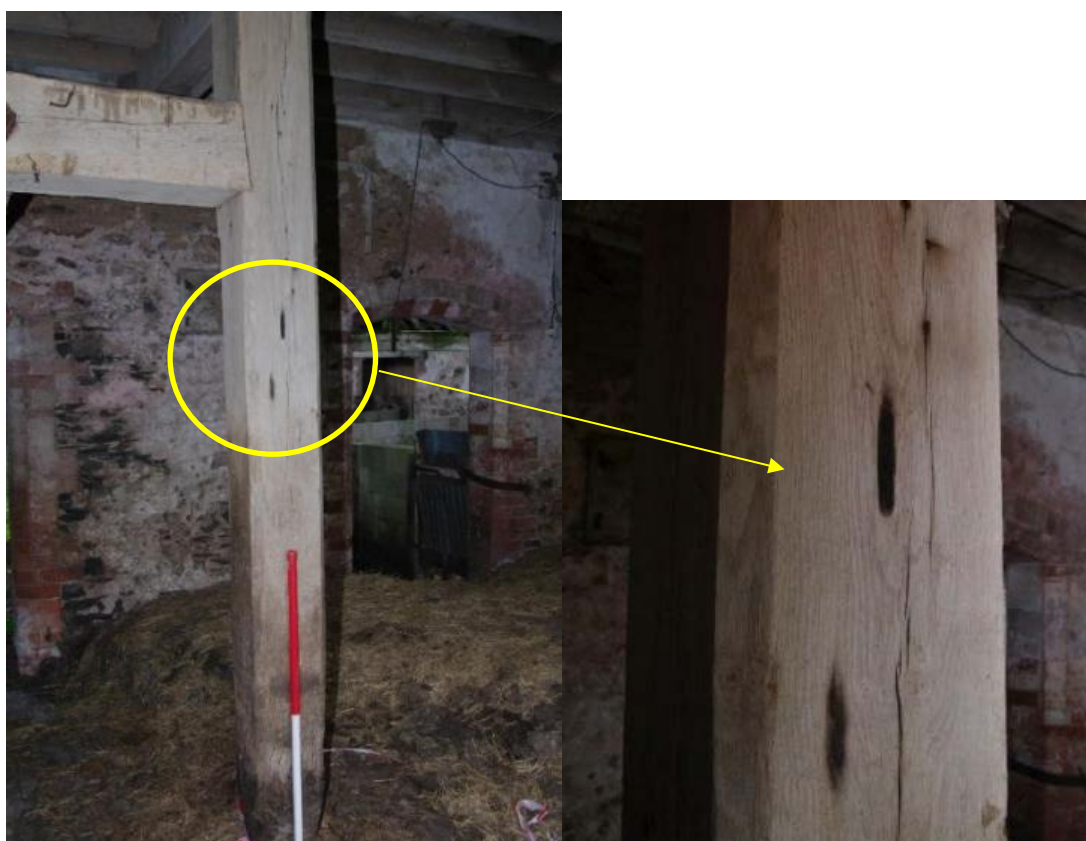
Figure 32 Building B ground floor south room possible apotropaic scorch marks  
Looking south-east. 1m scale in main picture. See also Figure 27

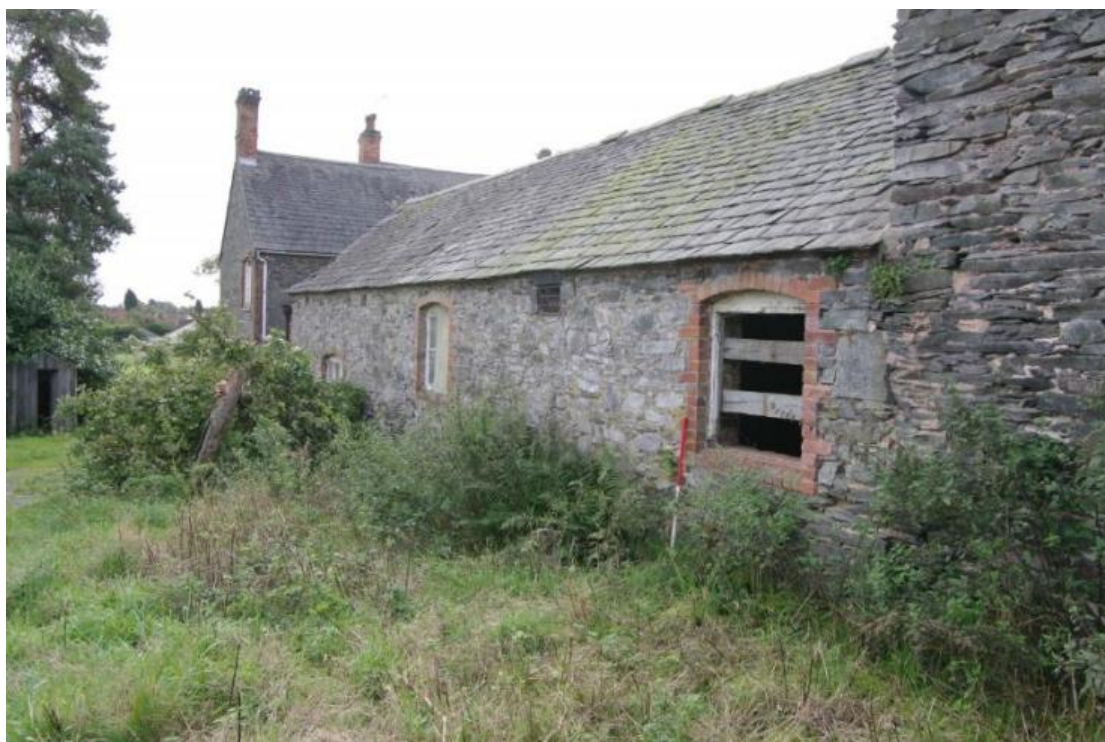
Figure 77 Building G north-facing elevation (east end)  
Looking south-east. 1m scale. Note joint in stonework to right of window

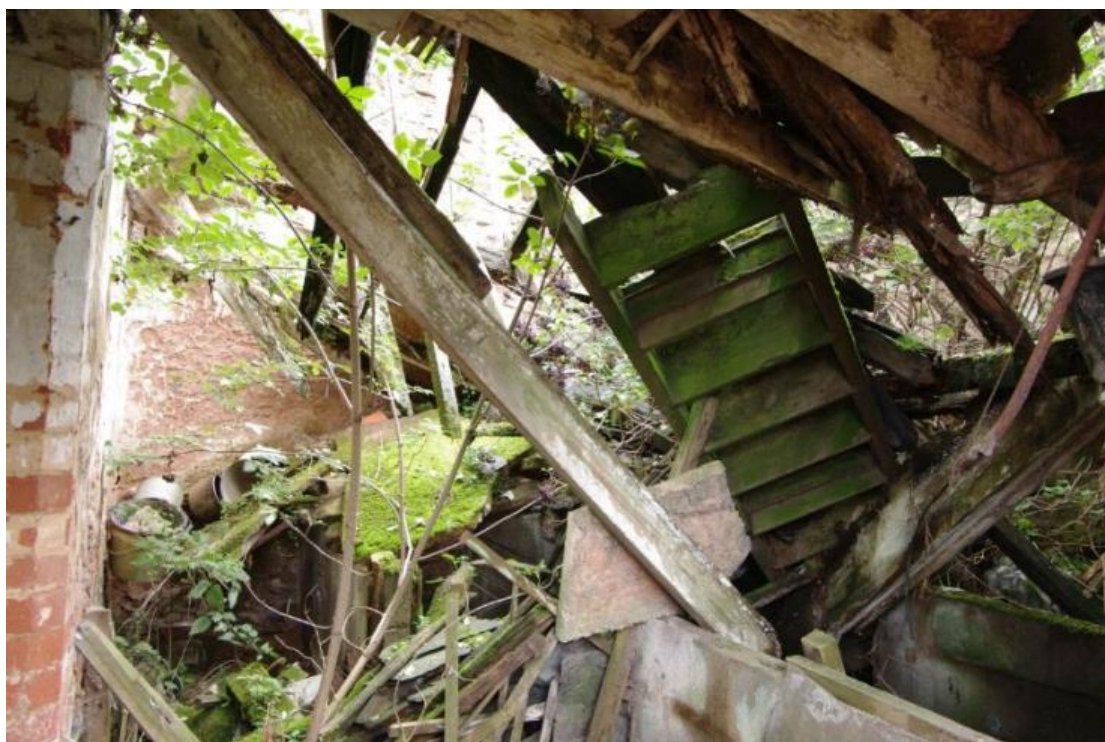
Inside Building G the western end roof has collapsed which prevented any inspection. As noted, from the doorway it was possible to see that this part of the building had two floors as there are the remains of a set of wooden steps within the collapsed roof material (Fig. 83). To the east of the collapsed roof portion is a large open room which is open to the roof (Fig. 84). There are no fixtures or fittings within the room although a deep layer of fairly fresh straw and bedding suggests that the room was most recently used for animal pens. The roof truss has metal straps suggesting a mid to later 19th century date. To the east of this room is another animal pen with a low stone trough along the north wall (Fig. 85). The trough is made out of two hollowed out blocks of local slate supported on blue bricks (Fig. 86). Attached to the west wall, close to the door, is a small piece of hand grinding equipment, possibly a kibbler (Fig. 87). Laths have been attached to the underside of the rafters and remnants of plaster remain. The purlins have been whitewashed and show evidence of possible apotropaic marks in the form of circles and double M or double V scored marks (Fig. 88). It is possible however that these may be shipping or rase marks.

Figure 83 Inside western end of Building G  
Looking north-east from doorway. Note wooden stairs within collapsed material
