**A Level 3 Historic Building Survey at  
The Rose and Crown,  
Tilton on the Hill,  
Leicestershire**

**NGR: SK74292 05655**

ULAS Report No. 2018-024  
©2018

**For: D W Hicks Building Co**

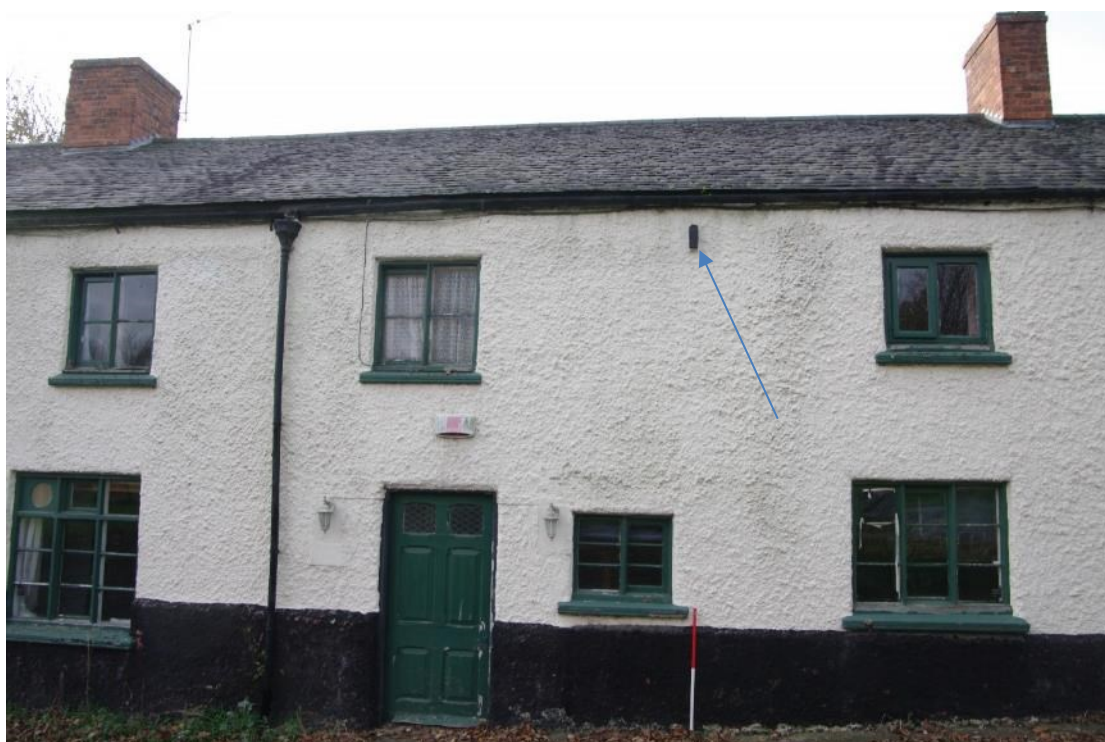
Figure 15 East-facing elevation, front door  
Looking west. 1m scale. Note projecting timber beam (arrowed)

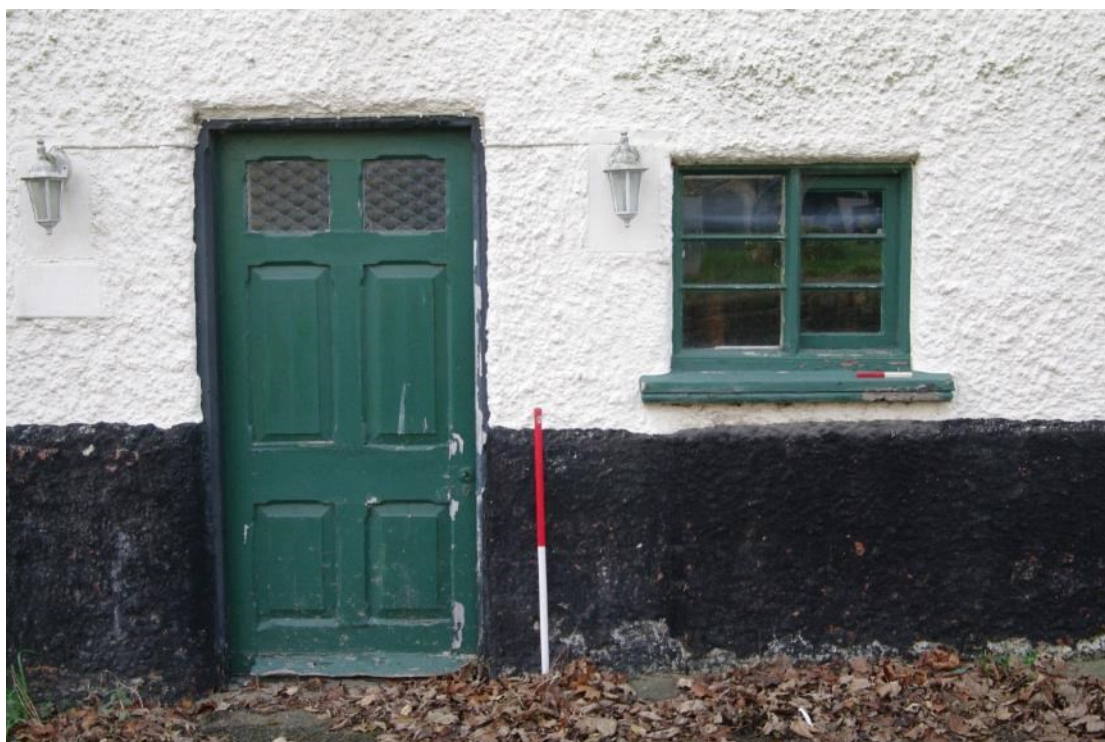
Figure 19 East-facing elevation, door and window detail  
Looking west. 1m scale

The only doorway on the principal range's east-facing elevation is a well-made feature with wooden stop-chamfered jambs and lintel (Fig. 19). The door has six panels with the top two panels having been replaced by later glass panes. The style of panelling suggests an 18th- or early 19th-century construction date. A plank-built stable door is located at the northern end of the range (see fig. 17). Adjacent to this is a small window which has plank boarding on it. The stable door and boarded window suggest that this part of the range was used for storage or animal housing. There is no visible evidence of any other doorways on this elevation although it is quite possible that the render may be masking other blocked doors.

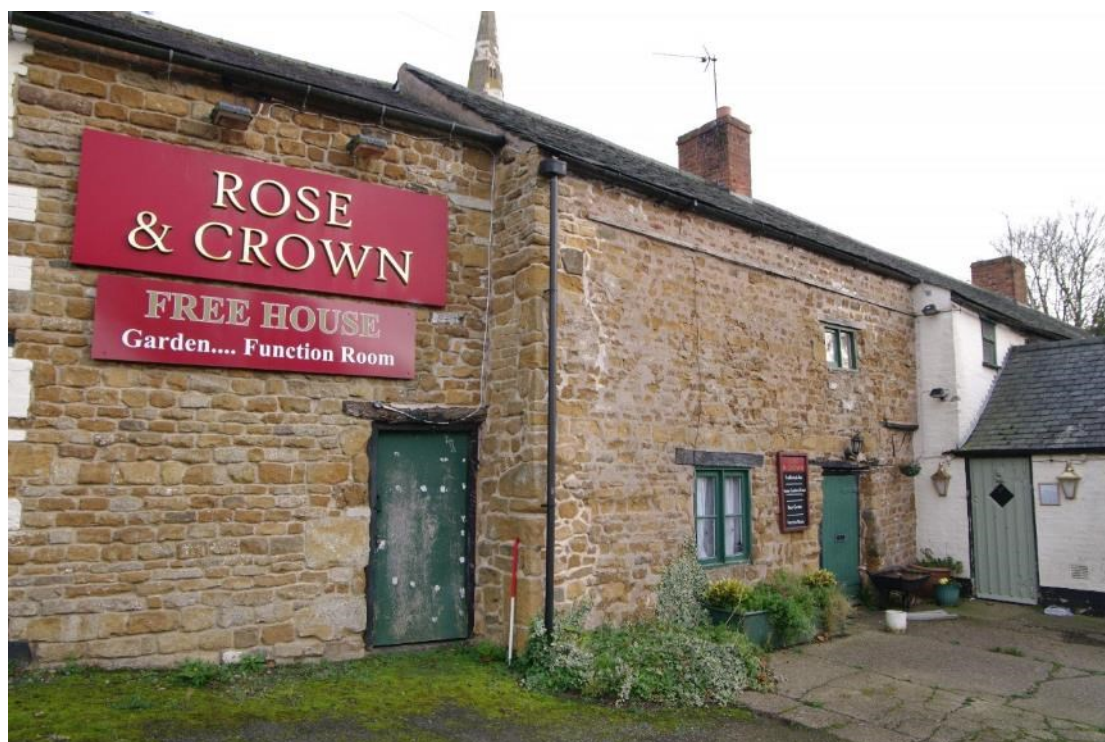
Figure 24 West-facing elevation of principal range  
Looking south-east at stepping of buildings. 1m scale

To the south of the brick and stone building is the start of the continuous range along Main Street. The visible face at this point is of coursed ironstone rubble which is quite heavily weathered (Figs 24 and 25). The northern corner has been repointed where the building has either settled or has been repaired. The ground and first floors have quite small casement windows with wooden lintels. The single ground-floor doorway also has a timber lintel but has a modern door. It seems likely that this was originally the main doorway into the range rather than the one currently in use on the east to west range. Another wooden lintel over a possible blocked opening is located at the point where the range steps out again and where the building material changes from stone to brick.

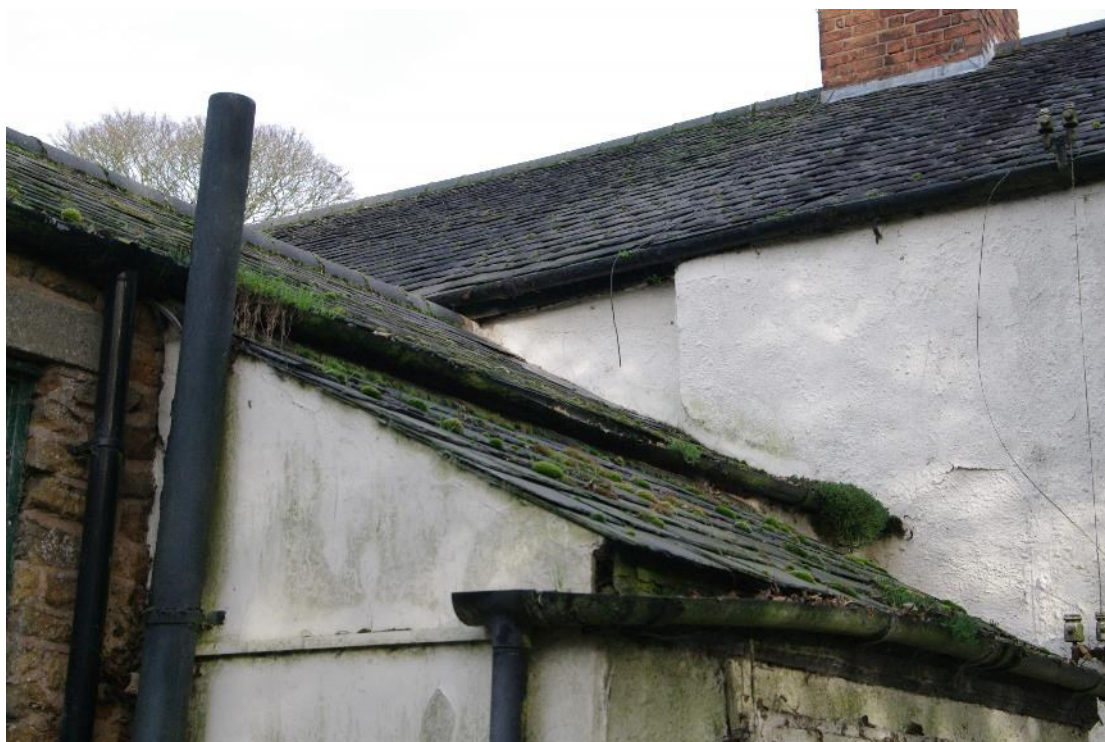
Figure 30 West-facing elevation and ridge of southern east to west kitchen range  
Looking north-east. Note thicker part of wall

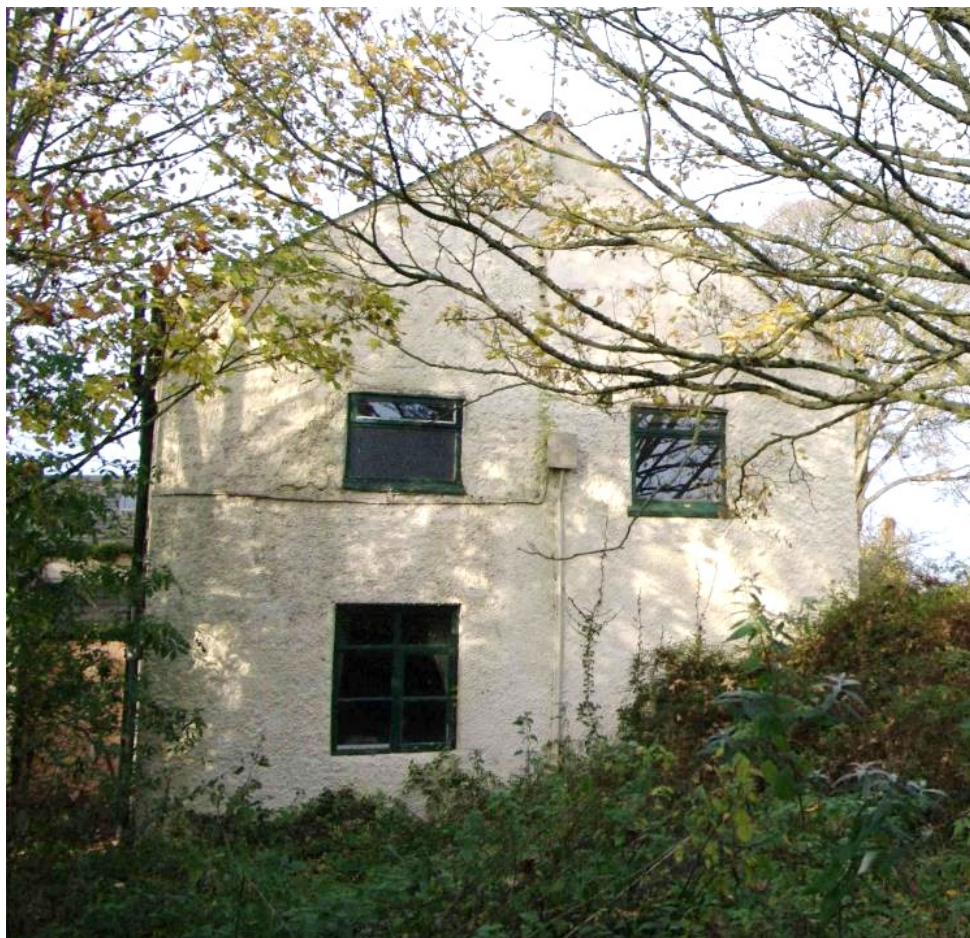
Figure 32 South-facing gable end of principal range  
Looking north. Main Street on right

The south-facing gable end of the principal range has three modern casement windows but has been rendered (Fig. 32).

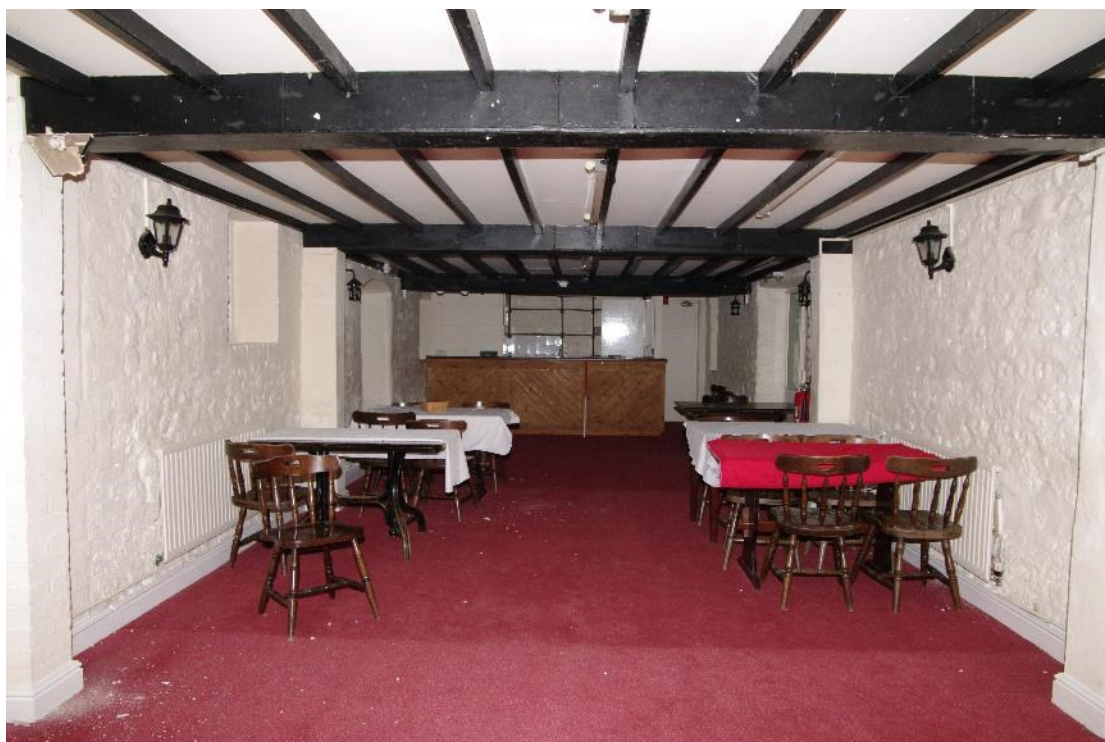
Figure 72 Room 9

Room 9 fills the stone-built portion of the east to west range and was presumably built with stalls and looseboxes although no trace of this remains (Fig. 72). Most recently it appears to have been used as a function room. The stone walls have been painted rather than plastered. Large north to south beams are supported on brick pilasters built against the side walls. The pilasters may be a later addition as one of them covers a blocked doorway as seen on the north facing elevation. Although filled with stone on the outside the doorway has brick infill on the inside (Fig. 73). It is possible that the ends of the beams were rotting and needed additional support from the new pilasters. The doorway

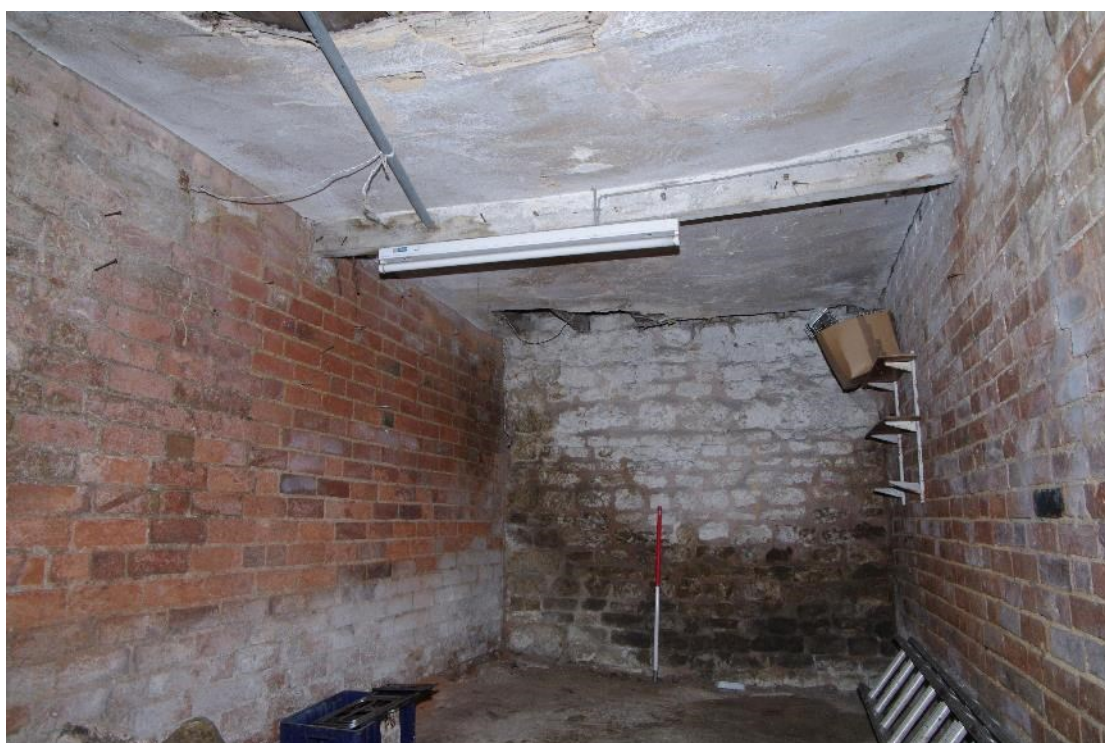
Figure 78 Room 11  
Looking east. 1m scale

This room has brick north and south dividing walls and a modern concrete floor (Fig. 78). The east end wall shows no evidence of having any doors or windows although it has been heavily pointed and whitewashed. Redevelopment proposals indicate that the internal brick walls are to be removed which, presumably, will also mean the removal of the first floor surface.

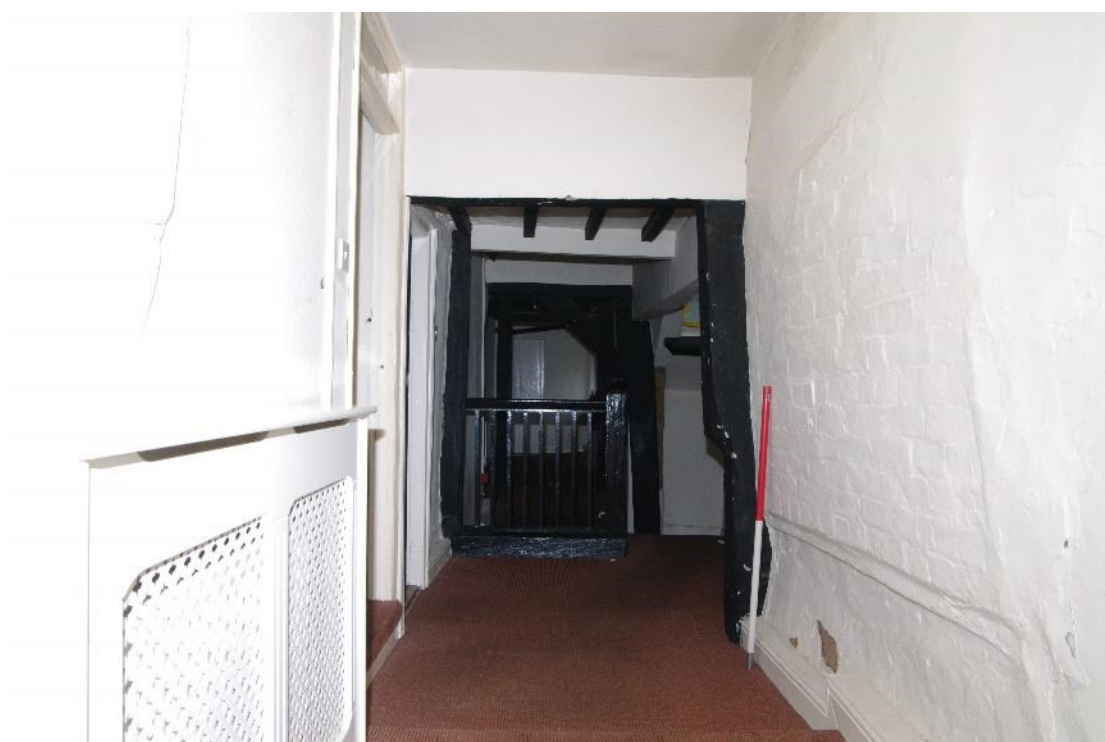
Figure 81 Corridor 12, north of stairs  
Looking south. 1m scale

Beyond Room 16, to the south, the corridor widens to form the landing around the staircase (Figs 81, 84 and 85). The rectangular section newel posts are of the same probable early 17th century style as seen at the foot of the stairs in Corridor 5. The handrails and balusters are not boxed in at this point and give an indication of what the original open staircase might have looked like. The handrails however at first floor level do not have the moulded decoration seen rising from Corridor 5 and may be later replacements. The balusters are simple square section pieces of timber but are likely to be original.

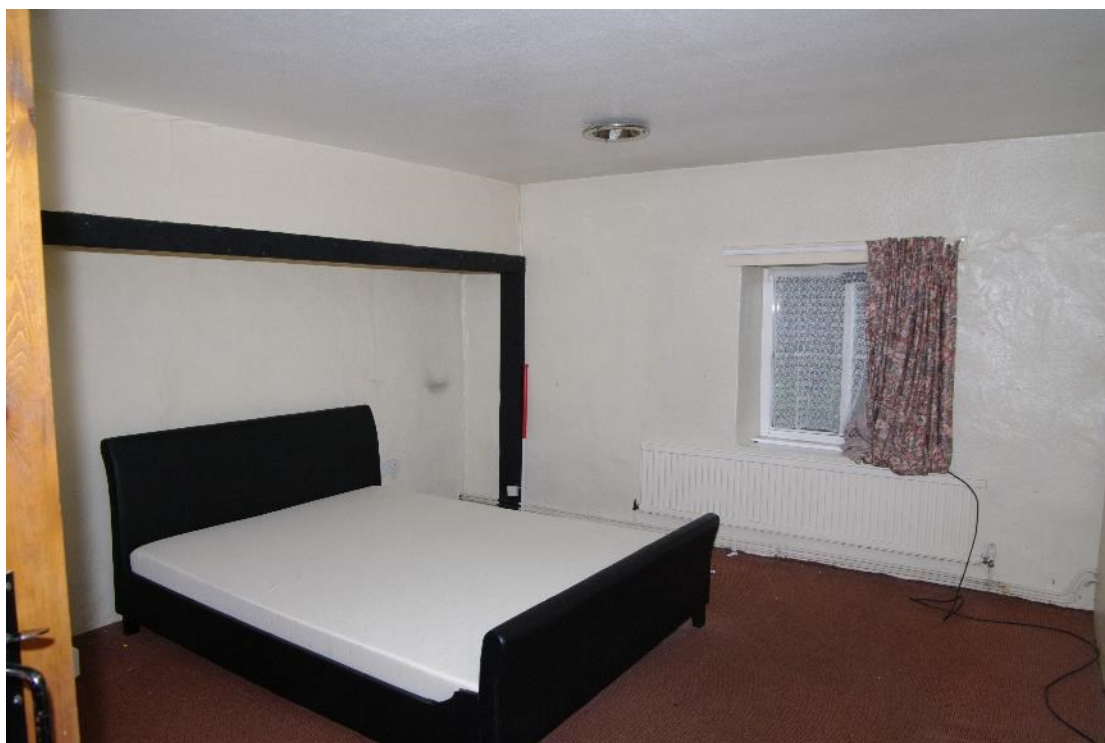
Figure 100 Room 17  
Looking north-east. 1m scale

Room 17 has a modern plank door from Corridor 12 into the room with a glass panel over the doorway. The room has been partially modernised and has concealed lights set into the ceiling (Fig. 100). A recess on the north wall has a timber frame around it which appears to be modern as the timbers seem to be quite freshly cut. This may mask or replace an earlier structure or may be part of the more recent modernisation of the room.

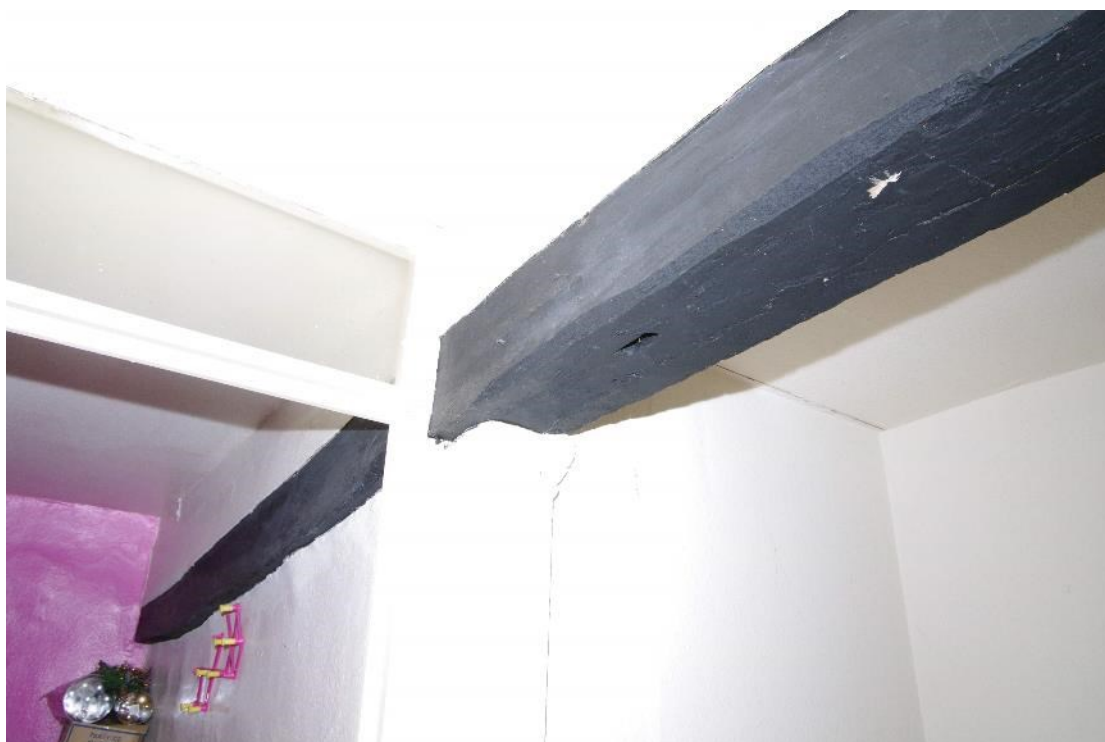
Figure 103 Beam extending from Room 18 across Corridor 12  
Looking south-west. Note redundant socket on underside of beam
