**A Historic Building Recording  
At Old Warren Farm,  
Lubbesthorpe,  
Leicestershire,**

**NGR: SK 53070 02290**

ULAS Report No. 2018-050  
©2018

**For: Andrew Hiorns Ltd**

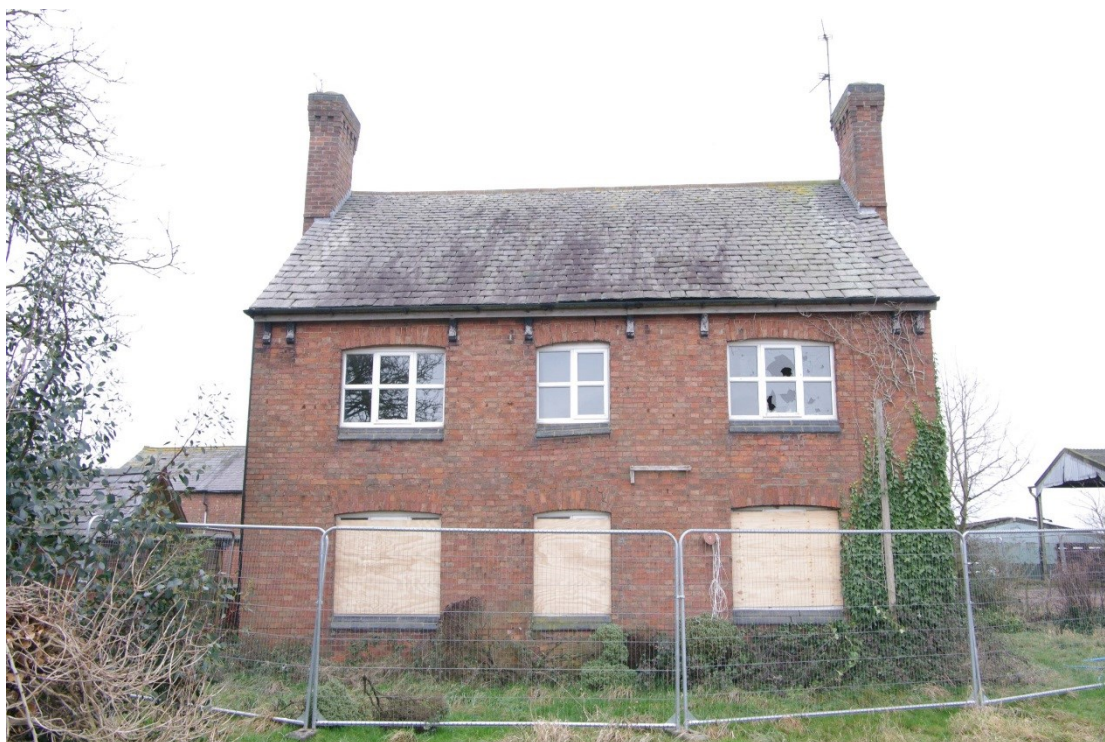
Figure 10 Farmhouse west facing elevation  
Looking east. 1m scale

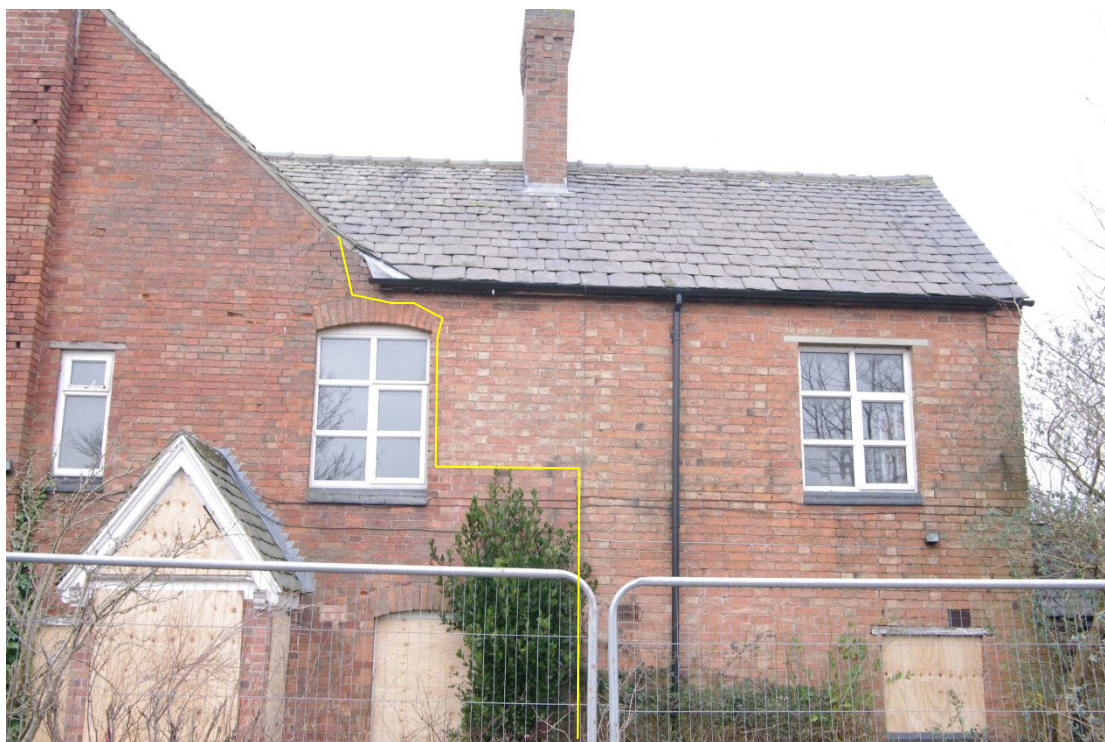
Figure 18 South facing elevation, rear range  
Looking north. Yellow line indicates rebuilding line

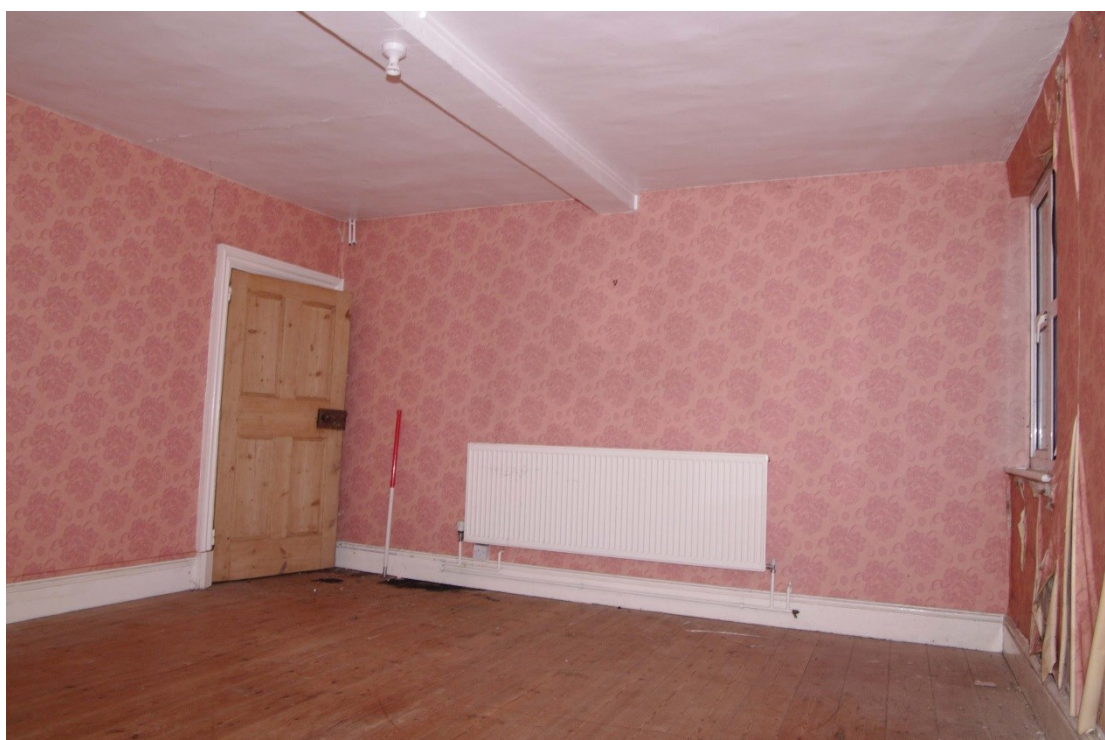
Figure 42 Room 3  
Looking south-east. 1m scale. Note narrow window on right which butts against the south wall

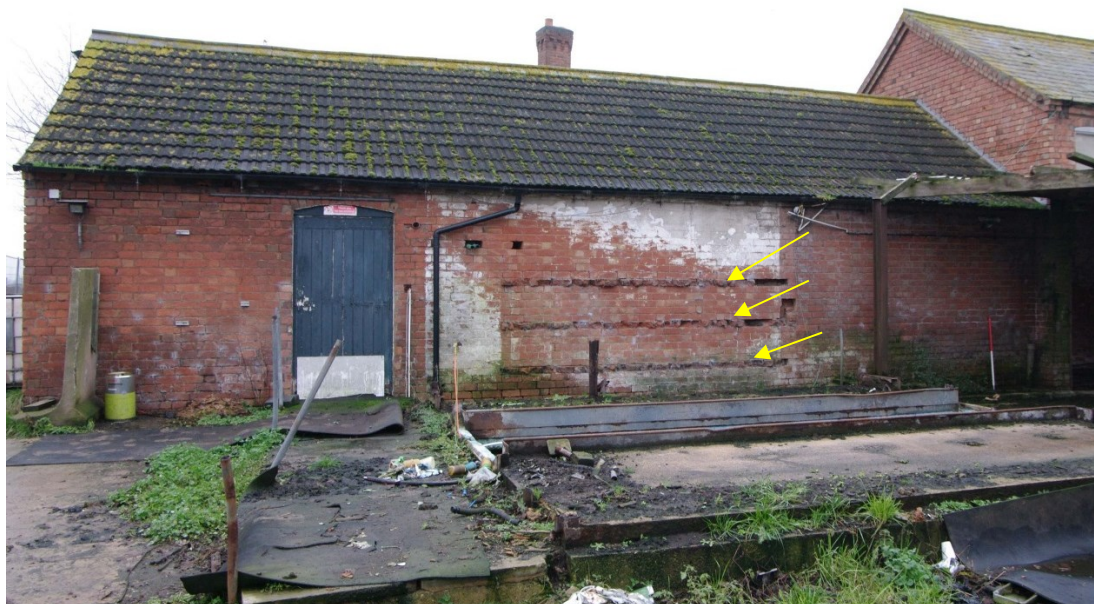
Figure 88 North to south barn. East facing elevation, south end of range. Looking west. 1m scale. Arrows point to broken brickwork projections

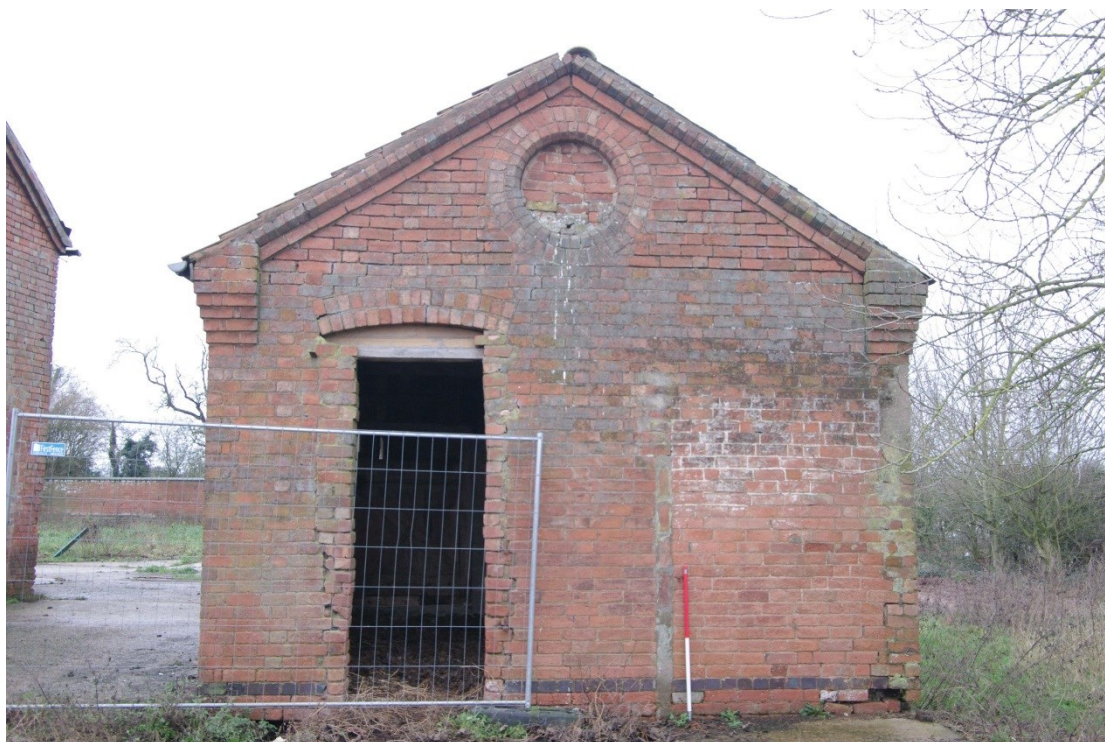
Figure 109 East to west barn, east facing elevation  
Looking west. 1m scale. Note scar of former structure to left of scale
