**A Historic Building Recording at
Heather Hall,
Sweepstone Road,
Heather,
Coalville,
Leicestershire**

ULAS Report No. 2018-055
©2018

For: David Granger Architectural Designs Limited

A Level 3 Historic Building Recording of the Morning Room at Heather Hall, Swebstone Road, Heather, Coalville, Leicestershire. NGR SK 3818 1057

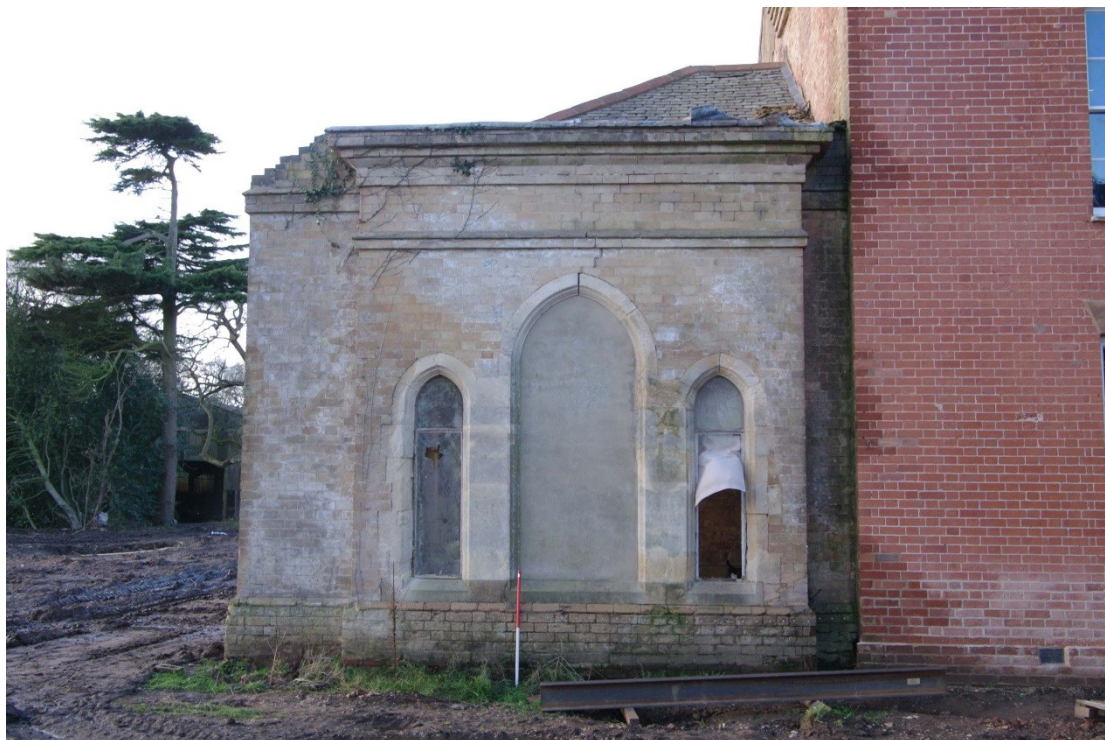
The east facing elevation is located on the south side the principal east facing façade of the original late 18th century farmhouse building (Figure 4 above). Where the two structures join the wall-line steps in to create a noticeable change rather than trying to blend seamlessly with each other (Figure 7). The brickwork of the morning room butts against the farmhouse rather than having been keyed into it. The east facing elevation has three lancet windows set below a projecting entablature and above a brick plinth. String courses and the top of the entablature are all made from yellow bricks. The window surrounds are made of fine-grained limestone with some moulding detail. The centre window has been blocked but a photograph taken in the early 1900s and shown in Finn's 2015 report shows this to be glazed, although there is no tracery present even at this time. There is a small settlement crack in the arch of this window which extends up to the top of the wall. The two flanking windows are smaller and retain some of their very plain wooden frames. Some glazing survives but most has been broken.

The wall line at the south-west corner of this elevation steps back and does not have the same entablature merely a narrow cornice or string course detailing. The wall above the cornice rises up in small steps and is a remnant of the truncated first floor which is no longer present following the fire. There is no evidence of any heat-affected brickwork from the fire.

Figure 7 East facing elevation of morning room
Looking west. 1m scale

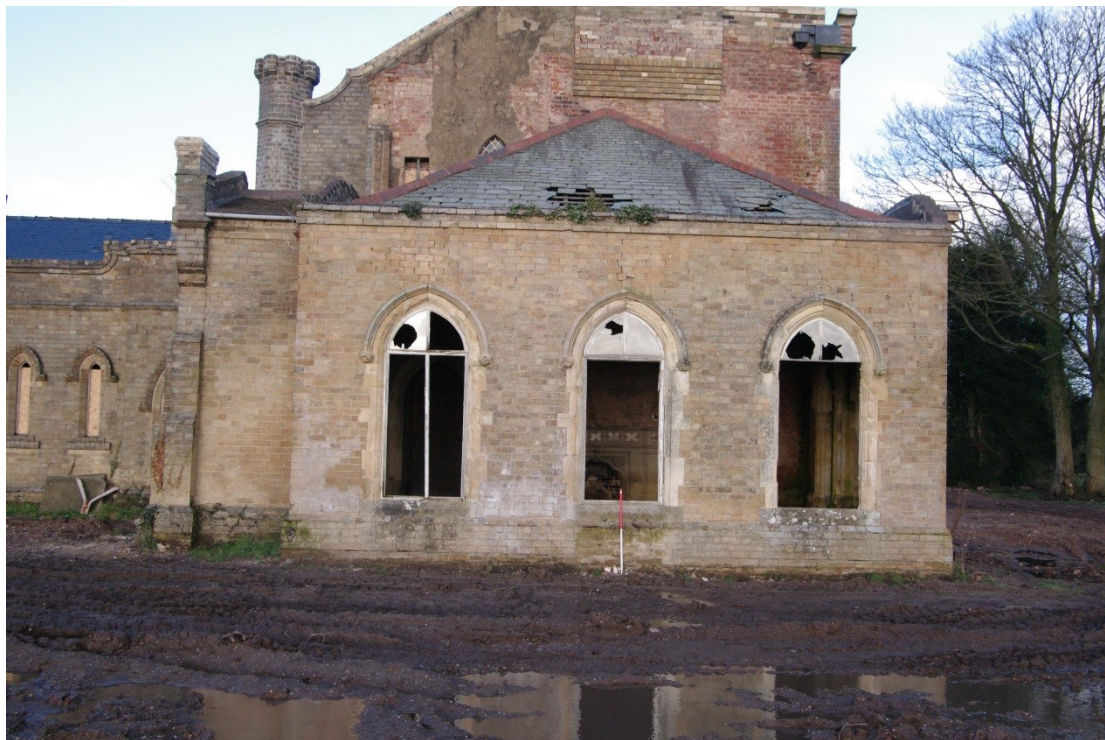
The south facing elevation also has three lancet windows although on this elevation the windows have hood mouldings and floral decorative stops (Figure 8). The hipped roof rises up to join the main farmhouse wall where the brickwork shows clear signs that the morning room once extended to two stories (Figure 9). Figure 10 shows the two-storied morning room in the early 1900s when it also retained its traceried ground floor window frames. At the time of the survey the windows only had glazing in the heads of the arches and remnants of very plain wooden window frames. The frames match those on the east facing elevation and indicate that the original frames are likely to have been replaced since the 1900s photograph was taken. The proposed new-build structure will be accessed through the centre window which will be lengthened to create a new doorway. This should cause minimal damage to the existing fabric of the building.

The brick cornice detail from the east facing elevation continues round onto the south facing elevation. Although this is a cornice decoration on the present structure the 1900s photograph shows that this was originally a decorative brick string course.

Figure 8 South facing elevation of morning room
Looking north. 1m scale. Note scarring on first floor of main house following removal
of the morning room first floor

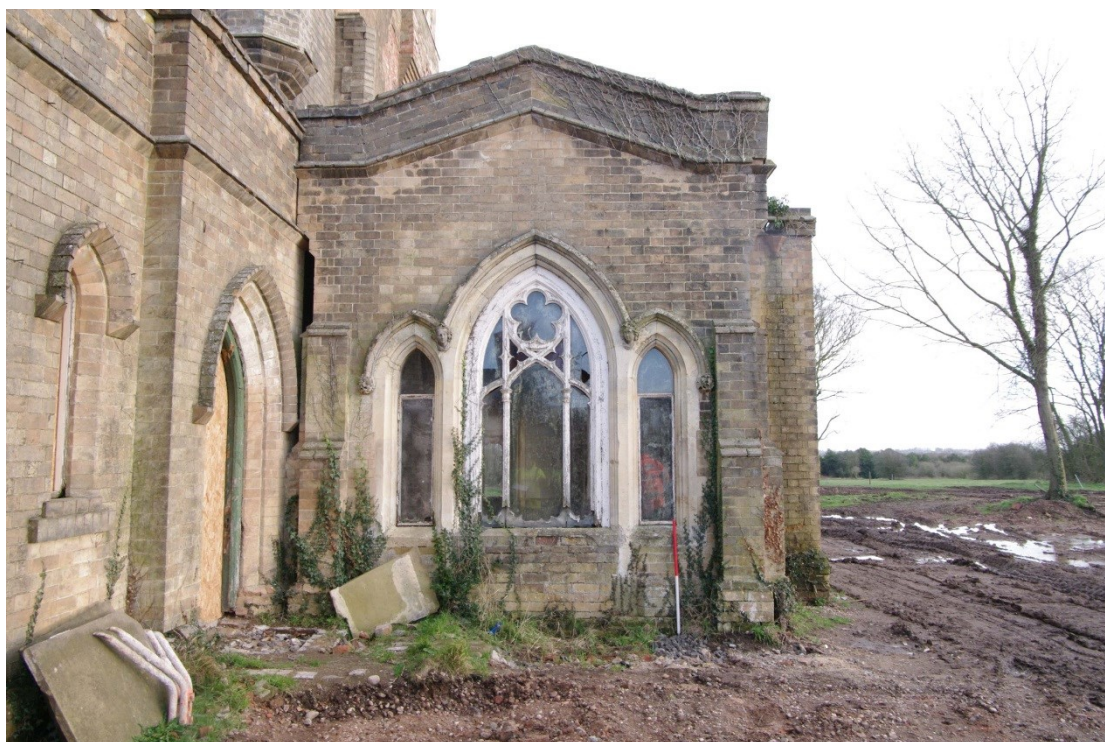
The west facing elevation is the most heavily decorated of the three outside elevations (Figure 11). This side of the morning room is dominated by the small area at the west end of the morning room presently called the orangery. As with the other elevations the west side has three lancet windows but, on this elevation, these have more detailed hood moulded decorations and decorative stops, two of which are carved in the form of human heads. The style of the heads is typically Victorian. The largest, centre, window has carved wooden tracery within it although the lower parts have rotted away. The tracery appears to be present in the 1900s photograph in Figure 10. The two flanking windows have later and much plainer frames with no tracery. Below the windows the projecting brick plinth stops underneath the centre window and what appears to be stone jambs reach from sill to ground level. This suggests that when first built the centre window was a doorway and that the orangery was in fact a decorative porch leading into the morning room. Above the windows is a gabled parapet with decorative brick string courses.

Figure 11 West facing elevation of morning room
Looking east. 1m scale. Note joint with main building on left hand side

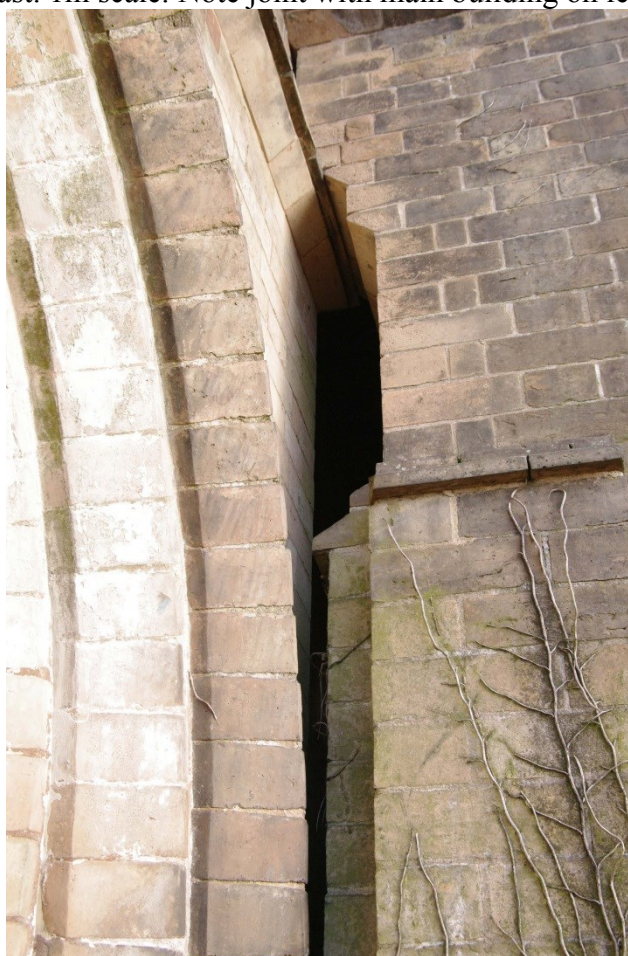
The joint between the morning room and the main building is curious. Both the morning room and the range running from east to west appear to be of the same, or very similar, construction date. Despite this similarity in date the morning room wall only butts against the east to west range in a few places and leaves large gaps in others (Figure 12). The gaps and wall profile of the morning room indicate that the morning room was probably built first and that the east to west range was added later. It is not clear why the builders felt it necessary to leave such a noticeable gap rather than filling it in.

Figure 12 Close up of joint on west facing elevation
Looking east

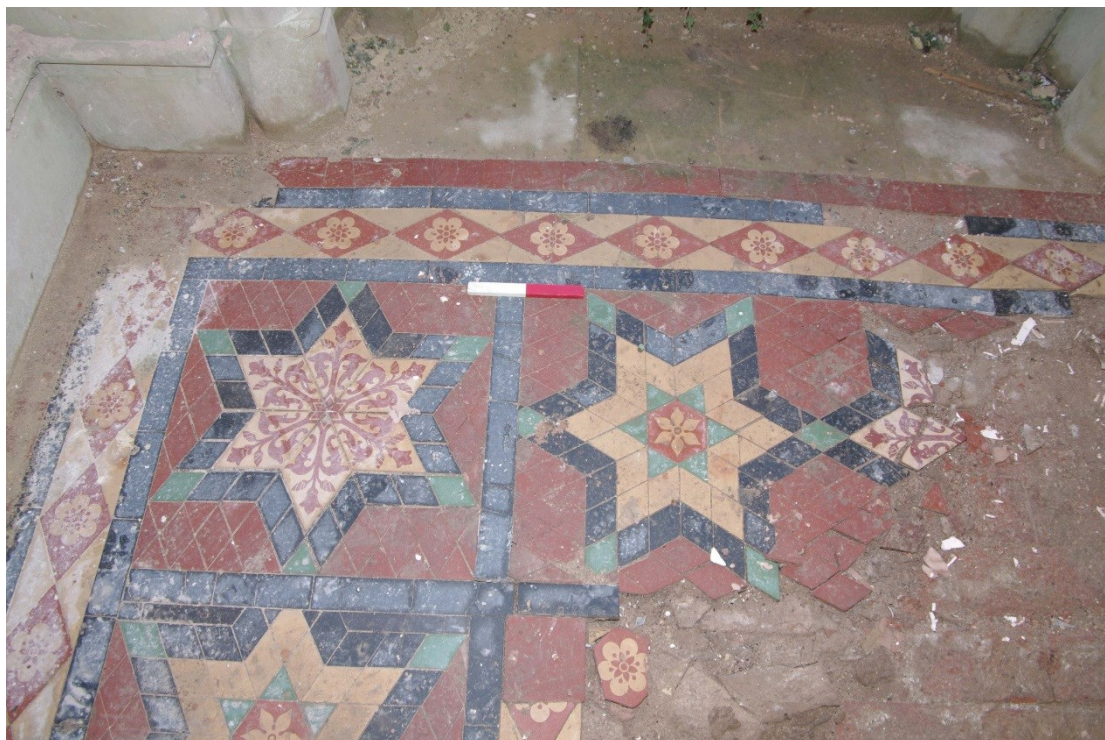
The floor has a central wooden area, presumably which once contained a carpet. Around the wooden area and leading up to the walls the floor has been laid with Minton, or Minton style, tiles with geometric patterns (Figure 15). The floorboards and the tiles have been badly affected by water and subsequent rot and will be repaired or replaced during the proposed works.

Figure 15 Floor tile detail in morning room
0.2m scale

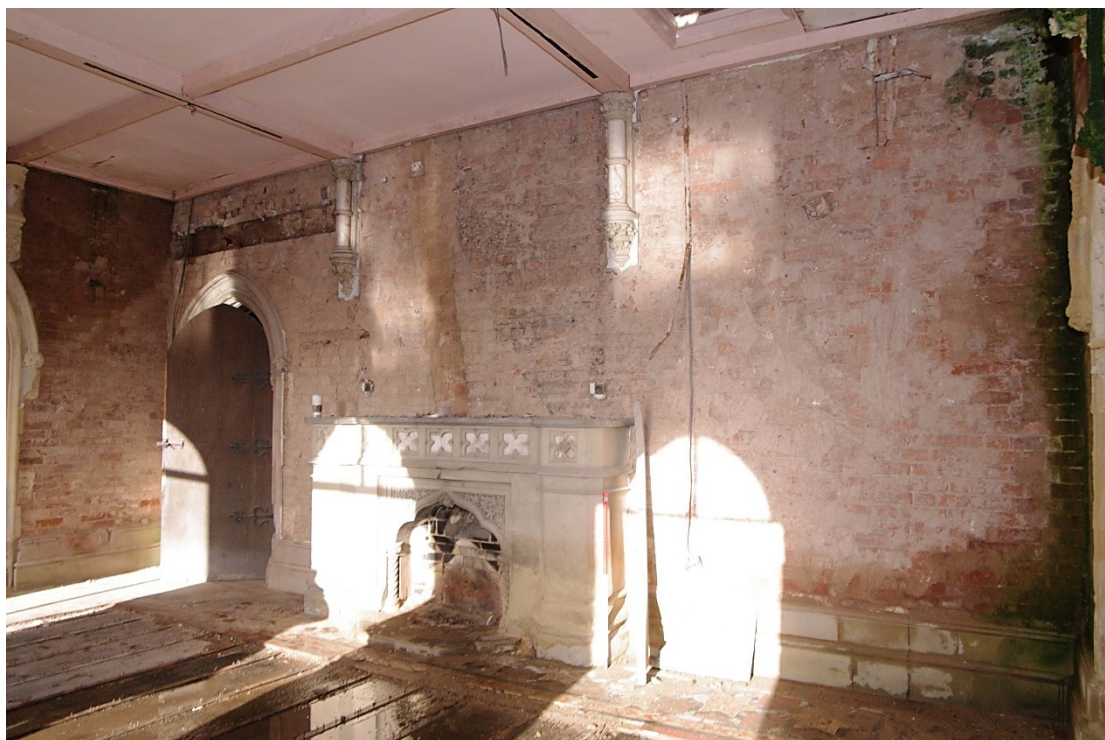
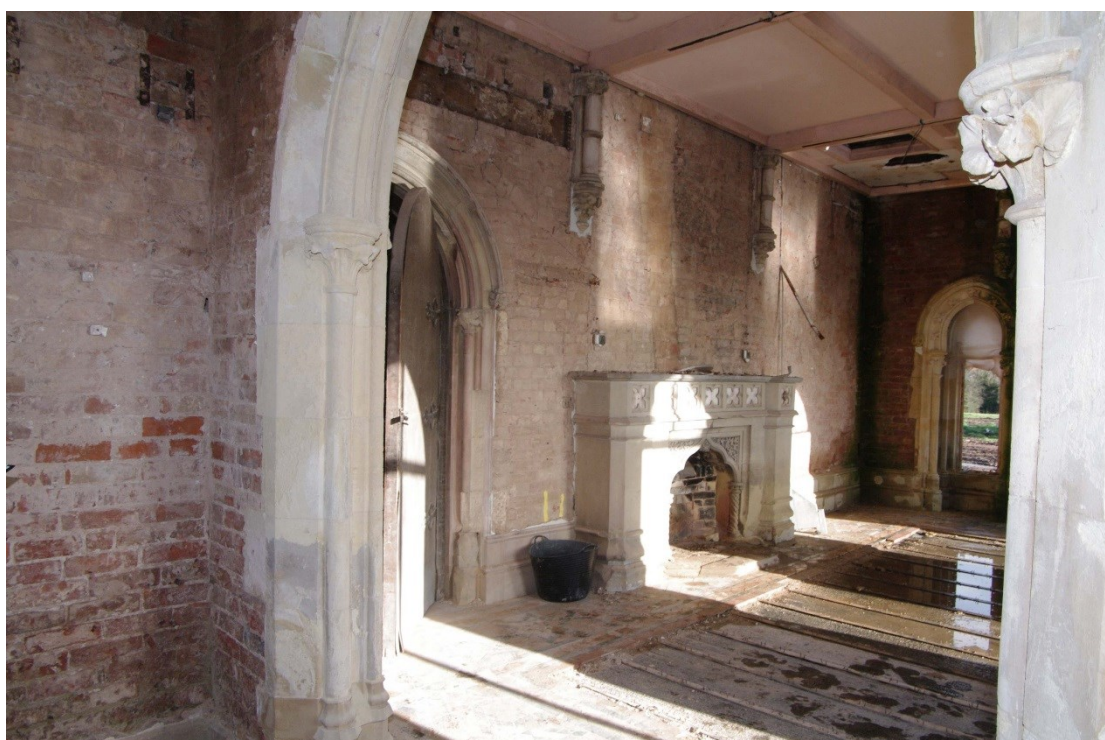
The north wall is the original outside wall of the 18th century farmhouse and, when first built, was an outside wall (Figure 19 and Figure 20). As a consequence of this the brickwork and pointing on this wall is of a better quality than the other internal walls which were never intended to be seen. A large stone-built fireplace has been added to the back of an earlier set of chimney stacks and the exposed brickwork shows where the new flue has been cut into the wall. The stone fireplace is built using limestone and matches the rest of the stonework in this room. The large archway leading from this room and into the main hall has deeply moulded details and again matches the other arches in the room. A diagonal line of bricks above the arched doorway may be evidence of an earlier roofline of a lean-to structure or it may be a relieving course above the inserted doorway. At the base of the wall is a high limestone skirting with moulded detail which runs around the whole room.

Figure 19 North internal wall of morning room
Looking north-west

Figure 20 North internal wall of morning room
Looking north-east through archway of the orangery

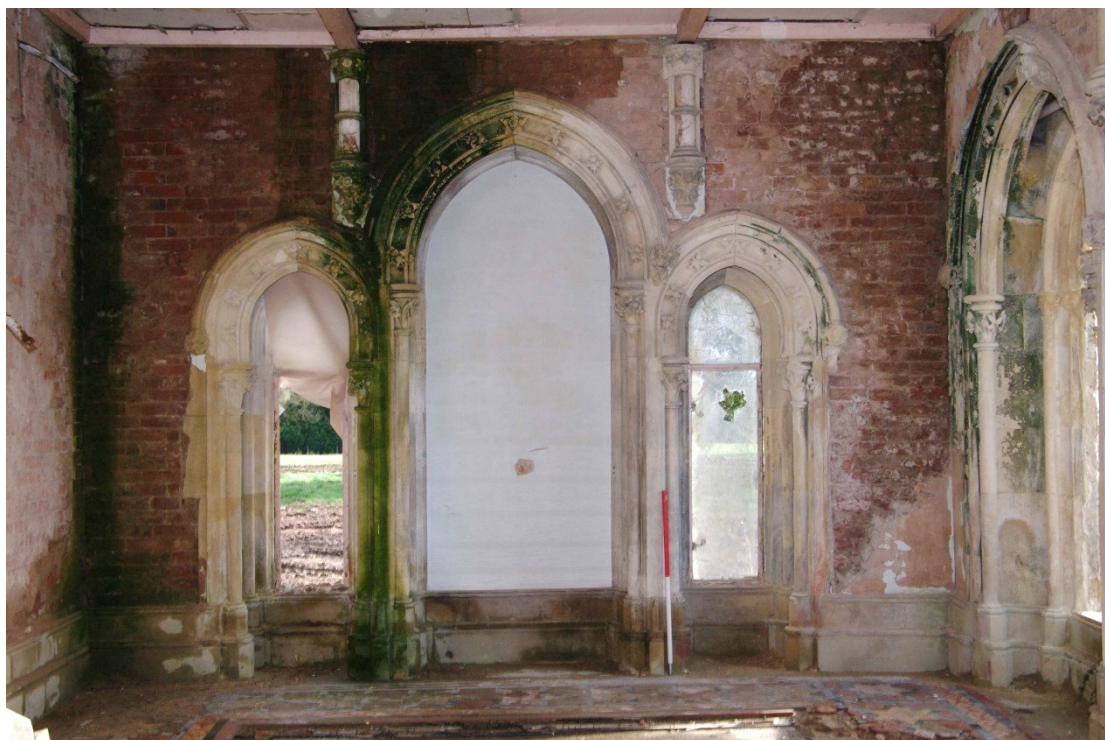
The east wall is dominated by the three Gothic lancet windows (Figure 21). The recessive arches are richly carved with additional decoration on the column capitals which run up the sides of each window. Each capital is different and includes a variety of foliage and flowers including daffodils and also one which contains a bird's nest including mother and chicks (Figure 22). In places the stonework has been badly affected by damp and has a large amount of green mould growing on it. Other areas of

stone are also crumbling away. The central window is the largest of the three and, at the time of the survey, was blocked. The proposals are to reopen this window which should have little or no adverse effect upon the historic fabric of the building. The two side windows have partial metal frames and monkey tail handles on the latches suggesting a 1920s date when they probably replaced the earlier frames. Modern fittings for blinds have been fitted into the apex of each arch.

Figure 21 East internal wall of morning room
Looking east. 1m scale. The centre window will be unblocked

The proposed new roof and the reopening of the window on the east wall should have a minimal impact on the historic fabric of the room. Very little of the window frames survive on any elevations so will need to be replaced in, hopefully, a sympathetic style. The existing floor is in a poor state and will clearly need to be replaced. It would be desirable, if possible, to retain and re-lay the existing floor tiles. The new access to the proposed flat-roofed extension with break through some historic fabric but this should cause a minimal impact on the room.

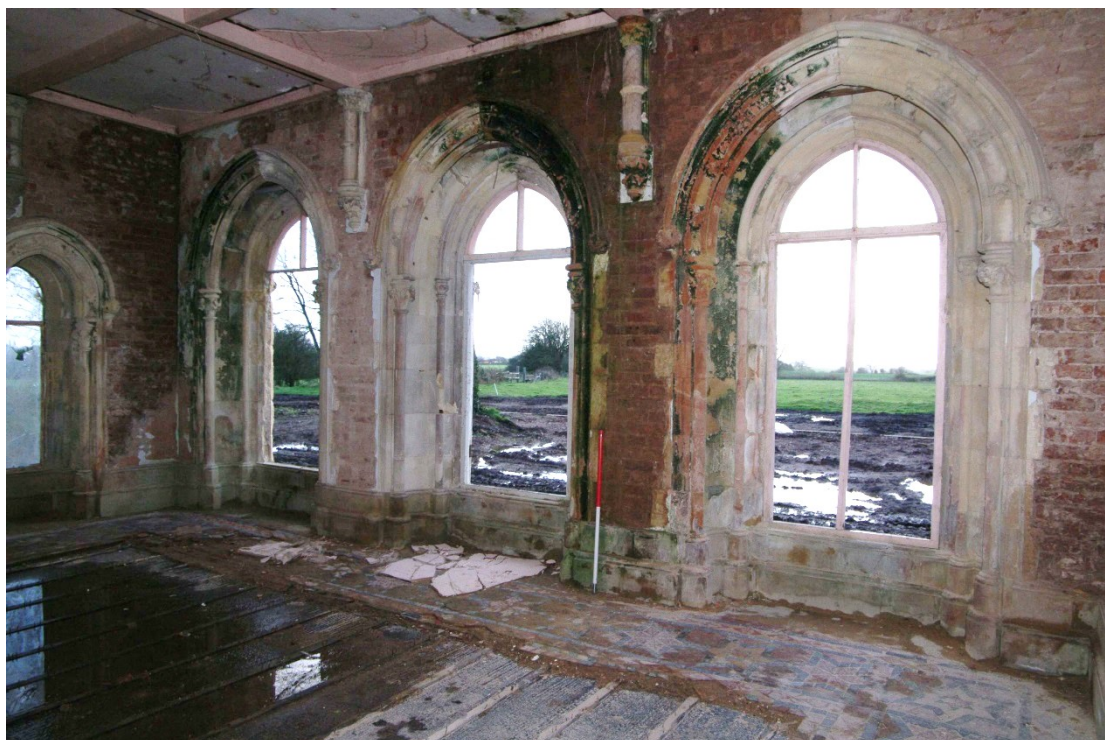
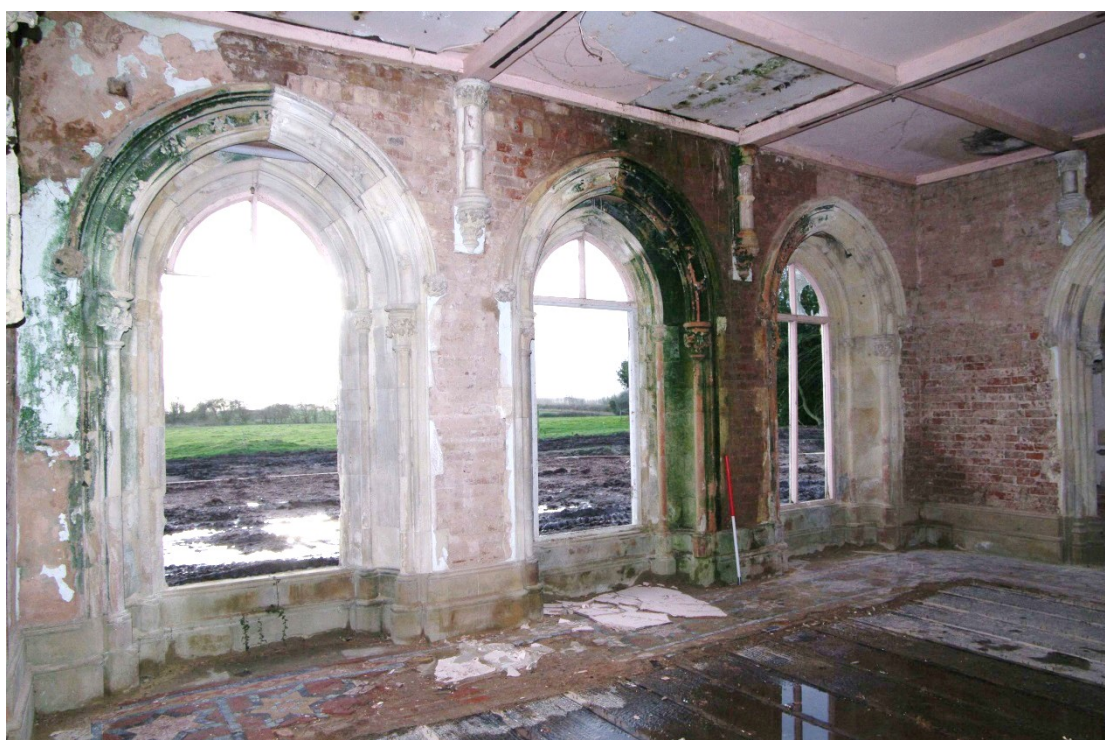
The south wall has three large lancet windows again with carved decoration around the arches and the tops of the columns (Figure 23 and Figure 24). The windows, as discussed earlier, have some of their wooden frames surviving but the low level of decoration suggests that the woodwork is a modern replacement. The proposals are to create a new doorway through the centre window to gain access to the new build room. The sides of the window are probably wide enough to be able to break through the brickwork without affecting the moulded stonework (Figure 25 and Figure 26).

Figure 23 South wall general internal view
Looking south-east. 1m scale

Figure 24 South wall general internal view
Looking south-west. 1m scale

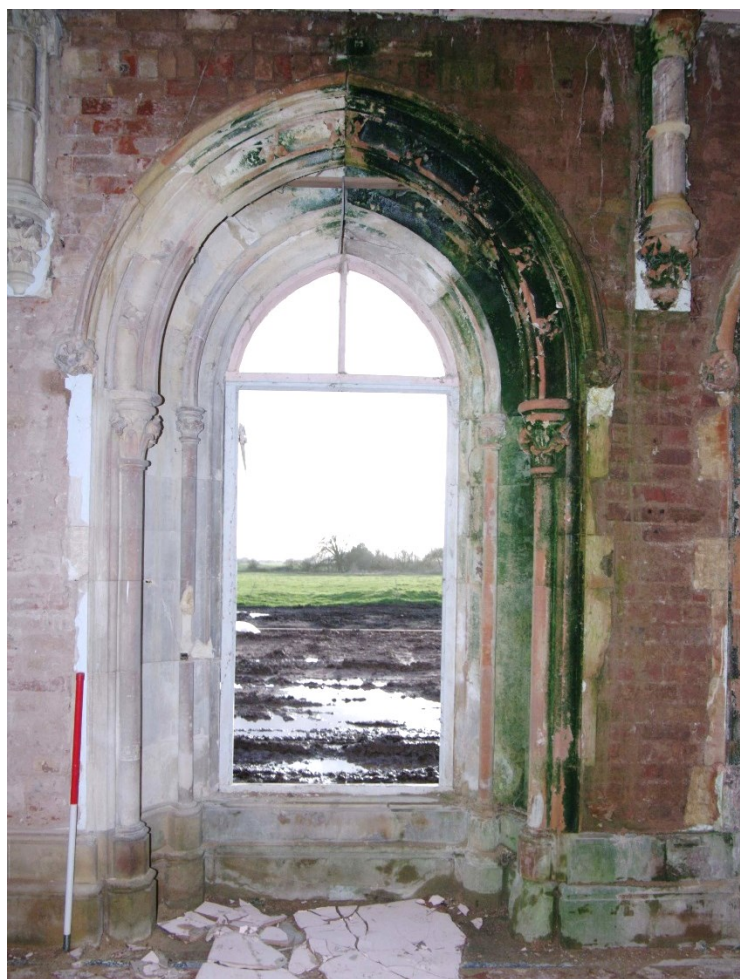
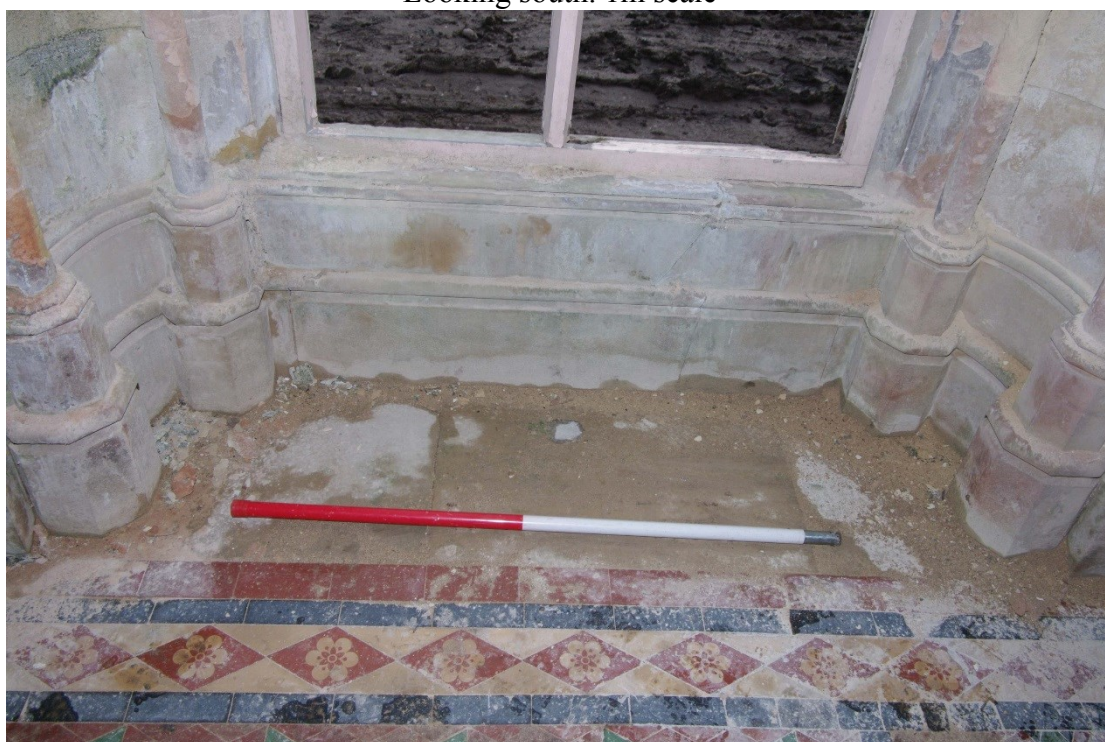
Figure 25 South wall, centre window internal detail
Looking south. 1m scale

Figure 26 South wall window moulding detail
1m scale

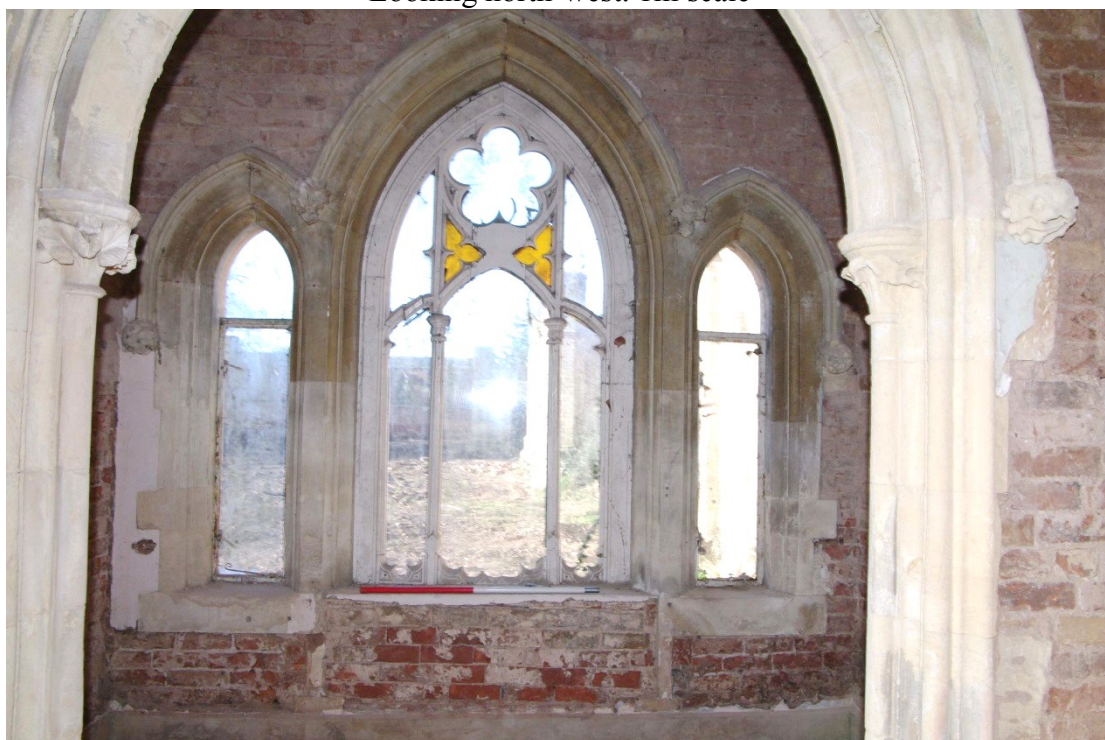
The west wall of the morning room is formed by a large recessed area currently known as the orangery (Figure 27). The space is reached by passing beneath a large arch which dominates the western end of the room. Three lancet windows are located within the space (Figure 28 and Figure 29). The centre window, as noted outside, has some wooden tracery remaining along with some stained glass panels. Although this seems to be late 19th century in date it appears to have been modified from a former doorway as the brickwork below the present window has been inserted between the original stone door jambs (Figure 30).

Figure 30 West wall lancet window detail
Looking west. 1m scale. Noted patched brickwork under centre window

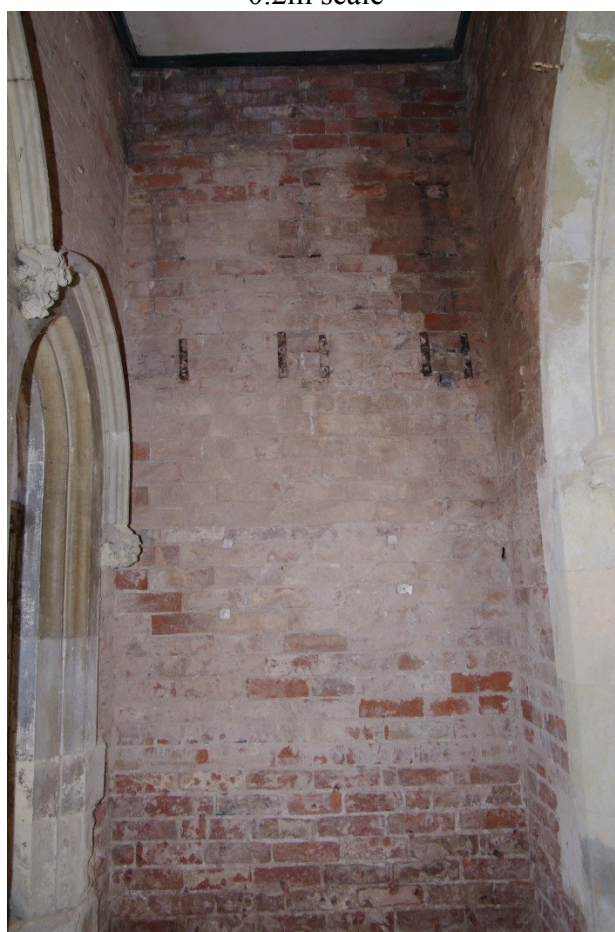
The floor of this recessed area has Minton style tiles which are of a different pattern to those in the main part of the room (Figure 31). The side walls (north and south) have traces of a vaulted ceiling which has since been replaced by a later flat ceiling (Figure 32). Despite it being called the orangery this space seems likely to have been built as a grand outside entrance porch to the morning room.

Figure 32 Brackets on south wall of recessed orangery
Brackets show where vaulted ceiling was supported
