**Launde Abbey, Launde,
Leicestershire:
Archaeological Evaluation**

For Trustees of Launde Abbey

University of Leicester Archaeological Services

Report 2006-016 ©2006

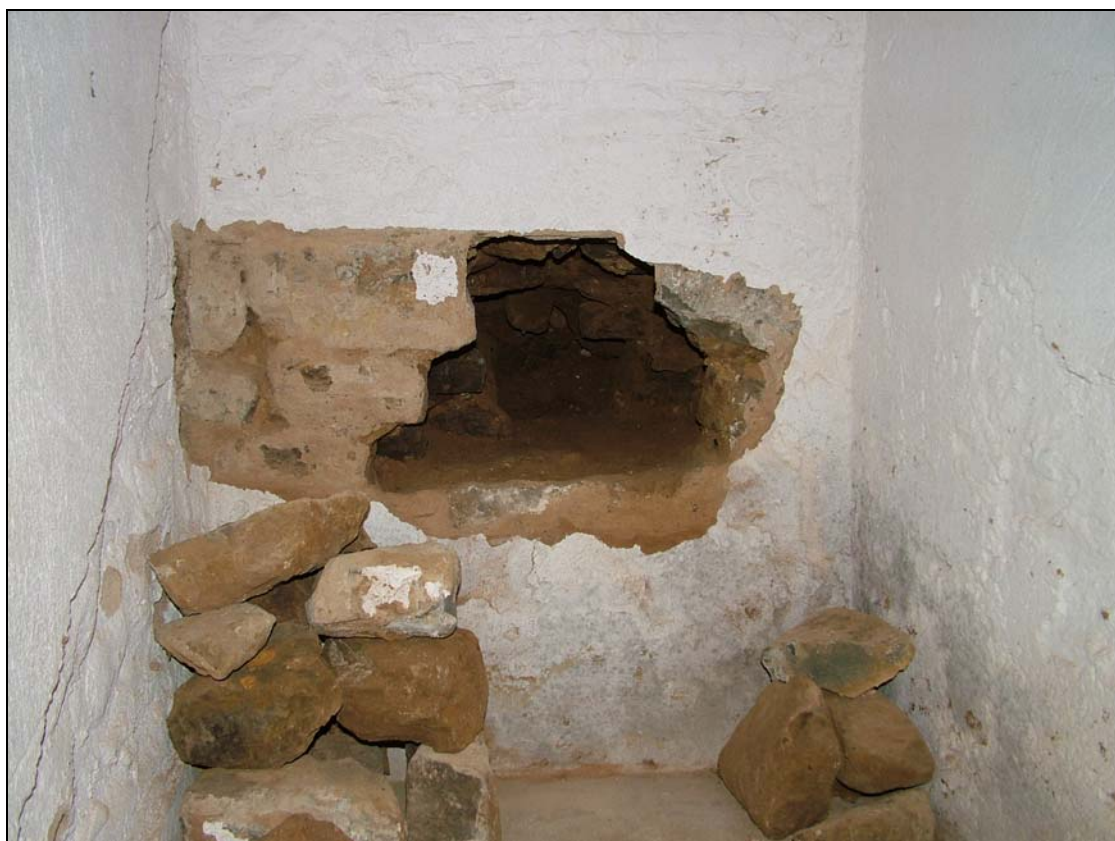
A single opening measuring 0.3m x 0.3m was created in the stonework blocking the Perpendicular archway, towards the base of the arch within the current Vestry (1 on Figure 2; Plate 1). The opening was created using a lump hammer and chisel. Rather than being blocking infilling the archway, it was apparent from the investigation that this masonry was a wall located hard against the west side of the medieval wall which accommodated the Perpendicular arch. The opening revealed that the wall was 0.56m (22 inches) thick and composed principally of ironstone. It was faced on both sides with roughly squared blocks bonded with mortar, whilst the core consisted of smaller irregular fragments bonded with clay.

Behind (west of) this wall was a rubble 'fill' consisting of fragments of stone and mortar, clay lumps and some brick fragments (context 40). Finds from this deposit included a sherd of 13th or 14th century Bourne B ware pottery and early brick fragments likely to be pre-Dissolution in date.

Based on the established chronology of the building, the wall within which the opening was made would be the east wall of the north wing, constructed between 1541 and 1586 by either Gregory or Henry Cromwell. This was constructed alongside the earlier west wall of the south transept of the priory church, within which the Perpendicular arch is set.

Forming a new doorway at this point would involve breaking out a section of this early post-dissolution wall, rather than the relatively more straightforward matter of removing later blocking from the medieval archway, as was initially envisaged.

Plate 1. Opening within lower section of Perpendicular arch (1 on Figure 2)

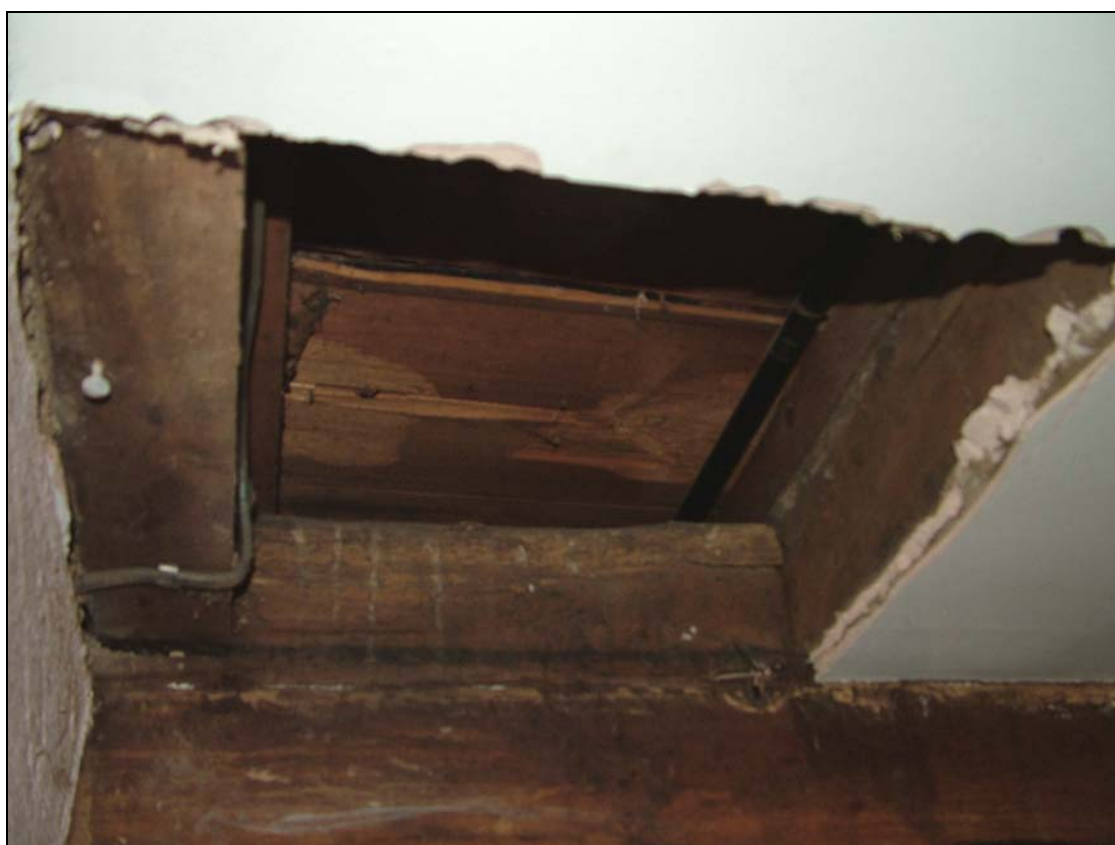
The Servery floor joists are underdrawn with plasterboard of comparatively recent date, forming the ceiling to the current Vestry. Two openings, each measuring c. 0.4m x 0.4m, were made in the plasterboard in order to assess the Servery floor structure from below (**2 & 3** on Figure 2; Plates 2 & 3). Three transverse oak beams support the floor joists, each measuring 204mm wide x 254mm high (8 inches x 10 inches). The beams towards the north and south ends of the room have crude chamfers but lack stops, that towards the centre of the room is un-chamfered. The west end of this central beam is supported on a pier composed of mortared ironstone constructed against the south reveal of the Perpendicular arch (**A** on Figure 2). The pier rises no higher than the beam and was evidently specifically built to support it. The transverse beam towards the north end of the room is supported at its east end by the brick wall dividing the Vestry from the Chapel on the north side of the Vestry door (see below and Plate 4). Its west end runs into a large block of masonry of uncertain date and function (**C** on Figure 2; Plate 5; and see below). The east end of the southern transverse beam is supported on a similar large block of masonry (**B** on Figure 2).

The floor joists are oak and average 100mm x 64-70mm (4 inches x 2½-2¾ inches), spaced at 381mm (15 inch) centres. The transverse beams are notched to accept the joists (cogged joists –Alcock *et al* 1996, F30), with the notches averaging only 25mm (1 inch) deep. 50mm (2inch) softwood battens are fixed to the upper face of the joists which support tongue and groove softwood boards typically 178mm (7 inches) wide.

The Servedy floor must be post-Dissolution in date as it overlies part of the south transept of the priory church. The overall form of the floor structure and the use of oak would initially seem to suggest a comparatively early date, say not later than the early decades of the 18th century. However, there are reasons to suggest that it is later than this, reusing earlier materials. The joist joints are extremely crude with the joists having only 25mm (1 inch) end bearing on the transverse beams. Whilst the overall effect *looks* correct for an early floor structure, from experience even the latest and crudest of traditional floors is more sophisticated than this. The suspicion is that this represents an attempt to produce an early looking floor structure at some later date. Furthermore the east end of the northern transverse beam is supported by a brick wall attributable to the 19th century (see below). Undated architects drawings (c. early-mid 20th century), reproduced as Figure 12 in the earlier Historic Building Assessment (ULAS report 2005-096), indicate that the current Servedy was a Butlers Pantry in Launde Abbey's final incarnation as a private house. It must have been floored at that time. Since the current door from the Chapel into the Vestry was not created until c. 1957 (see Plate 42 in the earlier Historic Building Assessment), what is now the Vestry must effectively have been dead space before that time (though possibly with limited access from the cellar beneath the present Kitchen). It may be that the Servedy floor structure was modified as late as 1957 as part of the alterations to create the Vestry, perhaps to provide a suitably 'early' feel to this space. The softwood battens above the oak joists are certainly late and the floorboards – which could be 19th or early 20th century – must have been re-laid at the same time.

Plate 2. Opening to expose underside of Served floor structure (2 on Figure 2)

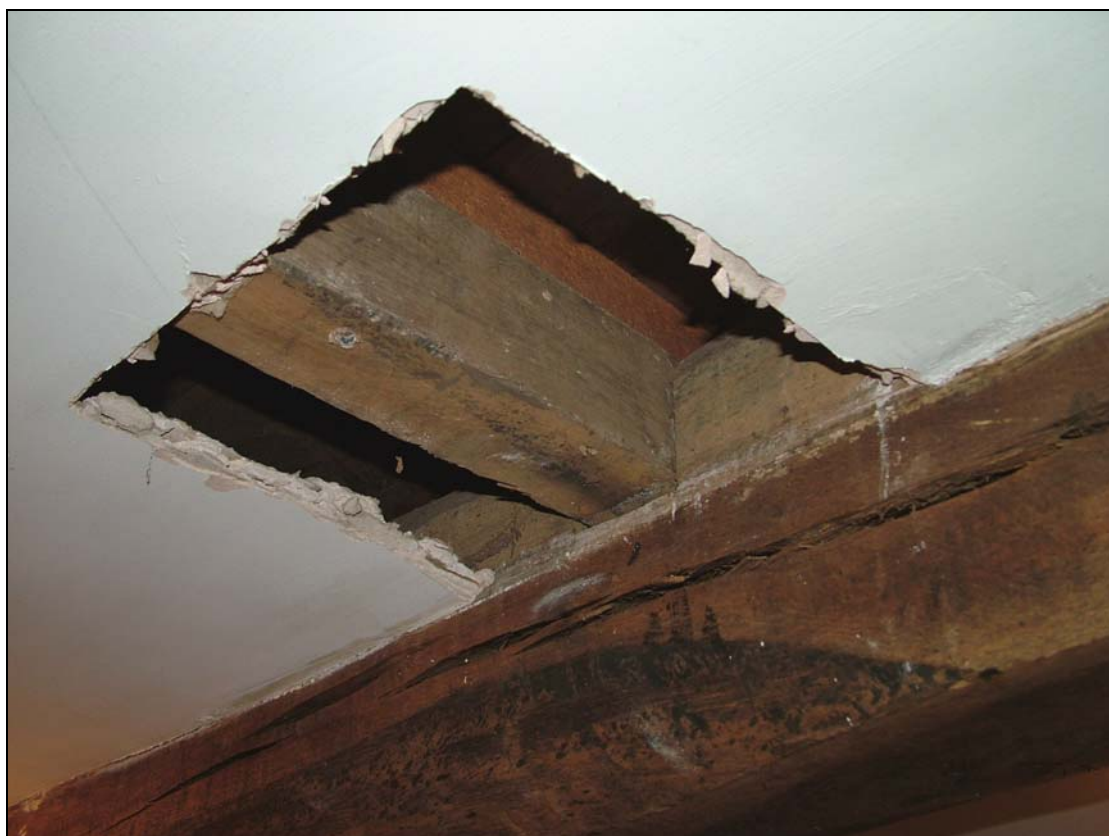
Plate 3. Opening to expose underside of Served floor structure (3 on Figure 2)

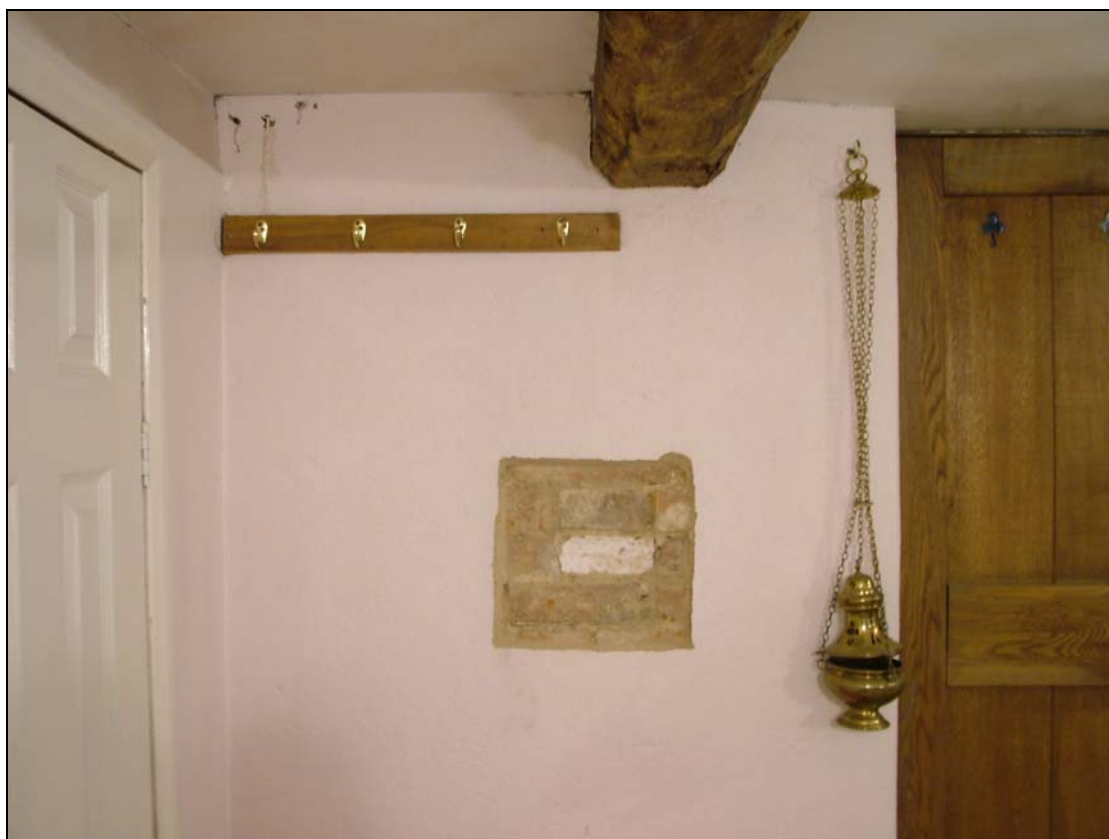
Two openings were made in the plaster of the east Vestry wall, north of the doorway, in order to assess the character and date of the wall fabric. The first opening measured 0.3m x 0.3m (5 on Figure 2; Plate 4). The wall was brick-built (brick dimensions: 229 x ? x 64mm (9 x ? x 2½ inches) and is attributable to the 19th century. Numerous incomplete and some overfired bricks were used and it was apparent that the brickwork was never intended to be visible. The west face of this wall, within the Chapel, is rendered with a decorative scheme of incised lines imitating ashlar masonry. The scheme is unbroken, except for some localised damage around the Vestry door, which was inserted in 1957. This decorative scheme can be traced through into the stairway leading to the garden on the south side of the Chapel, then up into the main corridor and as far south as the service staircase. The decorative scheme is attributable to the 19th century and may form part of Thomas Rickman's alterations of 1829. The fact that the service staircase added c. 1850 appears to interrupt the scheme would tend to support this interpretation.

Plate 4. Opening in east Vestry wall to assess underlying fabric (5 on Figure 2)

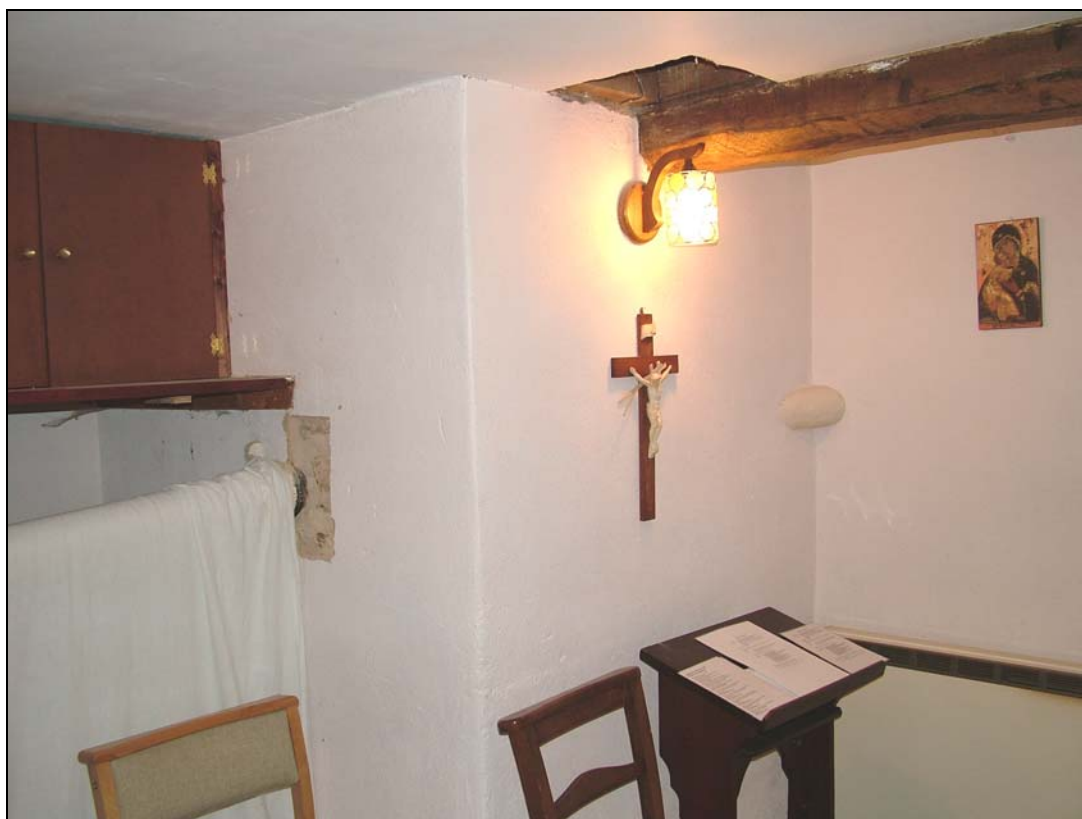
Two large blocks of mortared stonework within the present Vestry (**B** & **C** on Figure 2) are hard to explain. **C** (Plate 5) is located directly beneath a cupboard in the Butlers Pantry shown on the architects drawing referred to above (Figure 12 in the earlier Historic Building Assessment). This appears to be a relatively substantial structure (possibly a plate safe?), which may have required a reasonable foundation. No equivalent explanation can be suggested for **B**. Alternatively, both **B** and **C** may simply have been introduced to support the transverse beams of the Servedy floor, though if this was the case, why are they so large? A cast iron waste pipe of 20th century date passes through **C** and alters direction slightly within its mass. This would presumably require a joint in the pipe, which would suggest that **C** is a hollow structure rather than a solid stone mass.

Plate 5. Masonry block in northwest corner of Vestry (C on Figure 2)

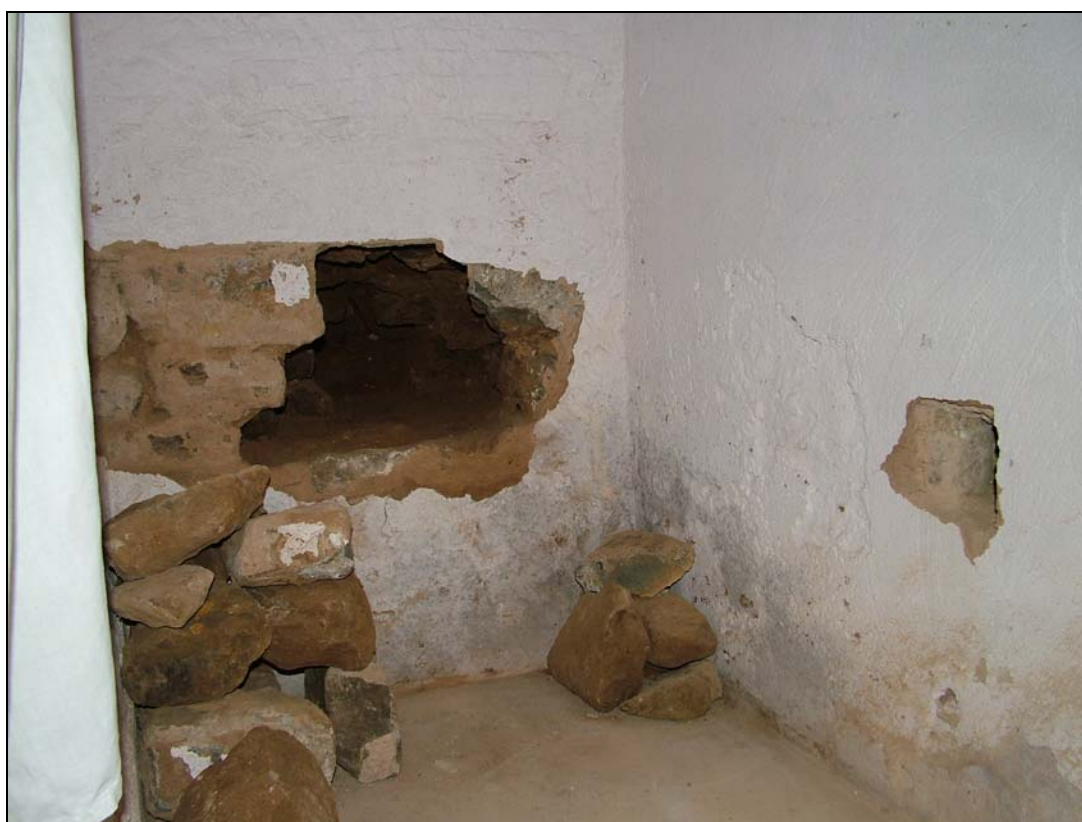
Plate 6. Small opening (on right) exposing moulding on north side, east face of Perpendicular arch within Vestry (illustrated on Figure 2)

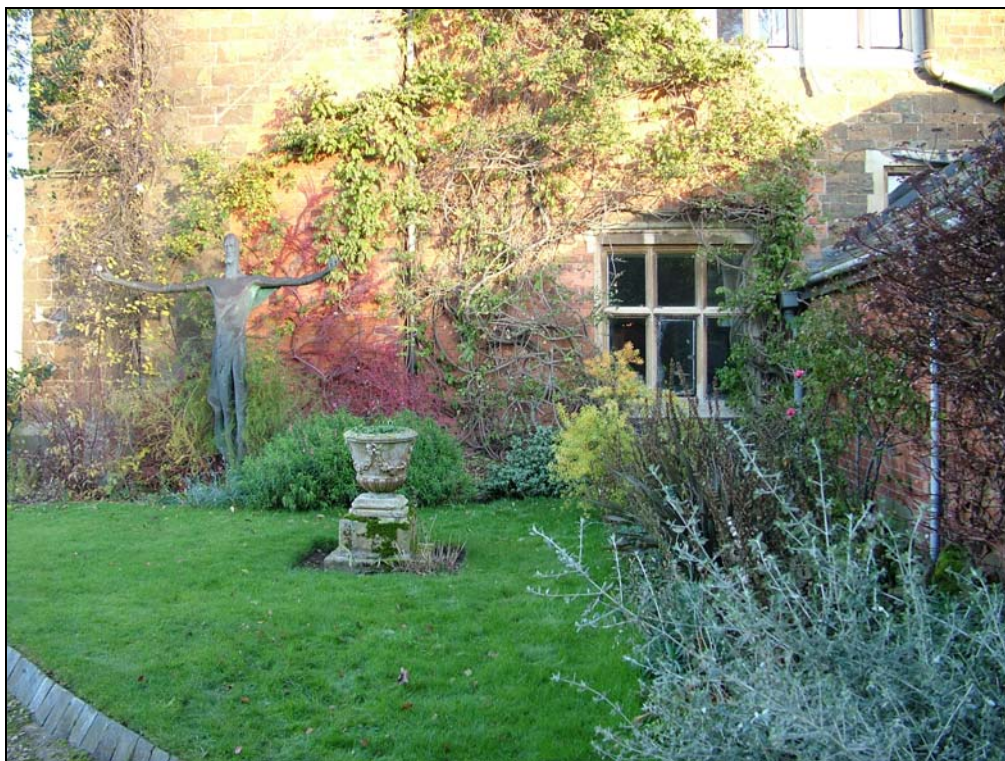
Both excavations were located immediately to the south of the western range of the main buildings in a small garden where a new public entranceway is planned to cover much of this area. A scar from the roofline of an earlier structure can be seen on the south facing wall with a large area of 19th century brickwork below this line. A window may indicate the location of an earlier doorway into the building from the main house (Plate 7). It was hoped that a trench in this area would reveal any surviving remains of this structure.

Plate 7. Pre-excavation location of Trench 1 and Test pit 3. Note earlier building scar above statue

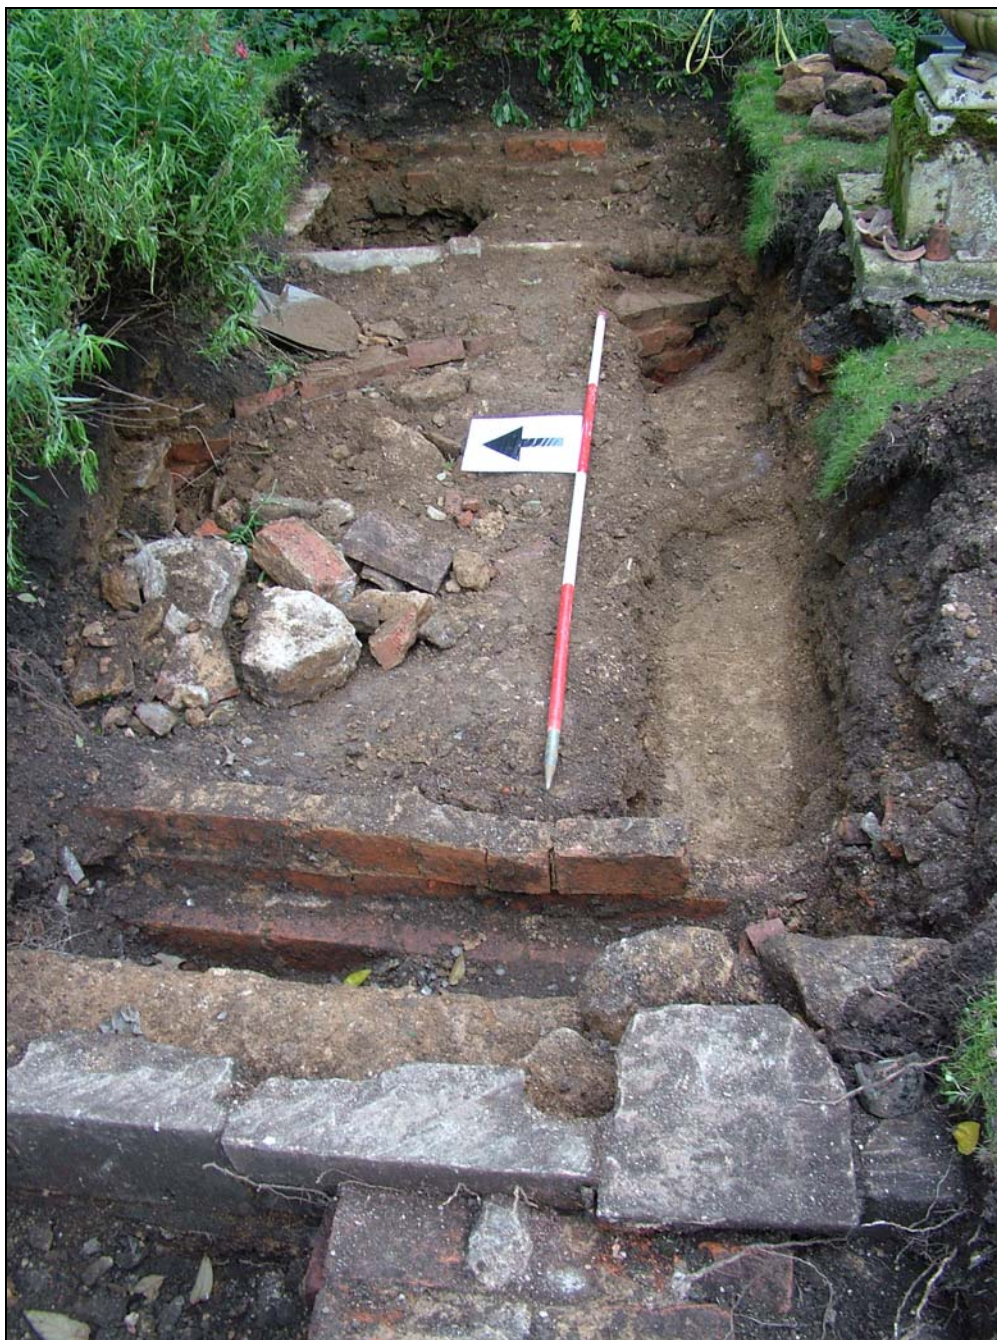
Plate 8. Trench 1

Originally specified as a single 9m long trench running north to south the information that a water pipe ran across the lawn and the location of a large garden urn made it necessary to adjust this to a 5m x 1.6m east to west trench and a 1.85m² test pit to the south of this (Figures 4 & 5). Approximately 0.1m of turf and dark brown sandy silty loam topsoil (1) containing a small quantity of modern white glazed pottery and plant pot fabric covered both excavated areas. Beneath this was a similar subsoil layer (2) with a depth of around 0.1m in Trench 1 and 0.14m in Test pit 3 containing a significant amount of brick rubble and a single decorated piece of floor tile of probable 19th century date. Sealed by the subsoil was a thick demolition layer (3)

consisting of a large amount of brick rubble, sandstone fragments, broken plant pot and broken glass in a loose matrix of sandy degraded mortar. A number of service pipes ran through this material which was confined in Trench 1 by a single north to south row of mortared bricks (measuring 235 x 110 x 75mm) at the eastern end and by a north to south brick channel (5) to the west. A large amount of broken glass was noted within this channel but was not retained. As Test pit 3 was much smaller this layer covered the whole of the excavated area with a loosely mortared brick wall just extending into the western section. In Trench 1 excavation of demolition layer (3) revealed a firmer pale cream coloured sand and mortar layer (7) without any demolition rubble into which a brick lined, tile capped culvert (6) was cut. The brick channel (5) also cut into, but not through, layer (7). Further excavation in Test pit 3 showed this layer was around 0.12m thick and had been laid on what appears to be a brick rubble levelling layer on top of a thin layer of light brown clayish sand which had evidence of either root disturbance or archaeological activity. Unfortunately a heavy duty electric cable ran across the base of the test pit and no further excavation was carried out. A faced stone wall (4) was observed immediately to the west of channel (5) running north to south across Trench 1 (Plate 8). The wall had a single surviving ashlar course of limestone blocks set on a coursed rubble ironstone foundation. Butting up against the west face of the wall foundation was a crudely constructed brick plinth (8) (bricks measuring 235 x 102 x 75mm) with a flat top set 0.16m below current ground level (Plate 8).

The faced stone wall (4) is in line with the scar seen on the south facing wall and appears to continue southwards beneath the present driveway although the exact limits are not known. The width of the foundations at 0.5m correspond with a reasonably substantial structure, in keeping with that illustrated in the undated engraving.

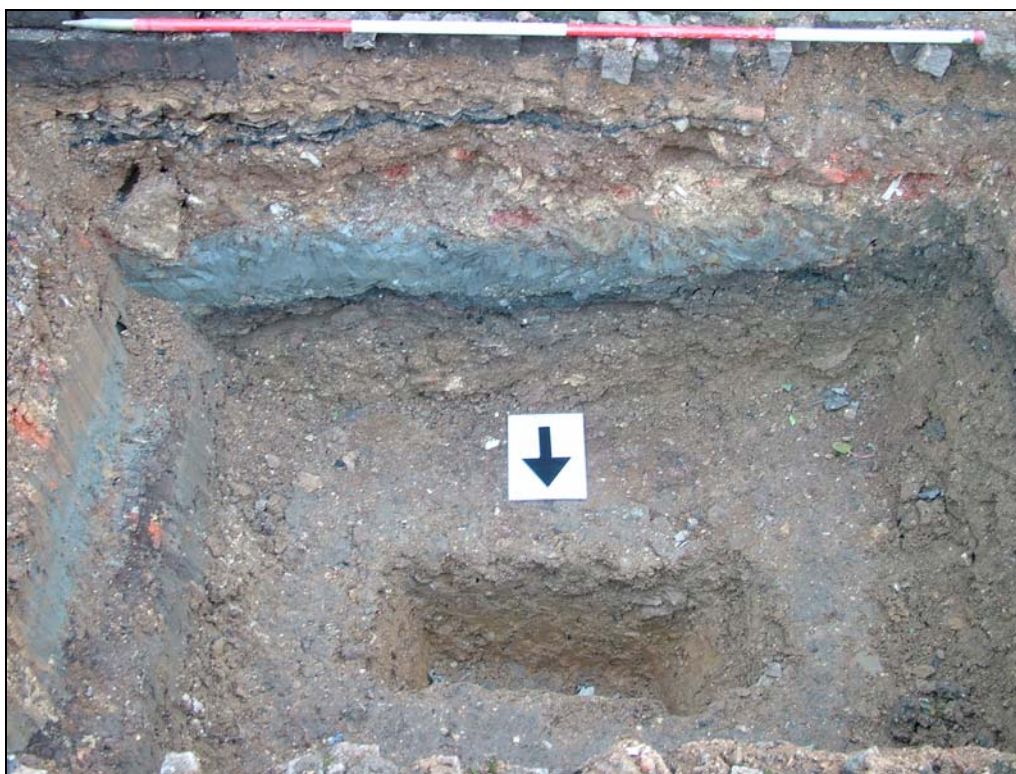
Beneath the granite sets and a thin sand bedding layer was layer of sandy rubble (9) that increased in depth from 0.1m at the western end to 0.2m in the east. This appeared to be laid on top of a very thin layer of ashes or cinders which further sealed a possible earlier cobbled, or metalled, surface (10). An apparent tipped layer of sandy mortar (11) with a large amount of broken brick rubble covered two dark grey clay layers (12) and (41) which were rather organic in their texture and smell. Running through these two layers were a number of thin bands of degraded mortar. A very thick layer measuring up to 0.6m in depth of grey brown clay and plaster rubble (13) was observed beneath the two organic layers. A cleaner 0.1m thick layer of yellow brown clay with a smaller quantity of plaster and mortar rubble (14) formed an earlier deposit which in turn sealed a very firm dark to mid brown clay layer (15) which had a small quantity of mortar fragments and charcoal flecks within it.

Due to safety considerations this trench was not excavated any deeper so the thickness of layer (15) is not known and the depth to undisturbed natural is also not known. The total depth of the stepped trench was 1.65m below current ground level (Plate 9).

Plate 9. Trench 2 North facing section

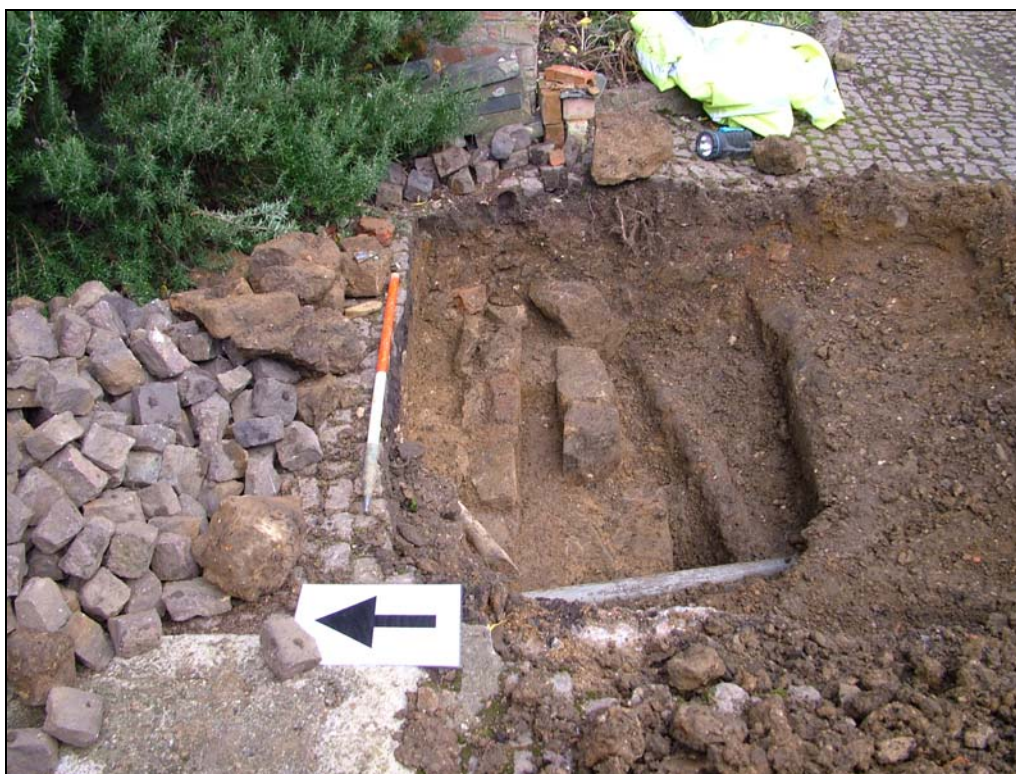
Careful machine excavation revealed a great deal of disturbance beneath the granite sets due to the presence of a cast iron service pipe, a lead water pipe and a later plastic pipe (Figures 8 & 9). Although these services had damaged any higher archaeological deposits the remains of a stone capped drain (16) could be seen running in a west to east direction down the slope of the courtyard (Plate 10). The base of the drain was lined with a 0.04m thick bed of red brown clay placed on top of a dressed stone base.

Plate 10. Test pit 2 plan

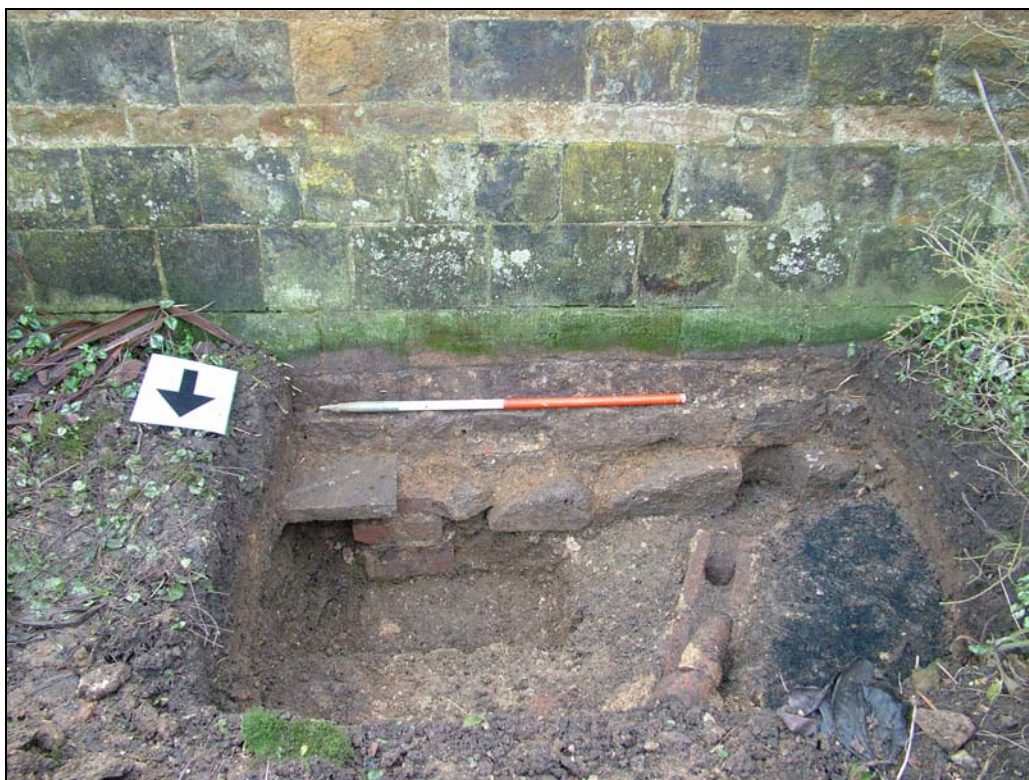
Removal of 0.25m of topsoil and subsoil revealed a beige grey brown clay layer (29) which sealed all lower features and butted up against the polychrome wall. This 0.12m thick layer was fully excavated to expose a dark ashy charcoal layer (30) cut by a land drain [32] and a north to south drain [26] and which butted up against the polychrome wall. Drain [32] headed away from the wall in a north easterly direction and consisted of inverted horseshoe land drains mortared at each joint with another

The polychrome wall (34) had rather shallow foundations extending only 0.5m below present ground level which is around 0.1m higher than the base of the foundations seen on the southern side.

Plate 11. Test pit 4 plan and polychrome wall

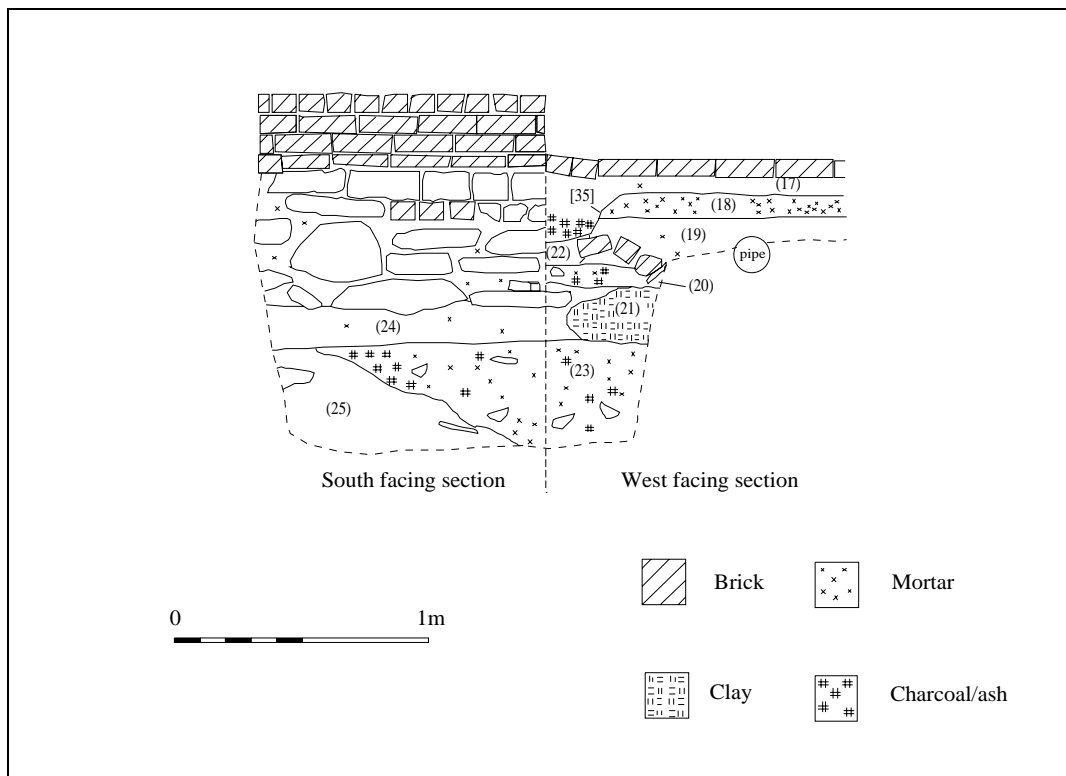
Figure 7. Test pit 1 South and West facing sections

The alley was paved in blue bricks laid on a silty clay bedding layer (17) on top of a plaster/mortar levelling layer (18). These two layers, and a further rubble fill layer (19) were cut by the foundation trench [35] for the wall. Because of the location of a ceramic drain or sewer pipe it was difficult to see if the layers beneath this, which consisted of an ash layer (20) and a grey clay layer (21) were also cut by the wall foundation trench although this does seem probable. A possible dump or pit filled with dark grey clay silt (23) lay beneath layer (21) but was not fully excavated. No undisturbed natural substratum was seen.

The excavation showed that the brick skin of the wall was laid on top of roughly coursed ironstone foundations bonded with lime mortar. The foundations were cut into a grey brown plaster rubble layer (24) similar to layer (13) seen in Trench 2. The dump of dark clay silt (23) could be seen extending beneath layer (24) and appeared to cut into a lower layer which was similar in nature to (24) but with slightly less rubble and a higher clay content.
