**A Historic Building Recording at the
Tudor Inn Hotel,
Bondgate,
Castle Donington,
Leicestershire.**

ULAS Report No. 2018-100
©2018

For: Castle Donington Parish Council

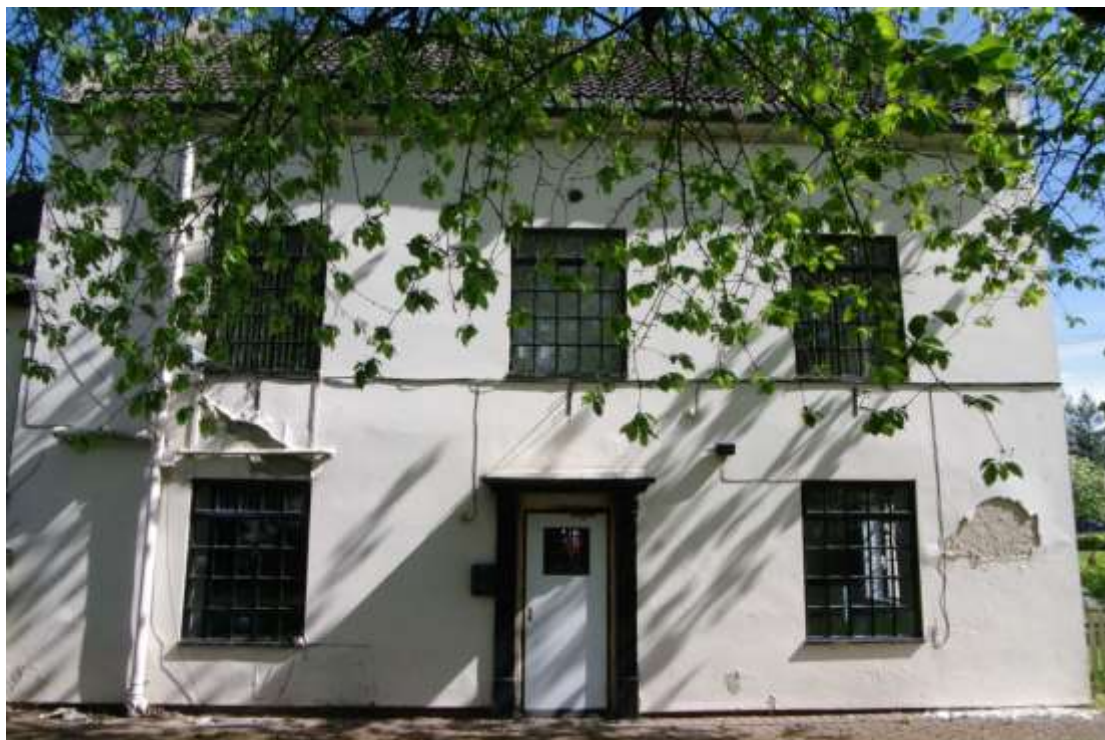
As noted, the north-west facing elevation looks out across a small grassed area onto The Spittal road and Bondgate (Figure 7 and Figure 8). A number of semi-mature trees are located within the grassed area in what was presumably an open garden giving unrestricted views both from the house and of the house. The elevation is relatively plain with three bays and a centrally located ground-floor doorway. The window openings appear to be in their original positions but the frames and fittings are from the later 20th century. When seen from inside the window openings have been reduced in width. This is discussed in more detail in the section below. The doorway has decorative pilasters supporting a small canopy all of which appear to be quite modern. They may have replaced an earlier porch although the plainness of the frontage suggests that the house probably had a relatively simple doorway with little decoration. The whole building has a coat of modern render which masks any indication of earlier modifications. Where the render is breaking away the original brick wall can be seen. It seems likely that the render was added to mask the scars left by the reduction in window size and possibly to hide the soft 18th/19th century bricks which may have been degrading. The bricks appear to be hand-made and of quite soft fabric.

Figure 7 North-west facing elevation
Looking south-east

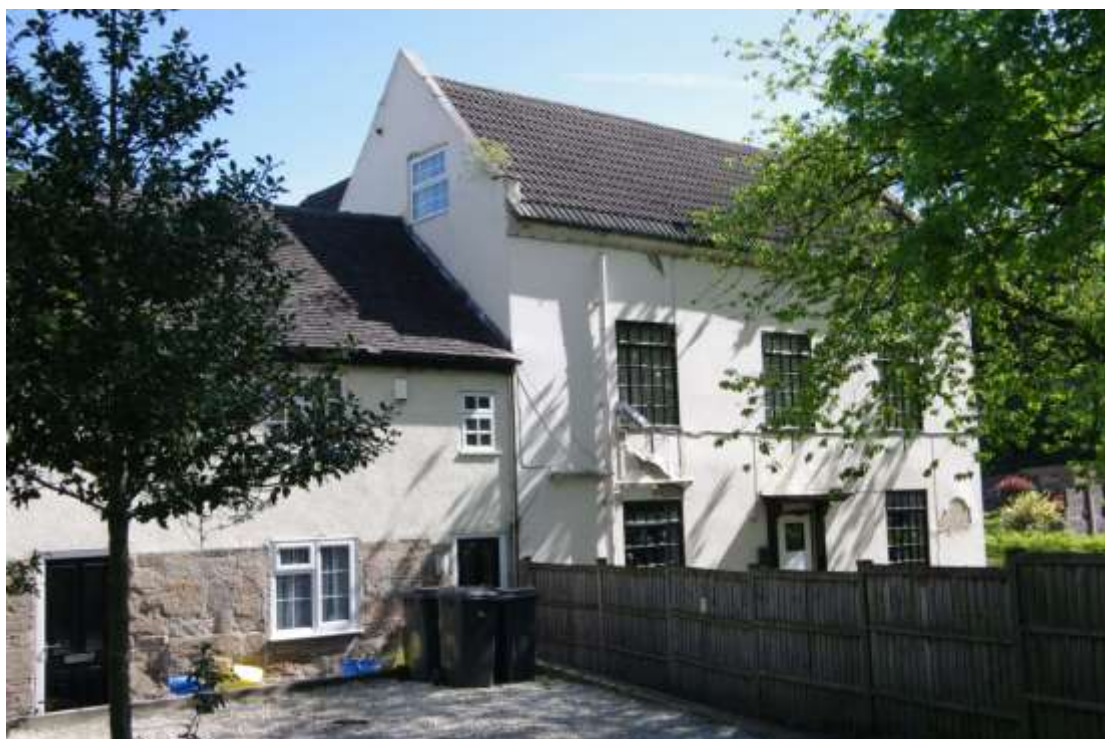
Figure 8 North-west facing elevation and adjacent cottages
Looking south

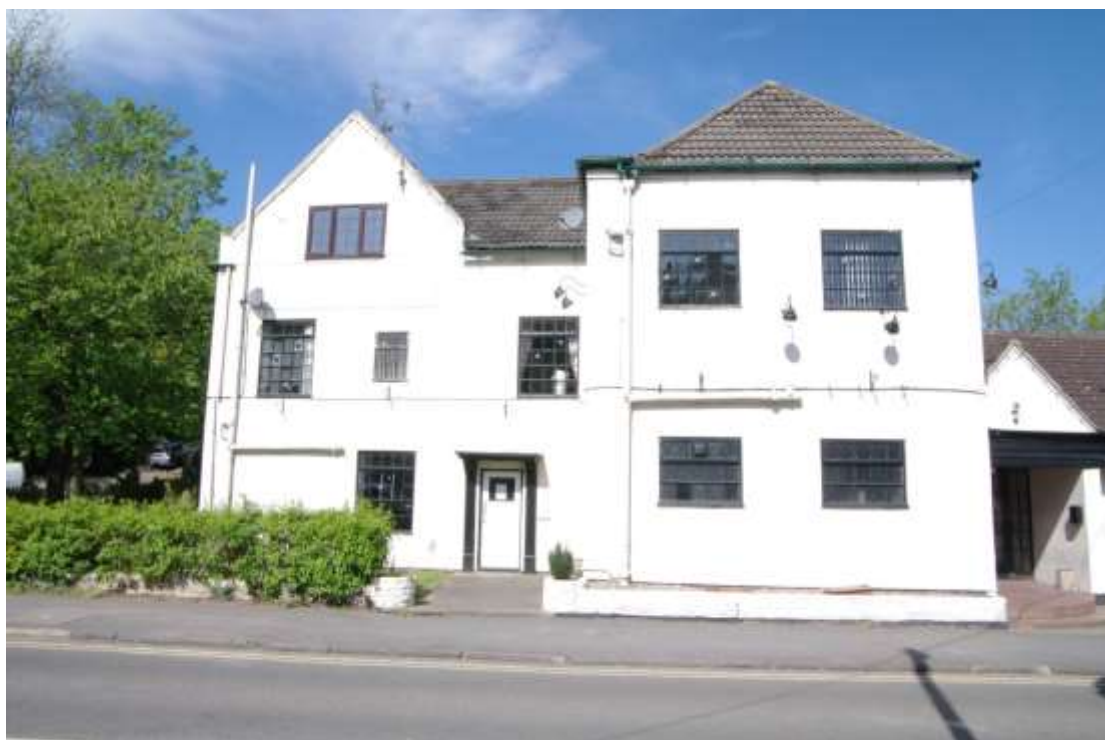
All of the window frames and fittings on this elevation have been replaced with modern ones and the walls are rendered. The elevation has three key components: on the western side is the gable-end of the north-west facing range, this is joined to a projecting range running across the back (south-east) of the north-west facing range. The final element is the single storey function room on the eastern side of this elevation (Figure 9 and Figure 10).

Figure 9 South-west facing elevation
Looking north-east. Modern function room on right

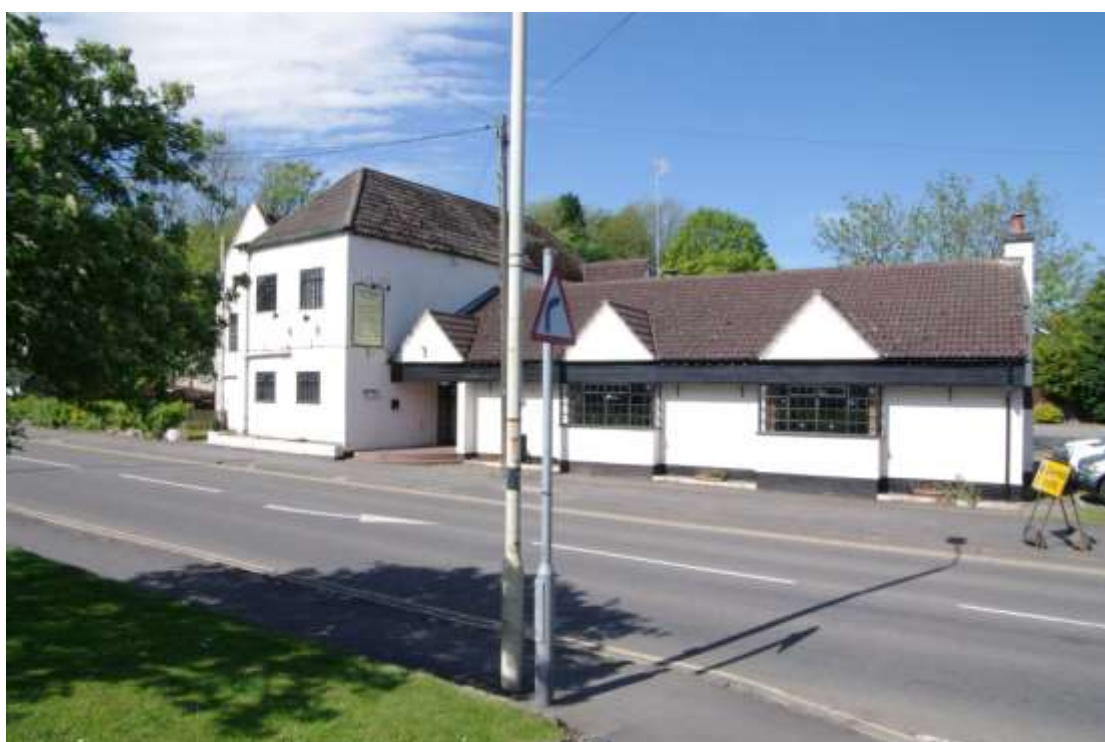
Figure 10 South-west facing elevation
Looking north.

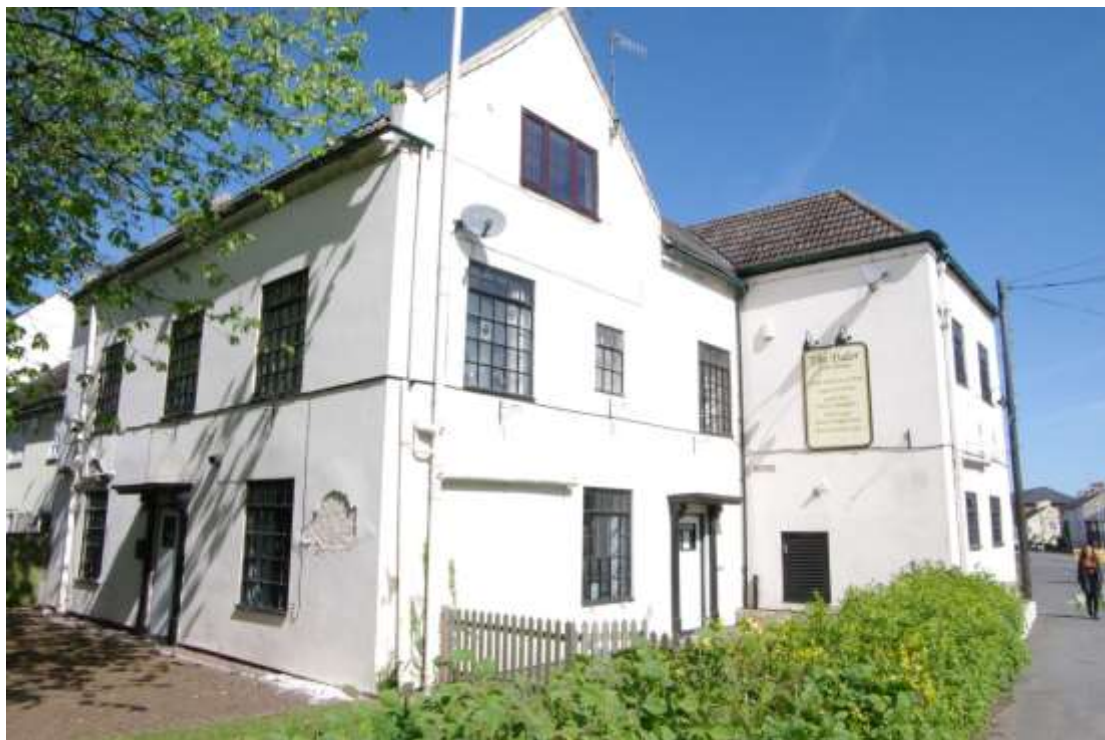
Figure 11 South-east corner of the Tudor Inn
Looking north-east

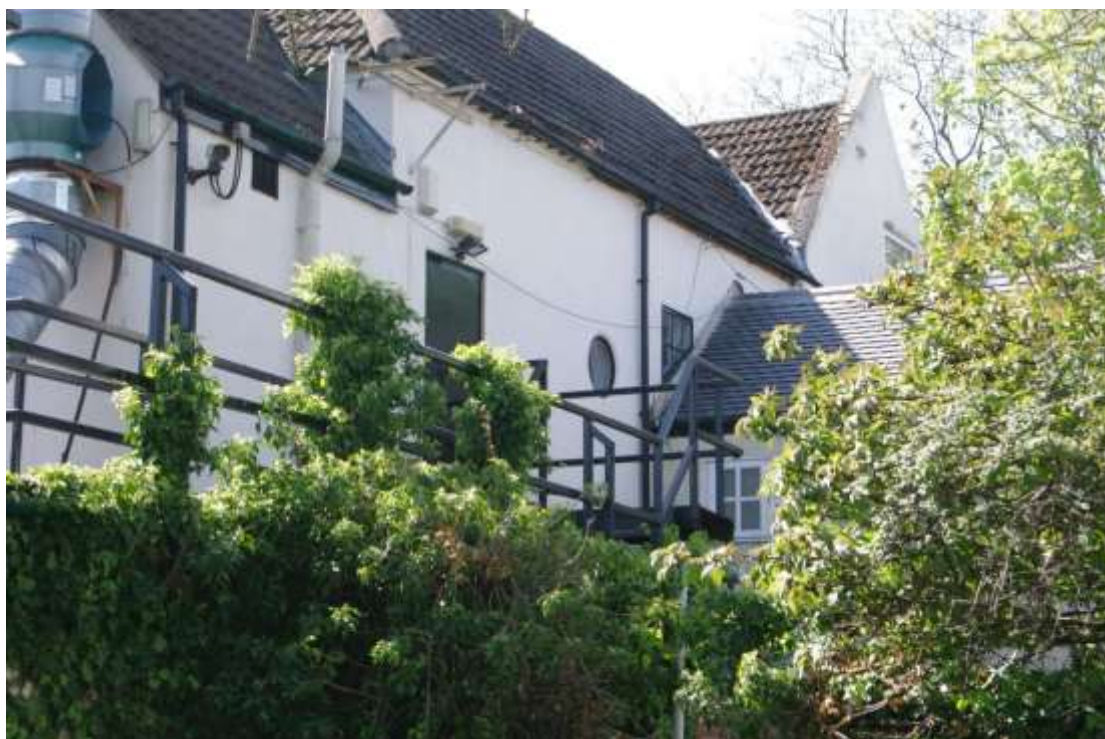
The ground floor of the north-east facing elevation is hidden by a modern flat-roofed extension to the rear kitchen (Figure 12). The cottages adjacent to the inn are double pile structures which hide most of the gable end of the north-west facing elevation. There are very few windows on this elevation and one is cut through by the roof of the cottages. A fire exit door, which may be a former window, leads out onto the kitchen roof.

Figure 12 North-east facing elevation
Looking west from car park. Toilet block on left, roof of adjacent cottage on right

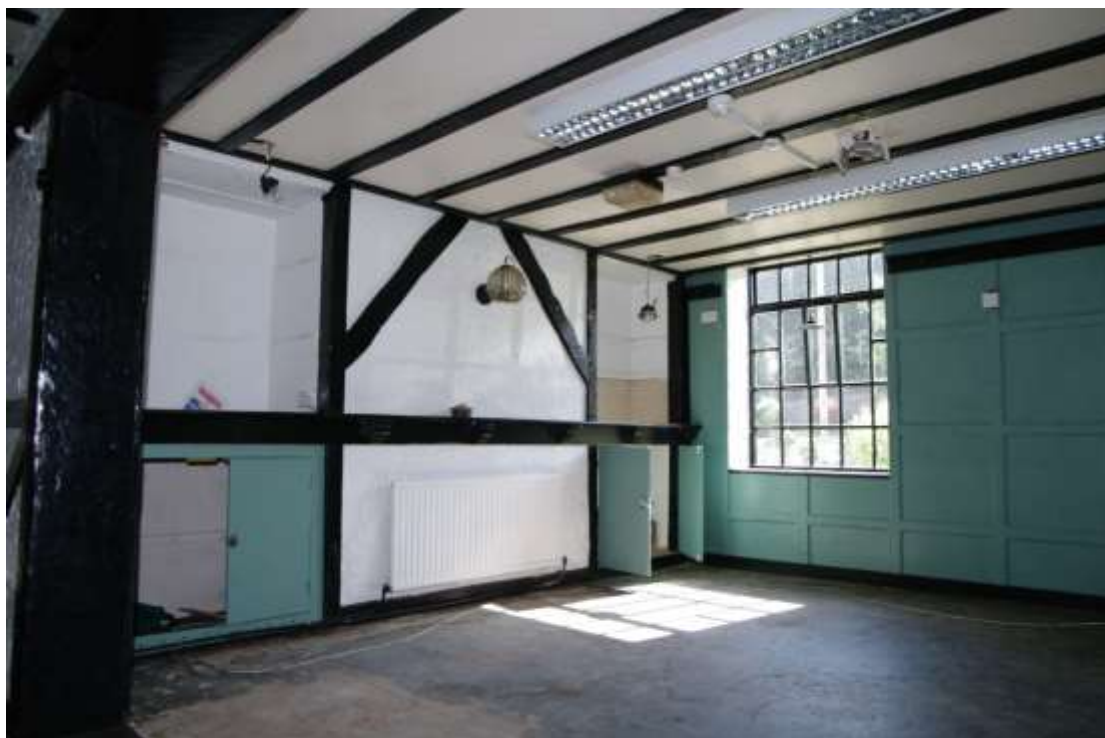
Figure 14 Lounge 1
Looking south. Before soft-strip. Stub of corridor wall on left

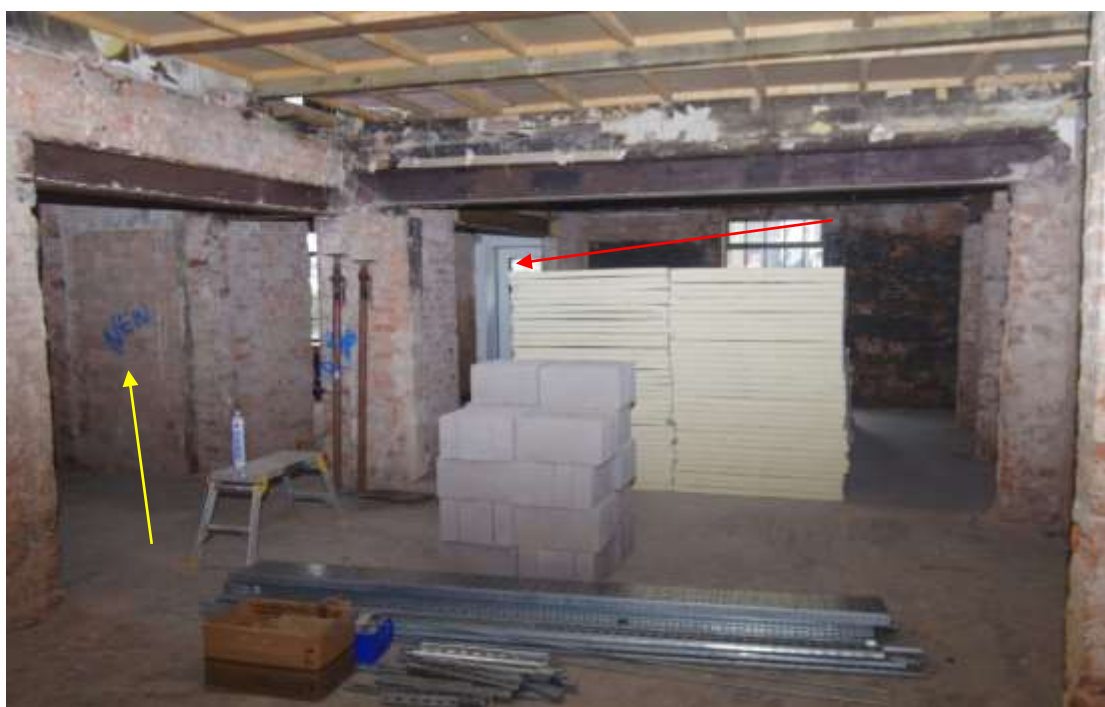
Figure 15 View of corridor wall stubs from lounge 3
Looking west. Lounge 2 behind stack of plasterboard. Original front door arrowed.
Blocked doorway into Lounge 1 shown with yellow arrow

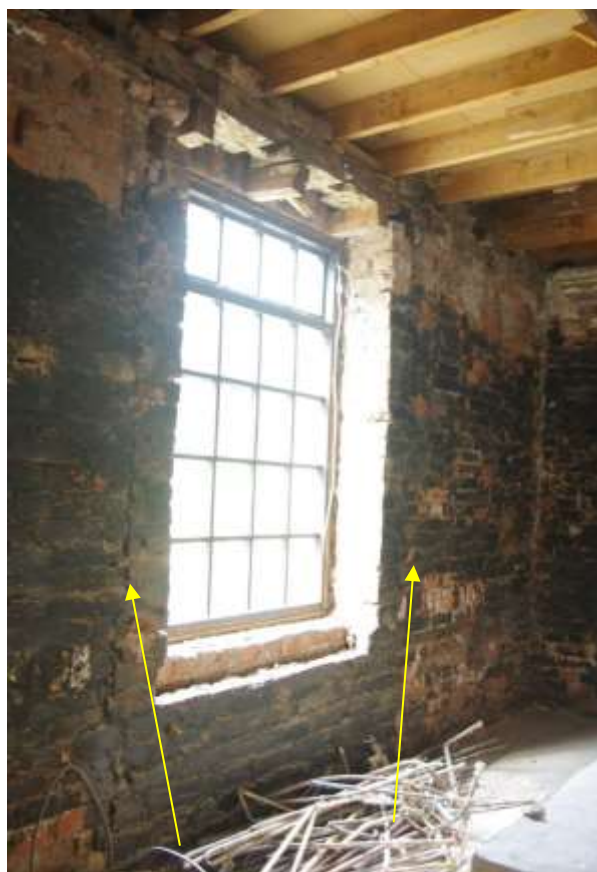
Figure 16 Lounge 2 north-west facing window
Looking north. Note infilled brickwork around window

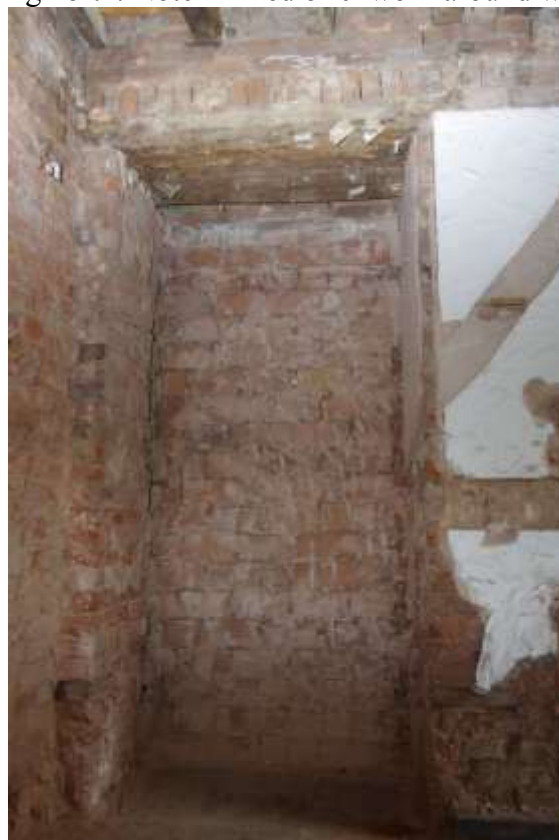
Figure 17 Lounge 1, blocked doorway to north of chimney breast
Looking east. Compare with Figure 14

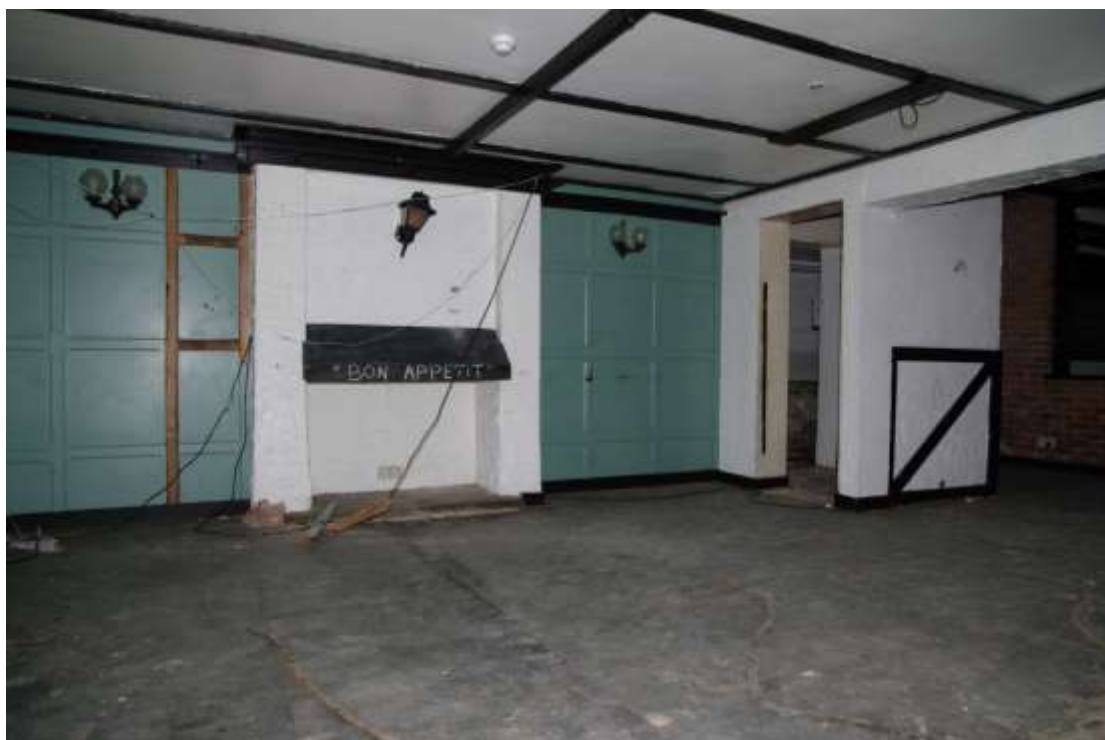
Both lounges have fireplaces which have been blocked. Lounge 1 fireplace has fitted cupboards either side of the breast (see Fig. 14). Removal of the cupboards revealed a small doorway to the north of the breast which led into the hallway to the east (Figure 17). The brickwork over the doorway is supported by several wooden lintels. The fireplace in Lounge 2 has its cheeks still in place but nothing else survives (Figure 18).

Figure 18 Lounge 2 fireplace
Looking north-east. Entrance to Lounge 3 on right

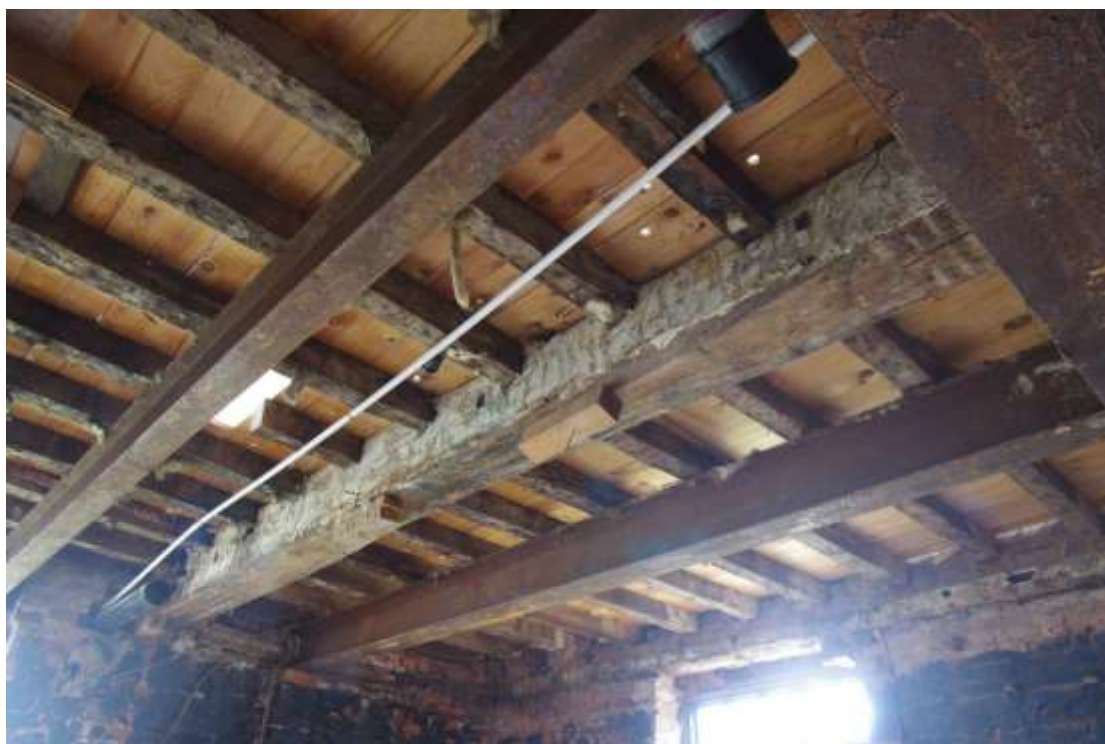
Figure 19 Lounge 1 ceiling detail
Looking towards south-west corner of the room

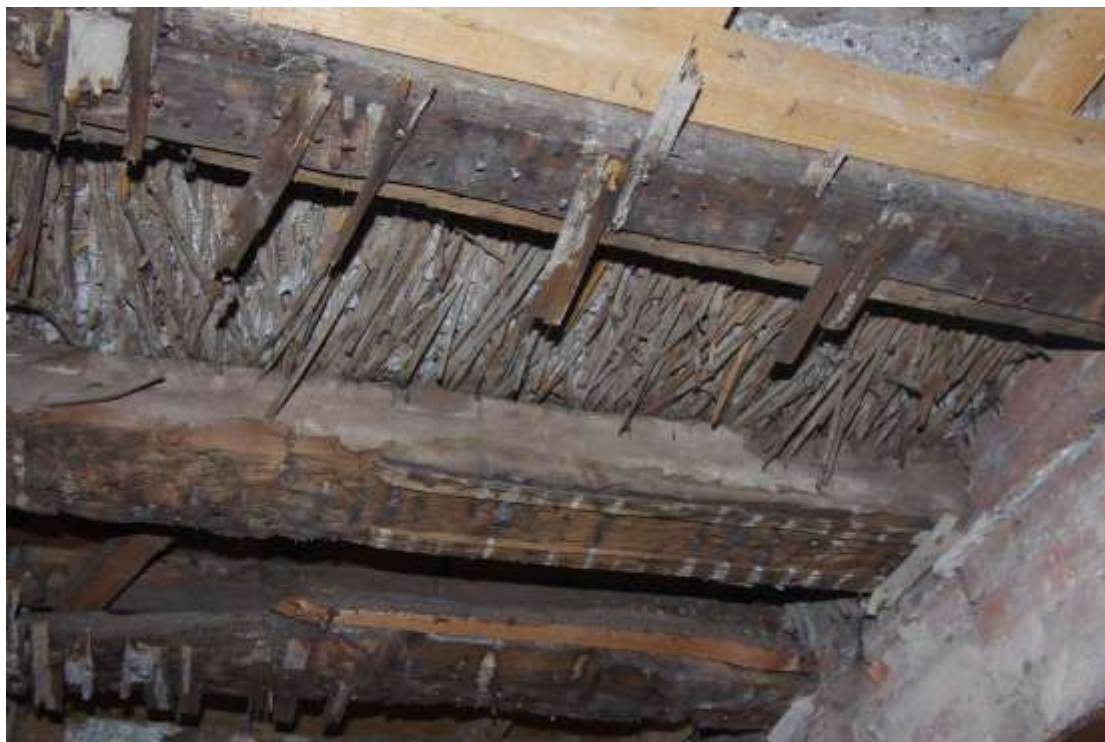
Figure 20 Ceiling above former corridor
Plaster floor above corridor

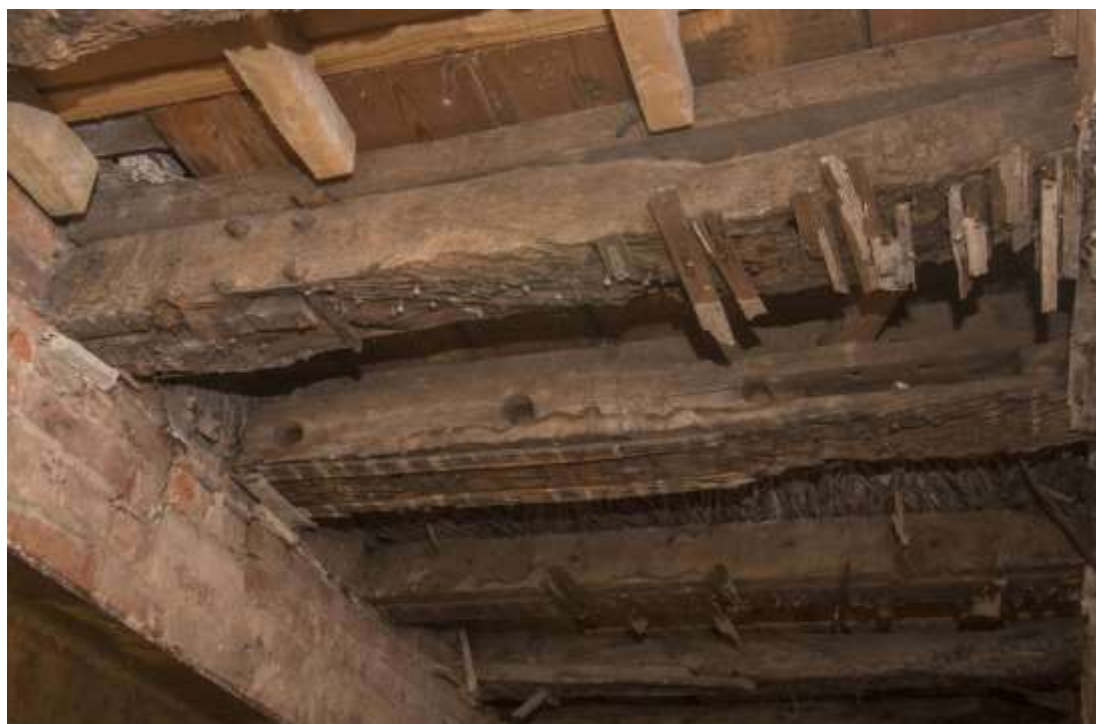
Removal of the modern ceiling covering revealed the original axial timber beams running from north to south across the rooms and supporting the floor joists. Most of the weight of the first floor is now supported by a series of modern steel beams which may have been added following the recent fire (Figure 19). Although most of the first floor floorboards have been replaced the ceiling above the former corridor retains some of its plaster and reed flooring (Figure 20). Parts of this structure appear to have been re-used from elsewhere as one of the joists is a possible rail turned on its side with a mortice socket for a stud along with some possible hexagonal mullion sockets. There are also redundant wooden pegs embedded in the timber (Figure 21).

Figure 21 Re-used timber joists above former corridor
Looking east

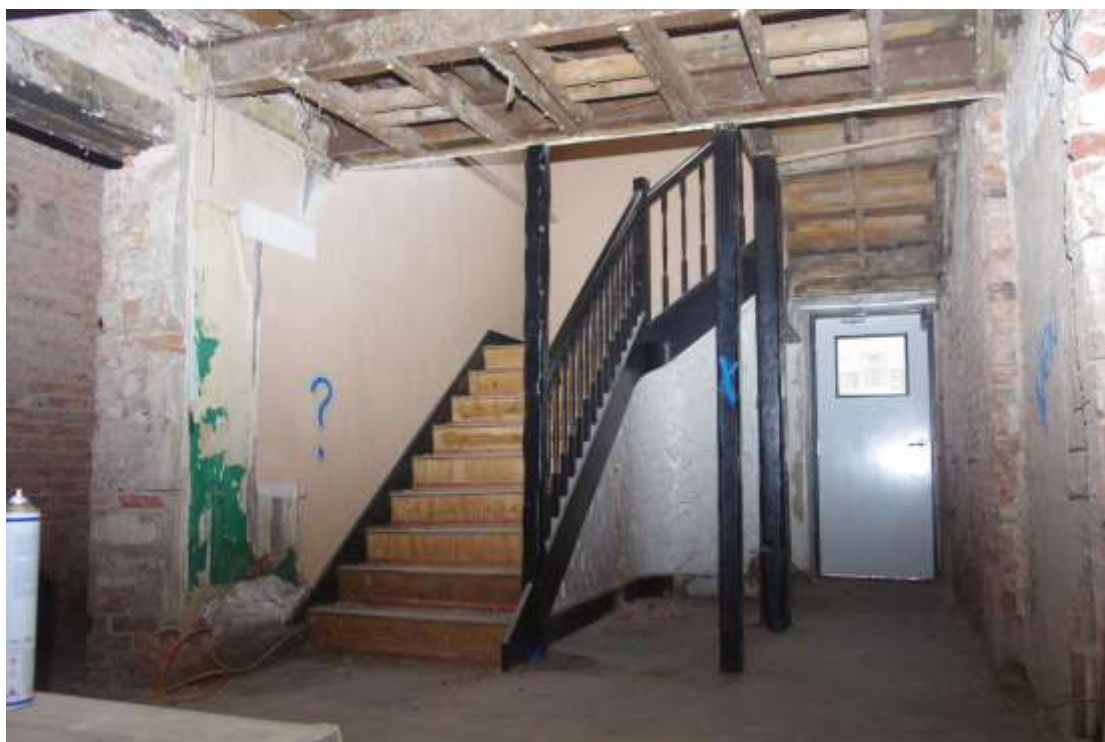
The hall contains the staircase which is probably in its original position but which appears to be of quite modern materials. This suggests that it may have been rebuilt or heavily repaired following the fire (Figure 22). The ceiling covering was modern and covered the timber and steel reinforced first floor. A small doorway at the side of the stairs leads out to Bondgate. This is in such an obscure position that it must have been intended as a secondary side entrance rather than the main entrance. The east wall of the hall area is quite thick and appears to be the original rear wall of the original house. Therefore the original plan of the house was probably an inverted L-shape which incorporated Rooms 1, 2, 3 and 4.

Figure 22 Hallway
Looking south. Doorway to Bondgate on right of stairs

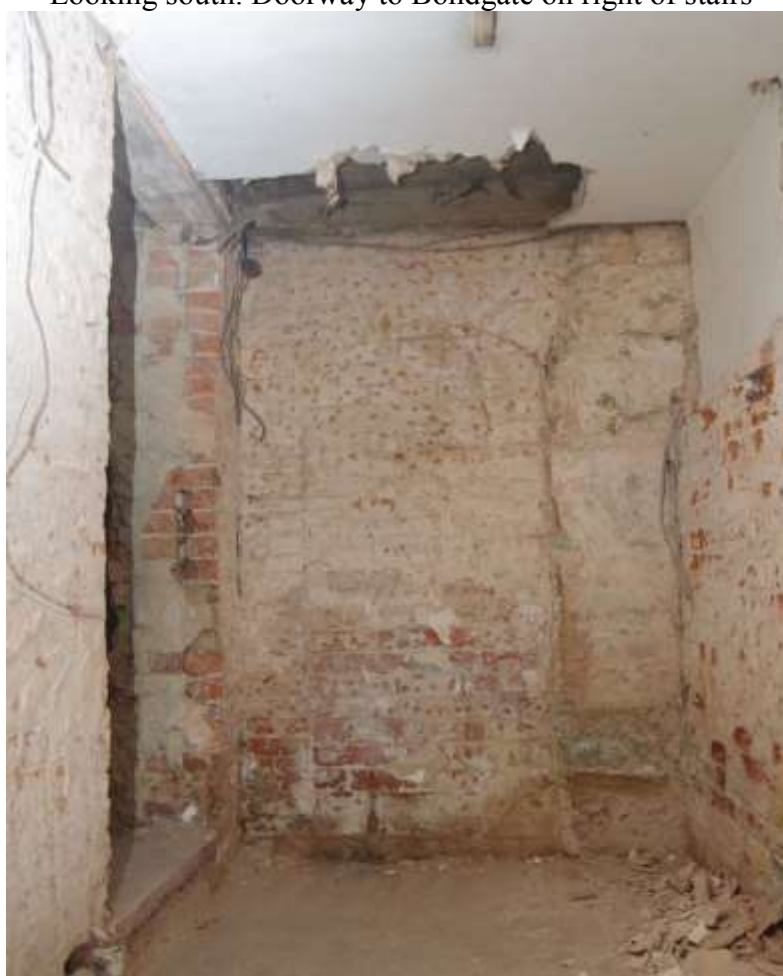
Figure 23 West wall of kitchen corridor
Looking west. Note archway and stone to right of arch

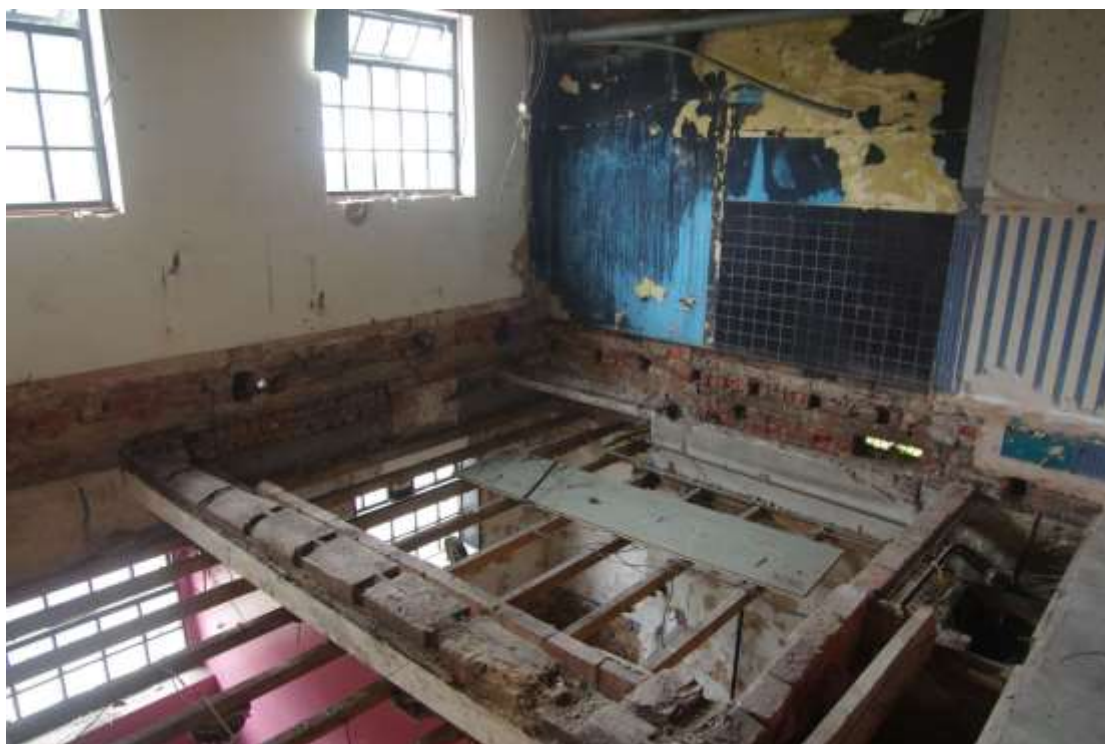
Figure 25 Exposed floor structure in former Bedroom 10
Looking south-west

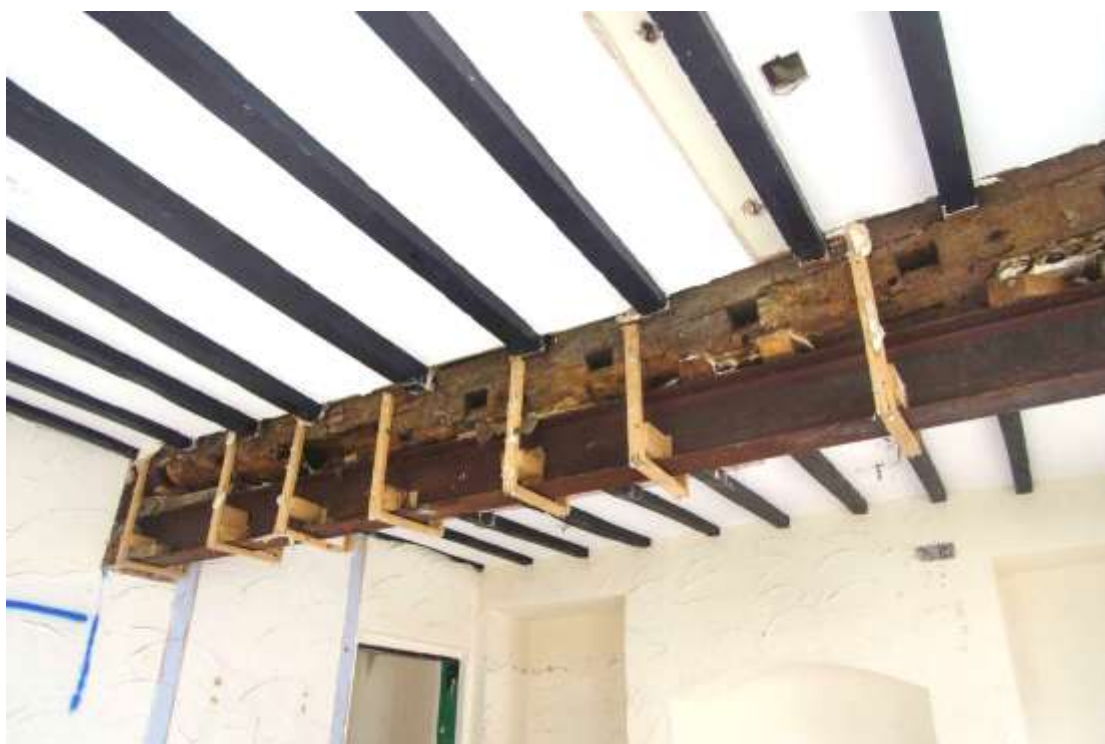
The partition wall between former Bedrooms 16 and 17 has been removed and has exposed a substantial timber axial beam running from north to south across the room with a number of redundant sockets indicating that it had been used elsewhere before being installed in the original part of the house (Figure 26).

Figure 26 Supported timber beam with redundant sockets
Looking north-east from the SW corner of Bedroom 16 towards fireplace in Bedroom
17 following the removal of the partition wall

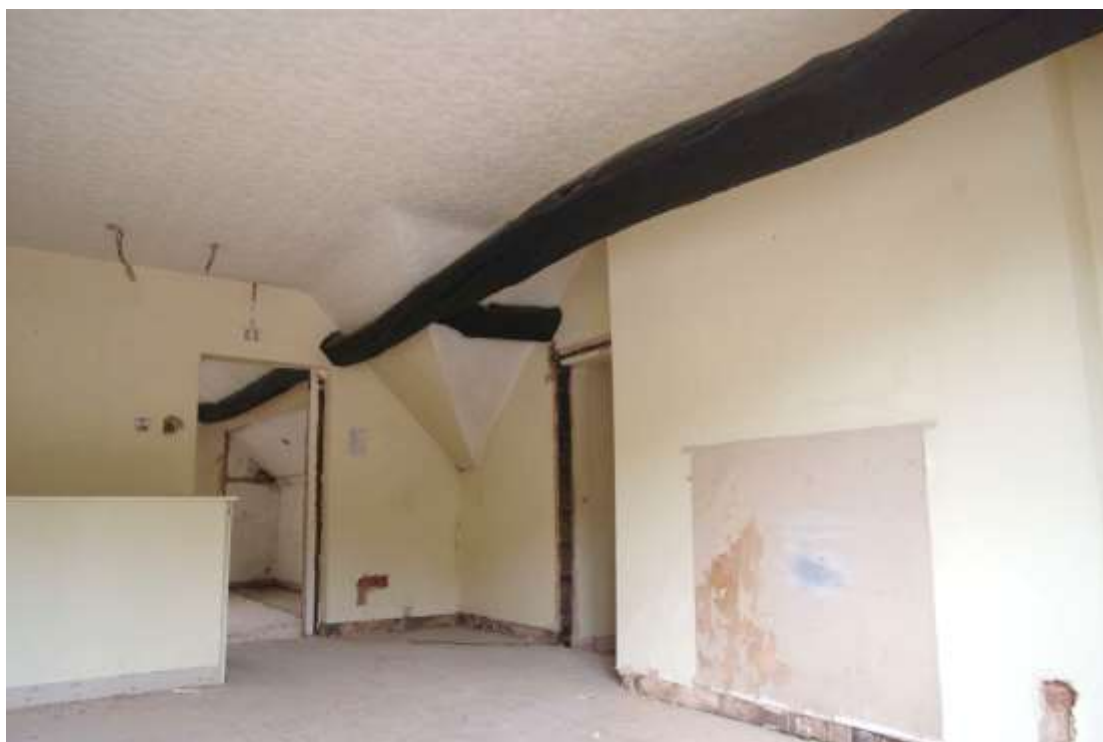
Figure 28 Second floor, former lounge
Looking north-east. Stairs on left, bedroom in centre, toilet on right

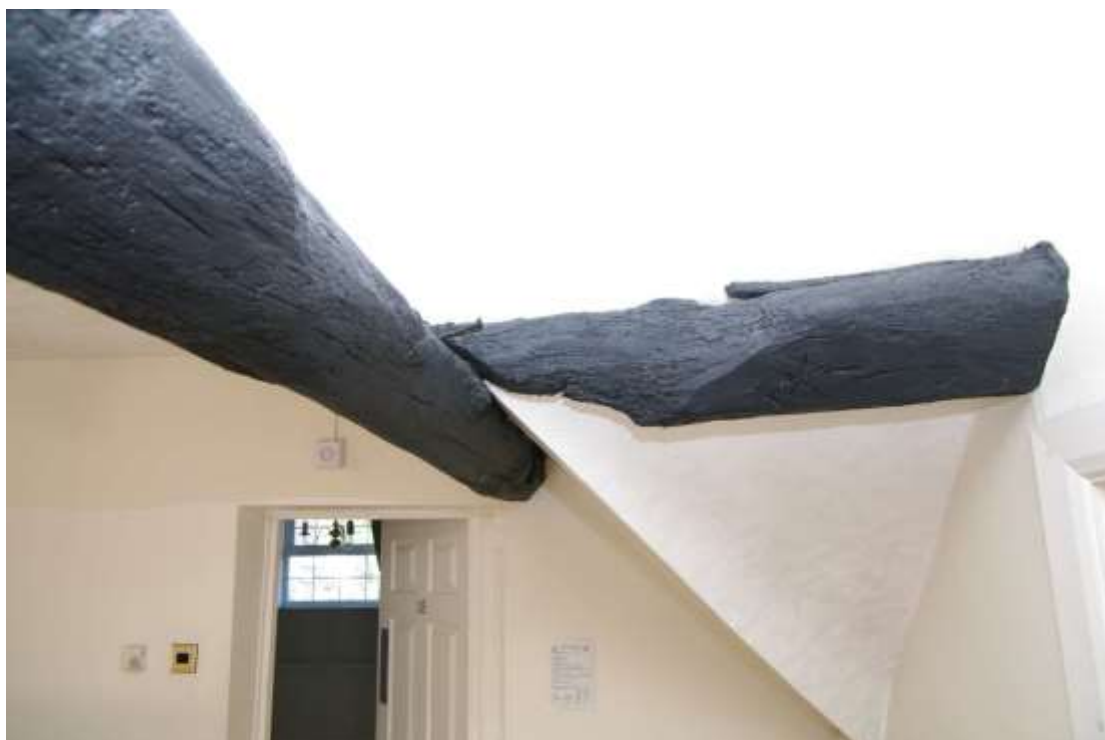
eastern purlin and supports the roof structure of the former toilet and dressing room. Where the purlins join the tip of the smaller purlin has nearly been burnt away leaving very little timber (Figure 29). A handmade nail is still present in the joint of what little woodwork remains. No timberwork can be seen in the toilet and dressing room.

Figure 29 Joint of purlins on former second floor lounge
Looking north-east

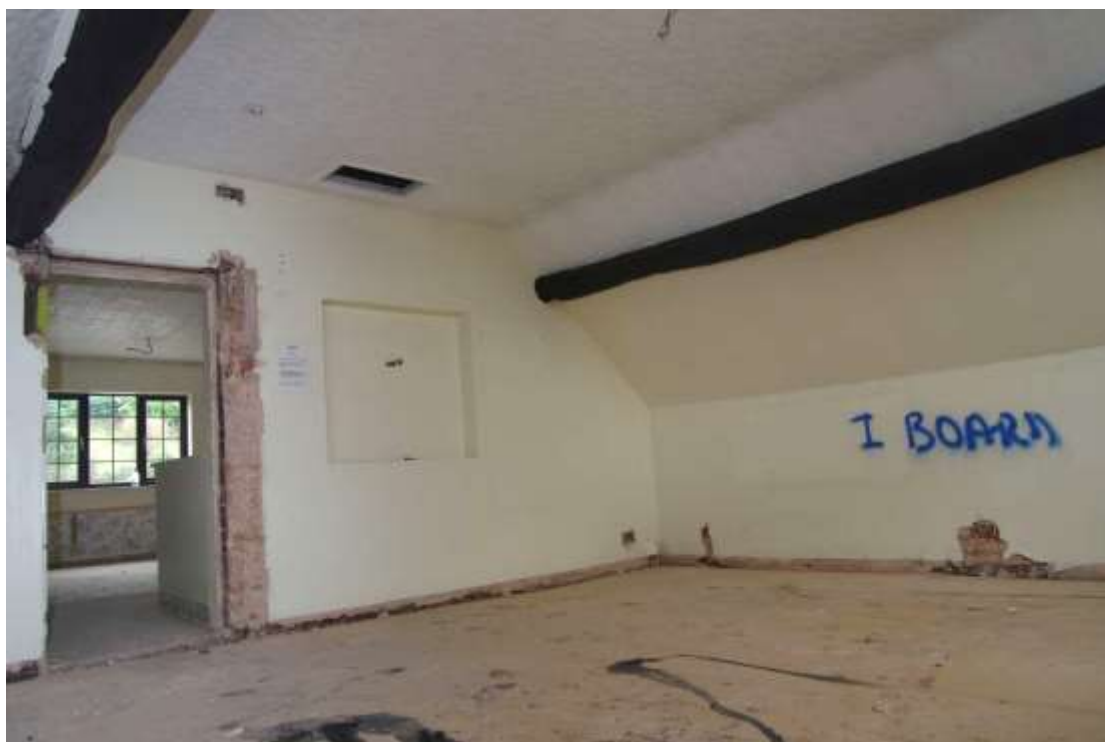
On the southern wall of the bedroom is a recessed rectangle cut into the thickness of the wall. This gives the appearance of a blocked window despite this wall always being an internal wall. It is possible that it was a window which provided a limited amount of light into the stairwell which, rather than having an open bannister, may have been fully enclosed (Figure 30).

Figure 30 Bedroom 18
Looking south-west. Note recess on wall for possible internal window

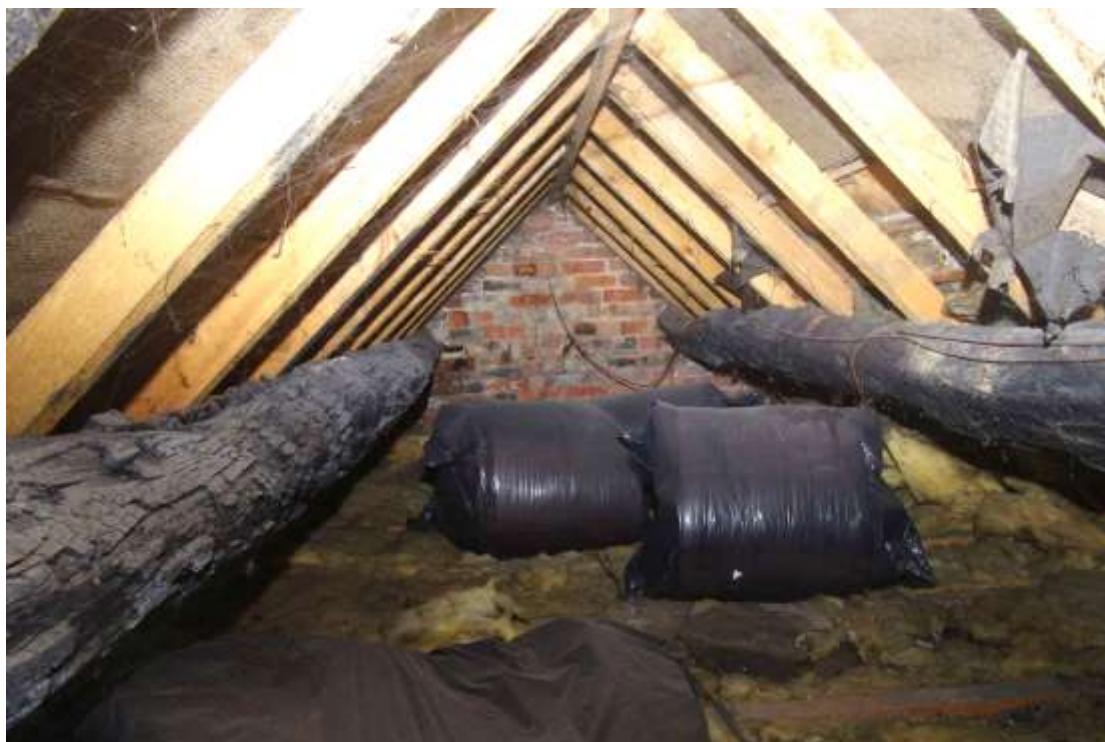
A small hatch in the ceiling of Bedroom 18 allowed a limited inspection of the roof space above the two rooms. Although the space was not entered it could be seen that there was another pair of purlins above the ones visible in the rooms below. The charring on these timbers was even more severe than the lower pair (Figure 31). All of the common rafters, which are supported by the purlins, are new.

Figure 31 Roof space above Bedroom 18
Looking north. Note charring on left-hand purlin
