**An Archaeological Evaluation at  
Ilott Wharf ,  
Bosworth Road,  
Measham,  
Leicestershire**

**NGR: SK 348 112**

ULAS Report No. 2018-103  
©2018

**For: Ashby Canal Association**

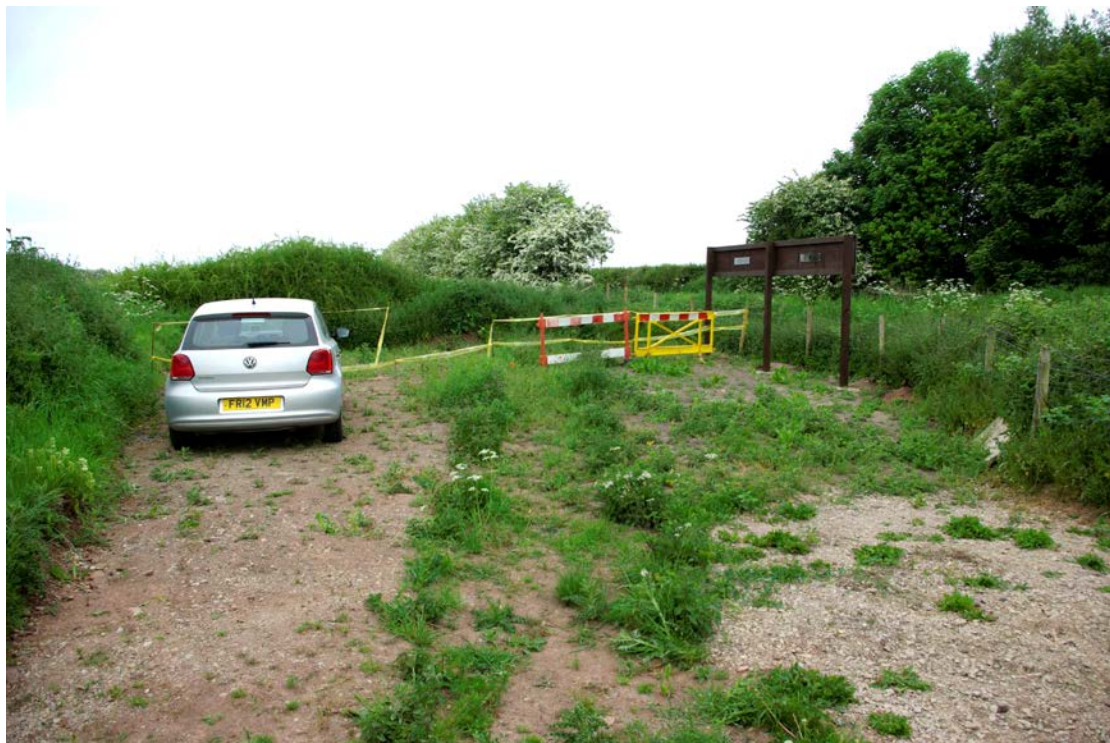
Figure 3 Ilott Wharf cleared area  
Looking north-west. Bosworth Road on right behind the brown sign. The brickwork  
exposed by the machine was protected behind the temporary barriers

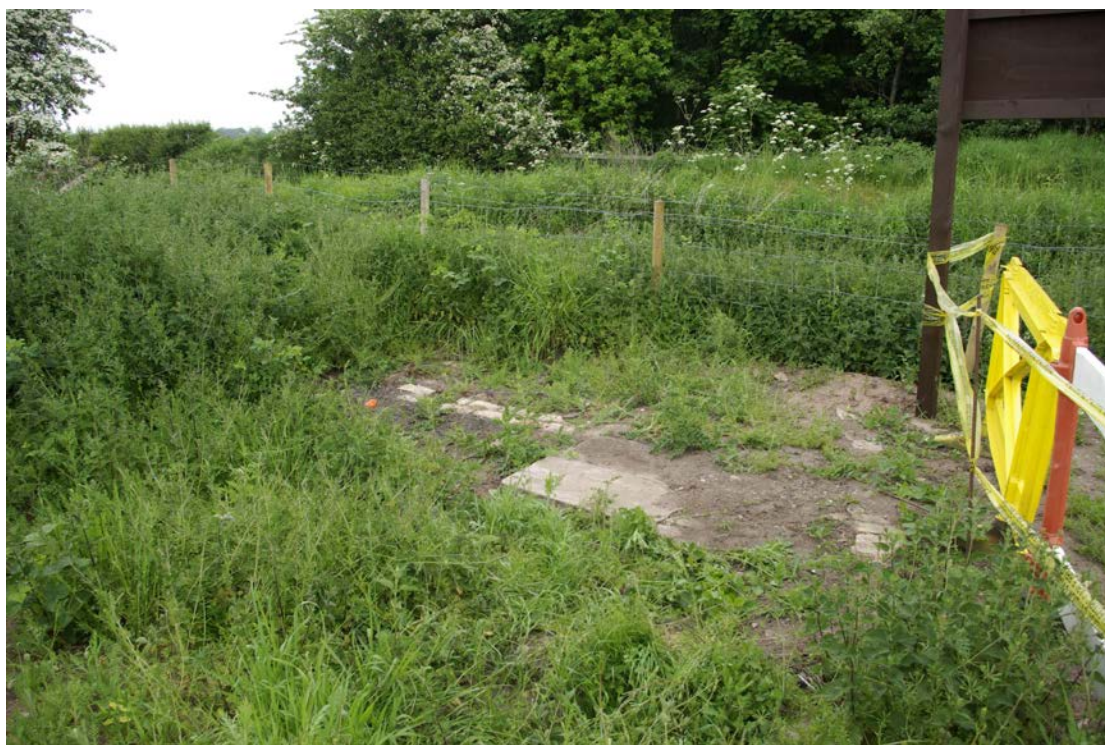
Figure 4 Brickwork exposed by machine prior to the evaluation  
Looking north. Former railway line ran across the road in the gap between the hedge  
lines on left of picture

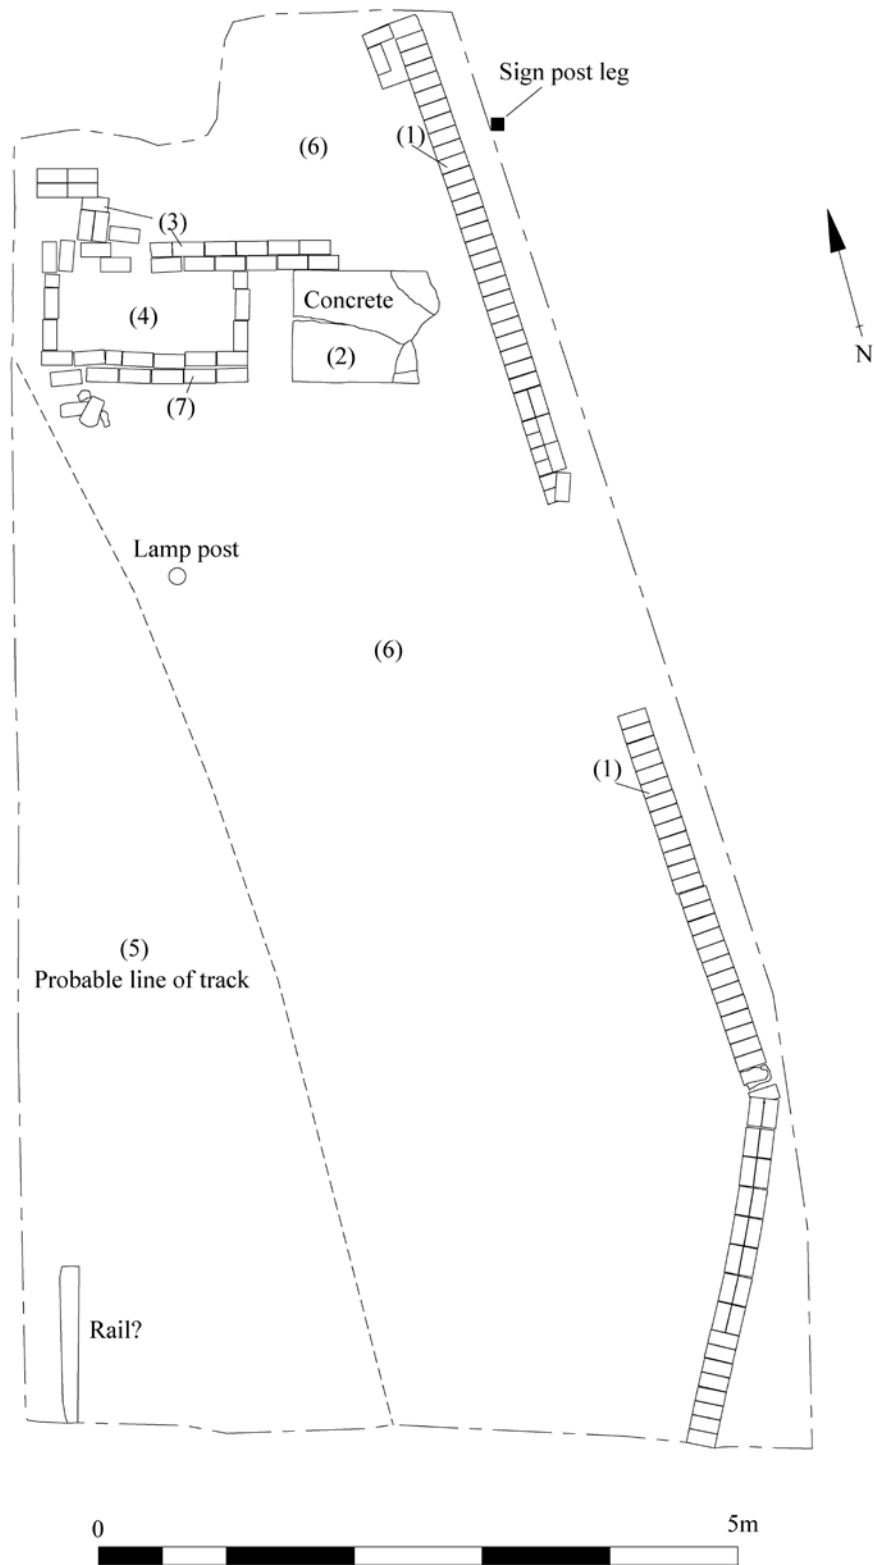
Hand cleaning revealed a small concentration of brick and concrete features located towards the northern end of the area and a brick-built boundary wall running along the eastern edge of the area (Figure 6). In addition to these structures it was also possible

to discern the probable edge of the former railway line which ran from north to south along the western edge of the area.

Figure 6 Results of cleaned area  
Bosworth Road runs across the top end of the site

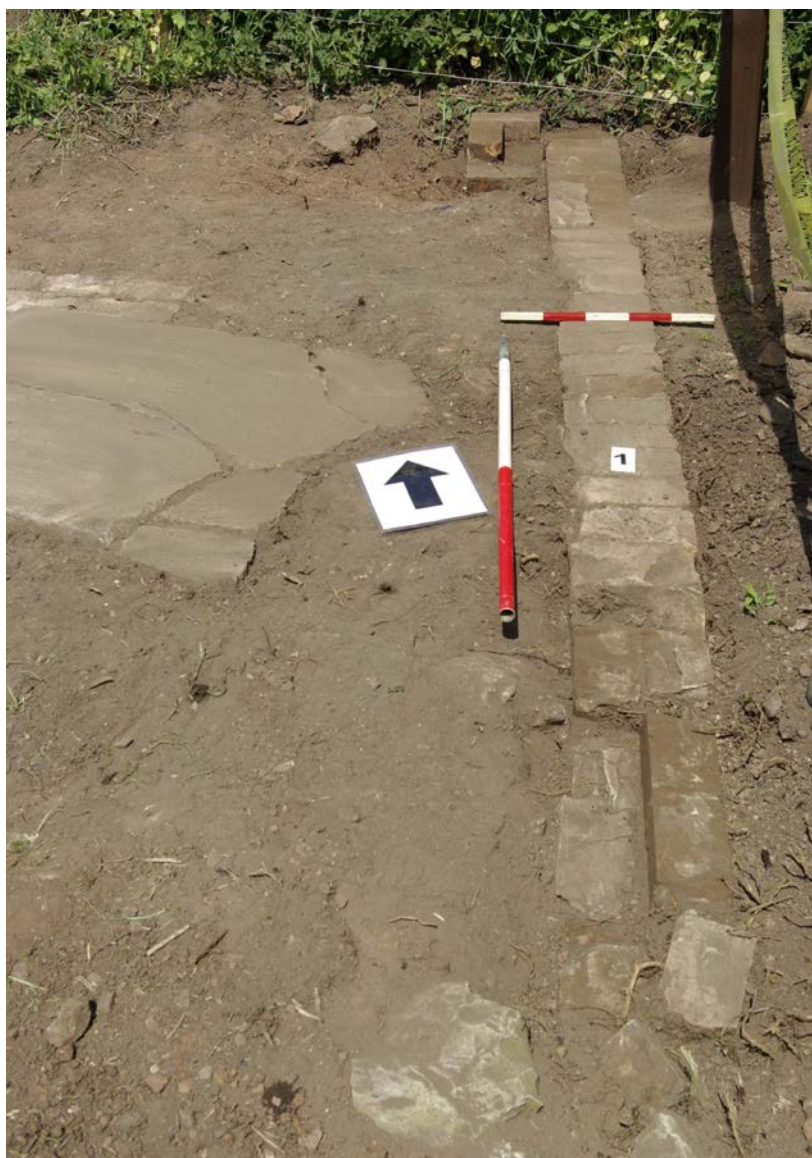
The cleaning showed that the boundary wall (1) started at the northern edge of the cleaned area with a brick pillar (Figure 7). From the pillar it continued southwards before stopping at an area of disturbed ground where the bricks showed signs of being broken and creating a gap in the wall. The ground to the east and west of the disturbed wall also appeared to be disturbed which suggested that the break in the wall was made after the closure of the site. After around 1.5 metres the wall began again on the same southern alignment before turning slightly to the south-west and continuing beyond the south edge of excavation (Figure 8). The wall appears to have been laid in an English bond i.e. alternating courses of headers and stretchers. The average size of the red bricks was 225mm long by 110mm wide by 63mm high ( $8\frac{7}{8}$ " by  $4\frac{3}{8}$ " by  $2\frac{1}{2}$ "). Partial excavation where the wall was disturbed indicated that there were at least four courses surviving.

Figure 7 Wall (1), northern end. 1m and 0.5m scales. The wall stops at the far end with an adjacent brick pillar

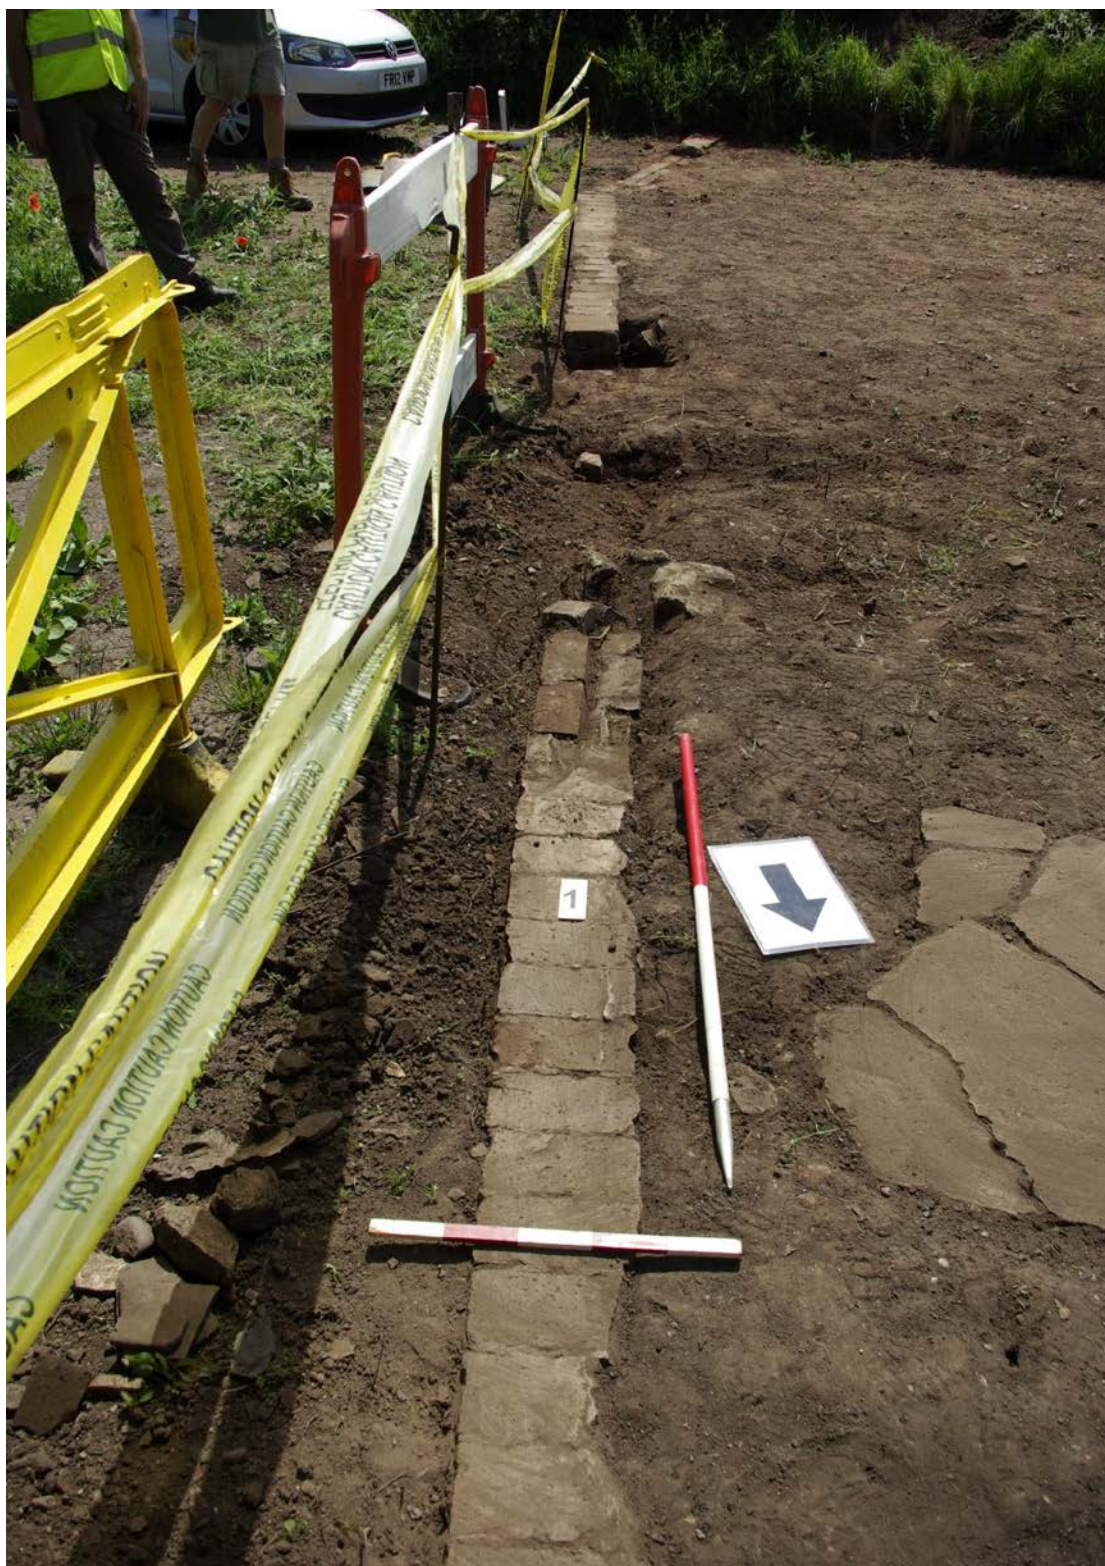
Figure 8 Wall (1), southern end  
1m and 0.5m scales

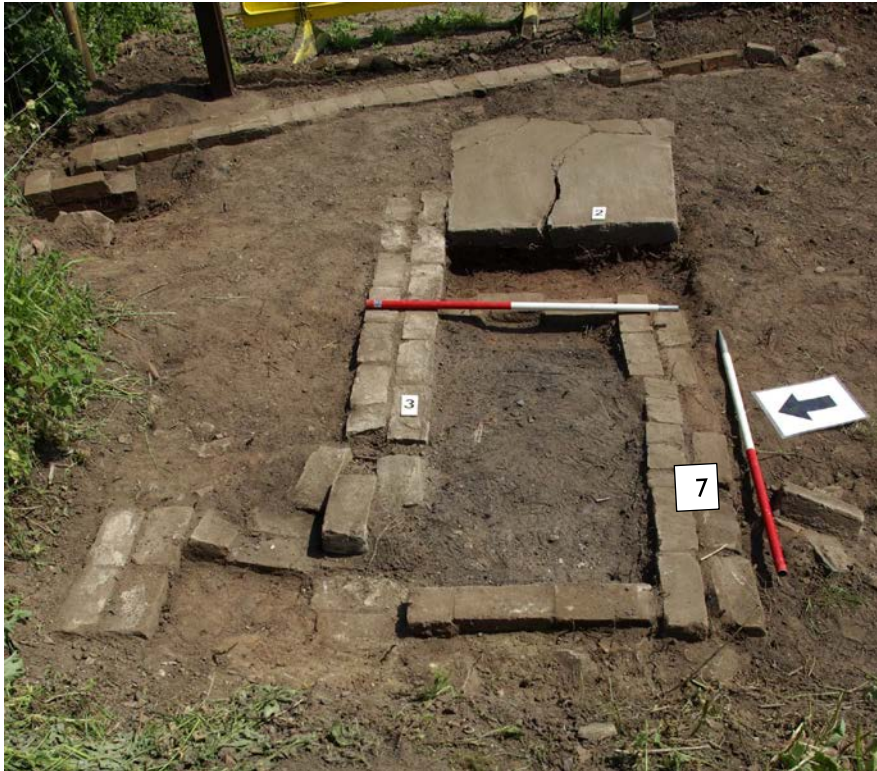
To the west of wall (1) the possible rectangle of brickwork consisted of two main parts: a roughly east to west double line of bricks (3) and a rectangle of slightly differently sized bricks (7) surrounding an ashy deposit (4) (Figure 9 and Figure 10). The double line of bricks (3) ran from north-west to south-east on a slightly different alignment to wall (1). It stopped, possibly due to disturbance, approximately 0.9m from wall (1) so there is no clear relationship, if any, between the two features. At the west limit of the bricks (3) and to the north was a rather unclear area of brickwork, which may possibly represent a corner to this feature. The red bricks of (3) were a different size to the wall (1) and measured 235mm long by 110mm wide by 75mm high ( $9\frac{1}{4}$ " by  $4\frac{3}{8}$ " by 3").

Butting against, but not joining, the south side of brick feature (3) was a small rectangle of brickwork (7). This feature had minimal mortar bonding it together and was only two courses deep. The bricks were a different size to the other brick features and measured 240mm long by 110mm wide by 70mm high ( $9\frac{1}{2}$ " by  $4\frac{3}{8}$ " by  $2\frac{3}{4}$ "). Within the rectangle formed by (7) was a greyish ashy silty deposit (4) sitting on top of a possible brick base.

Figure 9 Cleaned area of brickwork  
1m scales. Boundary wall (1) at top of picture

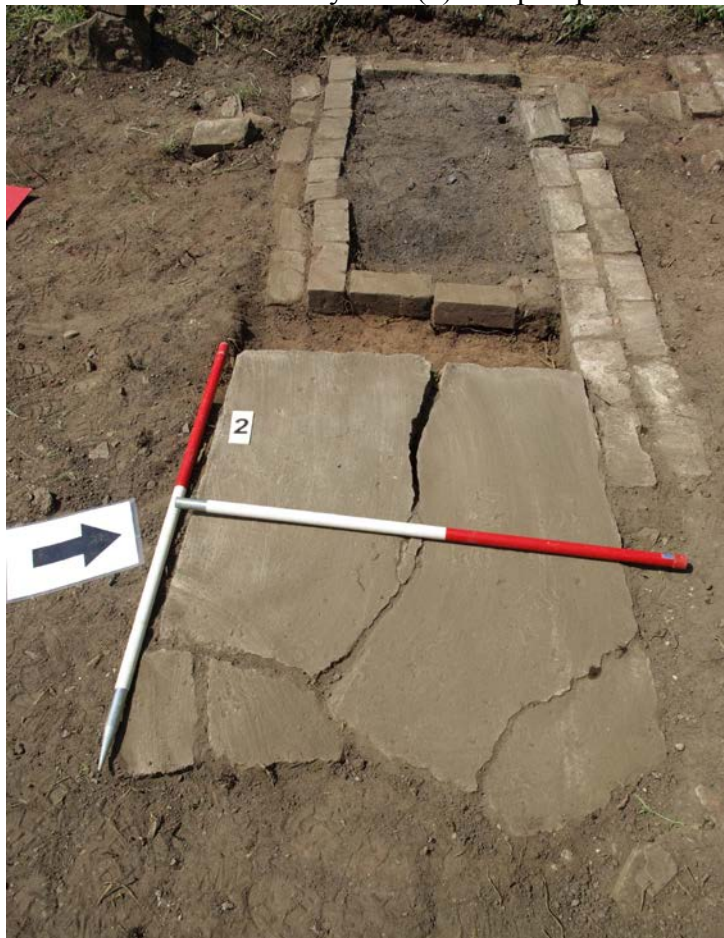
Just over 0.3m to the east of feature (7) and immediately south of (3) was a 90mm thick slab of concrete (Figure 10). The slab appeared to be sat on a layer of mid orange-brown clay which extended all the way west to meet (7). The slab is clearly associated with both (3) and (7) as it butts against (3) and extends as far south as the limit of (7). The slab had been extensively cracked although it was not clear if this had happened before or after the closure of the wharf.

Figure 10 Concrete slab (2)  
1m scales. Brick features (3) and (7) beyond

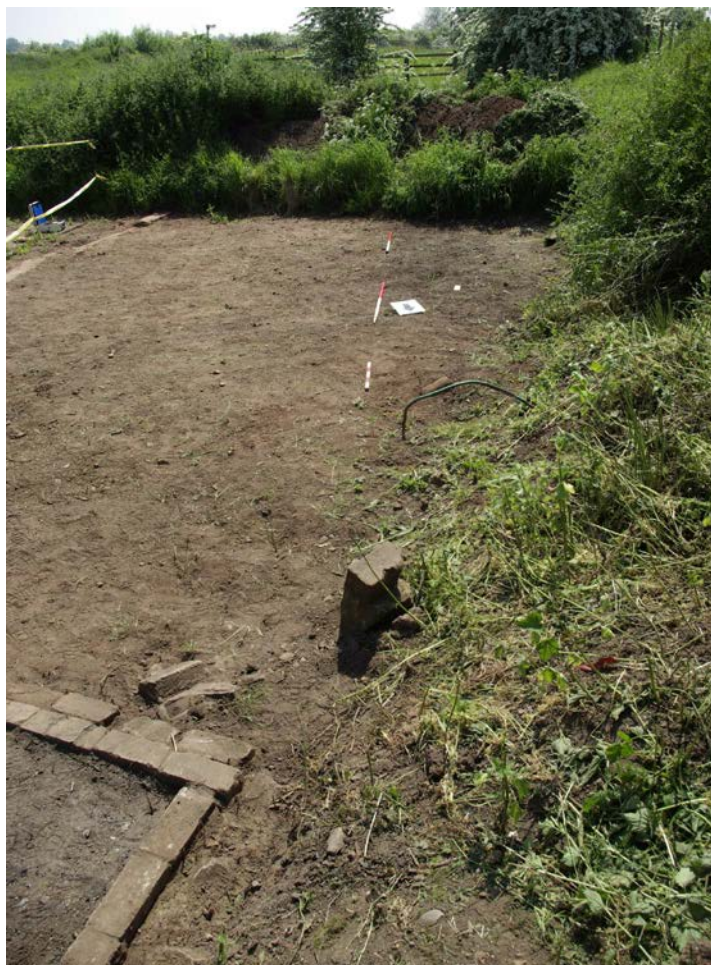
Running at an angle across the south-west corner of the area was a layer of mid-grey silty clay with traces of ash and frequent angular stone (5). The stones were similar to those used as ballast on railway lines and may represent the last trace of the edge of the former railway line (Figure 11). This line matches the approximate alignment of the railway as it crossed Bosworth Road, from the north, and continued to the south-west across the evaluation area. To the east of the layer (5) was a cleaner mid-orange brown silty clay layer (6) which extended as far east as the wall (1). This layer is probably disturbed subsoil and is likely to extend beyond wall (1) although no more trowelling was carried out east of it. Neither layer was excavated so it is not known how deep they were.

Figure 11 Possible line of former railway line  
The darker soil of the former line is shown to the right of the 1m scales.

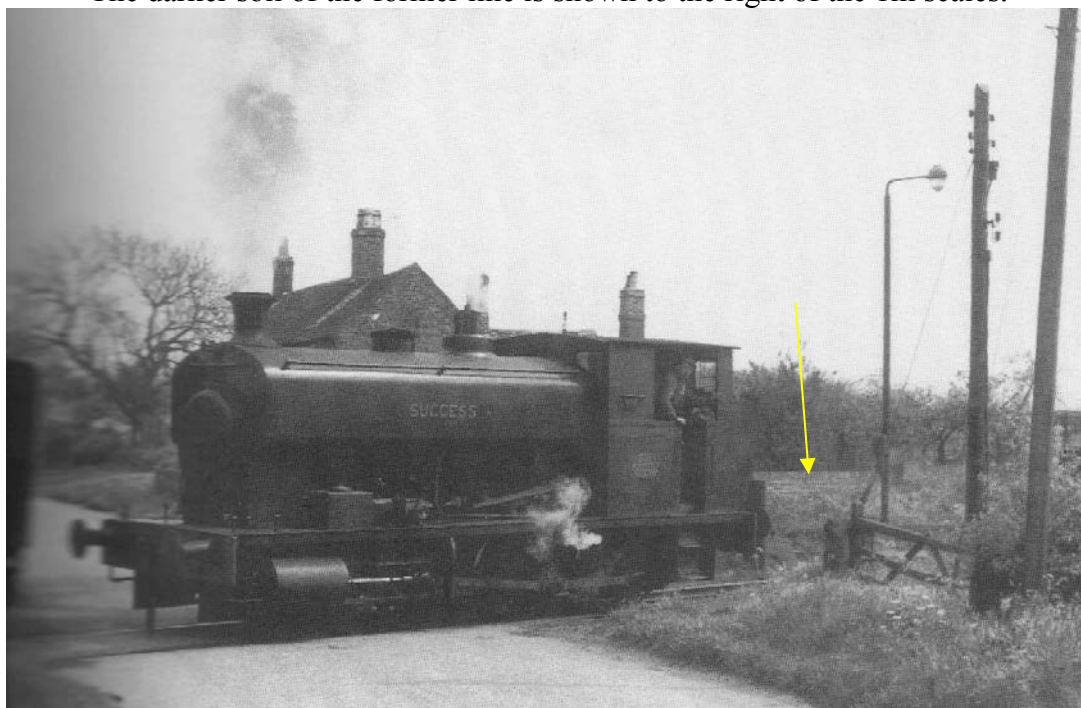
Figure 12 1950s Photograph of Bosworth Road crossing  
The boundary wall (1) is arrowed. The lamp post can be seen on the right  
Photograph supplied by Dr O Mulka

The most substantial feature revealed during the evaluation is the brick-built boundary wall (1) which continues southwards beyond the cleaned evaluation area. The 1950s photograph suggests that this was a relatively low structure and was perhaps only around four to five feet high. Although not completely clear it seems likely that the line of this wall is the boundary shown on the 1927 OS map which can be seen in Figure 2 above. The boundary persists and is still present on the 1959 map, and the clear kink in the wall can be used to locate the results (Figure 14). It is therefore most probable that the wall continued in use right up to the closure date. OS maps published before 1927 indicate that the alignment of the track was slightly different and further east so that none of the early maps show the boundary wall.

Apart from the boundary wall none of the other features can be seen in the 1950s photograph. A narrow chimney can be seen near to the location of (3) and (7) but it is

by no means certain exactly where it is located. The photograph however does appear to indicate that there are no structures to the south of (2), (3) and (7).

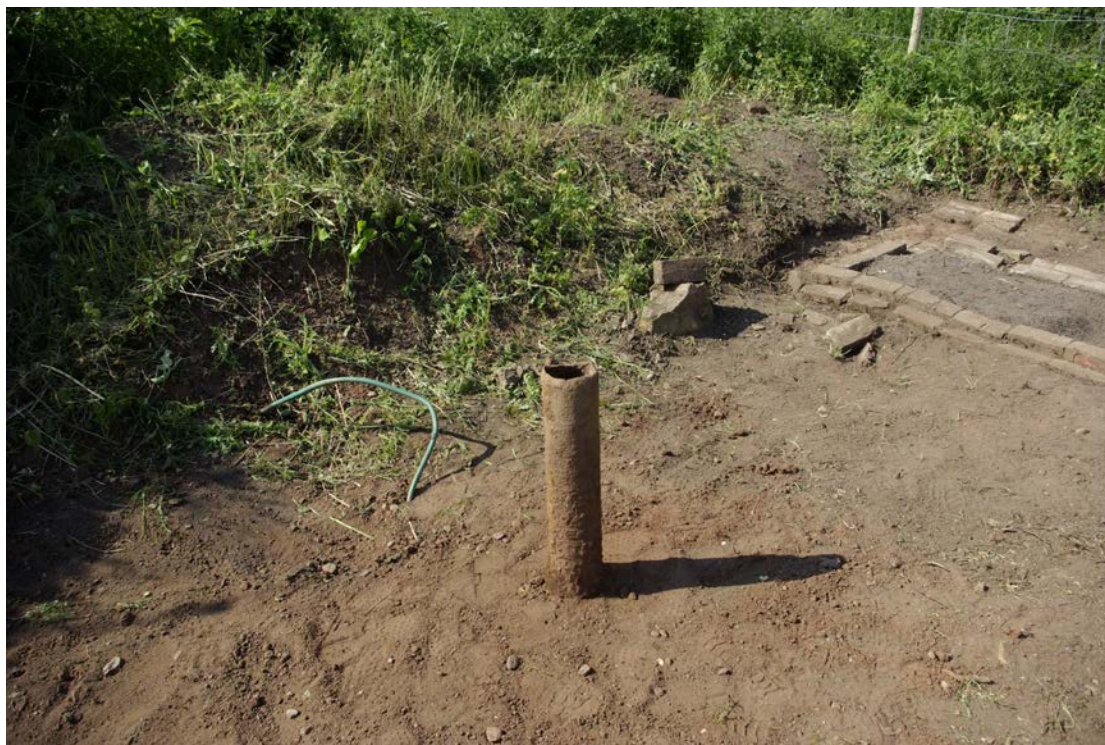
Near to the cable was a cast iron metal cylinder which was partially buried at an angle in the ground. During the afternoon Dr. Mulka brought in a photograph taken in the 1950s showing a locomotive which had just crossed Bosworth Road and is standing in front of the boundary wall which we had identified as wall (1) (Figure 12). The photographs also showed the top of a lamp post in a similar location to the metal cylinder already observed. Limited small-scale excavation around the cylinder revealed it to be the toppled base of the lamp post. This was easily stood upright in its original earthfast socket (Figure 13). It would appear that the cable runs to the base of the post.

Figure 13 Re-erected base of former lamp post
