**An Archaeological Observation,
Investigation, Recording and Analysis at
Numbers 3 + 3a High Street,
Daventry,
Northamptonshire**

ULAS Report No. 2018-111
©2018

For: First Light Photographic

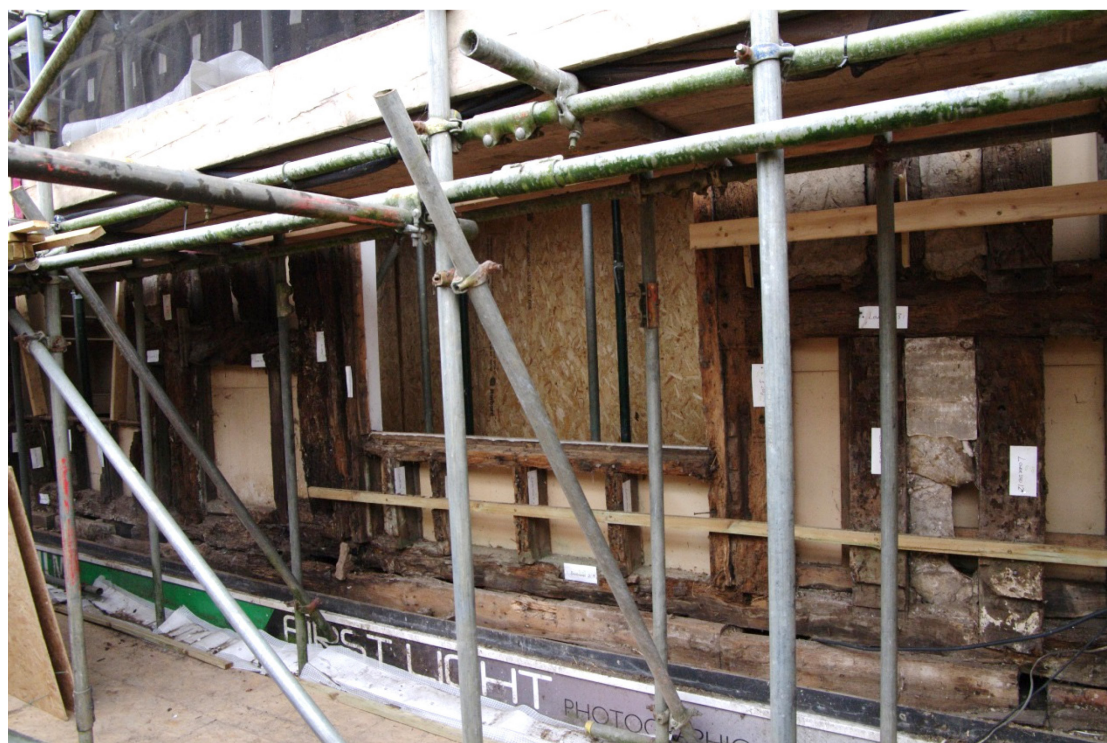
Much of the ground floor frontage is now a modern shop front of metal and glass. The steel shutter across the top of the shop front is however attached to the original joists and beams. The exposed ends of the jetty joists above the shop front at first floor level are badly weathered and many have lost much of their original shape and definition. The shutter is causing structural problems due to its weight pulling the timbers outwards

and downwards. The shop sign also runs along a similar alignment and is fitted in a similar way (Figure 4). Behind the top of the shop sign the horizontal bressumer beam runs across the front of the building. This appears to have been modified several times as there are at least two sections which have been replaced (figures 4 and 5). A probable Georgian repair of the bressumer has been noted where a metal spike has been hammered into the repaired beam without pre-drilling a hole. The result of this repair has split the beam and probably weakened it.

Figure 4 Top of ground floor north elevation with shop sign attached
Note also the joints in the bressumer beam 1 behind the shop sign (right side of picture). Viewed from scaffolding

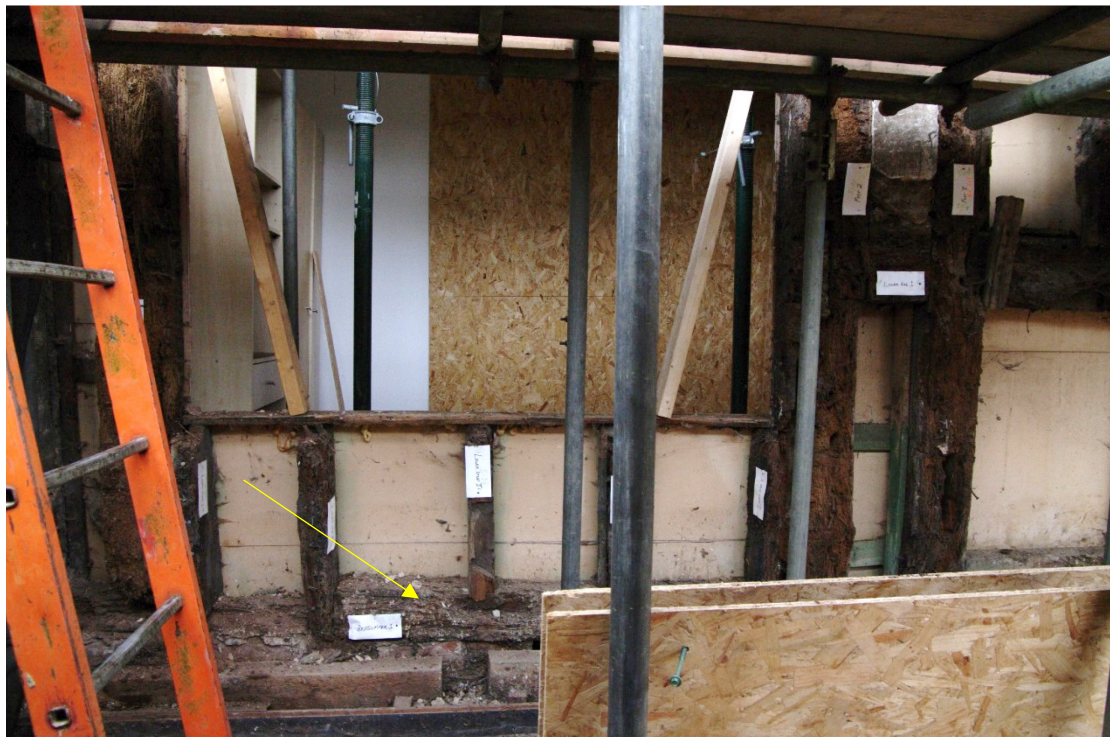
Figure 5 First floor, bressumer beam 1
Beam arrowed. Note Georgian window opening cutting across earlier timbers

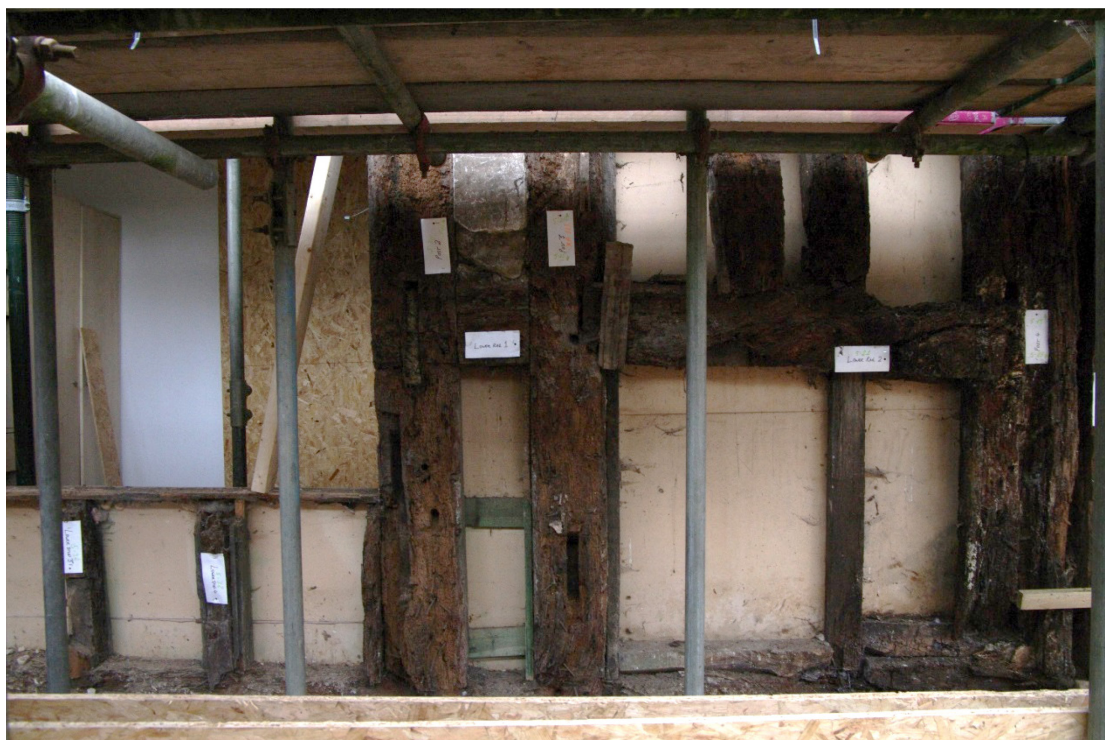
The insertion of the 18th/19th century Georgian windows appears to have cut across a number of vertical studs and horizontal cross-rails (Figure 6). This will have affected the structural integrity of the wall to a certain extent although most of the main posts appear to have been left in-situ and form the side frames of the inserted windows. Only two main posts have been cut through. Removal of the studs and rails will have reduced the façade's ability to withstand racking and sideways forces whilst the removal of the main posts will affect the load bearing ability of the wall. Later window modifications have used the existing openings created by the inserted Georgian windows.

Figure 6 First floor window cutting across timbers
Window on left of picture

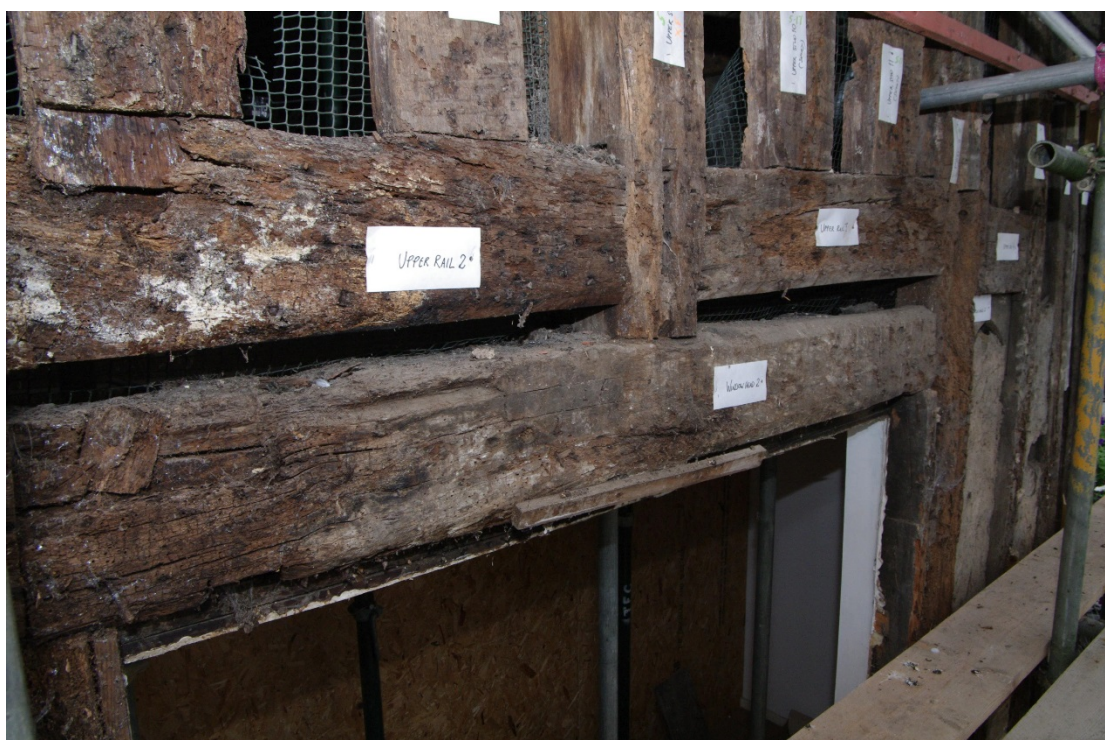
The Georgian windows had new lintels added when they were fitted which again has had some adverse effect upon the structural strength of the wall. The original sawn-through posts rest on the top sides of the lintels which show remarkably little deflection

Figure 7 Top of western inserted window
Note truncated post supported by inserted lintel beneath Rail 2

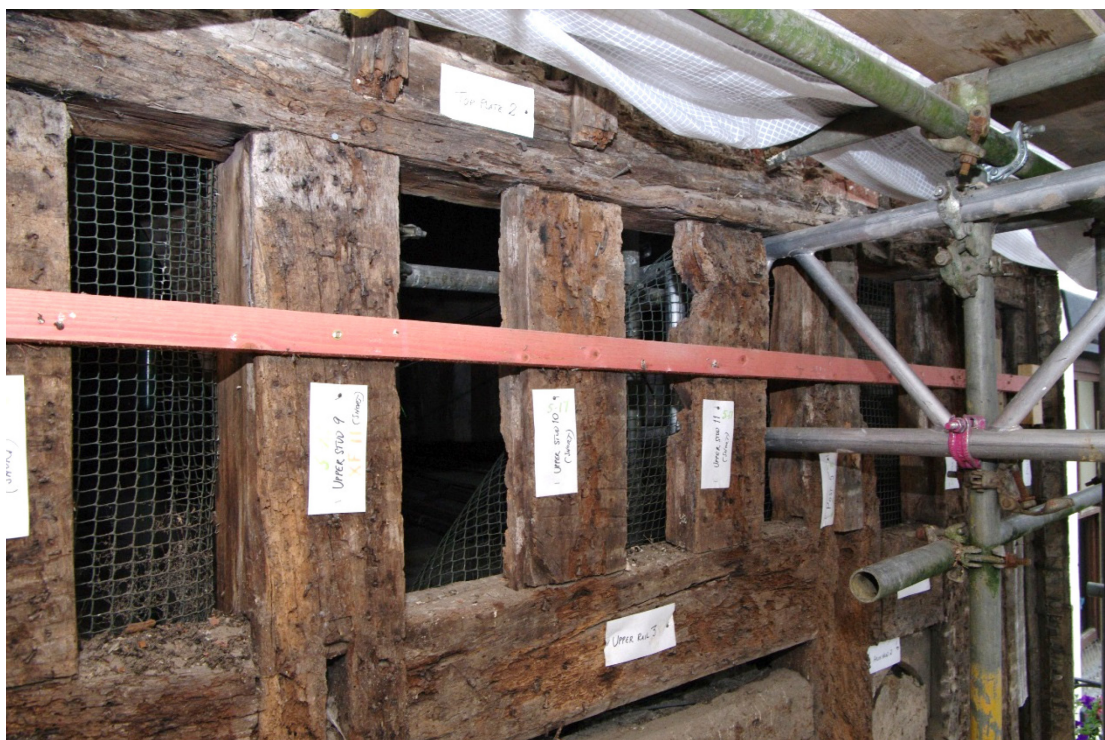
from this load (Figure 7). Above the windows is the best-preserved original timberwork which has not been quite so badly affected by water and rot as have the lower levels. In such places the pegged joints can still be seen quite clearly (Figure 8). Elsewhere on the façade many of the timber ends and joints have deteriorated to such an extent that a number of the dowels are visible along their lengths and the ends of the tenons have eroded away.

Figure 8 Timber-work near eaves above inserted window
Noted pegged joint above closest stud

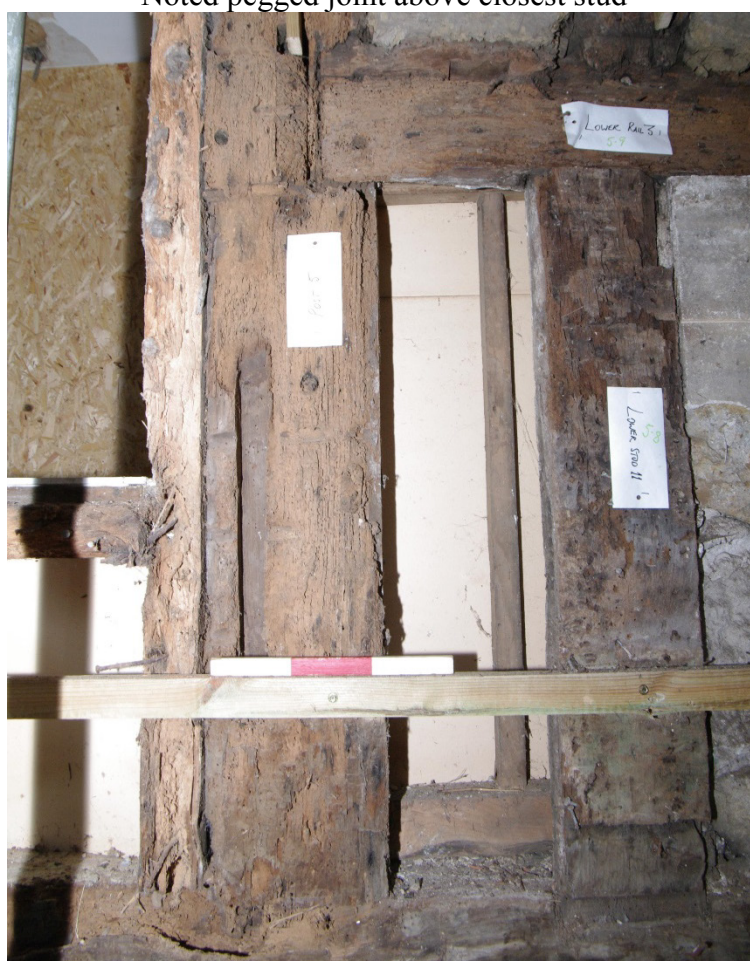
At a similar height to the inserted Georgian windows are a series of redundant long thin mortices on the outer faces of the posts (Figure 9). A number of the mortices still have their tenons still in place. The location and arrangement of these sockets are such that they have been identified by D Warren as evidence for the location and size of the original oriel windows. This seems to be quite a plausible explanation especially as the mid-rail is set quite low down and therefore may reflect the location of the earlier windows.

Figure 9 Redundant mortice from probable earlier window
Mortice is above the 0.3m scale. Inserted Georgian west window on left

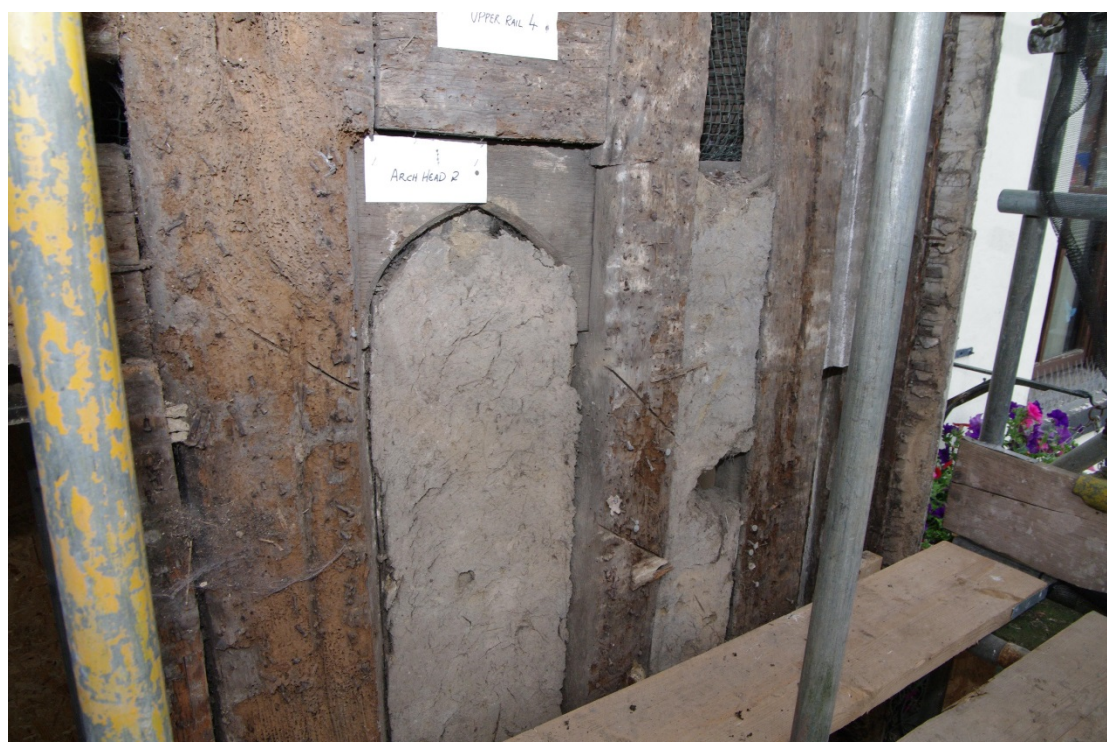
Removal of the modern render revealed two narrow arched boards of wood set between closely spaced posts (Figure 10). The underside of the arches are chamfered and were clearly intended to be seen from the street. The boards, which appear to be oak, are set into slots cut into the posts and appear to be part of the original building design. Lime plaster infill fills the space between the posts below the arches.

There are very few carpenter's marks visible on the timbers. This may be due to the degradation of the outer faces of the timberwork rather than a genuine lack of original marks. However, some deeper incised marks can still be seen in a number of places although most are unclear as to their purpose. One such mark can be seen running diagonally below the western arched board (see Figure 10). This cuts across the two

posts but does not mark the arched board nor does it mark the plaster infill. Its purpose or origin is unclear.

Figure 10 Decorative arch head between posts
Westernmost arch. Note diagonal grooves in posts

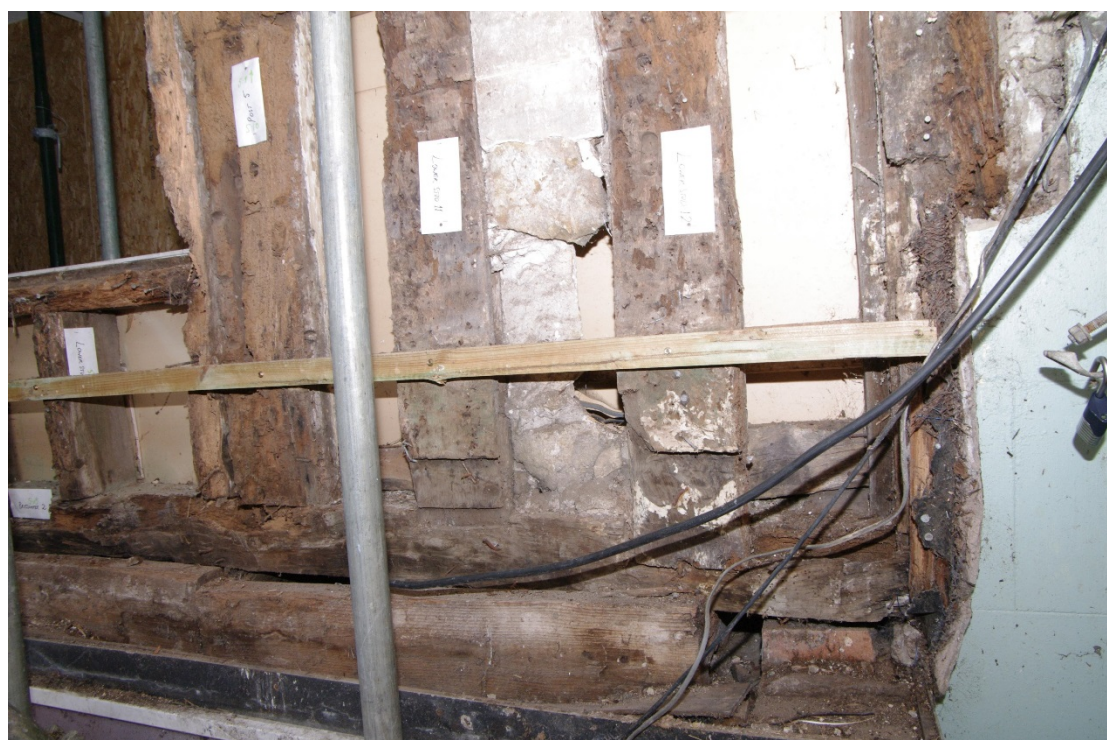
Remnants of lime plaster infill between the studs are still present in some parts of the elevation (Figure 11). The infill consists of a thin piece of stone wedged into a vertical V-shaped groove and covered with a layer of lime plaster. The stone appears to be naturally split or roughly worked ferruginous limestone similar in size and shape to Collyweston slates. The grooves cut into the sides of the studs are sufficient for the stone to be wedged firmly into the space which then provides a solid backing for the plaster (Figure 12). The grooves are fairly wide and around 5 to 10mm deep and would represent a significant amount of extra work to add such grooves to each side of every timber. A large amount of animal hair and some straw can be seen in the broken edges of the plaster. D Warren has seen similar examples in South Yorkshire but not in North Northamptonshire. It is possible that this building tradition was brought to Daventry by an itinerant builder. Limestone is a relatively easily available building material within the locality of Daventry.

Figure 11 First floor, eastern side
Remnants of plaster and stone infill between studs

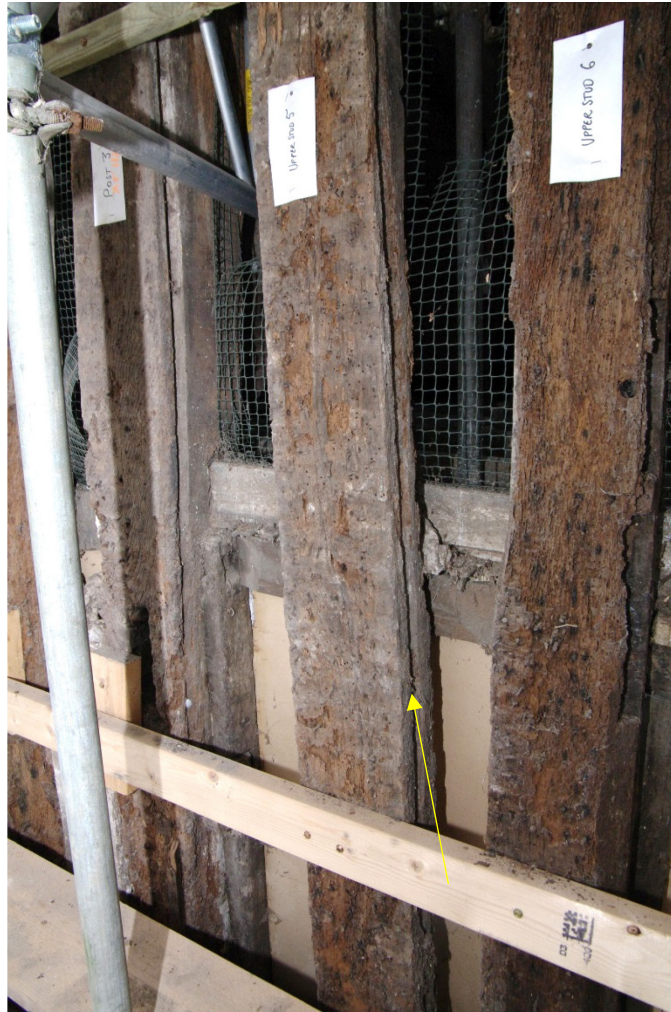
Figure 12 Close-up of groove for stones in timber post

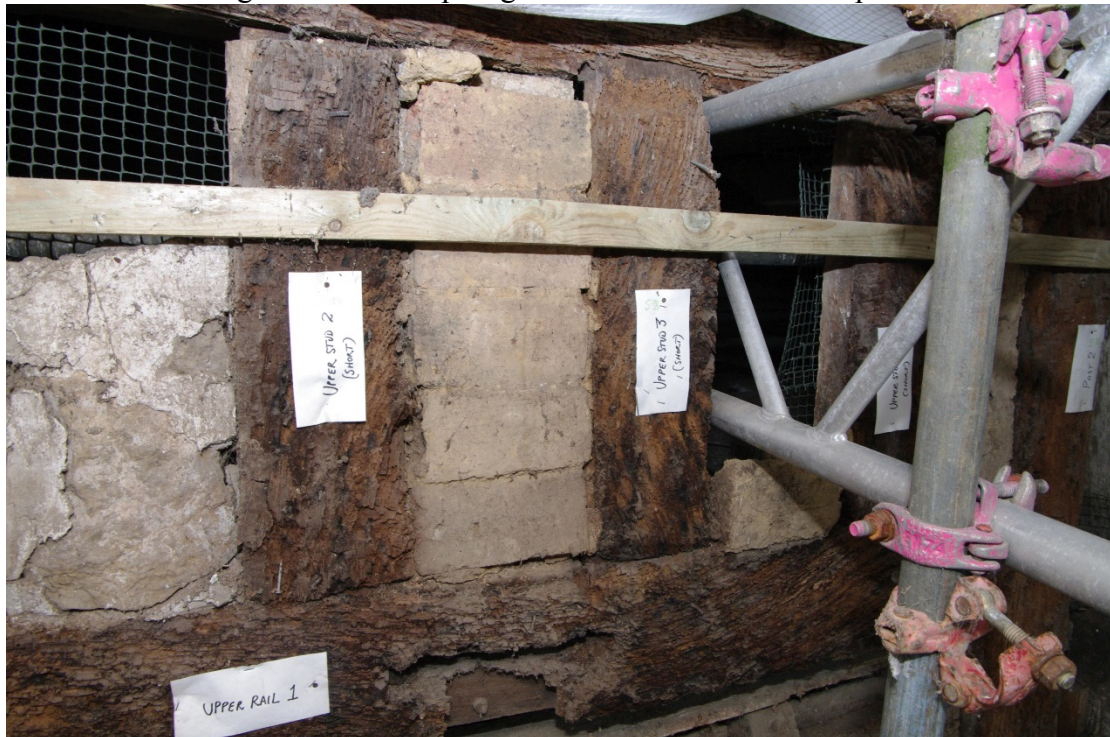
There are small areas of brick packing and infill across the frontage. Most noticeable is a near continuous row of two courses of brick along the wall-plate. The wall-plate is mostly original timber but the bricks appear to be of probable 19th century date. Warren's report notes that there was a fire in the 19th century and it may be possible that the bricks are a part of a repair from this time. Other small areas of brick infill repair work are visible between the studs and posts (Figure 13). Such infilling may have been an attempted repair where the original stone and plaster had fallen away. Elsewhere single bricks appear to fill the gaps between joints and damaged timbers.

Figure 13 Brick infilled panel close to top eastern corner of frontage
The brick infilled panel is the centre panel

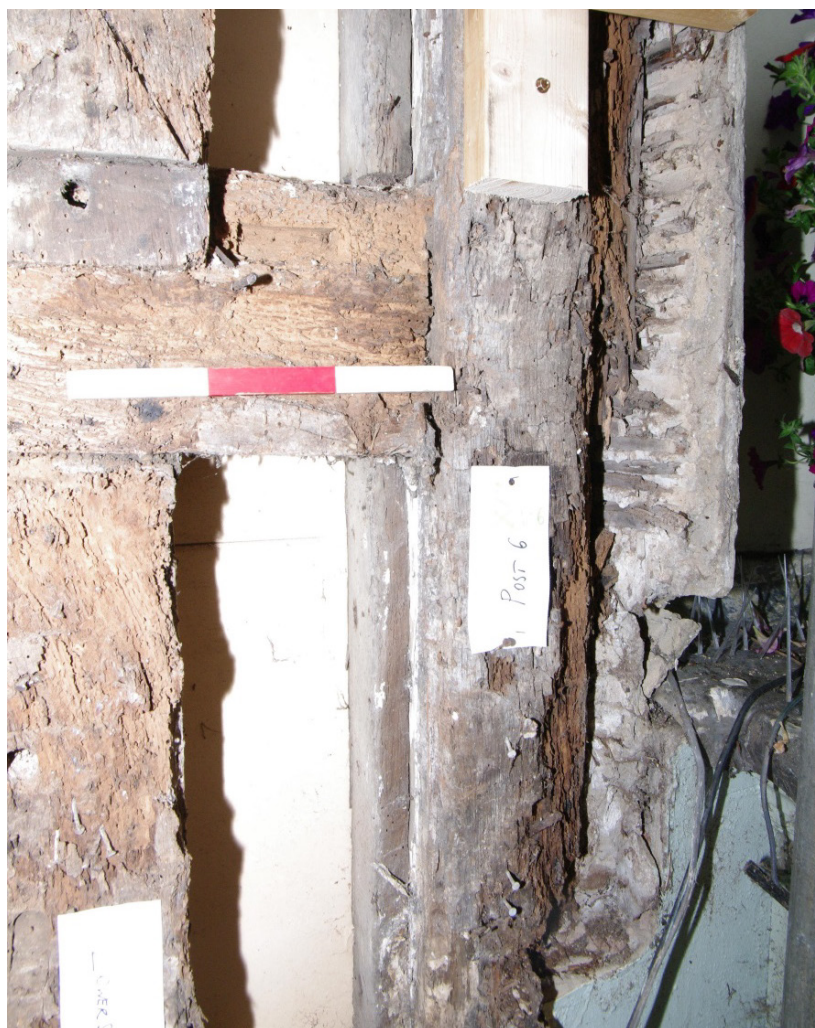
Along the joint between 3/3a and the adjacent building to the west is the exposed end of a lath dividing wall (Figure 14). The laths have a thick layer of render on their western outer face which may be a mix of earlier lime plaster with modern material over it. This seems to be a rather insubstantial wall unlikely to be an outside wall. It may therefore be possible that this was the dividing wall between another similarly sized and similarly dated building which pre-dates the present adjacent building.

Figure 14 Stub of lath and plaster west wall
Adjacent property (Number 5) to right of picture

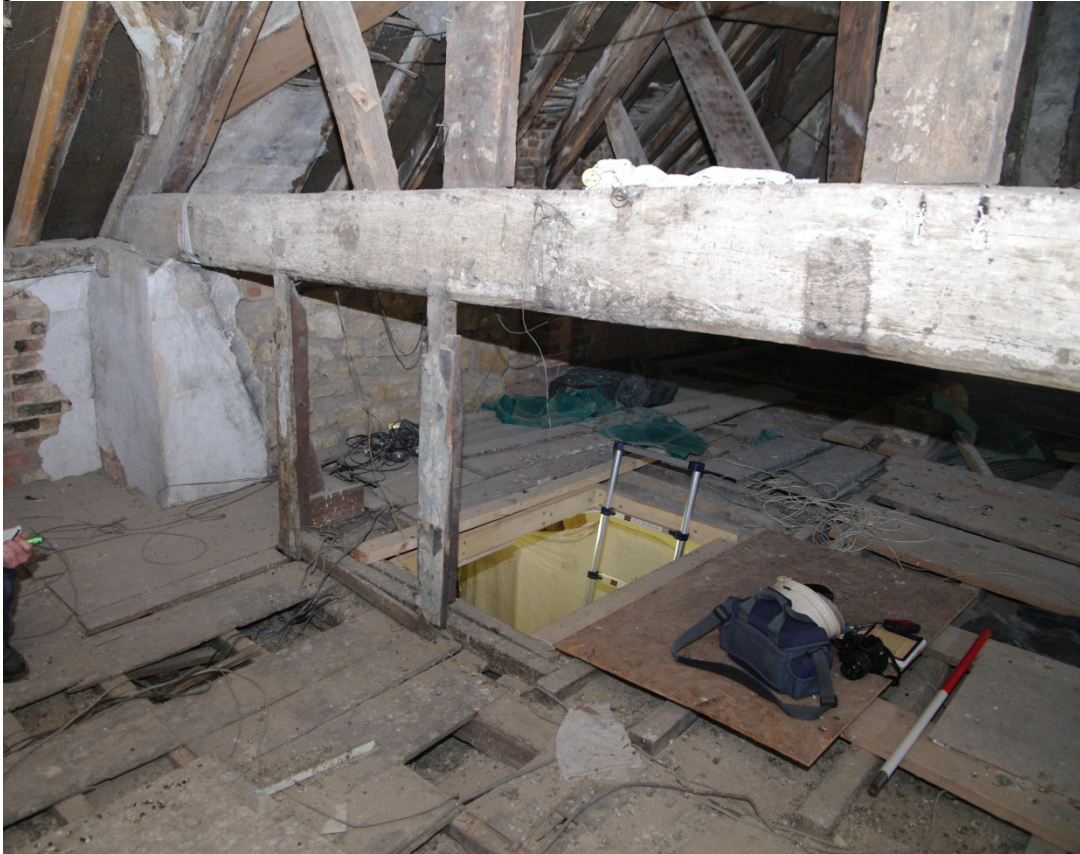
Figure 15 Roof space, east side of Truss 1

Truss 1 was originally closed below the tie-beam as shown by a series of large and regularly spaced stave holes cut into the underside of the tie-beam. However, the space above the slightly cambered tie-beam appears to have been open to the ridge. The truss consists of both king and queen posts set between the tie-beam and the collar. Flanking these are a pair of raking braces or struts which support the principal rafters and underside of the chamfered and pegged purlins. Additional stability is given by sets of braces rising up from the collar to support the upper purlins. Also present are pairs of windbraces connecting the principals and the upper purlins.

Looking south-west. Note difference in south wall building materials. The two upright timbers below the tie-beam show the sides of the door into the servant's quarters

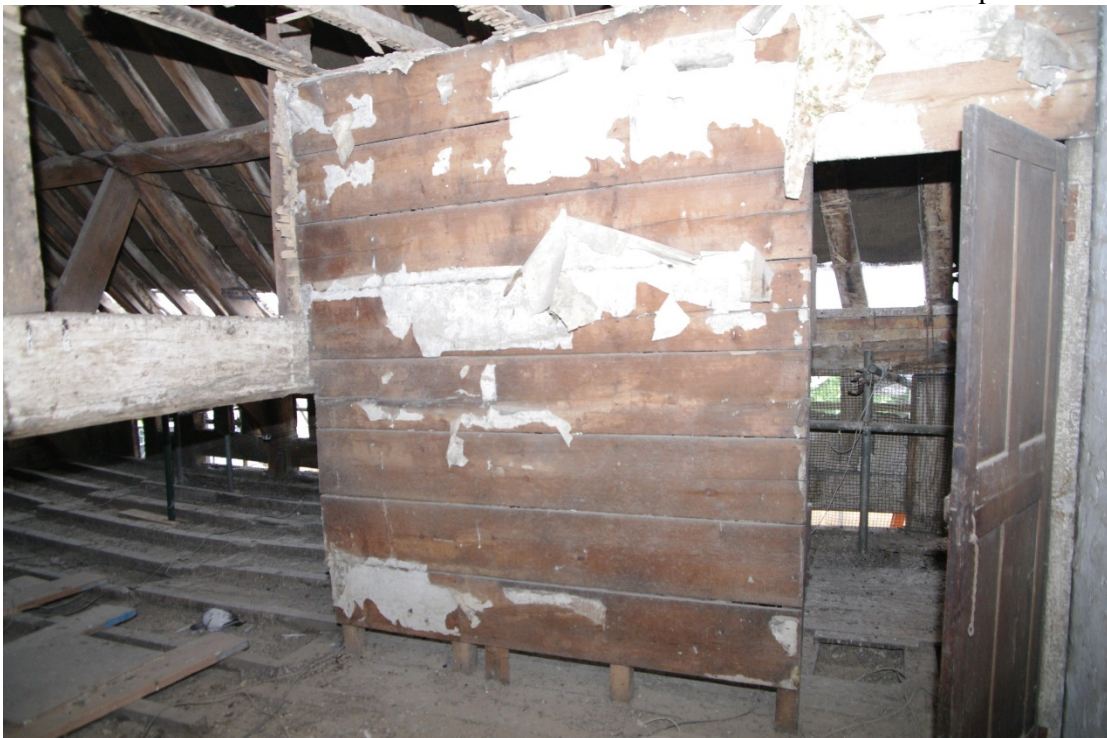
Possibly during the 19th century, perhaps following the insertion of the Georgian windows, the eastern bay was separated off to form two small rooms for servants' accommodation. A plaster and lath wall was attached to the east side of the truss with a low plank and batten door in the wall leading to a ladder to the first floor. The space was further subdivided by an east-west boarded partition wall with a four-panelled door (Figure 16). Part of the bell-pull pulley system for summoning the servants still survives. There does not appear to have been any source of natural light in either room.

Figure 16 Servant's quarters in roof space
Looking north-west

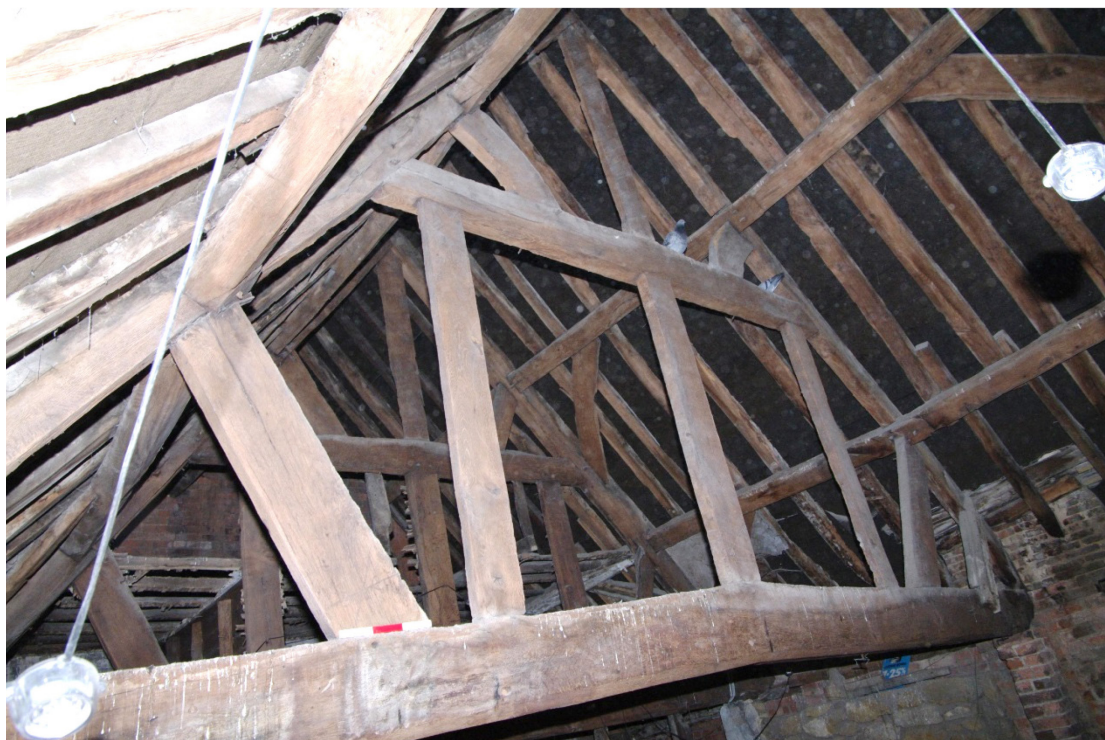
Truss 2, the central truss, is very similar in form to Truss 1 except that the braces above the collar are curved on this truss (Figure 17). Also there are no windbraces on this truss and no redundant sockets to show that any were ever present. Perhaps only the outer trusses were thought to need such additional stabilisation. The chamfered timbers and attention to detail especially around the clasped purlins and their joints suggests that this was all intended to be seen. This then suggests that this truss was across the centre of an open two-bay room when first built. The ceiling of the first floor is therefore a later, possibly Georgian, insertion.

Figure 17 Truss 2 seen from western side
Looking south-east. Truss 1 can be seen behind Truss 2

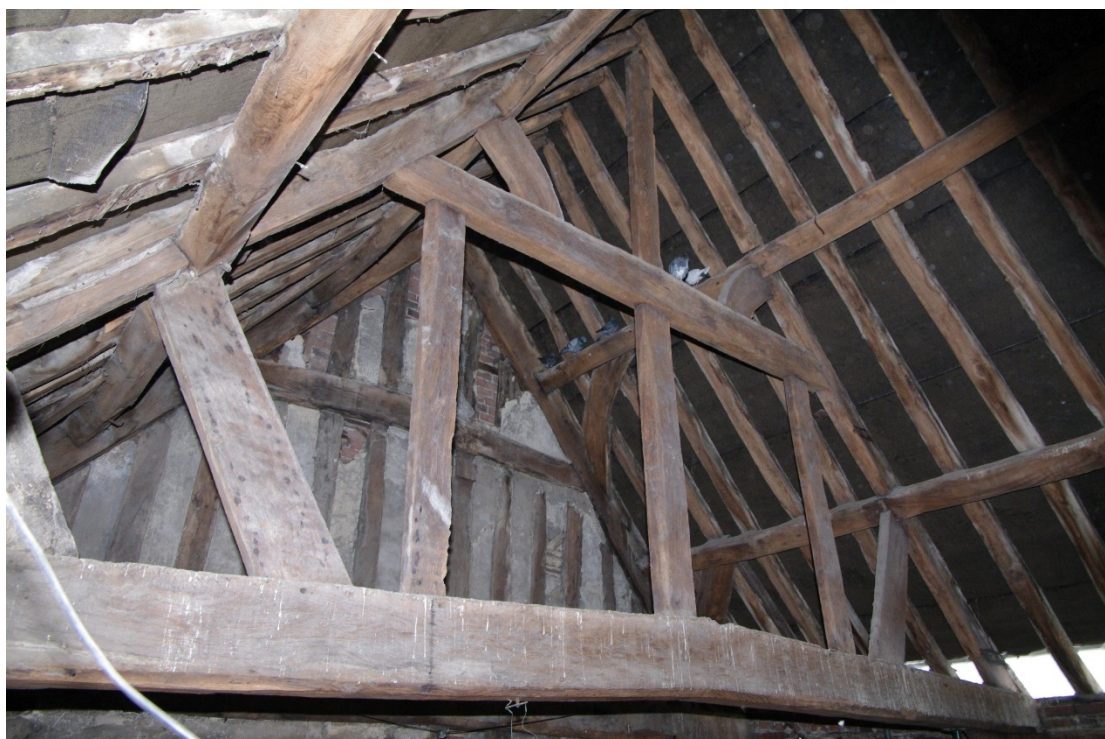
Truss 3 is located on the western wall of the building and is a closed truss forming the boundary wall between this and Property Number 5 next door (Figure 18). Close studding is set above and below the tie-beam and collar with most of the infill between the studs still surviving. There does not appear to be a V-shaped groove to hold stones as seen on the north facing elevation. Where the infill has broken away the brick gable

Figure 18 Trusses 1 and 2 from eastern side
Looking north-west with Truss 2 in foreground
