**An Historic Building Assessment of Rearsby Home Farm, Mill Lane Rearsby,
Leicestershire (NGR SK 647 144).**

Gerwyn Richards

University of Leicester Archaeological Services were commissioned by J.S Bloor (Measham) Ltd to undertake an historic building assessment of Rearsby Home Farm, Rearsby, Leicestershire. Outline planning permission had been granted for the demolition of some of the buildings and the conversion to residential use of other buildings during the re development of the site.

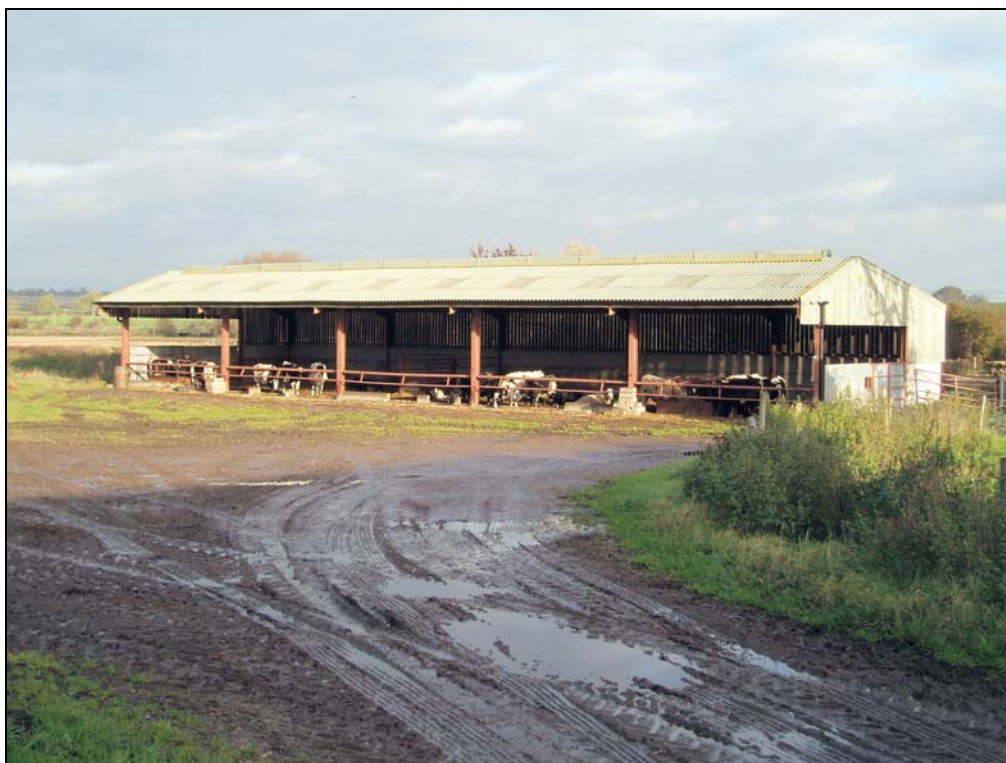
Figure 3 Building 1 from the South West.

Building 1 is located at the far northern edge of the proposed development area. It consists of a large modern open fronted cattle stall of a steel frame construction with corrugated steel box profile cladding and roof.

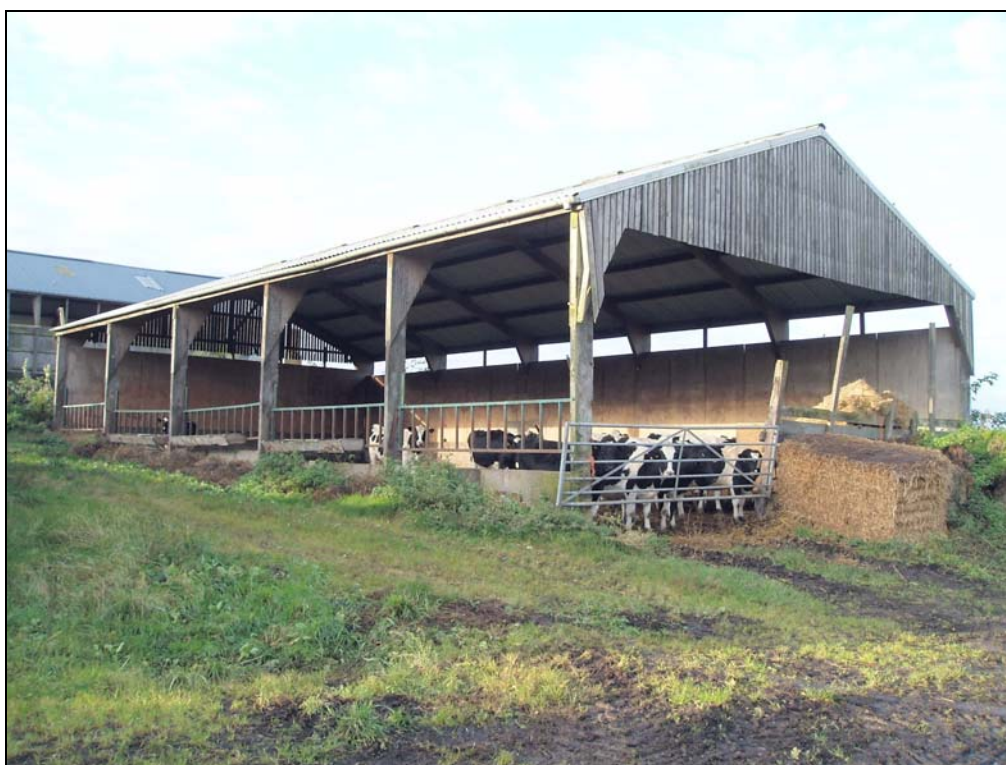
Figure 4 Building 2 from the East

Building 2 is another open sided cattle stall, this time, however, constructed with a timber frame with quarter height breeze block walls to the rear and both gables with steel stock barriers at the front. The rear and left hand walls have been clad in 20mm plywood sheets and once again the roof is corrugated steel box profile. The building is likely to be 1980's in date.

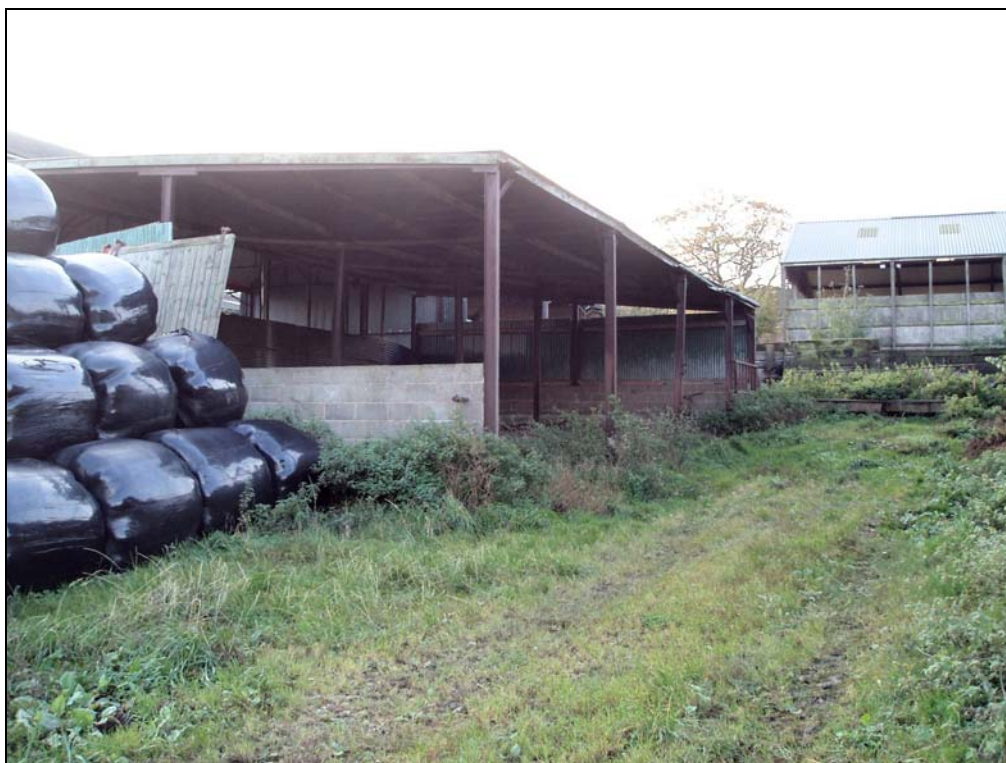
Figure 5 Building 3a from the North

Building 3a is located directly opposite building 2 and is again a large open sided building. This time steel framed with a corrugated steel sheet roof; there are half height breeze block walls on the gables along with steel cladding on the right hand gable. Being open down to ground level at the front, the building was likely to originally been a machinery shed, probably dating from the 1960's or 1970's.

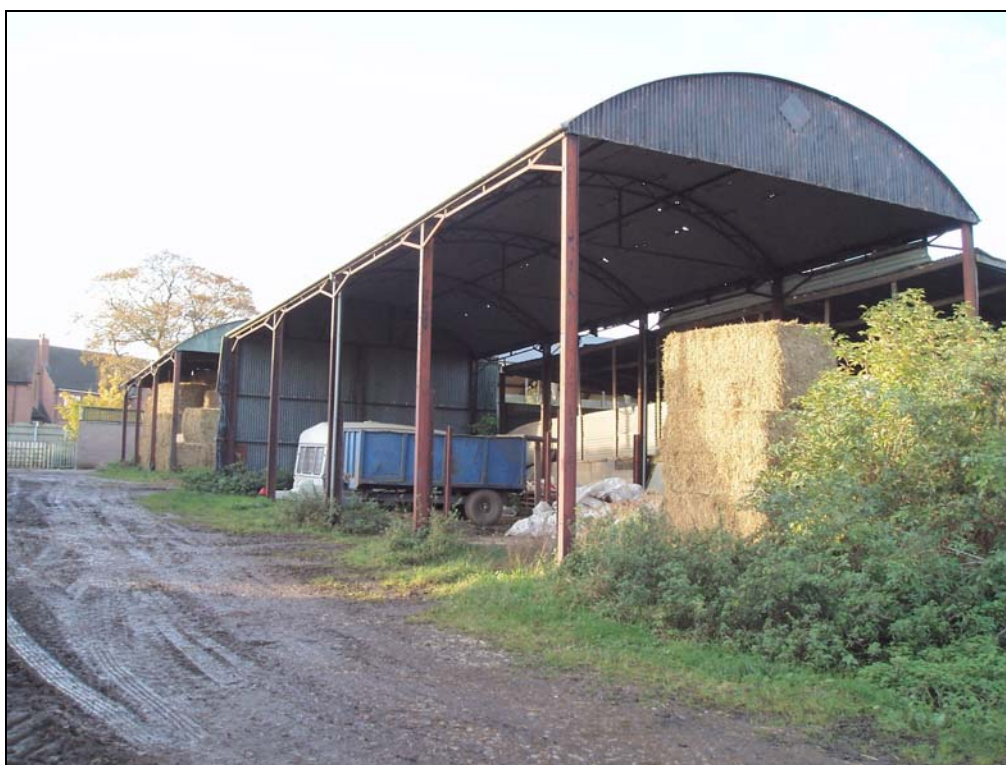
Figure 6 Building 3b from the North East

Building 3b is attached to the rear of building 3a and is undoubtedly the earlier of the two. The building is a classic Dutch Barn of four bays constructed of RSJ (Rolled Steel Joists) frame, angle iron roof frame and corrugated steel roof. There is diamond shaped makers plate on the right hand gable, sadly too weathered to yield any information and there is no makers stamp on the RSJ columns. The building appears on the 1965 Ordnance Survey but is almost certainly earlier in date; typology suggests a manufacturing date of the 1930's.

The building is of interest as it is the beginning of mass produced farm architecture and almost symbolic of the industrialisation of farming in the twentieth 20th century. The introduction of the now ubiquitous Dutch Barn was the beginning of the end of vernacular farm architecture.

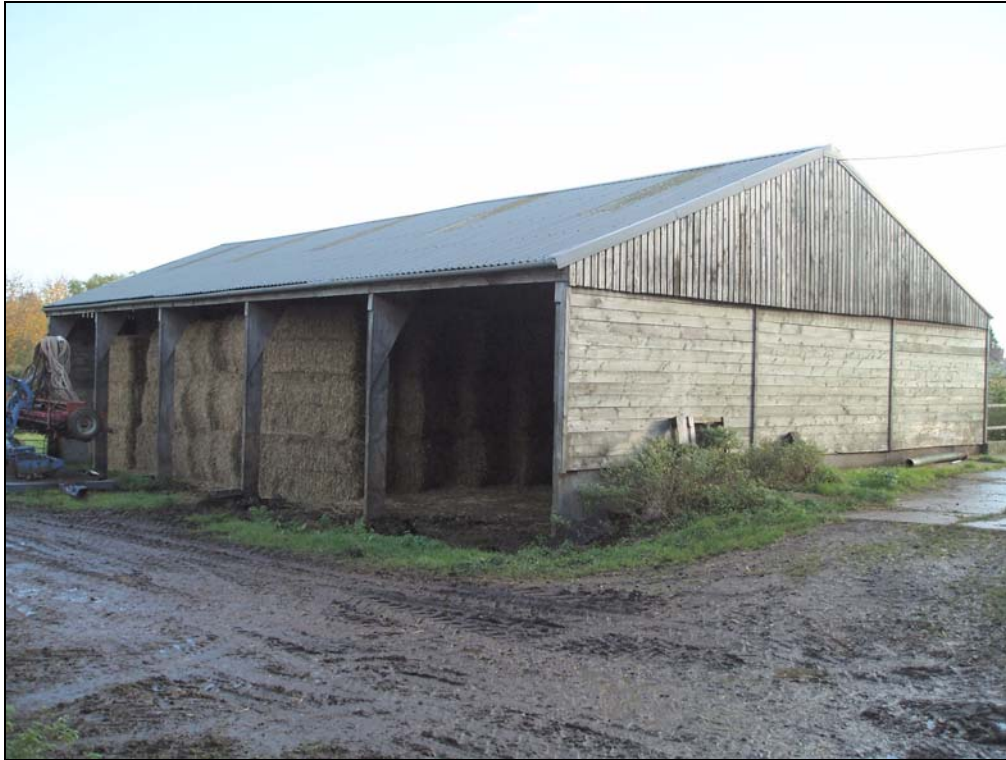
Figure 7 Building 4 from the South West

Building 4 is identical in form to building 2, rear wall and gables, however, have been clad in weather board, leaving only the front open. In all likelihood originally constructed as a machinery shed or hay barn, probably 1980's in date. There is cartographic evidence that this building is built on a site originally occupied by farm building dating to the nineteenth century.

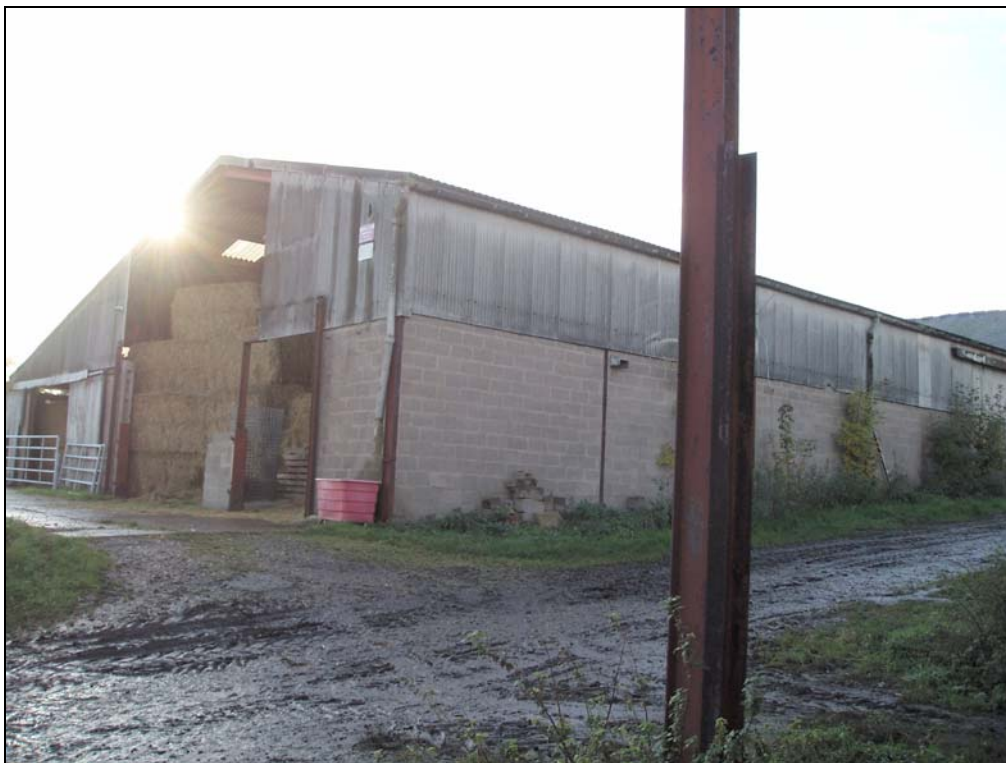
Figure 8 Building 5 from the North

Building 5 is by far the largest building within the proposed development area; it consists of a steel frame with three quarter height breeze block walls. The remainder of the wall and roof is corrugated asbestos concrete sheets. The building is currently used as a hay barn, however, the nearby slurry tank indicates that this was the original cow shed, the use of asbestos concrete cladding suggests an early 1960's date.

Again, the building is of interest as it reflects the industrialisation of livestock rearing in the later part of the twentieth century, the entire herd kept under cover with sufficient access for mechanical feeding and removal of slurry to the tank outside.

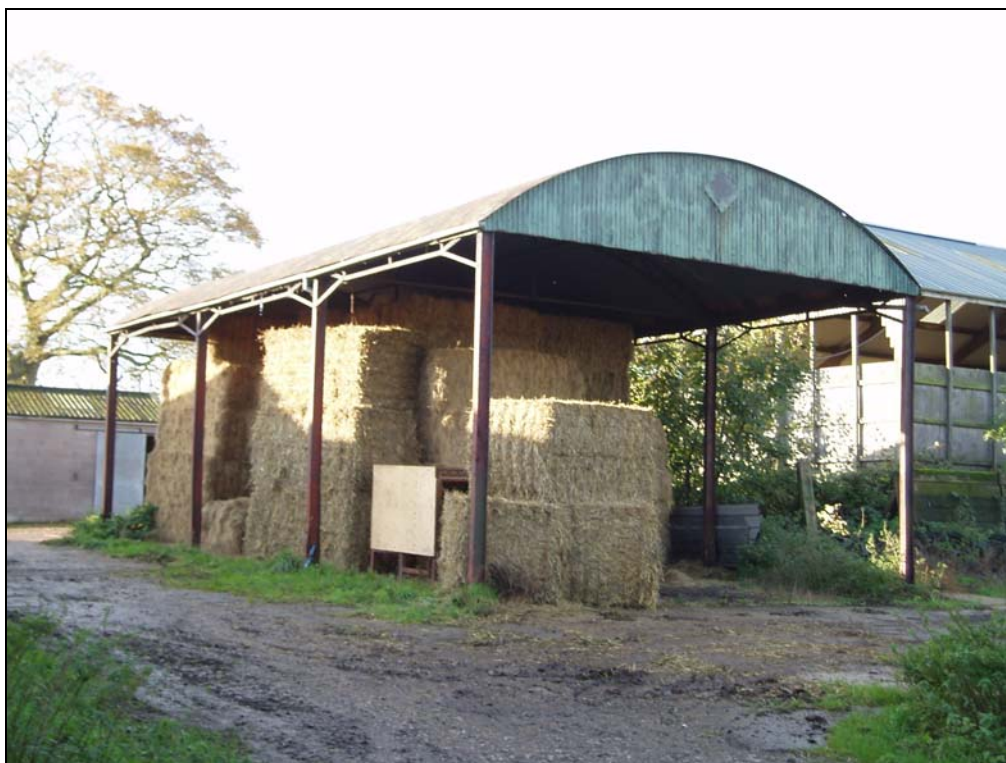
Figure 9 Building 6 from the North East

Building 6 is a Dutch Barn identical in design to building 3b, but being only 3 bays slightly smaller.

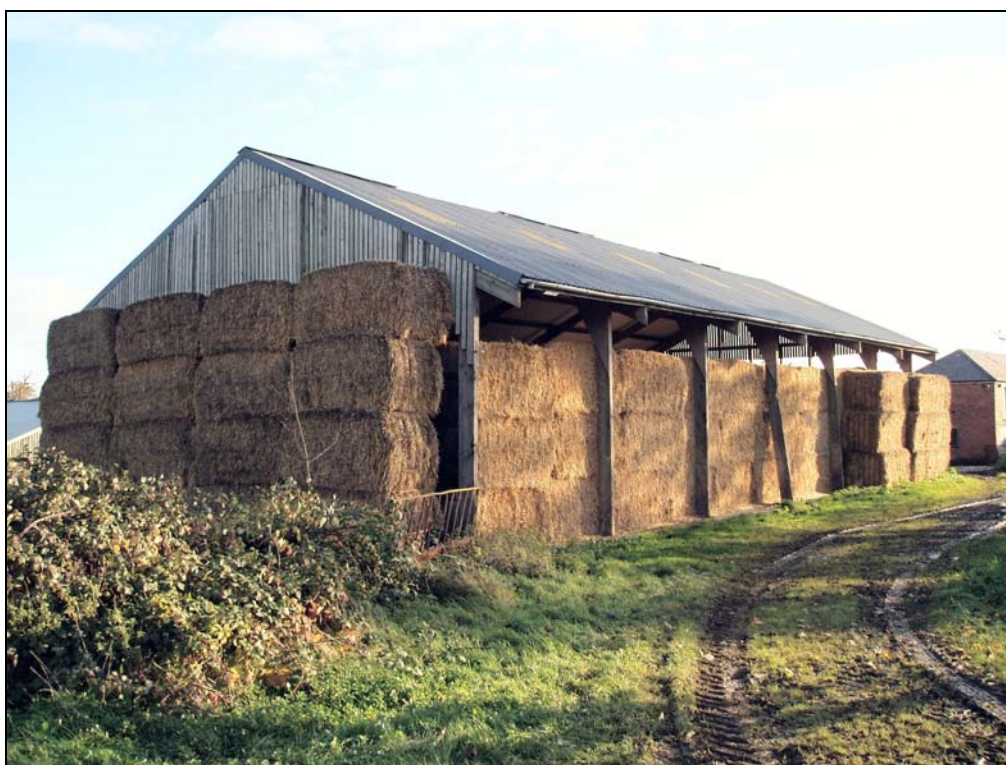
Figure 10 Building 7 from the West

Building 7 is the second largest building within the proposed development area and over wise identical in design to buildings 2 and 4. It is however, open on all sides and is currently in use as a hay barn, most likely its original and intended use. The building is likely to date from the 1980's, and can be seen as another step in the evolution of the classic Dutch Barn (Buildings 3a & 6, nearby).

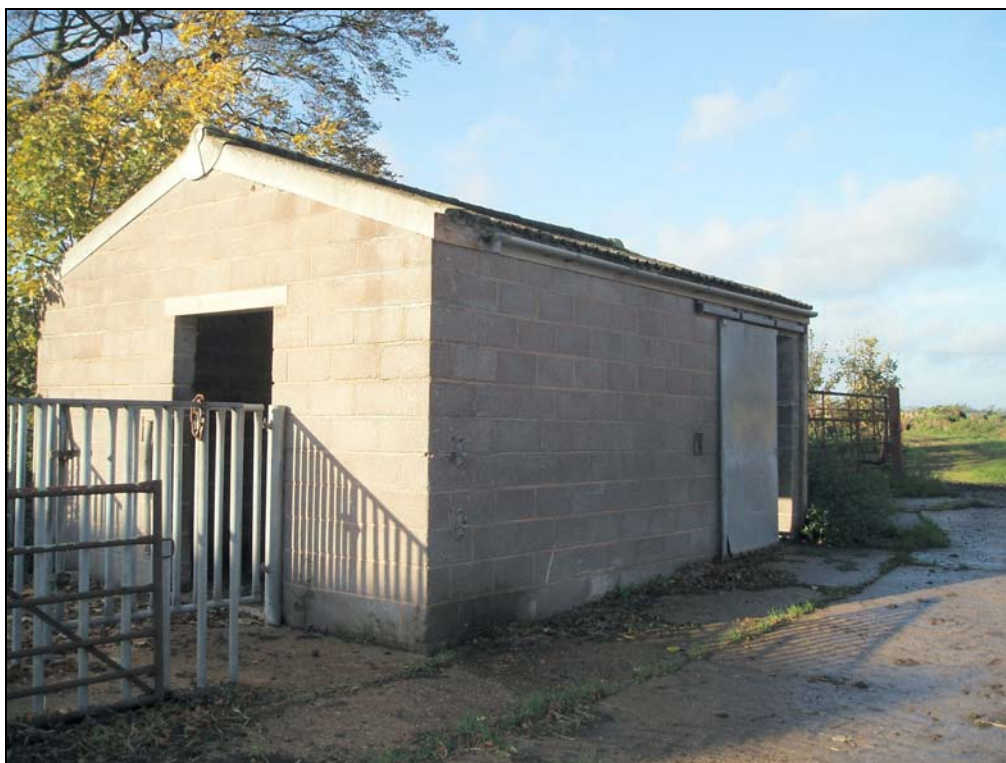
Figure 11 Building 8 from the North East

Building 8 is a small breeze block and asbestos concrete roofed building. There is a substantial internal partition of steel stock barrier and a mesh feeding trough. There is a pen of same steel stock barrier to the left of the building with a built in "cattle crush". In all likelihood the building was originally a bull pen to house bulls brought in to service the dairy herd.

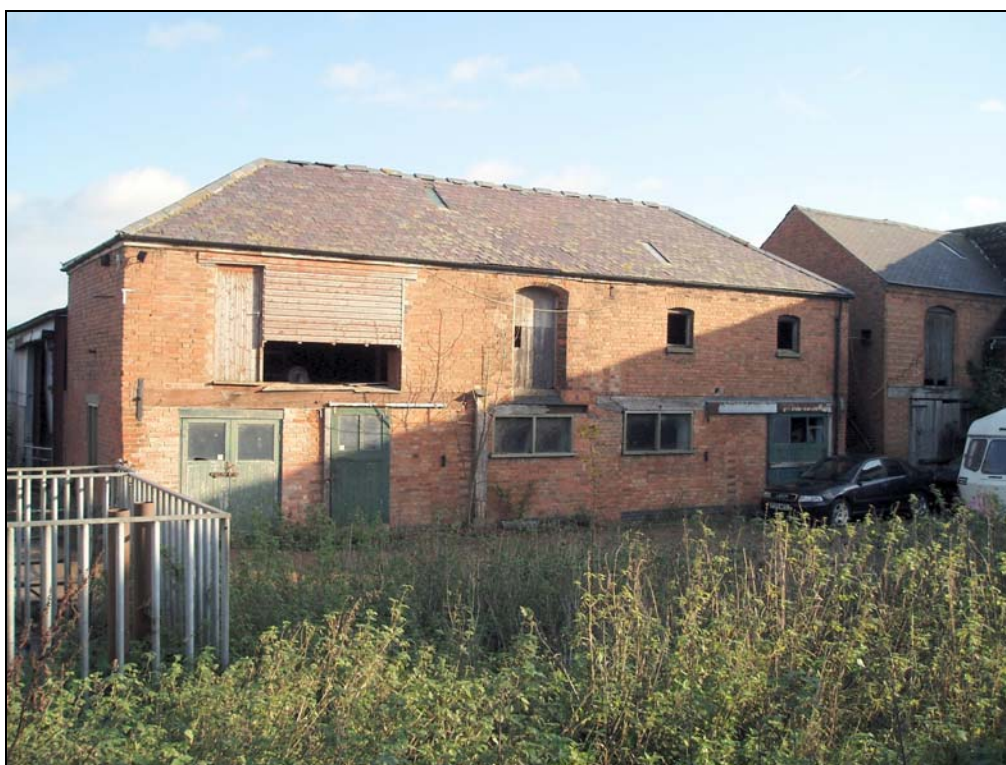
Figure 12 Building 9 from the South West

Building 9 is the first of early red brick buildings within the proposed development area. It consists of a two storied red brick building with a hipped roof of local slate, originally likely to be a milking parlour with a hay/grain loft over. It probably remained a milking parlour after the construction of the large cattle shed (Building 5) which adjoins the rear of the building.

Externally there is evidence that the front of the building was originally open and supported on two brick built columns carrying timber lintels. An inscribed brick bearing the date 1845 can be seen within the right hand brick column, the building is clearly identifiable on the 1885 Ordnance Survey, the date, therefore, would seem correct. The rear of the build also bears evidence of alterations, there is the scar of a lost wing at a right angle to the rear wall of the building near the left gable, and the 1903 Ordnance Survey confirms this.

The ground floor of the building was inaccessible at the time of the site visit, the first floor, however, could be accessed via external stairs on the right of the building. The far left bay contained some modern farm equipment, probably milking equipment. The remains of a line shaft and flywheels could be seen within the right hand bay, the shaft continued through wall into the adjacent building. The roof was of a king post design with raking struts.

The survival of the shaft and flywheel are evidence for the early industrialisation farming. The shaft was inserted into an earlier building to provide drive to new machinery probably in the later part of the nineteenth century or early twentieth century with a traction engine providing the power.

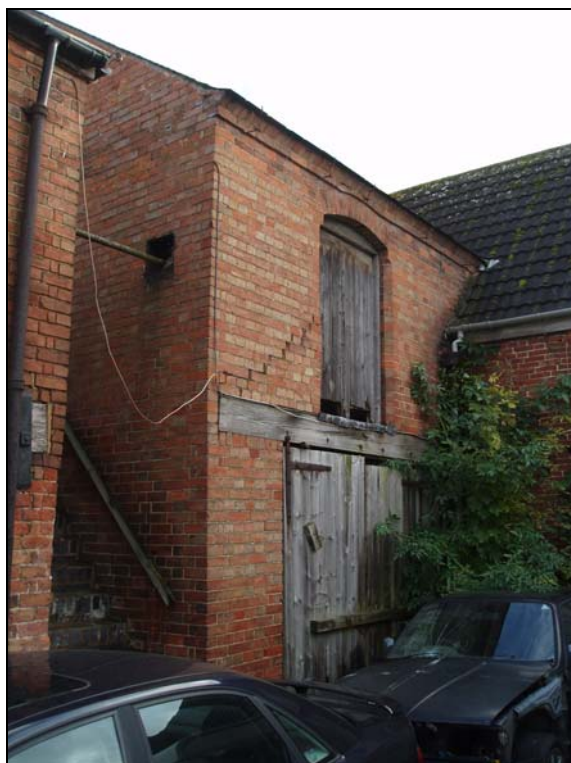
Figure 13 Building 10 from the South West

Building 10 is a small two storied red brick extension to the rear of building 11 which aligns with building 9; there is a flight of blue brick steps between building 9 and 10. With the exception of some pleasant angled brick corbelling at eaves level the building is very similar in style and construction to building 9 and may, therefore, be contemporary.

Once again the ground floor was inaccessible and the first floor devoid of any identifiable features, the line shaft observed within building 9, however, did continue. The roof structure was a queen post design. An entrance had been inserted into the rear wall building 11 providing access to timber built mezzanine floor inserted into the right hand bay of building 11.

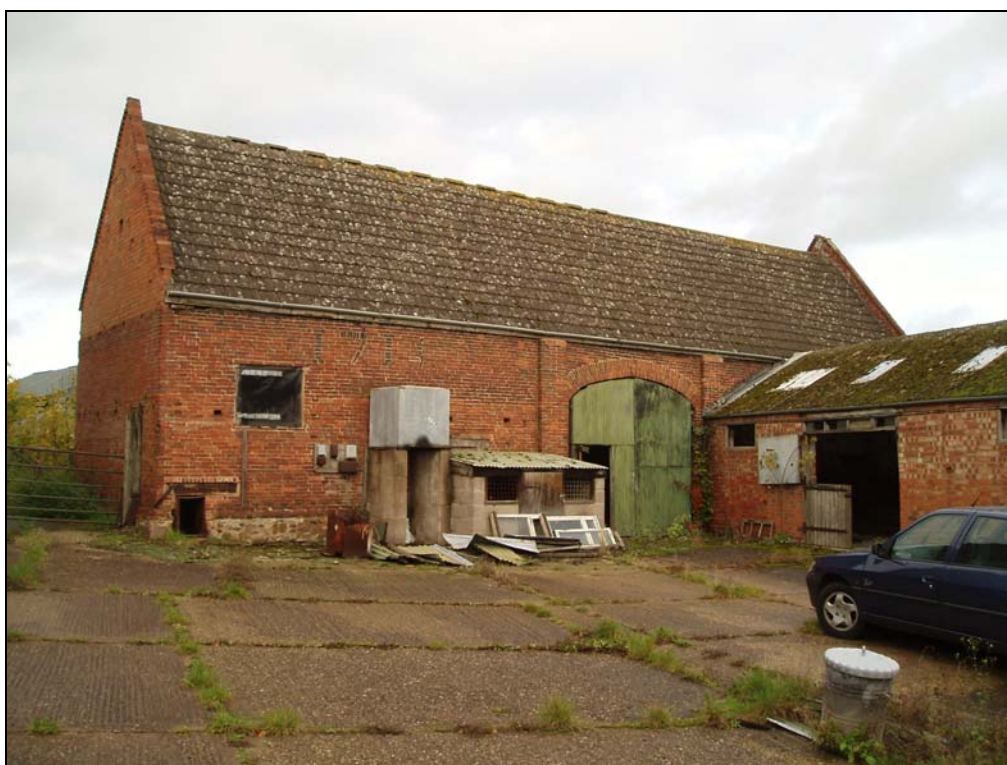
Figure 14 Building 11 from the South

Building 12 is one of the earliest buildings within the proposed development area and is one of the two buildings which are locally listed (Appendix i). The building is an early eighteenth century threshing barn in locally made red brick, sat atop a rubble plinth, it has been recently re roofed with brown concrete tiles. The date 1715 is high lighted in blue brick on the front wall of the left hand bay. The gables are steeply coped brick, clearly nineteenth century rebuild at height but possibly copying what they replaced.

Internally, a timber mezzanine floor supported on lower tie beams has been inserted into the right hand bay, the remains of possibly a wheat drying kiln is within the left hand bay. The roof is, without doubt, the great feature of this building and is described in the listing document as:-

Closer examination revealed surviving carpenters marks on the principal rafter within the right hand bay. It was not possible to examine other timbers during this visit, but further recording work will surely have to be done prior to any further work commencing.

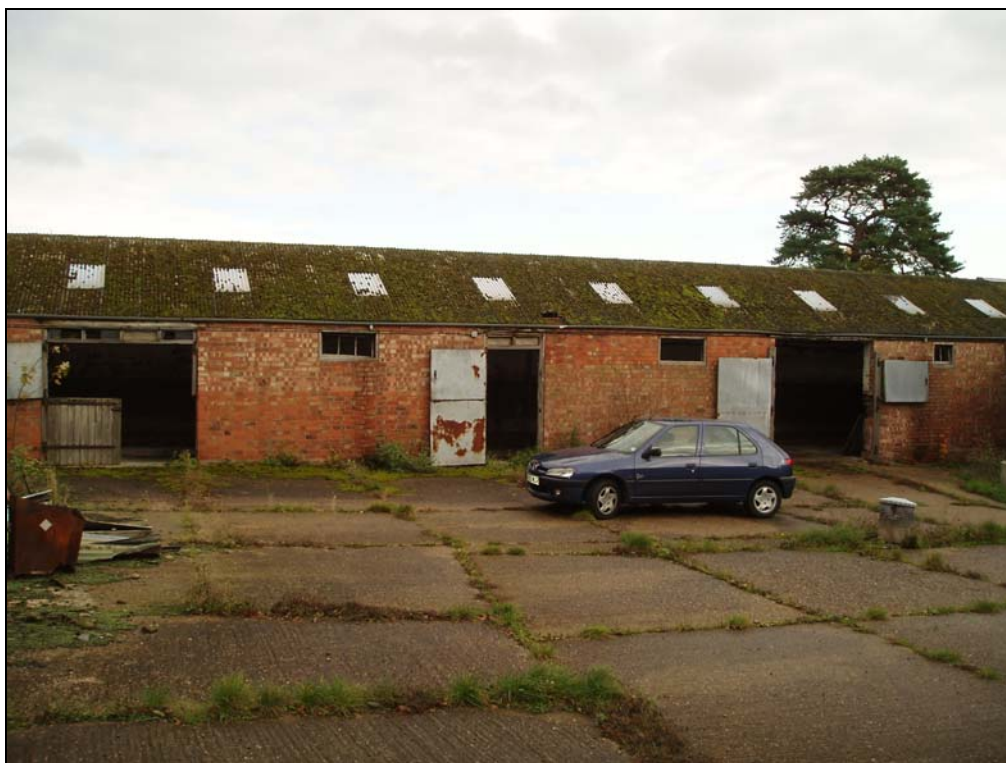
Figure 15 Building 12 form the South West

Building 12 is a single storey red brick and concrete asbestos sheet roof building; there are two double doors to the left and right and a central single door. The brick work is very mixed in appearance and the building may have originally been open fronted. Internally the building has been completely stripped, there are traces of feeding troughs on the rear wall, suggesting that it may originally been a milking parlour.

The building appears on the 1885 Ordnance Survey; however, the current building appears to be later in date, or else much altered and modernised. Nevertheless, the building remains of architectural interest.

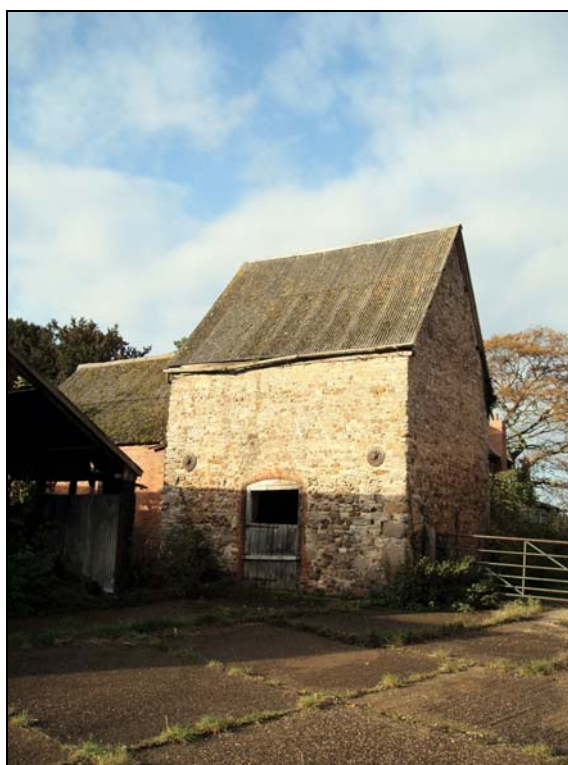
Figure 16 Building 13 from the South East

Building 13 is the second listed building within the proposed development area (Appendix i). The building is mainly granite rubble construction with what appears to be sand ironstone and unidentified large cobbles; there are a limited number of granite quoins at lower levels on the front of the building with a central door and an entrance high on the left hand gable. The roof is corrugated concrete asbestos sheets.

Internally there is nothing of architectural significance visible at ground floor level, the ceiling has right to left joists supported by a central axial beam. The ceiling itself appears to be a plaster and lathe construction. Access to the first floor is via a hatch in the front right hand corner, unfortunately access was not possible at the time. A limited view through the damaged hatch indicated a complicated pattern of brick work on the right hand gable. It is likely, therefore, that the first floor may be a dovecote, the entrance on the left hand gable being the flight entrance

Dating the building with a limited inspection is extremely difficult, the Listing suggests an early Eighteenth Century, it is possible, however, that it may be earlier. It is certain that further work will be required as the proposed building work will alter the building significantly.

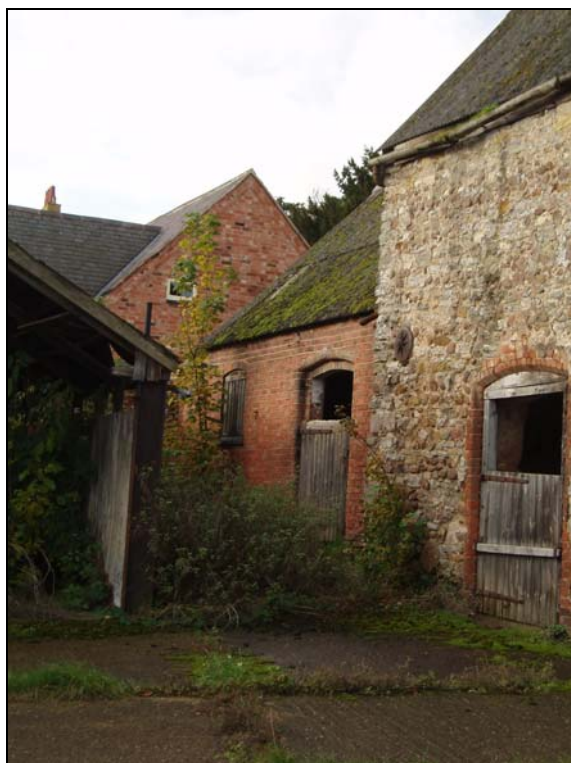
Figure 17 Building 14 from the East

Building 14 is a single storey red brick stable with a corrugated concrete asbestos sheet roof abutting, but not attached to the left hand gable of building 13. The bricks appear to be late nineteenth century in date. Internally there is a brick built and arched feeding trough along the rear wall and possible tack hooks on the walls and hanging from the roof timbers, including a probable saddle tree.

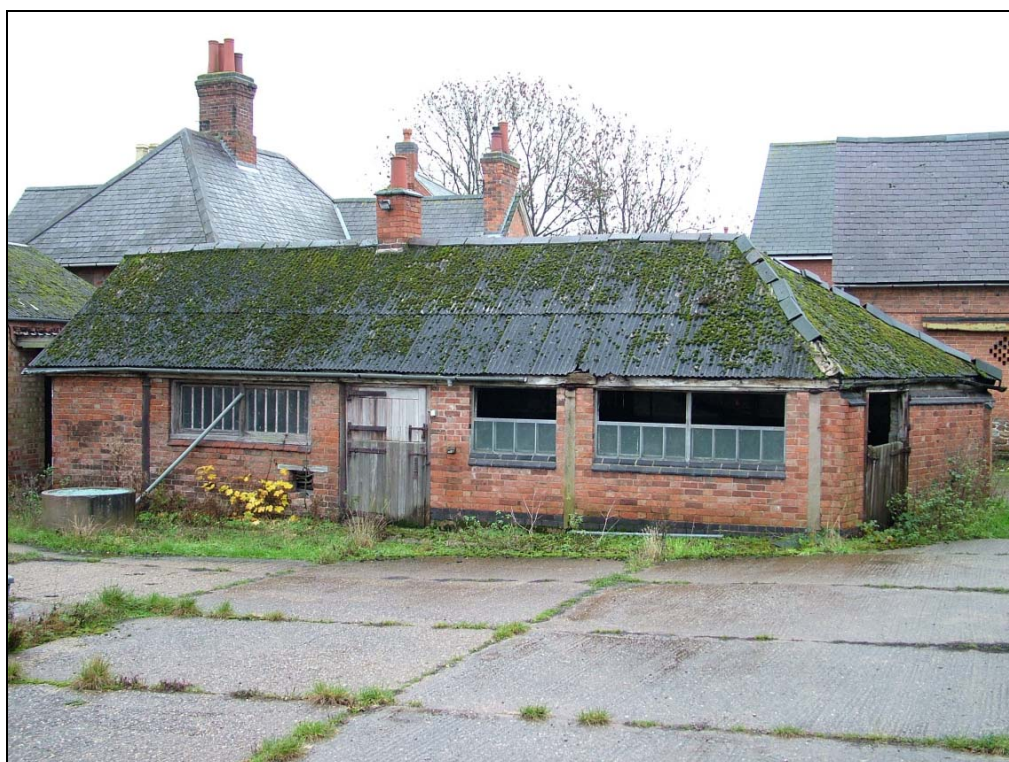
Figure 18 Building 15 from the North West

Building 15 is located opposite buildings 11 and 13, which along with buildings 12 and 16 create the first farm yard. The building is a single storied red brick with a half hipped roof of corrugated concrete asbestos sheets; the building was apparently originally open sided onto the yard, wall plate being supported on cast iron columns. This has since been filled and the columns concealed in concrete.

Internally the right hand bay originally appears to have been constructed as a cow shed with double stalls along the rear wall. The roof is a king post design.

The left hand bay has a fire place within the right hand wall and appears to be a general store. The king post within the right hand bay has been cut through to vent the chimney, suggesting that the partition, if not the entire left bay is a later addition.

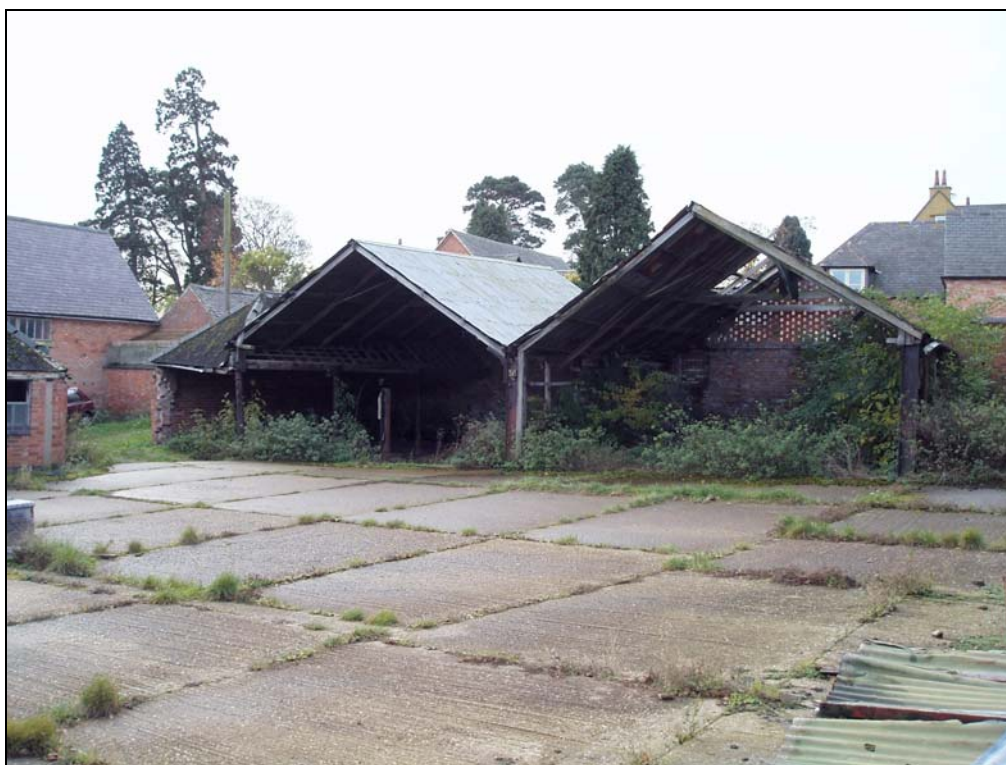
Figure 19 Building 16 from the North East

The final building within this part of the farm yard is building 16; it is an open sided steel framed building with a corrugated tin sheet roof. The rear wall is the boundary wall extended to fill the gable, the building on a whole is in a ruinous condition.

Interestingly the left hand bay has been constructed over a smaller building, leaving the roof and the cast iron columns in place as well as the rear wall in place. In all likelihood this building was identical in form to the adjacent building 15; indeed both buildings appear on the 1885 Ordnance Survey. The iron columns are cylindrical with rolled detail at the top and stamped "W RICHARDS & SON LEICESTER". In all likelihood this was identical in form to building 15 and was likely, therefore, to be a cowshed also.

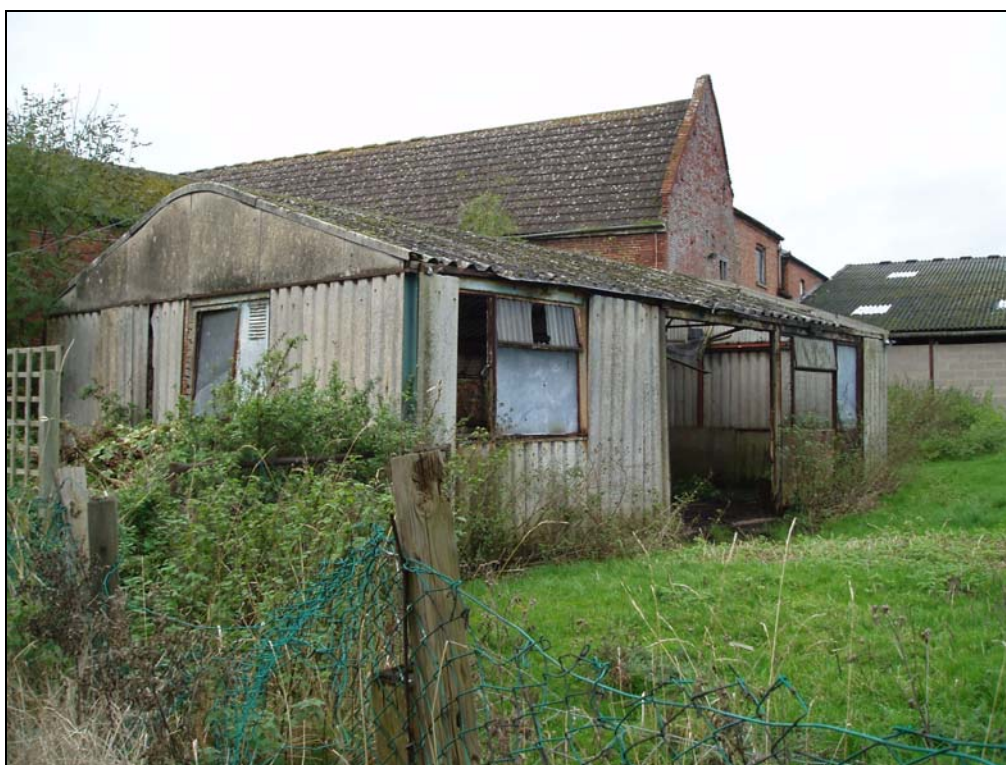
Figure 20 Building 17 from the East

Building 17 is a medium sized steel framed building clad in box profile concrete asbestos sheets to the rear of building 12. The building is probably 1970's in date and is a good example of the late twentieth century mass produced multi purpose architecture. Due to the perceived danger of asbestos these types of buildings are being destroyed at an alarming rate with no record and do merit further recording prior to demolition.

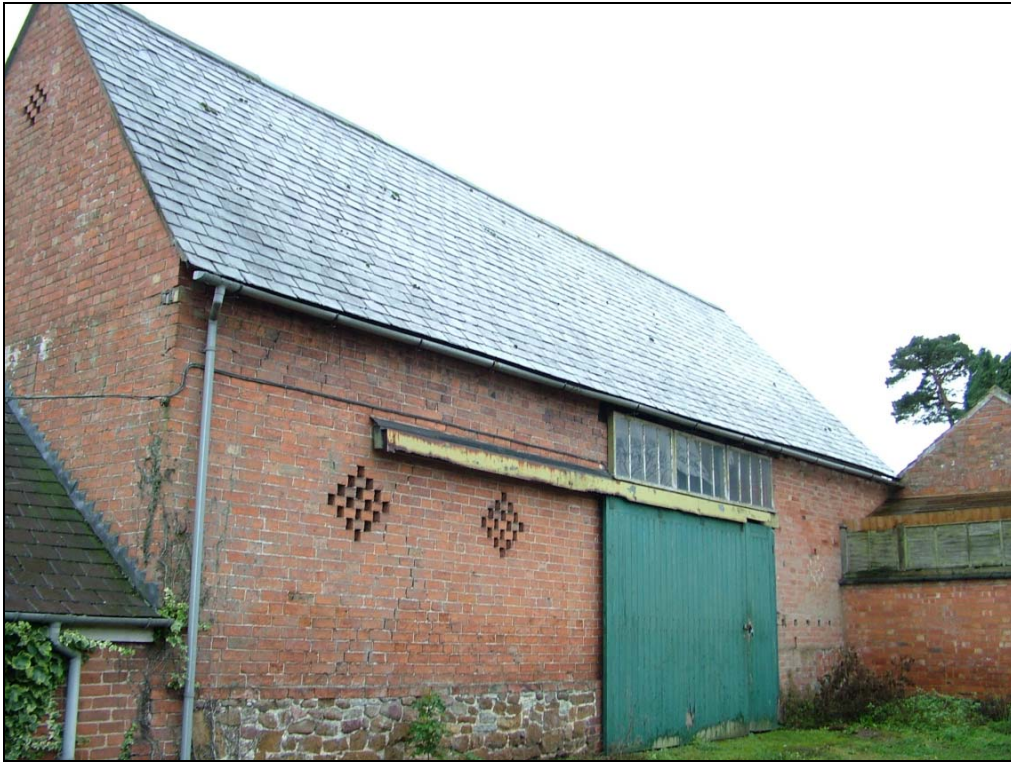
Figure 21 Building 18 from the North

The final agricultural building within the proposed development area is a substantial red brick threshing barn, immediately to the rear of 27 Mill Lane. The bricks themselves are 9inch by 2 3/4inch hand made bricks and there is a partial rubble plinth to the left, the stone appears to be sand ironstone. The roof is possibly a recent replacement of Welsh Slate.

Originally being a threshing barn, internally there is little of architectural significance. The roof timbers, however, are in very good condition and are undoubtedly original and is similar in design to that seen within building 11. Brick buttresses support roughly shaped tie beams below equally roughly shaped principal rafters, further detailed recording of the roof is undoubtedly required.

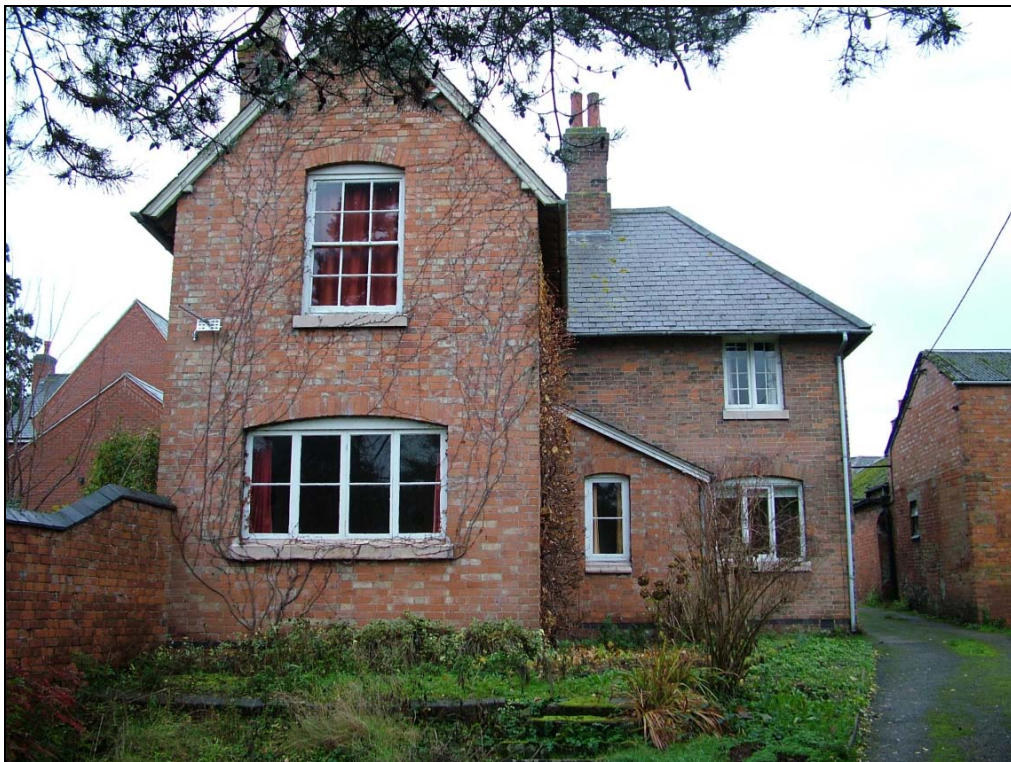
Figure 22 27 Mill Lane from the North East

The final building within the proposed development area is 27 Mill Lane, the farm house originally associated with the Home Farm. J.S Bloor Ltd have yet to finalise their proposals for this building, but it is likely that it will not be altered considerably during the proposed re development. There is a building recorded on the 1885

Ordnance Survey, but it is unlikely what, if any of this building remains, the existing building appears to be early to mid twentieth century in date.

Internal examination was not possible due to sitting tenants, but it is likely that further work would be required should J.S Bloor Ltd decide to carry out major alterations to the building.
