**A Photographic Survey of Glebe Farm, Shackerstone Walk, Carlton,  
Leicestershire (NGR SK 385 045).**

**Gerwyn Richards**

*University of Leicester Archaeological Services were commissioned by Charlie Yates Homes Ltd to undertake a photographic survey of Glebe Farm, Carlton, Leicestershire. Planning permission had been granted for the demolition of the farmhouse and associated outbuildings.*

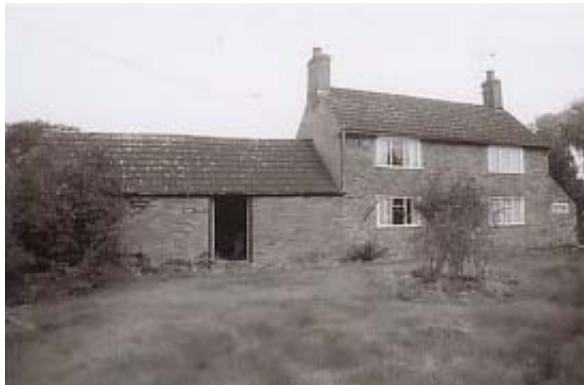
Glebe Farm is a traditional style brick built Midlands farmhouse, that appears on the first edition Ordnance Survey Map, with a barn abutting the left hand gable, a lean-to extension to the right and another lean-to to the rear. The brick work is 9 1/4inch by 2 3/4inch red bricks in a Flemish Garden Bond and there is a roof of concrete tiles. Neither the roof, nor the majority of the brickwork is original and is likely to be the result of twentieth century rebuilding; there are traces of possibly original brick work at first floor level on the right hand gable.

**Photo 1** Glebe Farm, Front Elevation

Fenestration is limited to four steel framed windows on the front elevation, undoubtedly late twentieth century in date and a small timber framed window on the right hand lean-to. There are no windows on the rear wall.

There is evidence of a blocked central doorway on the front elevation and access is now only via a door in the rear lean-to extension. Internally the farmhouse contains little of architectural significance; at ground floor level there are two principle rooms and two lesser rooms housed within the lean-to's, the rear lean-to contains the kitchen and the right hand lean-to contains the bathroom. There is evidence of a removed 'inglenook' fireplace on the right hand gable; the replacement fireplace is a later twentieth century open fire with a ceramic tile surround, the floor is red brick set in a herring bone pattern. The left hand ground floor room only contains a ceramic tile fireplace on the left hand gable.

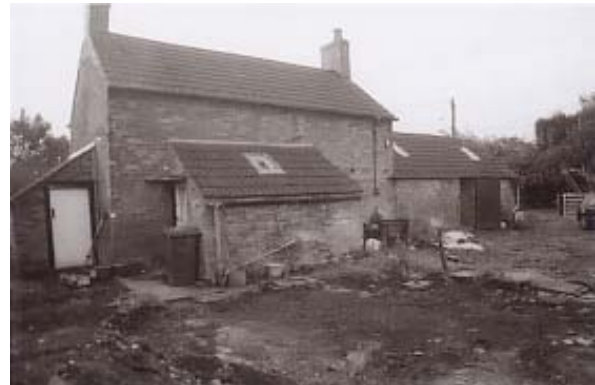
**Photo 2** Glebe Farm, Rear Elevation

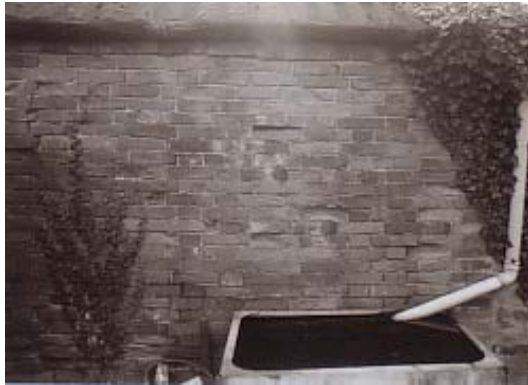
**Photo 4** Earlier Brickwork, Building 2

Building 2 is a single storey barn abutting the left hand gable of the farmhouse. There is modern brickwork on the front elevation suggesting that it was originally an open fronted building. The brickwork to the rear is 9 1/2inch by 2 1/2inch hand made red bricks as with the farm house in a Flemish Garden Bond. This brickwork is

much earlier than that on the farmhouse and may be indicative of the farmhouses original appearance.

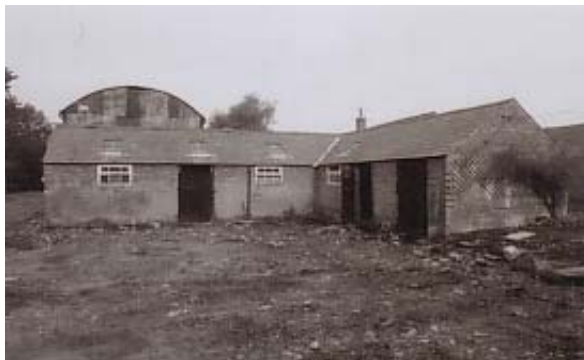
**Photo 3** Milking Parlour

The milking parlour contains four double stalls along the rear wall and a central door on the front wall and two steel framed windows and as is common in milking parlours all corners have been finished with bull nosed bricks. The roof construction is

a bolted king post construction supported on brick corbels. The floor is concrete, probably replacing an earlier brick floor.
