**A Photographic Survey of Top House Farm, Pincent Lane, North Kilworth,
Leicestershire (NGR SP 624 870).**

Gerwyn Richards

© ULAS 09/05/2007

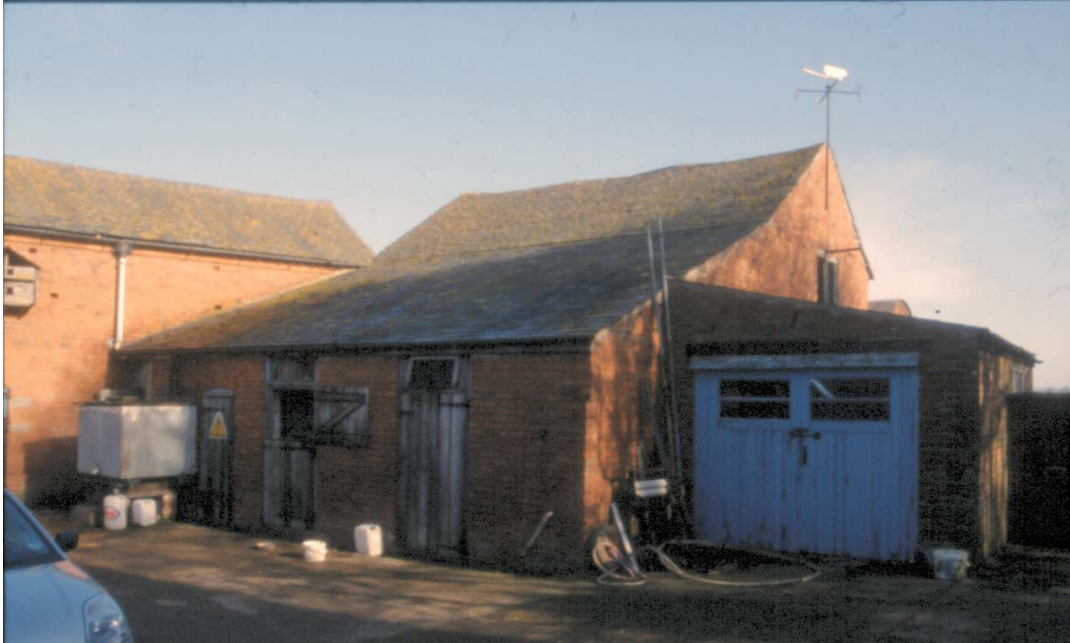
Colour Plate 1 Building A, Front Elevation.

The first building, building A is located on the eastern side of the quadrangle; it is two storied local red brick building with a roof of Swithland and Welsh Slate. The building is much altered with extensions to the front and to the right; the change in roofing material indicates the original outline of the building. First floor access is via a brick built stairway to the left, originally these stairs would have been external and served both building A and building B, they are now enclosed within the later extension.

The rear of the building was originally an open three bay building, probably a cart shed. The original timbers are still *in situ*, although now hanging doors of corrugated steel sheets.

Internally the front extension appears to have been used as stabling, a timber partition remains in the middle bay. The first floor is undoubtedly the original grain store, the original plaster and reed floor remains as does the pitching hole in the left hand gable. The roof is of a bolted king post with raking struts.

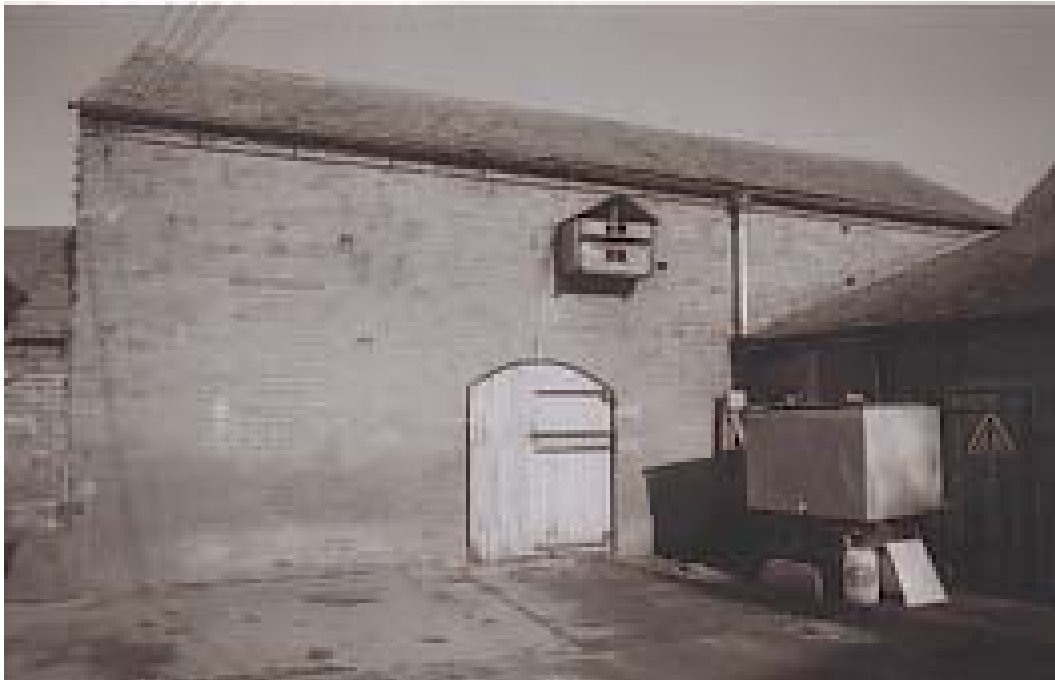
Colour Plate 2 Building B, Front Elevation.

Building B is at 100 degree angle to the left of building A, although an unusual angle, the buildings area clearly contemporary. The building is by far the largest within the proposed development area, originally a threshing barn with large central doors. There is corbelling at eaves level and carved sandstone hinge plates. There is an original plaster and reed floor in the right hand bay, there is a recent internal stair, but original first floor access was via the external stairs mentioned above.

Internally the building is largely unaltered, there has been some strengthening work carried with railway sleepers on the floor. An early twentieth century corn crushing mill is still in position. As with building A the roof is a bolted king post with raking struts, only larger.

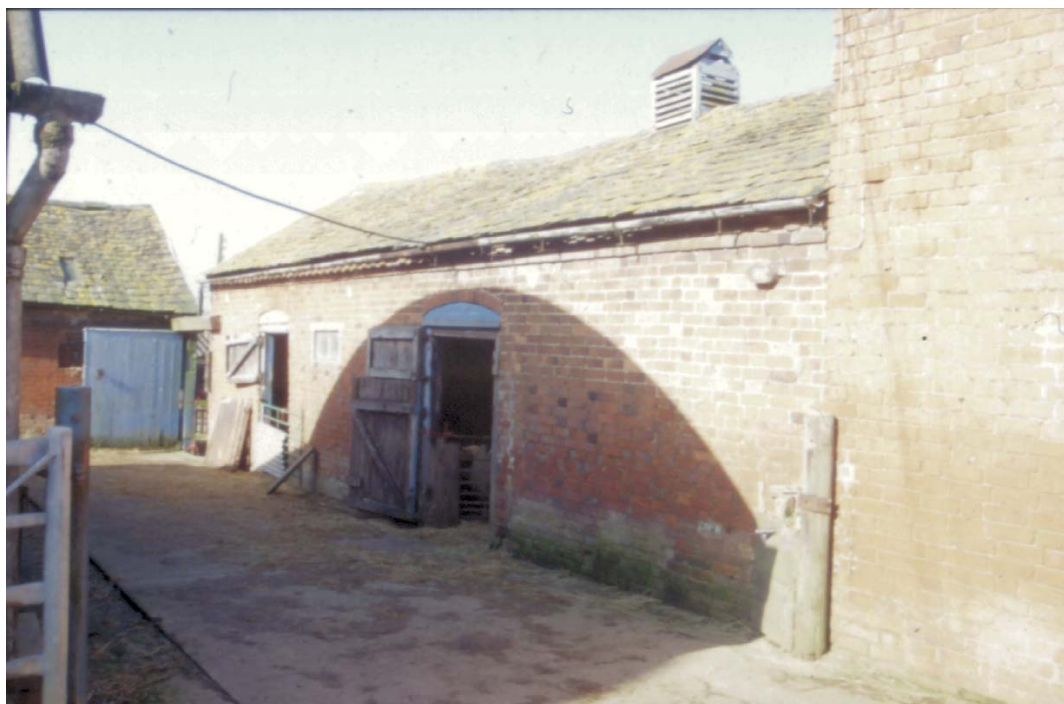
Colour Plate 3 Building C, Front Elevation.

Building C adjoins the left of building B, forming the northern wing of the quadrangle, but clearly from different phases of construction; there is a straight joint between the two and the brick work is different. The building is a single storey three-bay cowshed and largely unaltered. Internally there are brick built feeding troughs on the rear wall and some remaining partitions and the roof, unlike the other buildings is supported on purlins alone.

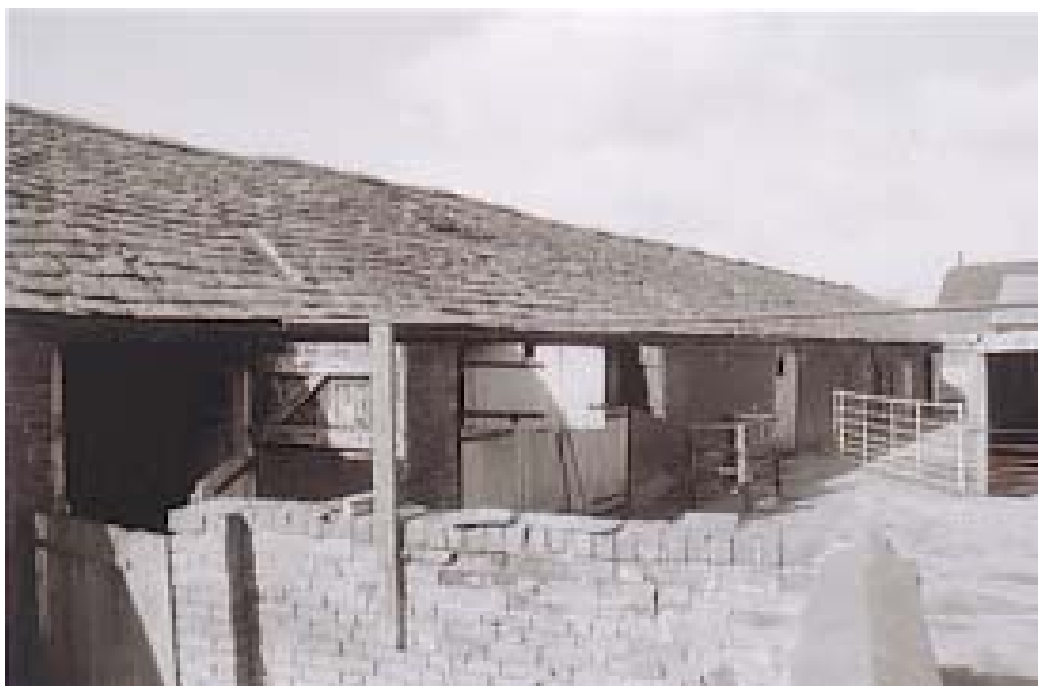
Colour Plate 4 Building D, Front Elevation.

Building D is at an approximate right angle to the left of building C, forming the final wing of the quadrangle. The building is similar in style and appearance to building C and is almost certainly contemporary. The building has the appearance of a milking parlour; however, the lack of original features prevents a firm conclusion.
