**A Photographic Survey in advance of  
the proposed Performing Arts Centre,  
Rutland Street,  
Leicester (SK591 045 )**

Planning Application No: 2002/0513 & 0514

University of Leicester Archaeological Services

Report No. 2004-037

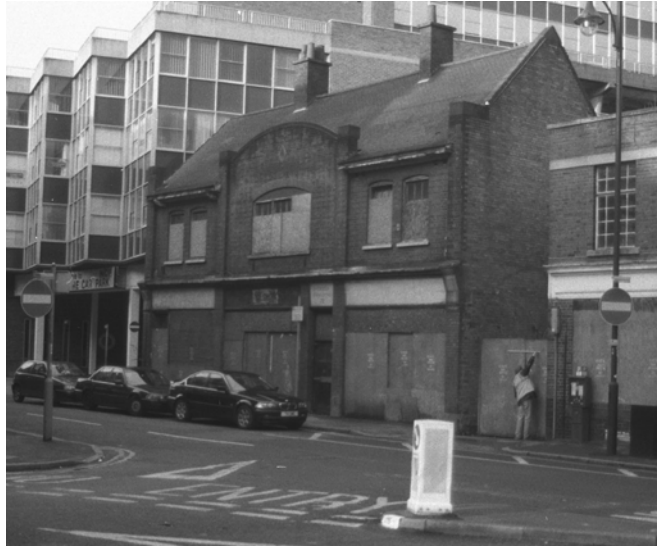
Plate 1 Frontage

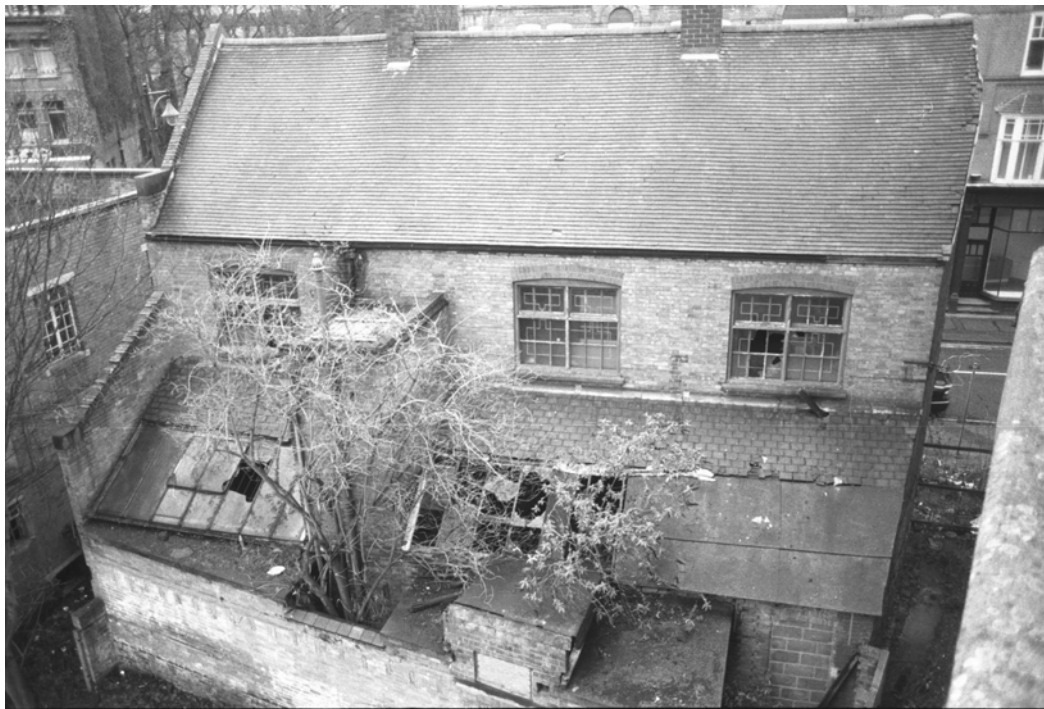
Plate 2 Rear

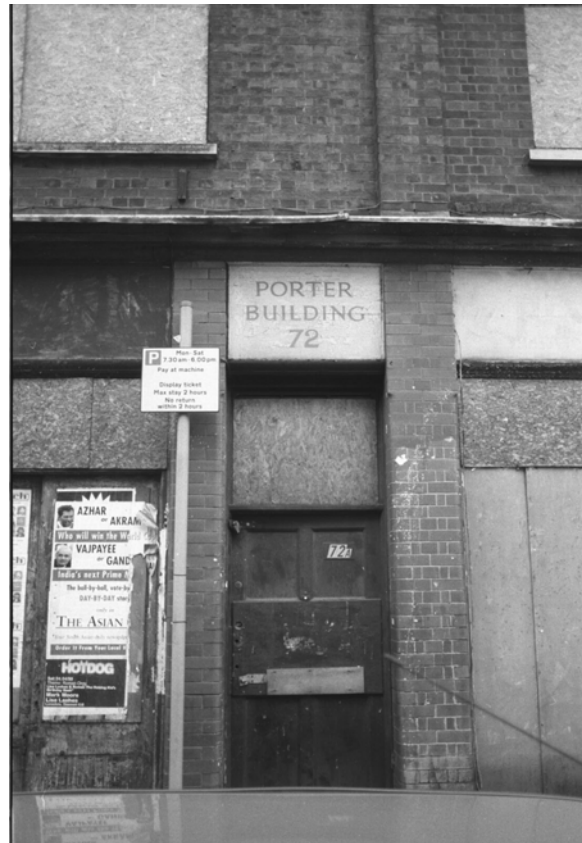
Plate 3 Detail of Frontage

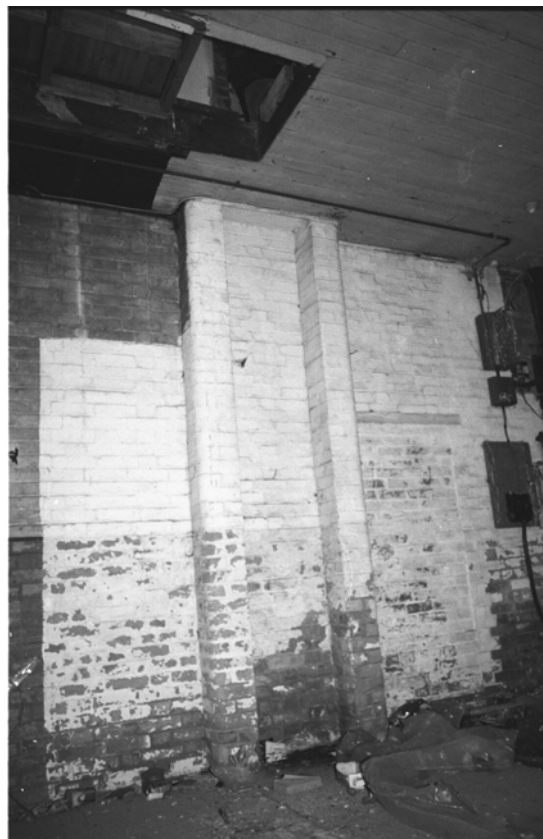
Plate 4 LHS ground floor bay

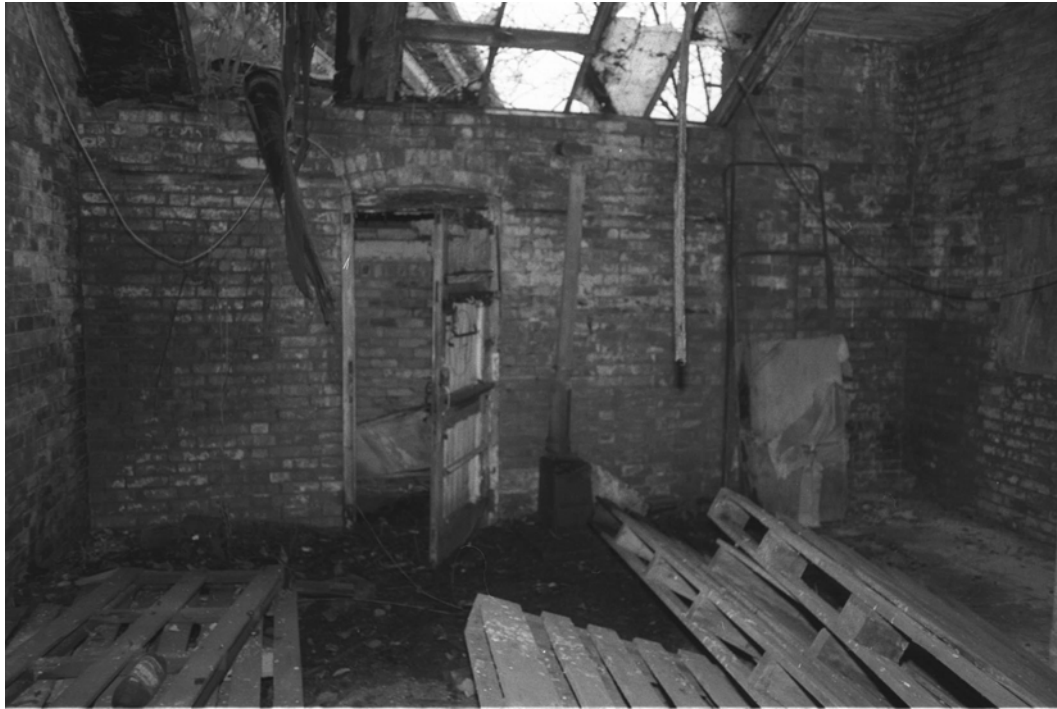
Plate 5 LHS ground floor bay looking to rear

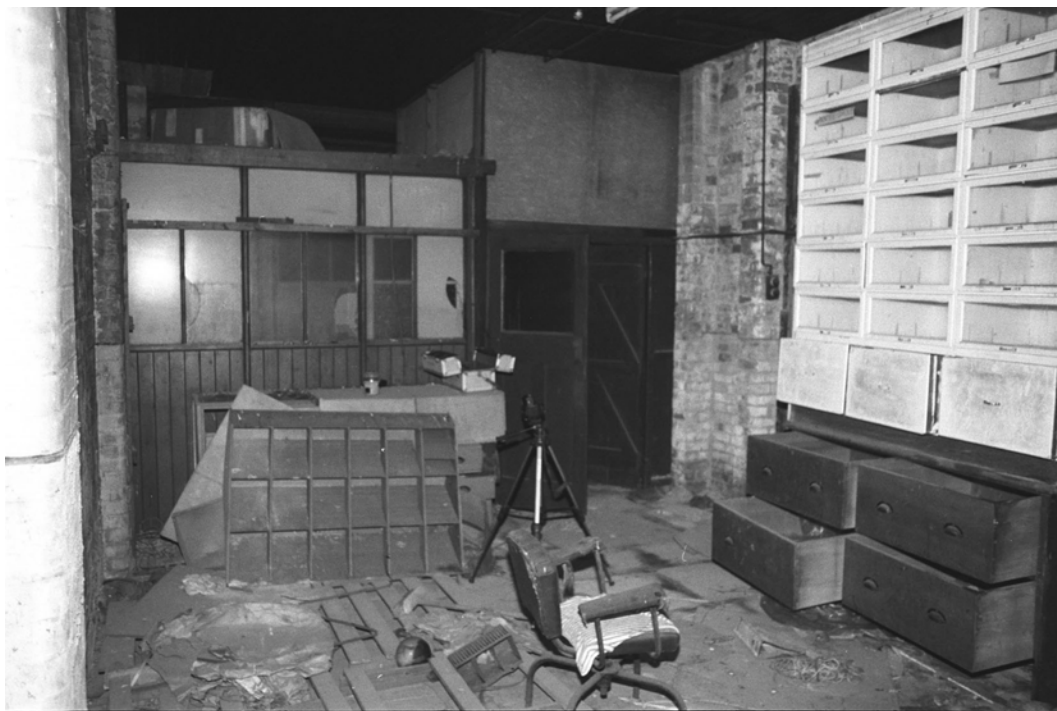
Plate 6 RHS ground floor bay looking to front

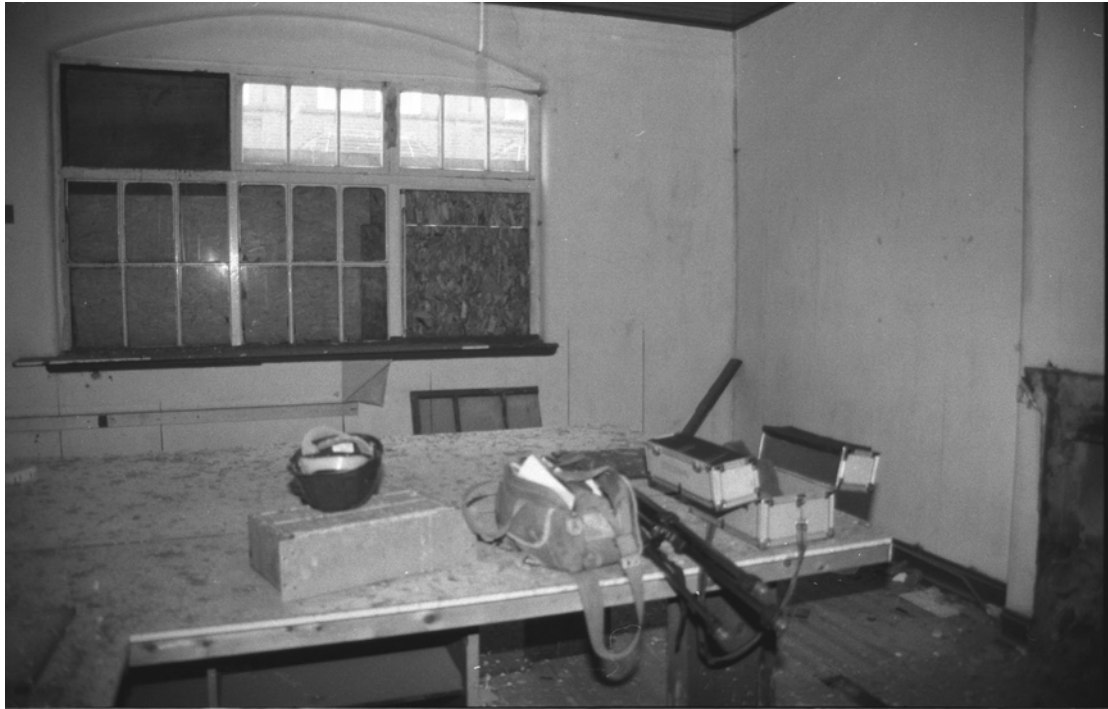
Plate 7 Central first floor bay looking to front

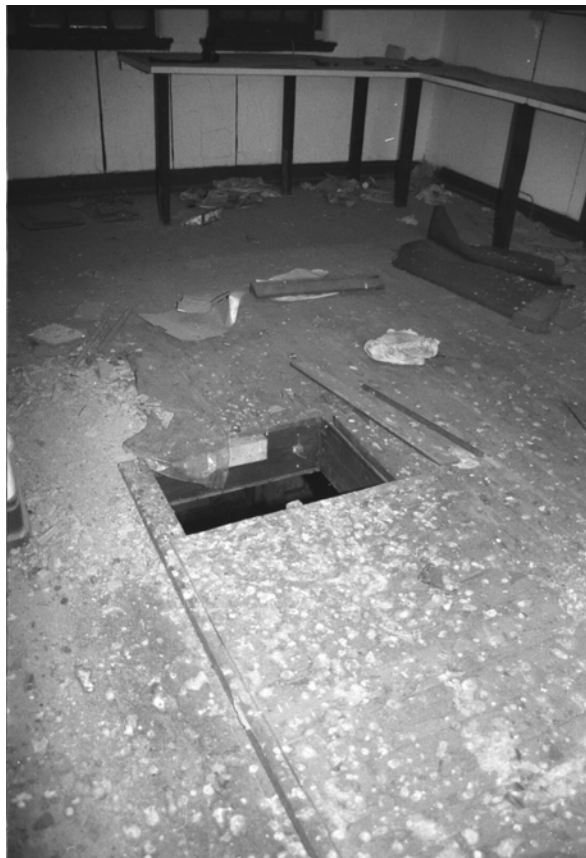
Plate 8 LHS first floor bay looking to front

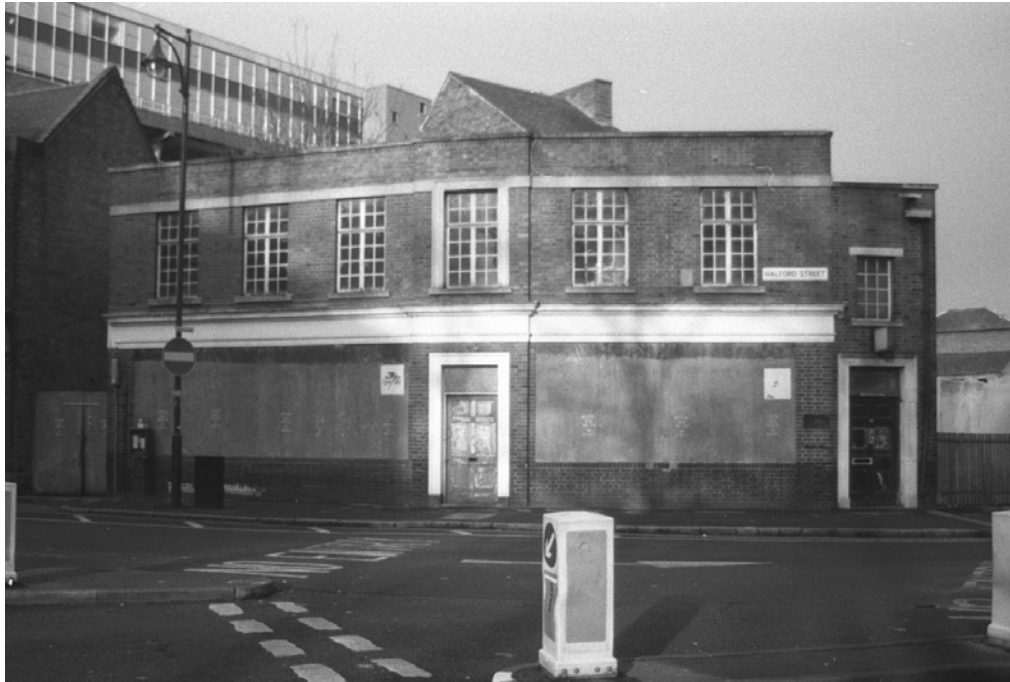
Plate 9 Frontage

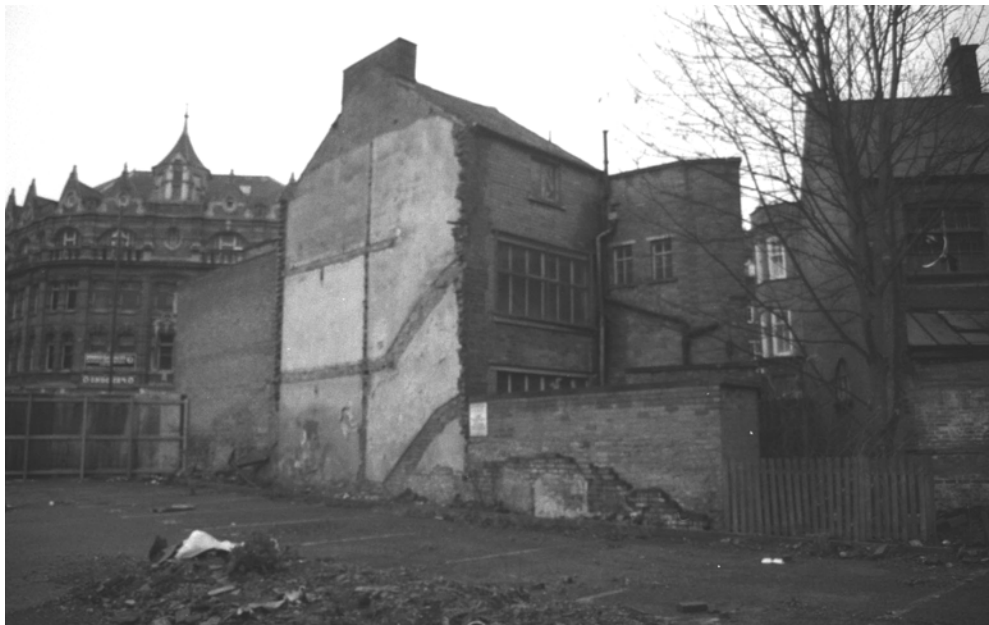
Plate 10 Side and Rear

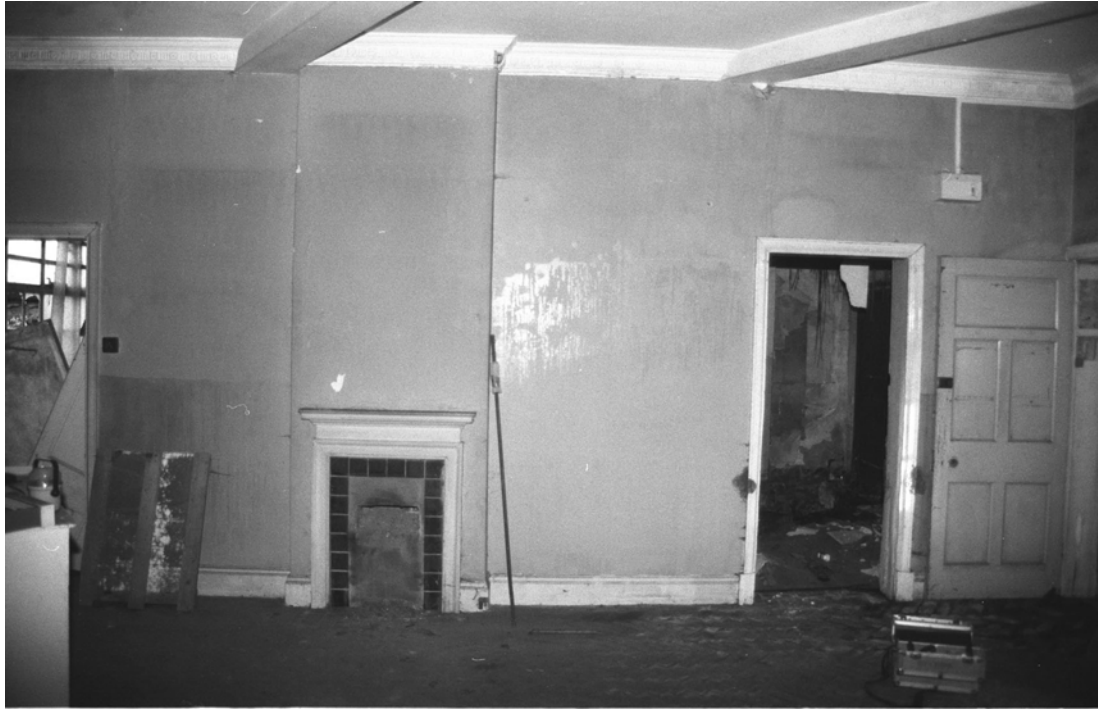
Plate 11 Main room looking to rear

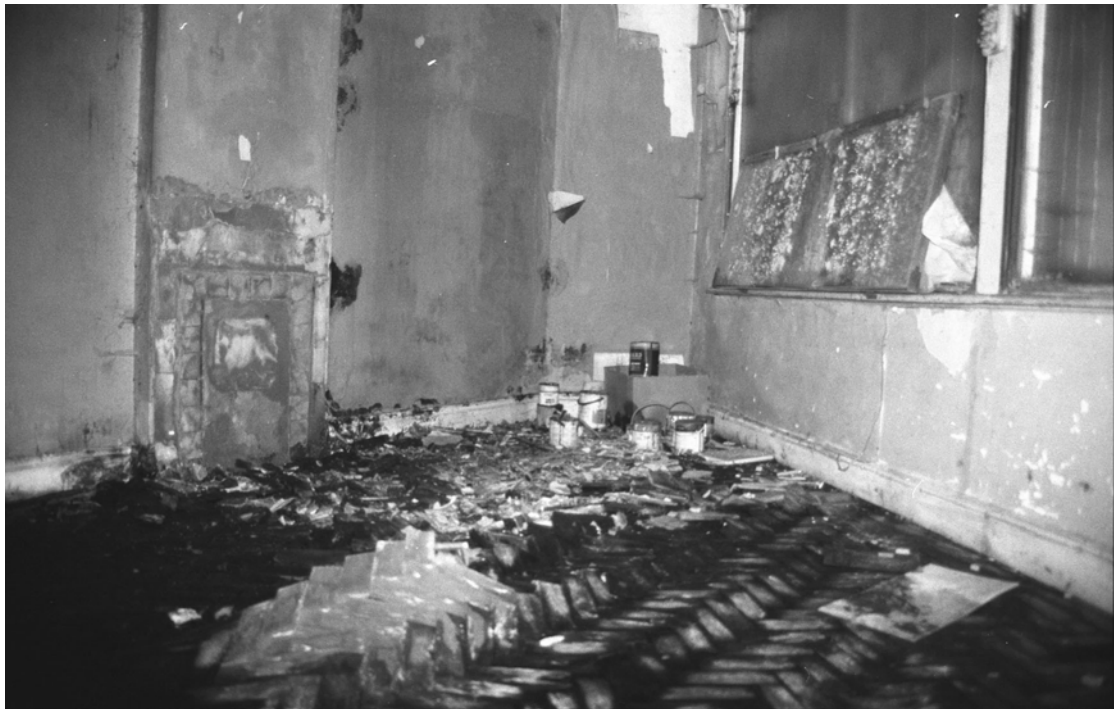
Plate 12 RHS room looking to rear/side

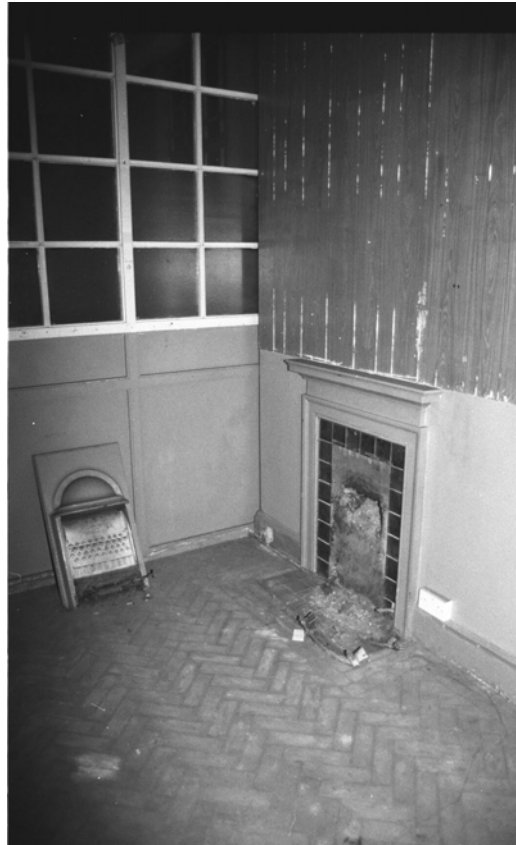
Plate 13 Partition room looking to front

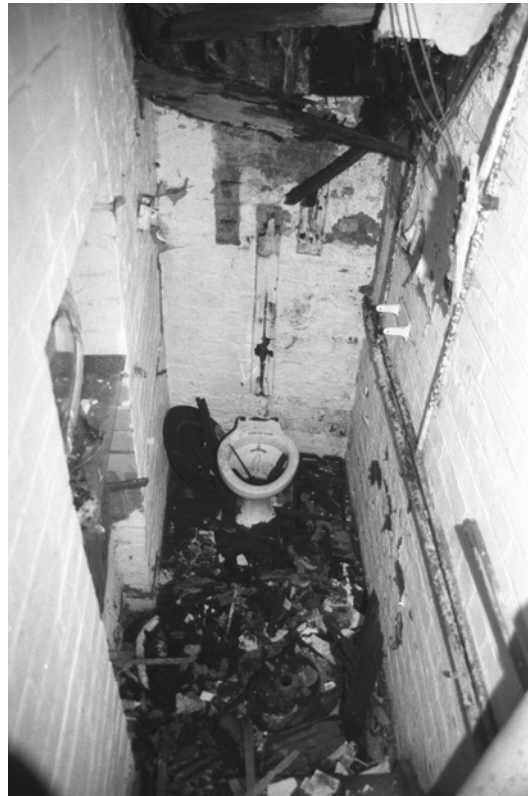
Plate 14 Basement toilet

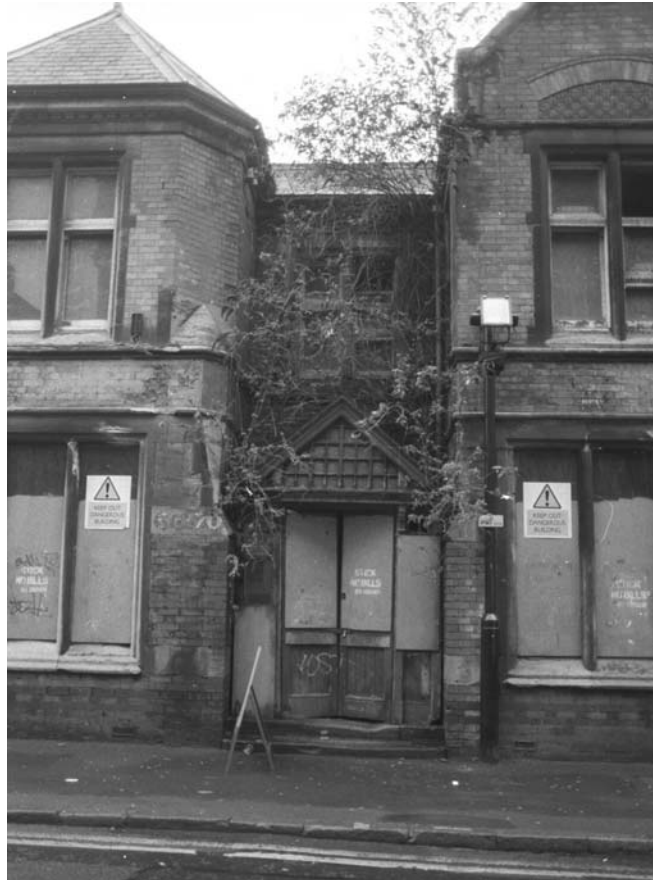
Plate 15 Frontage

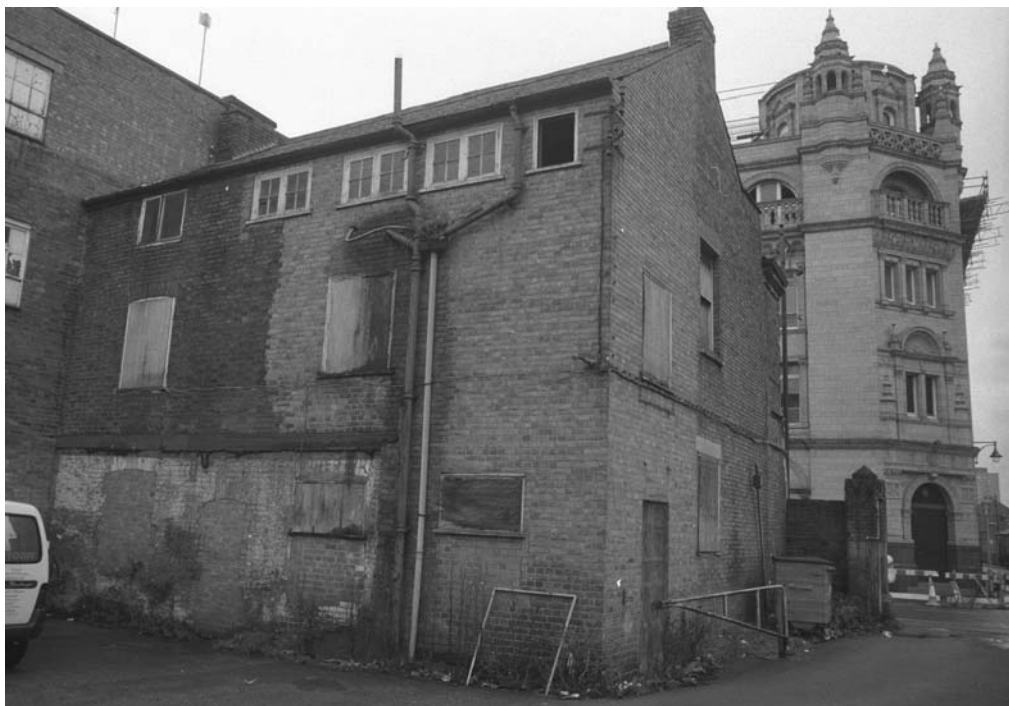
Plate 16 Side and Rear

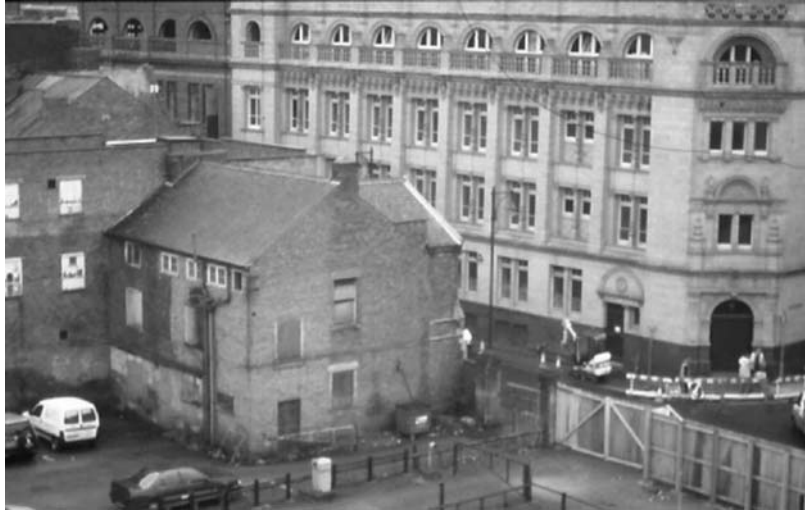
Plate 17 Side and Rear

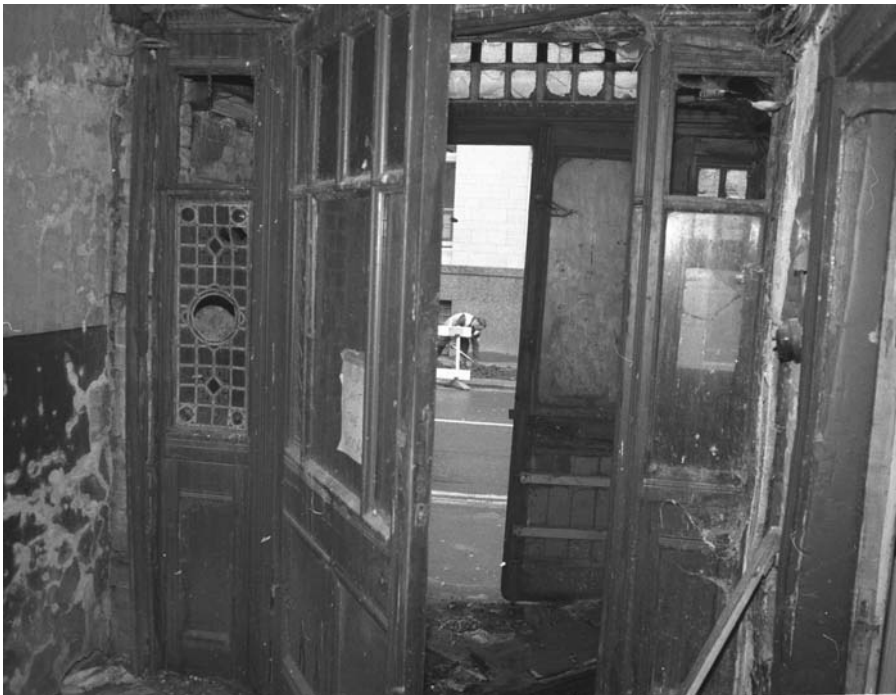
Plate 18 Entrance hall looking out to street

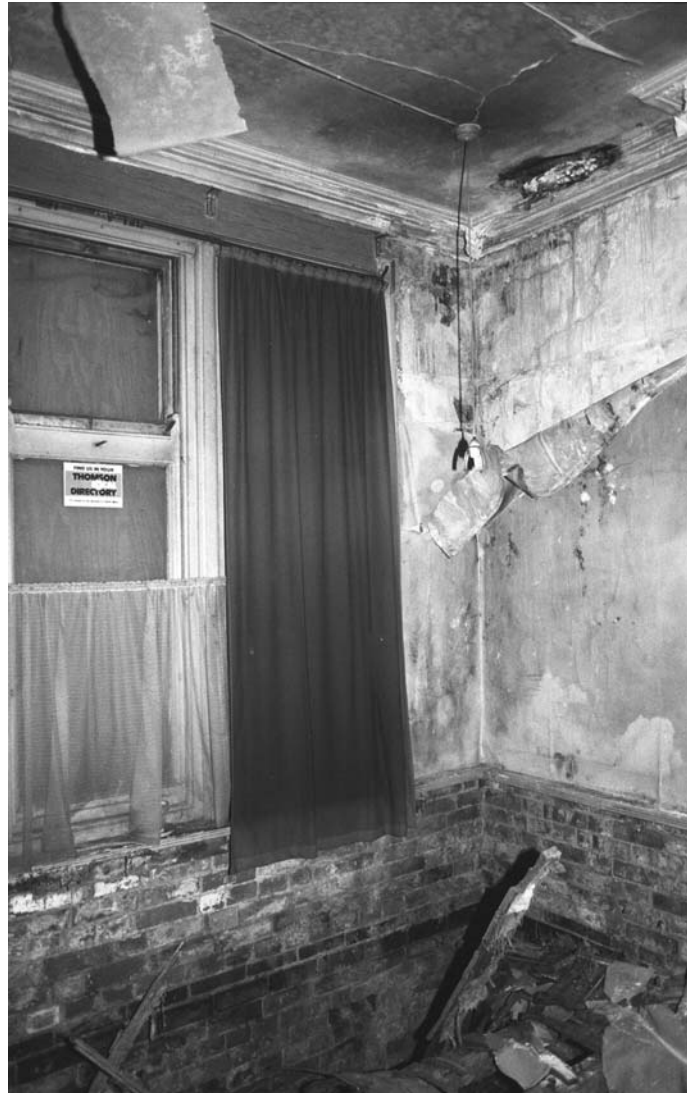
Plate 19 Ground floor LHS room looking to street/side

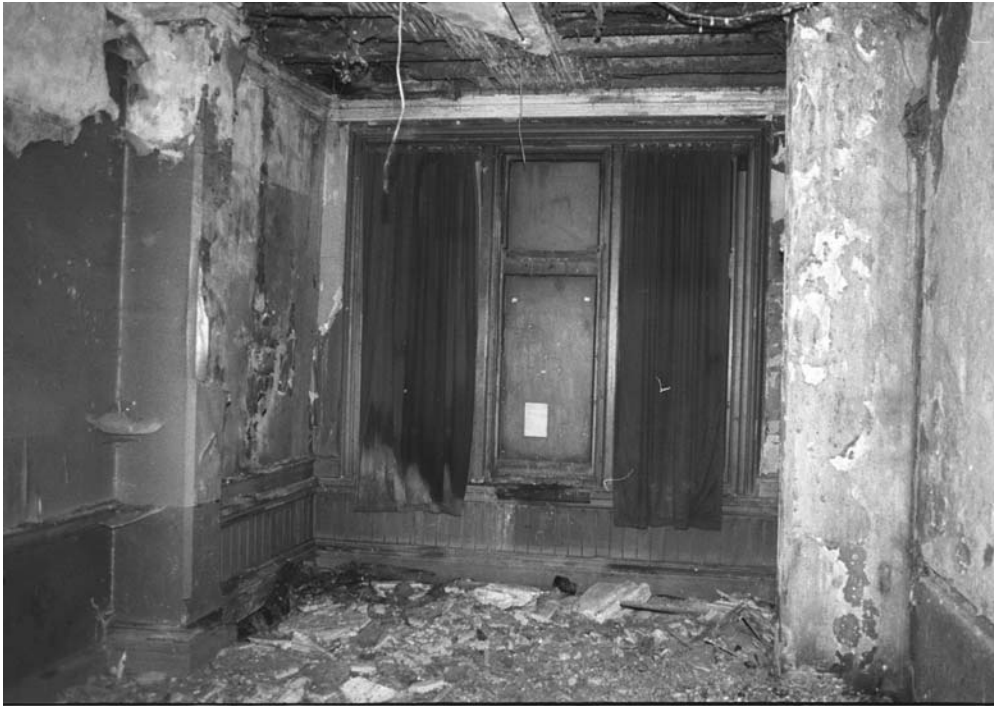
Plate 20 Ground floor RHS room looking to front

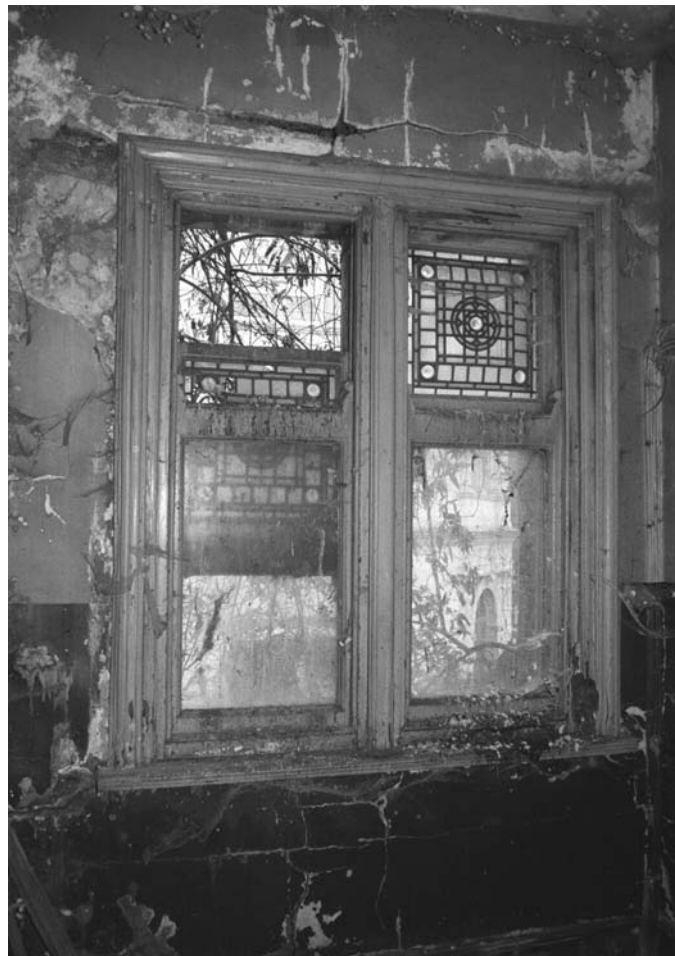
Plate 21 First floor central window

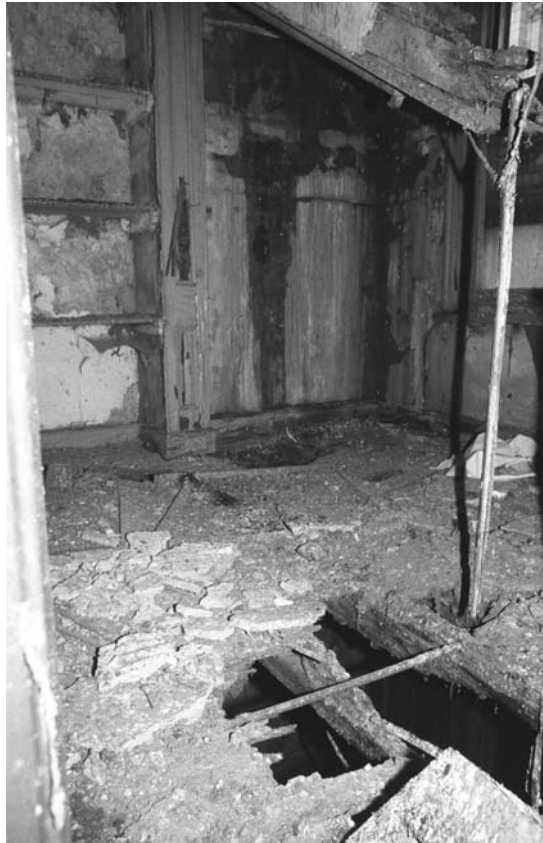
Plate 22 First floor RHS room looking to side/front

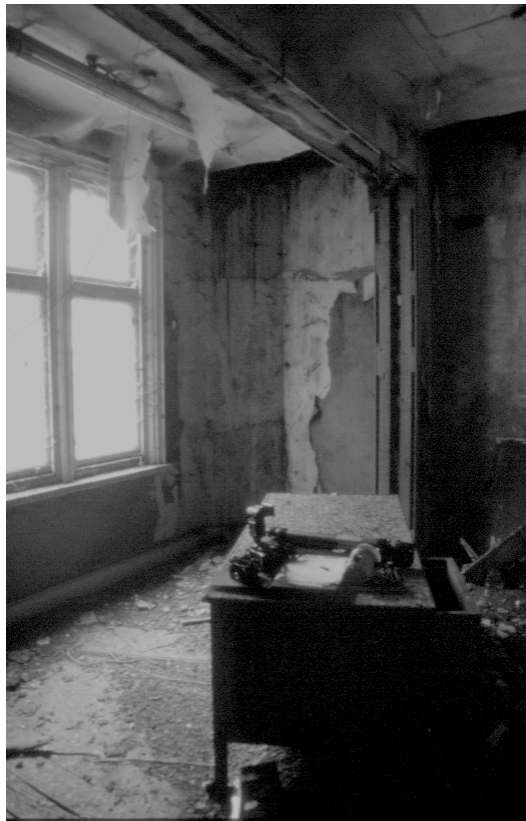
Plate 23 First floor LHS room looking to side/front

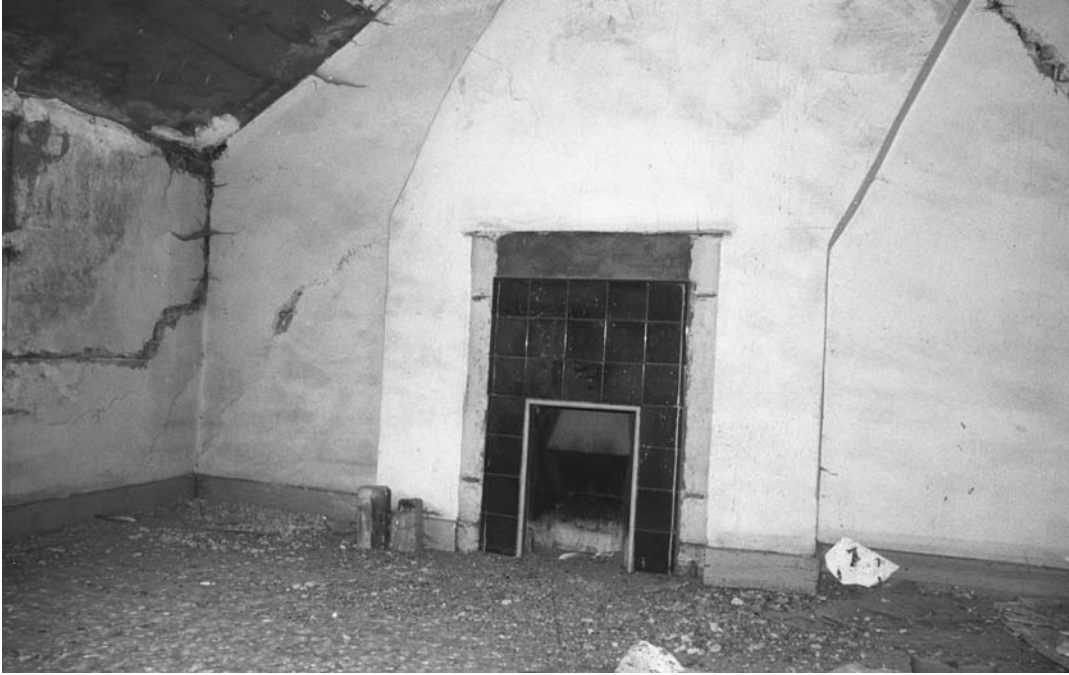
Plate 24 Top floor RHS room looking to side

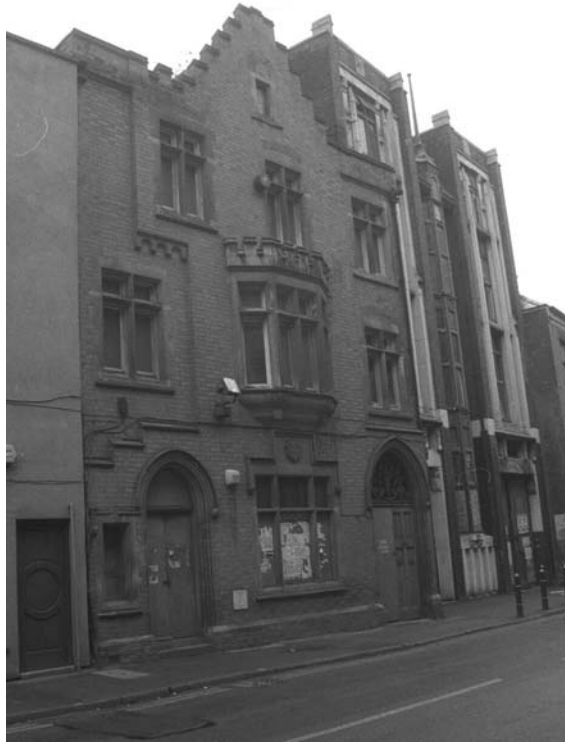
Plate 25 Frontage

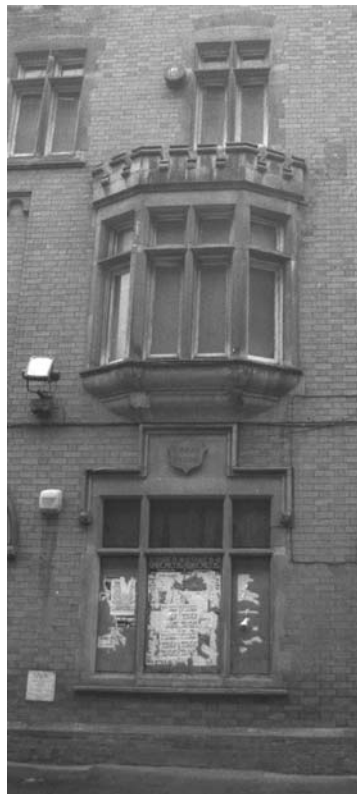
Plate 26 Detail of frontage

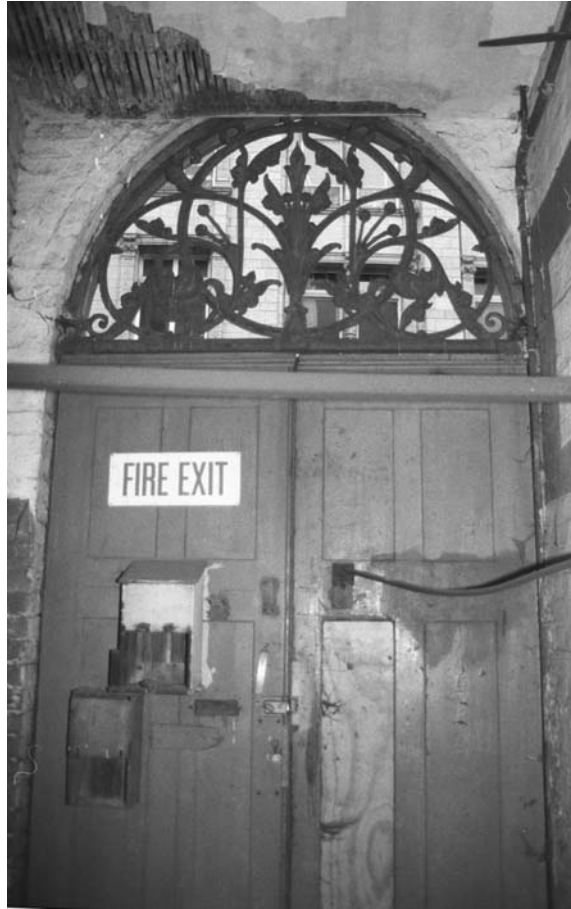
Plate 27 Decorative fanlight over double doors to street

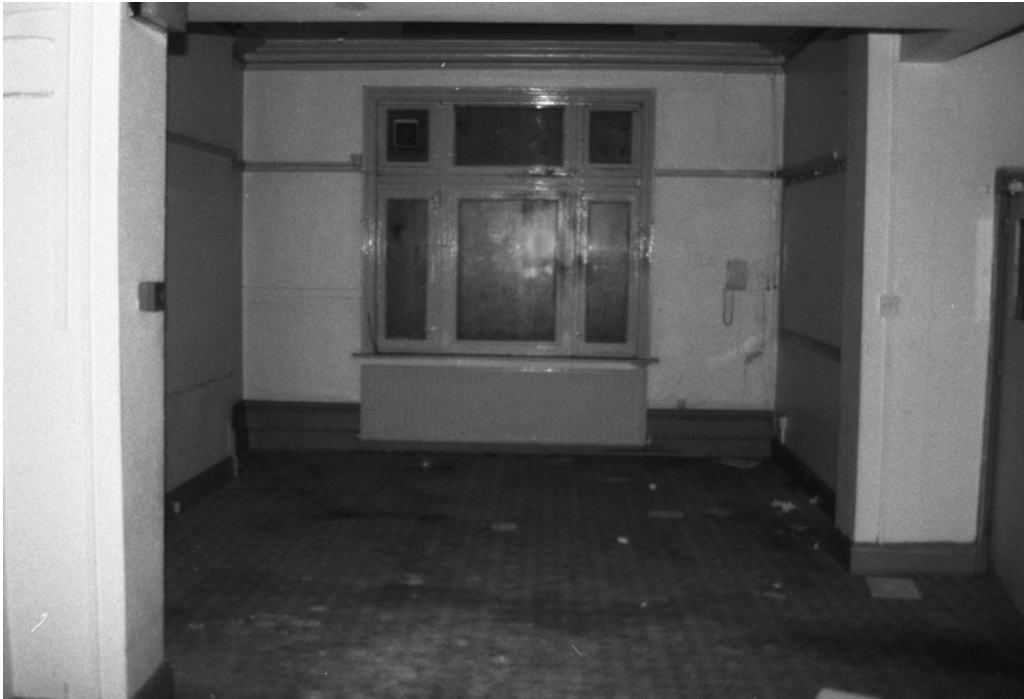
Plate 28 Ground floor main room looking to front

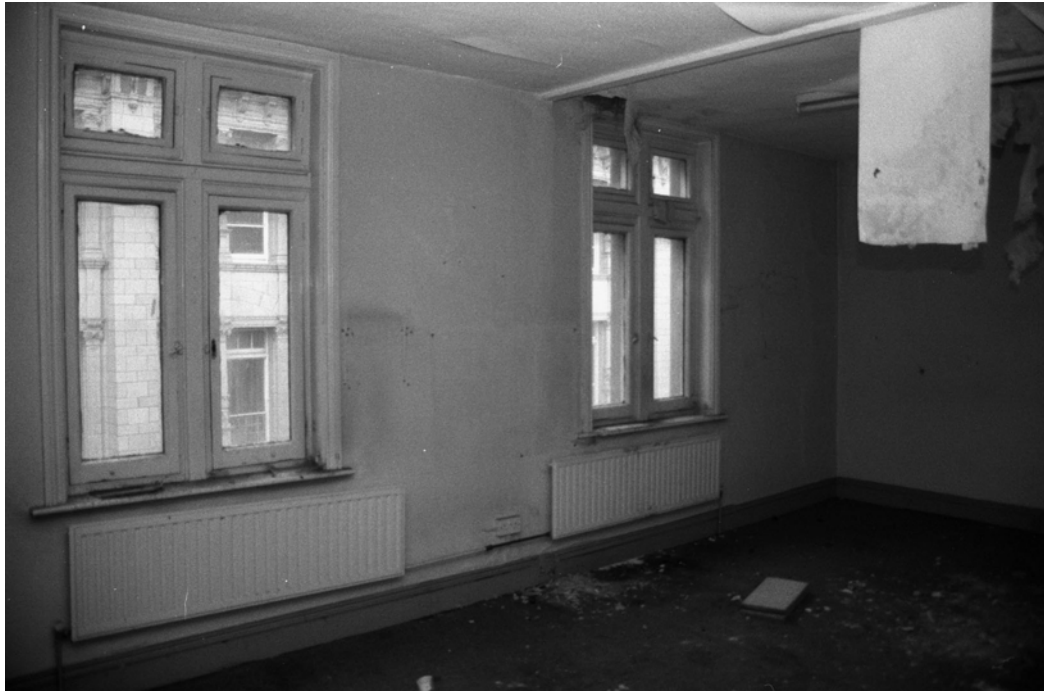
Plate 29 Second floor main room looking to front/side

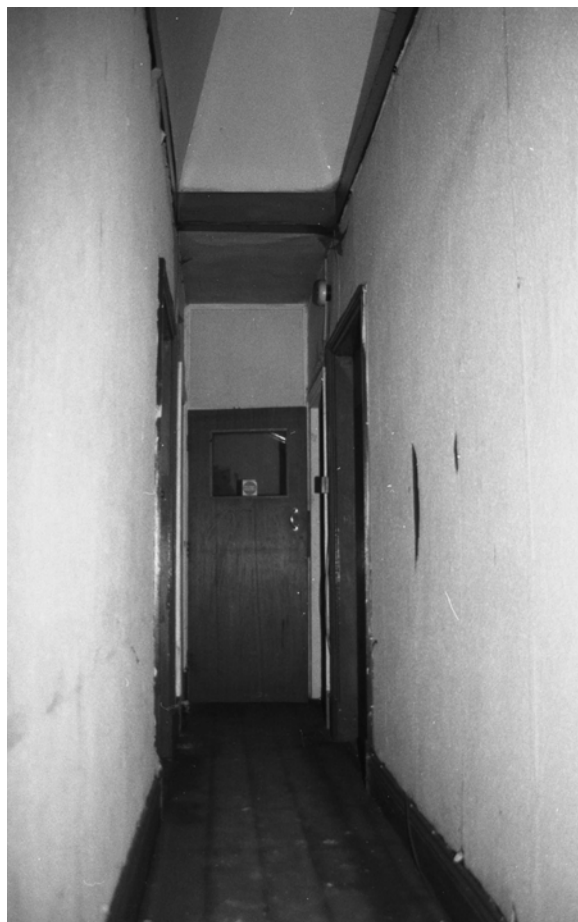
Plate 30 Second floor corridor with o/head lightsink looking to LHS

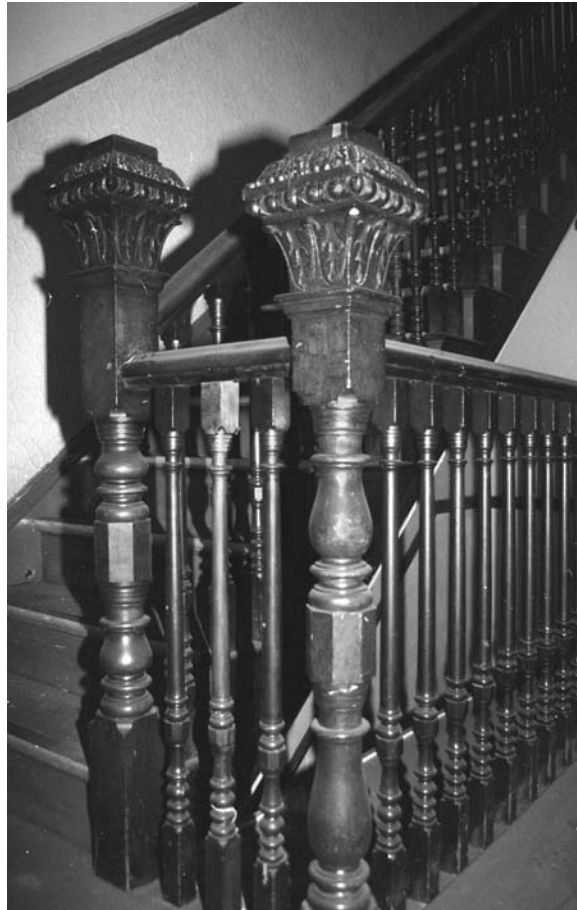
Plate 31 Decorated finials

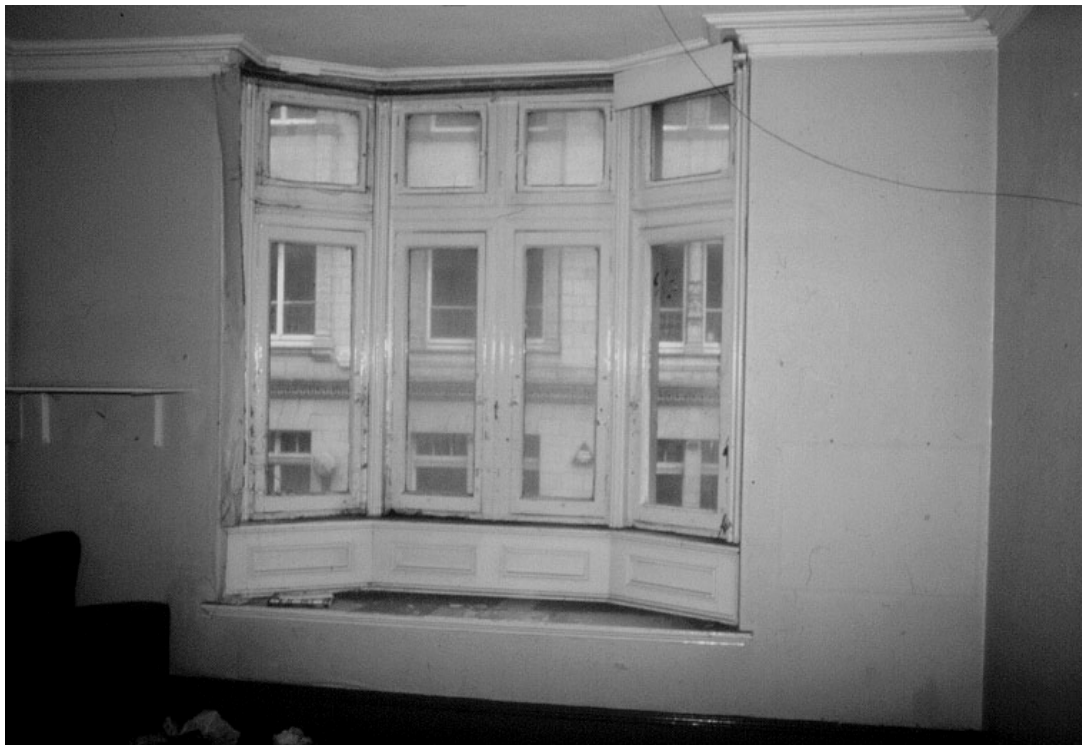
Plate 32 First floor main room looking into front bay

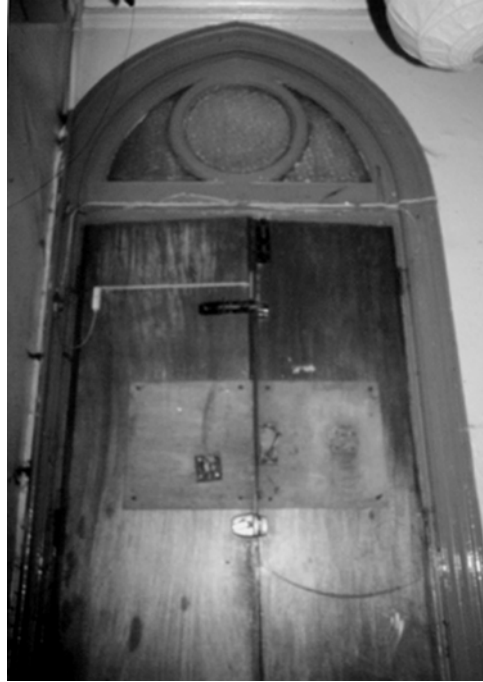
Plate 33 Main entrance looking towards street

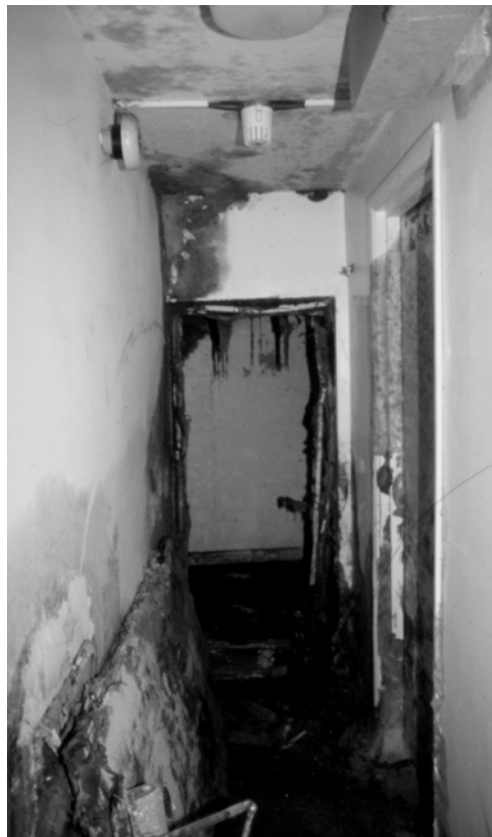
Plate 34 Basement corridor

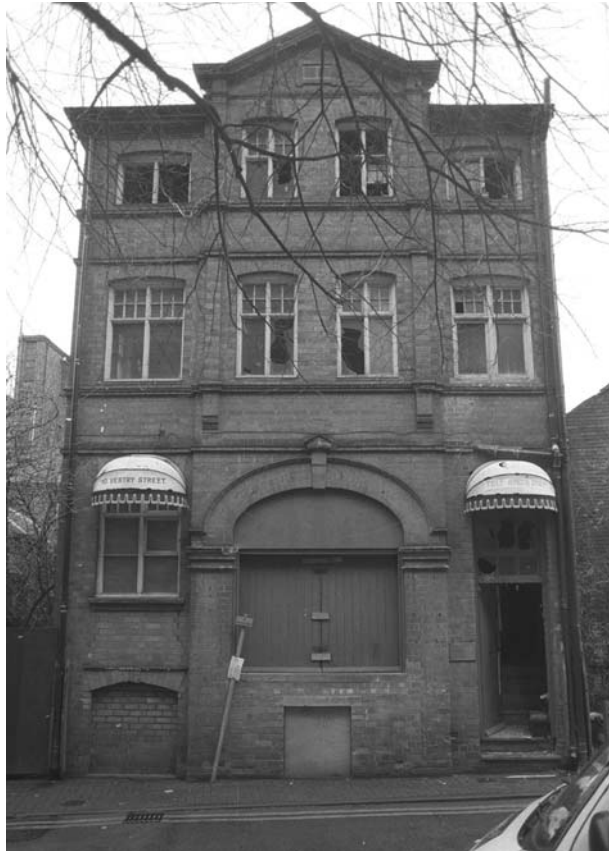
Plate 35 Frontage

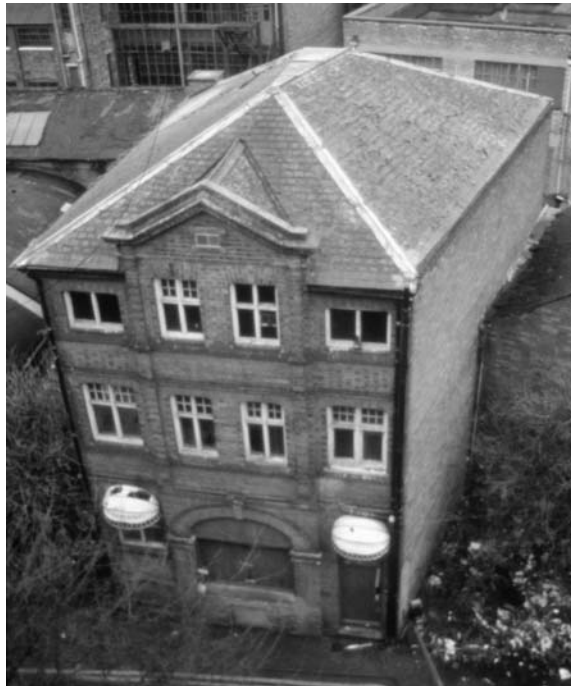
Plate 36 Birds eye view

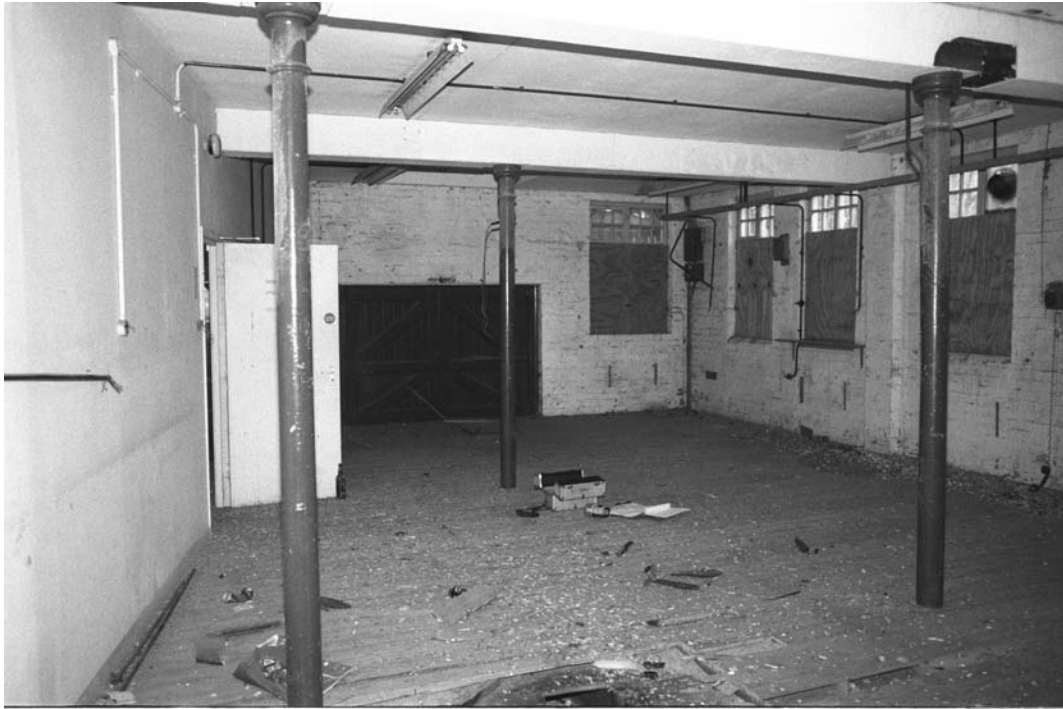
Plate 37 Upper ground floor looking to front

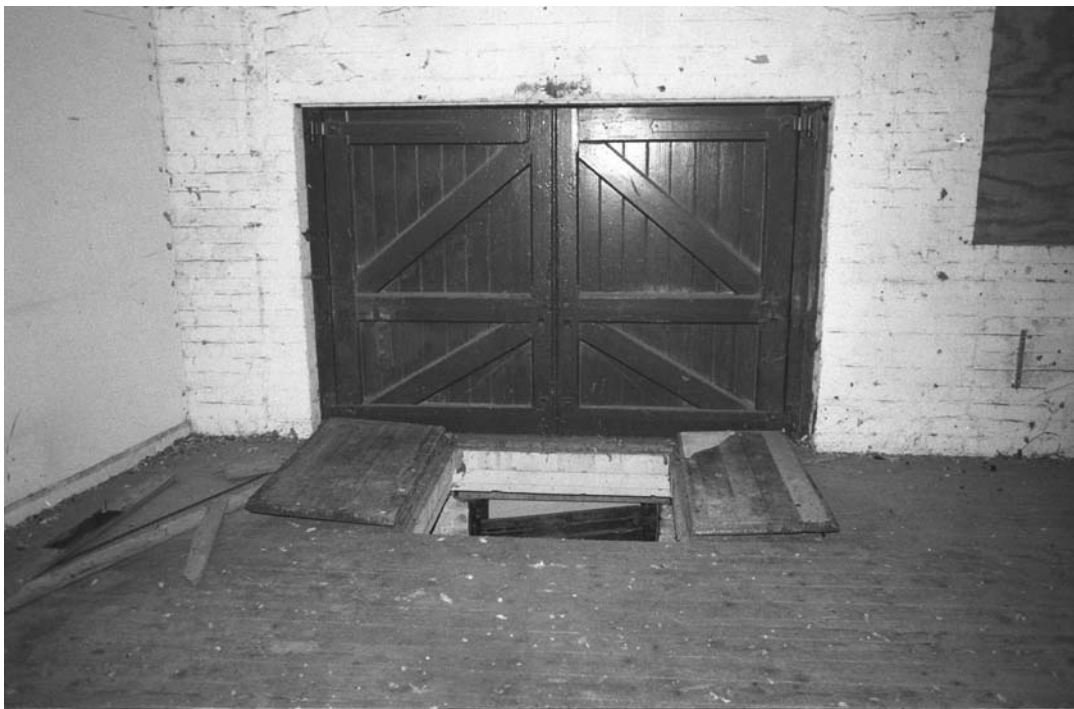
Plate 38 Upper ground floor looking to front: loading doors and hatch

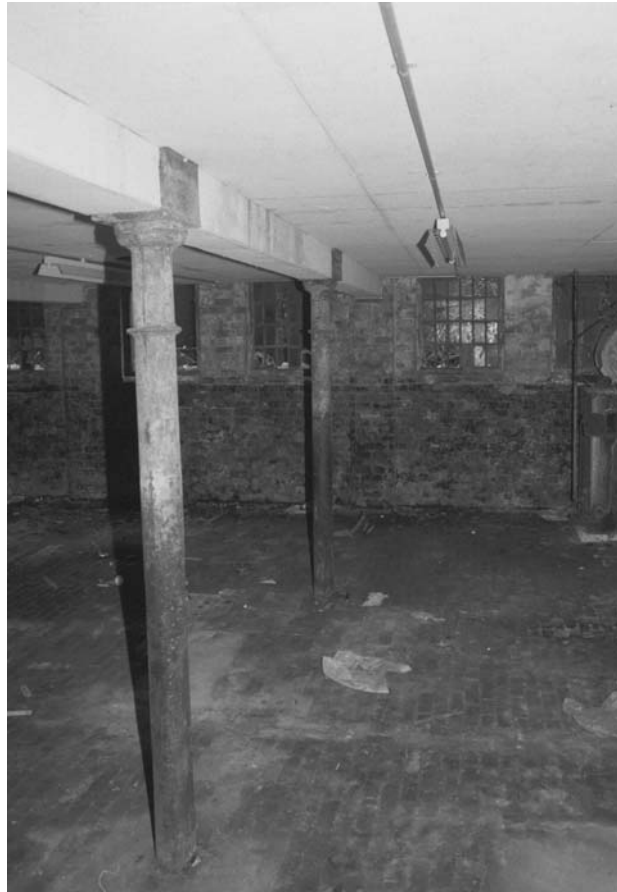
Plate 39: Lower ground floor looking to LHS
