**A Photographic Survey in advance of  
the proposed Performing Arts Centre,  
Rutland Street,  
Leicester (SK591 045 )**

Planning Application No: 2002/0513 & 0514

University of Leicester Archaeological Services

Report No. 2004-037

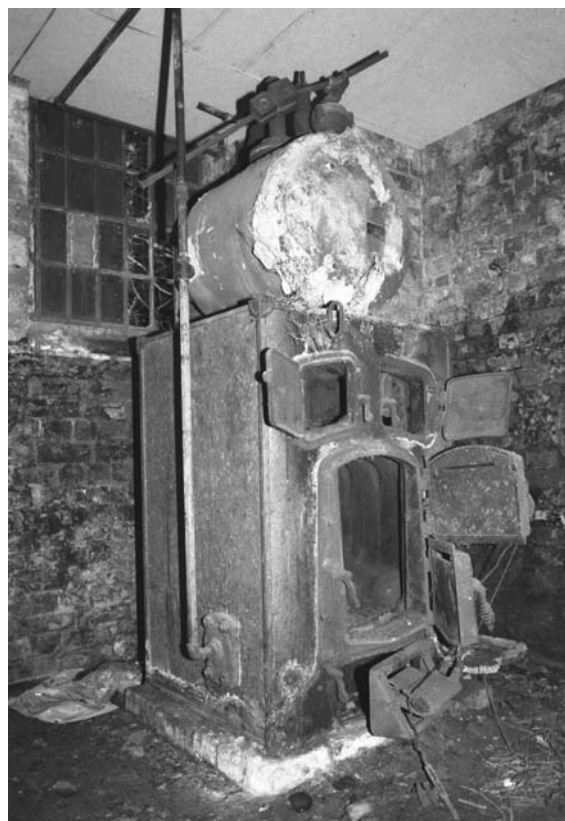
Plate 40 Lower ground floor boiler

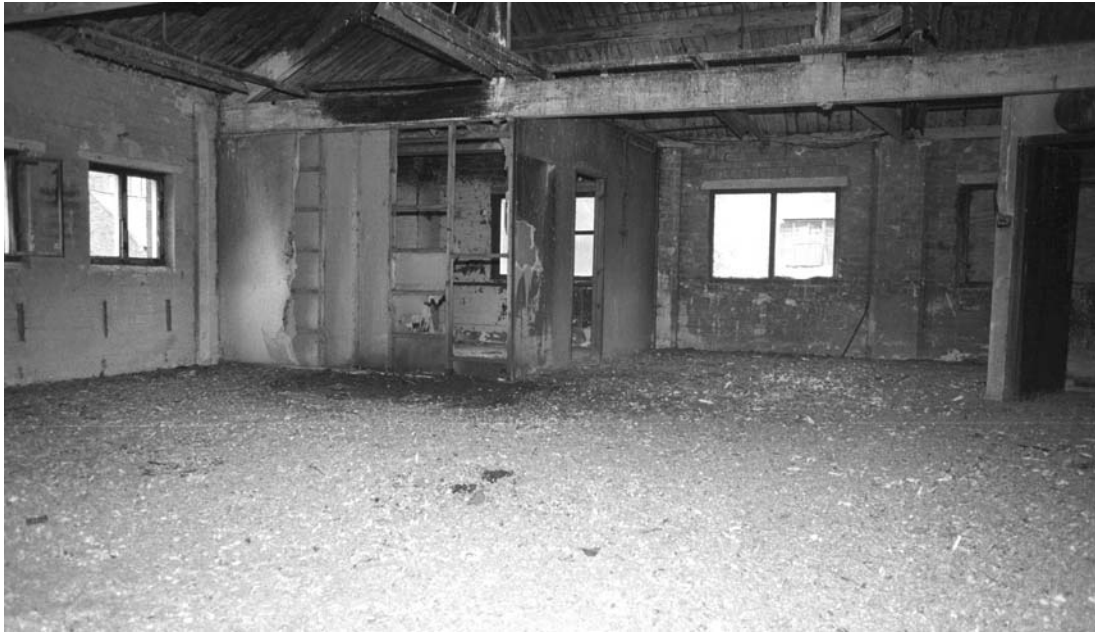
Plate 41 Top floor looking to the rear

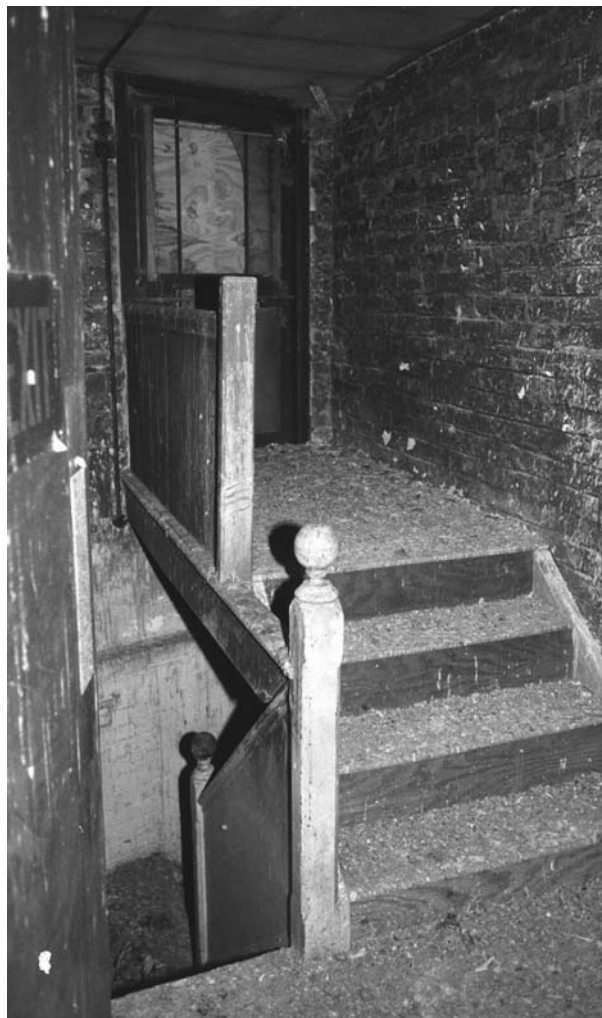
Plate 42 Top floor stairway looking to rear

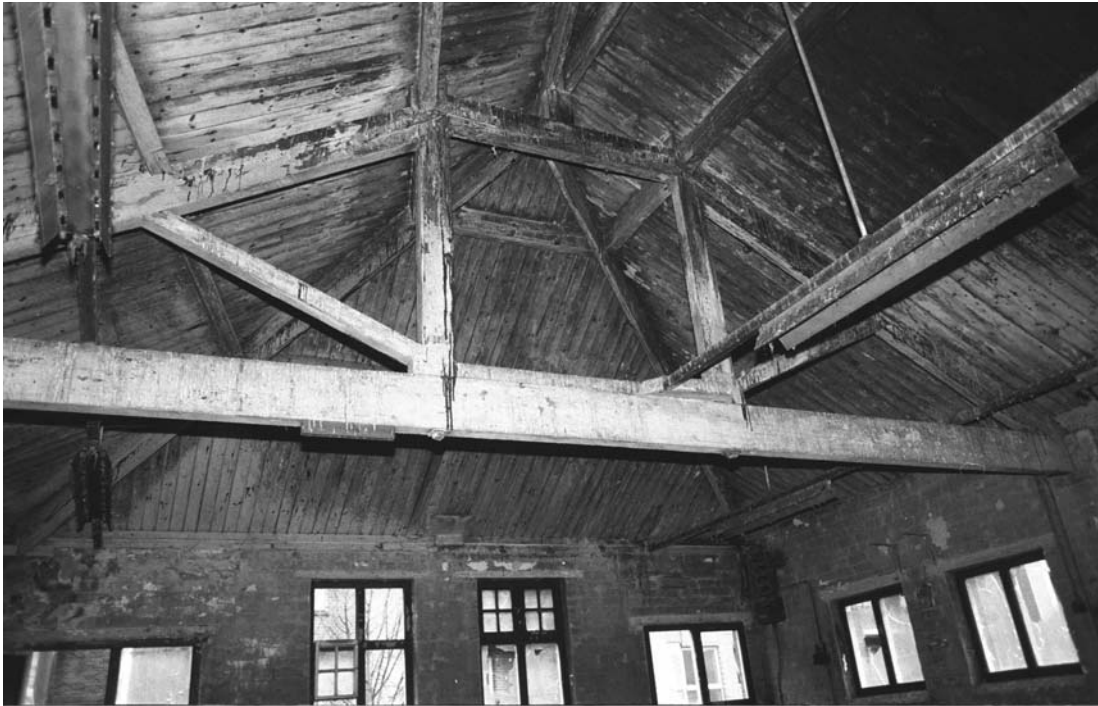
Plate 43 Roof structure looking to front

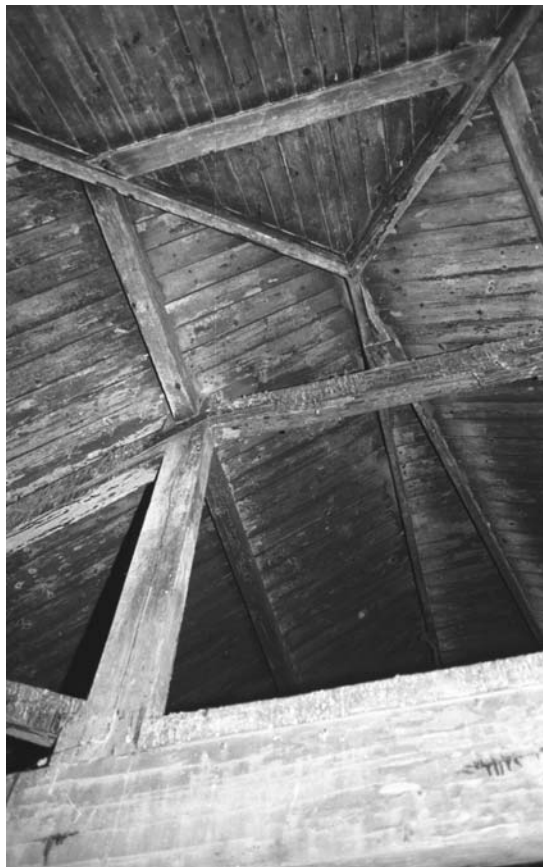
Plate 44 Detail of roof structure (note V twin ridge piece)

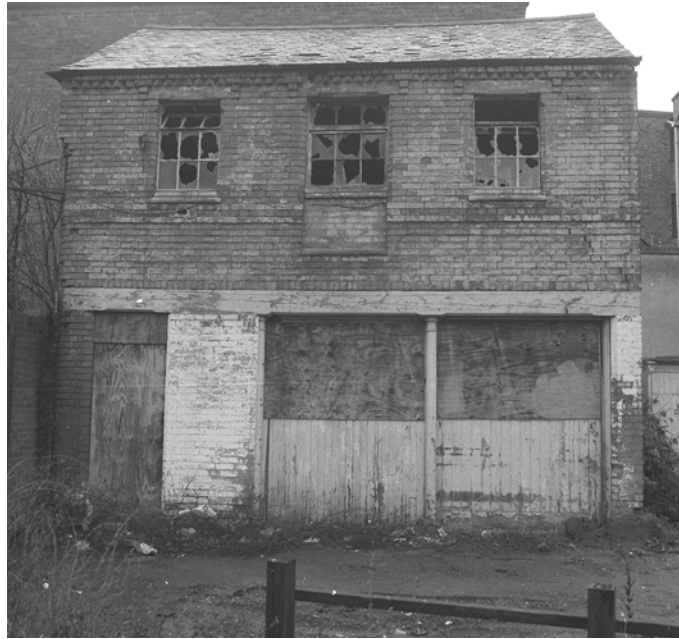
Plate 45 Carhouse to the side of 10 Vestry St
