**A Photographic Survey in advance of  
redevelopment at the former Mosan Mills,  
12 Sanvey gate,  
Leicester (SK584 050 area )**

**For Thomas Fish and Sons Ltd**

Planning Application No: 2002/0662

Report No. 2004-042      ©ULAS 2004

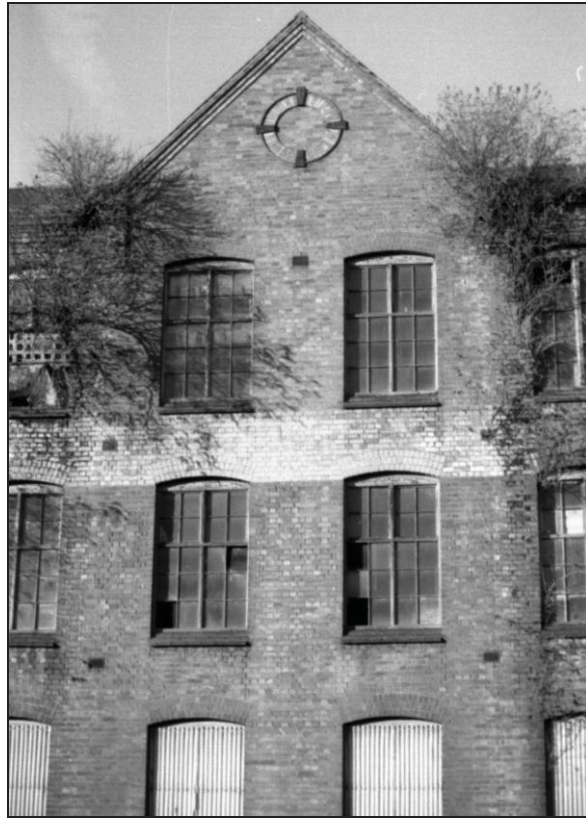
Although now standing in splendid isolation, the mill building was designed to be seen from the south courtyard which existed before the recent phase of demolition. The south facade is of fifteen bays, with the east and west ends brought forward to flank the face. An ornamental gable (plate 5) is present over the central bays. The west flanking bay is asymmetrical in plan due to being constrained by Olive Hill. This bay contained the original staircase, the lift, and paired toilets on each floor.

Plate 5 South facade central gable

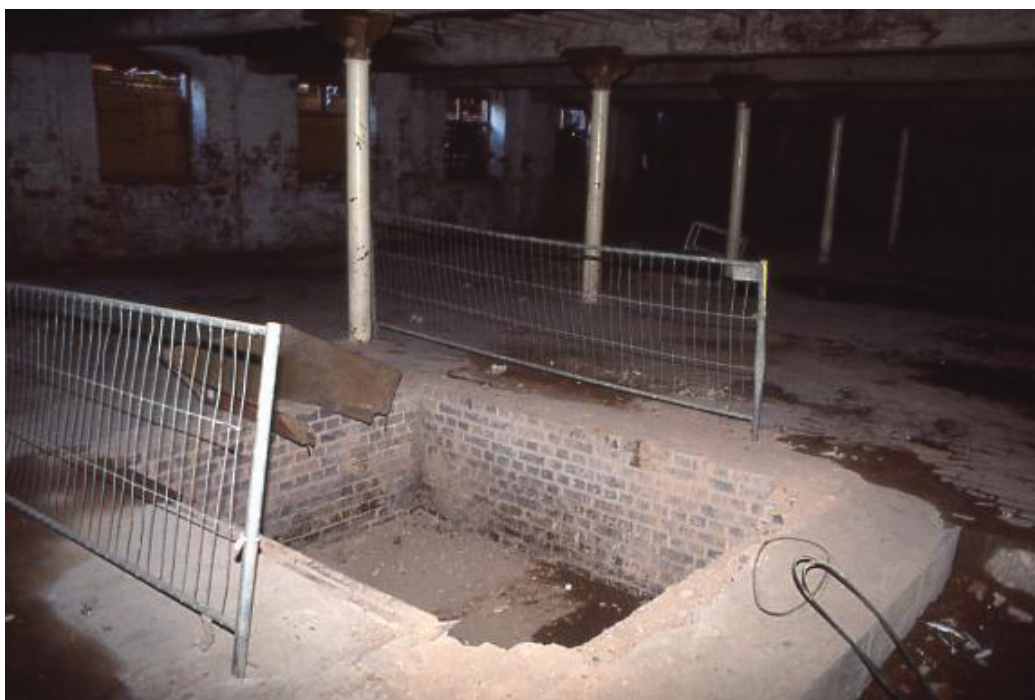
Plate 10 Modern lift base in basement

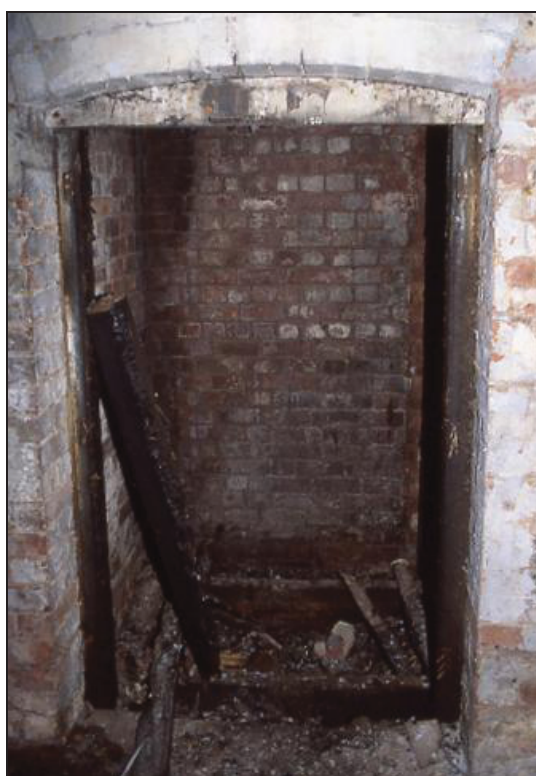
Plate 12 Base of lift shaft

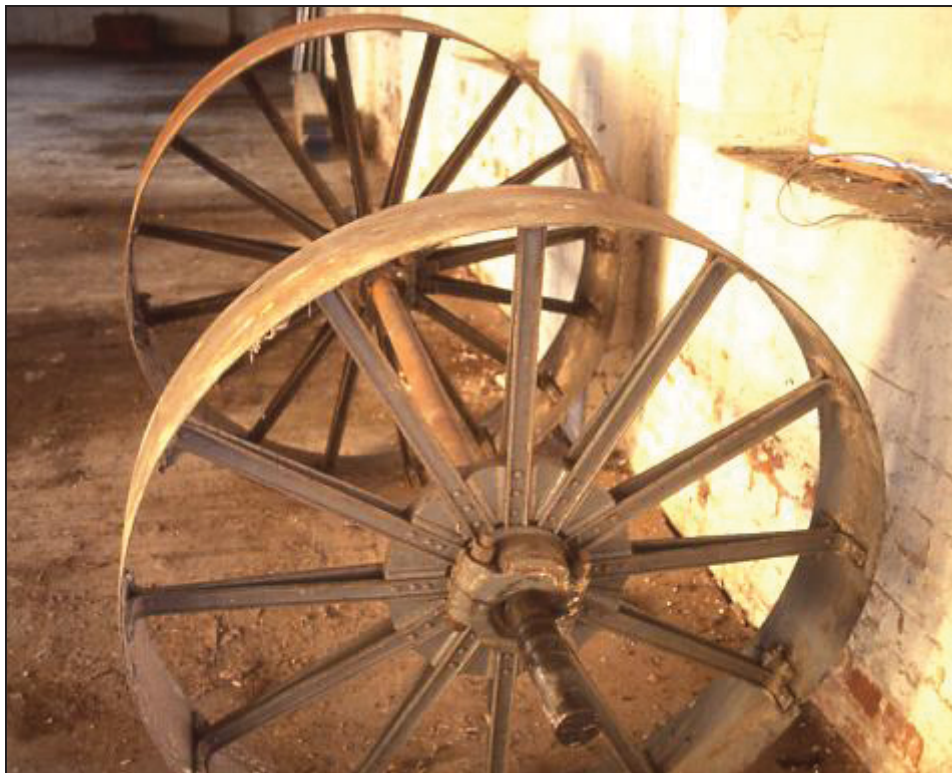
Plate 14 Part of lift power mechanism originally on top floor

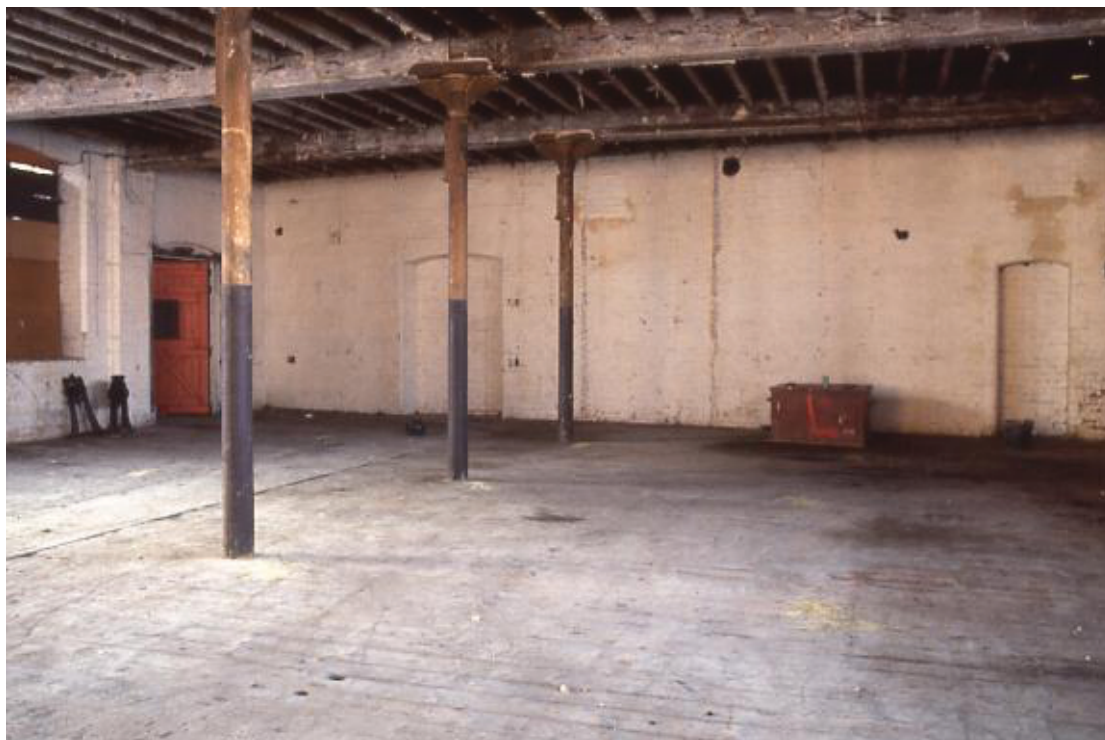
Internally, the floors are more or less identical, the exceptions being mainly modern alterations. There are several extant and blocked apertures on the lower floors (e.g plates 15,16) in the west gable to provide access into the adjacent building, whilst on the top floor blocked apertures indicate original windows, and block and tackle hoists or similar. Two curious hatches (plate 18) in the east gable on the first and second floors may represent further hoist positions.

Plate 15 Ground floor looking to south west corner

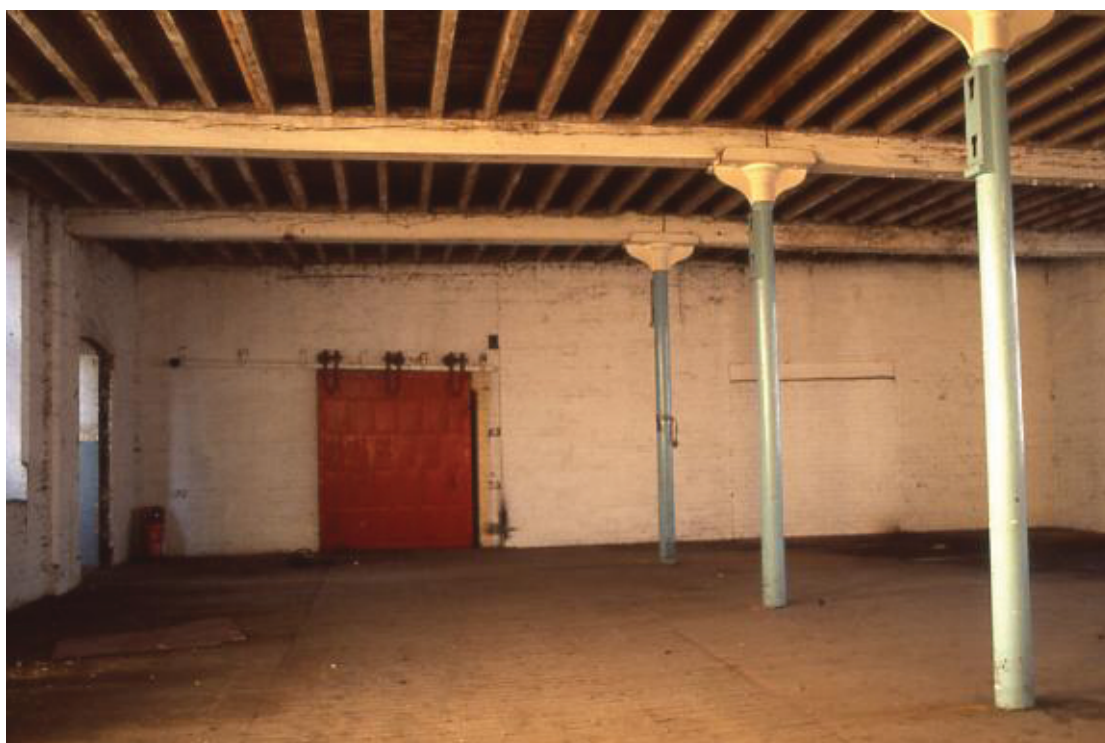
Plate 16 First floor looking west

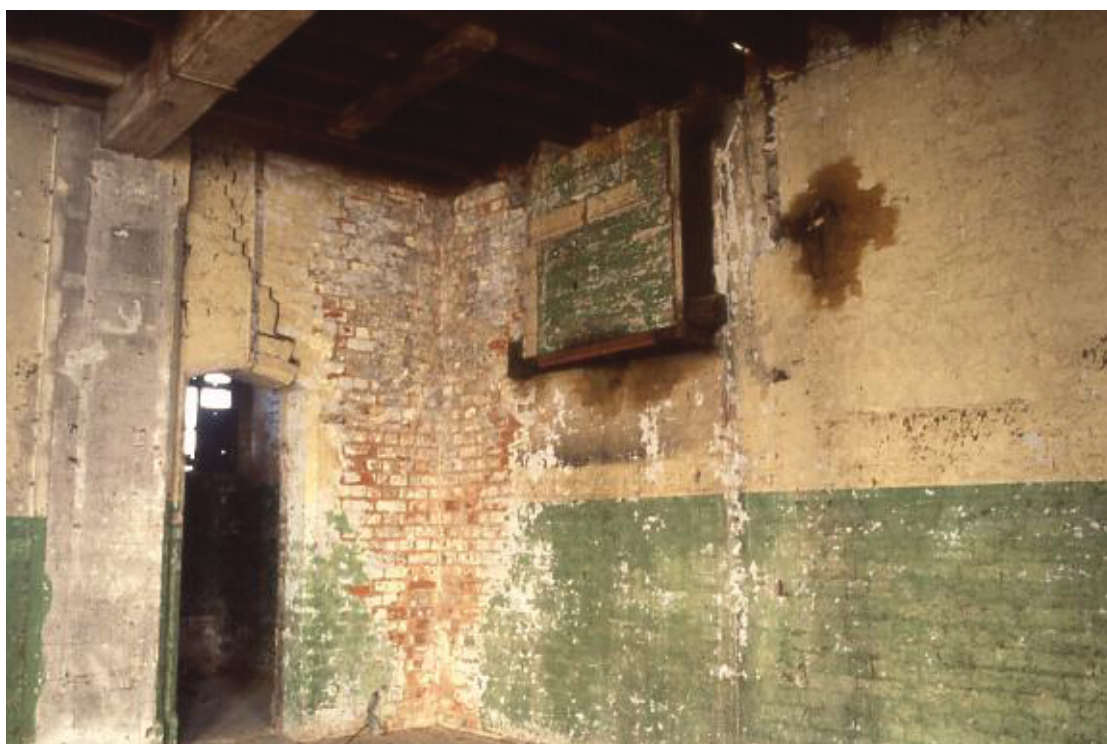
The north face has a toilet block protruding from the north east corner on each floor. The building assessment noted a change in brick bond at this point. Although presumed to be original build, it may be an afterthought to the original design at least: a plan in the building assessment report shows that the toilet block is of different wall thickness than the main range, it is provided with a slightly awkward lean to roof (plates 2,3) instead of being incorporated into the main roof structure, and the internal doors accessing the block are of unusually narrow width. Perhaps these door apertures were kept narrow for fear of weakening the load bearing corner, and some structural failure is in fact evident here (plate 18).

Plate 18 Second floor looking into north east corner

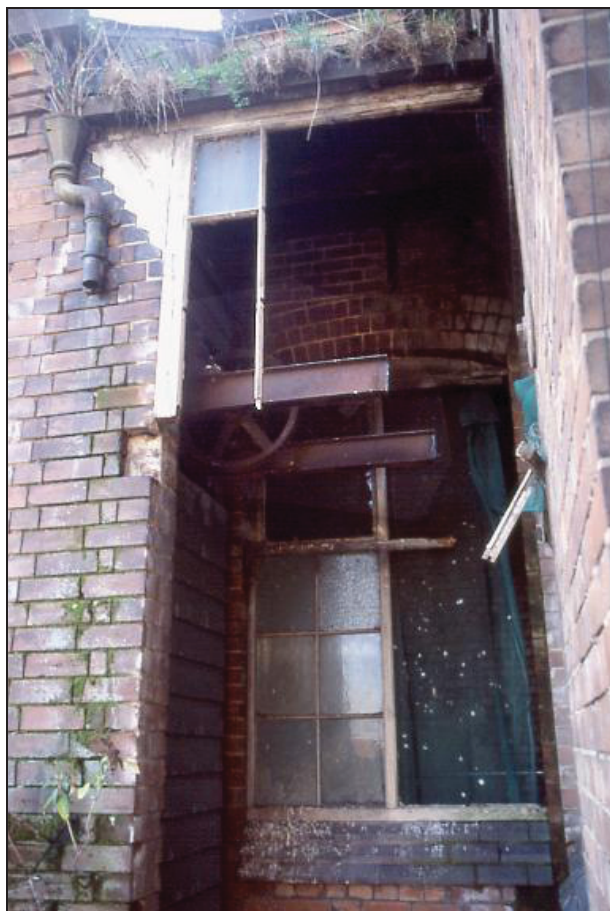
By the time of the photographic survey, most of the original fixtures, fittings, and plant noted in the building assessment had been removed, with the exception of the pulley for the lift counterbalance on the top floor (plates 23,24). However, access into the basement was possible. The basement has a lower ceiling height than the floors

Plate 23 Top floor exterior: part of lift mechanism in south west wing

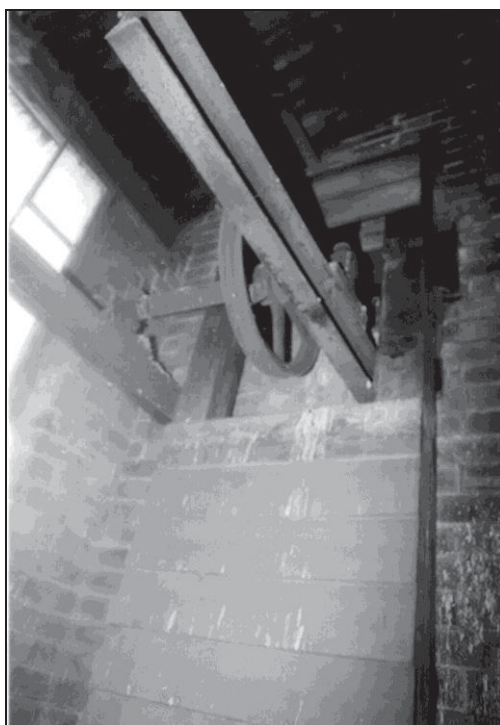
Plate 24 View of lift mechanism from interior
