**A Building Survey and Watching Brief  
in advance of redevelopment at  
17 Northgate, Oakham, Rutland  
(SK 8585 0895)**

**For Francis W. Keyworth on behalf of Mrs Joyce Wells**

**University of Leicester Archaeological Services  
Report No. 2004-181**

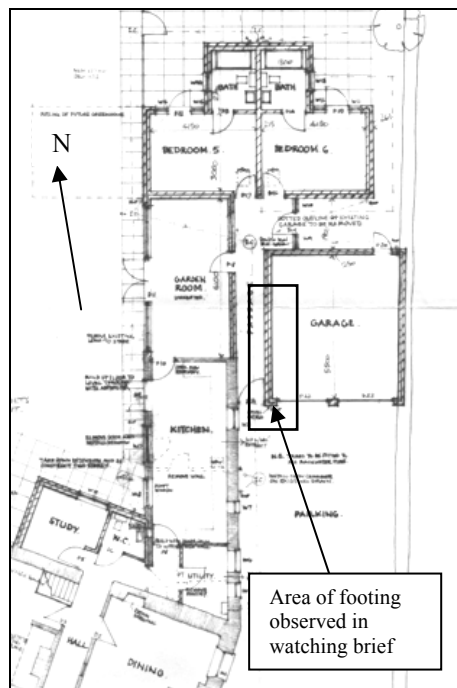
Fig 2 Plan of area observed during the watching brief. Taken from plan supplied by Architects.

Only the west wall footing for a new garage was inspected (fig 2). This showed *c.* 0.50m of garden soil with ceramic building material fragments, under which was *c.* 1.2m of greyish clay substratum, which appeared to have been disturbed. No archaeological deposits or finds were observed.

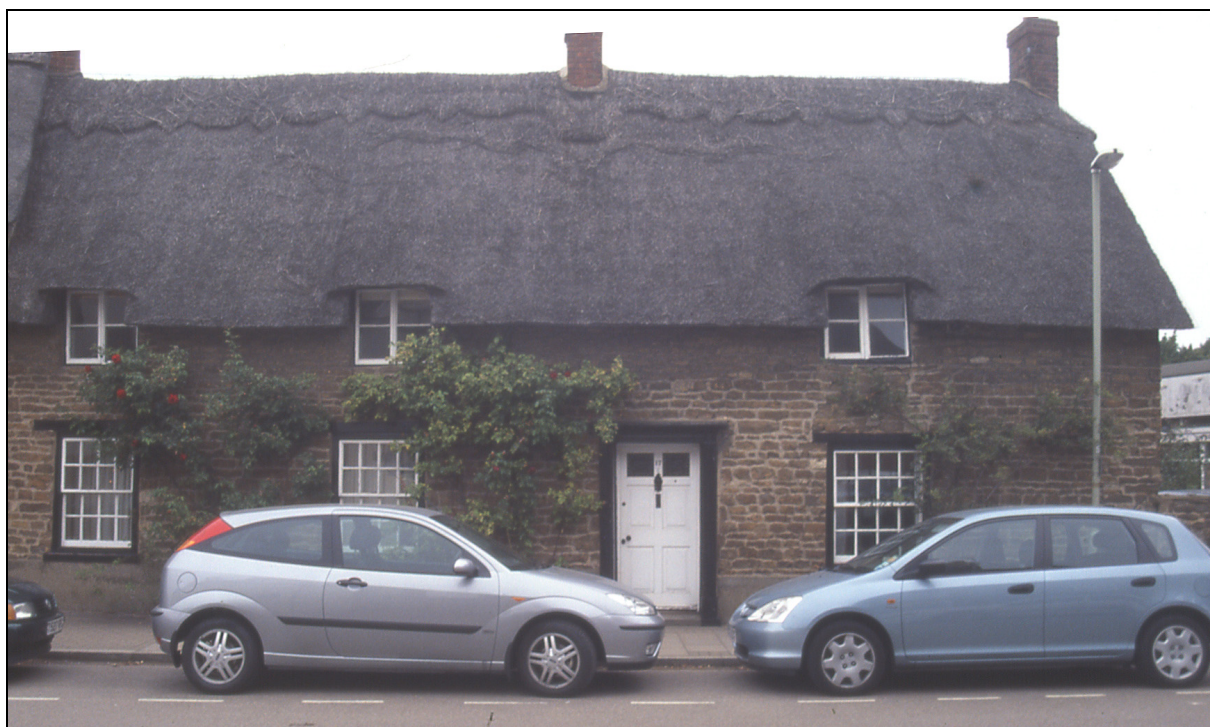
Fig 3 Frontage, looking north

The building fronts onto Northgate, Oakham (fig 3). It is listed as Grade 2. The listing description describes it as 'mid C17 house, 1-storey and attics. Coursed rubble. Reed thatch...'

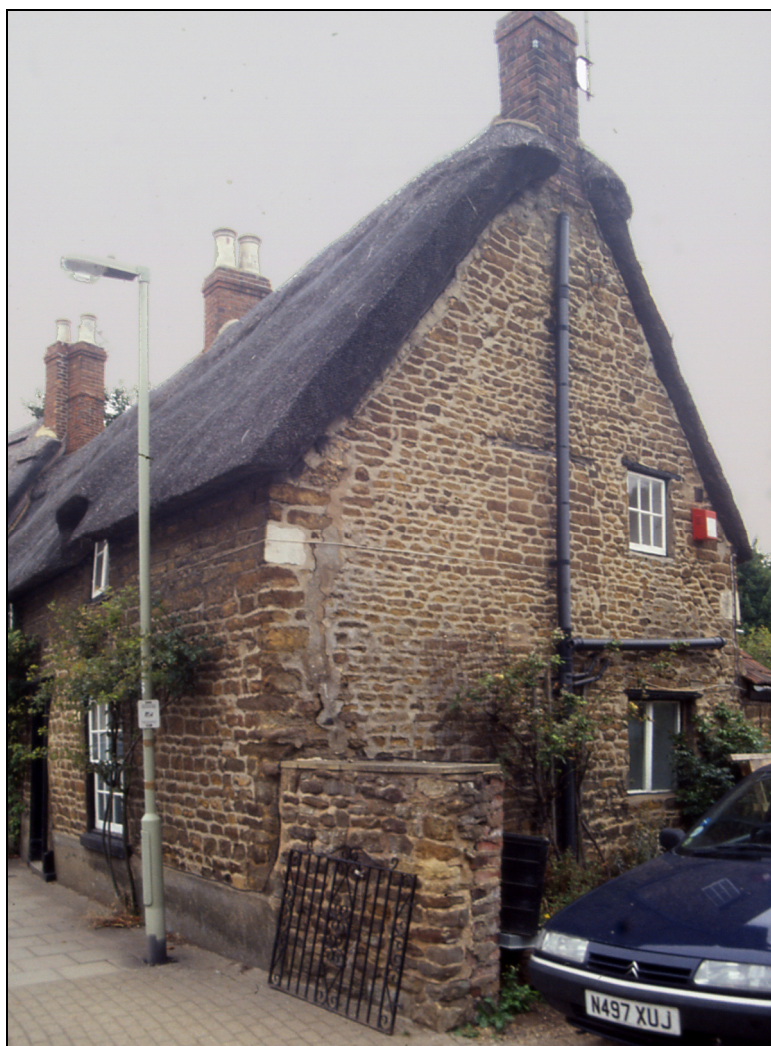
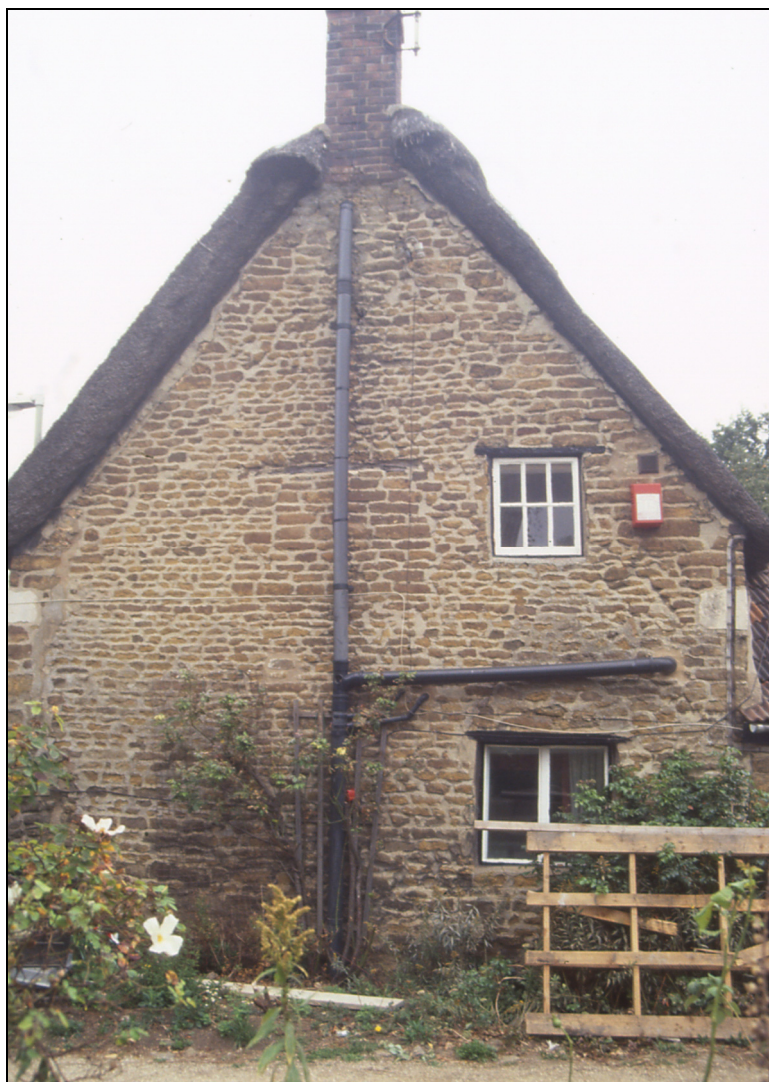
The building appears to be of three bay construction, with a central stack and two further stacks at either end. The east gable (figs 4,5) shows that the stack has been inserted, necessitating moving the first floor window to the north side. It appears from this gable that the roof may have been raised, perhaps converting attic space into a first floor proper; however the only evidence for this at the front is that the mortar in the top few courses appears to be a slightly different colour than that beneath. The rear elevation (fig 6) at ground level shows the installation of a large 20th century window looking out into the rear garden.

Fig 4 Front and gable, looking northwest

Fig 5 Gable, looking west

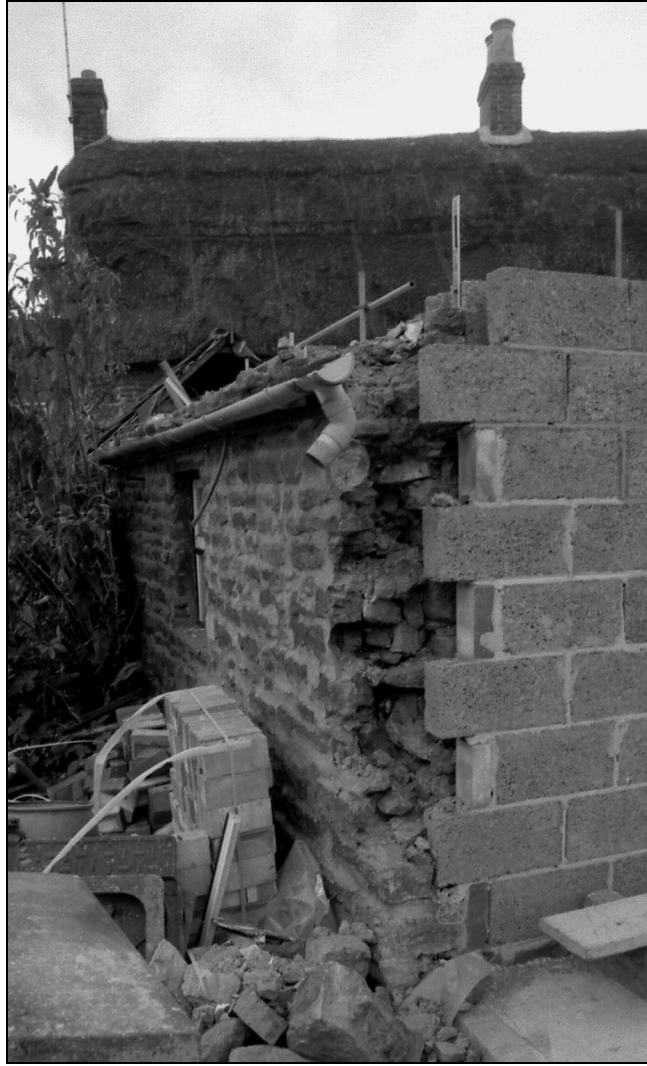
Fig 7 East wall of outbuildings, looking southwest

A range of single storey outbuildings to the northeast has been demolished with the exception of the coursed stone east wall (fig 7). A small rectangular flat roofed extension in the junction of the cross range and main building has also been demolished. Judging by a photograph of the small extension it was certainly late 20th century. The long range was obviously earlier; whereas the extant east elevation is stone, an unclear photograph of the west elevation shows a stone lean-to at the north end, but brick to the south. This range may have originally been built as an open fronted barn or carhouse, subsequently infilled.

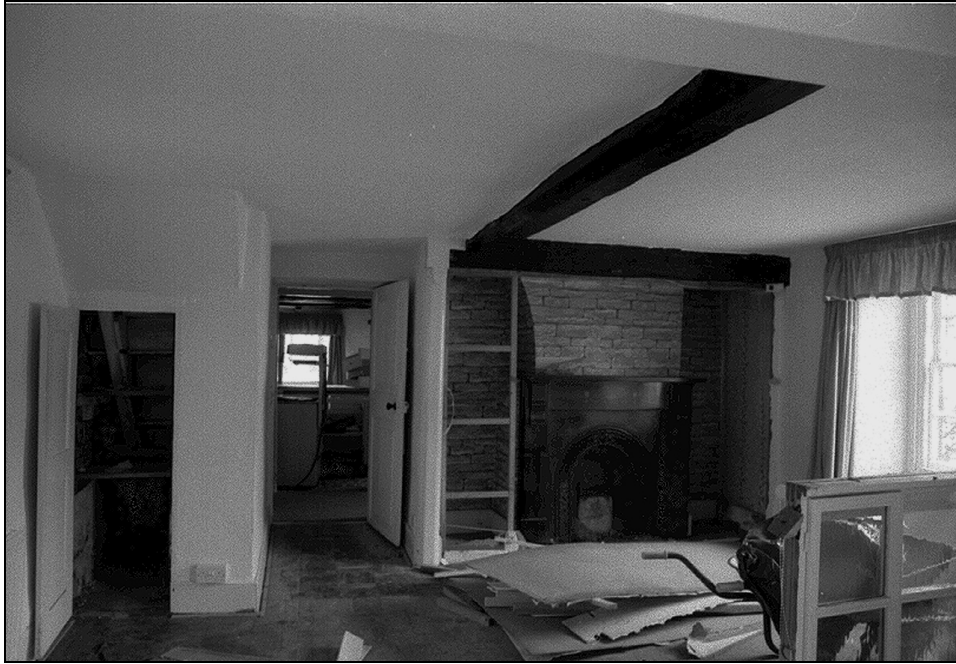
Fig 8 West and central bays, ground floor, looking east

In plan, the house appears to be of cross passage type, with one bay to the east and two to the west. On the ground floor the two west bays have been knocked through to form a single large room (fig 8). A slim transverse run of boxing (presumably covering a modern RSJ supporting the original longitudinal beam) probably indicates the position of the removed wall. Few original features survive in this area, except the full size main fireplace (fig 9) on the east wall with a later freestanding stove grate, a wall cupboard in the south wall, and the longitudinal chamfered beam itself. The fireplace on the west wall has been completely remodelled.

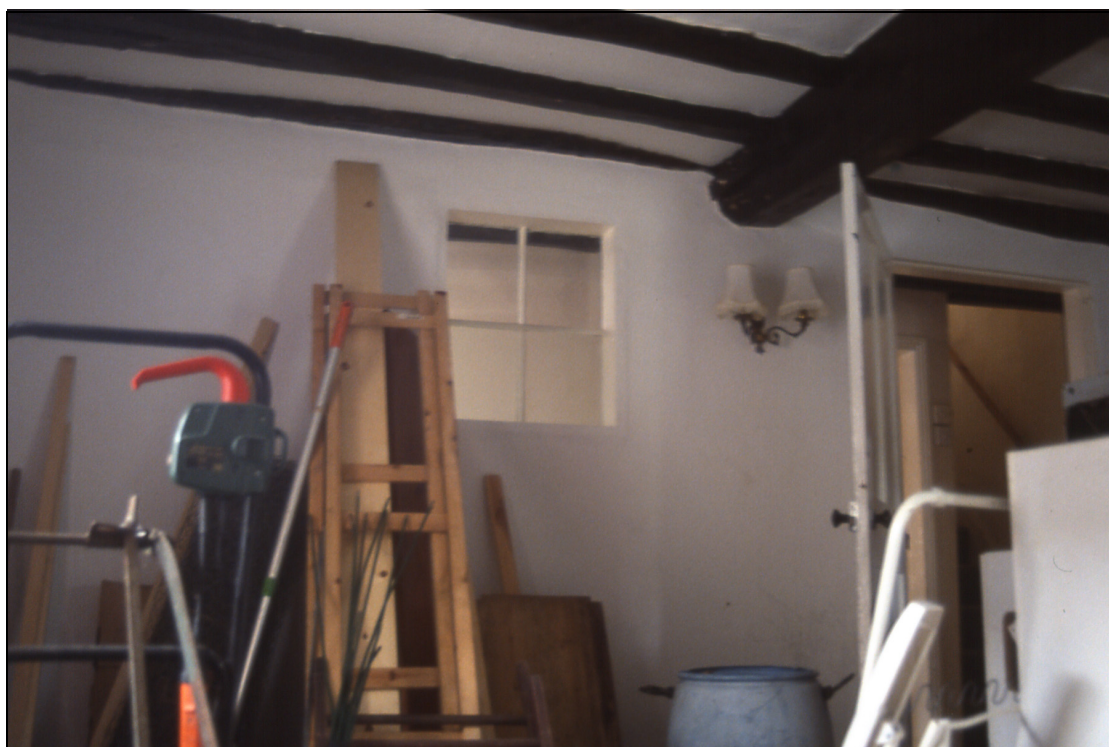
Fig 10 East bay, ground floor, looking westnorthwest

In the east bay, a thin partition with a small four light window separates the cross passage (fig 11) from the room (fig 10). A large stopped and chamfered longitudinal beam runs from the back of the central stack across the passage, through the partition, and under the joists to terminate in a slightly awkward buttress arrangement (fig 12) on the gable wall (presumably connected with the insertion of the stack). The joists in the northeast corner (fig 12) show a possible position of former access into the loft area. There is a cupboard in the north wall.

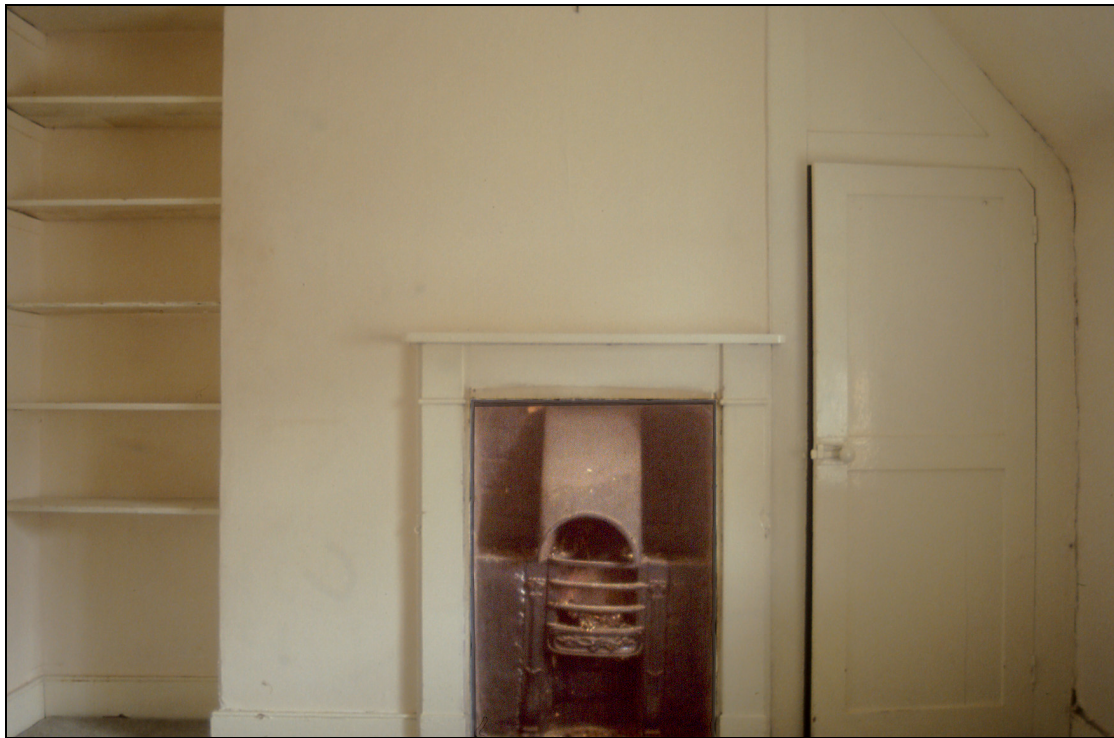
Fig 13 First floor central bay, looking east

On the first floor is an unusual layout of three bedrooms, a bathroom, a landing and a large lobby. The bathroom is completely modern and has been created by dividing the east room with a partition. The west and central rooms have a bedroom grate and built in cupboard. The hob grate in the central bedroom (fig 13) appears to be of Pantheon pattern, and along with the cupboard door latch adjacent, could be as early as the 18th century. The east chamber (fig 14) appears only to have the chimney without any obvious provision for a fireplace.

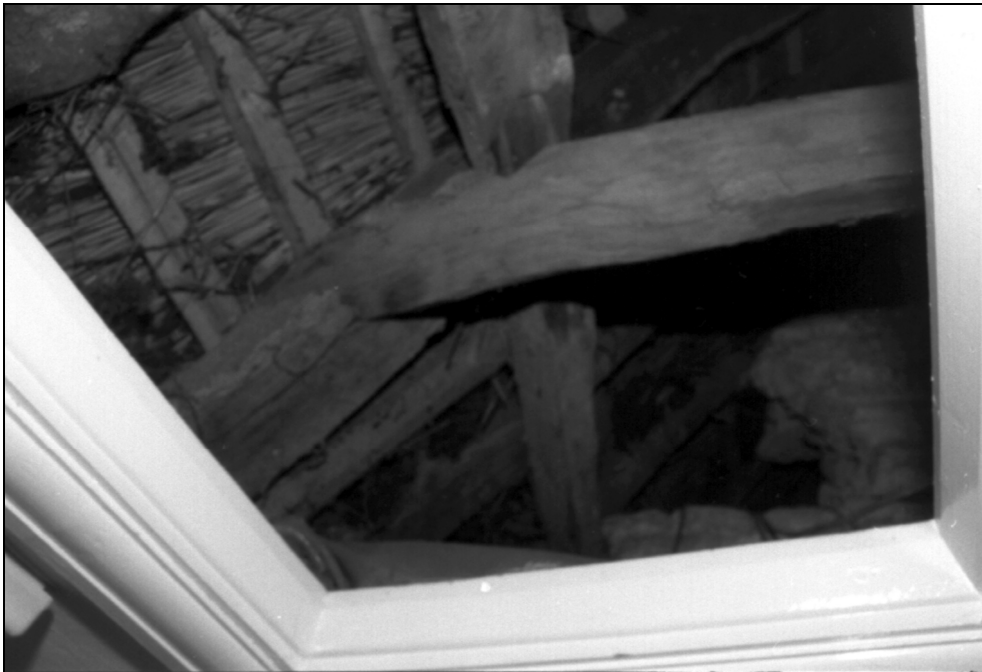
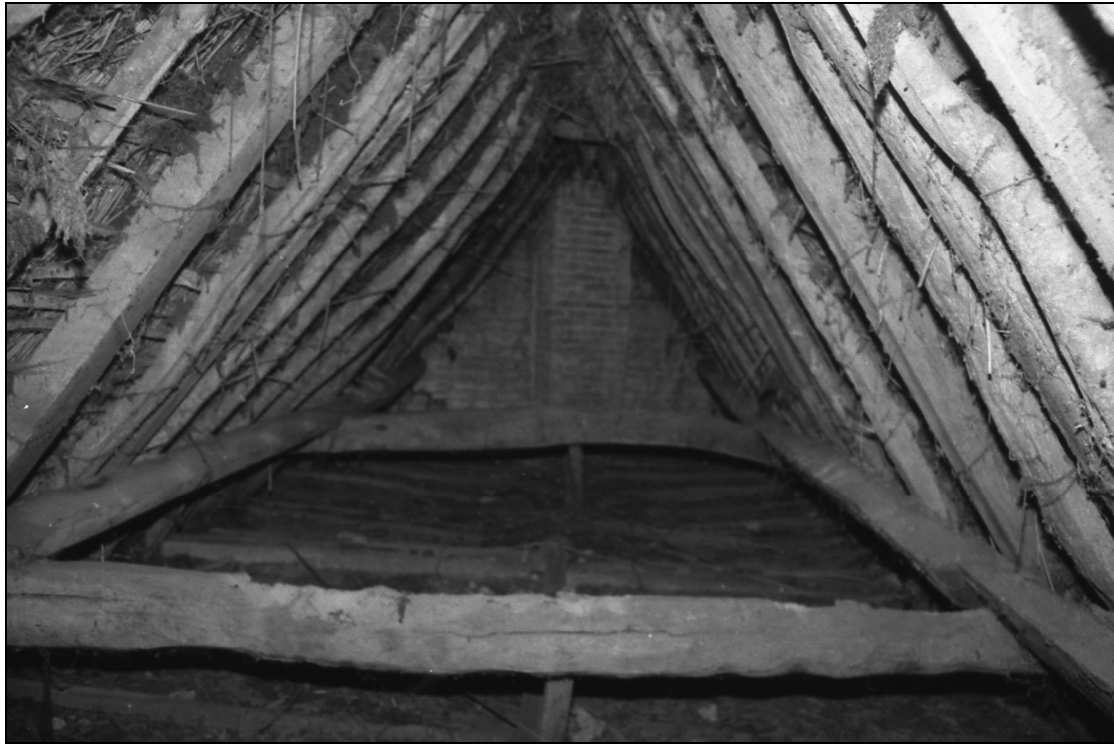
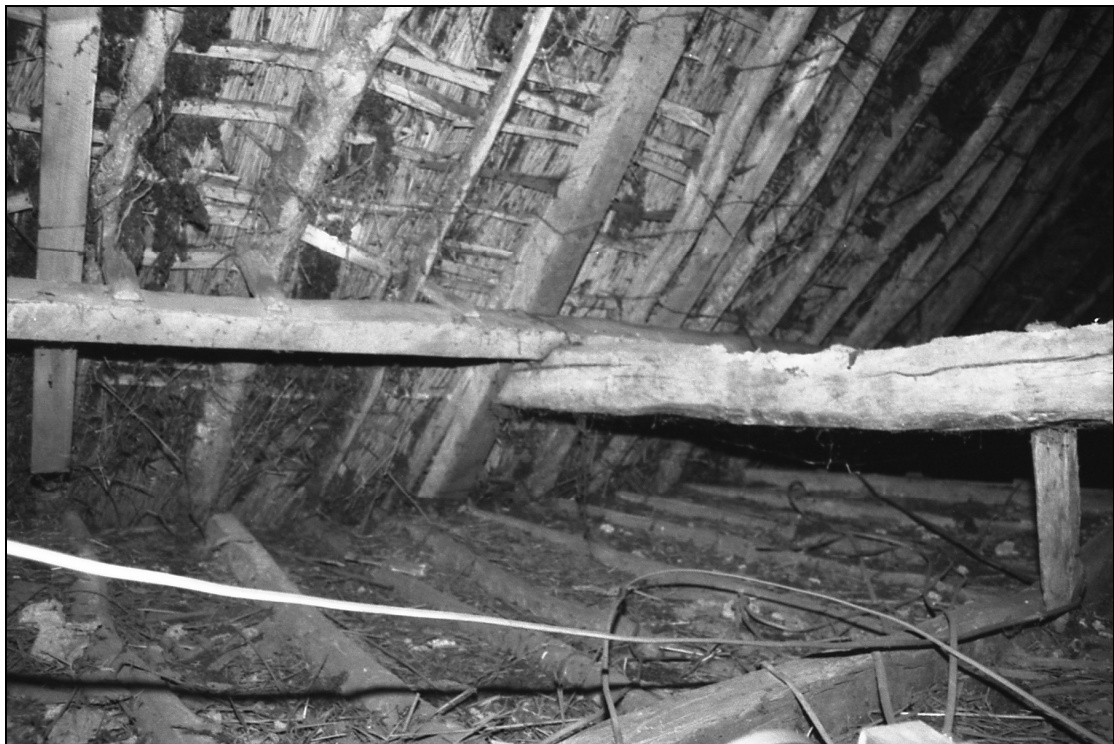
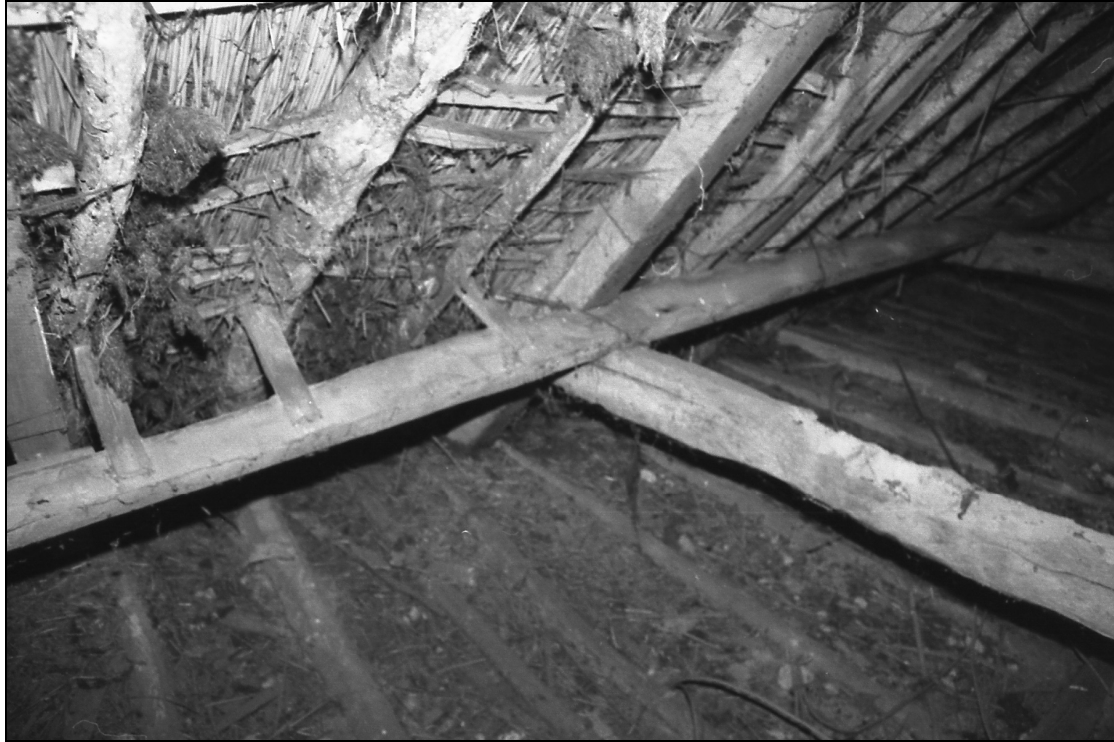
The roof space (figs 15-18) was accessible only in the central bay; none of the structure east of the central stack was visible. The roof type is not common in Leicestershire; the structure is of clasped purlin form, with the principal rafter trusses at the bay intervals carrying side purlins. Sub-collars on the principal rafter trusses support a square-set ridge purlin. The first floor ceiling beams are joined to the common rafters, effectively functioning as collars.

The roof timbers are relatively insubstantial with many of the common rafters being trimmed roundwood poles; the principal rafter trusses are converted timbers of slightly heavier scantling.
