**Archaeological Photographic Survey and watching
brief for 1a, The Borough & 2/2a Castle Street,
Hinckley,
Leicestershire (SP 426 937).**

Report No. ULAS 2006-071

For: Savage Haywood Ltd.

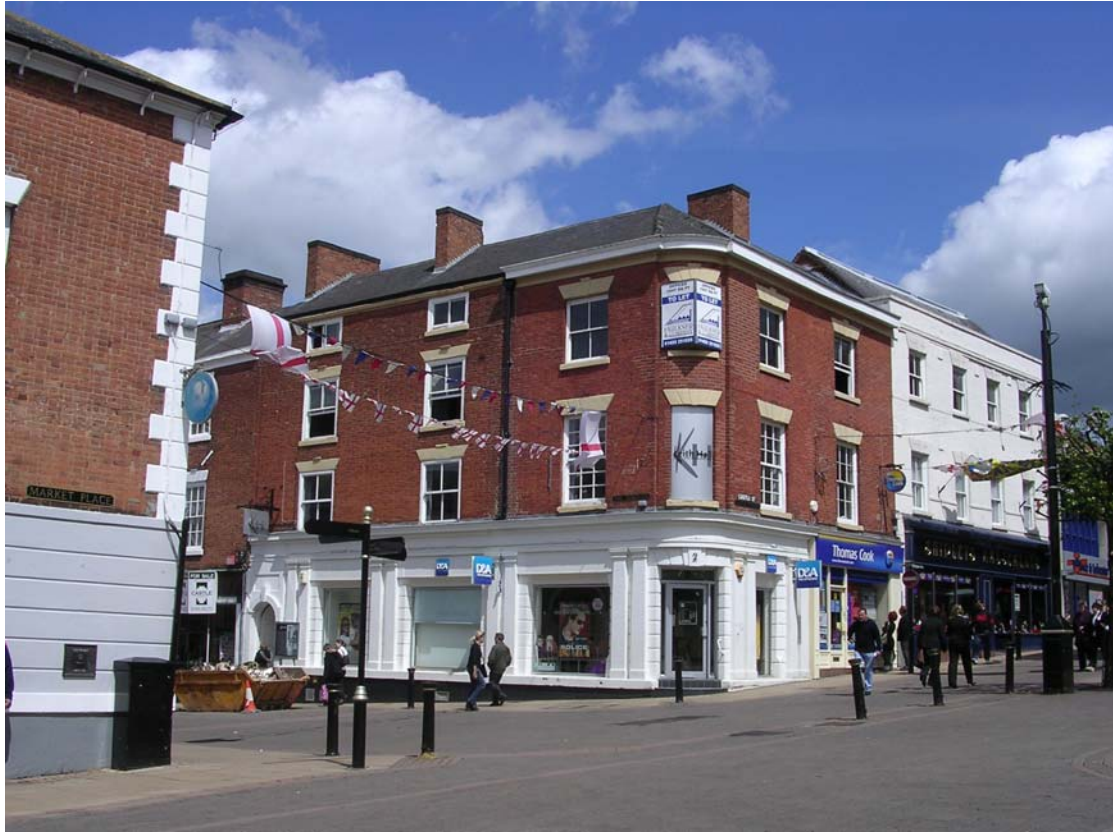
Figure 1: Exterior view of the corner of The Borough & Castle Street looking north east.

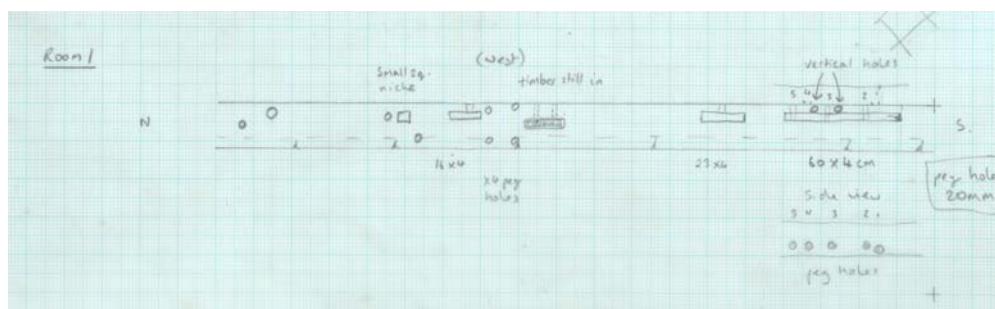
The principal beam across the ceiling was peppered with mortice and dowel holes (Figure 3) with indicate that the timber has been re-used.

Figure 3: Measured sketch of re-used beam in the ceiling of Room 1.

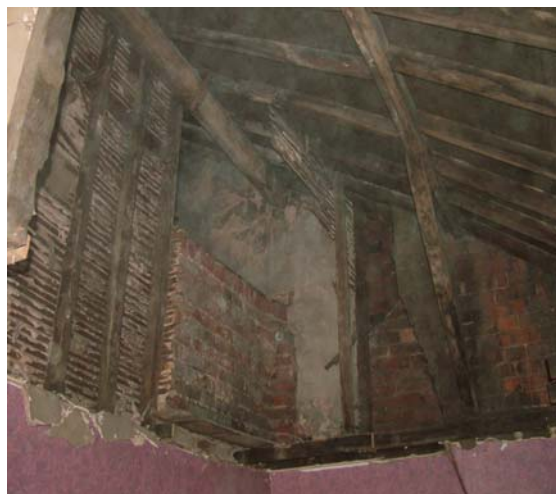
South wall – formerly timber stud partition with Room 3, timber laths above, on-edge bricks below (Figure 4 & Figure 5) . Modern staircase removed but former, probable original staircase line visible on west end of wall (to the right of the ladders in Fig.4). This would have connected rooms 2 & 3, but there was no clear evidence to suggest that this was the principal staircase for the property.

Figure 4: Room 2, looking south, stud and lath room partition.

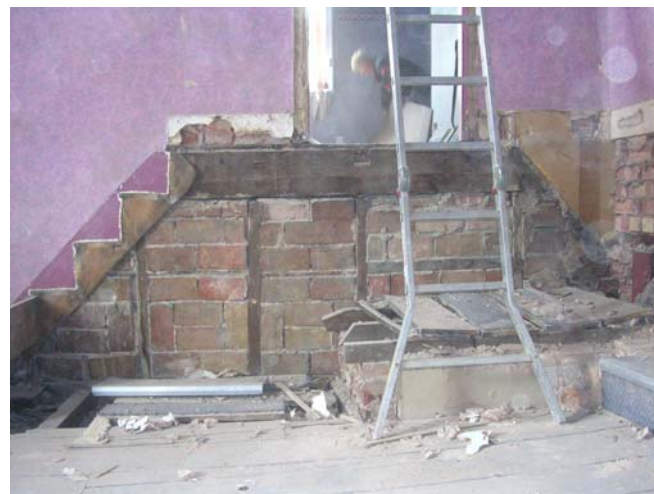
Where plaster had been removed from the east wall (opposite the window) timber wall studding could be seen, with on-edge brick infill (similar arrangement to that seen in Room 2, Figure 5, but less well-exposed). The mortar included horsehair.

Figure 5: Stud and on-edge brick wall, directly below wall seen in Figure 4.

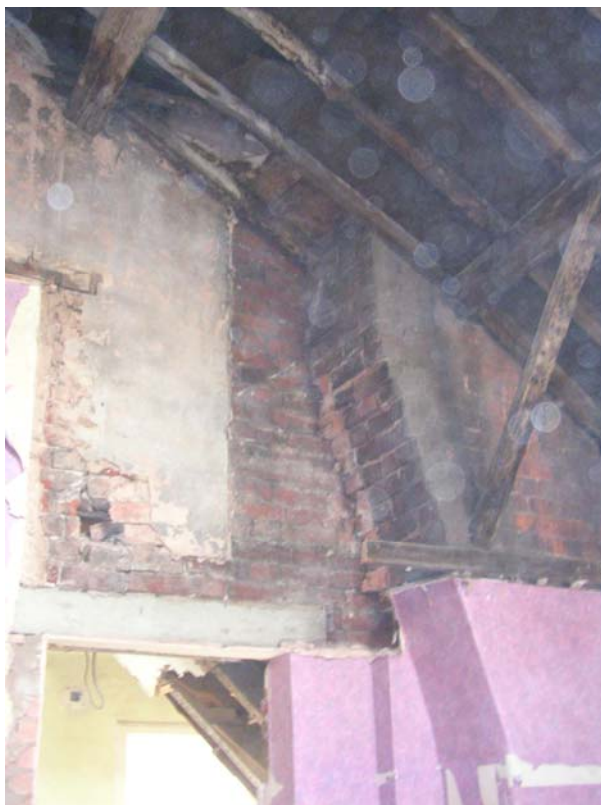
West wall – roofline of earlier two storey building visible (centre of Figure 6), aligned perpendicular to the original building fronting onto The Borough. It may even represent an extension to The Borough building. Sometime later (but not much) a three storey addition fronting onto Castle Street was erected. The roof of the Castle Street building appears to have encompassed the earlier two-storey building, creating an unusually large roof space (formerly divided, presumably into service rooms).

Figure 6: West wall chimney stack with former roof line visible

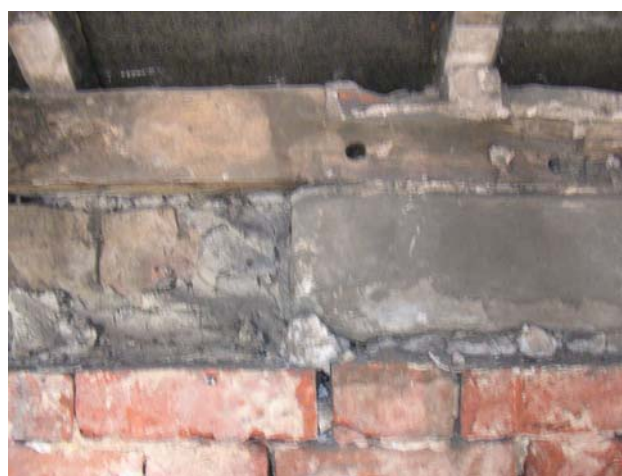
Figure 8: Re-used wall plate and rough rear face of eaves course.

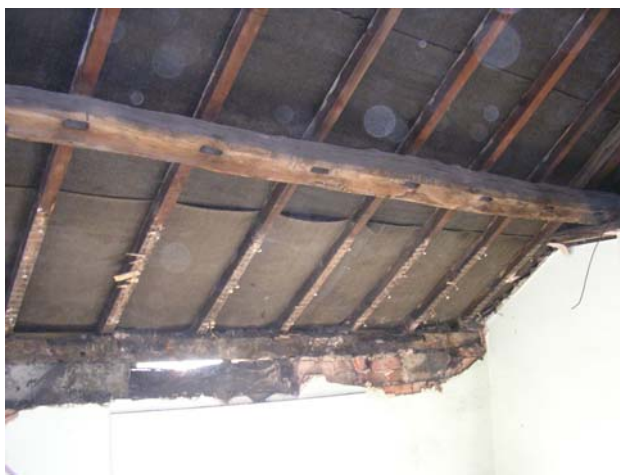
Purlins run parallel to The Borough. They contain old holes for studding (0.10 x 0.04m, curved at both ends. *i.e.* drilled with a bit) set at an angle. The angle suggests that the timbers are re-used (similar to Figure 9).

Figure 9: Mortice holes to support studding on purlin, Room 6. The angle of the mortices suggests the purlins are re-used.

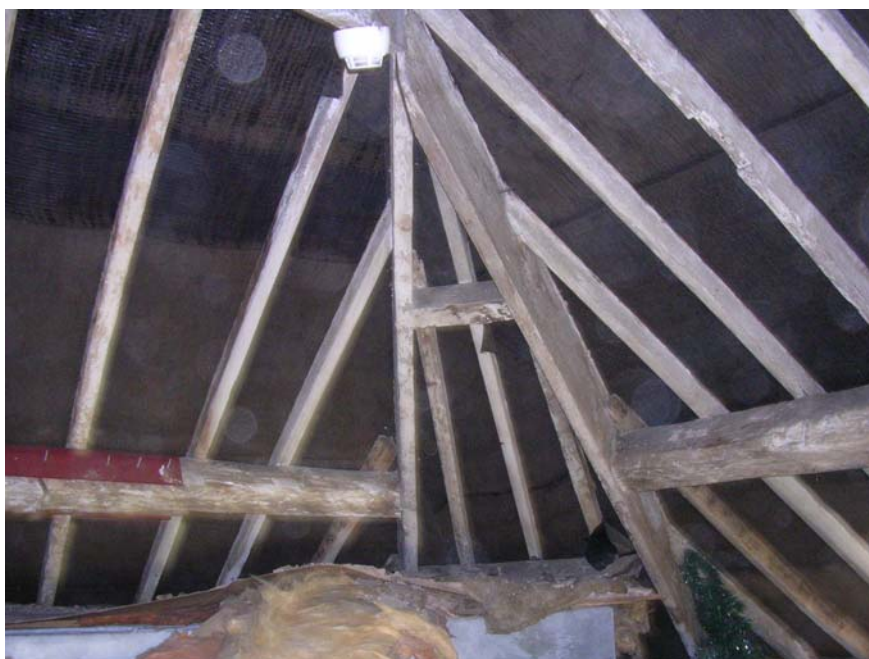
'Room 7' is actually the roofspace (former loft) above Room 4. The void was unlit and still contained property belonging to the former tenants, so access was poor, but the roof timbers appeared to be original with no obvious signs of re-use (Figure 10: Roof timbers of 'Room 7'). The roof felt was new.

Figure 10: Roof timbers of 'Room 7'.

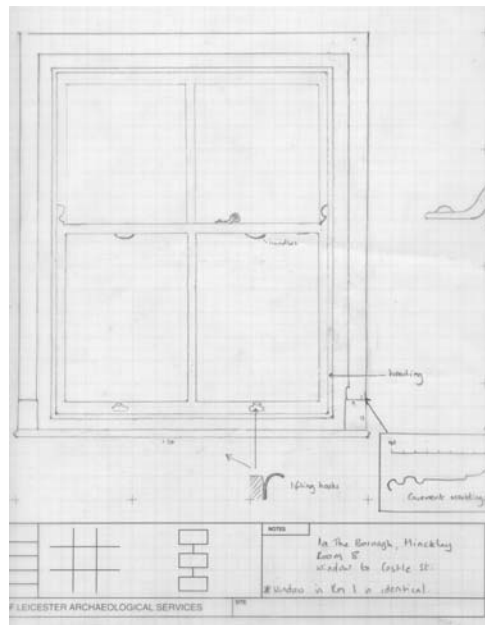
West facing window (a pair to that seen in the adjoining room 1). Replacement sash window with each sash containing two panes of glass. Sash horns on the frame of the c.1881-3 Monmouthshire type (Hall 2005, p.80).

Figure 11: Measured drawing of Room 8 sash, with details of mouldings and sash lock.

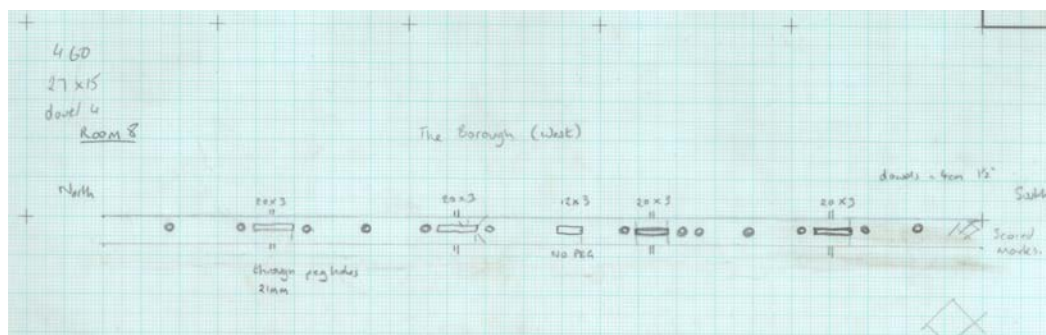
Figure 12: Measured sketch of the re-used beam in the ceiling of Room 8.

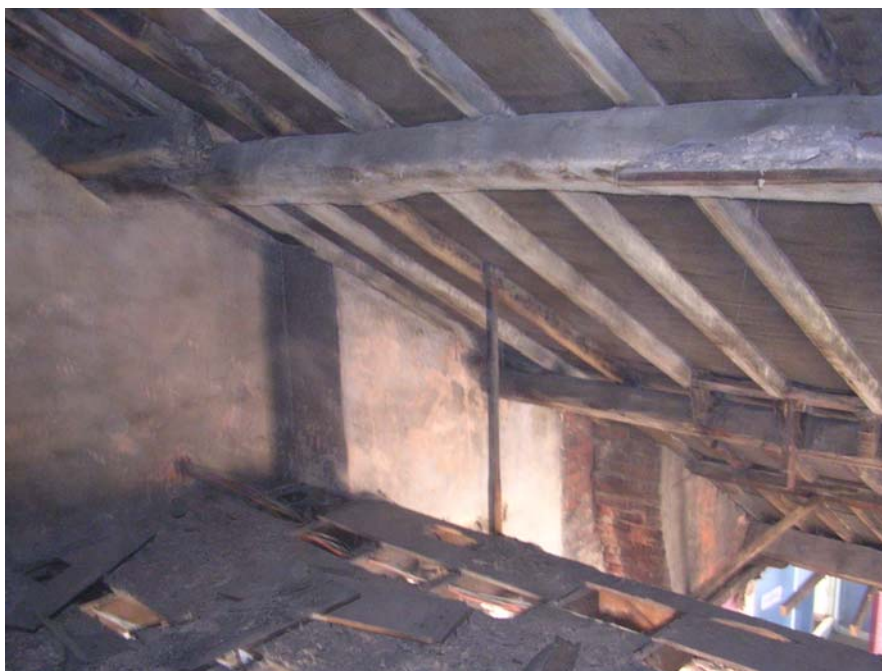
Figure 13: 'Room 9' looking down onto Room 2. Note the chimney breast which denotes an end wall for an earlier building on an east west alignment. The re-roofing of both the old roofspace and up to the ridge of the c. early 19th century three storey building fronting onto Castle Street has created an unusually large roof void.

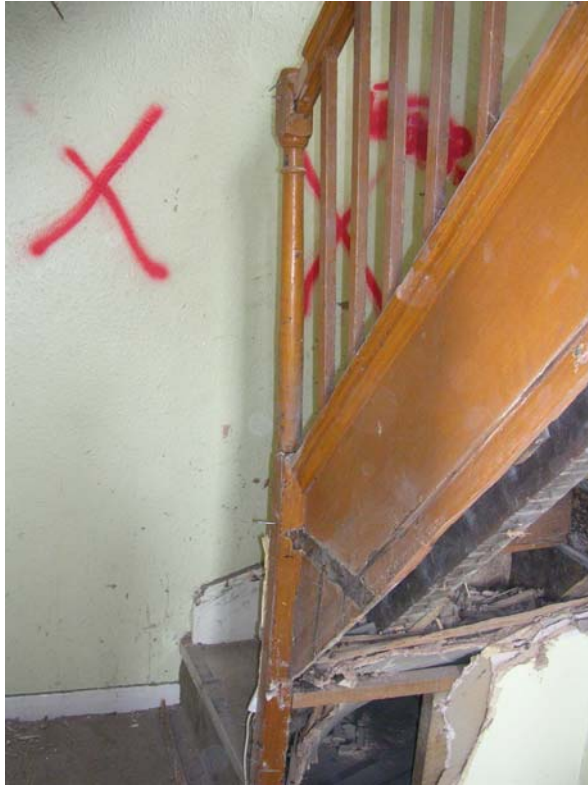
A simple straight flight service staircase with winder comprising a plainly turned newel, stick balusters (with a square cross-section) in a closed string. The handrail is plain; the nearest parallel being the 1986 'London' handrail (Hall 2005, Fig 4.67, p.128). The visible woodwork is all pine, painted in Victorian 'grain effect' with thick varnish, while the treads and risers are currently covered in modern linoleum. The whole is in poor condition with many balusters missing (5 out of about a dozen) and the newel post has been split (Figure 15).

There is little of historical distinction to clearly identify at what period it was constructed. The newel, balustrades and handrail are all of modest design typical of service stairs from the early 19th century onwards. It is possible that the stair fittings are all a later Victorian addition, although they are likely to have been sited where the original staircase lay.

Figure 14: Service stairs to attic rooms.

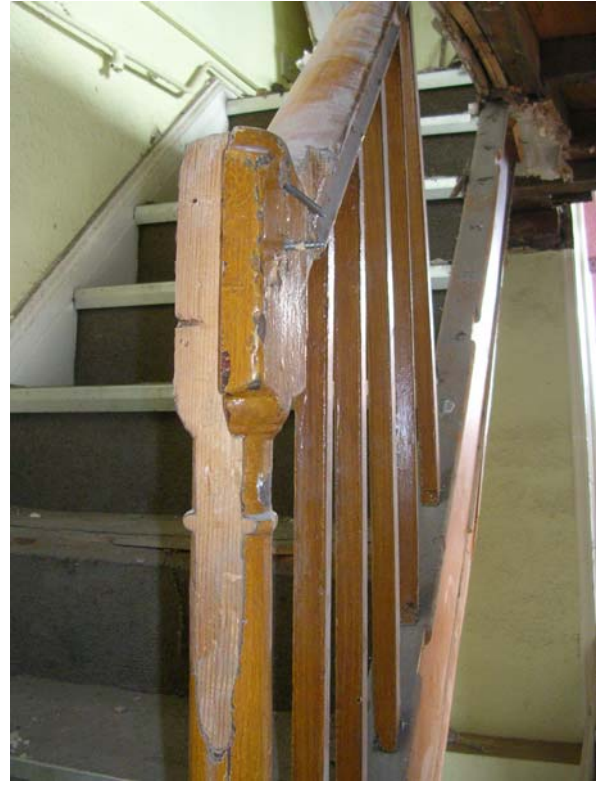
Figure 15: Split newel post .
