**An Historic Building Photographic
Survey at
12 – 16 De Montfort Street,
Leicester**

NGR: SK 5940 0382

ULAS Report No. 2019-066
©2019

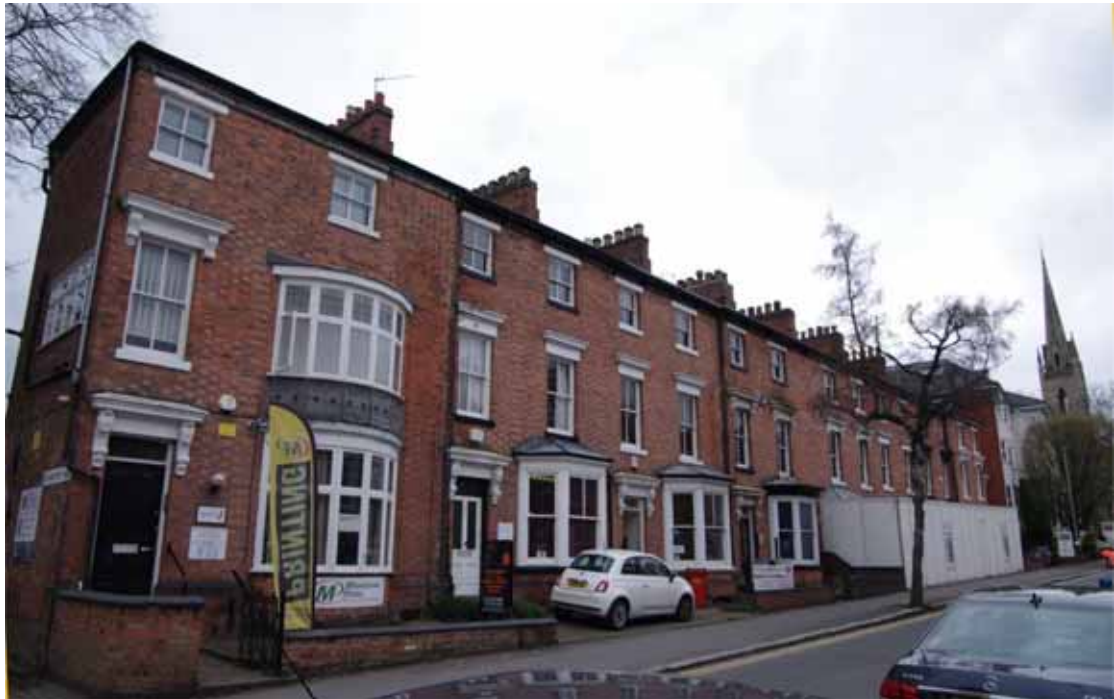
Figure 6 De Montfort Place Terrace
Looking south-east. Numbers 12-16 behind white hoarding. Note Bow-fronted bay of
Number 4 compared with the other ground floor bays of the remaining terrace

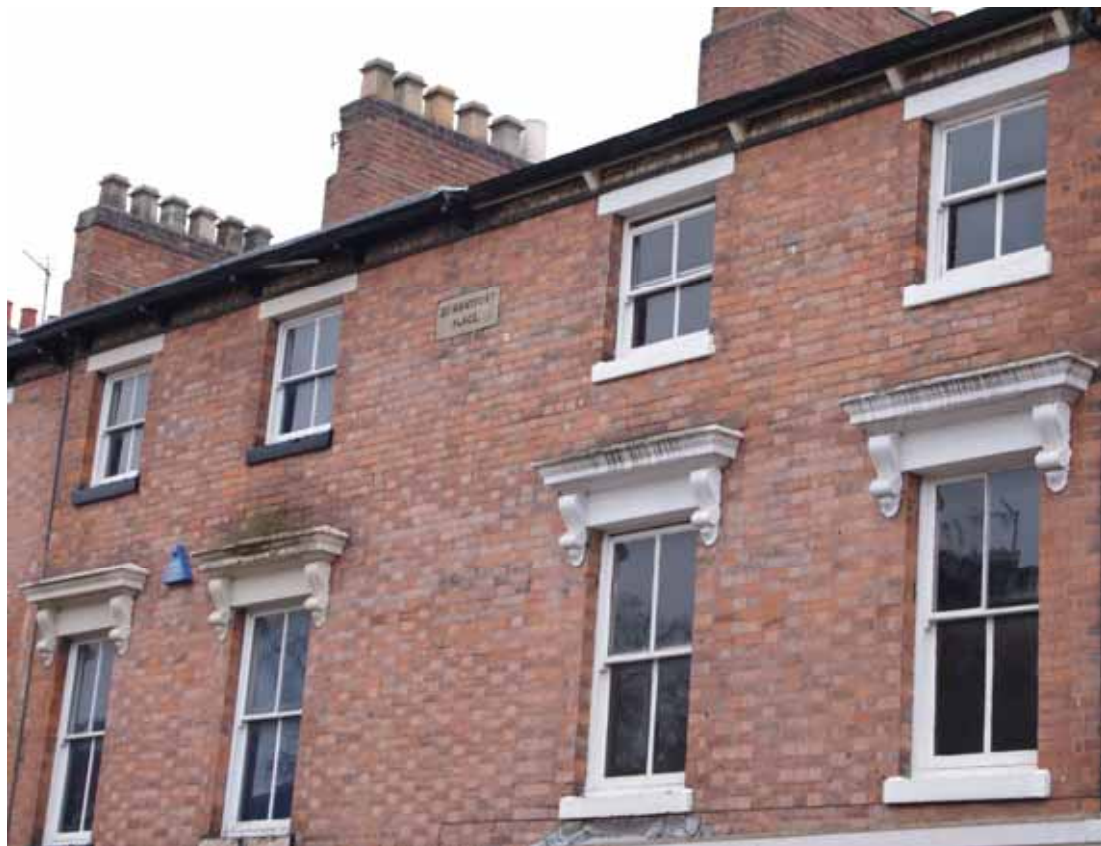
Figure 8 First and second floor detail of 10-12
Looking north-east. Note painted name

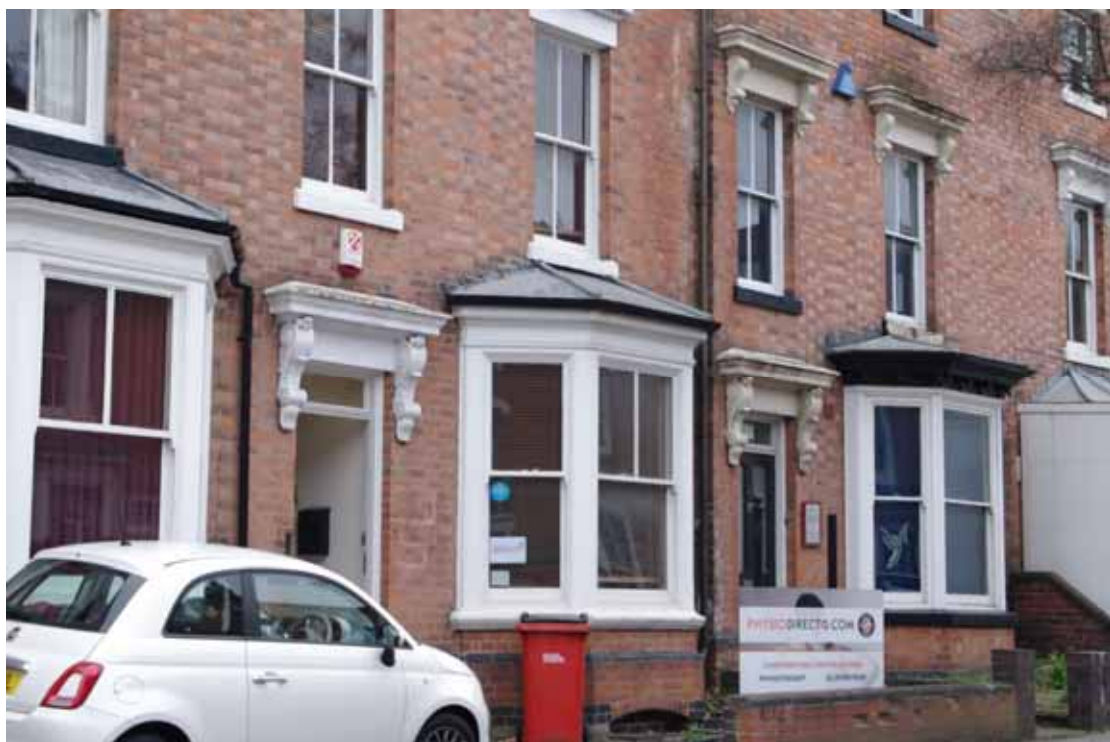
Figure 9 Ground floor bay windows of 8-10 De Montfort Street
These appear to be un-modified versions of what would have existed at 12-16
Looking south

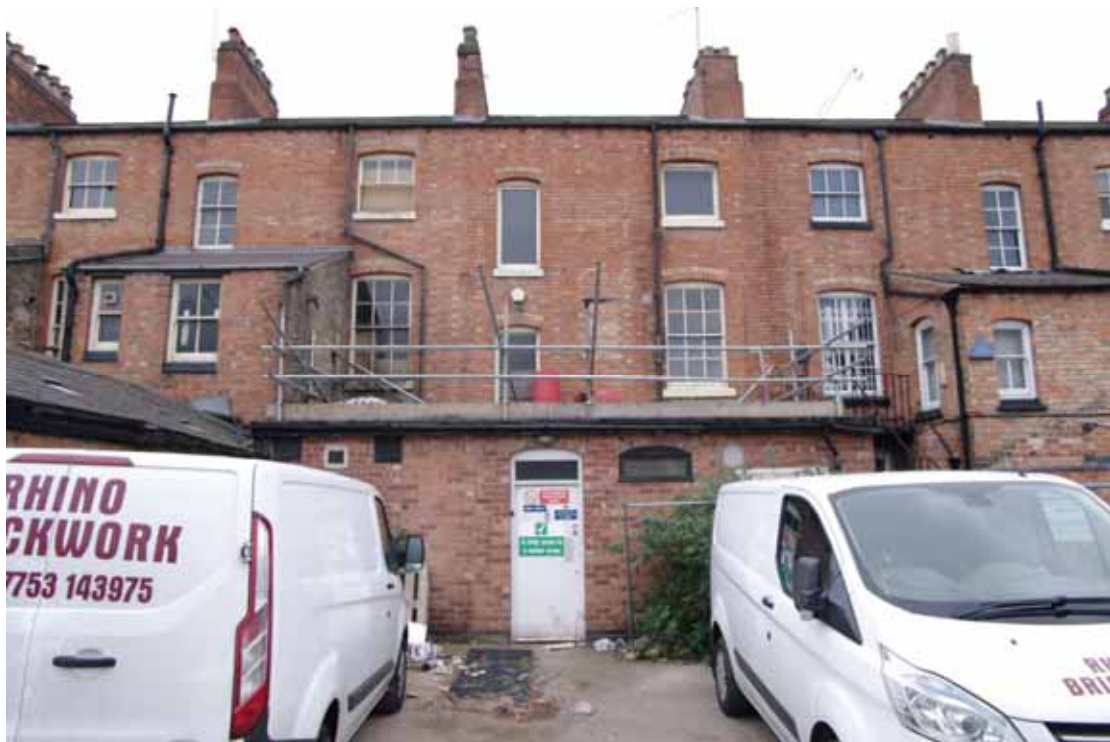
Figure 12 Rear of Number 12
Looking north-west. Number 14 to left. Note modified rear buildings and blocked doorways

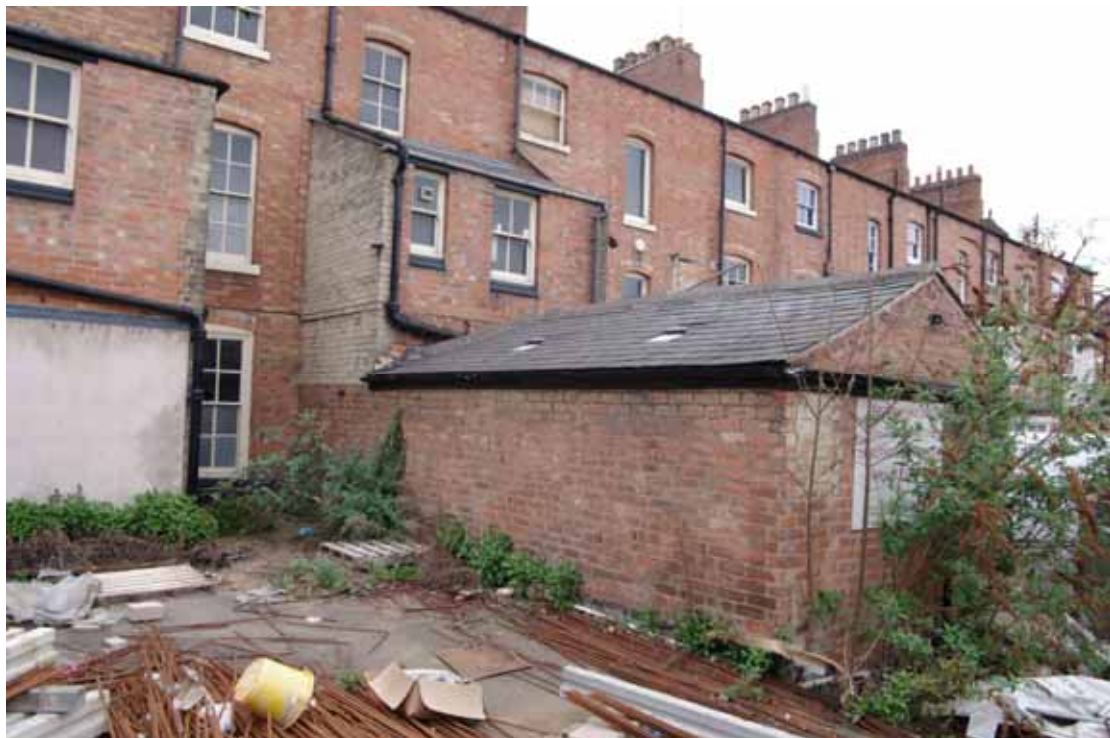
Figure 13 Rear outbuildings of Number 14
Looking north. Map evidence suggests that all three properties once had this type of extension

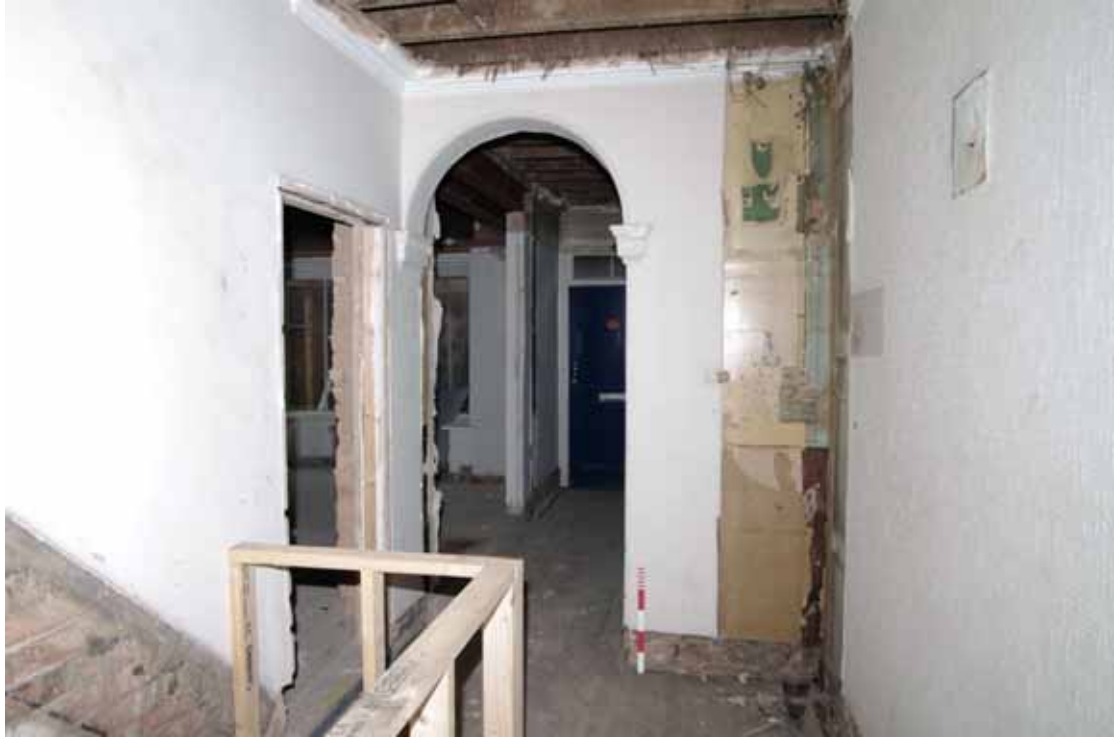
Figure 24 View into hallway of Number 12
Looking west. Openings on right are modern and connect to Number 14. Note decorative plasterwork around archway (see photo 25 below)

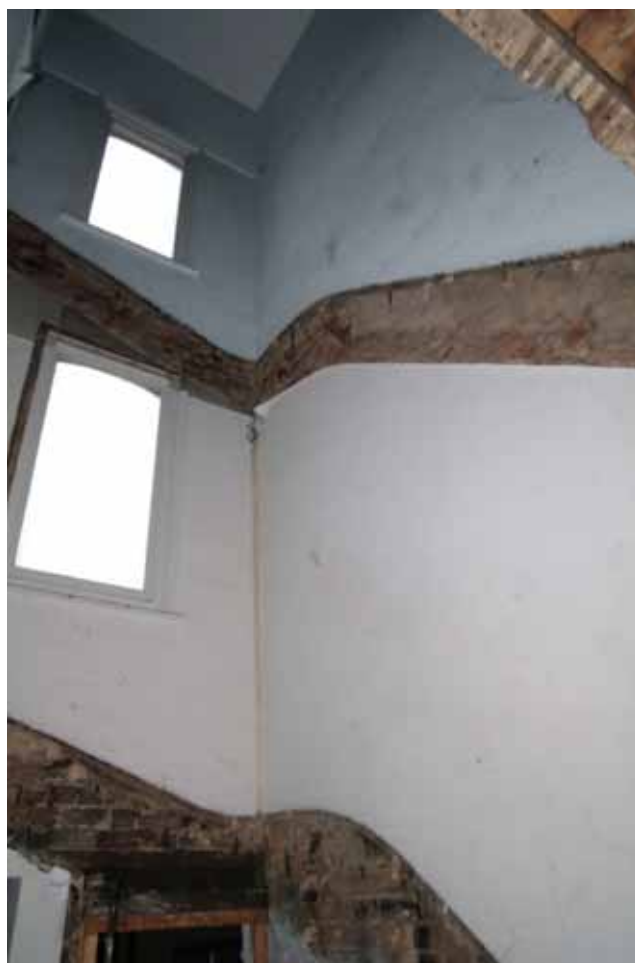
Figure 26 Removed staircase in Number 12
Looking north. Stairs were immediately above the cellar stairs

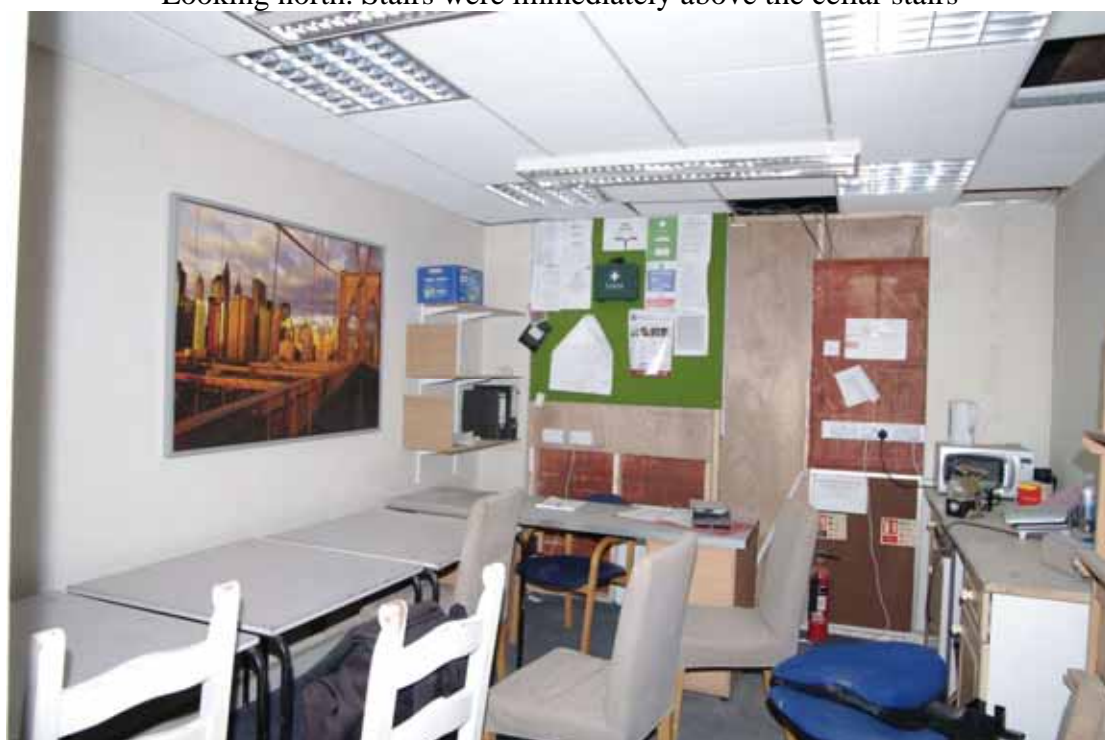
Figure 27 Ground floor, middle room of Number 12
Looking north-west. This is the only room with modern fittings remaining

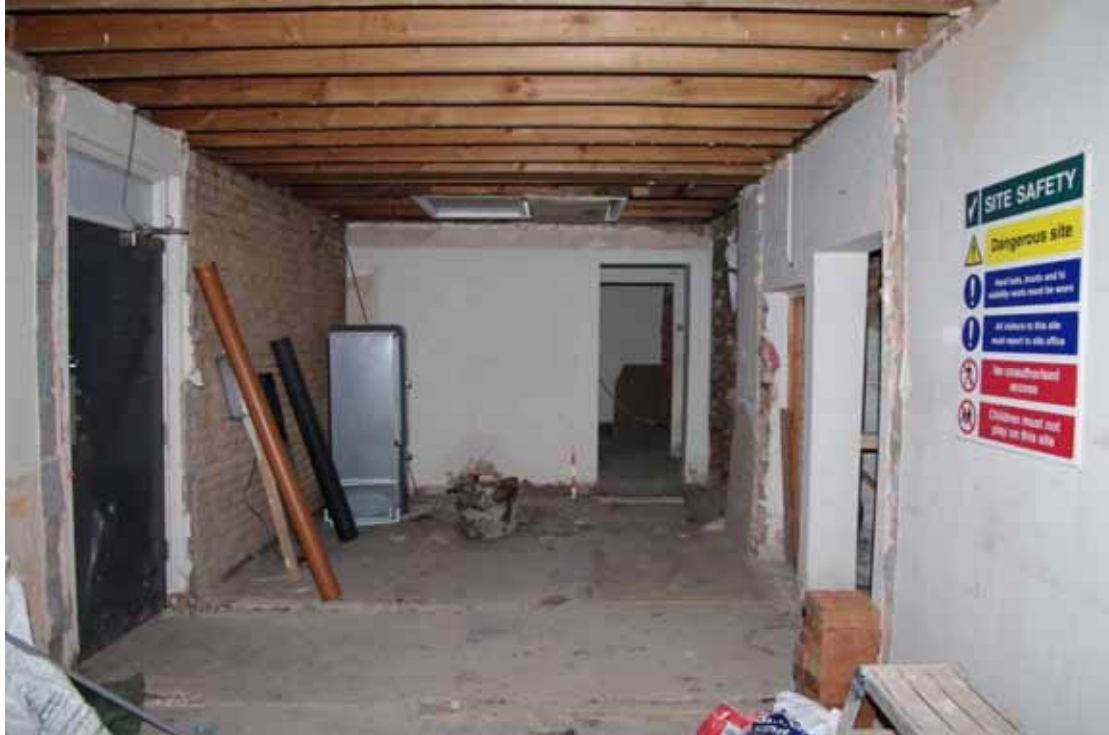
Figure 28 Ground floor rear extension behind Numbers 12 and 14
Looking south-west. This has replaced and enlarges the original rear toilet and wash
house of both buildings

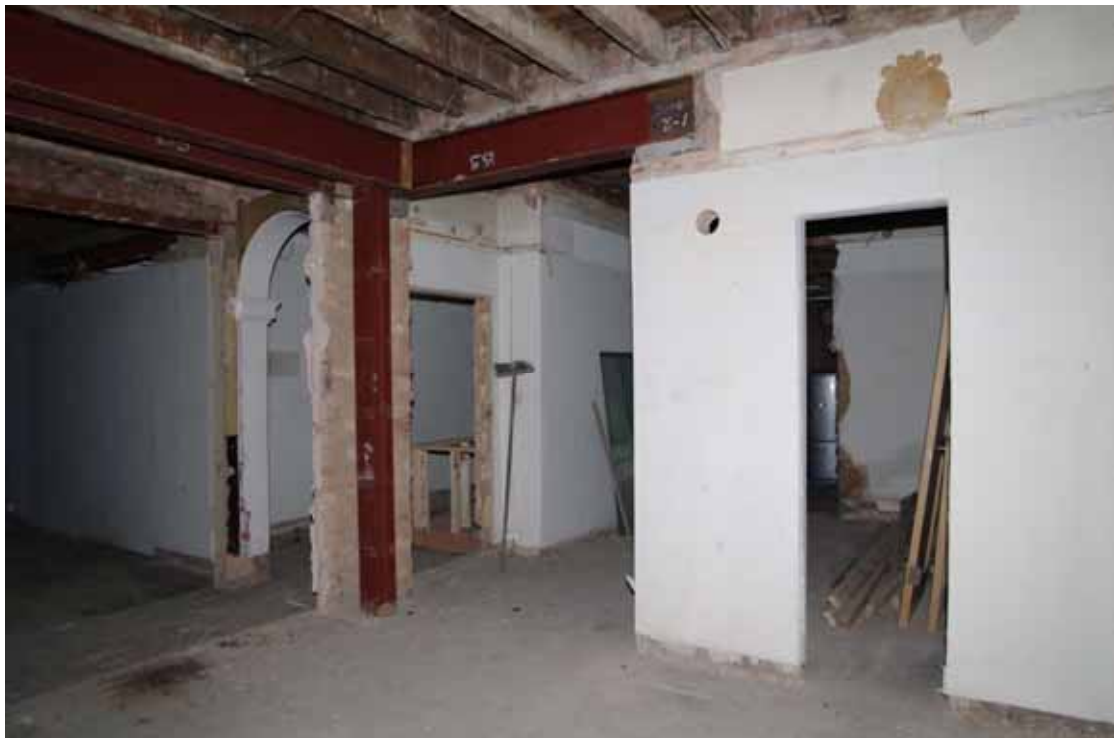
Figure 31 Number 14 ground floor front room
Looking east. Modern steelworks shows where the adjoining wall to Number 12 has been removed. Note removed plaster decoration and picture rail on right of picture

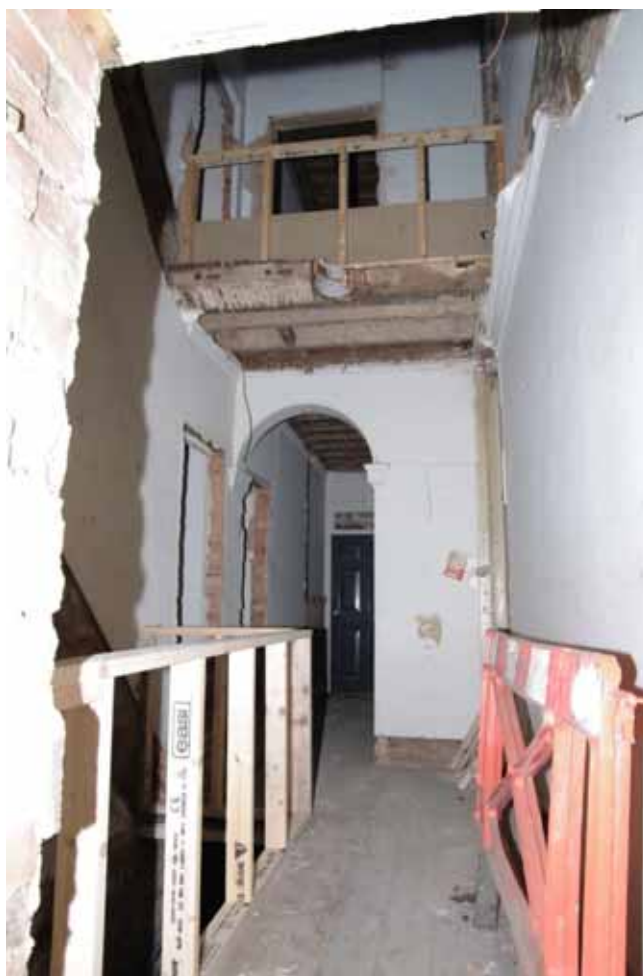
Figure 34 Number 14 hallway through to front door
Looking west. Main staircase has been removed

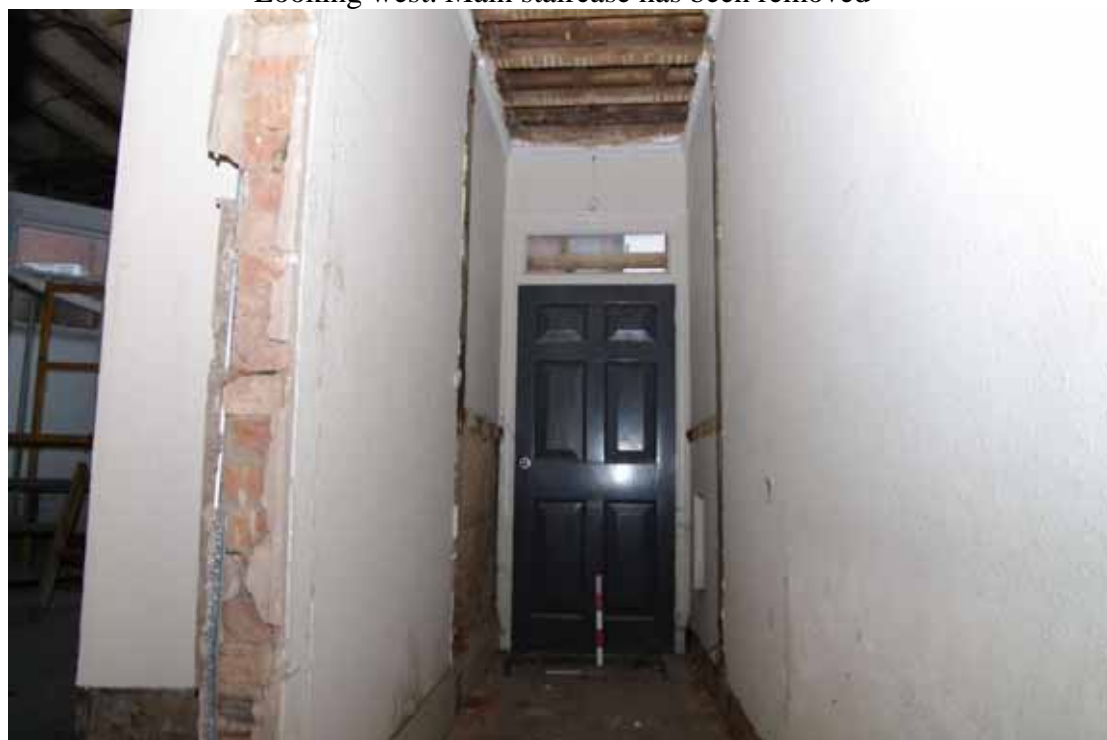
Figure 35 Number 14 front door
Looking south-east. Knocked-through doorway to Number 16 on right

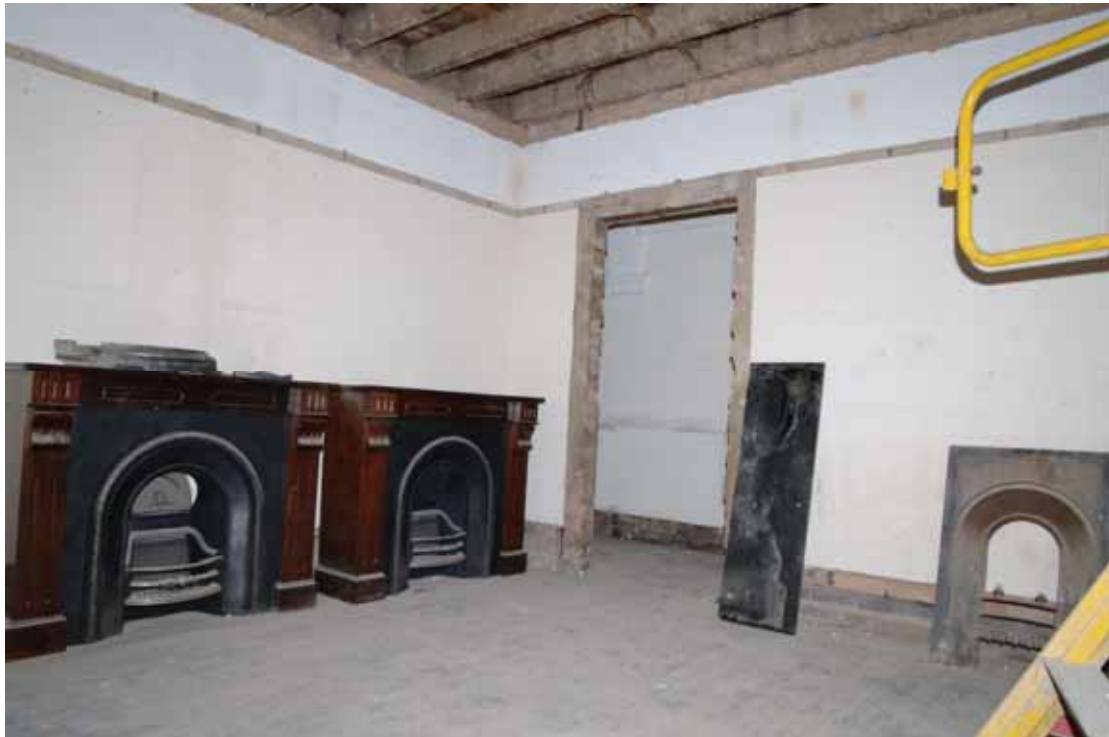
Figure 38 Number 16 front ground floor room
Looking south. Unclear where the fireplaces have come from

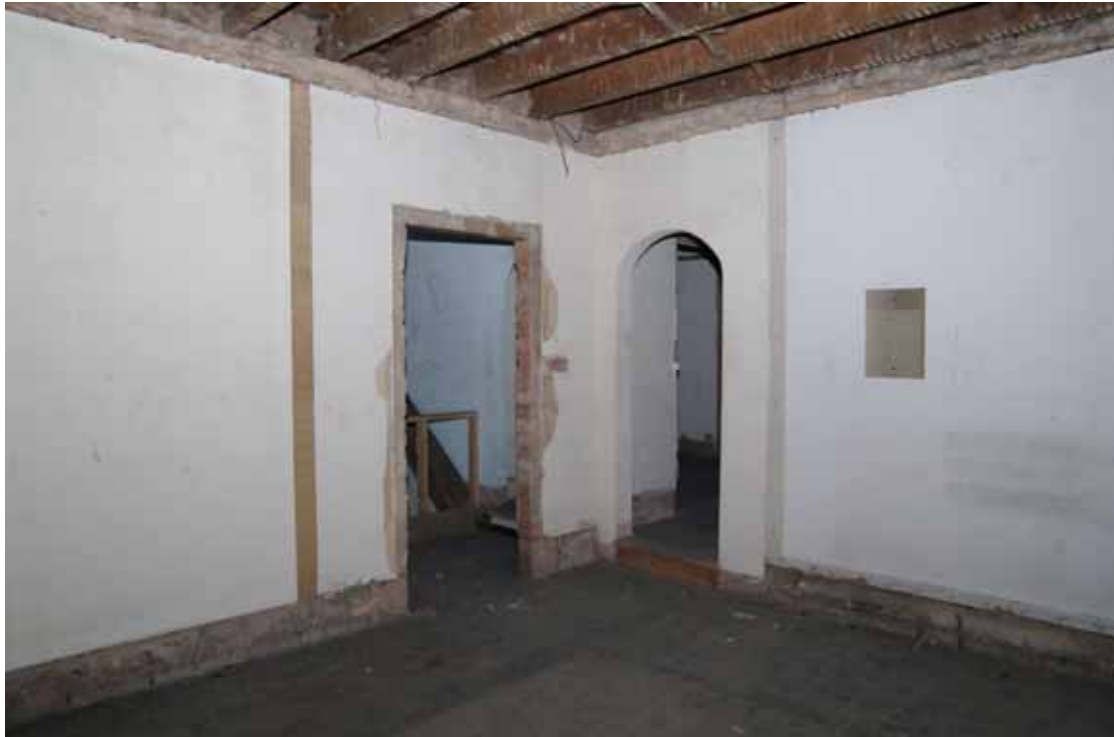
Figure 46 Number 12 first floor front room
Looking south. Round-headed door is a later insert to connect with Number 14

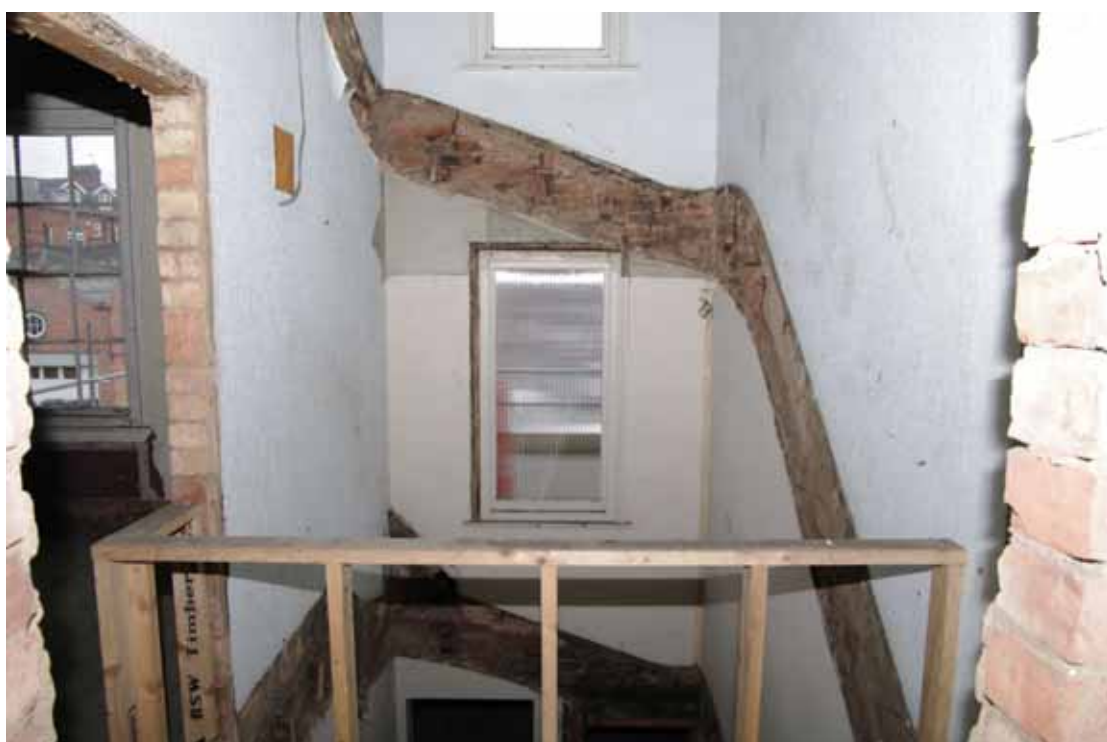
Figure 49 Number 12 removed stair case at first floor level
Looking south-east

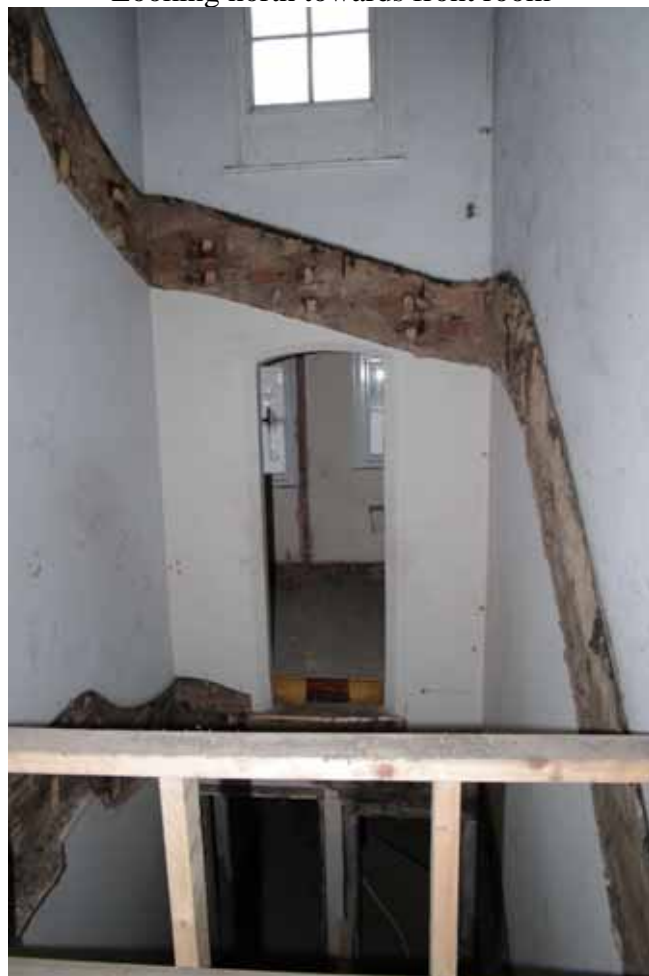
Figure 53 Number 14 removed staircase at first floor level
Looking south-east towards doorway to rear toilet block

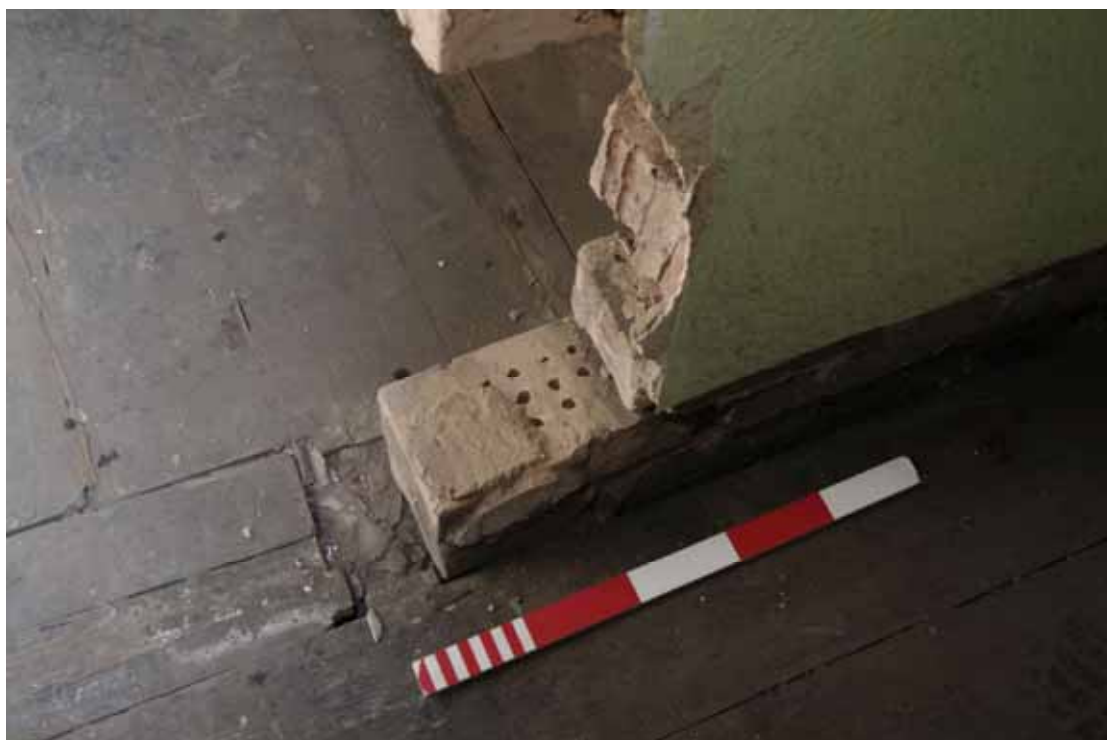
Figure 66 Number 16 second floor brick detail
This type of perforated brick appears to be used throughout the terrace
