**An Historic Building Photographic
Survey at the former
Rose and Crown Public House,
Leicester Road,
Kibworth Harcourt,
Leicestershire**

ULAS Report No. 2019-080
©2019

For: Staniforth Architects Ltd

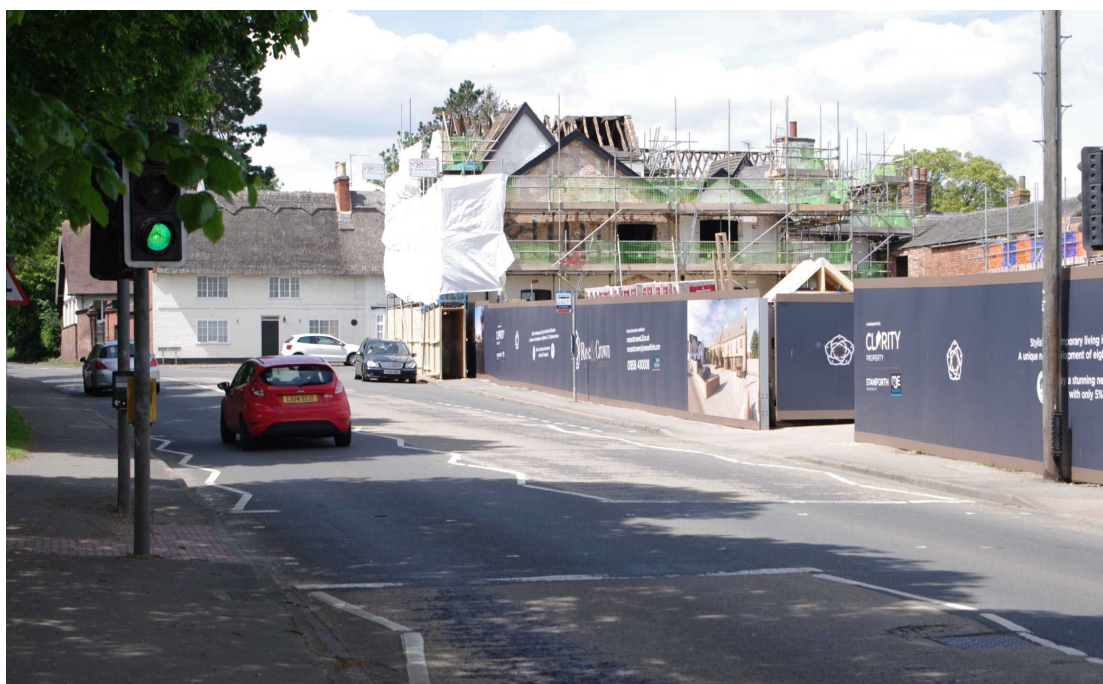
Figure 6 Site seen from Leicester Road
Looking north-east

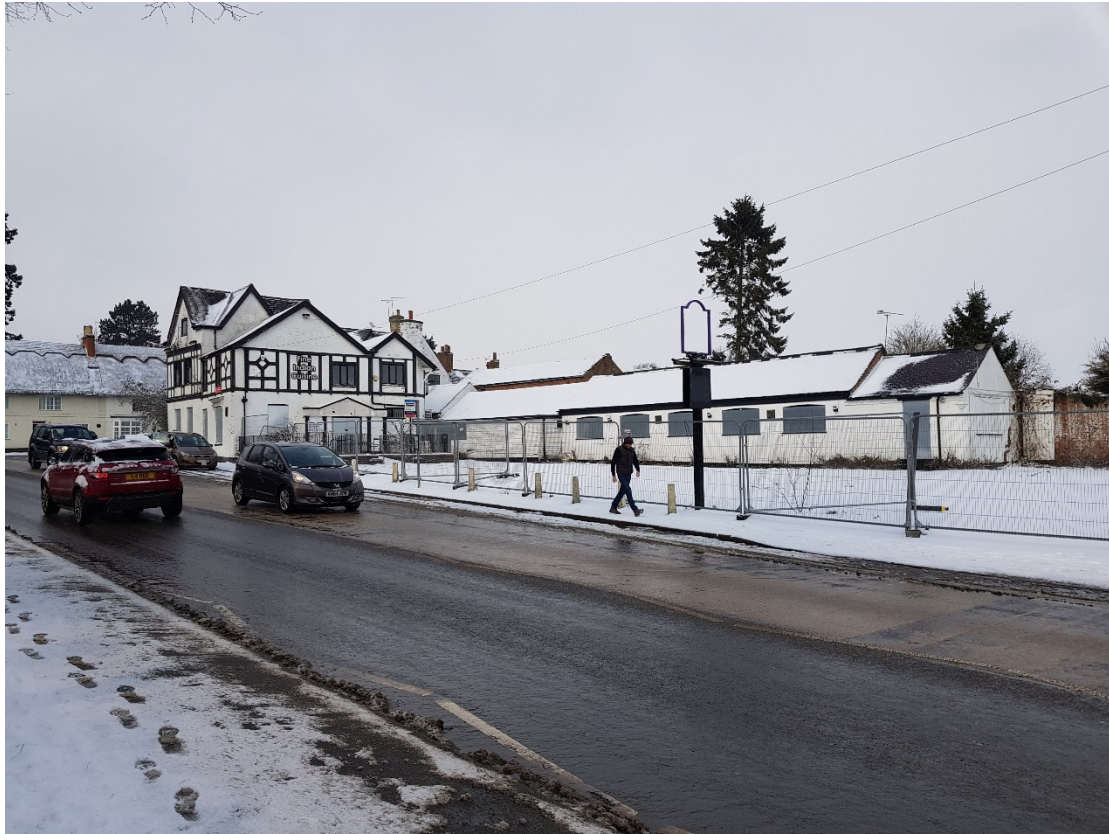
Figure 7 Site from Leicester Road
Picture taken February 2018. Note now-demolished stables on right

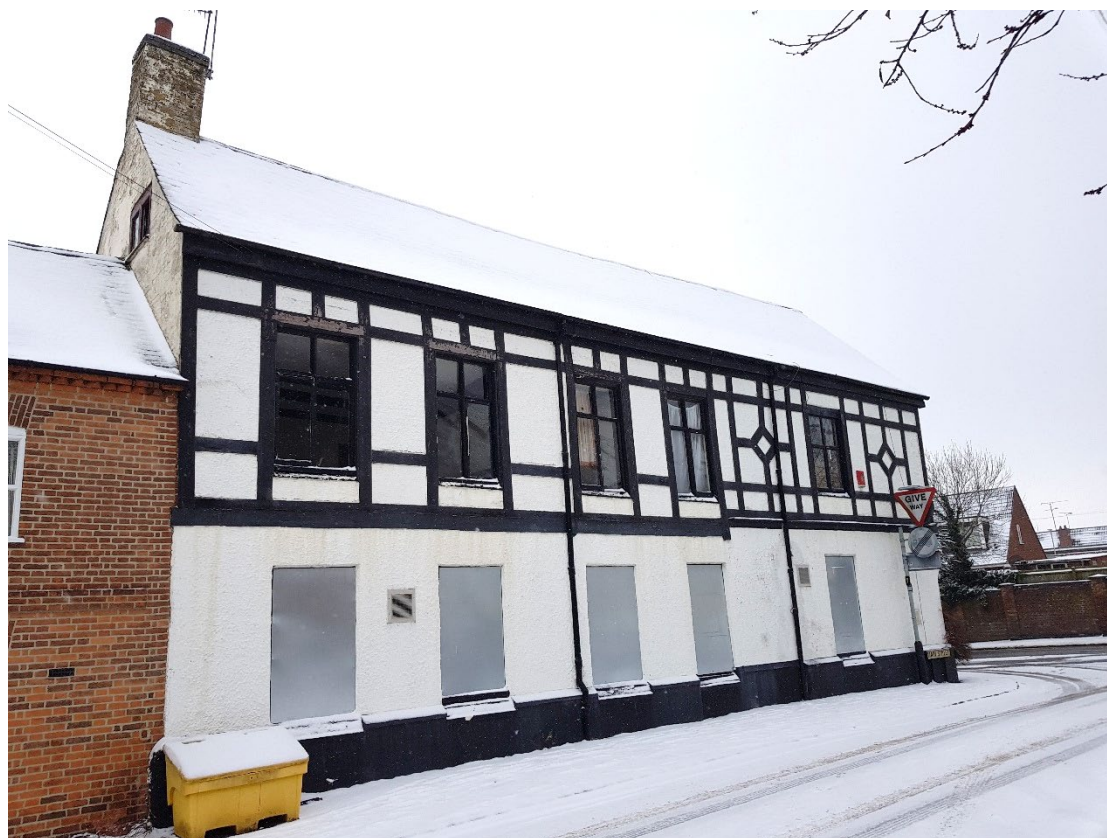
Figure 13 West facing elevation onto Main Street
Looking south-east. Picture taken February 2018

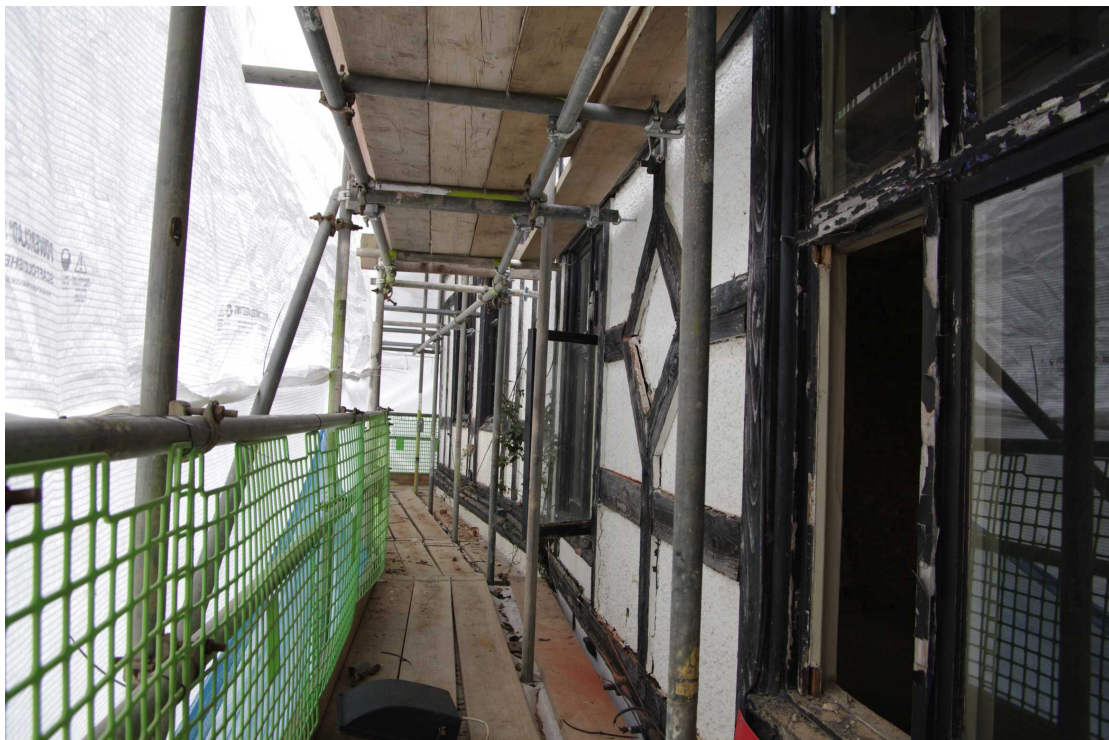
Figure 15 South facing elevation at first floor level
Looking west. Note kink in building line. "Tudor" timbers are nailed into the wall

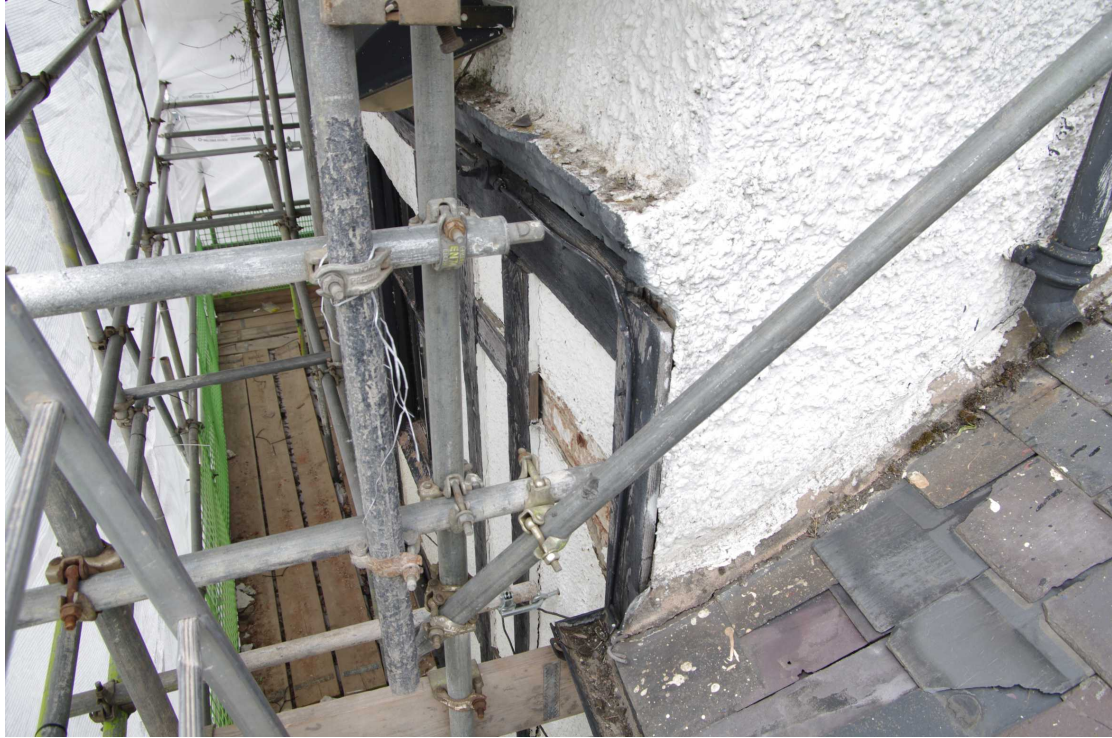
Figure 16 South facing elevation at first floor level
Looking north-west. Note moulded brick string course above window

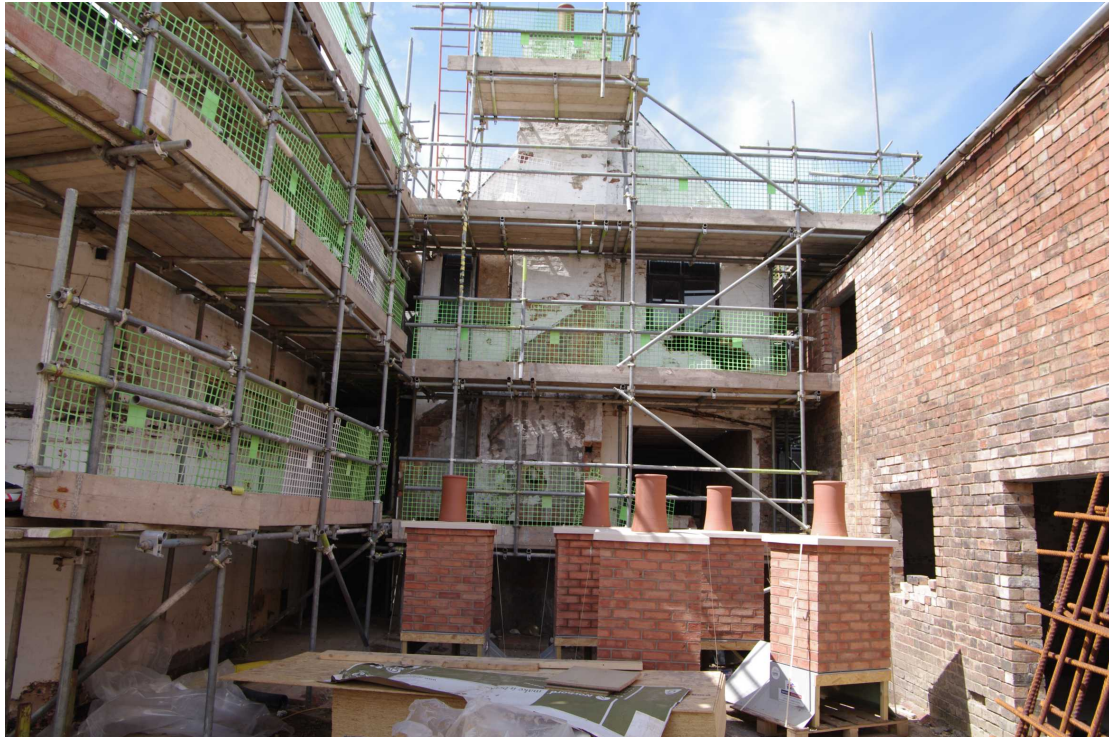
Figure 18 East facing elevation of rear northern range
Looking west. Note scar of gable from demolished stable buildings

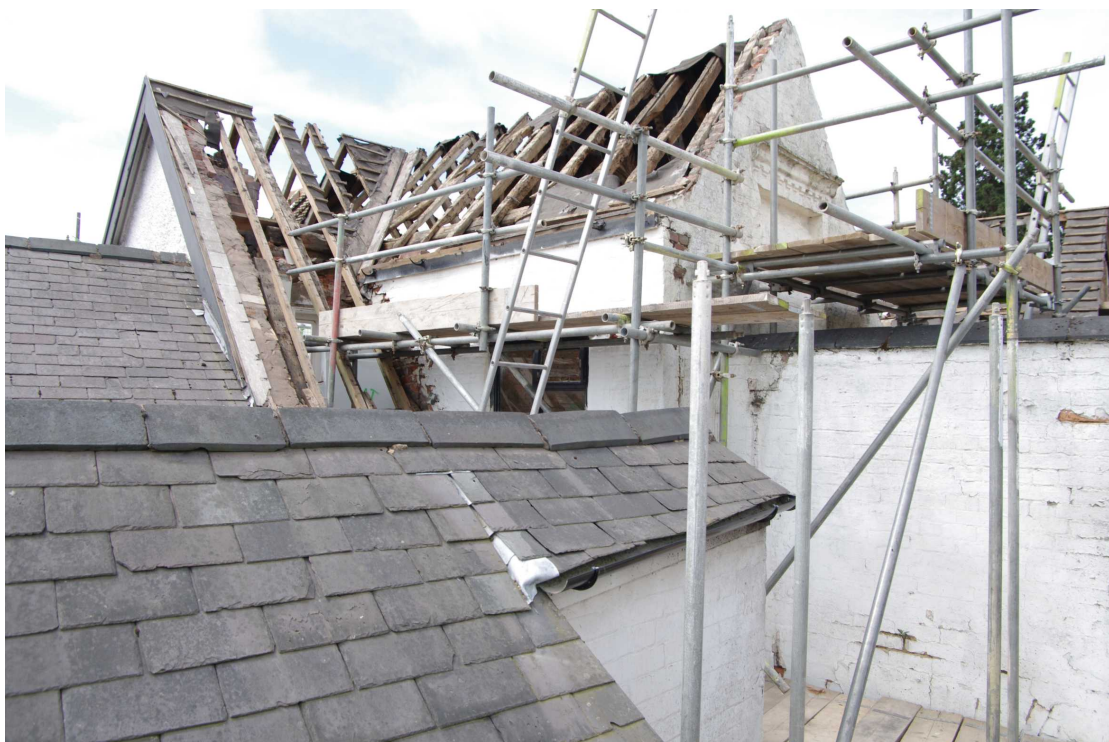
Figure 19 Roofscape of gabled southern extension
Looking south-west. Note drip-mould around redundant window in gable

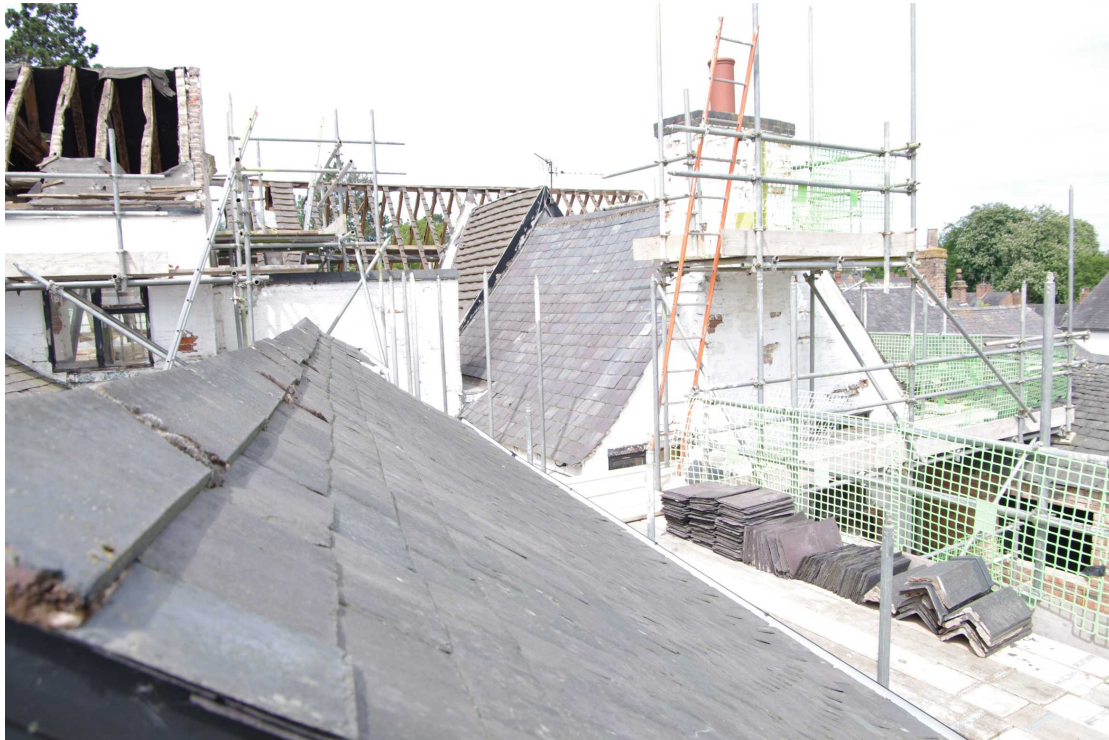
Figure 20 Roofscape of rear northern range
Looking north-west. The range consists of two phases with different height gable ends

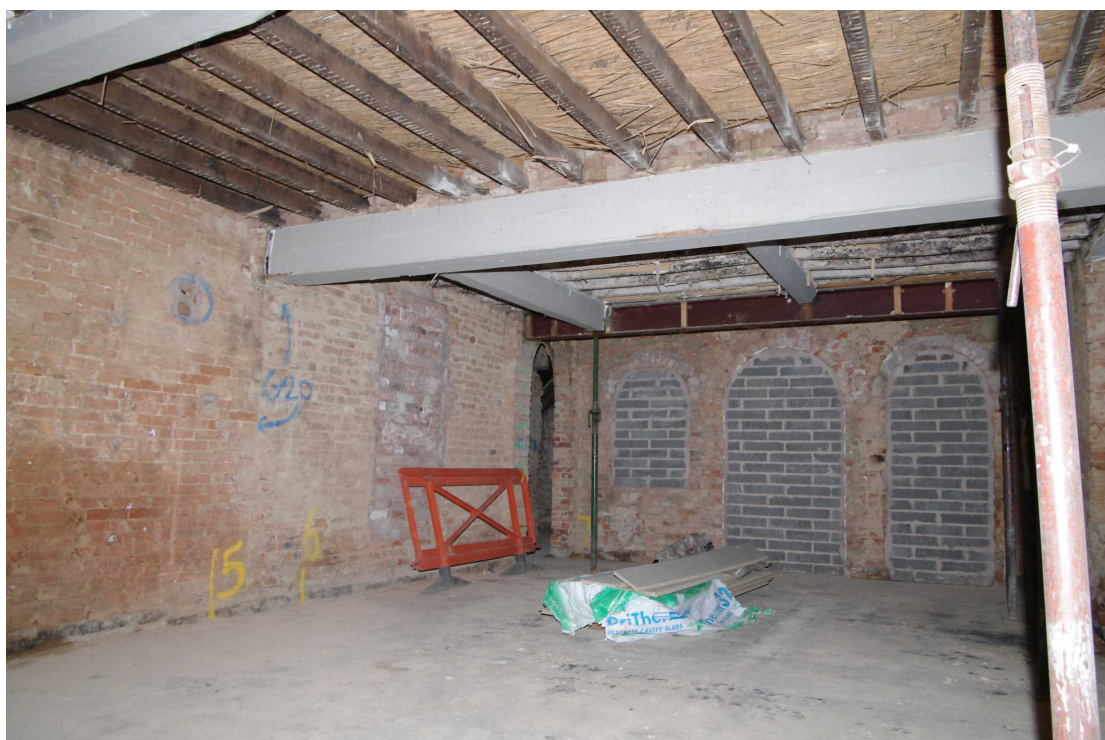
Figure 23 Northern room (1) of Main Street range
Looking south-east. Chamfered beam on left, beaded beam on right

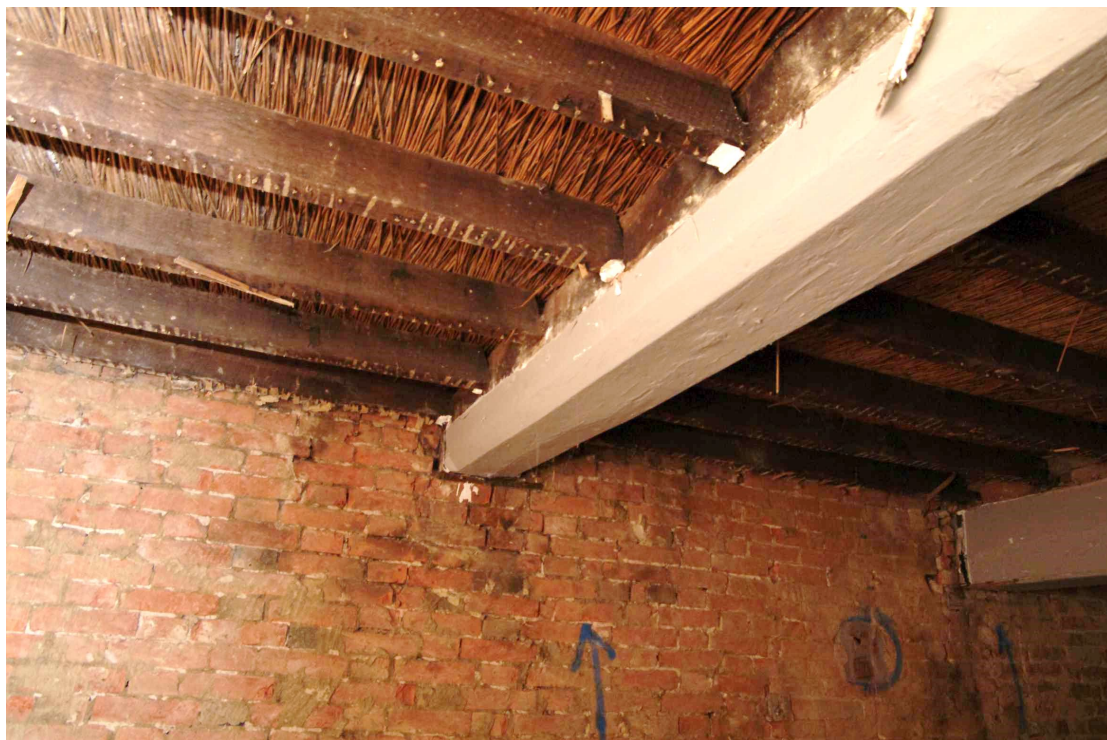
Figure 24 Stop-chamfered beam in Room 1
Looking north-east

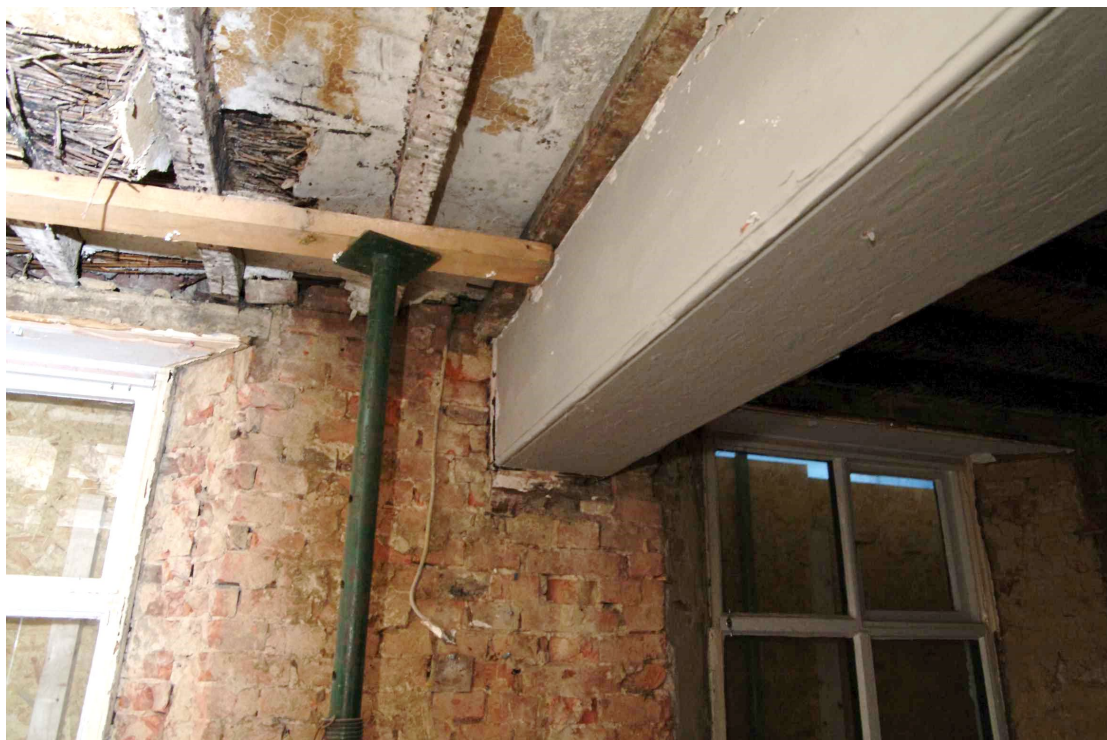
Figure 25 Beaded beam in Room 1
Looking west

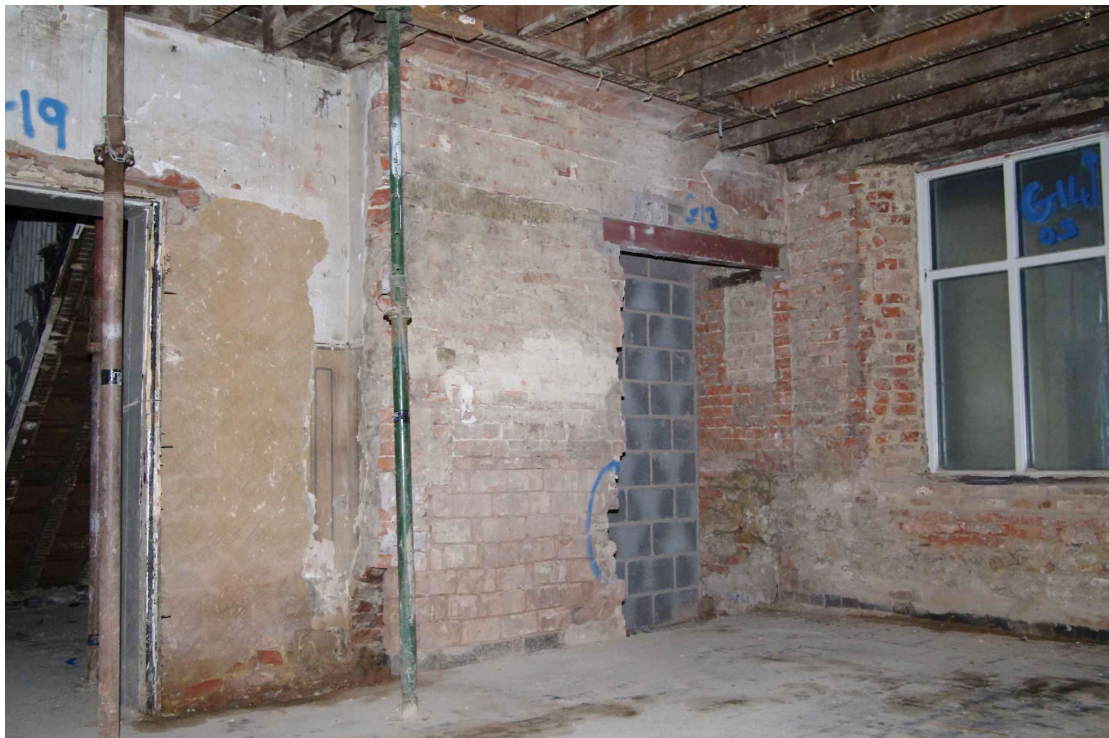
Figure 27 Southern room (2) of Main Street range
Looking south-east. Note remnant of wallpaper with panelled effect

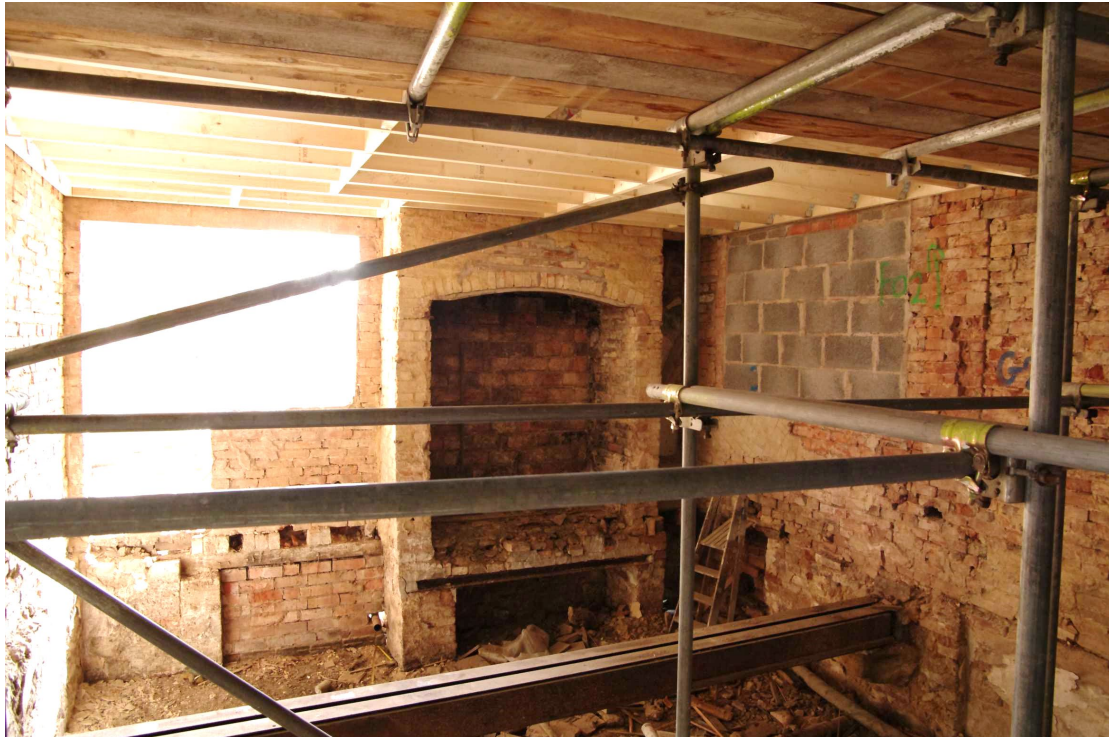
Figure 32 Room 5
Looking east. Floor level was at the top of the steel joist height

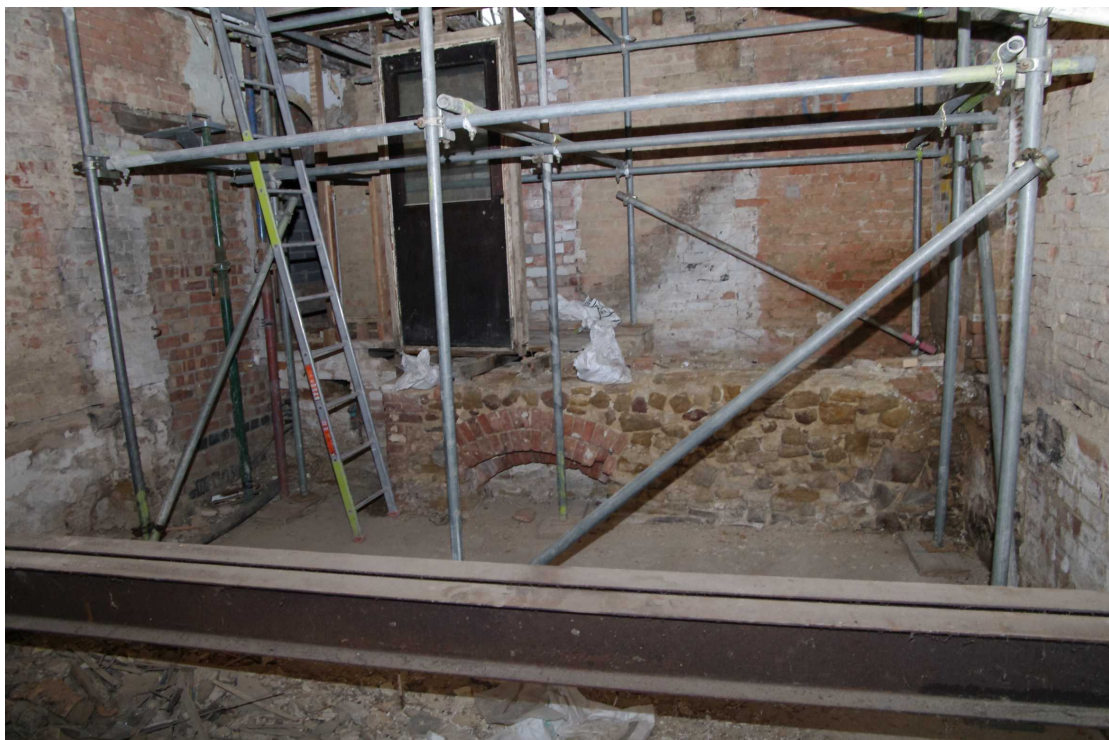
Figure 33 Room 5 base of stone wall and brick arch
Looking west. This may be part of a cellar or undercroft possibly extending as far north as Main Street

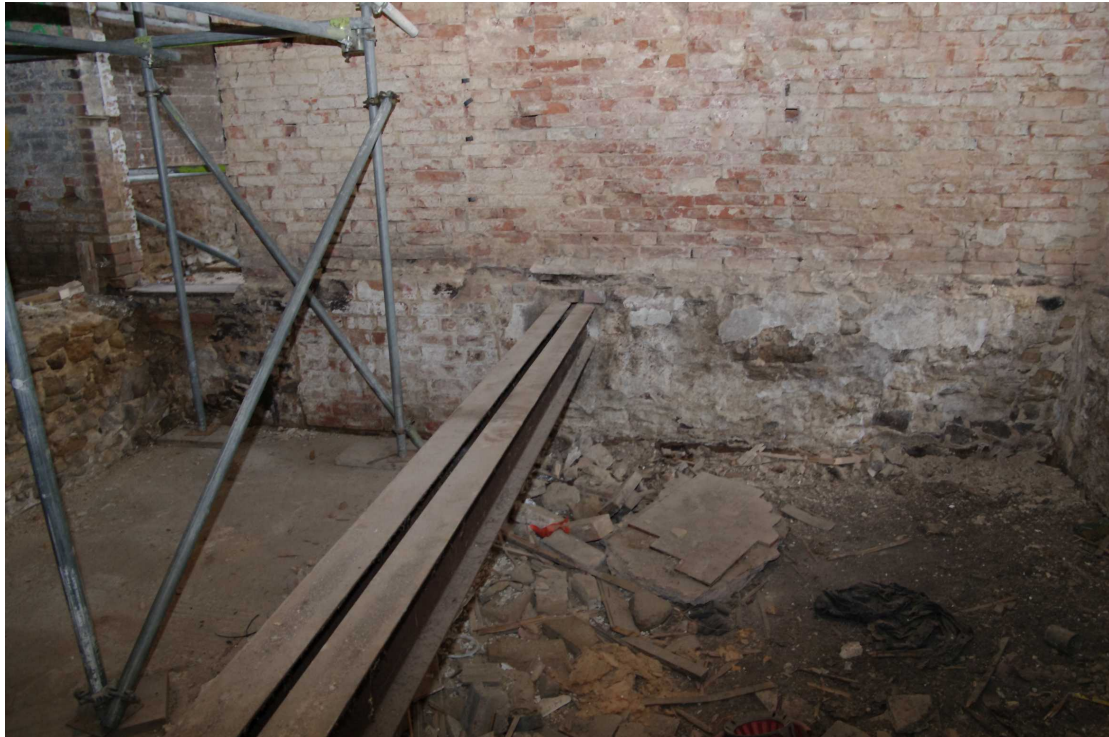
Figure 34 Room 5, fragments of stone north wall
Looking north. Stone wall seen in Fig. 33 on left

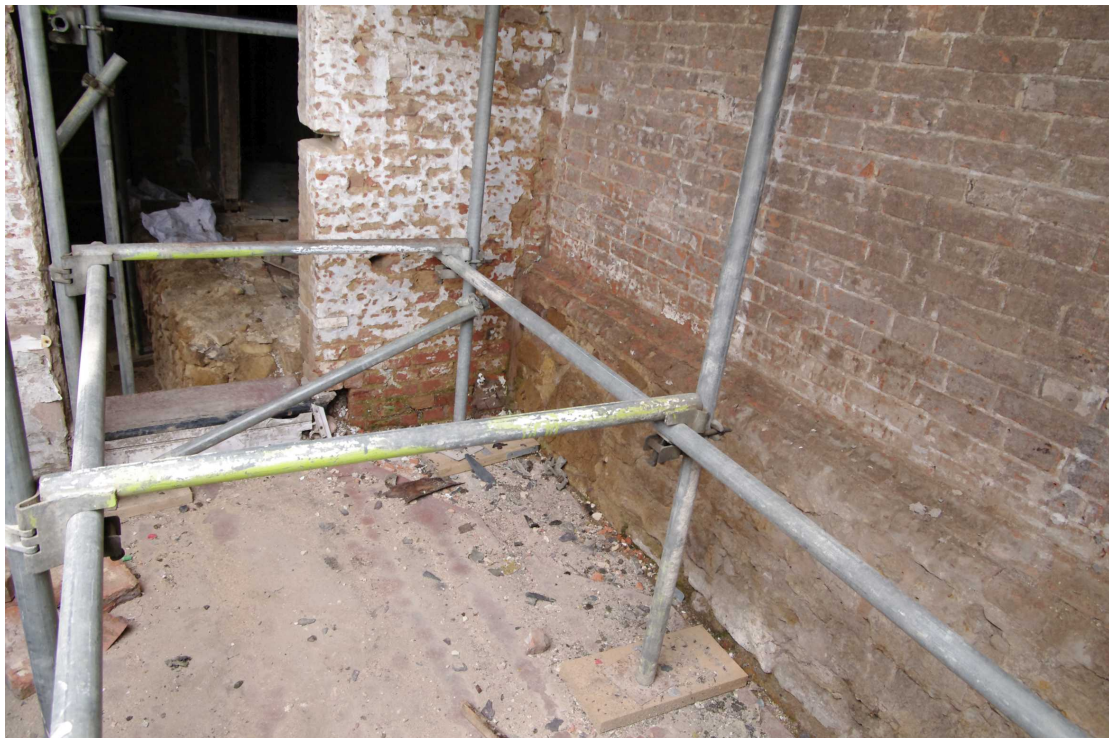
Figure 35 Outside wall of Room 5

This area was used as a pantry with a lean-to roof (see Figs 36 and 37 below). Wall with stone base on right is the rear of 1 Main Street. Wall through doorway is the wall shown in Fig. 33

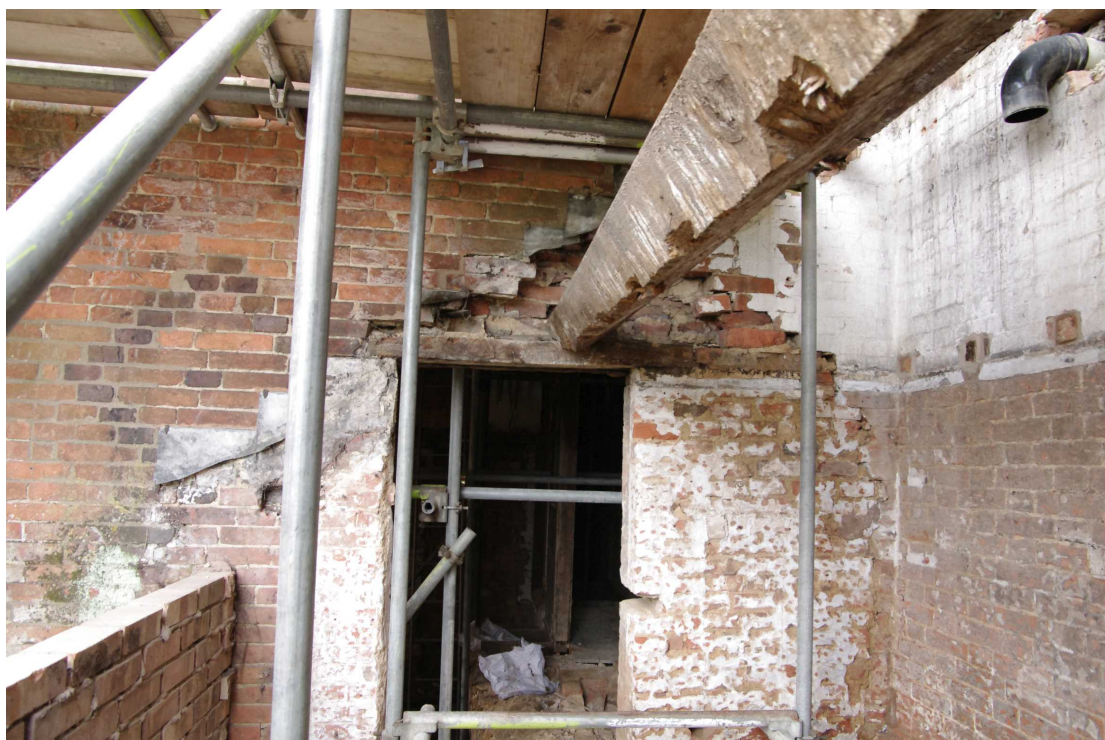
Figure 36 North wall of Room 5 from the outside in former pantry
Note diaper work to left of door

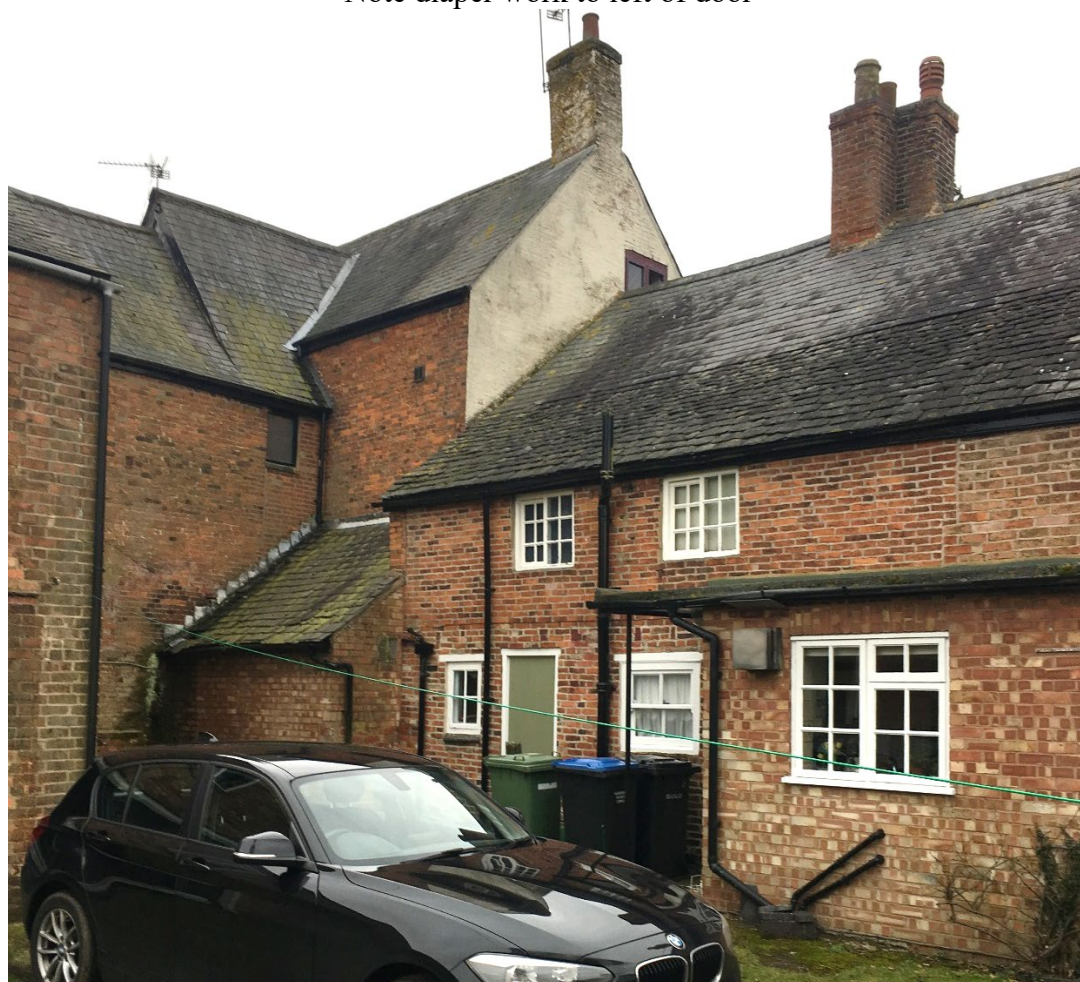
Figure 37 Diaper work and lean-to pantry before refurbishment
Photograph taken in March 2018. Diaper work is just above the car roof

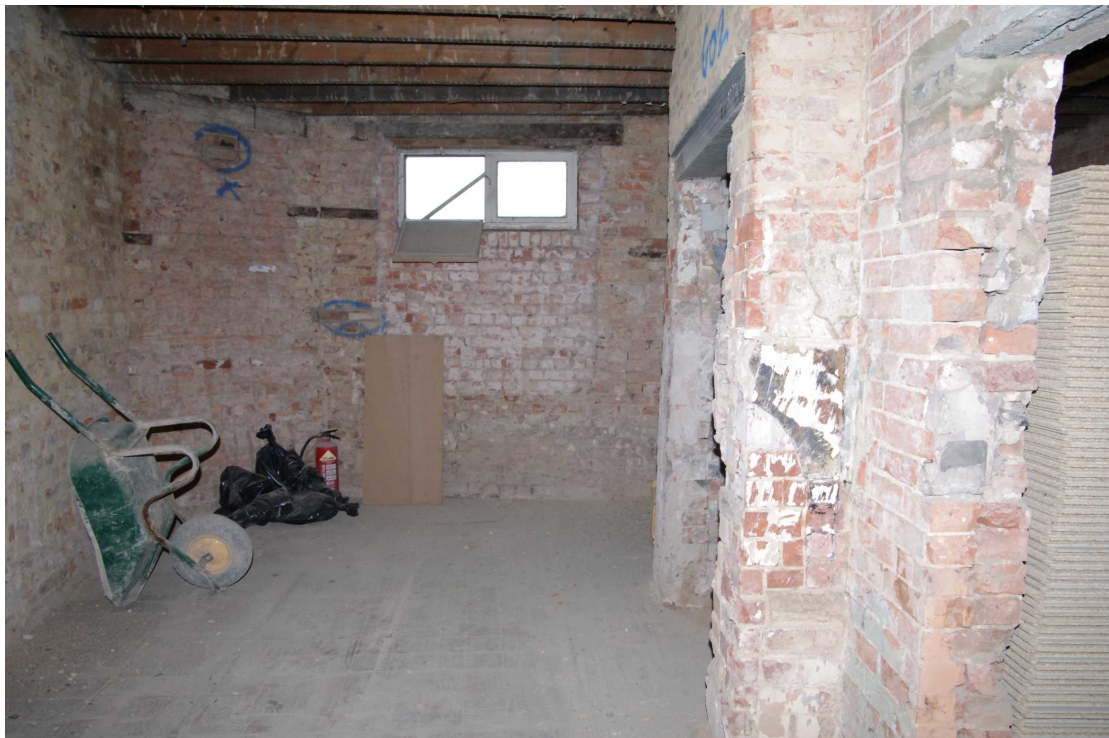
Figure 39 Ground floor Room 7
Looking north-east. Fireplace on right. Blocked doorway to right of barrow

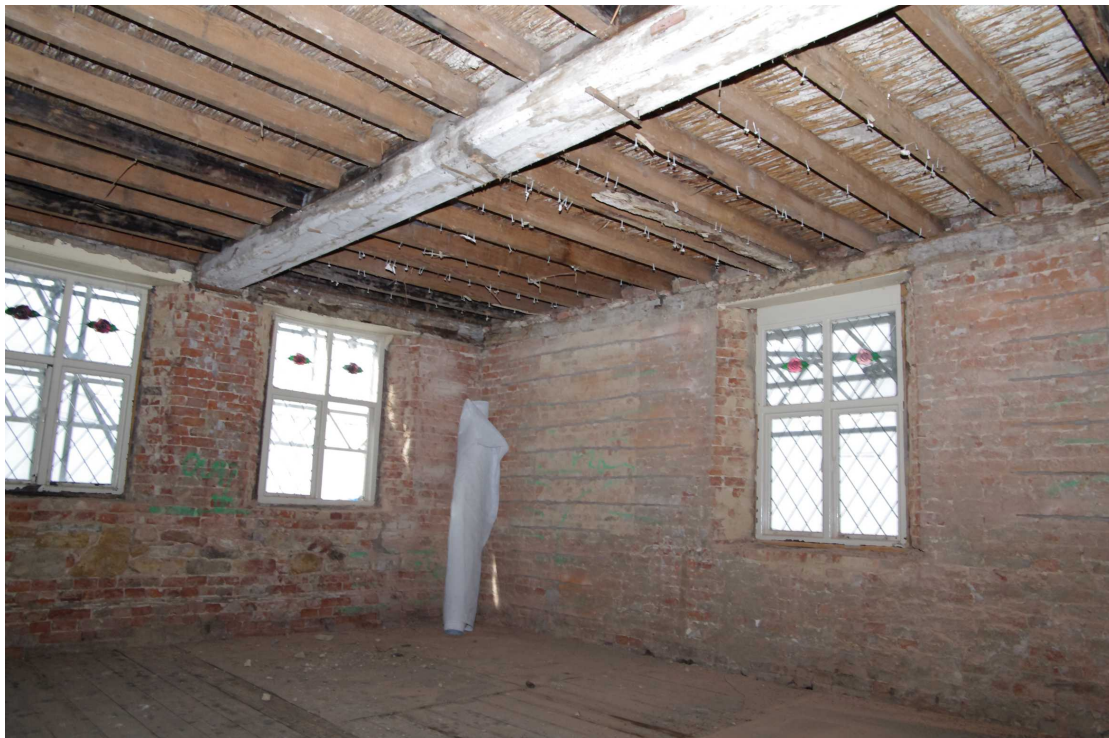
Figure 45 First floor Room 10
Looking south-west. Note blocked windows each side of window on right. These windows had been blocked by the time the illustration in Figure 5 was drawn.
Note stone patching in wall on left

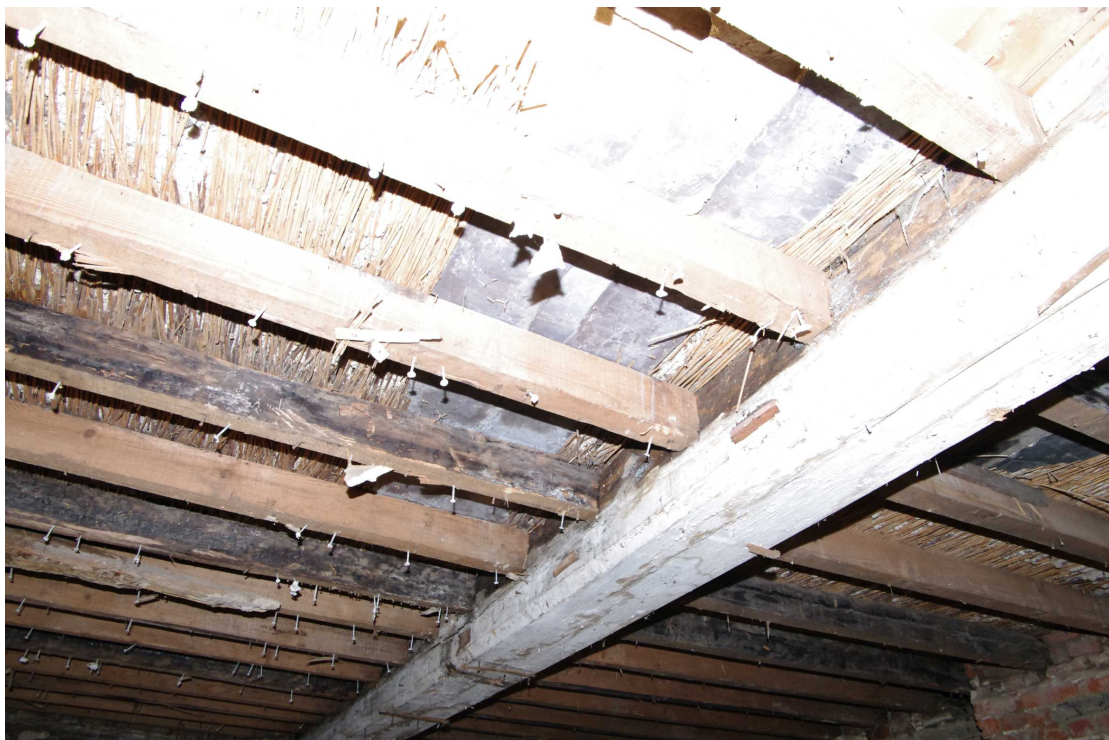
Figure 47 First floor Room 10 beam detail
Note redundant sockets

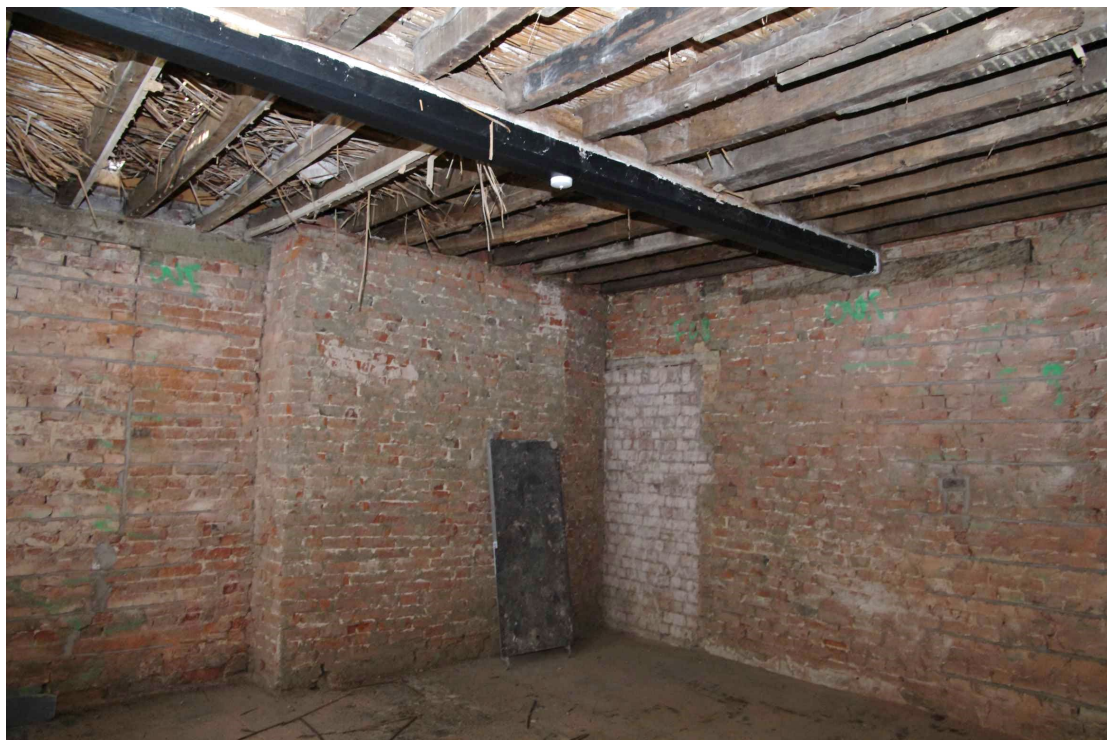
Figure 48 Room 11
Looking north-west. Note blocked window on left. The step in the centre of the picture is the south-east corner of Room 10

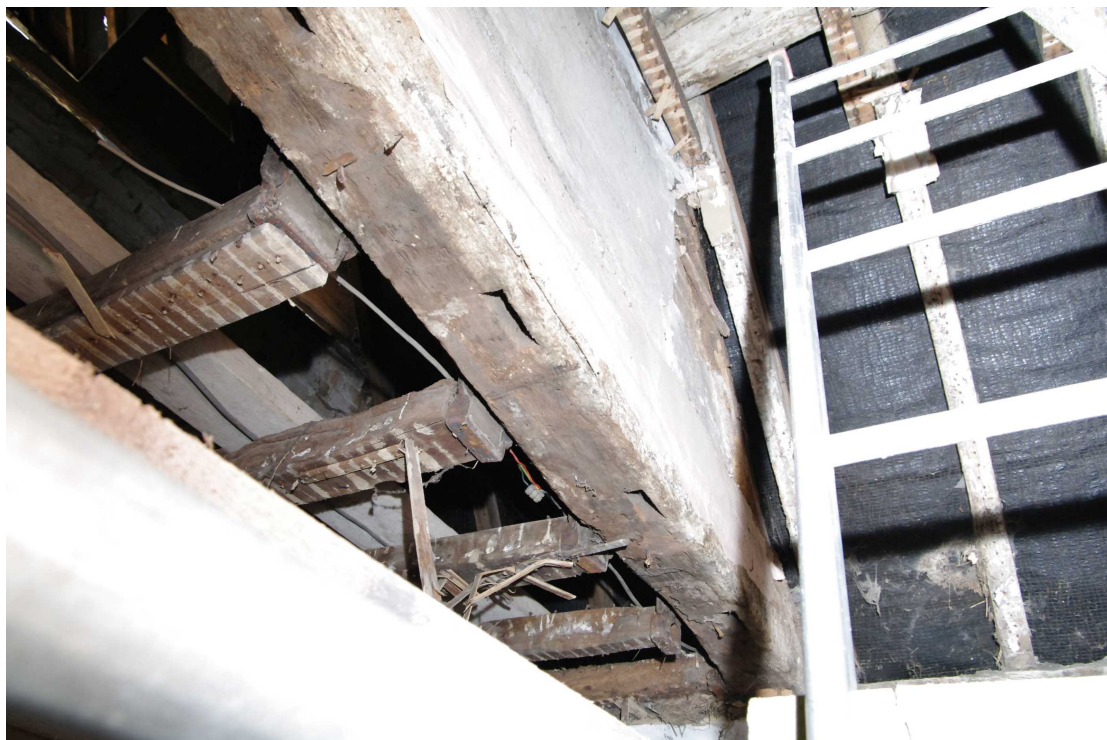
Figure 54 Room 13 underside of original gable end wall
Looking north-west. See Figure 37 for external view

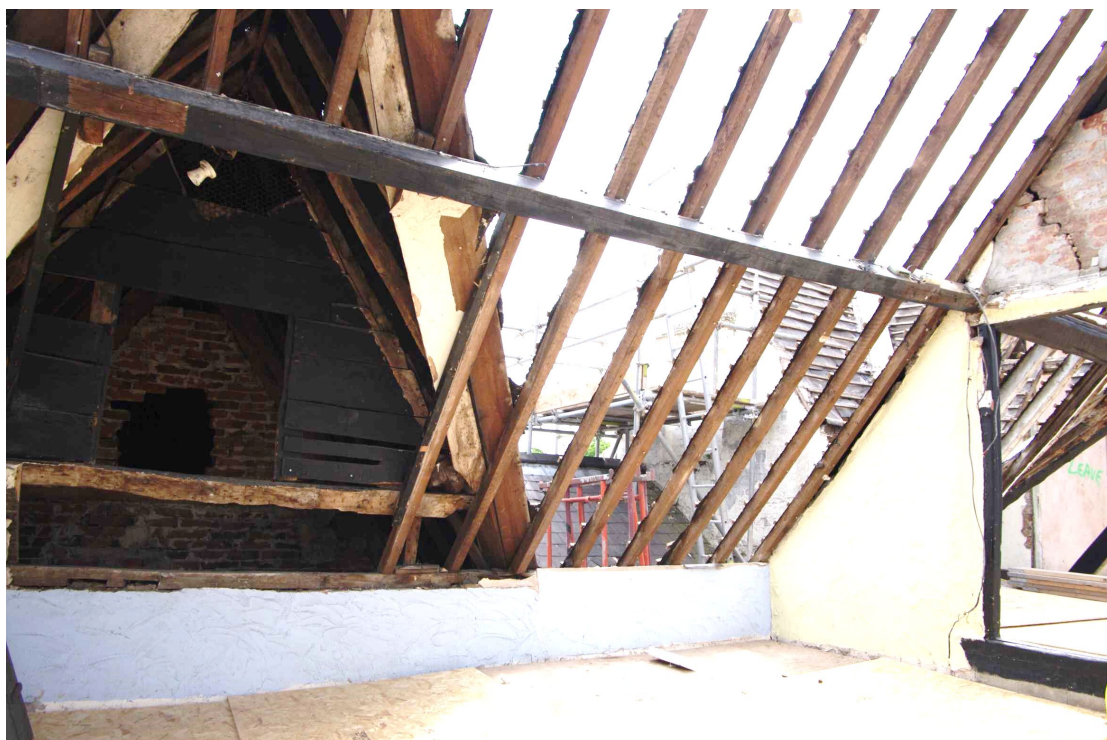
Figure 60 Room 18
Looking south-east. Room 19 on right. Note gable on left (see Figs 61 and 62)

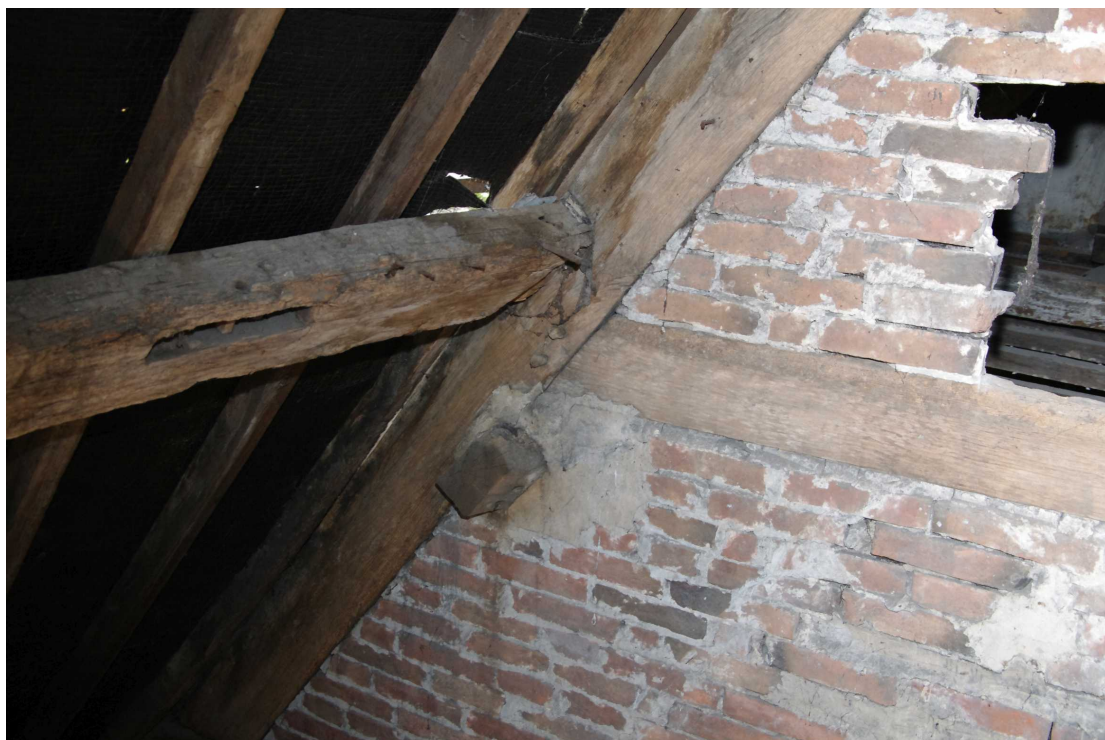
Figure 62 Pegged joints in gable seen from Room 18
Looking north-east

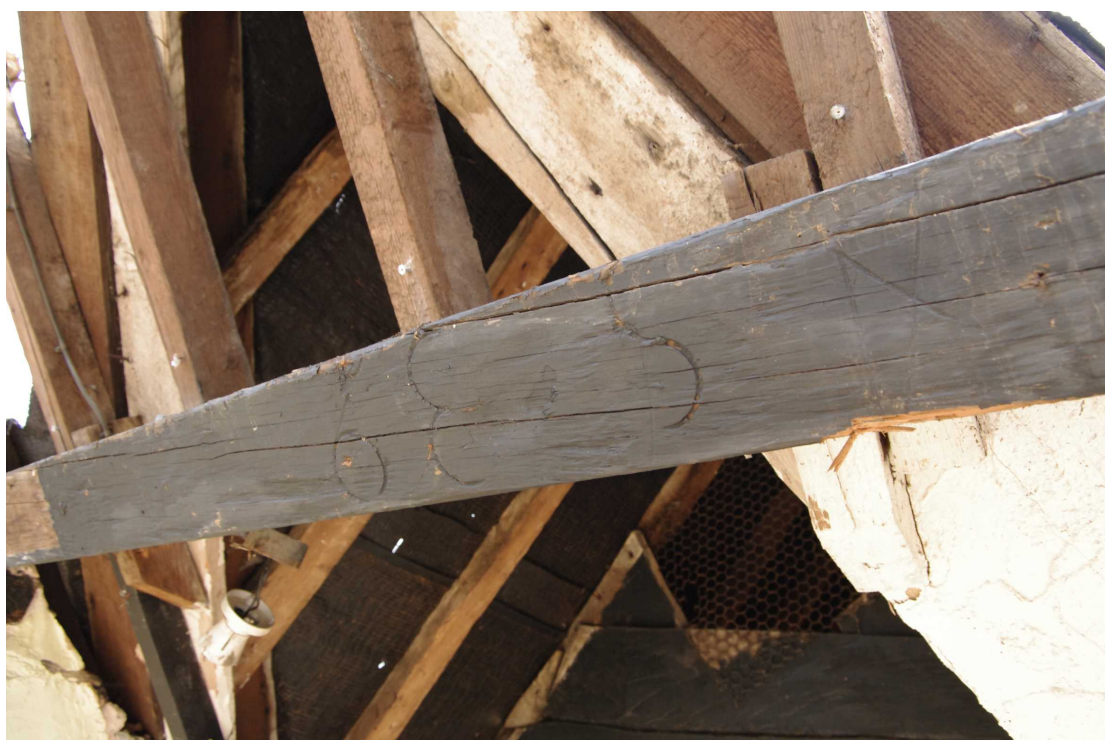
Figure 63 Room 18 marks on purlin
Looking north

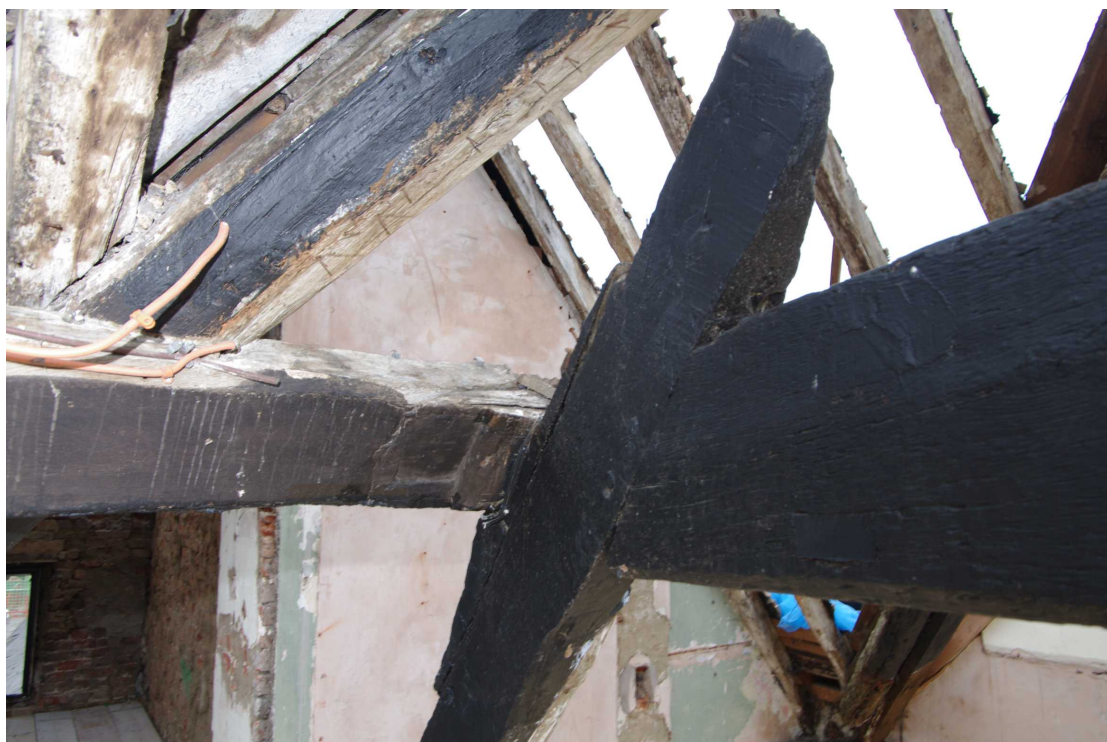
Figure 67 Room 19 joint detail of western frame
Looking south-east. Note marks on underside of principal rafter
