**An Historic Building Photographic
Survey at the former
Rose and Crown Public House,
Leicester Road,
Kibworth Harcourt,
Leicestershire**

ULAS Report No. 2019-080
©2019

For: Staniforth Architects Ltd

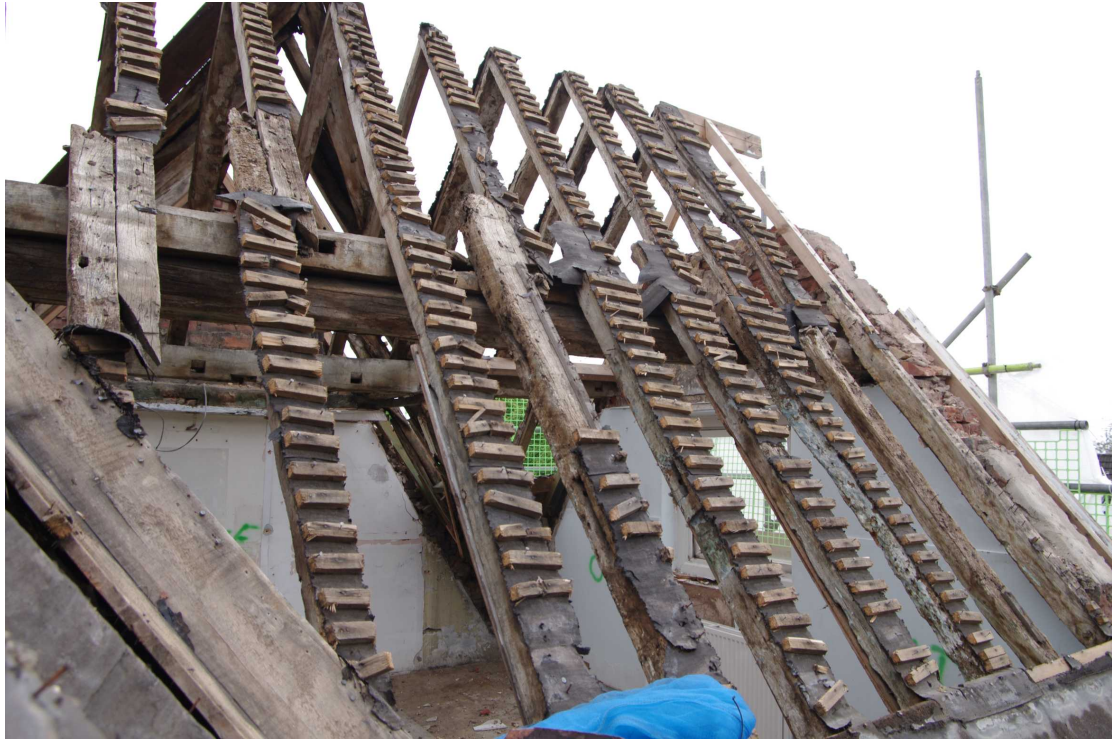
Figure 72 Outside of roof of Room 20
Looking south-east from Room 19. Note re-used timbers and patching

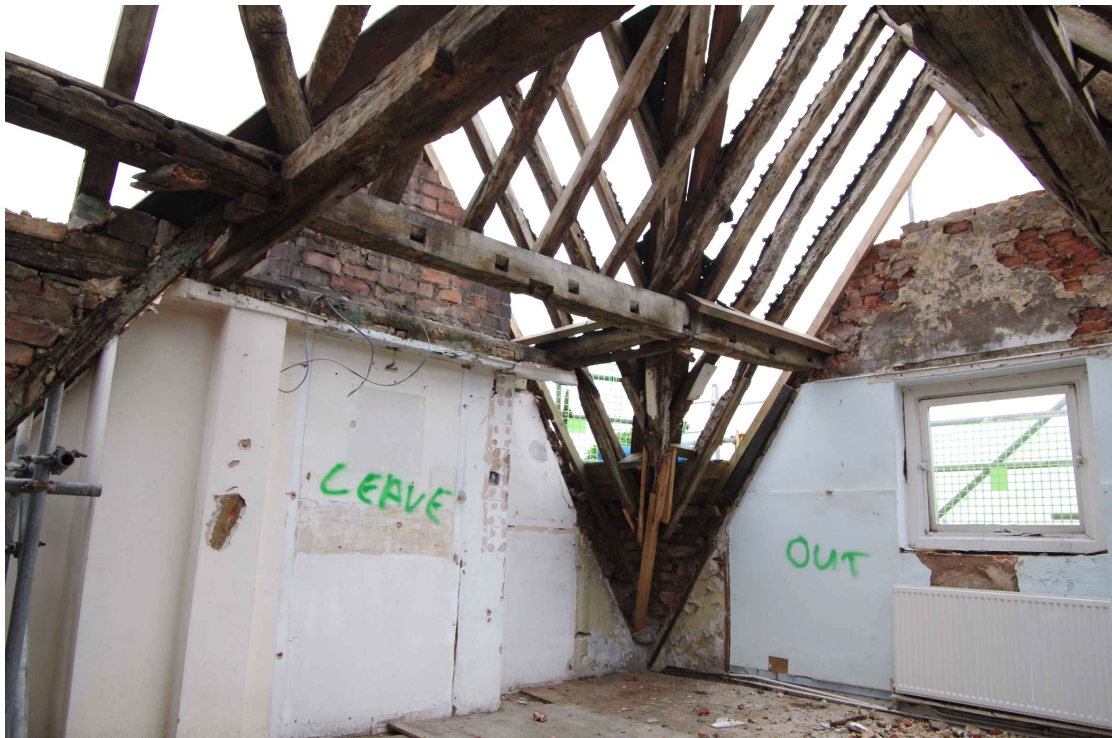
Figure 73 Room 20
Looking south-east. Lots of re-used timbers in this room
