**Free Grammar School,
Highcross Street, Leicester:
Report on Phase 2 Intrusive
Opening Up Works**

For Shires GP Ltd.

University of Leicester Archaeological Services

Report 2005/009 ©2005

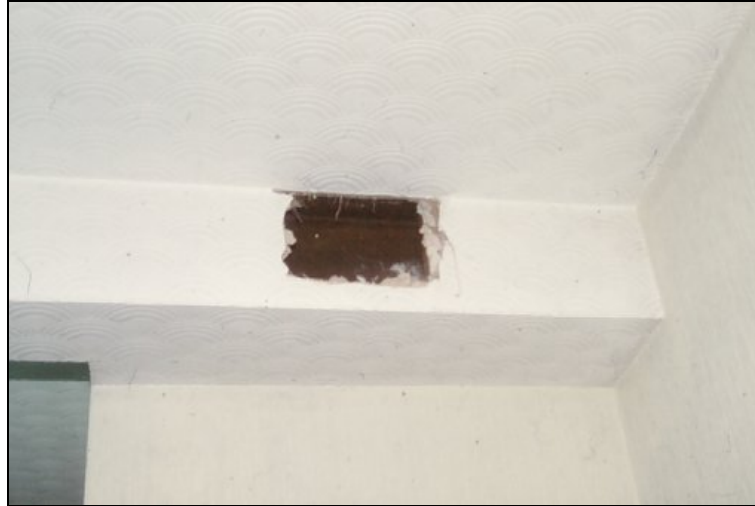
Plate 1. Area A opening to investigate first floor structure

Area A (Plate 1, Figure 1)

0.3m wide x 0.2m high opening at east end, south side of boxed in feature at ground floor ceiling level. *Sequence*: plaster skim over double layer of plasterboard fixed to softwood battens wedged into side of 10 x 6 inch (c. 254 x 152 mm) steel I-beam. No evidence of fabric predating c.1966.

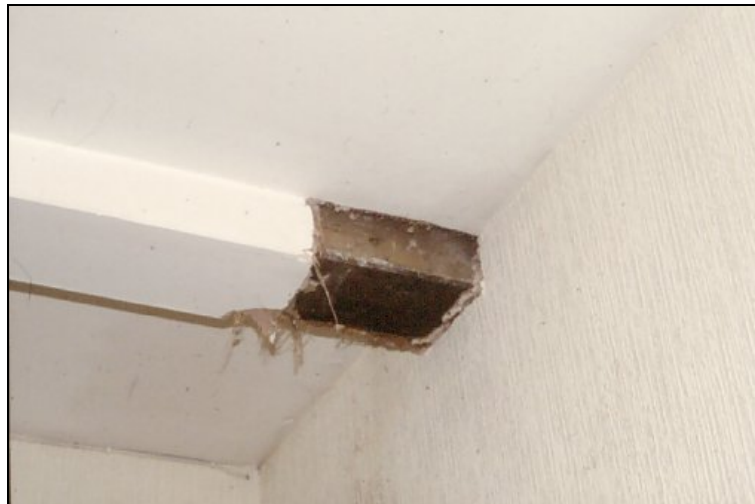
Plate 2. Area B opening to investigate first floor structure

Area B (Plate 2, Figure 1)

0.25m x 0.1m opening at west end, underside/north side of boxed in feature at ground floor ceiling level. *Sequence*: plaster skim over single layer of plasterboard on underside of 10 x 6 inch (c. 254 x 152 mm) steel I-beam; and plaster skim over double layer of plasterboard fixed to softwood battens wedged into side of I-beam. No evidence of fabric predating c.1966.

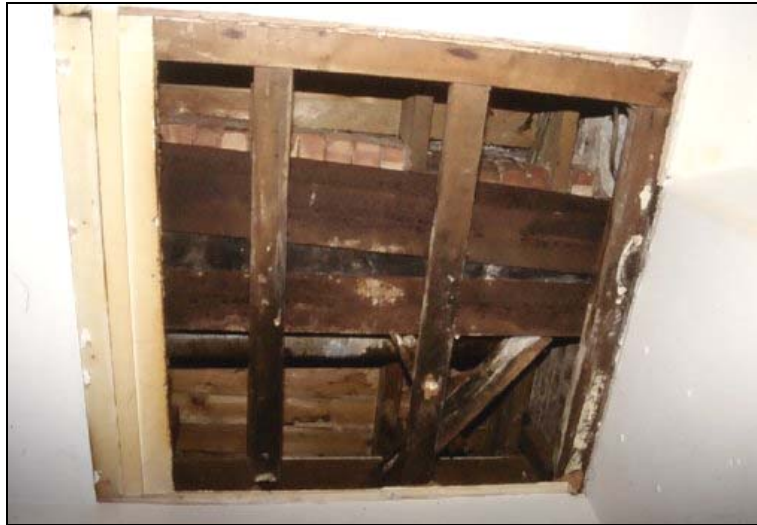
Plate 3. Area C opening to investigate first floor structure

Area C (Plate 3, Figure 1)

1.10m square opening in ceiling against west wall face. *Sequence*: plaster skim over single layer of plasterboard over fibreboard sheeting fixed with softwood battens onto 3 x 2 inch (c. 76 x 50mm)

ceiling joists running north-south at 16 inch (c. 400mm) centres. Exposing two 10 x 6 inch (c. 254 x 152 mm) steel I-beams supporting the c. 9 inch (c. 230mm) wide brick-built party wall between the two first floor flats. Note: the I-beams are not parallel, but diverge slightly to the east. A narrow gap between the beams is filled with reused Swithland slate roof tiles. No evidence of fabric predating c.1966.

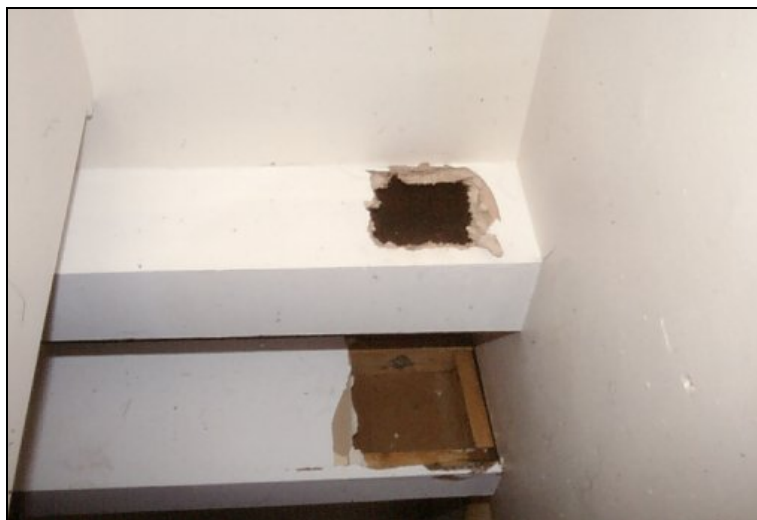
Plate 4. Area D (to rear) and E (to front) openings to investigate first floor structure

Area D (Plate 4, Figure 1)

0.35m x 0.4m opening at west end, north side of boxed in feature at ground floor ceiling level. *Sequence:* plaster skim over single thickness of plasterboard on 4 x 2 inch (c. 100 x 50mm) softwood frame. This appears to be the vestige of an earlier stud partition wall, the line of which is visible as a scar on the inside face of the west wall extending down to floor level. This corresponds with the arrangement shown on the 1966 proposed drawings e.g. Leicester Building Register plan B12738, dated 10.8.1966 (see Figure 25 of Historic Building Assessment ULAS report 2004-161). No evidence of fabric predating c.1966.

Area E (Plate 4, Figure 1)

0.2m x 0.25m opening at west end, north side of boxed in feature at ground floor ceiling level. *Sequence*: plaster skim over double thickness of plasterboard on softwood battens wedged into side of 10 x 6 inch (c. 254 x 152 mm) steel I-beam. No evidence of fabric predating c.1966.

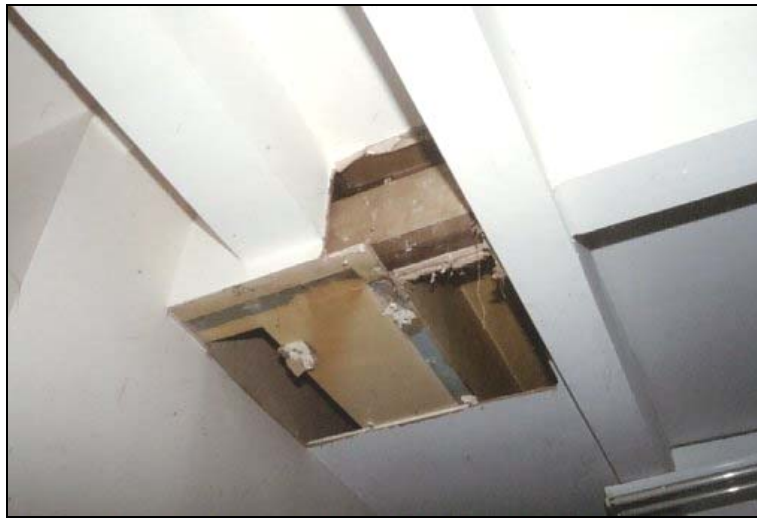
Plate 5. Area F opening to investigate first floor structure

Area F (Plate 5, Figure 1)

0.67m square opening in underside, and 0.36m x 0.3m opening in west side of boxed in feature at ground floor ceiling level. *Sequence*: ceiling - plaster skim over single layer of plasterboard, covering boxed in steel I-beam, being a further section of that exposed at Area E (above) and with equivalent covering. North-south aligned feature is a pair of 7 x 2 inch (c. 180 x 50mm) softwood timbers supported by the I-beams exposed at Areas E and C (above). No evidence of fabric predating c.1966.

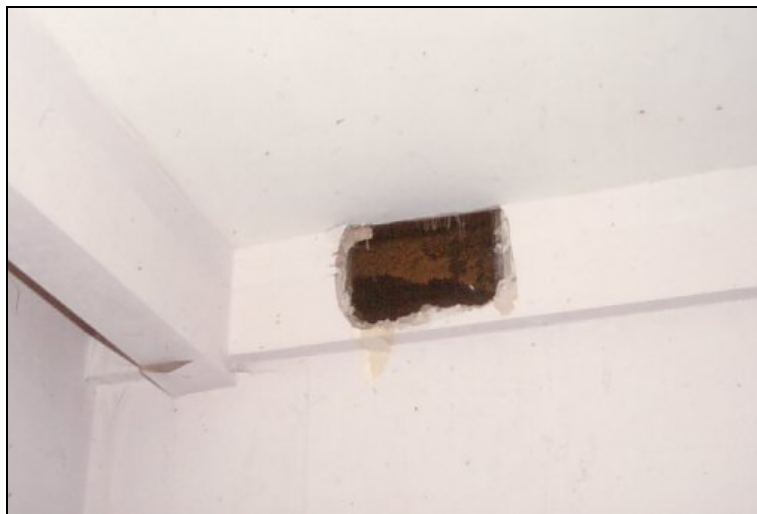
Plate 6. Area G opening to investigate first floor structure

Area G (Plate 6, Figure 1)

0.4m x 0.25m opening in south face of boxed in feature at ground floor ceiling level. *Sequence*: plaster skim over double thickness of plasterboard fixed to softwood battens wedged into south side of 10 x 6 inch (c. 254 x 152 mm) steel I-beam. No evidence of fabric predating c.1966.

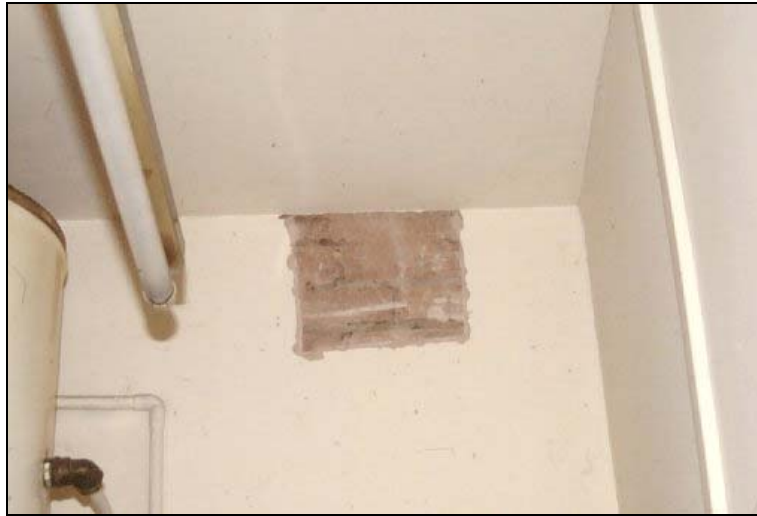
Plate 7. Area H opening to investigate first floor structure

Area H (Plate 7, Figure 1)

0.3m x 0.25m opening in south face of wall defining lobby/staircase to first floor flat at north end of building. *Sequence:* 20th century plaster over 20th century brickwork. No evidence of fabric predating c.1966.

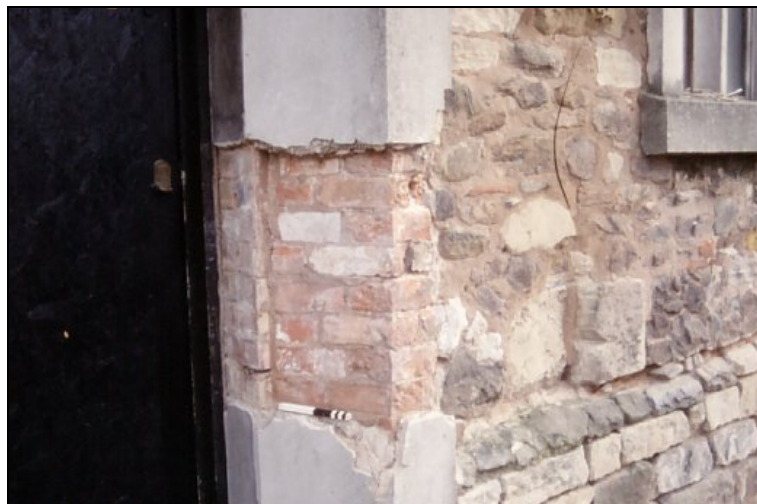
Plate 8. Area 1 opening to investigate surround of door D1

Area 1 Door D1 (Plate 8, Figures 2 & 6)

0.65m high opening in south jamb of surround to door D1. *Sequence:* 1966 concrete facing on steel mesh over earlier (?19th century) brown-coloured cementitious render applied over 19th century brick (brick dimensions: 9¼ x ? x 3 inches (235 x ? x 76mm)). The brickwork into which the doorframe is set is later, probably c.1966 (no complete brick dimensions recorded). The quality of finish of the 19th century brickwork is poor and this was apparently not intended to be seen, the brown-coloured render is assumed to be a contemporary finish.

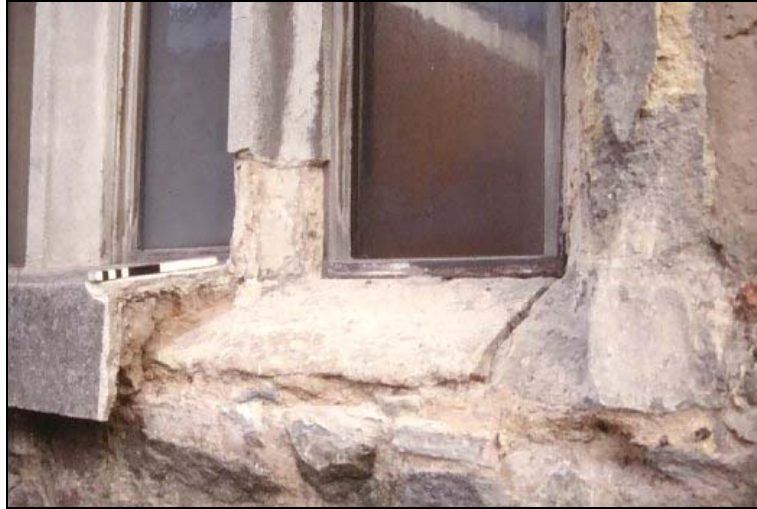
Plate 9. Area 2 opening to investigate surround of window W7

Area 2 Window W7 (Plate 9, Figures 2 & 9)

Opening at lower right corner of 3-light mullion window W7. Max length of opening: 0.75m, max height: 0.75m. *Sequence:* 1966 concrete facing over 1966 steel mesh reinforced concrete, over brown-

coloured cementitious render, this formed around a series of lengths of string/twine tied between nails driven into the mortar beds of the underlying stonework. Limestone window surround with sill, jamb and one mullion partly exposed. Jamb and mullion in oolitic limestone with the sill in a seemingly more durable shelly limestone.

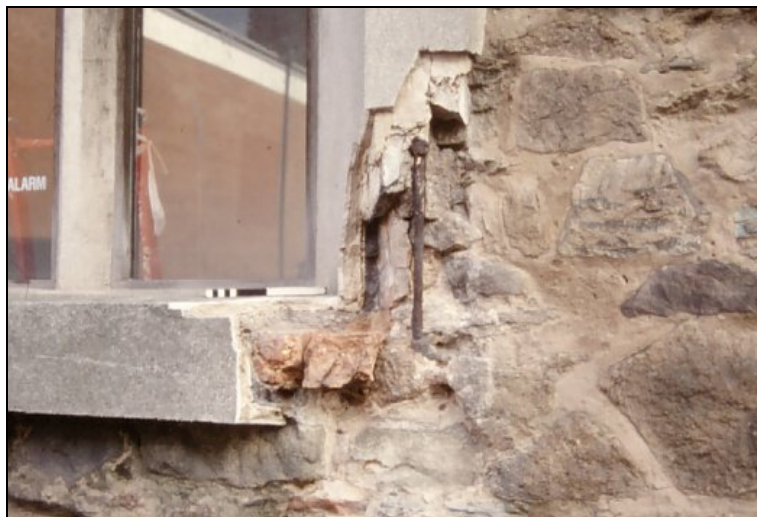
Plate 10. Area 3 opening to investigate surround of window W5

Area 3 Window W5 (Plate 10, Figures 2 & 8)

Opening at lower right corner of 2-light mullion window W5. Max length of opening: 0.35m, max height: 0.45m. Illustrative evidence indicates that this window was inserted some time between 1828 and c. 1880. *Sequence*: on sill, 1966 concrete facing over 1966 steel mesh reinforced concrete, over a coarser concrete with steel reinforcing mesh, over brick sill (brick dimensions: ? x 4½ x 3 inches (? x 114 x 76mm)). On right hand jamb, 1966 concrete facing over 1966 steel mesh reinforced concrete, over a coarser concrete formed around ½ inch diameter steel reinforcing bar, over black-coloured ash mortar render, over brown-coloured cementitious render forming splayed reveal, applied over rubble stonework of west wall.

A very hard black material applied over the brown-coloured render on the south jamb of the 2-light mullion window W5 (Area 3, Plate 10) is an ash mortar – a combination of lime and coal ash. This appears to represent a phase of repair or patching to this window surround some time prior to the application of the 1966 concrete covering.

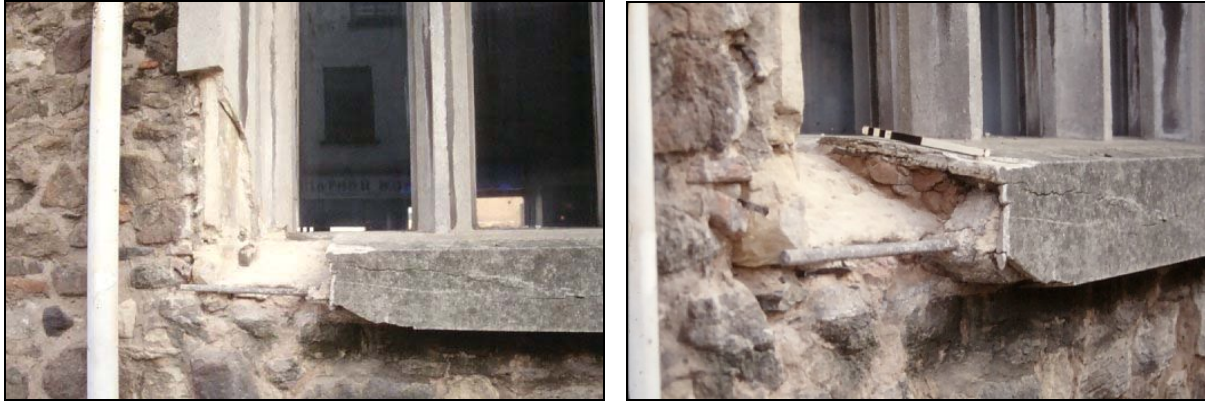
Plates 11 & 12. Two views of Area 4 opening to investigate surround of window W3

Area 4 Window W3 (Plates 11 & 12 ,Figure 1)

Opening at lower left corner of central 3-light mullion window W3. Max length of opening: 0.4m, max height: 0.65m. *Sequence*: 1966 concrete facing over 1966 steel mesh reinforced concrete, over a coarse concrete formed around ½ inch diameter steel reinforcing bar (on sill only, not jamb), over

brown-coloured cementitious render, this formed around lengths of string/twine tied between nails driven into the mortar beds of the underlying stonework. Limestone window surround with sill and jamb partly exposed, both in oolitic limestone. Fragment of timber shutter frame remains, with simple bead decoration.

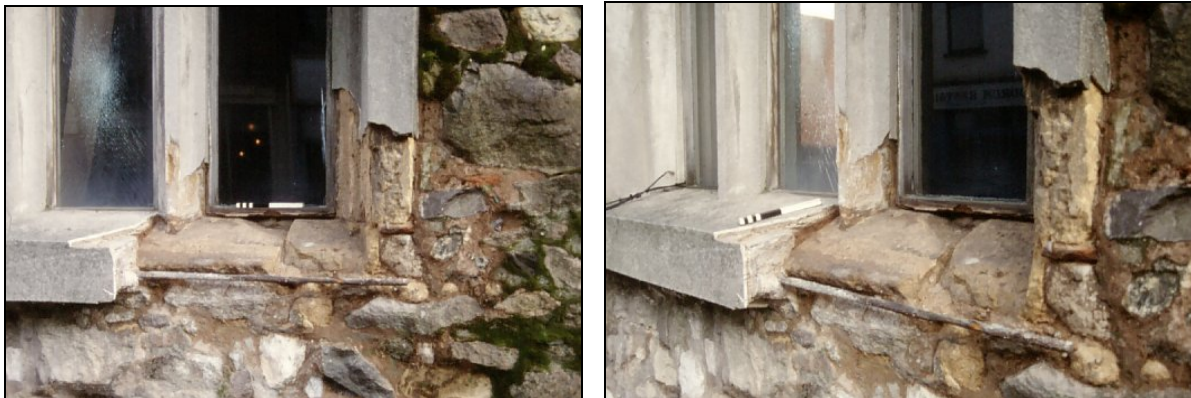
Plates 13 & 14. Two views of Area 5 opening to investigate surround of window W1

Area 5 Window W1 (Plates 13 & 14, Figure 2)

Opening at lower right corner of southernmost 3-light mullion window W1. Max length of opening: 0.75m, max height: 0.40m. *Sequence*: identical to that for Area 4 (above), including the vestige of timber shutter frame.

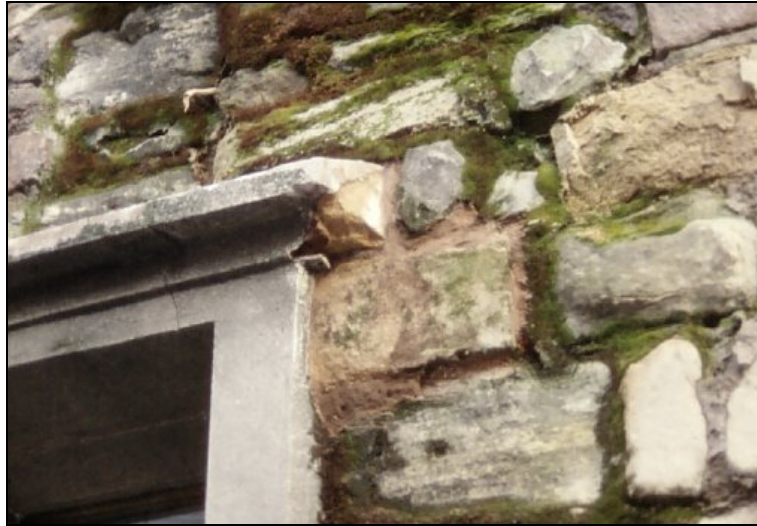
Plate 15. Area 6 opening to investigate hoodmould of window W1

Area 6 Window W1 (Plate 15, Figure 2)

Small opening at top right corner of southernmost 3-light mullion window W1. *Sequence*: decayed fragment of 1966 concrete facing removed, exposing corner of oolitic limestone hoodmould. No further investigation of hoodmoulds at direction of Conservation Officer.

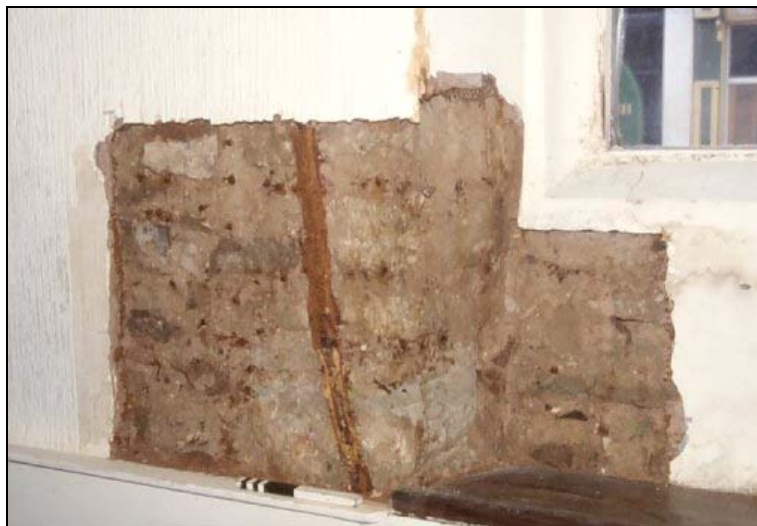
Plate 16. Area 7 opening to investigate internal wall coverings

Area 7 Adjacent to window W1 (Plate 16, Figure 4)

Opening to the south of/below southernmost 3-light mullion window W1 on west (Highcross Street) elevation. Lower edge of opening at sill/dado level. Total thickness of wall coverings: 35mm. *Sequence*: c.1966 gypsum plaster on steel mesh nailed to stonework; mesh also covers electrical trunking nailed to stonework. Slight traces of limewash on faced stones of window surround, but mainly bare stonework. The wall is very damp as a result of water ingress from a leaking gutter above this point. The steel mesh, corner reinforcing, electrical trunking and fixing nails have all corroded. There is also root penetration from a buddleia bush that was growing out of the external wall face above this window.

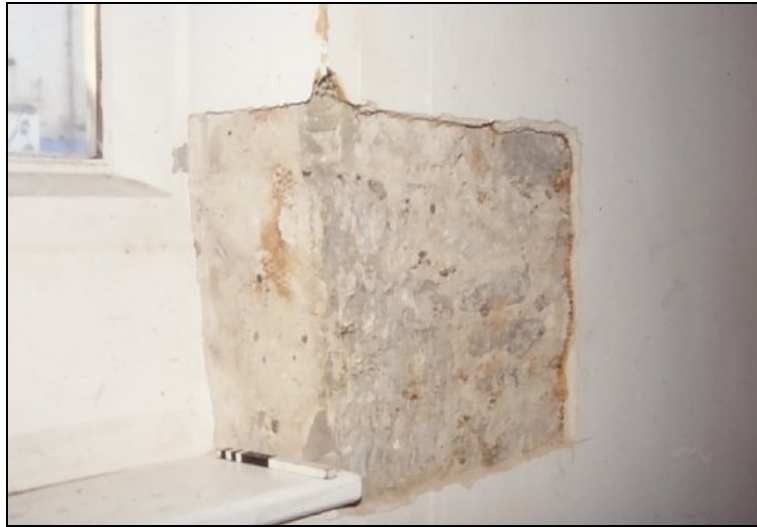
Plate 17. Area 8 opening to investigate internal wall coverings

Area 8 Adjacent to window W3 (Plate 17, Figure 4)

Opening on north side of central 3-light mullion window W3 on west (Highcross Street) elevation. Lower edge of opening 70mm below sill level. Total thickness of wall coverings: 30mm. *Sequence*: inner face of wall, c.1966 gypsum plaster on steel mesh nailed to stonework; window splay, c.1966

gypsum plaster on steel mesh over lime render over stonework. There is localised damage to the lime render from nails used to fix mesh. Wall is slightly damp and steel mesh, corner reinforcing and fixing nails have corroded, resulting in rust staining to surviving render in window splay. Any early render on inner wall face must have been removed as part of, or prior to, the 1966 alterations.

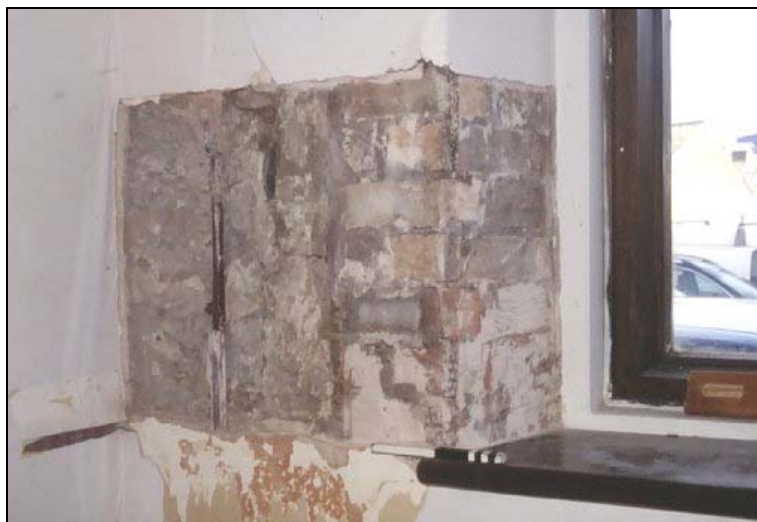
Plate 18. Area 9 opening to investigate internal wall coverings/window W6

Area 9 Adjacent to window W6 (Plate 18, Figure 4)

Opening to the north of/below 3-light mullion window W6 on east (car park) elevation. Lower edge of opening at sill height. Total thickness of wall coverings: 25mm. *Sequence*: late 20th century wallpaper over c.1966 gypsum plaster on steel mesh (at corner of window splay only) over brickwork and limewashed/painted stonework; electrical trunking nailed to stonework. There is a vertical joint 0.2m north of the corner of the window opening with limewashed/painted rubble stonework to the north and 20th century brickwork to the south, the latter forming the window opening. This vertical division corresponds with the position of a vertical joint in the stonework on the external face of this wall with apparently original rubble stonework to the north and later repair/infilling to the south. There is no clear evidence for there having been an original window opening at this point.

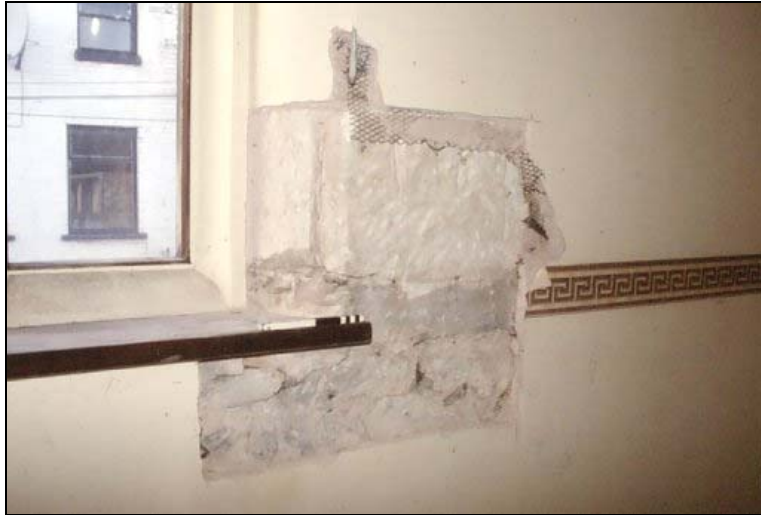
Plate 19. Area 10 opening to investigate internal wall coverings

Area 10 Adjacent to window W11 (Plate 19, Figure 5)

Opening to the north of/below central 3-light mullion window W11 on west (Highcross Street) elevation. Dimensions: 0.4m wide, increasing to 0.7m below sill level x 0.6m high; return into window aperture: 0.25m wide x 0.4m high. Lower edge of opening 0.25m below sill level. Total thickness of wall coverings: 25mm. *Sequence*: painted c.1966 gypsum plaster on steel mesh nailed to stonework. No earlier wall coverings survive on inner face of wall but traces of limewash are present on the window return. Dressed sandstone blocks form the window aperture; these 'pecked' to provide a key for internal rendering.

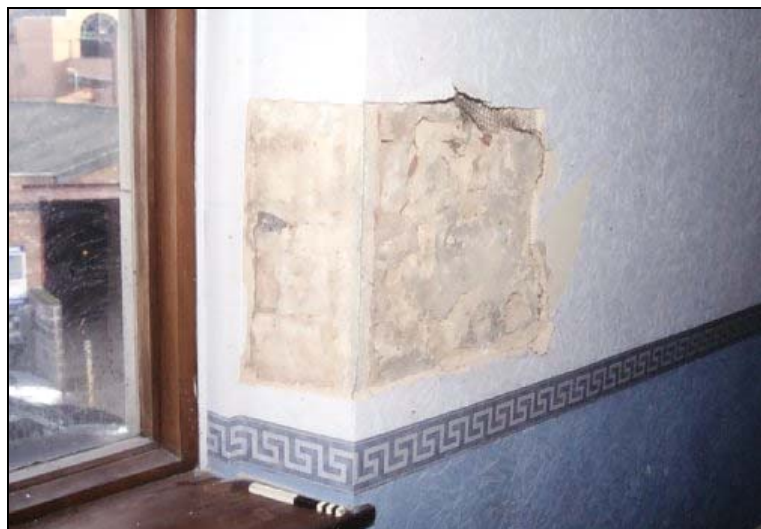
Plate 20. Area 11 opening to investigate internal wall coverings/window W14

Area 11 Adjacent to window W14 (Plate 20, Figure 5)

Opening to the south of 3-light mullion window W14 on east (car park) elevation. Dimensions: 0.5m wide x 0.5m high; return into window aperture: 0.25m wide x 0.5m high. Lower edge of opening 0.2m above sill level. Total thickness of wall coverings: 25mm. *Sequence*: Late 20th century wallpaper on c.1966 gypsum plaster on steel mesh, over smear-rendered stonework with limewash finish, this badly damaged by nails used to fix steel mesh. The window opening is finished in brick with cement mortar. The exposed stonework is random rubble with no clear indication (e.g. larger dressed blocks) of an original window opening at this point (c/f Area 12 below).

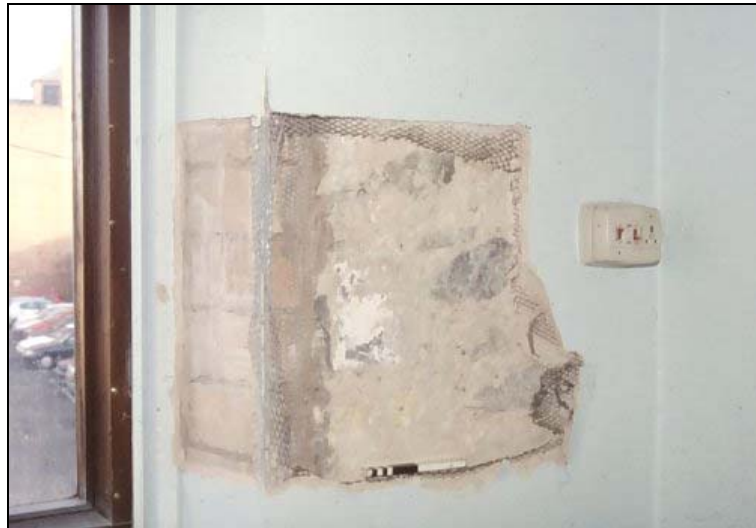
Plate 21. Area 12 opening to investigate internal wall coverings/window W16

Area 12 Adjacent to window W16 (Plate 21, Figure 5)

Opening to the south of the 3-light mullion window W16 on east (car park) elevation. Dimensions: 0.5m wide x 0.56m high; return into window aperture: 0.25m wide x 0.56m high. Lower edge of opening 0.15m above sill level. Total thickness of wall coverings: 20mm. *Sequence*: Inner wall face, painted gypsum plaster on steel mesh, over smear rendered stonework. There are fragmentary traces of limewash on larger dressed stones that are the remains of an original/early window opening at this point. On window return painted gypsum plaster covers c.1966 brickwork forming present window opening. Large dressed stones forming the south jamb of an early window at this point are also visible externally (Plate 22); these were truncated by the insertion of the present pre-cast concrete surround in 1966.

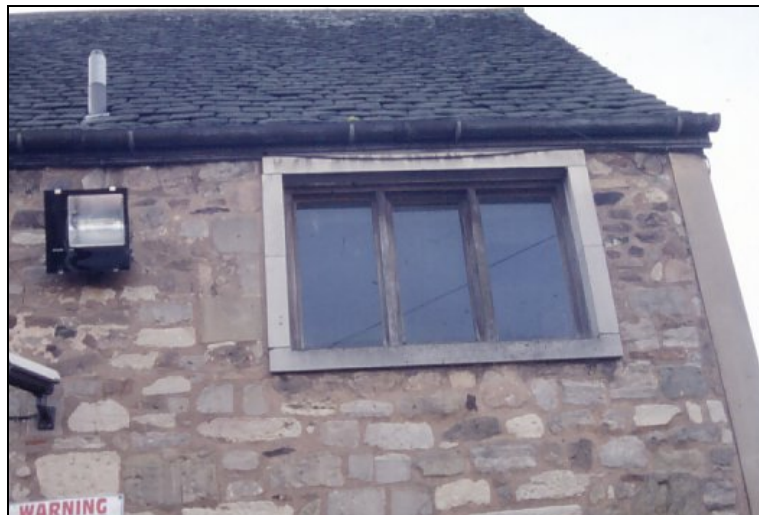
On the east (car park) elevation, two early window openings on the ground floor, W2 & W4, were reconstructed in 1966 with new stonework copying the profile of surviving moulded window jamb fragments. It is notable that the early stone window surrounds on the east elevation are in sandstone, whereas those of the Highcross Street elevation are limestone. All other window and door surrounds on the east elevation date from 1966 and consist of pre-cast concrete sections inserted into the stonework of the wall face. The remains of one other early stone window surround is apparent on this elevation: the northernmost first floor window W16 (Plate 22). In this case the stonework of the south window jamb was truncated in 1966 when the pre-cast concrete surround was inserted. Removal of internal wall coverings at this point also exposed large, dressed stone blocks confirming the position of an original/early window opening (see Area 12).

Plate 22. Window W16 east (car park) elevation showing remains of early stone window surround to left of and truncated by 1960s concrete surround

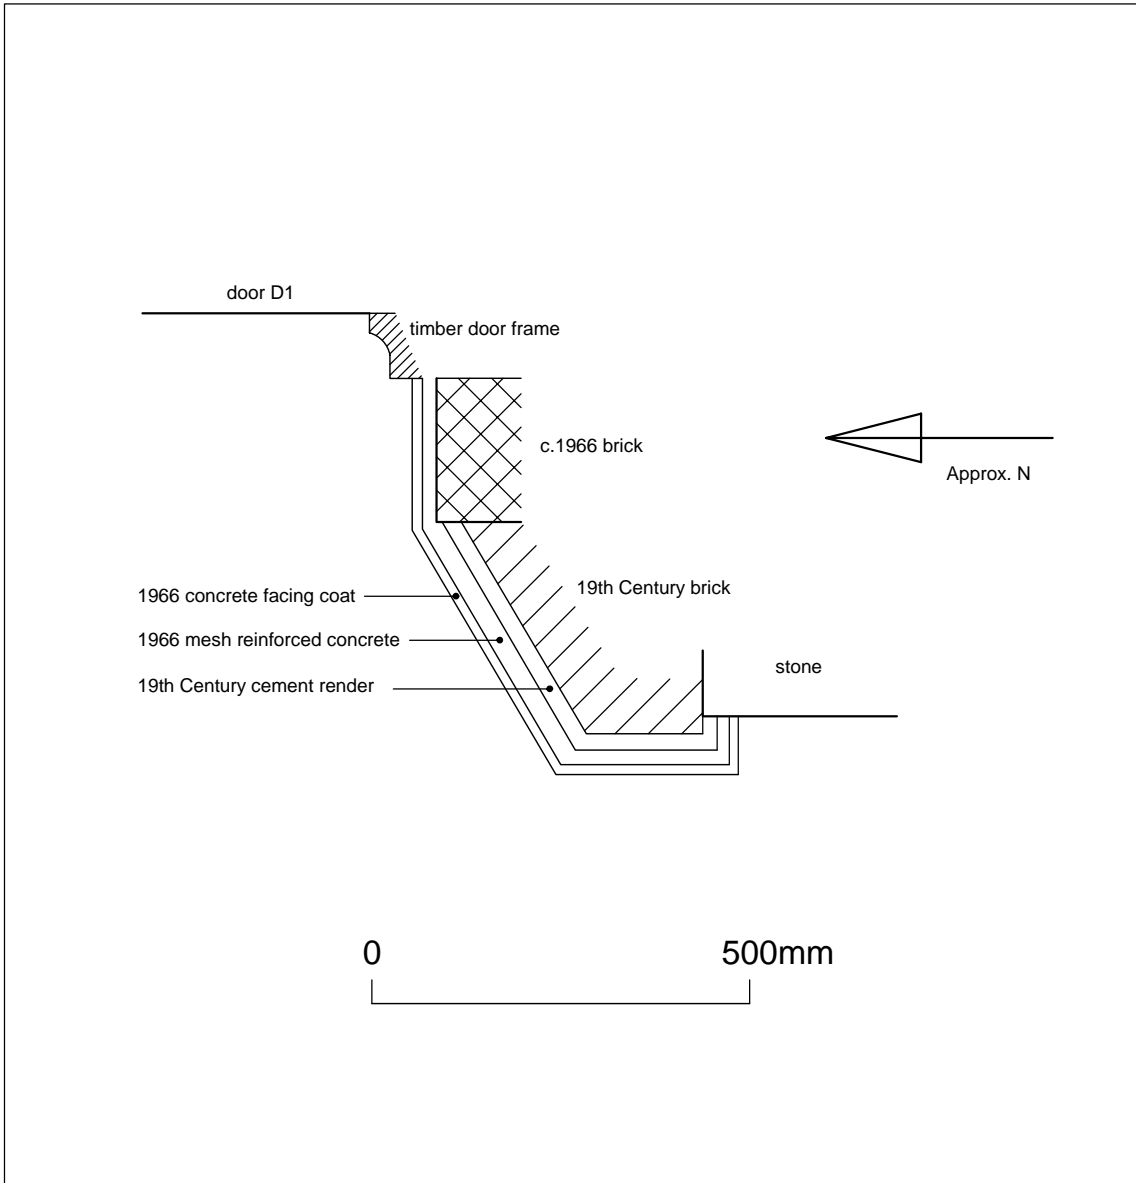
Figure 6. Plan view illustrating sequence of materials forming surround to doorway D1 (Area 1)

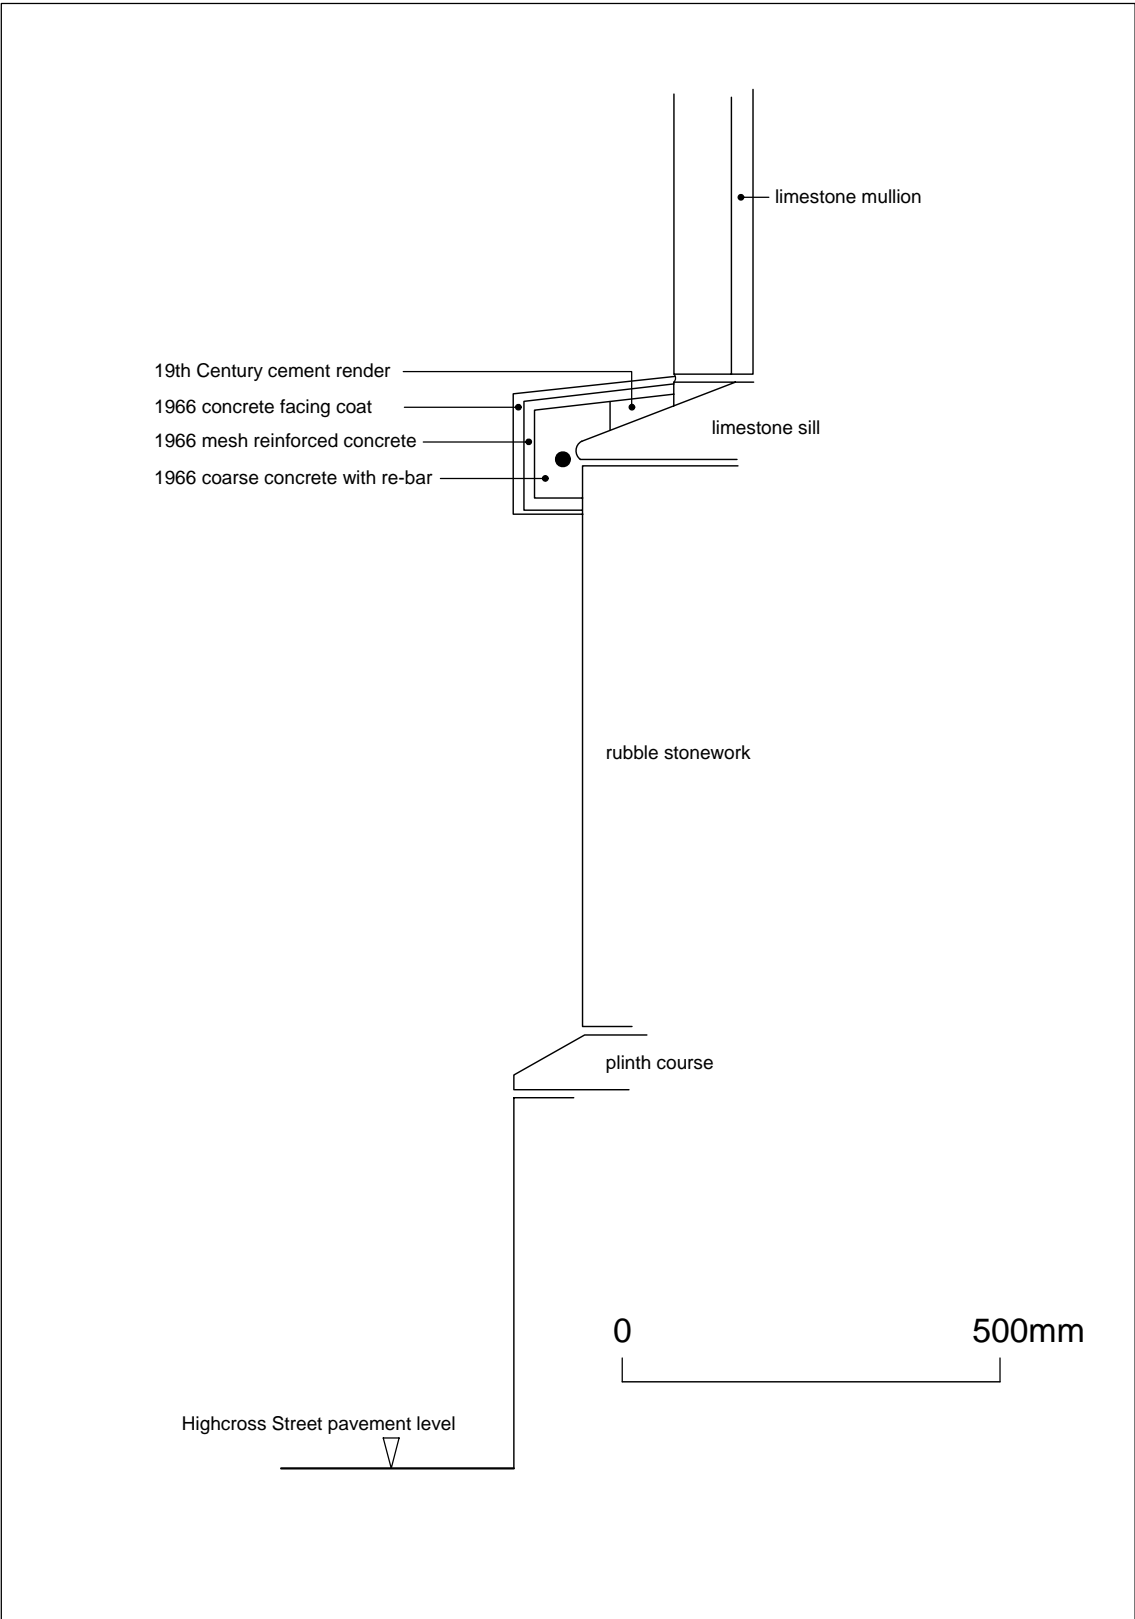
Figure 7. Section illustrating sequence of materials forming surround to window W1 (Area 5)

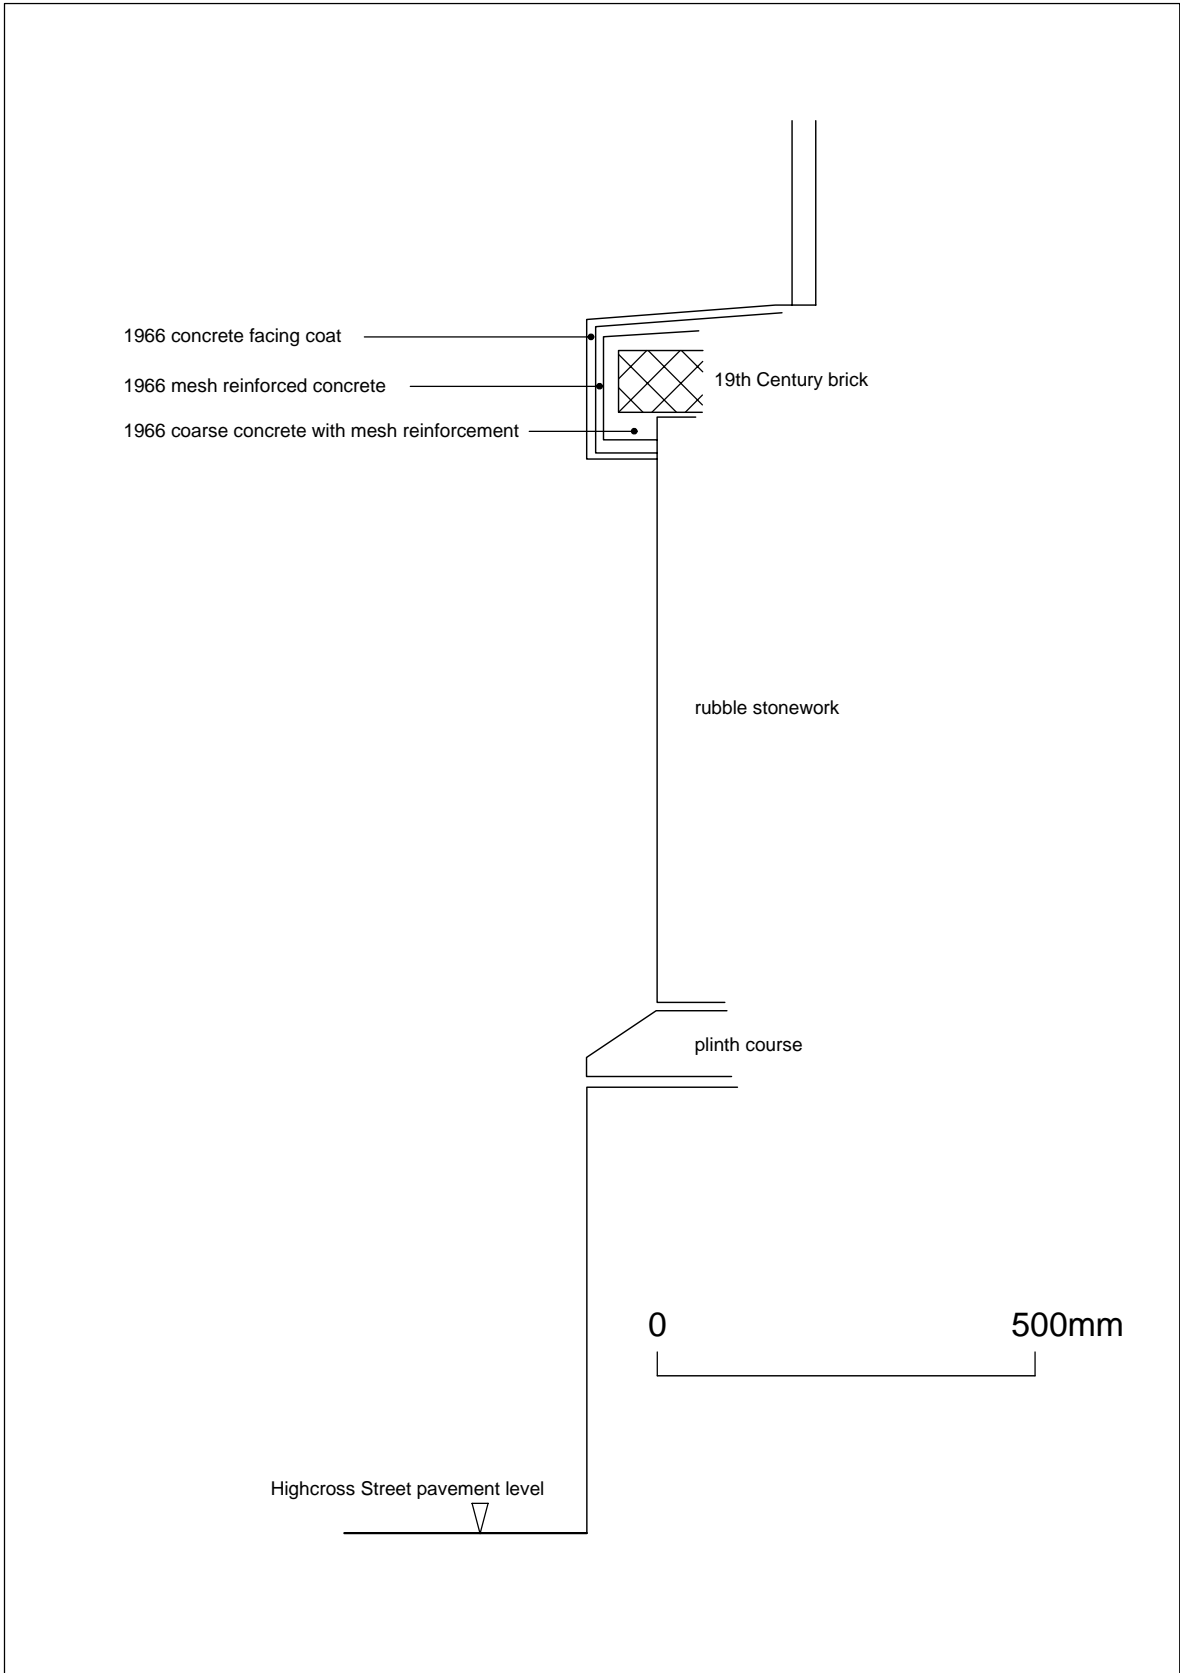
Figure 8. Section illustrating sequence of materials forming surround to window W5 (Area 3)

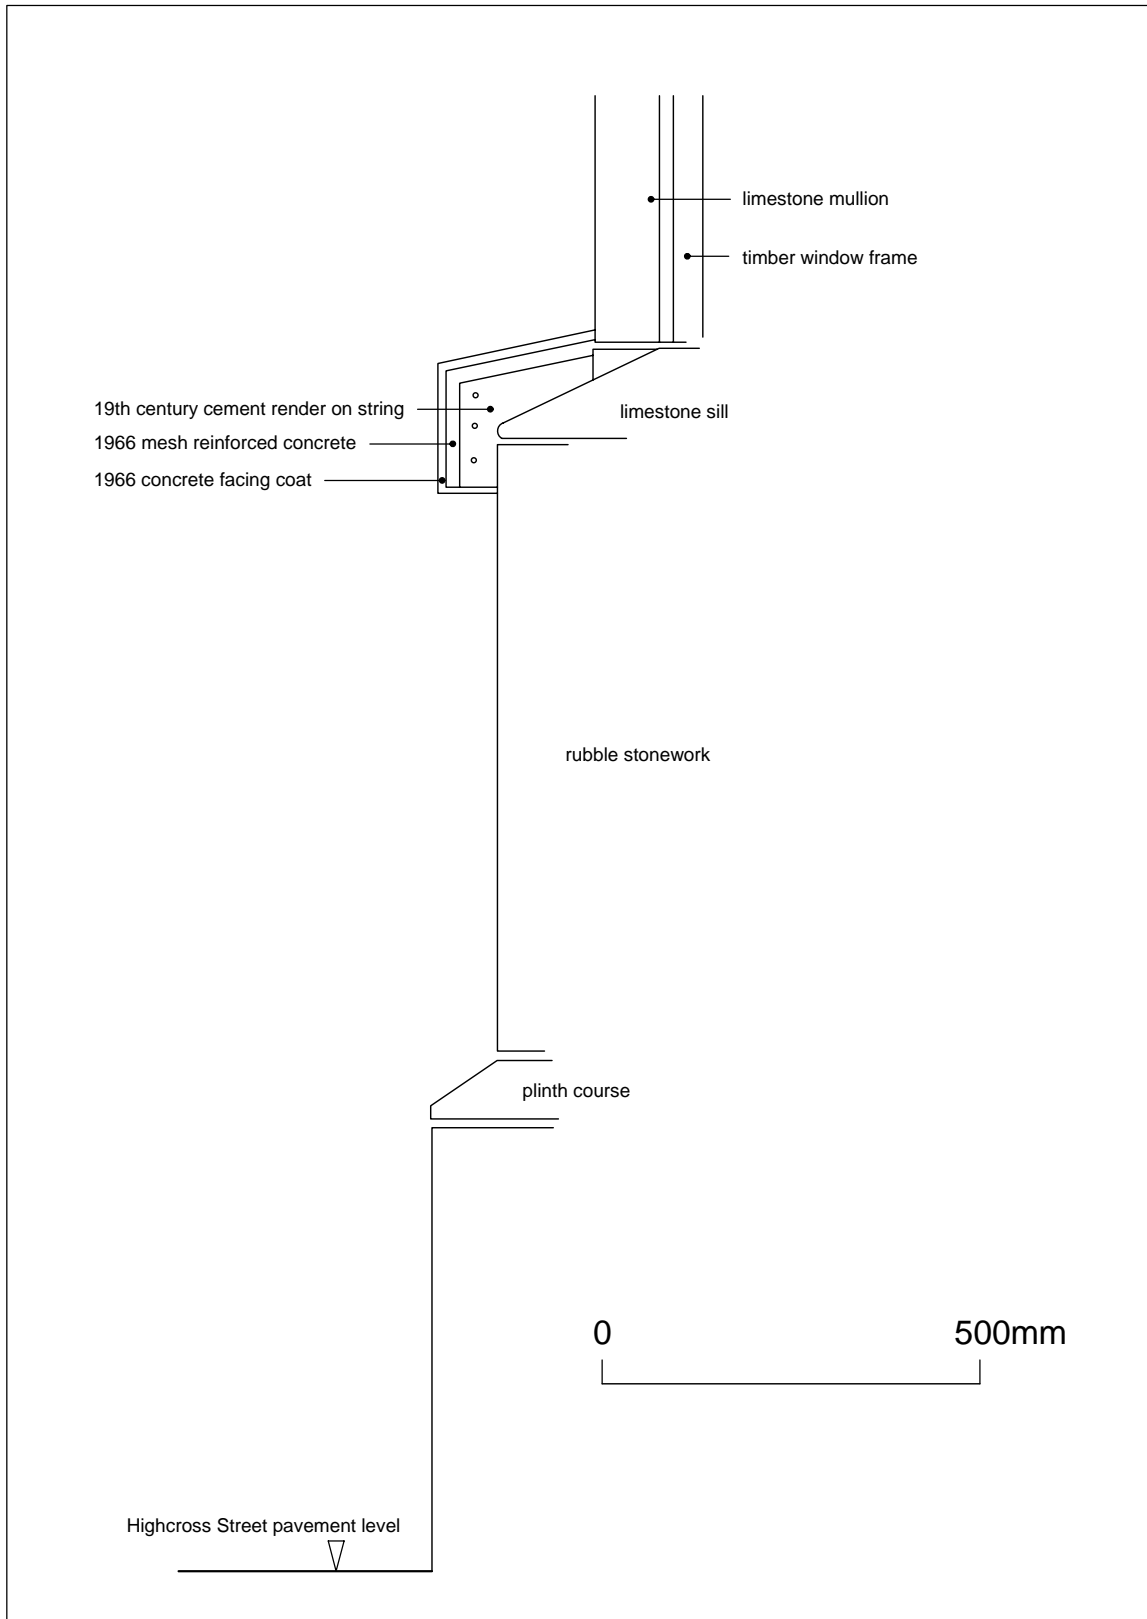
Figure 9. Section illustrating sequence of materials forming surround to window W7 (Area 2)
