**An Historic Building Photographic  
Survey at  
Saddle House, Churchgate,  
Hallaton,  
Leicestershire**

ULAS Report No. 2019-092v2  
©2019

**For: Mr D Pochin.**

## **An Historic Building Photographic Survey at Saddle House, Churchgate, Hallaton, Leicestershire.**

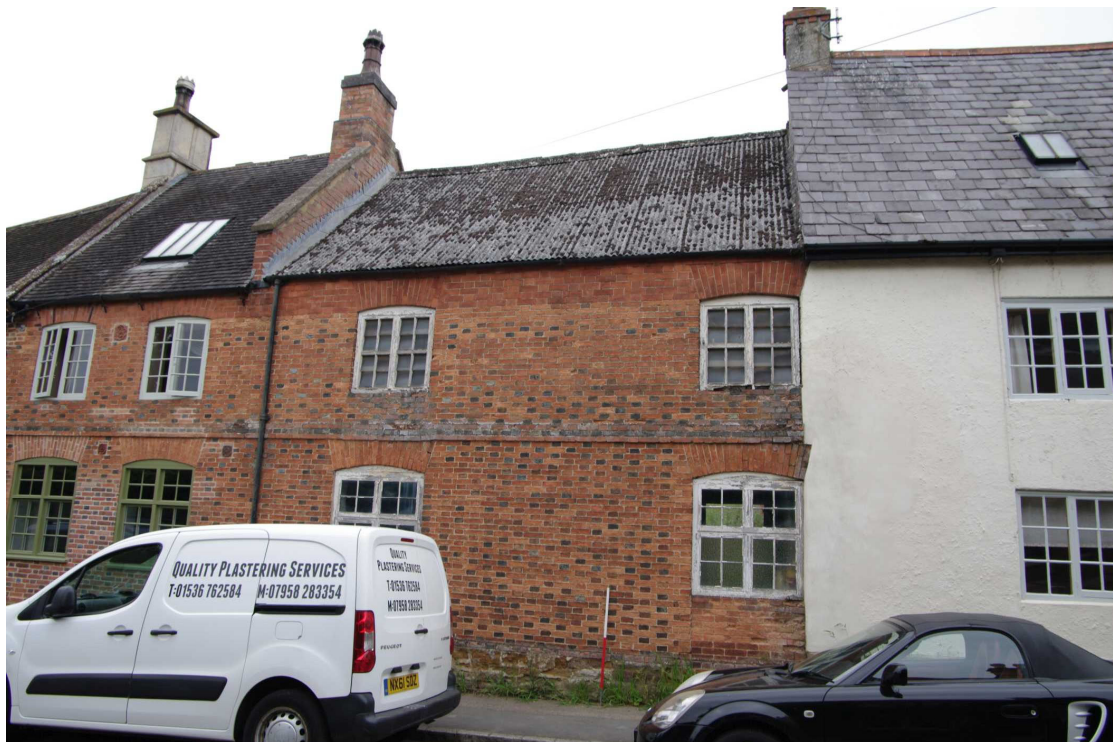
Figure 7 Saddle House south facing elevation onto Churchgate Looking north. 1m scale. Note stone base of wall and raised eaves. The blocked doorway which is now a window is on the right behind the black car's bonnet

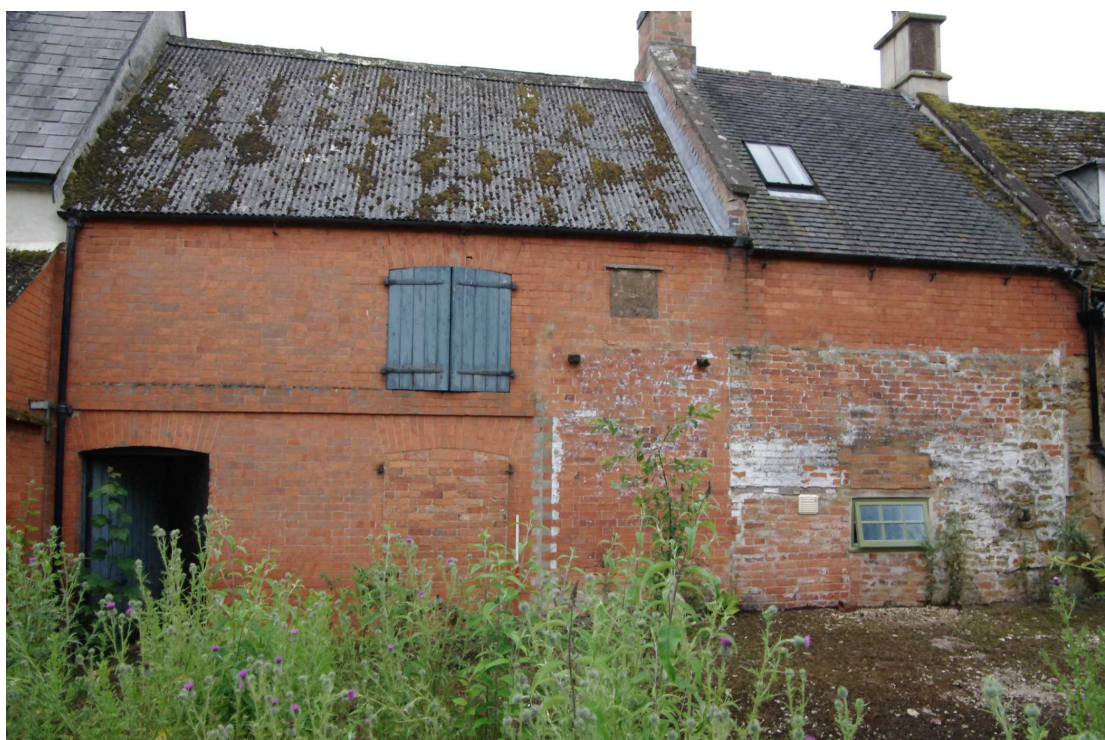
Figure 11 Saddle House north facing elevation  
Looking south. 1m scale. Note blocked ground floor window. The brick string course  
above the door stops to the right of the hayloft door. The offset date plaque to the  
right of the hayloft door has I.H.D. 1821 carved on it

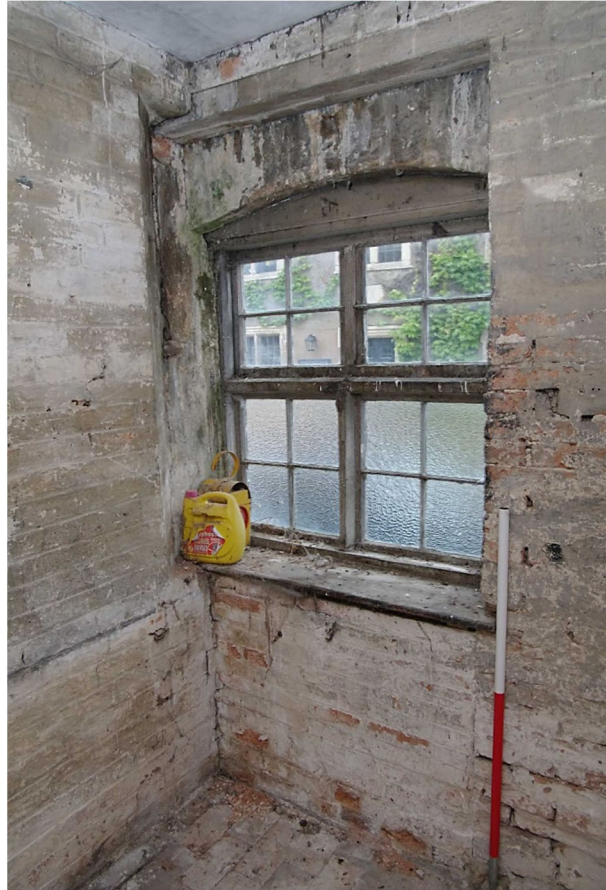
Figure 14 Saddle House ground floor eastern room. Modified doorway  
Looking south-east. 1m scale. Note how the left hand edge of the doorway is  
chamfered into the wall

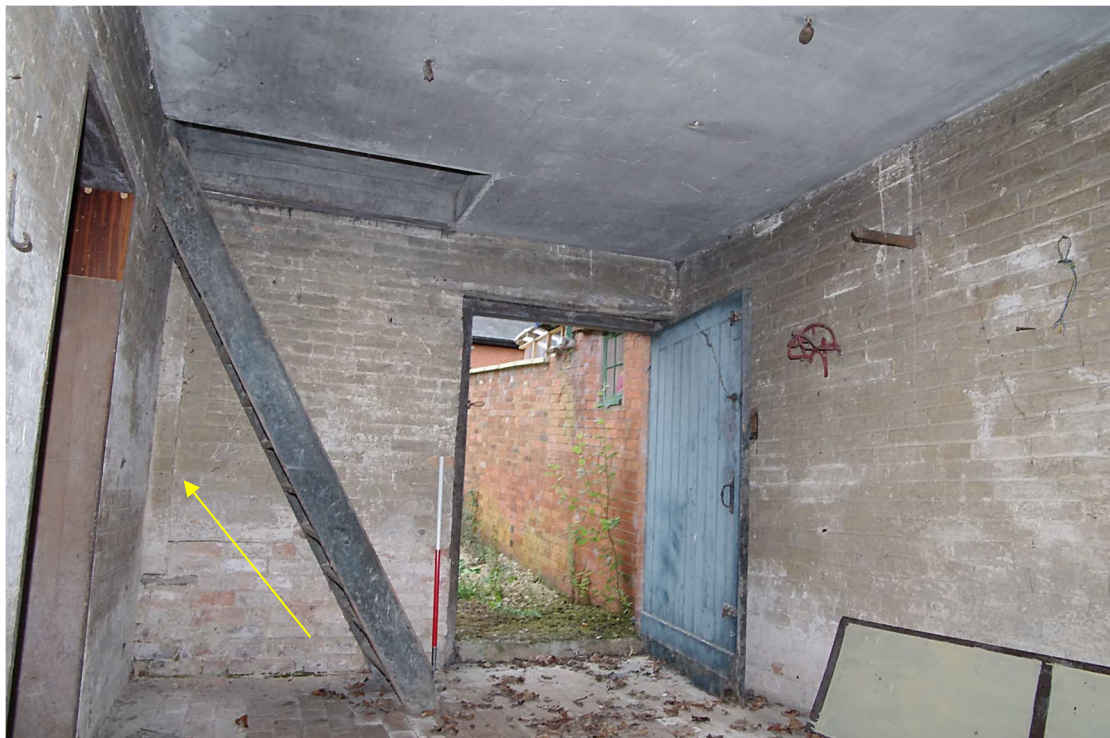
Figure 15 Saddle House ground floor eastern room  
Looking north-east. 1m scale. Steps lead up to first floor. The arrow points to blocked  
edge of window which has been partially obscured by the inserted dividing wall

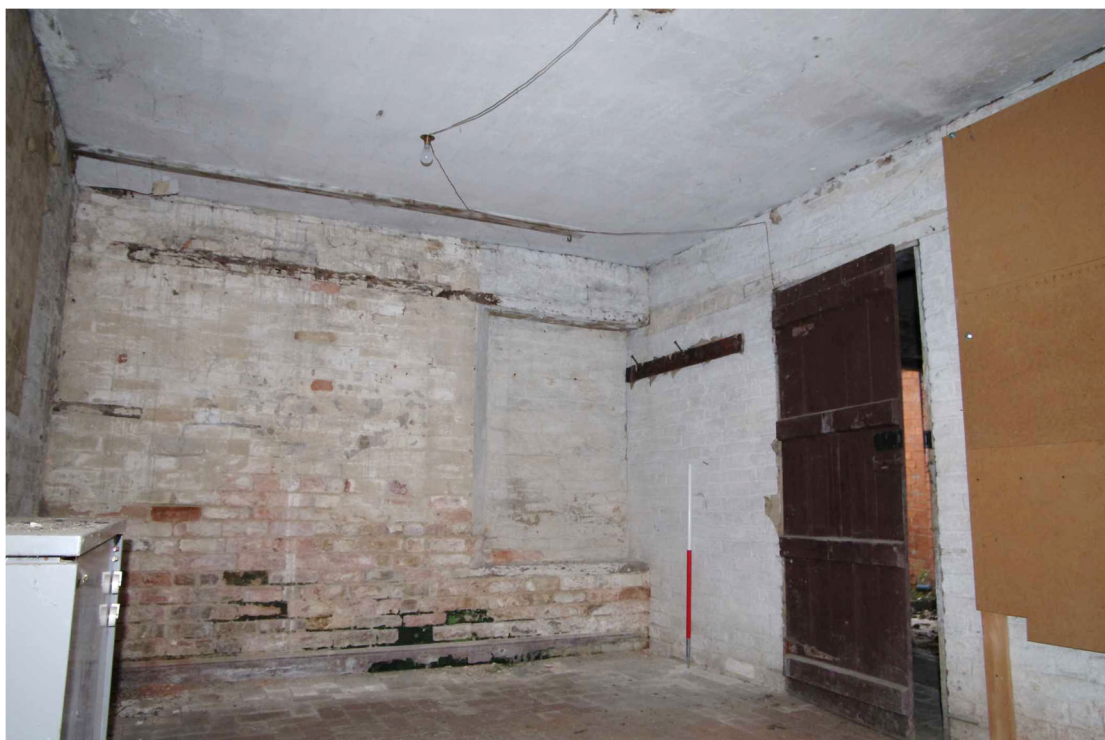
Figure 22 Saddle House ground floor western room  
Looking north-east. 1m scale. Note blocked window and inserted dividing wall. This room also has remnants of a skirting board and some wallpaper

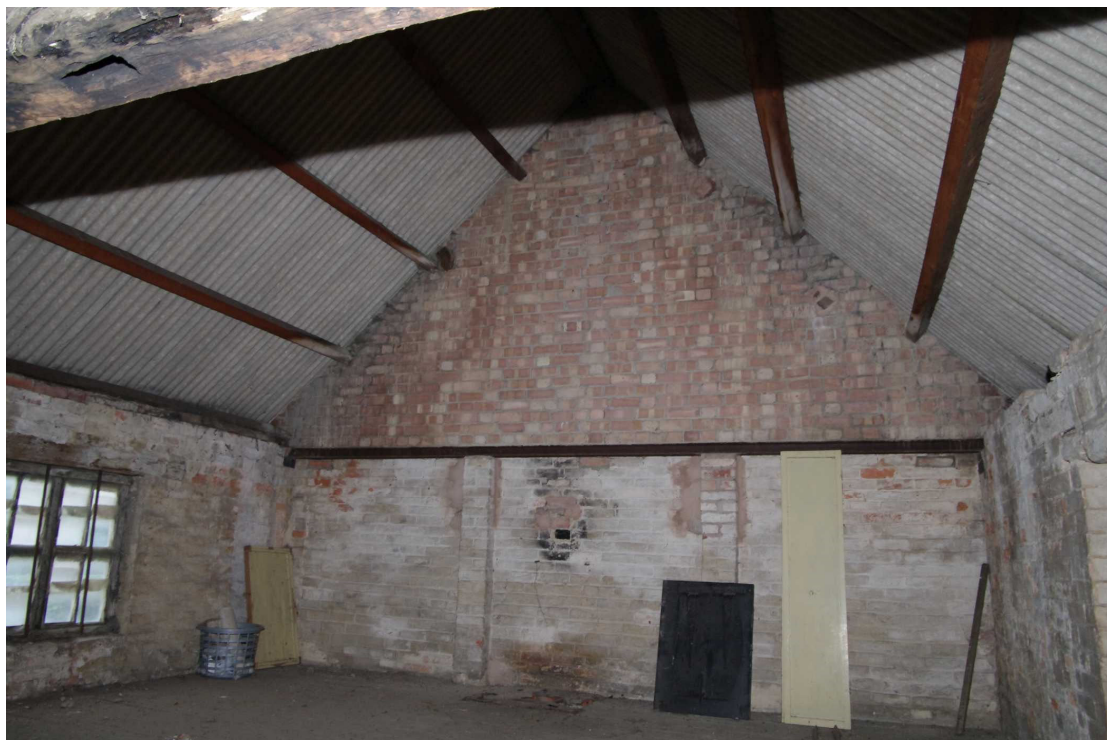
Figure 24 Saddle House first floor  
Looking south-west. The modern brickwork in the gable rests on a horizontal girder

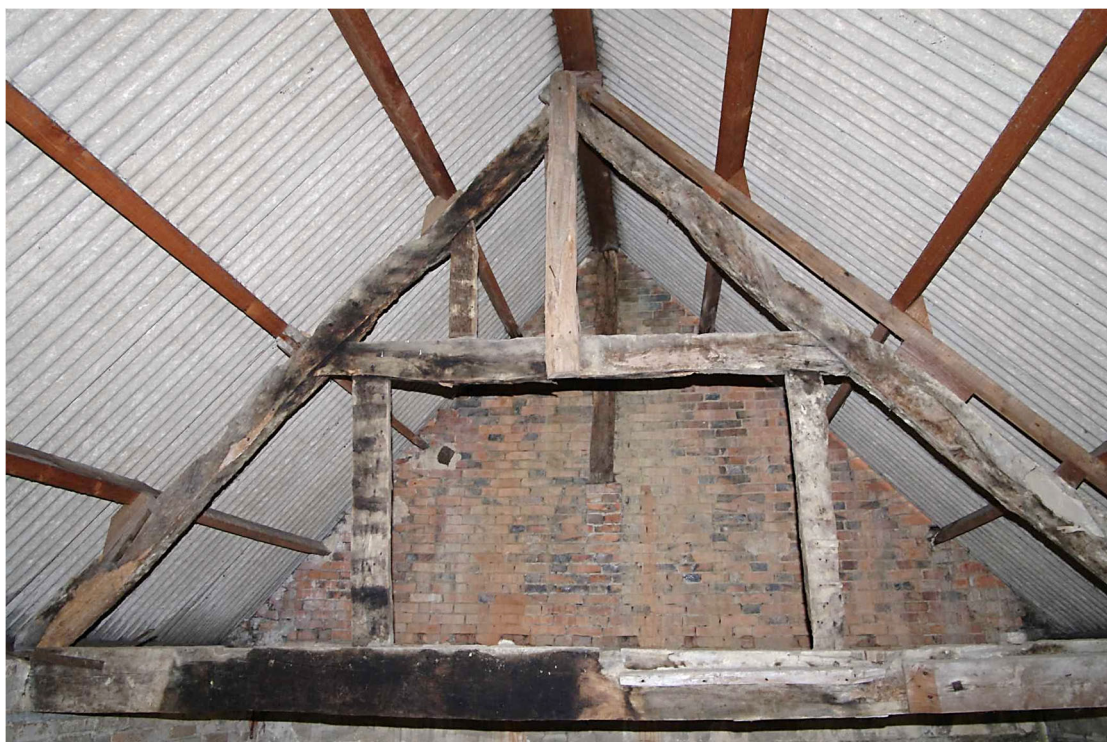
Figure 25 Saddle House roof structure  
Looking east. Joints are pegged with many reused timbers. There is some burning present on the truss

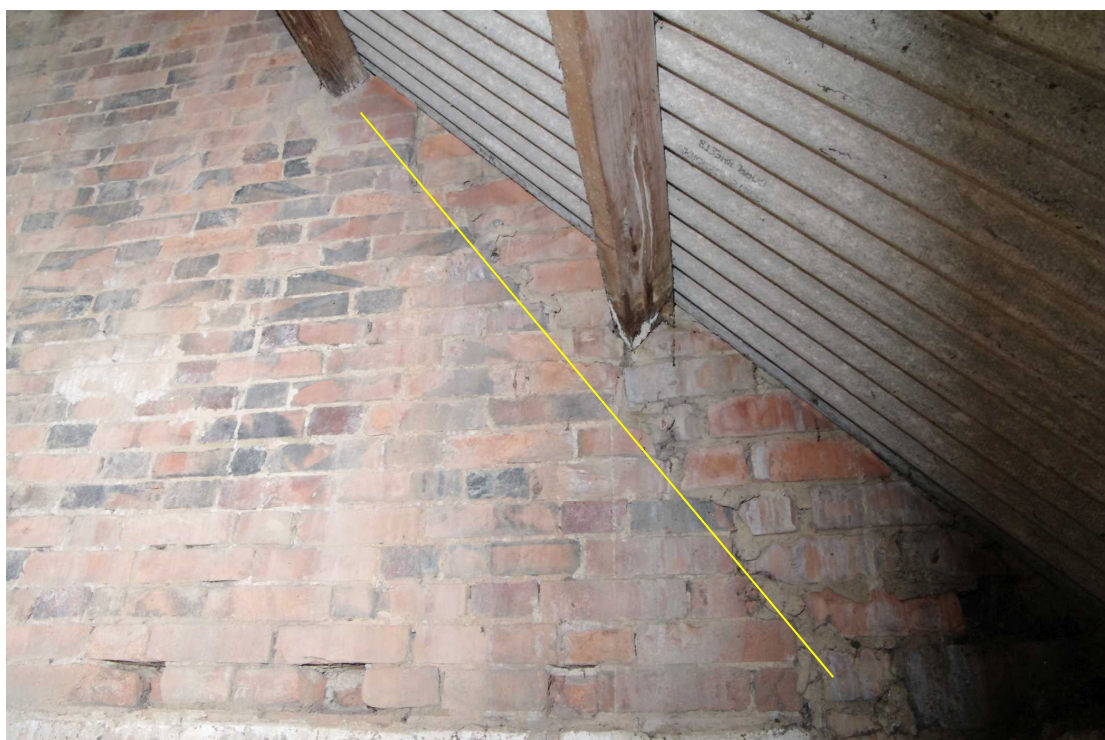
Figure 28 Saddle House rebuilt eastern gable end  
Looking east. Yellow line shows the original roof pitch

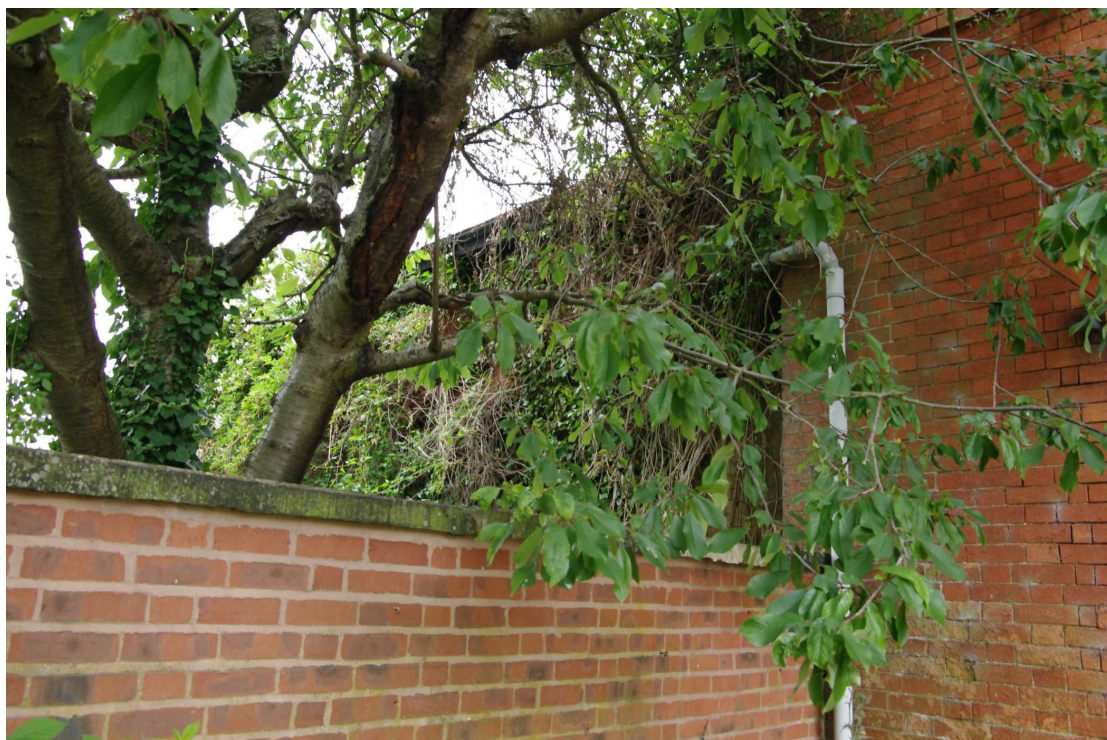
Figure 32 The Coach House south facing elevation, west wing  
Looking north-west over dividing wall. The west wing is covered with vegetation

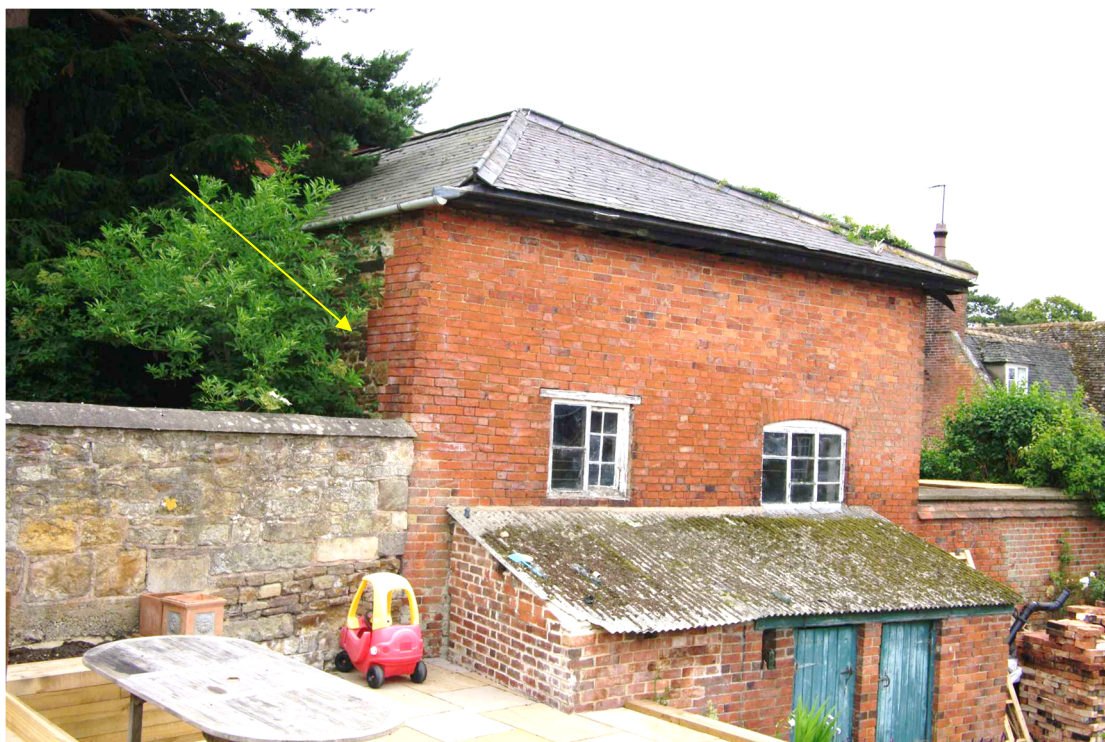
Figure 37 The Coach House west facing elevation  
Looking south-east. Note how the rear (north) facing elevation changes from brick to stone (yellow arrow)

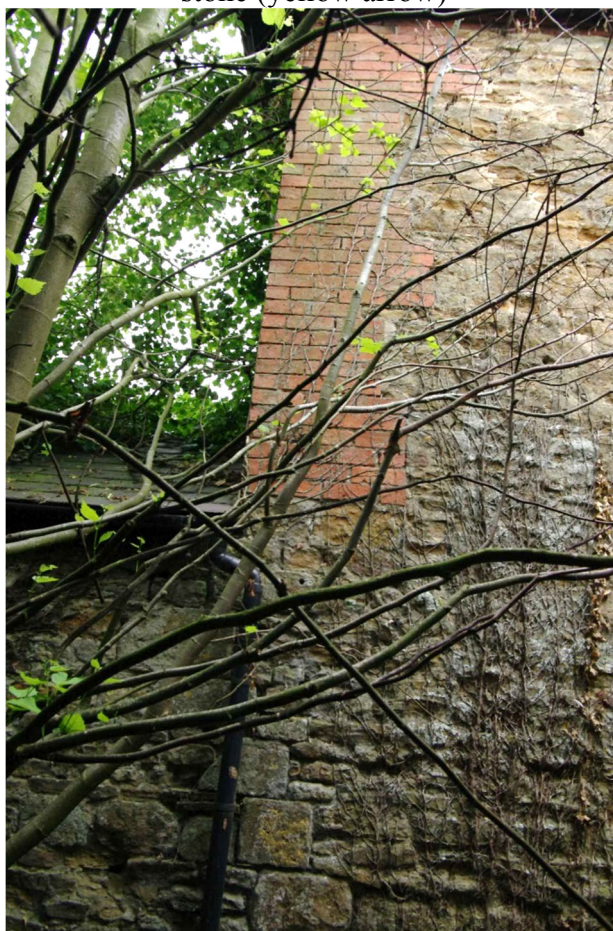
Figure 38 The Coach House east corner of north facing elevation  
Looking south through undergrowth which hides much of this elevation

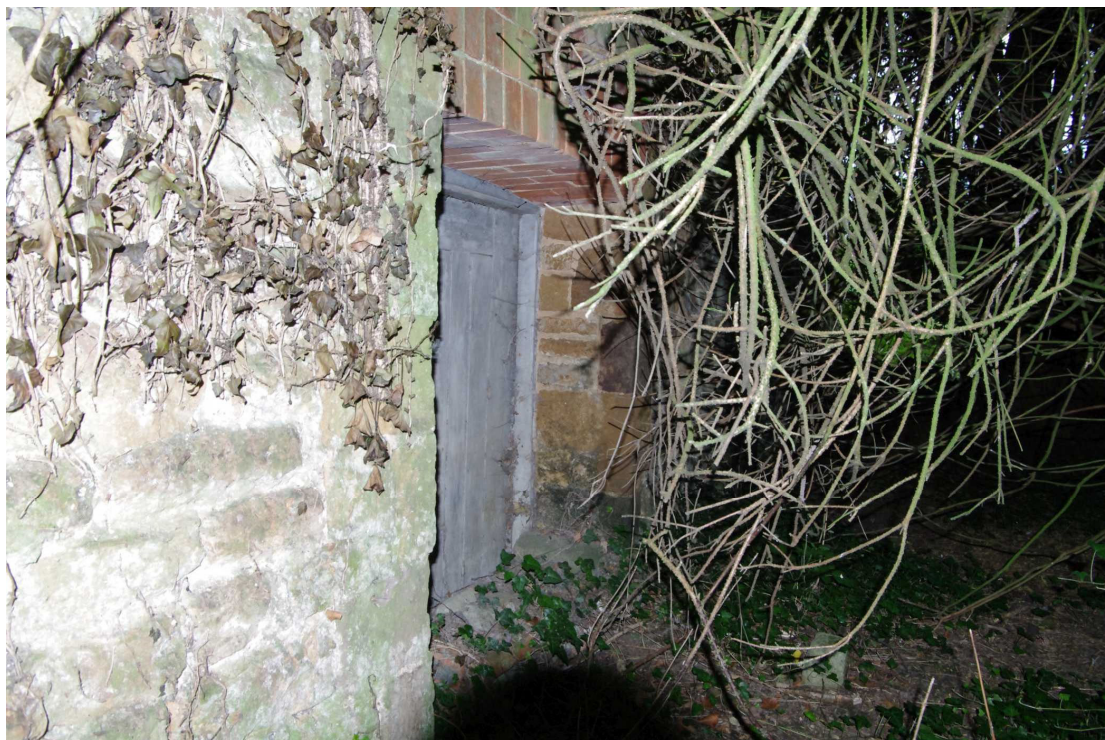
Figure 39 The Coach House north facing elevation doorway  
Looking south-west. The ground level on this side of the building has risen to half  
cover the doorway
