**A Standing Building Survey  
of Farm Buildings,  
Old Hayes Farm,  
Ratby,  
Leicestershire  
(SK 490 064 centre)**

**For Lychgate Homes Ltd**

Report No 2006-021

## **A Standing Building Survey of Old Hayes Farm, Rathby, Leicestershire (SK 490 064)**

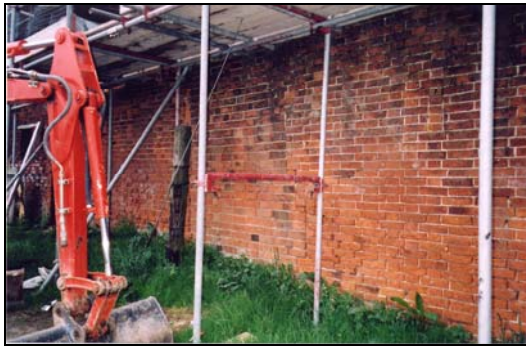
Plate 2. Patch of rebuilt brickwork on the centre of the west elevation.

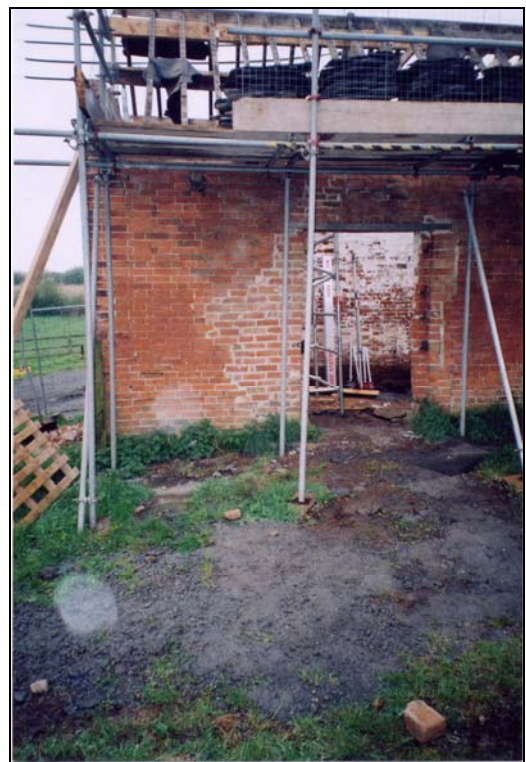
The southern range (Building One) appears to have had little alteration since it was first constructed. The southern door on the east elevation appears to have had some structural repair which has removed the original segmented arch above it. The use of this building seems to have been a stable and the fragments of heel posts and sockets in the brickwork are an indication of the position of former stalls. Another indication is the recessed door openings which would have originally housed substantial stock doors.

Plate 4 The east elevation southern door.

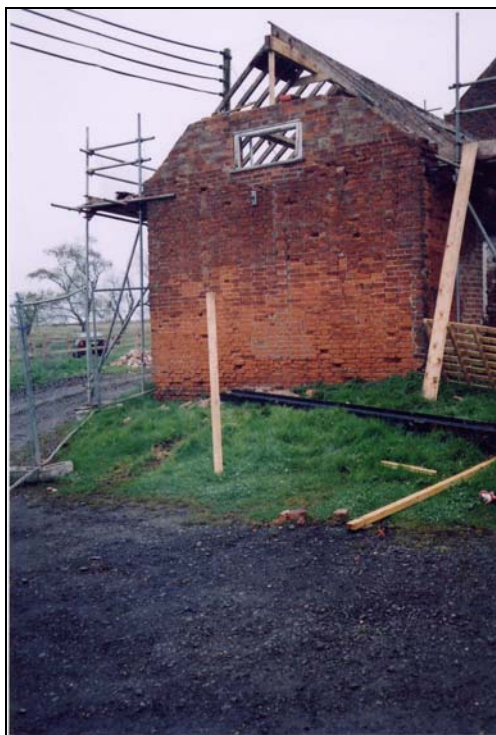
The southern elevation gable apex has been rebuilt in relatively modern common brickwork in stretcher bond (plate 6). It appears when this rebuilding was undertaken a relatively modern top hung ventlight was also installed. Below the apex the brickwork is the same red brick as found elsewhere on the building laid in a variation of Flemish garden wall bond. There are a number of patch repairs and repointing on this elevation together with four blocked ventilation openings, two at high level and two at low level (plate 7). There are also the remains of what appears to have been a brick plinth of four or five courses at the base of the wall.

Plate 5 Northeast corner butt joint of southern wall of Pigeon House. Plate 6 The south elevation gable wall.

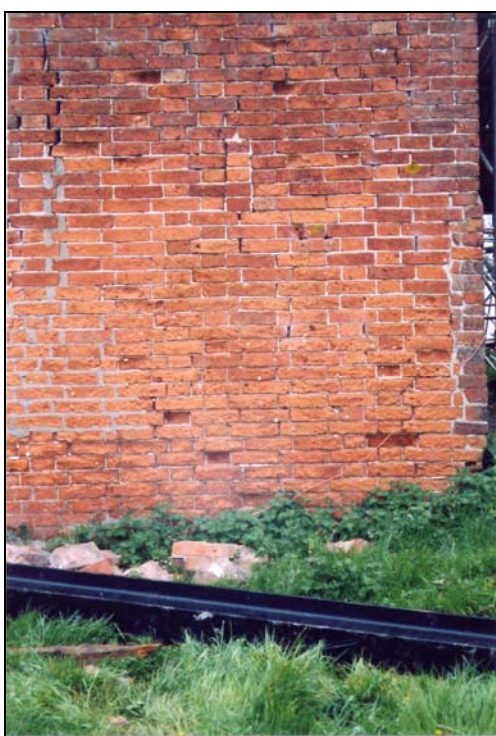
Plate 7. Blocked former vent opening on the south wall.

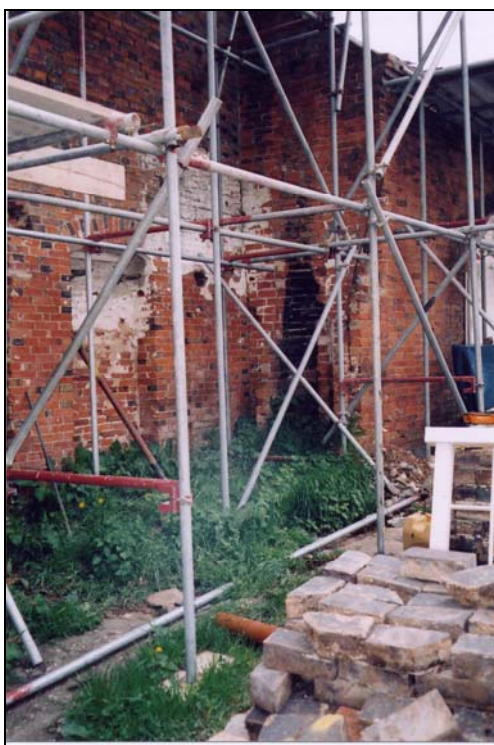
Plate 9. General view of east elevation of the Pigeon House. Plate 10. A view of the blocked central east door and remains of former flue.

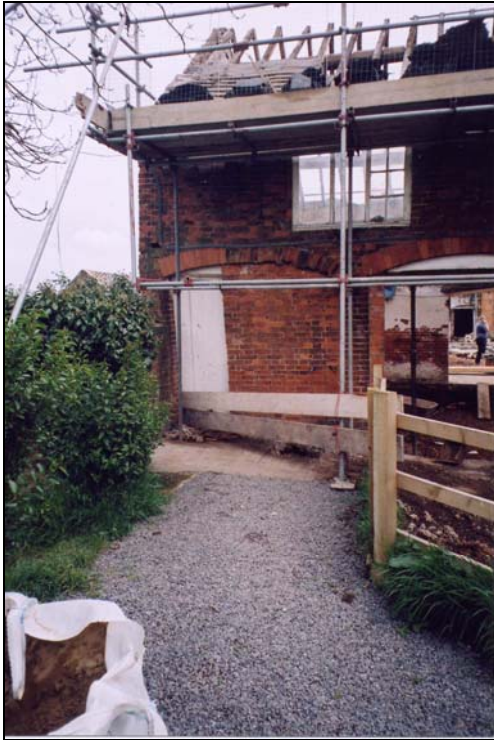
The west elevation is of brick construction using the same bond as mentioned above. This wall however has four large segmented arched openings with intermediate piers (plate 19). The northern most opening has been partially bricked up and now access is via a small timber door (plate 21). A small section of segmented arch has been replaced directly above this door. Some structural work has also been undertaken on the next arch (central left) and the segmented arch soldier course has been replaced and the left hand jamb strengthened with an additional narrow brick pier (plate 22). Other evidence of structural repair is from the iron restraint ties in between the left and central left arches corresponding with a tie on the east elevation.

Plate 21. The partially blocked northern most bay.

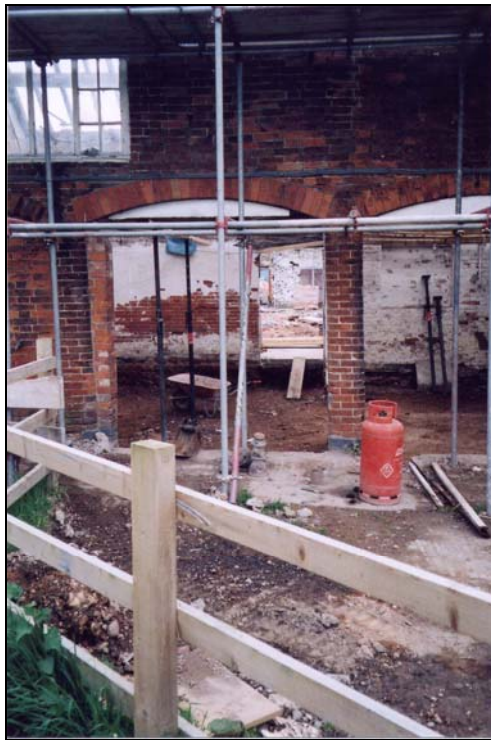
Plate 22. The centre left bay arched opening showing rebuilt soldier.

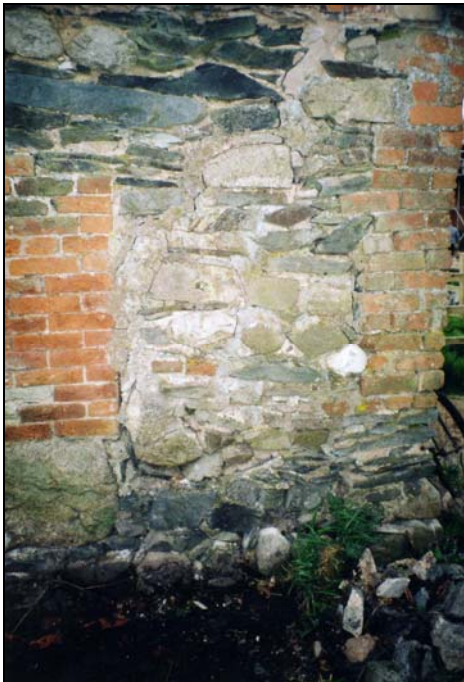
Plate 32. Detail of north elevation showing blocked door. Plate 33. West elevation of building four.

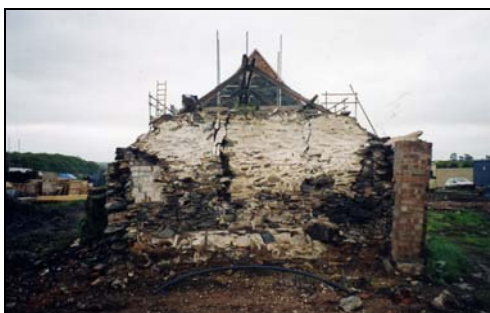
Very little remains of the northern section of the building (plate 36) except a brickwork section on the west elevation that may have been the right jamb of a door opening. The east wall has been totally demolished and the north gable is in a very poor condition. This gable is constructed of roughly coursed slate which has been limewashed indicating it was once an inside wall. At ground level on this gable there are three concrete drinking troughs still *in situ*.

Plate 36. The ruinous north bay of building five.

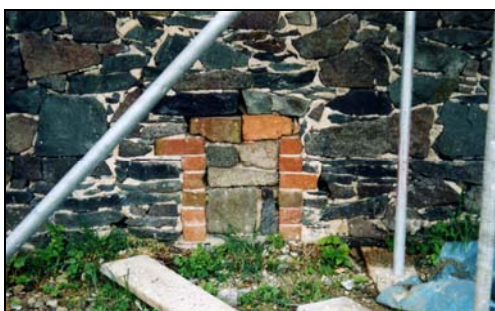
Plate 59. Blocked feature on south wall of building eight.
