**A Level 2 Historic Building Assessment  
at Hall Farm, Hall Lane, Packington,  
2 Leicestershire SK 36047 14710**

ULAS Report No. 2018-067

**For: Lychgate Homes Ltd**

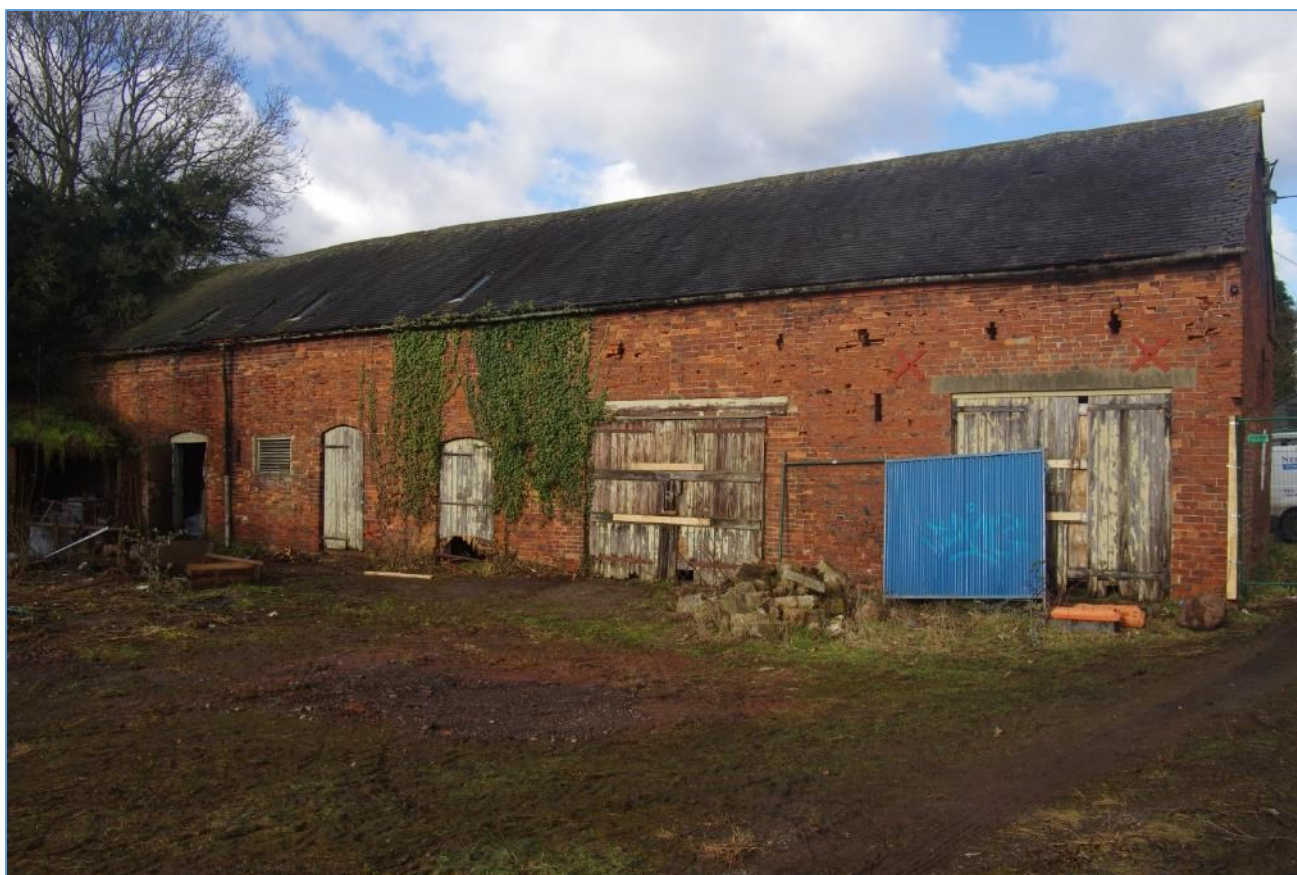
Built of brick with a plain nib tile roof, with dentilled eaves, Block A appears to be an unusually large combination barn, partly on two floors. It has undergone extensive re-construction and remodelling over the course of its life, as can be seen in the brickwork. The yard frontage (Figure 4) shows multiple blocked windows on the first floor. The west side of the range has two storeys, the upper reached via a brick stair.

*Figure 4 Block A south elevation*

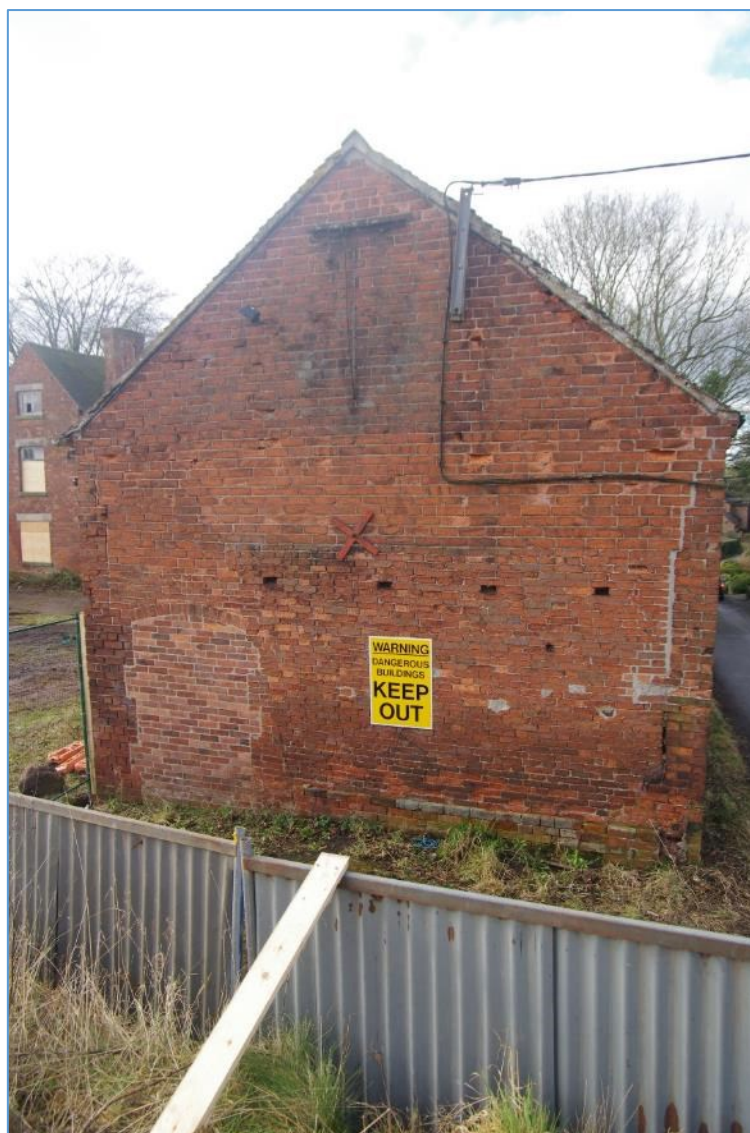
The west gable is not visible due to ivy. The east end (Figure 5) shows numerous builds including an inserted side door, with larger bricks forming the gable in a line roughly where the wall tie appears. Of note is that the building may have been re-skinned judging by the vertical joints on the yard side and the street side. The roof across the range, however, is homogeneous: king post trusses and single purlins which are part supported by cleats, part trenched into the back of the principals. These are relatively late given the metal bolts running through the tie beams up into the post.

*Figure 5 Block A east elevation*

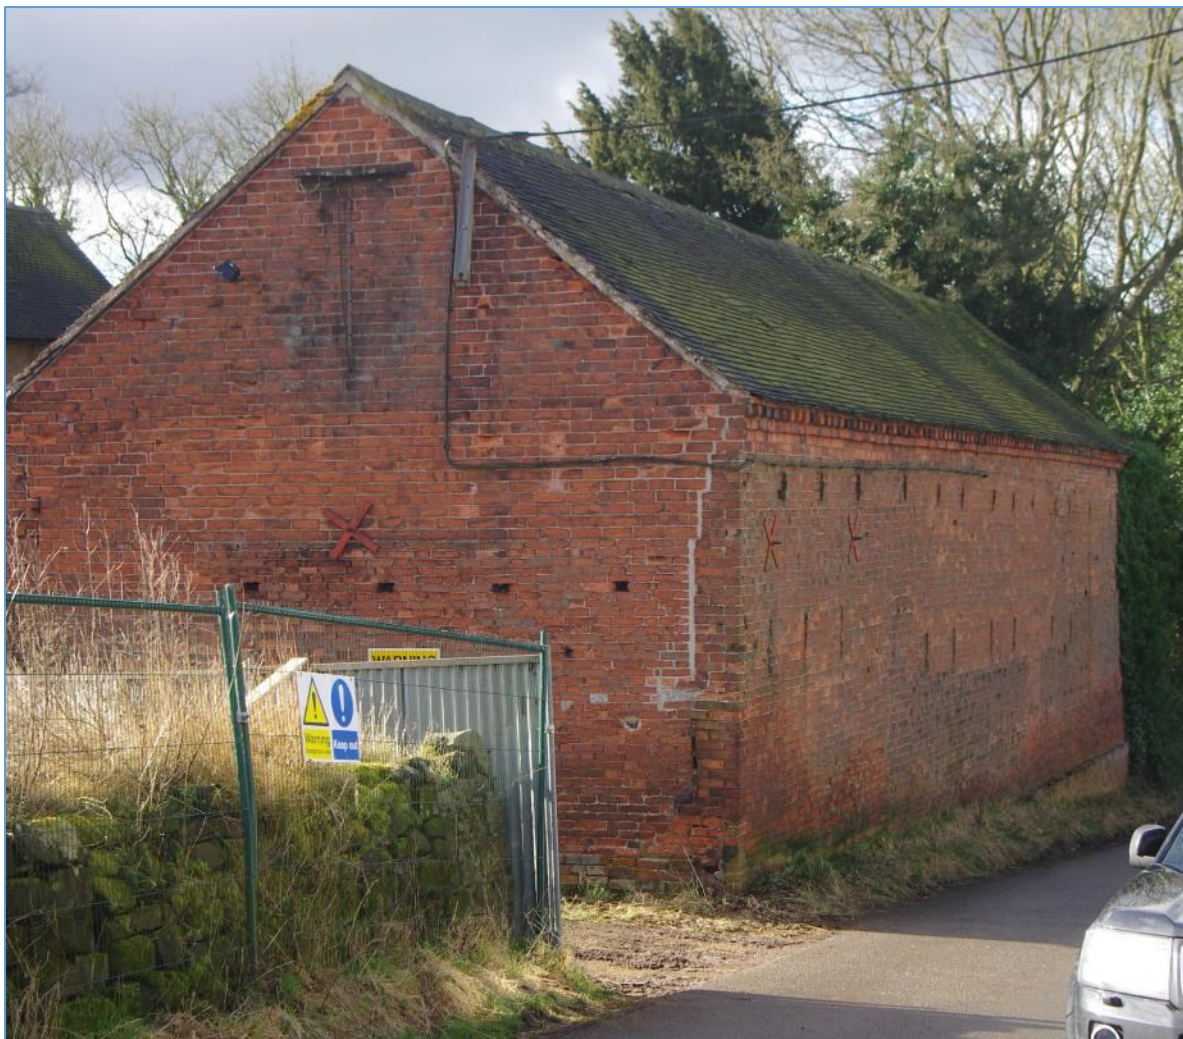
The rear wall (fronting the street, Figure 6, Figure 8) is mostly of early 18th-century style brick, hand-made; the lower part of the middle and west end is rougher quality, exhibiting a high percentage of spalled, overfired, and ill-sorted fabric (Figure 7). This could indicate a different build, or may just be that the lower part was a different firing, as brick kiln firing conditions were not tightly controlled at this date. Blocked openings onto the street are in evidence.

*Figure 6 Block A east and north elevation*

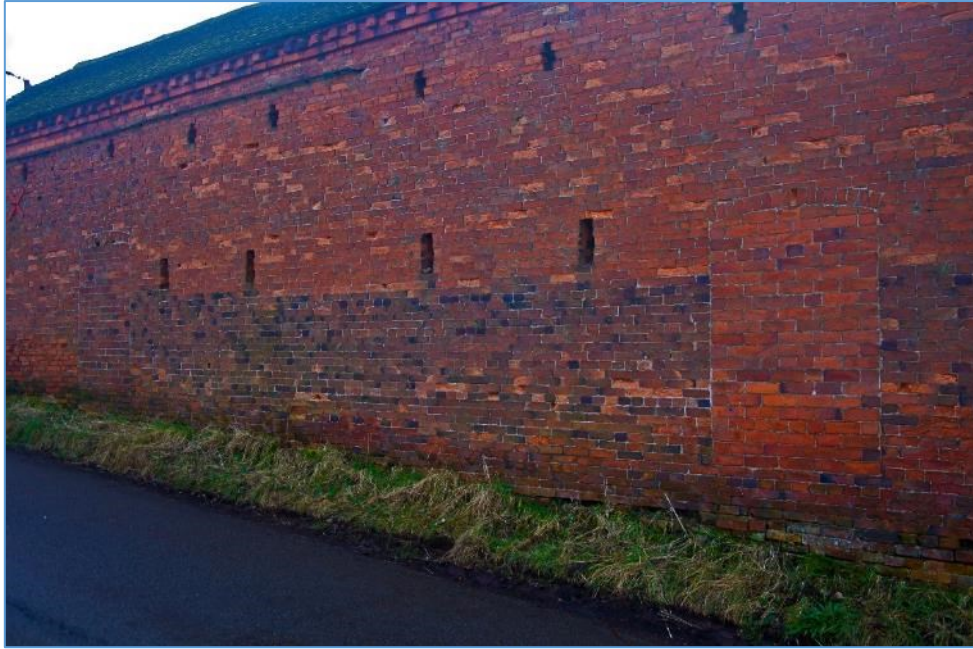
*Figure 8 Block A part of north elevation*

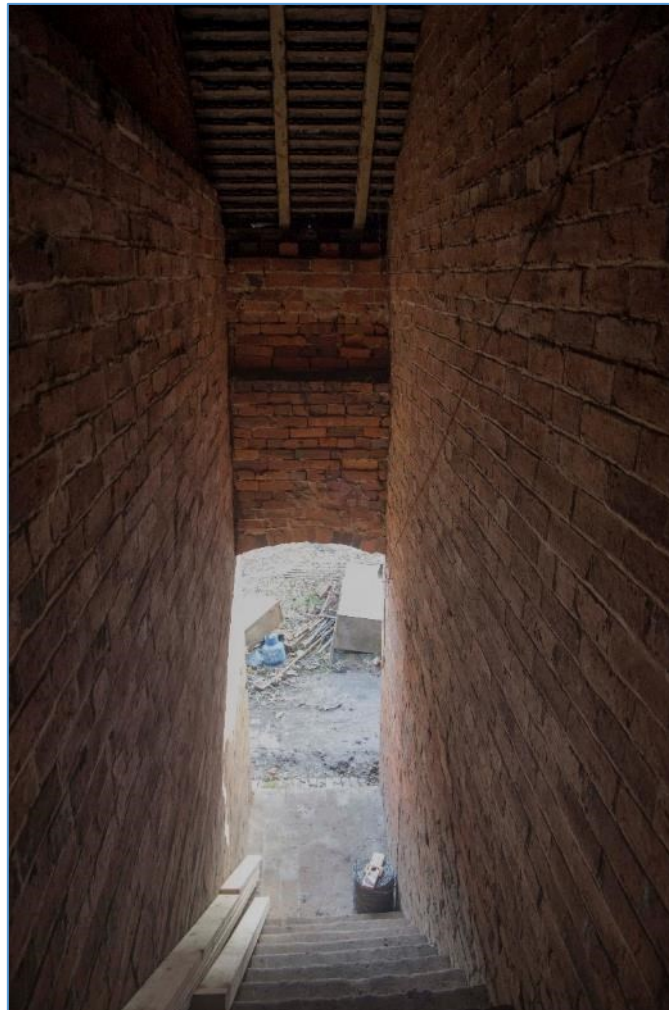
The west end is two storied with access to the upper floor via brick stairs (Figure 9). The floor of the upper story is machined deal, probably of the same date as the roof (Figure 11); it looks to be an insertion or replacement. A small section of floor (Figure 12) on the eastern side of the west end has earlier hand-sawn beams of much larger scantling.

*Figure 9 Block A. View down the stairs from the upper floor, looking south*

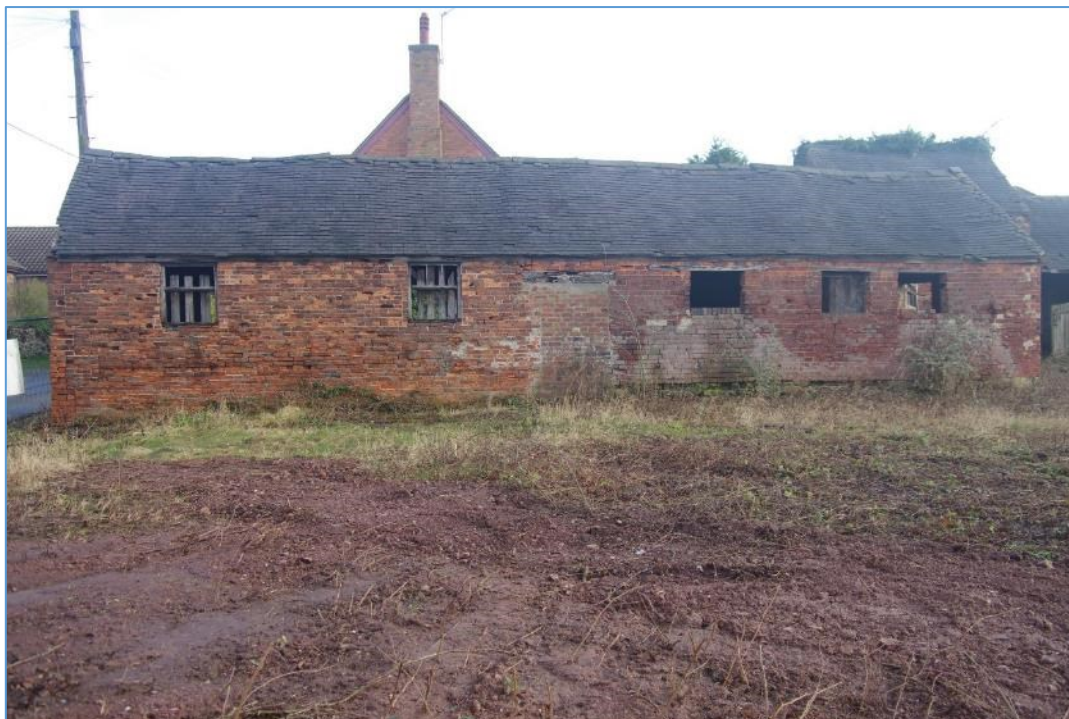
Block B appears originally to have been two separate buildings: the north unit uses 18th-century style bricks whereas those of the south are probably early 19th century (Figure 15). At a later date the two were incorporated: the north gable rebuilt, the south unit heightened slightly (Figure 18) and a common rafter roof extended across the two, turning the gap in between into a covered passageway. The south unit has an intermittent stone plinth. The southern end has an odd geometry with a chamfer on the west wall corner, and south gable at an angle to the side walls, presumably to fit in with some obstacle which has since disappeared.

Figure 15 Block B. North unit to left. The blocked central opening indicates the original gap between the two units

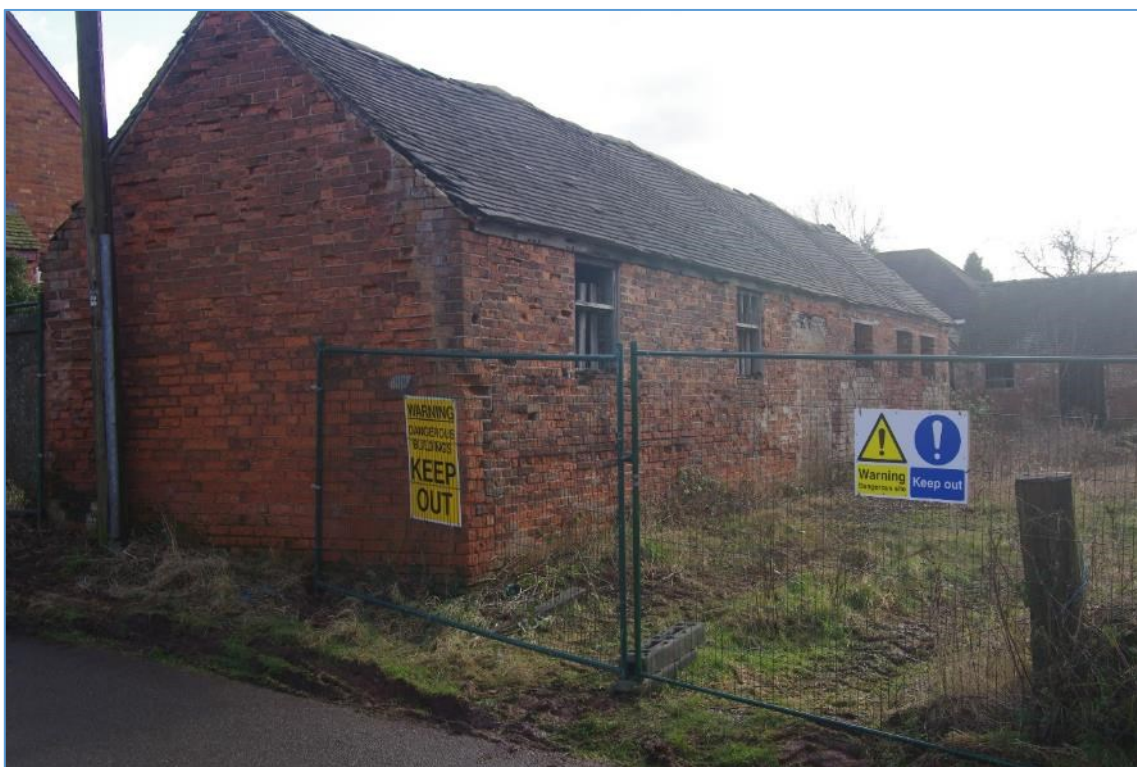
Figure 16 Block B looking south-east. Note rebuilt gable end

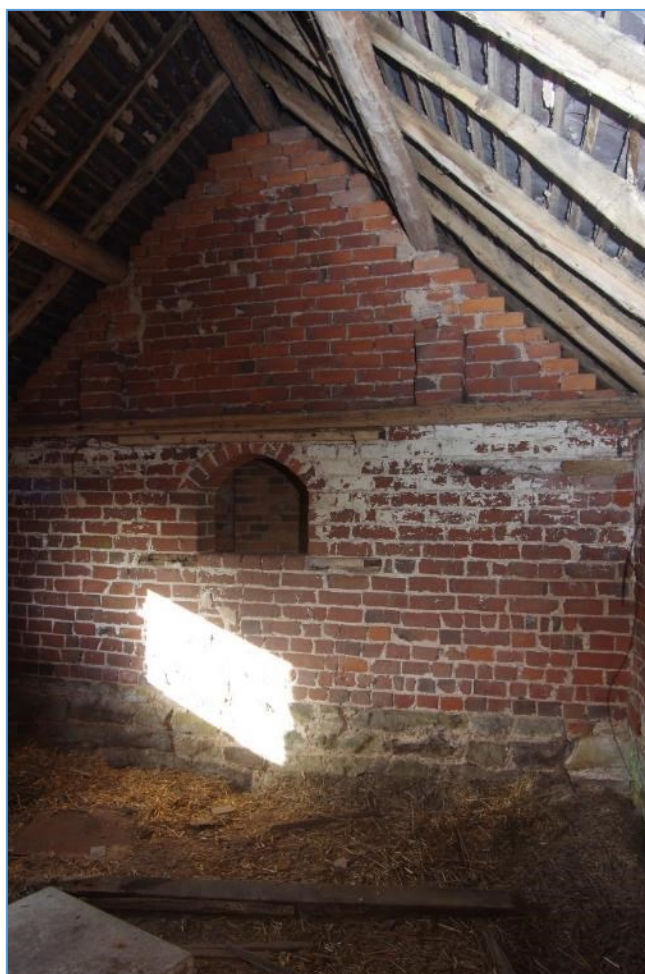
*Figure 18 Block B South unit looking north towards original gable end. Note heightened gable and small brick pillars which would have supported the purlins of the original roofline*

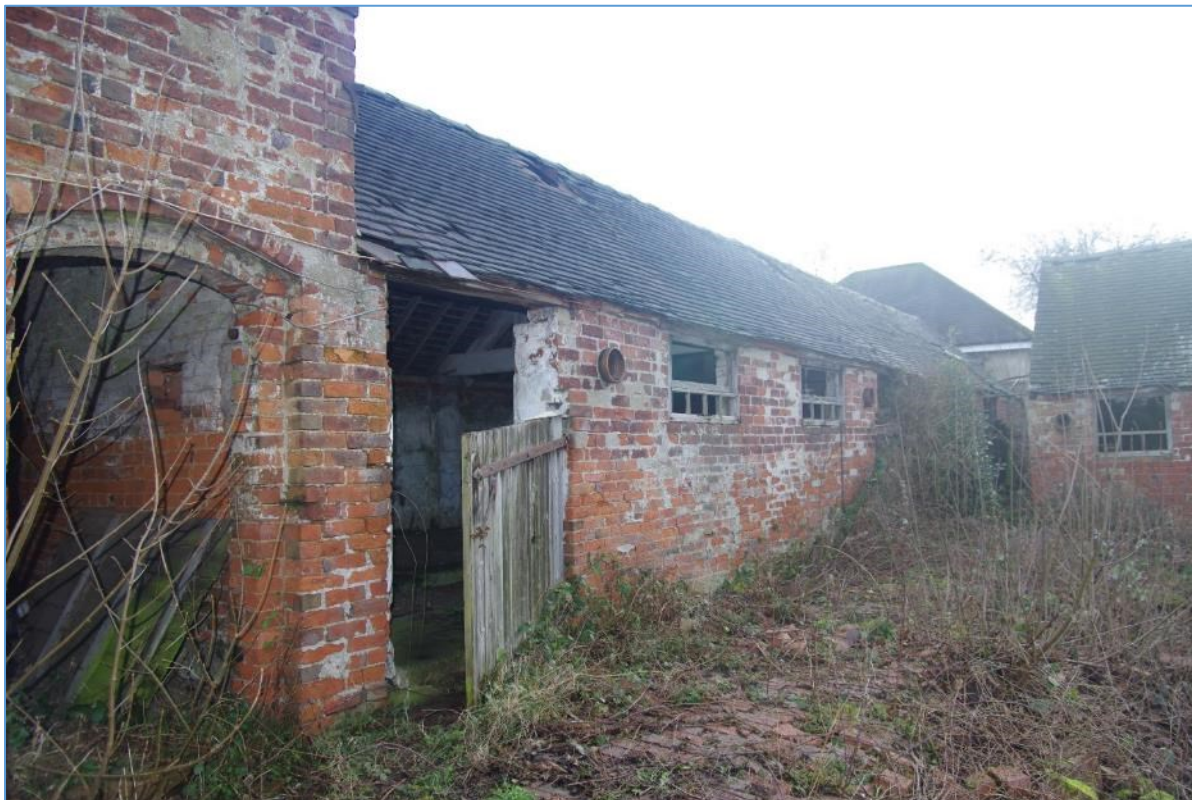
*Figure 20 Block C west elevation looking south-east*

Block C comprises two units. To the north is a tall sub square unit (Figure 17, Figure 20, Figure 21). This appears to have started life as a single storey building of probable 18th century. It was subsequently heightened to allow space for another storey, and there is an opening high up in the north gable, but there is little indication that any floor has been removed and so if it were two storey, perhaps a free-standing platform arrangement was used. The roof is common rafter.

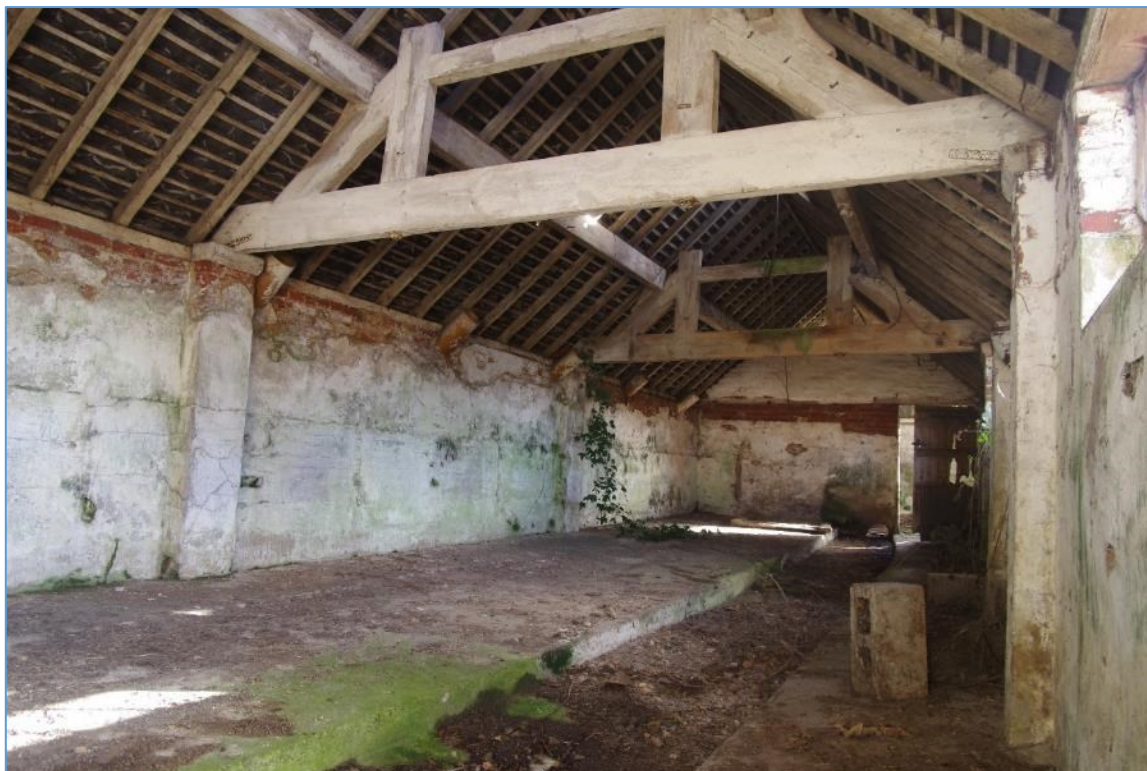
To the south is a cow parlour (Figure 22), vented with pipes inserted through the walls at eaves level. Two queen strut trusses of heavy scantling sit on brick pilasters, supporting purlins which are cleated and semi trenched into them. The southern end has a separate loose-box style unit with a surviving stall and feed rack.

*Figure 22 Block C central, looking south-east*

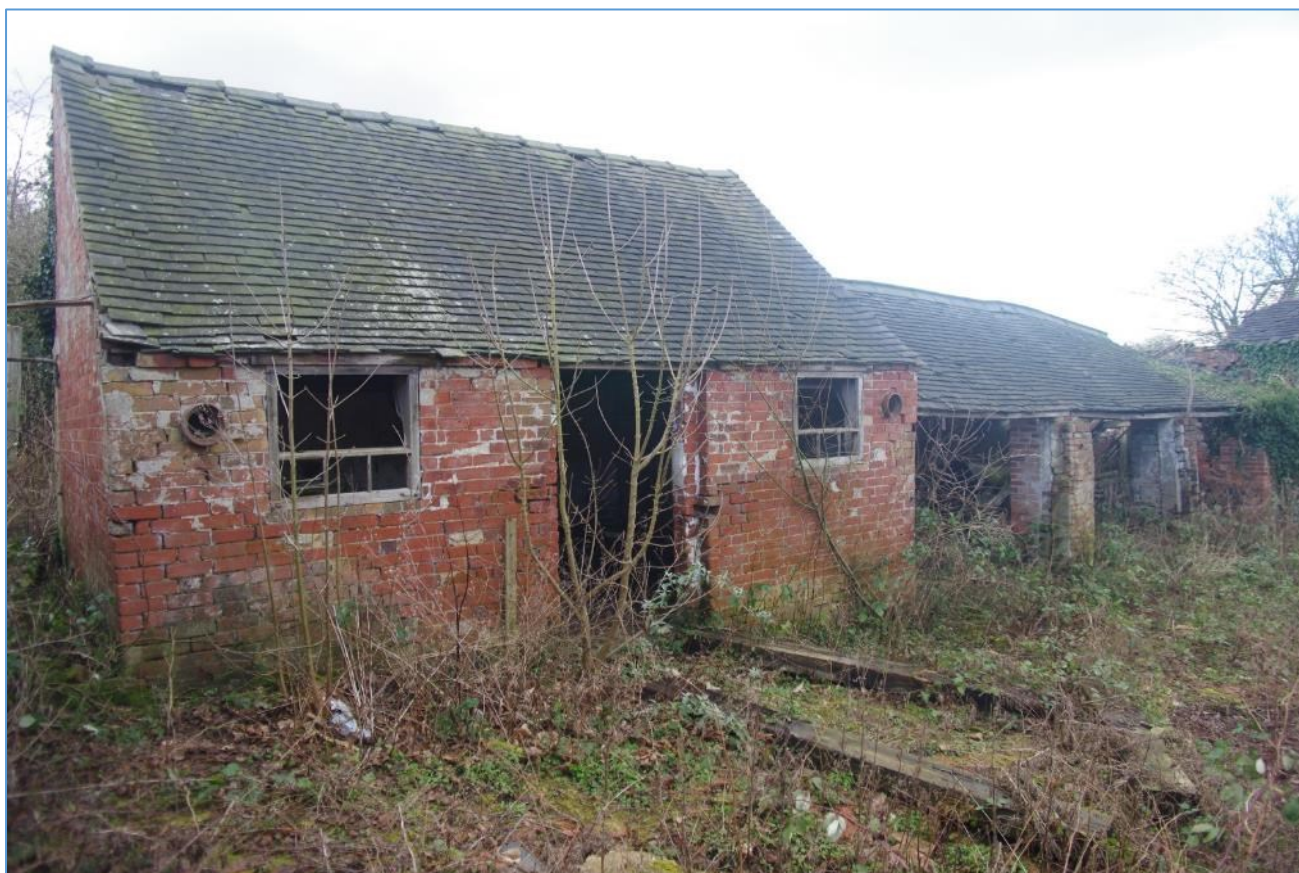
Block D (Figure 24) comprises two separate units, a smaller animal house to the east (Figure 25), later 19th century, also with vents at the eaves, and queen strut trusses very similar to the ones in block C except that the purlins are more trenched into the back of the truss and the cleats omitted. Also of note is the use of bullnose brick at the entrance which is an indication that this is a slightly later build than block C. Adjacent and to the west, another unit (Figure 26) is semi-derelict. The roof is supported on king post trusses, bolted through the tiebeam, with the purlins sat on cleats. The tiebeams are sat on the wall plate to the rear, but at the front brick pillars have been added to the inside of the original wall line to help support the tiebeam. The explanation may be that this building, being vented and whitewashed, started off as a cow parlour, but got converted into an open front cart/equipment barn with the increase in mechanisation.

*Figure 24 Block D looking south west*

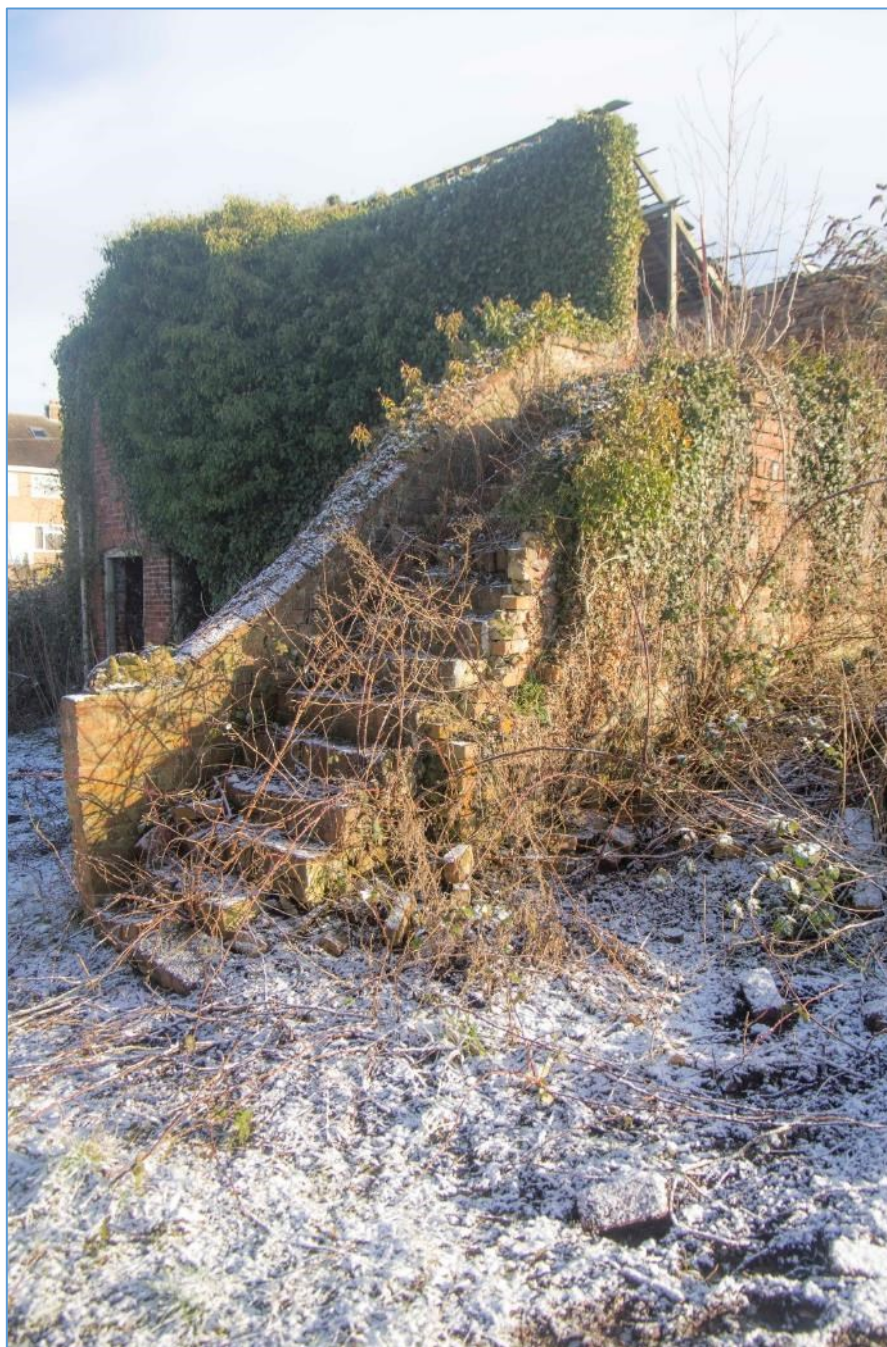
Block E (Figure 27 - Figure 31) is a unit of four stables, with probable haylofts over (there is no safe access into the upper floor), accessed by external stairs. The stall at the north end is still in reasonable condition but water damage gets progressively worse towards the southern end, which is derelict.

*Figure 27 Block E looking north*

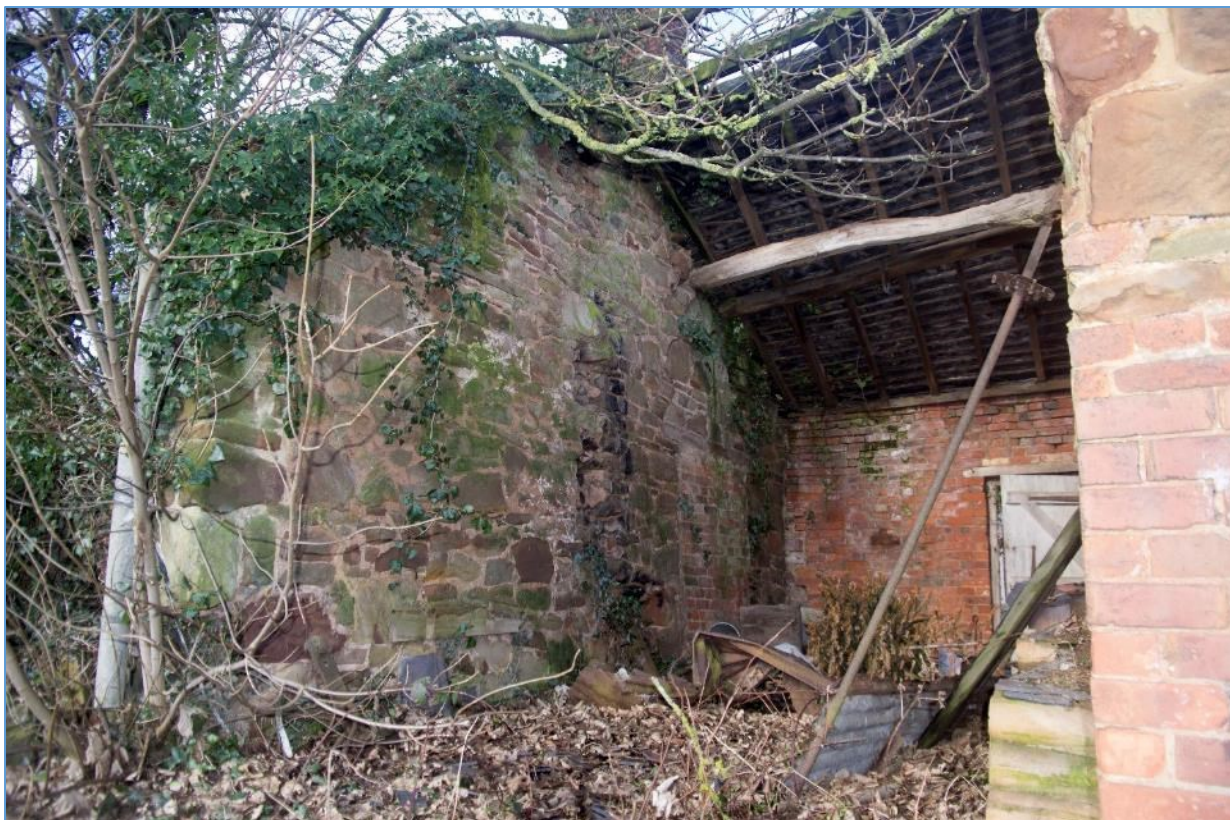
floor. The roof structure was the usual machine-cut deal, but there seems to be a (presumably earlier) purlin left in-situ at the west end (Figure 34). Also at the west end a vertical run of blackened stone may indicate the position of a removed flue. A short run of masonry comes off the south west corner, and although the building would make slightly more sense were the cell structure at the east end replicated at the west, clearly nothing has been removed from the north-west corner, and moreover nothing was seen in the evaluation trench previously excavated here (ULAS Report No. 2018-028). Little useful can be said about this structure except that the provision of a trough implies use by animals at some stage in its life.

*Figure 34 Block F, west end, looking north-west. Note purlin, and possible course of flue*

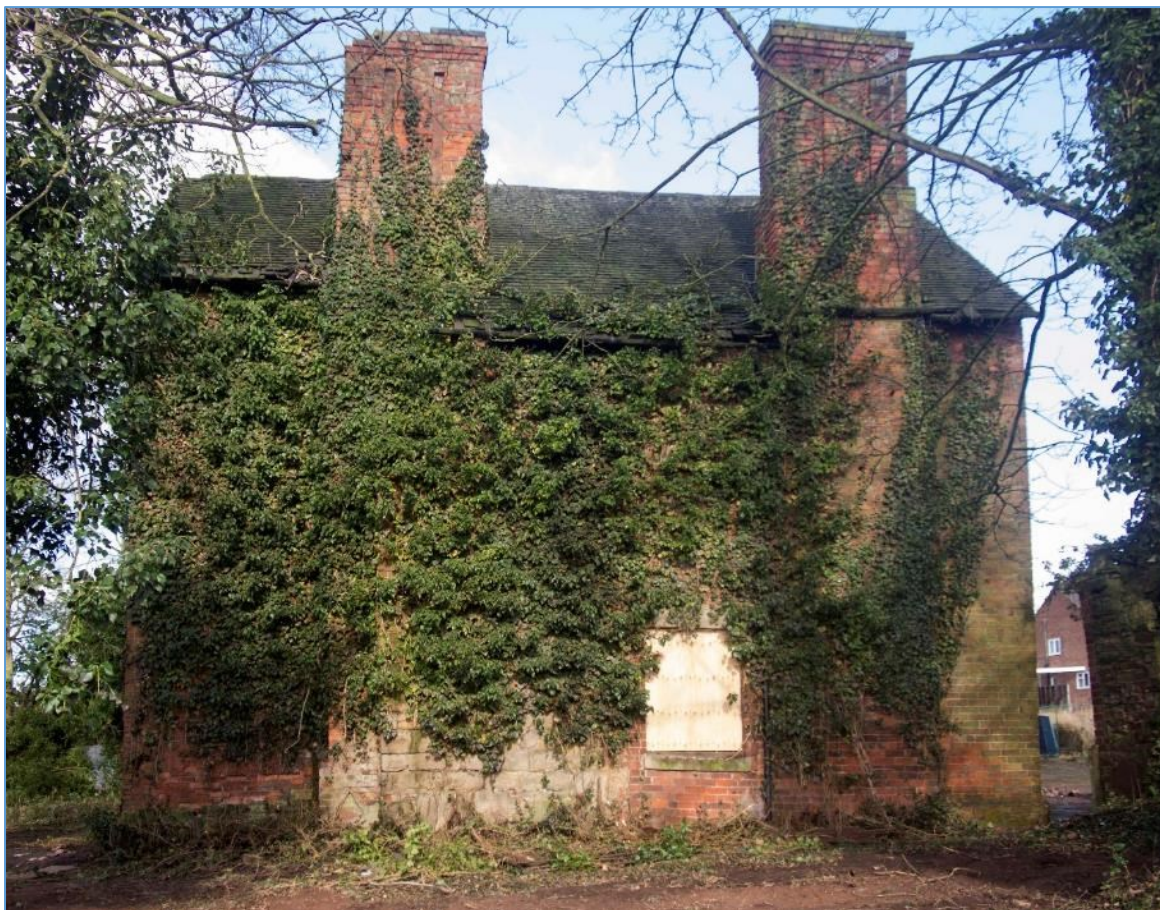
The south elevation (Figure 41) is mostly obscured by ivy, but of note is that the south west stack, or at least its lower portion, is masonry, and moreover the south-west corner has what appears to be earlier brickwork up to head height. Moving around this south-west corner, it can be seen that where the brickwork looks older, the building sits on a stone plinth, whereas the more recent brickwork sits on a brick plinth (Figure 42). The main part of the house has bricks of 24 x 7 cm length x height, the southwest corner 23 x 5 cm length x height, although this is an average as they are irregular.

*Figure 41 South elevation showing masonry stack base and earlier brickwork to left. Looking north*

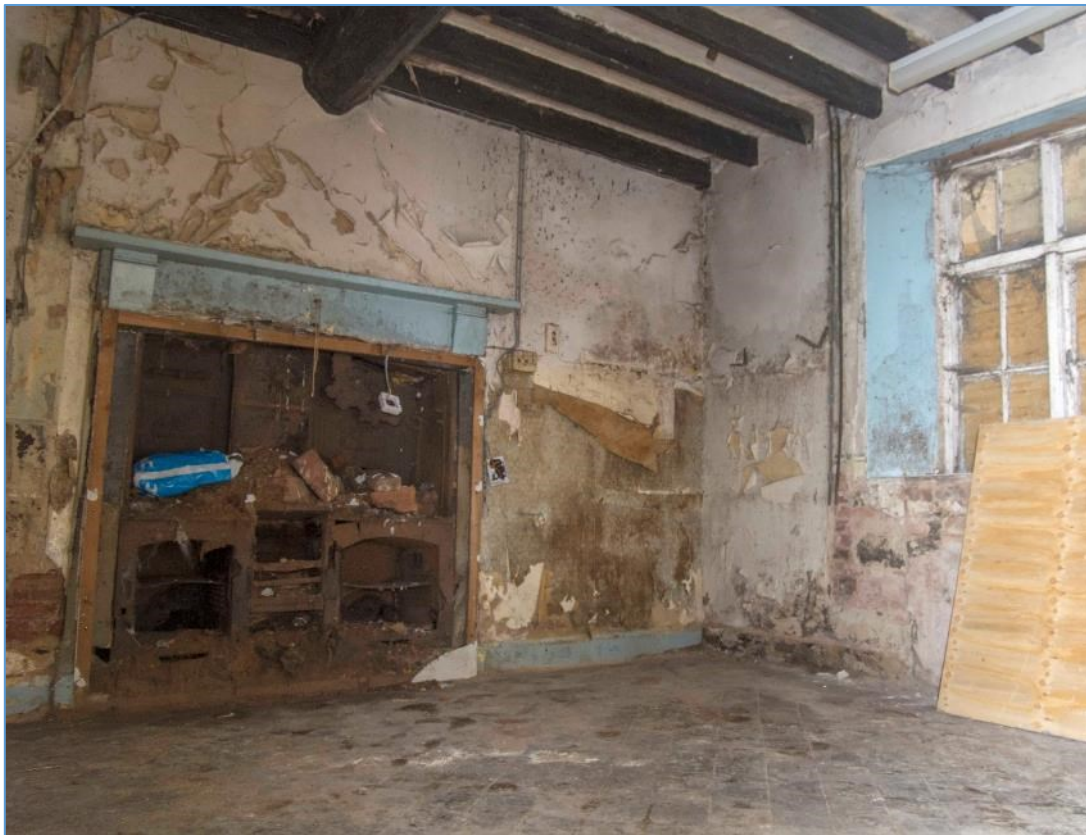
The room in the north-east corner was the kitchen, which looks out over the farmyard. A much decayed closed range (Figure 45) is set into one wall. The latches on the six-panel fielded door are likely to be original, and the servants bells still *in-situ*. The floor over is supported on a heavy axial beam with very wide chamfer, plain joists still have meat hooks (Figure 46).

Figure 45 Kitchen, looking north east

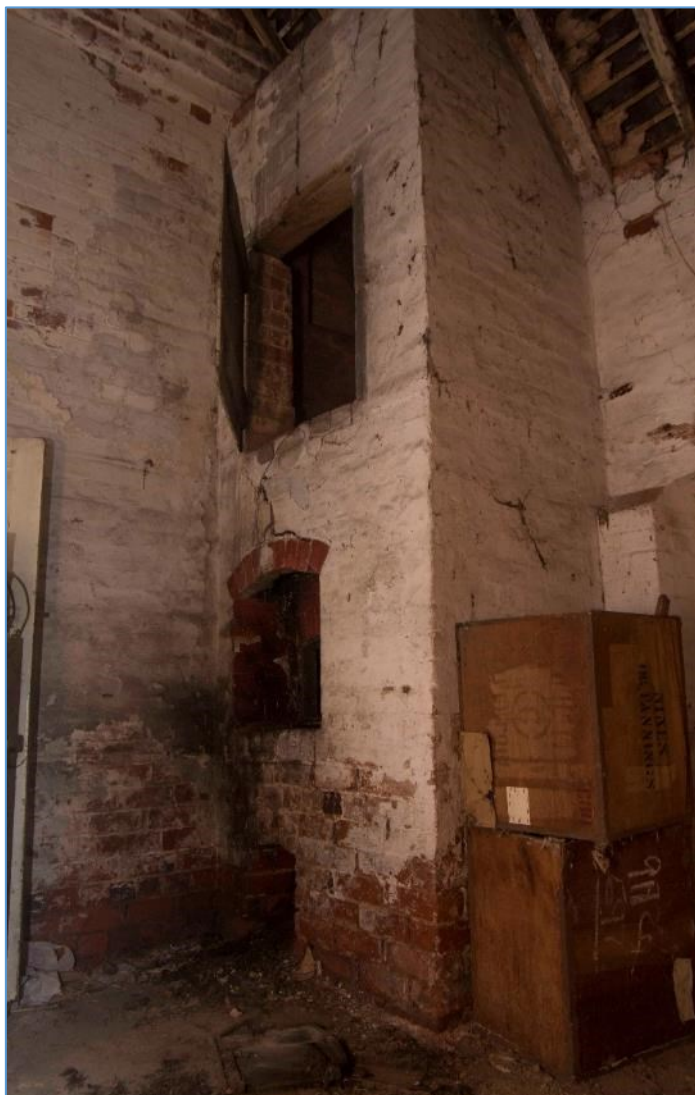
*Figure 50 Oven in bakehouse/scullery. Looking south west*

The scullery/bakehouse has an oven (Figure 50) in the south west corner, probably for bread; it is a domed affair lined with firebrick. The large door in the stack above could have been for access to an arrangement for smoking meat in the flue. In addition another range (Figure 52) sits on the north wall.

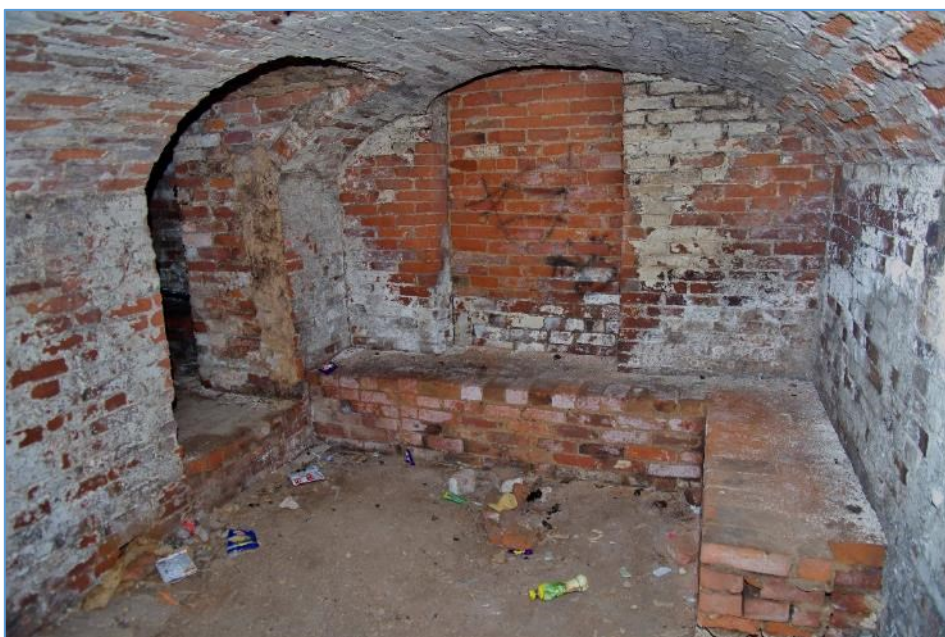
The cellar (Figure 65, Figure 66) is accessed via a four panelled door in the hallway. Descending some very worn brick steps, the two rooms occupy the space under the front of the hallway, and the south-west corner. The ceilings are brick vaults, and much of the construction uses the older-looking early 18th-century style bricks, although the thralls and the supporting wall down the side of the stairs appear to be 19th century. The southern room has what looks like a blocked coal chute set into the west wall, and has curious blocking apparent along part of the east wall, as though there may have been another room.

*Figure 66 Cellar, beneath reception room, looking east. Note blocking to rear wall*
