**A Photographic Survey of  
16-22 Churchgate, Leicester  
NGR: SK 589 059**

Andrew Hyam  
June 2005

*Planning Application Ref: 204/0808  
Client: Corporate Architecture Limited.*

Report No. 2005-072 © 2005

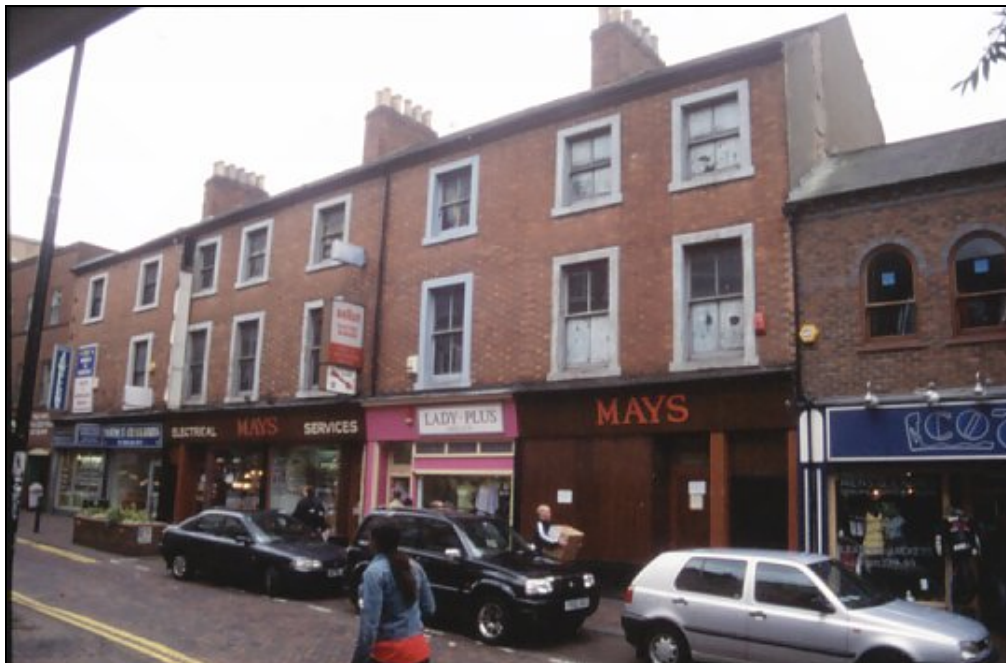
Plate 1. 12-22 Churchgate.

The site forms part of a larger terrace of six properties numbering from 12 to 22 Churchgate each of which consists of three stories plus a basement (figs. 3-8). Numbers 16 and 22 have wider frontages so that they have pairs of windows on the first and second floors compared to the single windows of the remaining four properties (plates 1 and 2).

Far left No. 22 (single window), No. 14 (single), No. 16 (double windows), No. 18 (single), No. 20 (single), far right No. 22 (double).

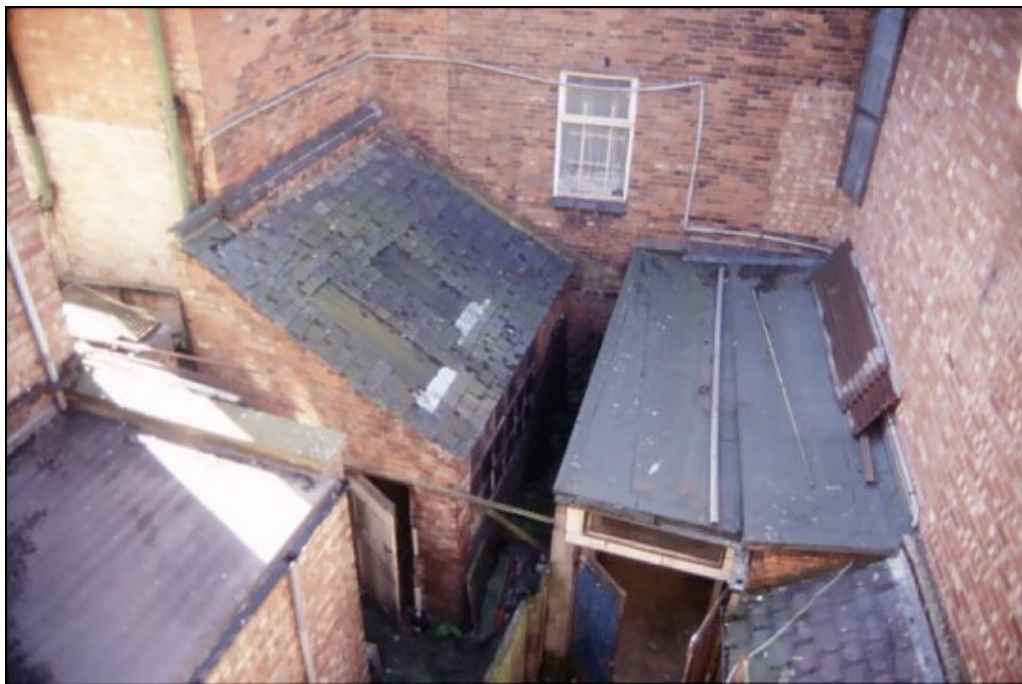
The backyard, paved with brick, contains a number of single story outhouses attached to the rear of the property and to the western boundary of the site (plate 3). The earliest appear to be contemporary with the main building and are constructed of brick with pitched welsh slate roofs and would have served as toilets and workshops. Later 20th century additions include brick and breeze-block workshops, one of which bears a notice restricting its use solely for Mr May, the founder of the Mays shops that most recently occupied numbers 16, 18 and 22.

Plate 3. Outbuildings to the rear of the property.

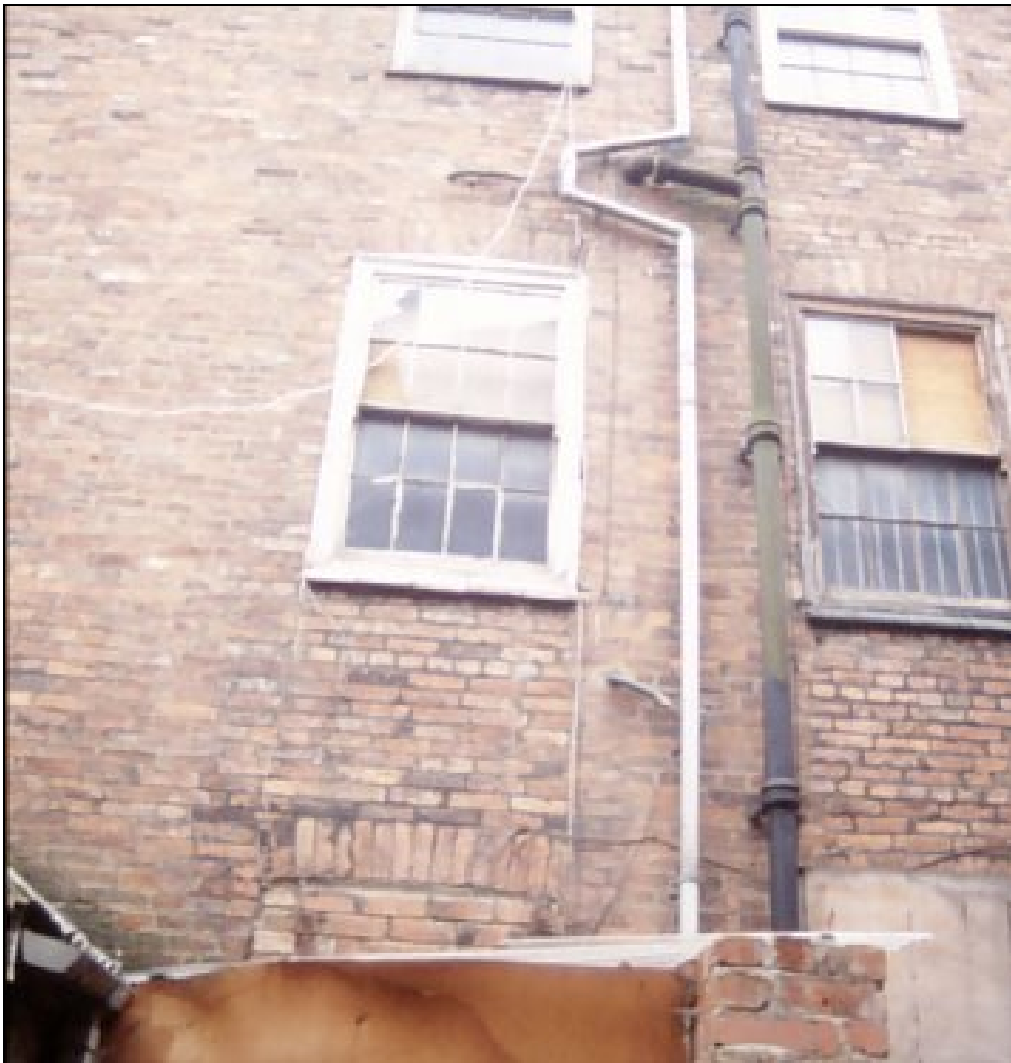
The back of the property is constructed of brick measuring 9 x 4¼ x 3 inches (229 x 108 x 76mm). The bricks are laid in English Garden Wall bond with typically five courses of stretchers between header courses, no coloured pattern has been attempted as on the front. A single exposed box sash window with 8 x 8 panes allows light to each floor of each property (plate 4). The windows have a thin blue brick coped sill with timber infill between the frame and the arches formed by brick headers. The ground floor windows of numbers 20 and 22 have been blocked using 20th century bricks whilst the ground and first floor windows of 16 and 18 have been removed following the construction of the modern extension mentioned above.

Plate 4. Rear elevation showing sash windows and blocked ground floor windows.

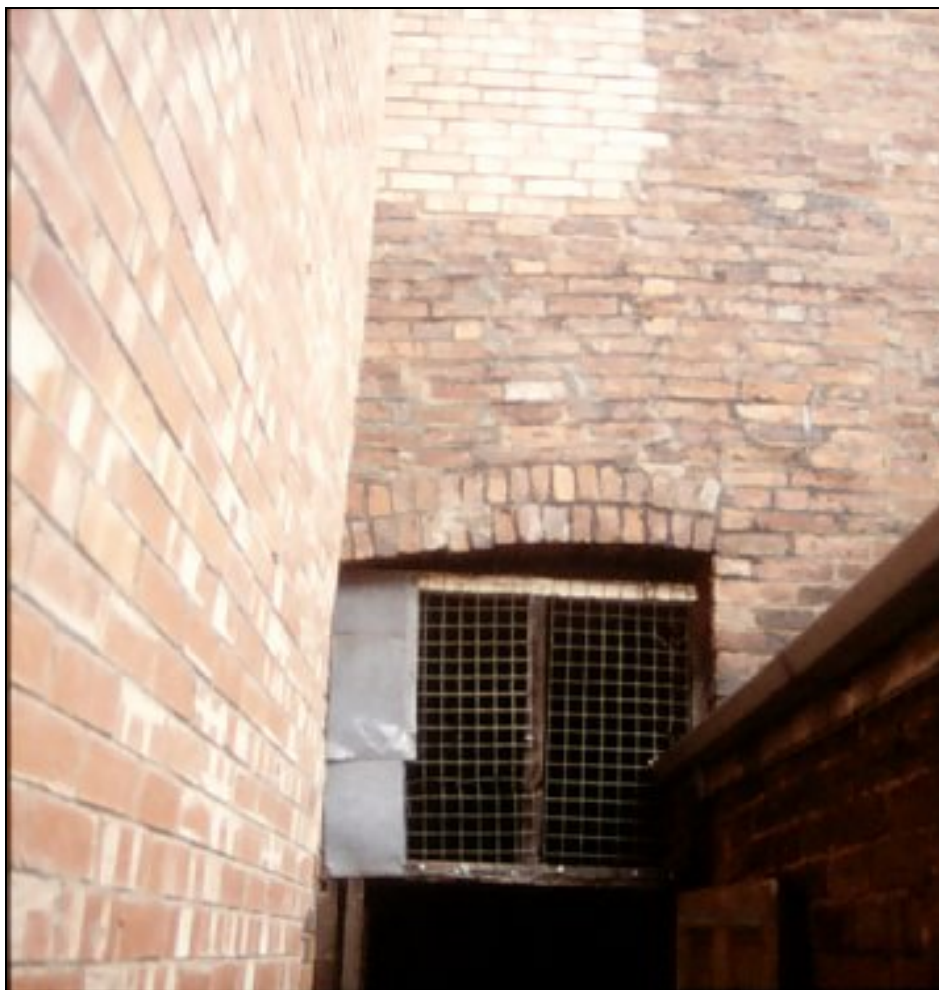
The passageway arch at the side of number 22 has settled under the weight of the building resulting in the rebuilding of the corner of the first and second floors (plate 5). The new bricks appear to be of late 20th century origin.

Plate 5. Settlement and rebuilding of the passageway arch of number 22.

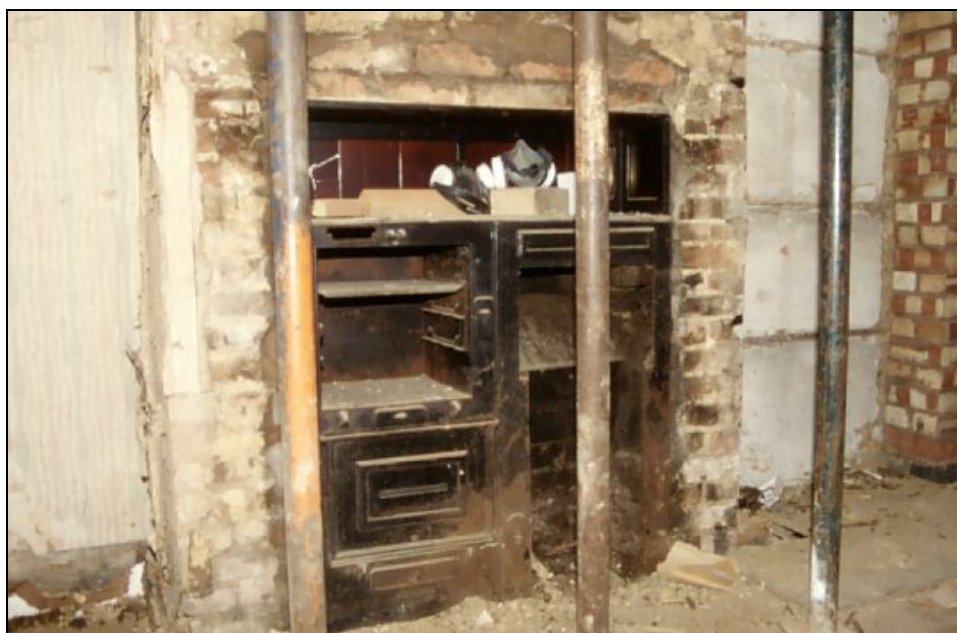
Plate 6. Remains of the ground floor range in the back room of No. 20

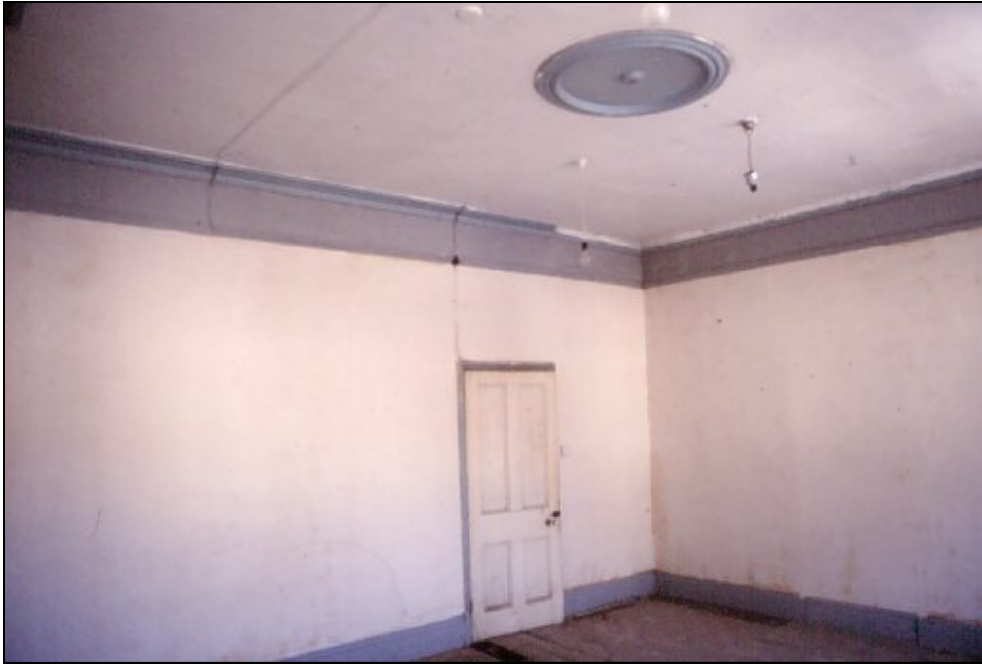
The front rooms on the first floor represent the principal living quarters and contain a number of additional decorative architectural details not included in other rooms or floors. These details include plaster architraves, cornices and ceiling roses (plate 7). Stylistically these features probably date to around 1880 or slightly earlier and would appear to be contemporary with the newer façade as discussed above. Additionally, the front rooms have rather more intricate skirting boards than those seen in the back room and landing which are, in their turn, more decorative than those on the ground and second floors (fig 9). These rooms are also the only rooms that have a picture rail. The doors into the first floor rooms are all four panelled with moulding on both sides and have sprung catch locks. Some of the back rooms have larger locks which are of a different design but a similar date. Large floor to ceiling cupboards in numbers 18 and 22 have four panelled doors with moulding on one side only, they also have sprung catch locks. The only two original fireplaces remaining unblocked are the rear fireplaces in 20 and 22 which are of similar date to the plaster decoration. The front fireplace of number 16 has been replaced with a modern 1950's version.

Plate 7. First floor front room of No. 22 with plaster decoration and panelled door.

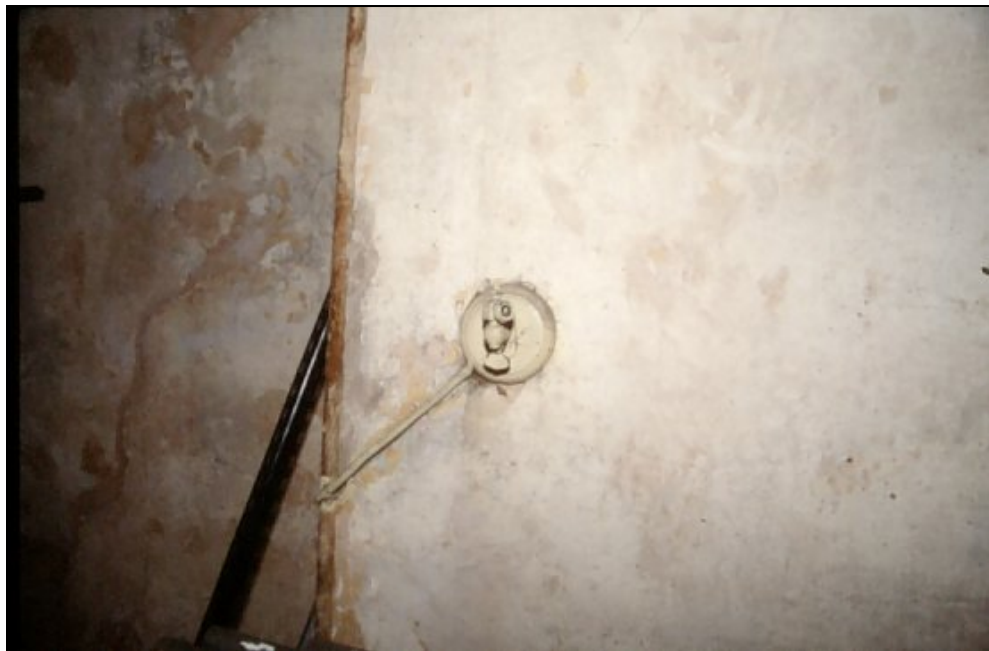
The rooms on the second floor are of noticeably lower status than on the first and do not have the plaster decoration or skirting boards mentioned above. Numbers 20 and 22 have cast-iron fireplaces in both rooms and, although they are of a similar style to those on the floor below, their surrounds are not as large or as decorative. The fireplace and surround in the rear room of 18 has been replaced by a 1930's style fire. None of the doors have decorative moulding but have the same spring catch locks seen on the first floor (plates 8 and 9). Most of these rooms appear to have been little used apart from storage for a number of years and some still have evidence of gas light fittings, one of which can be seen on the back room chimney breast of number

20 (plate 10). The back room of number 22 has been converted into a bathroom which also appears to have had little use for many years.

Plate 10. Gaslight fitting in No.20.

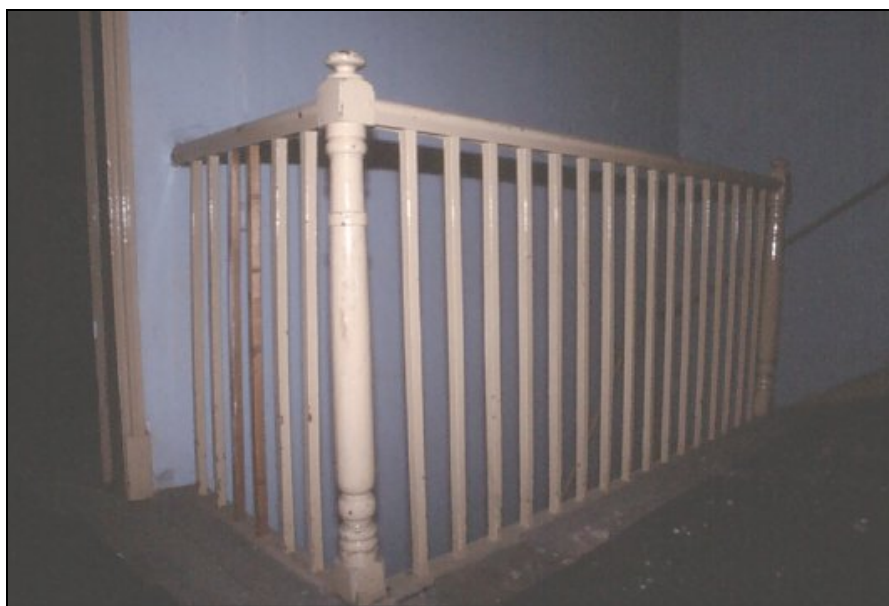
The rear windows of 16 and 18 have been enlarged to form doorways allowing entry into the modern extension. As well as having only one front window, and therefore being narrow, the front rooms of 18 and 20 are further reduced in size by the stairs to the second floor running between the front and back rooms (figs 7 and 8). The central position of the stairs means that the back rooms of all four properties are identical in size. The stairs from first to second floors in number 16 are partially open with a plain banister rail at second floor level. At numbers 18 and 22 the stairs are enclosed by the walls of the front and back room. A rather more decorative banister can be seen at number 22 which also has a matchboard clad landing (plate 11).

Plate 11. Second floor stairs. Banister and landing in No. 22.
