**A Level 2 Historic Building Survey and Heritage Statement for
The Old School, Church Lane,
Goadby, Leicestershire (SP 74999 98818)**

ULAS Report No. 2018-010

A Level 2 Historic Building Survey and Heritage Statement for The Old School, Church Lane, Goadby, Leicestershire (SP 74999 98818)

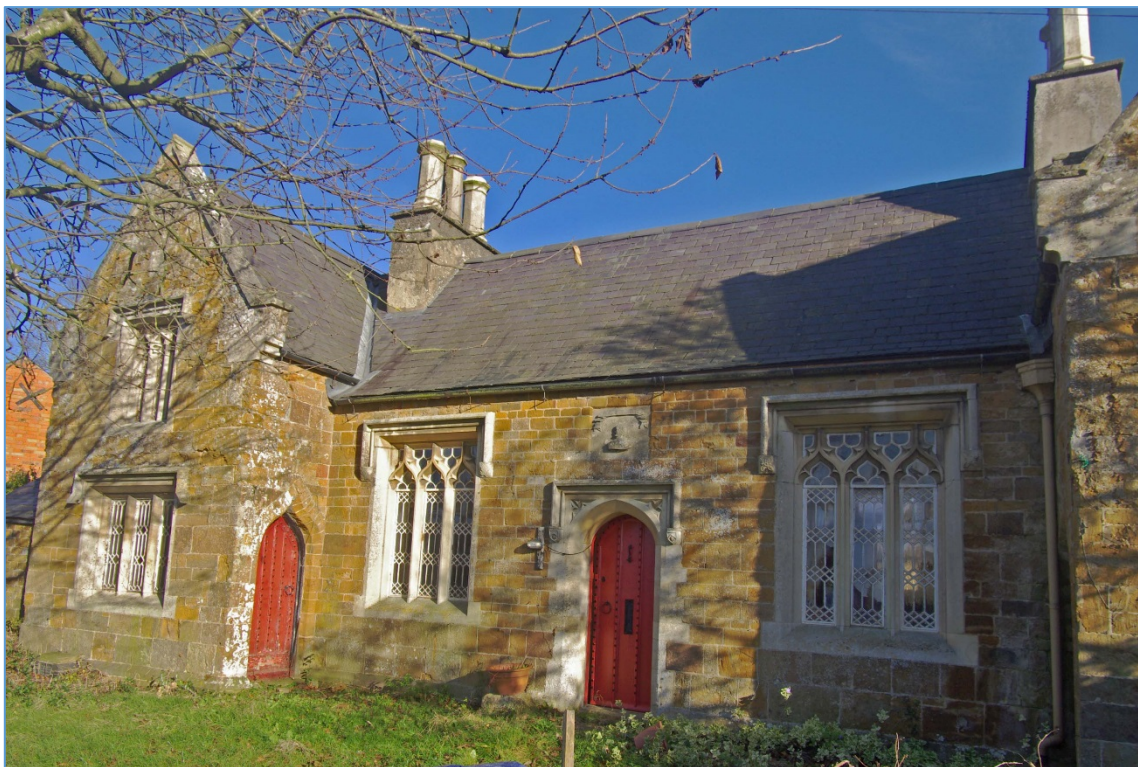
Figure 3 Main façade, looking north

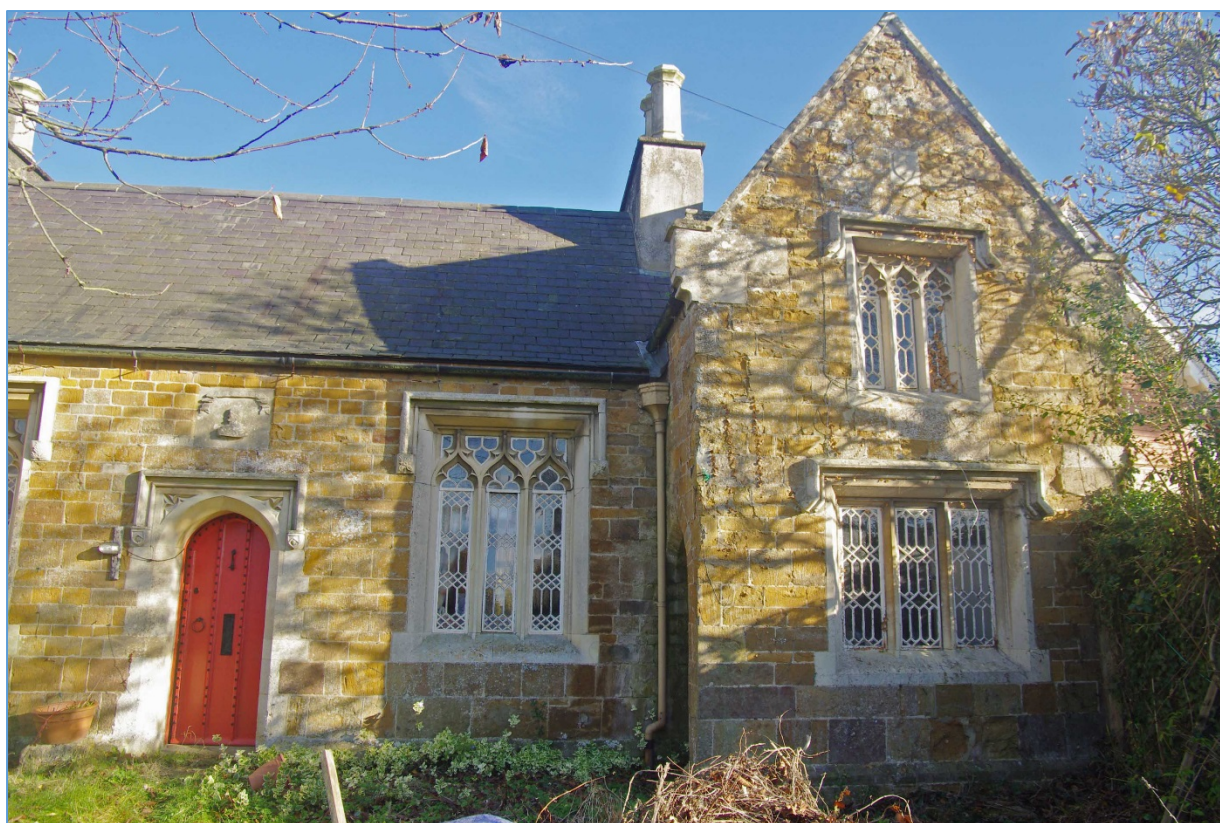
Figure 4 Main façade, looking north-east

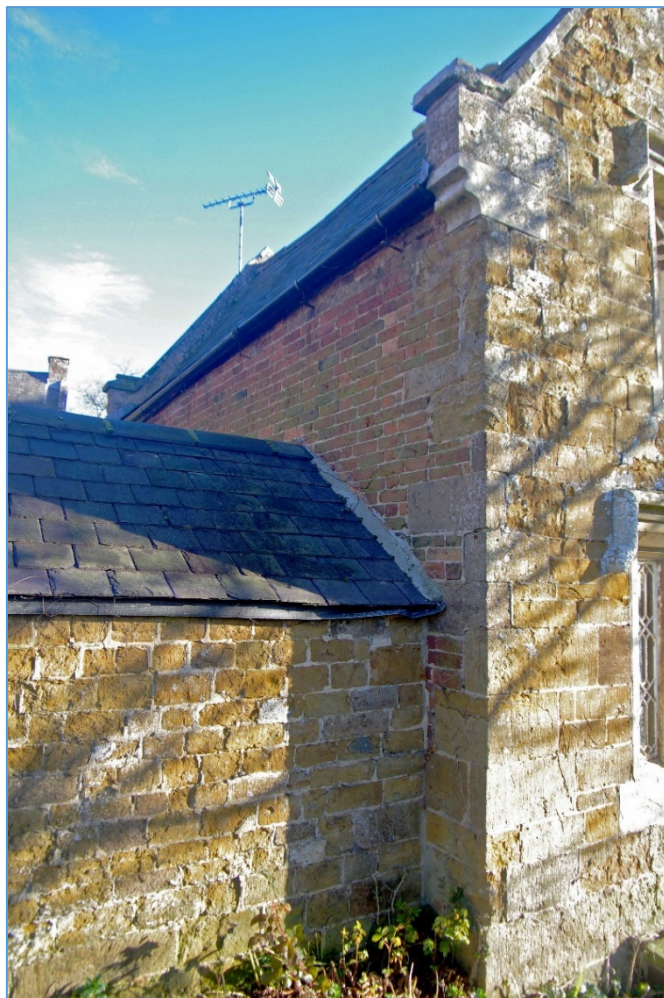
Figure 6 Junction of lean-to and façade, looking north-east

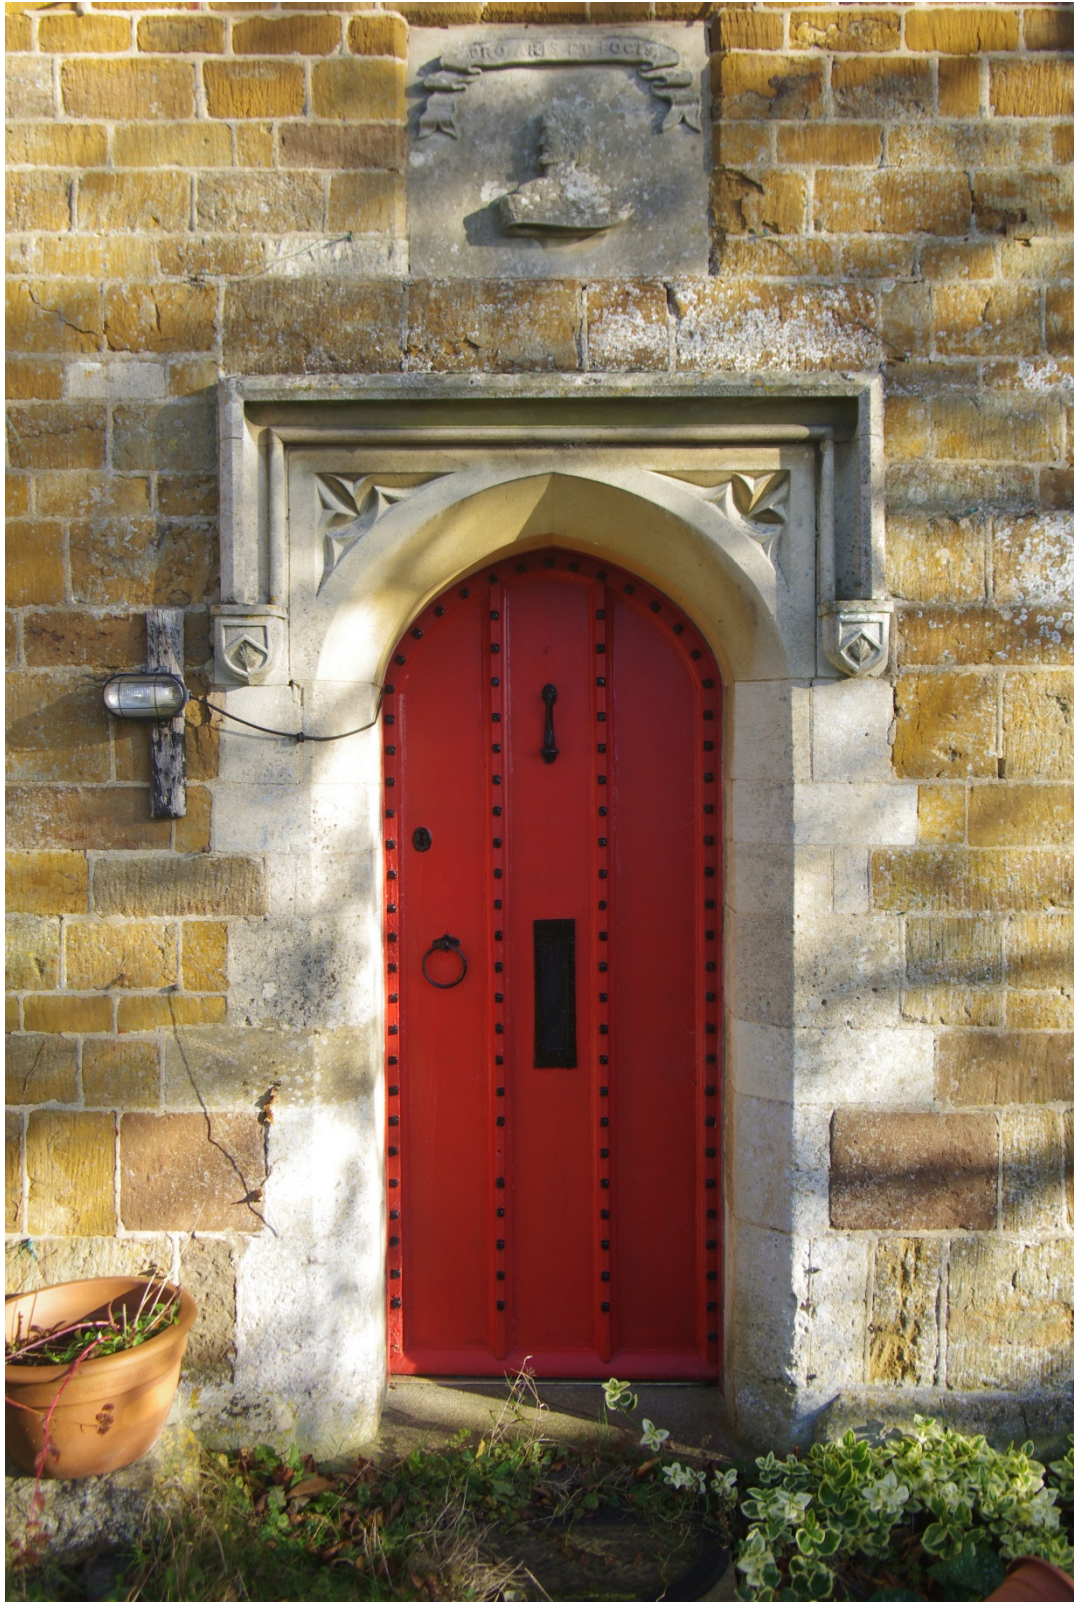
Figure 7 Central door

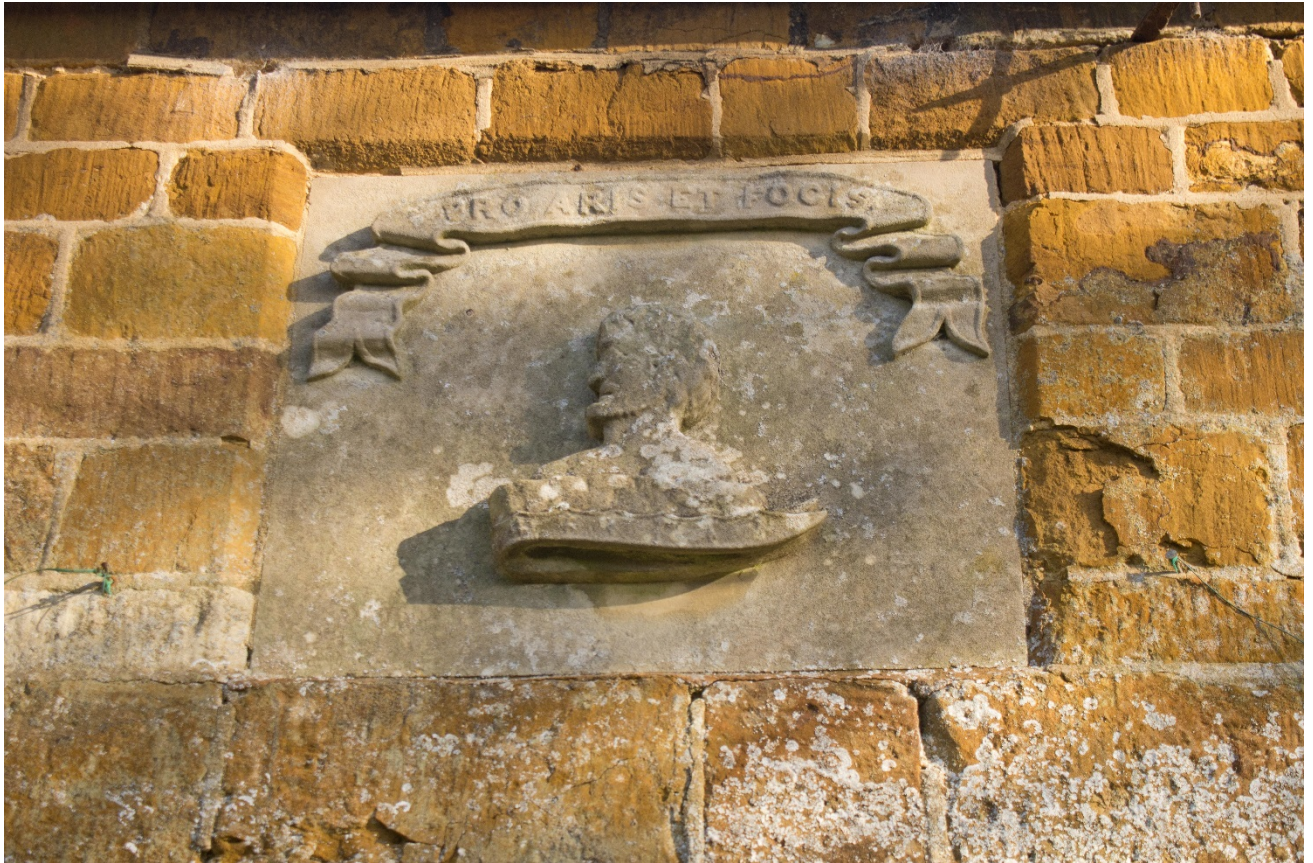
Above the central doorway (Figure 7) the motto (Figure 8) over the rather weathered bust reads '*pro aris et focis*'; although in the original it translates roughly as 'for hearth and home', by this period was more taken to mean 'for God and Country', and was a common military motto. The man who funded the school, Sir Arthur Hazlerigg, 12th Baronet of Noseley Hall, came from a family with a military tradition.

Figure 8 The motto reads Pro aris et focis

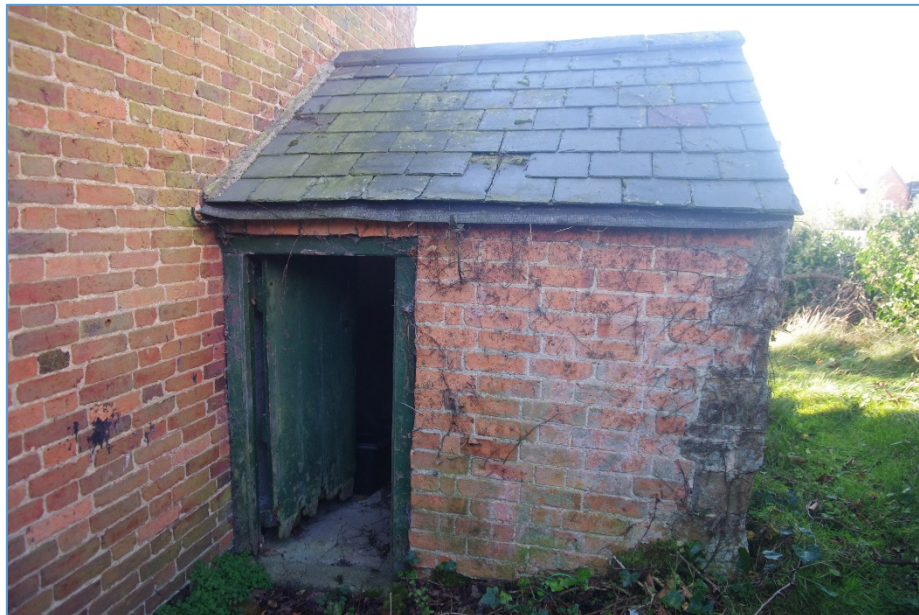
Externally, to the left hand side a small lean-to shed (Figure 9) has been added. The builders went to the trouble of using ironstone to the façade side to match the building, the rest is brick. There is a cramped yard area bordered by a range of single storey coal and storage sheds with corrugated roofs along the back boundary (Figure 12). A recent addition to the rear is the present bathroom block. The accommodation wing (Figure 13) has a rear door into the yard, and the other wing would have had another, judging by the now-blocked opening (Figure 11).

Figure 9 Lean-to, looking south

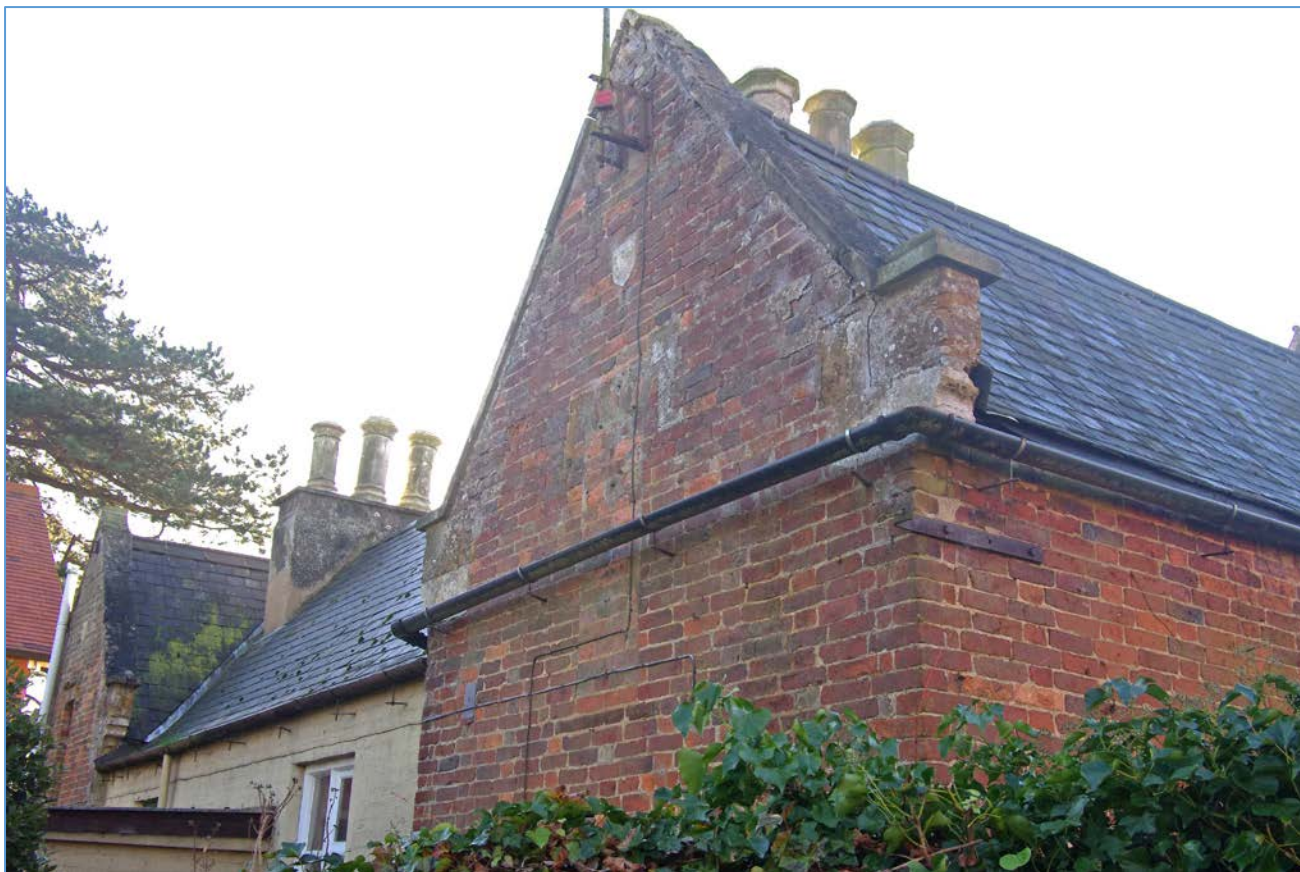
Figure 10 Rear, looking south, showing blocked window and removed hoodmould in nearest gable

Whilst there is a blocked-up window and removed hood to the first floor, using this evidence to infer the presence/absence of an upper chamber is problematic. If it were once an open hall, why would they bother to do this (the front one is not blocked)? Conversely, if it was a room, why do it at all – as the window would have provided much needed natural light? Notwithstanding all of this conjecture, it is considered that the insertion of an entirely new floor is a sensible alteration as it makes the building far more fit for habitation.’

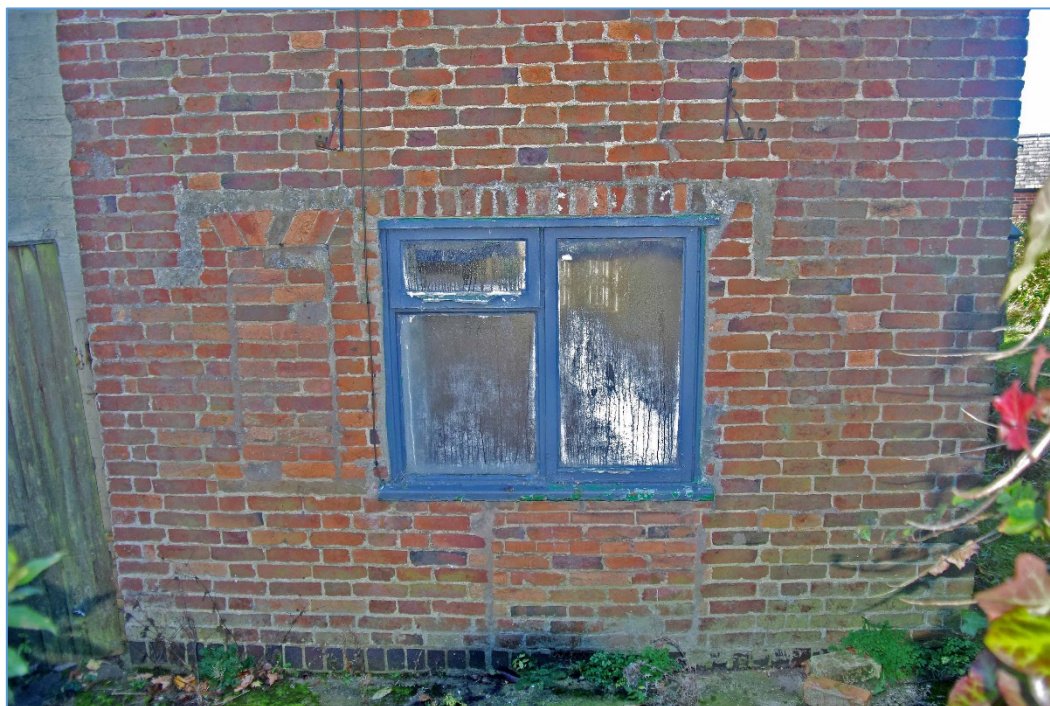
Figure 11 Blocked door and window, north-west wing

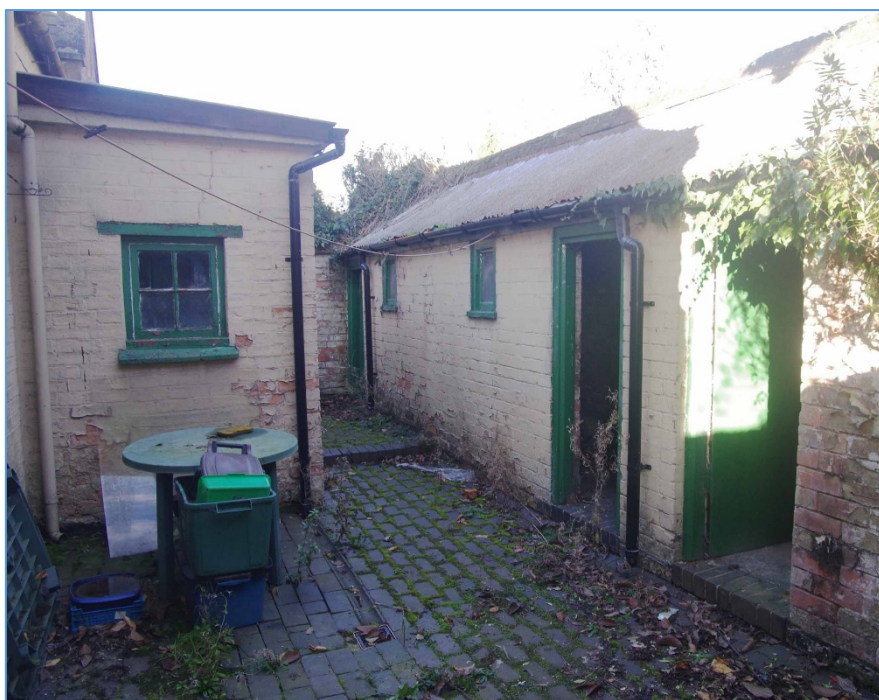
Figure 12 Rear yard, looking north-west. Added bathroom block to the left

These are not original, and would appear to be no great loss.

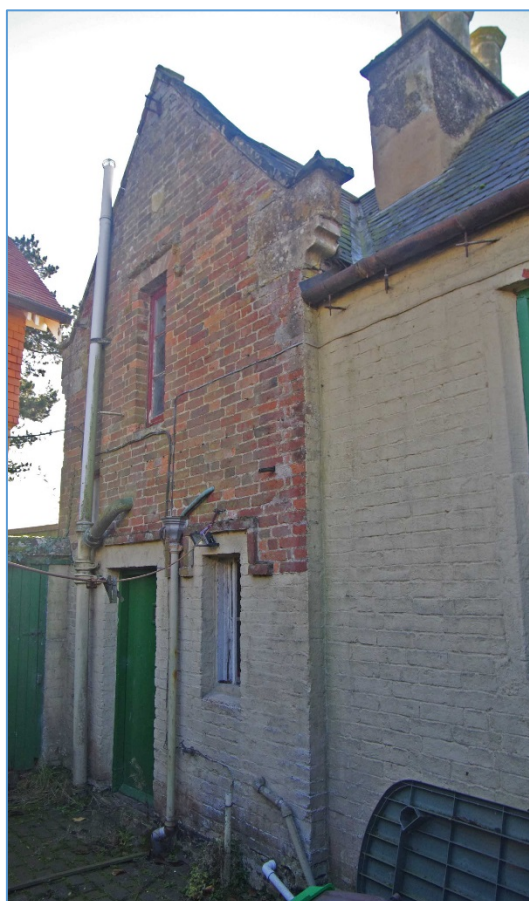
Figure 13 Rear of accommodation wing, looking south-east

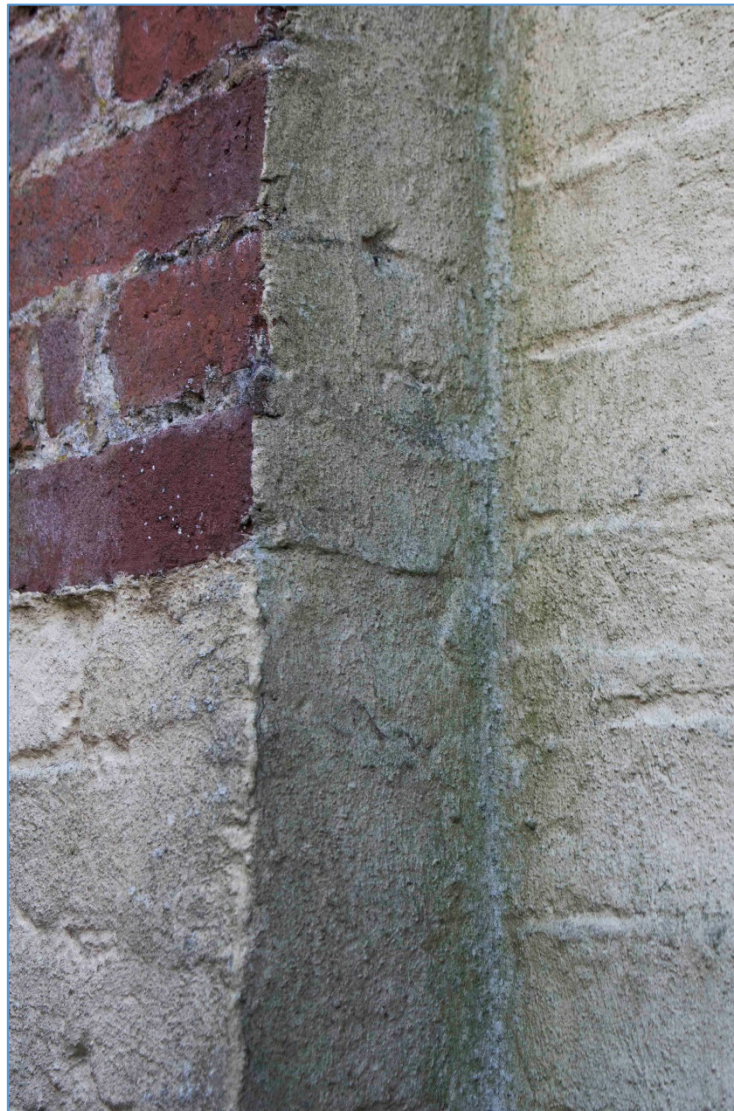
What is curious about the junction between the wings and the rear wall of the central range (Figure 14) is that they are not tied together; they are different thicknesses and must be separate

build. As the building makes little sense without this wall being present, the only explanations that occur to the author are that either this wall had to be re-built, or re-faced and thickened. There is some internal evidence for this, see below.

Figure 14 Junction of wing (left) and rear wall (right); detail

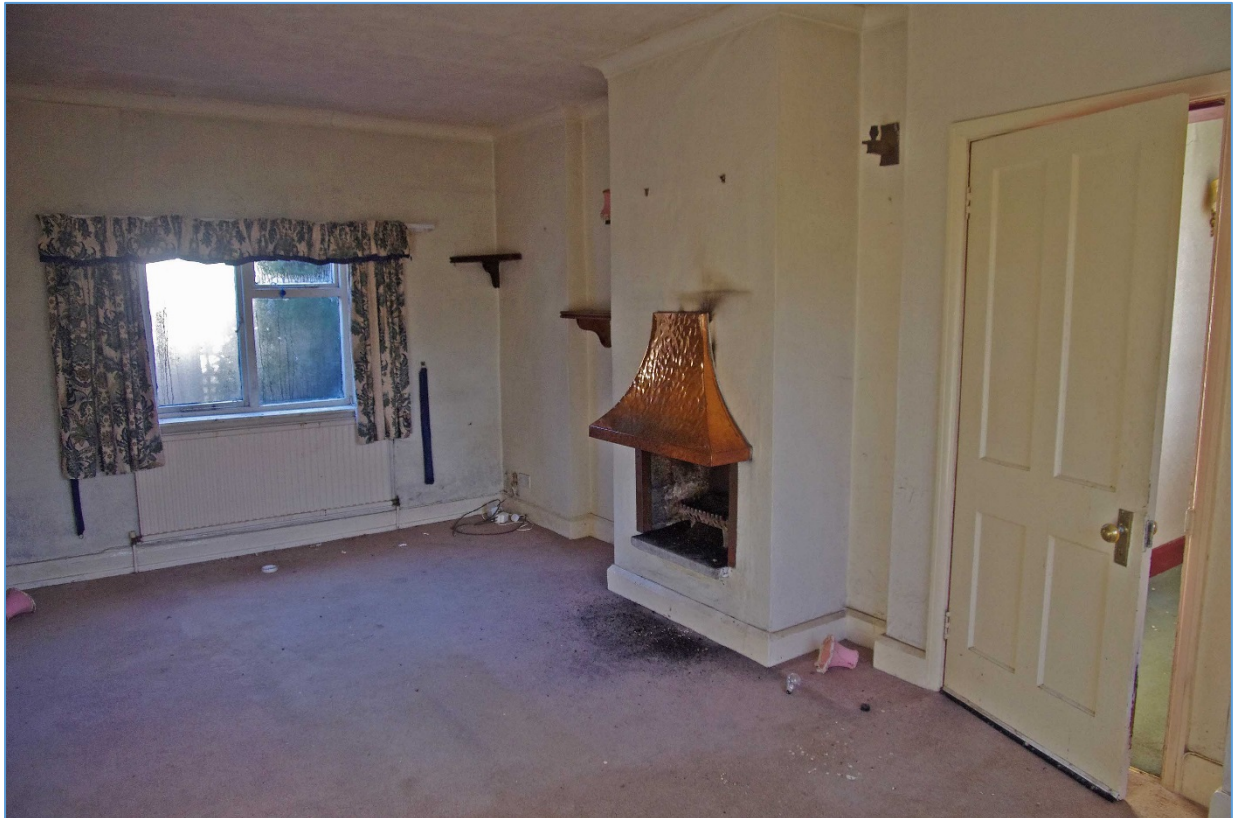
Figure 15 North-west wing ground floor, looking towards rear

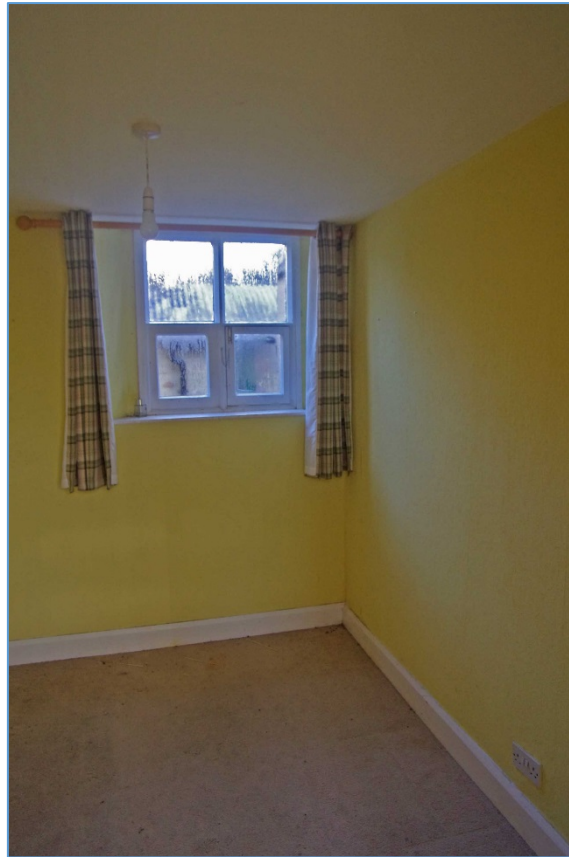
Figure 16 Bedroom adjacent to north-west wing, looking to rear

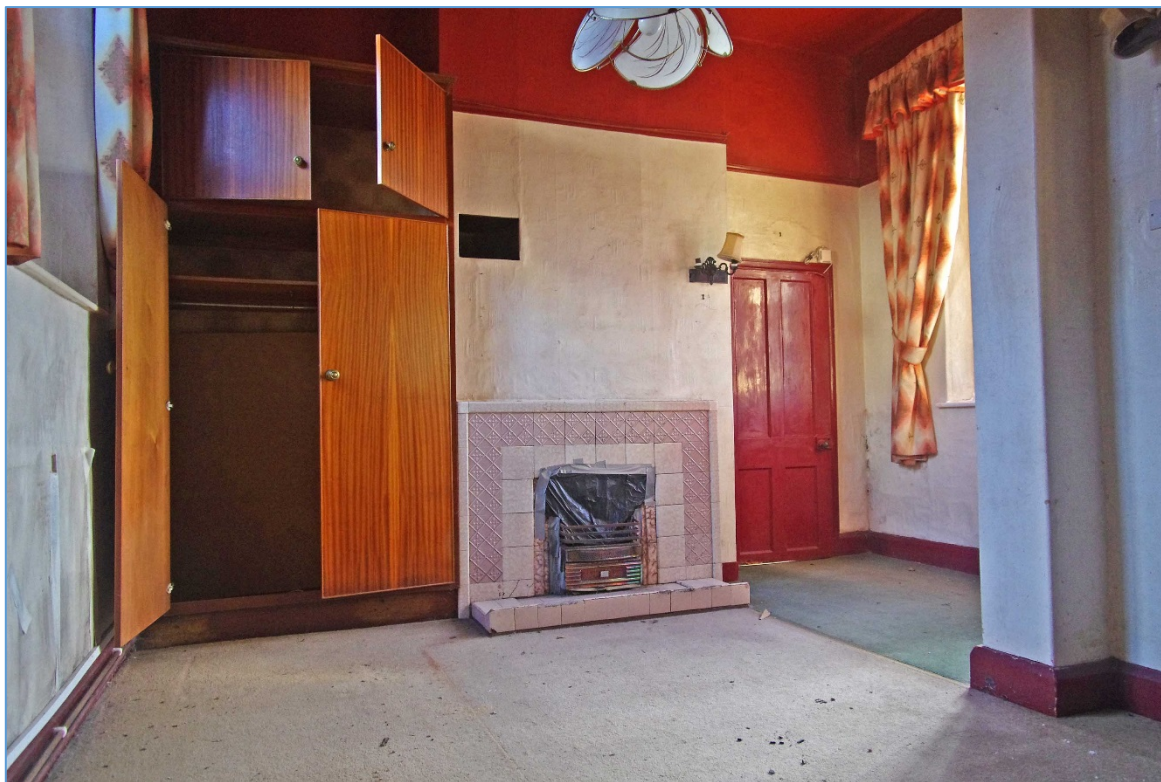
Figure 17 Central room, looking to south-east. Corridor wall to right. Note cut-down panel door into accommodation wing

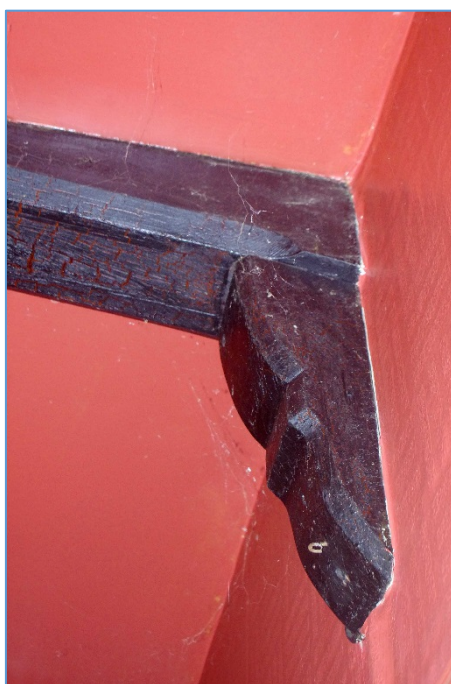
Figure 18 Chamfered and stopped foot of truss tie beam in rear wall

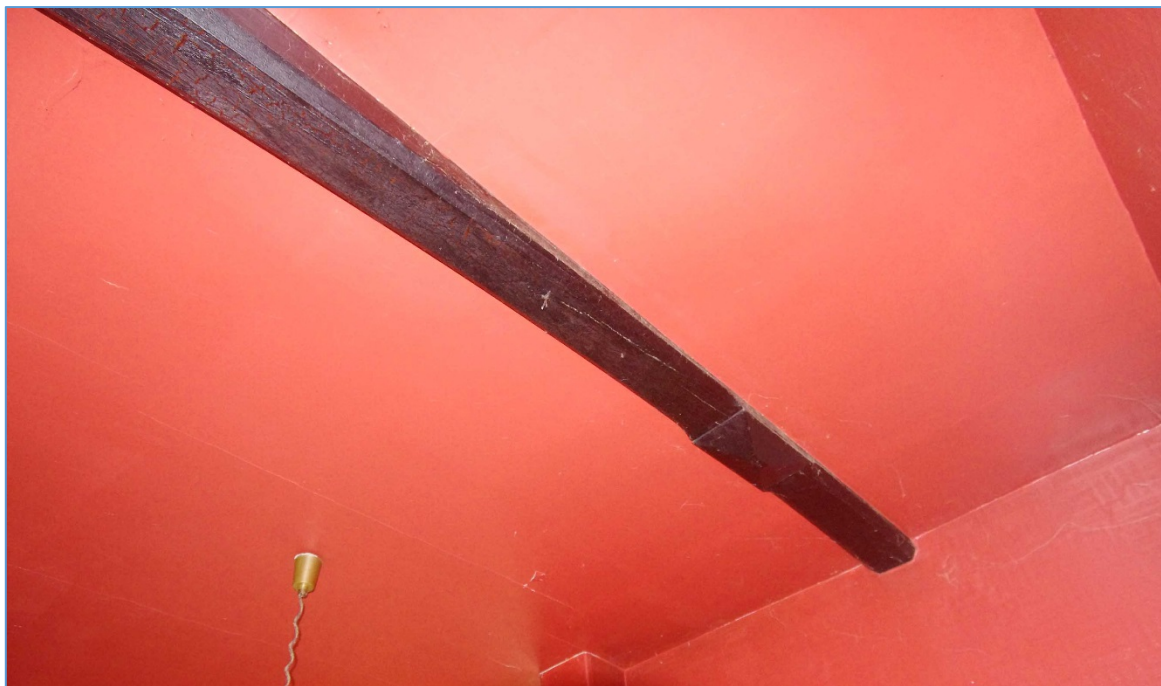
Figure 19 Underside of tie beam showing off-centre boss, disappearing into corridor wall

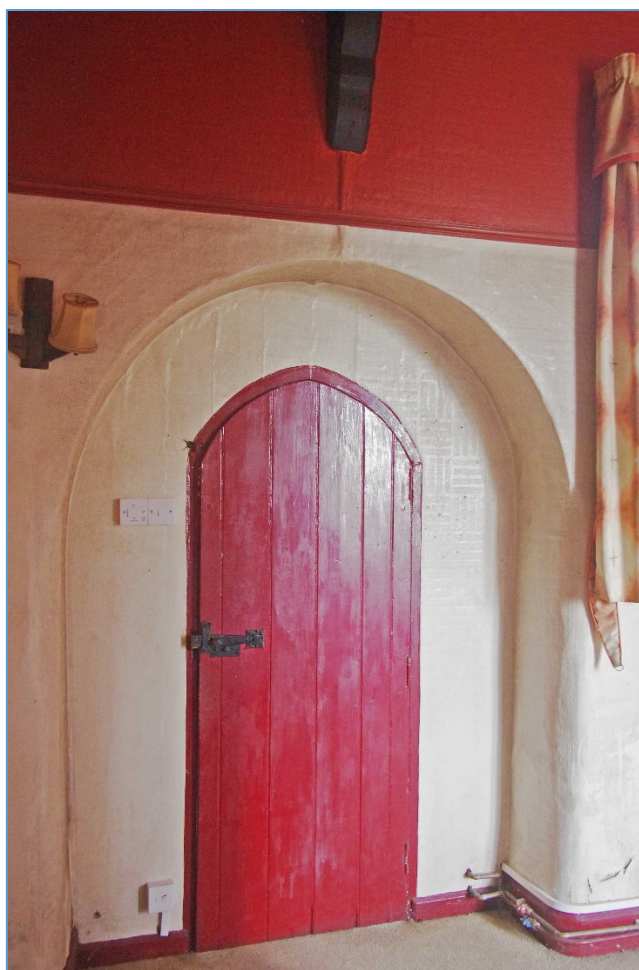
Figure 20 Rear door of centre range

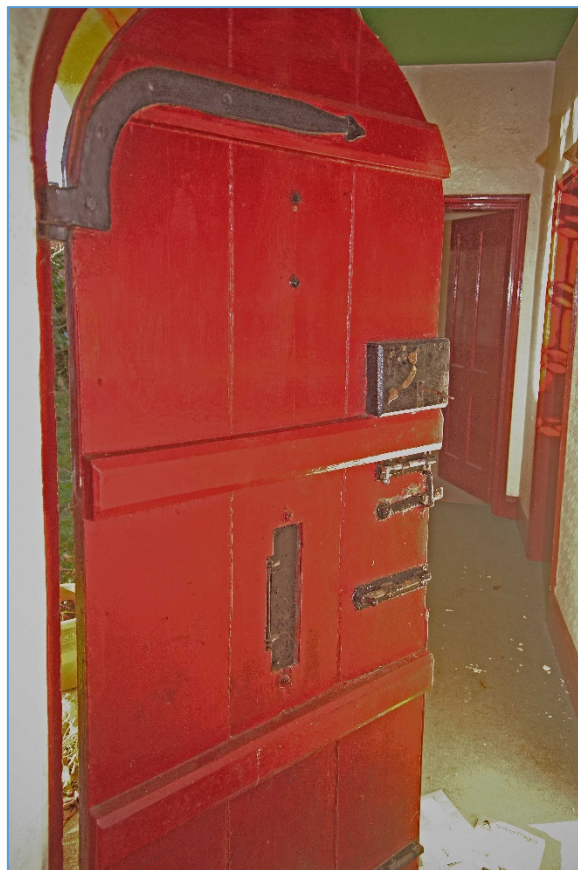
Figure 21 Front door and corridor looking north-west

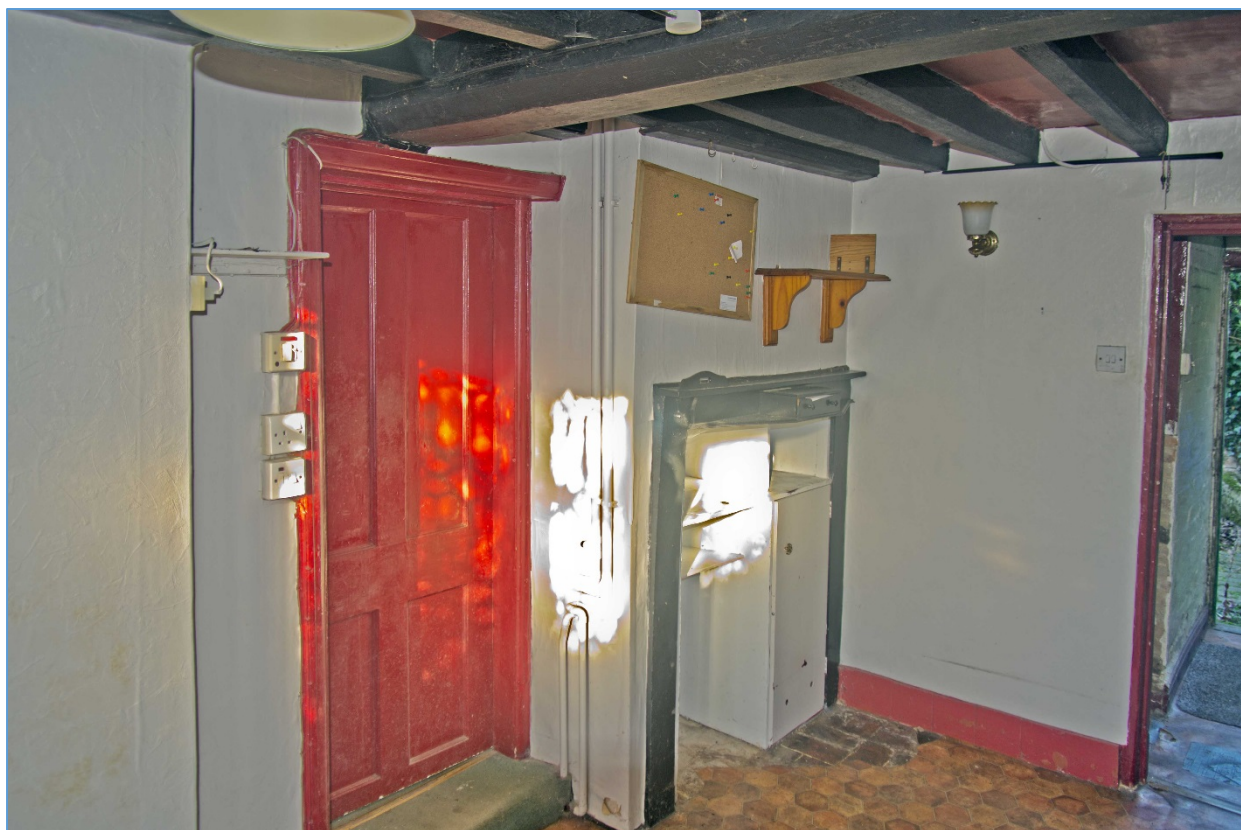
Figure 22 Accomodation wing ground floor, looking north

The accommodation wing has a 10cm step down on entering, which seems a little eccentric given that one would have thought that either the entire ground floor would have been dug out to this level, or the relatively low ceiling (2.04m to the axial beam) in this room made higher to accommodate a higher floor, as there appears to be ample headroom upstairs. The floor beneath the vinyl is brick/tile, the only place on the ground floor in the property where the original floor is visible. The position of the axial beam also seems odd – it seems to be resting on the door frame – perhaps it is lapped into an unseen transverse beam running across the top of the door. The beam has a wide chamfer but no stop. The chamfered joists, like the axial, appear to be rather heavier than necessary, either a ‘belt-and-braces’ approach, an attempt to make the room look more ‘medieval’, or simply that this timber was available at the time of building. Certainly there is little evidence for re-used timber, nor an underdrawn ceiling.

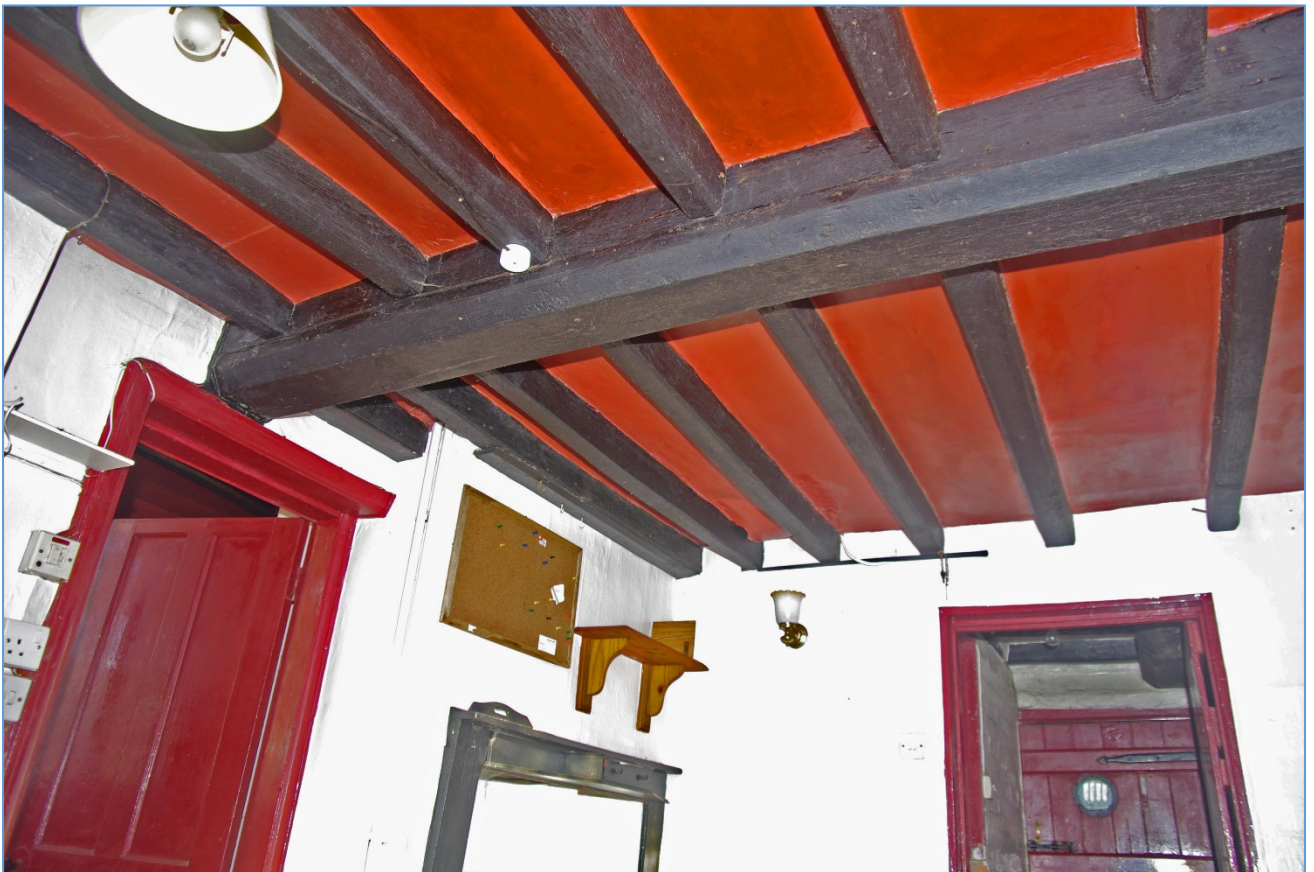
Figure 23 Ceiling structure, looking north. Rear exterior door visible at the back

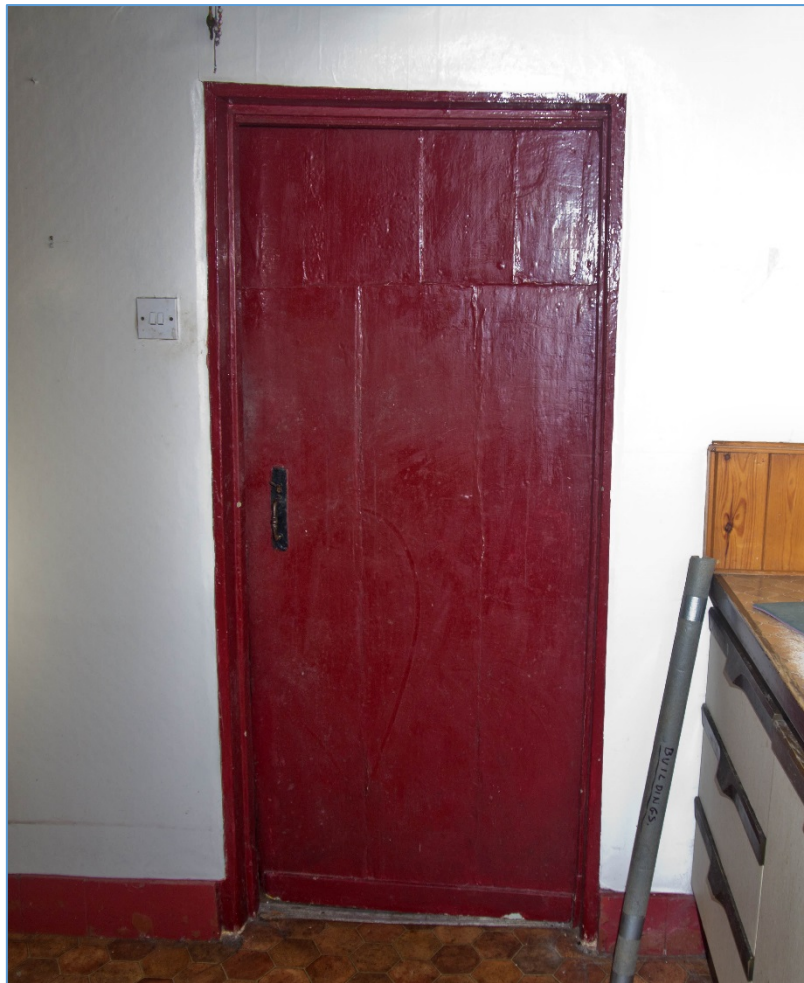
The repaired door from this room into the scullery/stairs may well be genuinely old rather than rustic, reused from another property. The exterior door is plank and rail with strap hinges, it has had a spyhole cut into it.

Figure 24 Door into scullery/stairs

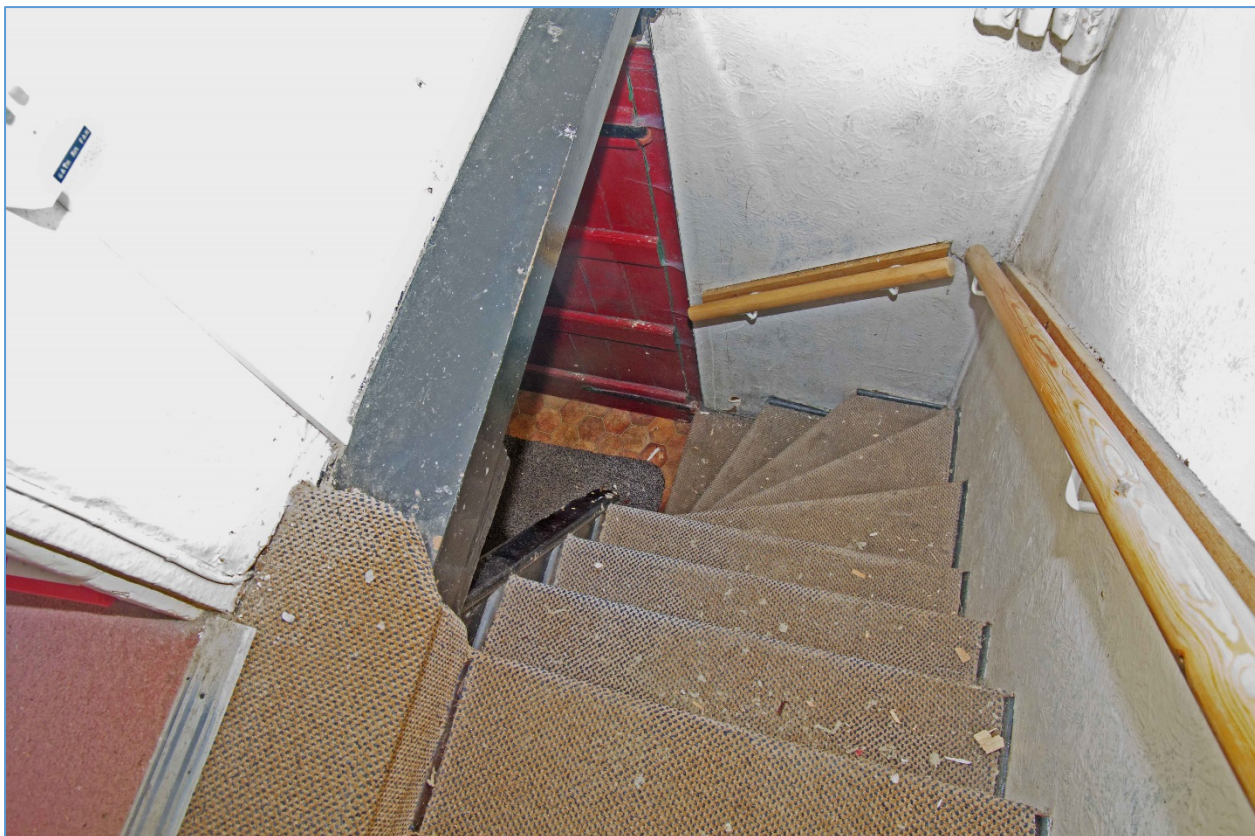
Figure 25 Looking down stairs towards back door

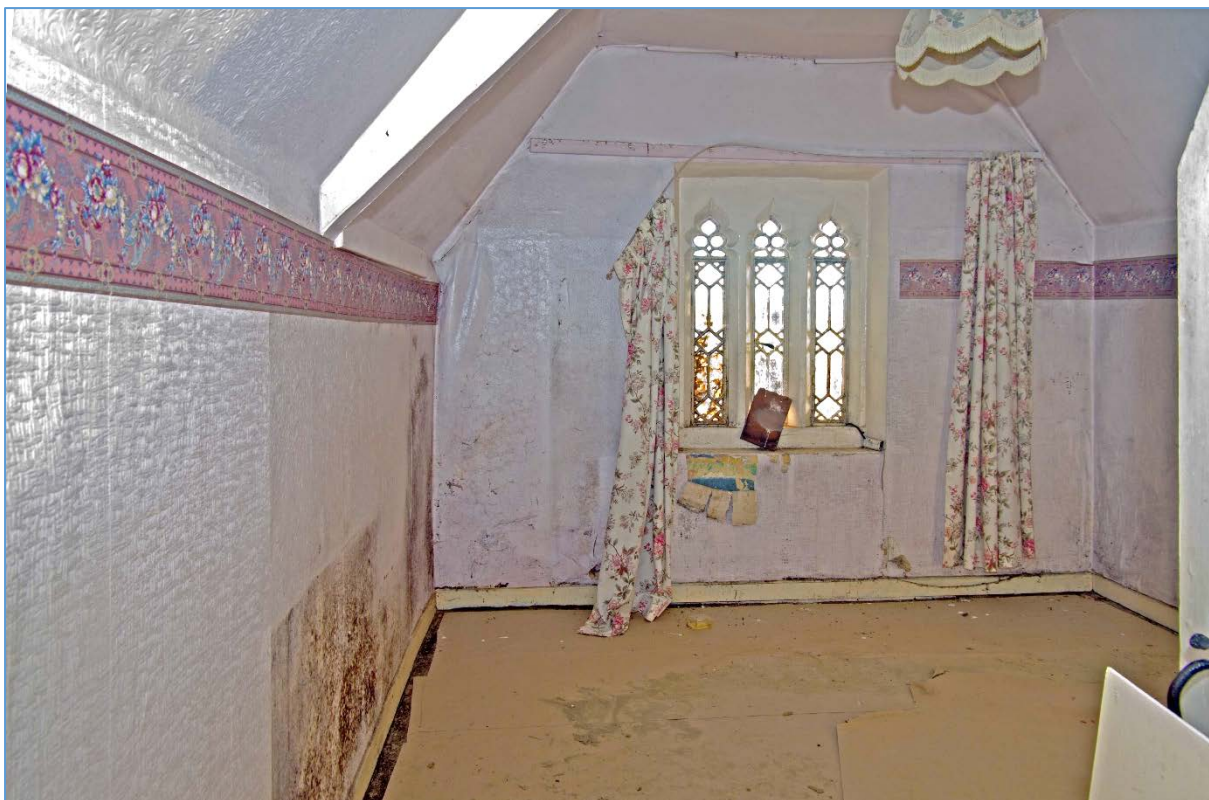
The upper floor houses a dank modern bathroom with no original fabric aside from the window opening, and a larger, originally heated room. An airing cupboard housing the hot water cylinder sits in front of the original fireplace (which appears to be *in situ* behind). The feet of the roof truss are visible, perhaps an A-frame with the collar above the ceiling. The floor may be lime ash, and if so worth keeping as it can always be covered if future owners want a different arrangement underfoot.

Figure 26 Upper chamber, looking to front. Truss foot on left hand wall
