A Level 3 Historic Building Survey
at Barnsdale House, 17 Barnsdale,
Great Easton, Leicestershire
(SP 847 928)
Jon Coward

ULAS Report No.2018-003

For: Langton Homes Ltd

A historic Building Survey of Barnsdale House, Great Easton, a Grade II listed building, was carried out by the University of Leicester Archaeological Services (ULAS) in October 2017. Planning permission has been granted for the refurbishment of Barnsdale House to include demolition of existing two storey and single storey rear extensions and erection of single storey side and rear extension; two storey rear extension and a first floor extension to the rear; installation of a new access and new railings, rendering of the existing wall and erection of a detached garage. (Planning Application 17/01014/FUL). The cartographic evidence indicates that the present house was erected after 1814 but before 1886; on stylistic grounds it is likely to be pre 1850. The outbuildings range in date from the mid 19th century to the 1960/70's. There are reasons to suspect that an earlier pre-existing building was incorporated into the main house at its construction.

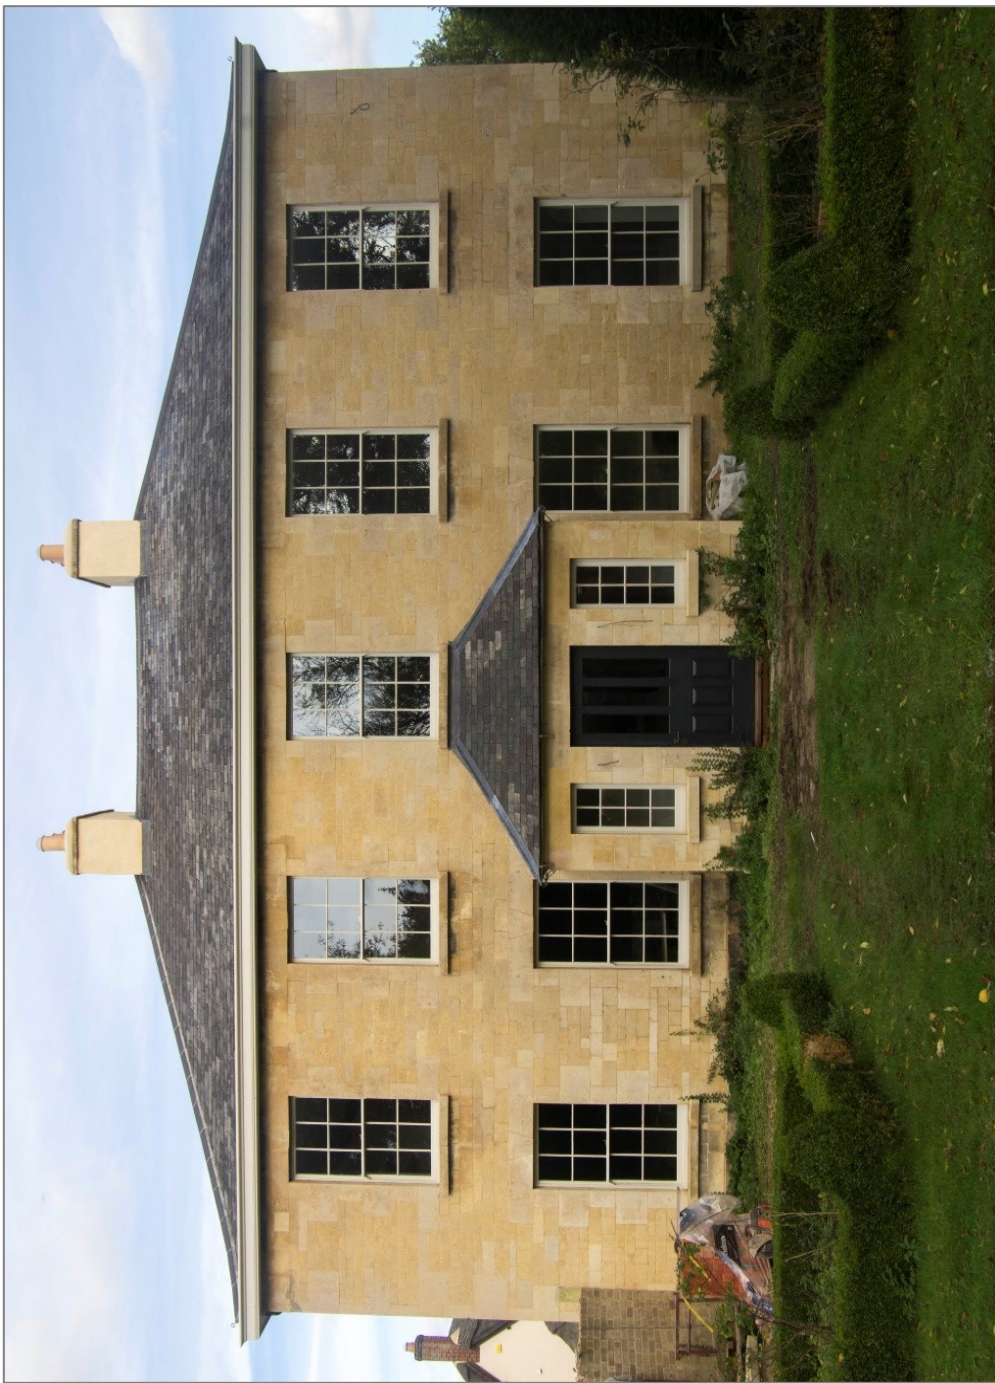
In addition the main façade is set on a low plinth of a stone type unknown to the author, but probably local as odd blocks of it are present in the boundary walls which are otherwise ironstone. The plinth ignores the porch, which has been added later.

Figure 3 Main (west) facade

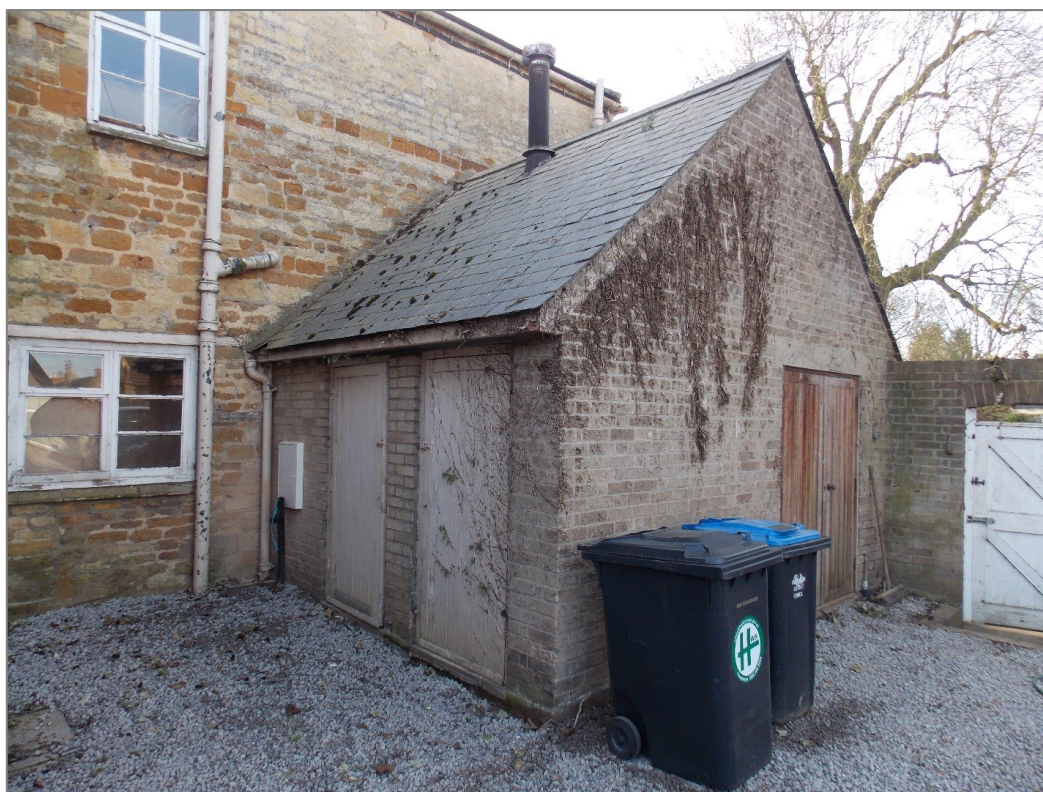
There is little useful to say about block C. Described on the plan as W.C./stores/log store, a photograph (Figure 9) taken before refurbishment shows it to have been modern brick, second half of the 20th C. It is tied into the boundary wall which is of the same brick.

Figure 9 Block C, looking north-west

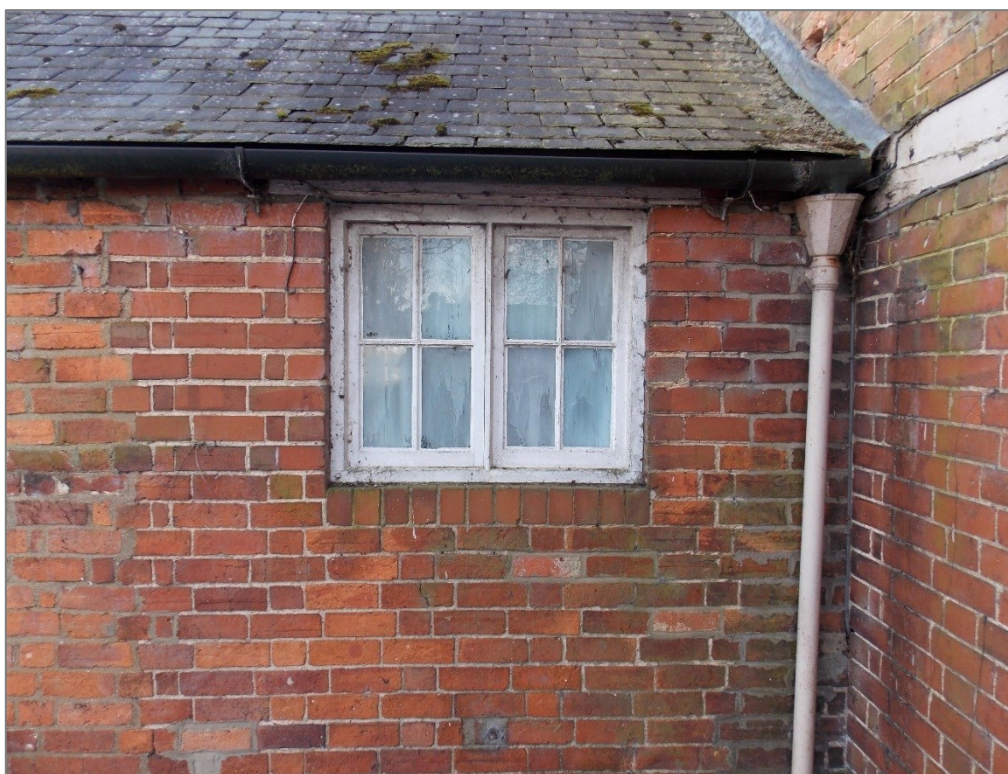
Block E is obviously earlier, probably mid- 19th C. It uses an irregular Flemish bond. The casement windows at each end of the north face (Figure 11, Figure 12) are inserted into wide blocked openings, and the middle window is over a blocked door. There is no provision for heat. The roof is common rafter in deal with Welsh slate. This range was probably originally used for storage and/or smaller livestock. The gable end shows different episodes of build, including a row of headers under a row on edge (above the wheelie bin Figure 13) which may indicate where a structure such as a pig run has been removed. A curiosity is that if both the present door and the blocked door to its left in Figure 12 were in use at the same time, they would be opening into the same room; so either the one succeeded the other, or some re-organisation of the internal layout is indicated. At some time this building has been converted into living accommodation, which has removed most of the evidence of its previous use; all the floors are modern tile. The windows on the south side (Figure 14) probably relate to the domestic use rather than the agricultural.

Figure 11 Junction between blocks D and E, north face. Photo provided by client

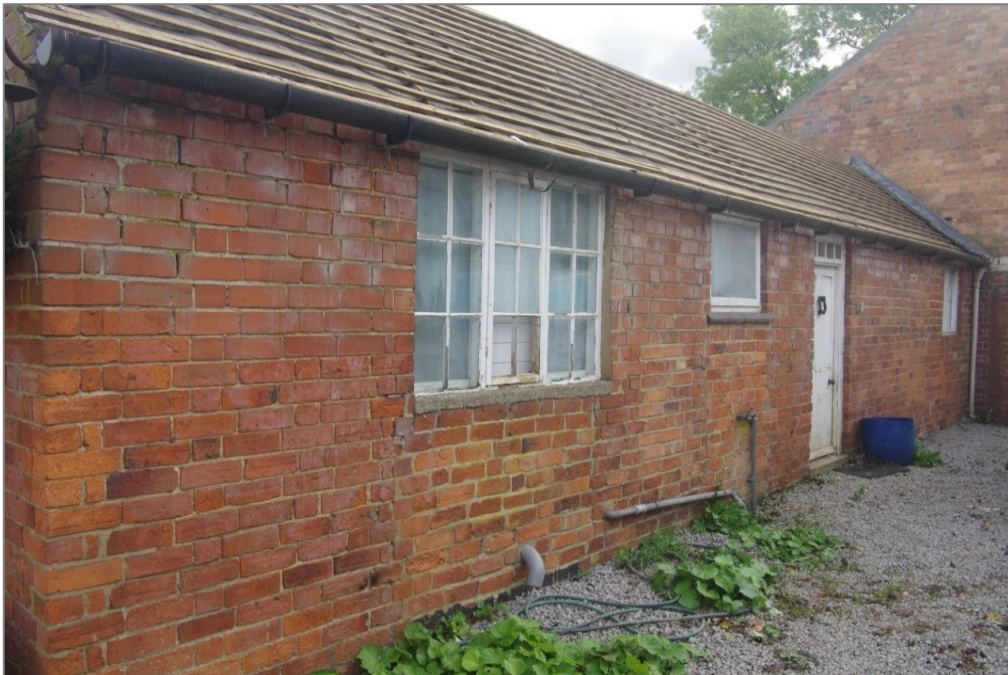
Figure 12 North face block E

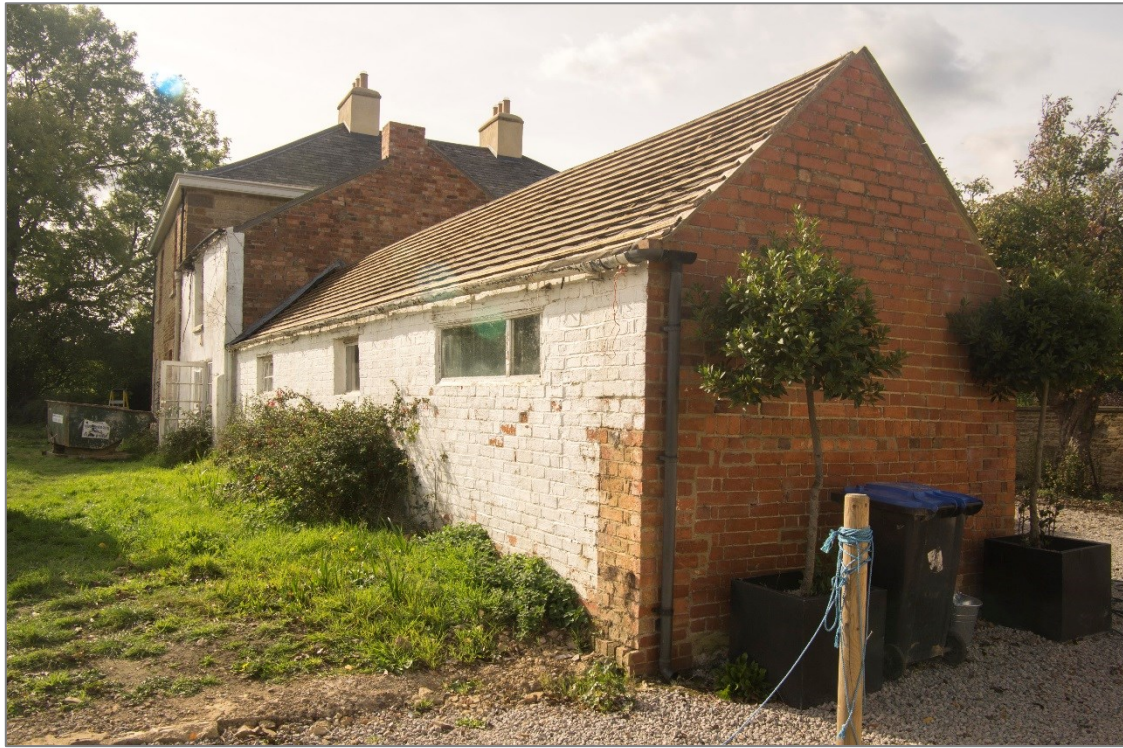
Figure 14 South, and East faces, block E

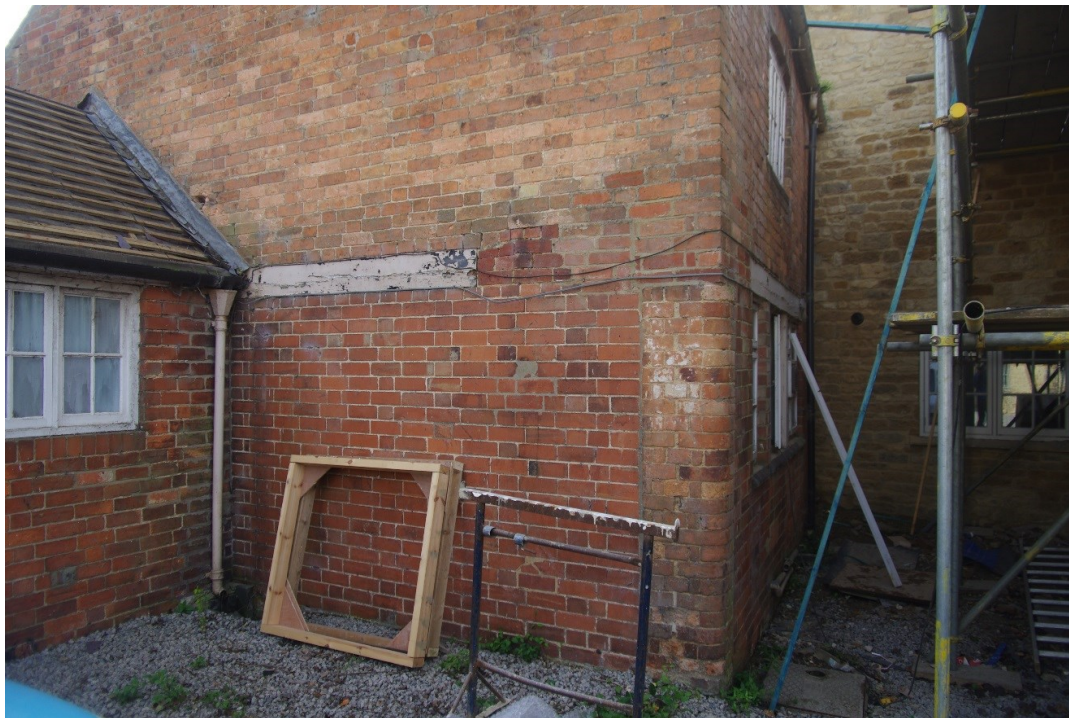
Block D is probably the most comprehensively remodelled block of the group, and it may have been remodelled more than once. Its history is not immediately comprehensible in its present state. Its odd orientation is perhaps best explained by it being the last to have been built; whereas the slight difference in alignment between the main house and block **E** would not be particularly noticeable if they were separate buildings, when joined by block **D** it becomes very apparent. The gable shows it to use an irregular bond. The chimney is either rebuilt, or probably added later, and part of the gable looks to have been rebuilt. Large blocked openings to the east and north (Figure 19) show that at one time the north side of the ground floor was open-sided; the pillar supporting this corner is constructed of bull-nose bricks, which indicates that carts or beast were moving in and out at some time. The south side (Figure 20) is rendered with scored imitation ashlar.

Figure 19 Block D looking west. Note bull-nose pier and blocked openings

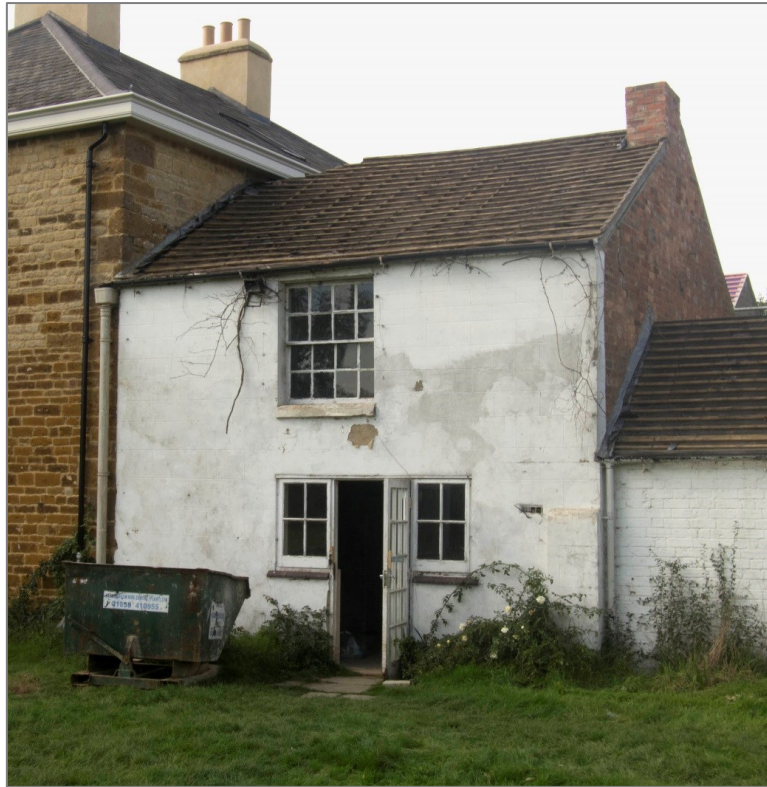
Figure 20 Block D south face

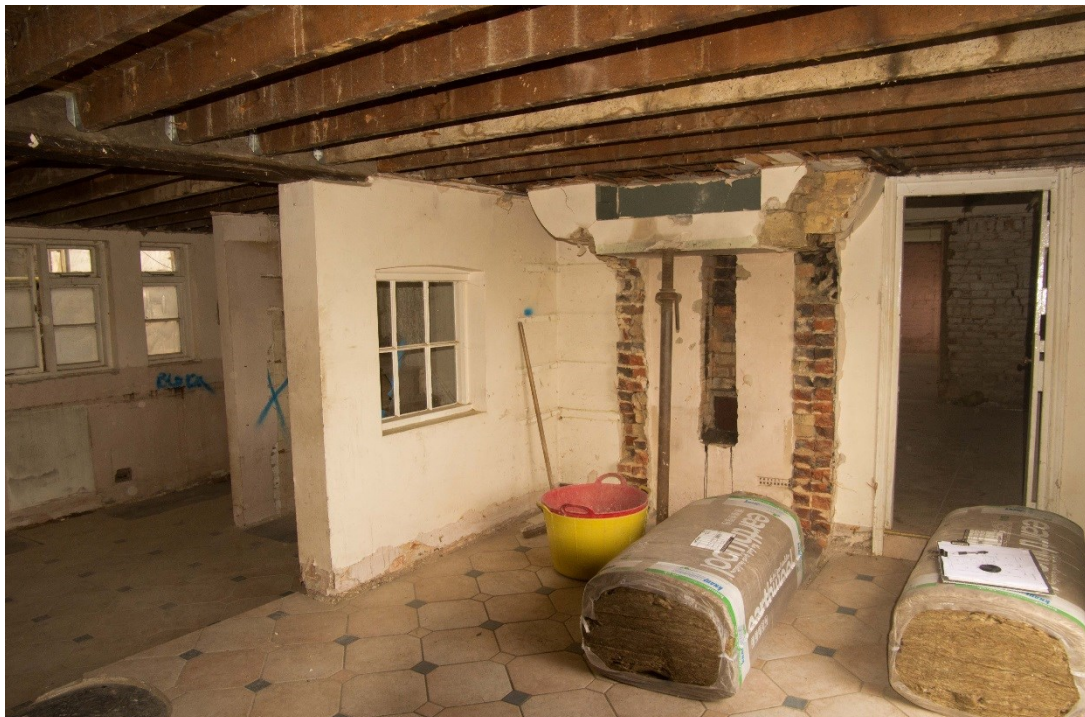
It is no more straightforward internally. The floors are modern tile. Part of the north wall of block **E** appears (Figure 21) to carry on into the interior, together with a window; there is a 20cm step down between the south (which is on a level with block **E**) and north side. The doorway on the south corner between this block and the house proper shows the ground floor of block **D** to have been raised to match that of block **E**; this doorway must have gone out of use at this point. The door and flanking

Figure 21 Block D, looking north east. Note apparent continuation of north wall of block E into interior

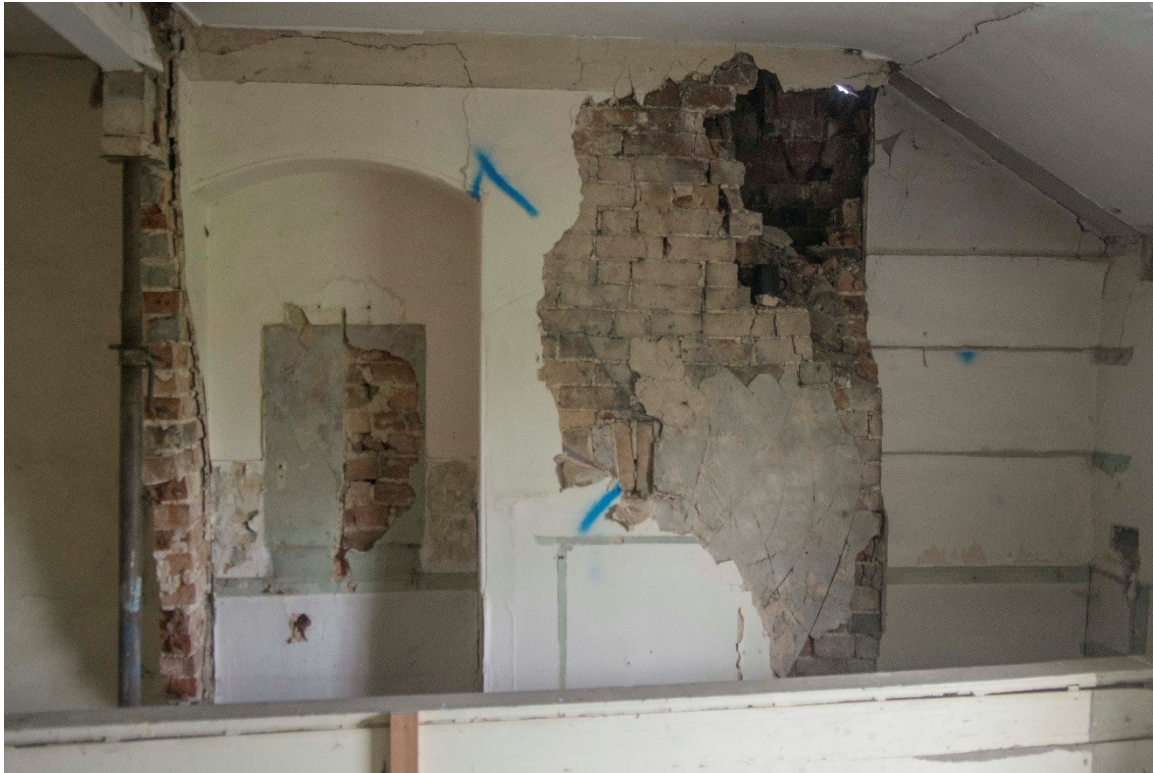
Figure 23 Block D upper floor, blocked fireplace and flue above removed range

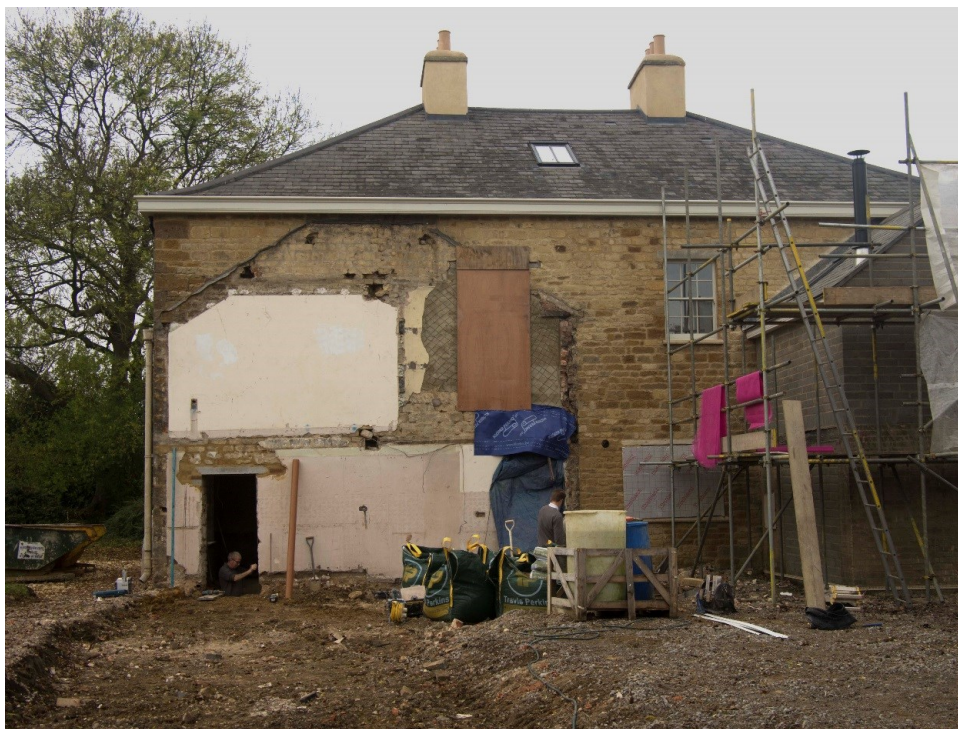
windows on the south side of block **D** relate to this floor raising. Perhaps the step down to the north side was retained simply to allow access from the main house via the other door (behind the blue tarpaulin in Figure 25), the present opening into the main house on the first floor is new. Some sort of a range or boiler has been removed from the ground floor, and the base of the chimney breast above is supported with a prop. There is a covered well adjacent to the south door (the Victoria County History states that in 1958 the parish still relied on well water). The joists of the floor above are fixed with modern-looking steel joist hangers. The upper floor, reached by a plain stair (Figure 22), has a casement window to the yard (Figure 24) and an odd 18th century style 8/8 sash window to the south which presumably came from a different property. The flue and fireplace on the upper floor above (Figure 23) have the look of a slightly ramshackle addition, rather than original build with the gable wall behind. The line of the ridge dipping to slip under the eaves of the house proper seems unusual, and may indicate a raised roof, or the addition of a second storey. Most or all of these alterations indicate conversion from agricultural into domestic use, and integration of this block with block **E**.

Figure 25 Main house, east side after removal of outbuildings.

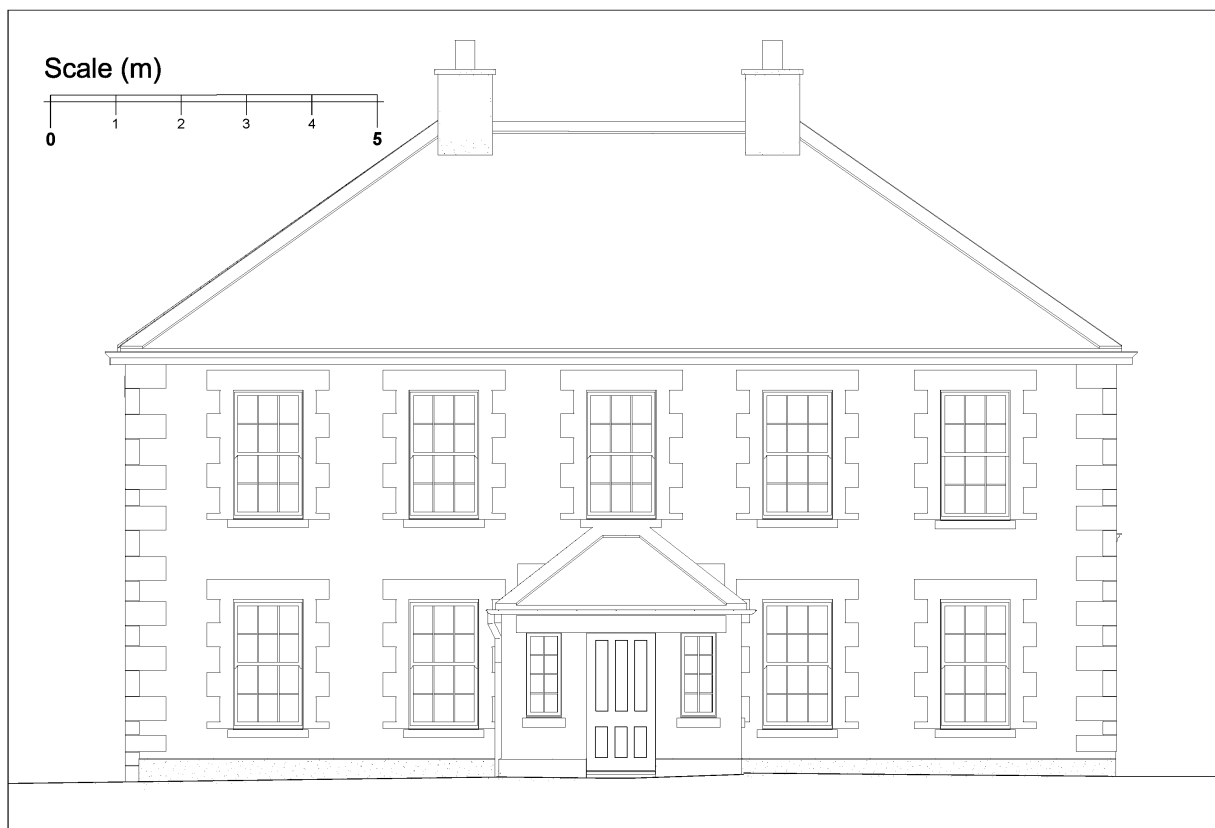
The elevation plan (Figure 26) shows the roof at a pitch of about 35⁰ on the north-south axis and 32⁰ on the east-west (this corresponds with the measured truss angle). Both are too shallow for the local Collyweston slate, indicating that the roof was originally meant for Welsh slate, given that Swithland slate would be an unusual choice this far east within the County.

Figure 26 West facade. Plan provided by client

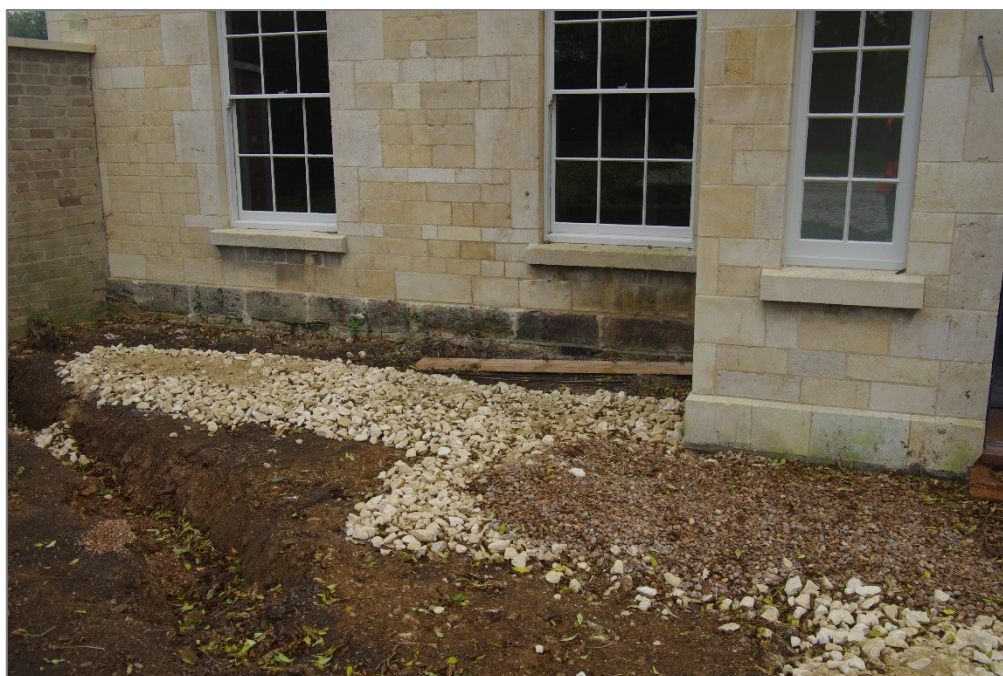
The porch is not original; map evidence shows it to have been built after 1900 but before 1962 (see below), the pre-renovation photos show it to have had casements in metal frames.

Figure 27 Detail of main facade and added porch, showing plinth

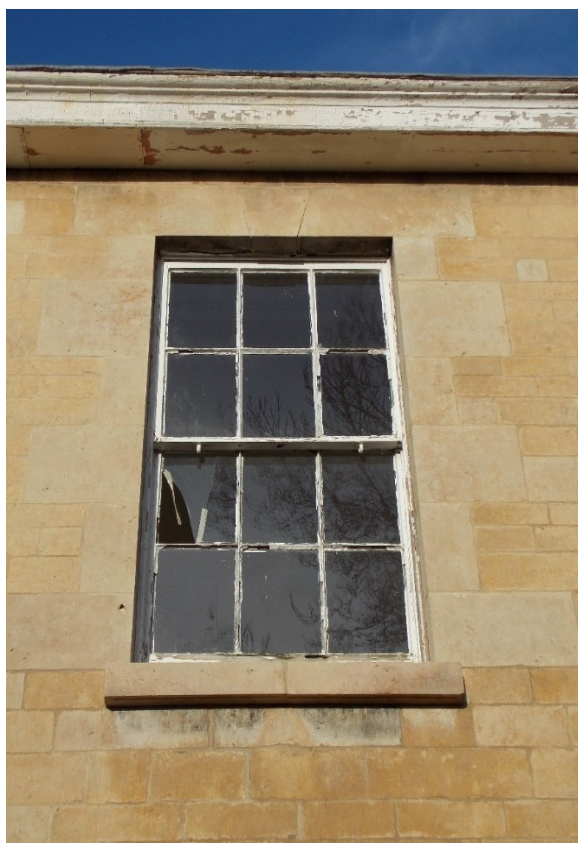
All the windows are new, but they are copies of the previous ones, which were themselves replacements. The pre-renovation photographs show the window on the top right-hand frontage (Figure 28) to have had the original hornless sash, whereas all the rest on this facade were horned

Figure 28 Original hornless sash on west façade. Photo provided by client

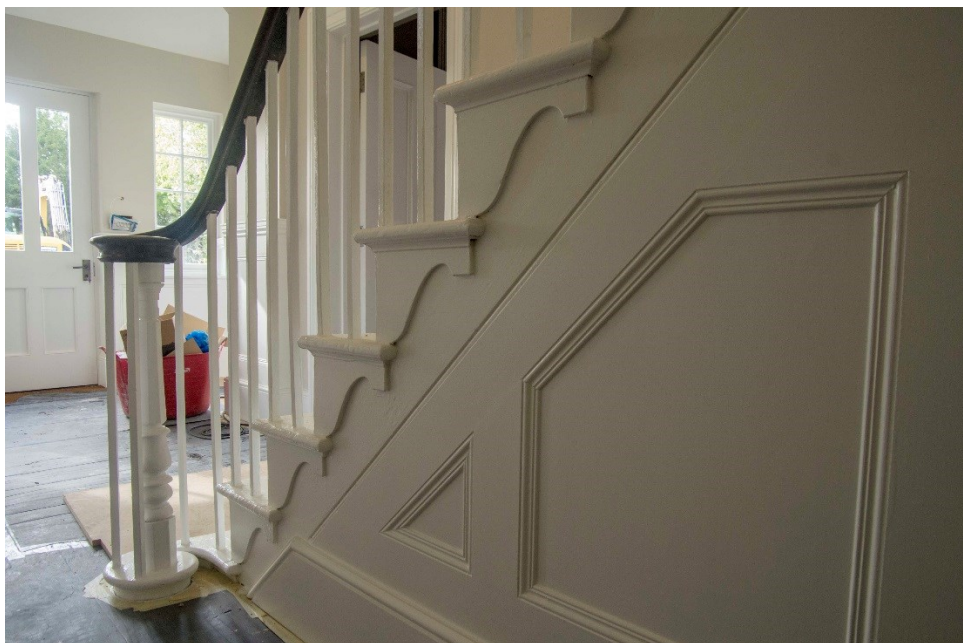
Inside the porch, the hall has a nice open string staircase (Figure 30) in keeping with an earlier 19th century date: moulded hardwood rail over painted deal stick bannisters, with the occasional iron one for reinforcement, ending with a restrained flourish on the curtail step. The arrangement as the stair meets the first floor (Figure 29) is however pretty unusual, and may just reflect the whim of the owner, as it seems to give no practical advantage over a simpler layout.

Figure 30 Stair and curtail step

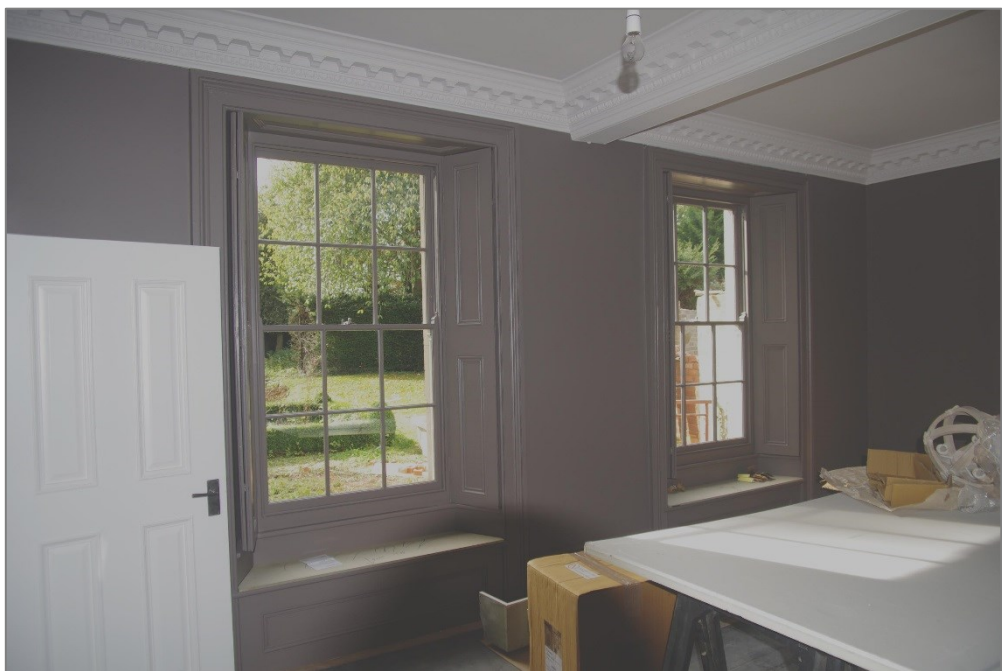
The ground floor north reception room in block A has an axial ceiling beam across the middle of the room (Figure 31) whereas the equivalent south room (Figure 33) does not. It is unlikely to represent a removed wall given the central position of the fireplace. The fact that there is a slight mismatch at the junction of the axial beam with the west wall may mean it was a later addition to deal with a perceived structural problem in the floor above; the reason for this is unclear as there would appear to be no difference in loading. The ceiling in the south room is very slightly lower than the north, but whether this is a result of using joists of slightly heavier scantling or merely a difference in ceiling treatment cannot be said. The cornice design common to both the north and south rooms is as pre-renovation photographs show, but may not be the original design. Those of the hallway, stairs and landing (Figure 37) are probably original.

Figure 31 Reception room, north side

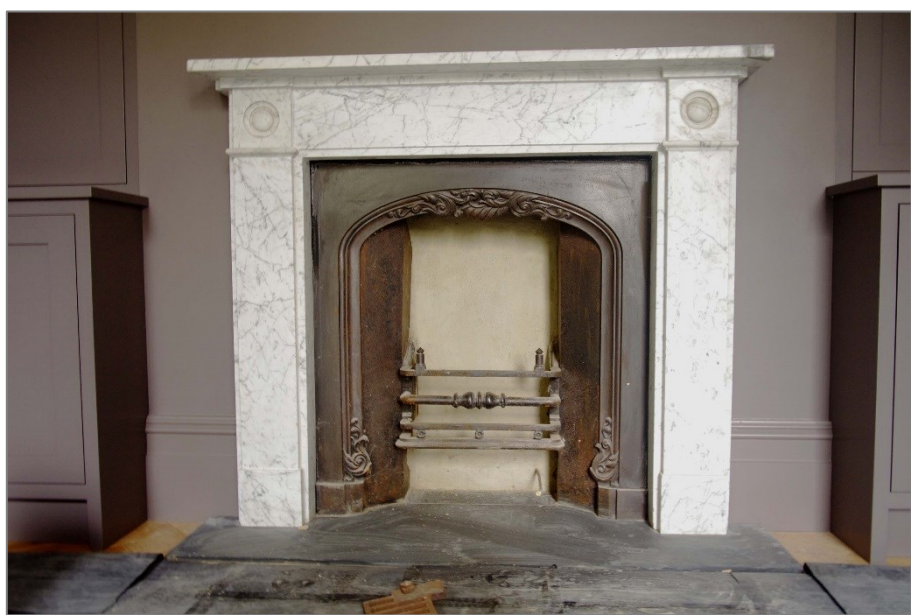
The two ground floor rooms in block A still have their shutters and bars (Figure 36); the fireplace in the north room (Figure 32) originally came from the bedroom above (Ben Cripps, *pers. comm*)

Figure 32 Fireplace in north reception room, relocated from bedroom over

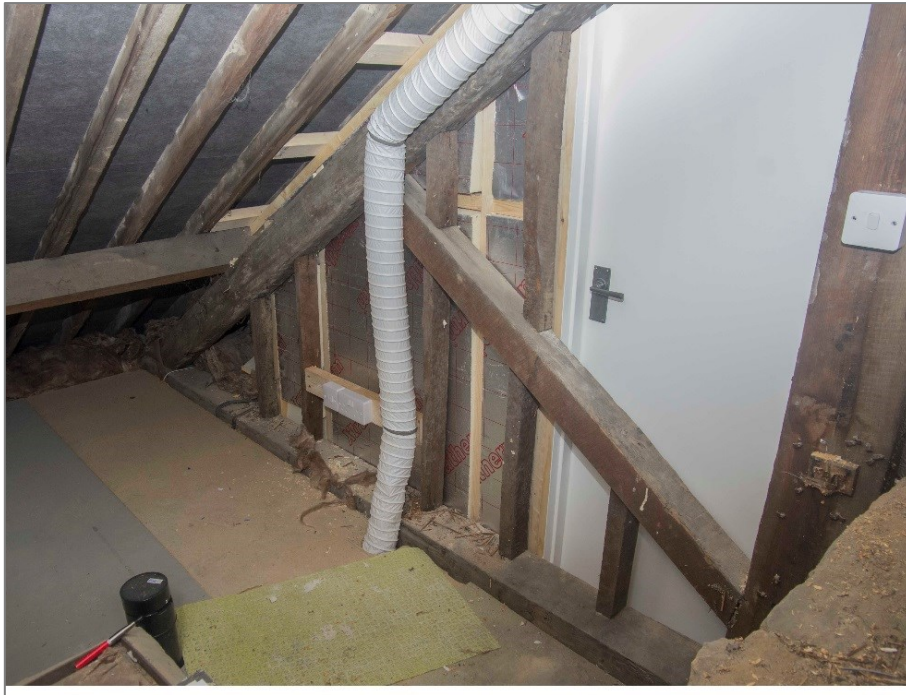
The attic room and window are new, but given the presence of a stair, there originally would have been some provision for servant accommodation in this space. Within the roof space, the roof is supported (Figure 38, Figure 39, Figure 40) on a type of queen strut truss, with twin purlins, in deal. The collar of the truss is supported by the brick chimney stack as well as the queen struts, with the purlins carried on cleats lower down the back of the truss. The junction between the truss and the tie beam is re-enforced with an iron strap (Figure 39). Only the north truss was accessible but the south is presumably the same arrangement.

Figure 38 North roof truss, east side. Queen strut to the right with light switch

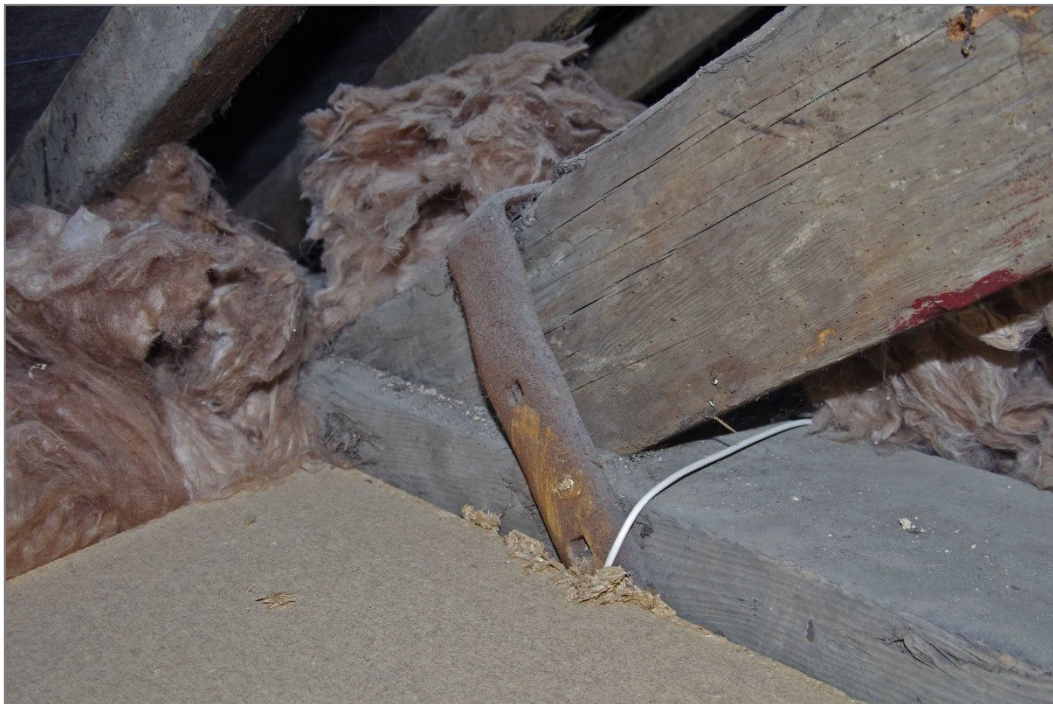
Figure 39 Detail of truss

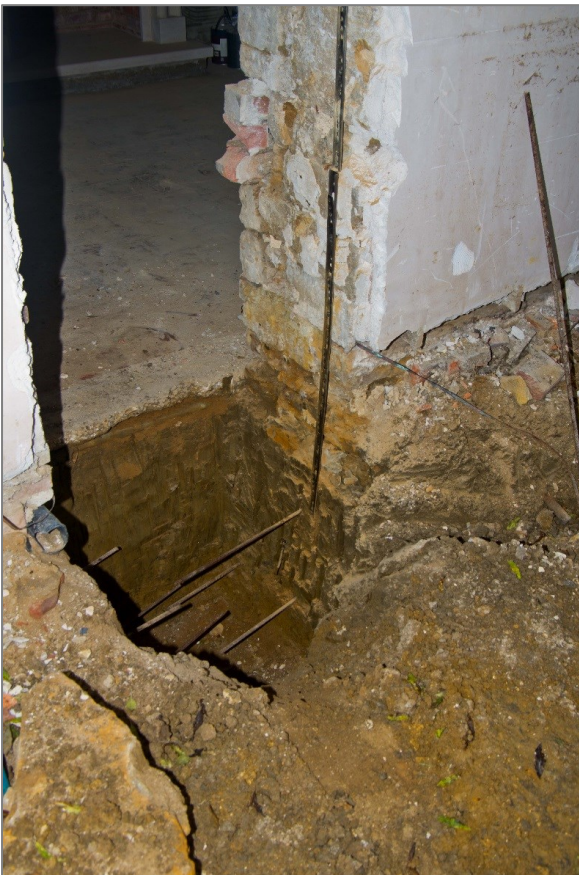
Neither Block D nor E were provided with proper footings. This is not unusual in agricultural buildings of this date range, but may be an indication that block **D** started off life as a single storey structure.

Figure 46 South east corner of main house, showing wall built straight onto the clay ground. Re-enforcing bars hammered into the sections for subsequent underpinning encountered no footings.
