**A Photographic Survey of School Farm, Main Street, Bruntingthorpe,  
Leicestershire (NGR SP 602 900).**

**Gerwyn Richards**

### ***Summary***

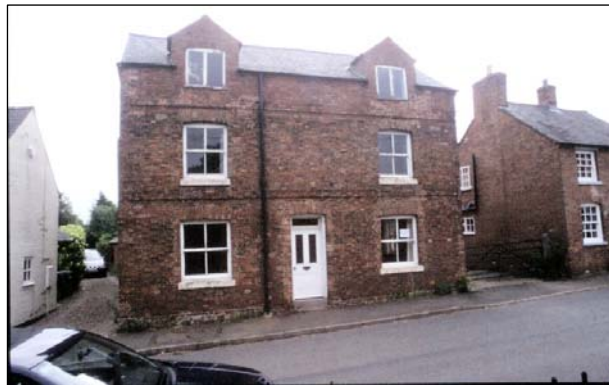
As part of the proposed development a number of alterations were to be carried out to the building, and the purpose of this photographic survey is to record the building prior to these alterations taking place. The farm house itself consists of a two bay, three storied building fronting onto Main Street, and there is a symmetrical mid eighteenth century façade. Structurally the building is of 9 inch by 2 inch locally made red brick in a Flemish Bond and a Welsh Slate roof; there is a rubble plinth, approximately 300mm high confined to left hand bay.

Fenestration consists of two four light casement windows on the ground and first floor and dormer windows on the second floor, with concrete sills and flat cambered arched lintels above a central door. There is a line of corbelled bricks immediately above the first floor windows, probably indicating the original eaves. The roof was almost certainly raised and the dormer windows added, probably during the later nineteenth century, as there is a clear change in the brick work on the right hand gable.

**Colour Plate 1** School Farm.

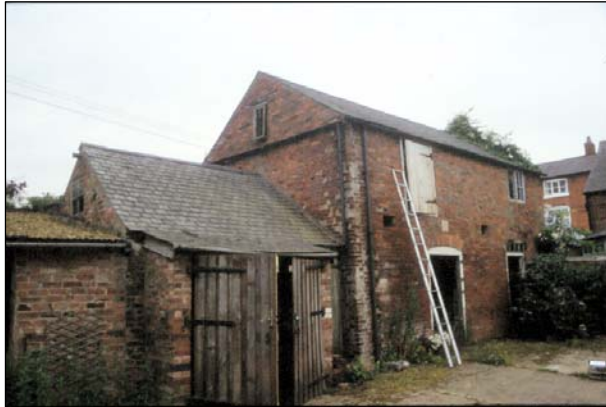
The second building was a two storey barn to the south of the farm house. Due to its precarious state planning permission had been granted to demolition the building. Structurally the barn consisted of 9 inch by 2 ½ inch red brick in a Flemish Bond. The roof is mono pitched in Welsh Slate. Above the centrally placed door there is a sandstone date stone inscribed RJR 1886. Internally, as expected of a barn, there is little of architectural significance; there is a feeding trough along the full length of the rear wall. There is a change in the brickwork within the rear wall which also suggests the barn utilized an existing wall, possibly the boundary wall during construction. It is likely that the footings for this wall were insufficient for the building which explains its current precarious condition.

**Colour Plate 2** Building 2.

One significant feature was the ceiling within the barn; the ceiling had been constructed by placing slate atop of the joist onto which plaster was then skimmed to create the floor above. An unusual technique not seen before by the author, it may represent a primitive attempt at fire proofing or simply

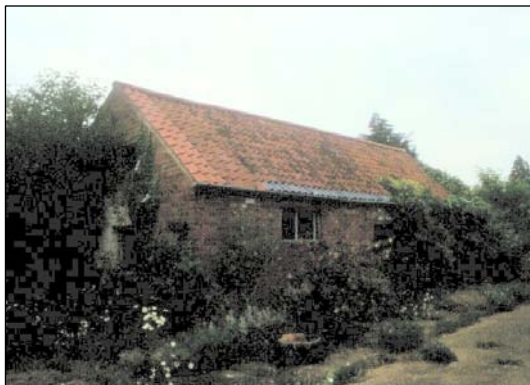
**Colour Plate 3** Building 3.

The next recorded building was the milking parlour to the rear of the farm house, on the property's northern boundary. The brick work was 9 inch by 2 ½ inch red brick in a variation of Flemish Garden Bond and a pan tiled mono pitched roof. Internally there are five double stalls along the rear wall with cattle doors in

each gable end, as well as a central door in the front wall. The roof is a bolted king post design with raking struts.

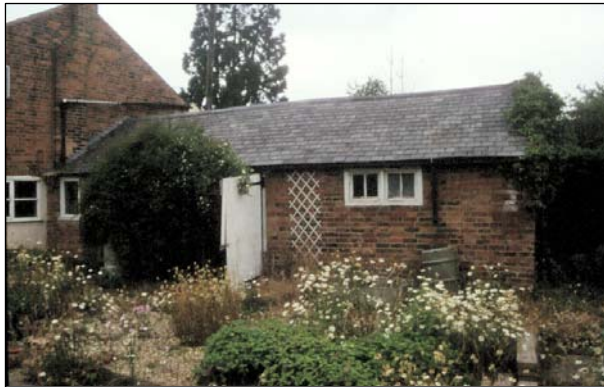
The final building was another milking parlour which adjoined the rear of the farm house. The brick work is 9 inch by 2 ½ inch red brick in Flemish Garden Bond while the roof is of local Swithland Slate. Internally there are three double stalls along the rear wall there is downward angled ceramic vent pipe in each stall. The roof construction is a king post design with raking struts.

**Colour Plate 4** Building 4

There is evidence of a lost building between the two milking parlours and more interestingly there is a line shaft and flywheel. There is no evidence of an engine so power was likely to have come from a mobile engine with a power take off unit.

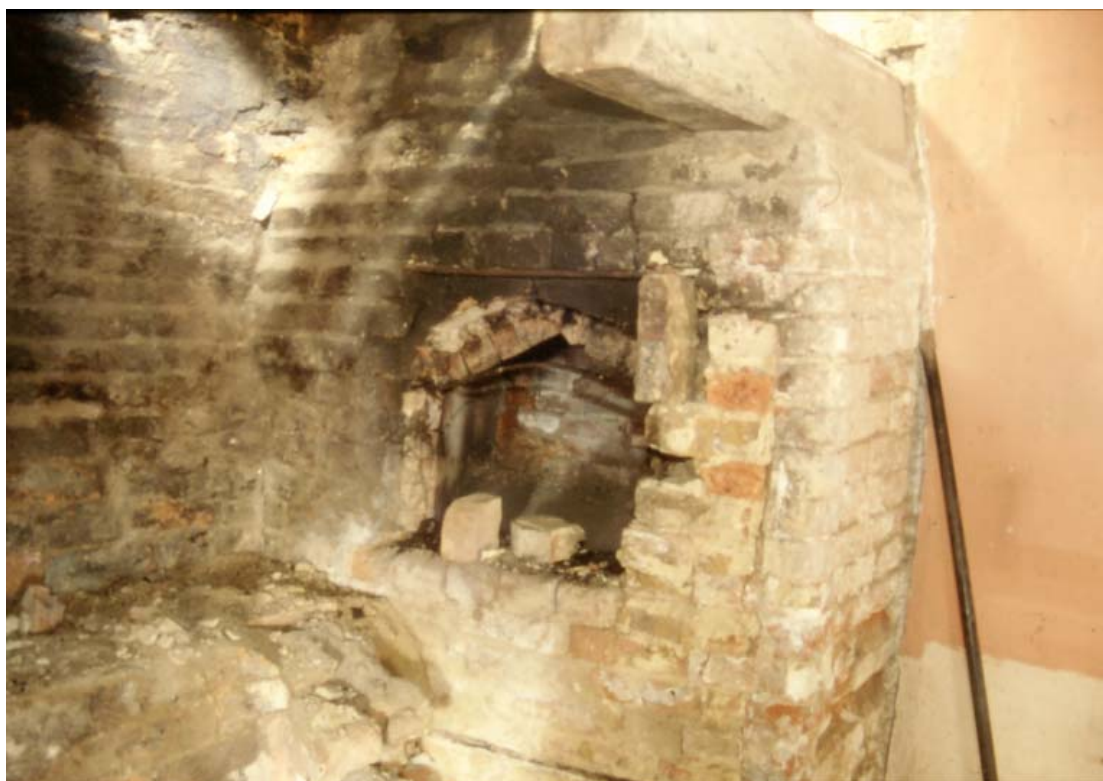
It is internally that the farm house becomes truly interesting; within the left bay there is a substantial centrally located ‘inglenook’ fireplace. Although much altered, the fireplace is likely to be older than the rest of the building and likely to be of medieval origin. A bread oven was later uncovered to the right of the fireplace, the brickwork of which was mainly Victorian in date, which is to be expected as brickwork would be replaced as the bricks burnt out. It is likely that the left bay was originally a medieval open hall house, originally perpendicular to the road. Further to this is a window in the left gable, the probable remains of the cross passage. The building of the chimney allowed the evolution of the house and a first floor was added with stairs. There is even evidence for these original stairs visible at first floor level with a change in the floor boards where these stairs were blocked when the building was extended.

**Colour Plate 5** Newly Exposed Bread Oven (to the right of the fireplace).

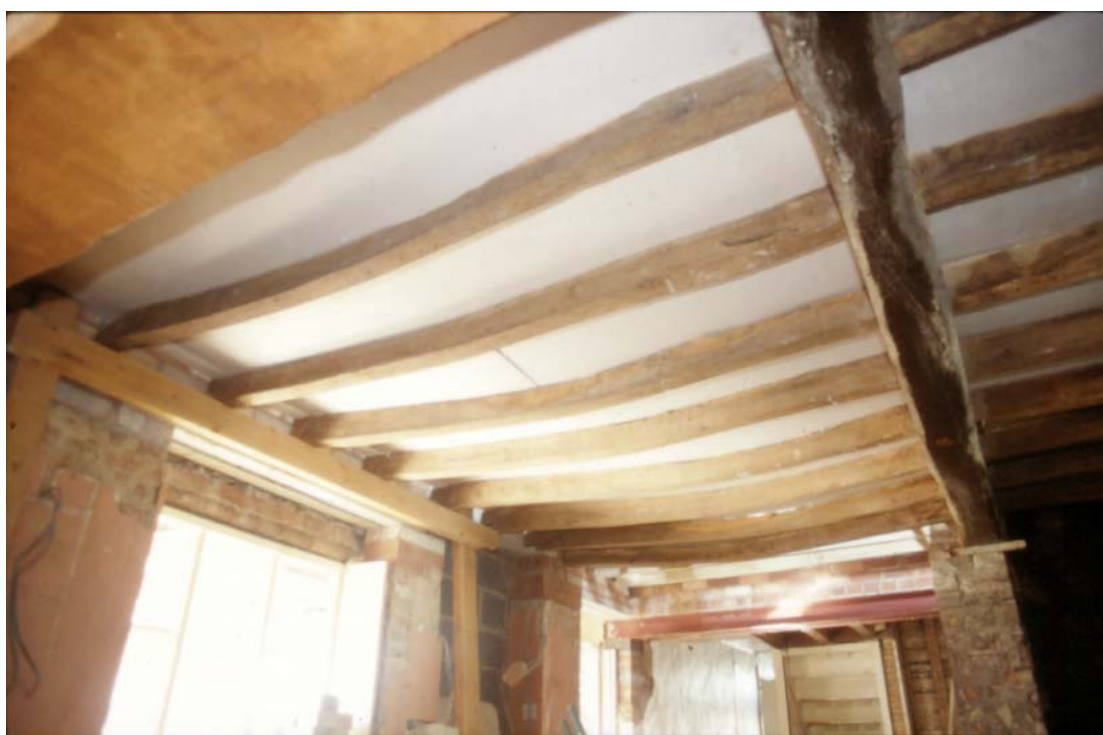
**Colour Plate 6** Newly Exposed Ceiling Joists.

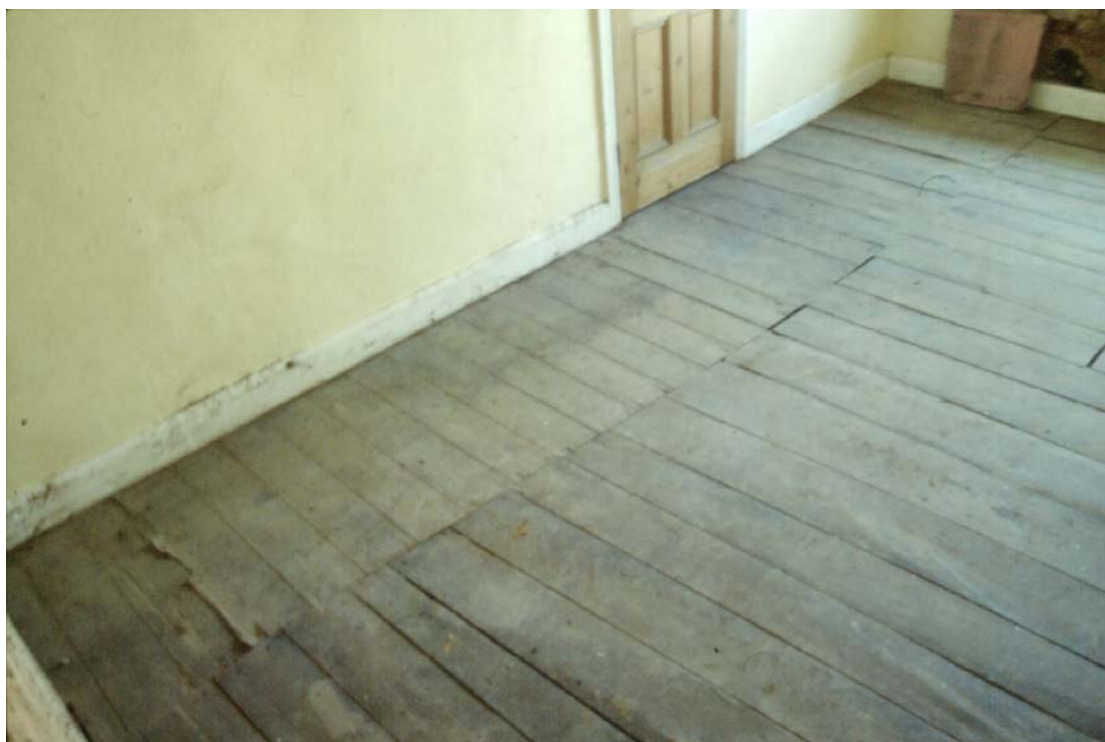
**Colour Plate 7** Evidence of Older Staircase in First Floor Floor Boards.

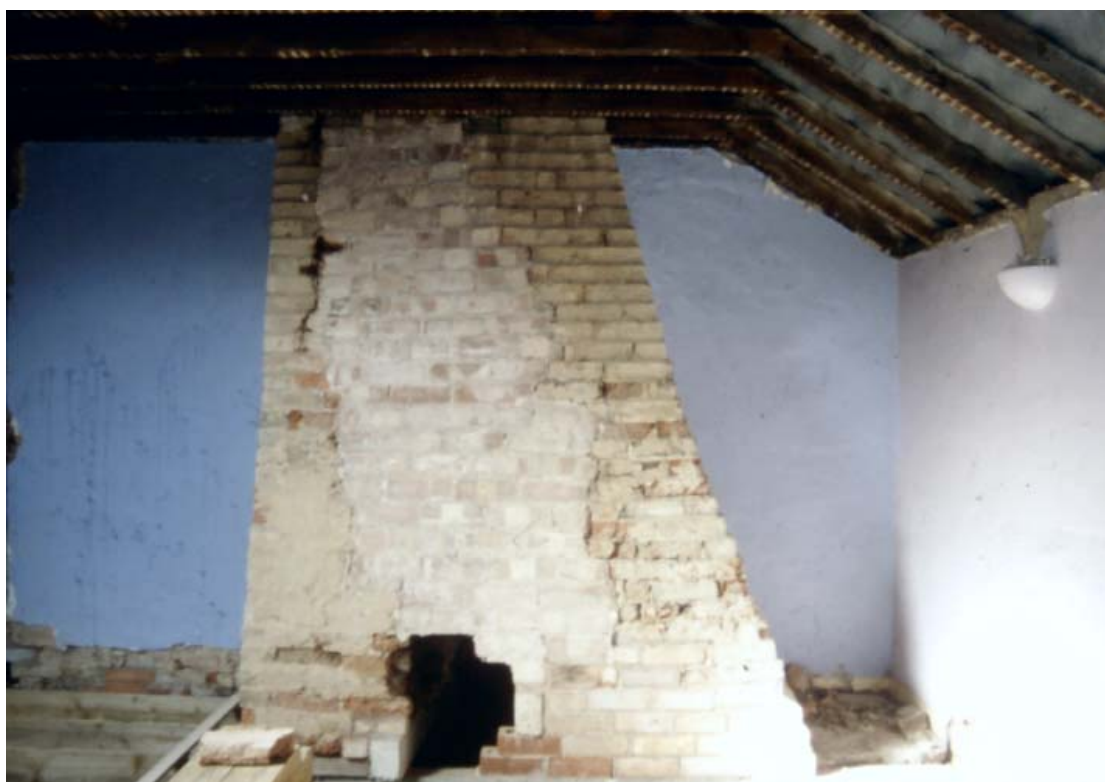
**Colour Plate 8** Newly Exposed Chimney Breast
