**A Photographic Survey and Watching Brief on a New Access Road at Wakeley
Farm, Lutterworth Road, North Kilworth, Leicestershire. NGR SP 584 843.**

University of Leicester Archaeological Services were commissioned by Ames Developments Ltd to undertake a photographic survey and archaeological watching brief at Wakeley Farm, North Kilworth. The photographic survey recorded the farm buildings prior to their conversion to residential use; the buildings were mainly nineteenth century in date.

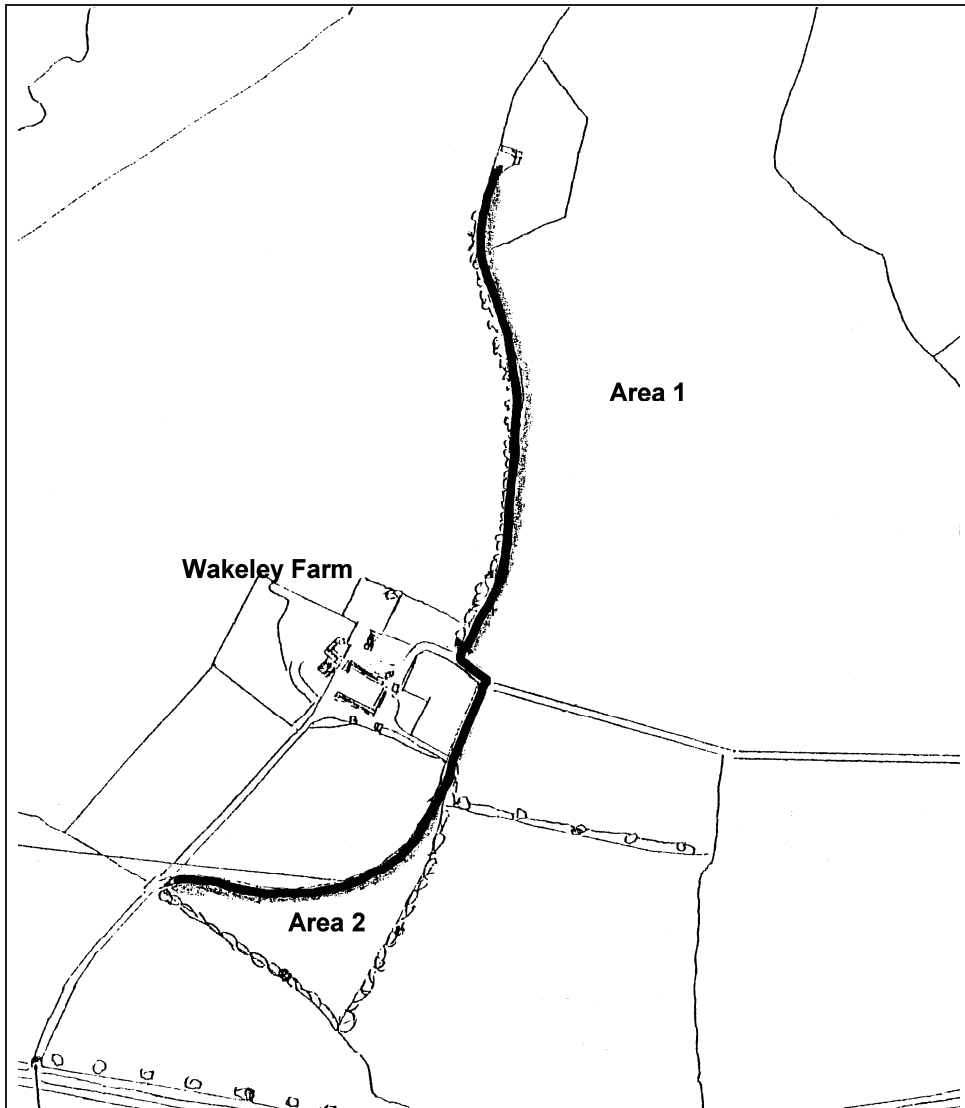
Figure 4 Location of Groundworks

The first area covered by the watching brief was the excavation of the new access road between the main farmyard and barn 4, to the northeast, approximately 450-500m in length (*Fig 4*). Approximately 350mm of topsoil was excavated until weathered clay bedrock exposed, an examination of the exposed surface indicated considerable disturbance.

It appears that this area had been extensively used as a track way along the field boundary, causing deep rutting, which affected the underlying clay. Along with this the service trench to barn 4 had already been excavated, causing damage and up-cast from maintaining the adjacent stream had also been deposited in this area. As a result the likelihood of any significant archaeological remains being present were highly unlikely, it was decided therefore to discontinue the watching brief after 2 visits.

Approximately 250mm to 300mm of topsoil had been excavated exposing an horizon of mid orange brown silty clay subsoil with occasional patches of exposed and weathered bedrock in places. The area closest to the farm buildings showed evidence of extensive modern truncation, probably as a result of the construction of the adjacent, modern buildings; this disturbance petered out as the route moved away from the farm buildings.

Once within the adjacent field, with the exception of several field drains and a larger pipe trench, there was no evidence of modern disturbance. There was, however, evidence of ploughed out medieval ridge and furrow ploughing aligned north-northwest - south southeast in the south-easternmost part of the route, which followed the contours of the slope. There was also evidence of a colluvial build up at the base of the slope; it is possible that this deposit may conceal deeper archaeological features, however, the nature of the ground works undertaken means that any deeper archaeological remains will be unaffected.

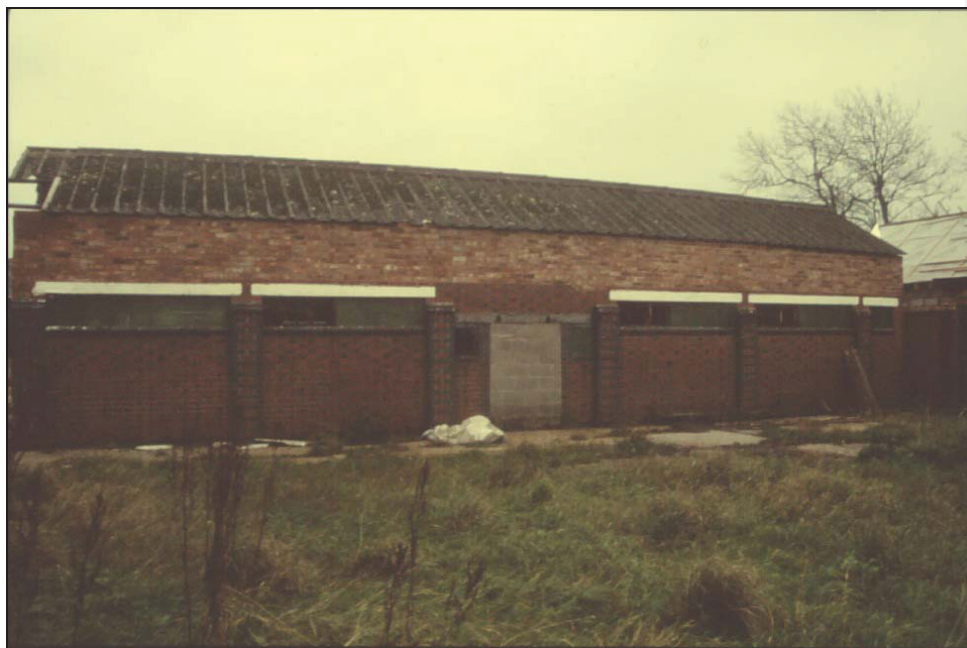
Colour Plate 1 Barn 1 Northwest Facing Elevation.

Barn 1 forms the southeastern range of the farmyard (*Fig. 2*). Originally the building appears to have been used as a milking parlour but has been greatly altered in more recent times and appears to have been last used as a store. Structurally the building is a five bay brick construction with decorative blue and red brick patterning on the front facing the yard (northwest facing elevation); there was also an original central doorway which has been blocked with modern breeze blocks. The building has been extended upward by fifteen courses and re-roofed with corrugated asbestos sheets and steel trusses. The lack of original roof structure makes dating the building difficult, however an examination of the brickwork, suggests a late nineteenth, - early twentieth century date.

Internally there has been much alteration, leaving virtually nothing original. There were downward facing ceramic vent pipes set into the rear wall, indicating the likely location of the stalls. The north easternmost gable has been taken down forming a large new entrance. A drain runs the length of the floor and is visible within the external concrete surface, suggesting the building was originally larger.

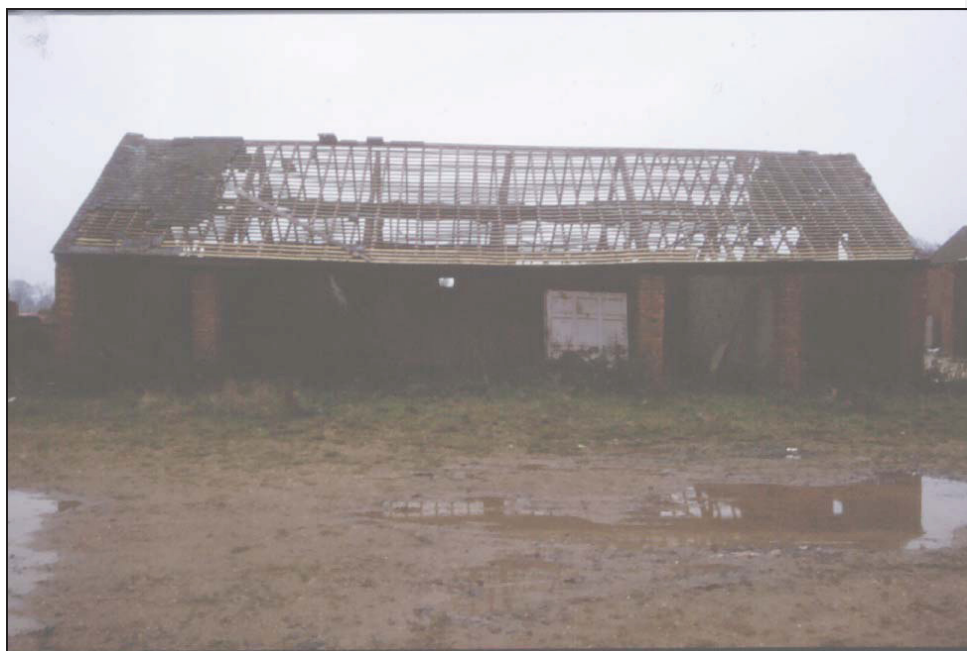
Colour Plate 2 Barn 3 Northwest Facing Elevation.

Barn 3 is located to the north of the main range of buildings (*Fig. 2*) and is a 6 bay open sided implement store, in a much-ruinous condition. Construction is of 9 by 2.75inch machine made red bricks and Staffordshire Blue tiles, the majority of which are missing. The front of the building is open and the wall plate is supported on three brick-built pillars and two timber uprights; the brick pillars appear to be modern and probably replaced original rotten timber uprights. There is a pitching hole in the right hand gable.

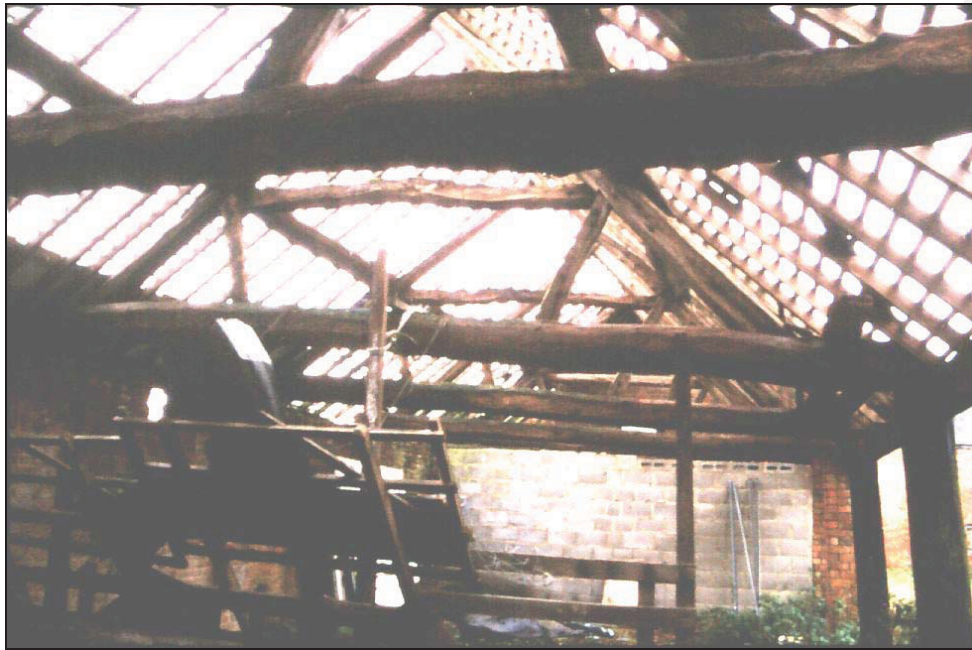
Colour Plate 3 Barn 3 Detail of Roof Construction

The interior is completely devoid of any identifiable features; the roof is of raking strut construction and once again the timbers are roughly squared oak beams, which appear to be in remarkable good condition considering their prolonged exposure to the elements.

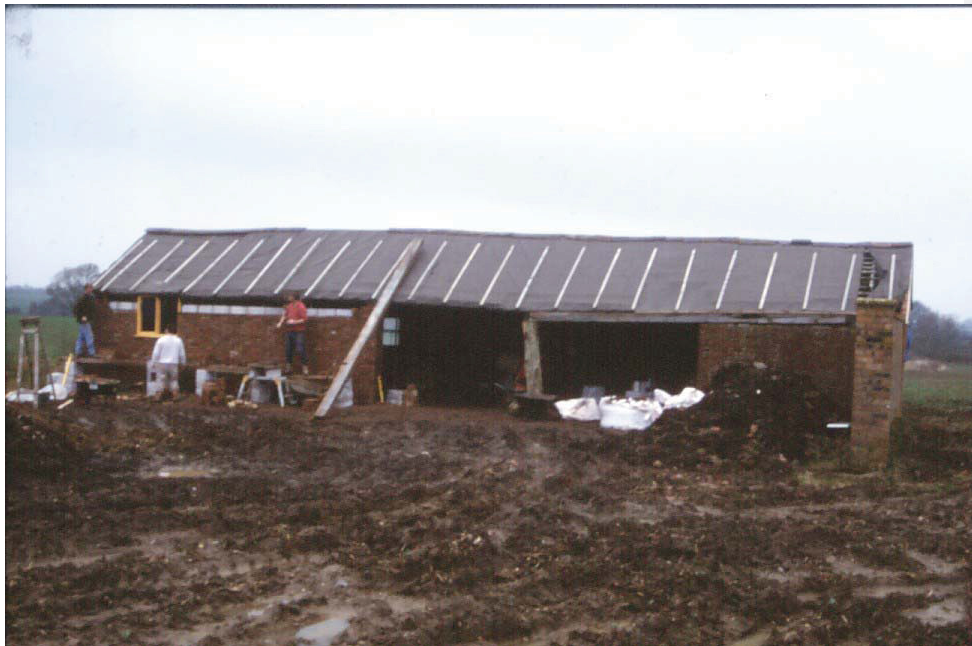
Colour Plate 4 Barn 4 Southwest Facing Elevation.

The final barn, (Barn 4, *Fig. 2*), is located approximately 500m northeast of the main farm complex and conversion work had already begun prior to the site visit. The barn is a single storey field barn constructed of 9 by 2.75inch machine made bricks. The roof had already been stripped, but the few remaining tiles were again Staffordshire Blues. It appeared to originally have been of four bays with the two central bays being open at the front. There is a small window on the right hand gable and a pedestrian door and window to the right on the back wall.

Again the interior is devoid of any identifiable features; the right hand bay had been divided from the main space by a brick-built wall, approximately chest high. The roof timbers appeared to be modern replacements.

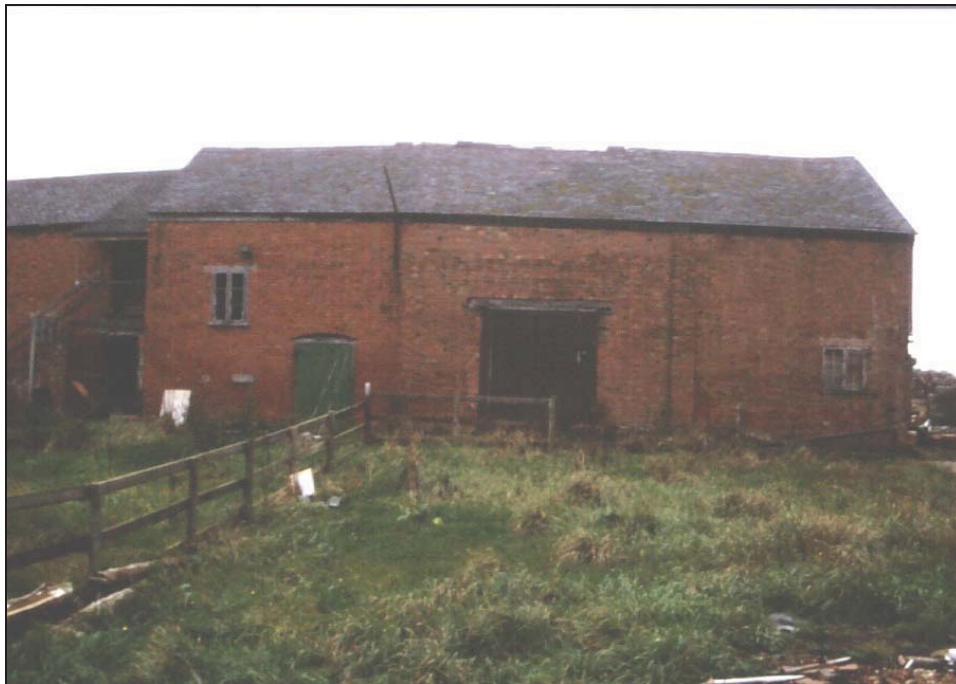
Colour Plate 5 Barn 2a Southwest Facing Elevation.

Barn 2 consists of two separate phases of buildings on the north-easternmost part of the farmyard; the easternmost barn (*Barn 2a/Fig 2*) is a large 3 bay threshing barn, which is probably the earlier of the two buildings. Barn 2a is constructed of handmade 2.5inch red bricks with a Blue Tile roof. The front is unchanged from the original build, with a large central threshing door and a smaller door to the left and two windows, one at ground floor level and the second at first floor level, possibly a modified pitching hole. The rear, however, is much altered, the threshing door and adjacent walls have been completely removed and replaced by an open ended extension of modern brick and corrugated tin roof, altering the roof line.

The roof appears to be original and is of timber and tile construction with the exception of the modern corrugated tin and timber within the central bay. The right hand bay is of raking strut construction, while the left hand bay is of suspended king post construction; both are roughly squared oak beams. The tiles are 7.25 by 11.75 inch Staffordshire Blue tiles and modern roofing felt has been used, indicating the recent renewal, however, the tiles are likely to be the re-used originals.

Both the easternmost gable end and the rear wall of the left hand bay have weathered white lime paint indicating additional building were at one stage attached to this barn, but have since been demolished.

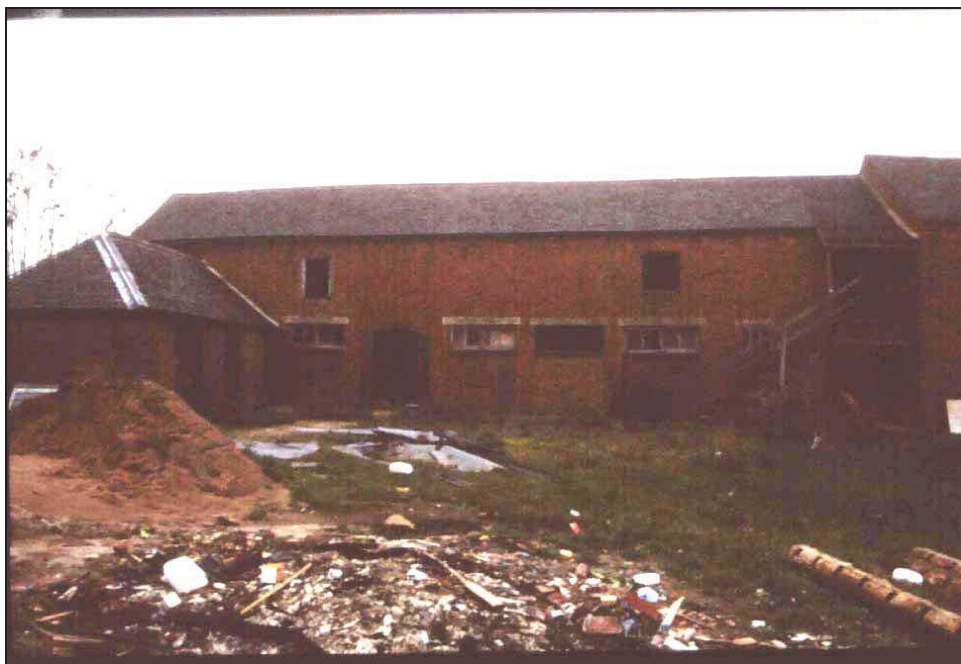
Colour Plate 6 Barn 2b Southwest Facing Elevation.

The western part of Barn 2 (Barn 2b/*Fig 2*) appears to be a later addition and has been built slightly out of line with to Barn 2a. Barn 2a was located to maximise the through draft from the prevailing wind for threshing, Barn 2b was then added to complete the range around a central yard. Barn 2b is built of 9 by 3inch machine made red bricks and again with a Staffordshire Blue tile roof of two storeys. A single storied hipped roofed extension has been added at a right angle to the far left of the building.

The barn originally appears to have been a cowshed; access was originally through 3 double doors, since blocked and a single pedestrian door, still in use. The ground floor is much altered and with the exception of a number of tethering rings, nothing remains of its original use. There is small room to the right, acting as a cross passage with no internal access; there are front and rear doors. There is no evidence of the room's original use; debris would suggest it was used as a general store room, until recently.

The roof construction is again suspended king post and as with the adjacent threshing barn the beams are roughly squared oak. Once again new roofing felt indicates the building has been re-roofed.
