**A Level 3 Historic Building Survey of  
10 Short Hill and the rear wings of  
54-56 High Pavement,  
Nottingham,  
NG1 1HW  
Final Report  
NGR: SK57749 39620**

ULAS Report No. 2019-115  
©2019

**For: MDA Consulting Limited**

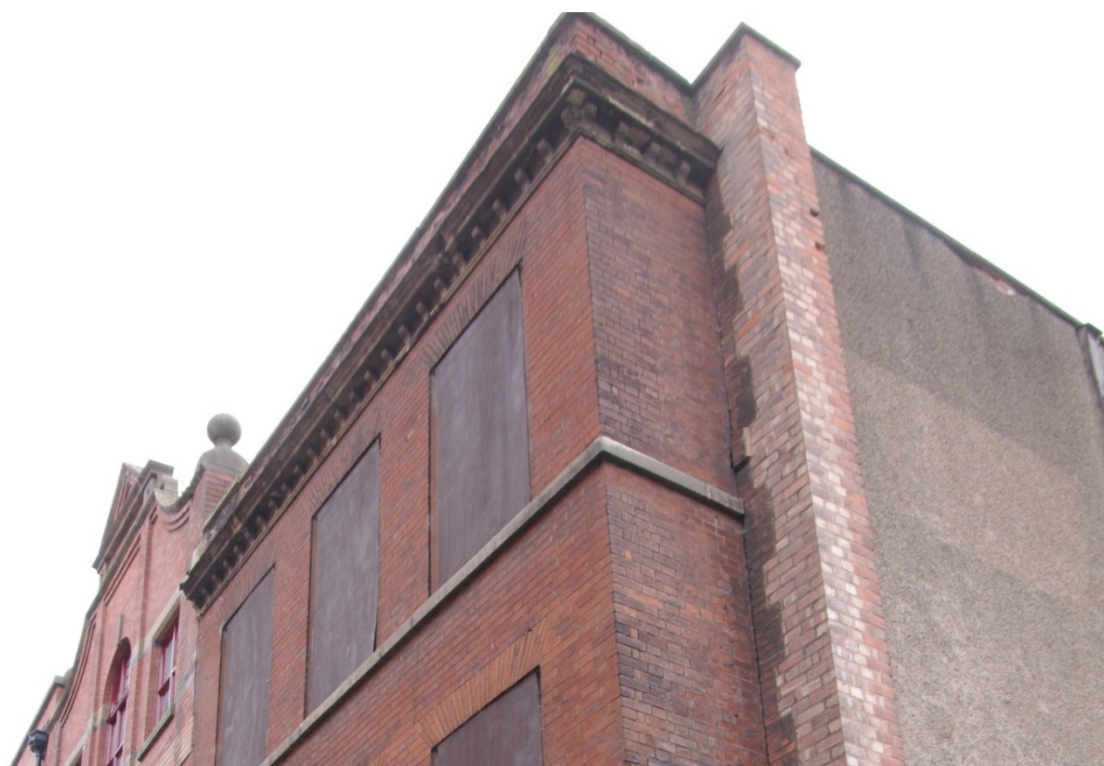
Above the second floor windows is a limestone cornice with ornate dentil detailing which, as with the stone string courses, wraps around onto the west facing elevation. The dentils have floral decorations carved onto them. Above the cornice is a brick parapet which appears to have been added in an attempt to mask the roofline of the building and maintain its Georgian style façade (Fig. 19). The parapet bricks are of a slightly different colour and, unlike the rest of this elevation, have been badly affected by frost and weather.

Figure 19 Number 10 Short Hill, north facing elevation. Cornice detail  
Looking south-east

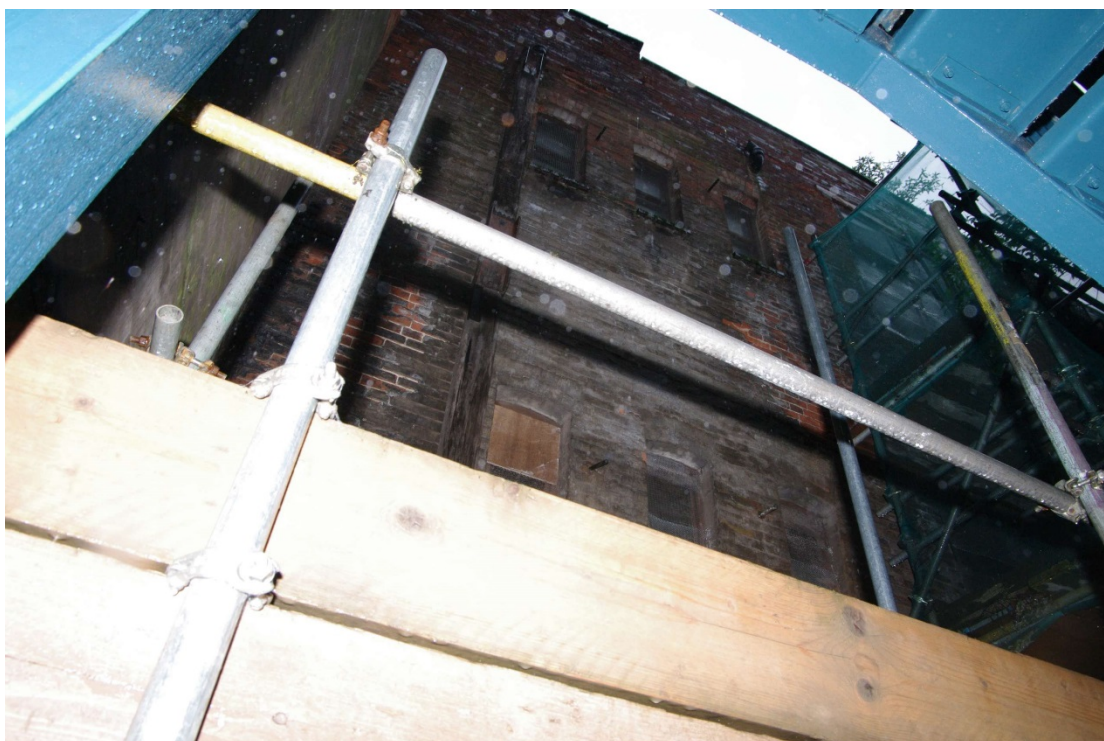
The east facing elevation was inspected in heavy rain conditions which showed the bricks to be quite porous and that water was running down many parts of the wall (Fig. 20). A network of scaffolding had been erected to protect occupants of adjacent buildings from falling masonry. Despite the scaffolding being in place it could be seen that this elevation served the toilet block of the three storey building with rows of three narrow sash windows towards the southern end of the east facing wall. The sashes were made of wood whilst the arched window lintels were brick-built. Wider windows with timber lintels on each floor continued northwards and lit the warehouse rooms (Figure 21). The window frames of the wider windows appeared to be quite modern and may date to the second half of the 20th century. It is not clear if the wider window openings had been modified from earlier and smaller openings.

A pair of vertical timber and steel beams at either end of the wall appeared to be bracing the brickwork below. These appeared to have been present for some time and probably represent a longer-term structural problem dating to the wartime bomb damage. The

eaves finished in a flat parapet wall which shows evidence of modification and rebuilding. The parapet may be responsible for some of the blocked gutters and the consequent water damage. Patches of brickwork were bulging outwards in places and a number of apparent settlement cracks in the brickwork were visible.

Figure 20 Number 10 Short Hill, east facing elevation  
Looking up through scaffolding at first and second floors. Note timber bracing

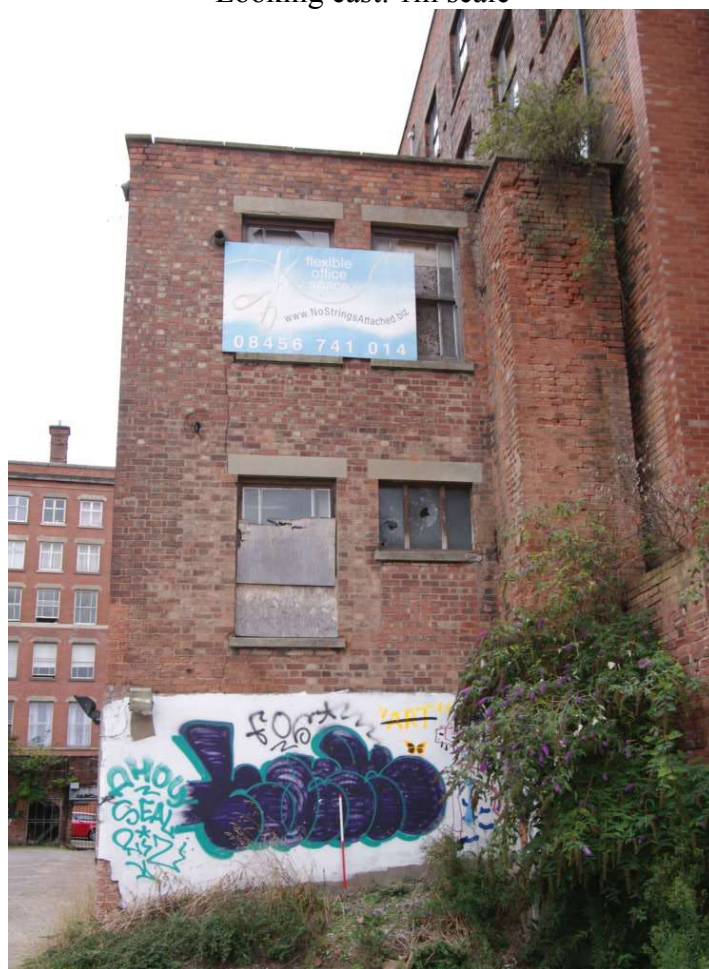
The south facing elevation of Number 10 had been completely rebuilt in the same way as the upper and end parts of the west facing elevation had been (Fig. 27). The basement level was covered in render with no openings apparent. The pairs of windows on the ground and first floors all had sash windows with concrete lintels. The ground floor west window had been reduced by modern brickwork to make a much smaller window. A truncated chimney stack or vent had been built against the corner of the wall but neither this, nor the wall of the main building, were bonded to the wall of the adjacent property.

Figure 27 Number 10 Short Hill, south facing elevation.  
Looking north. 1m scale

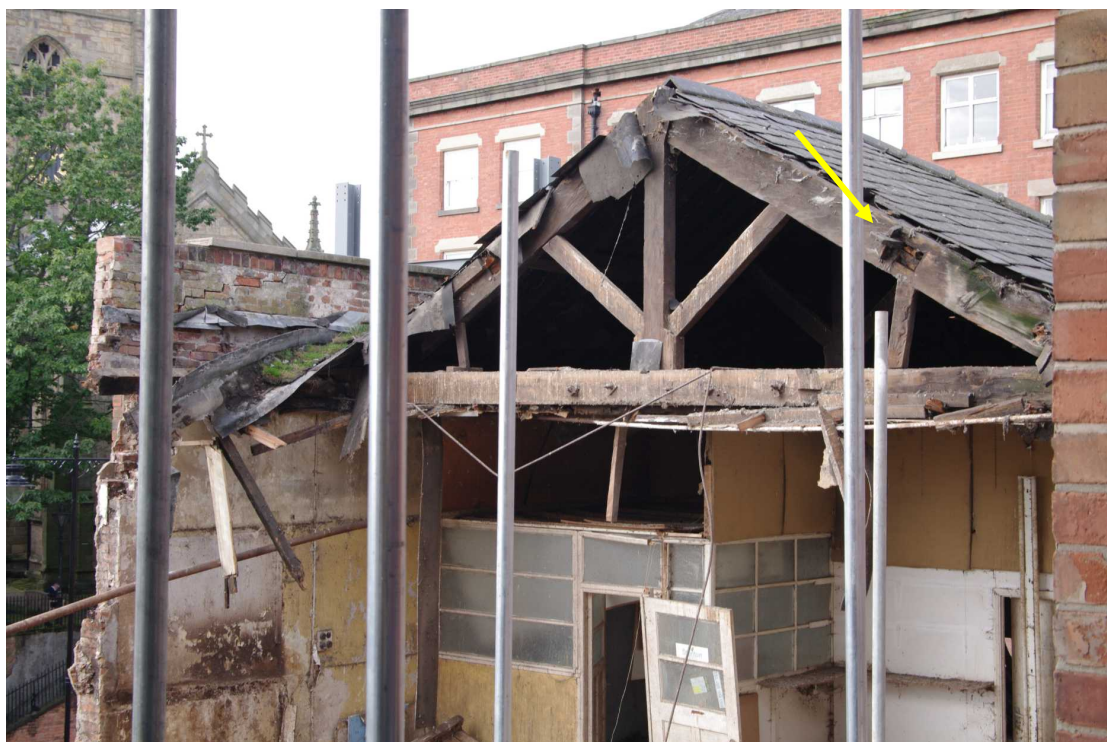
Demolition of the centre section of 10 Short Hill exposed the roof structure of the front (northern) section of the building. As demolition of the centre and front sections progressed it could be seen that the front section building had been modified from its original hipped roof to form a continuous gable across both sections. A new truss on a slightly different angle had been added to replace the original front section hip and supported the ridge of the centre section. This new truss consisted of a relatively lightweight king post supporting bolted principal rafters with raking struts (Fig. 38). Presumably the roof modification took place when the centre section was altered around the turn of the 19th/20th century. Once this truss had been removed the original hip and the slightly more substantial northern section roof structure could be seen (Figs 39 and 40). As the roof was removed the end of the trusses were exposed which revealed carpenter's marks in the form of Roman numerals indicating that the trusses had probably been fabricated off-site (Fig. 41). Once the hip structure had been removed it could be seen that the purlins were joined to the end principal rafters using a pegged or wedged mortice and tenon joint (Fig. 42).

Figure 42 Close-up of roof front section structure  
Pegged tenon of purlin arrowed. Looking north-west

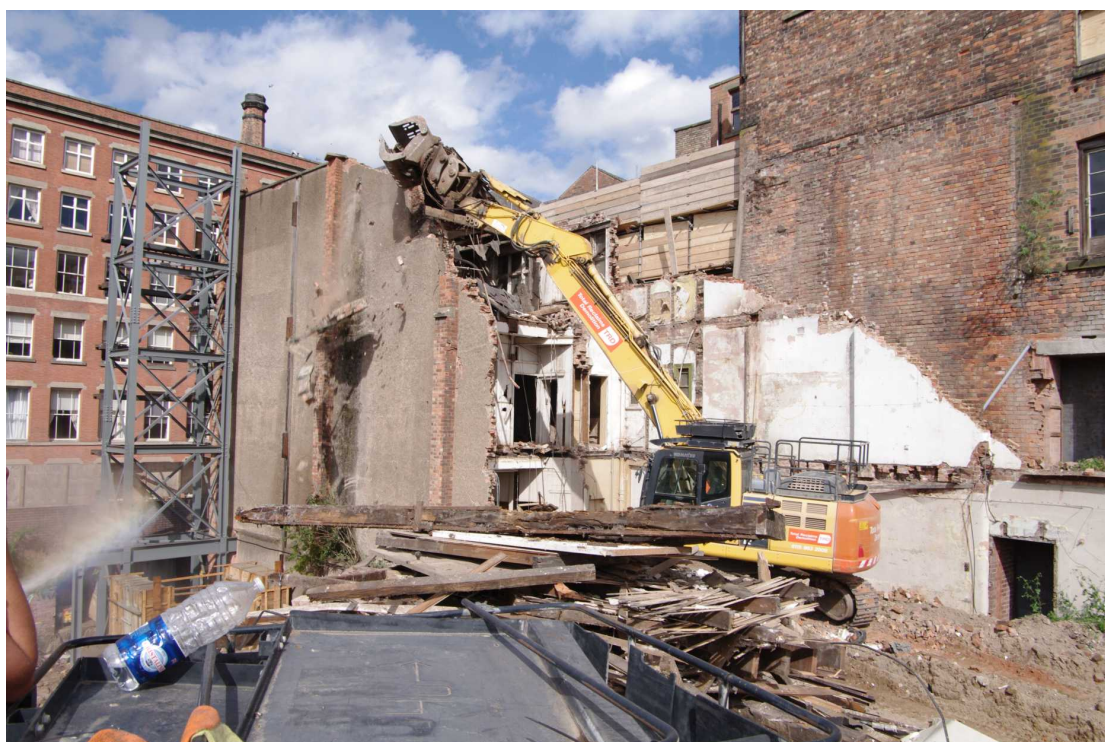
The western side wall of the front section appeared to be relatively poorly built and may have been further destabilised by the removal of the bombed building. The vertical wooden timbers on the east and west walls were connected to metal tie rods which extended through the building to prevent the walls from splaying. Some of these rods appeared to have rusted through since their installation during the war. The brick buttresses also appeared to add a minimum of stability to the wall.

As Number 10 was removed more of the western wall of Number 9 was exposed. It could be seen that the brickwork was fairly poorly pointed and that this building appeared to be built against Number 10. There was also no physical contact between the two buildings except for the basement and first floor doorways which appear to be later insertions.

Figure 44 Number 10 during demolition and west facing wall of Number 9  
Looking north-west
