**A Level 2 Historic Building Assessment
at Hallfield Farm, Diseworth, Leicestershire**

SK 45499 24499

ULAS Report No. 2018-077

For: **John Sutton Developments**

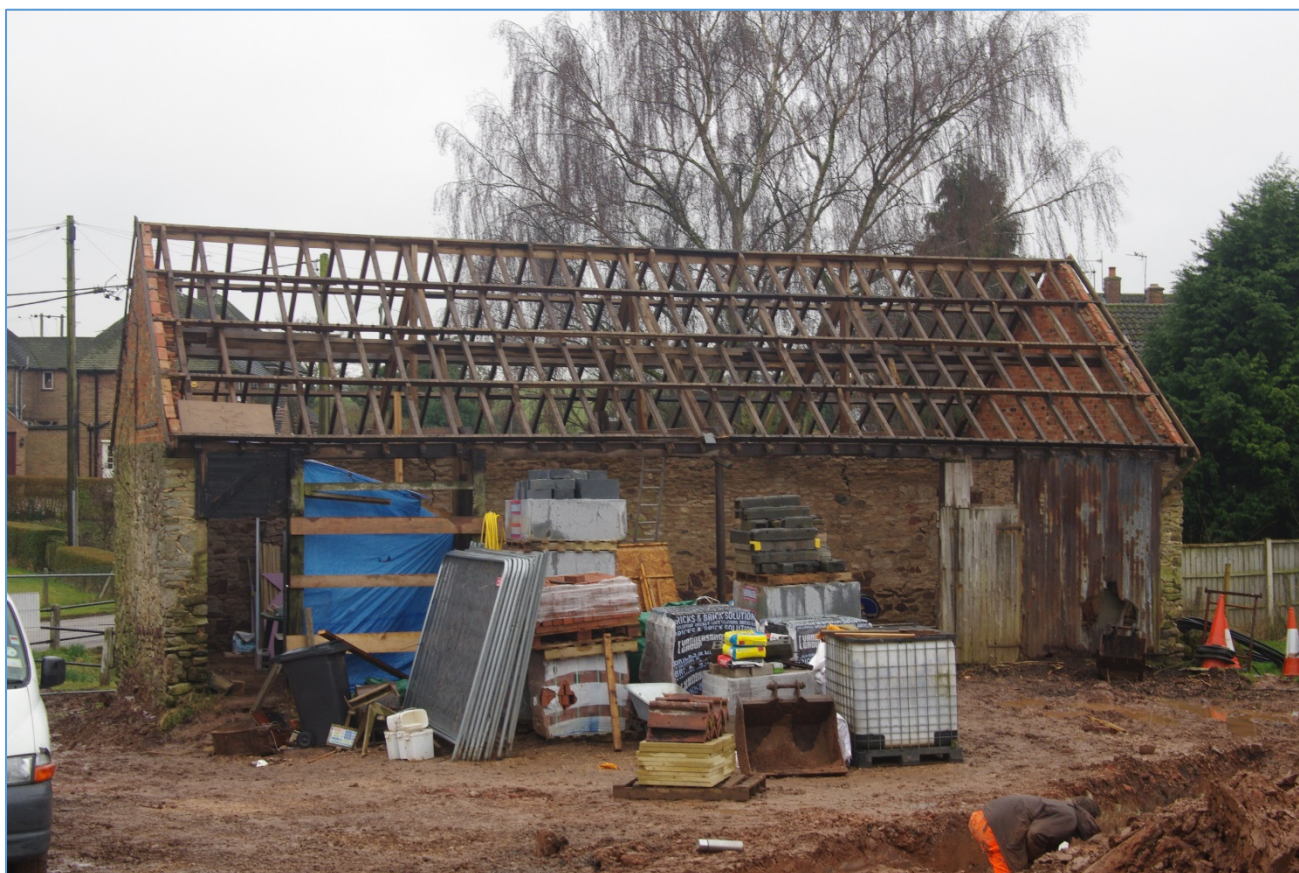
Figure 3 North face

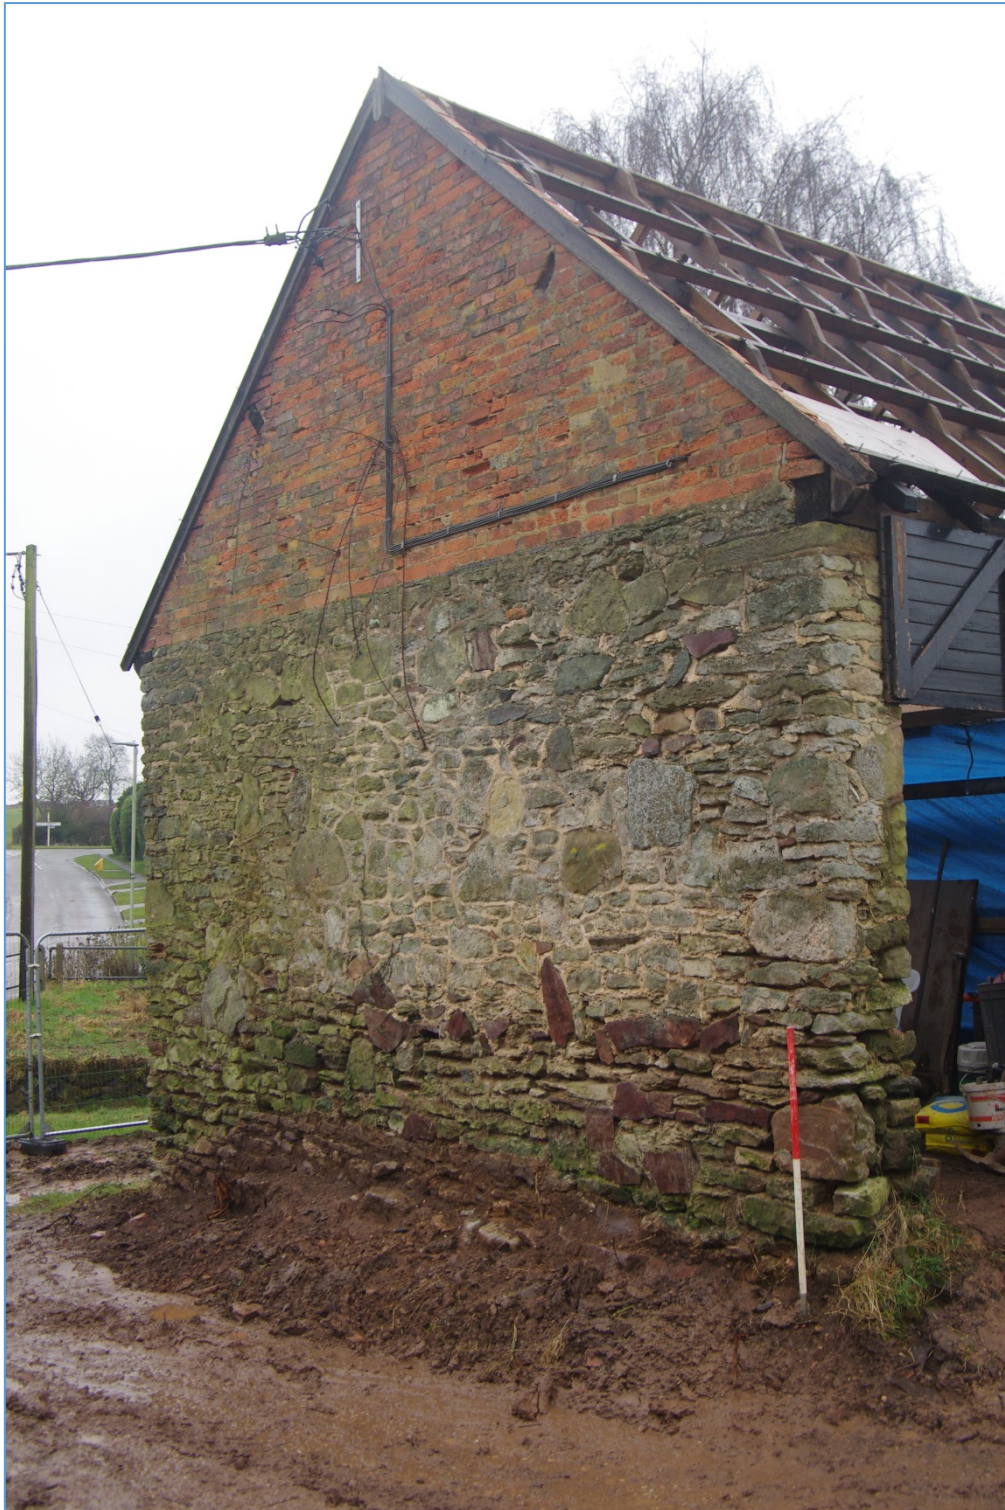
Figure 4 East wall. Note broken millstone centre left in the masonry

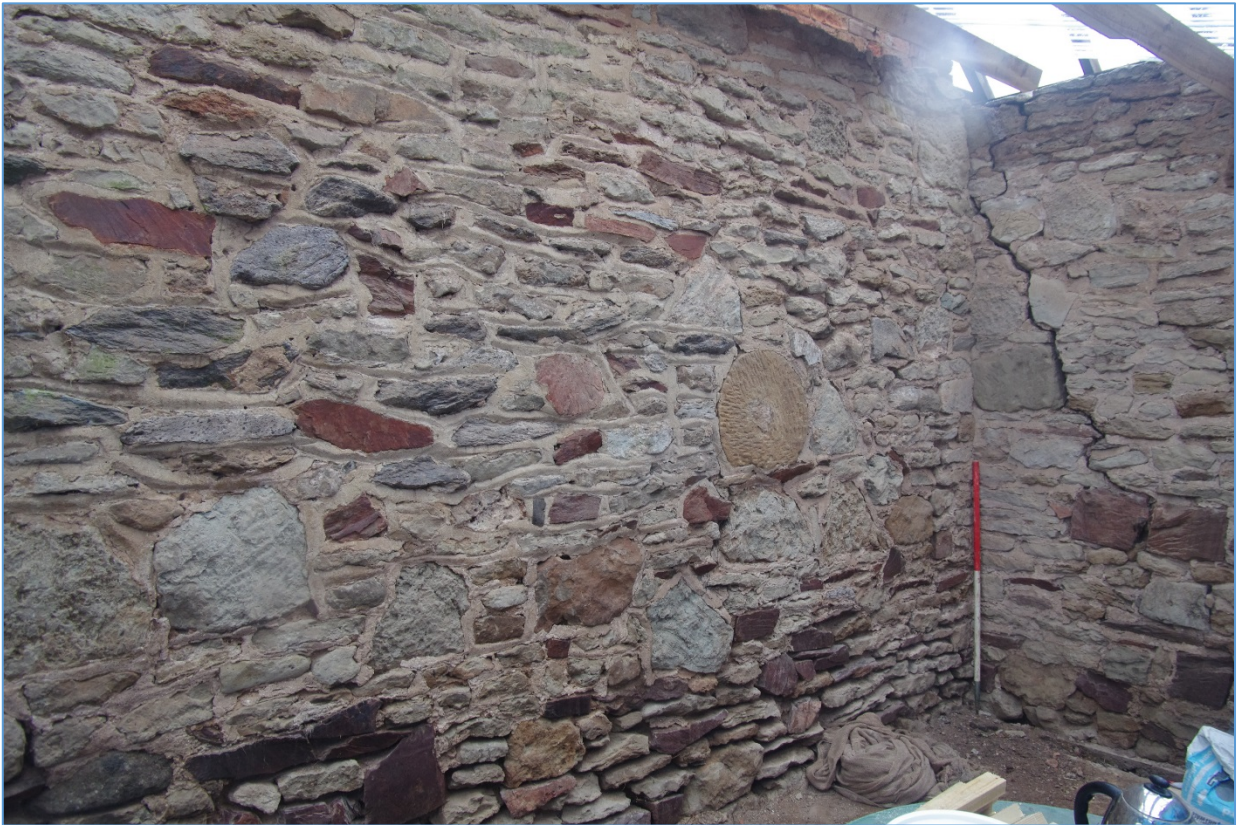
Figure 5 East wall, internal, looking south east

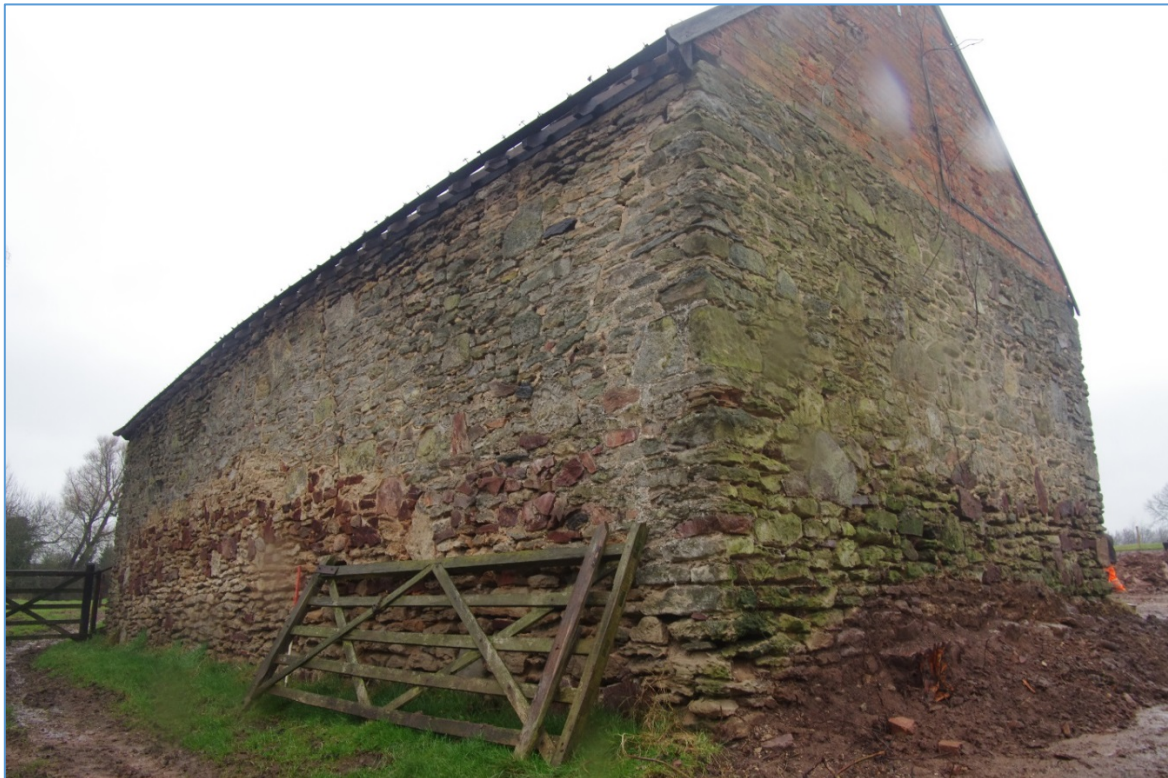
Figure 6 South, and east walls

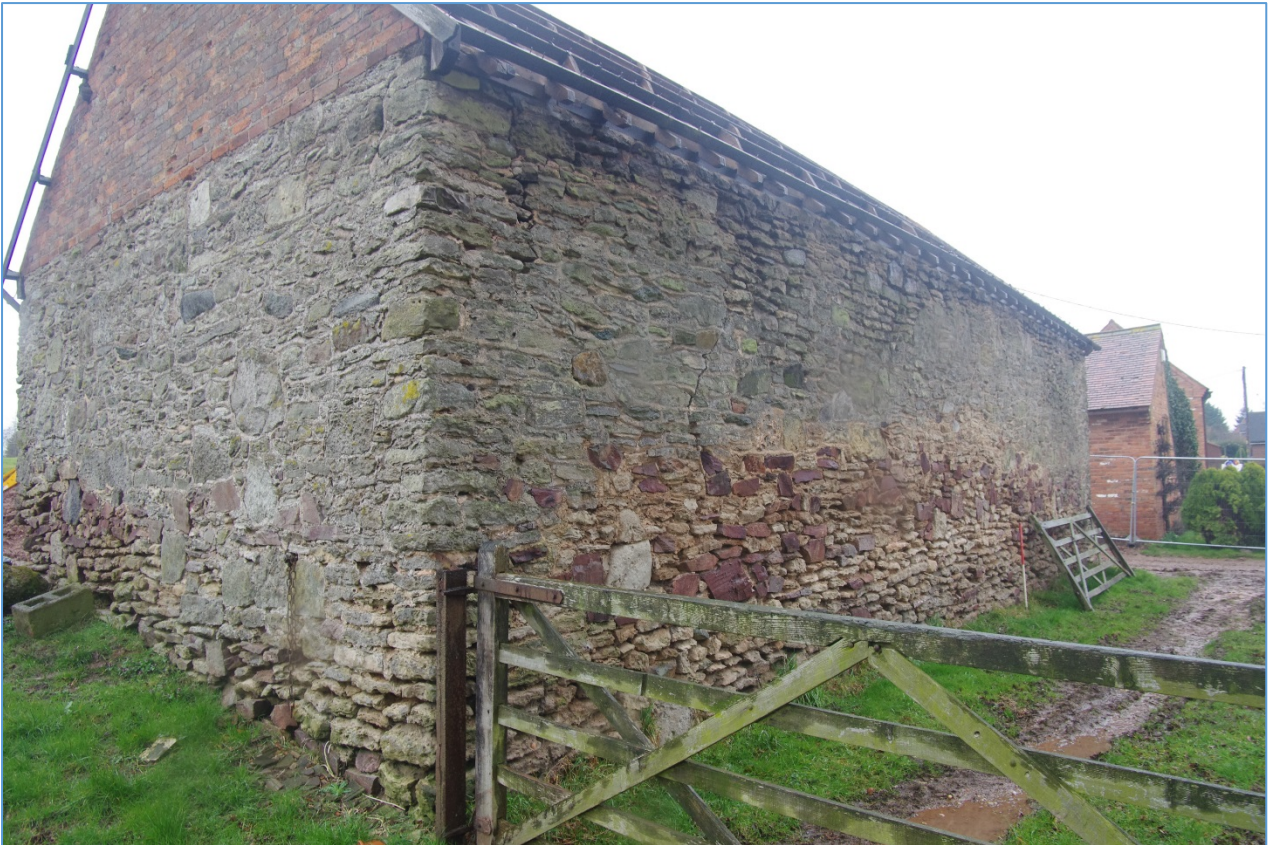
Figure 7 West, and south walls

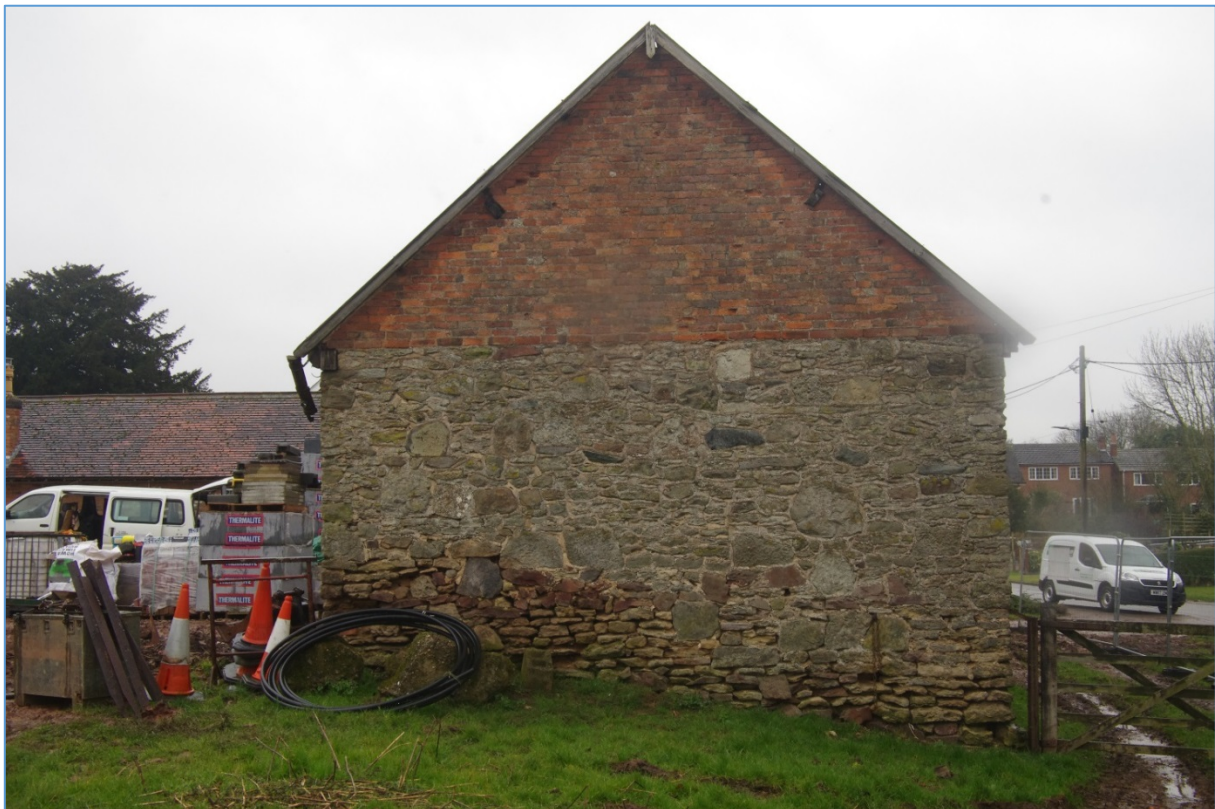
Figure 8 West wall

accept the present roof structure (note the rebuilding line visible in the west gable, Figure 8) which was probably originally in tile or slate, then replaced with sheeting.

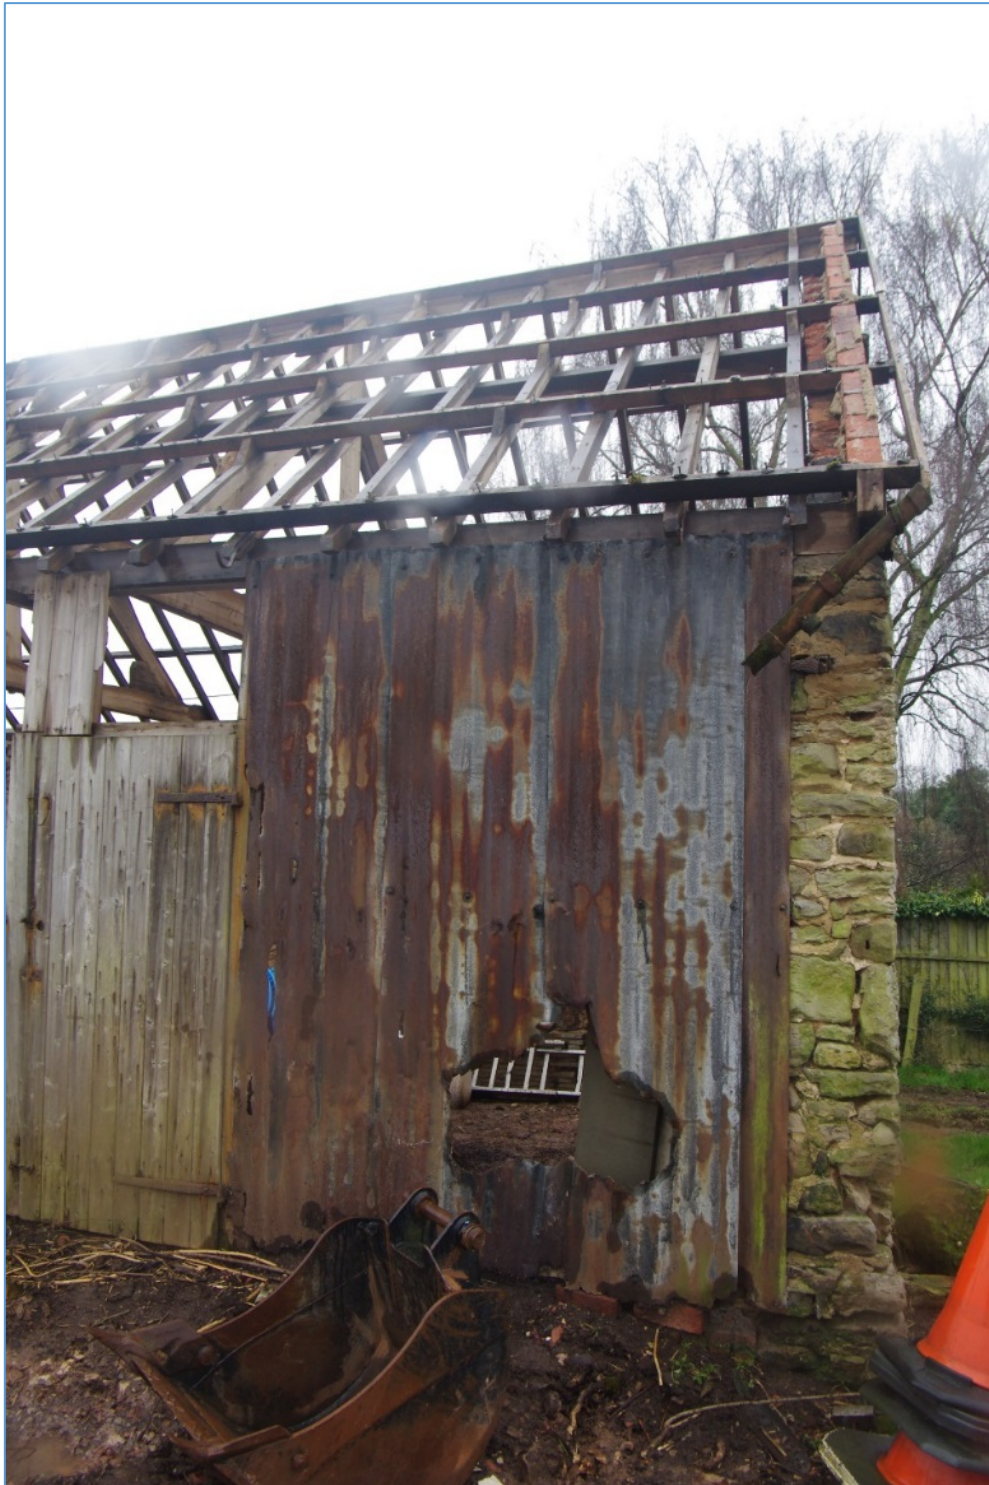
Figure 9 North elevation, west end. Note superstructure over rafters for corrugated sheets

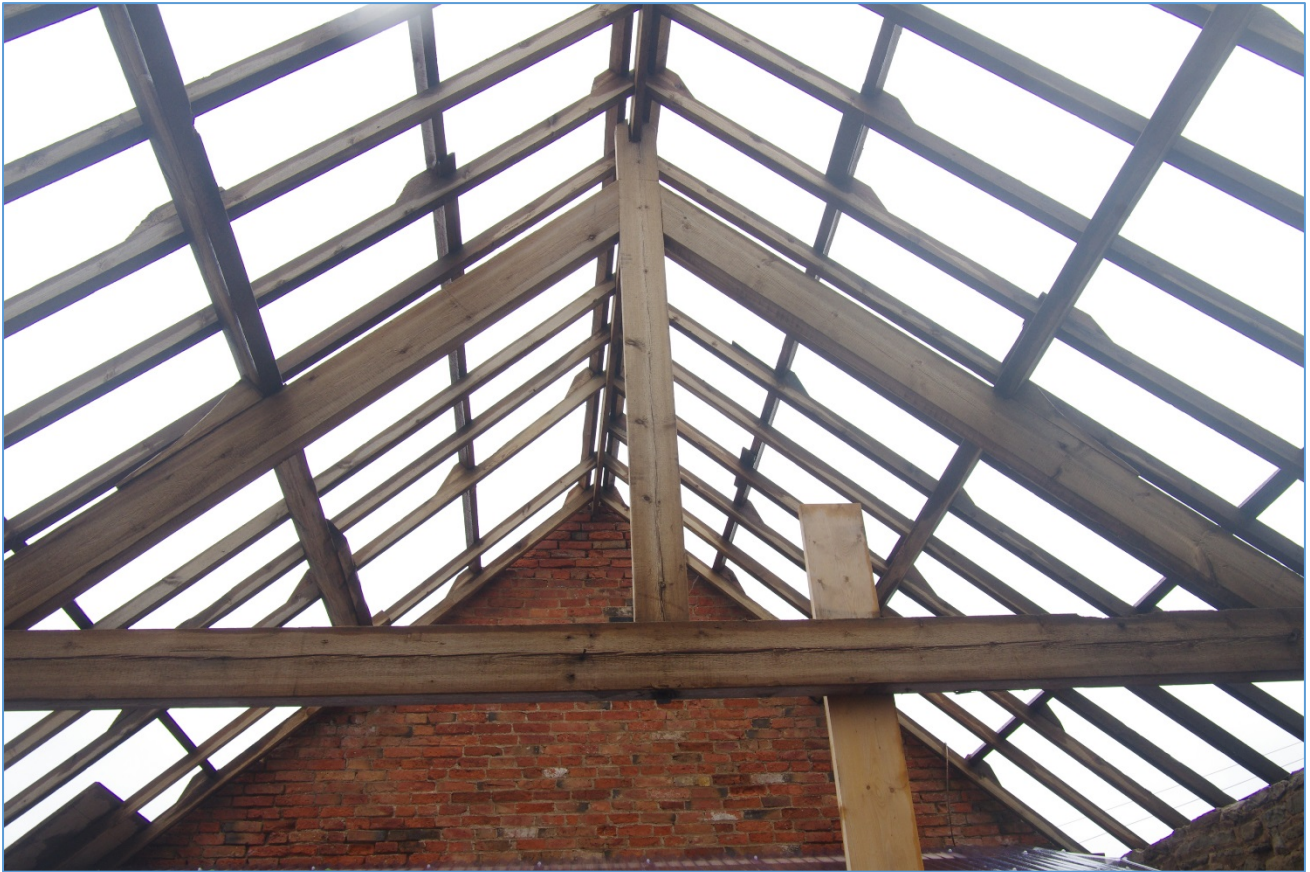
Figure 10 Roof structure, looking west

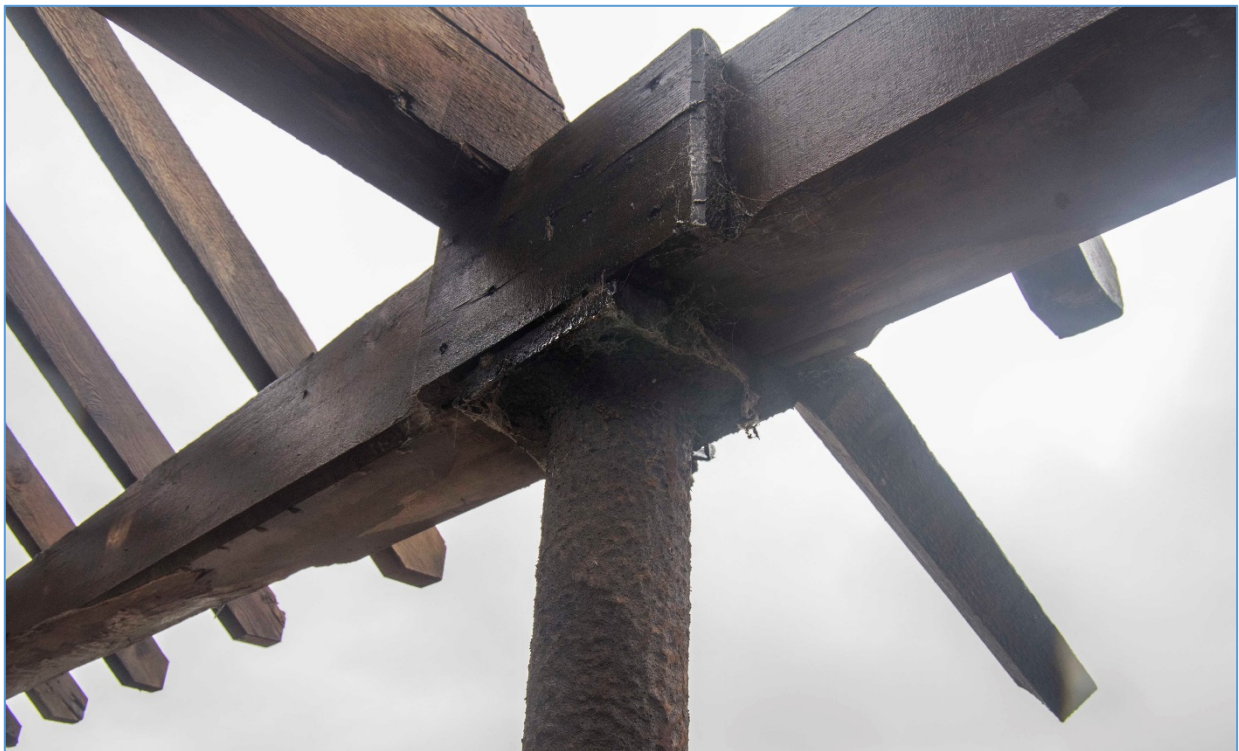
Figure 11 Detail of junction between column and lintel. Note chamfer and stop

The cartographic evidence ties nicely into the physical survey of the barn, in that it appears very likely that the north wall has been removed. The tie beams of the trusses sit nicely over the rear wall, but only perch on the front lintel (e.g. Figure 11, Figure 14). The lintel itself is a curiosity in that it is chamfered and stopped, which is unusual in an agricultural building. It is unlikely to be a single piece of wood, presumably it is in at least two sections, the join hidden by the columns and tie beams. Each section is of a size to have been suitable as an axial beam in a house, so may be re-used, but there are no signs of mortices for joists, and moreover the chamfers and stops correspond to the position of the column / tie beam junctions. The trusses themselves are unusual in that the foot of the king post (Figure 10) would normally be joggled to accept diagonal braces out to the principals; they seem in very good condition and may be 20th century rather than 19th.

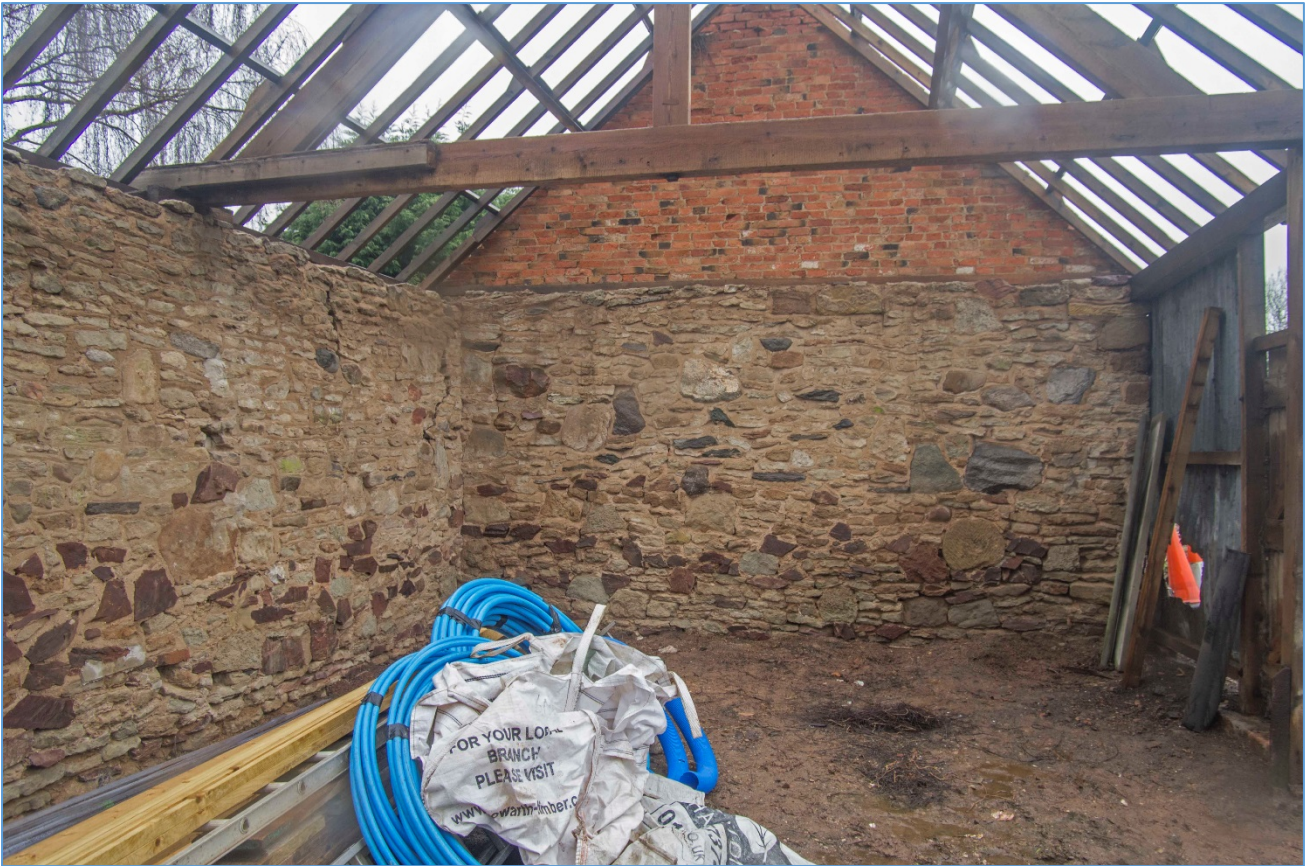
Figure 12 Interior, west end

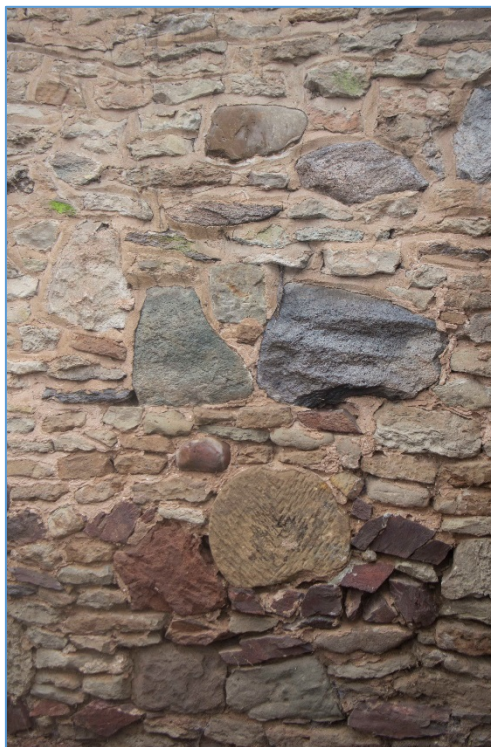
Figure 13 Millstone in west wall interior

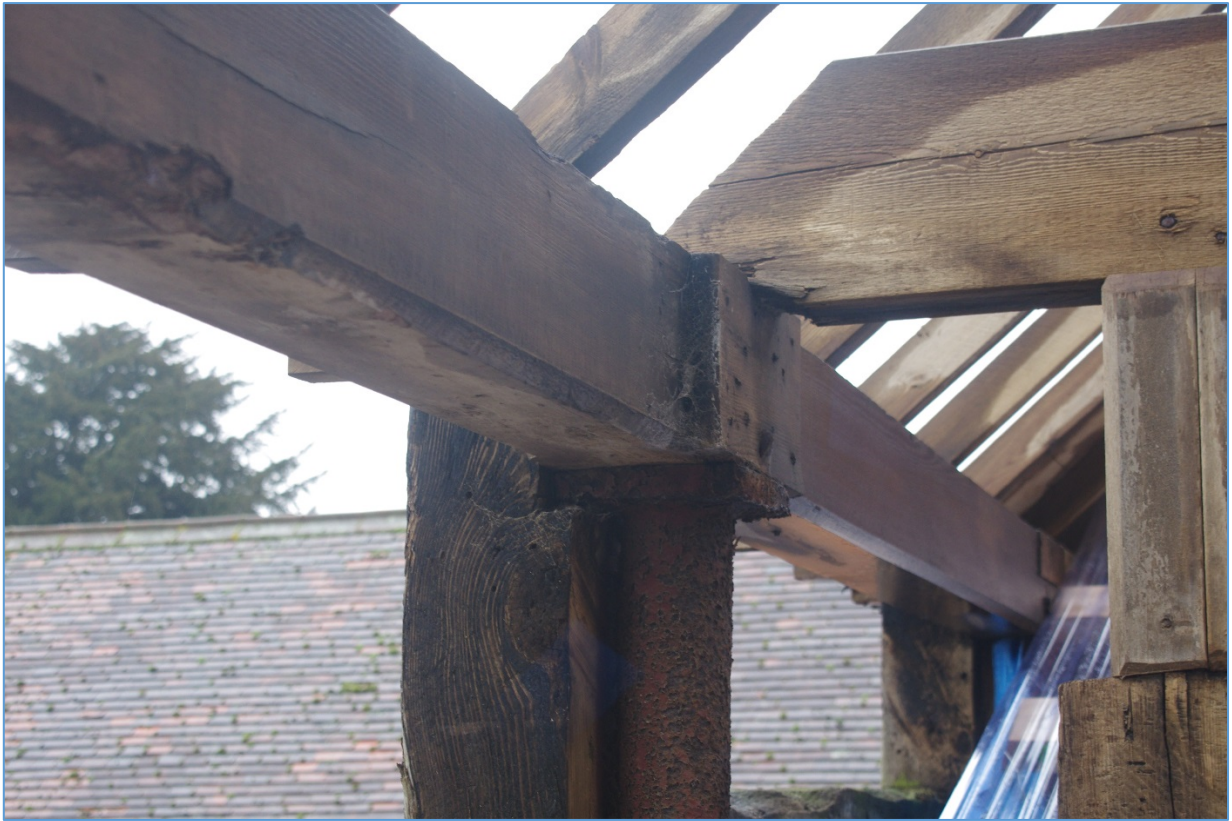
Figure 14 junction of tie beam, lintel, column

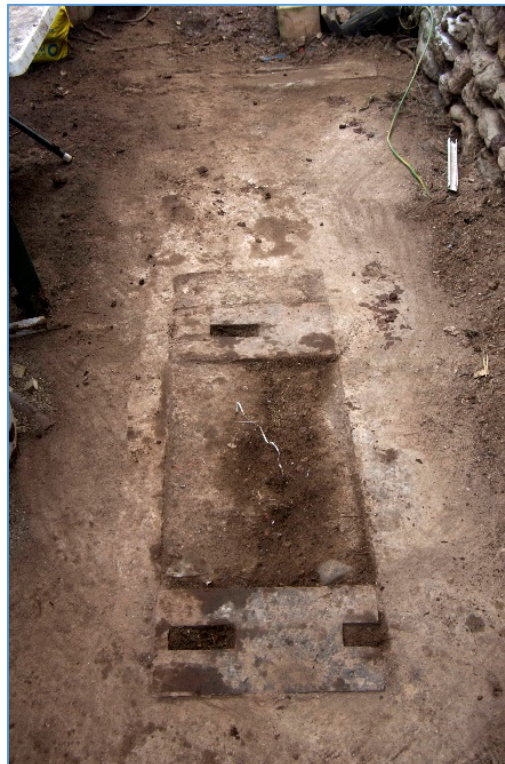
Most of the floor is unmade except a raft of concrete at the east end, where slots in the floor indicate static machinery.

Figure 15 Mounting sockets in floor, east end

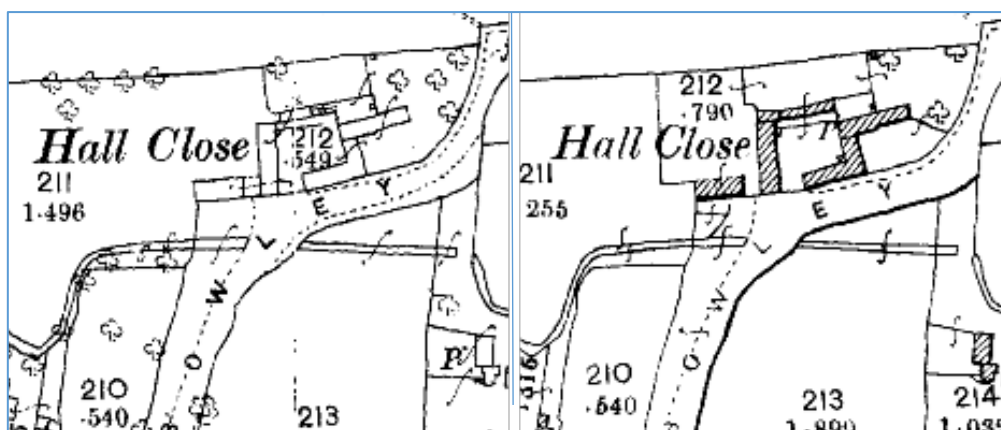
The barn does not appear on the 1796 enclosure map for Diseworth, but nor do most of the buildings in the village centre, so this is of little use. It appears on the OS 1884 first edition; of note is that the north wall is represented by a solid line, whereas the second edition of 1903 shows a dashed line, indicating an open front. There is no change to the building itself in subsequent editions, although the large Dutch barn adjacent which has been recently removed had appeared by the 1961 edition.

Figure 17 Ordnance Survey First (left) and Second editions: detail.
