**A Historic Building Appraisal (Rapid Assessment) of barns at Park House, 4  
Main Street, Stoke Golding, Leicestershire (NGR SP 398 970).**

**Gerwyn Richards**

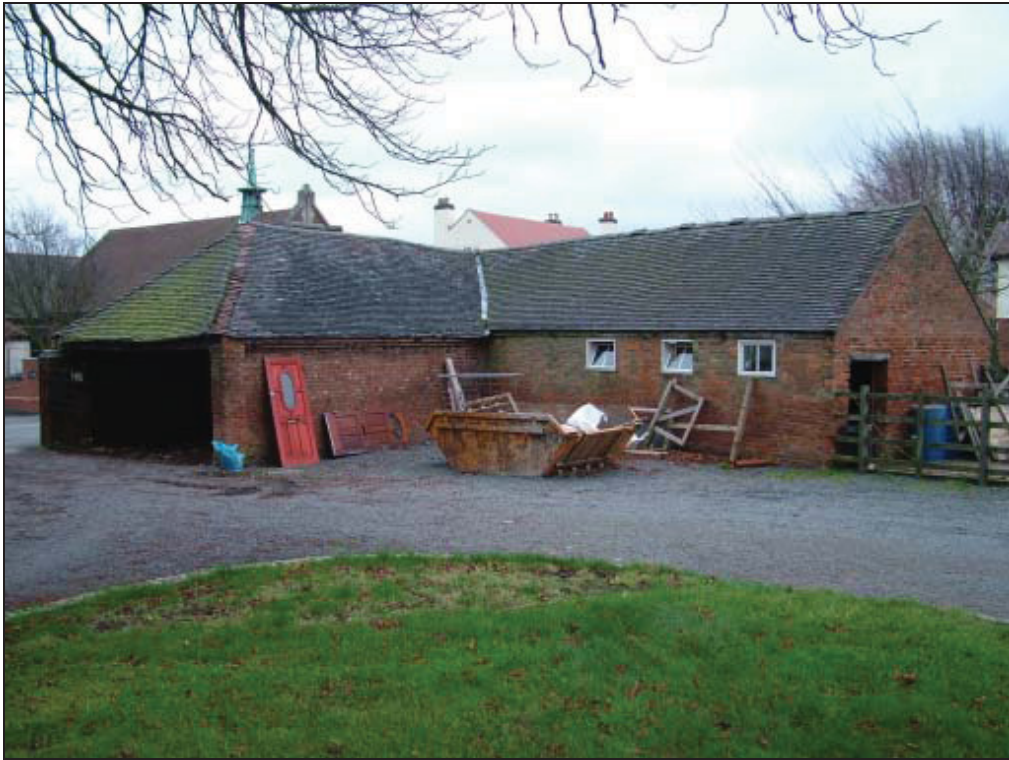
**Colour Plate 1** Building 1 from the North West

Building 1 is located at the eastern edge of the proposed development area, fronting onto Main Street, it consists of a single storied red brick building, in an “L” shaped plan, with an open north west facing gable. Closer examination indicates the brick work is multi phase most likely as a result of repair and renewal and there is evidence of blocked windows. The earliest brick work appears to be within the wall fronting Main Street. The wing fronting Main Street has a hipped roof while the second wing has a simple mono-pitched roof, there is a significant coverage of moss on the roof, but it is likely that the tiles are Staffordshire Blues.

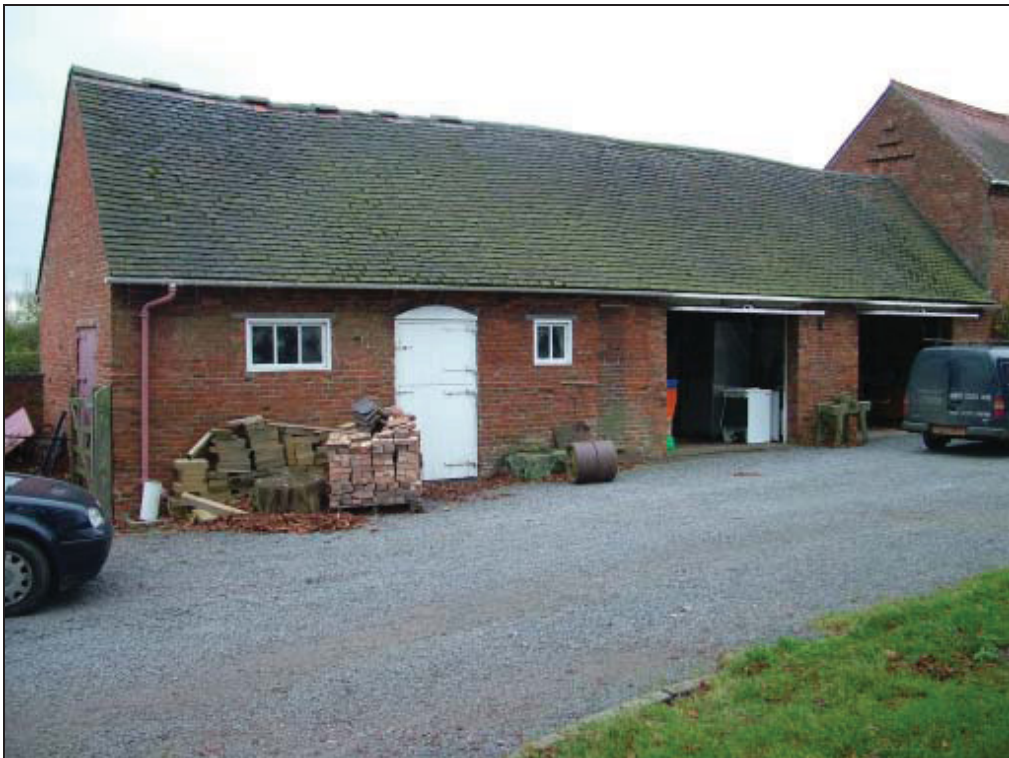
**Colour Plate 2** Building 2 from the North

Building 2 is located to the right of building 1 and abuts building 3, again further to the right. As with building 1, it is a single storey red brick building of three bays with a tiled roof, two modern “up and over” type garage doors have been inserted into the front walls of the central and right hand bay, the left hand bay has an older stable type door. The brick work appears largely original and unaltered.

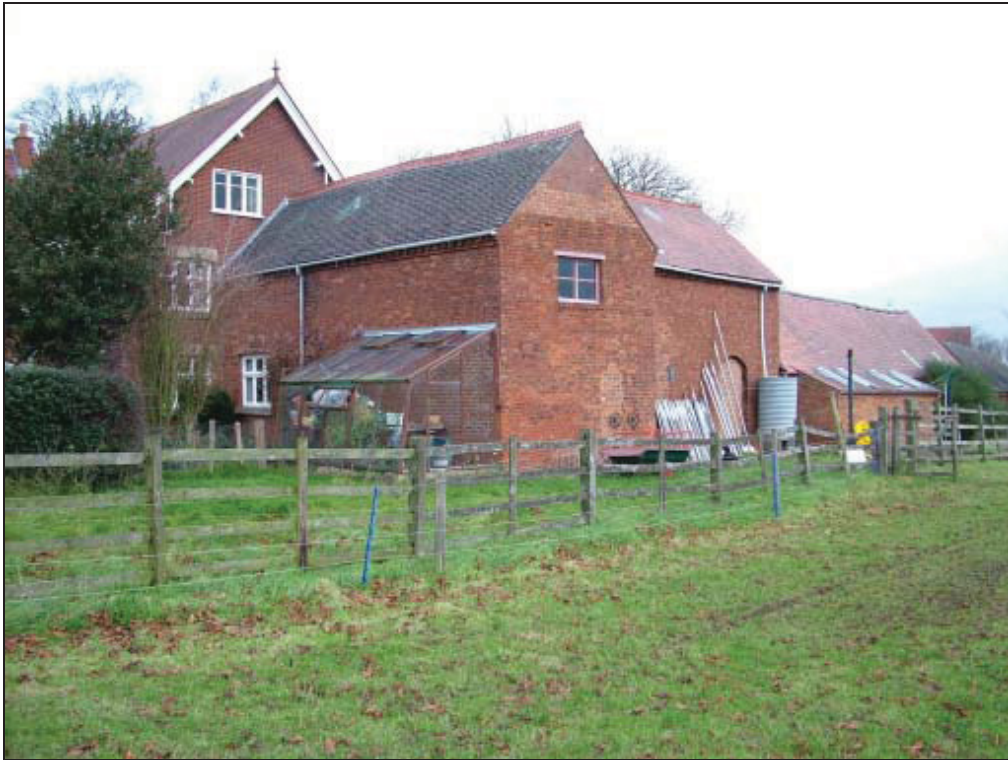
**Colour Print 3** Building 3 from the South West

The final agricultural building within the proposed development area is building 3, a two storied red brick barn which abuts the right hand wall of Park House, some of which has already been converted into residential use, housing the central heating for Park House. There has been much alteration, concealing or destroying most of the original architectural features; the first floor is almost certainly a recent insertion. Two arched entrances have been in filled on the rear wall, the left hand one may originally have been a window, but the other is far too small, so its original purpose is unclear.

As with the earlier buildings, it is the roof structure which has remained the most diagnostic feature within the building. It has remained largely unaltered and is likely to be original and along with the others would require additional recording work prior to any alteration work.

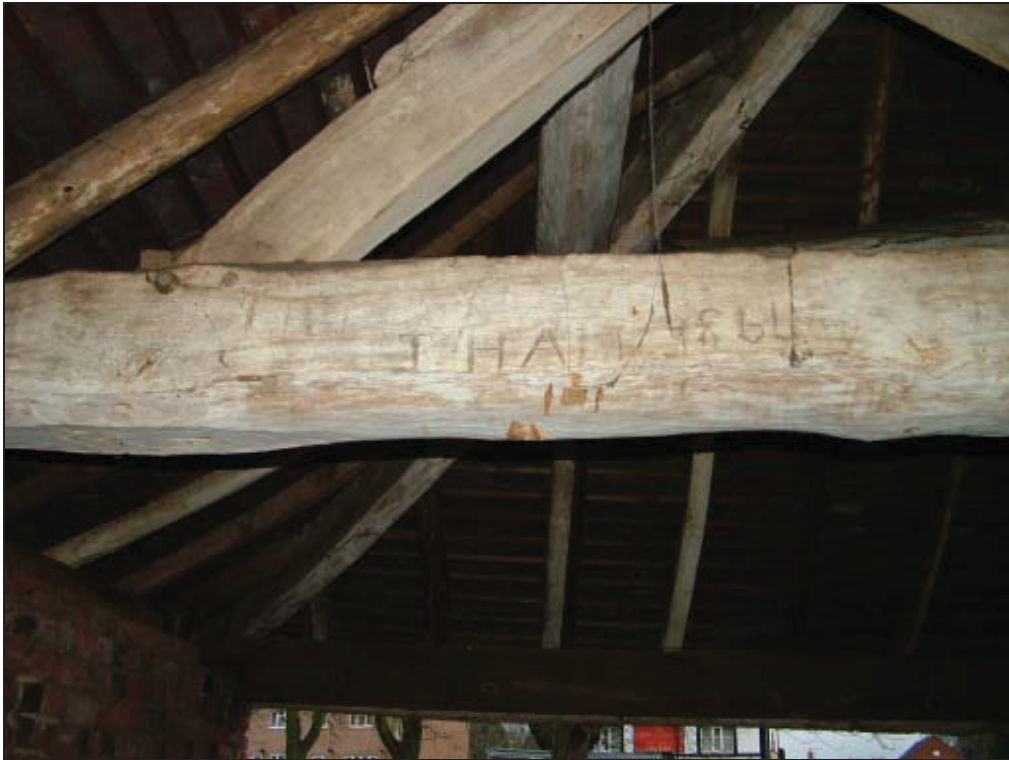
**Colour Plate 8** Inscribed Tie Beam

Internally, with the exception of the roof timbers, there is very little of architectural significance. The only feature of interest is the fact that the front walls of the two wings do not appear to be tied together; this suggests that the two may not be contemporary. There is no evidence of a straight joint on the rear wall, but the demolition of a wall would have left a ragged edge to which new brick work could have been joined, leaving no trace. As mentioned earlier, the roof timbers are the only diagnostic internal feature, the trusses within the Main Street wing are roughly shaped timbers in a bolted King Post design with raking struts, some of which are pinned. The left hand tie beam has been inscribed with the Name “T HALL” and the date 1861, there is another, much fainter inscription on the same beam, reading “AH 8” or “A 18”. Oral evidence suggests that Park House was owned by a family called Hall in the past.
