**A level 3/4 historic building survey of the Old Mill,
Mill Lane, Castor,
Peterborough,
Cambridgeshire
NGR: TL1280 9682**

Site Name: The Old Mill, Mill Lane, Castor, Peterborough,
Cambridgeshire. PE5 7TB

Client: WGP Architects

ULAS Report Number: 2020-088v2

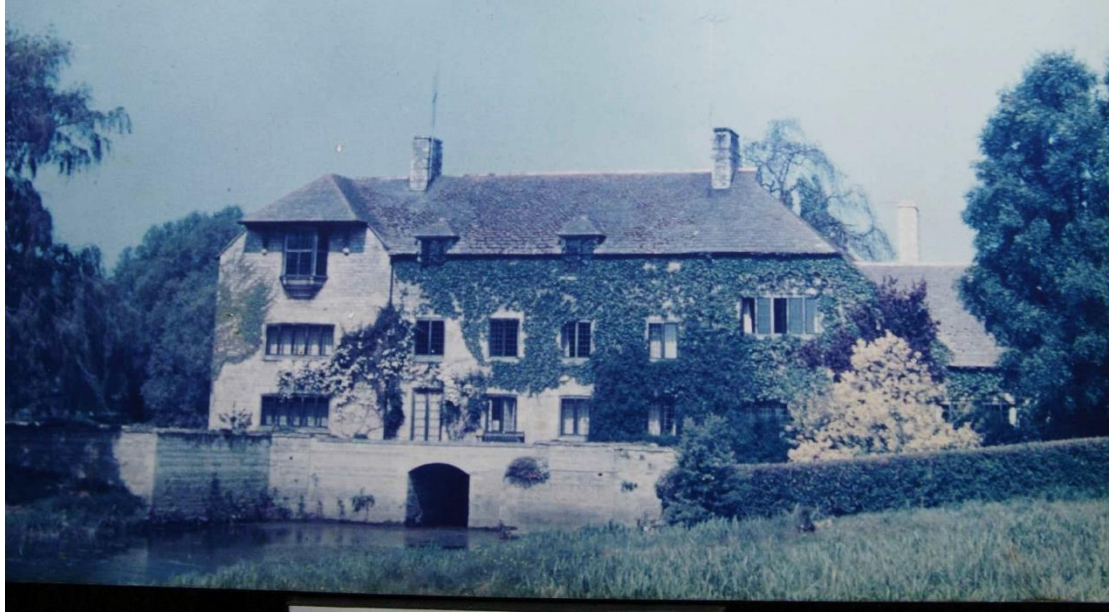
A 1950s photograph found inside the house during the survey shows the same south-east facing elevation twenty or more years after the 1930s work (Fig. 12). This photograph shows the same detail which exist at present with the exception of the concrete balustrade showing this to be a much later addition.

Figure 12: 1950s photograph of the south-east facing elevation
Photograph found during the survey. Note lack of balustrade

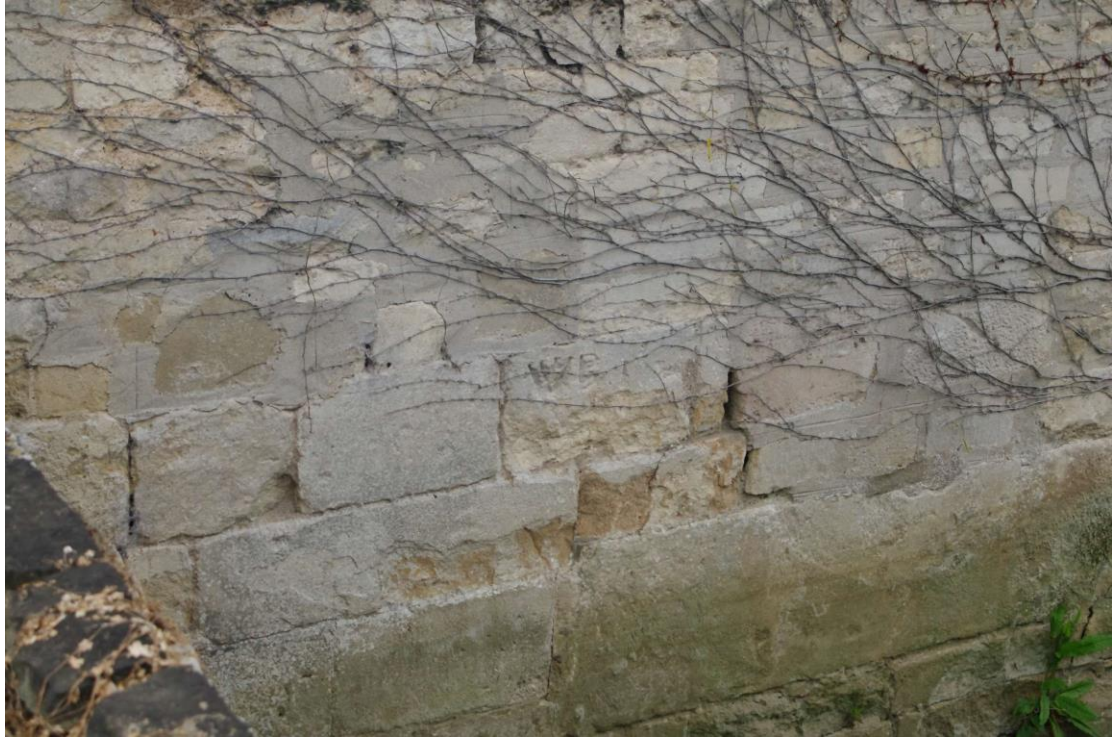
Figure 20: “WB” graffiti and circular scored marks caused by the water wheel

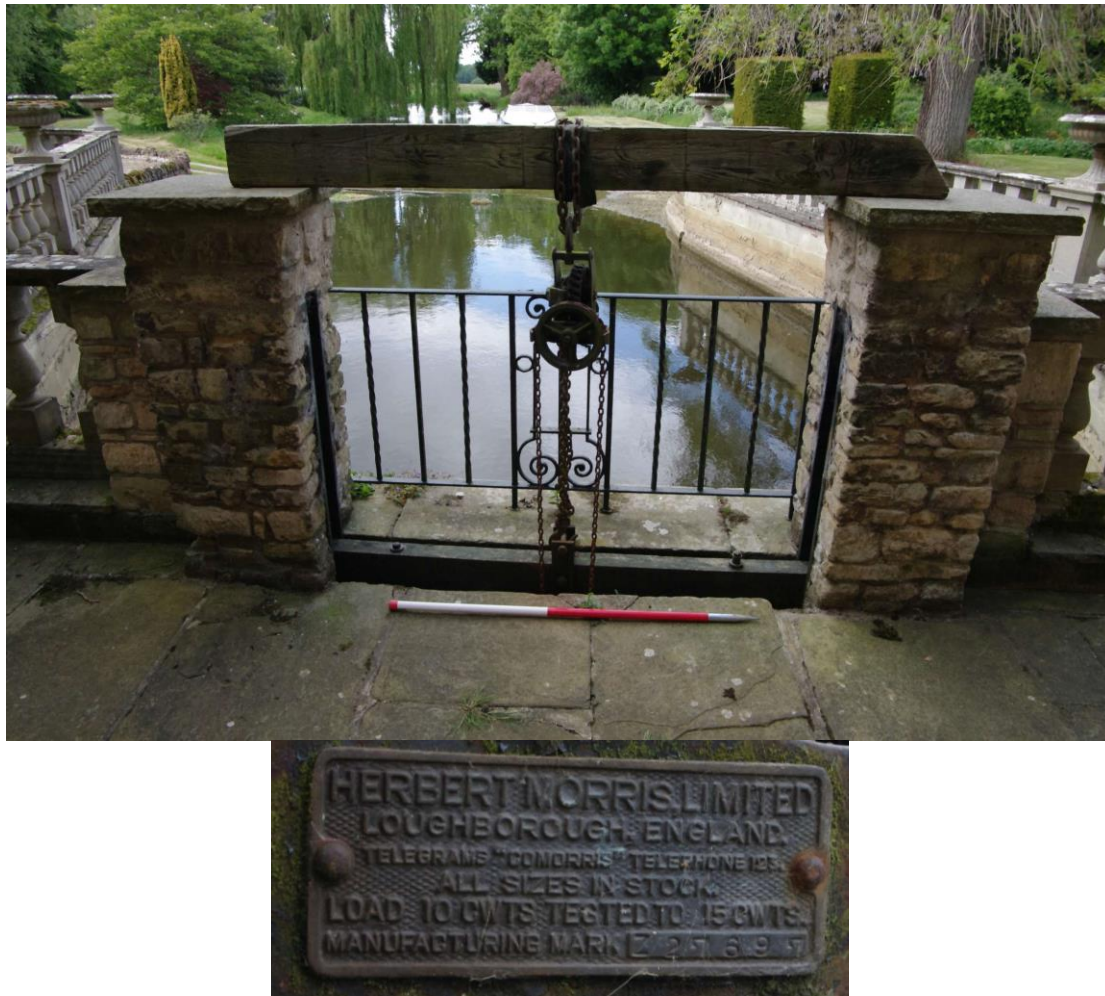
Figure 32: Internal water wheel sluice gate
Inset below is the maker's plate. Looking north-west. 1m scale

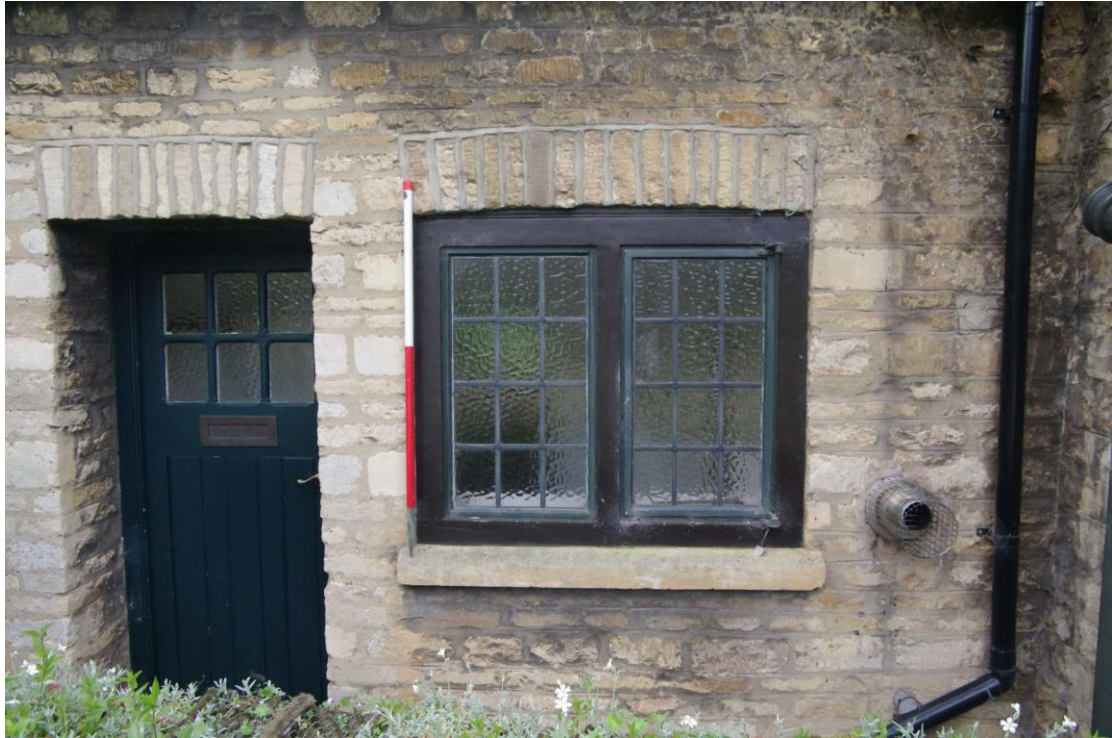
A datestone beneath the north window gives a date of 1983. This seems likely to be a refurbishment or repair date rather than a construction date otherwise the windows and doors are extremely faithful and accurate new replacements (Fig. 36). Some stonework around the corner appears to be quite clean and crisp as does some pointing supporting a 1983 modification rather than an entirely new structure.

Figure 36: Window and door detail, north end of NW facing elevation
Looking south-east. 1m scale

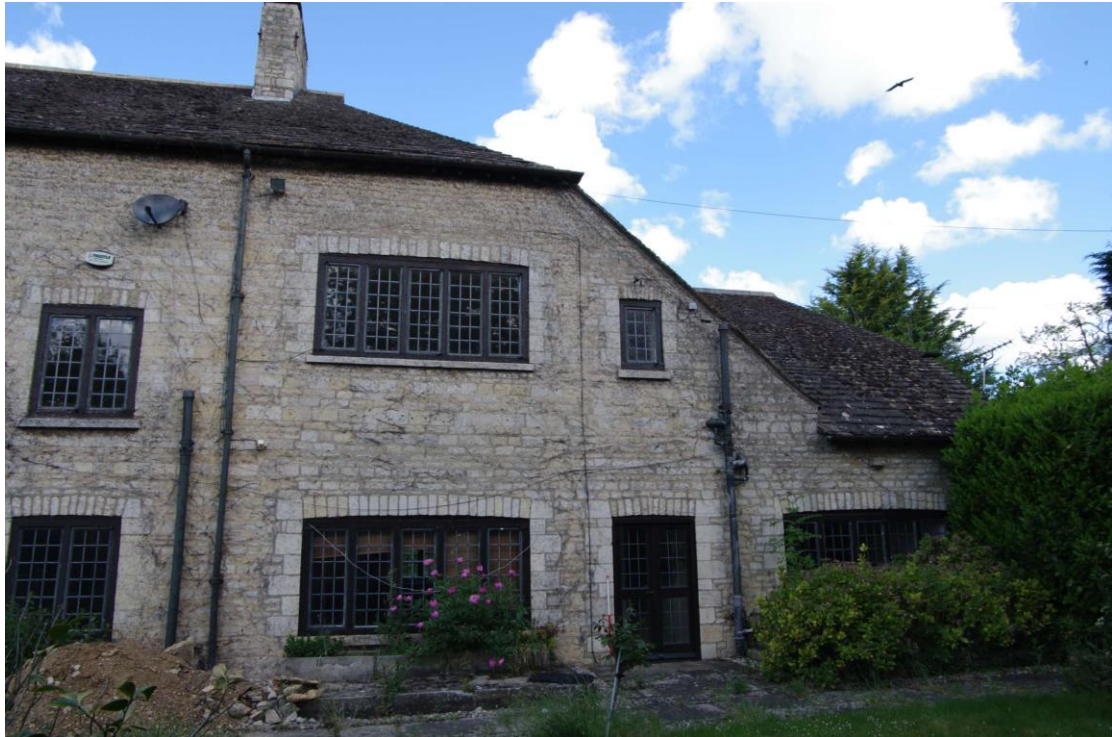
Figure 44: Northern end of the south-east facing elevation
Looking north-west. Possible line in stonework can be seen at first floor level to the side of the pipe on the right

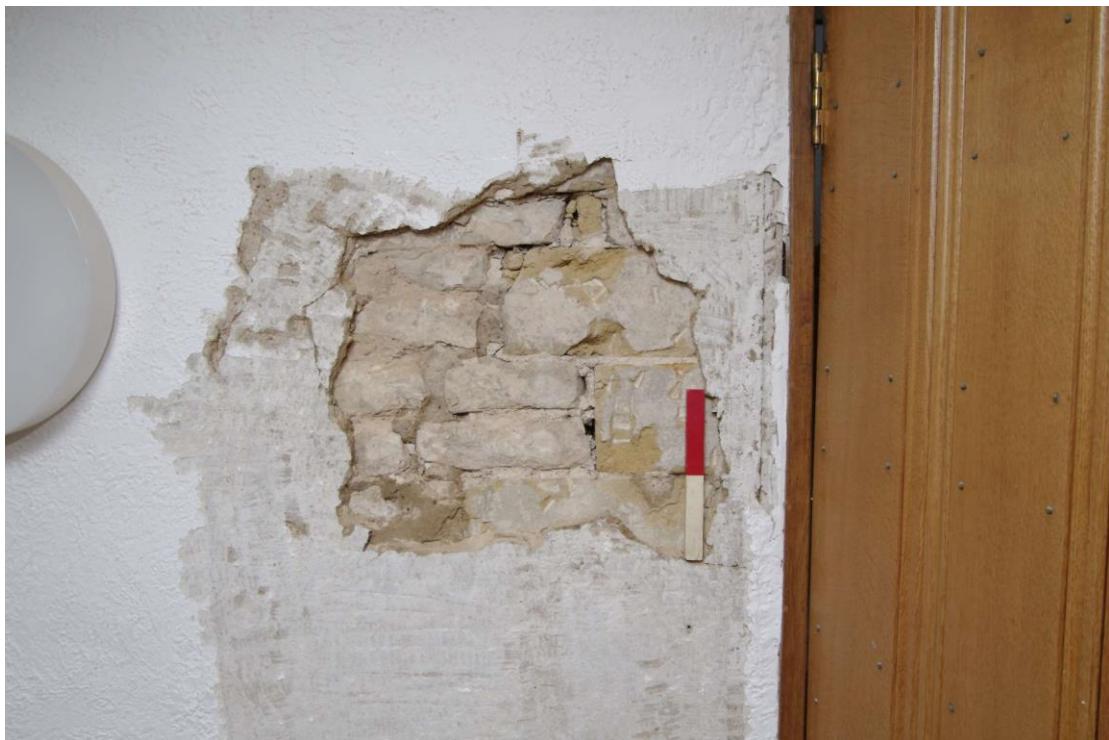
No evidence of the 1930s lighting can be seen and the present wall lighting is very modern. The wall and ceiling plaster appear to be quite modern in this room. A patch has been chipped away on the north-east wall close to the door which reveals earlier plaster over coursed stone rubble (Fig. 60). As noted earlier it is likely that the wall plaster covers much of the earlier history of the building and will be obscuring evidence of earlier openings.

Figure 60: Room G1, exposed stonework on north-east wall by door
Looking north-east. 0.2m scale

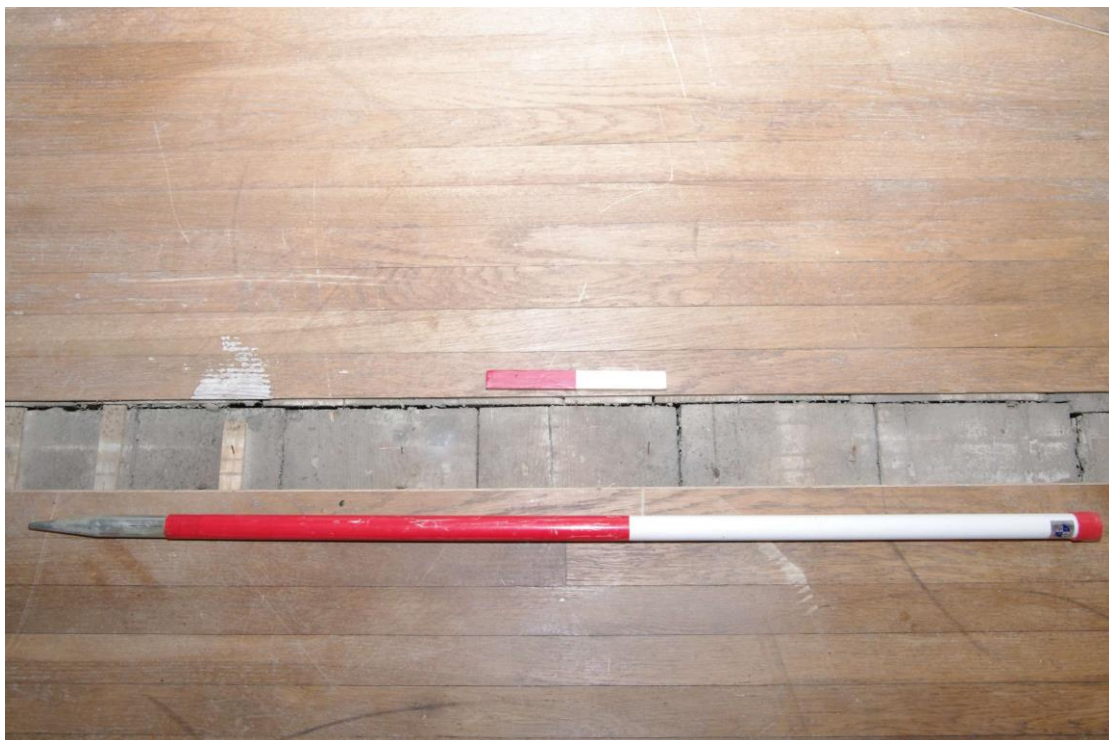
The wooden narrow 1930s floorboards have been partially lifted in this room to expose earlier wider boards beneath (Fig. 95). The older boards appear to be much cruder and worn and are likely to be from the water mill phase of the building. Other rooms may have more modern flooring laid over the earlier boards. The earlier boards may retain evidence of the former locations of stairs and mill machinery but may be relocated as they sit on later beams.

Figure 95: Room F6 original floorboards beneath 1930s boards
1m and 0.2m scales

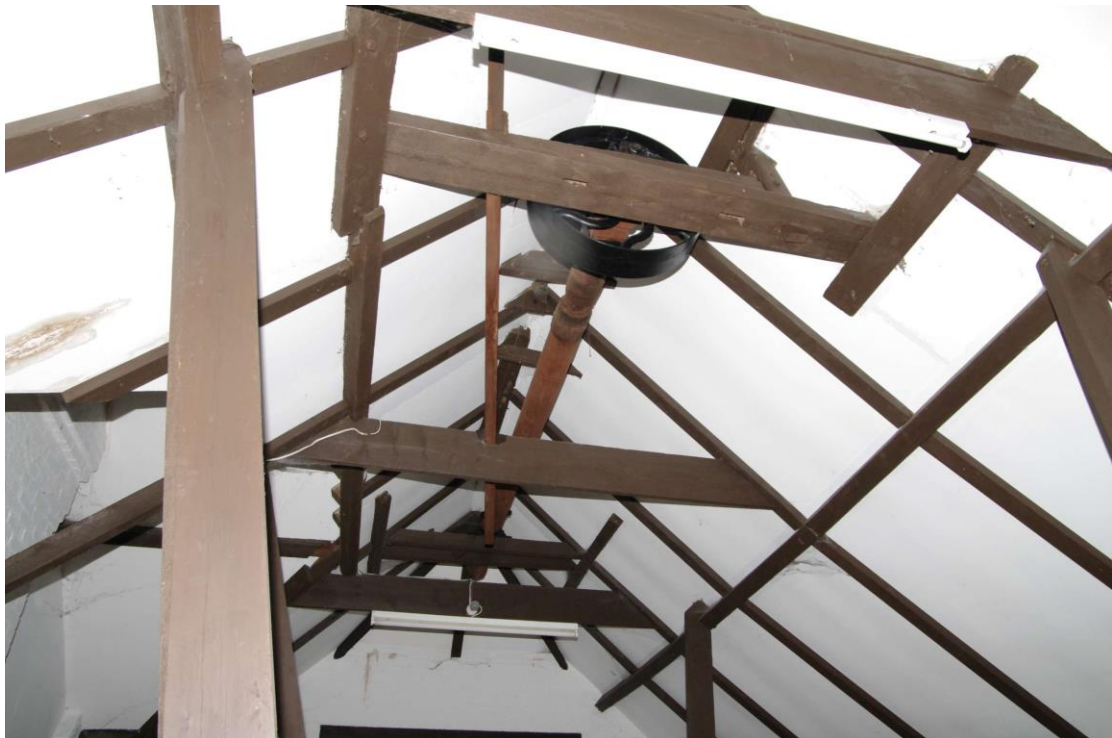
Set into the apex of the roof structure are the remains of the sack hoist which extended out to the dormer projecting from the south-east facing elevation (Fig. 106). Not all of the mechanism has survived and some parts appear to have been crudely altered. Clark notes that the mechanism is of a traditional standard design which incorporates a Fairbairn dog clutch (Fig. 107). The belt wheel is still present and, along with evidence of rope wear on the shaft, shows where the drive belt and ropes would have been located (Fig. 108). It is possible that beneath the modern floor covering the original holes and traps in the floor may still survive although limited opening work has not revealed any evidence. If the original floor survives it may also show where stairs may have been located along with other equipment such as grain bins.

Figure 106: Room R1 sack hoist mechanism
Looking north

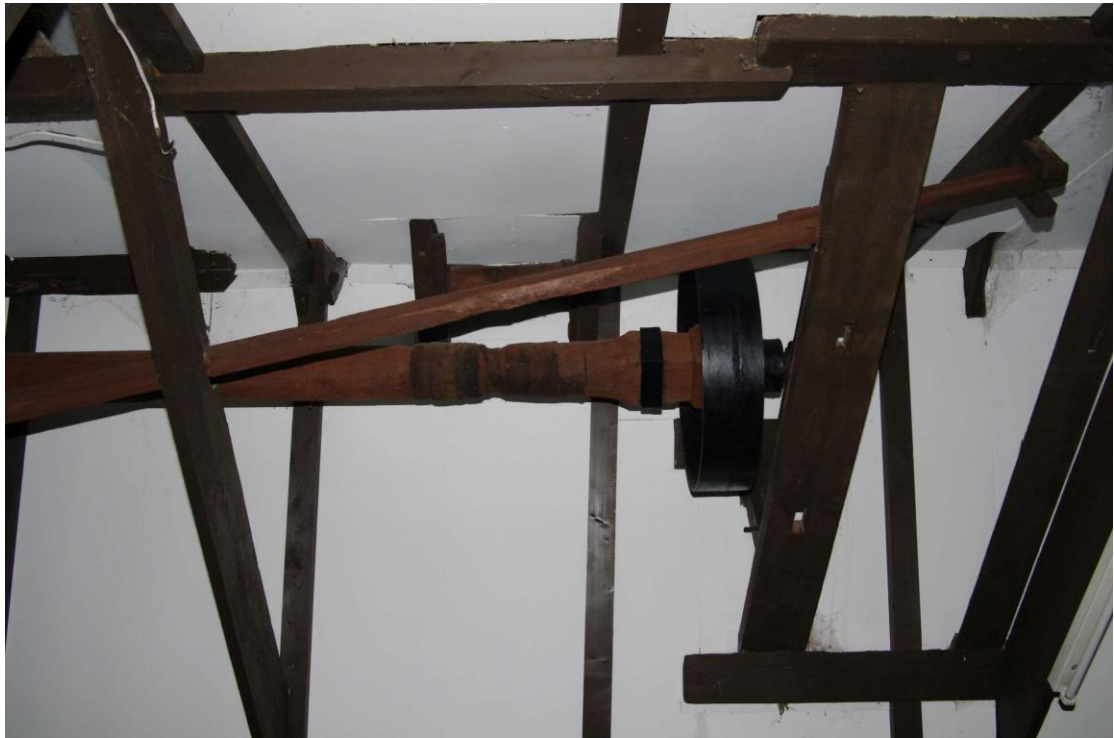
Figure 108: Sack hoist shaft showing rope wear

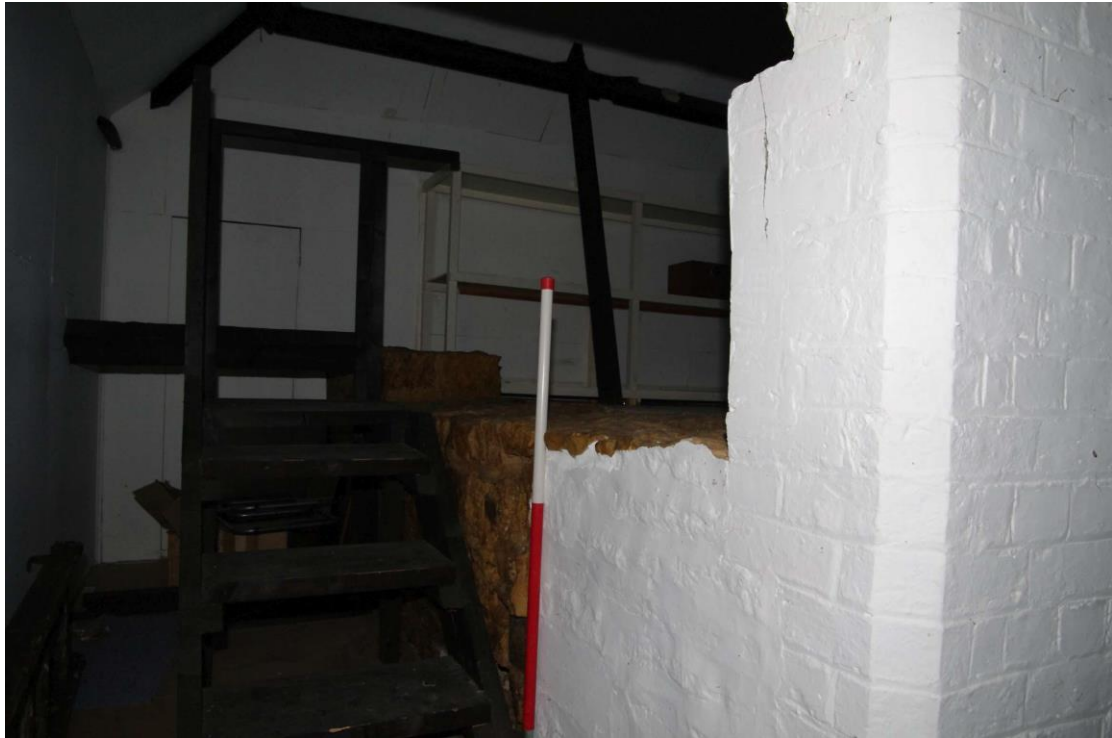
Room R3 is the roof space above the former miller's house. The dividing wall between R2 and R3 has been partially rebuilt with brick. The floor level is higher than the adjacent R2 in order to accommodate the higher ceiling of Room F8 below (Fig. 113). A short length of stonework work runs along the north-western side of R3 and is supported by the thicker walls on the floor below. It is probable that this was the extent of the original miller's house before modifications extended it further outwards. The rest of this space is formed by the modified roof hip created in the 1930s work (Fig. 114).

Figure 113: Room R3 from R2
Looking east. 1m scale. Note the stone wall
