**A level 2 historic building survey at
Hallaton Grange,
5 Churchgate, Hallaton
Leicestershire,
NGR: SP78728 96510**

**ULAS Report No 2020-120
©2020**

Site Name: Hallaton Grange, 5 Churchgate, Hallaton, Leicestershire.
LE16 8TY

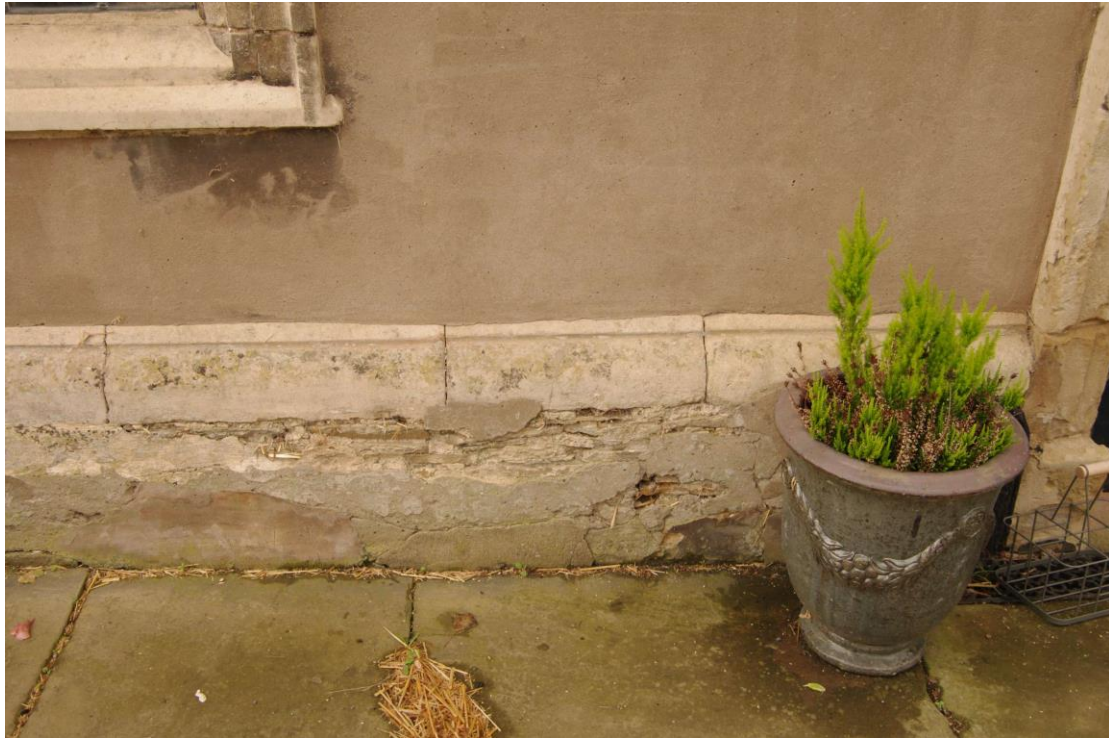
Figure 5 Stone plinth on which the 1691 range sits
Looking south on eastern side of front door. Note how the plinth consists of a
moulded stone course above stuccoed rubble

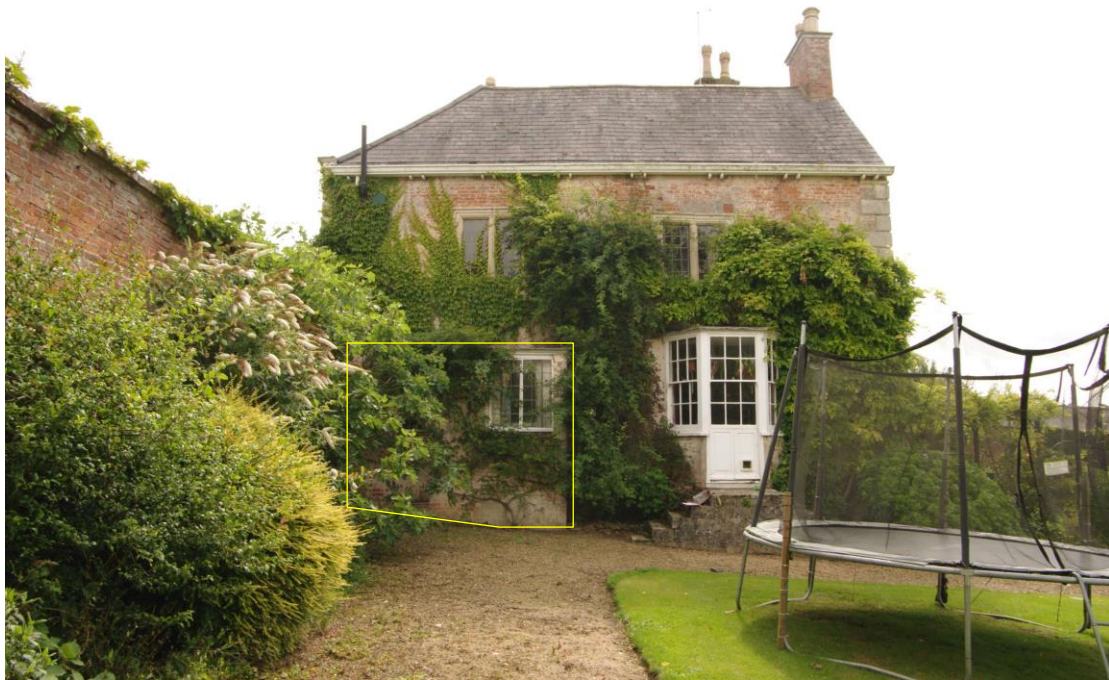
The only alterations proposed which will be visible on the outside is the demolition of the single storey extension on the west facing elevation (Figs 15 to 17). This has a flat roof and appears to use modern hard-fired bricks of probable mid-20th century date. It is significantly longer than that shown on the First Edition OS map suggesting a rebuild or replacement of an earlier structure. The windows are metal Crittal-style frames with leaded lights and concrete lintels (Fig. 18). At ground level there is evidence of a blocked opening which may be access to the cellar, perhaps for a former coal chute (Fig. 19). Much of the extension and the west facing elevation is obscured by vegetation making inspection difficult although there did not appear to be any visible evidence of a former doorway at this point. Removal of the vegetation may expose the wall and removal of the extension would give a better view of the original fabric.

Figure 15 West facing elevation with single storey extension
Looking east. The extension is outlined in yellow. The stairs to the right of the extension will be extended northwards

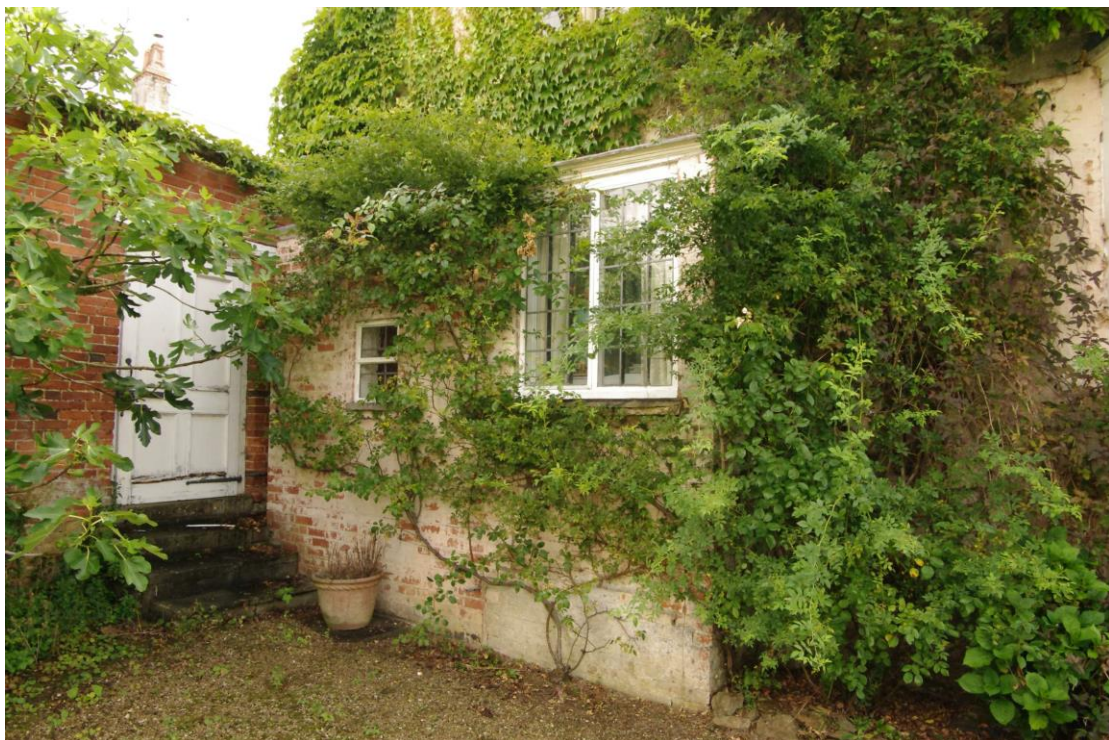
Figure 16 Single storey extension
Looking north-east. The wall on the left is the boundary wall to Churchgate. The small window lights the inside toilet

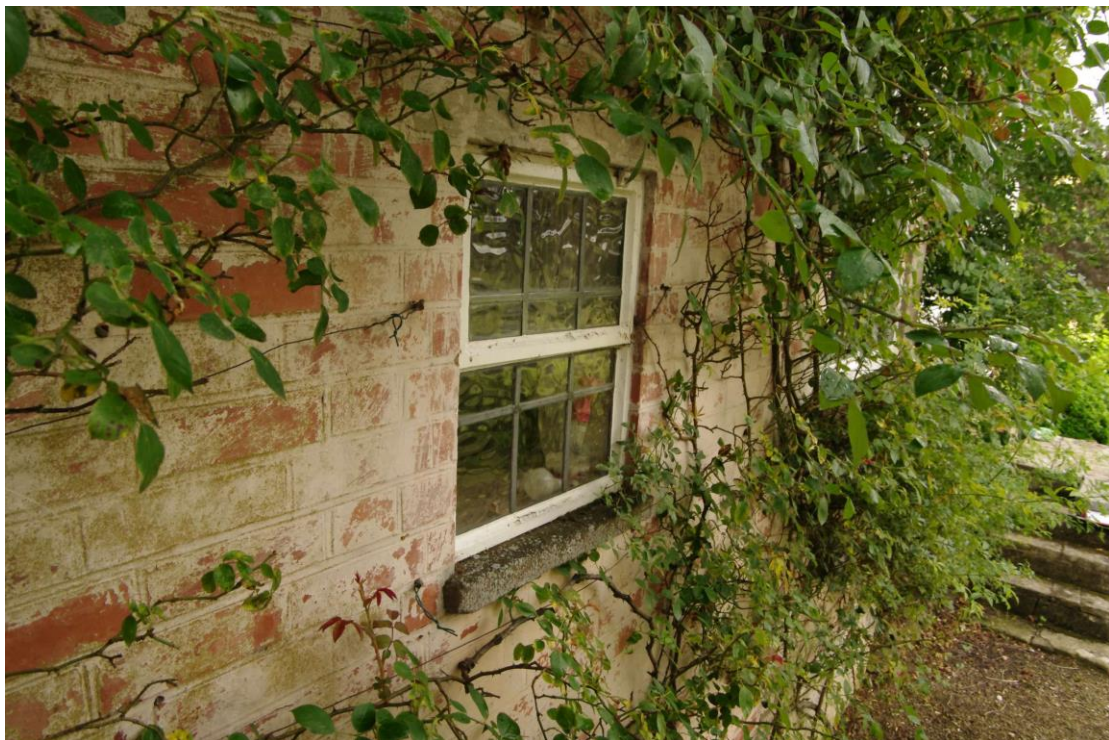
Figure 18 Single storey extension window detail
Looking south-east. Note hard-fired bricks

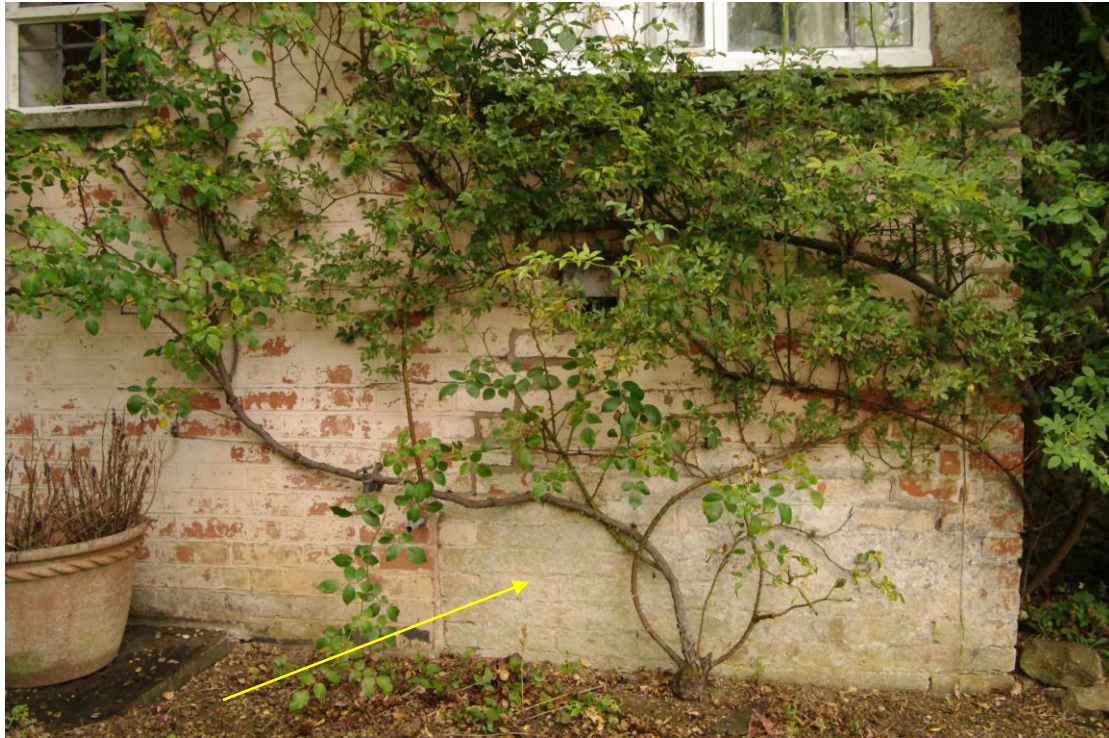
Figure 19 Blocked opening on extension
Looking east. Arrow points to blocking brickwork

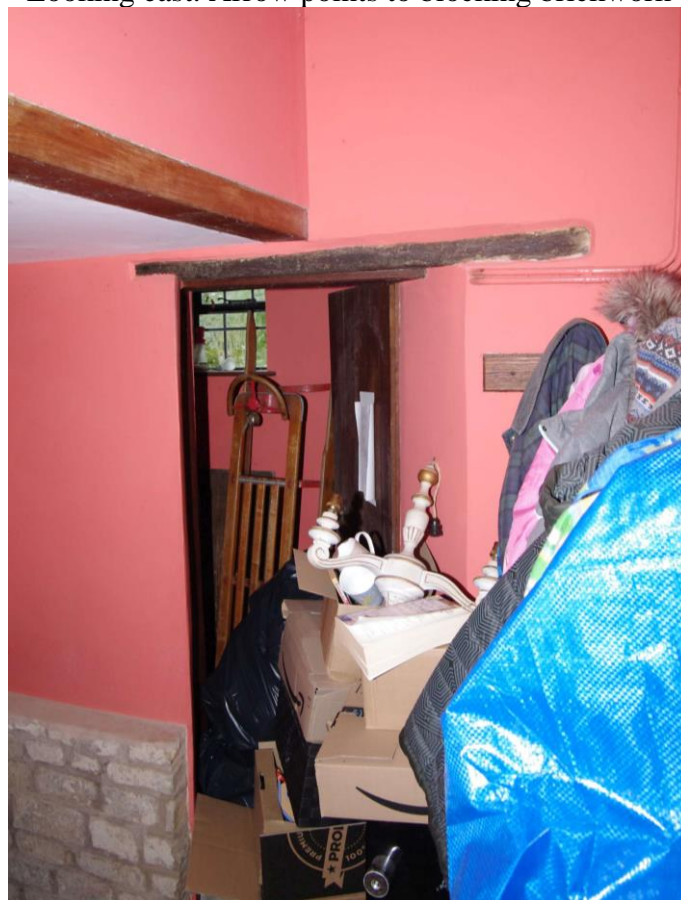
The cellar will not be significantly affected by the proposed works with the exception of the removal of the toilet within the single storey extension. At present the toilet door is half way up the cellar steps (Fig. 20). The existing doorway to the toilet will be blocked.

Figure 20 Doorway to toilet within single storey extension
Looking south-west. Stair to cellar go down to left of picture. The visible window is
the one shown in Figures 16 and 18

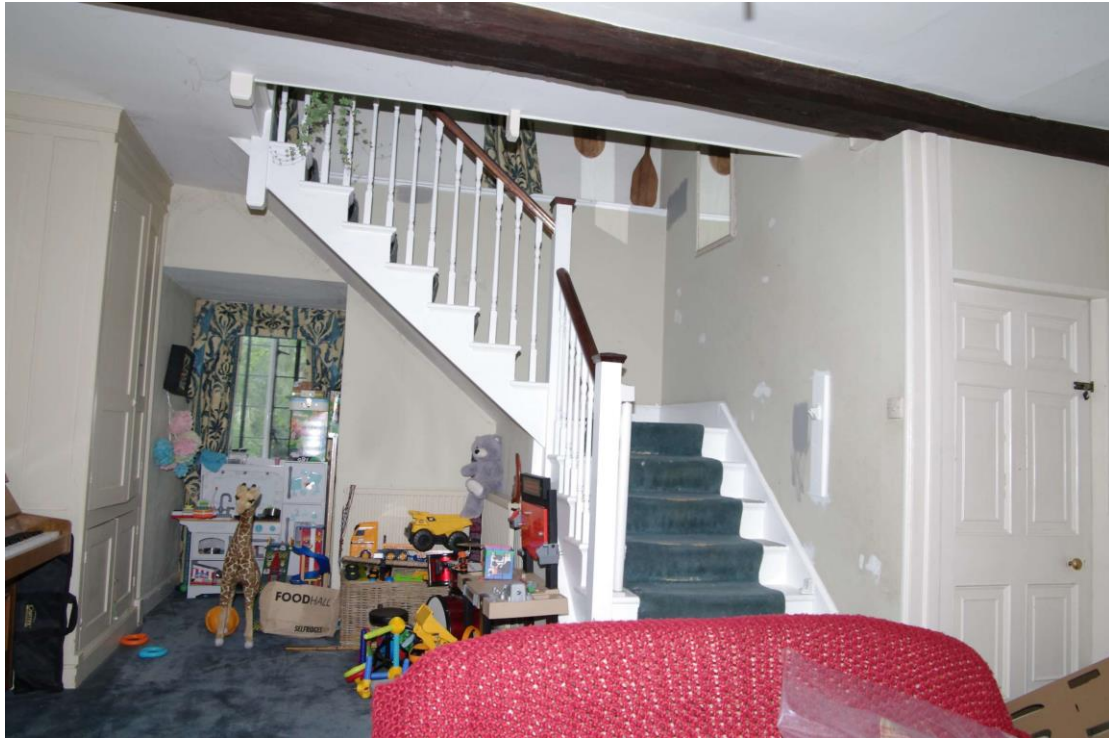
Two key changes are proposed for the ground floor. The first will be the installation of a new entrance where the present single storey extension is (Fig. 21). At present the space beneath the staircase leads to a small alcove built into the extension which has a large metal-framed window. Hickie suggests that this may be the location of an earlier entrance from the garden which led into a small hall with the stairs. At present there is no visible evidence of this with the plasterwork appearing to be relatively new. As part of the works the existing stair case bannister may be replaced. The present one appears to be quite modern and of late 20th century origin (Fig. 22).

Figure 21 Ground floor stairs with single storey extension below
Looking west. Doorway on right leads down to cellar and toilet seen in Fig. 20. The
window beneath the stairs is the larger window seen in Fig. 16.

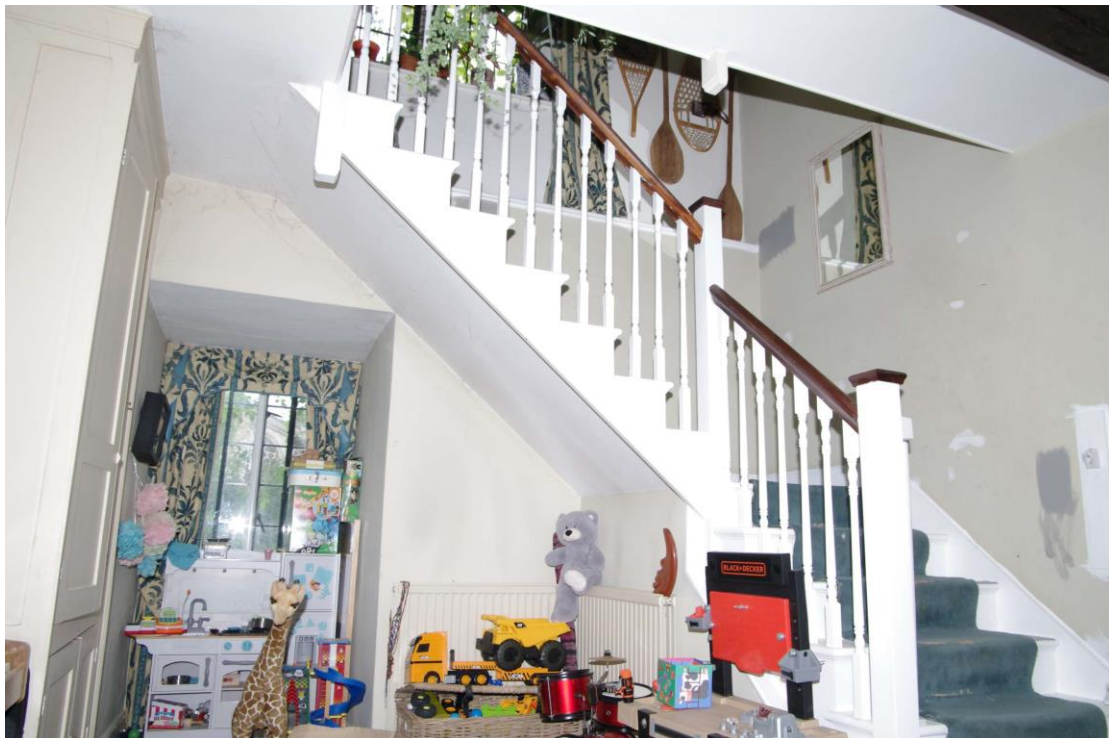
Figure 22 Ground floor stairs
Looking north-west. Single storey extension window on left

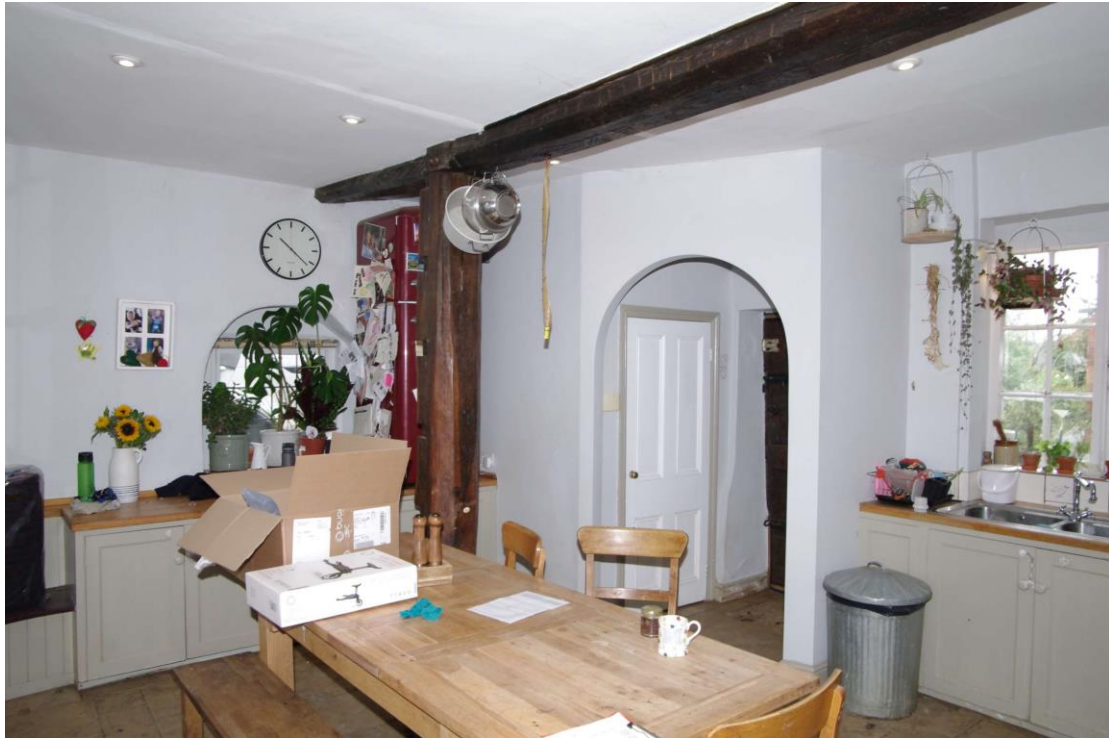
Figure 23 The ground floor kitchen
Looking south-east. The toilet is located behind the door below the arch. Note the wooden post in the centre of the picture

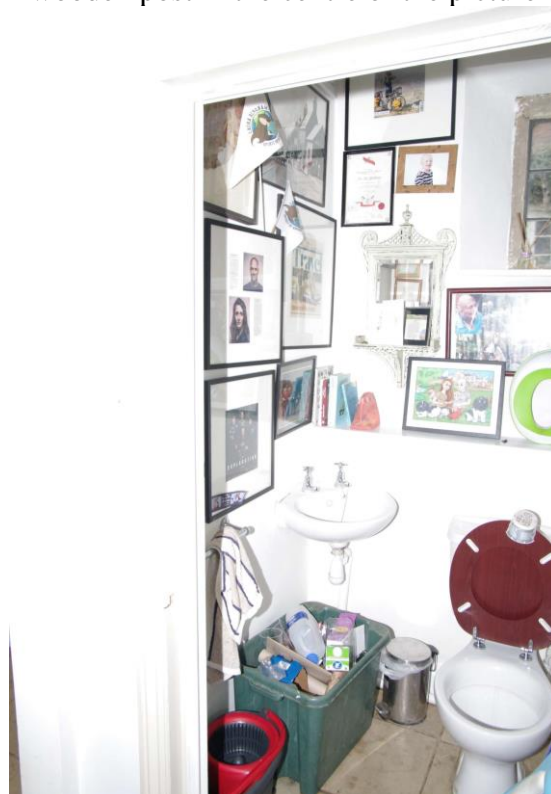
Figure 24 Inserted toilet in the kitchen
Looking west. The small window may originally have lit an understairs store

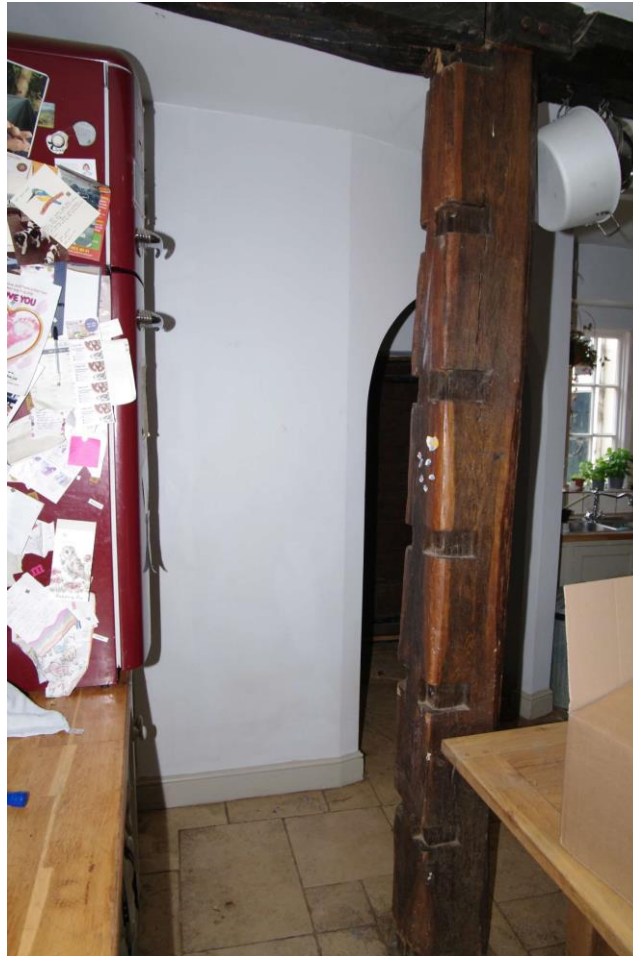
Figure 25 Ground floor, kitchen. Timber post
Looking south towards inserted toilet wall

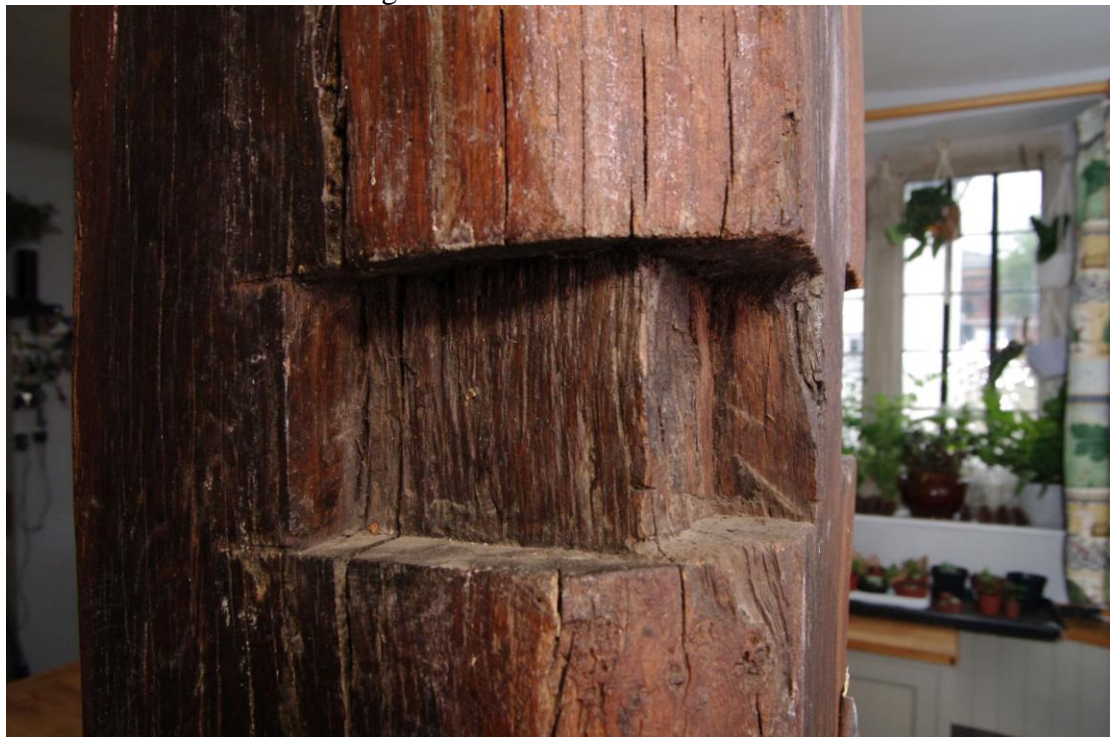
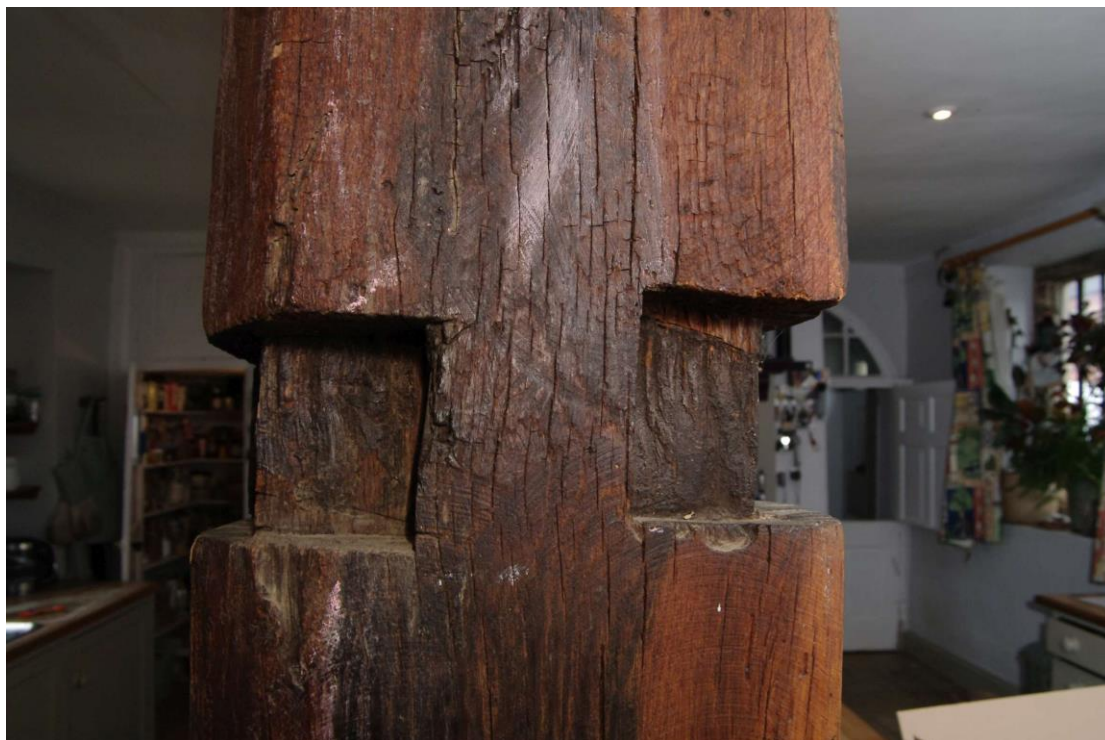
stairs Figs 26 and 27). The post stands quite a distance from the corner of the kitchen and is not directly beneath the first to second floor stairs. Its offset position however in the kitchen does suggest that it may be associated somehow. Equally, it is possible that the post may be a re-used beam with joist sockets which has been built into what was the lower status kitchen area where decorative features were not deemed to be necessary. At present it supports an east to west beam. The outside door leading to the back of the house appears to be the original door with horizontal boards and still retains its wooden lock case and late 17th century iron strap hinges (Fig. 28).

Figure 26 Timber post in kitchen socket detail

Figure 27 Timber post in kitchen socket detail

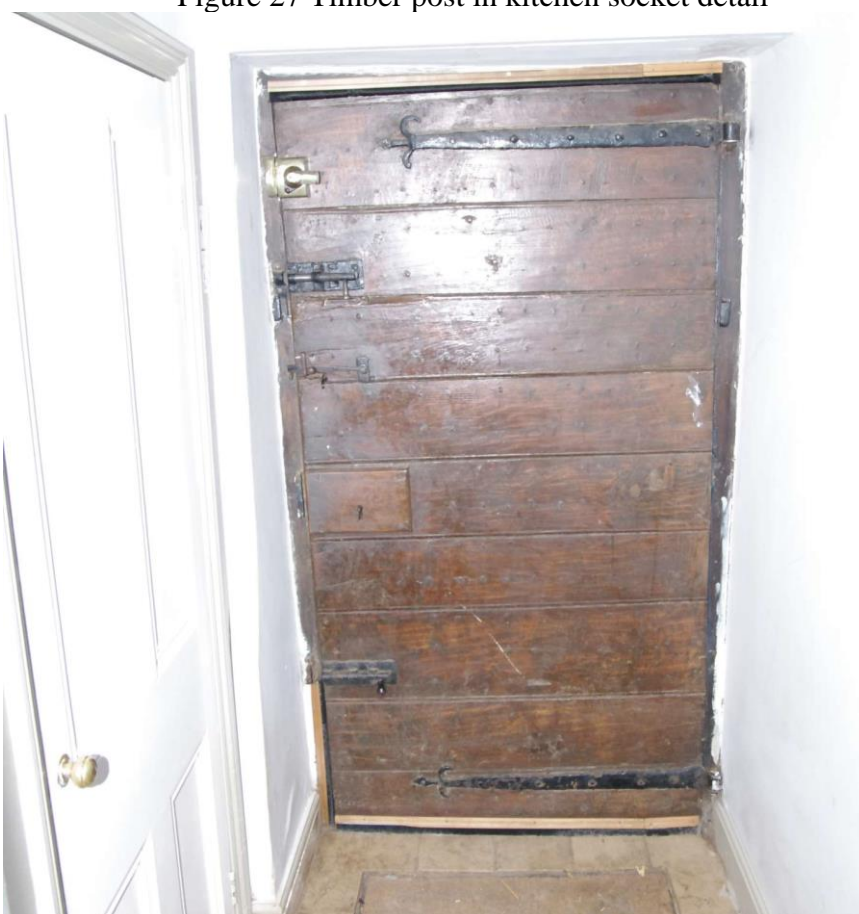
Figure 28 Rear kitchen door detail
Looking south. Note wooden lock case and the strap hinges. Inserted toilet on left

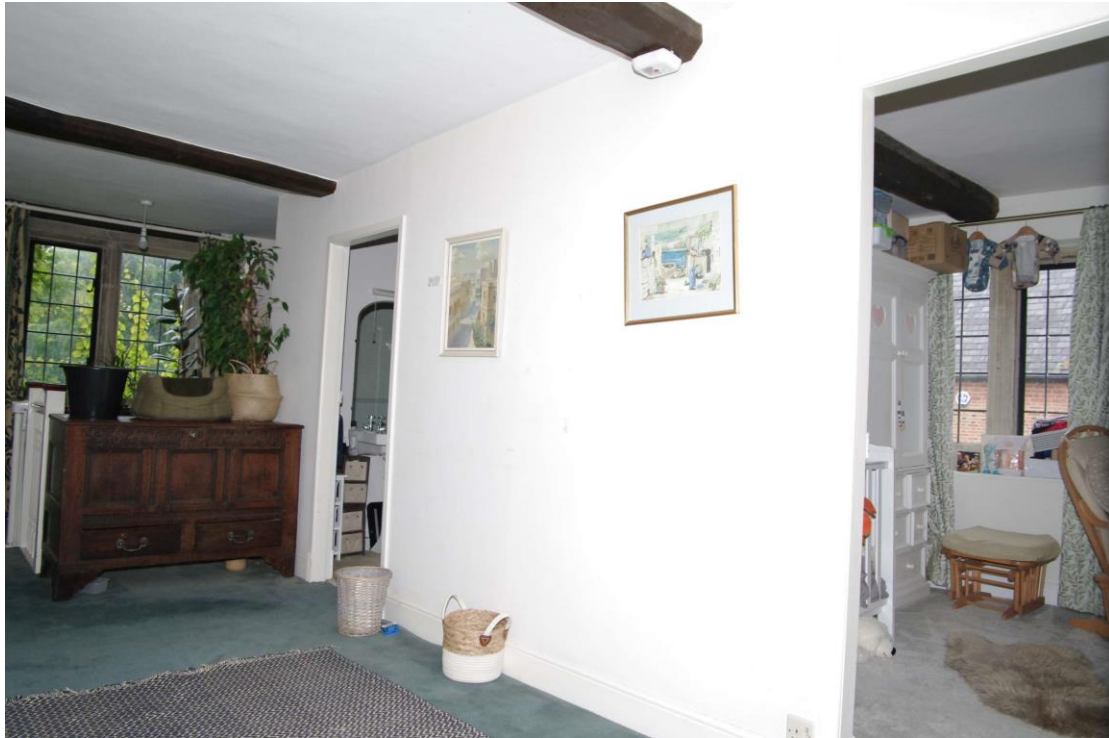
Figure 29 First floor landing area

Looking north-west. The stairs down to ground floor are behind the wooden cabinet. The plasterboard walls on the right are to be removed. New stairs up to the second floor will replace the toilet seen through the doorway centre left. Note continuous chamfered beams running across the landing and rooms

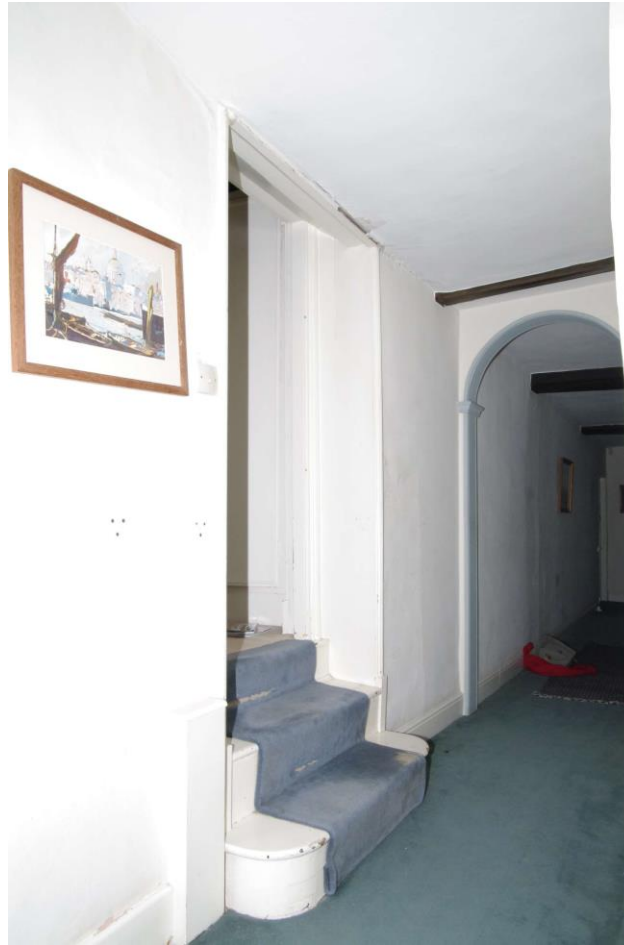
Figure 31 First floor landing area and door to 18th century extension
Looking southwest. The new doorway will be just beyond the archway

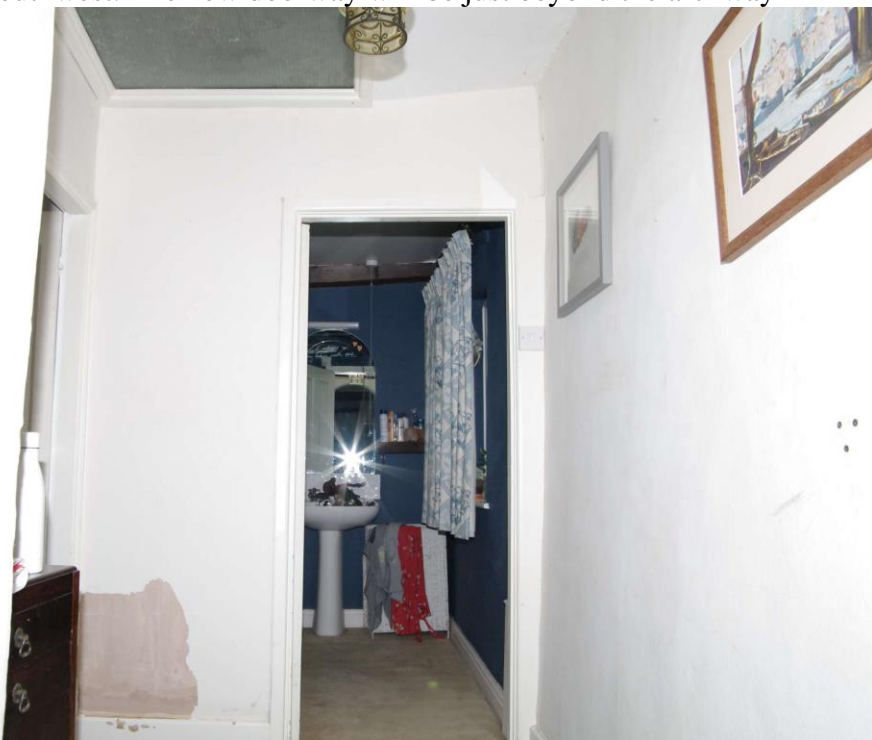
Rather than going through an existing bedroom to get to the service stairs on the east side of the house an inserted bathroom will be removed and a new doorway opened up (Fig. 32). It is possible that there may be a doorway already where the proposed new one will be located although the modern plasterwork currently masks this possibility.

Figure 32 Inserted toilet wall at east end of first floor
Looking east. A new doorway to the service stairs will be located where the sink is

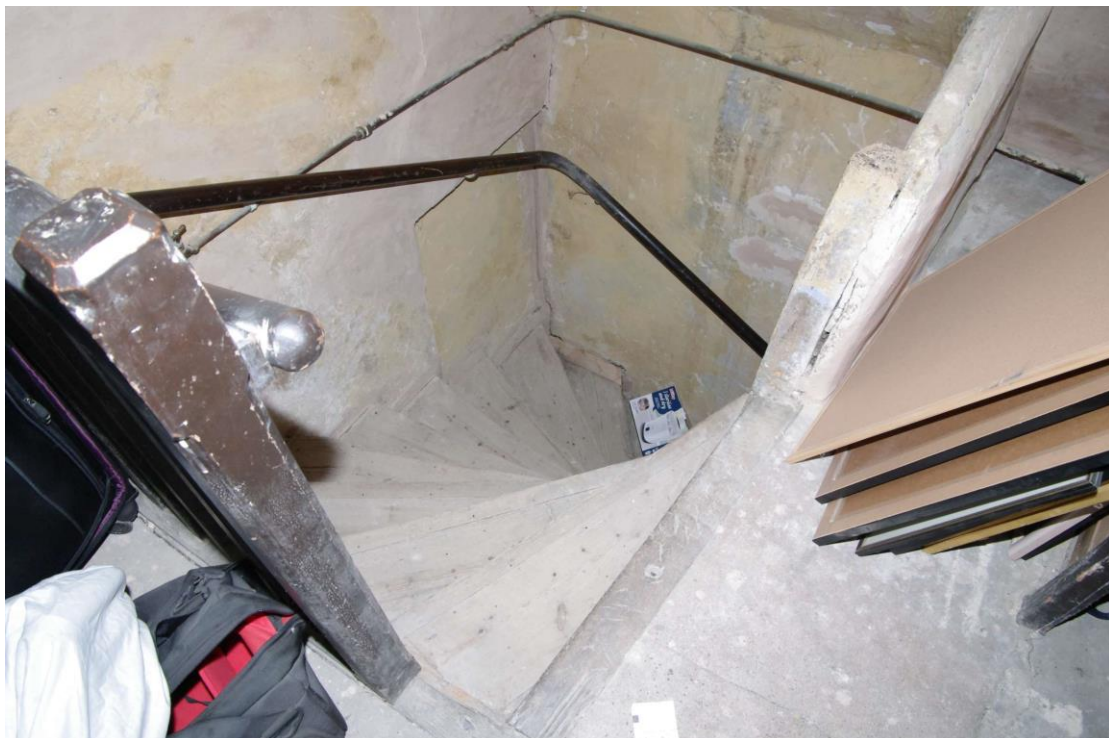
Figure 34 Second floor service stairs
Looking down from second floor. Blocked window by angle in handrail

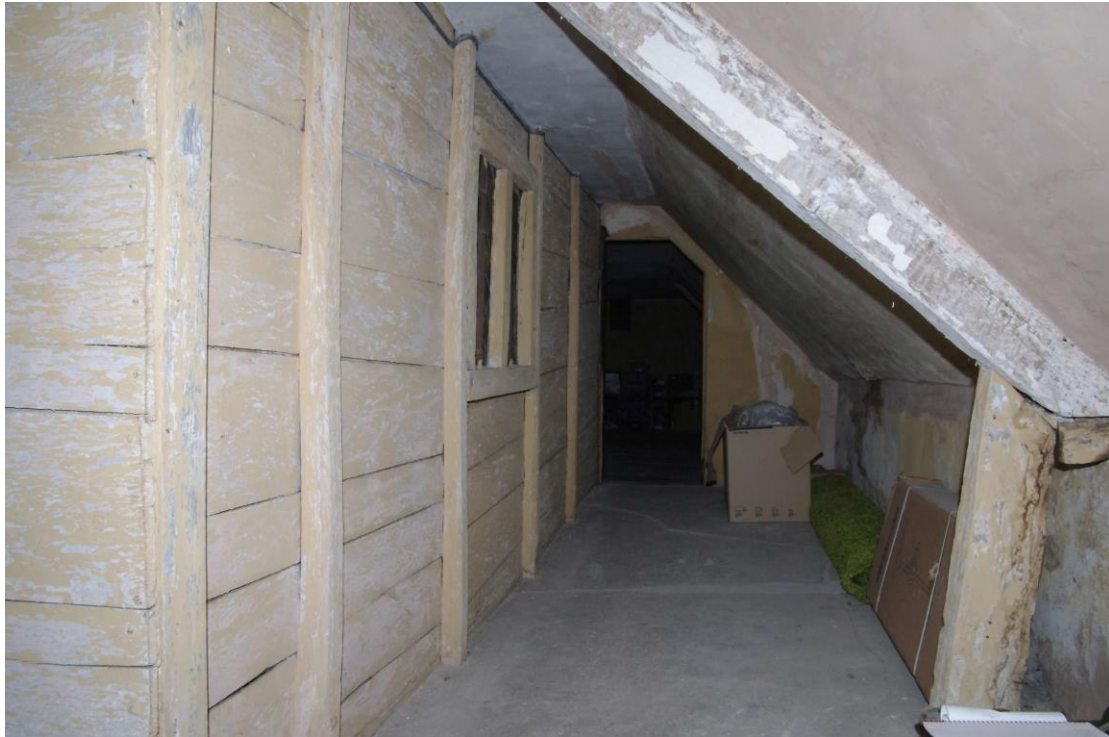
Figure 35 Second floor corridor

Looking west. A new wall will be inserted beneath the closest principal rafter. A new door will be inserted in the board wall just beyond the window. A new wall will be inserted where the rafter is and a fire escape door will be fitted at the end of the corridor. Note gypsum floor

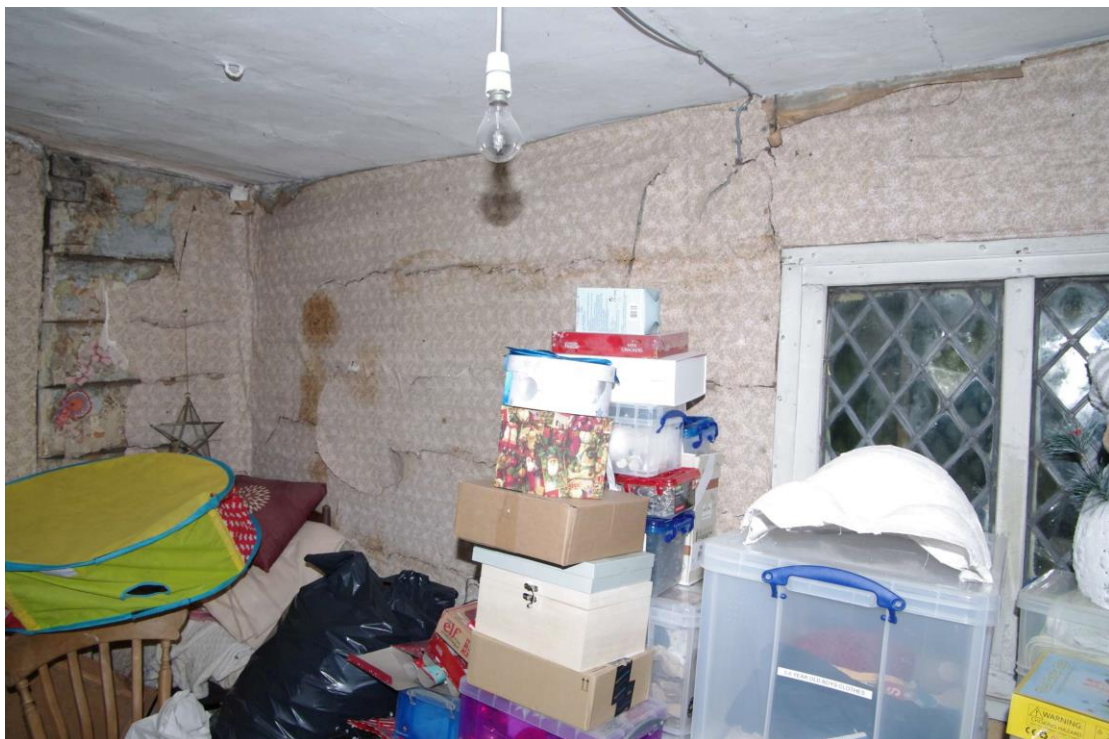
Figure 36 Second floor, inside the partitioned room

Looking north-west. Note leaded window giving light to the corridor shown in Fig. 35
The new doorway will be inserted to the left of the window

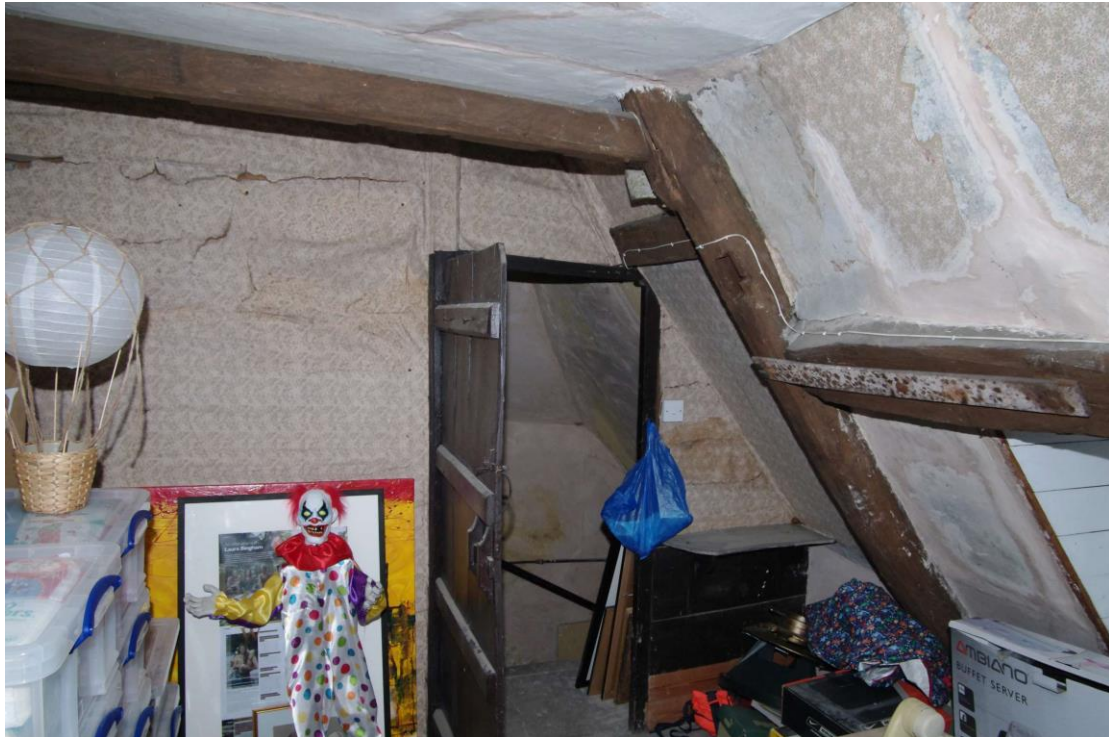
Figure 37 Second floor, inside the partitioned room
Looking south-east. The door may be moved slightly to the left

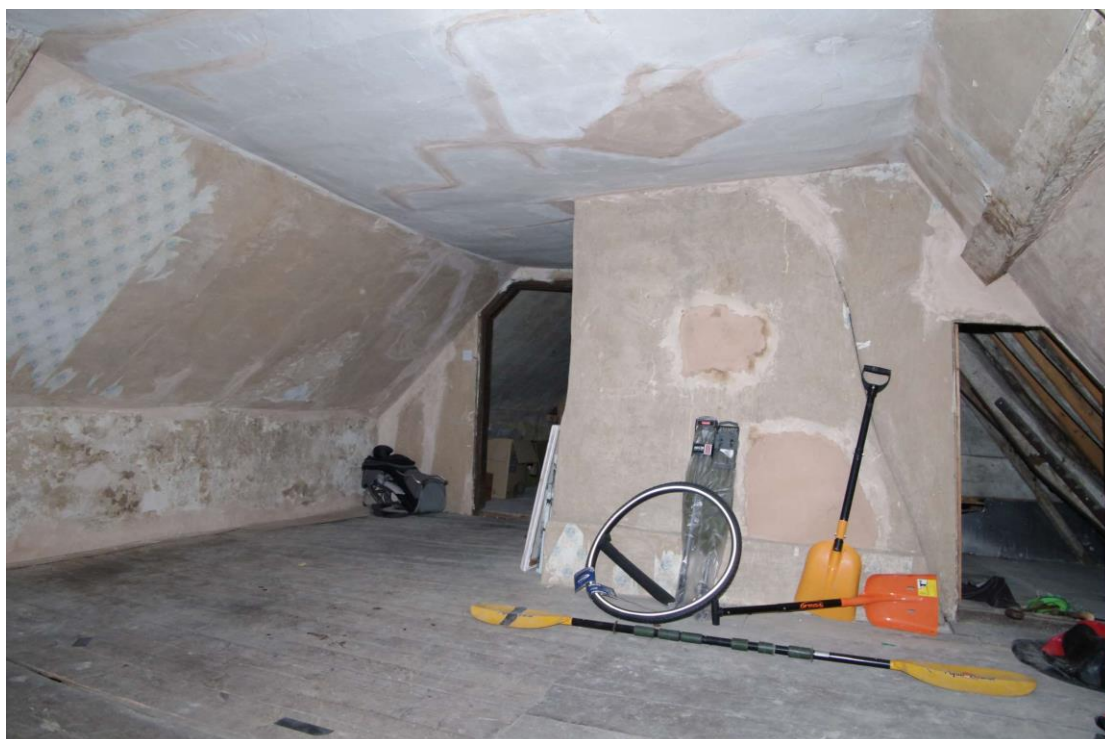
Figure 40 Second floor, middle room
Looking north-east towards partition wall corridor (on left). A new bathroom will be inserted into the space on the left of the picture

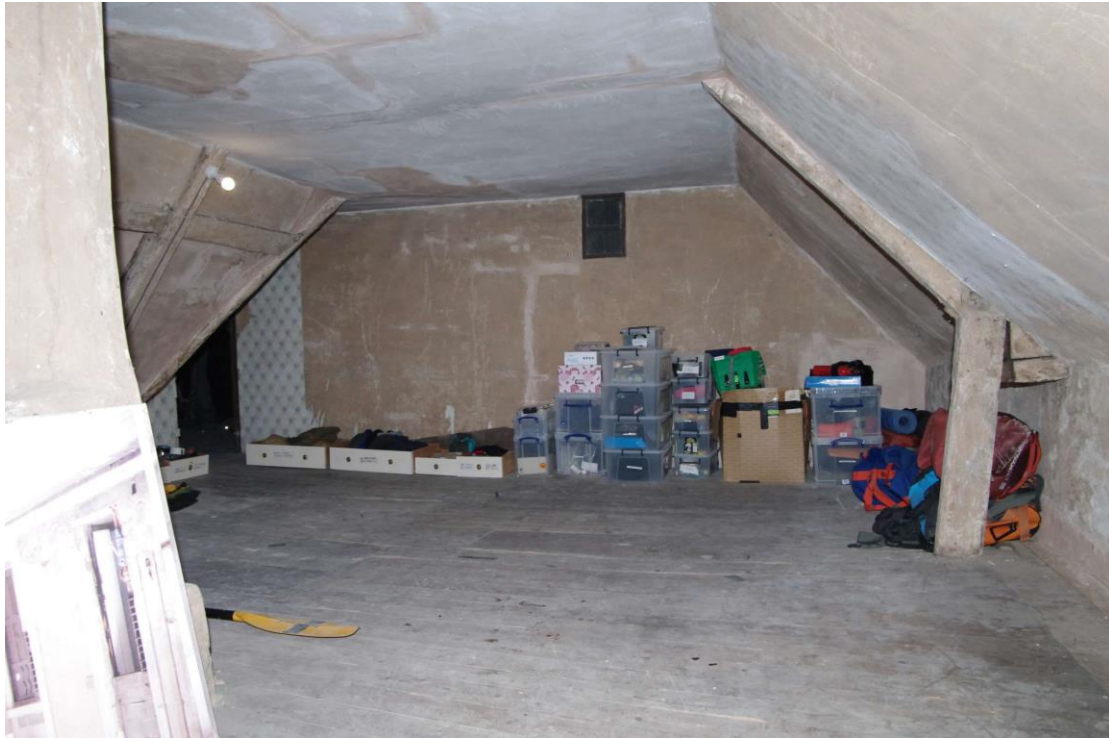
Figure 41 Second floor, middle room
Looking west from corridor. A new door will be inserted to the left of the small window. The doorway on the left will be blocked

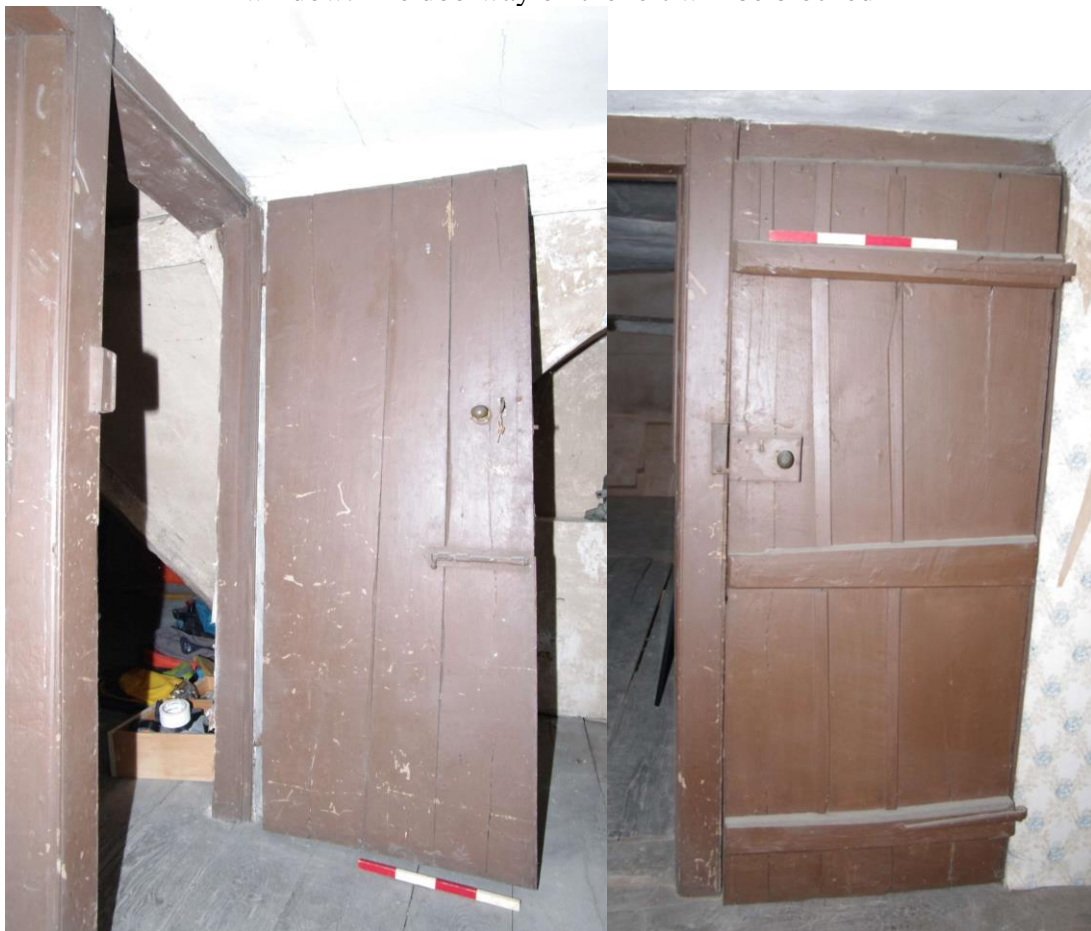
Figure 42 Second floor. Wide-boarded door from middle room to rear range
0.4m scale. This doorway is proposed to be blocked

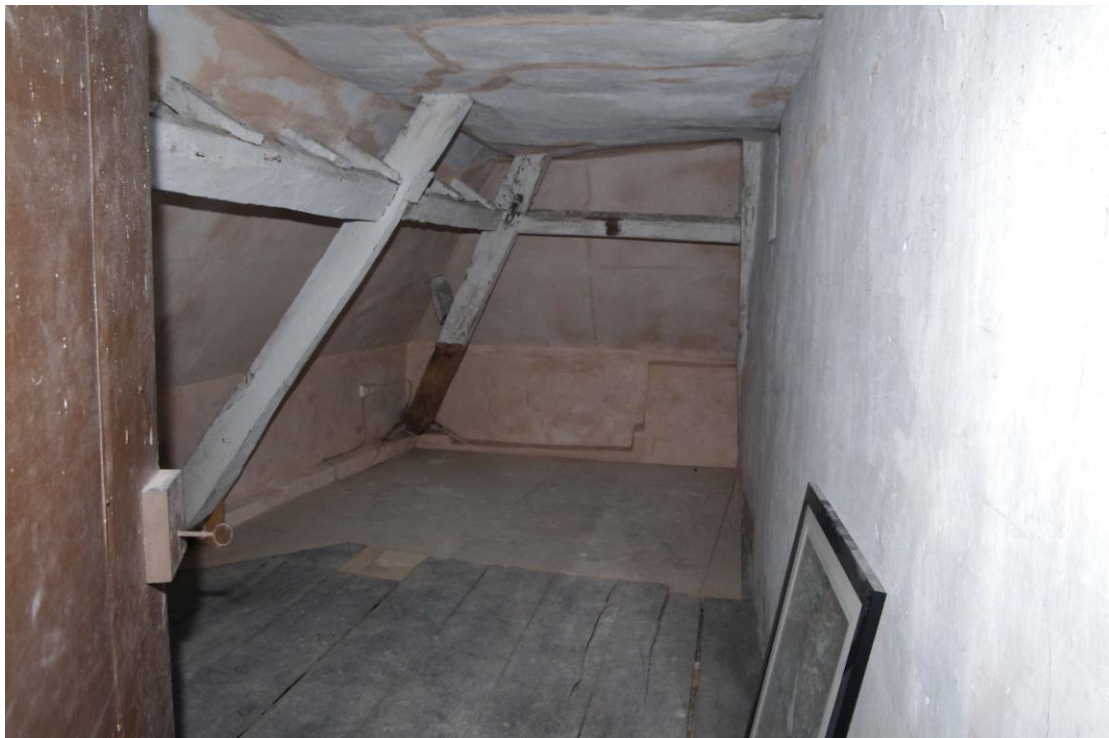
To the west of the middle room is a rectangular space lit by the small window on the dividing wall (Figs 44 and 45). This is the former landing serving the former staircase which rose from the first floor. At present the location where the stairs were located is covered over by modern boarding. The proposal is to build a new set of stairs in this location. The doors into this area leads into the rear bedroom. The door itself consists of two wide boards held together by battens (Fig. 46). The metal fittings appear to be hand-made. The lock case is wooden and, unusually, still retains its key which is a very rare survivor for such an item.

Figure 44 Former second floor landing and stairs in NW corner of house
Looking north. The boarded area at the far end indicates where the stairs were located.
Note the small window (top right) which lit the stairs

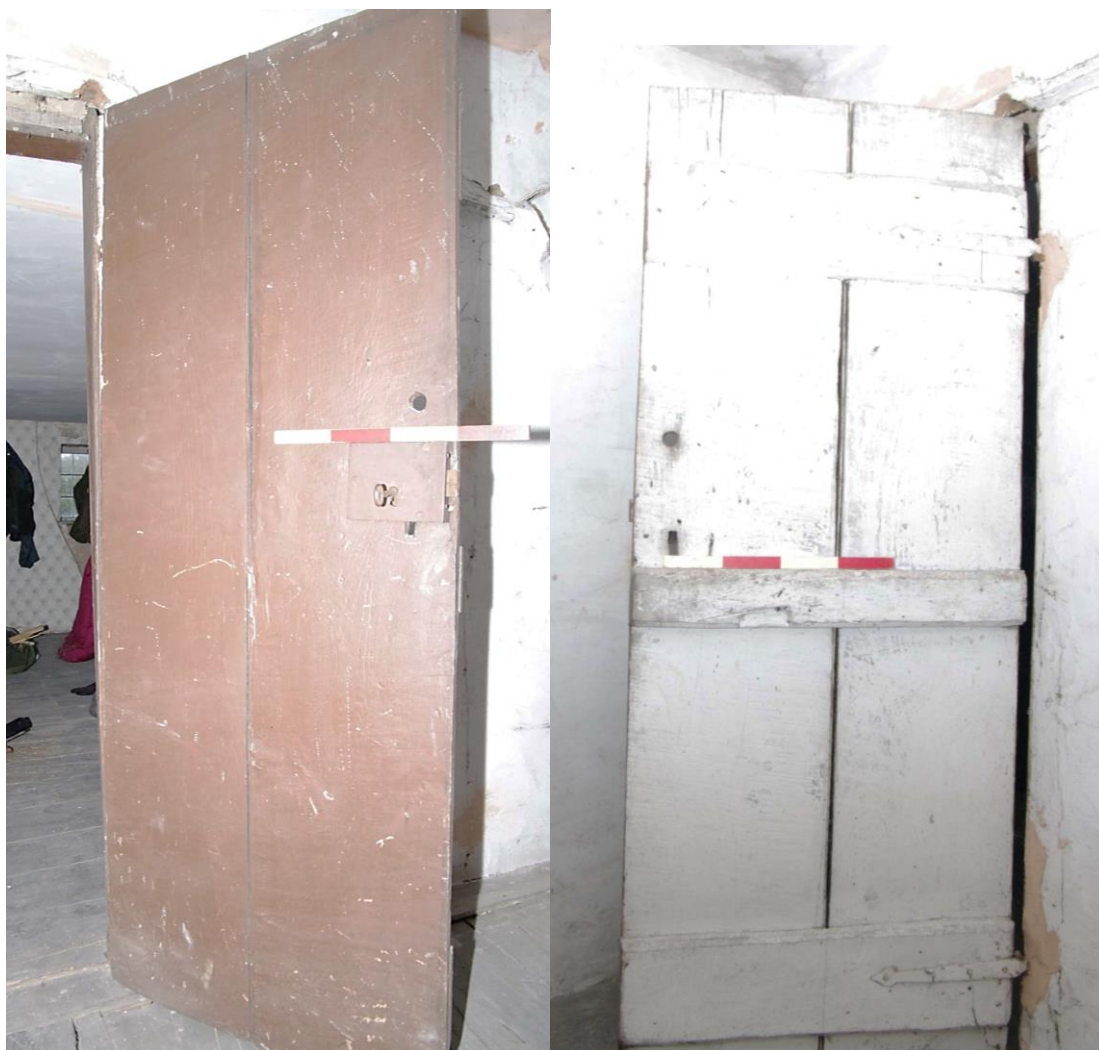
Figure 45 Door from former landing to rear room detail
0.4m scale. Note wooden lock plate still with key
