**AN HISTORIC BUILDING RECORD
CONCERNING THE EXISTING
COURTYARD RANGE OF BUILDINGS AT**

**THE LODGE FARM
MARKET BOSWORTH ROAD
DADLINGTON**

ULAS Report No. 2004-136 ©2004

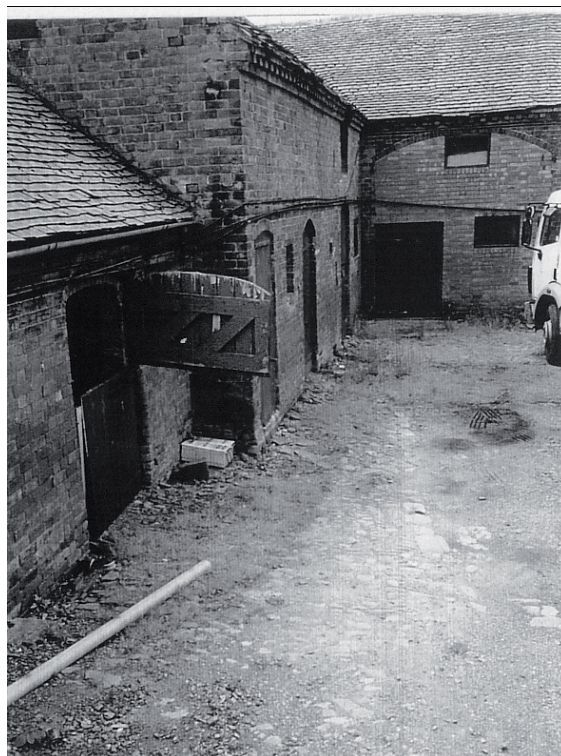
The south outbuilding range consists of two bays of brick building that appear to have originally have been a single storey farm office and a stable probably serving as accommodation for a trap horse, (*see A on Plan - Fig 3, and Plate 1*). The farm office door was a standard, rectangular headed door; the adjacent stable door had a

The original, opposed, wagon entrance doors, situated on the east and west sidewalls of Building **C** were now blocked in with brick. On the east side this blocked feature had a wide, rectangular headed entrance door and a window built into it at ground floor level, (*see Plate 1*). A second window, providing additional light into the internal area of the barn was set in the brickwork of the blocked doorway at a point level with the first floor window of Building **B**. On the west side, the entire opening was completely blocked in with a later brick, (*see Plate 5*). The barn was of three bays length, each bay was partly partitioned by short, brick walls that rose to a point just below the position of the upper series of purlins at a point where a horizontal beam formed a lintel and also supported seven courses of brickwork that carried the upper series of purlins. This simple arrangement removed the need for roof trusses and is noted by Marshall, (1789) as an “improving” practice in barn construction, (*see Plate 6*). The roof timbers appeared to include both original and replacement sections. Access to the west end of the barn was also obtained by a segmental arched doorway set in the side-wall overlooking the yard.

Plate 1 *South range (left) showing trap pony stable door, other doors and window in range and decorative eaves work. Also shows West range (ahead) with original wagon entrance door, now blocked and later doors and windows.*

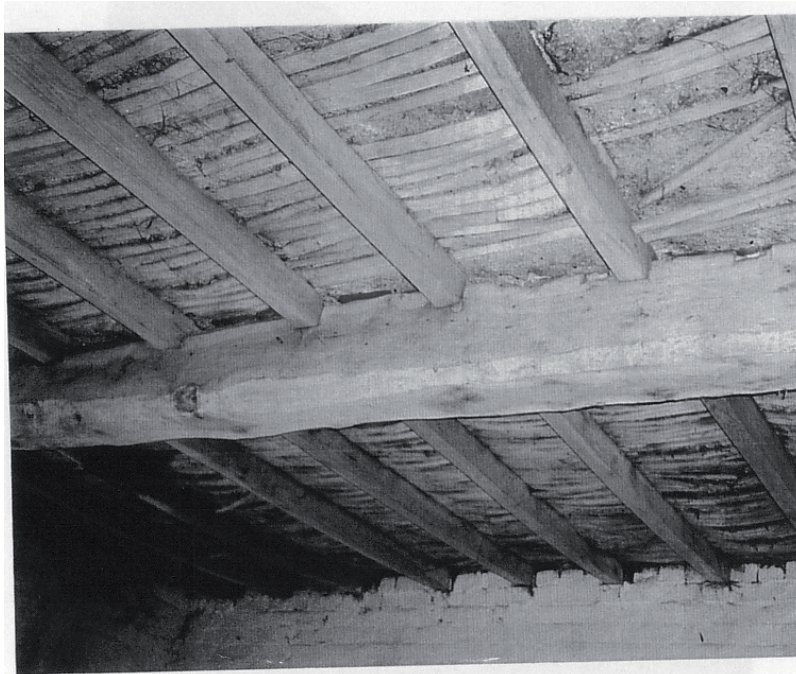
The upper floor area was of lime ash laid over split laths, the underside of this floor could be seen in the loose-box area of the ground floor, (*see Plate 2*). The upper floor was lit by a single window on the north side of the building and two windows on the south side, all these windows were set a wall-plate, i.e. floor level. In addition there was a segmental arched window set in the east gable, this lit the brick stairs rising alongside the gable wall and the eastern bay. The presence of further, internal partitioning in the upper floor area and a door and doorway of domestic form might indicate this area had been used at some time as sleeping accommodation for a horse groom or outdoor farm servants. The unsafe nature of this floor prevented close inspection of the inner bay of building in this range.

Plate 2 *Underside of lath and lime-ash plaster floor to upper storey. South range.*

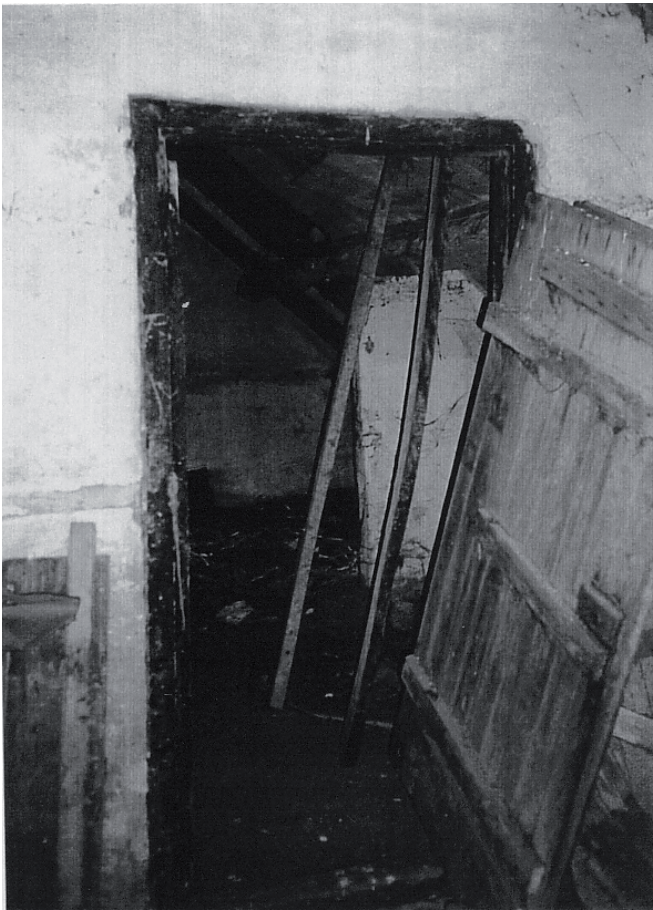
Plate 3 *South range-upper floor area showing domestic doorway and inner of this range.*

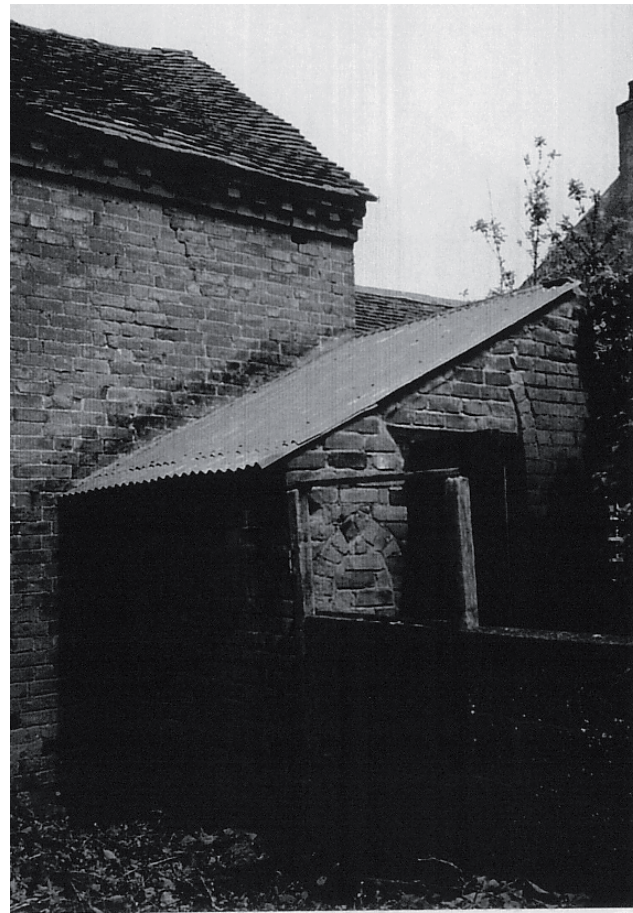
Situated on the south side of the south range and set against Building **B** was a substantial, brick privvy, (*see L1 on Plan - Fig.3, and Plate 3*). This building now had a mono-pitch roof covered with corrugated iron. Residual details in the brickwork indicated the building originally had a pitched roof. The brickwork of the south gable wall of this building had two, small, Gothic arched windows set either side an access door which had a similar Gothic arched head to it. Although the internal furnishings of this building were missing the hatch in the sidewall for removing the bucket through was still present.

Plate 4 *Lean to I, privy on south elevation of south range, shows Gothic window detail and part of doorway arch.*

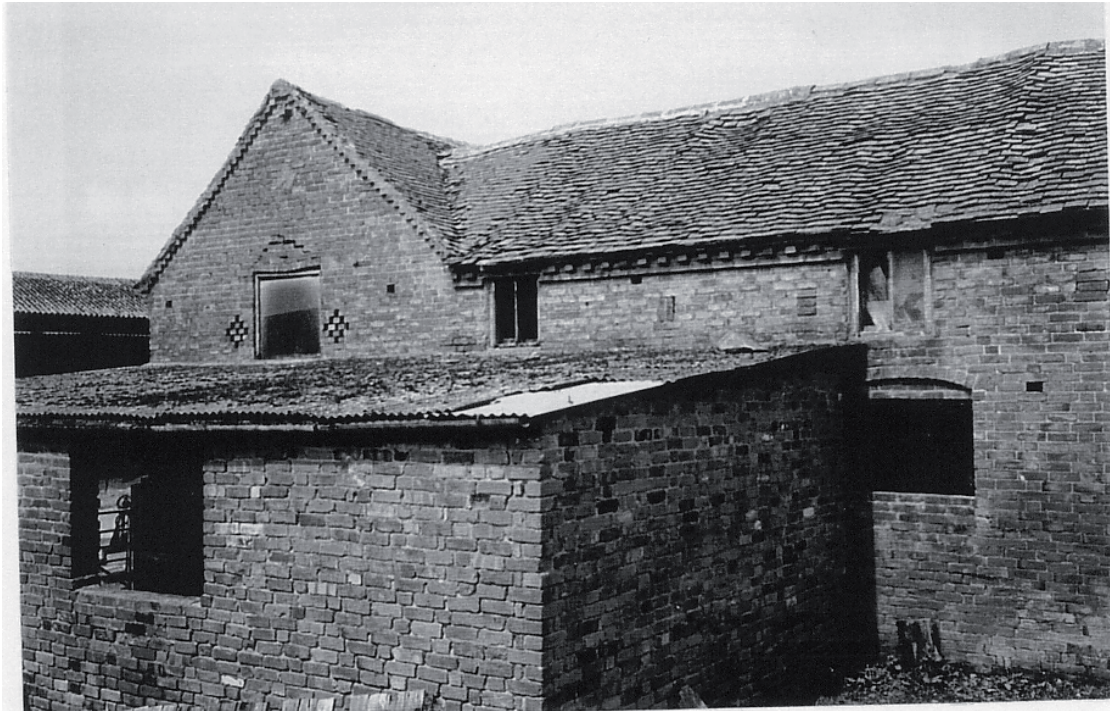
A later, single storey, brick lean-to with a shallow, mono-pitch roof had been built at a considerably later date alongside part of the south side of Building **B** and across the lower section of the south gable of the Barn, (*see L2 on Plan – Fig.3, and Plate 4*).

The south gable and the east and west, side-walls of the barn had a series of diamond pattern, ventilator panels in their brickwork, (*see Plate 4*). This feature was not present on the north gable. The eaves and the gables of the barn carried the same brick detailing as recorded on Building **B**.

Plate 5 *Lean-to II, adjacent to southwest corner of south range and south gable of west range. Also shows diamond ventilator panels and stepped brickwork of the south gable.*

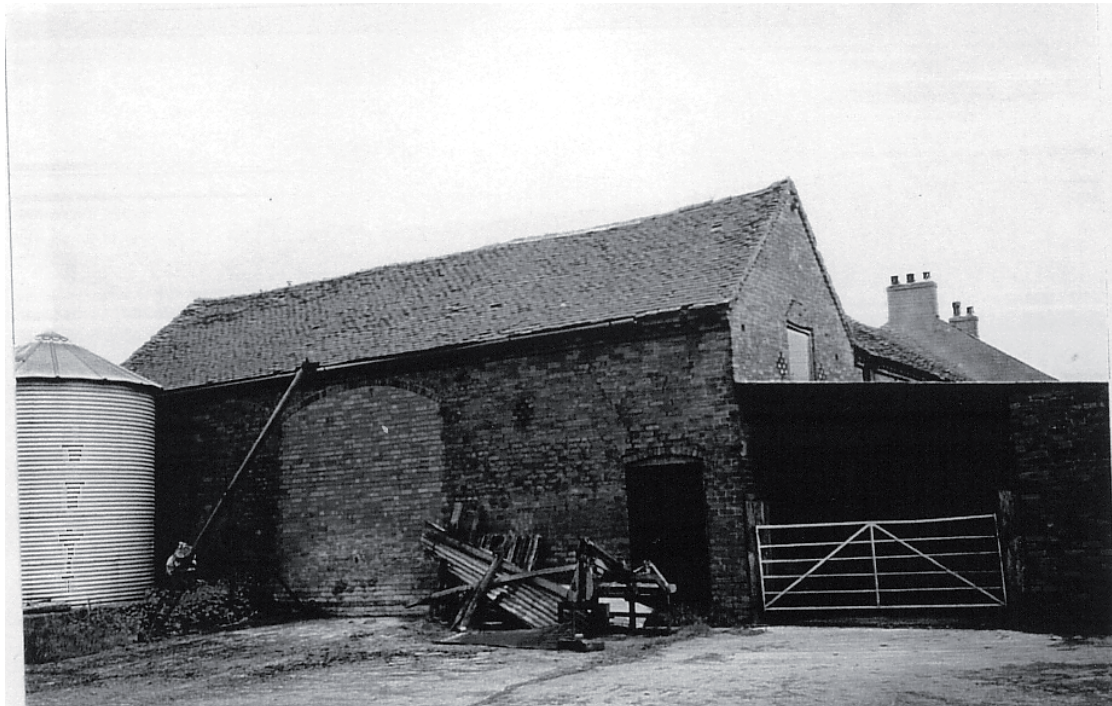
Plate 6 *West range, west elevation of brick barn with original wagon entrance doors blocked and Lean-to II at gable end of barn. A single diamond ventilator panel survives in west elevation sidewall.*

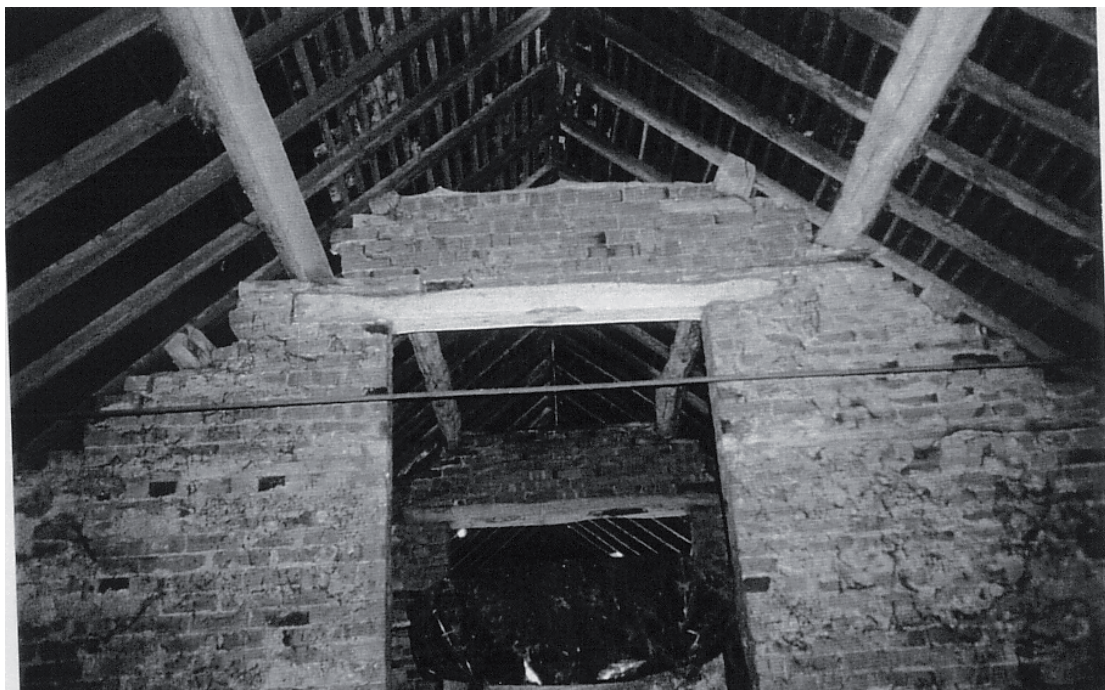
The absence of any earlier diagnostic details makes it difficult to suggest the present complex succeeded an earlier range of buildings. The only evidence of earlier building fabric relates to the purlins and other sections of timbers in the Barn roof, which are clearly re-used from earlier buildings. The early, post-Enclosure history of farm buildings in most areas of Leicestershire saw the raising of all-purpose buildings on a chosen site within the newly allocated lands of the Enclosure.* Such buildings were often contingency arrangements that enabled continuity of farming to be maintained as the newly allocated lands were brought into use in the new farming regimes. These buildings survived until the farming processes had been stabilised when attention could be turned to building a new farmhouse and associated outbuildings in the fields attached to the farm. For various social and economic reasons this transition occupied varying amounts of time and the presence of a post-Enclosure farmhouse and outbuilding complex of the mid-19th century is not at all unusual in this context.

Plate 7 *Interior Detail-West Range- Barn, showing brick walls as supports for purlins and some re-used fabric serving as purlins on the inner bay.*

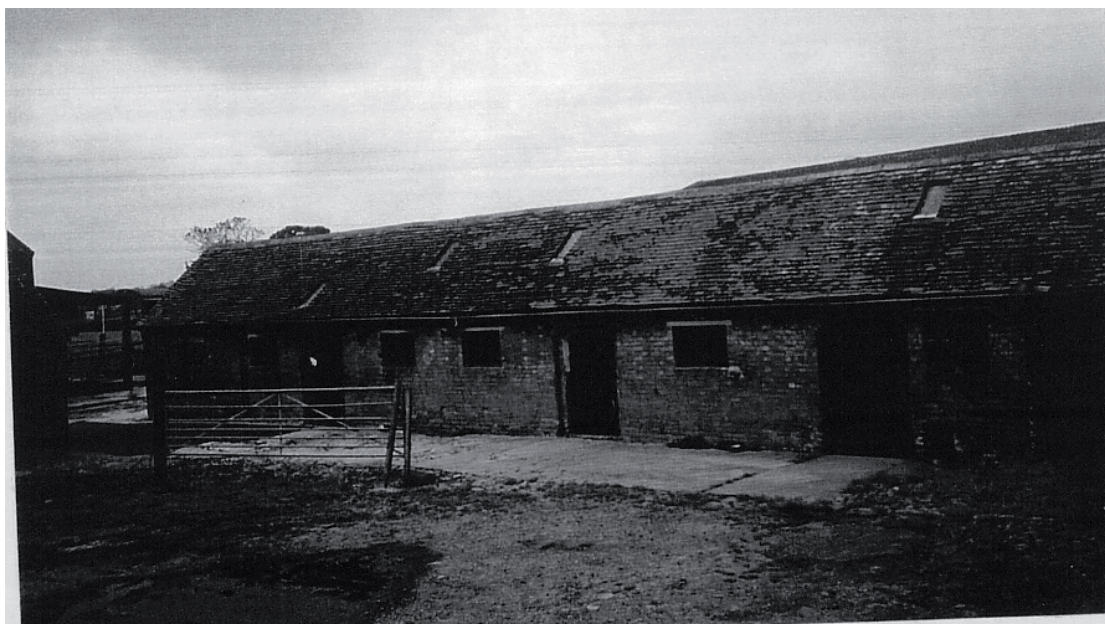
The entire north range of this courtyard plan consisted of a single-storey, brick, milking parlour, which ran the entire length of the north side of the courtyard, (*see E on Plan - Fig.3, and Plate 7*). The roof was supported by a series of industrially produced, bolted, king-post trusses with raked struts set against the swollen base of the king-post, (*see Plate 8*). The trusses carried a single, through purlin, which was supported by a wedge, nailed to the topside of the principal rafters of the king-post. The milking parlour was accessed by one double and two single width doorways. The doorways set on the yard, i.e., south side of the building; all had cambered arched heads with bull-nosed facings and were rebated. Interspersed between the doors were a series of windows, most of which were now boarded over. A single, three-over-three paned window of a similar pattern to that recorded in Unit A, was retained in the wall between the double-width doorway and a further, single width door which provided access to a separate part of this range of buildings currently being used as a farm office. The entire range also gained light from an early series of roof lights set into the ceramic tiled roof.

Plate 8 *North Range- Milking Parlour- shows earlier form of roof lights set into tiled roof. Original window surviving on right-hand side of view all doorways are rebated with bull-nosed bricks.*

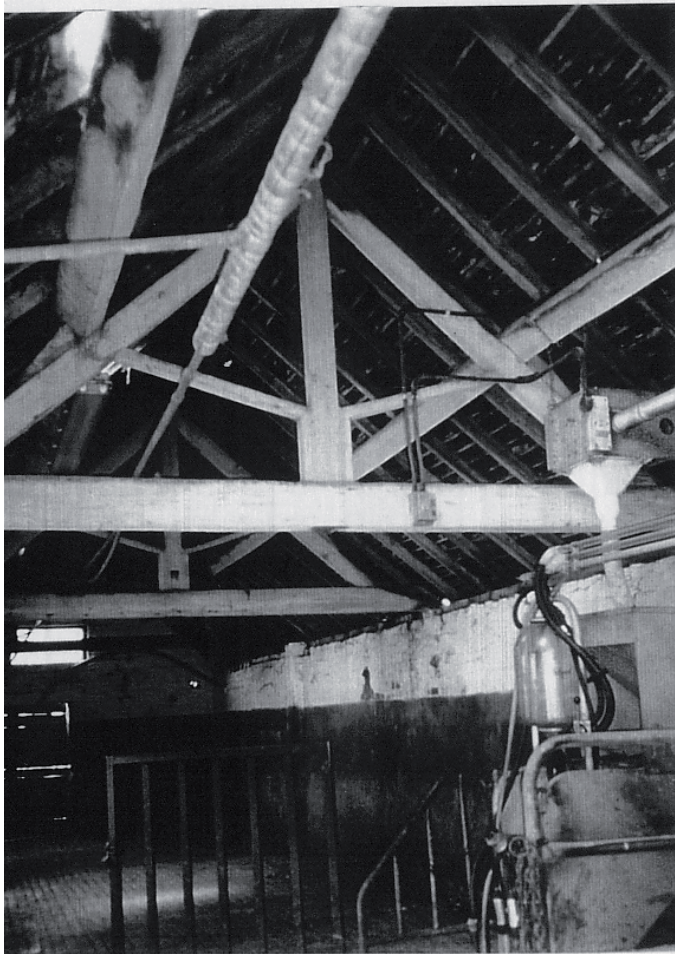
Plate 9 Milking Parlour-North Range-truss detail. A similar Truss is used in the single storey building of the West range.

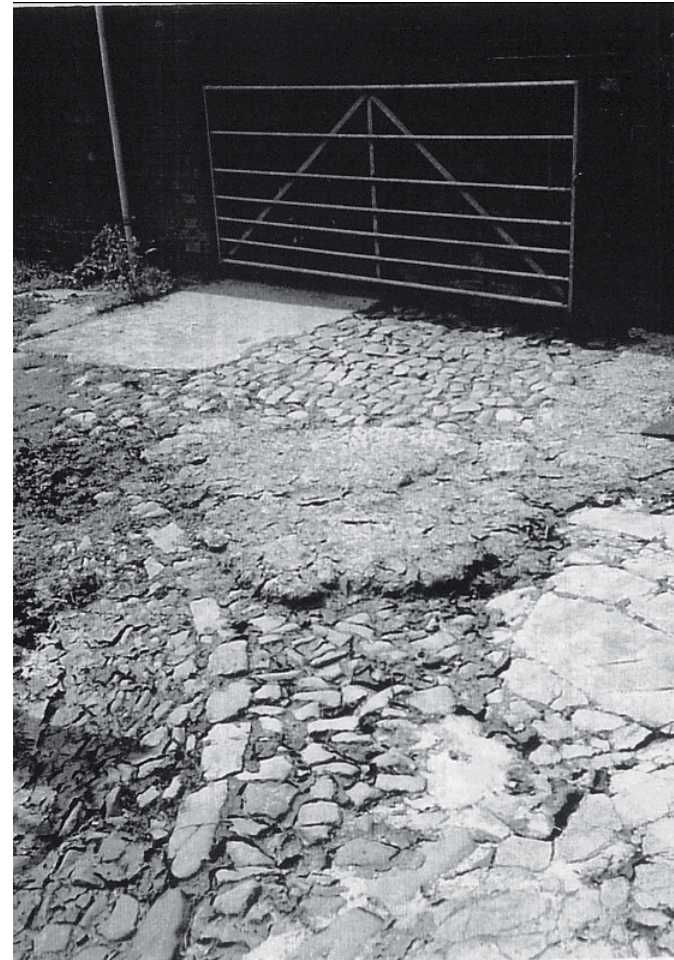
The courtyard area of the farm contained substantial sections of ranged stone. The predominant stone used was granite trimmed cobbling and smaller, granite waster pieces, in some areas this appeared to have replaced earlier sections of water-worn round-stone cobbling. The granite sections of the yard showed some evidence of being laid out in graduated sizes of stone with small, pieces being used towards the central area of the yard where it appeared there was an un-cobbled area where the 'muck-hole' or midden was situated.

Sometimes the cobbling of a courtyard area can provide indications of an earlier building layout. At Lodge Farm, the cobbling, where it is intact, respects the present plan form in these areas the cobbling appears to be of granite wasters. There are other sections of the yard where the more commonly found roundstone cobbling form the yarding. This mixture of materials may indicate two distinct phases to the courtyard area's history, in its present overgrown state it was not possible to identify such detailing with any certainty.

Plate 10 Detail of ranged cobbling partly using granite wasters with some dressed cobbles in Courtyard area. Areas of concrete appear to cover the traditional roundstone cobbles.
