**An Archaeological Standing Building Survey and
Trial Trench Evaluation of the Former King William IV
Public House, Barsby, Leicestershire.**

Planning Application: 05/01833/6

For: Darian Homes

University of Leicester

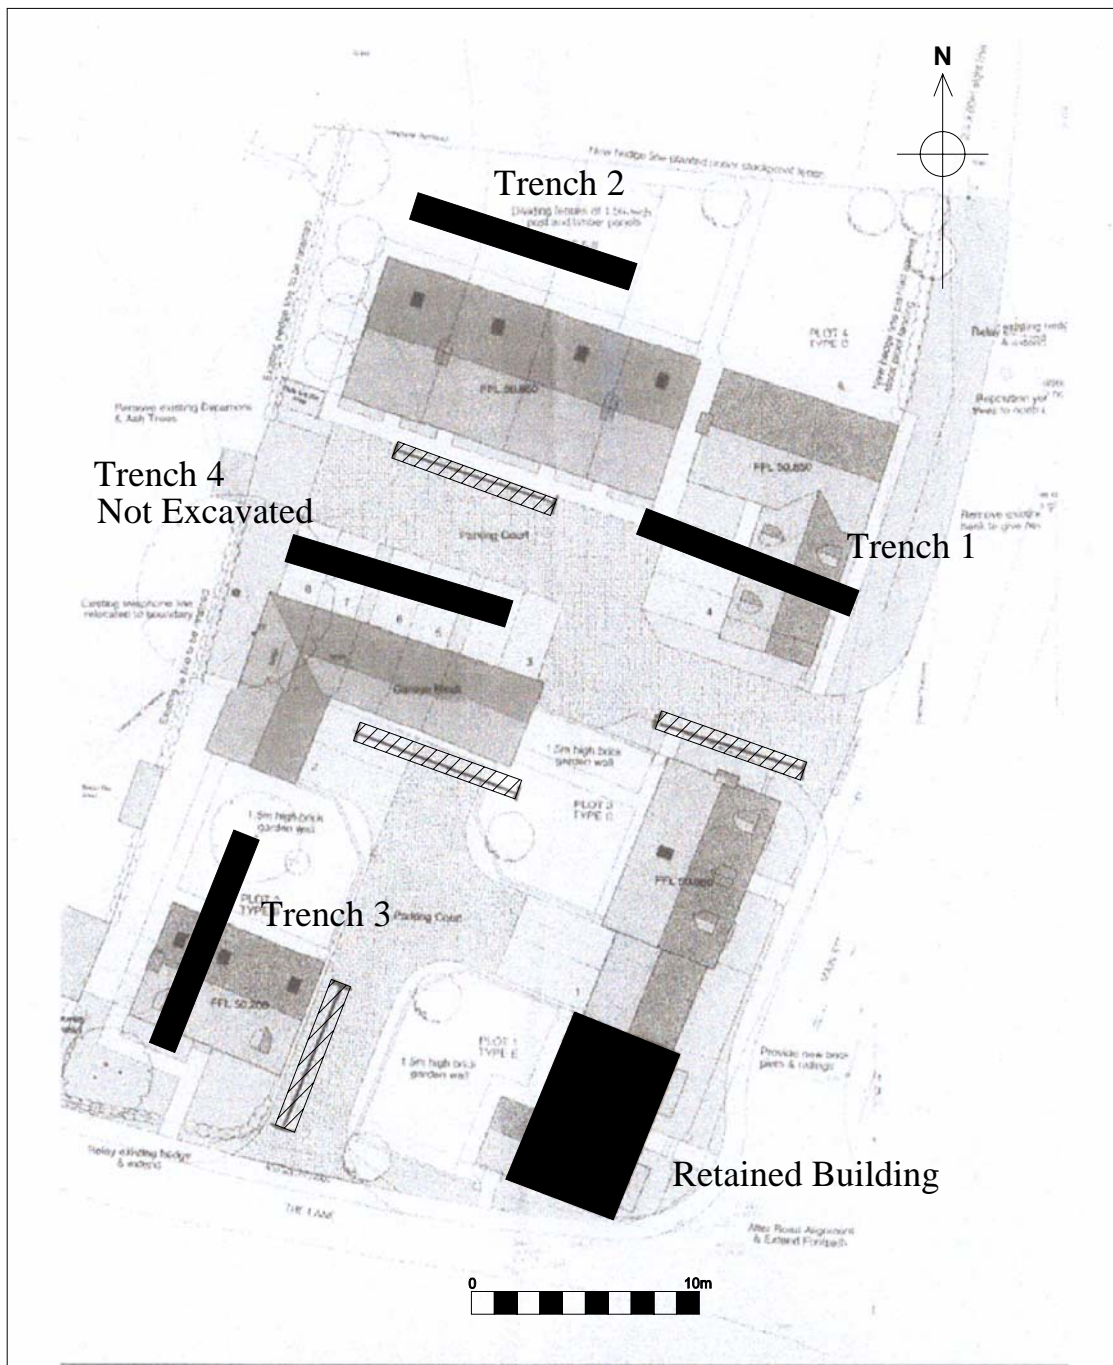
Figure 3 Trench Location Plan Proposed & Actual in Bold.

Trench 1 was excavated towards the north-easternmost corner of the proposed development area (*Figure 3*), aligned west north-west to east south-east, ten metres long by 1200mm wide, approximately perpendicular to Gaddesby Road. The area had recently been used as car parking and approximately 150mm to 200mm of tarmac and roadstone was excavated before an horizon of grey green weathered clay bedrock was exposed. A further 100mm to 150mm of this bedrock was removed to ensure it was undisturbed.

Trench 2 was excavated in the north-westernmost corner of the proposed development area (*Figure 3*), aligned west northwest east southeast, ten metres long by 1200mm wide, approximately perpendicular to Gaddesby Road. Again, an area formerly used as car parking revealed a similar depth of tarmac and roadstone as trench 1 with again the same grey green weathered clay substratum. Towards the eastern edge of the trench another deposit of demolition material was exposed; unlike that within trench 1, this deposit appeared more recent (including fibreglass insulation) and may, therefore, be considerably later in date and relate to the extensive rebuilding which took place in recent decades.

Trench 3 was located in the south-westernmost corner of the proposed development area (*Figure 3*), aligned north-east to south-west, ten metres long by 1200mm wide, approximately perpendicular to The Lane, towards the western edge of the footprint of the recently demolished building. Extensive ground reduction during the initial building work and more recent ground disturbance during demolition and grubbing out (*Colour Plate 3*) suggested that preservation would be limited within this part of the proposed development area.

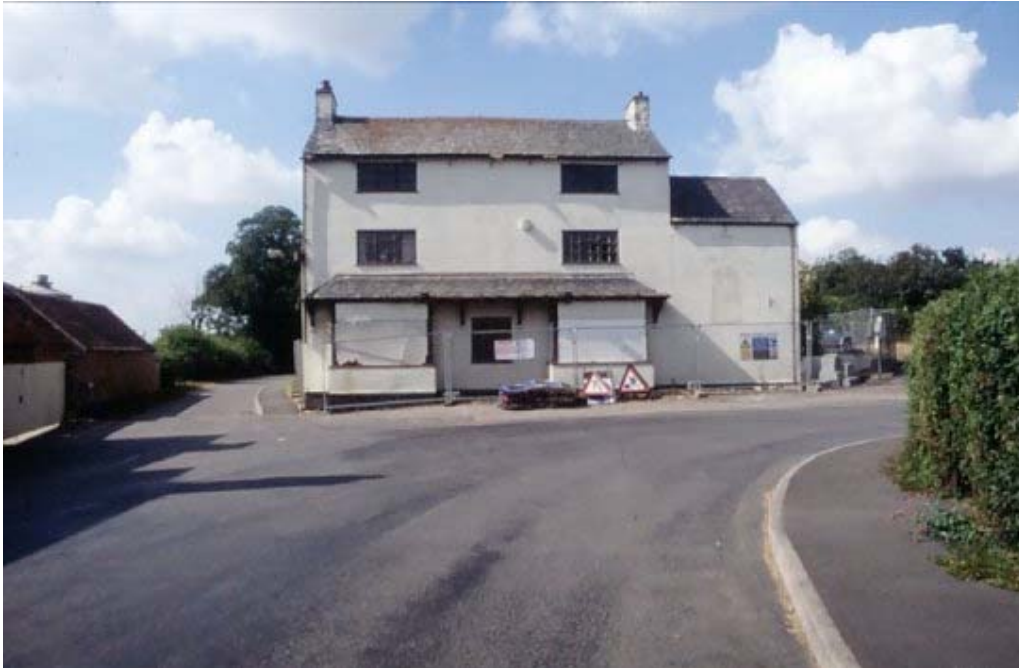
Colour Plate 1 Front Elevation.

Externally, there is little visible of architectural or historical interest; with the exception of a limited area on the left-hand gable, which has fallen away, the building is covered in painted cement render, while the roof of (A) is Swithland Slate. The area where the render has fallen away indicates that the front wing (A) at least is brick built, with the exposed 9 ½ inch by 3 inch possibly machine made red bricks in a Flemish Garden Wall bond. The ground floor windows have all been over-boarded to prevent unauthorised entry and cannot be seen externally; the first and second floor windows are late twentieth century timber frames, containing the ubiquitous reproduction Bulls eyes. There are two large bay windows on the ground floor along with a smaller central window, which in all likelihood, was originally the location of a door but has since been turned into a window. This absence of a door on the village side makes the pub appear a rather uninviting place.

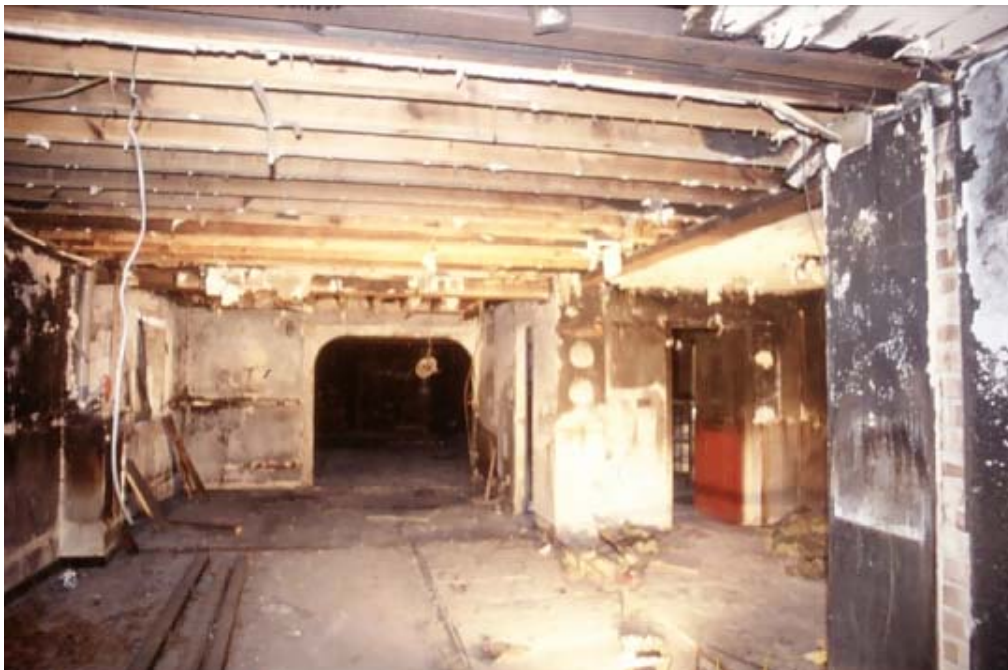
Colour Plate 2 Extent of Damage, Ground Floor.

Internally there is very little of architectural or historical interest surviving. The ground floor of (A) has suffered extensive fire damage and has subsequently been stripped of all fixtures and fittings. There are two gable fireplaces, apparently of modern brick; the original line of the back wall can be seen as a stub projecting from the left hand wall

and damaged plaster work here revealed Fletton bricks beneath. These bricks indicate a twentieth century date. The collapsed ceiling panels also revealed modern timbers. This along with the Fletton bricks suggests extensive structural work, if not rebuilding was carried out in the later part of the twentieth century.

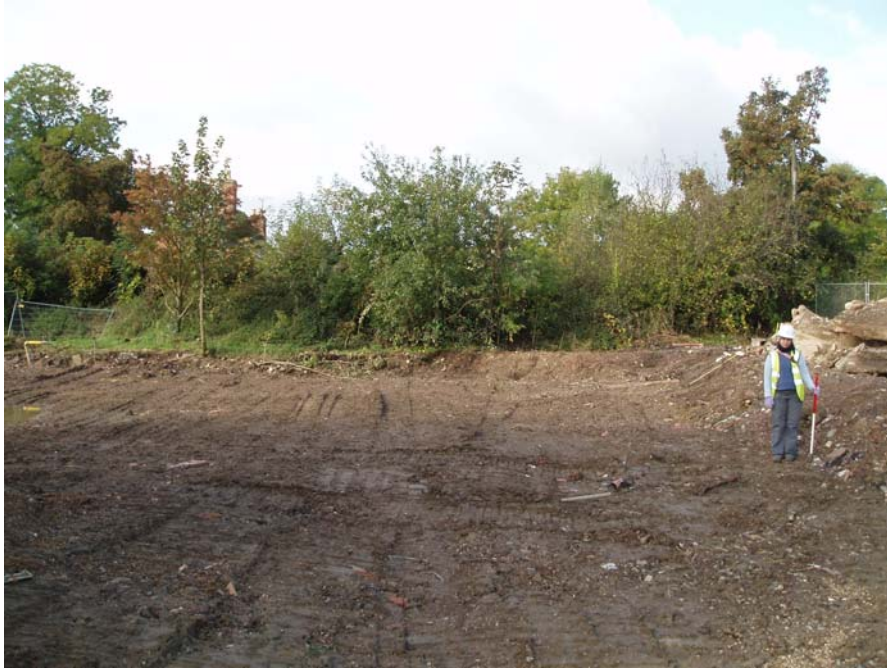
Colour Plate 3 Extent of Ground Reduction.

Excavation confirmed this assumption, only 150mm of disturbed and redeposited surface material overlay the weathered clay substratum. Nothing of archaeological significance was observed within the trench and after a photographic record was made the trench was released for backfilling.

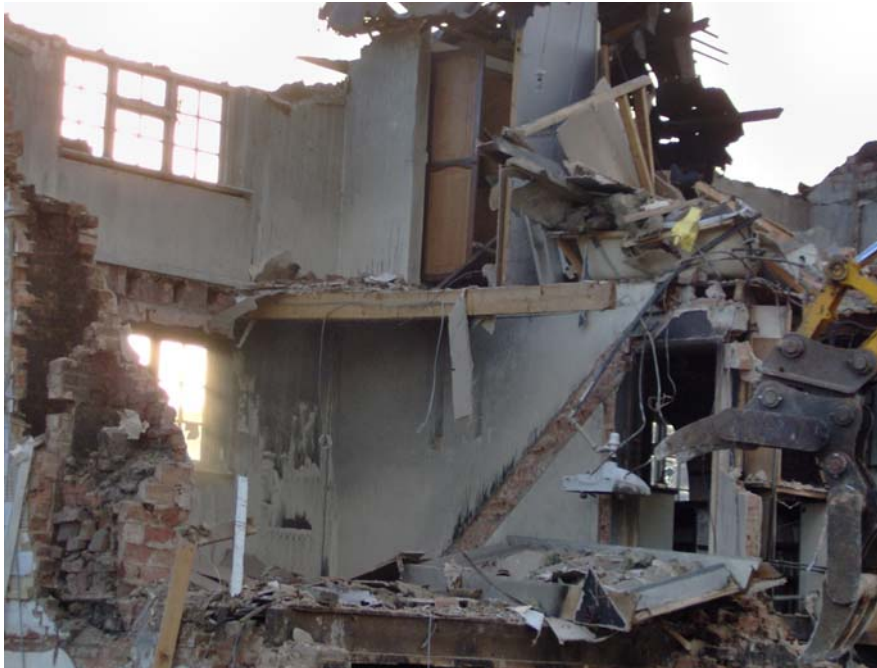
Colour Plate 4 Demolition in Progress.

As demolition progressed it was clear that internally the building was twentieth century in date. All of the internal timbers were machine sawed pine with numerous galvanised joist hangers as opposed to hand carved or pinned joints. All partition walls were modern plaster board or in the case of the few remaining load bearing walls Fletton Bricks. This evidence, along with the observed new copper water pipes and plastic insulated electricity cables indicated the building had been stripped back to the bare shell and completely rebuilt, therefore, confirming the results of the standing building survey.

The main fabric of the building, exterior walls and roof structure on the other hand was not as easy to date. A close examination of the bricks recovered from the right hand gable does provide a cautious date of the early to mid Nineteenth Century (Between 1825 and 1850). The dimensions of the bricks match those established by the Brick Tax in 1803 (Effectively limiting the size of green bricks to 10inch by 5inch by 3inch), thereby confirming the early nineteenth century date. This along with possible indication of the bricks being wire cut suggests a pre 1850 date but certainly post 1803.
