**A Level 2 Historic Building Recording at
7 King Street,
Sileby,
Leicestershire
NGR: SK 6013 1527**

**ULAS Report No 2021-093
©2021**

Site Name: 7 King Street, Sileby, Leicestershire.

Client: UCR Construction and Development Limited

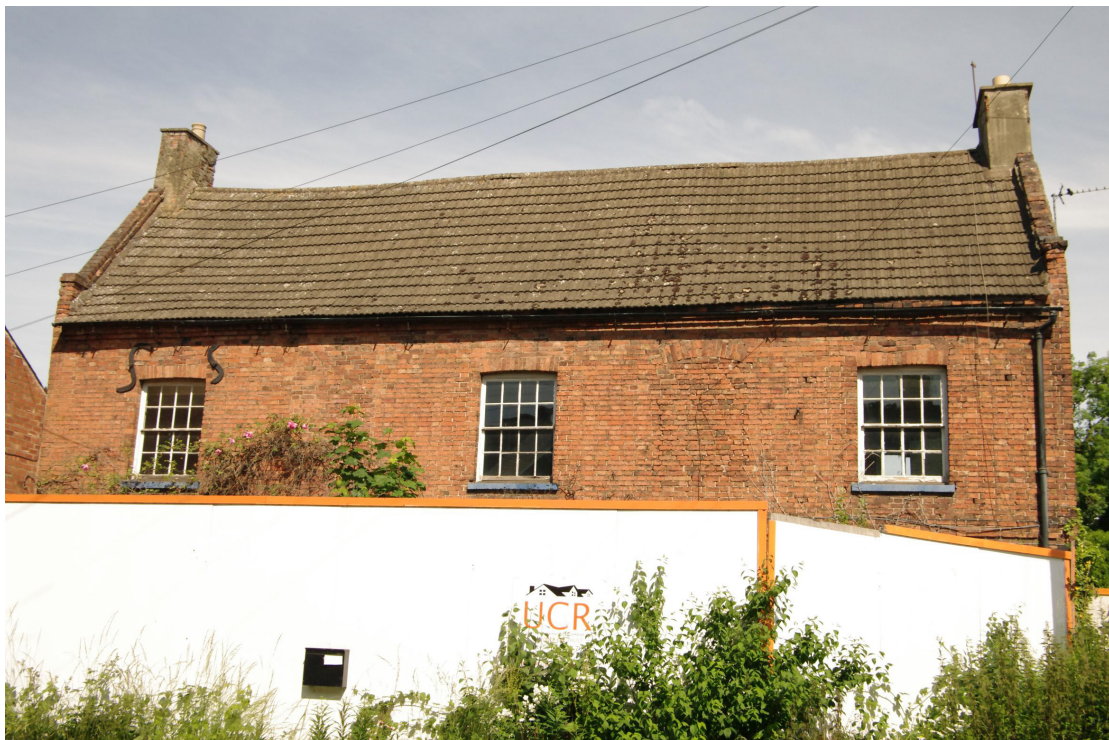
Figure 15 South-east facing elevation first floor detail
Looking north-west. Note earlier and smaller infilled windows either side of the central window. The cement tiles are likely to be 1950s or later

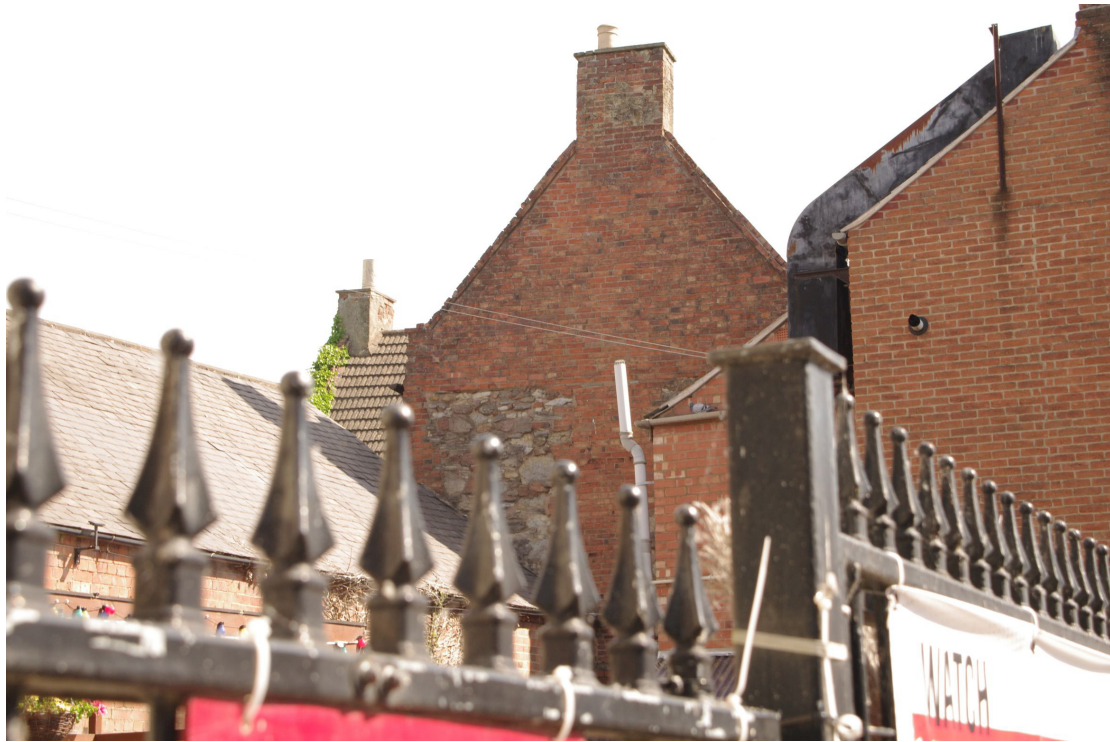
Figure 18 South-west facing gable end seen from King Street
The rectangle of stonework suggests that part of an earlier range was incorporated into the 18th century range

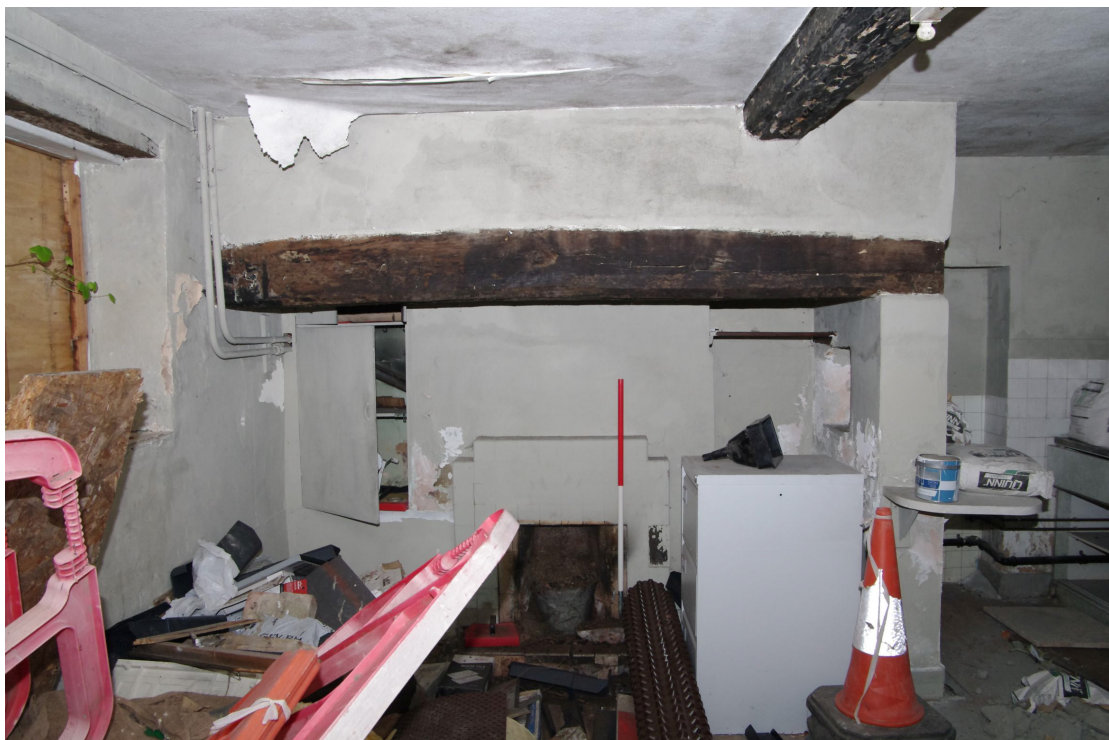
Figure 33 Room G1 fireplace
Looking north-west. Note the blocked possible former doorway to right of fireplace.
1m scale

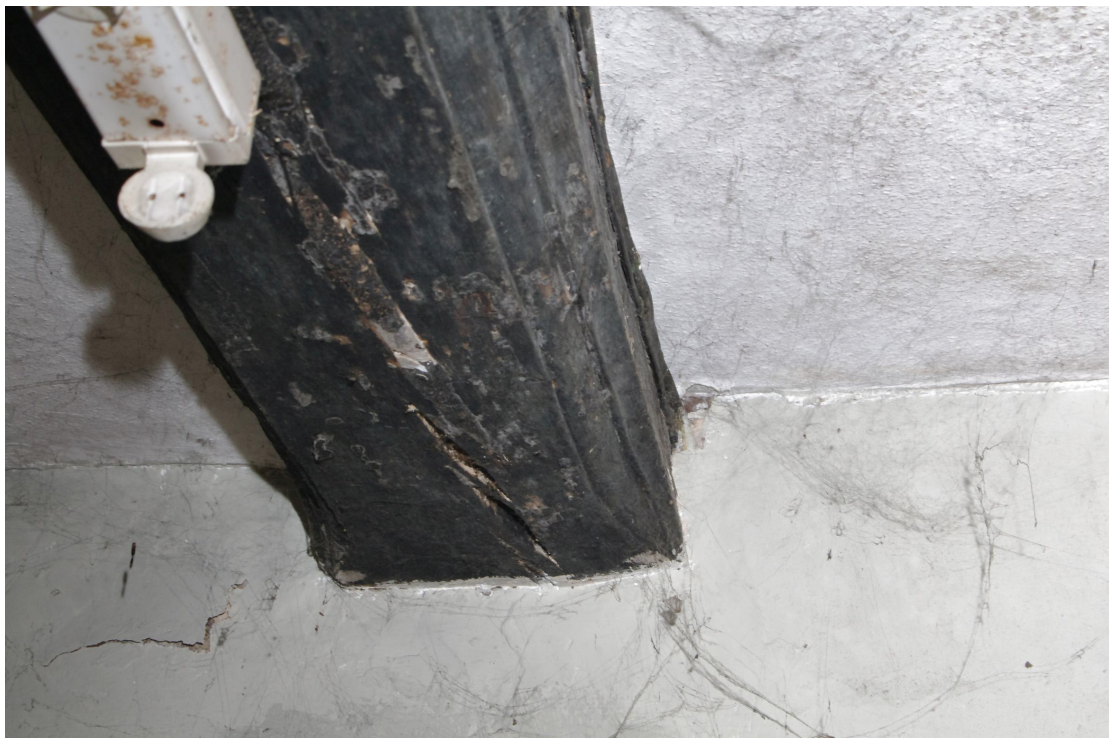
Figure 35 Room G1 beam detail at south-east end
The chamfer appears to end in a stop-chamfer at the wall suggesting that it was once a longer beam cut to fit this room

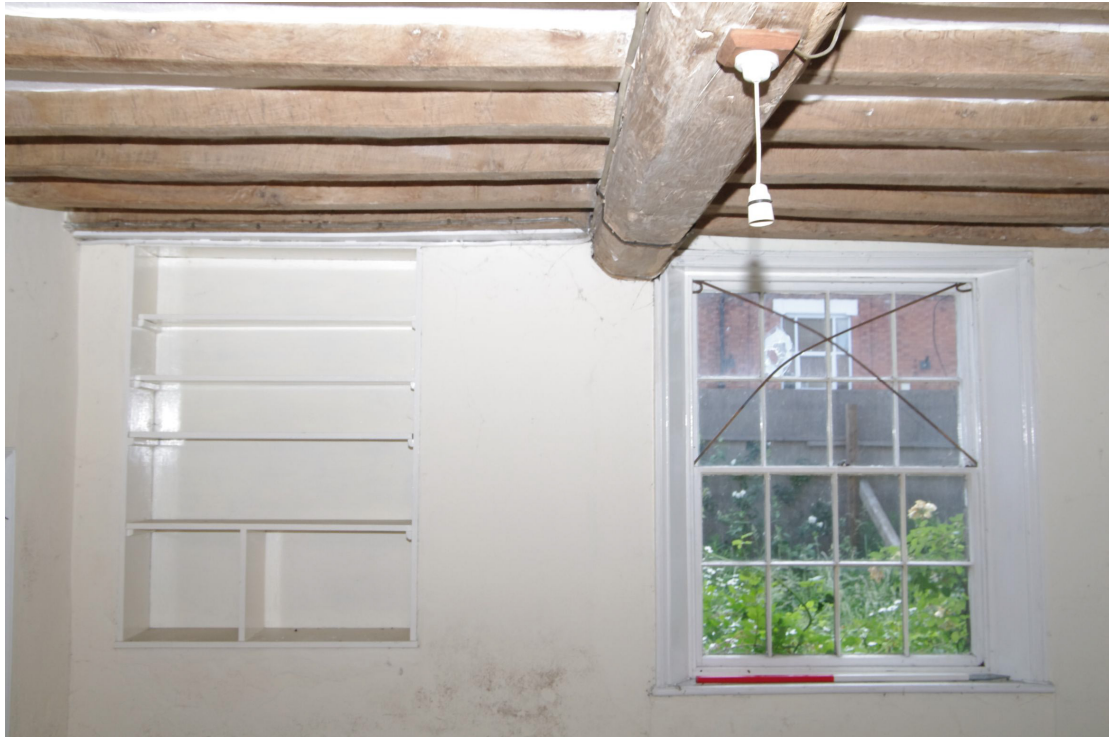
Figure 44 South-east wall and window detail of Room G5
Looking south-east. Note earlier and smaller blocked window on right adapted to be used as shelving. The later windows are splayed whilst the earlier blocked ones are not. 1m scale

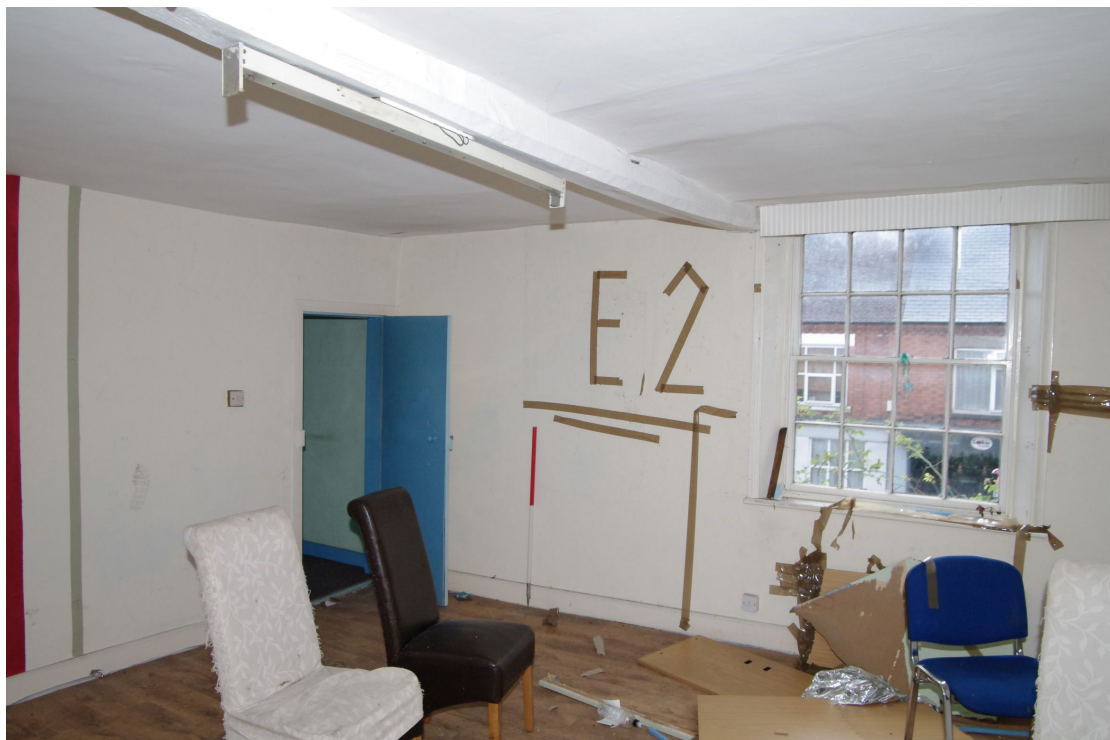
Figure 55 General view of Room F2
Looking south-east. A blocked window can be seen on the outside wall to the left of
the 1m scale

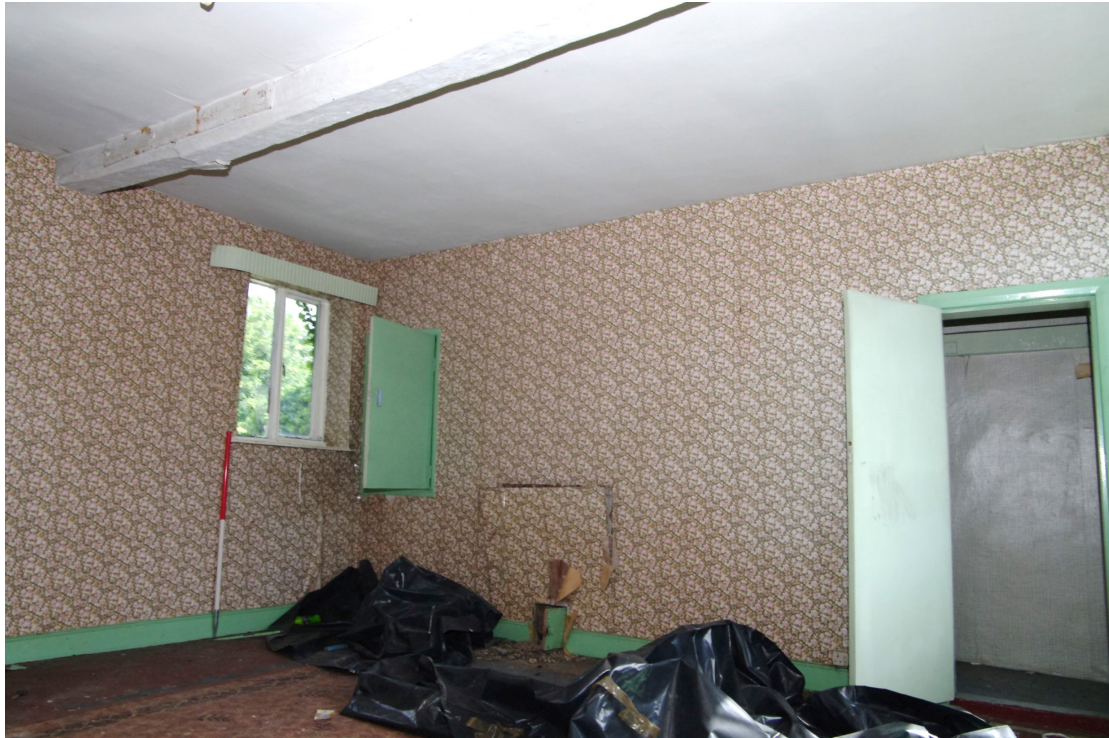
Figure 58 General view of Room F3

Looking north. Doors to right lead to cupboards either side of chimney. Note iron bar added to strengthen the beam where it has cracked at a redundant socket. The repair appears to be quite old. 1m scale

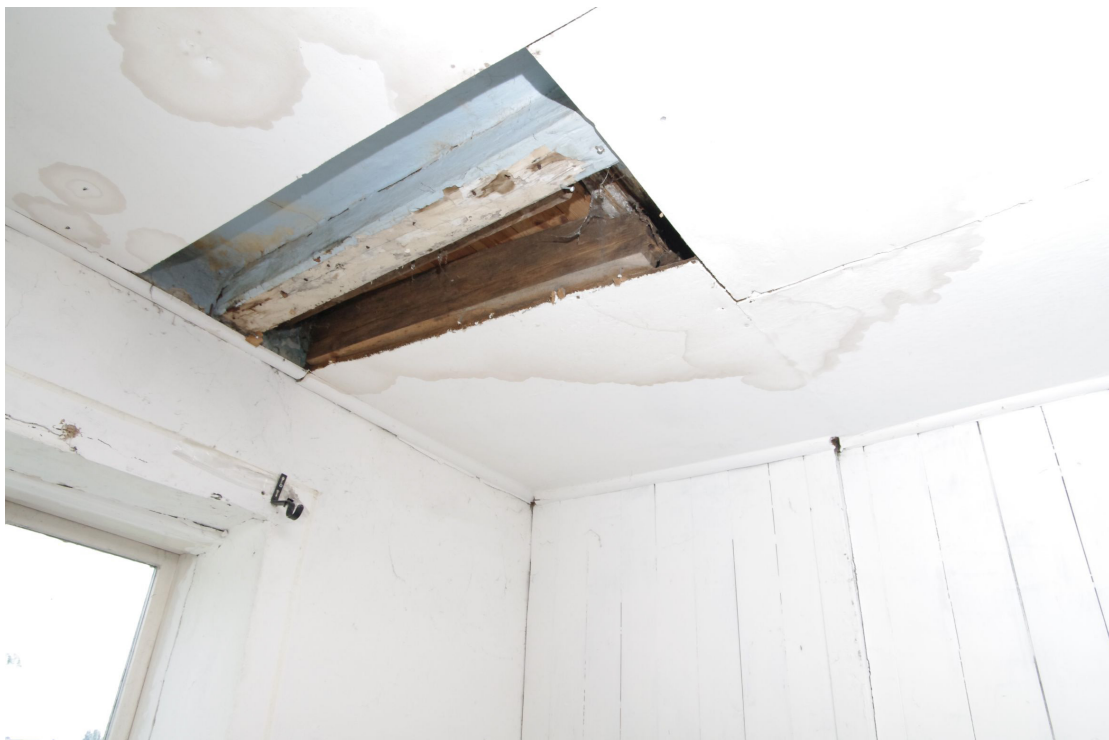
Figure 65 Room F6 ceiling and former staircase scar
Modern ceiling covering masks the original location of the stairs which had a dogleg

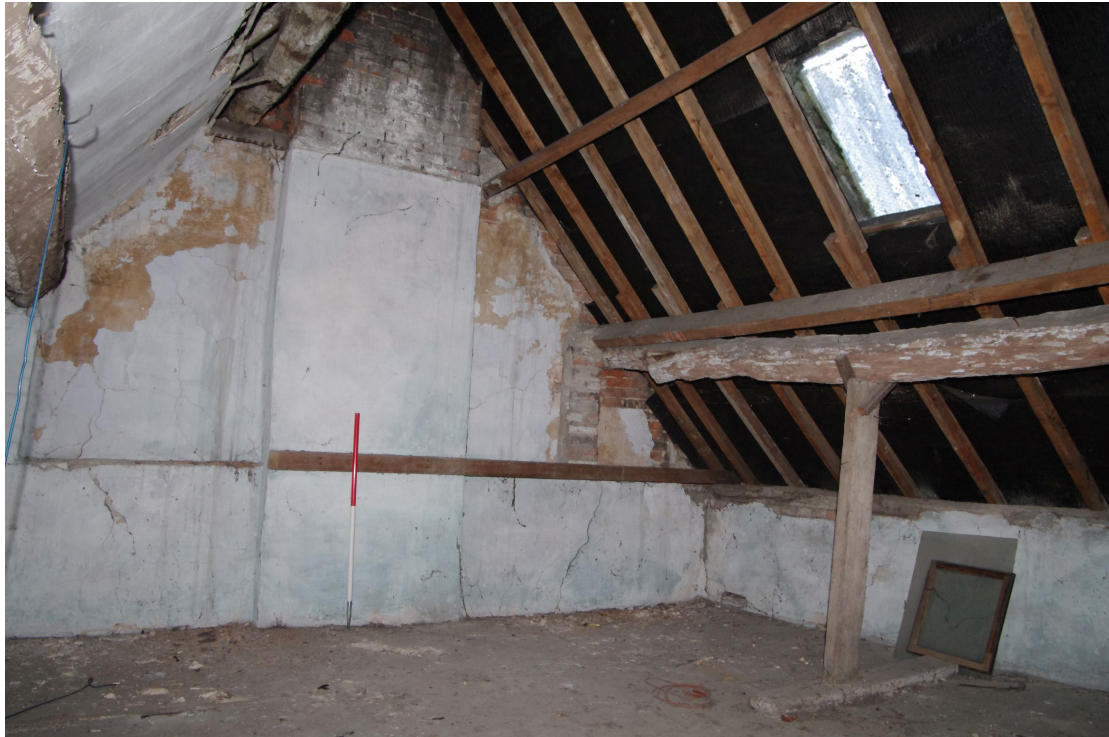
Figure 74 General view of Room S3
Looking west. Note supported purlin and the two later replacement purlins and rafters probably added in the later 20th century. 1m scale

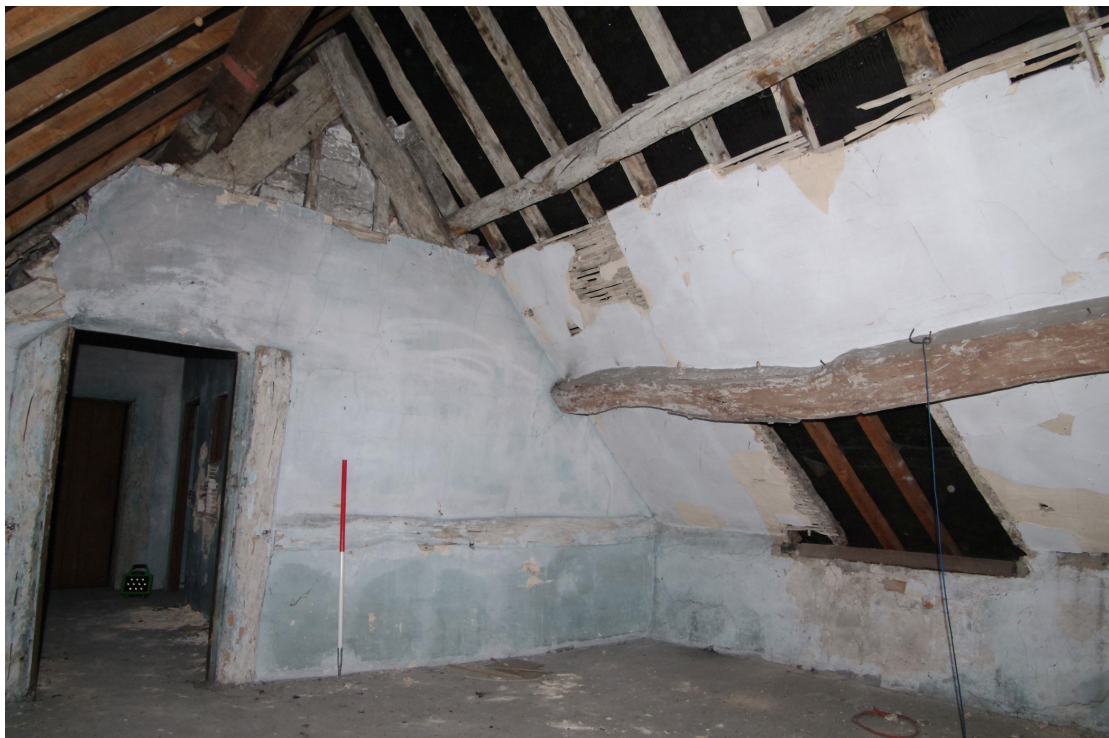
Figure 75 General view of Room S3
Looking east. Doorway leads to Room S2. Both purlins and the rafters survive on this side of the roof. The lower purlin has begun to split and has had a plate bolted to it. Pegged roof truss with redundant sockets on the left side. 1m scale

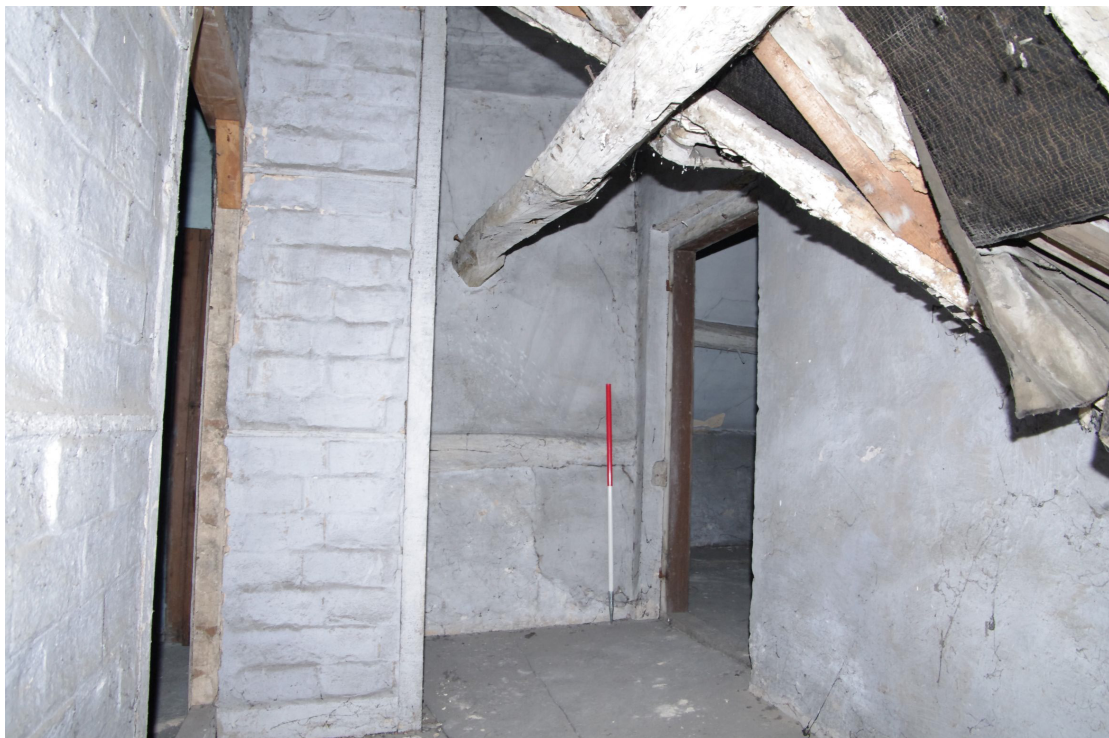
Figure 81 General view of Room S5
Doorway to Room S4 on left, S6 on right. The purlin has many redundant sockets and
peg holes (see next image). 1m scale

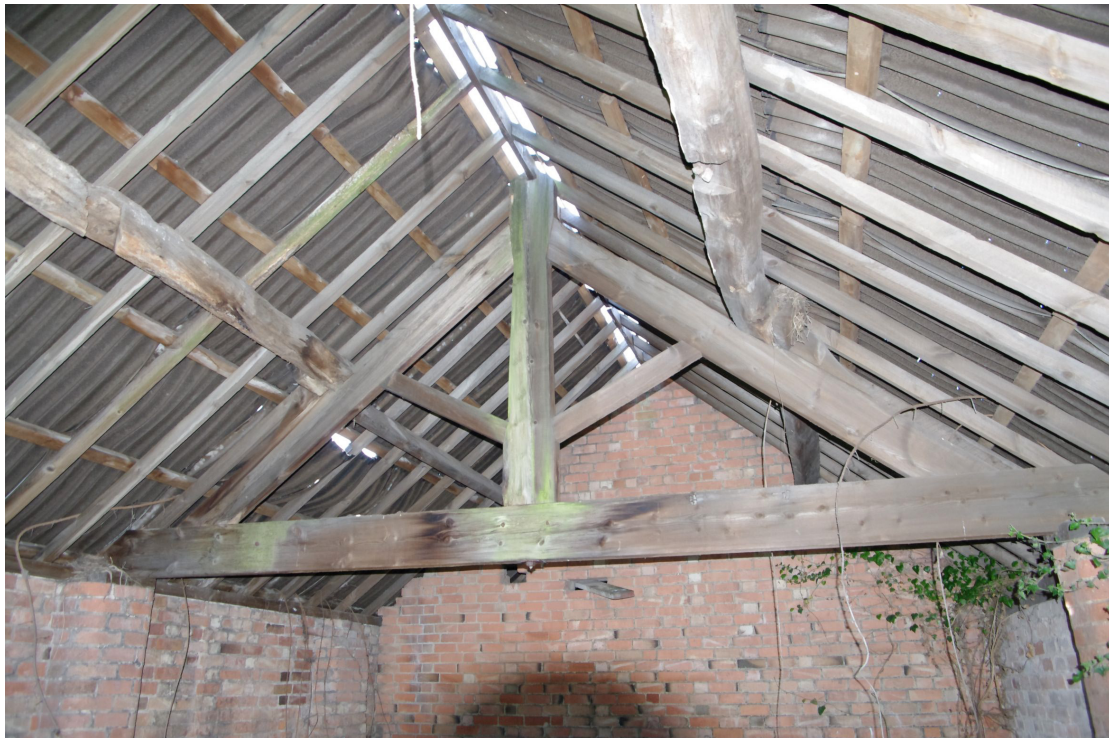
Figure 89 Barn 1, northern room
Looking south-east. Note redundant sockets for braces on the purlins

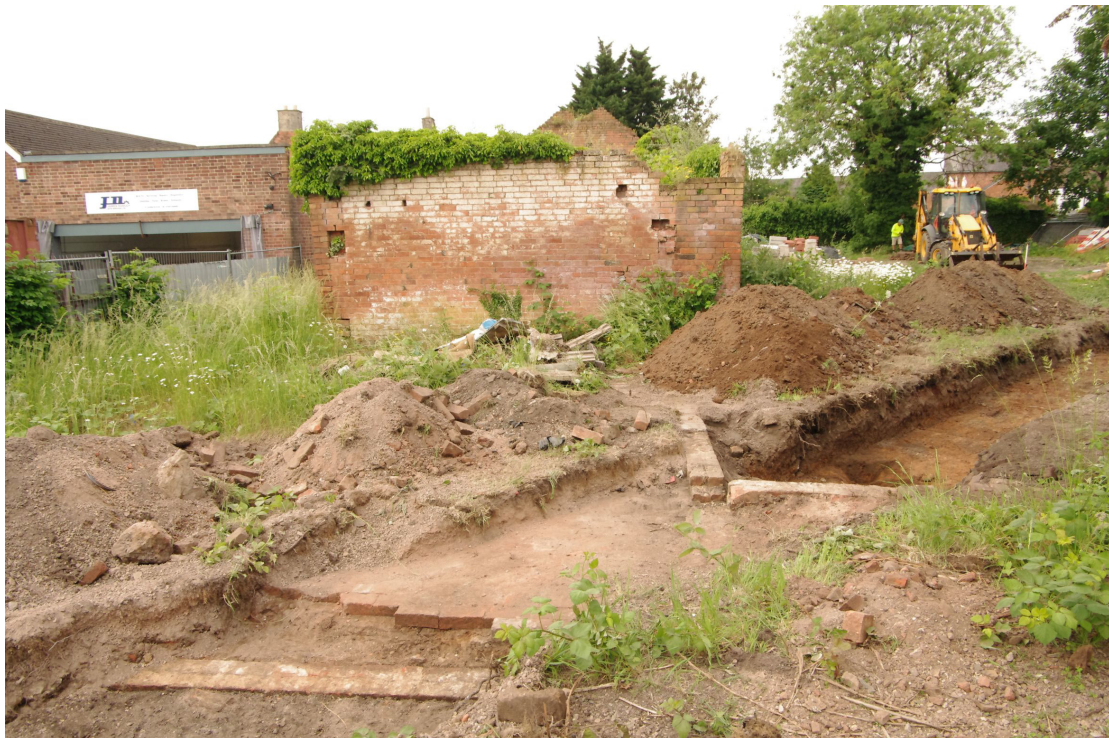
Figure 97 Barn 2, north-east facing elevation
Looking south-west. The evaluation trench shows the foundations of the corner of the
former courtyard ranges which can be seen in the foreground, as can the link to
Barn 1 on the right
