**A Level 2 Historic Building Survey at  
Limes Farmhouse Barns,  
22 Main Street,  
Breedon on the Hill,  
Leicestershire  
NGR: SK 40569 22848**

**ULAS Report No 2021-156  
©2021**

**Site Name:** Limes Farmhouse Barns, 22 Main Street, Breedon on the Hill, Leicestershire.

**Author:** Andrew Hyam

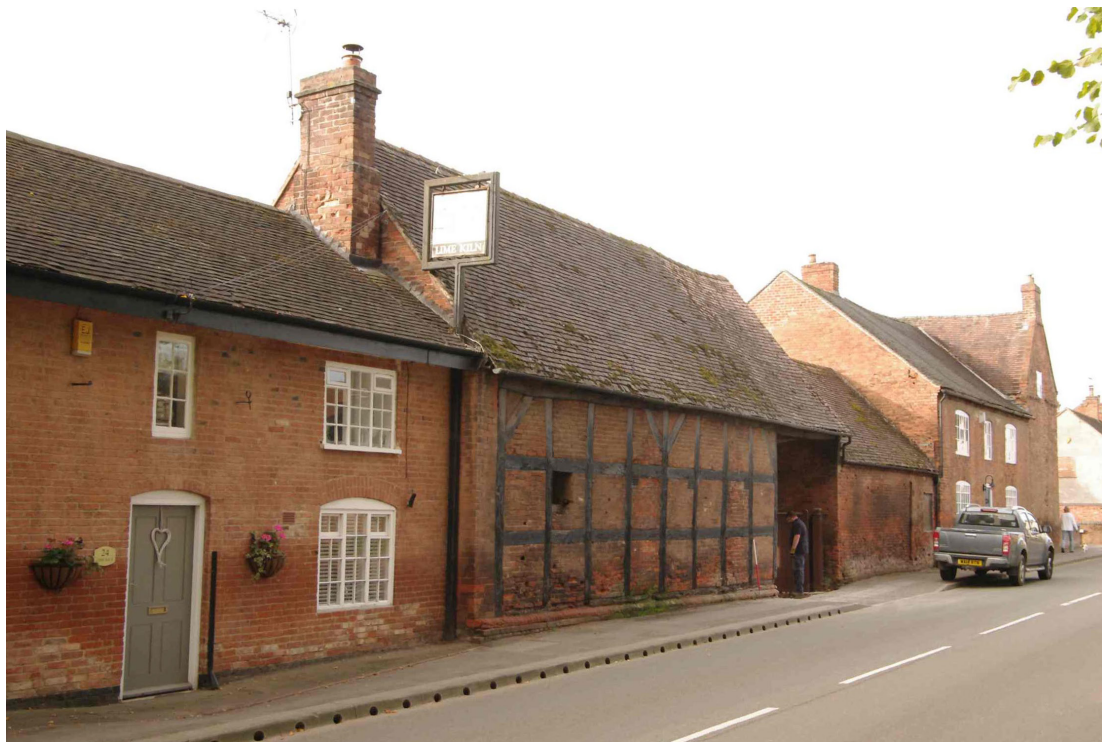
Figure 14 North facing elevation  
Looking south-west. Former Lime Kiln pub (with pub sign above the roof line still present) on left,  
Limes Farmhouse on right

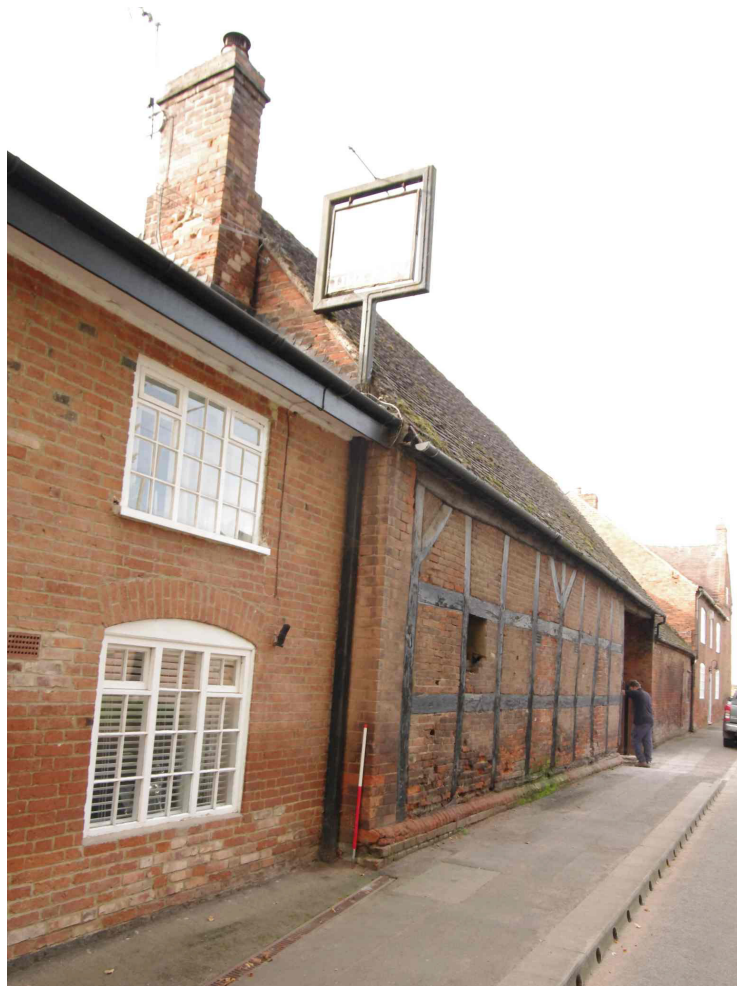
Figure 15 North facing elevation and joint with former public house  
Looking south-west. The brickwork behind the 1m scale is late 19th or 20th century

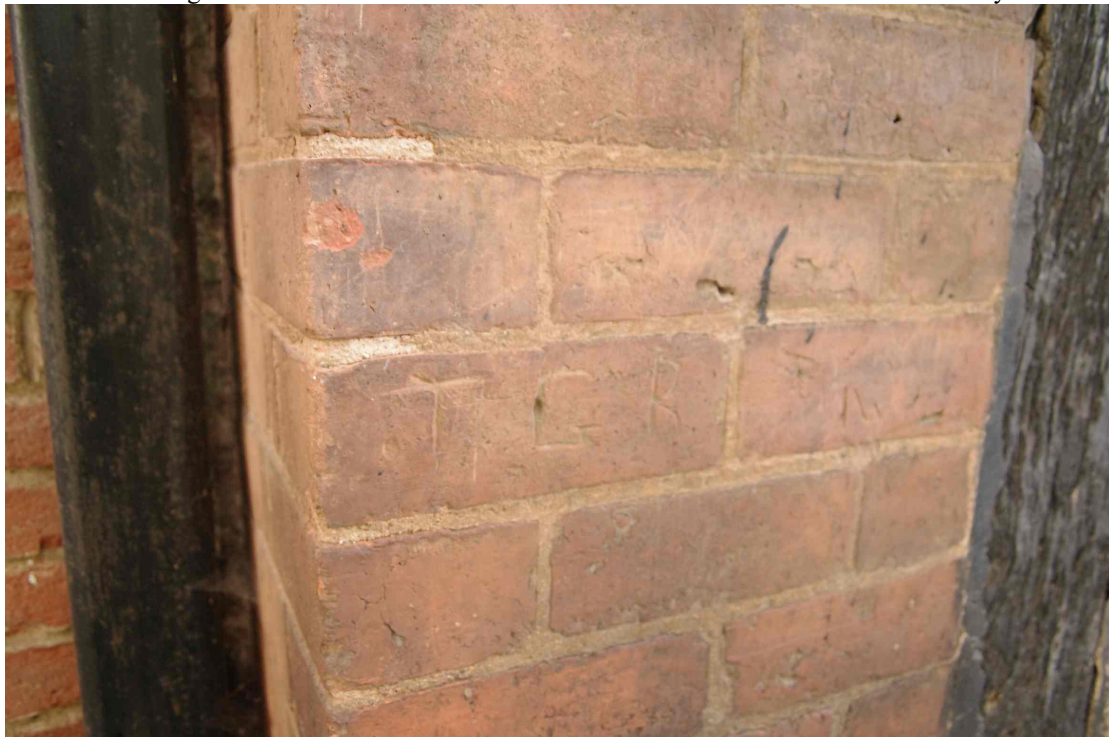
Figure 16 Graffiti on modern brickwork forming NE corner of barn  
Former pub on left

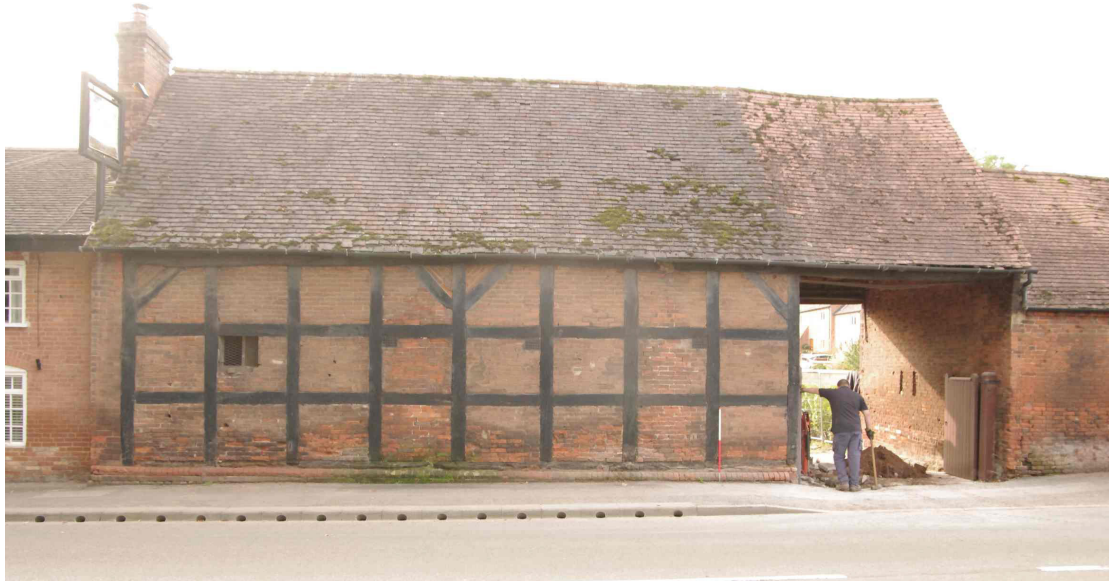
Figure 17 General view of north facing elevation  
Looking south. 1m scale. See Appendix 1 for details of each joint

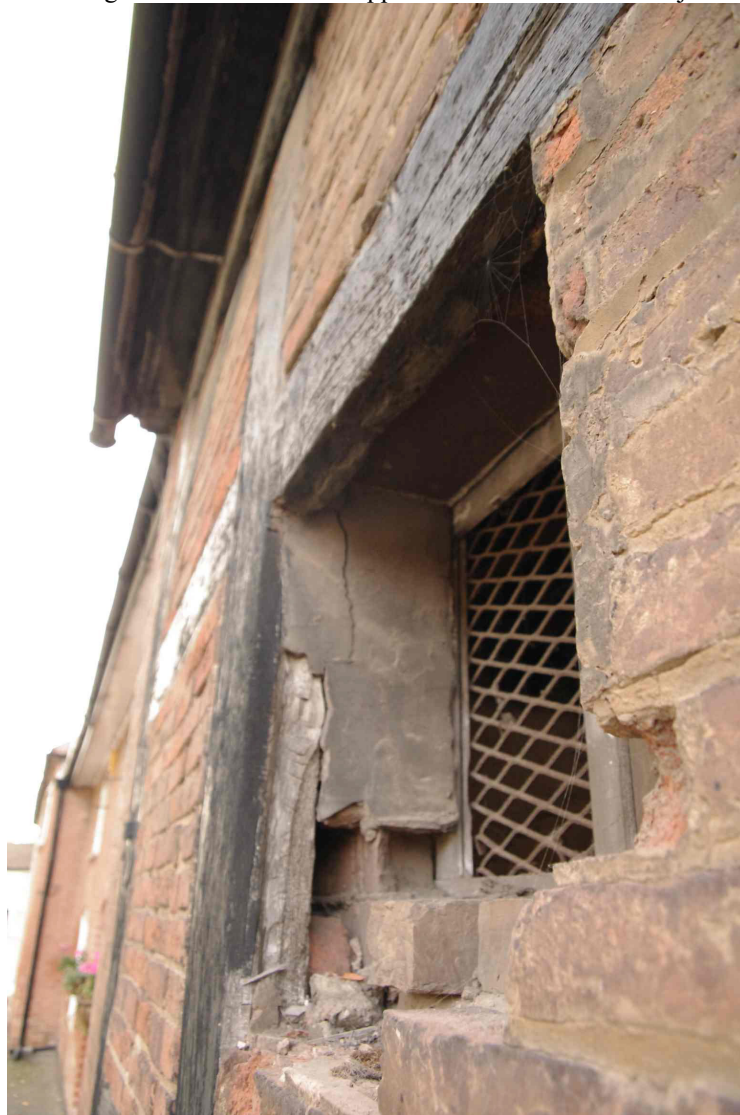
Figure 18 Close-up of timber frame and later inner brick skin  
Looking east along north facing elevation

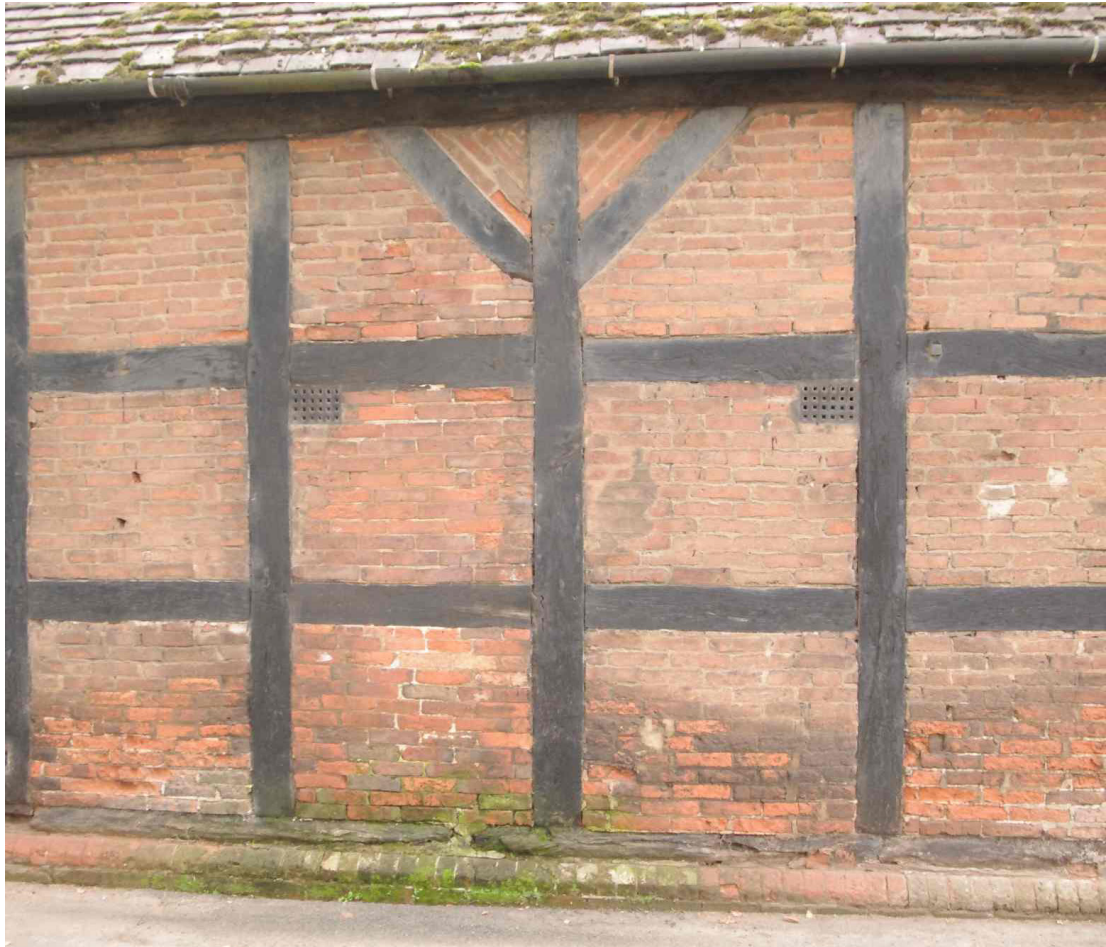
**Figure 19 Close-up of brick infilling**  
Looking south at north facing elevation. Note the brick plinth supporting the sill-beam

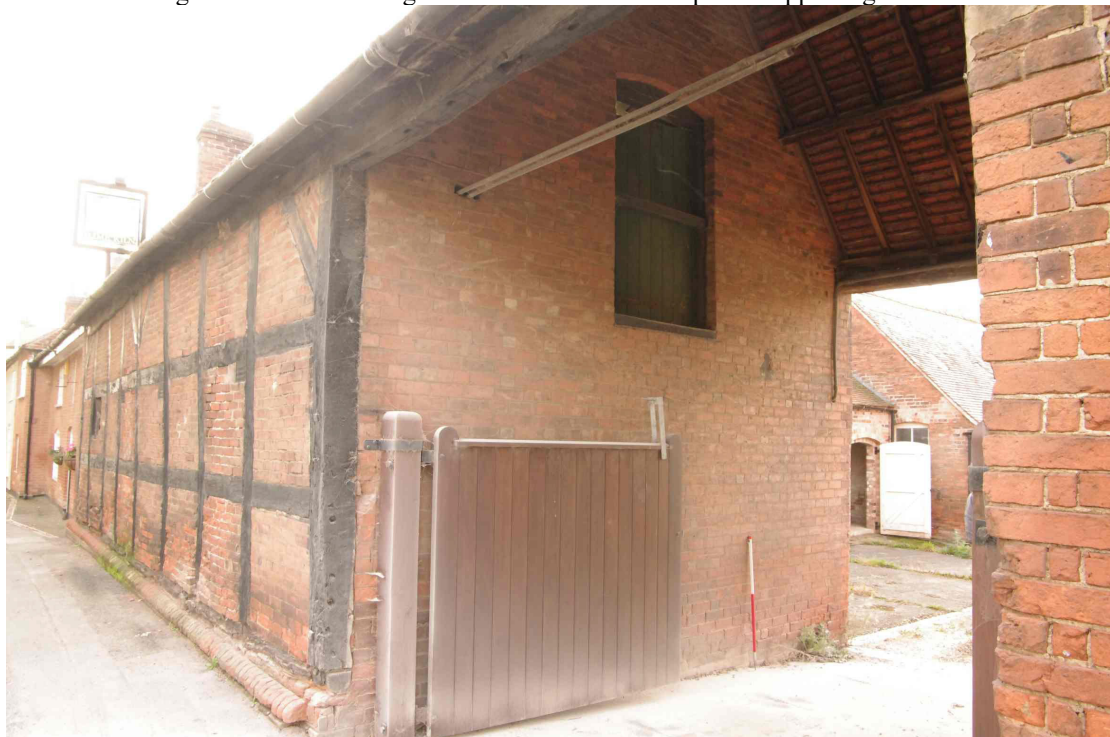
**Figure 20 Covered entrance into yard**  
Looking south-east. 1m scale. Note re-used timber used as a lintel above the entrance

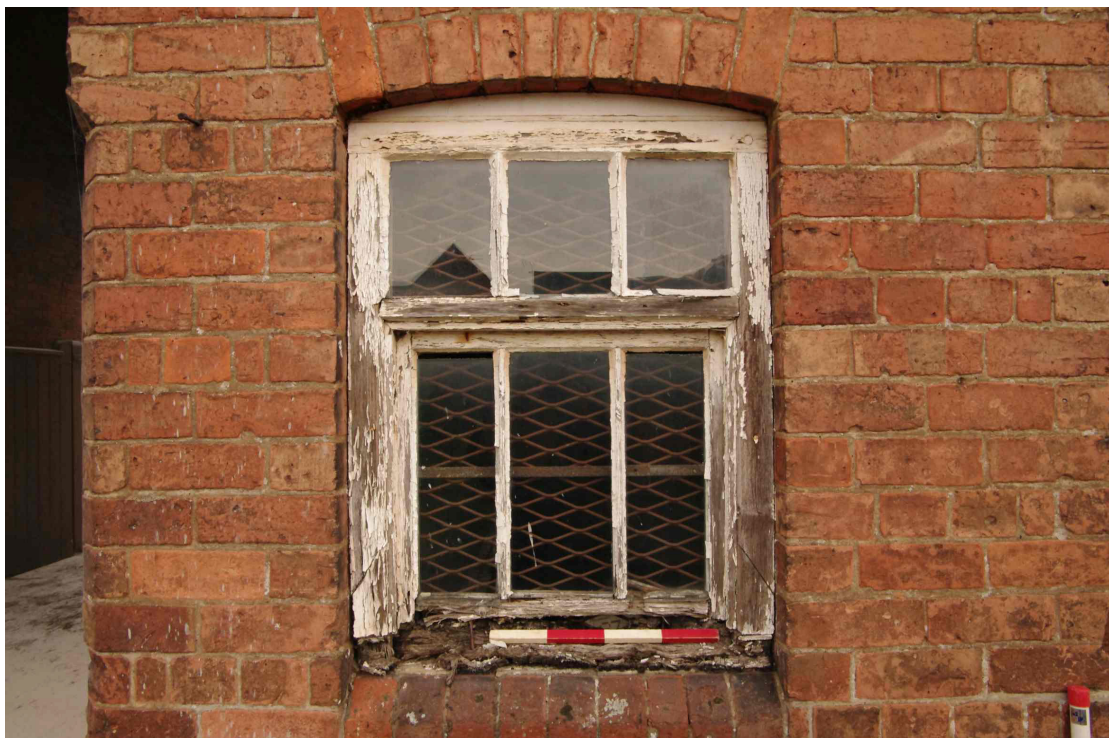
Figure 24 Window on south facing elevation of northern barn  
Looking north. 0.4m scale. Note chamfered brick corner on left

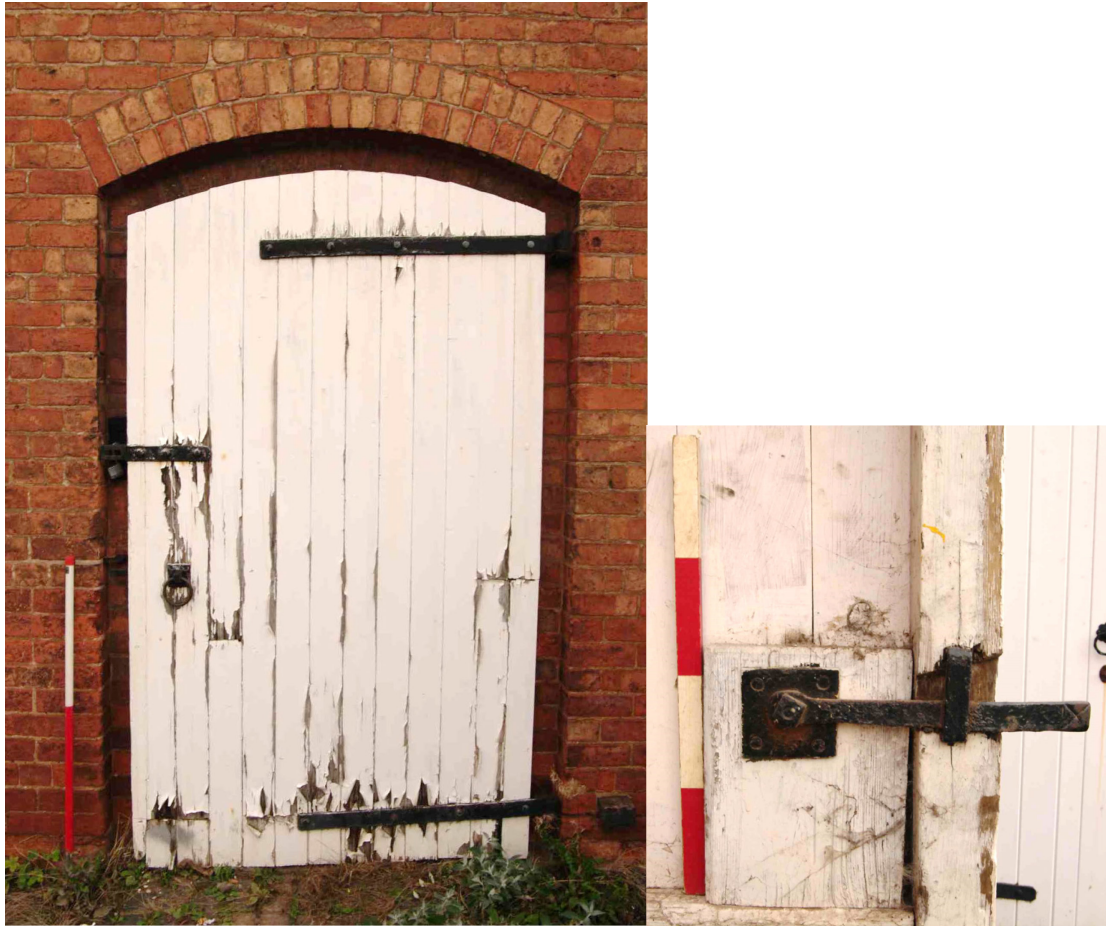
Figure 25 Door on south facing elevation of northern barn  
1m scale on left picture. Inner latch detail on right. Note the Saltire cross on the end of the latch, a feature normally seen on the outside rather than the inside, suggesting that it has been moved from an earlier position

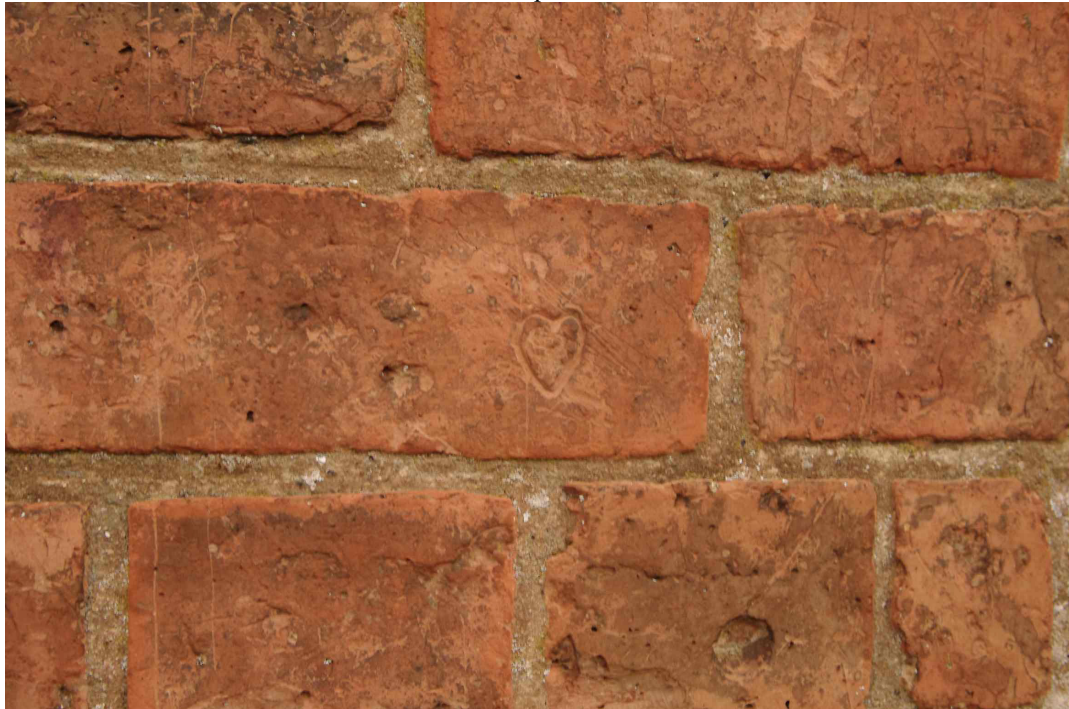
Figure 26 Incised heart motif between door and window on south elevation  
There are a number of hearts scratched in this location at around chest height

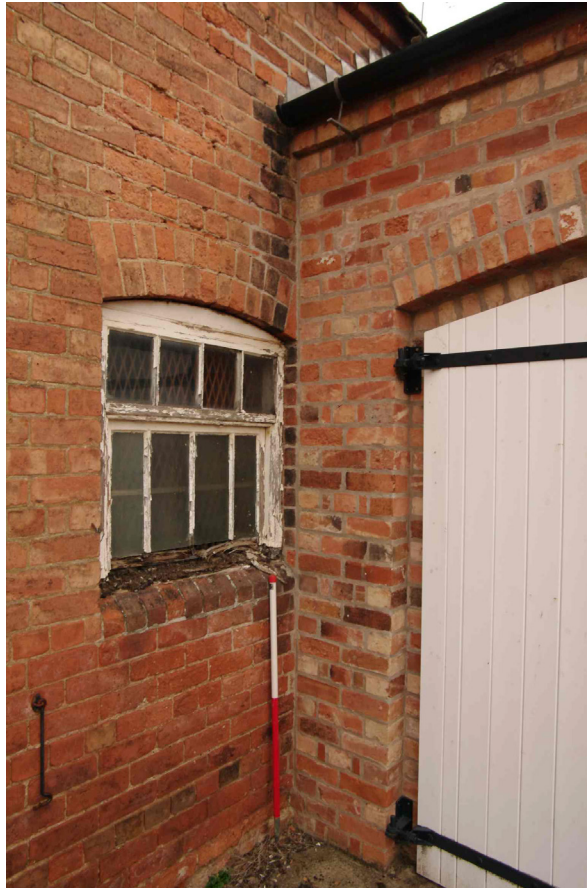
Figure 27 Junction of north barn and middle barn  
Looking north-east. 1m scale. The location of the (rebuilt) wall and the closeness of the window suggests that the middle barn is a later phase

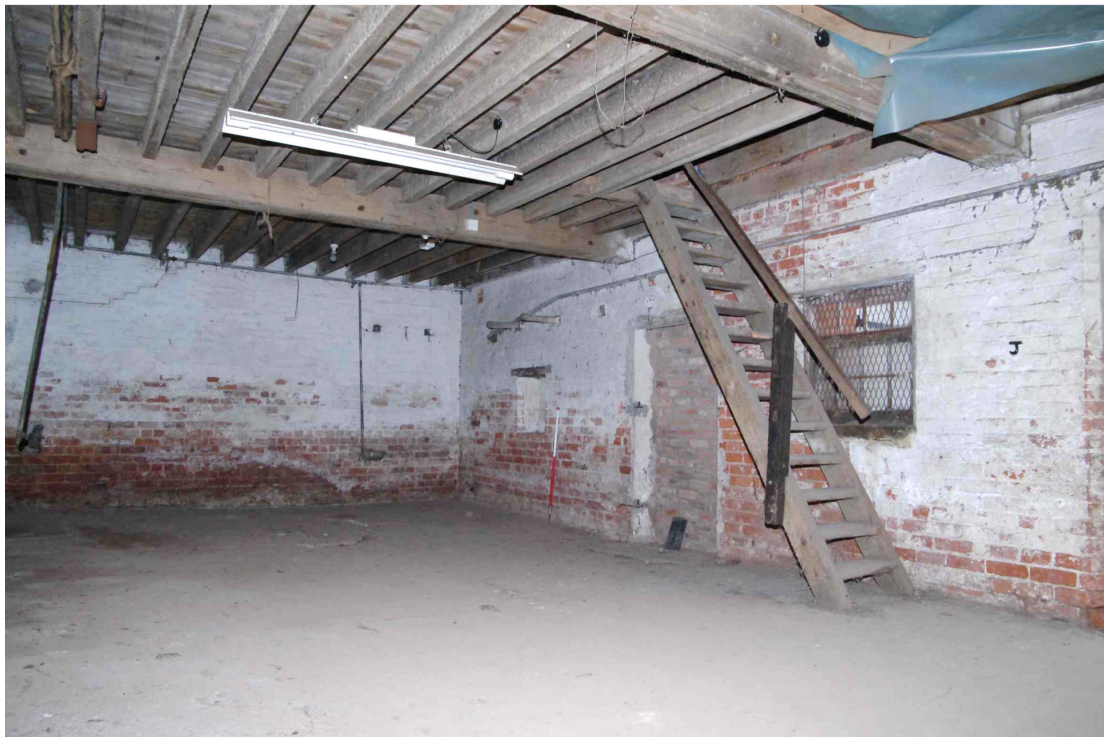
Figure 29 General view of north barn ground floor  
Looking south-east. 1m scale. Note blocked door and window. Also the saddle trees and empty sockets in the far corner

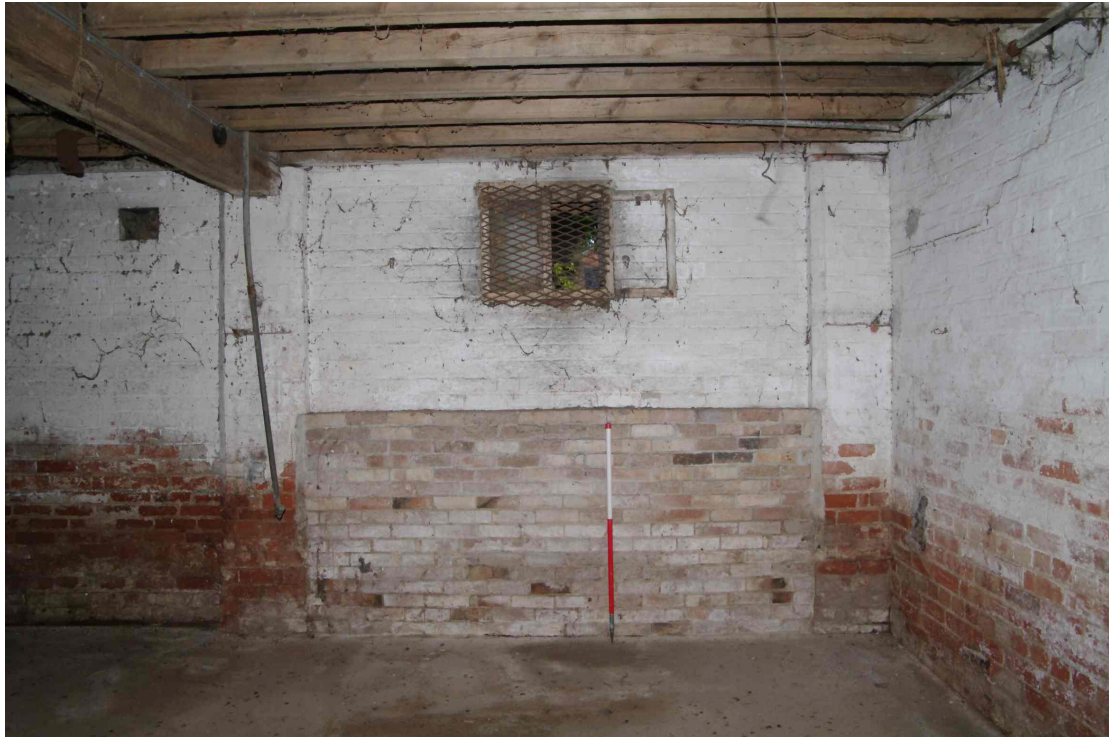
Figure 31 North barn, ground floor. North wall  
Looking north at window shown in Figure 18. 1m scale The brickwork masks the outer timber frame

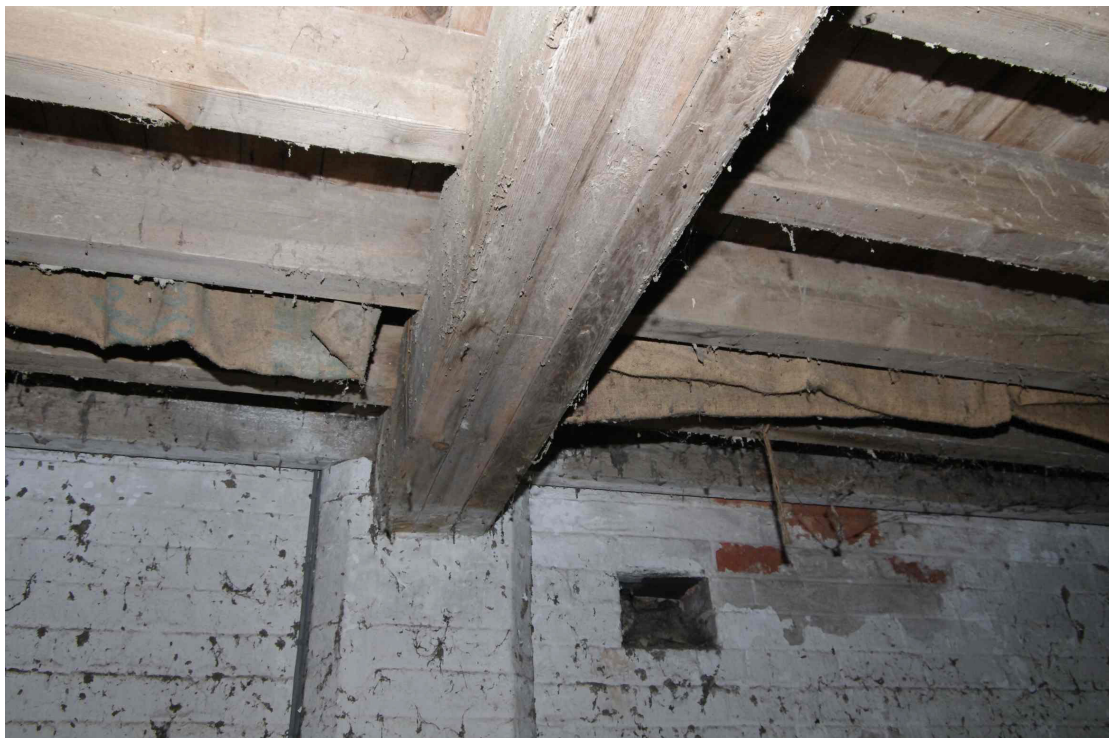
Figure 32 North barn, ground floor. Beam detail  
Looking north. Both beams are constructed using a ply of three narrow timbers

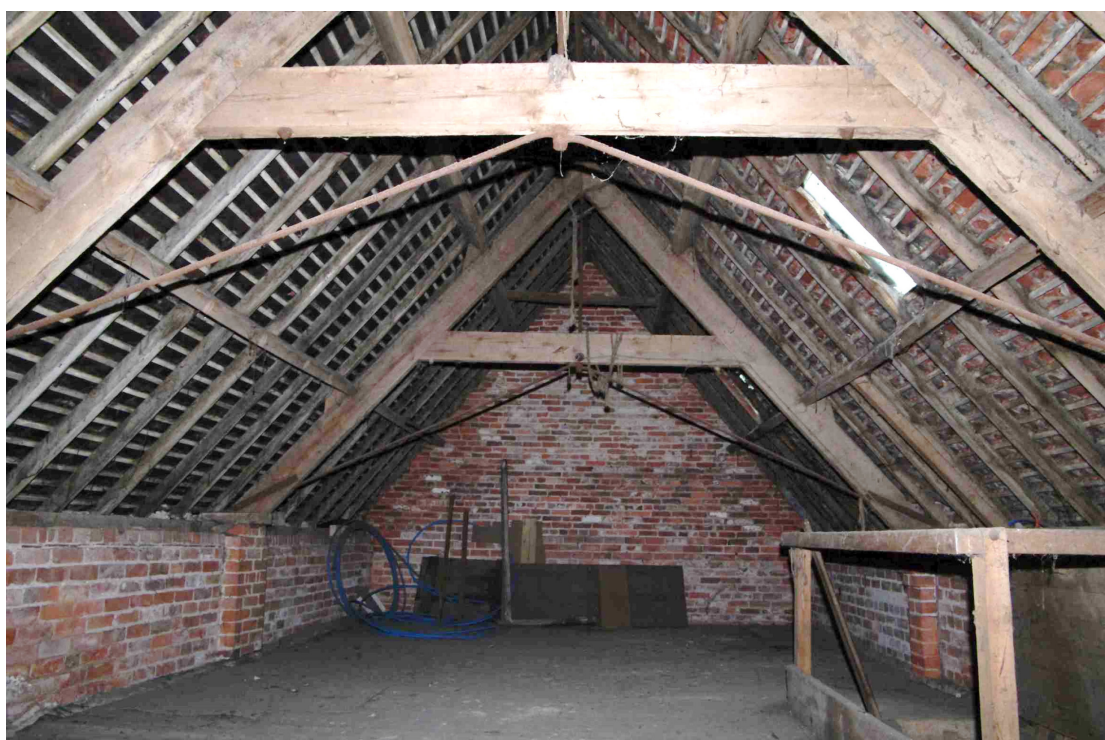
Figure 34 North barn, first floor  
Looking east. The bolted roof structure suggests a mid to late 19th century date

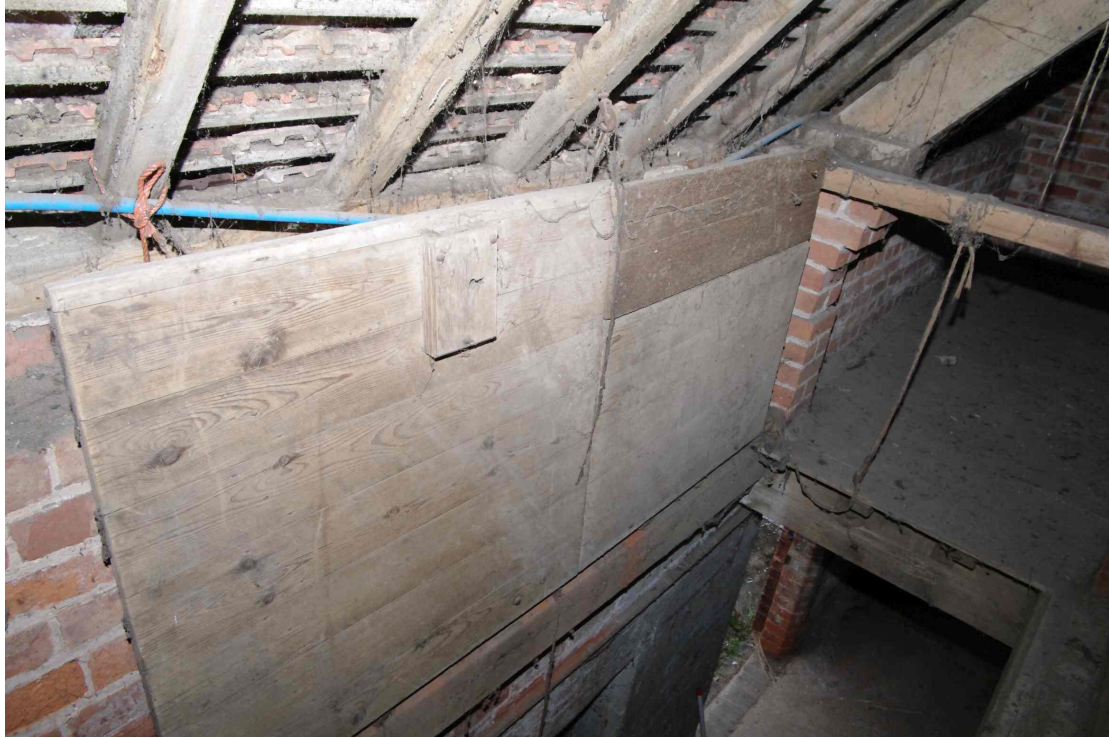
**Figure 35 North barn first floor, stair hatch**  
Looking south-west. The hatch is made from a re-used door which retains its wooden lock case

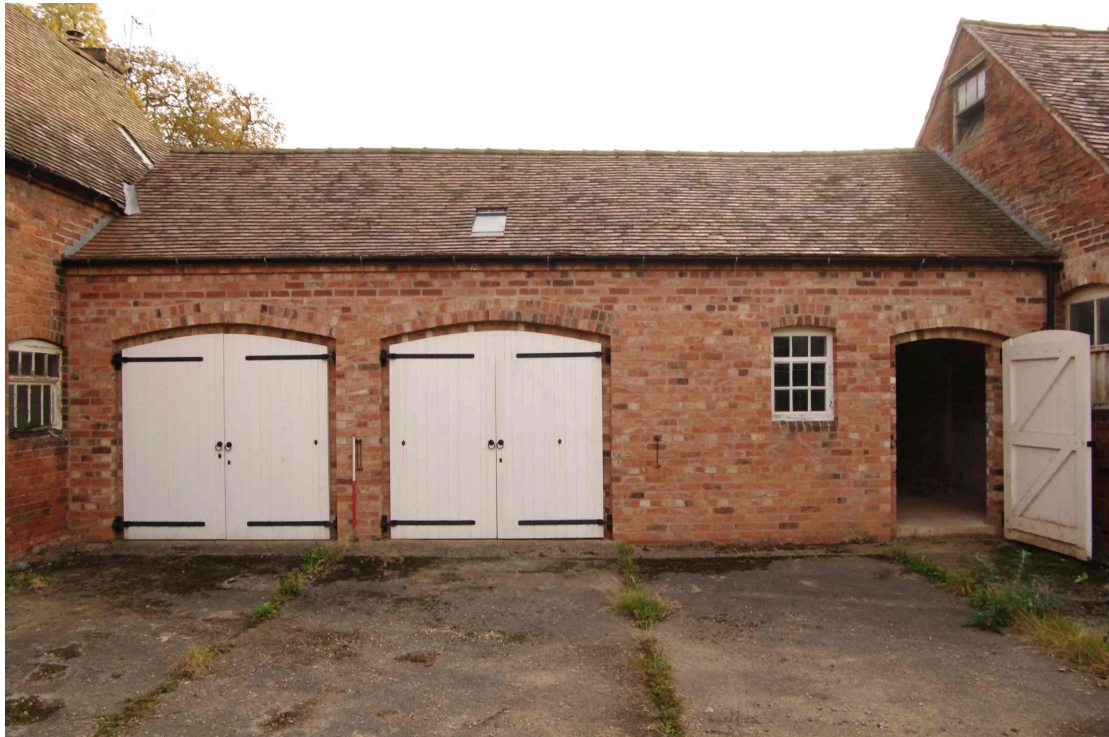
**Figure 36 Middle barn, west facing elevation**  
Looking east. 1m scale. This wall has recently been rebuilt but appears to follow the earlier wall line and has used old bricks. It is not known if the doors and windows follow an earlier layout. The woodwork is all modern

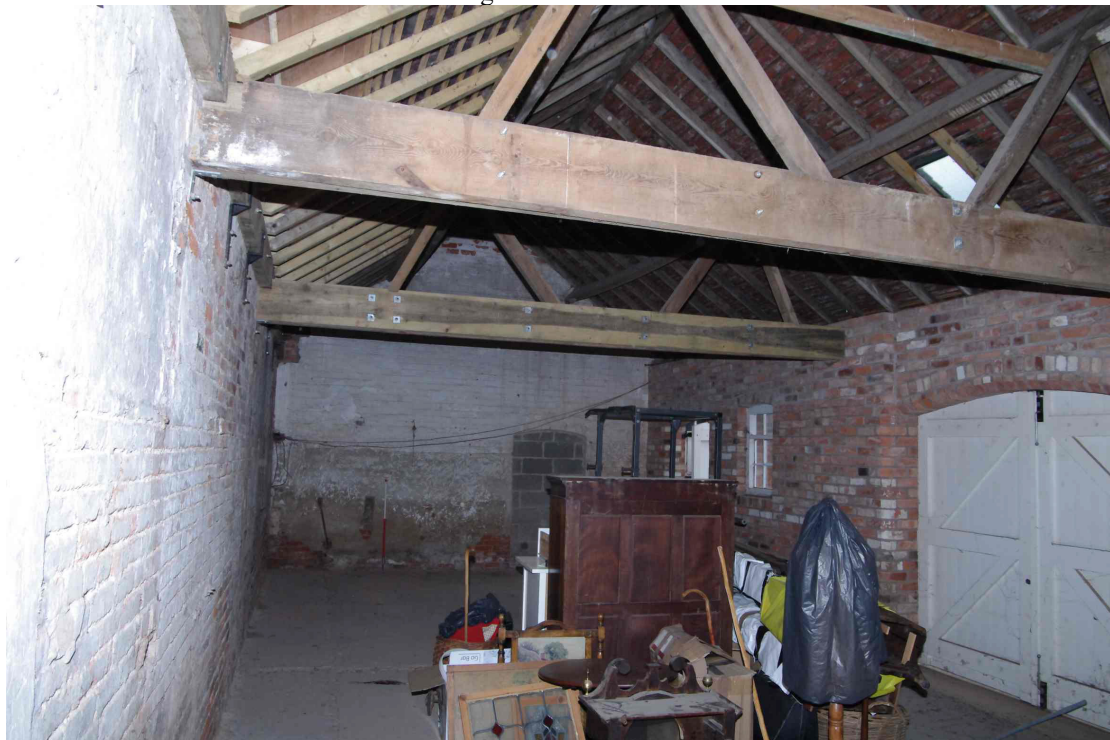
Figure 38 Inside the middle barn  
Looking south-west. Only the west wall (on right) appears to have been rebuilt along with the roof structure. Note blocked door to south barn on end wall

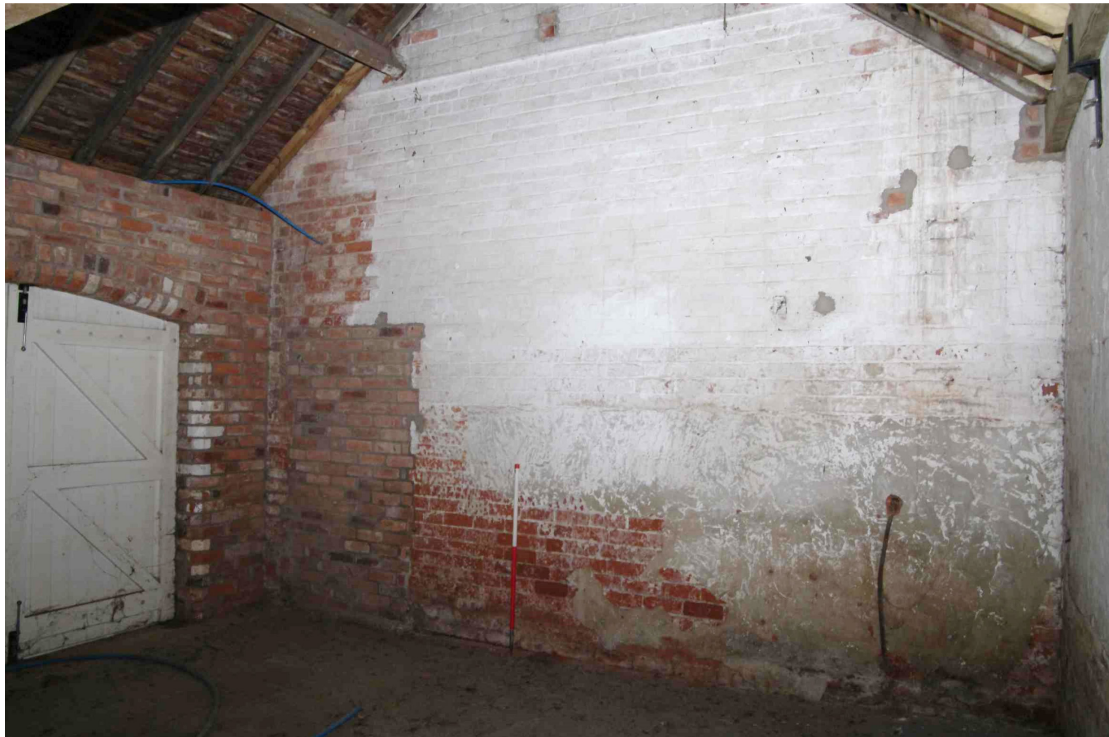
Figure 39 Middle barn north end wall

Looking north-west. The blocked doorway to the left of the 1m scale is also shown in Figure 29

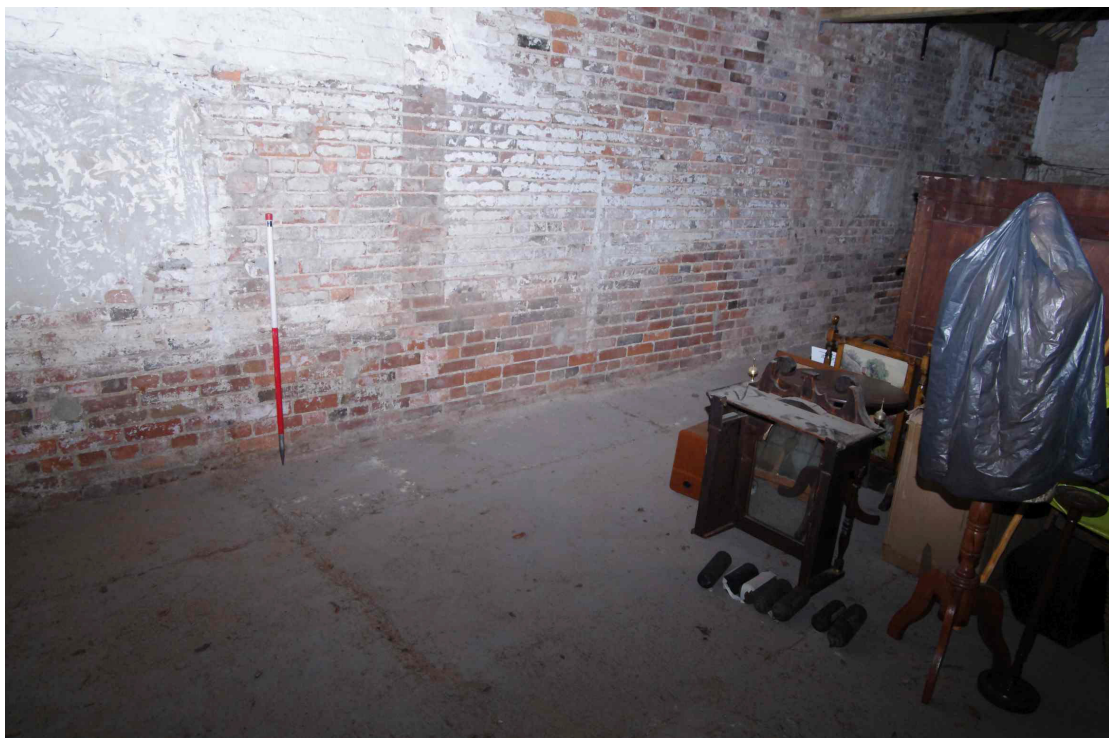
Figure 40 Middle barn east wall

Showing traces of loose box or similar dividing bays on the wall and floor

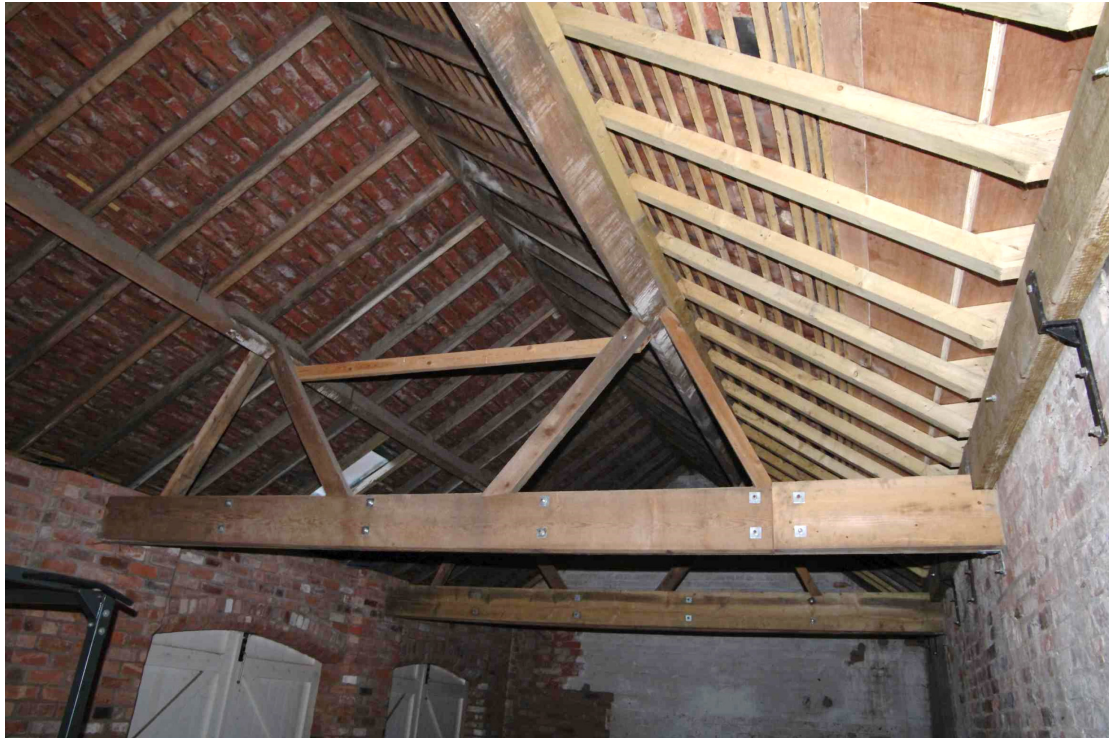
**Figure 41 Middle barn roof structure**

The roof structure is modern and added before the client became the owner

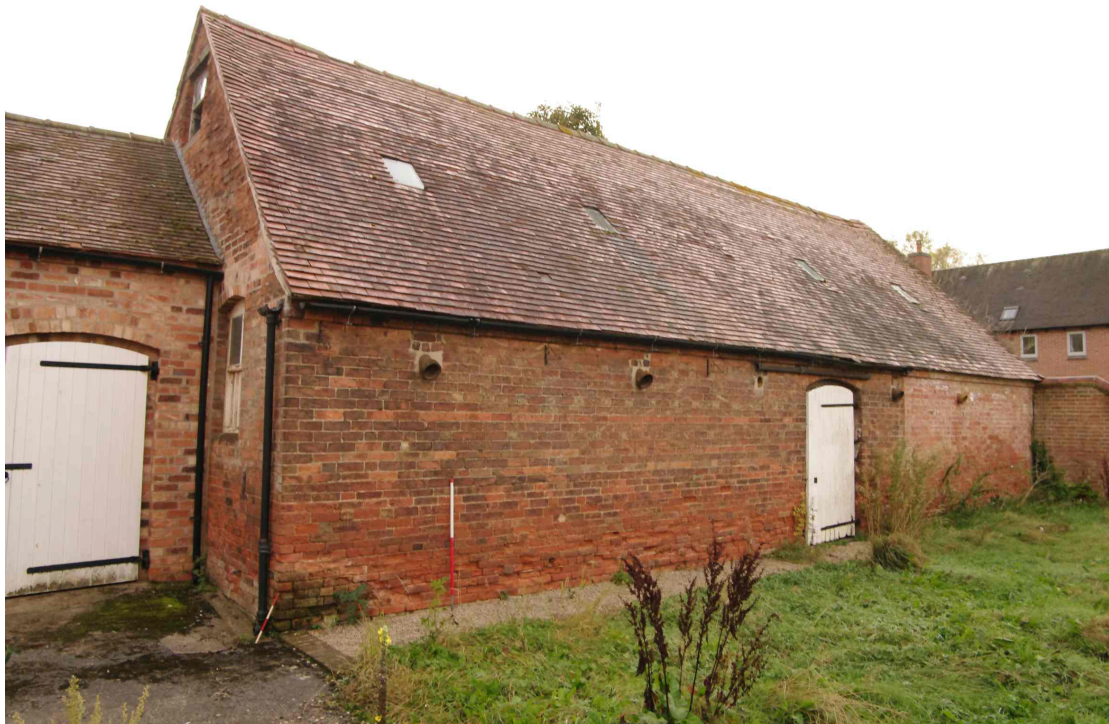
**Figure 42 West facing elevation of the south barn**

Looking south-east. 1m scale. Middle barn on left. The pale brickwork at the right hand end shows where a lean-to structure was located

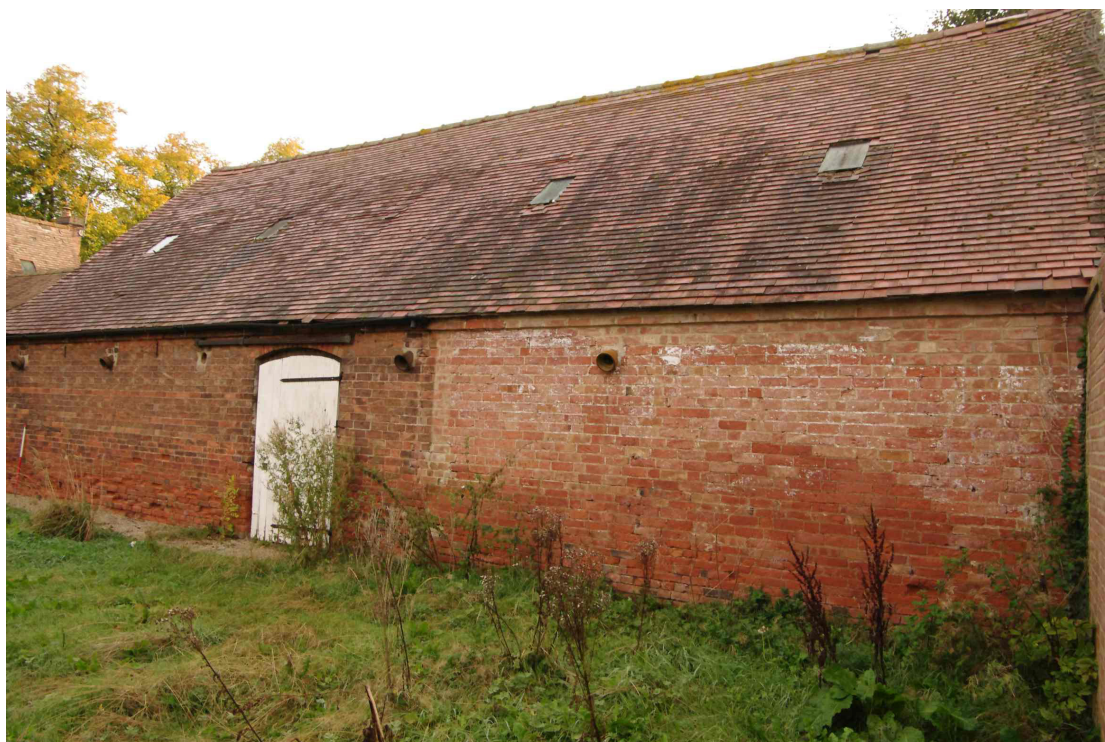
**Figure 43 West facing elevation of the south barn**  
Looking north-east. 1m scale. The wall on the extreme right of the picture is a modern wall built along the edge of the brook

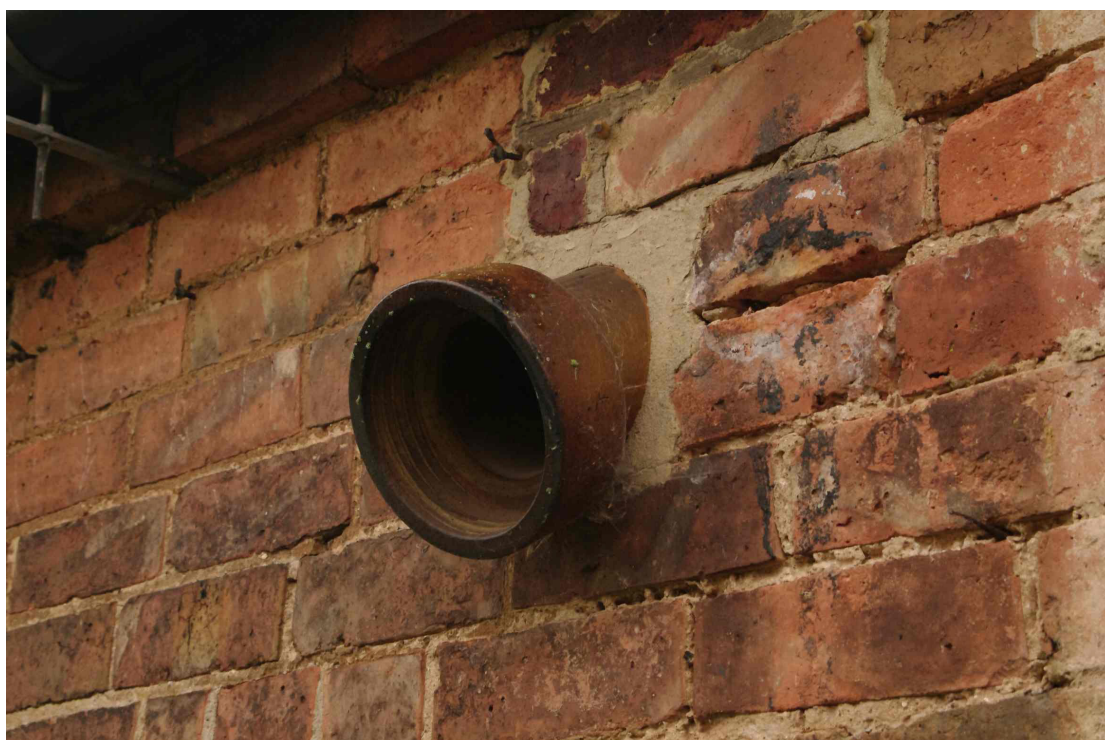
**Figure 44 West facing elevation of the south barn. Vent detail**  
The vents are made from ceramic drain sections and are likely to be mid to late 20th century replacements

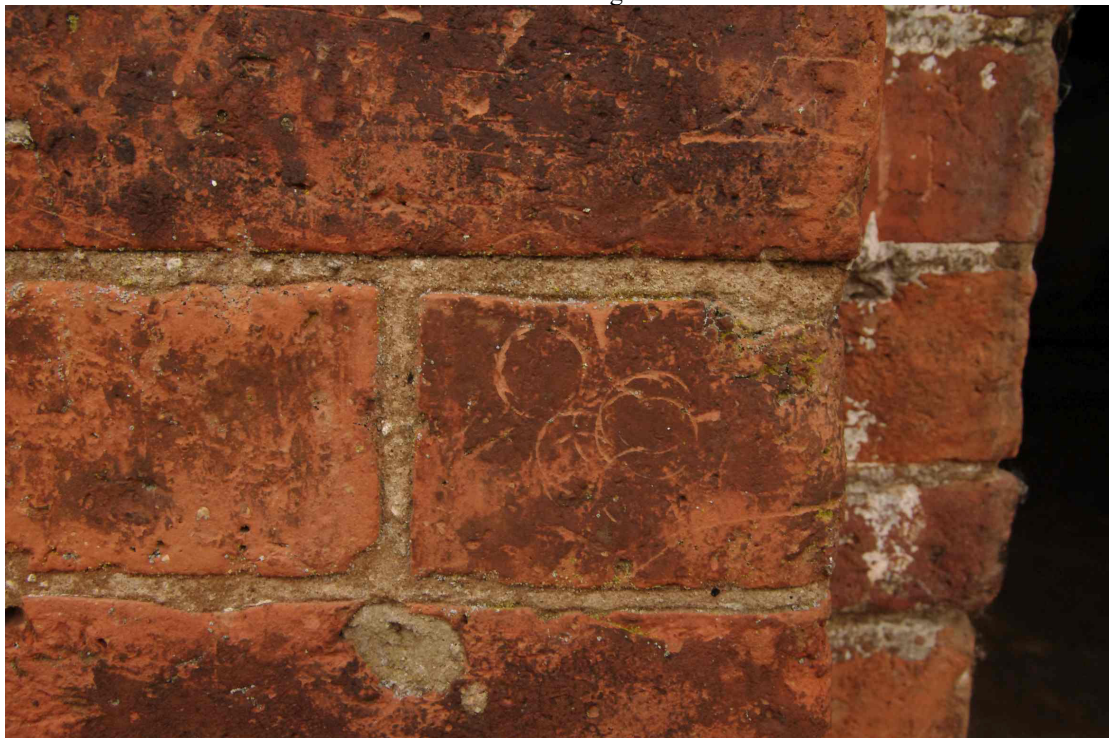
Figure 46 Possible apotropaic marks to left of doorway

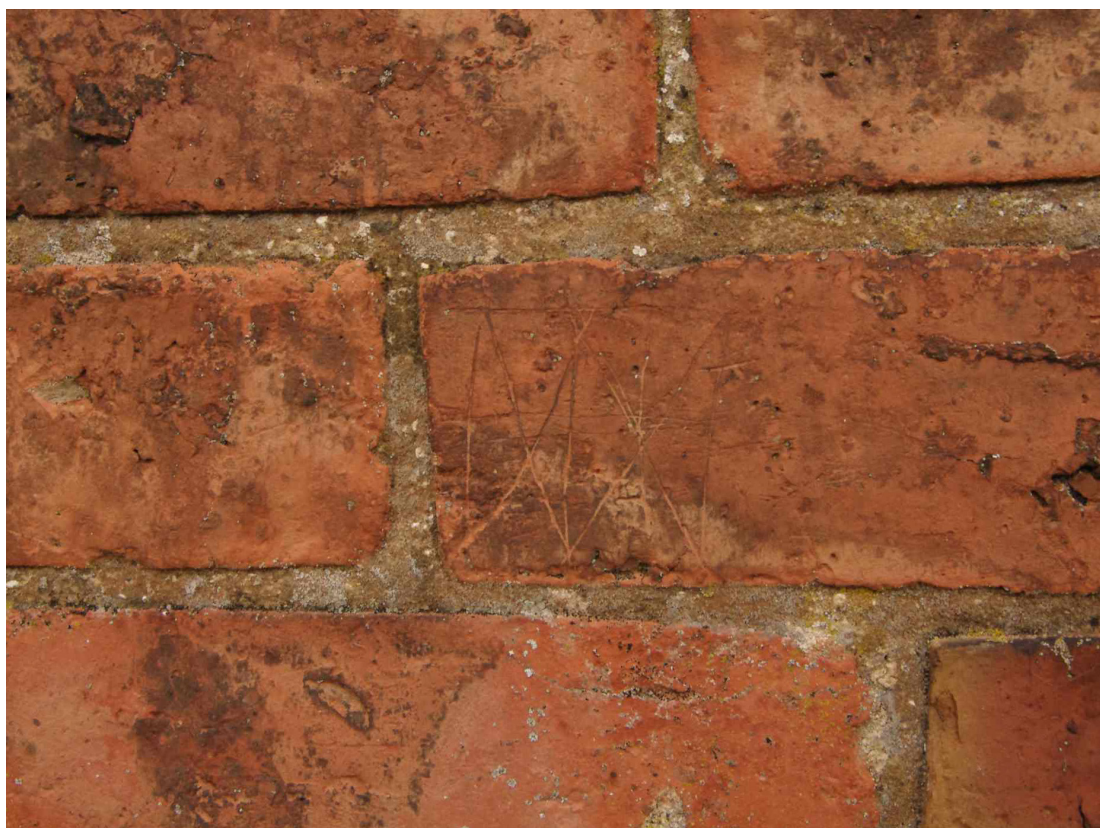
Figure 47 Possible apotropaic mark on west facing elevation  
Located approximately midway between the doorway and the north-west corner of the barn

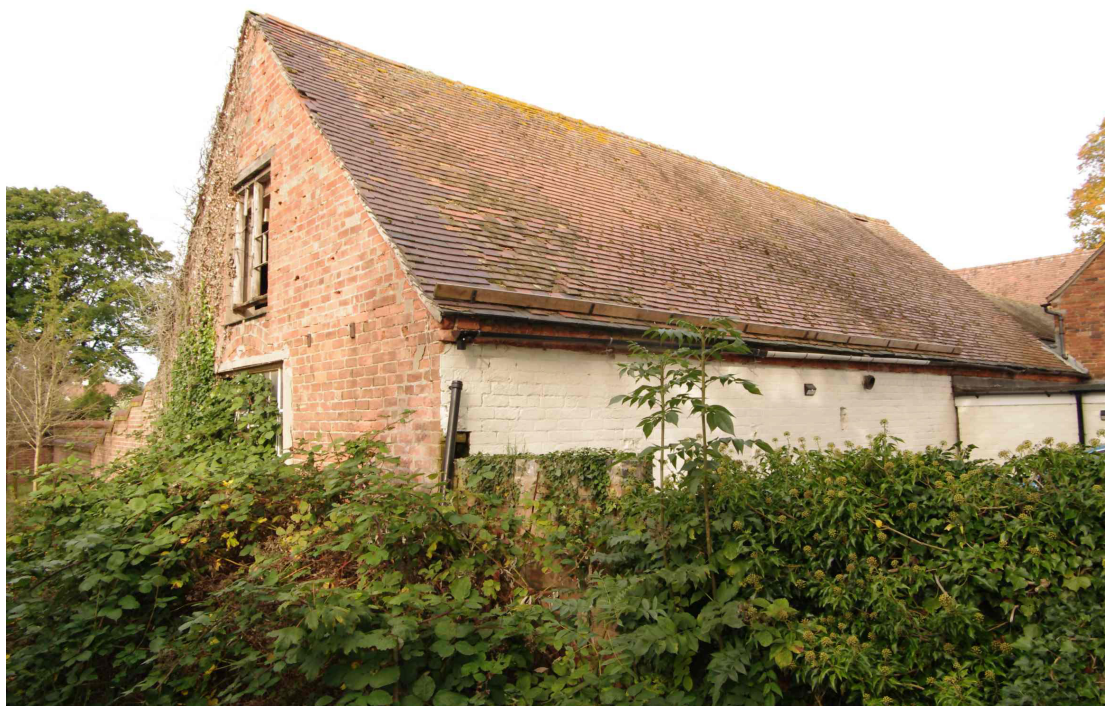
**Figure 49** South barn, south facing gable end and east elevation

Looking north-west from across the brook. Note that the ground floor window appears to have been opened up from a smaller arched doorway or window
