**A Level 2 Historic Building Survey at  
Limes Farmhouse Barns,  
22 Main Street,  
Breedon on the Hill,  
Leicestershire  
NGR: SK 40569 22848**

**ULAS Report No 2021-156  
©2021**

**Site Name:** Limes Farmhouse Barns, 22 Main Street, Breedon on the Hill, Leicestershire.

**Author:** Andrew Hyam

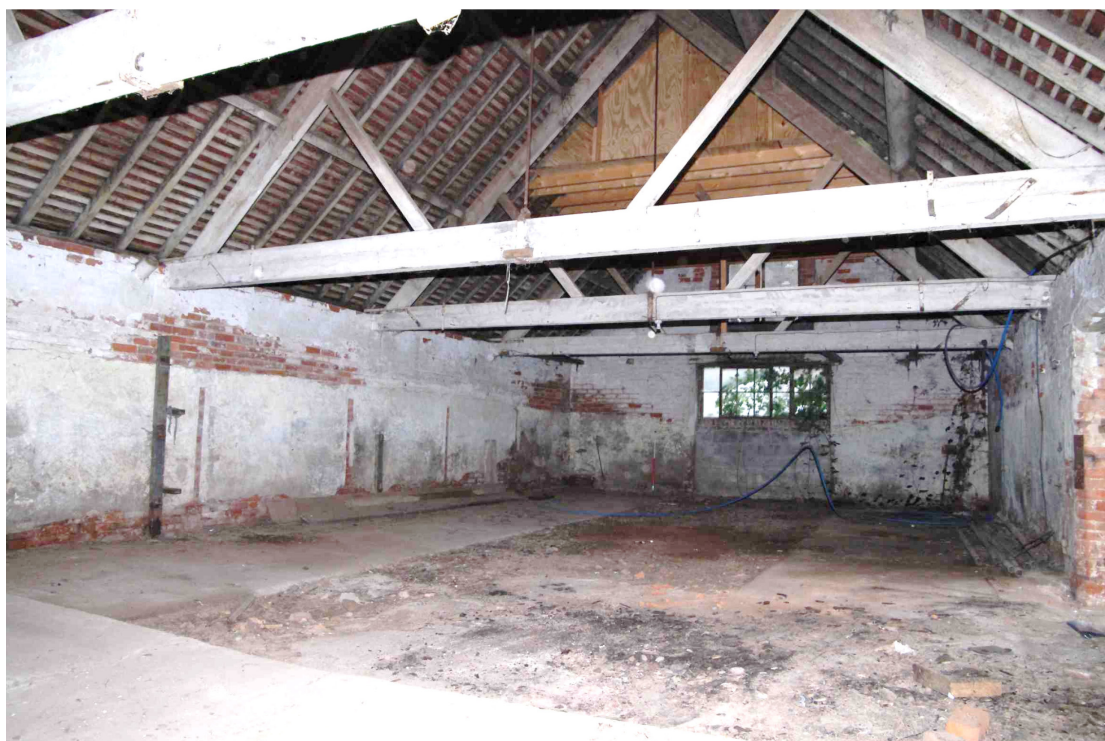
**Figure 50** South barn, general view

Looking south-east towards south end wall. Note the slightly raised concrete floor around the edges of the barn for bays or loose box type structures

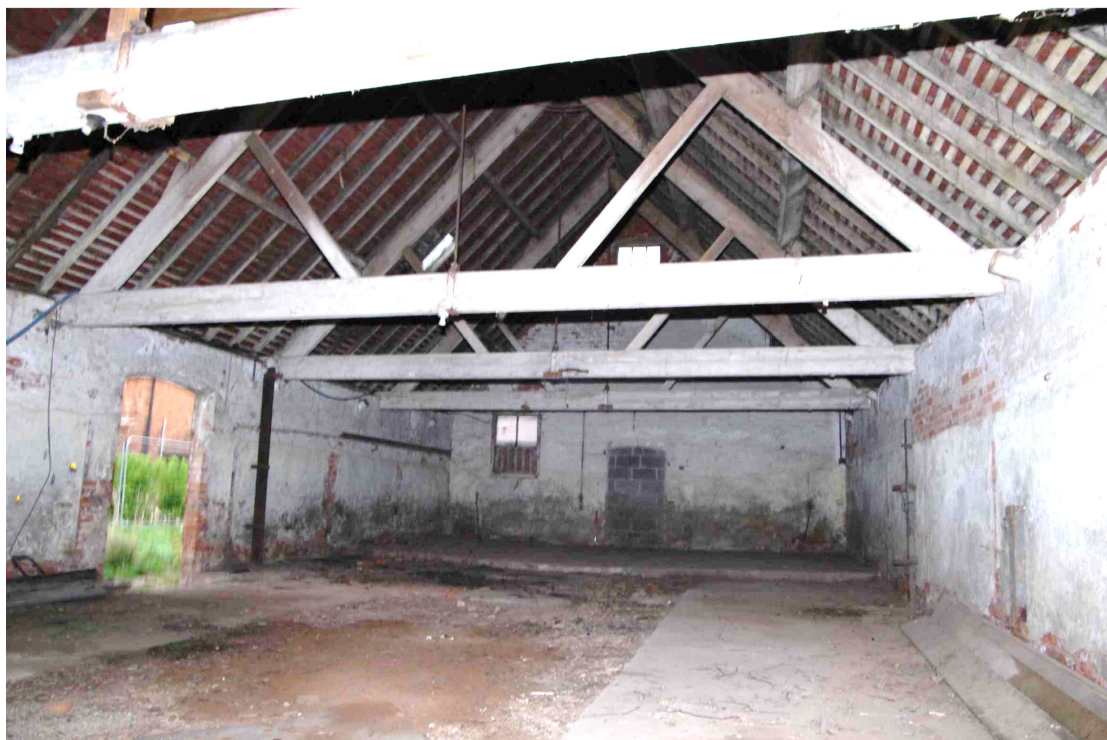
Figure 51 South barn, general view

Looking north-west. Note the blocked doorway on the north wall which is also shown in Figure 38

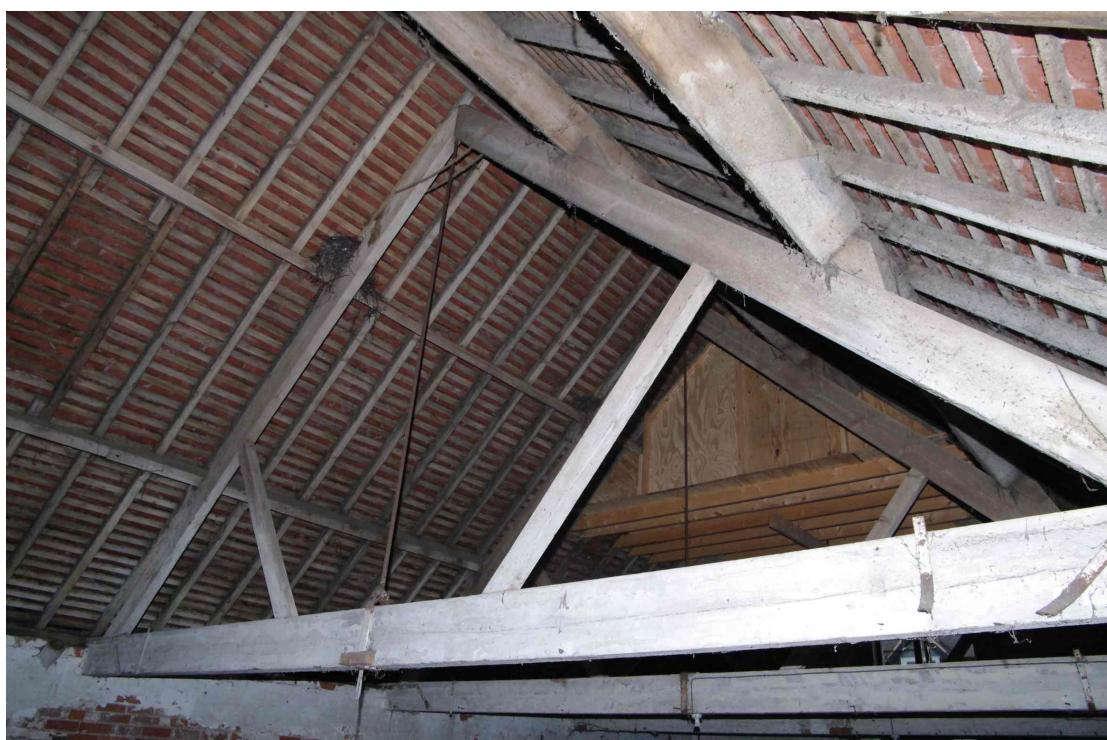
Figure 52 South barn roof structure

Looking south-east. The bolted joints with metal stirrups suggests a later 19th or early 20th century construction date. The modern timber box in the roof apex is a large modern bat roost

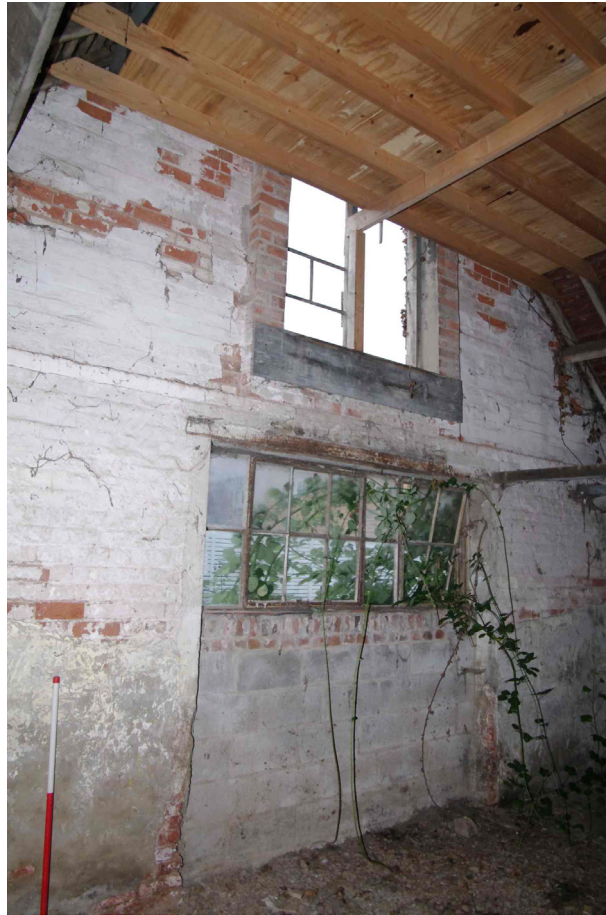
Figure 53 South barn, southern end wall

Looking south-east. 1m scale. Both windows appear to have undergone modification (see also Figure 49). The modern timberwork cutting across the upper window is the bat roost

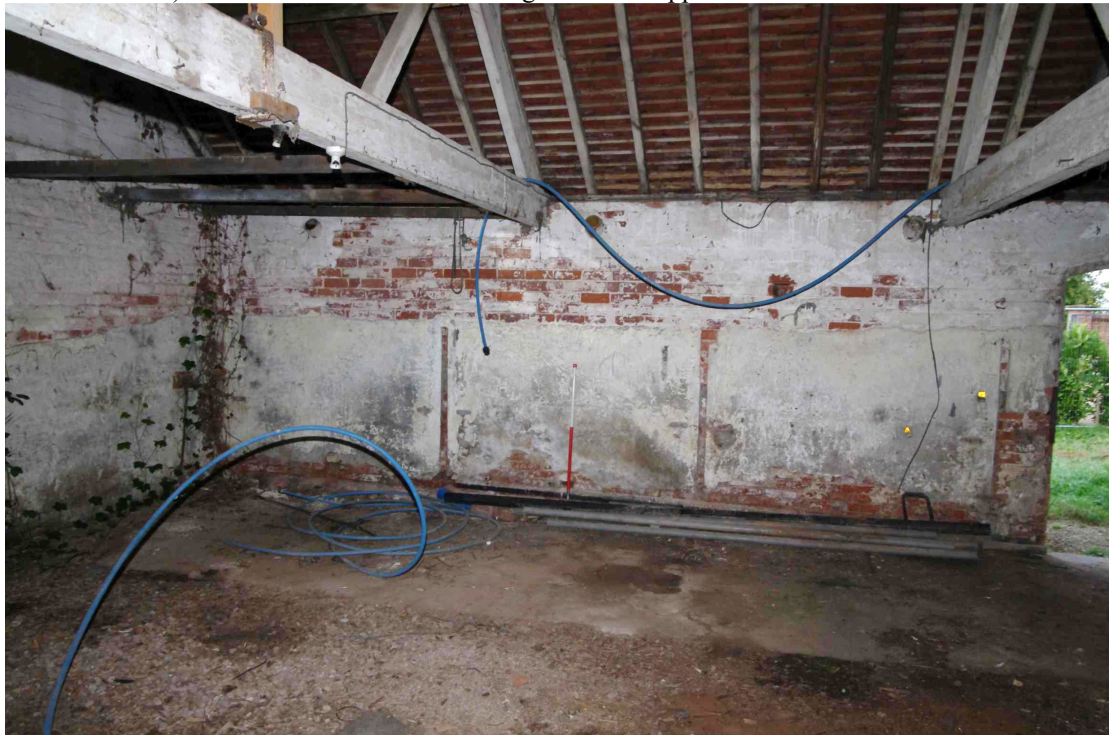
Figure 54 South barn, west wall

Looking west. 1m scale. The location of dividing bays can be seen all around the barn walls
