**A Level 2 Historic Building Survey at
Winfrey Farm,
Dadlington Lane,
Stapleton,
Leicestershire
NGR: SP 4234 9844**

Client: David Granger Architectural Design Limited

ULAS Report Number: 2021-158

A Level 2 historic building survey at Winfrey Farm, Dadlington Lane, Stapleton, Leicestershire (SP 4234 9844)

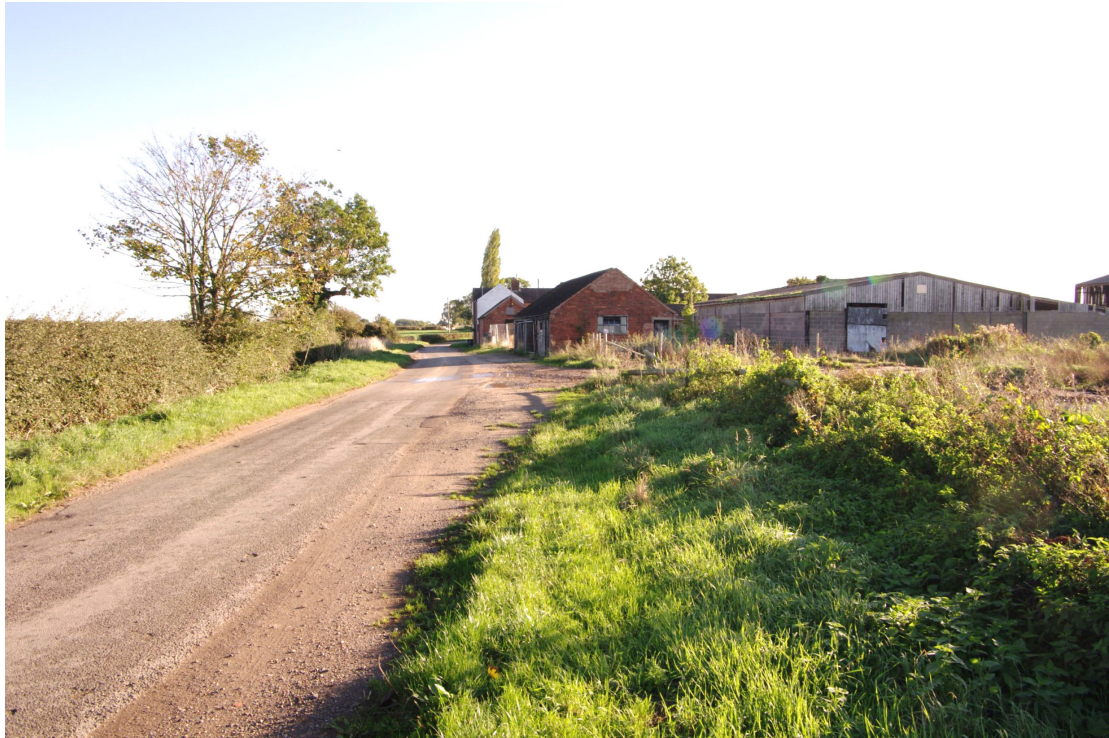
Figure 5 Winfrey Farm from Dadlington Lane
Looking east

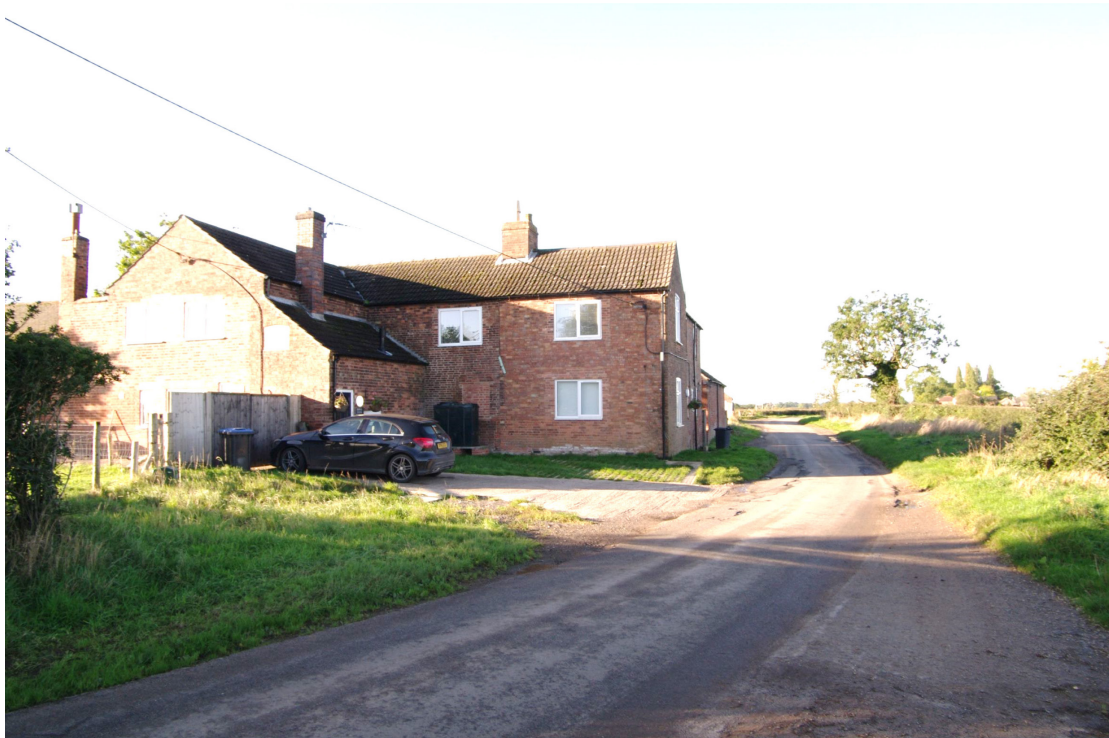
Figure 6 Lodge Farm from Dadlington Lane
Looking west. Winfrey Farm buildings are behind Lodge Farm

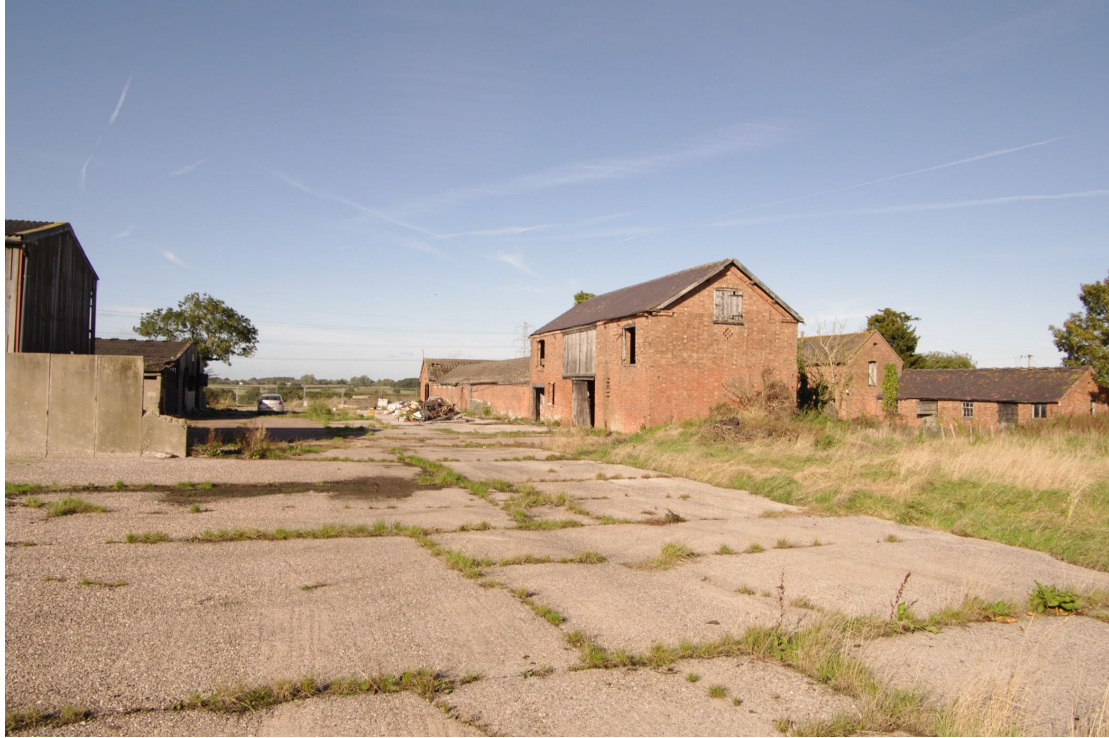
Figure 7 Winfrey Farm site
Looking north. Building 6 in foreground. Modern building 3 on left

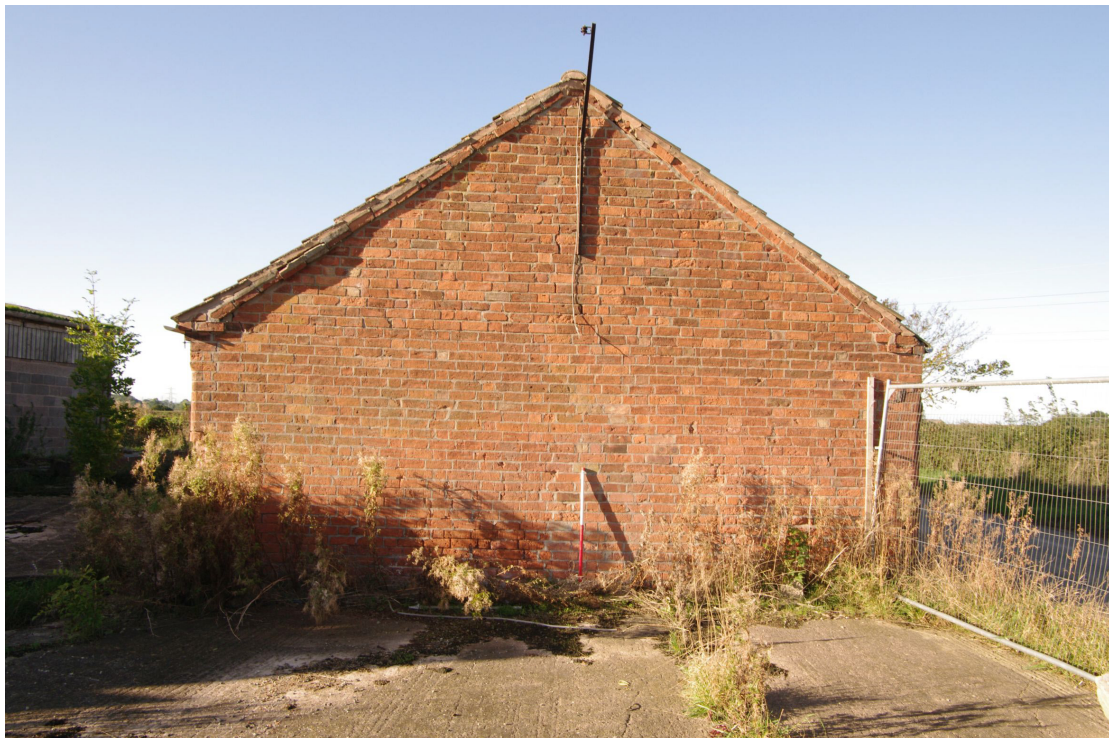
Figure 12 Western gable end of Building 1
Looking south-west. 1m scale

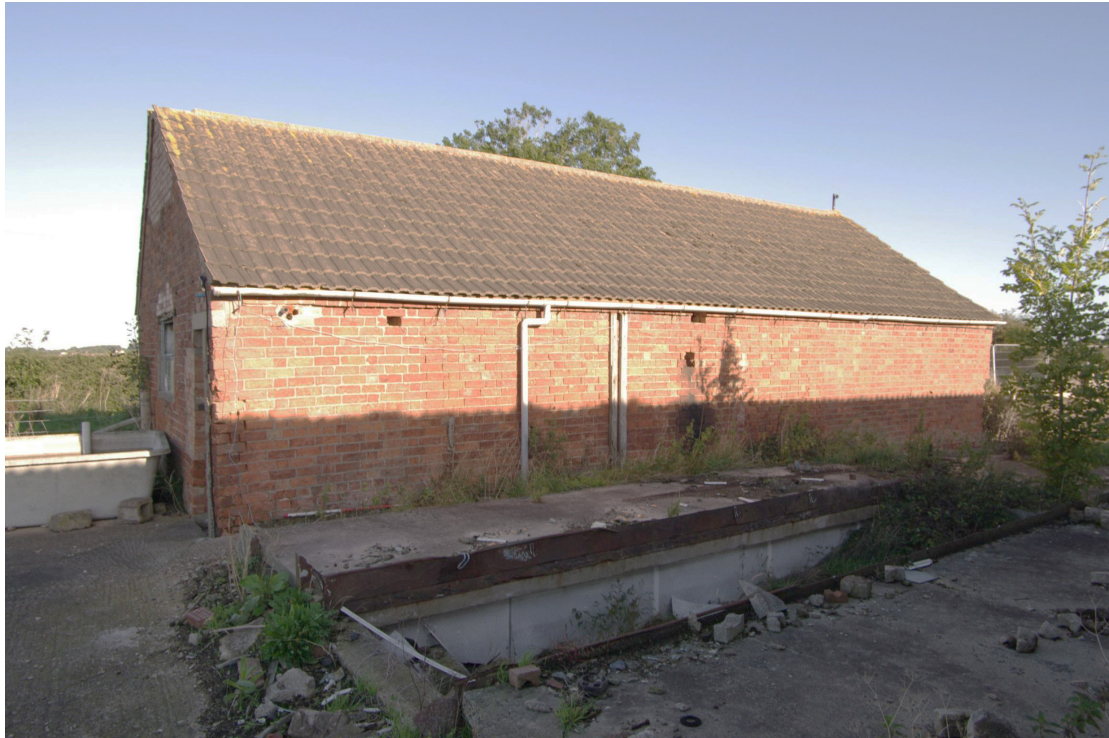
Figure 13 Building 1 south-east facing elevation
Looking north.

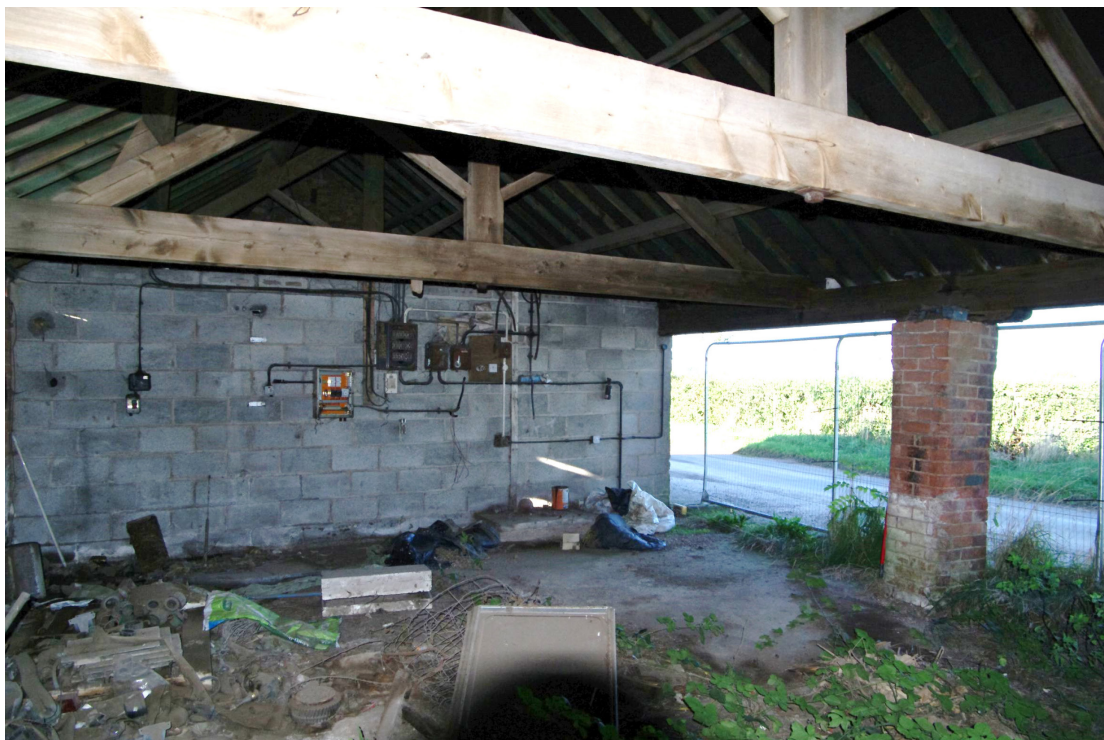
Figure 15 Building 1, internal view
Looking north-west towards modern blockwork

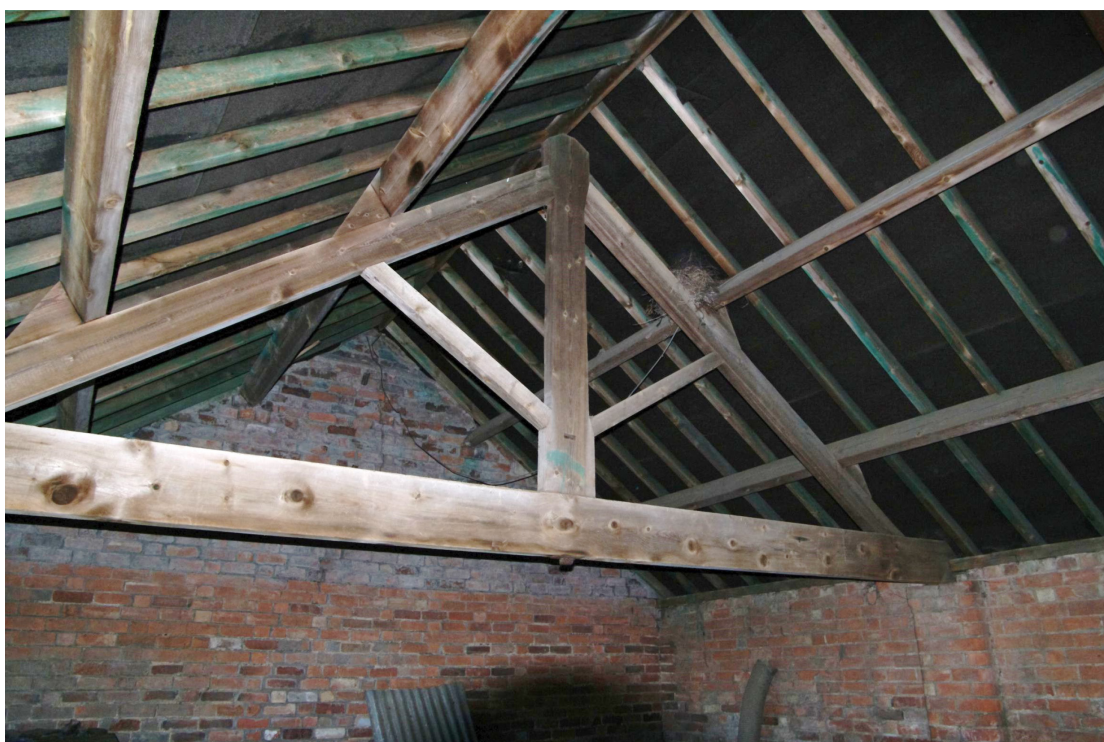
Figure 16 Building 1 roof structure
Looking west. The bolted timbers are typical of late 19th century agricultural structures

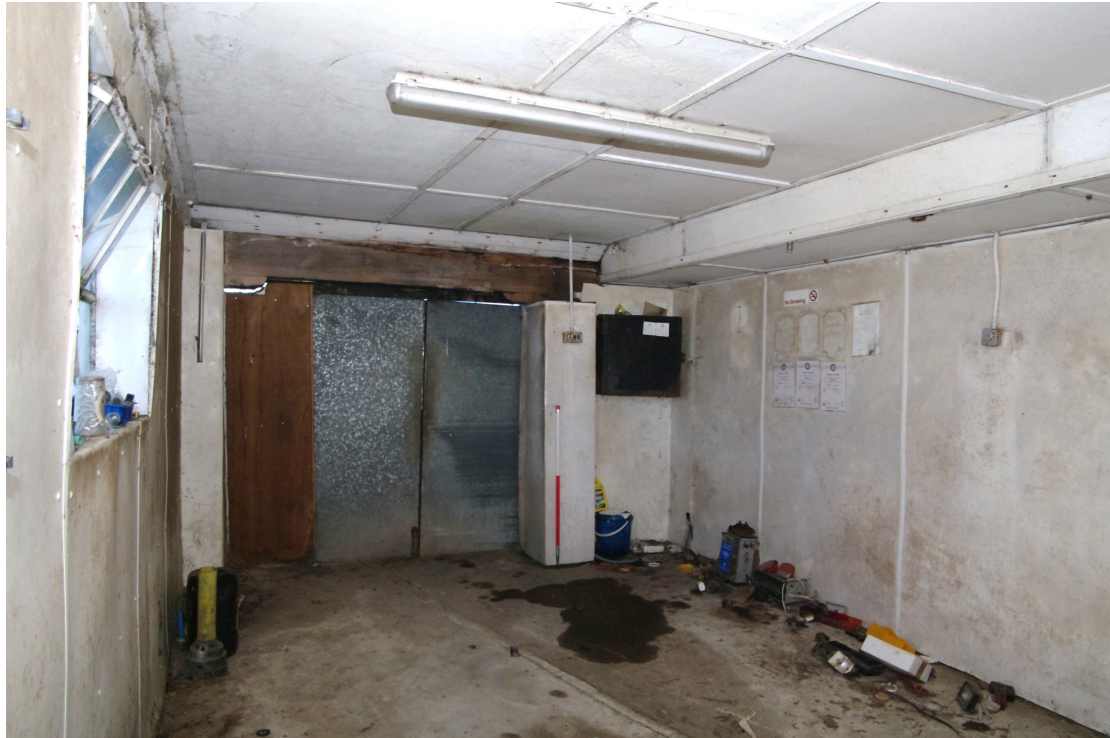
Figure 17 Building 1 side room
Looking north-east. 1m scale. The room has been lined for dairy work

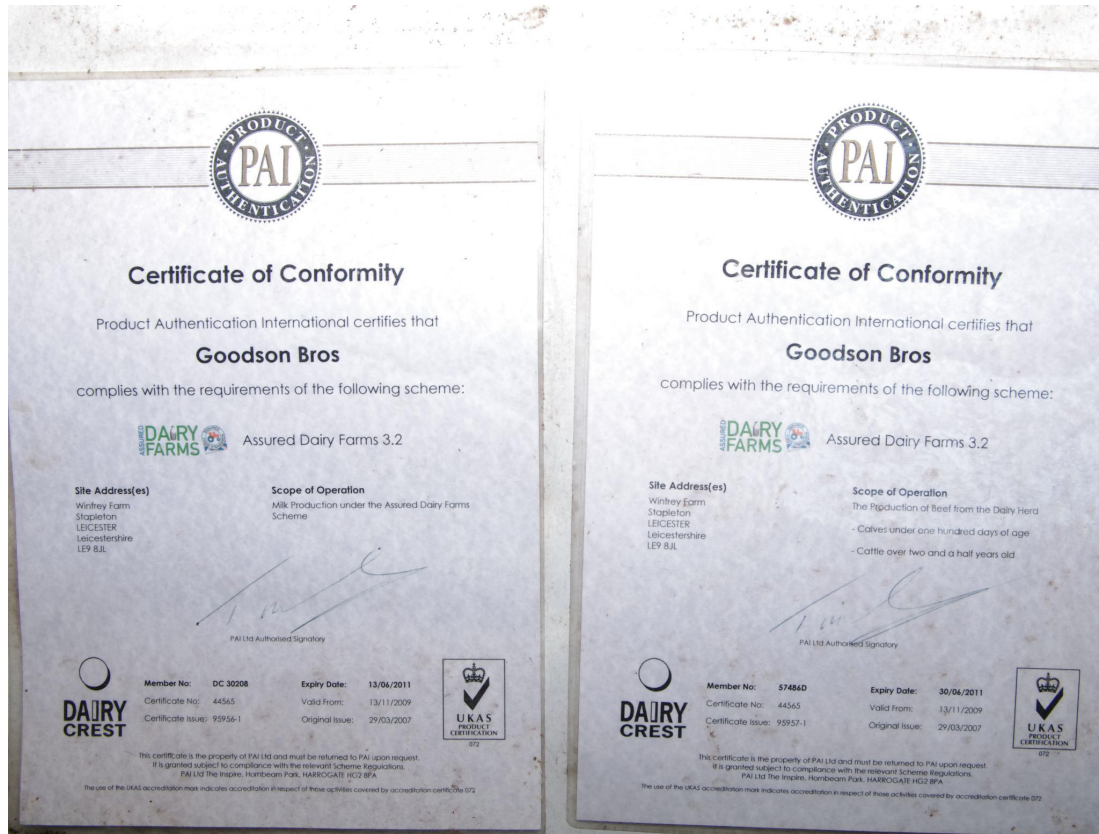
Figure 18 Building 1 side room, dairy certificates
Both certificates expired in 2011

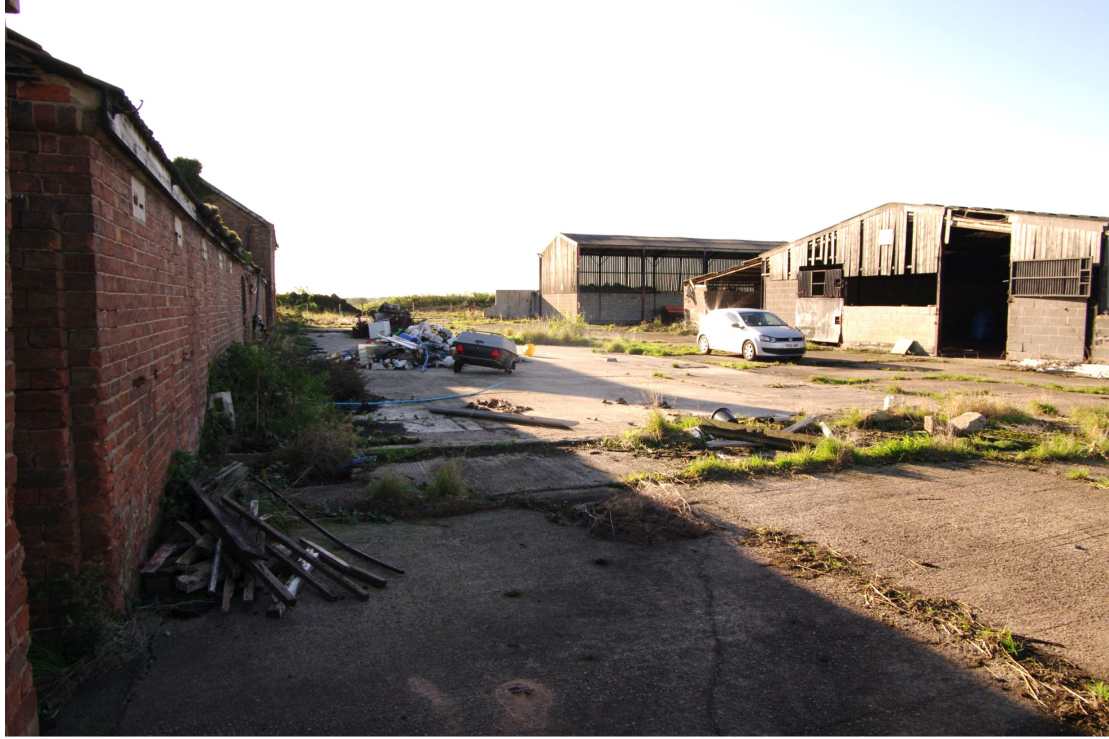
Figure 19 Buildings 2 and 3
Looking south. Building 2 on extreme right, Building 5 on left

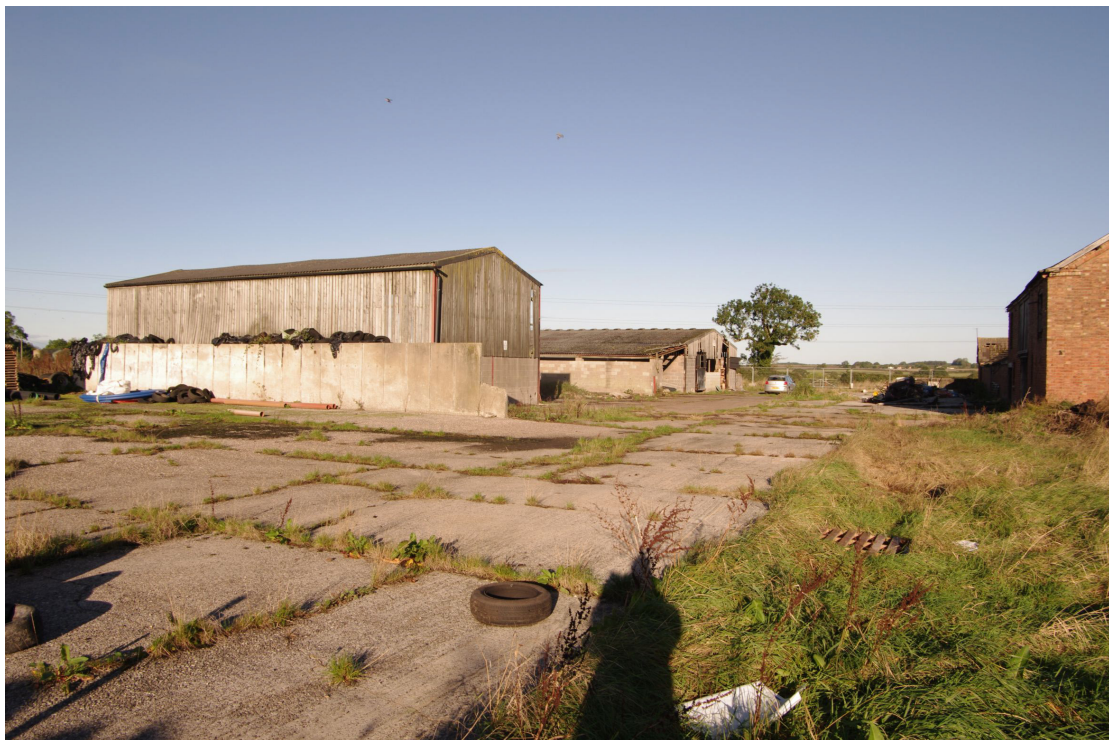
Figure 20 Buildings 2 and 3
Looking north-west. Building 3 on far left, Building 6 on right

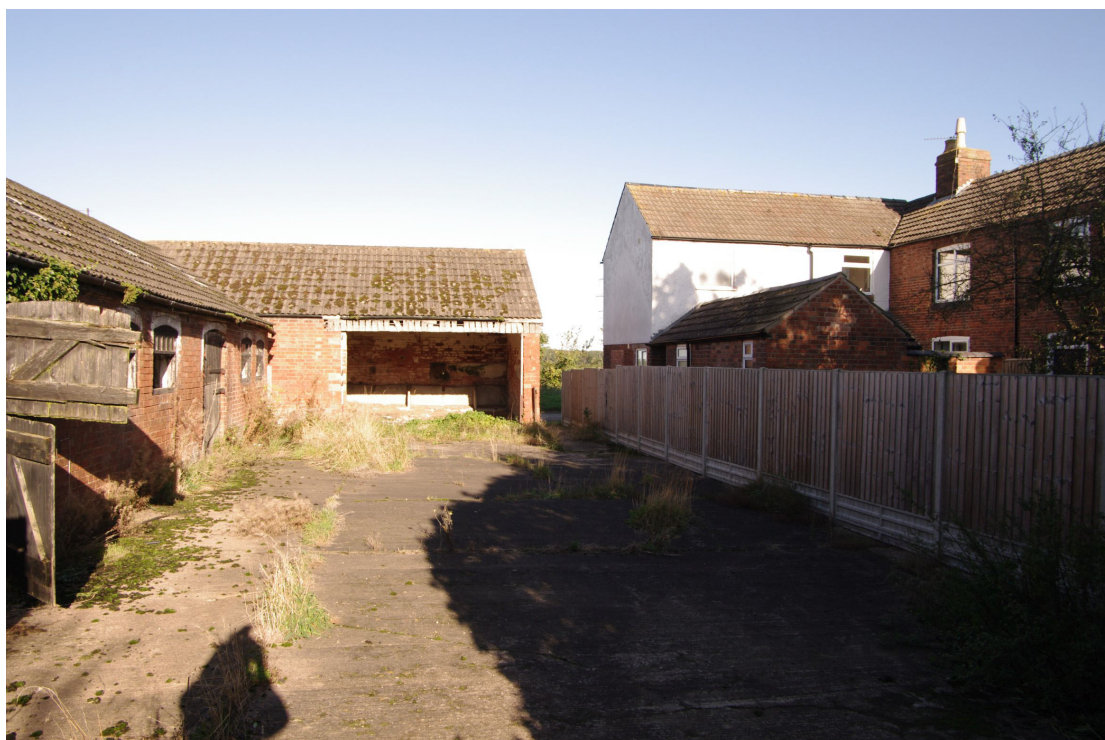
Figure 23 Building 4 south-east facing elevation
Looking north-west. Building 5 on left. Lodge Farmhouse on right. Note how new boundary on right cuts the former yard in half

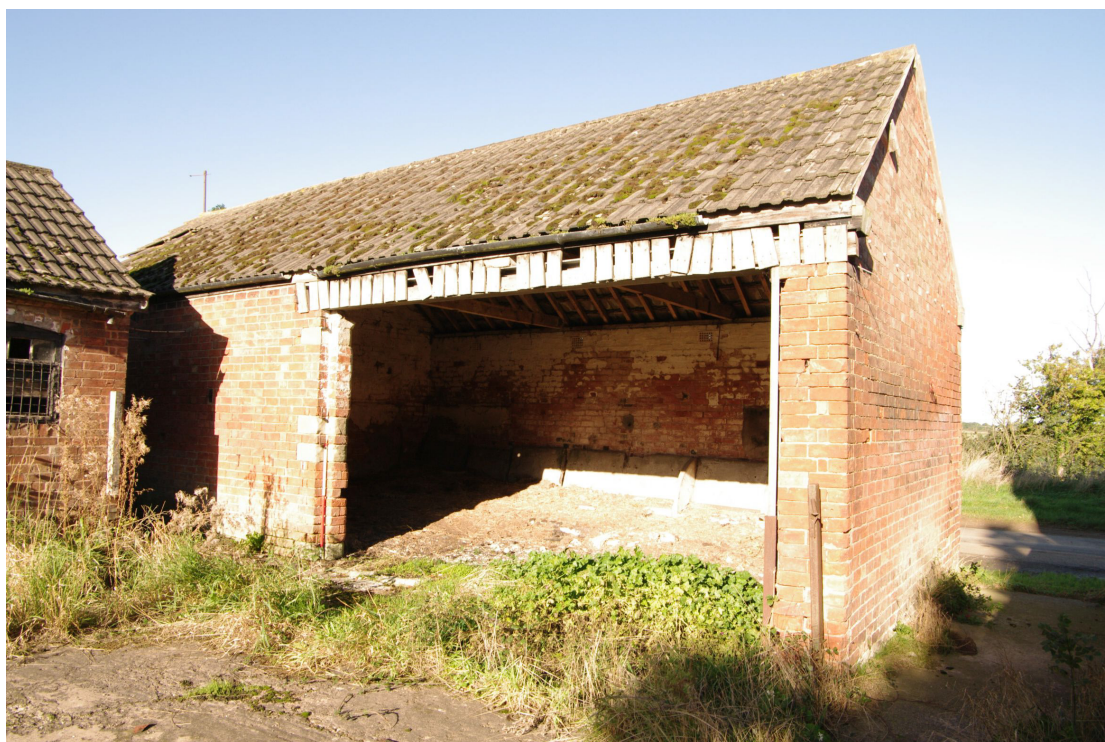
Figure 24 Building 4 south-east facing elevation and north-east gable end
Looking north-west. The purlins extend beyond the gable end showing where they continued across to the farmhouse. Dadlington Lane to right

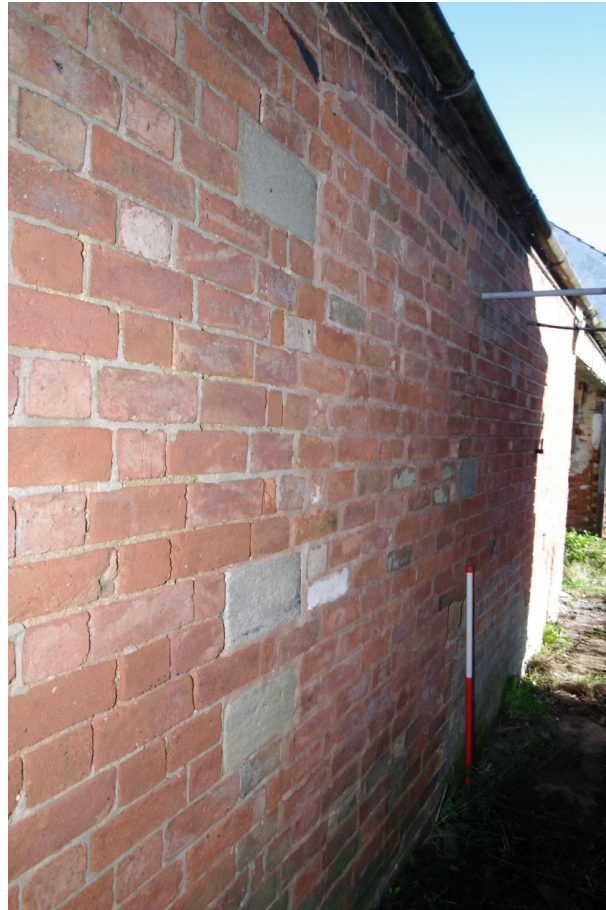
Figure 25 Passageway between Buildings 4 and 5
Looking north-east. Noted bricked up doorway to left of 1m scale, this might suggest that Building 4 (on left) is earlier than building 5 (on right)

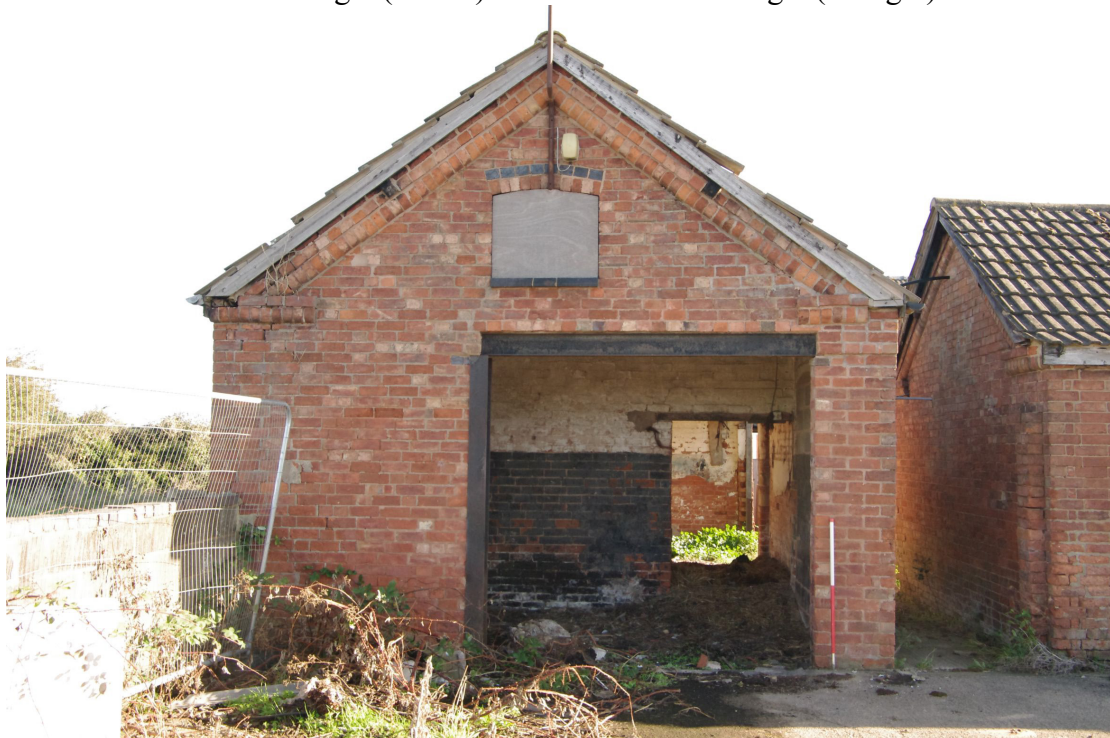
Figure 26 Building 4 south-west facing elevation
Looking north-east. The large opening to the left of the 1m scale is modern and has a steel lintel

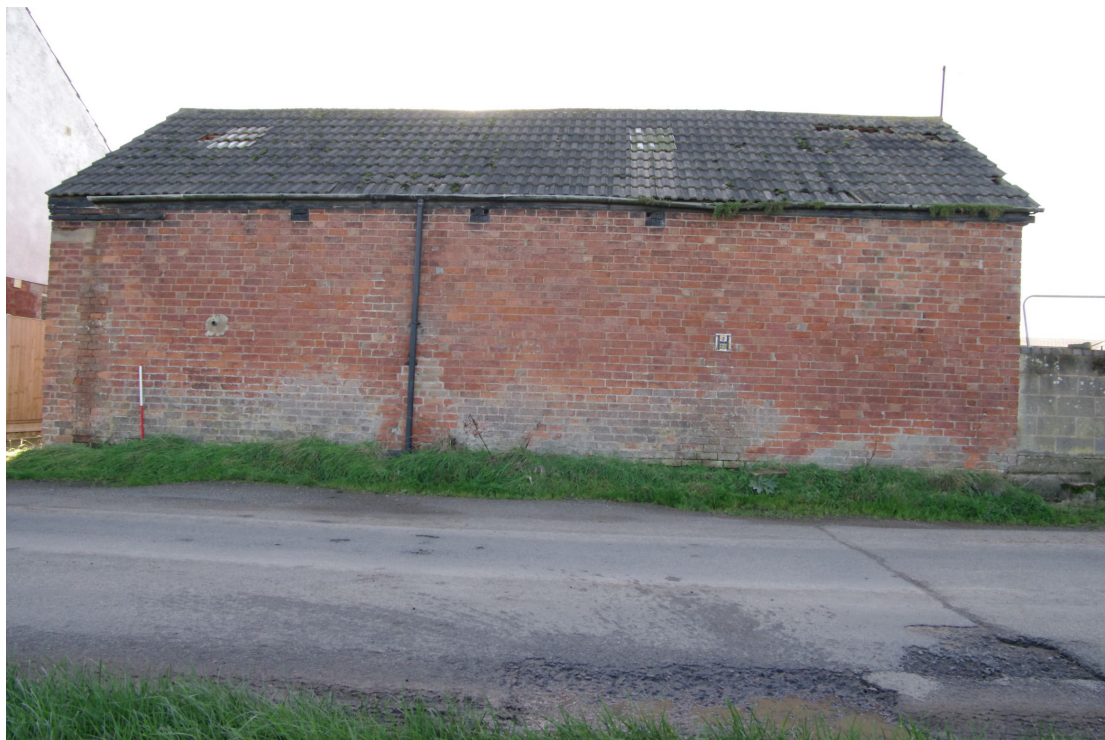
Figure 27 Building 4 north-west facing elevation

Looking south-east across Dadlington Lane. Note the stone block at the top left hand corner. This may be a remnant of the covered area between this building and the farmhouse shown on the OS map in Figure 4 above.

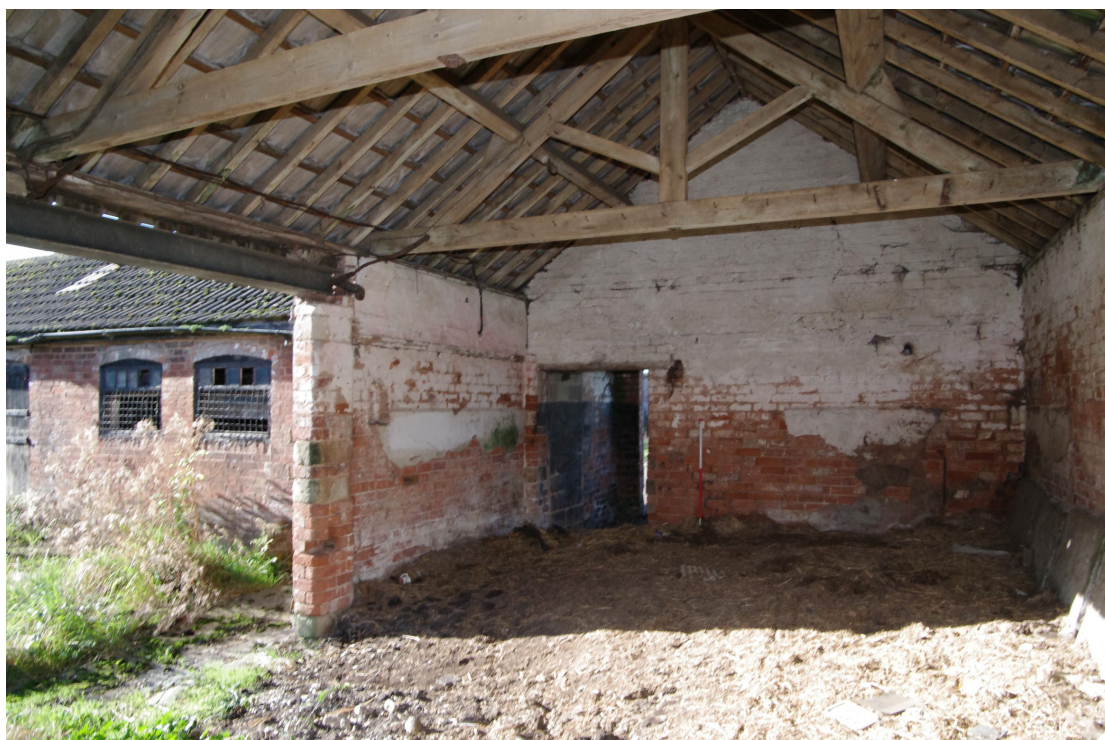
Figure 28 Internal view of Building 4

Looking south-west across the main open space of this building. Note the later 19th century roof structure and modern RSJ lintel. 1m scale. Building 5 on left

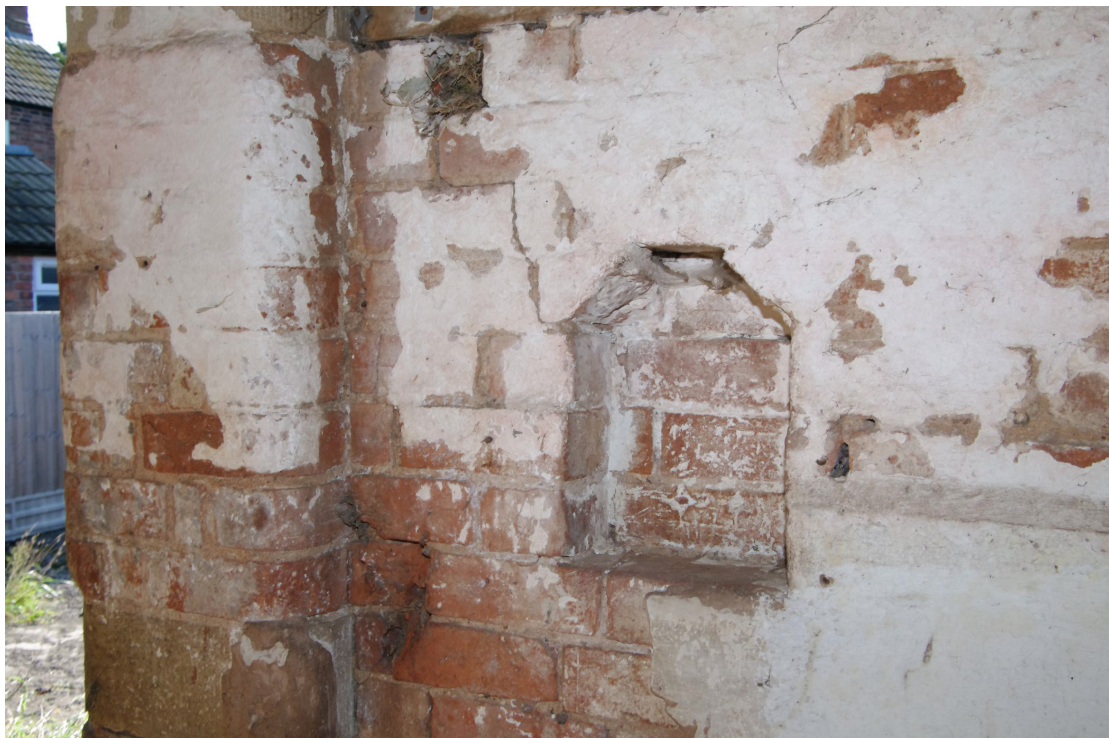
Figure 30 Lamp/candle niche in Building 4
Looking south-east. Main doorway to left

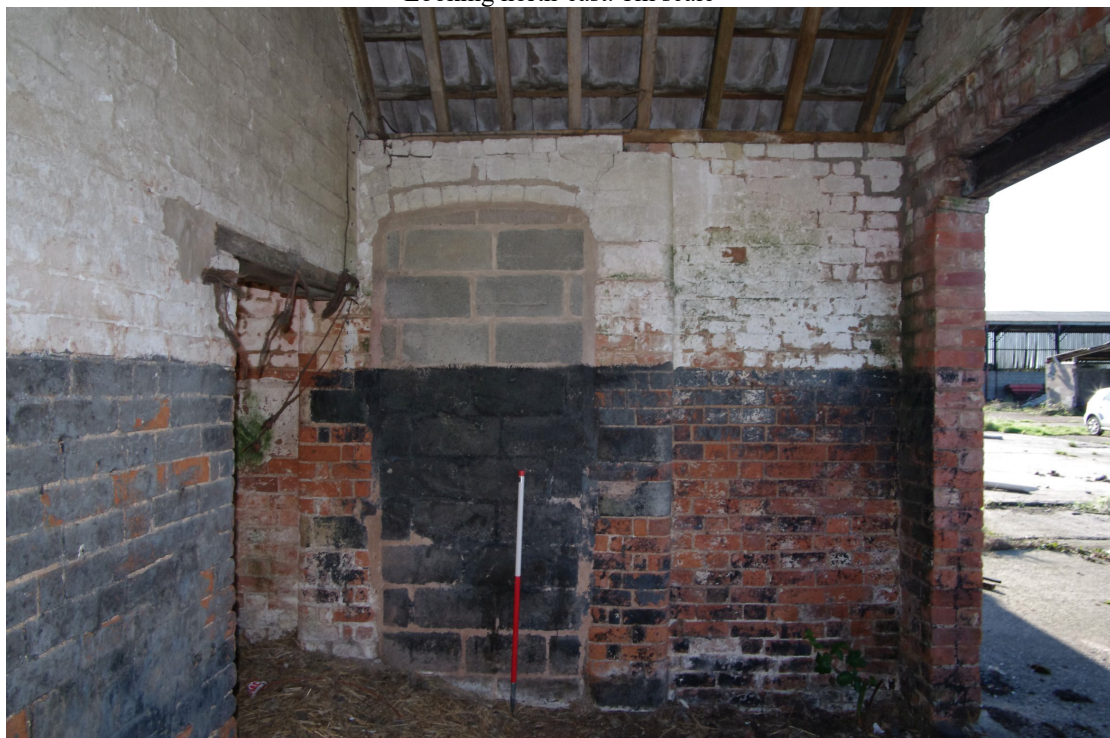
Figure 32 Building 4: western end room
Looking south-east. Blocked doorway (seen in Fig. 25) behind 1m scale. Note modern steel lintel on opening to right

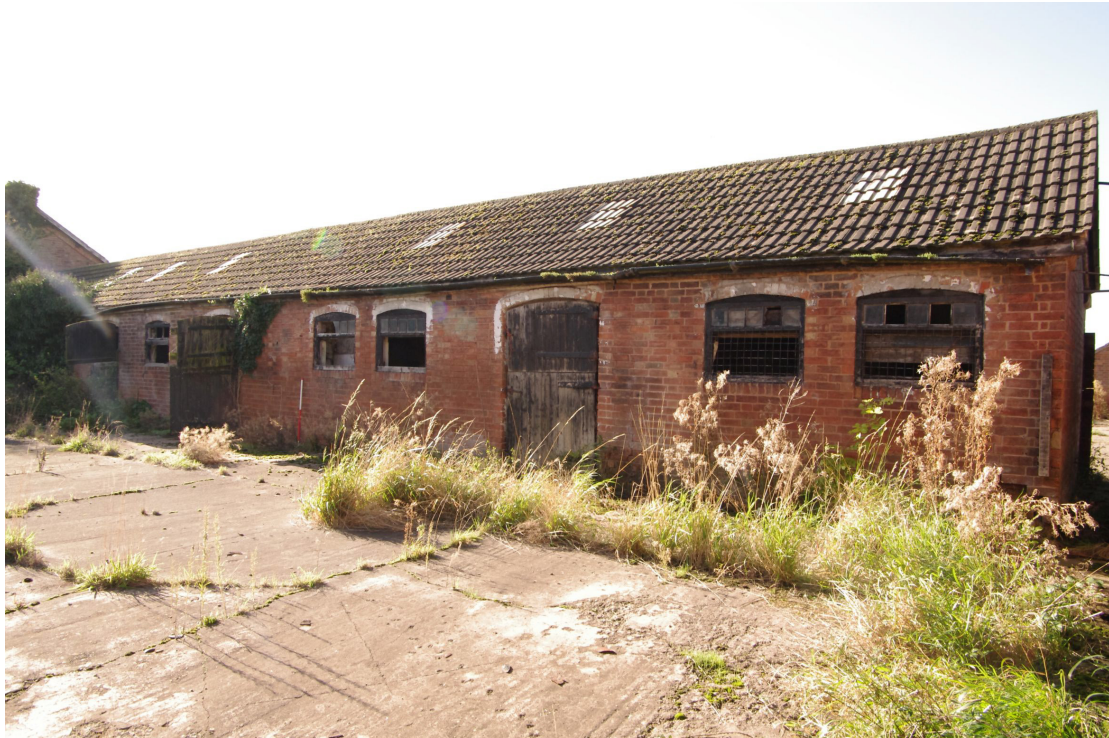
Figure 35 Building 5 north-east facing elevation
Looking south-west. The gable end of Building 6 can be seen on the far left. 1m scale

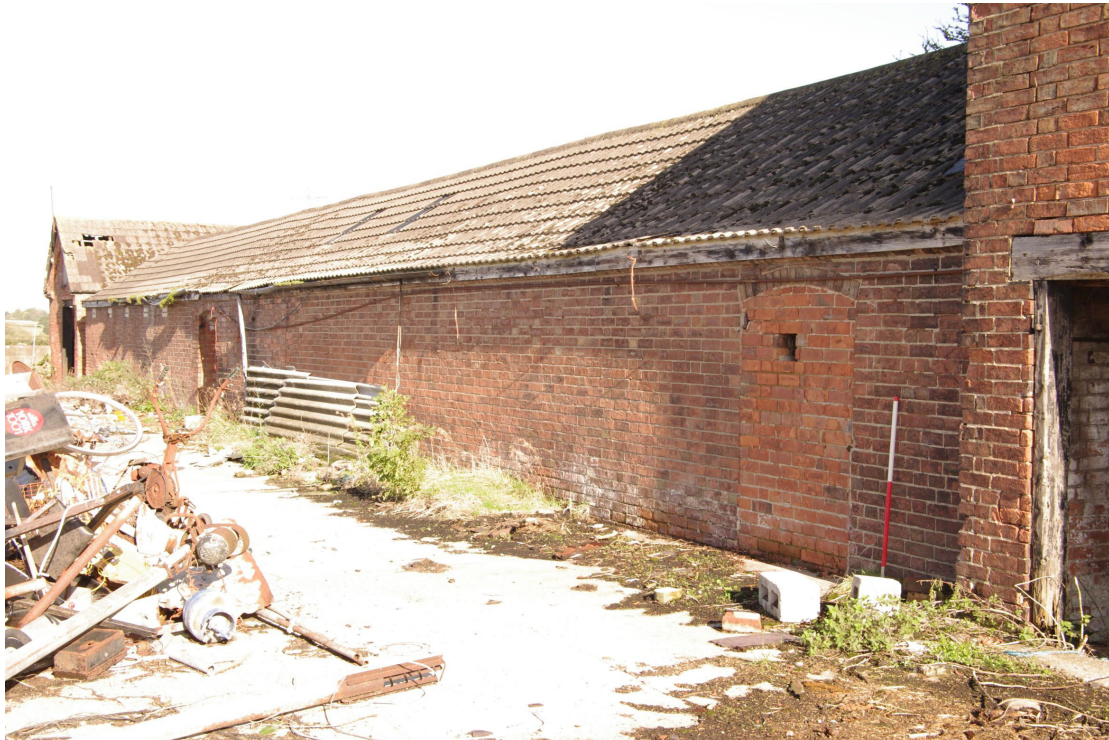
Figure 39 Building 5 south-west facing elevation
Looking north-east. Note blocked doorway to left of 1m scale, one of only two doors on this face

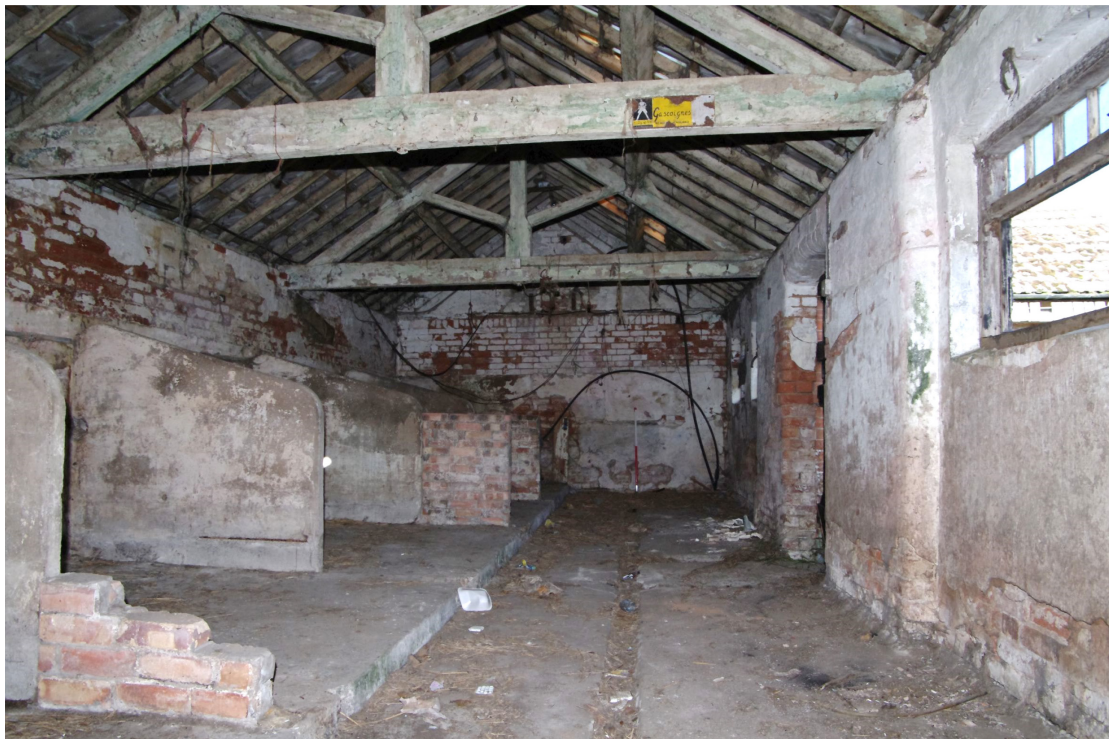
Figure 40 Building 5, northernmost room
Looking north-west. Note concrete stalls, later 19th century roof structure and enamel sign on beam
(see Fig. 41 below). 1m scale

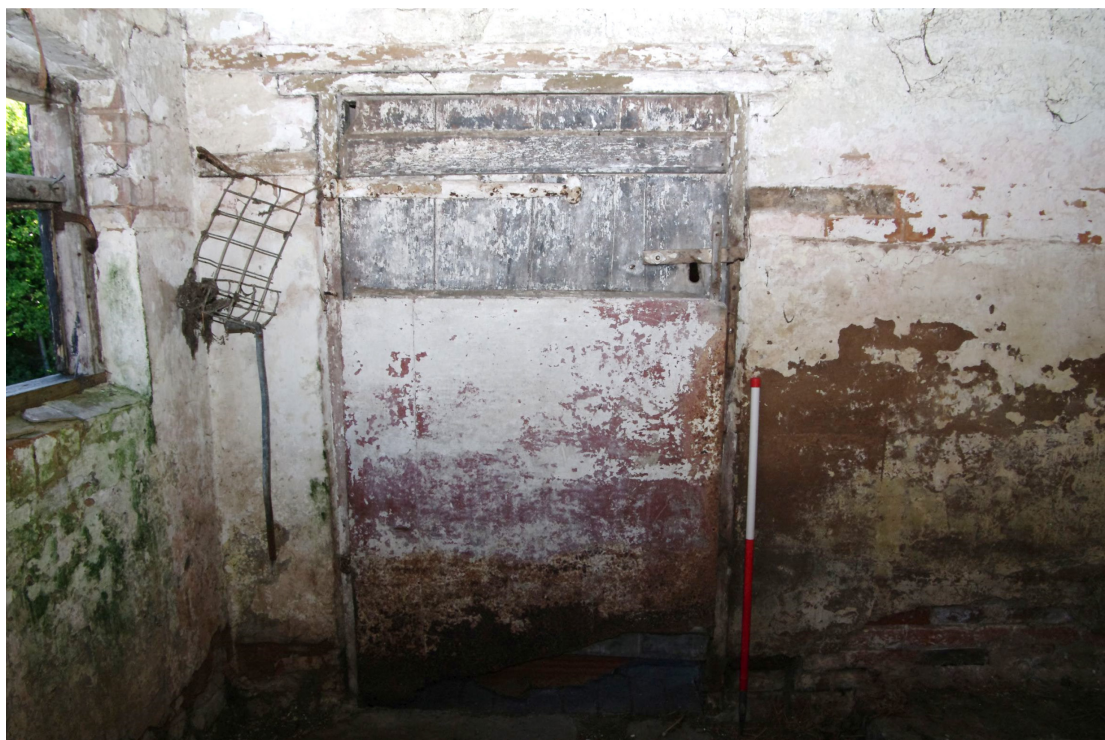
Figure 43 Building 5. Door detail at southern end of north room
Looking south-east. 1m scale. The lower part of the door has a modern covering but still shows the hand-made hinges and wooden latch (see Fig. 44 below)

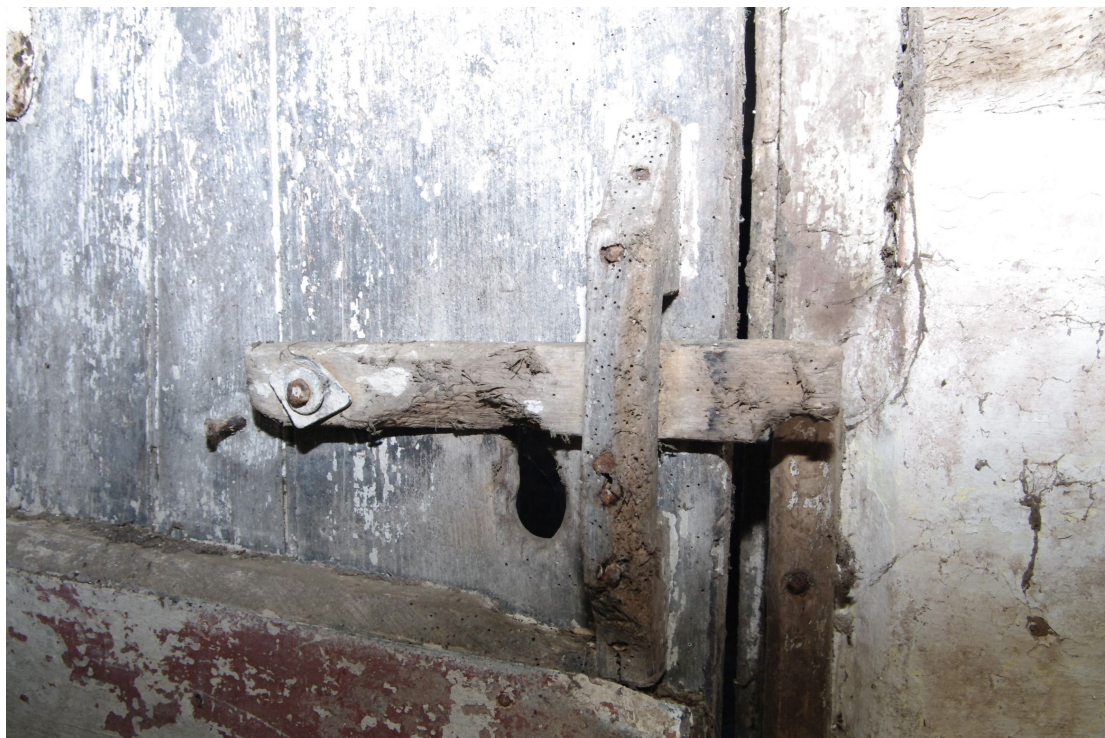
Figure 44 Building 5. Door detail at southern end of north room
The latch and catch are both wood

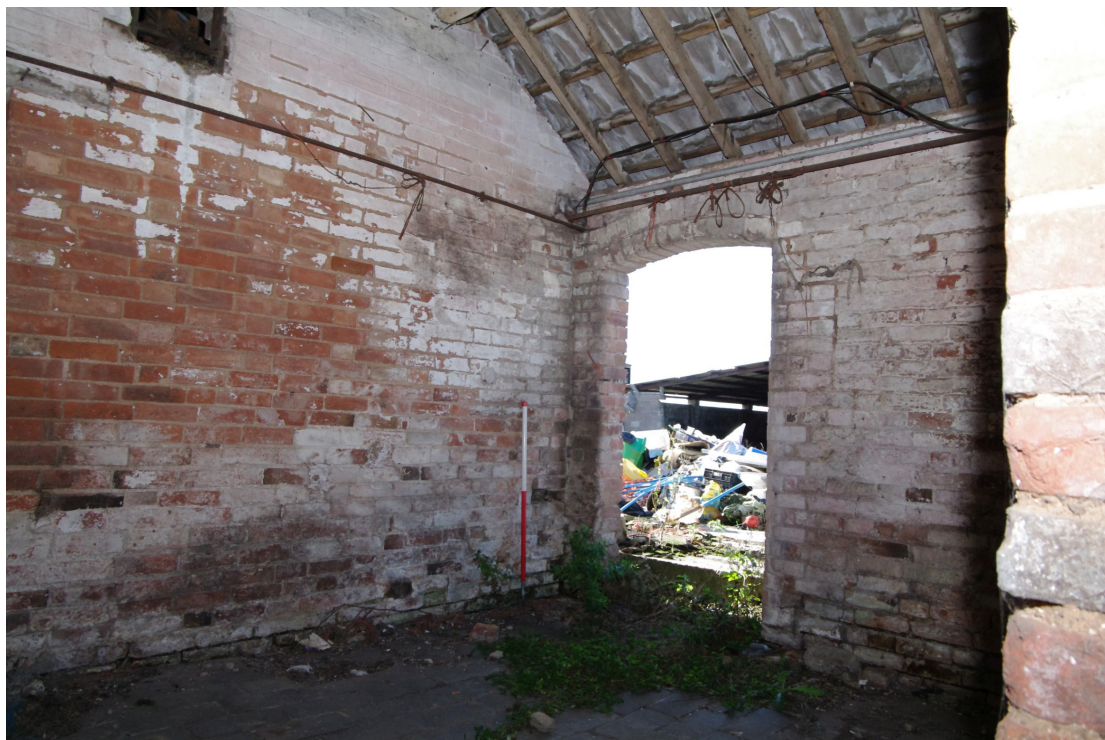
Figure 45 Building 5. Cross-passage from the yard
Looking south-west. Note the bearing box top left. Building 2 can be seen through the doorway

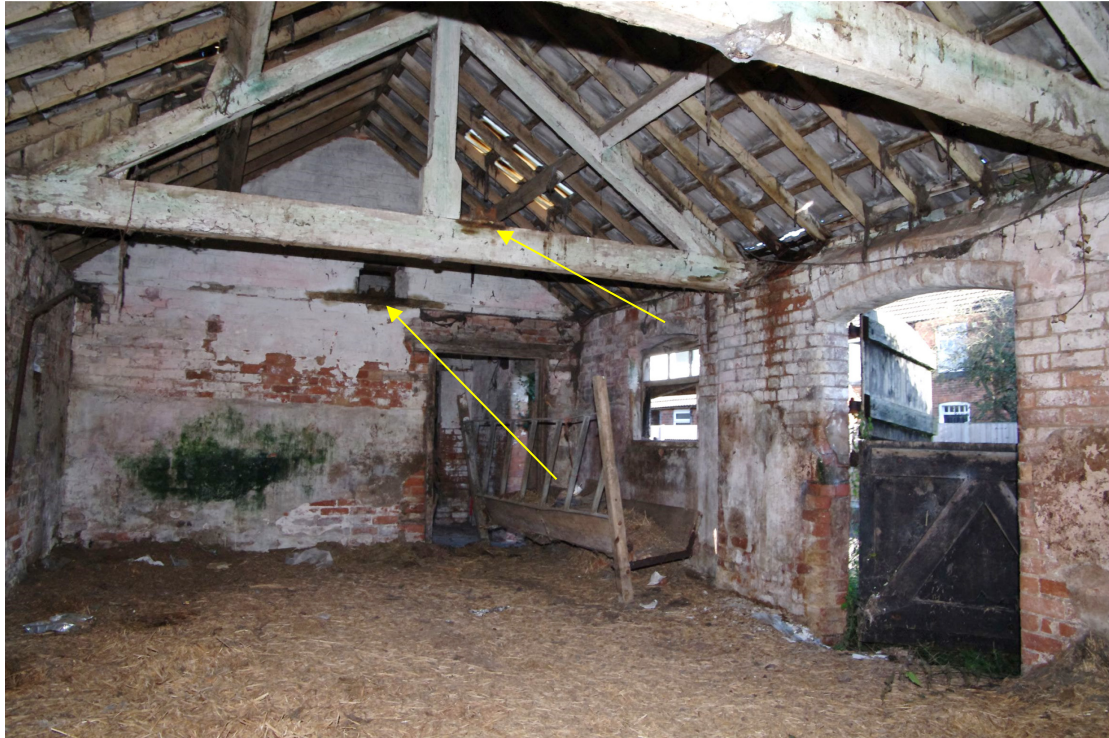
Figure 47 Building 5. Centre room
Looking north towards the cross-passage doorway. The two arrows point towards the bearings

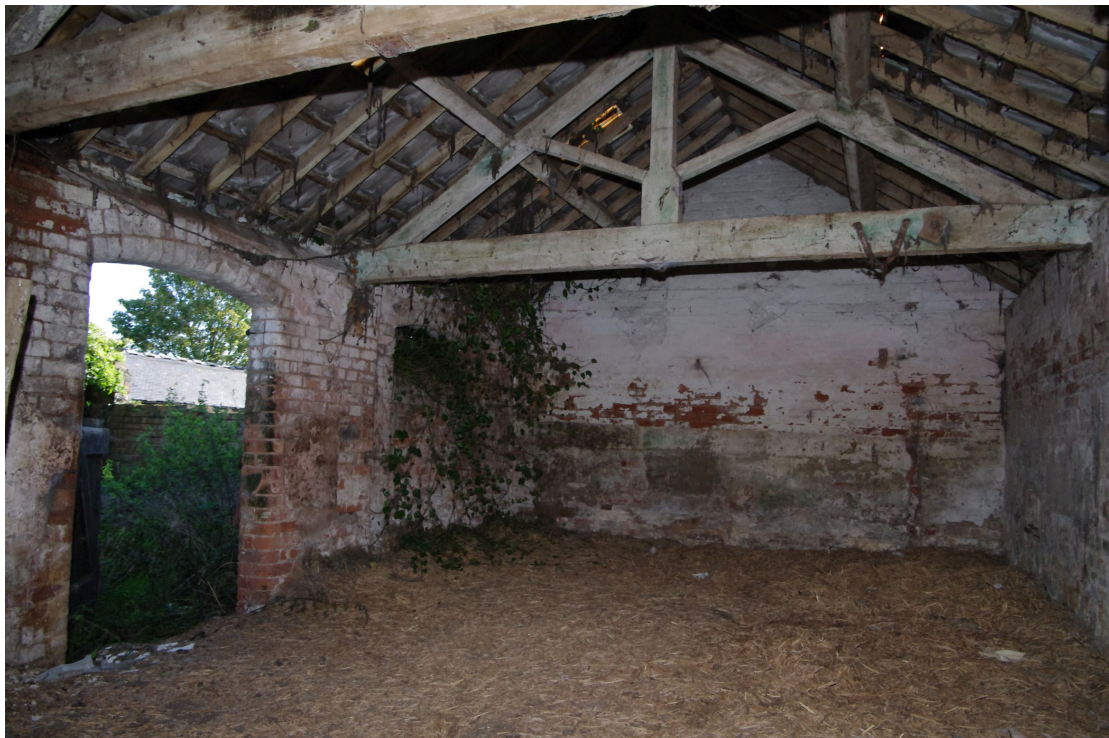
Figure 48 Building 5. Centre room
Looking south-east. The roof structure appears to be later 19th century
