**A Level 2 Historic Building Survey at
Winfrey Farm,
Dadlington Lane,
Stapleton,
Leicestershire
NGR: SP 4234 9844**

Client: David Granger Architectural Design Limited

ULAS Report Number: 2021-158

A Level 2 historic building survey at Winfrey Farm, Dadlington Lane, Stapleton, Leicestershire (SP 4234 9844)

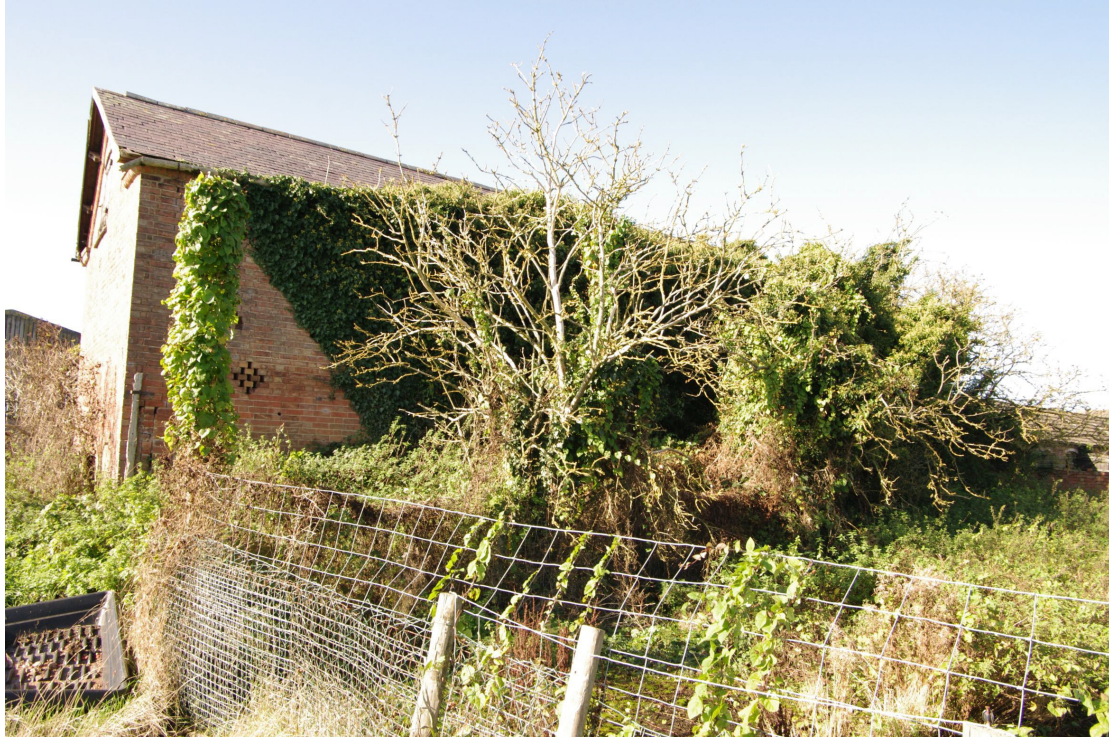
Figure 55 Building 6 north-east facing elevation
Looking north-west. Beneath the vegetation is another partially blocked central doorway and a blocked ground floor doorway to the north of the central opening

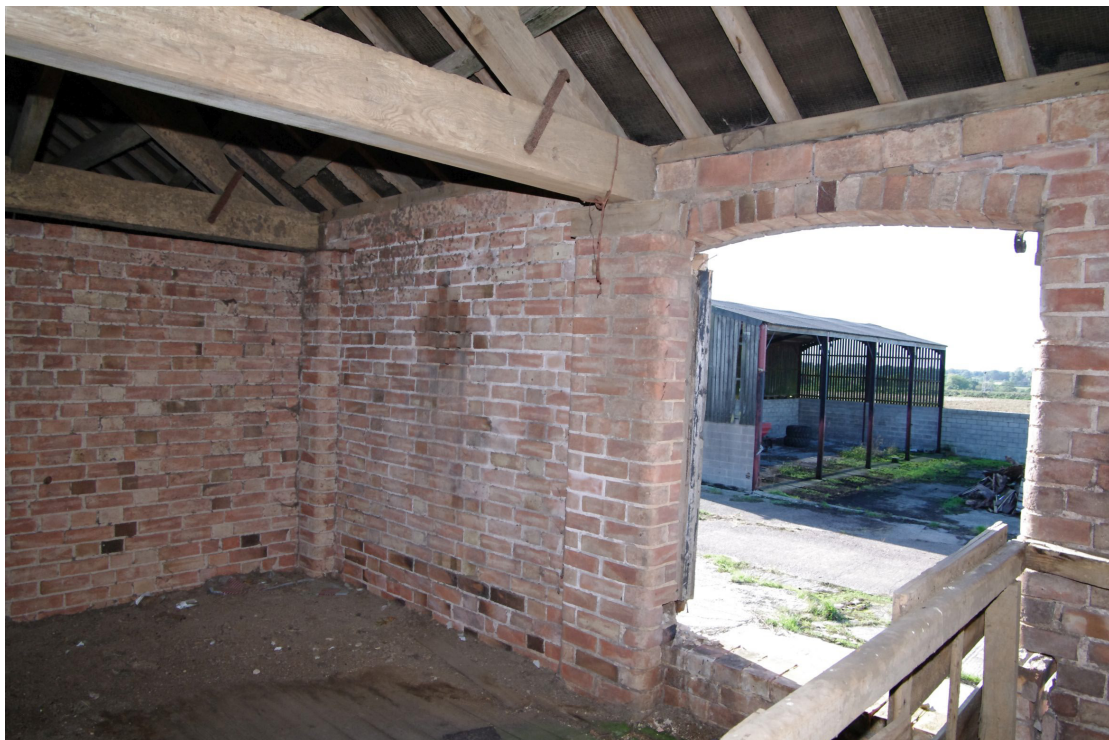
Figure 58 Building 6. First floor room on north side
Looking south-west. Part of the wall on the left was open to the central area of the threshing barn but has been blocked with brickwork. Building 3 can be seen through the window

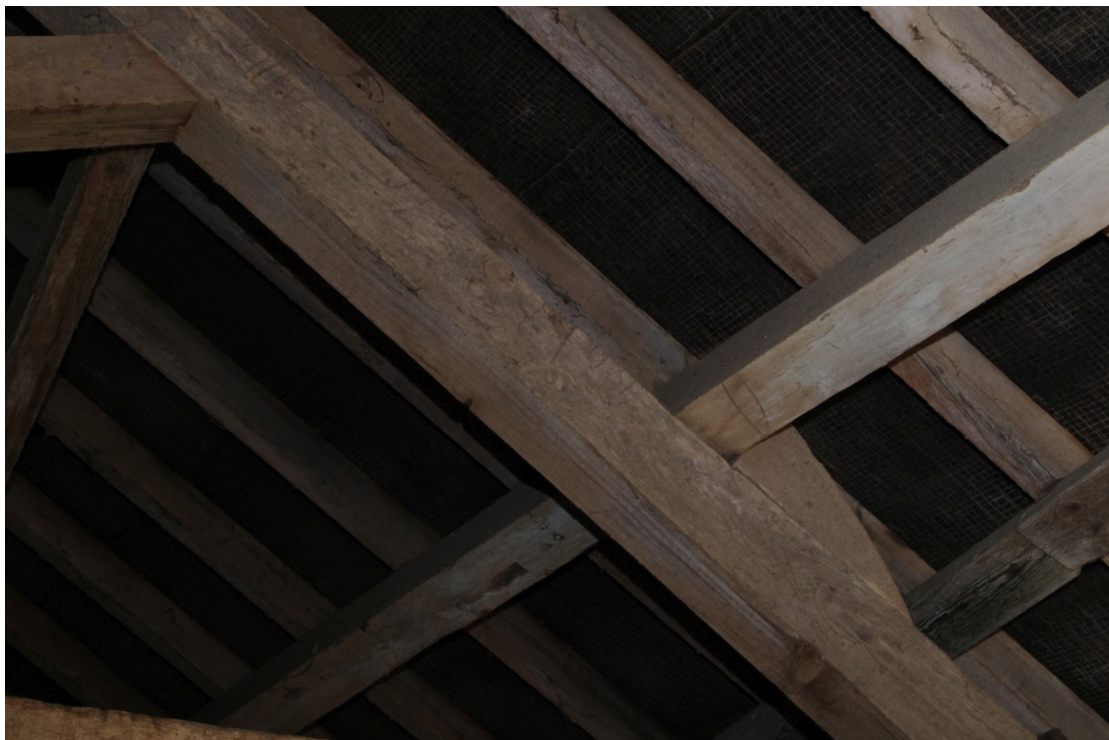
Figure 60 Building 6 rase marks on principal rafter and purlin
Looking south-east from first floor room

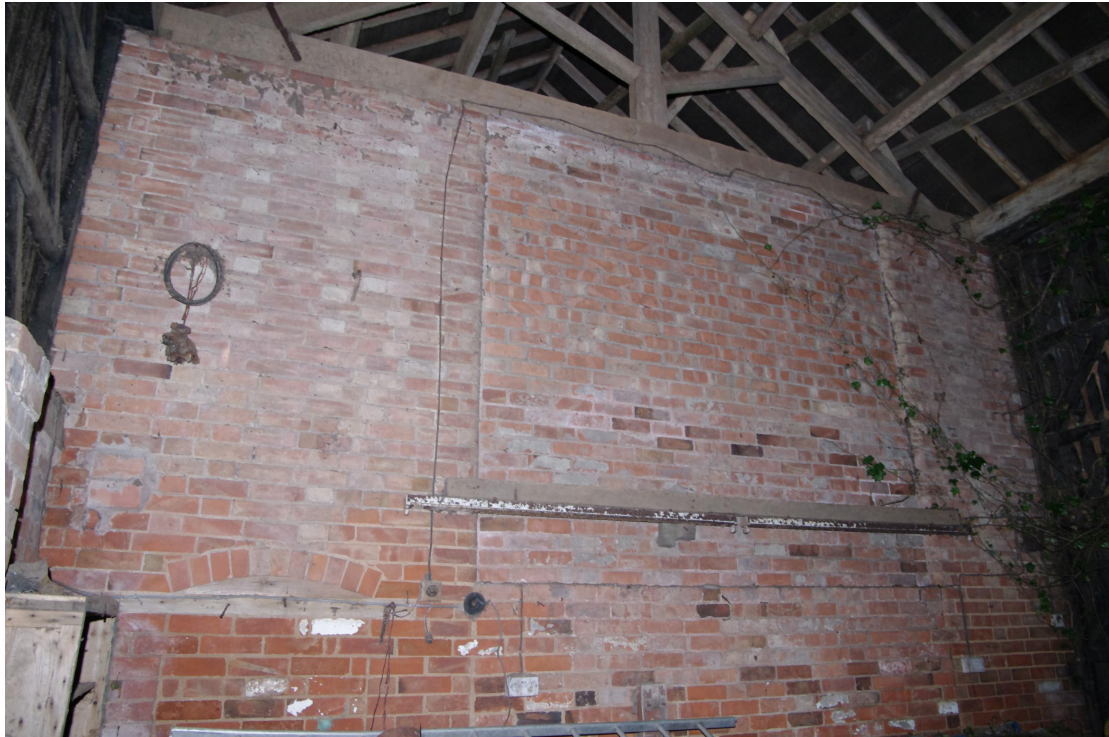
Figure 61 Building 6 Wall on northern side of central space
Looking north. Note the blocked ground floor doorway and partial blocking of the first floor hayloft area. Note also the timberwork either side which blocks the upper levels of the former threshing doors

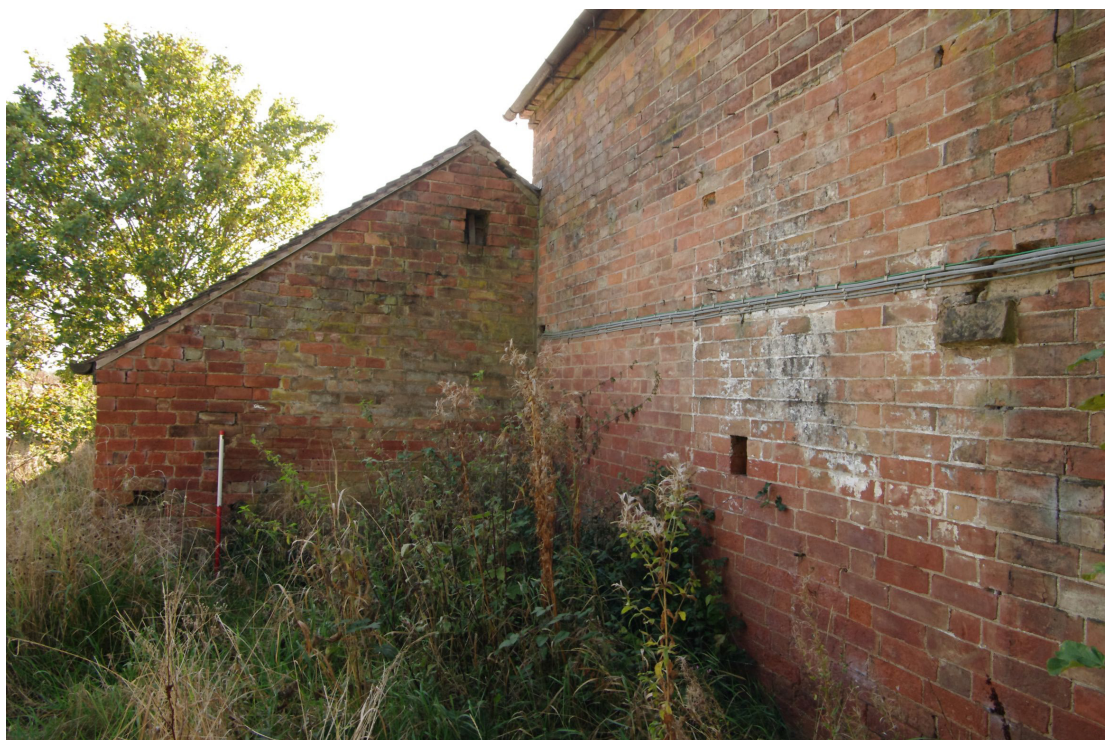
Figure 74 Building 7 north-west facing gable end of single storey range
Looking south-west. 1m scale. The brickwork shows evidence of a now removed lightweight lean-to
being fitted into the corner of the two ranges

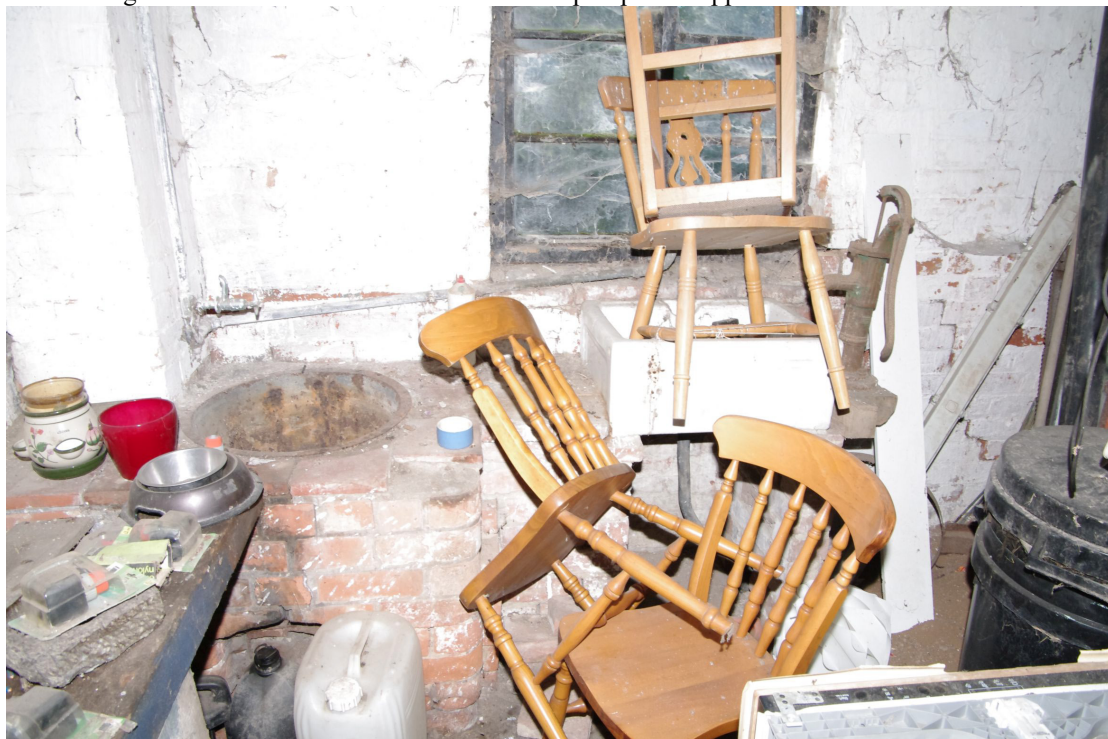
Figure 79 Building 7. Room 2 water pump

Looking north-west. The copper is to the left of the sink

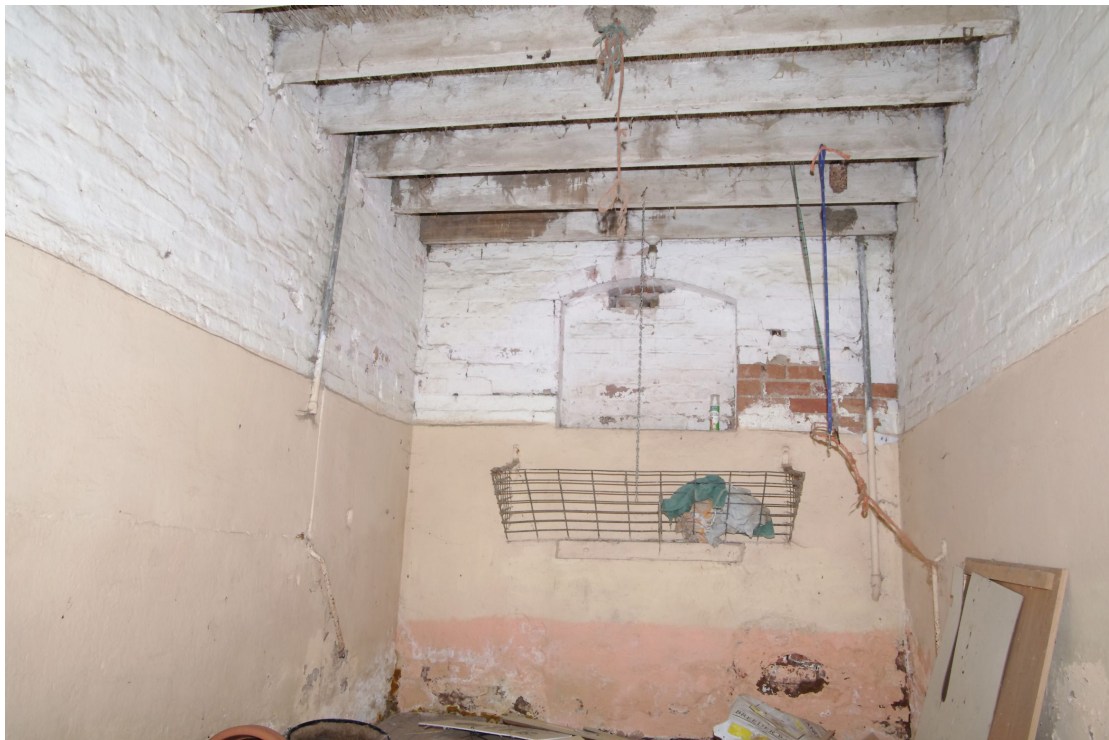
Figure 81 Building 7. Room 3
Looking north-west. The small window has been blocked due to the addition of the outside lean-to Room 1 behind it

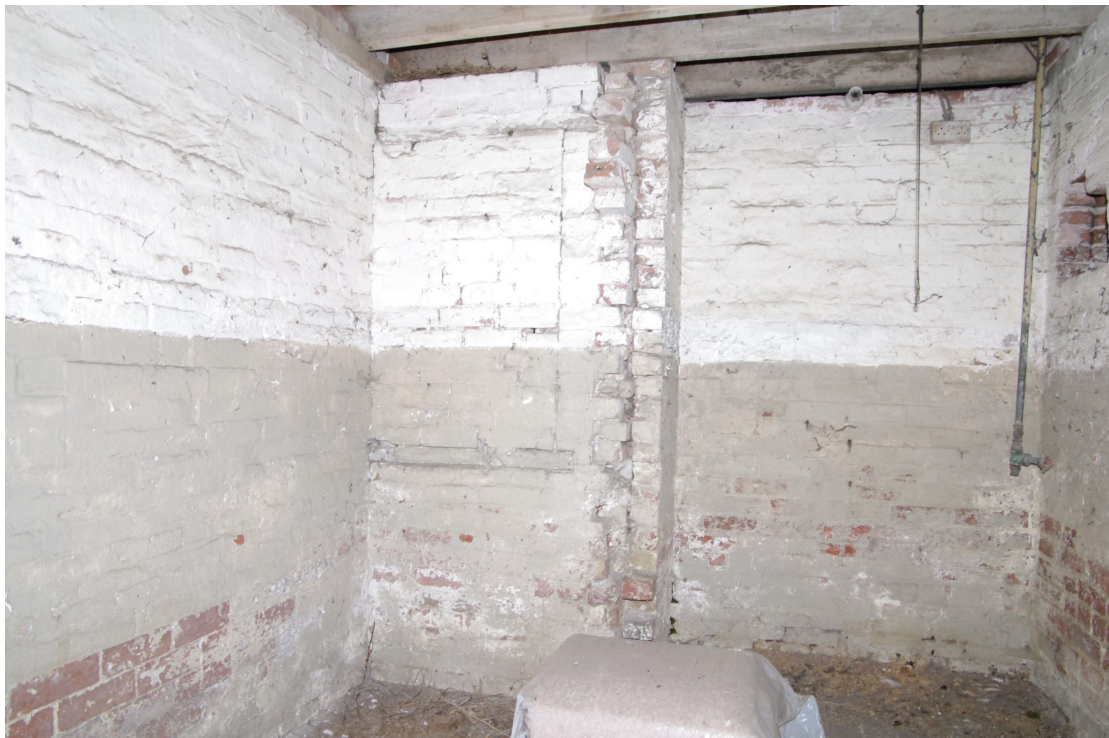
Figure 83 Building 7. Room 5

Looking north-east. The far wall steps out to accommodate Room 4 behind it

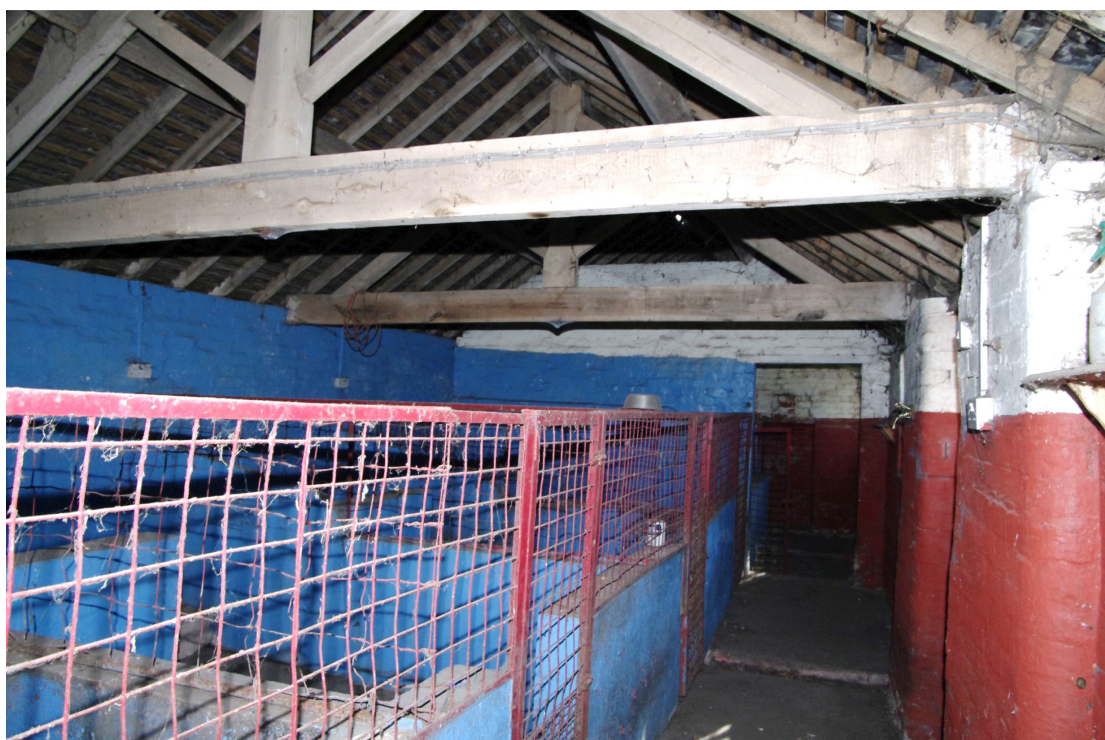
Figure 87 Building 7. Room 8

Looking south-east from doorway seen in Figure 85. This room is in the single storey range. The low concrete block and wire pens are recent and appear to have been for dogs
