**Historic Building Photographic Survey
Lodge Farm, Stathern Road,
Eastwell, Leicestershire.**

ULAS Report Number 2009-014

An Historic Building Photographic Survey at Lodge Farm, Stathern Road, Eastwell, Leicestershire. SK 774 295

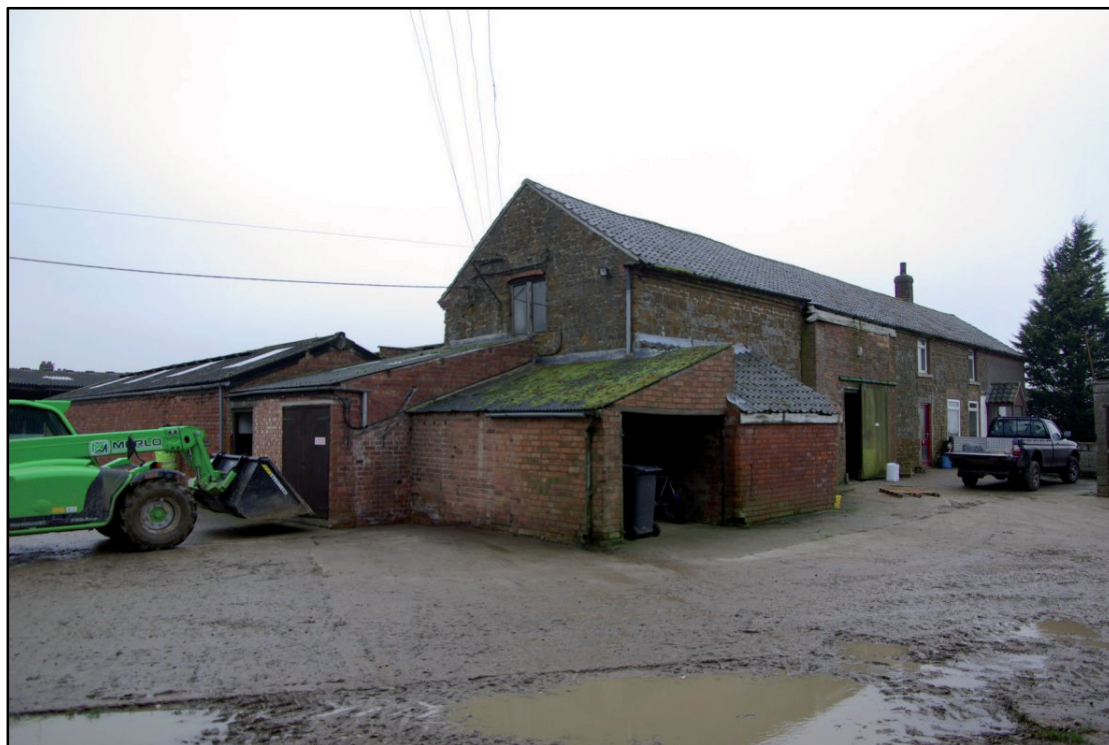
Three brick outhouses are attached to the eastern end and northern corner of the threshing barn (fig. 7). All are built of the same modern brick with Portland cement bonding the Flemish garden wall bonded courses. The south eastern lean-to building is the largest of the three structures and has a corrugated asbestos sheet roof. Internally it has a concrete floor and partially rendered walls associated with its former use as part of the dairy. Next to this, on the northern side and extending beyond the barn's north wall, is a lower but similarly shaped lean-to using the same type of bricks and corrugated asbestos roof. This is an open fronted structure with a wooden lintel and pins indicating the presence of a missing set of double doors. Filling in the gap between this lean-to and the north face of the threshing barn is a brick built shed with a blue pan tiled (locally produced Bottesford Blue pan tiles) roof. The outer corners of this structure have chamfered bricks.

The threshing barn is chiefly constructed of locally quarried coursed ironstone rubble with brick detailing and a blue pan tiled roof (figs. 7 and 8). The eastern end is currently obscured at ground level by the buildings discussed above but these will be removed to reveal the stonework beneath. A rectangular window with brick stretchers forming a lintel is centrally located at eaves height on the eastern end whilst a smaller opening below this has been blocked by the addition of the lean-to structures. Two north and south facing small arrow slit openings at the eastern end of the barn have also been blocked by the addition of later buildings (figs. 5 and 9). Bricks are used at the eaves to create a small stepped decoration on all faces. The same 215mm x 63mm x 114mm wide bricks as in the eaves have been used to create pillars stepping out either side of the northern threshing doors. This large opening has been subsequently blocked to create a smaller doorway using 215mm x 57 x 108mm wide bricks. The opposing southern threshing door is also blocked with brick which is flush with the building line. A metal-framed 2 x 5 paned window pierces this brickwork as does a single, blocked, door (fig. 10). Another blocked doorway with a single arch of brick

Figure 7 North and east faces of barn, farmhouse and outbuildings. Facing south west.

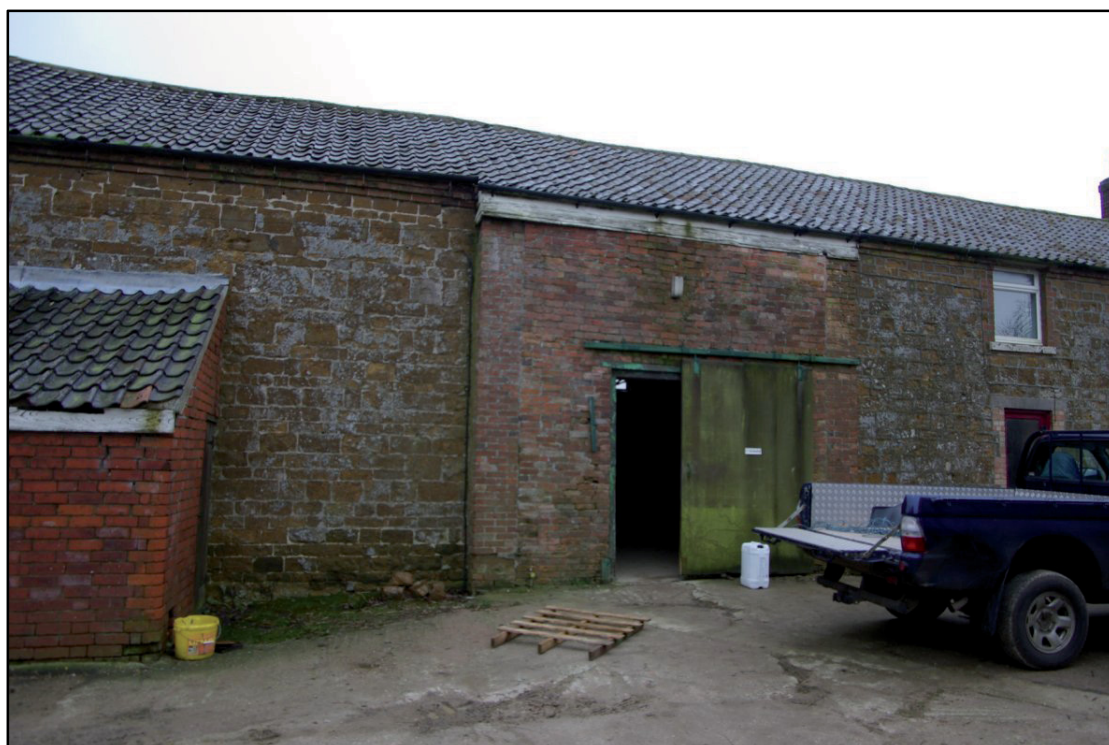
Figure 8 Blocked door of threshing barn. Facing south.

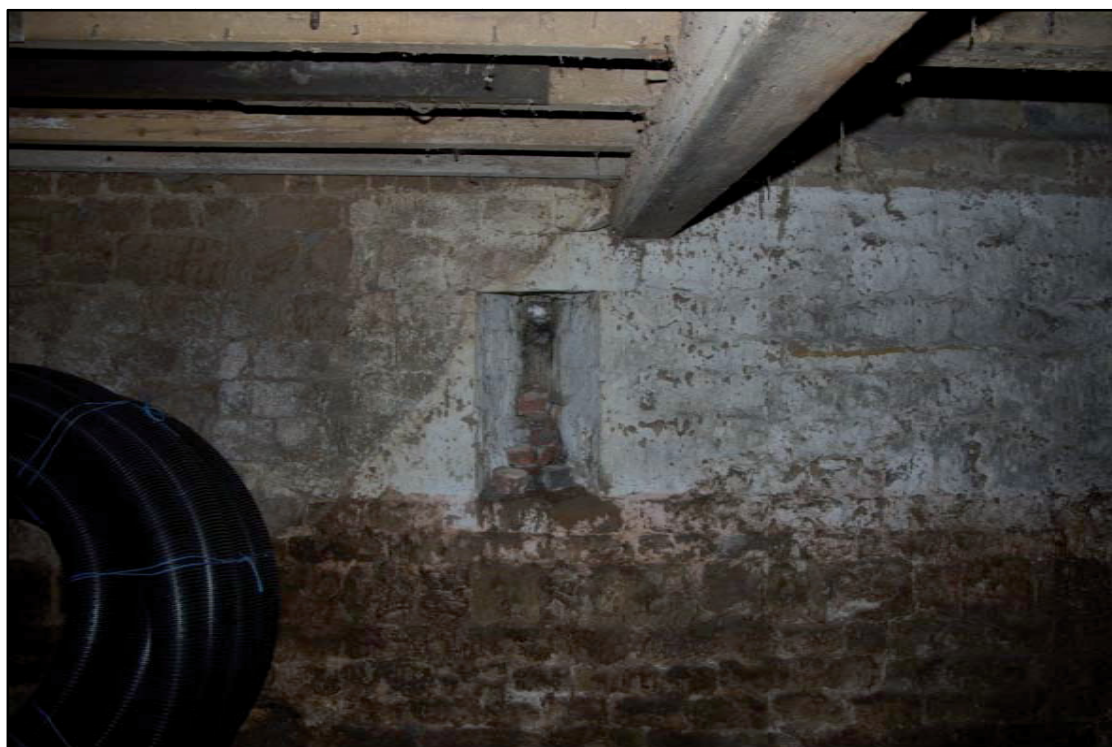
Figure 9 Blocked splayed window. South side of barn.

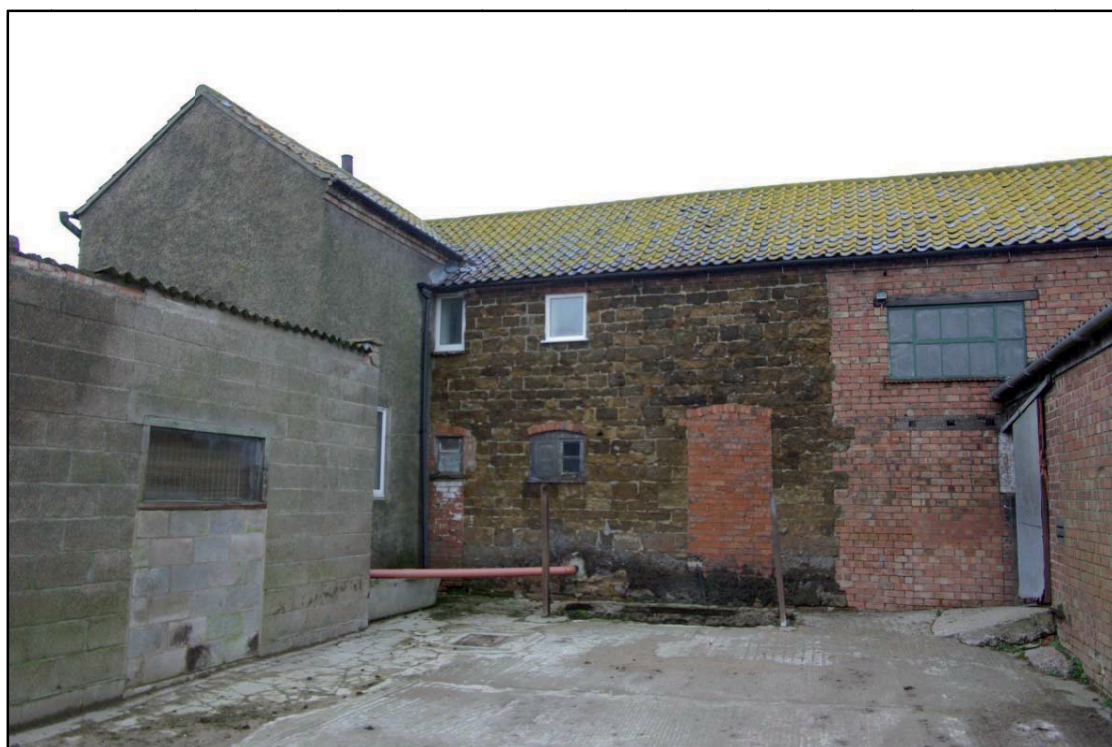
Figure 10 South face of farmhouse and barn.

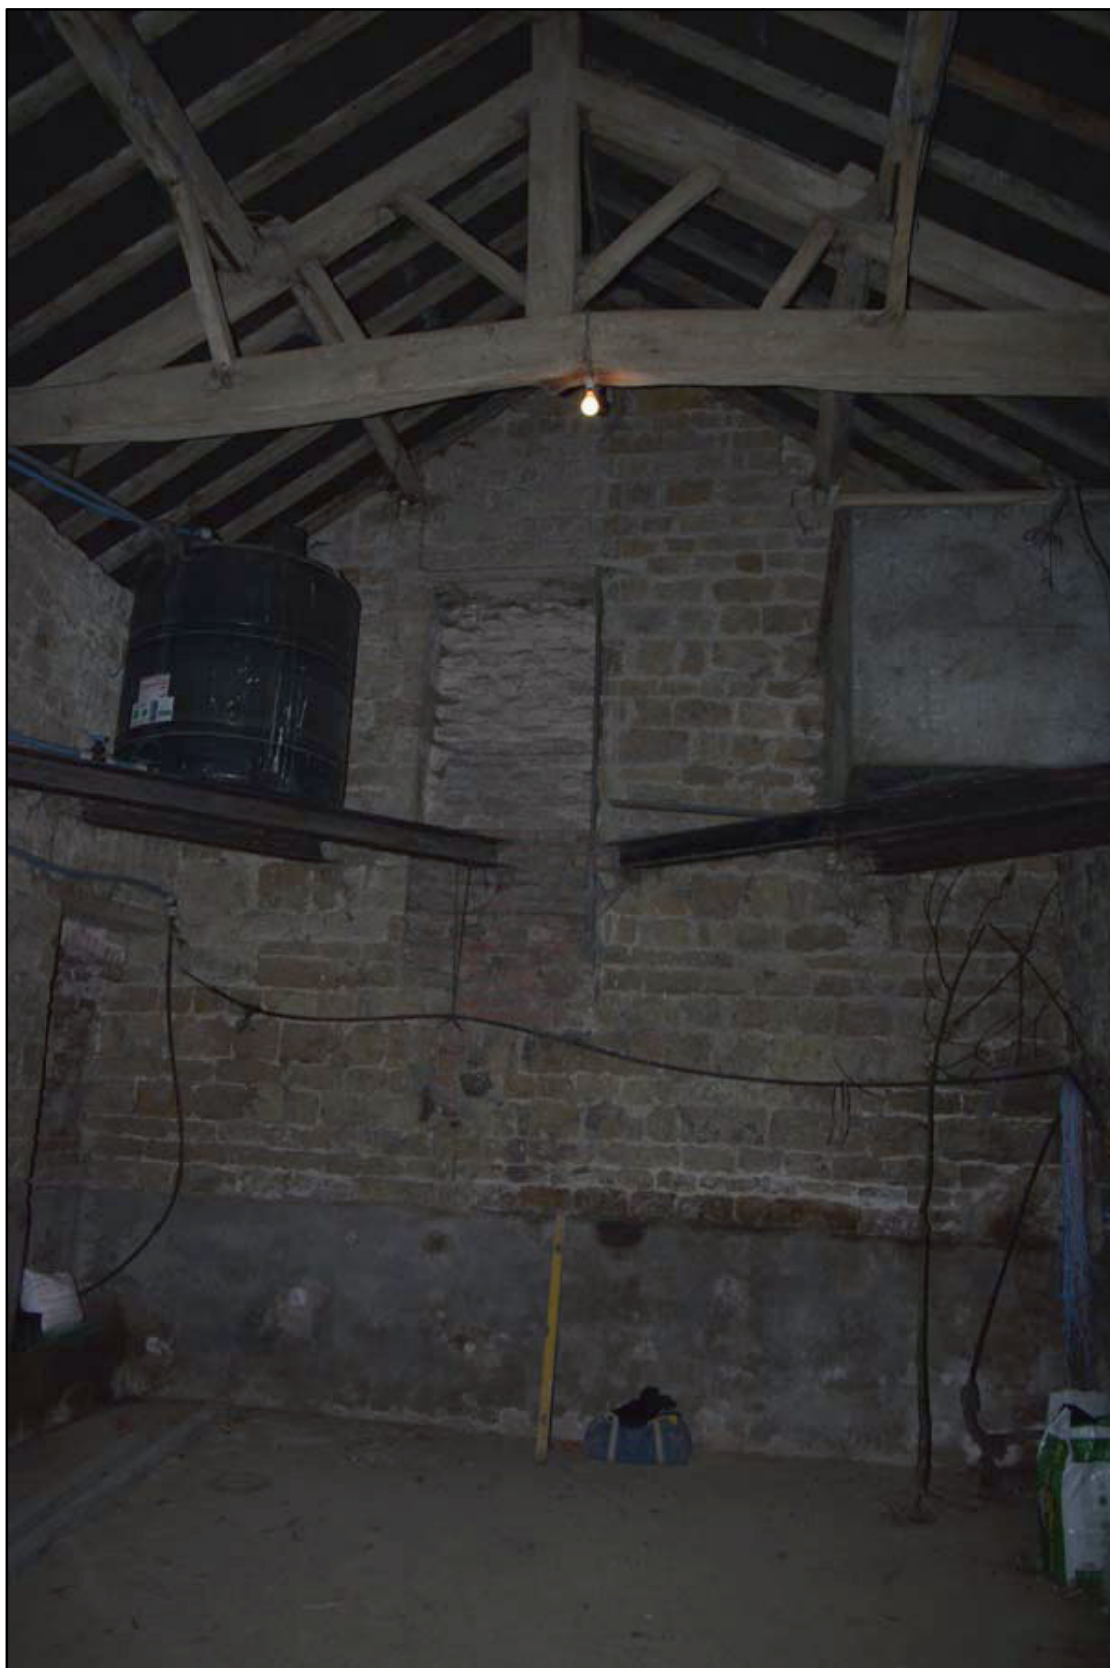
headers is located in the south western corner of the barn. A large rectangular opening, roughly the size of a door is located at first floor height on the western end wall and which is now blocked by the farmhouse end wall (fig. 11). The barn floor is a mixture of brick and concrete patching which may overlie an earlier flooring material. A timber mezzanine floor, which is reached by a set of steep wooden steps, fills the eastern half of the barn beyond the doorway (fig.12). A single unshaped log that rests directly onto the brick floor forms the support for the mezzanine.

Figure 11 West end of threshing barn.

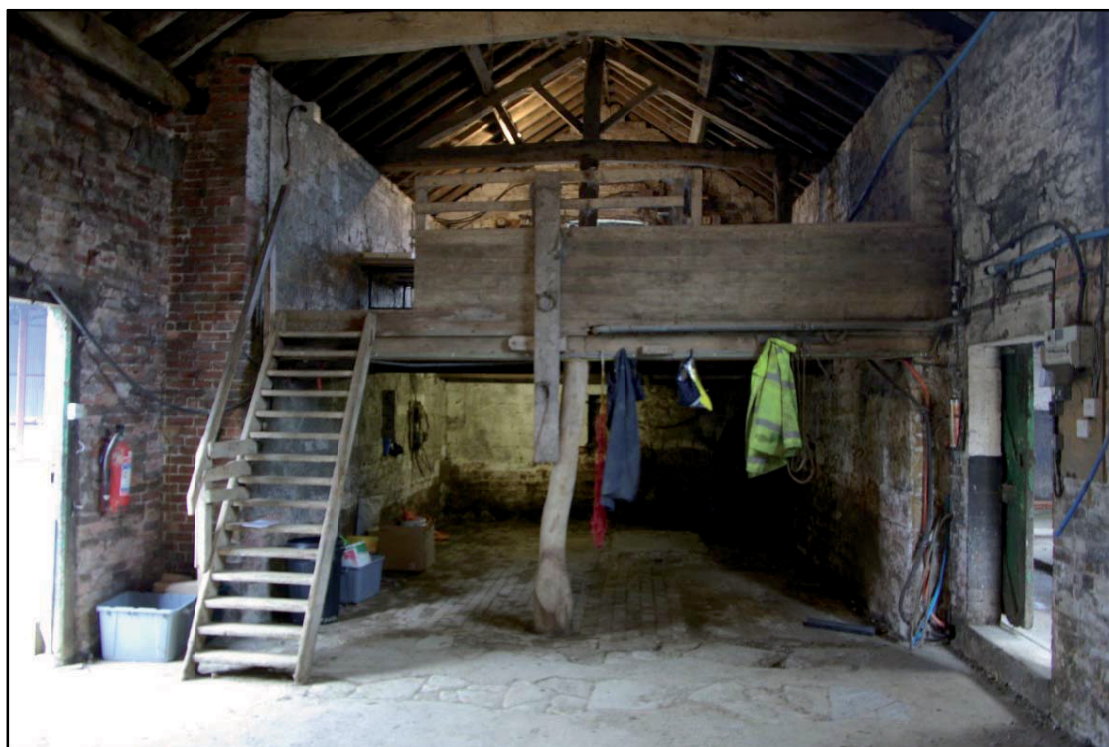
Figure 12 East end of threshing barn and mezzanine.

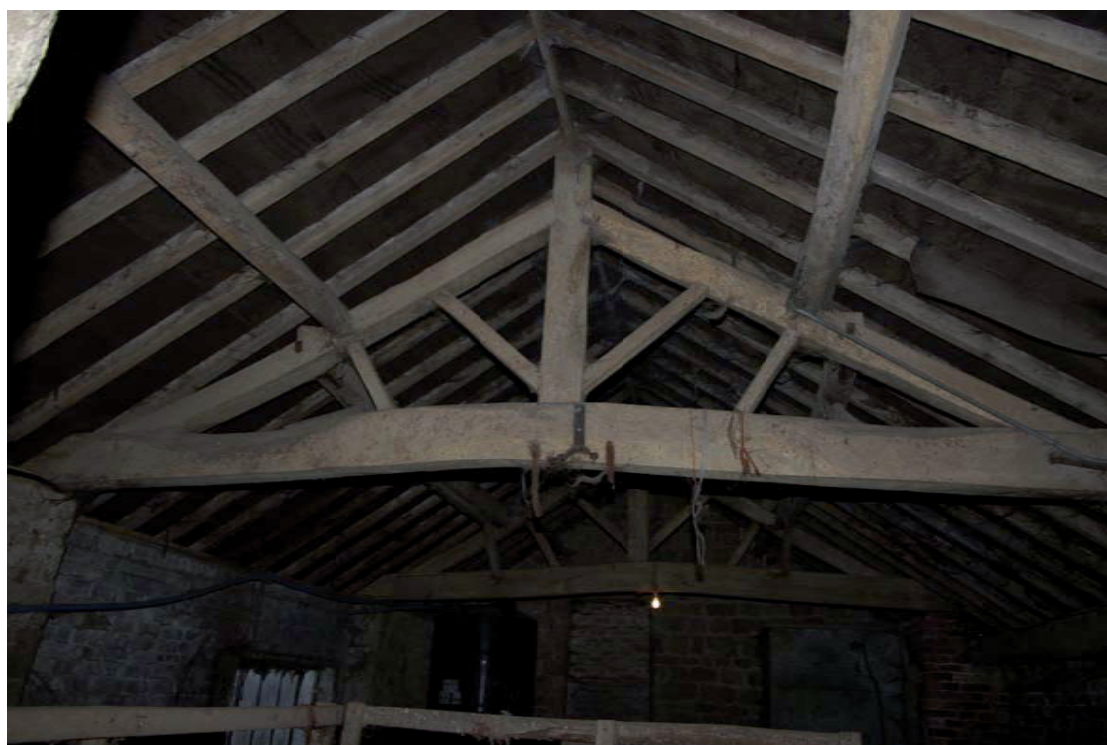
The trussed rafter king post roof has three similar trusses made from Elm (fig. 13). In each the tiebeam is slightly cambered exploiting the natural curve of the tree. The king post, which lacks joggles, is tenoned into the centre of the tiebeam and supports a narrow ridge board at the apex. The principals are notched into the king post well below the apex and tenoned into the tiebeam. Raking braces rise from the kingpost to the principals. Short outer raking struts rise from the tiebeam to the principals. Staggered purlins support the common rafters. Over the former threshing doors the purlins are reinforced and supported by nailed braces, rising from the tiebeam. No metalwork has been used for any of the joints within the roof. The south end of the easternmost truss is in a poor state of repair and is temporarily supported by a number of substantial logs.

Figure 13 Roof structure of threshing barn. Facing west.

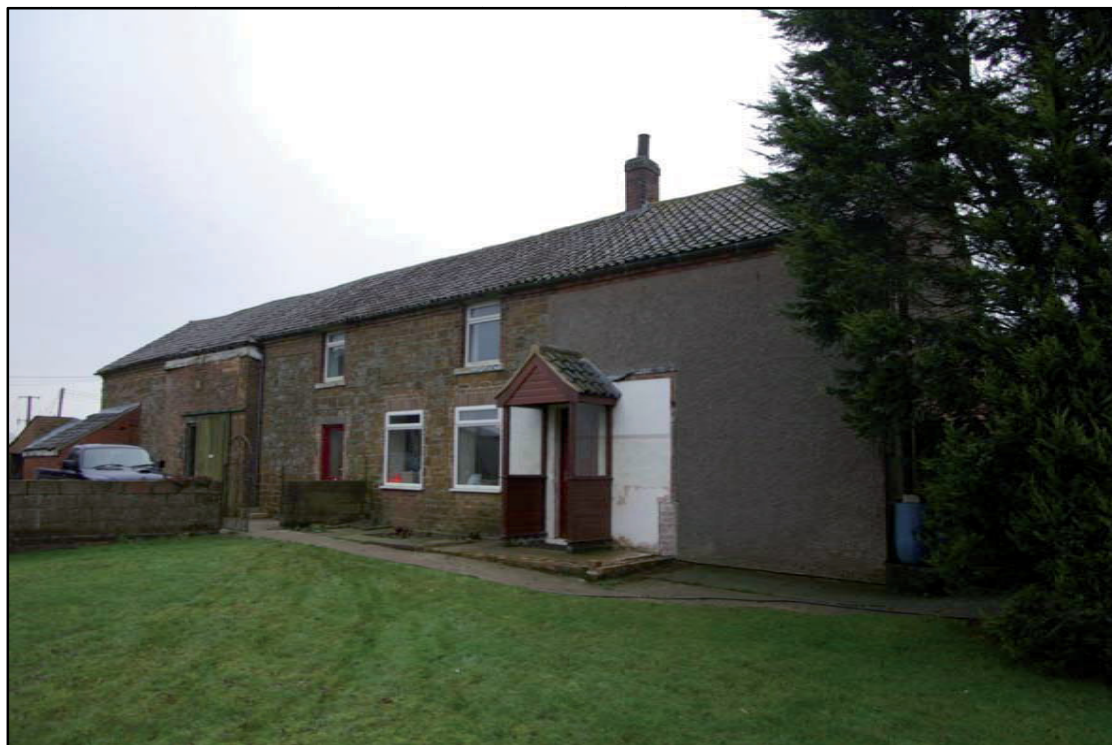
The outside walls of the barn and farmhouse give the impression of a single phase of construction with no apparent breaks or joins in the stone courses from one building to the next (figs. 14 and 15). The blue pan tiled roof is also continuous from one building to the other. The present owner reports that this building was originally constructed as a second barn.

Figure 14 North face of farmhouse.

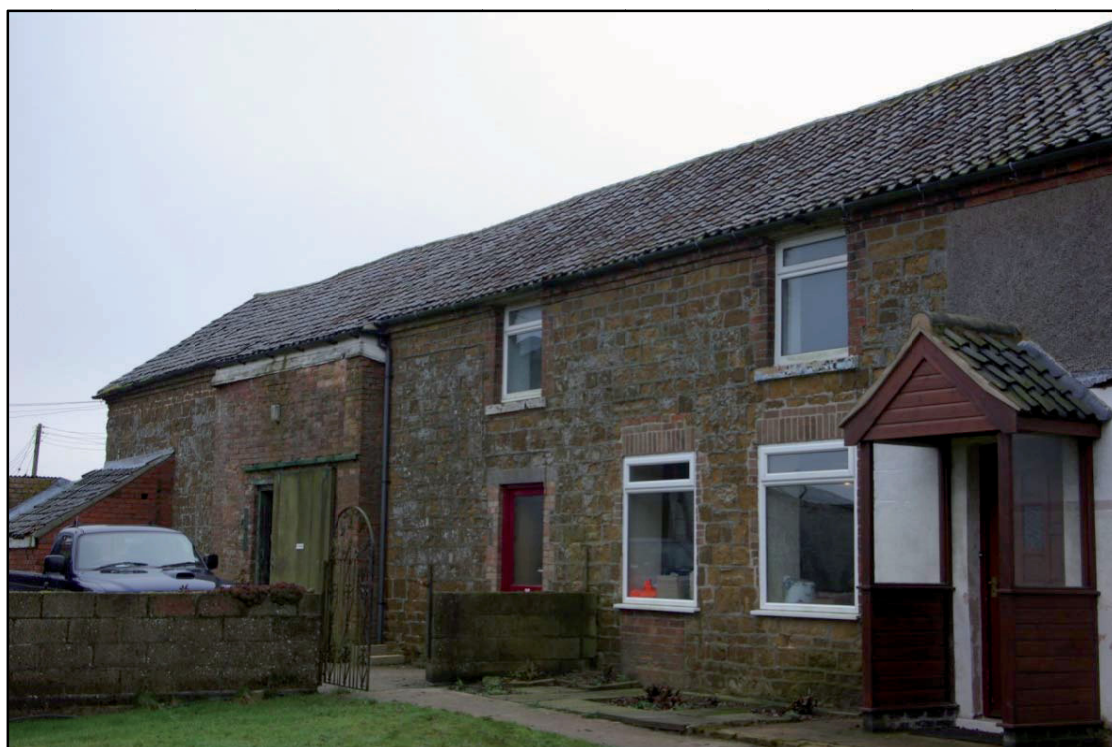
Figure 15 Original portion of farmhouse. Blocked doorway in centre.

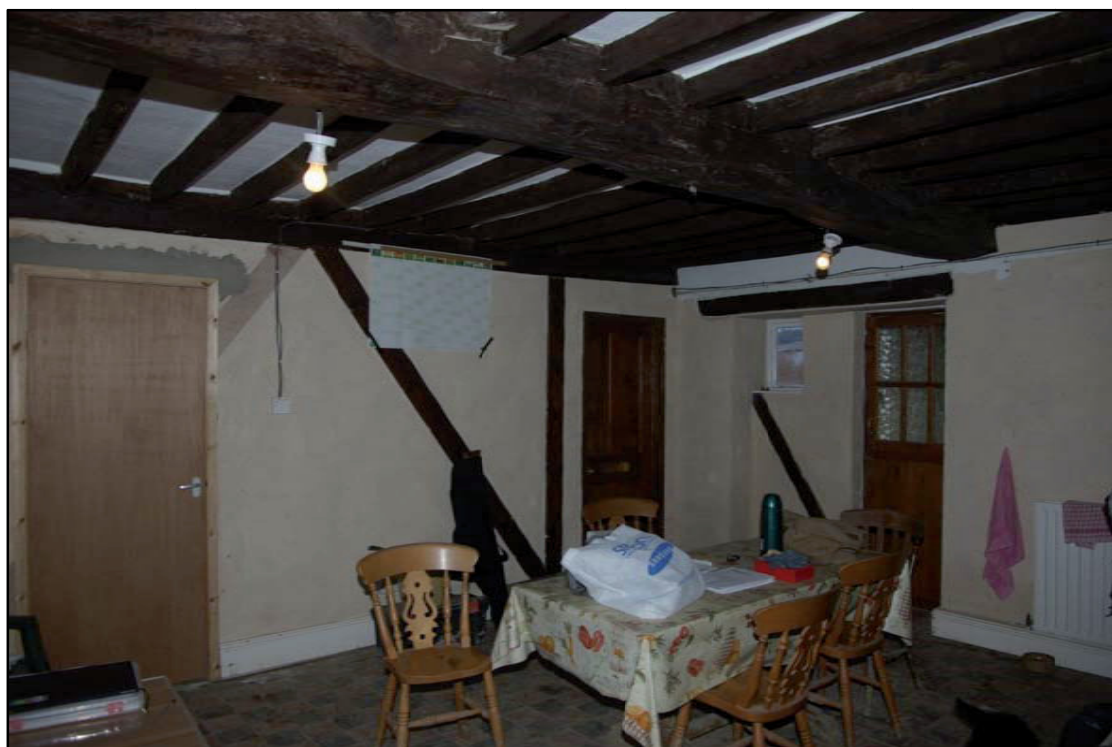
Entry into the house is through the inserted doorway on the north elevation into a small lobby which probably contained the original staircase. The main room of the house has a large chamfered timber beam running north to south across the room (fig.

Figure 16 Main ground floor room. Facing south east.

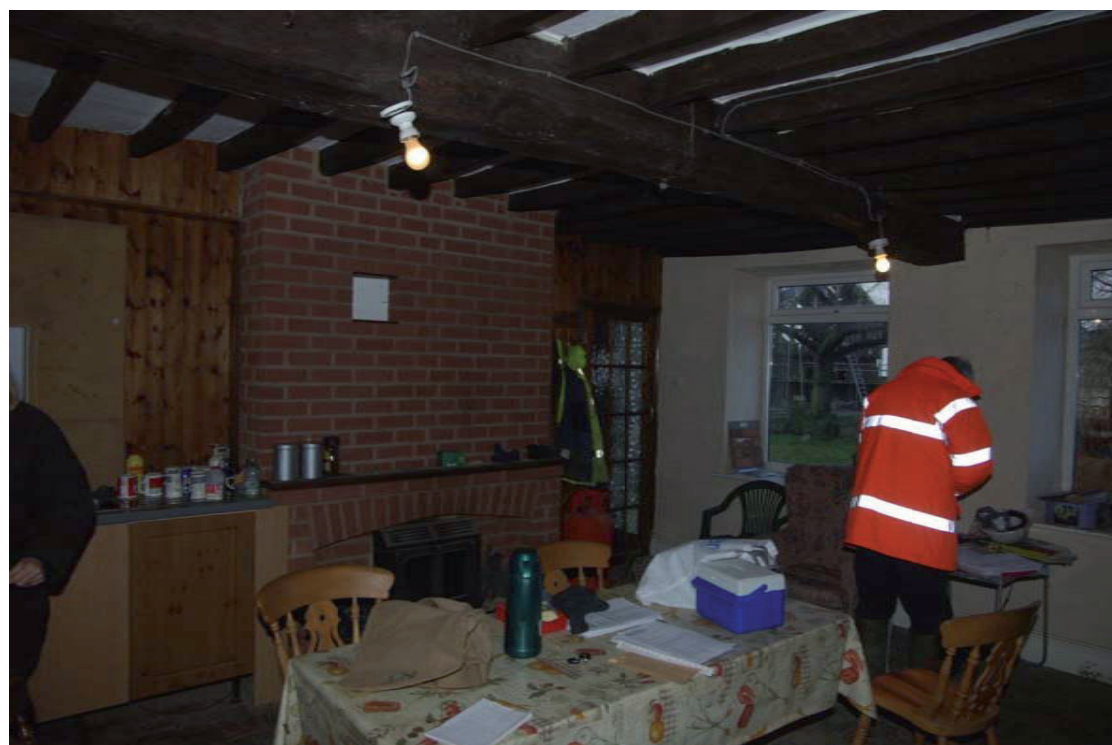
16). The floor has 6" square quarry tiles, as has the lobby and adjacent hall. The fireplace is quite modern with a skin of brick which may mask an earlier construction beneath (fig. 17). A door to the east leads to a pantry which would formerly have been beneath the stairs. The door to the south leads out into the modern gable extension kitchen with little visible of historical value (fig. 18). This leads through into the stable, currently being used as a utility room and storeroom (fig. 19). The western extension is entered from an inserted doorway to the side of the chimney breast in the main room. The new stairs are immediately on the south side with the outside door, with the modern porch are to the north. Beyond this is a large sitting room with probable 1970s fittings masking anything earlier (fig. 20). The fireplace appears to be blocked as no chimney is visible outside at roof height.

Figure 17 Main ground floor room. Facing north west.

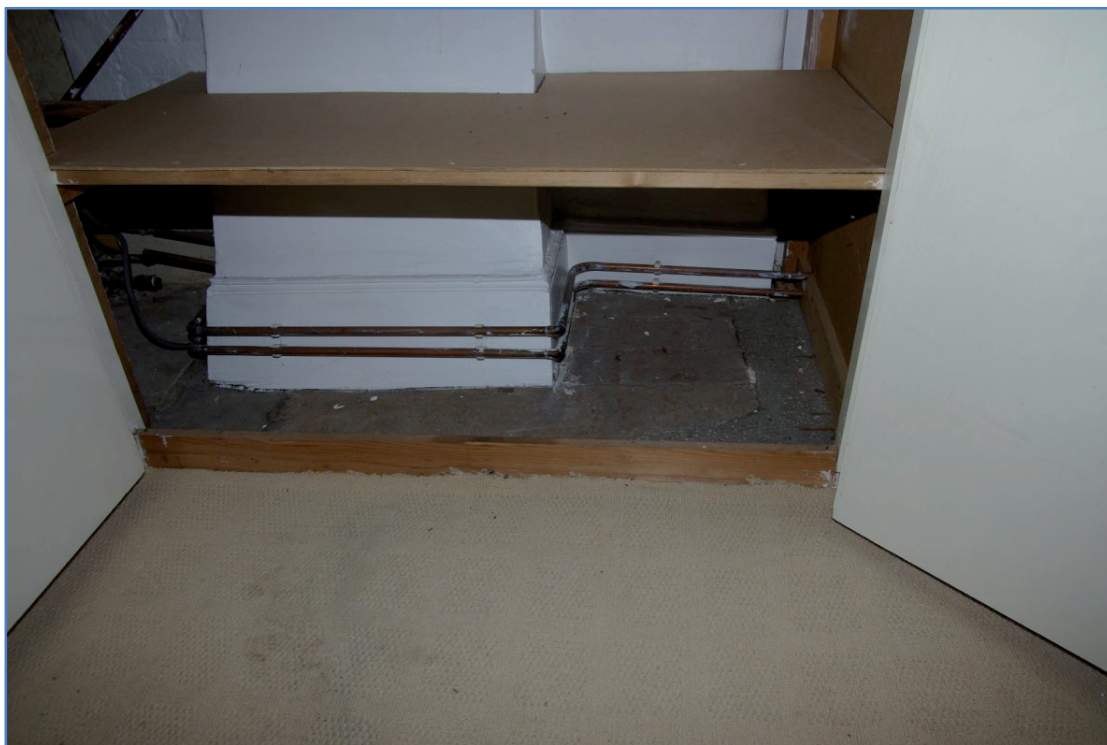
Figure 26 First floor centre room. Bricks around chimney breast.

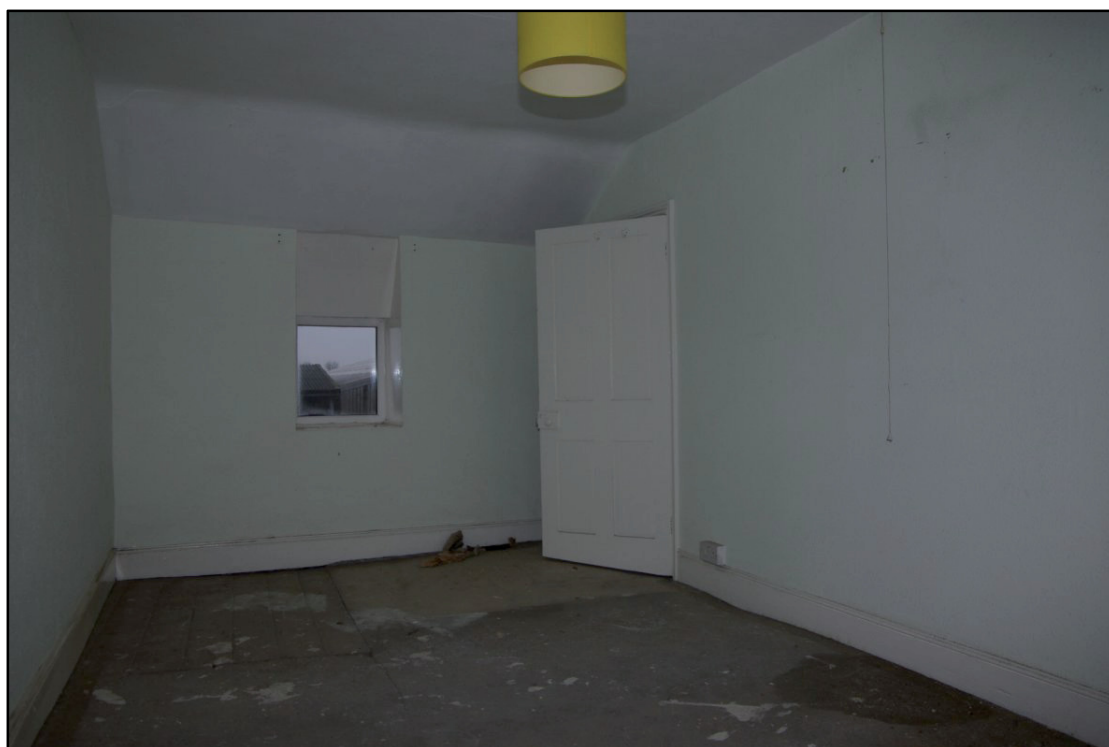
Figure 27 First floor, eastern room. Boarded hole in corner. Facing south west.

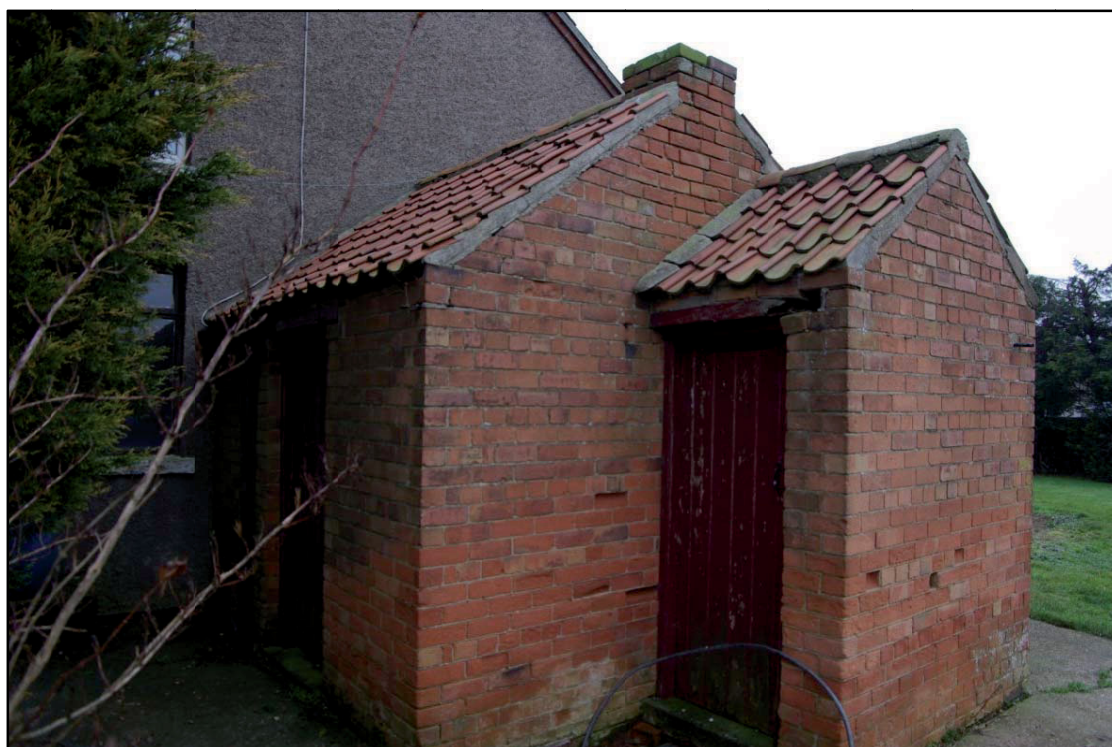
Built of 230mm x 70mm x 108mm bricks to form a larger wash house and smaller outside toilet with red pan tiles the two outhouses are built against the western end of the farmhouse extension (fig. 29). The bricks are very weathered and may explain why the farmhouse extension has been rendered if the same bricks have been used. Little evidence of the original internal fittings survives inside the wash house.

Figure 29 Outhouses at western end of farmhouse. Facing south east.

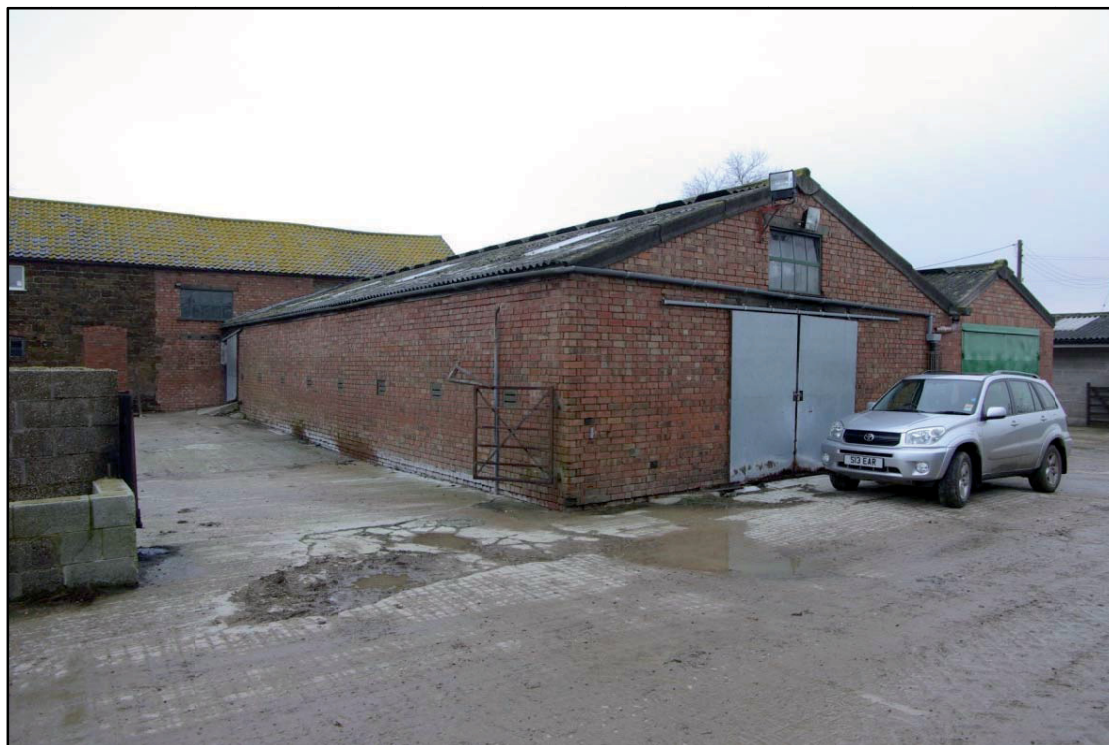
The milking parlour is attached to the southern wall of the threshing barn (fig.30). It is constructed of modern (mid-late 20th century) brick with a corrugated asbestos roof supported by narrow L-section steel trusses (fig. 31). The floor is of concrete with a long pit along the western side for milking purposes. Most of the milking equipment has recently been removed leaving a large open space.

Figure 30 Milking parlour. Facing north east.

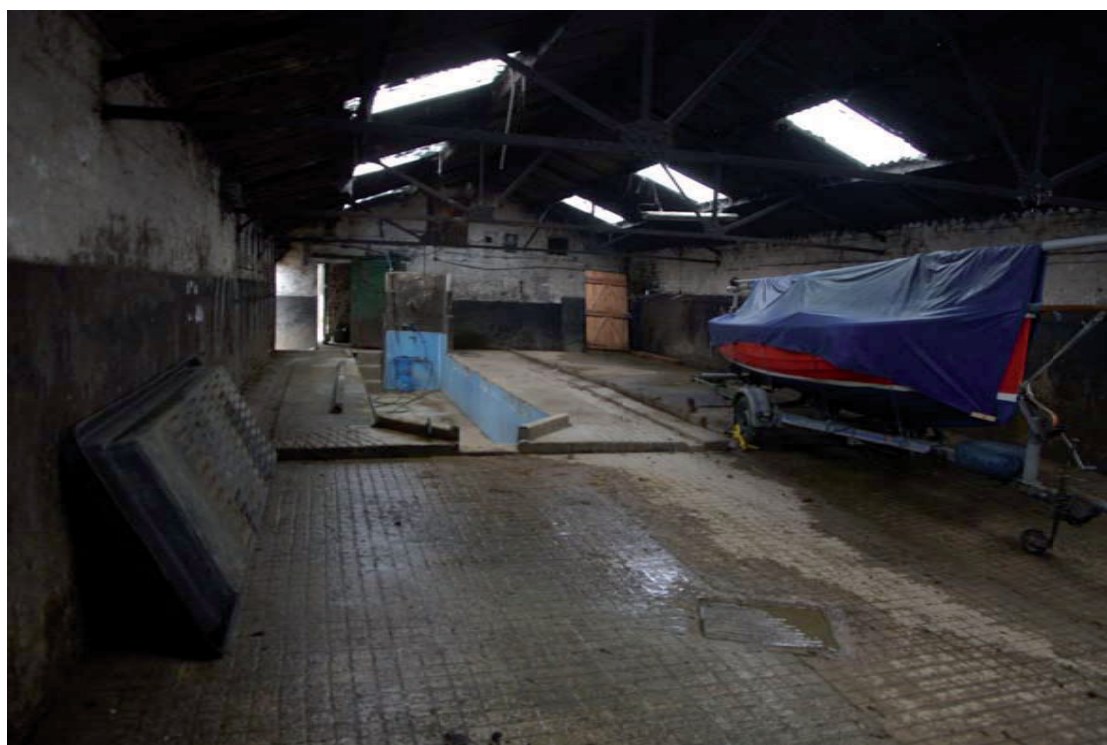
Figure 31 Inside milking parlour. Facing north east.

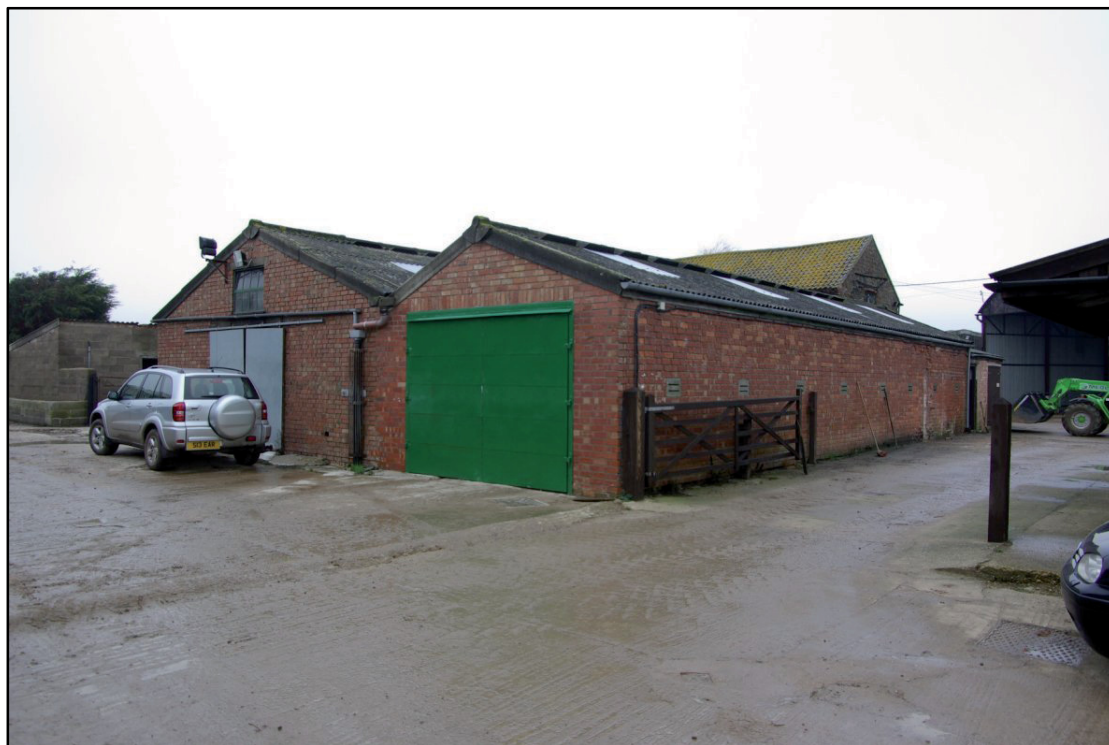
Built along the eastern side of the milking parlour, and using the same central wall is another similarly constructed cattle shed. This is of the same length and height but is not as wide (figs. 32 and 33). Attached to the eastern wall are a series of cast iron

individual drinking troughs. A small internal store room has been constructed at the northern end of the building. As with the milking parlour the shed has a number of interesting concrete ventilator blocks set midway down the outside walls (fig. 32).

Figure 32 Shed attached to milking parlour. Facing north west.

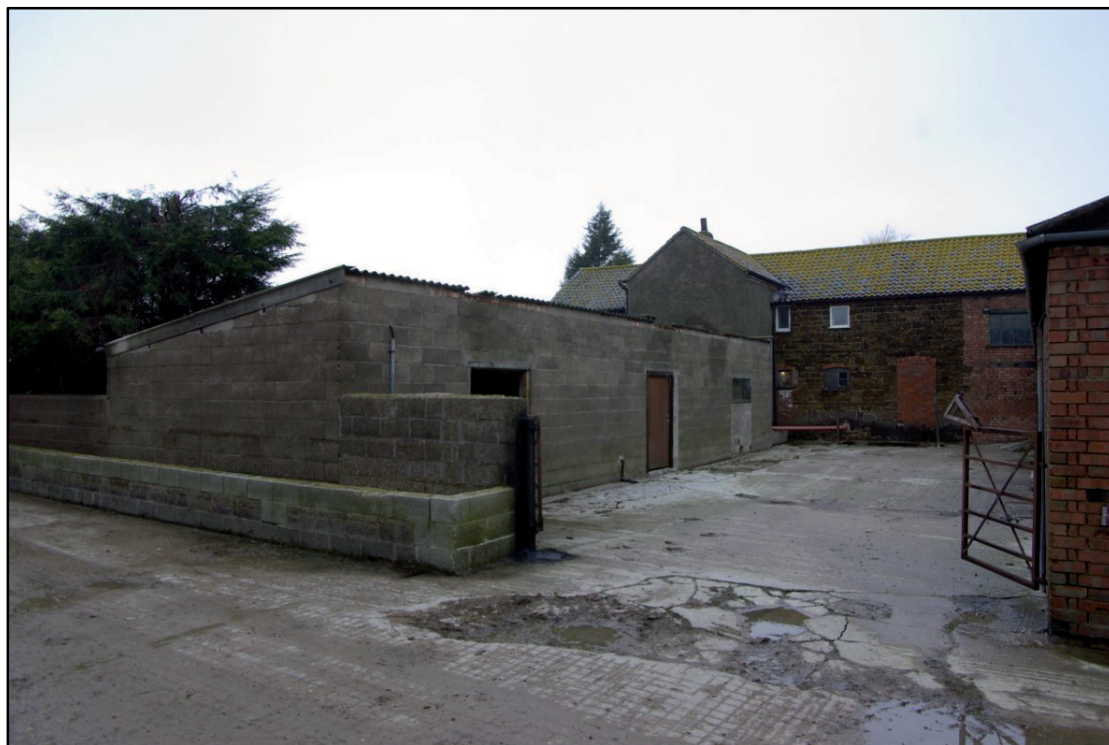
The stable is constructed to the rear of the farmhouse gable extension creating a small yard between it and the milking parlour (fig. 34). It is constructed of modern concrete blocks with a corrugated pitched roof and concrete floor (fig. 35). Much of the northern end has been converted to use as a utility room for the farmhouse as already noted above. Only the southern end remains as a stable although this is currently in use as a wood store.

Figure 34 Stable block. Facing north west.
