**An Historic Building Analytical Survey (Level 2)
of the Bothy; Walled Kitchen Garden,
Belvoir Castle, Belvoir, Leicestershire**

Andrew Hyam

For: The Duchess of Rutland

ULAS Report Number 2009-020

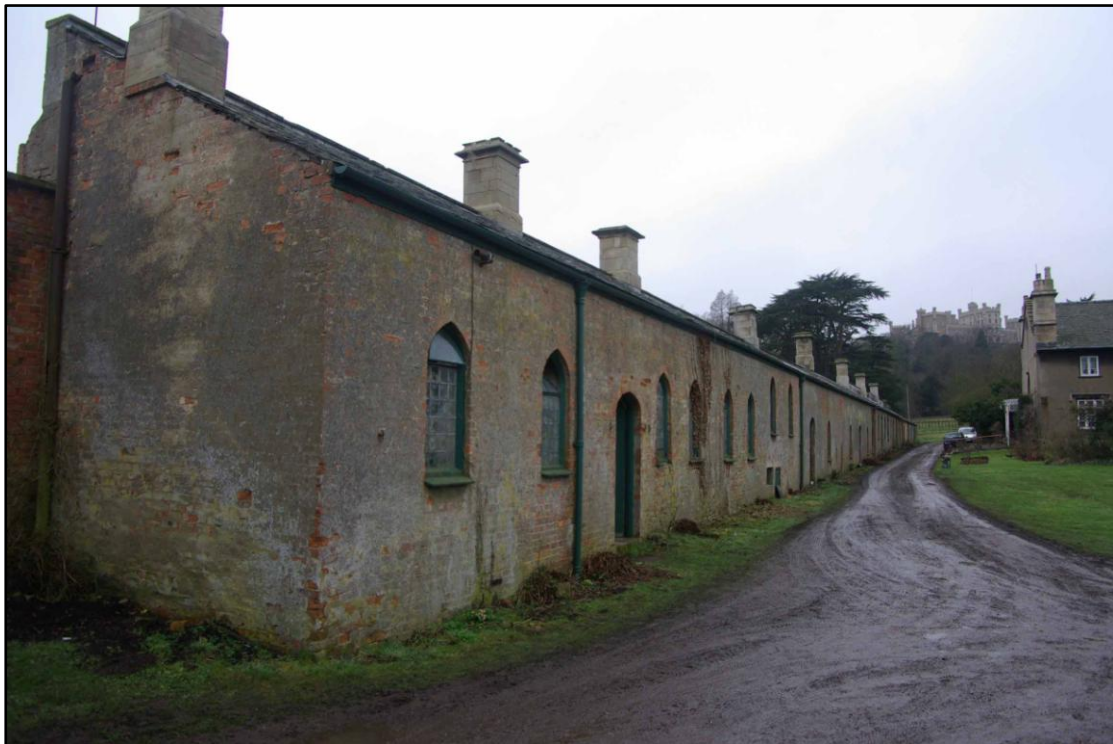
The subject of this study forms the eastern end of an attractive range of lean-to buildings extending along the whole length of the northern wall of the garden (fig. 4). The whole range is uniformly constructed of red bricks measuring 215mm x 65mm x 105mm wide laid in an English bond. A thin skim of cement render has been applied to the outer face of the building although it is not clear if this is an original treatment or a later addition. In many places this skim is flaking quite badly to expose the brickwork beneath. A number of small brick sized cast iron vents pierce the wall at irregular intervals at ground level. The original cast iron gutter and downpipes survive. The roof is covered in grey slates laid with diminishing sized slates towards the ridge formed by the garden wall. Further west along the range the garden wall is raised to form a higher parapet. Set at intervals along the length of the building are a series of ashlar limestone chimneys rising from the back wall except for the easternmost chimney which is set part way down the roof.

Figure 4. Bothy range looking west.

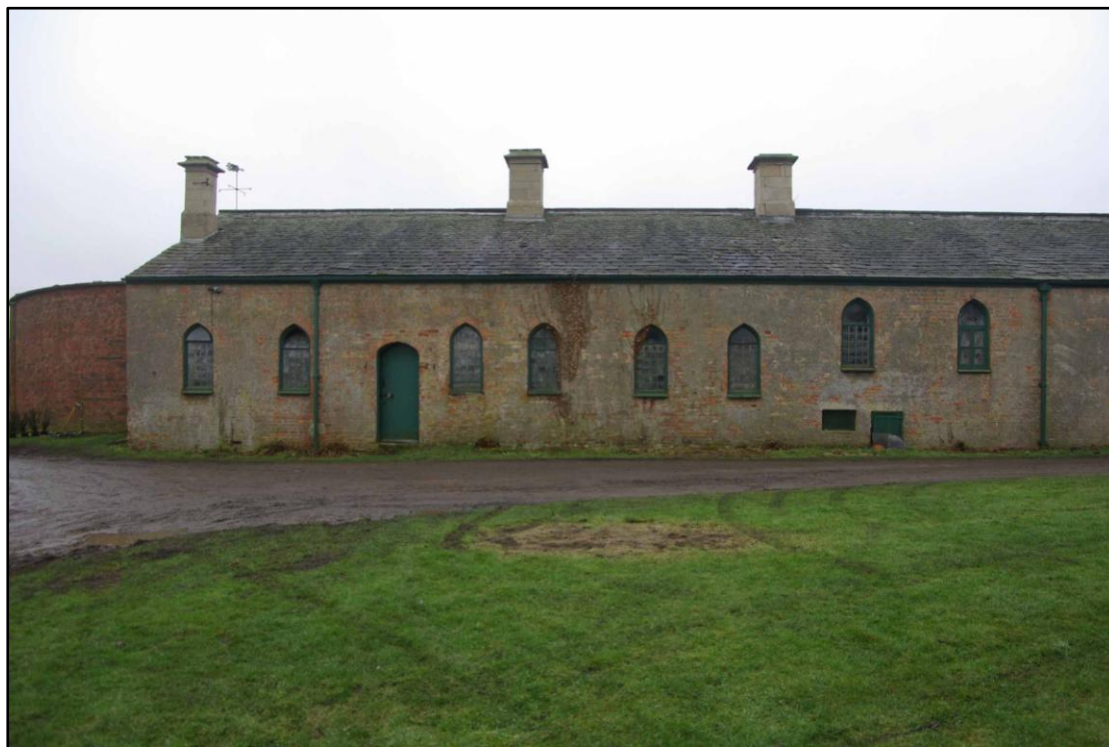
The bothy, which is the subject of this survey, has eight gothic style windows set within plain brick openings with a single row of brick headers forming the pointed arch head (figs. 5 and 6). The basic design of each window is of rectangles of leaded glass attached to narrow metal horizontal cross pieces giving the glass some stability. However the detail of each window is slightly different and warrants a brief description of each. Numbering each window from east to west they are as follows:

Figure 5. Bothy.
Looking south.

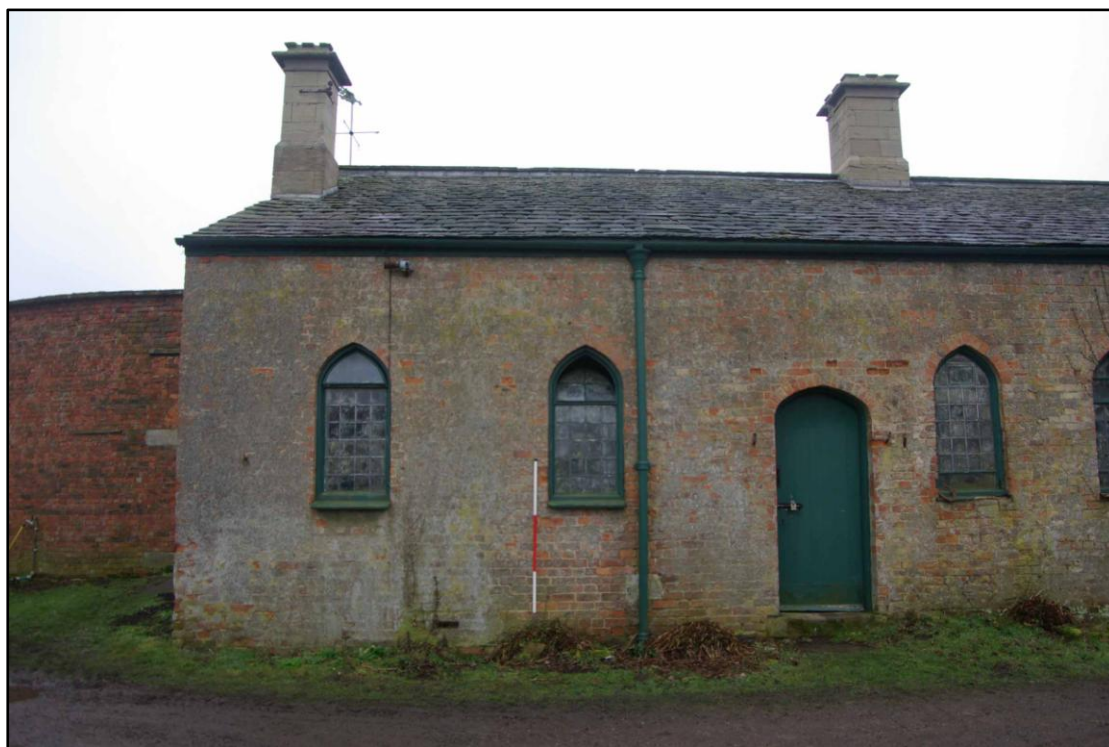
Figure 6. Windows 1-3 and door detail.

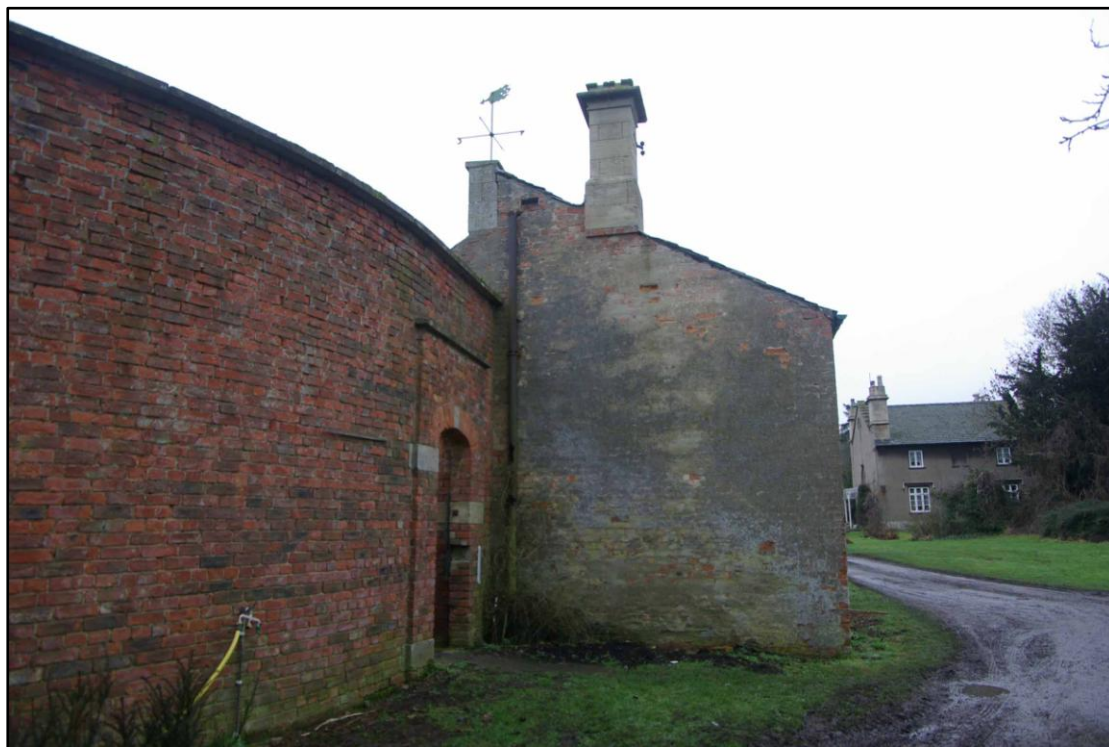
The eastern face of the bothy is of plain rendered brick and appears to join the garden wall as one continuous phase of construction (fig. 7). The garden wall bricks have the same dimensions as those used for the bothy range and are again laid in English bond courses. Access to the walled garden is through a small arched gateway to the east of the bothy.

Figure 7. Eastern wall and walled garden entrance.
Looking west.

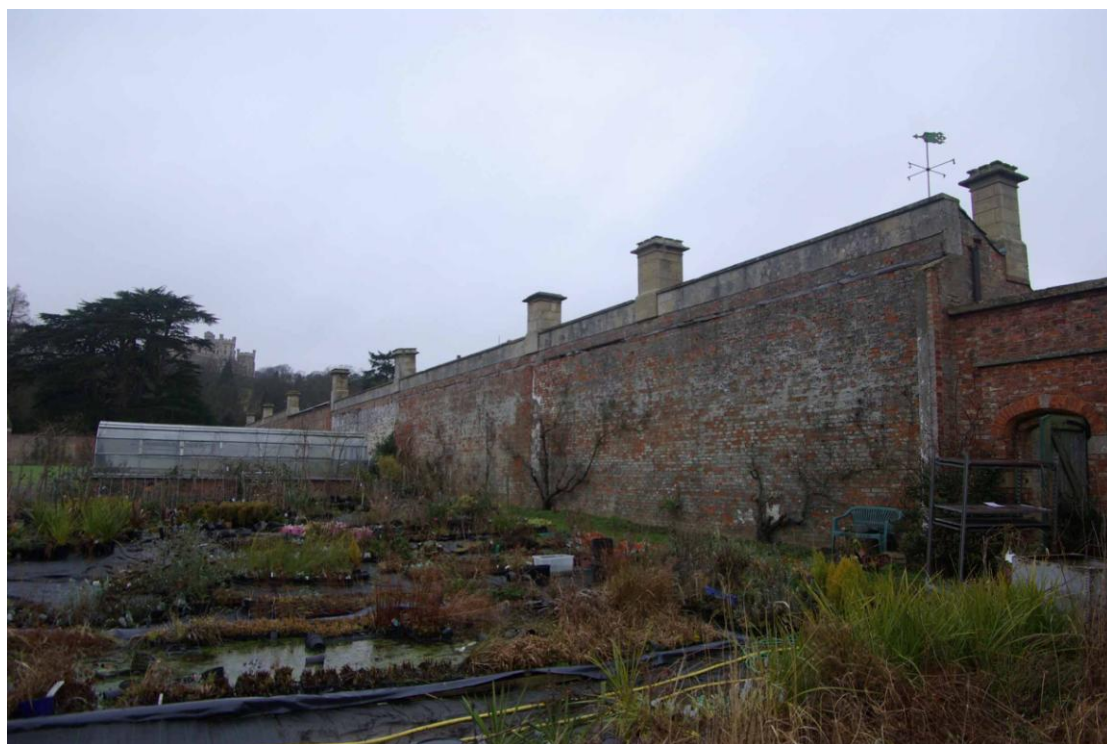
The south face of the bothy is the northern wall of the walled garden as mentioned above (fig. 8). A timber beam runs below the limestone parapet giving the impression that at one point a lean-to glasshouse was attached to this wall. A small brick arched opening has been bricked over at ground level in the eastern corner and two similar openings below the third chimney (from the east) have also been blocked with brickwork. The function of these openings is not clear and they cannot be seen from rooms five and six inside the building.

Figure 8. South wall of bothy from walled garden.
Looking north west.

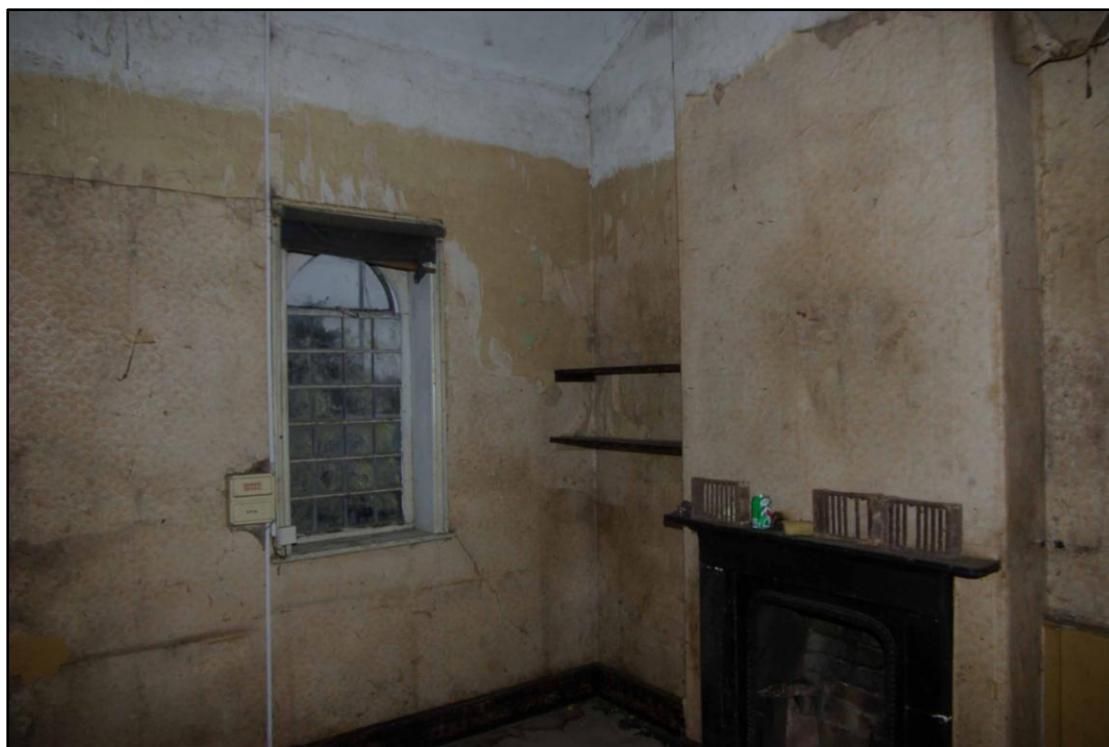
This room has a raised wooden floor and is entered from room two through a 4-panelled door. A cast iron fireplace with a 0.52m wide opening is located on the eastern wall hence the offset chimney discussed above (fig. 9). There is a cement hearth let into the floor around the fireplace. Wooden panelling up to dado height is attached to the wall to the south of the chimney breast, whilst plain wooden boards form two shelves to the north. The window, in common with all the others, has a wooden sill and casements with a moulded bead decoration around the inside. Rudimentary roller blinds of indeterminate date act as curtains. The skirting board has some beading detail along its upper edge and is 0.18m high. The plasterwork has been affected by damp and is in a fairly poor state of repair and is flaking off in places to reveal the brickwork beneath. Elsewhere a number of layers of wallpaper survive, some with the border still present with "CROWN MADE IN ENGLAND" printed along it. There is no evidence of the blocked opening seen on the southern outside wall.

Figure 9. Room one.
Looking north-east.

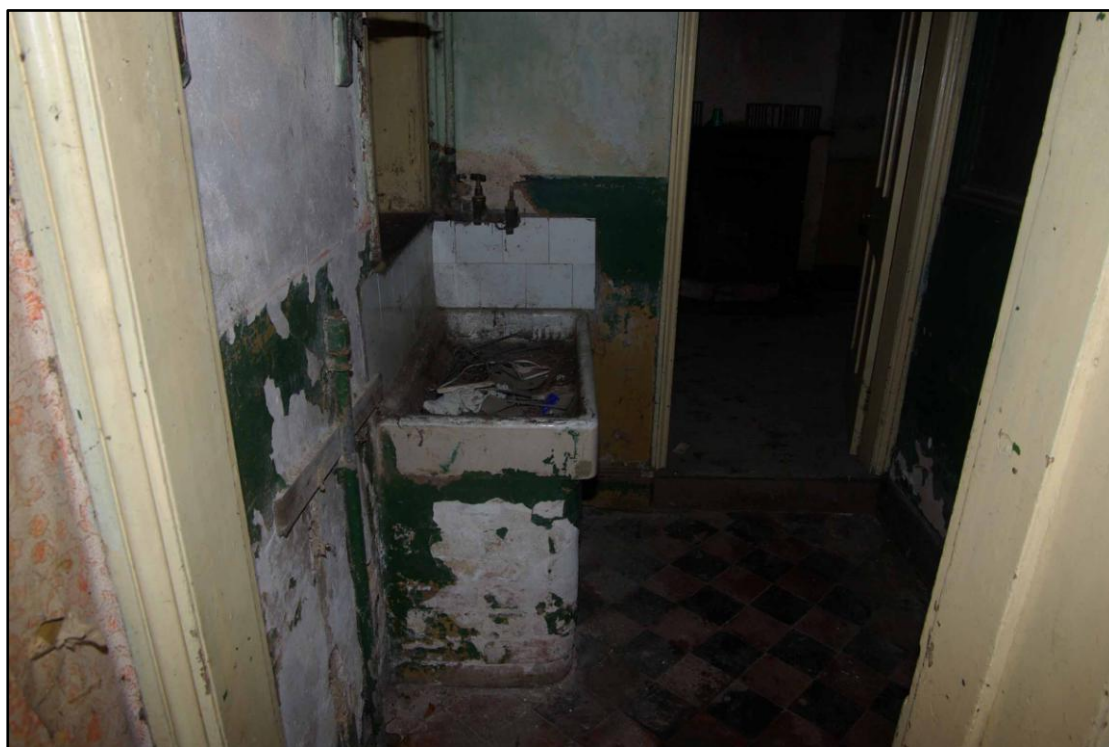
The door between rooms two and three is missing although the wooden doorframe is still in place. The floor has alternate red and black 6" quarry tiles set in a diamond pattern. All plasterwork is painted to waist height in a dark green with a pale blue-green above and on the ceiling. A large shallow sink resting on two brick piers is built into the north east corner (fig. 10). A brick wall divides this room into two along an east to west axis to create a substantial pantry with a wooden door and a small mesh window (fig. 11). Some of the pantry shelving remains although it is doubtful if this is original.

Figure 10. Room two.
Looking east.

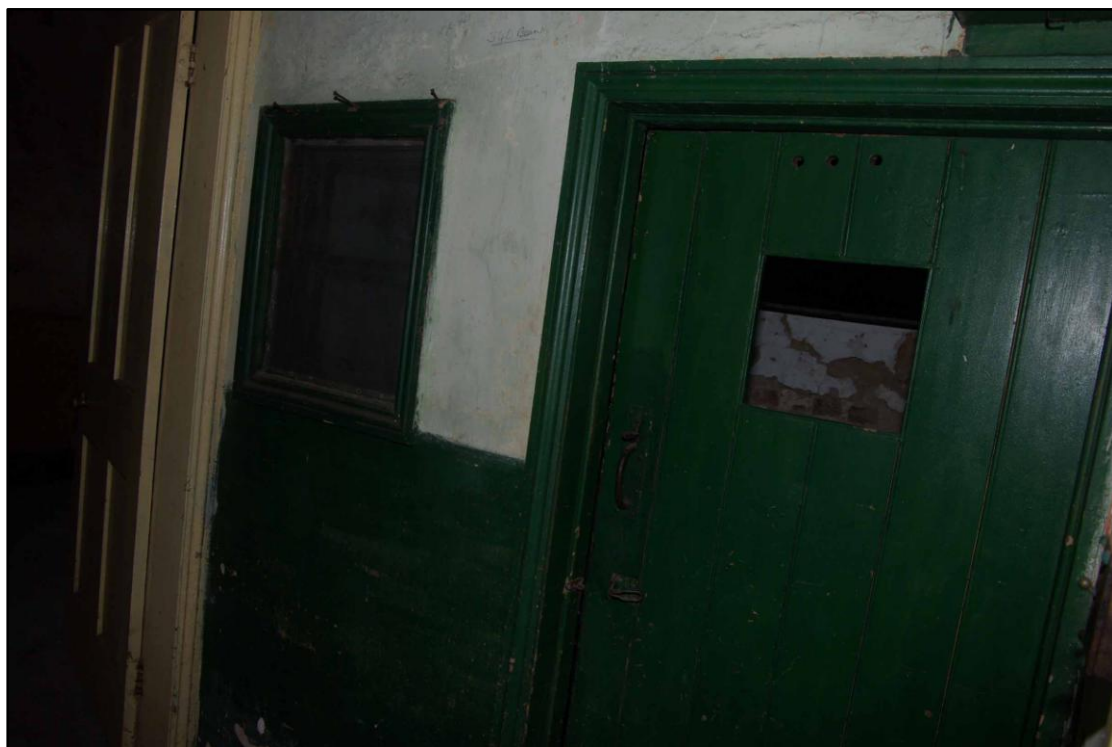
Figure 11. Pantry door and window.
Looking south-east.

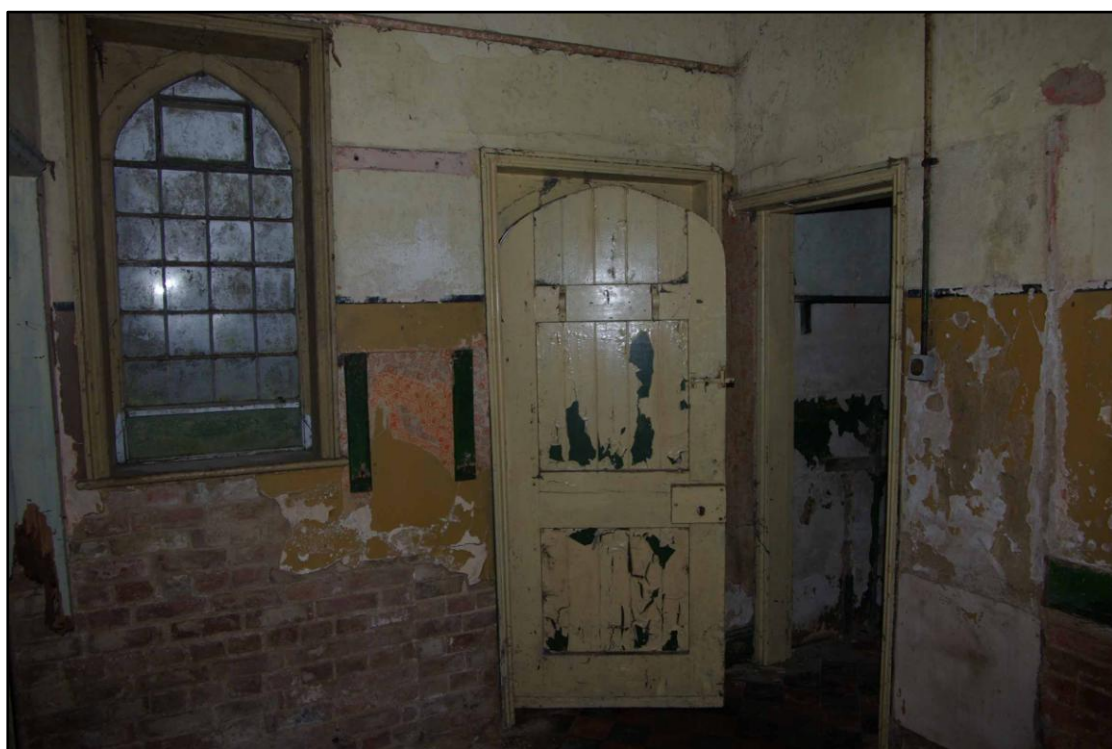
This room is the main entrance room for the building and appears to have been used as the kitchen (fig.12). Quarry tiles as seen in room two are used for the flooring. A 1950s style range with a raised hearth is located on the southern wall. A large four-door wooden cupboard with relatively fine moulded door and cornice detail is built in to the recess at the eastern side of the chimney breast (fig. 13). Apparent damp problems have caused extensive damage to the wall plaster and may also be responsible for the lack of skirting boards which only survive in places.

Figure 12. Room three and front door.
Looking north-east.

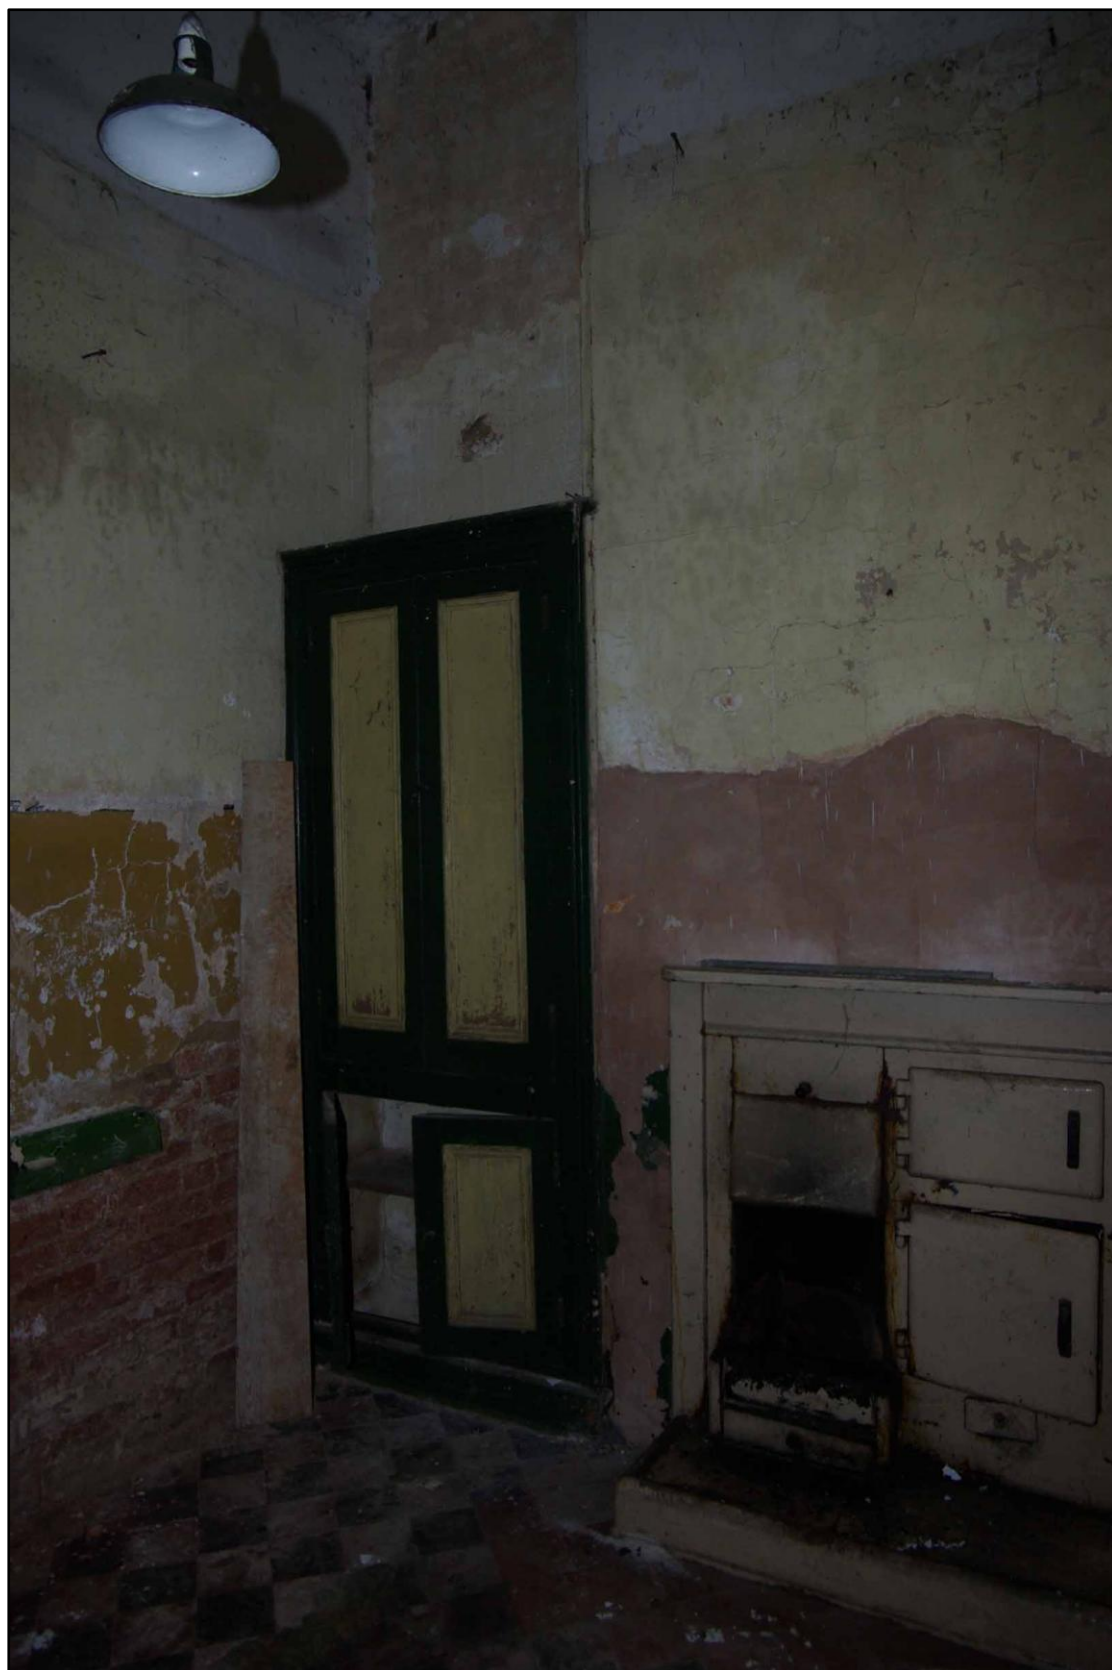
Figure 13. Room three range and cupboard.
Looking south-east.

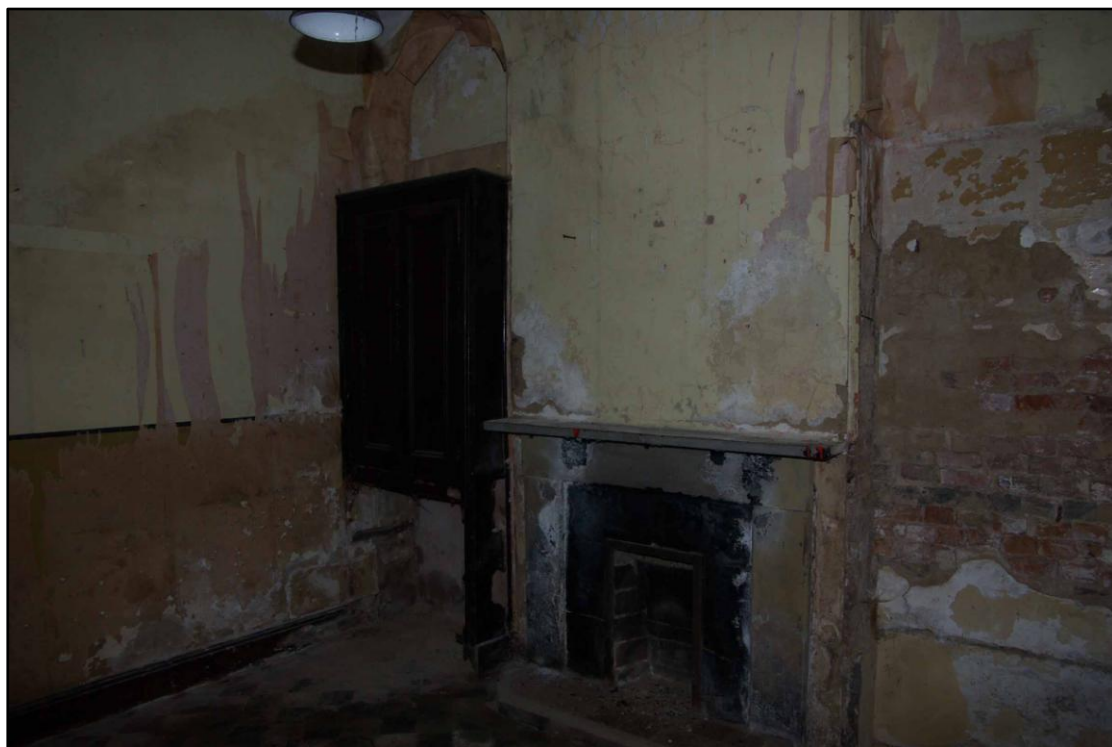
Room four is the largest room of the bothy having two outside windows and a large central hearth constructed from limestone (fig. 14). The fireplace has had its internal fitting removed to leave the bare stonework. A damaged cupboard similar to that seen in room three is located to the east of the chimney breast. There is also evidence in the plaster and paintwork to indicate that until recently there was another matching cupboard to the west of the chimney. The quarry tiles continue from room three into this room. Again damp has caused extensive damage to the plasterwork and skirting boards.

Figure 14. Room four fireplace and cupboard.
Facing south east.

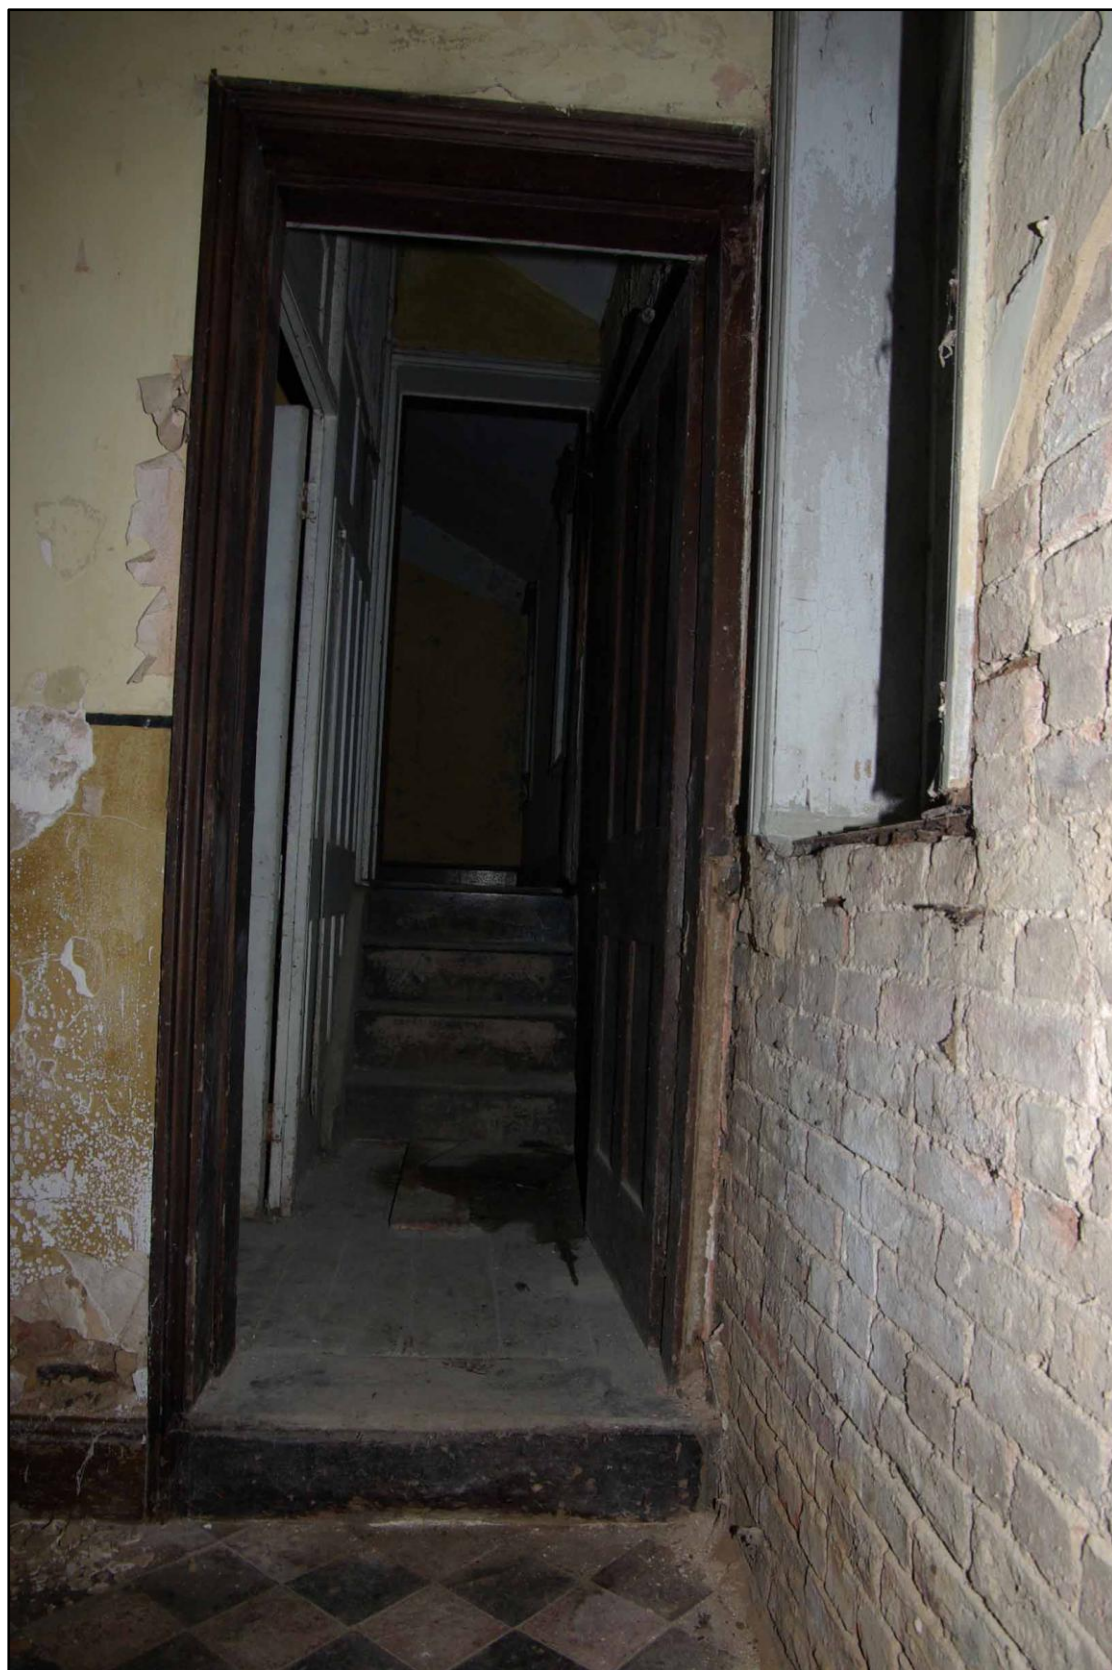
Room five has a wooden floor and serves as a bathroom with a wood and glass partition separating the bathroom from the corridor which leads up three steps to room six (fig. 15). The partition has patterned moulded glass with iron bars at the top reaching to the ceiling (fig. 16). A boarded over water tank is located high up on the southern wall next to an undecorated wooden cupboard with panelled doors. The ceiling over the corridor shows some evidence of water ingress causing some damage and collapse.

Figure 15. View from room four through room five and stairs to room six.
Looking west.

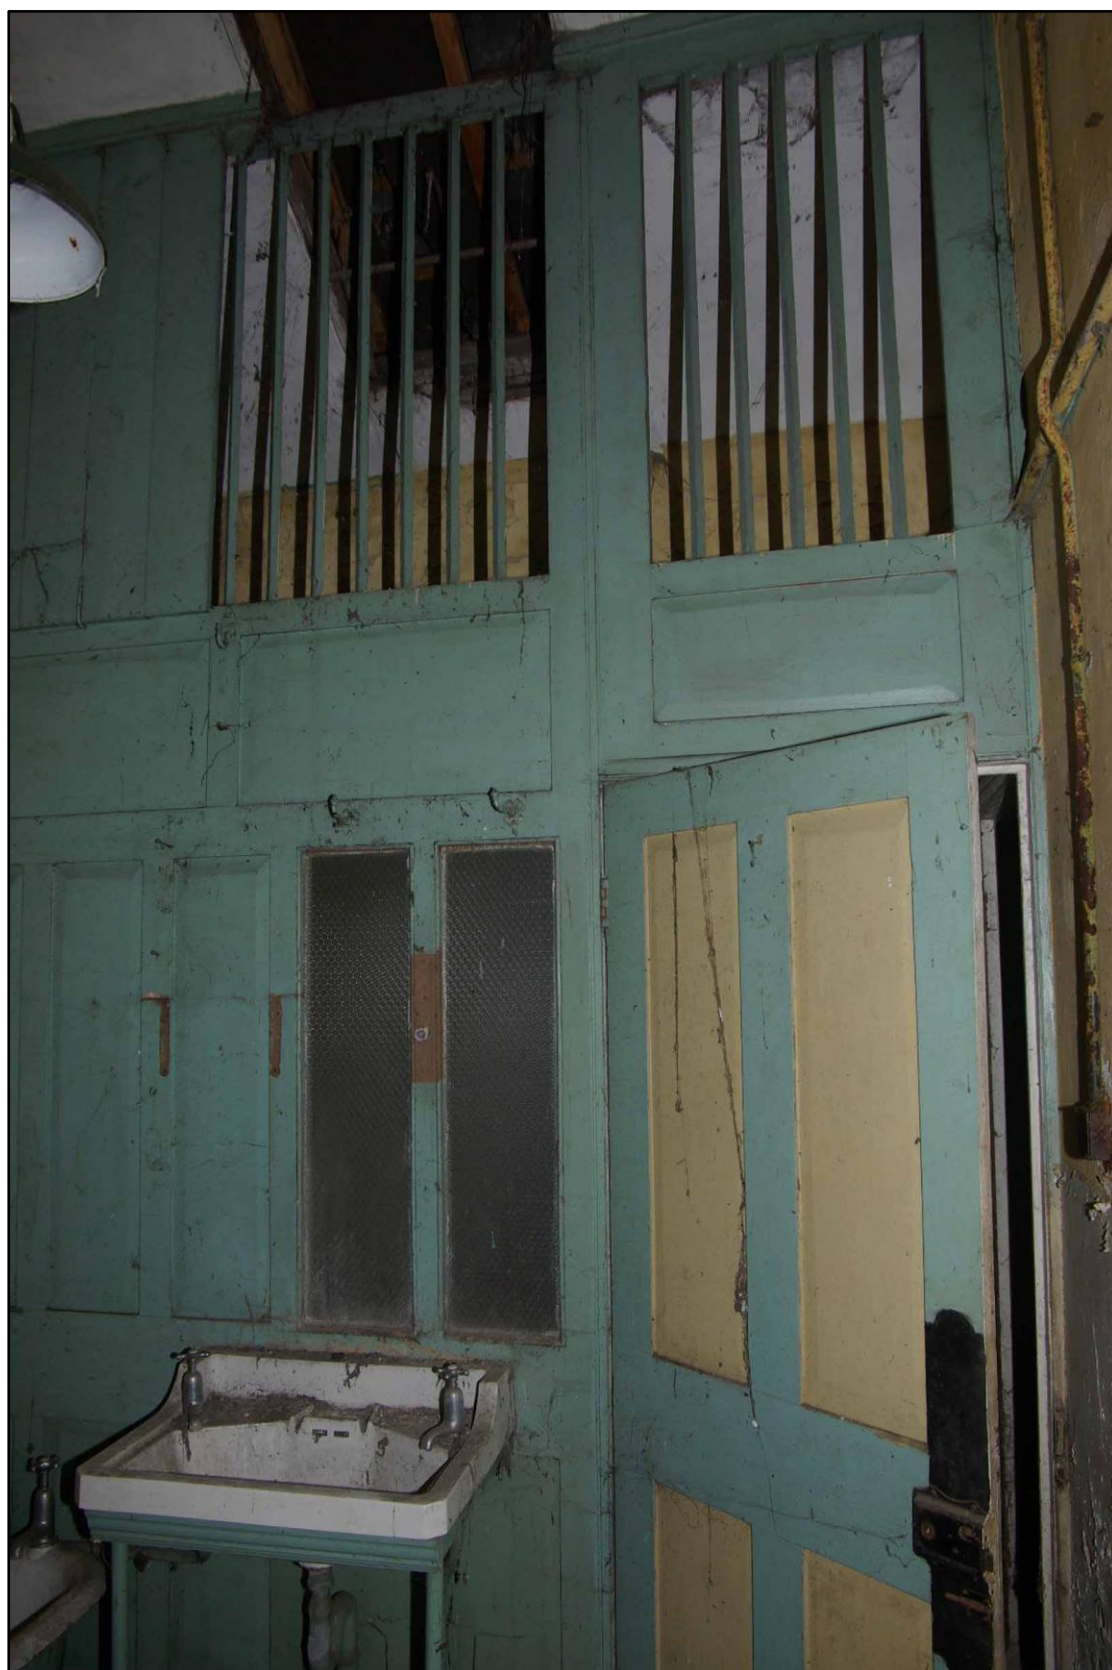
Figure 16. Room five bathroom partition.
Facing north.

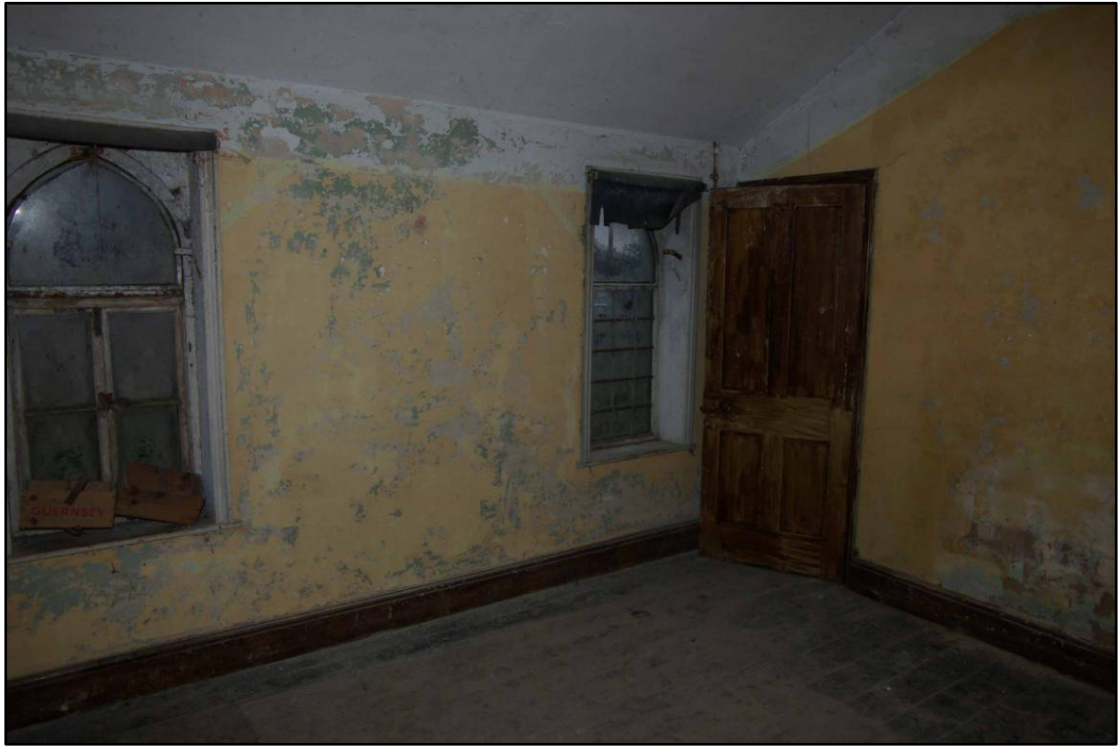
Figure 17. Room six.
Facing north-east.

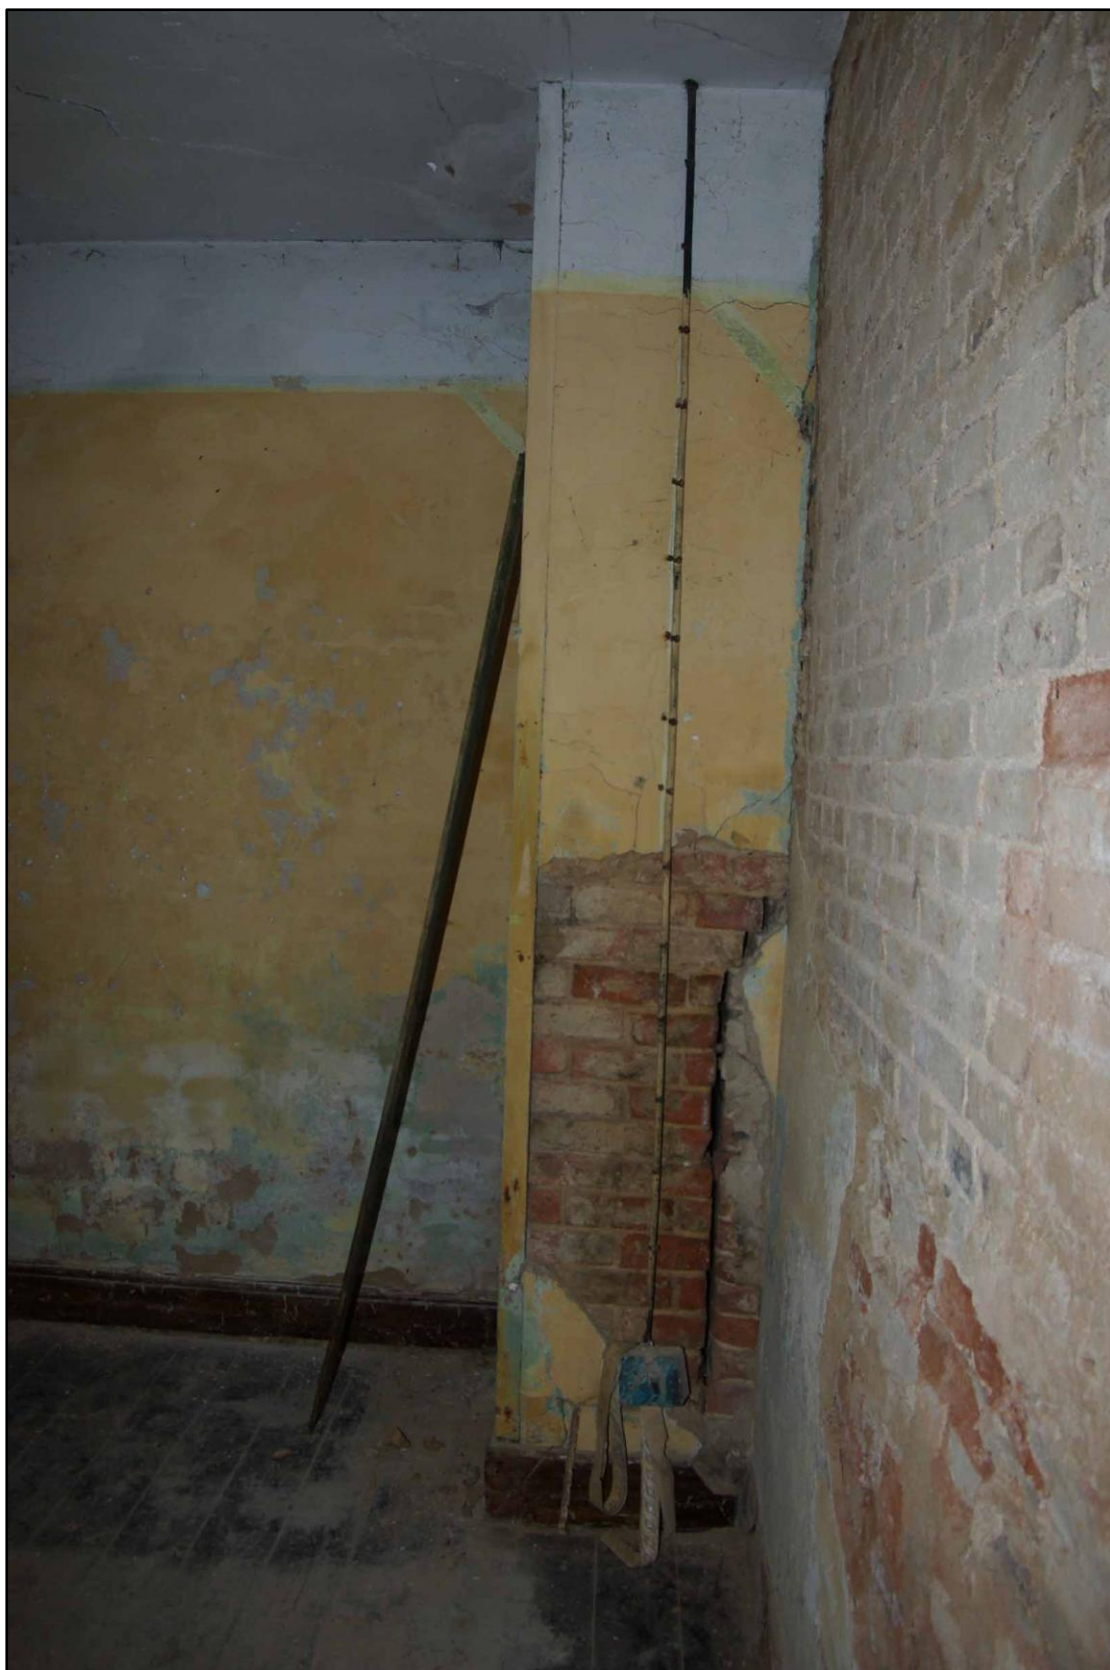
The wooden floor of room six has been deliberately raised to accommodate the coal store beneath which appears to be part of the original design. The wooden 4-panelled door with lock and brass door knob is still present as are the beaded skirting boards except on the south wall which has also been stripped of all plasterwork (fig. 17). The chimney breast in the south-east corner has no visible fireplace or evidence of a blocked fireplace. It does however have a straight line joint against a smaller buttress built into the wall which indicates that this may be a later addition (fig. 18).

Figure 18. Room six. Straight line joint at chimney.
Looking east.
