An Historic Building Photographic Survey

The East Pavilion, Leesthorpe Hall,

Pickwell Road, Leesthorpe, Leicestershire

ULAS Report Number 2009-074 ©2009 Accession Number: XA.131.2009

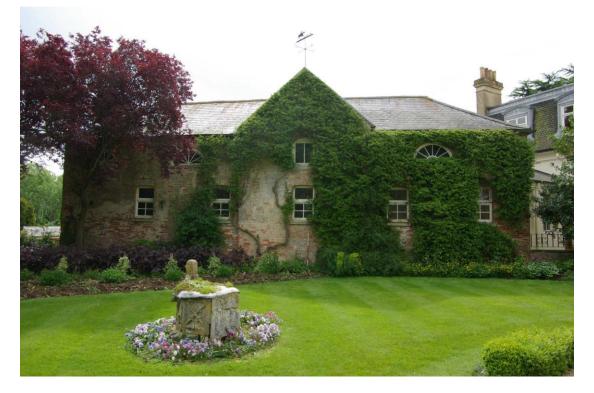
The north-west elevation is the principal elevation of the building and is constructed of handmade red bricks with a slate roof (figs. 8 and 9). Much of this face is covered in vegetation making a detailed study difficult. The ground floor has five wooden framed windows each with a tilting upper pane. The first floor semi circular windows all have varying styles of glazing bars despite being of the same size. An off centre brick gable with a first floor circular window has been built using larger bricks to those on the main face and appears to be a later addition (fig. 10). There is evidence of a blocked doorway being converted into a window on the ground floor of the bay (fig. 11). A blocked window can be seen between the two ground floor windows at the northern end of this elevation (fig. 12).

Figure 8 North-west elevation

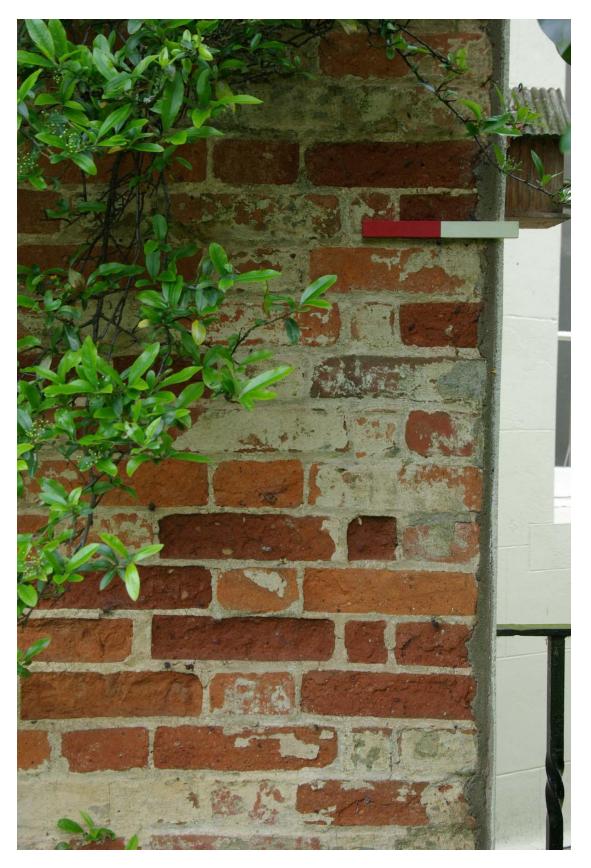
Figure 9 Brick detail at south-western corner of north-west elevation 20cm scale

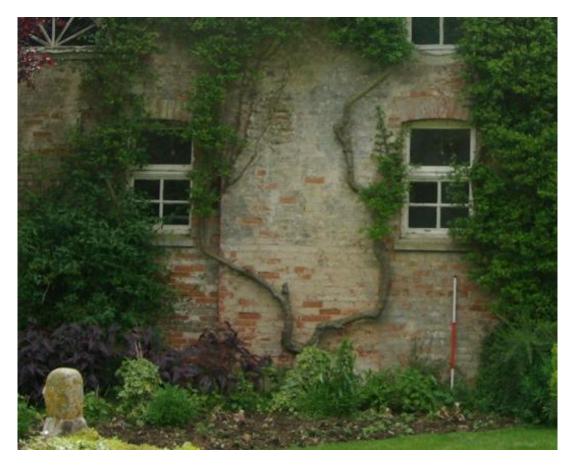
Figure 11 Blocked opening beneath ground floor gable window 1.5m scale

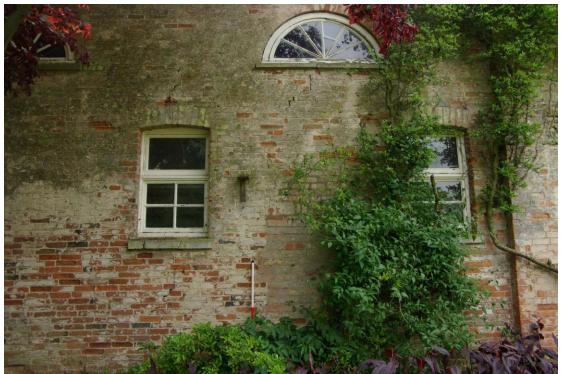
Figure 12 Blocked doorway on north-west elevation

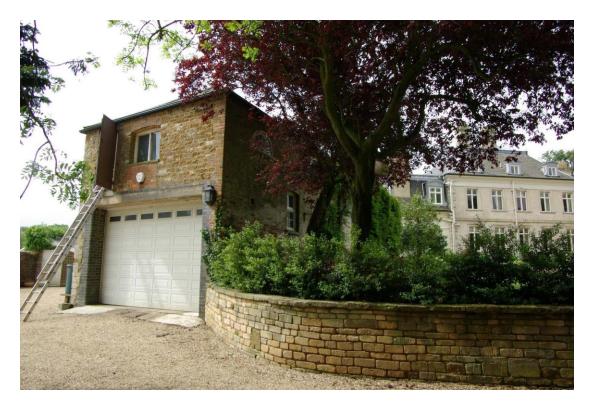
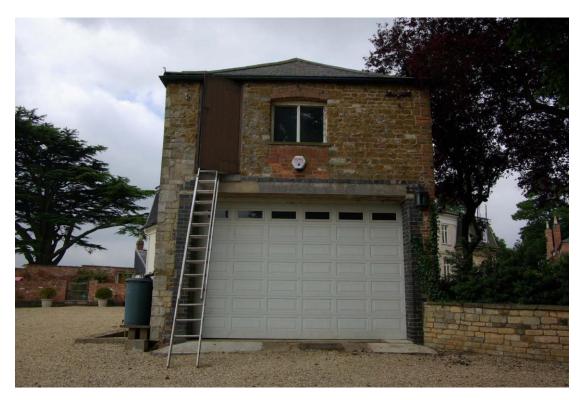
The north-east elevation is constructed from locally quarried coursed ironstone rubble with the bricks from the north-west elevation being keyed into the stone to form decorative quoins (fig. 13). Limestone quoins can be seen on the south-eastern corner. Much of the wall at ground floor level is obscured by the insertion of a large garage door with blue brick surround (fig. 14). A single door at first floor height is the only access to this level. To the west of the doorway is a small window with brickwork

blocking an earlier opening below it. There is also evidence of a smaller window being built within this blocking which was then subsequently blocked.

Figure 13 North-east elevation

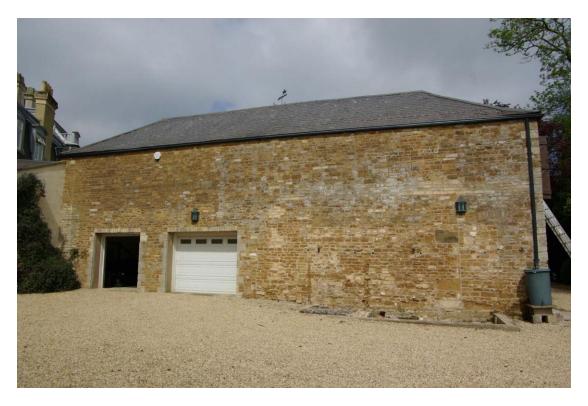
The south-eastern elevation is also constructed from coursed ironstone rubble (fig. 15). There appears to be a straight line joint in the masonry approximately 2.25m from the north-eastern corner indicating that the building has been extended. Large blocks of ironstone have been used for the quoins of the original corner. The remains of a segmental headed blocked window can be seen in the extended section of the wall. A wooden lintel is situated above one of the two modern garage doors and indicates the presence of an earlier opening. Two small blocks of limestone have graffiti carved into them in the form of initials and symbols (figs. 16 and 17). A scar at the eastern end of this elevation reveals where a small single storey structure was once attached.

Figure 15 South-east elevation

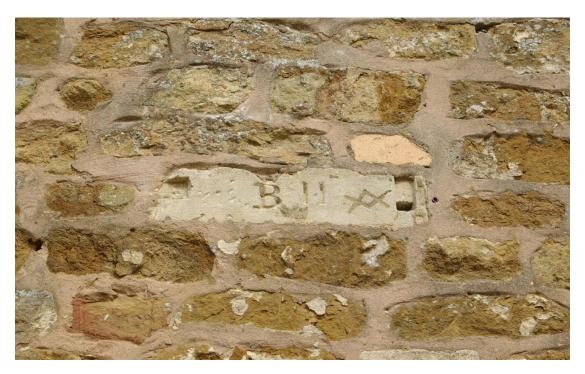
Figure 16 Graffiti on south-east elevation

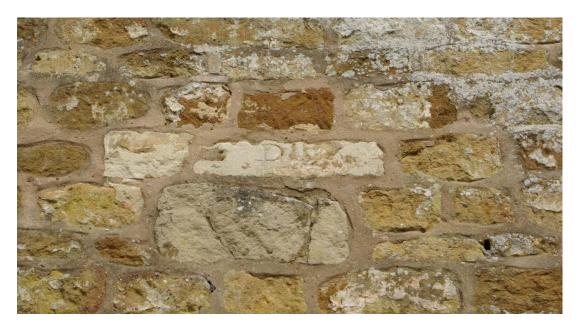
Figure 17 Graffiti on south-east elevation

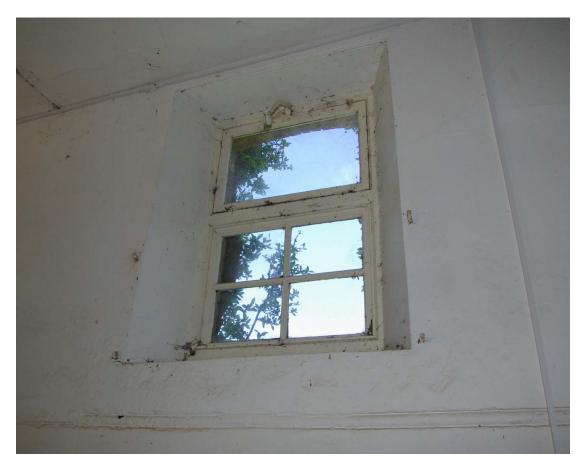
Figure 20 Ground floor window detail and plaster bead beneath

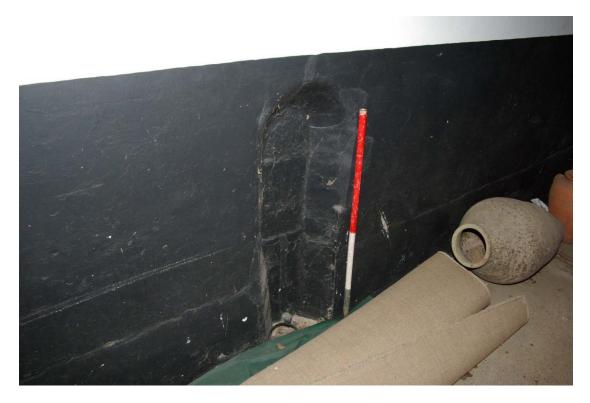
The ground floor is a single open room running the length of the building (figs. 18 and 19). It has a concrete floor and plaster boarded ceiling. The windows on the north western side are set above head height and have metal fittings either side presumably for shutters or covers (fig. 20). A moulded plaster bead runs around the room below window height and is cut by the modern garage doors. A wooden boarded partition, or downstand beam, is suspended from the ceiling with a corresponding line in the concrete floor. This is the only evidence of possible internal divisions. A small recess has been cut into the thickness of the south eastern wall for a tap which may be a modern modification (fig. 21).

Figure 21 Recess in south-eastern wall 1m scale

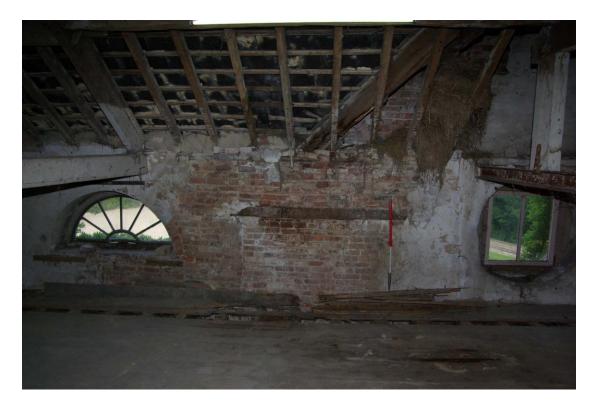
Figure 31 Blocked opening behind gable 1m scale
