**An Historic Building
Photographic Survey at
Cophill Farm,
Launde Road, Loddington,
Leicestershire.
NGR: SK 798 031**

ULAS Report No. 2009-146
©2009

For: Mr A Collie

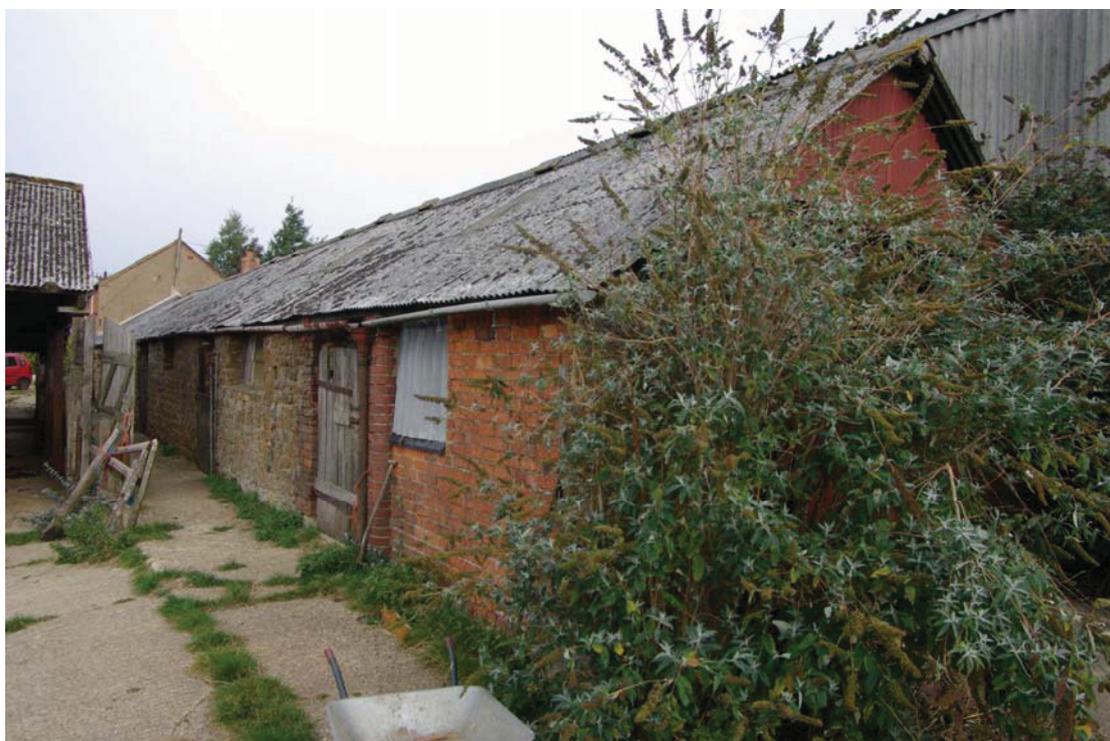
This elevation faces what would originally have formed an elongated courtyard opening out onto fields at the south-eastern end (fig.13). A straight line joint between the barn and the ironstone cottage wall indicates that it is either of a later date or that an open-bay has been filled in that once extended as far as a second straight line joint 6m to the east (fig.14). Four doors pierce this elevation at irregular intervals. From west to east, the first door has a plank and batten door with handmade brick reinforcement around the jambs. The door has a plain wrought iron latch. The wall appears to be unmarked as far as the next door which is a $\frac{3}{4}$ height plank and batten door. The iron hinges have spearhead style decorative ends of the same pattern seen on the pig-pen doors which may indicate a similar construction date (fig. 15). A small window at eaves height between the second and third doors appears to be original and has a wooden frame and concrete sill. The third door is a modern replacement with modern fittings set within the original opening which has brick reinforced jambs. To the east of the third door is a second window at eaves height again with a wooden frame and concrete sill. The window extends almost as far as a straight line joint in the stonework. Beyond this joint is the fourth and easternmost door. The flat strap hinges have decorative incised fullers at their ends and the handmade latch has a Saltaire cross detail which is a commonly used apotropaic mark (fig. 16). Such decorative features went out of use in the 18th century, however the latch is attached to the door by Phillips screws and is therefore likely to be a reclaimed fitting from an earlier door. A pillar made of rounded bricks forms the eastern door jamb beyond which larger sized bricks infill what appears to have been a large opening extending to the stone built south-east corner of the barn (fig. 17).

Figure 13 SW elevation of Barn A
Looking north-west.

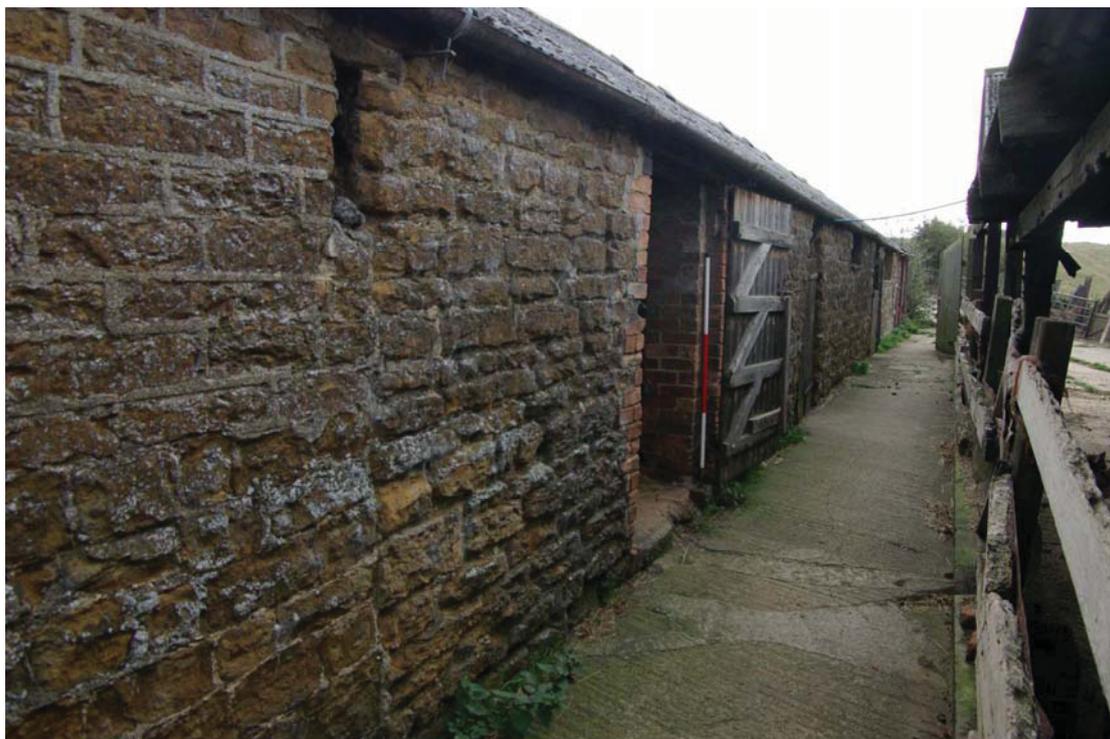
Figure 14 Barn A. Straight line joint
Looking east. 1.5m scale

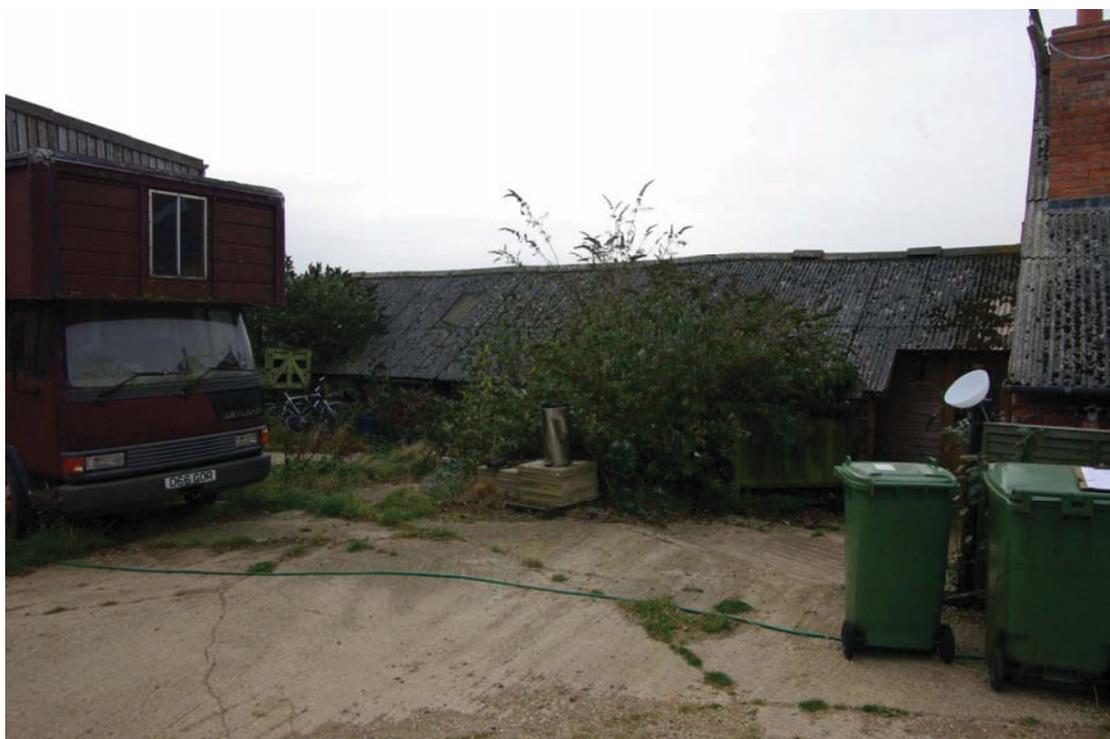
Most of the north-east elevation is obscured by the modern barn built up against the wall of Barn A (fig. 19). It is proposed that this later barn will be dismantled and moved to a position to the north-east of the present complex. Currently the ground level of the concrete yard is approximately half way up the wall of Barn A. However the presence of two doorways in the north-west elevation suggests that the ground was slightly lower and that it has been remodelled to create a level platform on which to build the later barn. The eastern doorway is completely blocked by the later barn and cannot be seen from the outside at all. The western door can still be seen but is currently unusable as the lower half has been blocked with concrete presumably to prevent rainwater washing down into the barn (fig. 20).

Figure 19 Barn A NE elevation
Looking south.

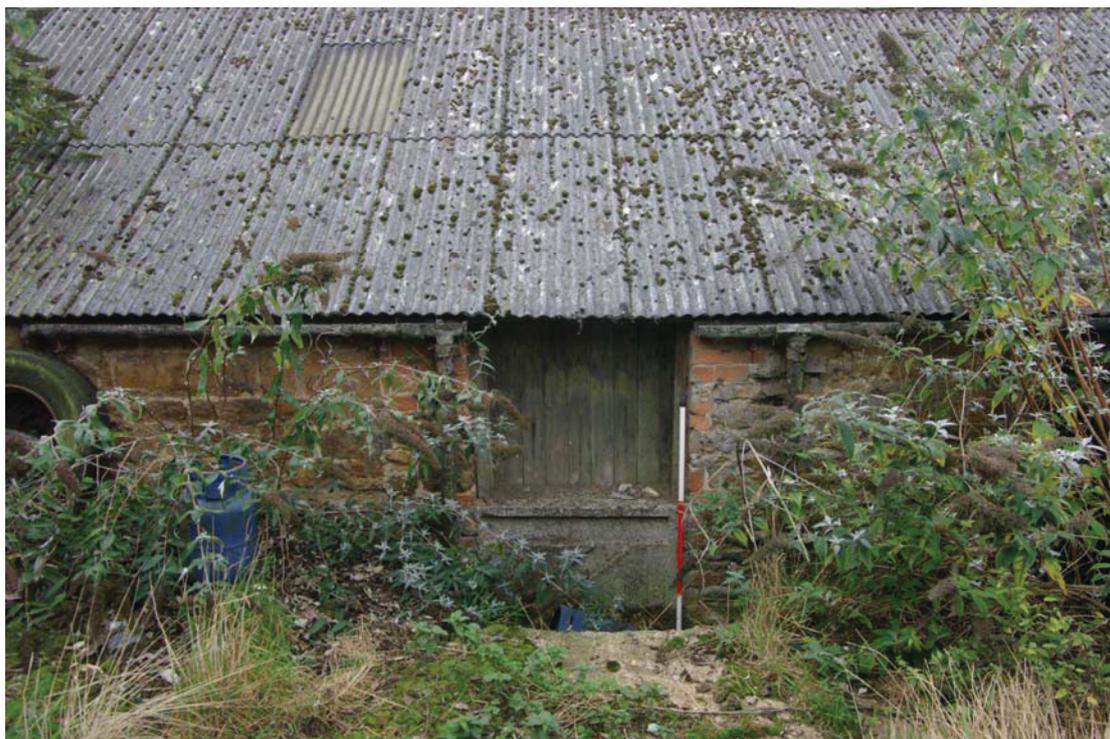
Figure 20 Barn A NE blocked doorway
Looking south-west. 1.5m scale.

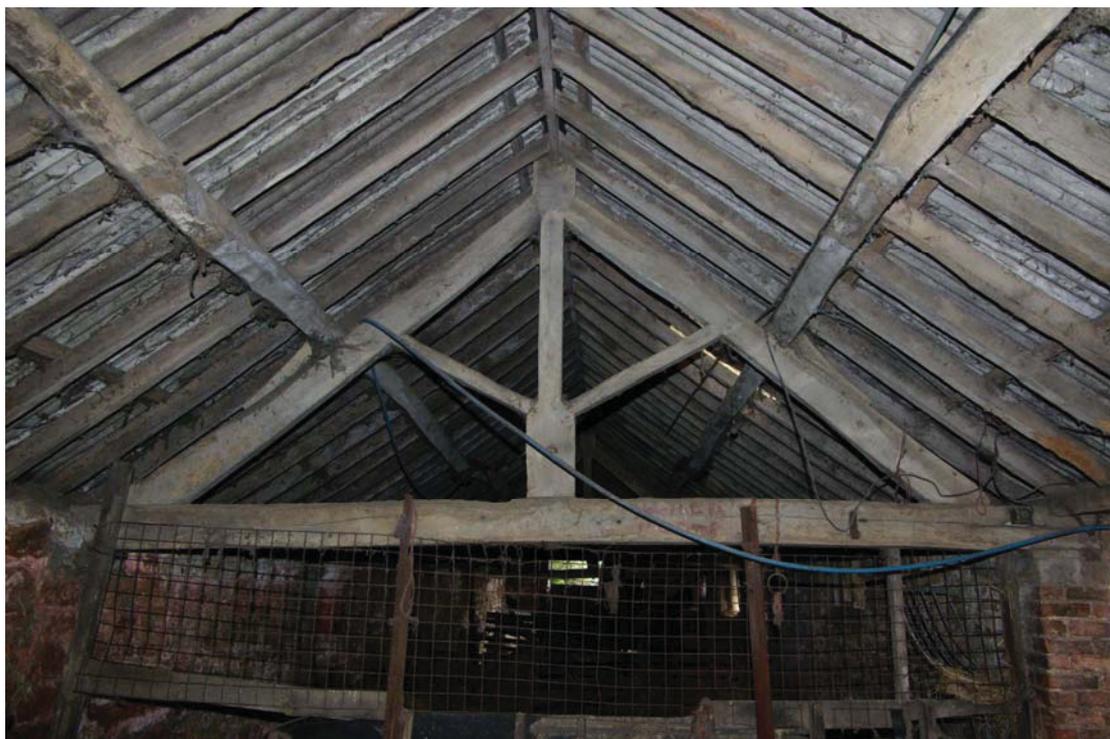
The barn was originally constructed with seven bays but two of the roof trusses have been removed at some stage. At each roof truss low wooden fences divide each bay to create loose boxes presently used for horses and storage but likely to have been designed for cattle. The first bay, at the west end, has a brick wall to the west dividing the barn from the cottage outbuilding (figs. 21 and 22). The straight line joint seen on the south-west elevation can be seen on the inside and on the north wall although the purpose of this is not clear. A slit window on the north wall mirrors the one already noted on the south wall. The blocked doorway to the north-east can be seen on the north wall still with the wooden door in place. The floor is of red brick and is badly worn. The roof truss at this point is of a different pattern to the remaining three in this barn. Here raking queen struts from the truss support a collar onto which the purlins sit without the use of a principal rafter (fig. 23). The remaining trusses are of typical later 19th century agricultural design with a king post bolted to the truss. Raking struts joined to the king post support the principals with cleated purlins on their upper faces (fig. 24).

Figure 24 Barn A roof structure
Looking south-east.

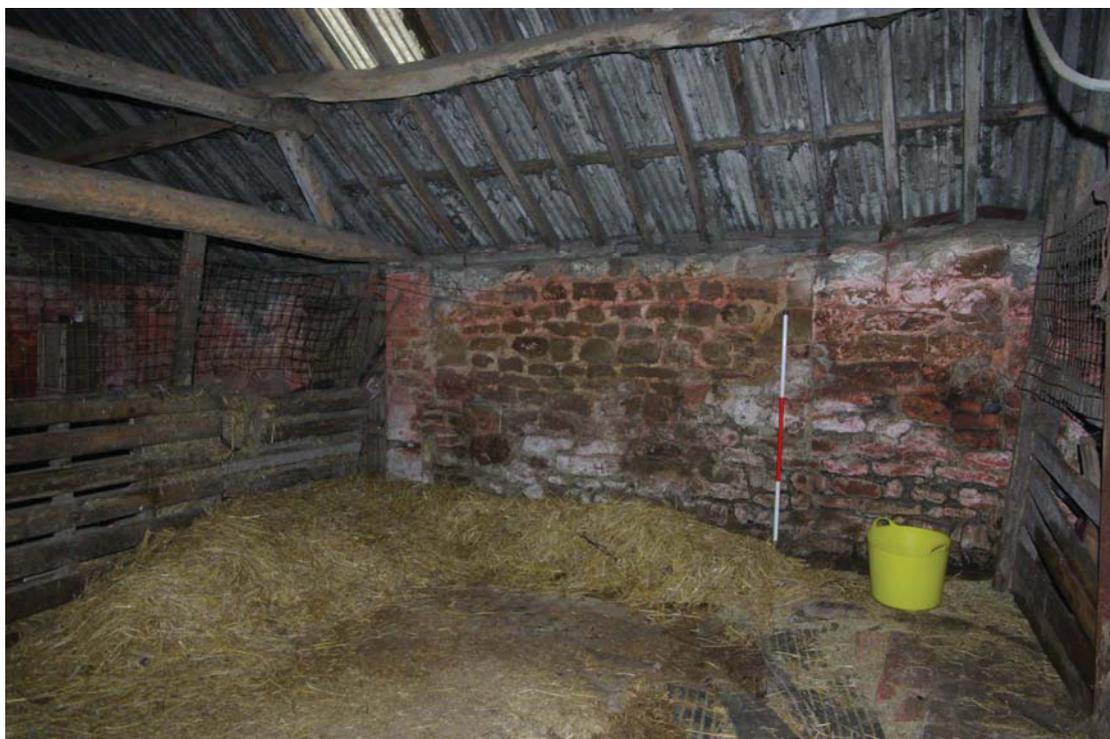
The second bay, from the west, has a straight line joint in the stonework directly opposite the doorway (fig. 25). There is no apparent reason for this and the later barn blocks the outside wall preventing further inspection. As with the first bay this bay has a brick floor (fig. 26).

Figure 25 Barn A second bay and straight line joint
Looking north-east. 1.5m scale.

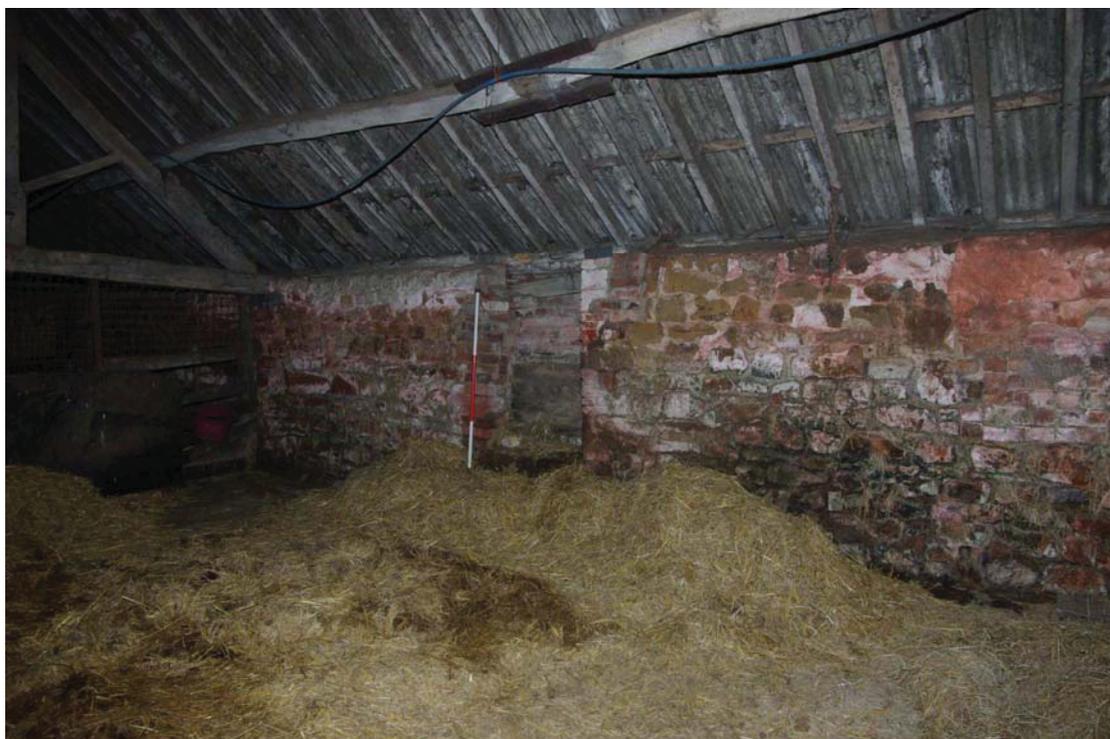
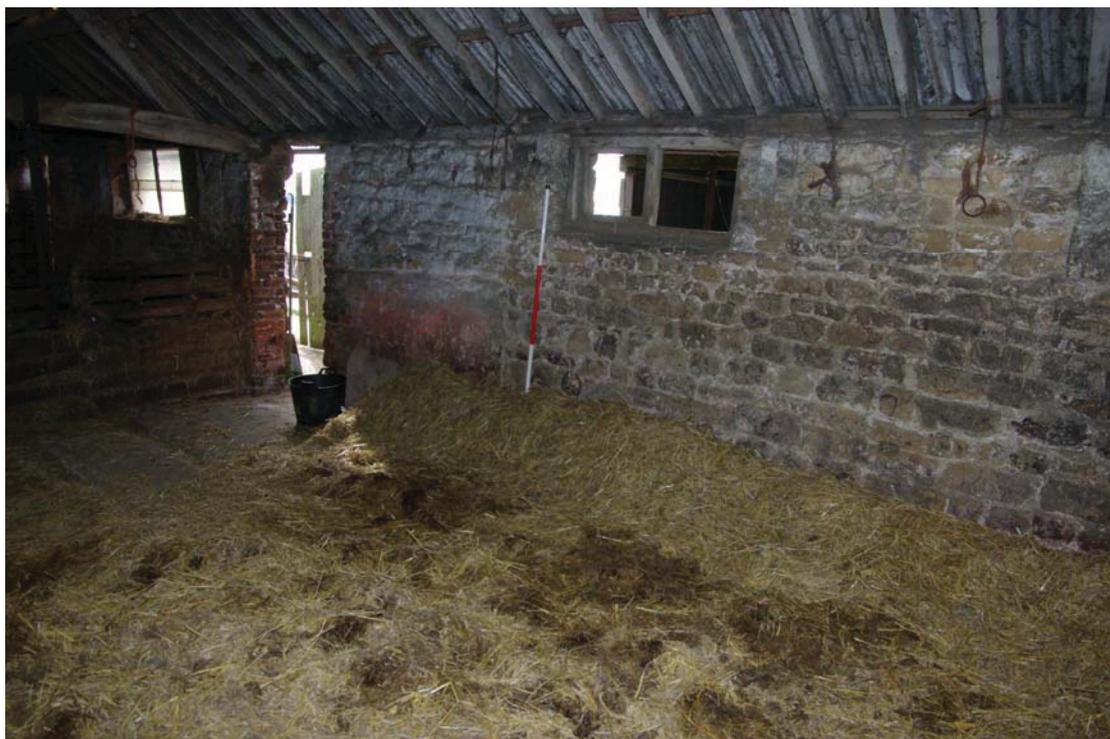
The third bay is of double length as a roof truss has been removed leaving holes in the wall where it was seated in. The purlins have been rather crudely supported by two lengths of L-section iron being bolted to each side but are sagging quite badly. The doorway on the north wall that is obscured by the later barn has been bricked up leaving just the recess and step (figs. 27 and 28).

leaking roof may rot the roof timbers which could account for the two missing trusses that would not need to be replaced if such a lightweight asbestos roof was added.

Figure 27 Barn A blocked doorway and missing roof truss
Looking north. 1.5m scale.

Figure 28 Barn A third bay
Looking south. 1.5m scale.

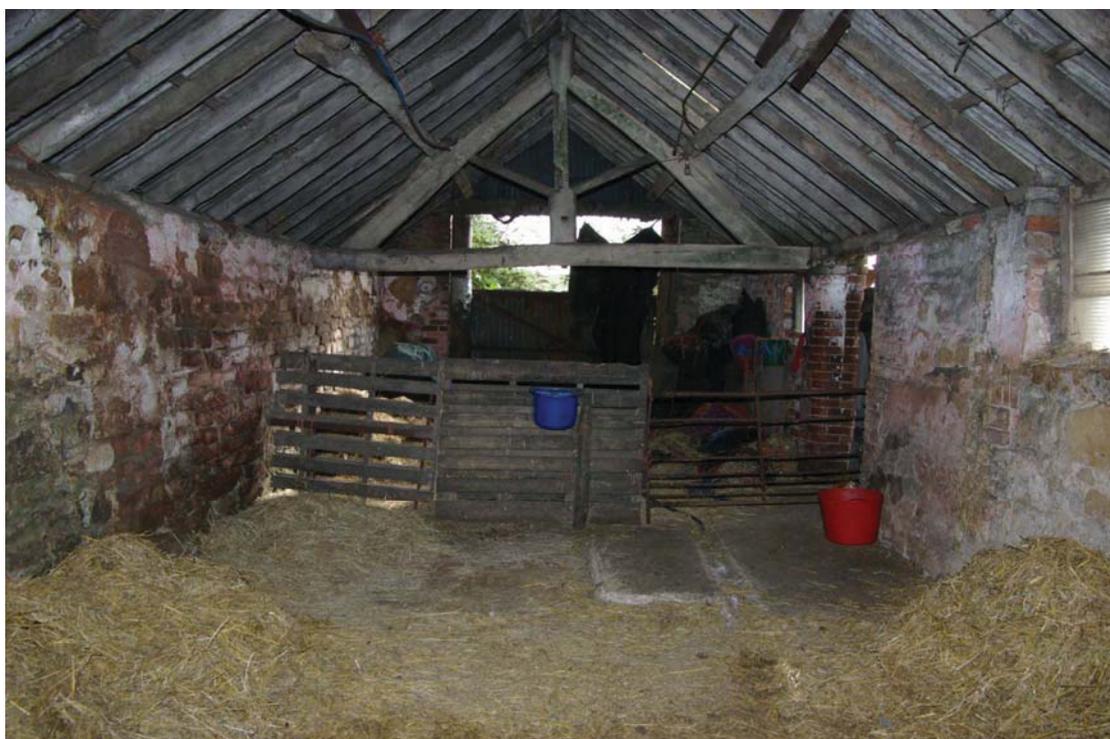
The fourth and fifth bays form an open space which has an earth and cement floor. Another roof truss has been removed leaving the purlins to be supported by more lengths of L-section iron (fig. 29). Large diameter circular pipes set at eaves height on the north wall form what appears to be a row of ventilation holes (fig. 30). The south-eastern gable end is open, as mentioned, and has a modern corrugated sheet metal gate set between the two wooden posts (fig. 31).

Figure 29 Barn A fourth and fifth bays and missing roof truss
Looking south-east.

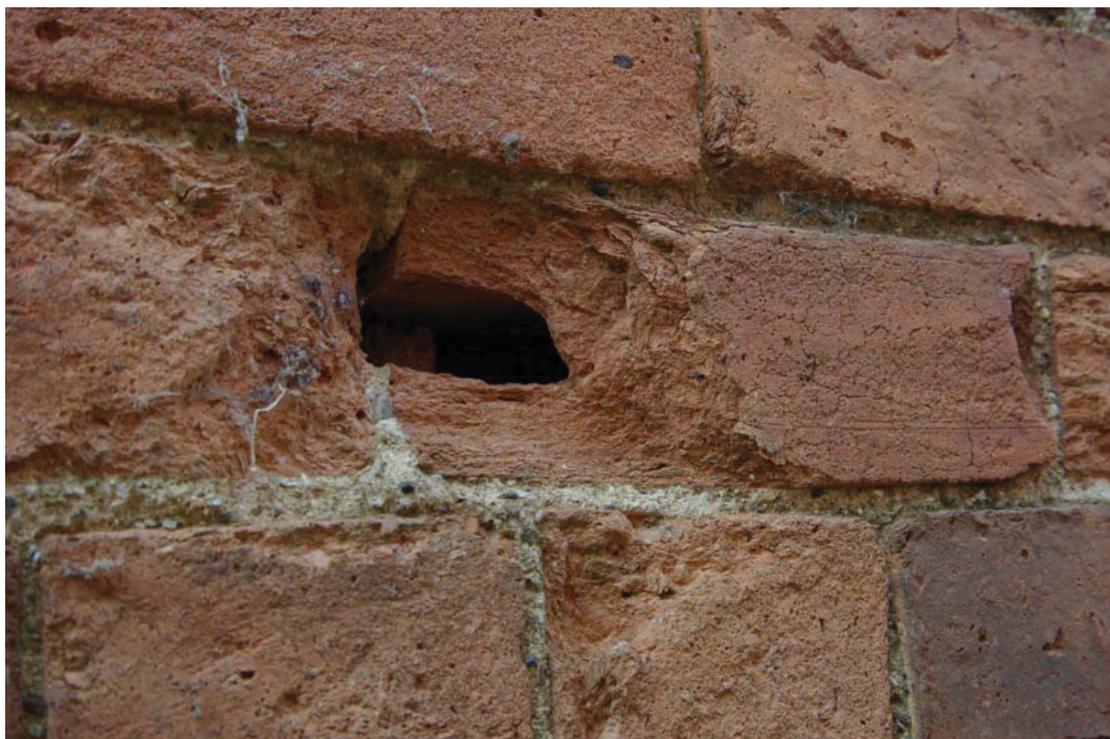
Wall bond, are weathering quite badly in places showing that some have a hollow core possibly used for insulation properties (fig. 34). A wood and glass lean-to greenhouse was attached to the south-western corner but is in a state of disrepair.

Figure 34 Barn B example of hollow brick

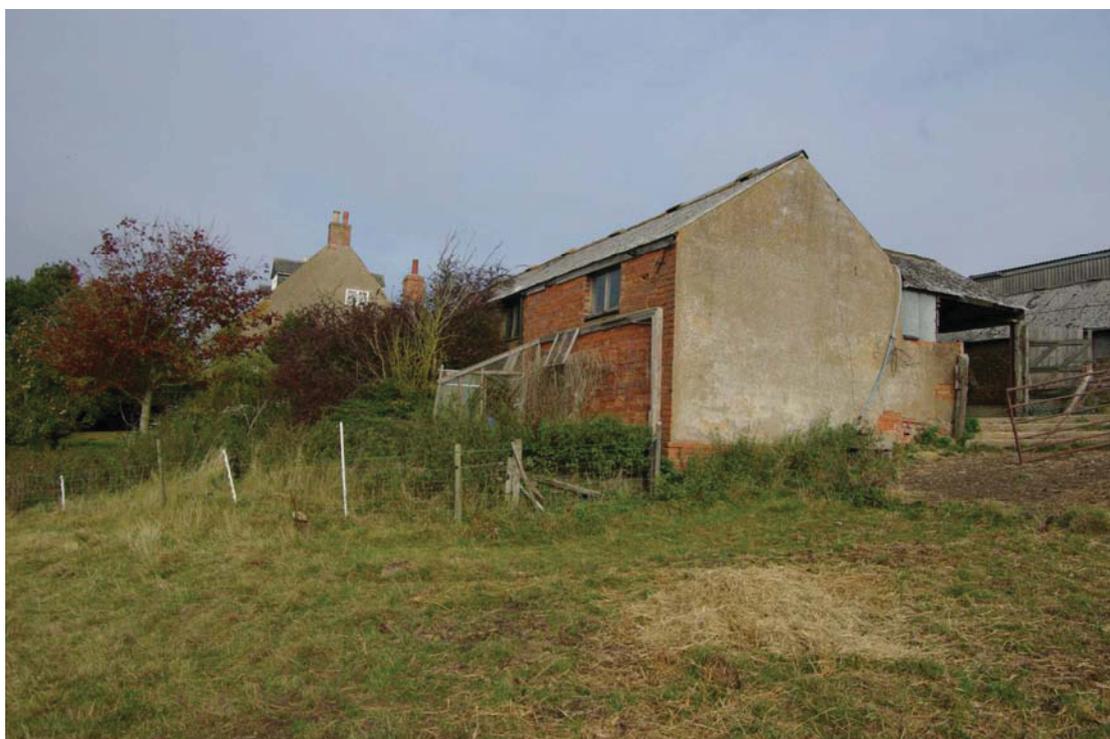
Most of this gable end has been rendered with only a few of the lower courses of brick showing (fig. 35).

Figure 35 Barn B SE gable end
Looking north-west.

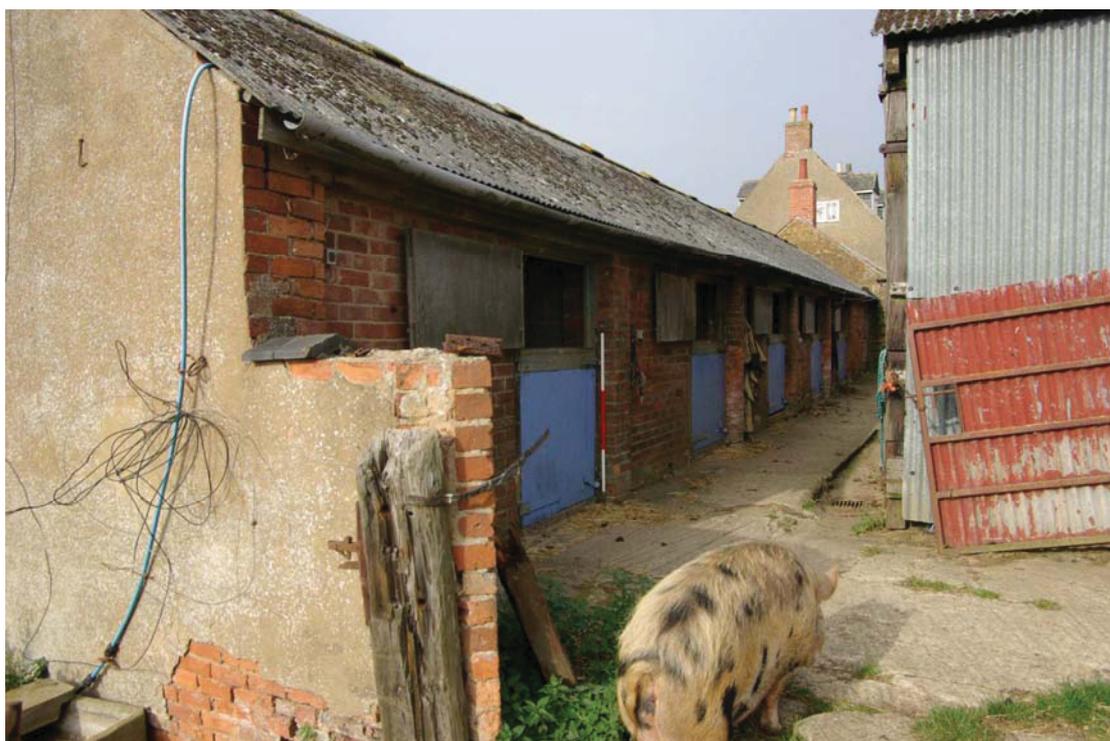
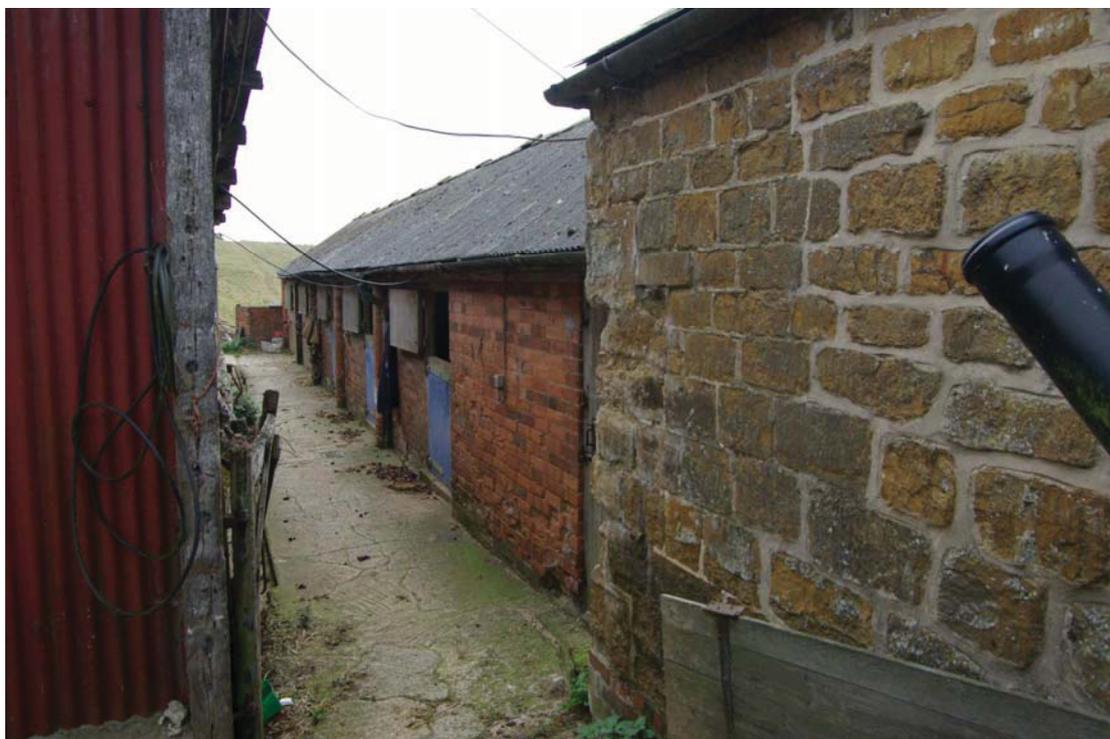
The elevation is divided into six bays with rounded brick pillars separating each bay except for the final eastern bay which appears to have been rebuilt (figs. 36 and 37). The rounded pillars are original but the brick infill between them in the first five bays was added by the client to create individual loose boxes with modern doors. Originally the barn would have had an open front to each bay.

Figure 36 Barn B NE elevation
Looking west. 1.5m scale.

Figure 37 Barn B NE elevation
Looking south-east.

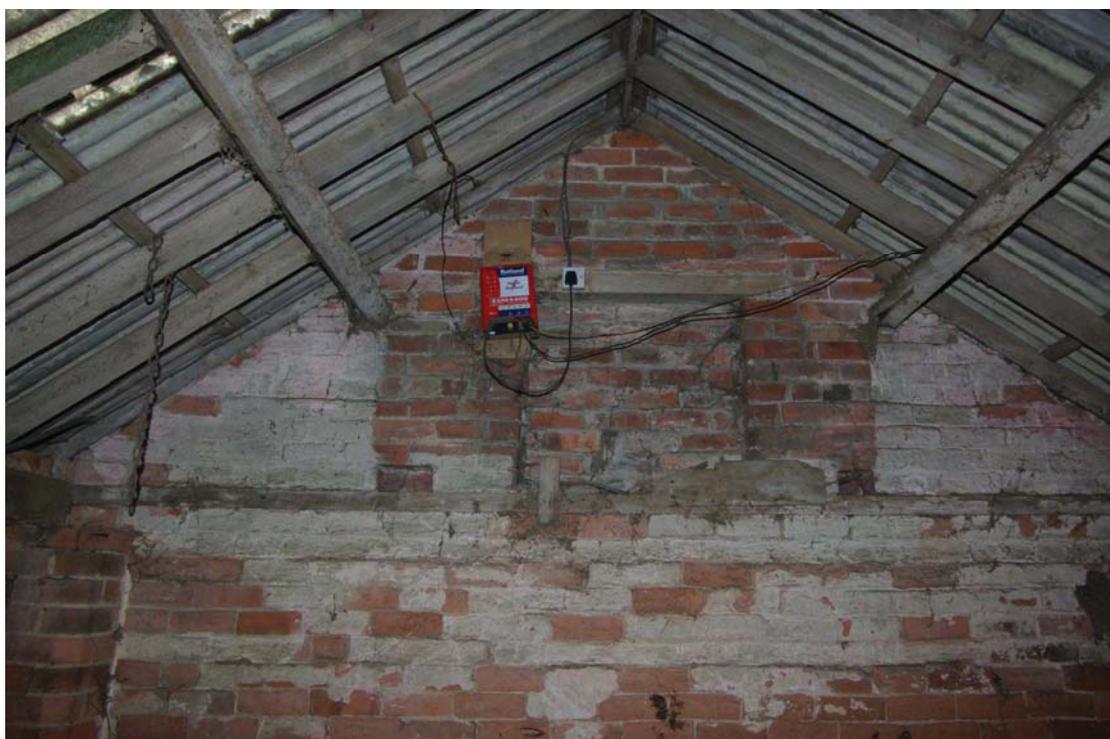
At the same time as the brick infill to the north-eastern elevation was added each bay was divided by a breeze block partition wall (fig. 38). Each partition wall has a rectangular window with bars and extends as high as the lower face of the roof trusses. The roof structure consists of two queen posts and a central collar. Cleated purlins sit on the outer face of two raking struts (fig. 39). All of the rooms are the same and have a modern concrete floor and a fixed glazed window on the south-west wall (fig. 40). A small rectangular window located in the gable of the south-east wall has been bricked up (fig. 41).

Figure 41 Barn B east end gable blocked window
Looking south-east.
