**A Level 2 Historic Building  
Survey of Church Farm, 10  
Melton Road, Waltham on  
the Wolds, Leicestershire  
NGR: SK 801 250**

ULAS Report No 2010-137.  
©2010

**A Photographic Survey of Church Farm,  
10 Melton Road, Waltham on the Wolds,  
Leicestershire**

**For: Mr and Mrs Duffin**

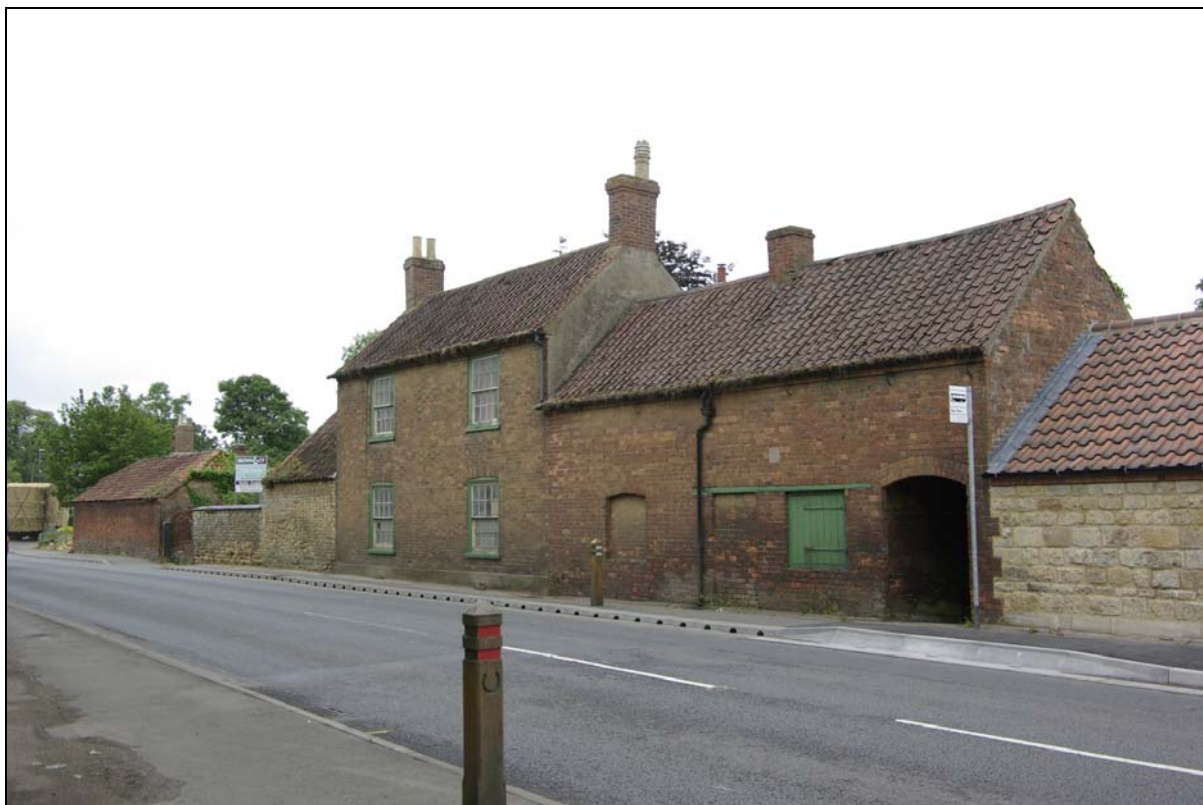
Plate 1. Church Farm, Melton Road elevation, looking south-west

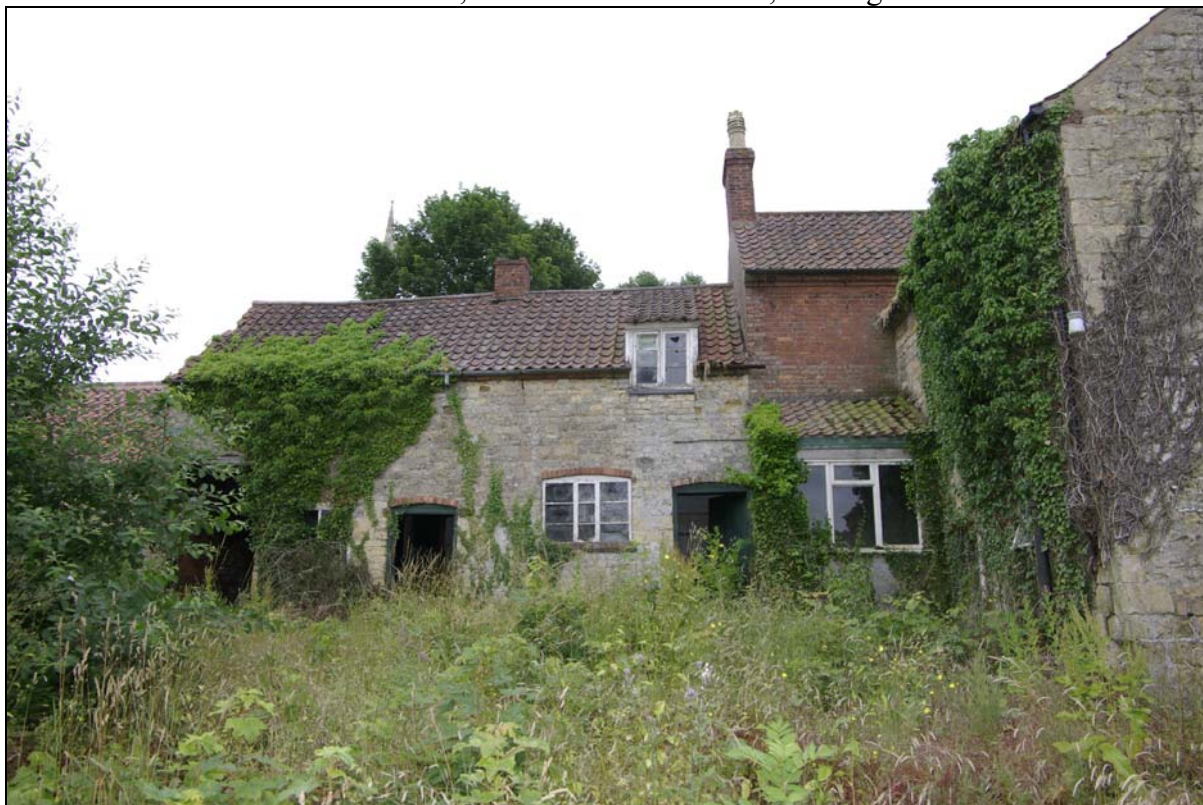
Plate 2. Farmyard elevation, looking east

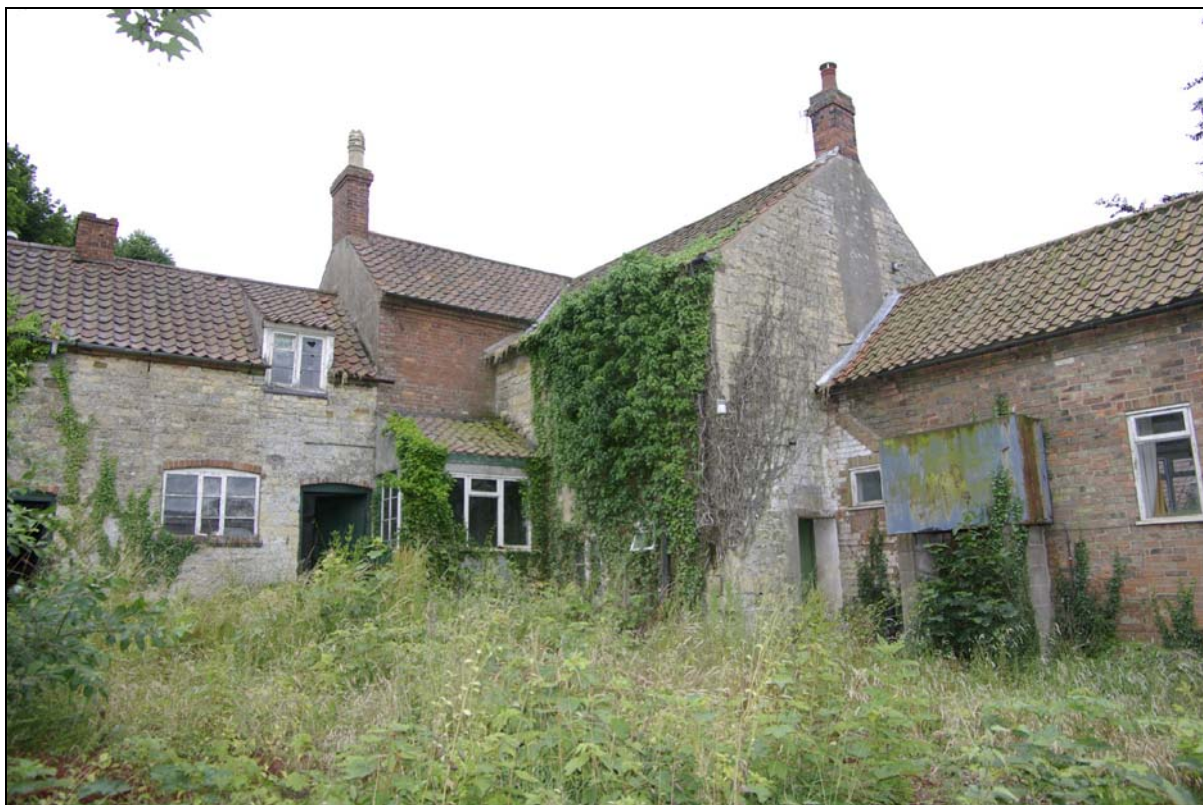
Plate 3. As above, looking south-east.

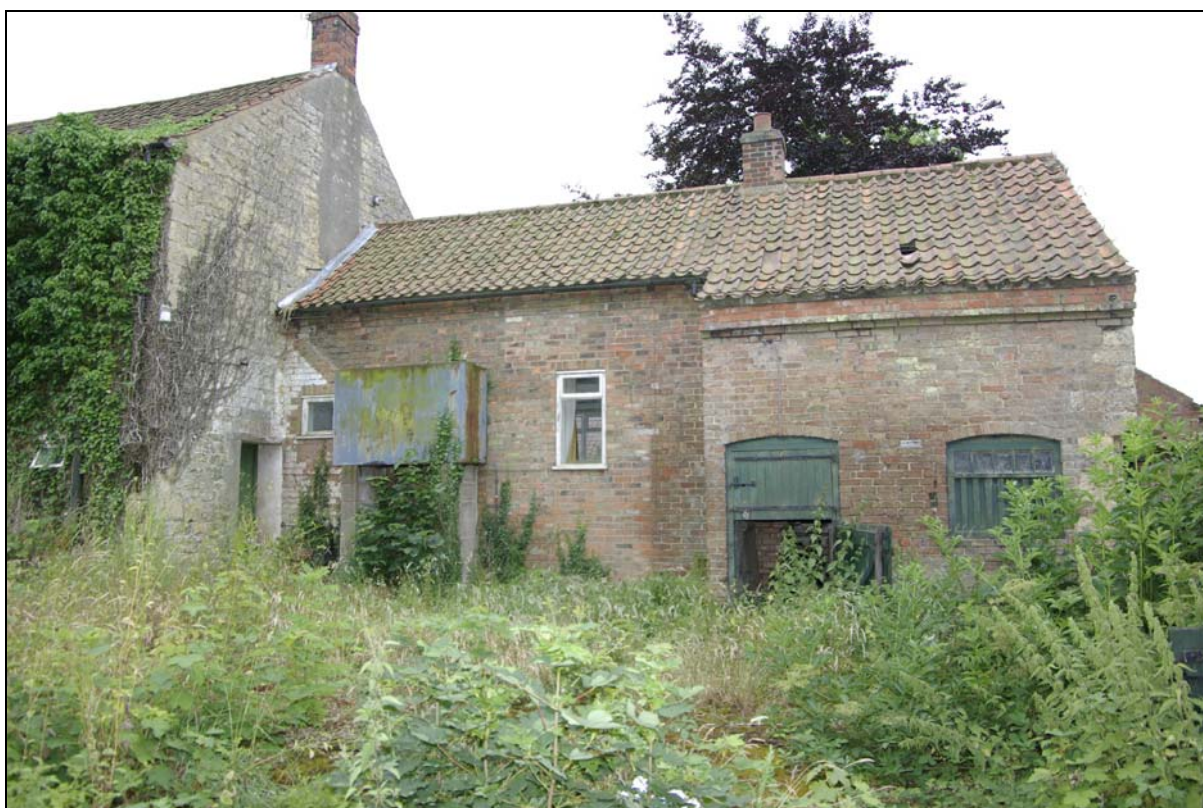
Plate 4. Western range, farmyard elevation. Looking east.

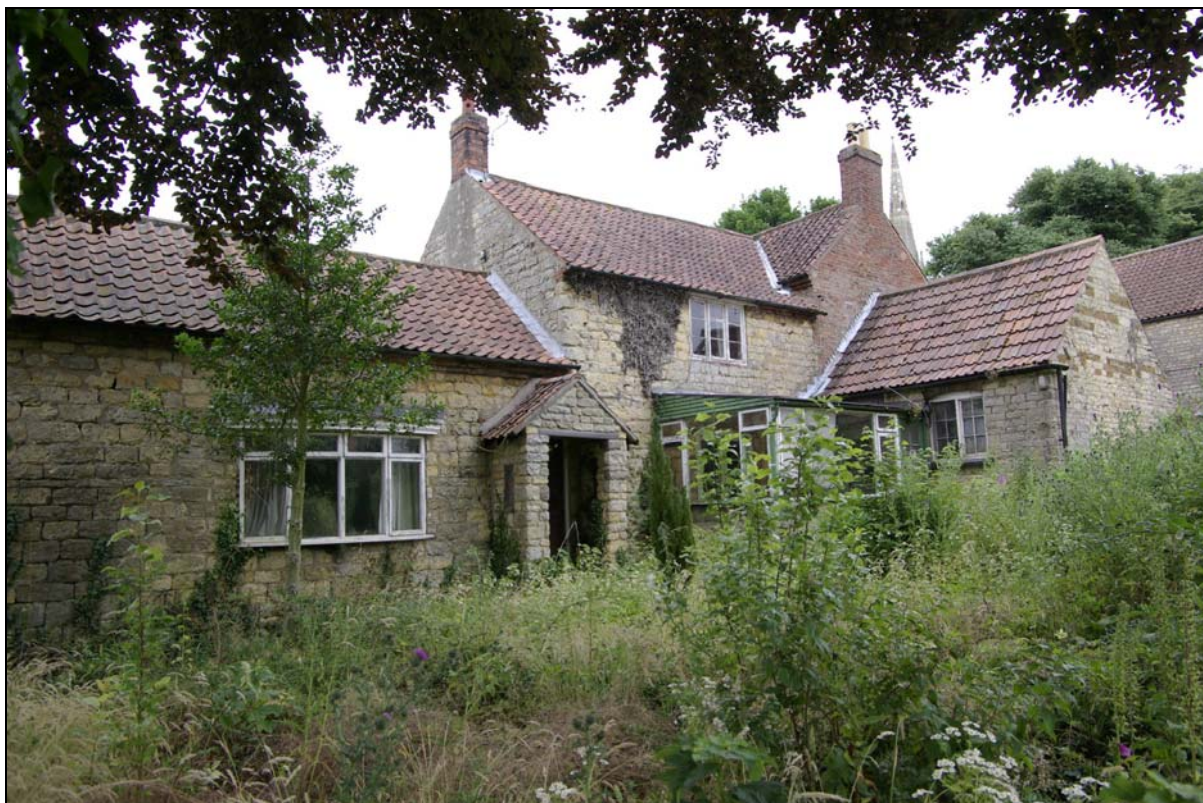
Plate 5. Garden elevation, looking north-east.

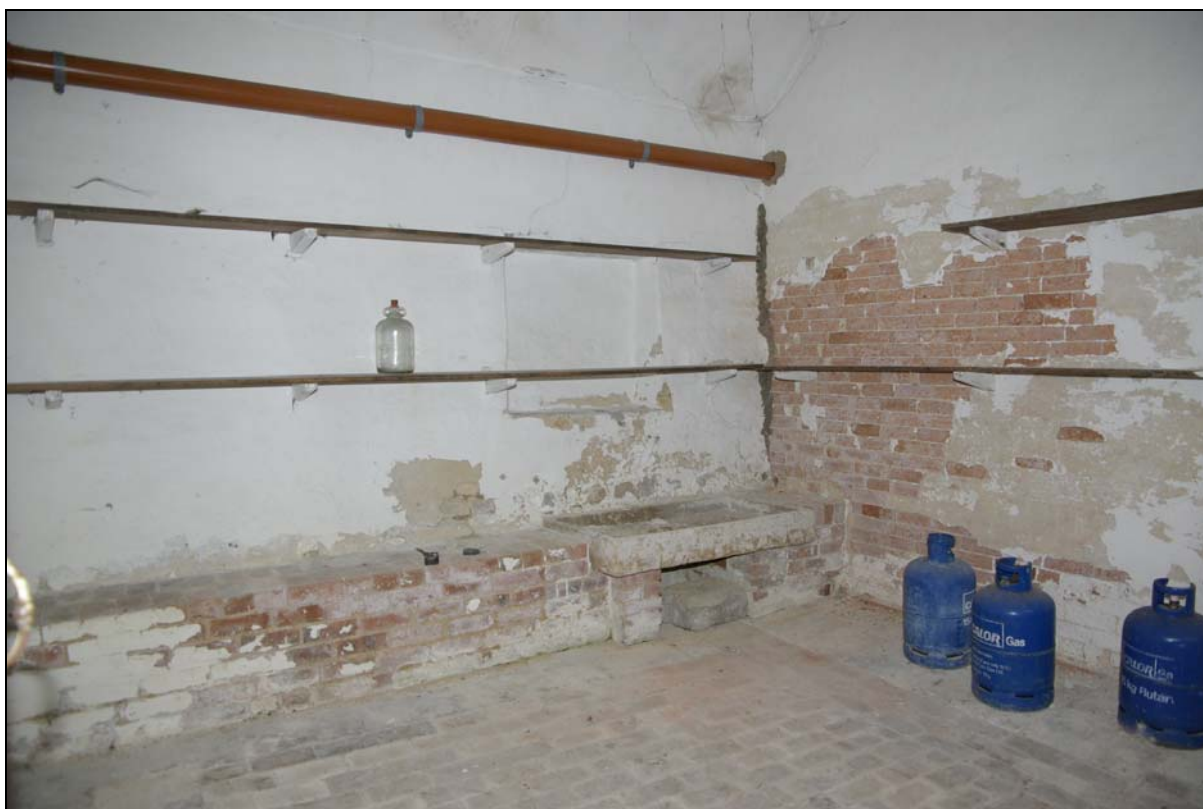
Plate 6. Dairy. Looking south-east.

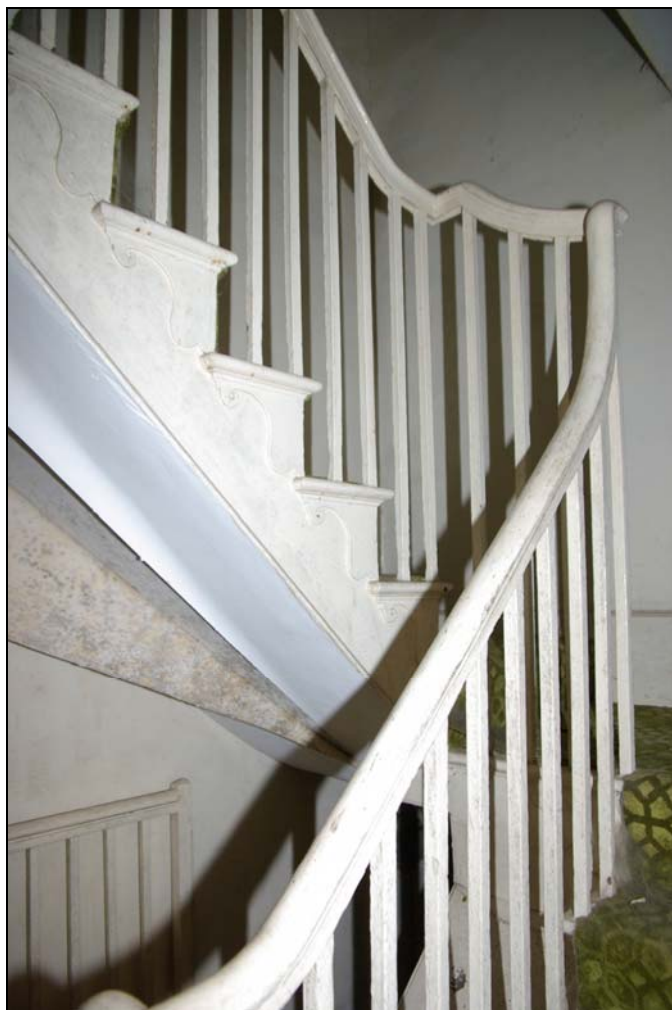
Plate 9. Open-string staircase, with moulded handrail and decorative brackets. Looking west.

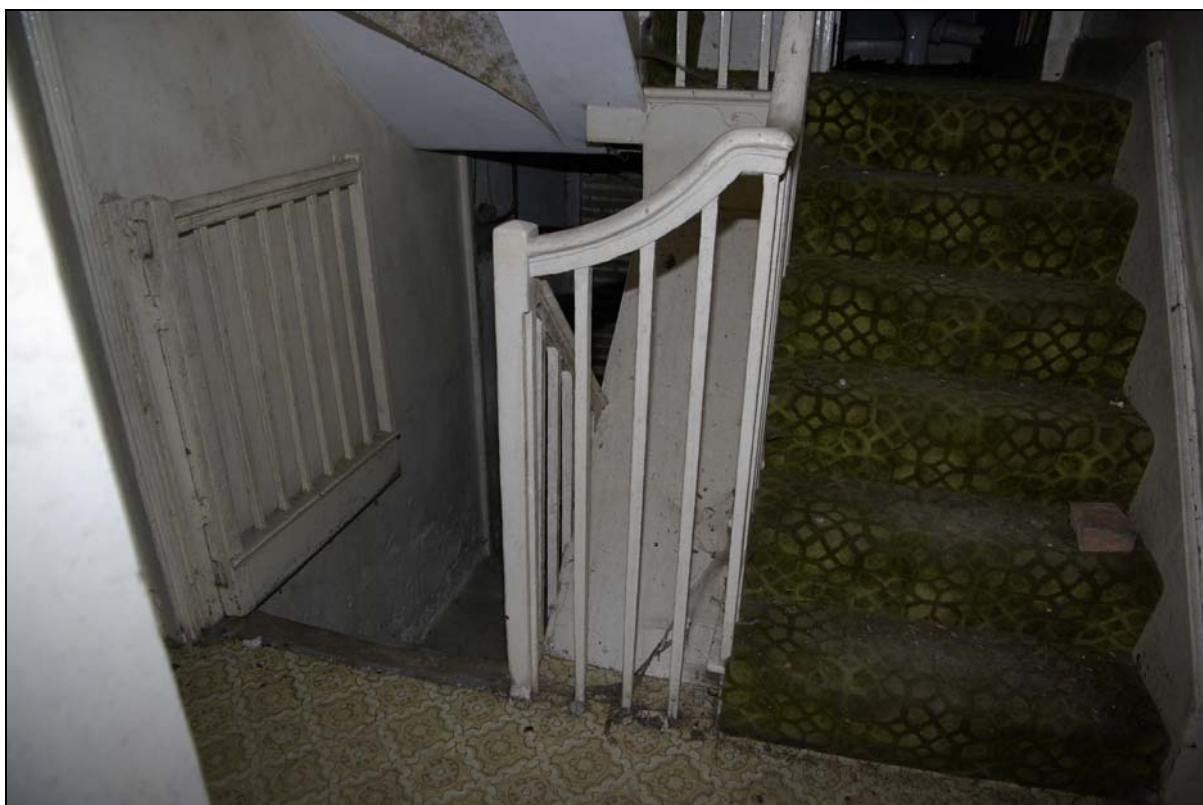
Plate 10. Dog-gate, opening onto cellar steps. Looking west.

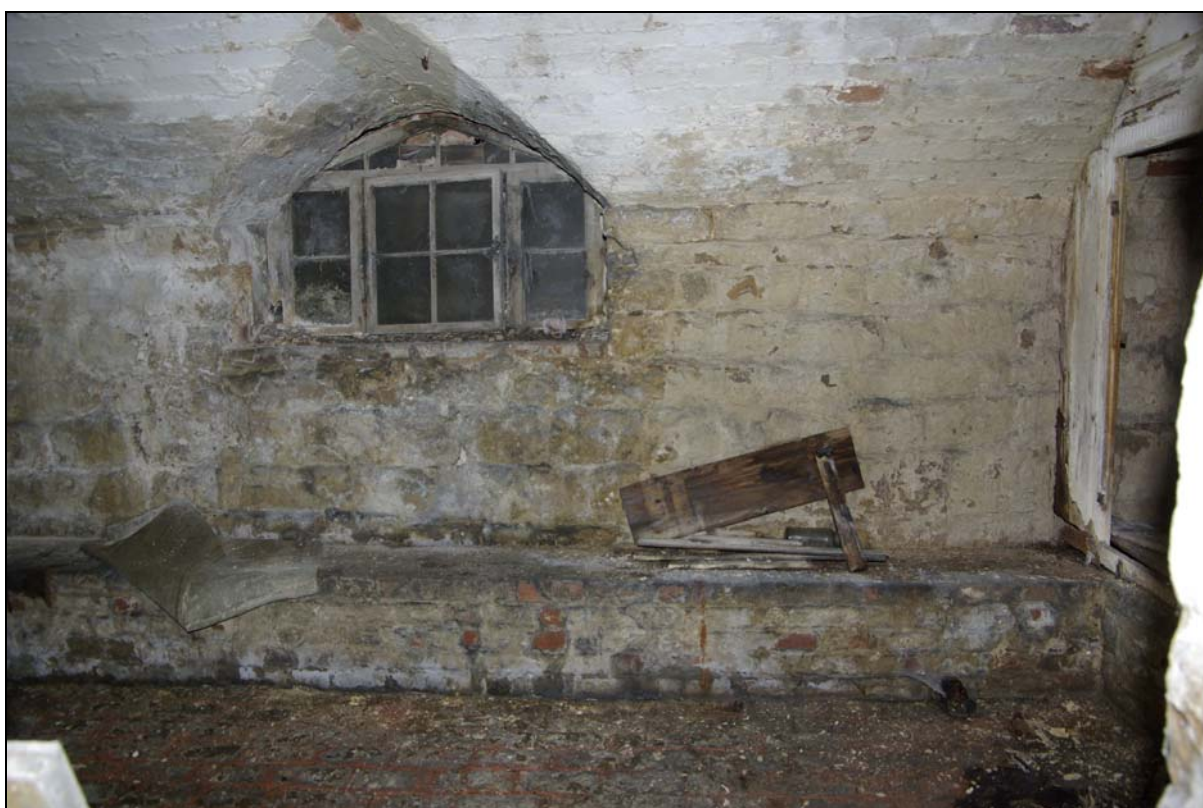
Plate 11. Stone cellar, with vaulted brick ceiling and thrall. Looking south.

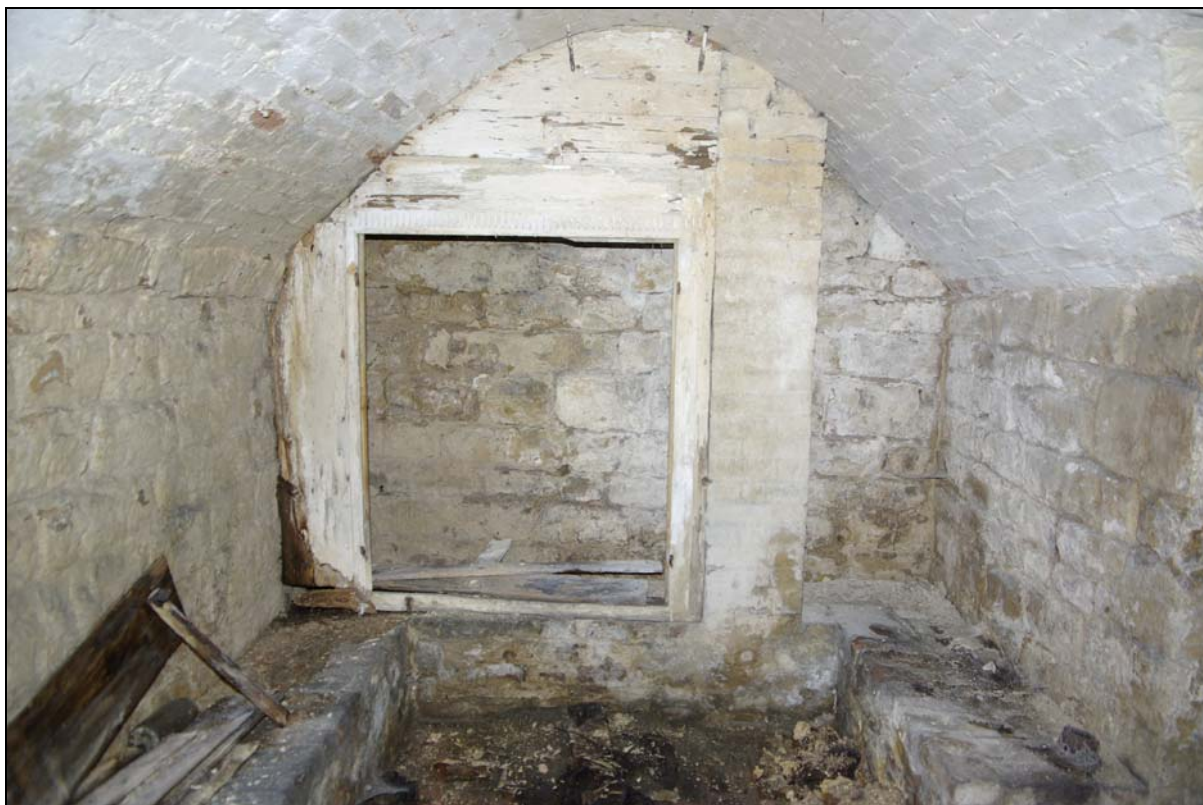
Plate 12. Stone cellar, with built-in cupboard. Looking west.

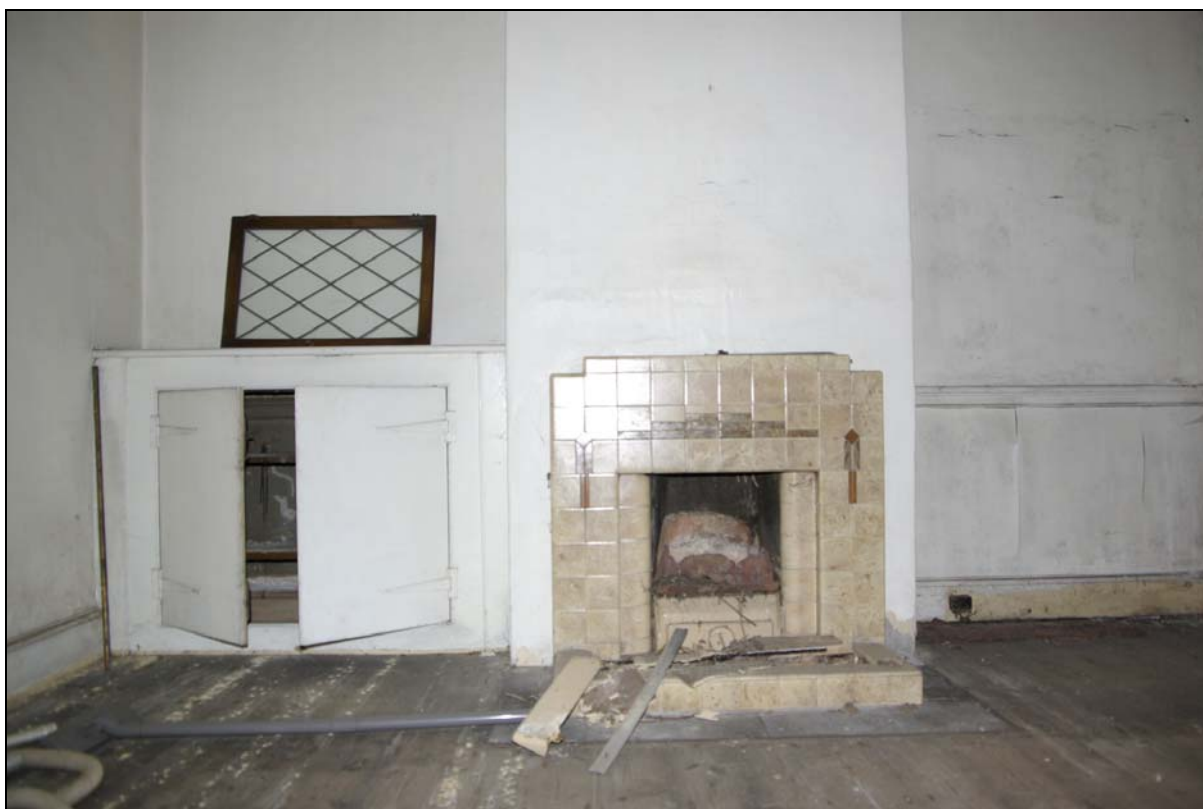
Plate 13. Sitting room, with c. 1930s fireplace and built in cupboard. Looking north.

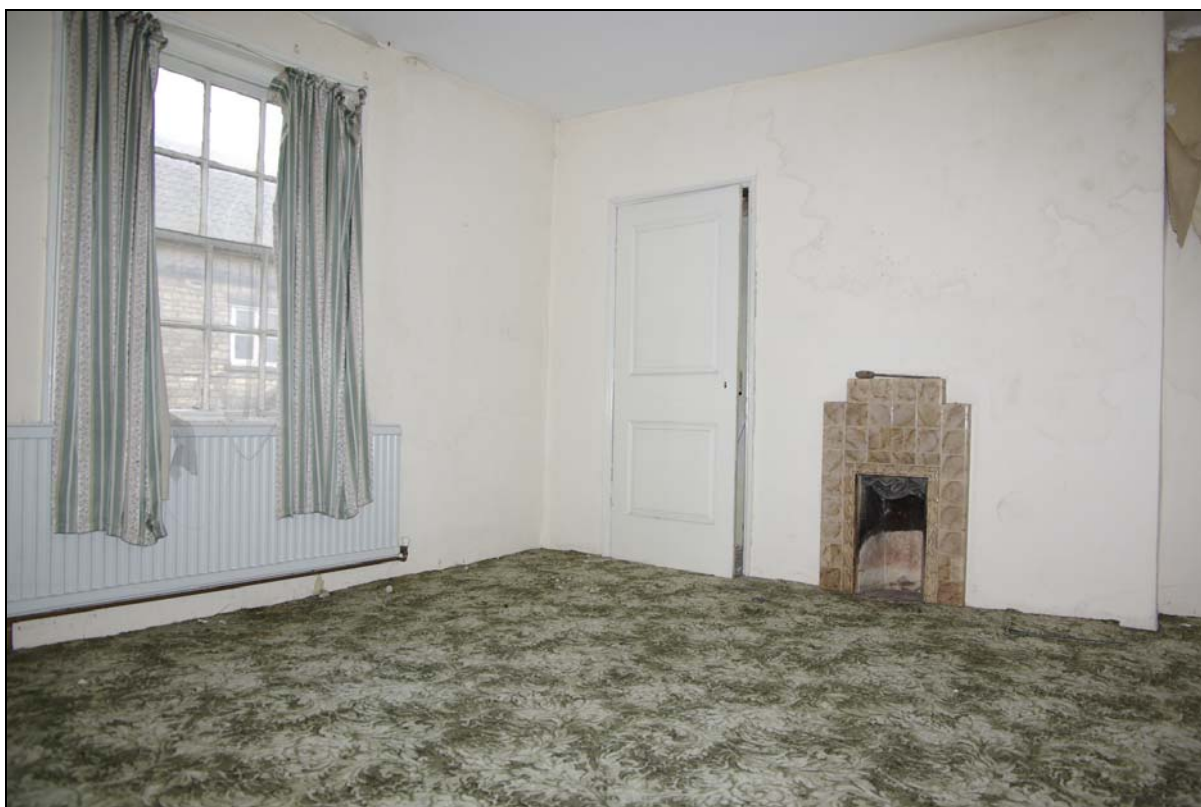
Plate 14. First floor bedroom, with sash windows, 1930s fireplace and built-in cupboard with panelled door.

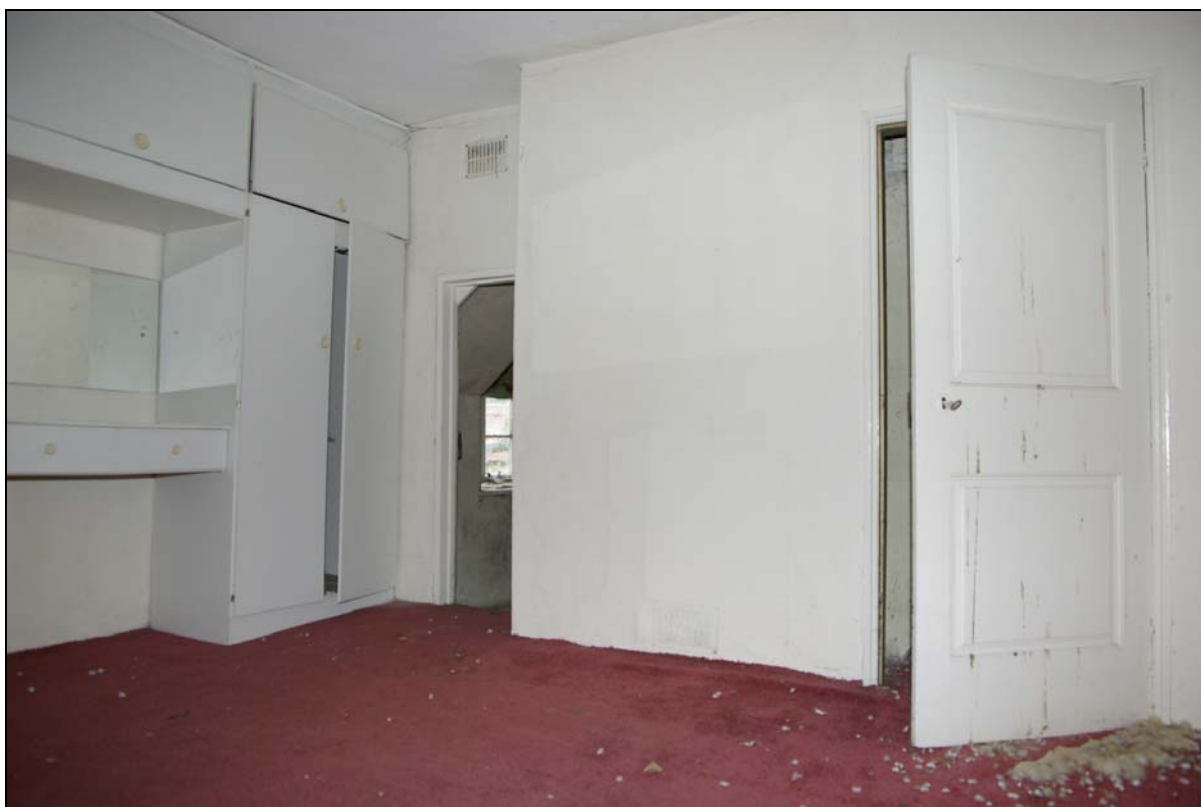
Plate 15. First floor bedroom, with panelled door to built-in cupboard and doorway leading on to store-room.

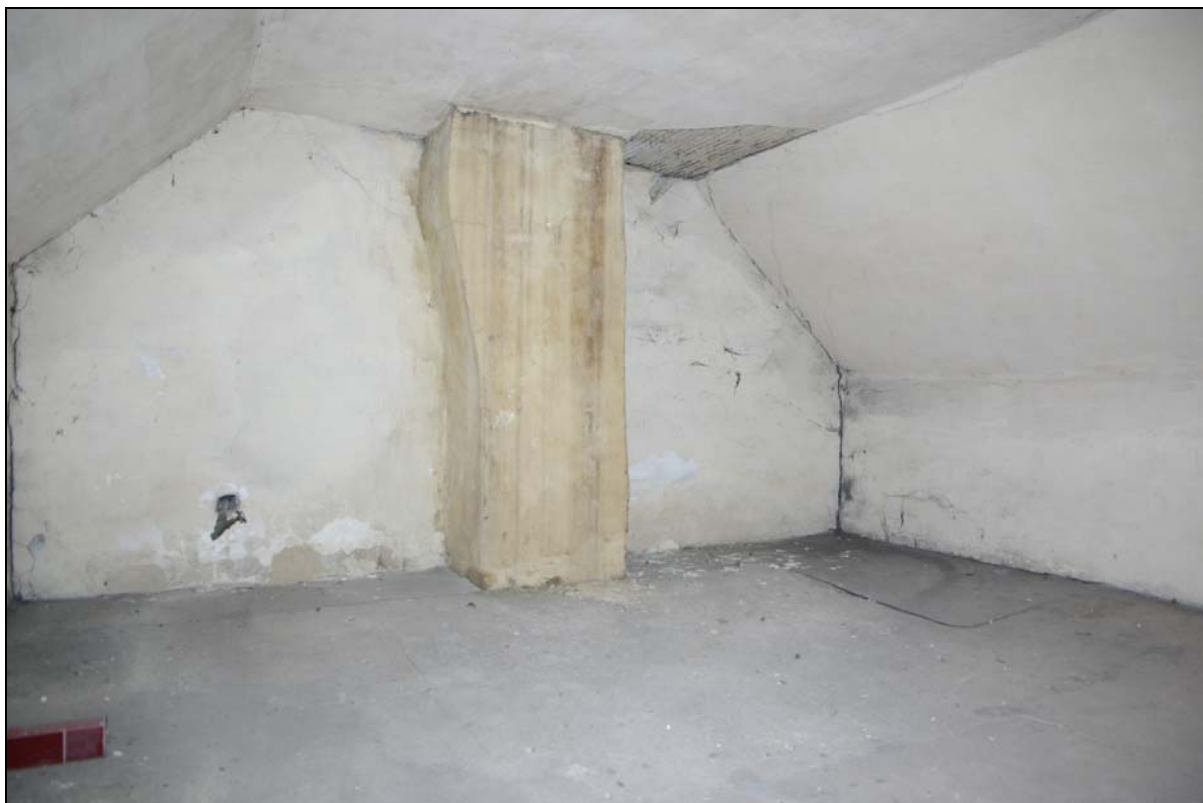
Plate 16. First floor store-room with lime ash floor. Looking north.

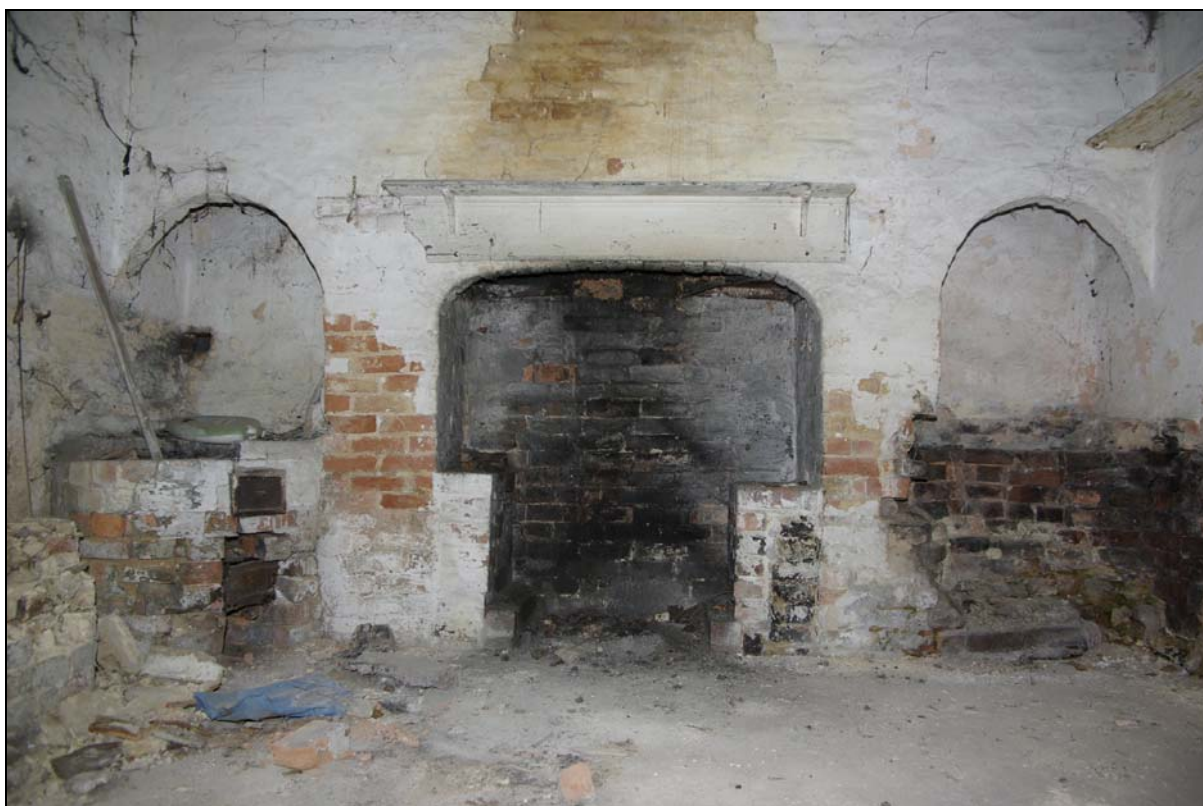
Plate 17. Washhouse, with hob-grate fireplace and cast-iron 'coppers' removed. Looking north.

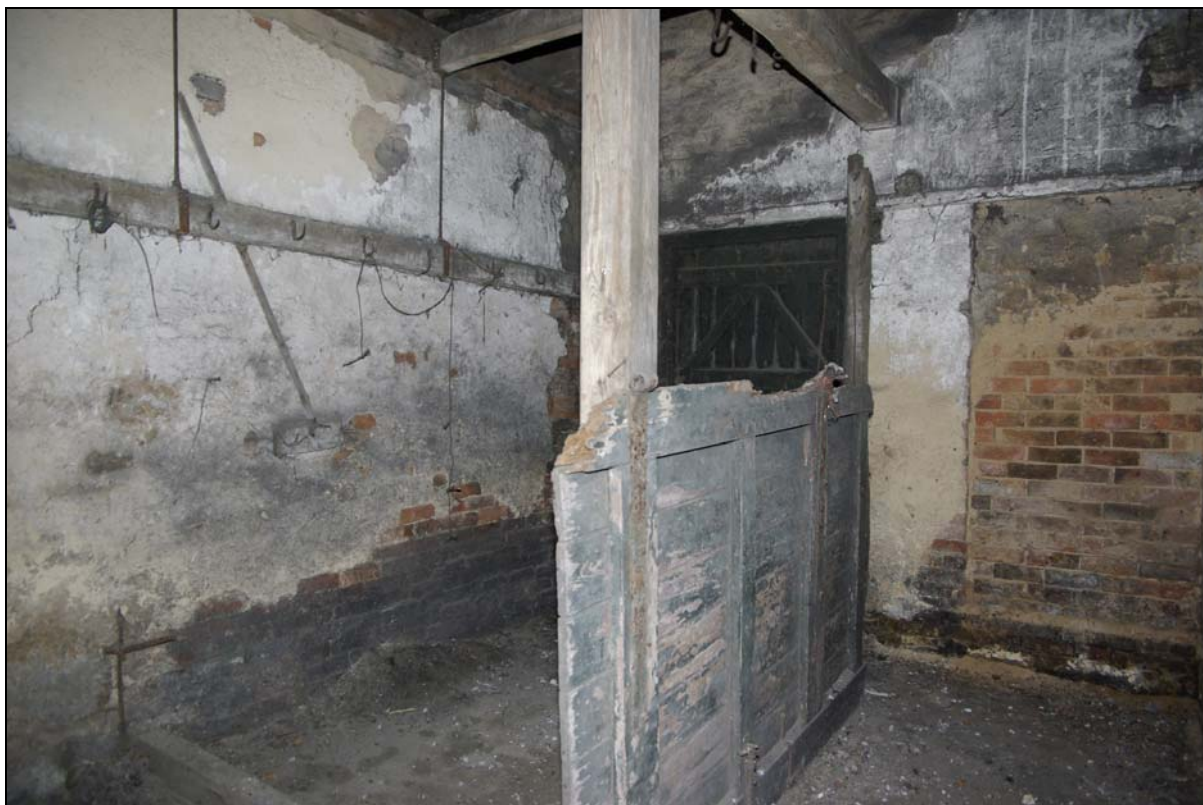
Plate 18. Coal shed and storage. Looking east.

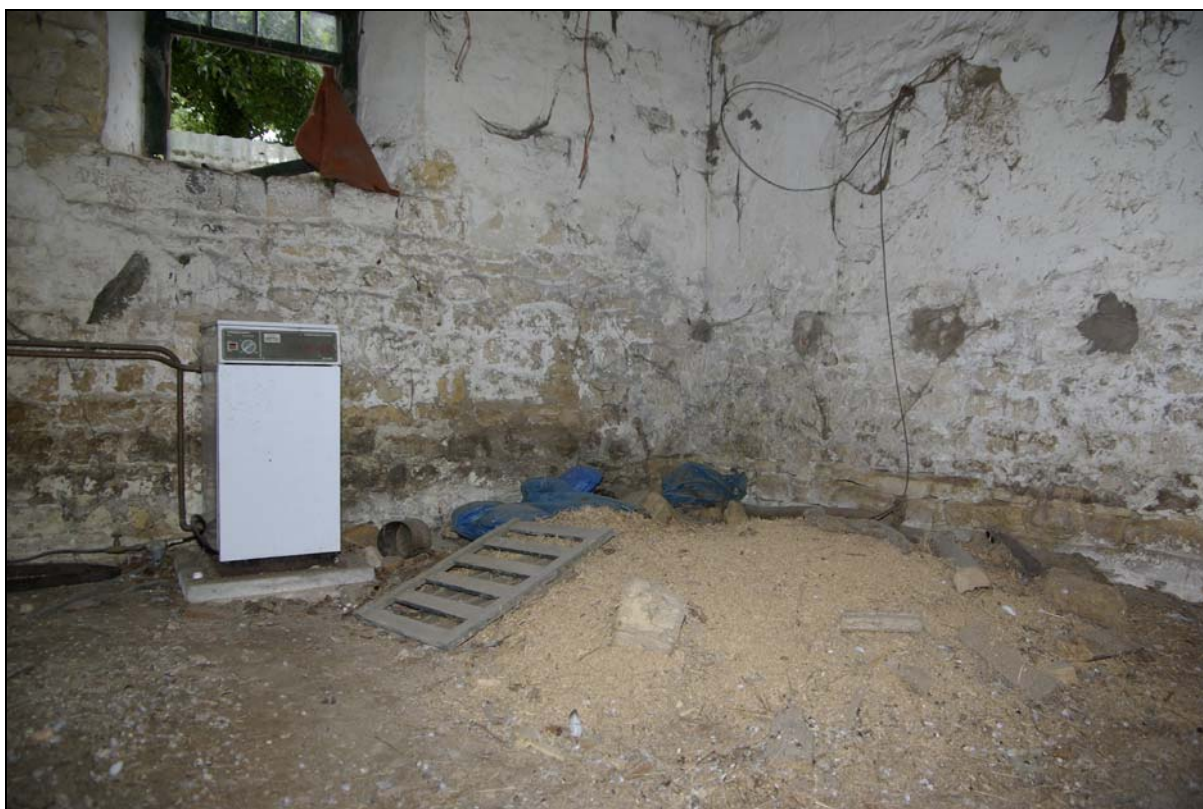
Plate 19. Former workshop and woodstore, with modern boiler. Looking south-west.

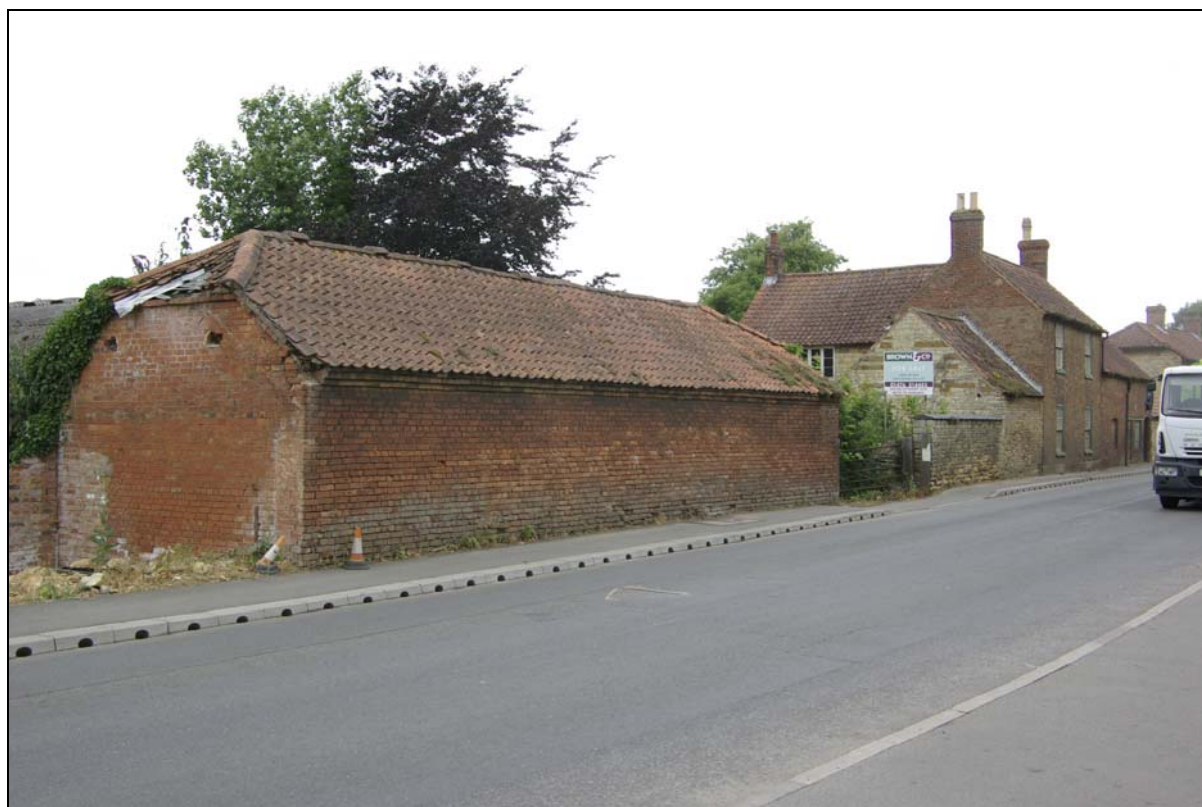
Plate 20. Cowshed. Melton Road elevation, looking north.

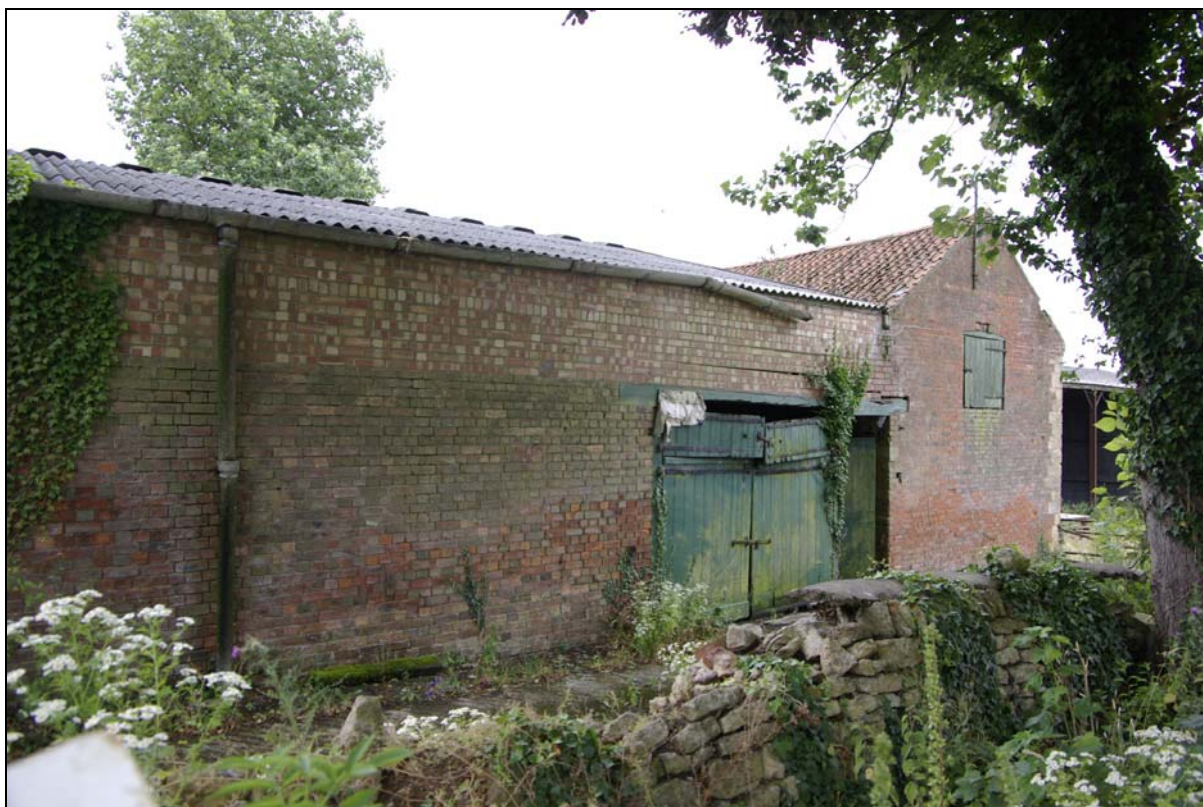
Plate 21. Infill structure between cow-shed and barn. Looking west.

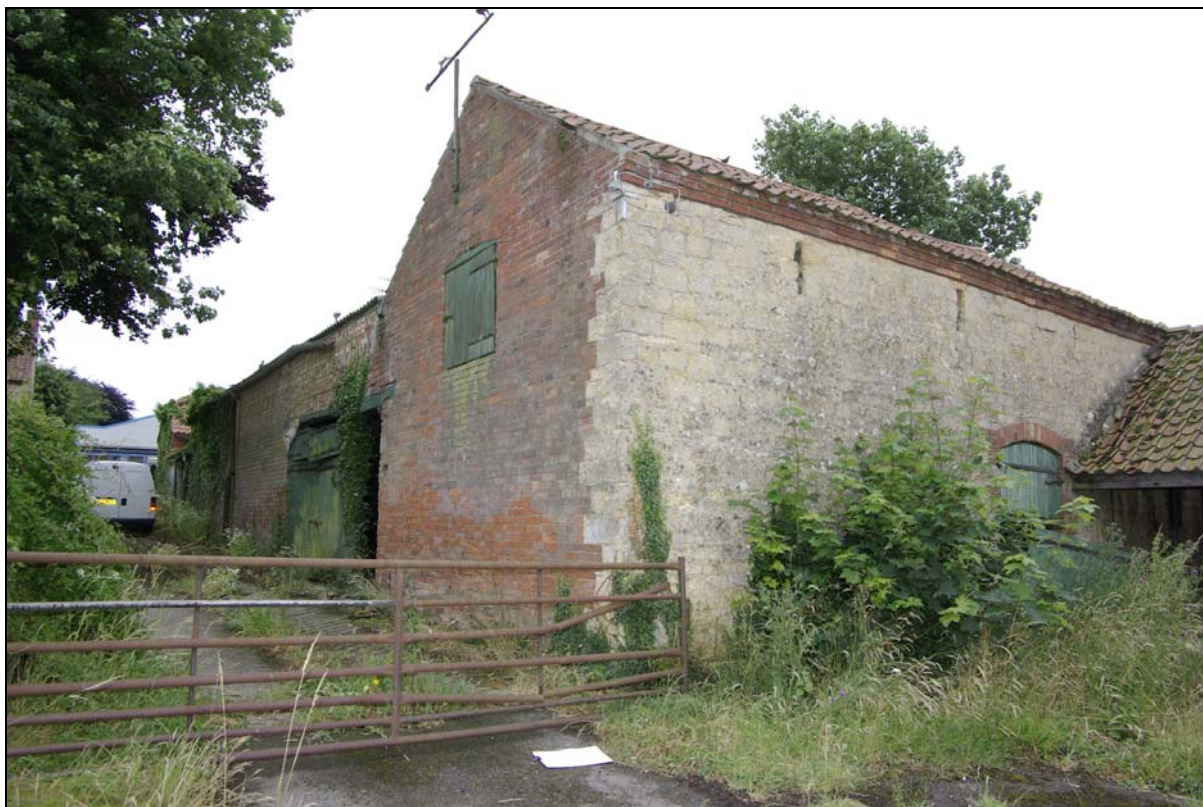
Plate 22. Stone and brick-built barn. Looking south east.

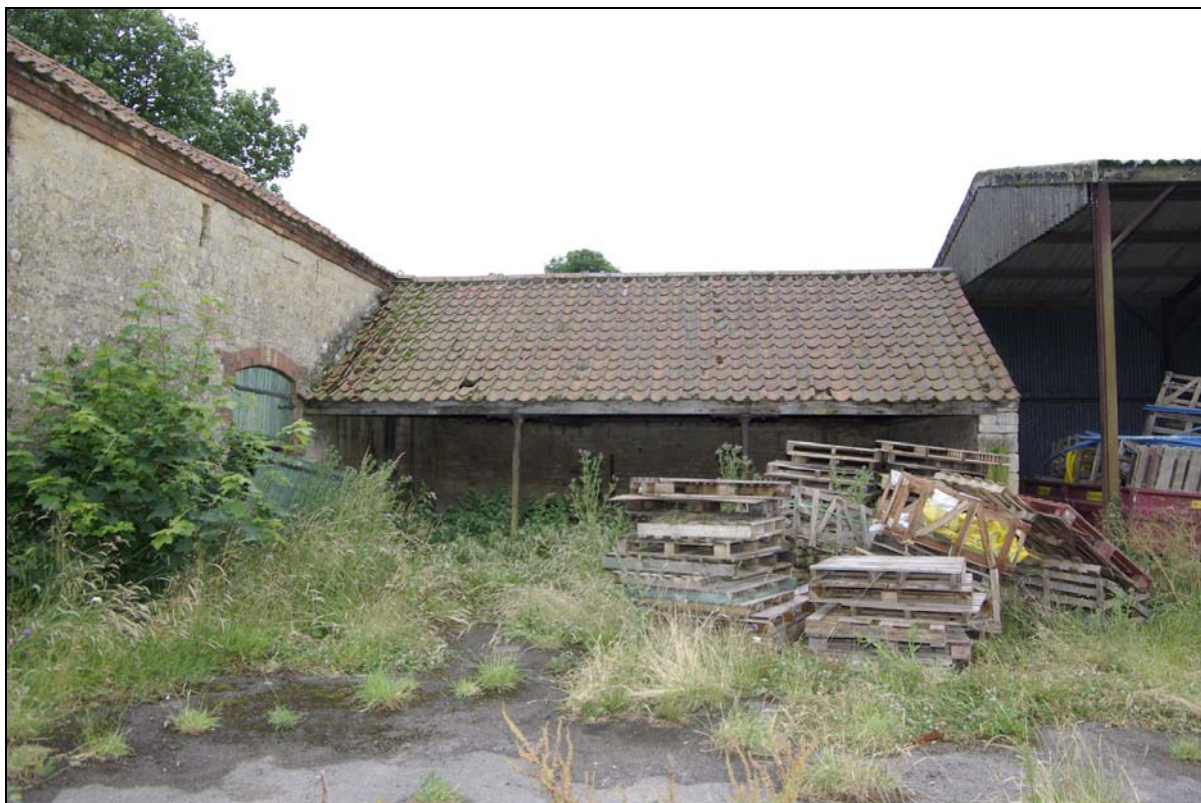
Plate 23. Open fronted cart-shed. Looking south.

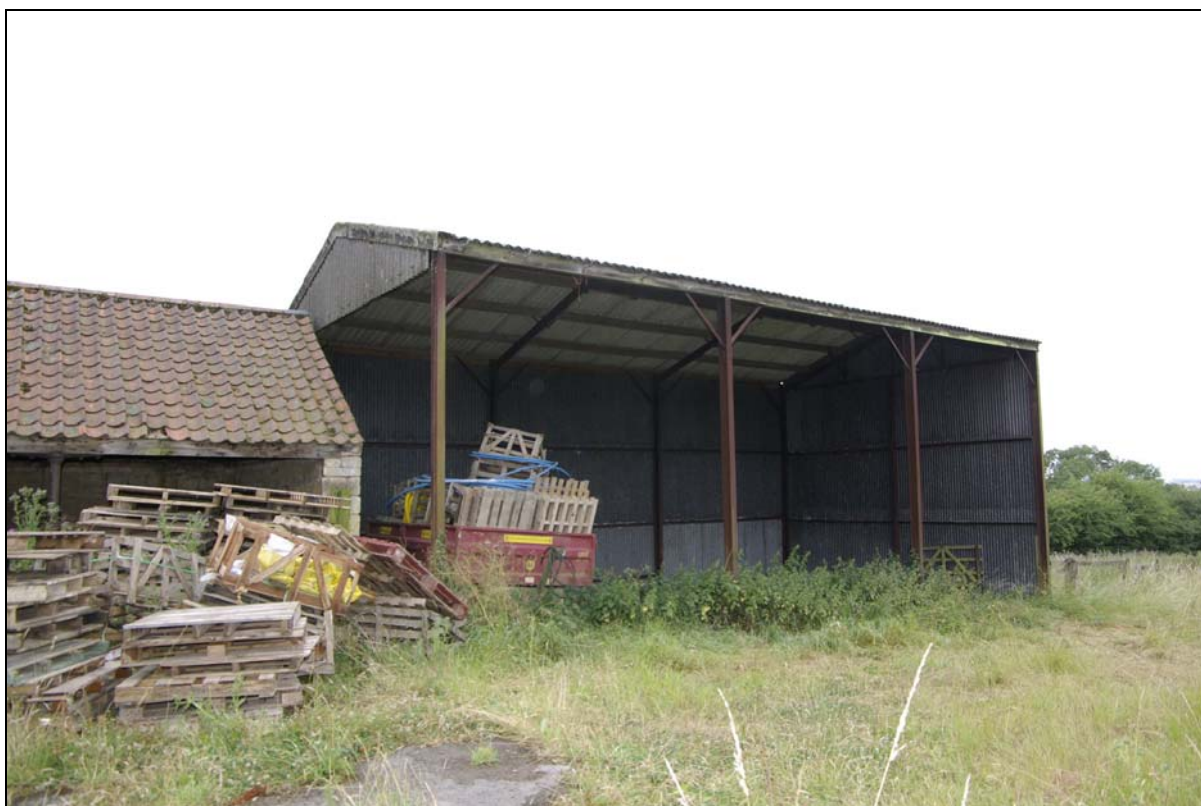
Plate 24. Dutch-barn. Looking south-west.

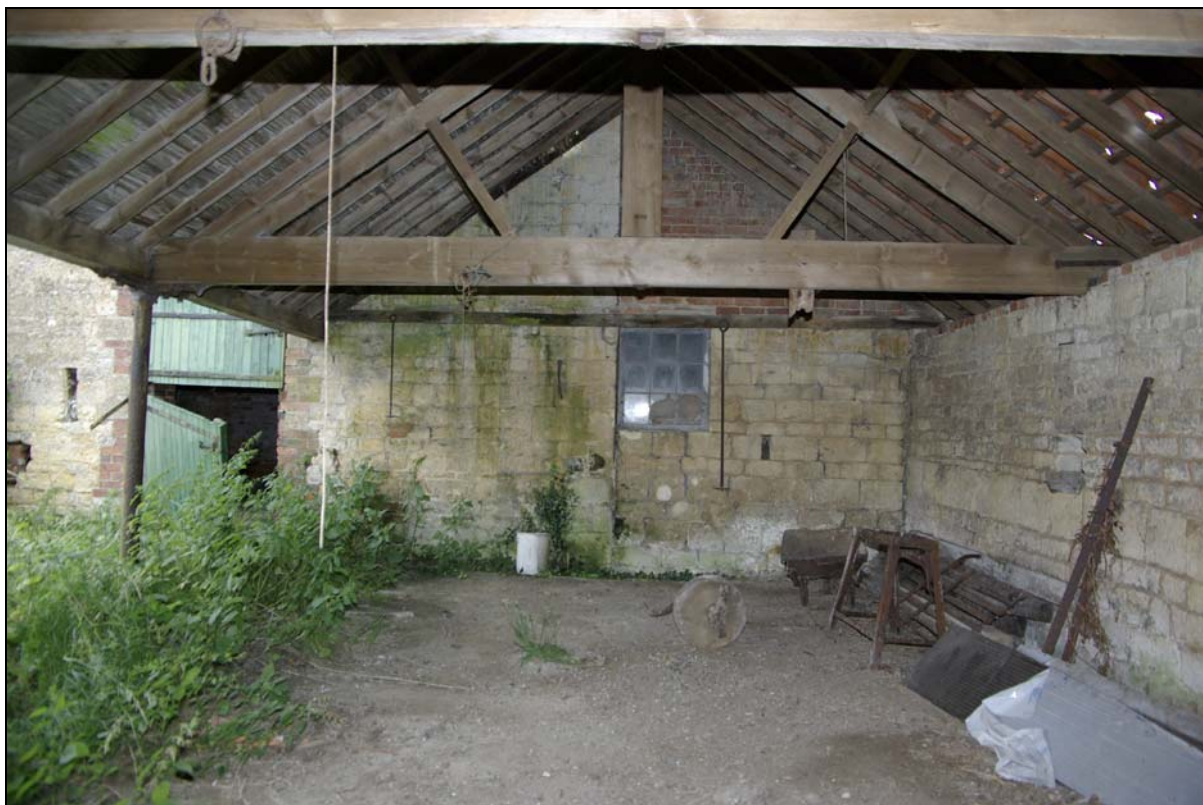
Plate 25. Cart shed interior. Looking south-east towards barn.

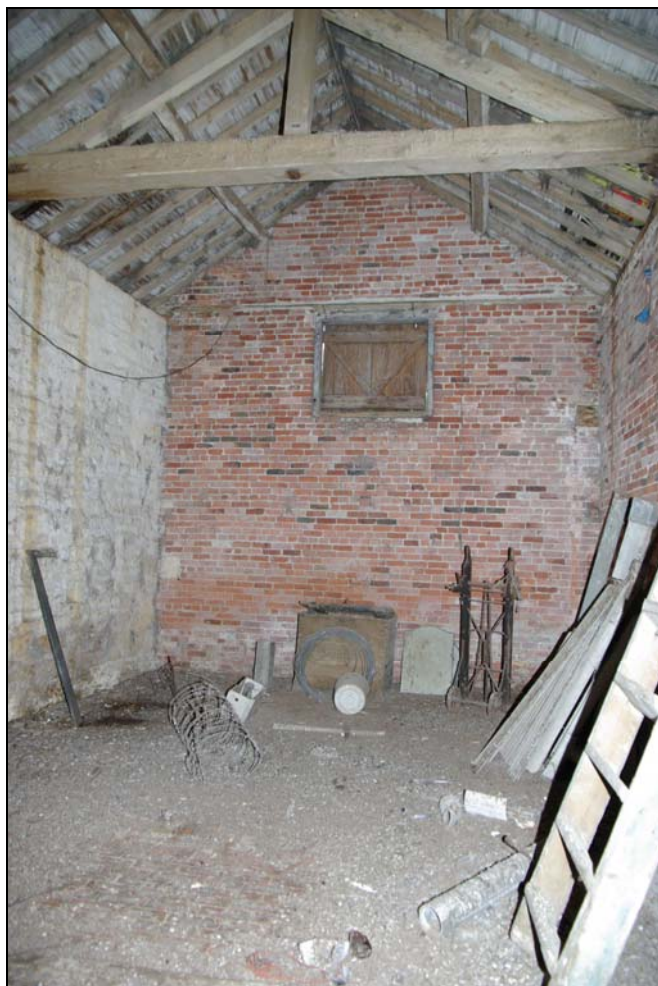
Plate 26. Barn interior. Looking north.
