**A Level 2 Historic Building  
Survey of Church Farm, 10  
Melton Road, Waltham on  
the Wolds, Leicestershire  
NGR: SK 801 250**

ULAS Report No 2010-137.  
©2010

**A Photographic Survey of Church Farm,  
10 Melton Road, Waltham on the Wolds,  
Leicestershire**

**For: Mr and Mrs Duffin**

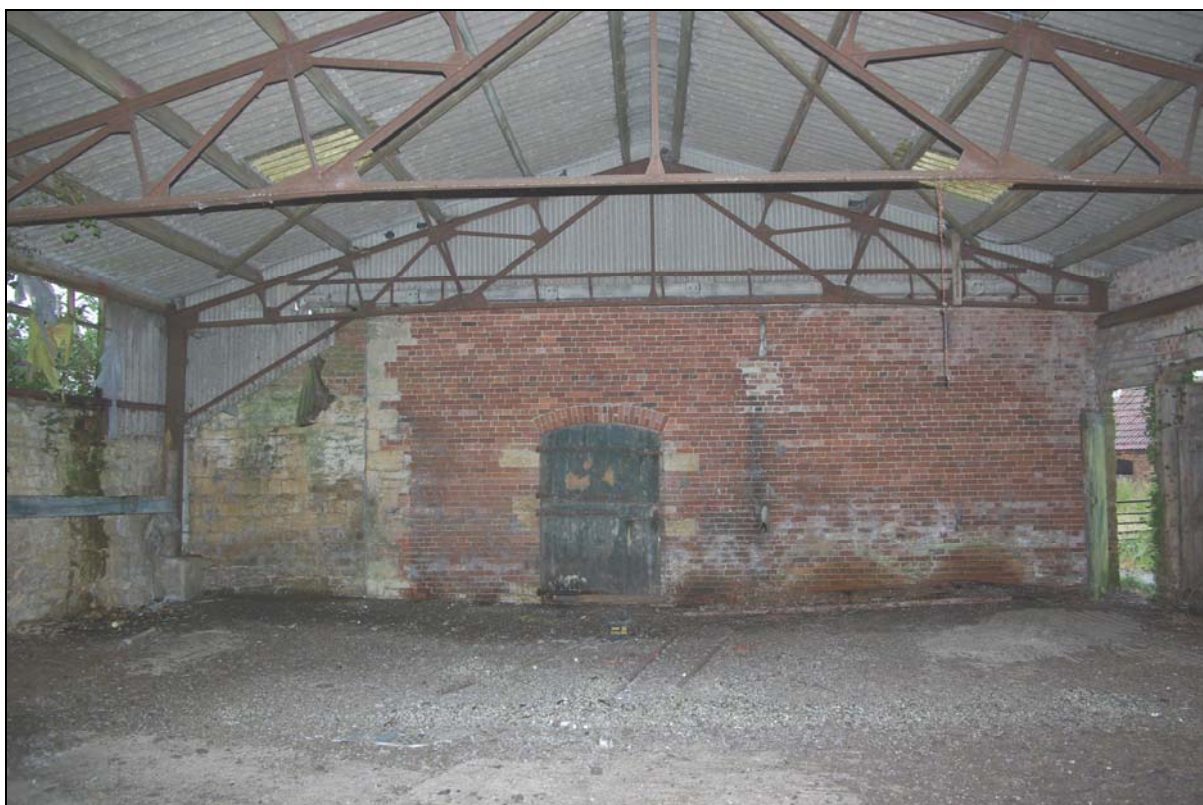
Plate 27. Infill structure interior, looking west towards barn.

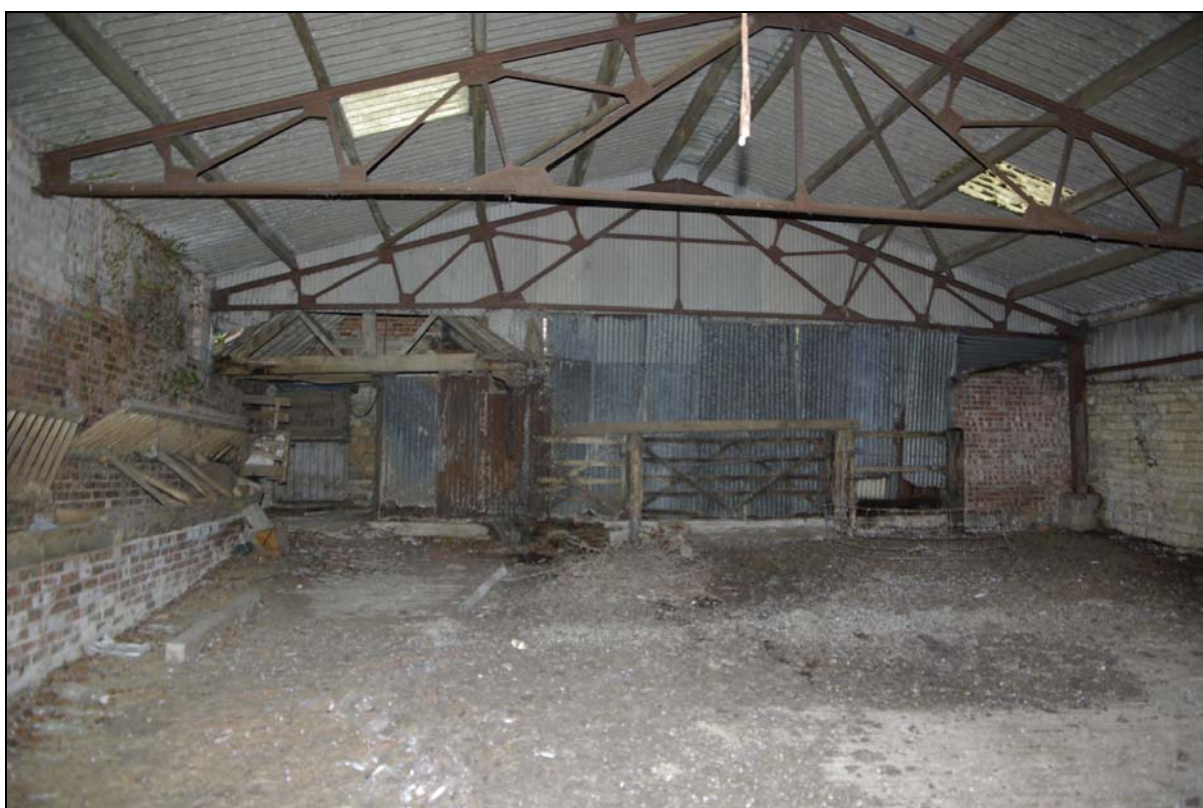
Plate 28. Infill structure interior, with brick feeding troughs and timber hayracks. Looking east.

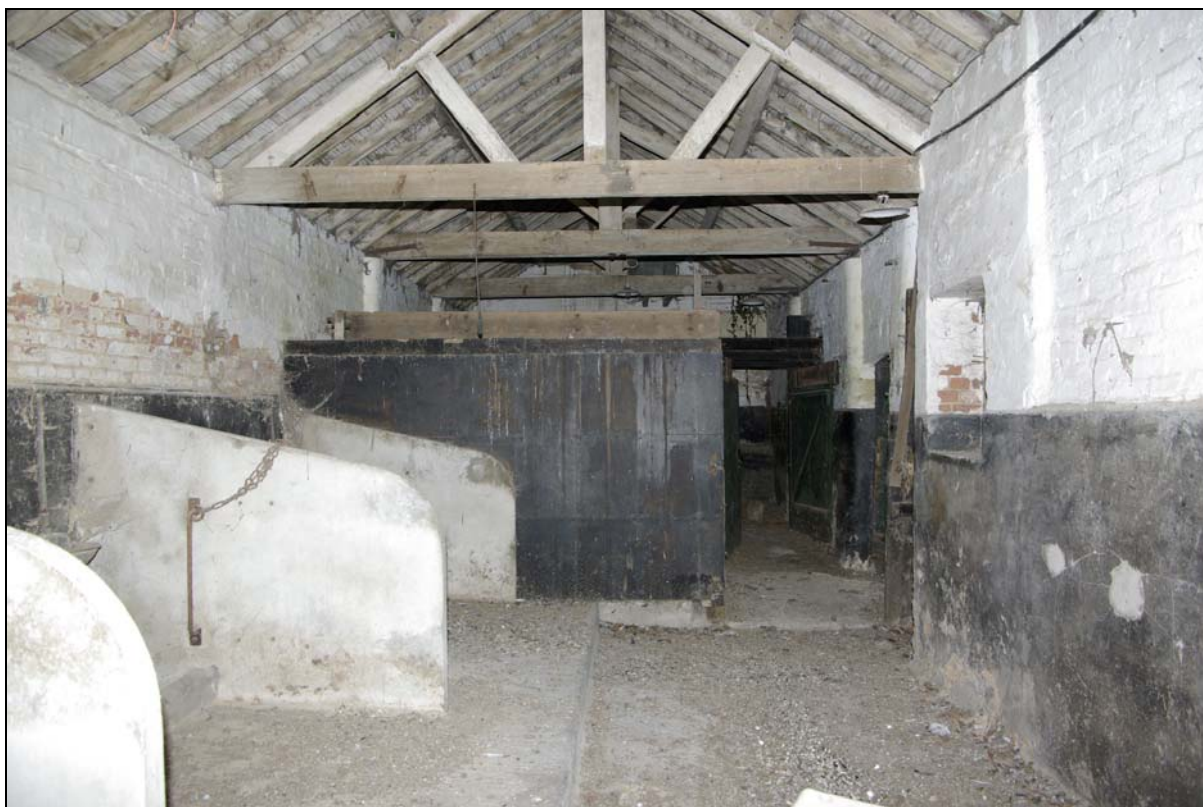
Plate 29. Cow-shed interior. Looking south.

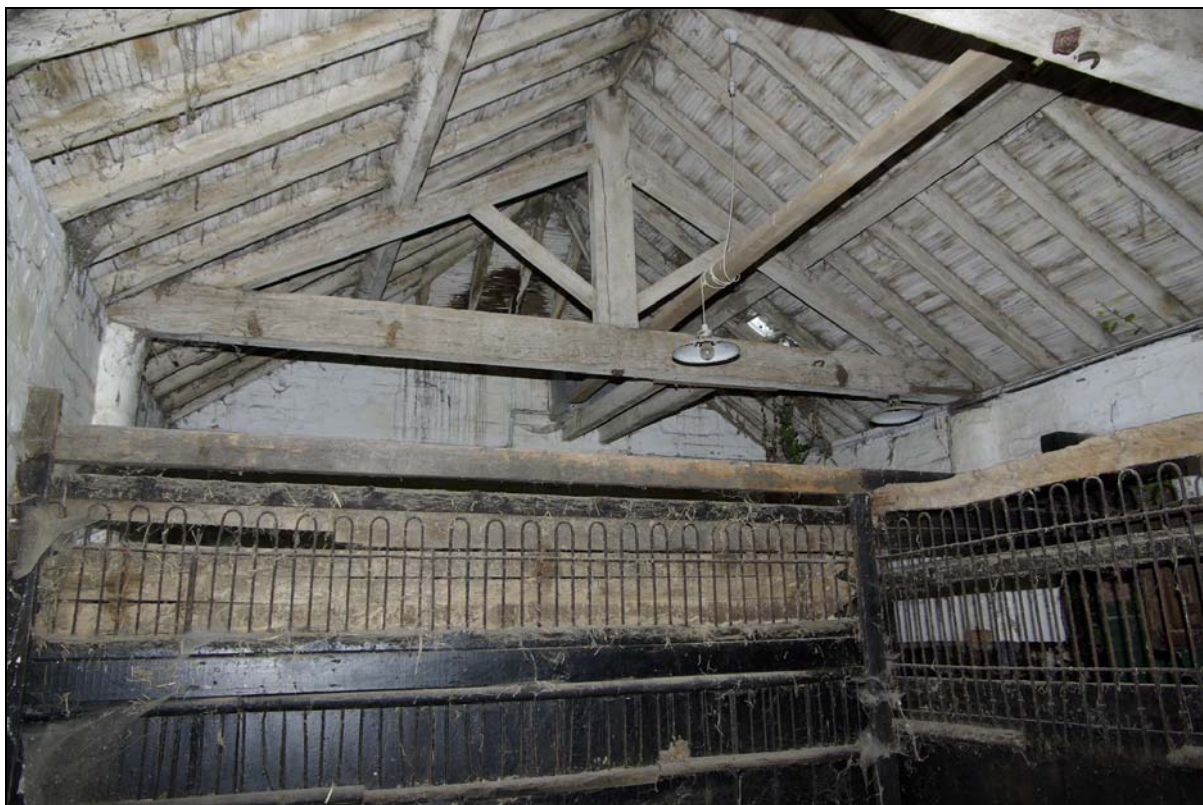
Plate 30. King post roof truss and timber partition walls forming stabling for horses at southern end of cow-shed. Looking south.

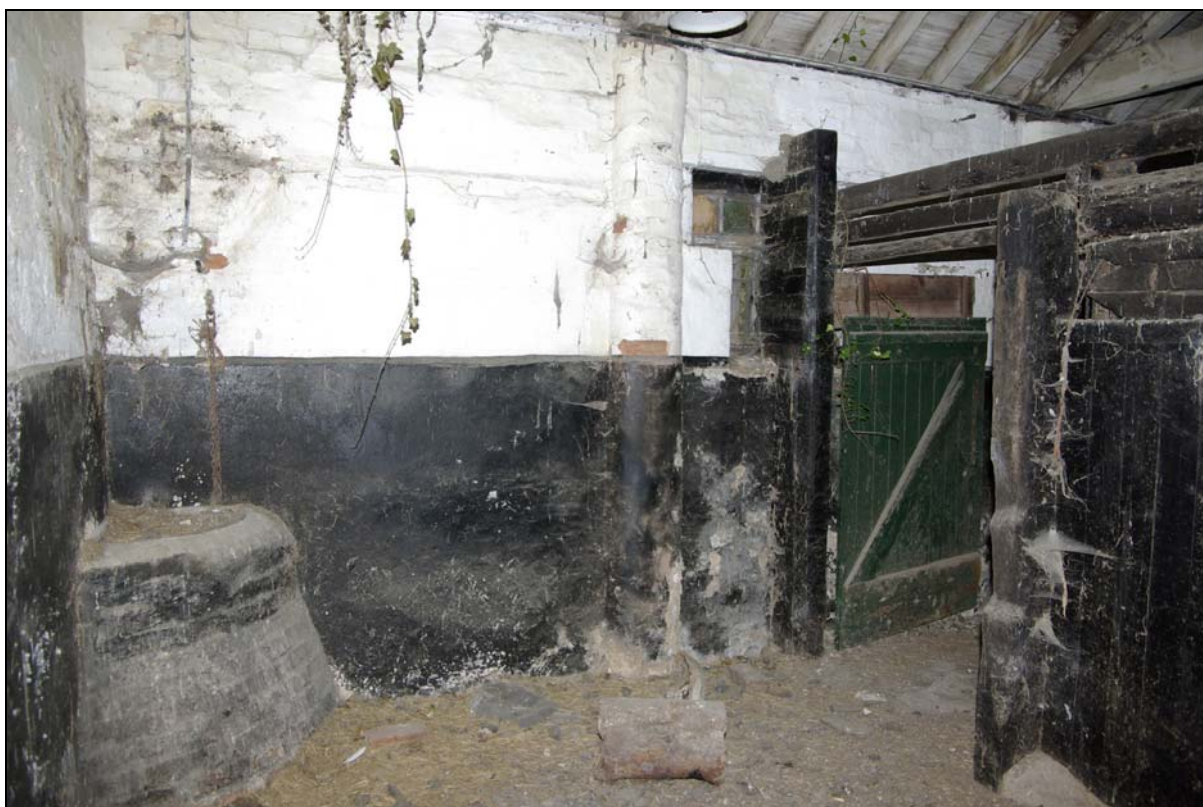
Plate 31. Brick trough in stable (cast iron hayrack removed). Looking west.

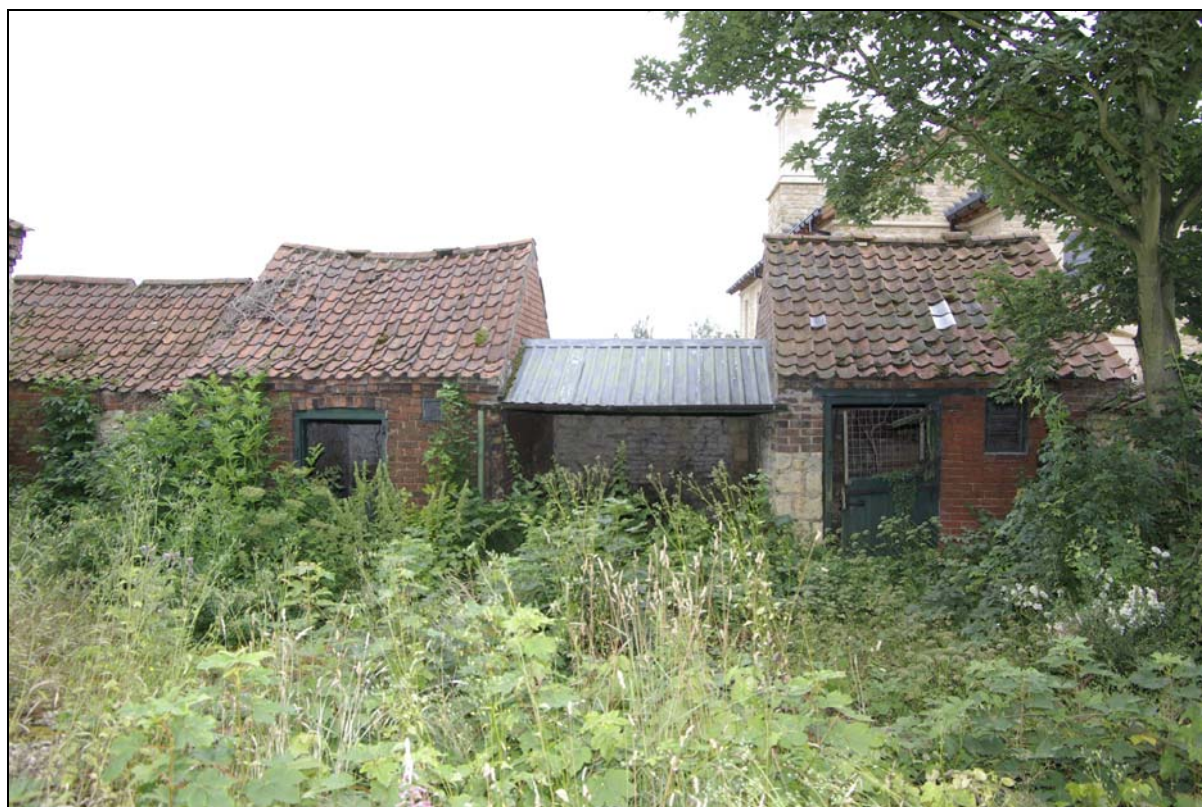
Plate 32. Brick stables with central implement shed. Looking west.

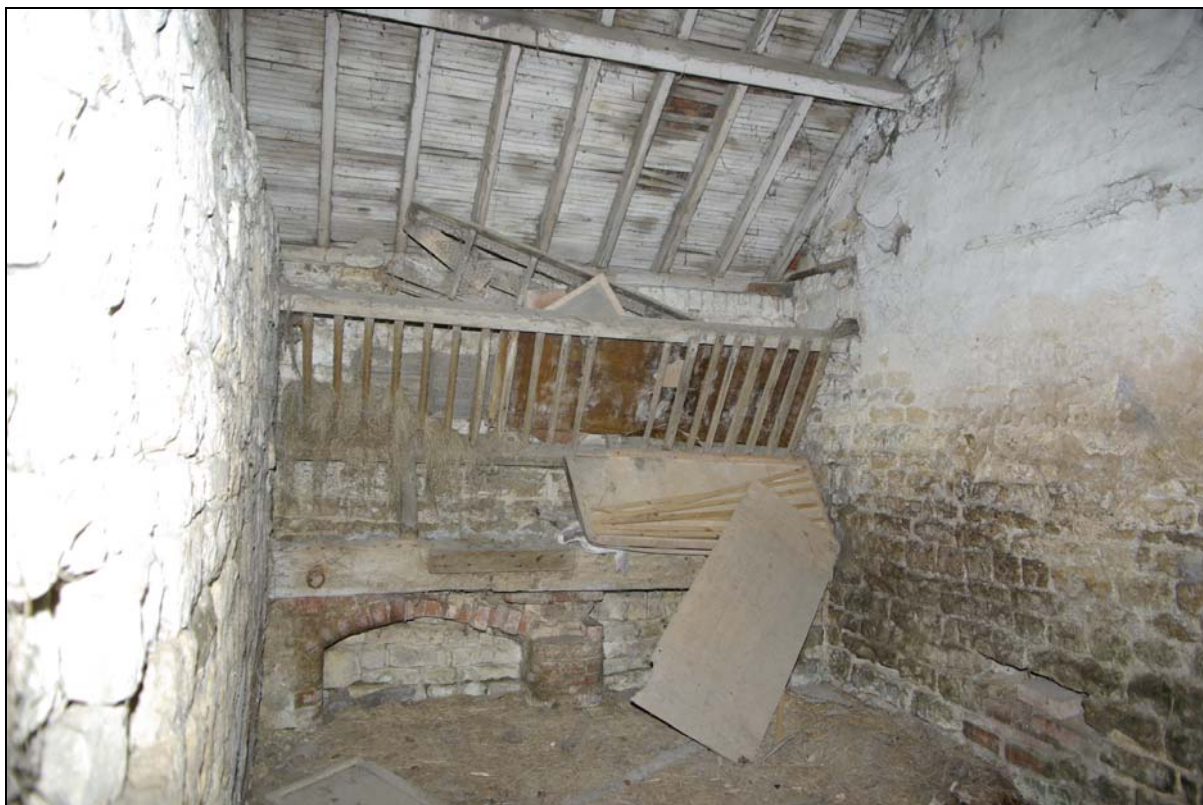
Plate 33. Stable interior, with timber hayrack. Looking west.

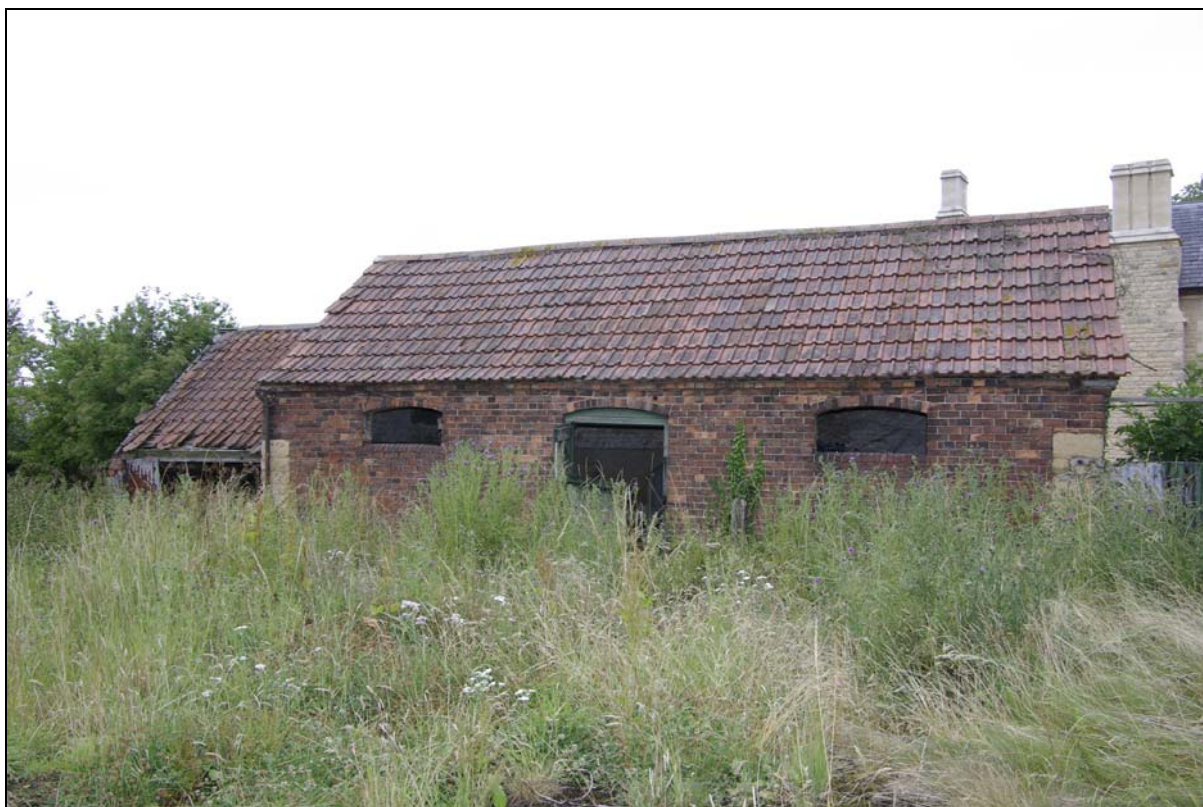
Plate 34. Brick cow-shed, located on western side of farmstead. Looking north.

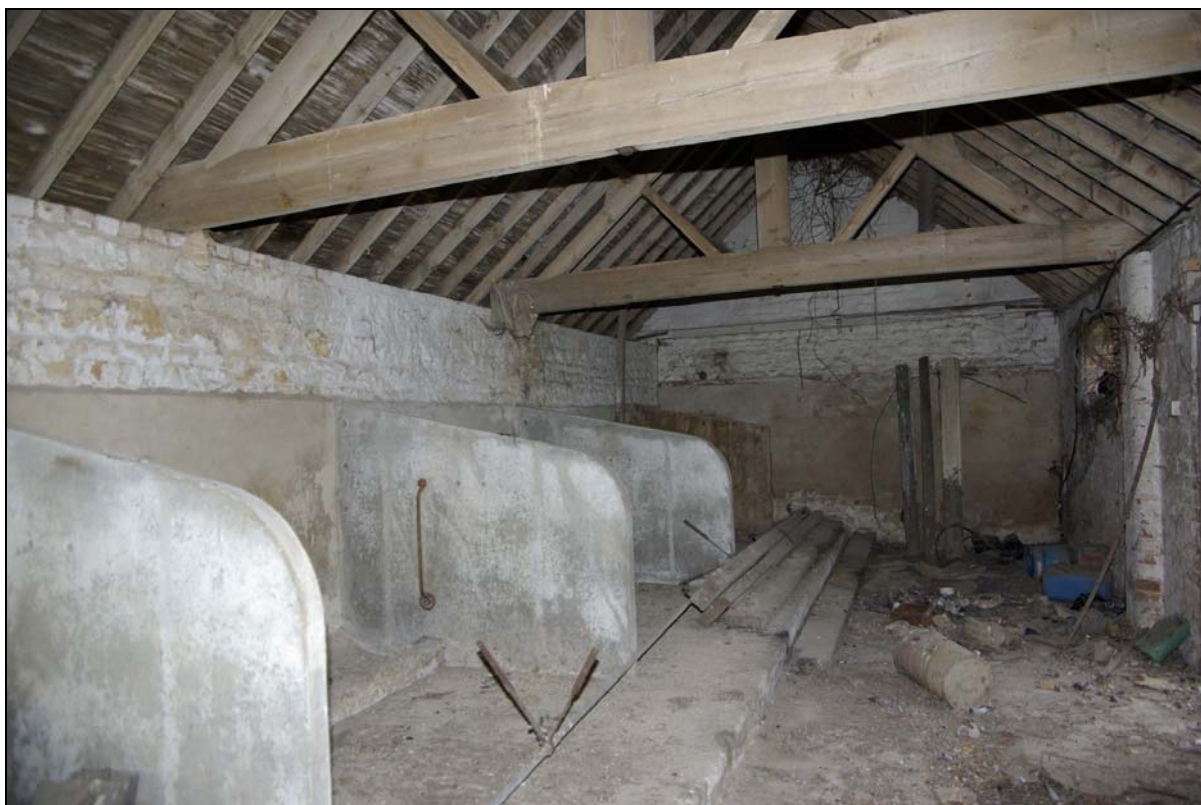
Plate 35. As above, interior. Looking east.
