**Old Star Cottage, 1, Main Street,  
Frisby-on-the-Wreake, Leicestershire:  
Historic Building Survey**

ULAS Report No 2009-173  
©2009

**Planning & Listed Building Applications: 09/00305/FUL, 09/00305/LBC**

**For: Mr J. Mensley, Country House Limited**

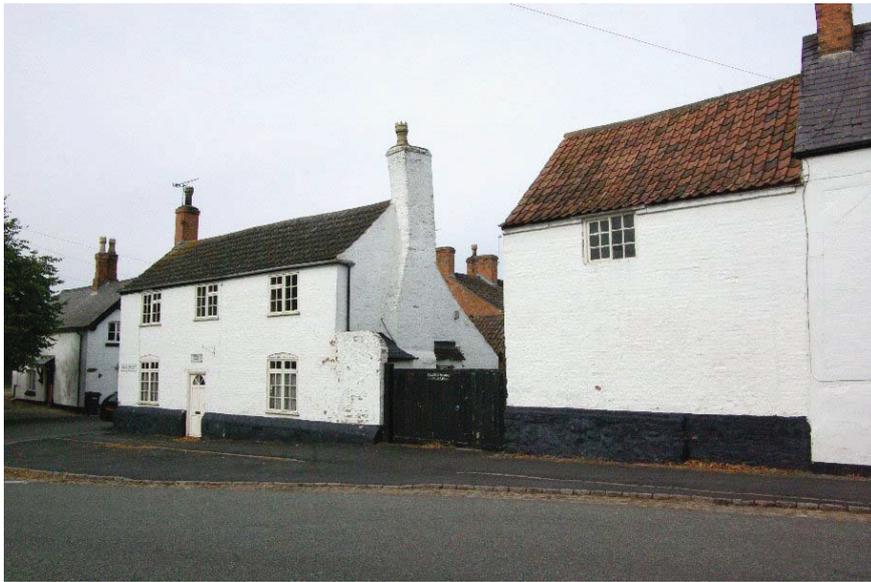
The property at 1, Main Street, Frisby-on-the-Wreake occupies a corner plot at the junction of Main Street and Water Lane (Figure 2, Photo 1). A two-storey dwelling known as Old Star Cottage occupies the Main Street frontage with an attached one and a half storey range fronting Water Lane. Beyond Old Star Cottage on the Main Street frontage is a gateway providing access to a rear yard and garden and then a two-storey former stable-block which adjoins the adjacent property, 3 Main Street. Number 3 Main Street is a grade 2 listed timber-framed building and the listing also covers the adjoining stable-block belonging to number 1 Main Street. Old Star Cottage is not listed. The property is located within the Frisby-on-the-Wreake Conservation Area. At the back of the property, a brick-built lean-to range adjoins Old Star Cottage and a brick and timber washhouse adjoins the range fronting Water Lane. In the garden there is a ruined brick-built pigsty and outside toilet. The name of the property commemorates its former function as an inn called the Old Star. There is evidence for part of the property having been used as a slaughterhouse and butchery at one time.

Photo 1. Main Street elevation of Old Star Cottage with former stable-block to right

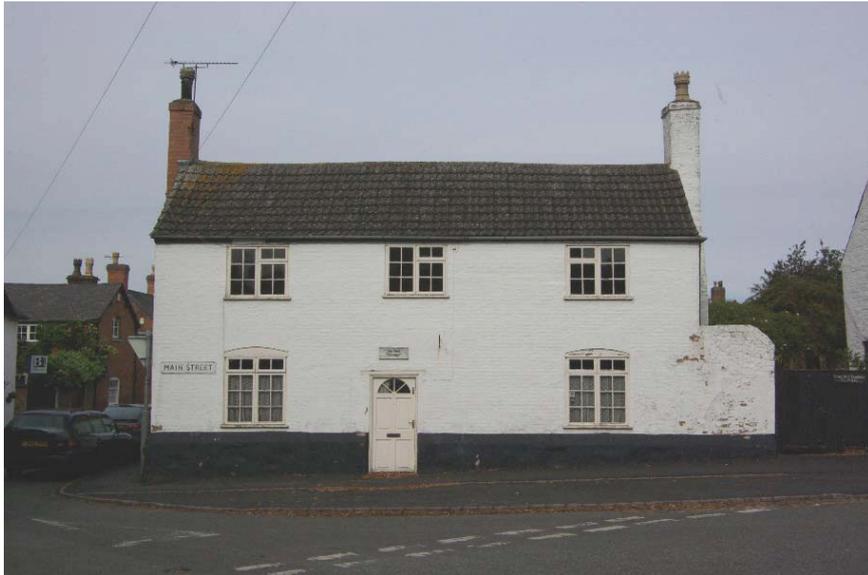
Photo 2. South elevation of Old Star Cottage

The south elevation has a near-symmetrical arrangement of openings, though the offset position of the front door upsets the balance (Photo 2). This doorway is not an original opening and there is evidence for an earlier arch-headed window, to the east of and partly truncated by the door, the position of which corresponds with the first floor window above. The other ground floor windows have similar arched heads. All window frames and the door are late 20<sup>th</sup> century in date. There is evidence for a blocked doorway with segmental arched head immediately to the west of the current door.

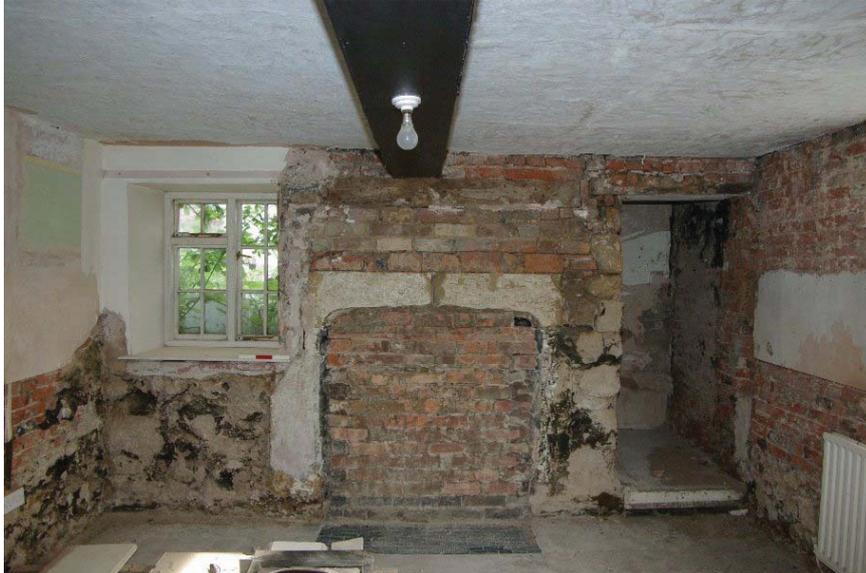
Doorways at the north end of the hallway open into the two principal rooms to the east and west and a third doorway to the north gives access to the later ranges B and C. The room to the east has in its gable wall a four-centred arched limestone fireplace (Figure 5, Photo 3). This has simple chamfered decoration and a fairly depressed arch and is broadly attributable to the 16<sup>th</sup> or 17<sup>th</sup> century; it is in a poor state of repair and had until recently been covered by a large Victorian gothic fire surround. The east gable wall appears originally to have been constructed of ironstone rubble at this level, though subsequently much altered with the insertion of a late 20<sup>th</sup> century window north of the fireplace and a doorway to its south. This doorway, which is clearly broken through the stonework of the wall, opens onto a small cupboard housed in an awkward external lean-to addition; it is possible that this was at one time an external doorway.

Photo 3. Range A ground floor east room with early fireplace, looking E

There is extensive, if fragmentary evidence of an earlier building on the site of Range A. *In situ* elements of this include the stone-built cellar, wall foundations, fireplace and chimneystack, which indicate that the earlier building occupied a similar ground plan to Range A, measuring *c.*11m long and 4.7m wide, its long axis parallel with Main Street. Since access to the cellar appears originally to have been through an opening in its north wall, this suggests the existence of a contemporary rear range of which no other evidence has survived. The four-centred arched fireplace is not closely dateable but can be broadly attributed to the sixteenth or seventeenth century.

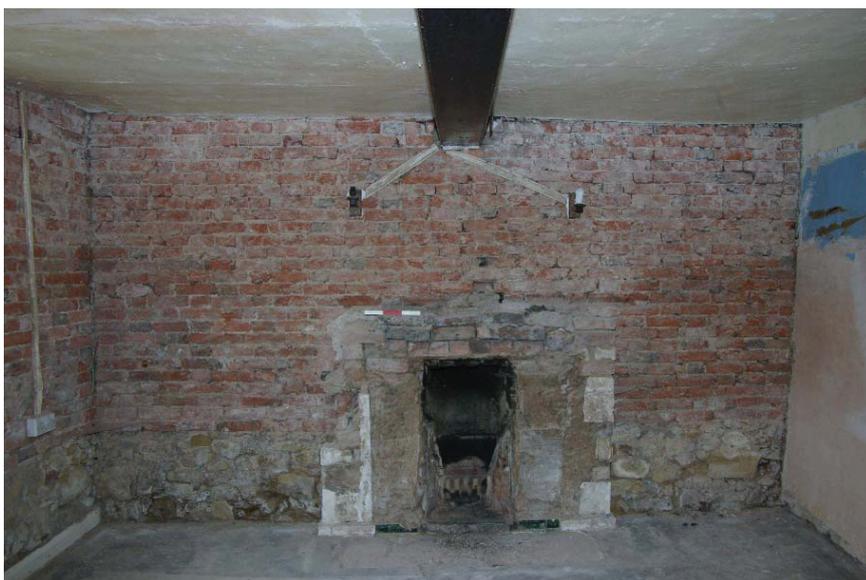
Within the room to the west of the entrance hall much of the plaster has been stripped from the walls and the blocked door in the south elevation, previously noted, is clearly visible. It is unclear whether this is an original door position or a later insertion. In the west gable wall is a poorly constructed projecting fireplace (Photo 4). The axial ceiling beam in this room is again boxed in and the ceiling underdrawn; the axial beam is not a continuation of the moulded beam fragment embedded in the wall between this and the hallway.

Photo 4. Range A ground floor west room, looking west

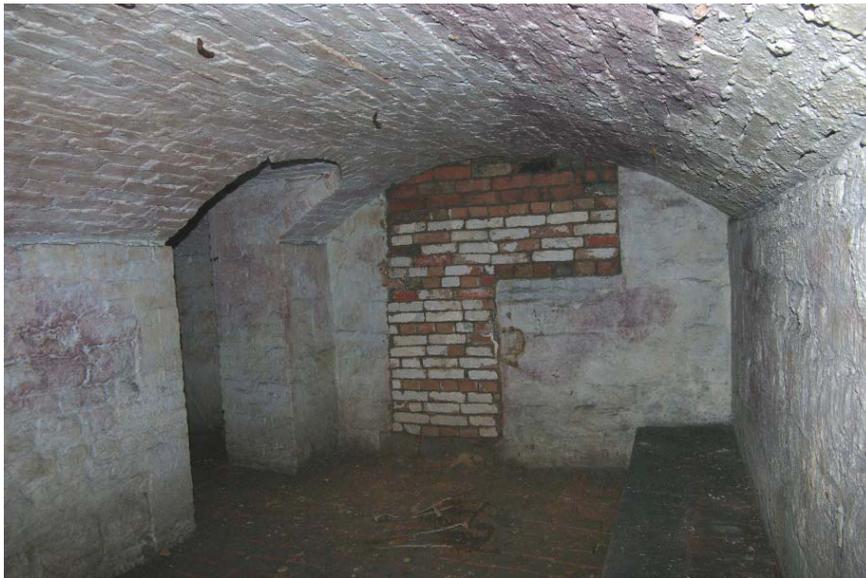
Beneath part of the east room and hallway of this range is a cellar constructed from roughly squared ironstone blocks laid to courses (Figure 4). This has a vaulted brick ceiling and the floor is paved in brick. There is a low brick thrall along the east wall. The original access to the cellar was in the north wall and is now blocked (Photo 5). The present access is via a small recess off the main room at the south end which has its own brick vault. There is another room off the main room, under the hallway, again with a brick vault and floor.

Photo 5. Range A cellar showing blocked original entrance, looking north

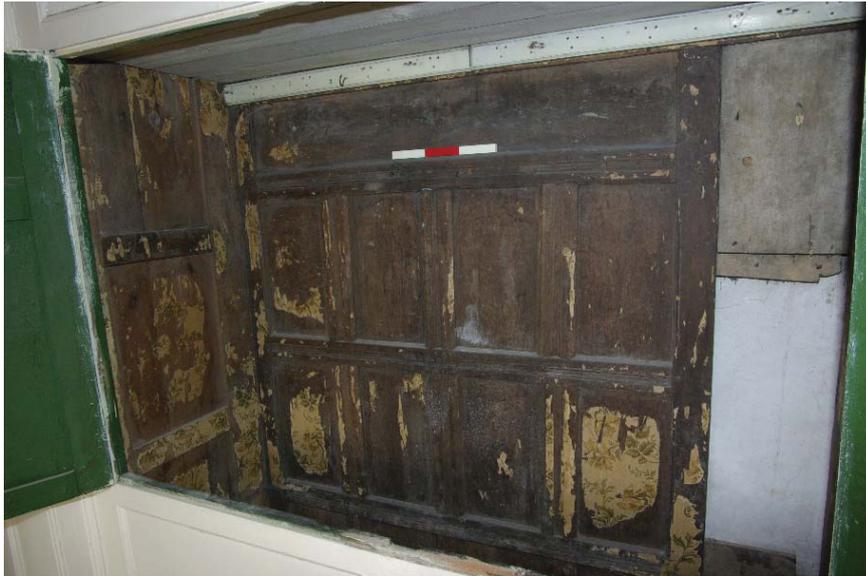
The late 20<sup>th</sup> century staircase rises to a first floor landing at the north end of which is an early fitted cupboard. This is constructed in deal with panelled doors and has a low drawer; it is in a poor state of repair with severe woodworm infestation. Forming the back of the cupboard is a section of earlier small-square oak panelling (Photo 6); this is clearly reused in its present position.

Photo 6. Range A reused panelling in landing cupboard, looking north

The reset panelling forming the back of the cupboard on the first floor landing also seems to be of seventeenth century date. Small-square panelling with plain panels was popular from the later sixteenth century until the second half of the seventeenth century, with examples in dated contexts common from 1580 to 1665. In general more elaborate mouldings tend to be earlier and the relatively plain moulding on the panelling at 1 Main Street, Frisby-on-the-Wreake (Figure 7) suggests a seventeenth century date (Hall 2005, 139-140).

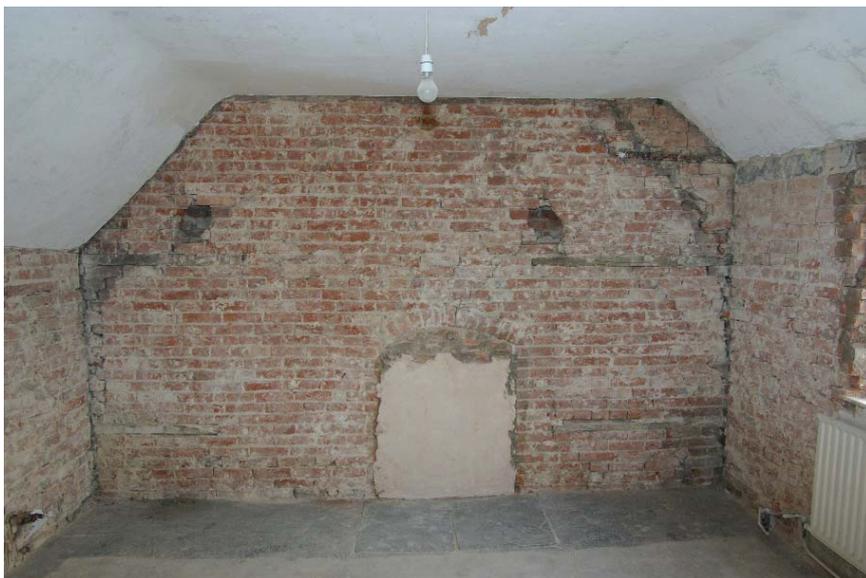
The two principal first floor rooms have 4-panelled doors with L hinges. These rooms have also been partly stripped of plaster and the scar of the original roofline is apparent in both gable walls (Figure 5; Photo 7). In the east room there is a blocked fireplace opening with segmental arch head in the gable wall. At first floor level this east gable wall is of 18<sup>th</sup> century brick. The west room was unheated. In both rooms the rough finish to the brickwork of the window reveals indicates that these have been altered and enlarged. The upper floors throughout this range are of solid gypsum or lime plaster type.

Photo 7. Range A first floor east room, looking east

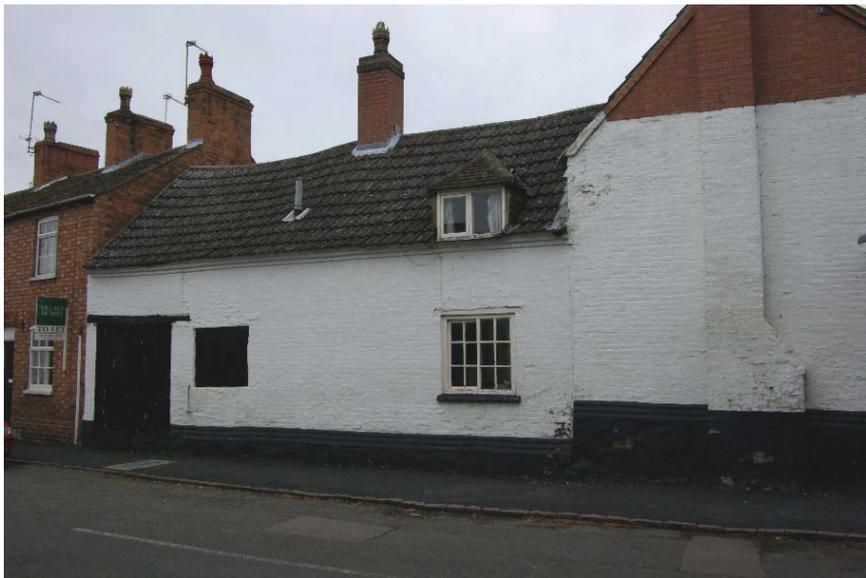
The range occupying the Water Lane frontage is a low, brick-built structure of two bays with a modern concrete tiled roof (Photo 8). The south bay is storeyed with the upper floor room lit by a gabled dormer on the front. The north bay is of a single storey open to the rafters and has a vented window and double doors opening on to Water Lane. Only the south bay was in domestic use, most recently (and probably originally) as a kitchen. Access to the ground floor room from range A is via the door at the north end of the hallway. This room is lit by a horizontal sliding sash window (Yorkshire sash) in the Water Lane elevation. A door in the east wall opens into the rear yard. The floor is nineteenth century quarry tiles. At the north end of the room is a substantial former fireplace. Exposed ceiling beams span the length of the room without intermediate support and are carried on the fireplace bressummer. Adjacent to the fireplace is a small pantry with a brick thrall. The pantry occupies the position of a blocked door which formerly gave access to the northern bay.

Photo 8. Water Lane elevation of Range B, looking north-east

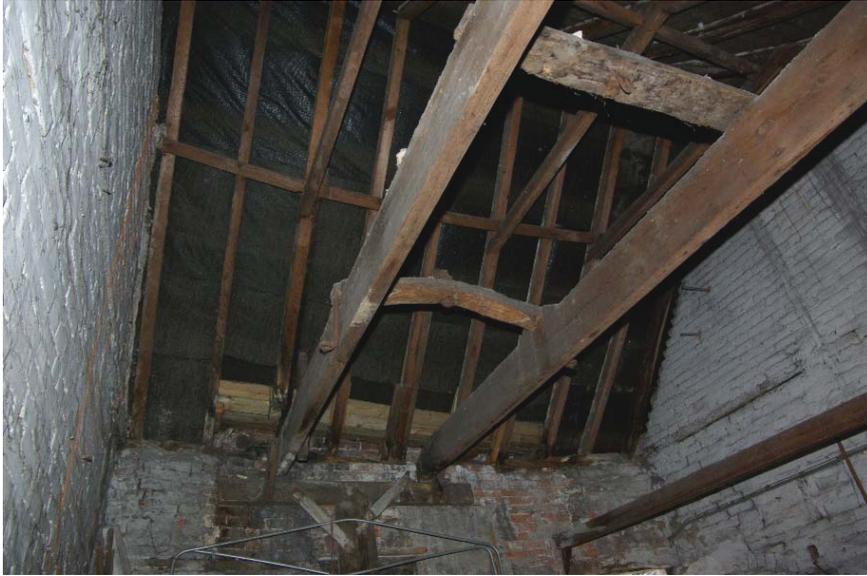
The northern bay of the Water Lane range is a former slaughterhouse. This is open to the rafters with the frame used to hang carcasses *in situ* at eaves level (Photo 9). As noted above, this area was at one time accessible directly from the room to the south, but access is now via a doorway in the east wall from the yard and the double doors in the west wall from the street. There are vented windows with sliding timber shutters in the east and west walls.

Photo 9. Interior of former slaughter house with hoist for hanging carcasses

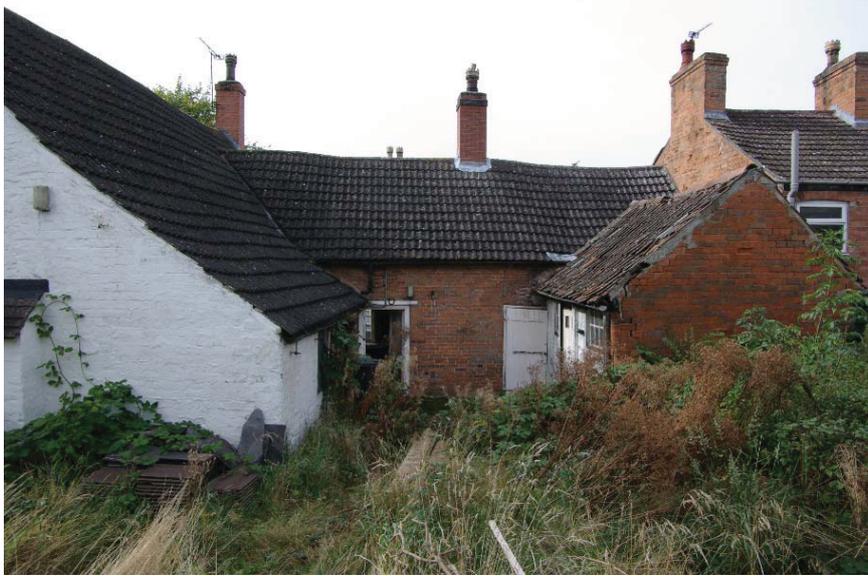
Constructed against the north wall of range A in the later 19<sup>th</sup> century is the brick-built lean-to range C. This appears to have functioned as a scullery. The room is lit by a horizontal sliding sash window in the north wall and there is also a door in this elevation, opening onto the rear yard. A lobby area at the west end of this range provides internal access to ranges A and B. There is a timber roof truss over the centre of the room, its form illustrated in Figure 5. A stepped brick plinth visible on the south side of this room marries the narrower brick-built north wall of range A to the wider stone walls of the cellar beneath. The cellar was formerly accessed from within the area of range C and there was presumably an earlier structure at this point predating the construction of this range.

Photo 10. View from yard looking west with range C to left and range D to right

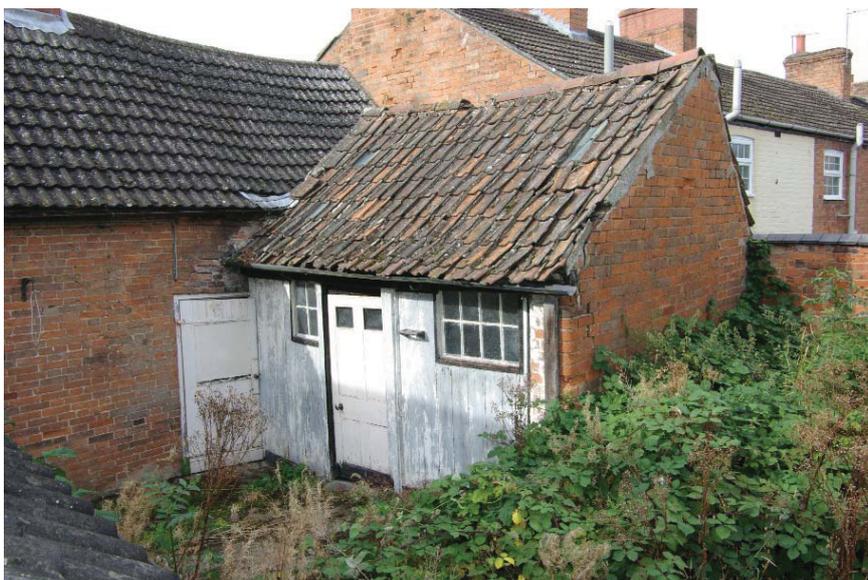
Adjoining the east side of the slaughterhouse and abutting the adjacent property to the north, number 2 Water Lane, is a former washhouse range D. The walls are brick built, except for the south wall which is of timber construction suggesting that this range may originally have been open-fronted. The washhouse is later in date than range B and is attributable to the later 19<sup>th</sup> century. The door and two fixed light windows are in the southern elevation (Photo 11). Internally there is a copper for heating water in the north-east corner. Against the west wall there is a stone sink and drainer and a water-pump (Photo 12). There is also a butcher's chopping block within this room and this area may have double as a meat preparation area, being immediately adjacent to the slaughterhouse. The roof is covered in pantiles and a number of glass pantiles provide additional light to the interior.

Photo 11. Range D washhouse exterior, looking north-west

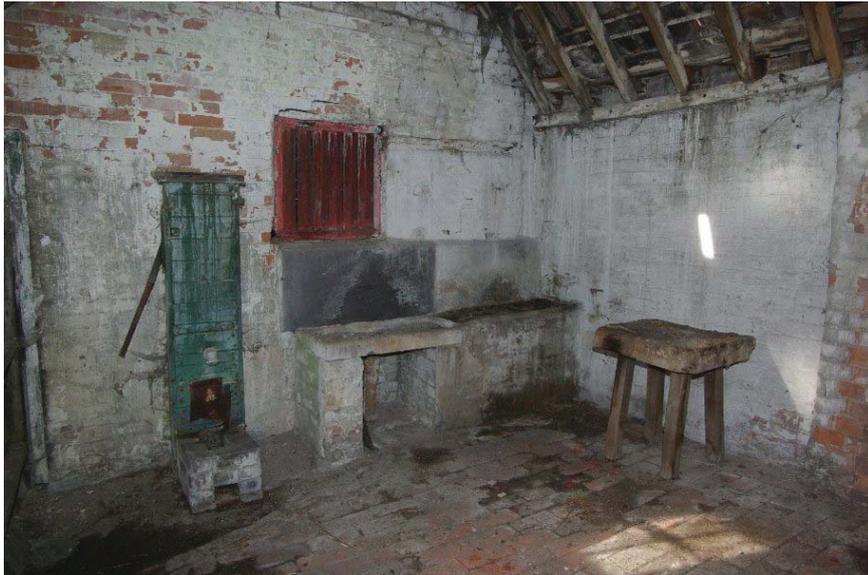
Photo 12. Range D washhouse interior, looking north-west

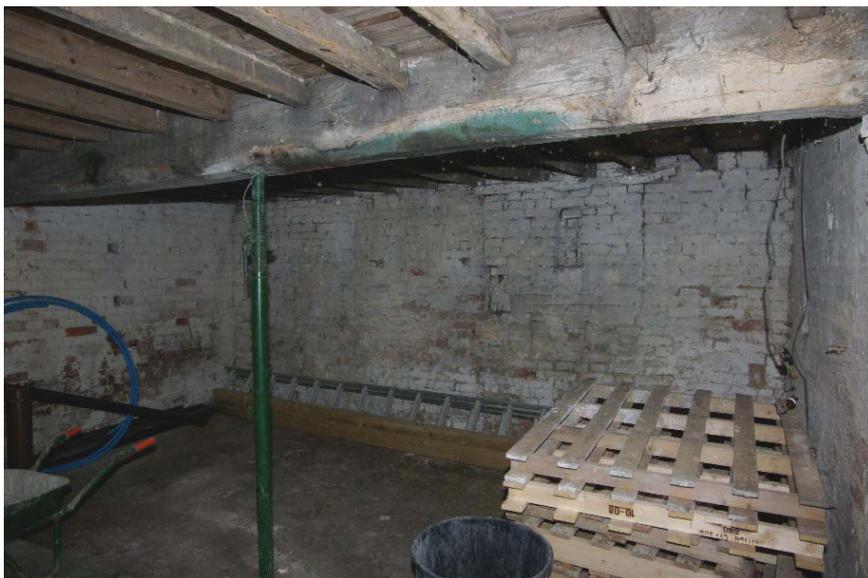
On the Main Street frontage, east of the yard entrance, is a former stable-block. This is brick-built on a rubble stone plinth with a pantile roof. It is of one bay and two storeys and abuts the adjacent timber-framed number 3 Main Street (Figure 6; Photo 1). In the white-painted Main Street elevation there are blocked door and window openings to the ground storey and an off-centre two light upper storey window below the eaves. In the west gable wall a stable door provides access to the ground floor interior. The only natural light at this level is provided by a small fixed light window in the north elevation. There is a brick-built, timber-lined trough or manger in the north-east corner. The first floor is supported by a chamfered axial beam with scroll stops at its east end, which may be reused (Photo 13).

Photo 13. Range E stable-block ground floor interior, looking south-east

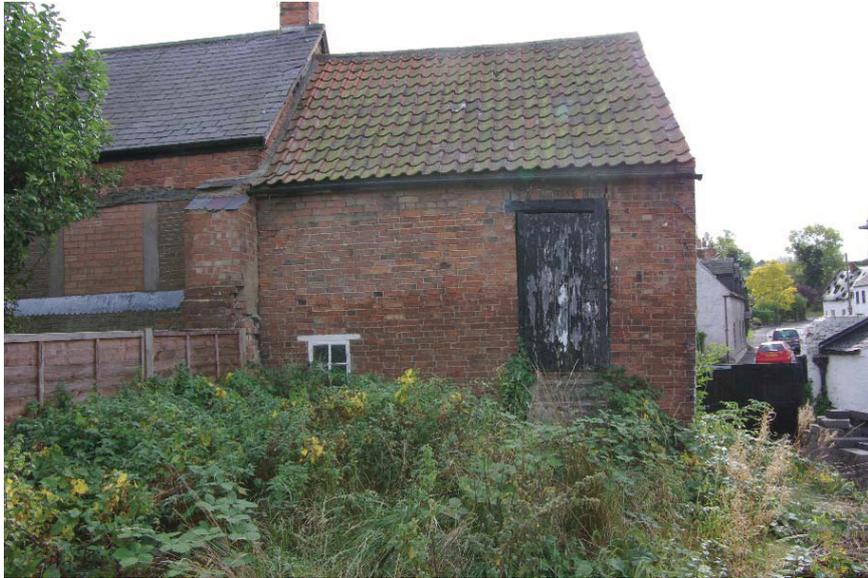
Access to the upper floor is via an external staircase on the north side, within the yard (Photo 14). The boarded first floor is in a poor state of repair, limiting access. In the north wall, east of the door, is the scar of a removed brick structure of uncertain function. The upper floor room is open to the rafters, which are modern replacement softwood items, supported on earlier roughly trimmed roundwood purlins. The only window, in the south elevation overlooking Main Street is a two-light horizontal sliding sash.

Photo 14. Range E stable-block north elevation and first floor access, looking south

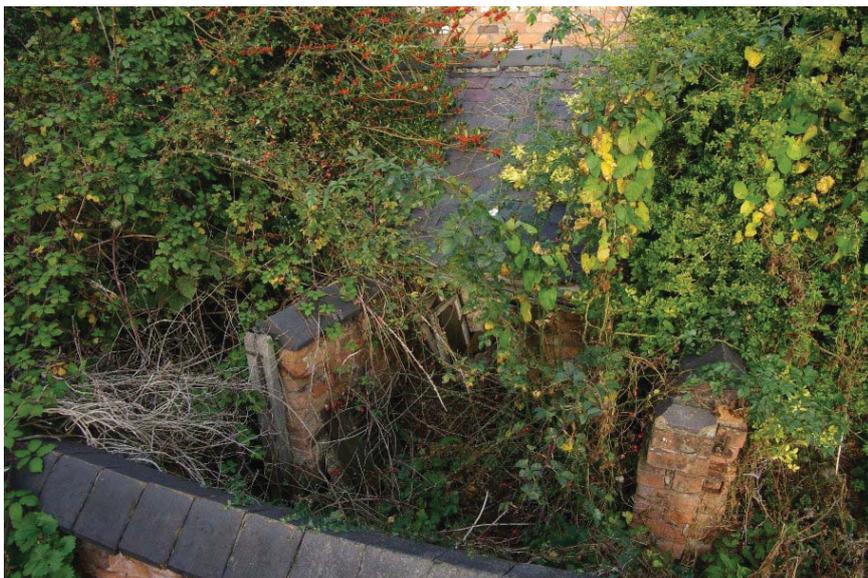
In the garden to the rear of the property are a brick-built and slate roofed pigsty and an adjacent walled yard of late 19<sup>th</sup> century date (Photo 15). There is also an outside toilet. These structures are in a poor state of repair and largely overgrown.

Photo 15. Pigsty in rear yard, looking north-east

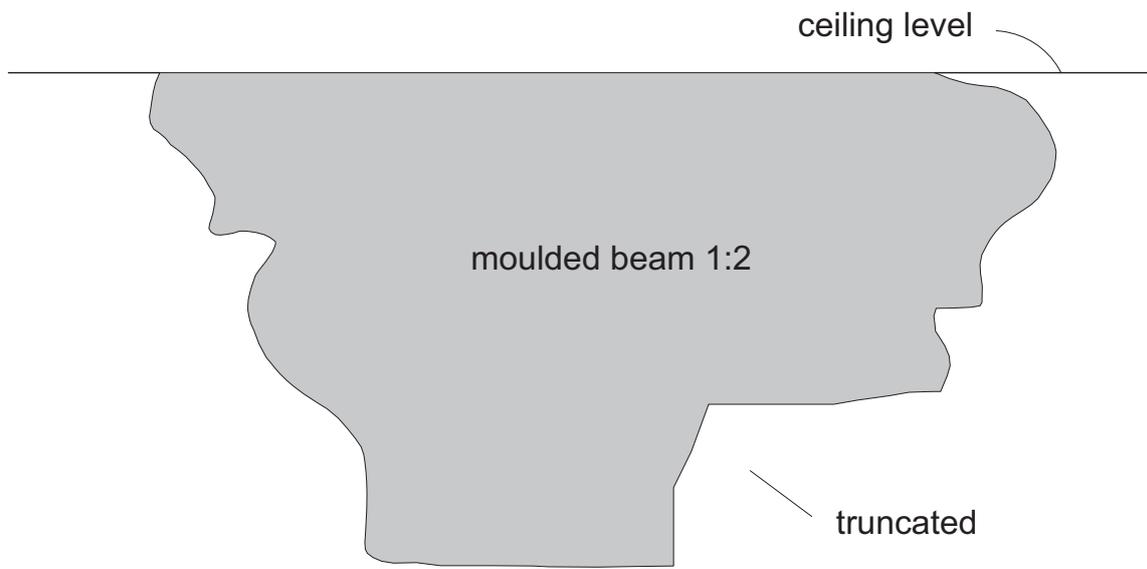
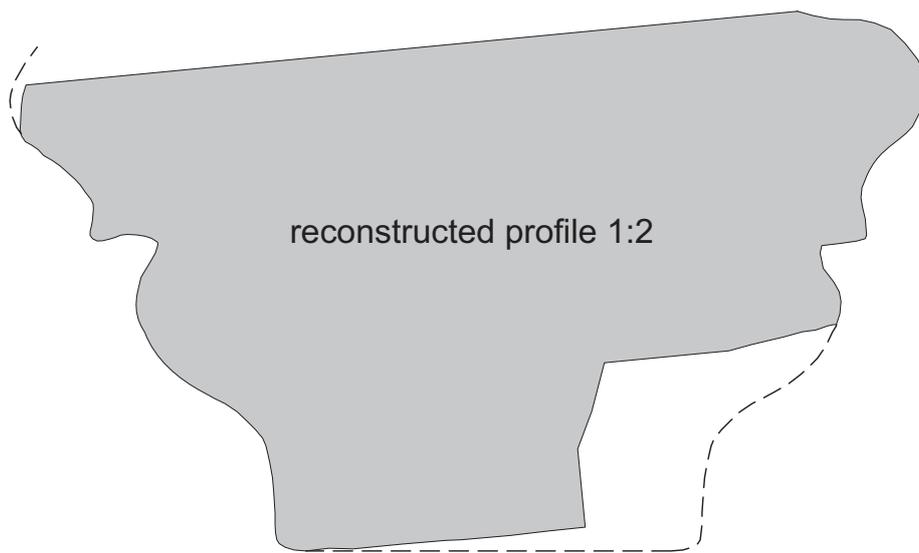
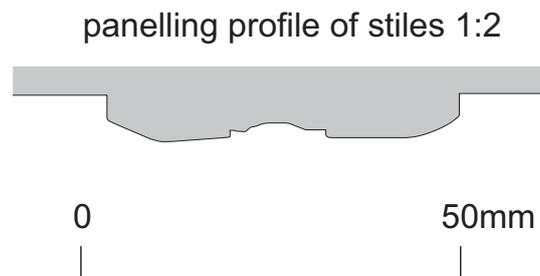
FIGURE 7. OLD STAR COTTAGE, 1 MAIN STREET, FRISBY-ON-THE-WREAKE : Moulded Beam (above) and panelling (below) scale 1:2

The front door opens into a central hallway which has a late 20<sup>th</sup> century timber staircase rising to the first floor. Access to the cellar is from the hallway via a very narrow opening beneath the stairs; this is not the original cellar entrance (see below). Embedded in the west wall of the hallway, at ceiling height, is the truncated remnant of an oak beam with an ogee moulding; it is unclear whether this is an *in situ* timber or is reused in this position (Figure 7).

The moulded beam fragment embedded in the wall between the hallway and western room of Range A may be more diagnostic. Double ogee mouldings have a wide period of use however single ogee mouldings are rarely used on beams before the seventeenth century, with most belonging to the period 1630-1700 (Hall 2005, 157-8). The truncated state of the beam fragment makes it difficult to reconstruct its original profile with confidence (see Figure 7), however it most closely resembles seventeenth century examples illustrated by Hall (*ibid.*, Figure 6.9).
