**An Archaeological Historic
Building Assessment for
The Laundry, Belvoir Castle,
Belvoir, Leicestershire.
NGR: SK 823 338**

ULAS Report No. 2009-171
©2009

For: The Duchess of Rutland

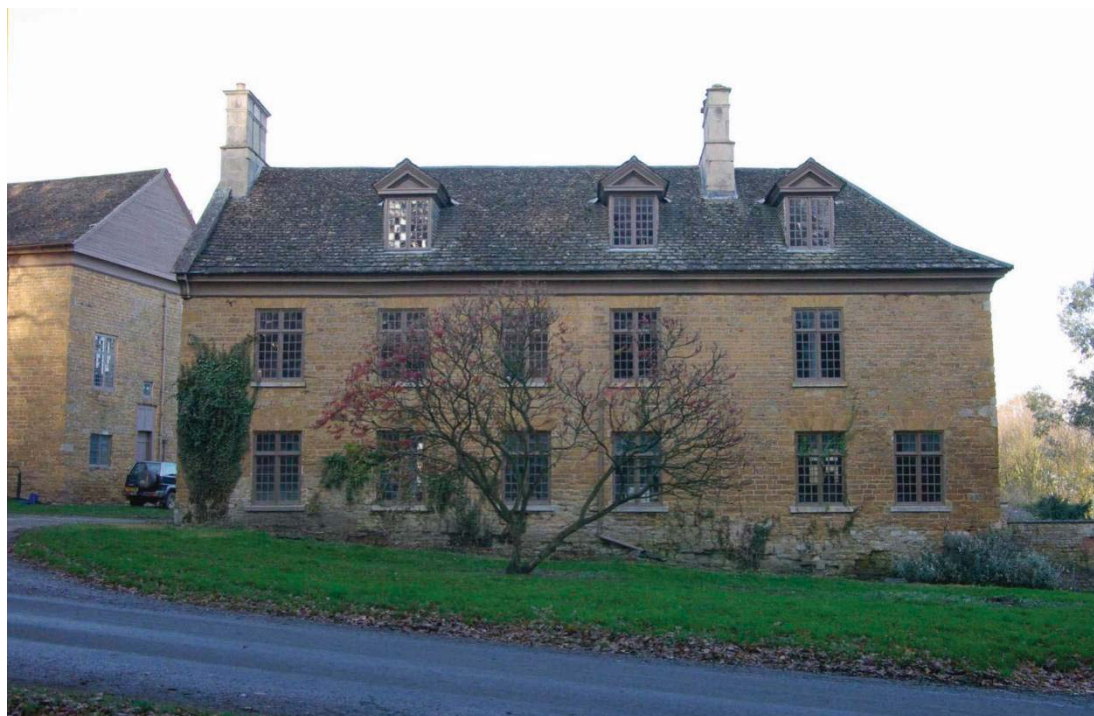
The south-west elevation is the main face of the building as it faces towards the castle and a road which leads around the estate. The ironstone elevation has six bays that are irregularly spaced due to the presence of a thick internal wall and chimney stack located on the western side of the north-east to south-west wing (fig. 6). There are six wooden framed casement windows on the ground floor and five on the first floor with a missing window, which does not appear to have been blocked, at the eastern end. The windows are of the same size and design as on the main north-east elevation of the building. The roof is pierced by three dormer windows above bays 2, 4 and 5 which have deeply recessed pediments of similar design to those seen on the nearby Main Stables. Brown slates, which could be Collywestern, are attached to the sides of the dormers. The whole of this elevation has been pointed with modern hard mortar which stands proud of the stonework and is causing the stone to corrode.

Figure 6 South-west elevation
Looking north-east

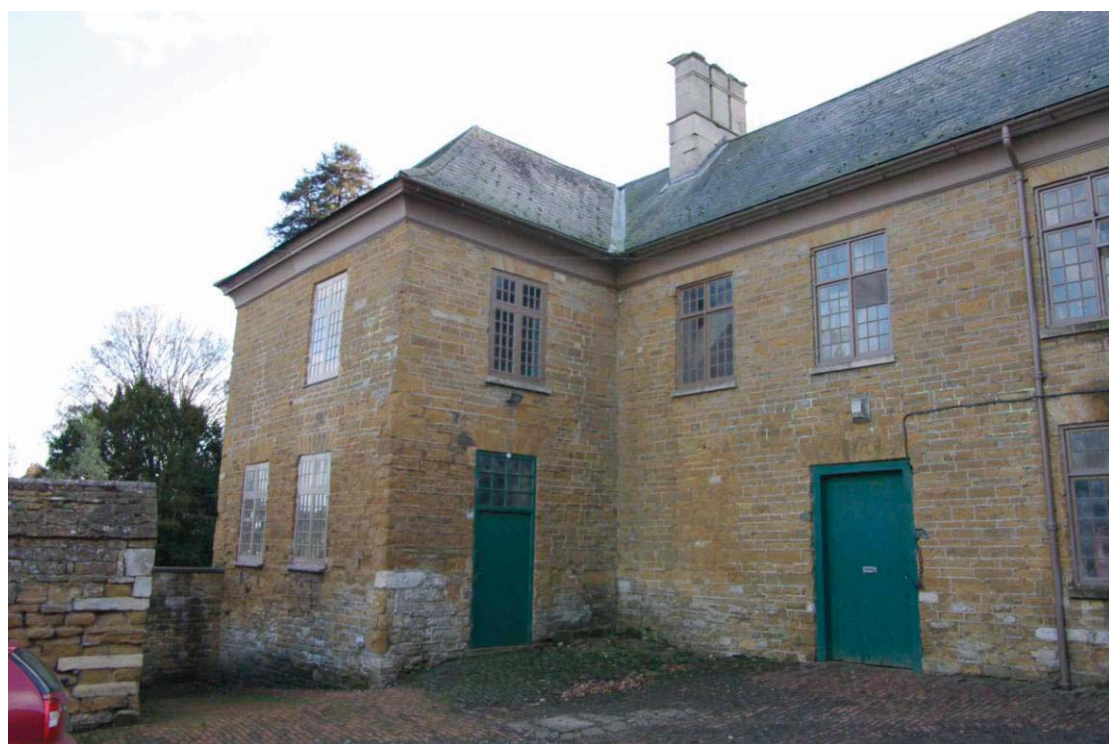
The north-west facing corner of the north-east to south-west wing has a wooden plank and batten door with a rectangular glazed panel above it. The first floor window has a limestone sill but the casements are flush with the frame which is not the case with the main building windows (fig. 7). The two bays of the wing also have flush windows but these have wooden sills. There is only a single window at first floor height.

Figure 7 North-east to south-west wing. North-eastern elevation
Looking south

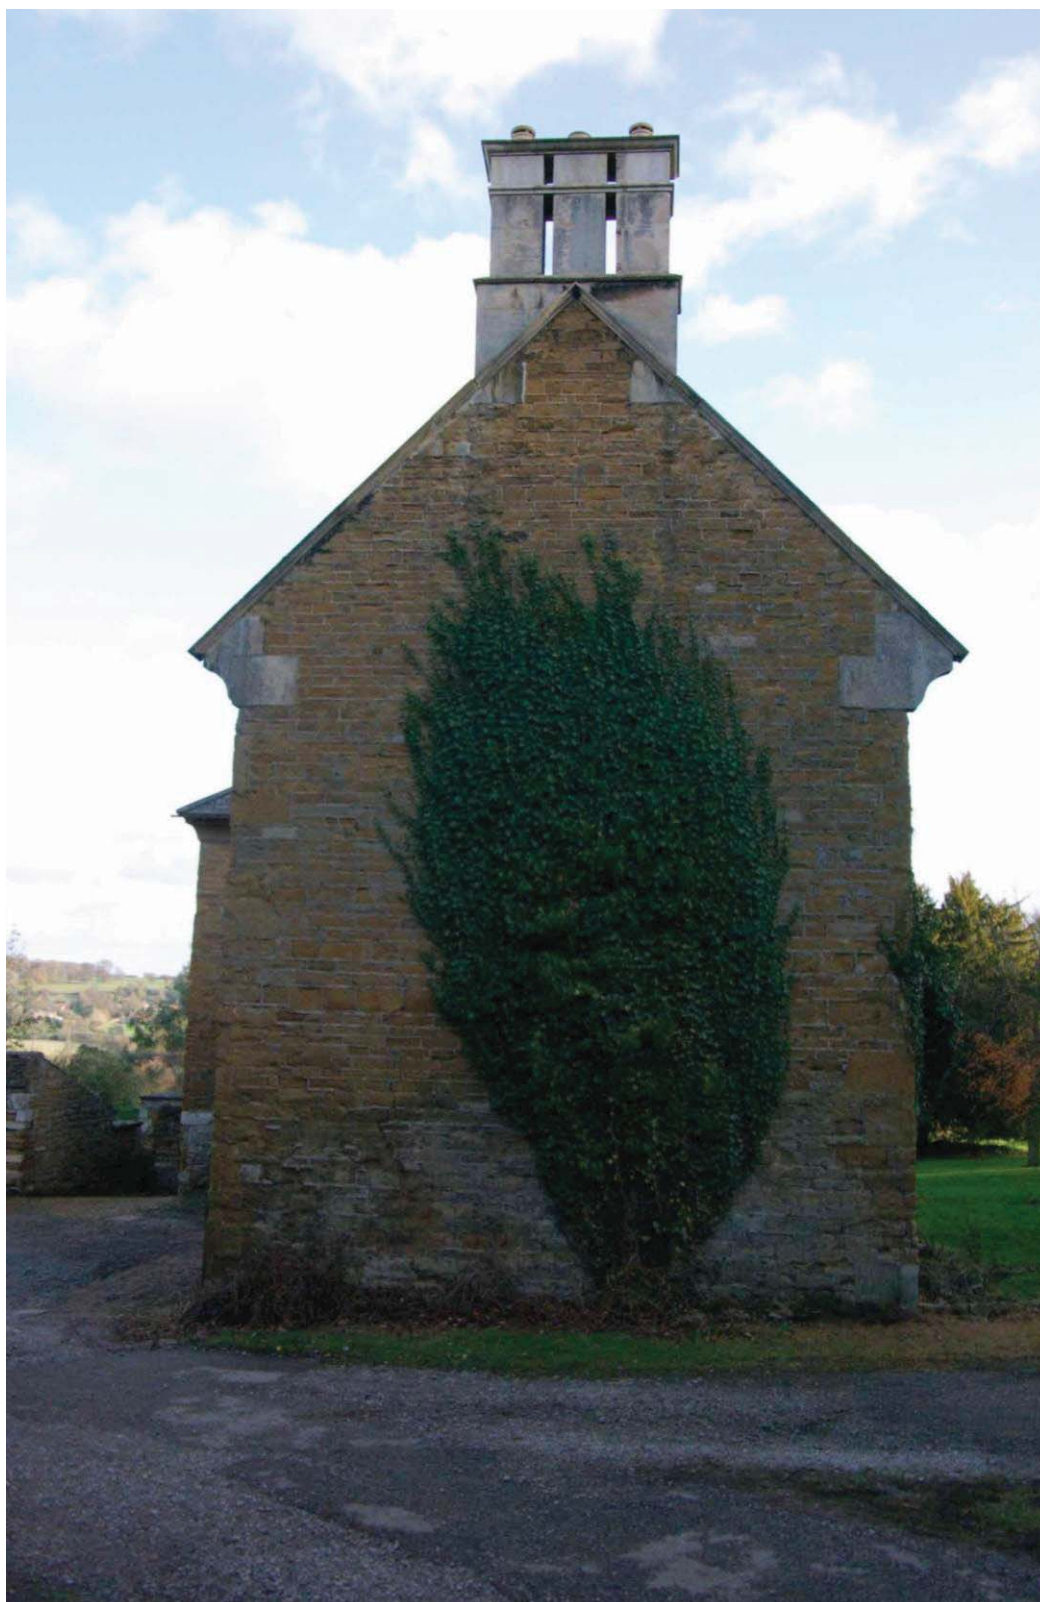
The gable end appears to be as originally constructed with no later modifications. Dressed limestone blocks support the eaves and chimney (fig. 8).

Figure 8 North-west gable end elevation
Looking south-east

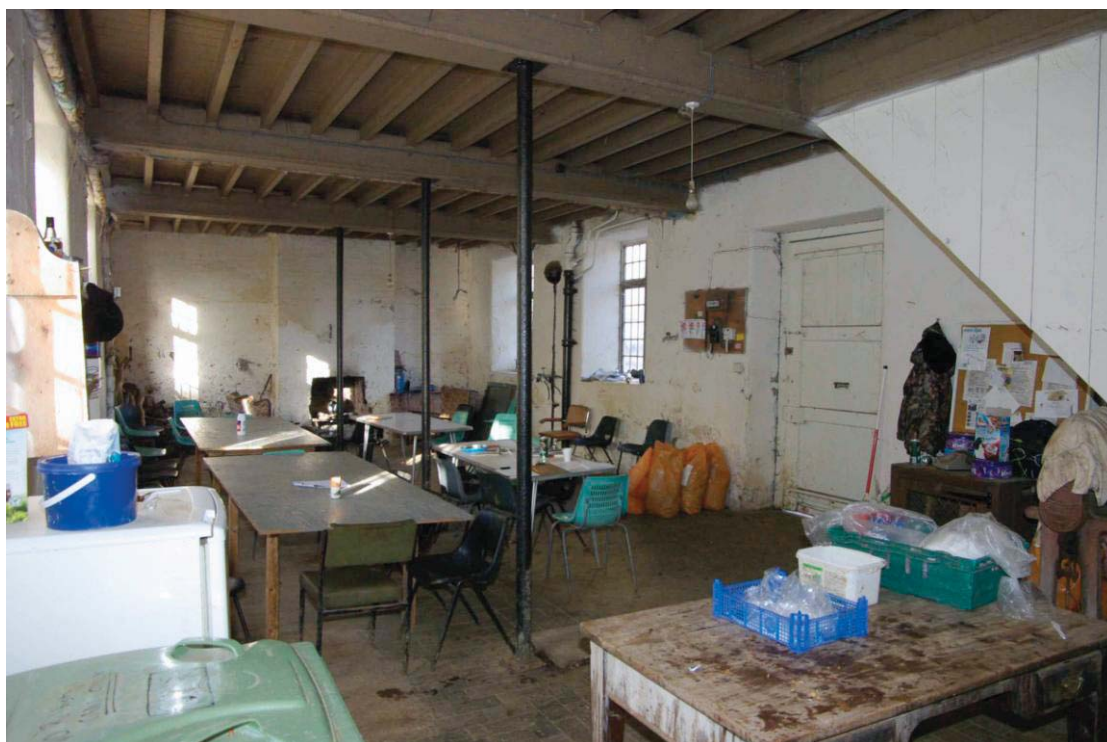
smaller kitchen across the western end. Three large stop-chamfered beams run from north-east to south-west across the room and are supported by three 75mm (3 inch) diameter cast iron columns. The columns are badly corroded possibly indicating that the atmosphere in the room has been quite damp, which is consistent with it having been a laundry. These do not appear to be original as they have been wedged between the beams and floor rather than properly fitted. Two additional shorter wooden beams run across to the base of the stairs. The floor joists are lap jointed onto the tops of the beams and support the beaded floor boards (fig. 11). Running along each long wall are a series of inverted boxes set into the ceiling (see fig. 11). There are two of these on the north side and four on the south. It is not clear what these were for but in the floor on the first floor it can be seen that a circular attachment has been removed and the hole blanked off with a piece of flat metal (fig.12). The floor is laid with blue bricks, measuring 235mm by 115mm, with a drainage channel running down the centre leading to a covered drain. A modern sewage pipe has cut through this floor on the western side of the room. A large stone slab covers what appears to be a well near to the south-eastern corner of the room. Extending a hand-tape through a small hole in this cover indicates that there is water approximately 2m below floor level.

Figure 9 Ground floor
Looking north-west

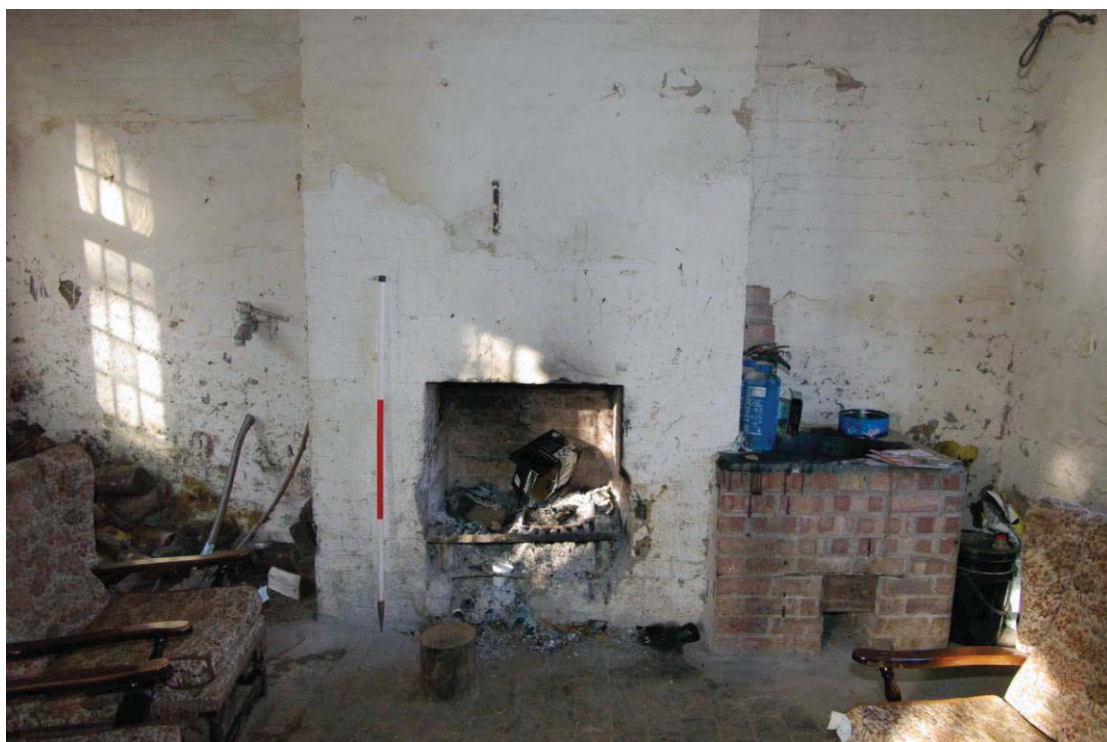
A chimney breast is located on the western gable end and is constructed of whitewashed bricks measuring 235mm long by 75mm high by 125mm deep (fig. 13). The same sized bricks are also used as the internal skin of this end wall. The fireplace is in a fairly poor condition and the stove or grate has been removed leaving a rough hole. A large stone above the fireplace has three incised circles each of 85mm diameter in what seems likely to be an apotropaic mark (fig. 14). To the side of the fireplace is a copper built from modern bricks which must date from the second half of the 20th century although a small grate and ashpan built into the base appear to be earlier. A large angular tap is attached to the wall to the south-west of the chimney breast (fig. 15).

Figure 13 Ground floor fireplace and copper
Looking north-west. 1.5m scale

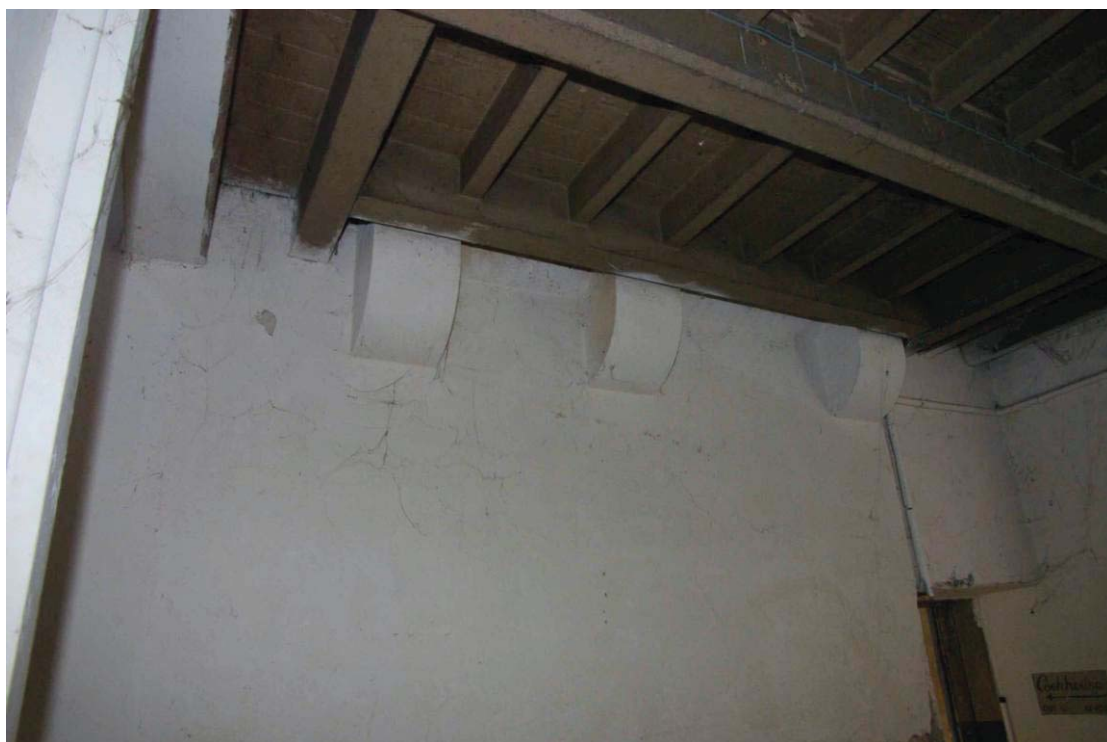
The eastern end wall has three irregularly spaced corbels at ceiling height supporting a projecting fireplace and chimney stack on the floor above (fig. 23). A single

Figure 23 Ground floor, corbels on east wall
Looking south

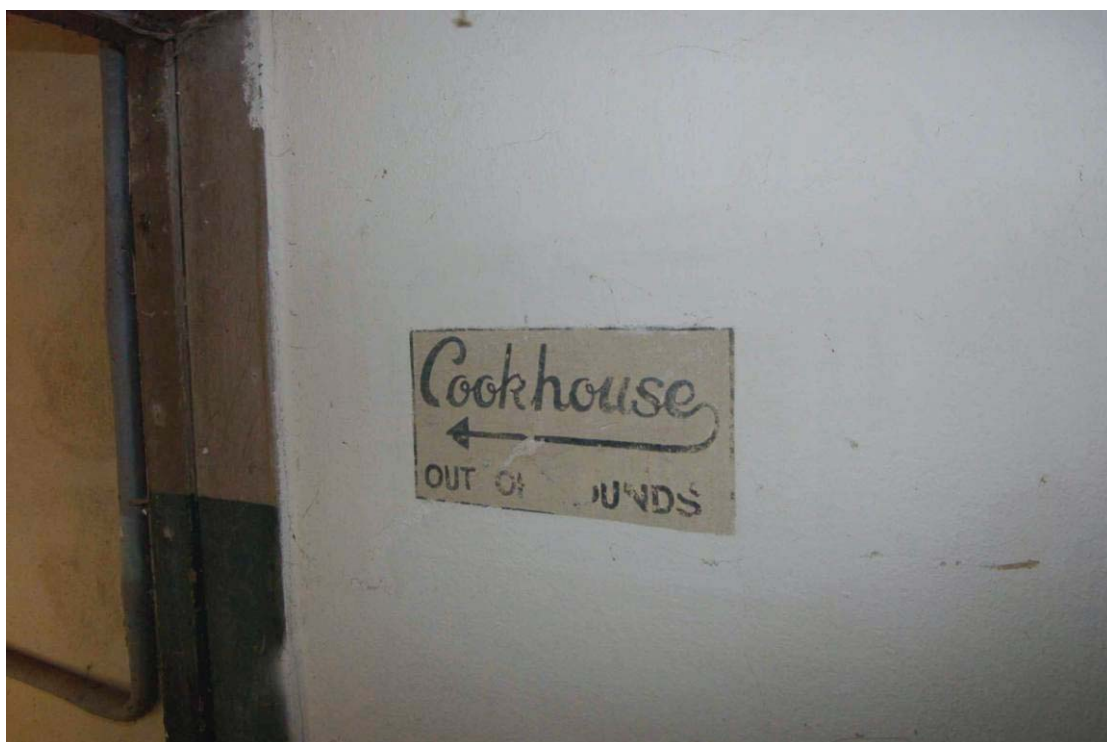
Apart from the four windows the south-western wall is plain plaster with no evidence of any fittings or modifications. Of note however is a painted sign at the side of the connecting door into the north-east to south-west wing. This is an old sign which has been painted around rather than over and points towards the *Cookhouse* which is *out of bounds* (fig. 24).

Figure 24 Ground floor, painted sign

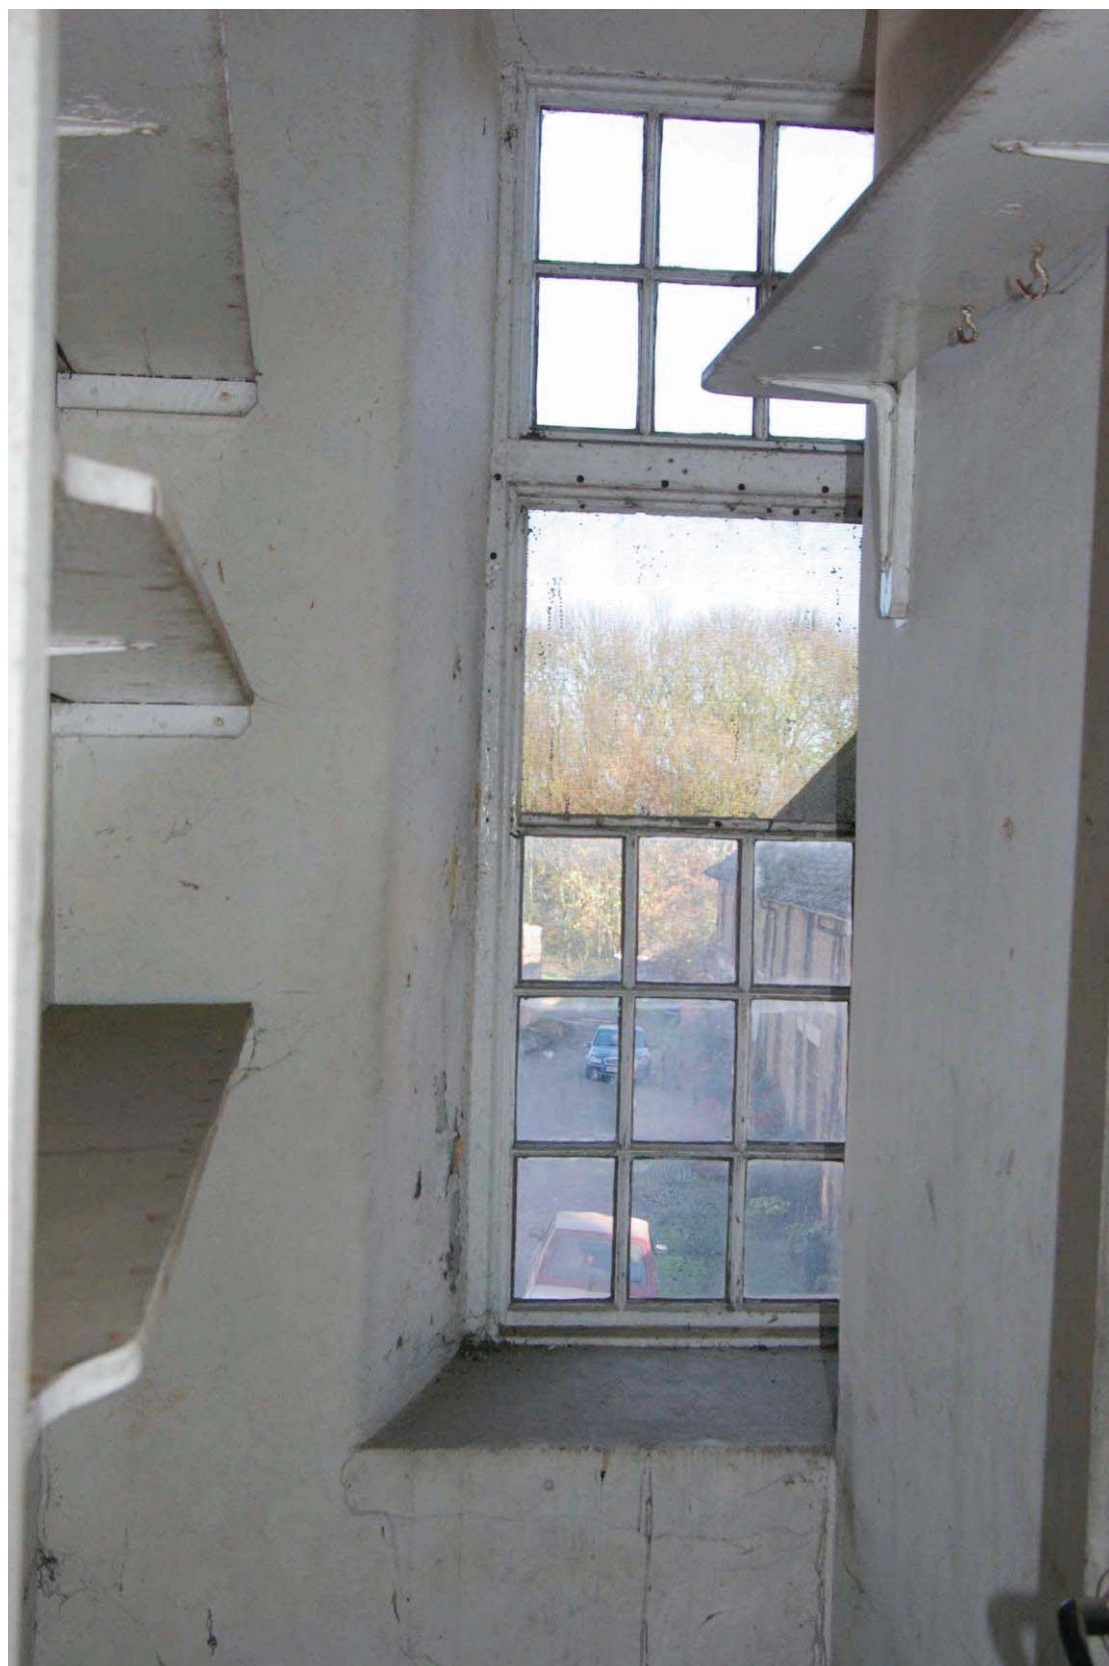
Figure 29 First floor, store room showing inserted wall across window
Looking north-east

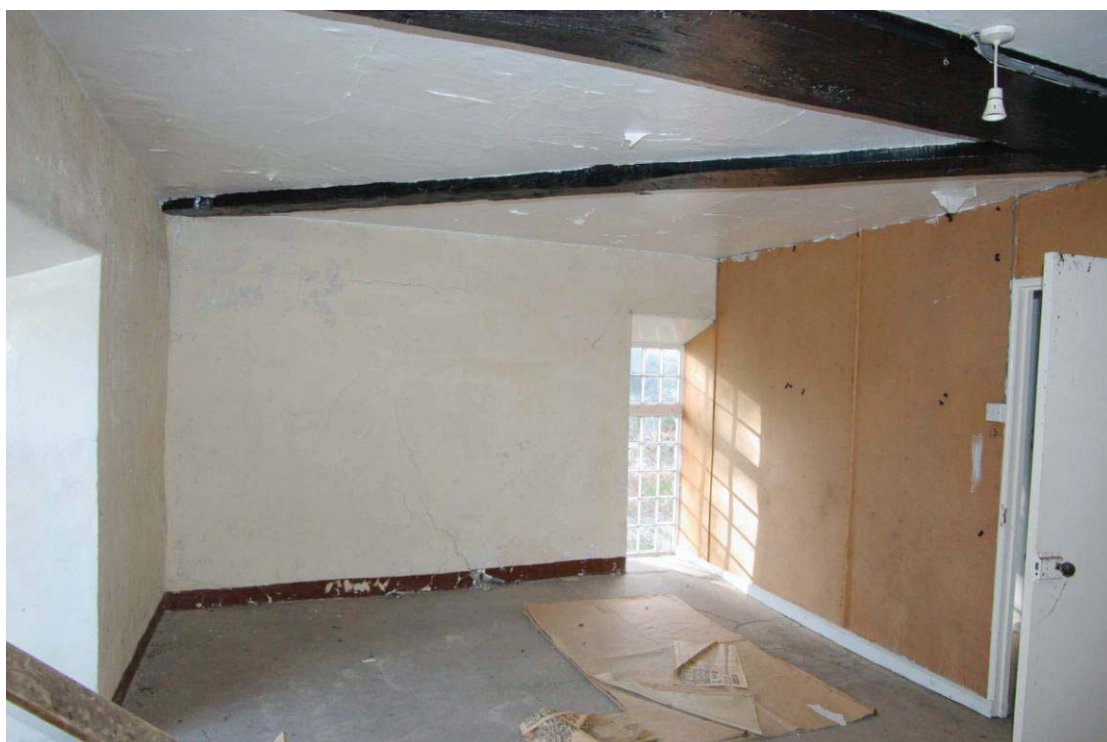
Figure 38 North-east to south-west wing, southern room and inserted wall
Looking west
